EXPERIENCES IN THE STABILIZATION OF A LARGE GULLY AT SPRINGS AREA PROPERTY FROM AGUA MINALBA VENEZUELA.

Keywords: gully, bioengineering, erosion, embankments.

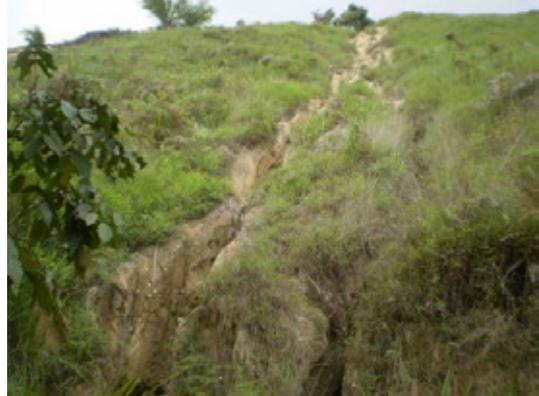
Photo 2: Gully in the beginning (2.006)

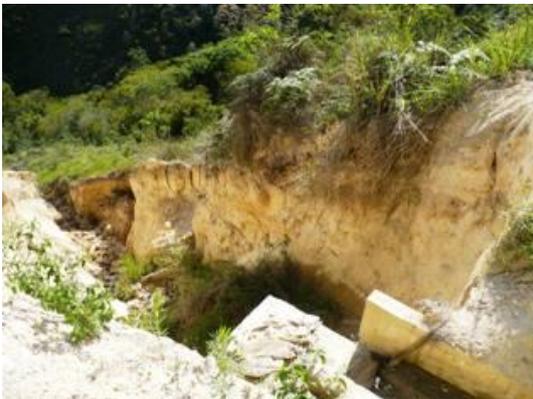
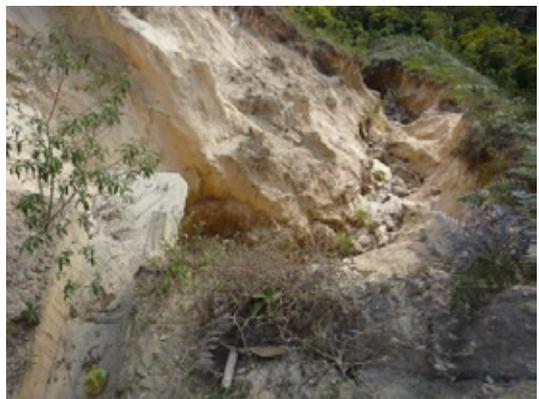
Photos 3 y 4 State of the gully in May 2009, before applying VS

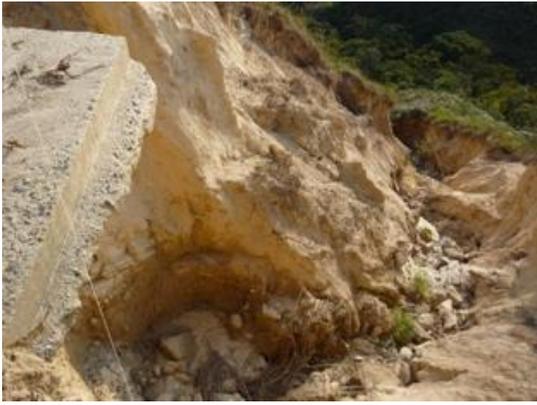
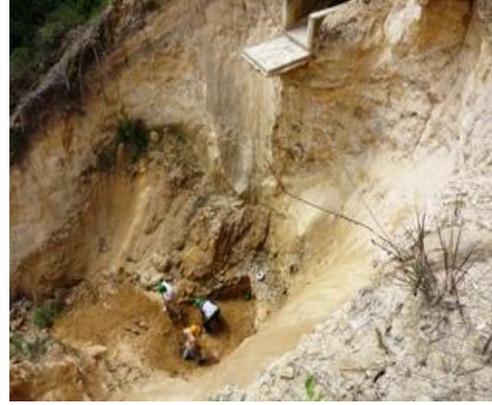
The soils of the area where the gully is located are sandy loam, containing 65% sand, 29% silt and 6% clay. The soil erodibility caused the gully to progress from 6.00 meters to 10.2 meters (pictures 5 and 6).

Photos 5 and 6: The depth reached by the gully. The size of the people serves as a reference (Aug. 2009)

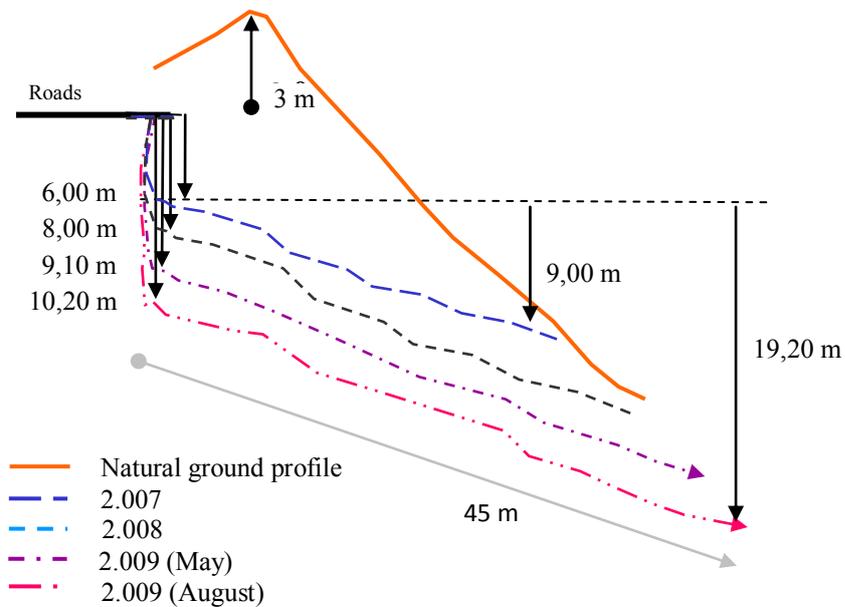
Erosion caused a difference in height of 4.2 meters in just 3 years of monitoring, as shown in the curves of Figure 1, while on the slopes outlined irregular shapes that became in some cases vertical. Some areas showed fractured soil blocks.

Figure 1: Curves of annual erosion

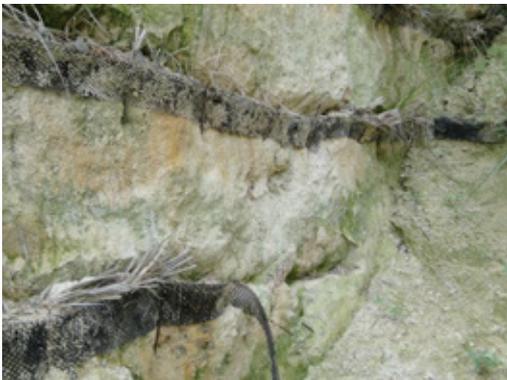
Rains during 2010 season were abundant, in fact, the beginning preceded one month the historical cycle, and they caused mudslides in areas close to where the gully is located. However, it was not observed the reactivation of erosion in areas previously treated with vetiver, except in small areas on the walls of the slopes where it had not been a good development for the time (photos 15 and 16).

Foto 15: Failure observed in fatigues

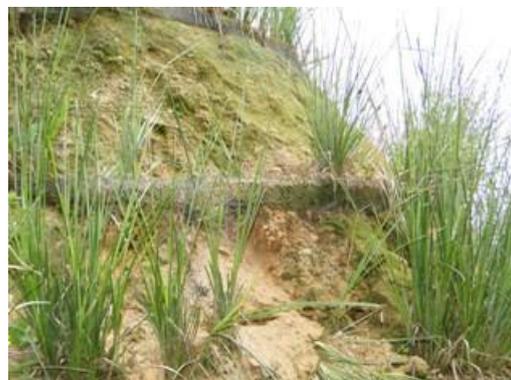
Foto 16: Material retained by the barrier shot lower

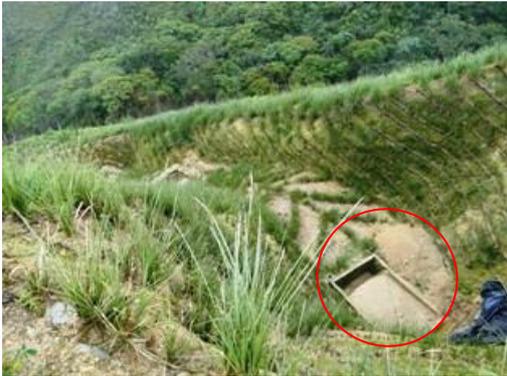
The drainage system worked well from July 2010 (when it was given full access to the water) and May 2011. During this period heavy rains occurred in the months of November and December (2010) and the beginning of May 2011 which caused damage to surrounding areas, but the system worked well. Notably, during the construction phase of the road drainage channel, made by another company, all the sediments from the excavation were overturned in the receiver tanquilla and some barriers of vetiver, without later remotion (Photo 17). Moreover, the slope on the front (photo 18)

Foto 17: Sand deposited in the recipient tanquilla. vetiver barriers are seen covered (October 2010)

- Repair the drainage system.
- Use rigid pipe with a high roughness index, the more effective diameter and length not exceeding 6 meters.
- Replace the 16 lines HDPE Hose 4 "by 2 rigid pipe 16."
- Set the final drainage system, with both dissipation tanquillas built in reinforced concrete.

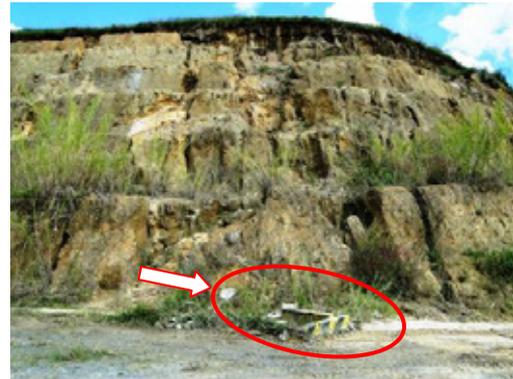
significantly increased the sediment supply to the gully. From the second week of May 2011 the system collapsed.

Foto 18: Slope that provides the gully sediment
Arrow: direction of flow. Circle: Capture Tanquilla

In order to prevent the migration of large volumes of sediment to the gully microbasin that could suffocate vetiver in the bed, and in order to overcome the erosion which can lead to landslides on the slope, it is necessary to stabilize it. Given the results, apply the VS, which we believe should be associated with forage peanut (*Arachis pintoi*).

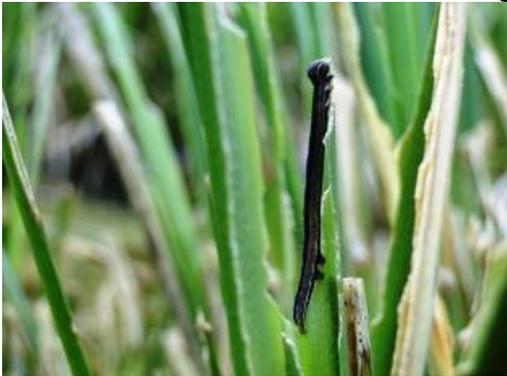
- Vetiver growth was inharmonious because of water stress to which it was subjected at the initial stage for a significant period.
- This resulted in the death of a significant number of plants, particularly in the walls of the steeper slopes.
- Similarly, vetiver plants with lower development were located on the slopes.
- The largest plant growth occurred in the bed of the gully.
- Plants respond well to the work of fertilization during drought
- In July 2010 it was noticed an infestation of pastures defoliant worm (*Mocis latipes*) throughout the region, which also attacked vetiver (photos 19 and 20). Control involves critical applications of DECIS (deltamethrin), a pyrethroid type insecticide at the rate of 1cc/litro with good results.

Photo 19: Worm grass peeler

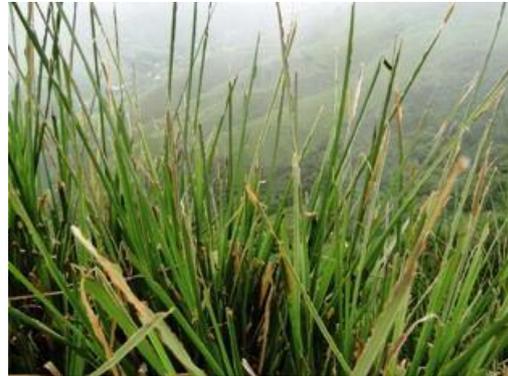
Photo 20: Damage caused by the worm

- After controlling the worm it was found that the attack caused no significant damage in the crop, except in some young plants.
- Between October 2010 and early May 2011, the VS work without erosion evidences in the gully, on the contrary, trapped sediment was found behind the barriers. Vetiver handled well, both the water flows in the microbasin, as well as that entered through the external drainage system. During that time, sediments were observed trapped in bed (photos 21, 22).

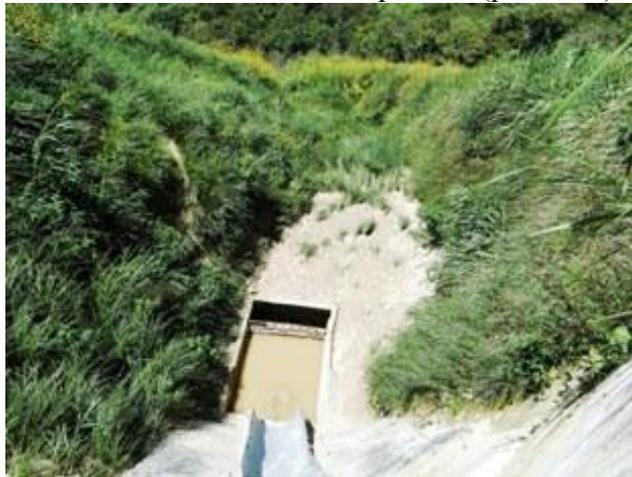
All the gully was stabilized in less than 1 year, despite disturbing elements of the system were observed during monitoring. In view of this, recommendations were made to remove excess sediment and eliminate weeds present (photo 23).

Photo 23. State of the gully in October 2010.

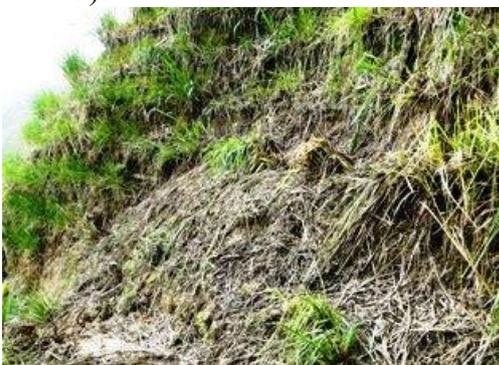
- This activity was conducted by a different company than Vetiver Antierosion, CA, in early May 2011, improperly handling vetiver pruning to 25 cm from the floor, cutting off the foliage and with it the ability to retain water flows and slow runoff (photos 24 and 25).

Photo 24: Vetiver pruned to 25 cm

- Maintenance should be limited to control weeds before they bloom, and the fertilization of vetiver
- Maintenance work must be performed by qualified personnel.

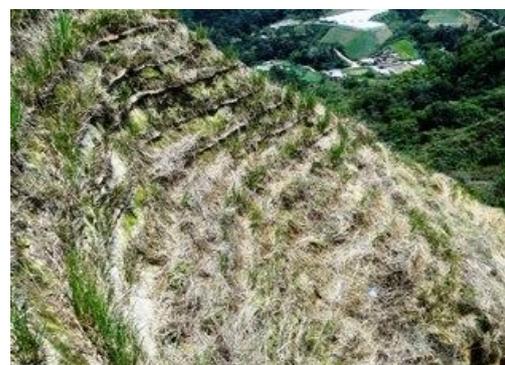
Photo 25: Waste dumps on vetiver weed

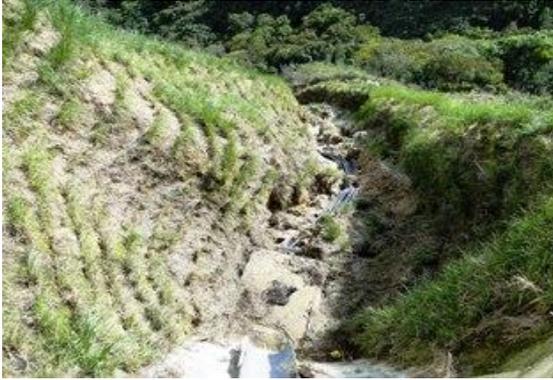
As a result of excess sediment that smothered a portion of the bed barriers, and because of the bad practice done by pruning in the second week of May 2011, the water moved freely through the bed of the gully dragging a major portion of the soil surface and

restoring soil erosion processes already under control by the vetiver, however, the walls of the banks did not collapse (photos 26 and 27)

Photo 26: The gully bed collapsed

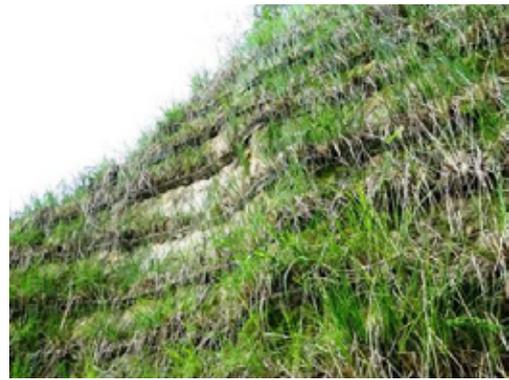
Photo: 27 barriers were not damaged slopes
