# Ho Chi Minh Highway Fourteen Years Later

(2000- 2014)

*A Photo Essay on the Role of Vetiver System in Controlling Erosion on the Highway Following a Visit in February 2014*

**Dr. Paul Truong**

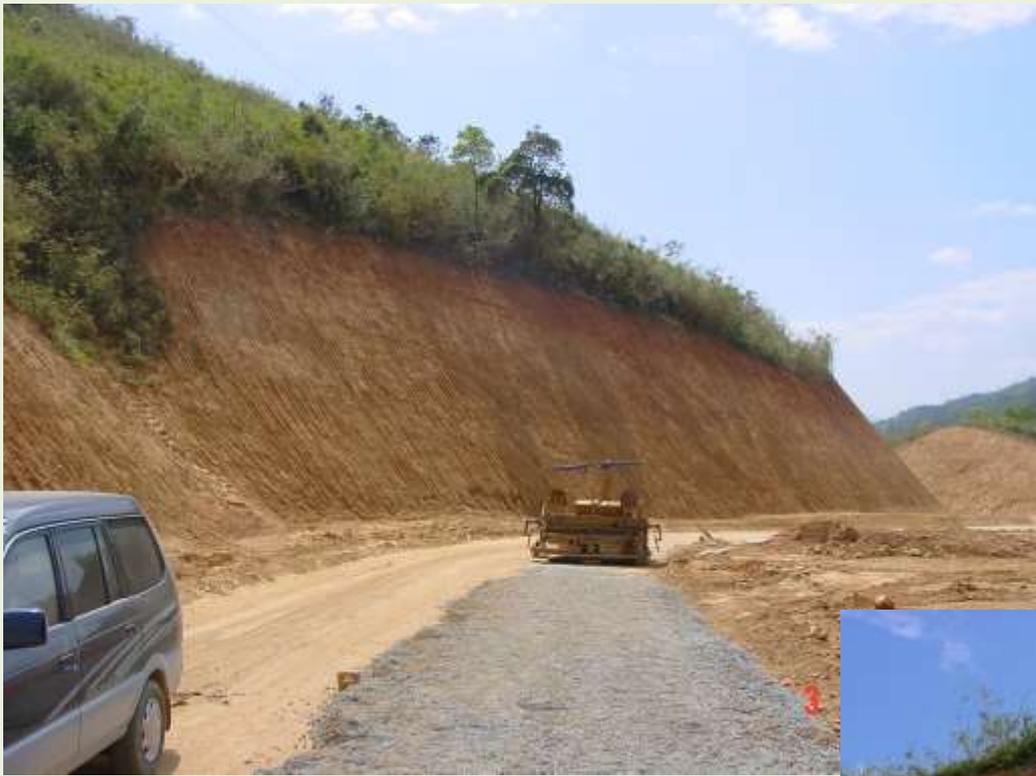
**Very steep cutting and no benches or drainage channels**

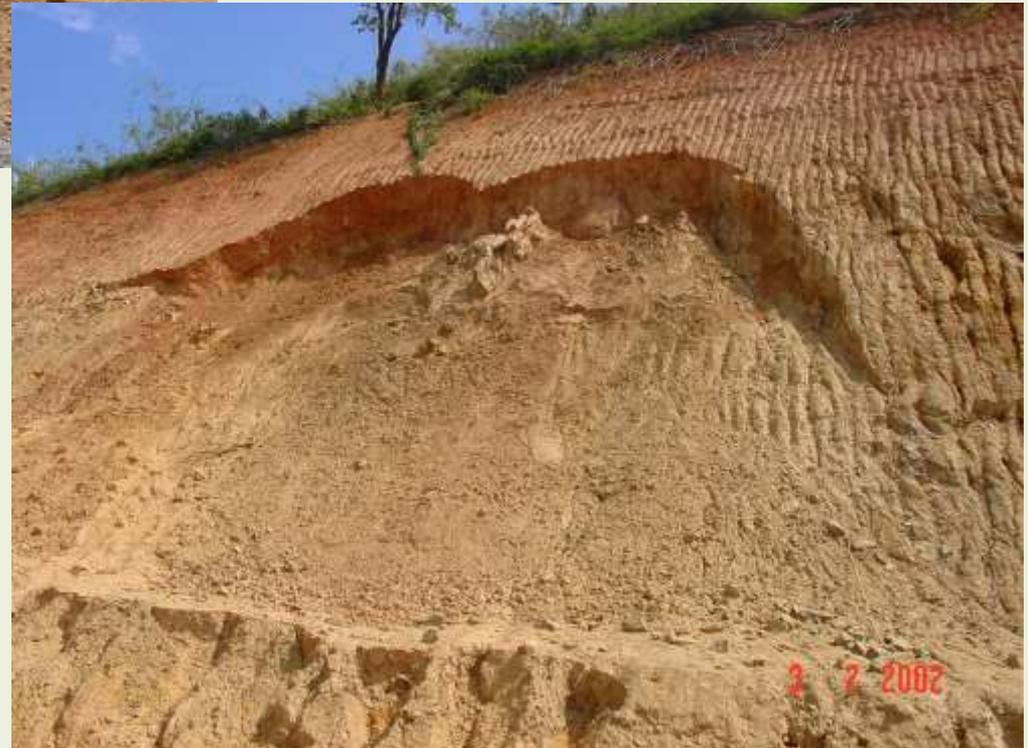
**Collapsed under its own weight in the dry season, 3 months after cutting**

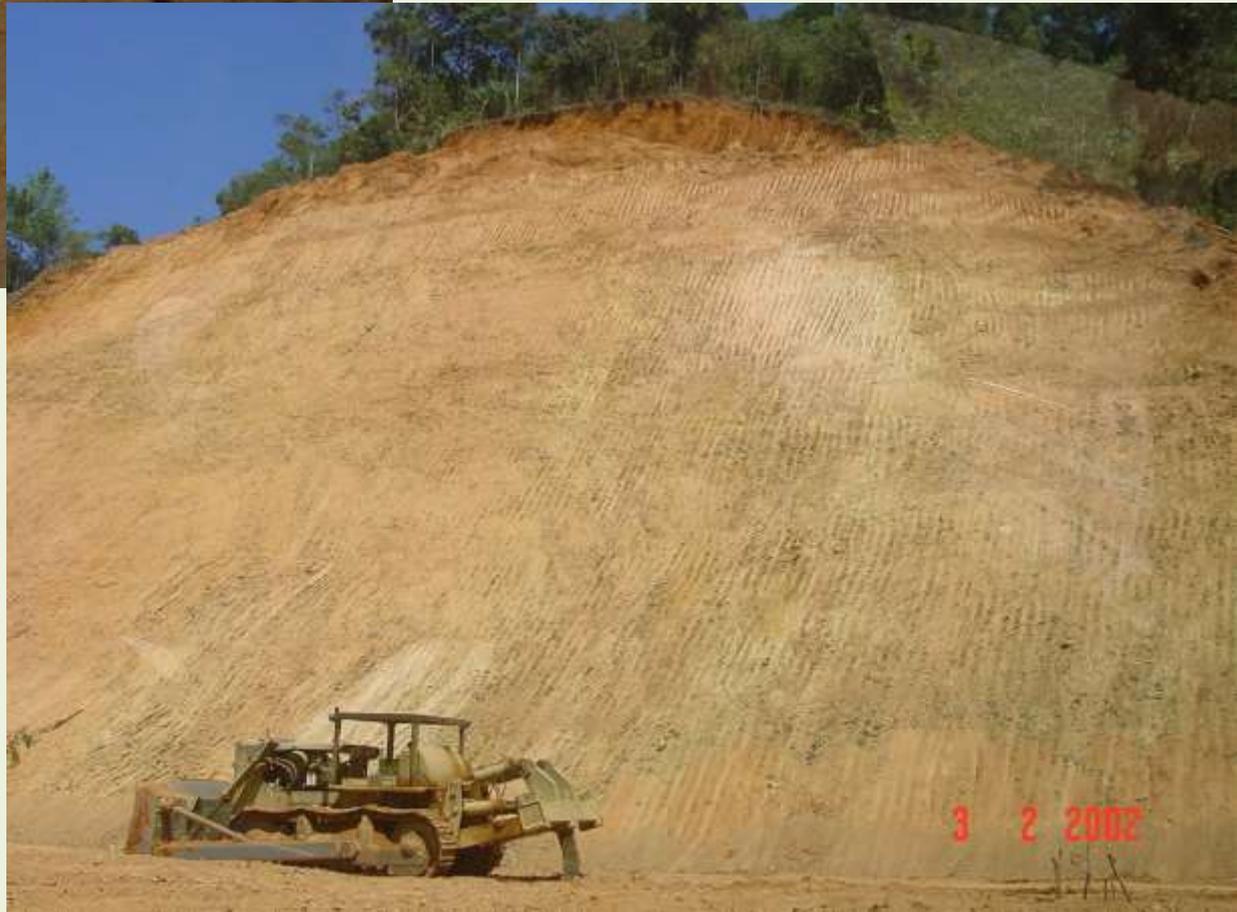
**Very steep cutting and no benches or drainage channels**

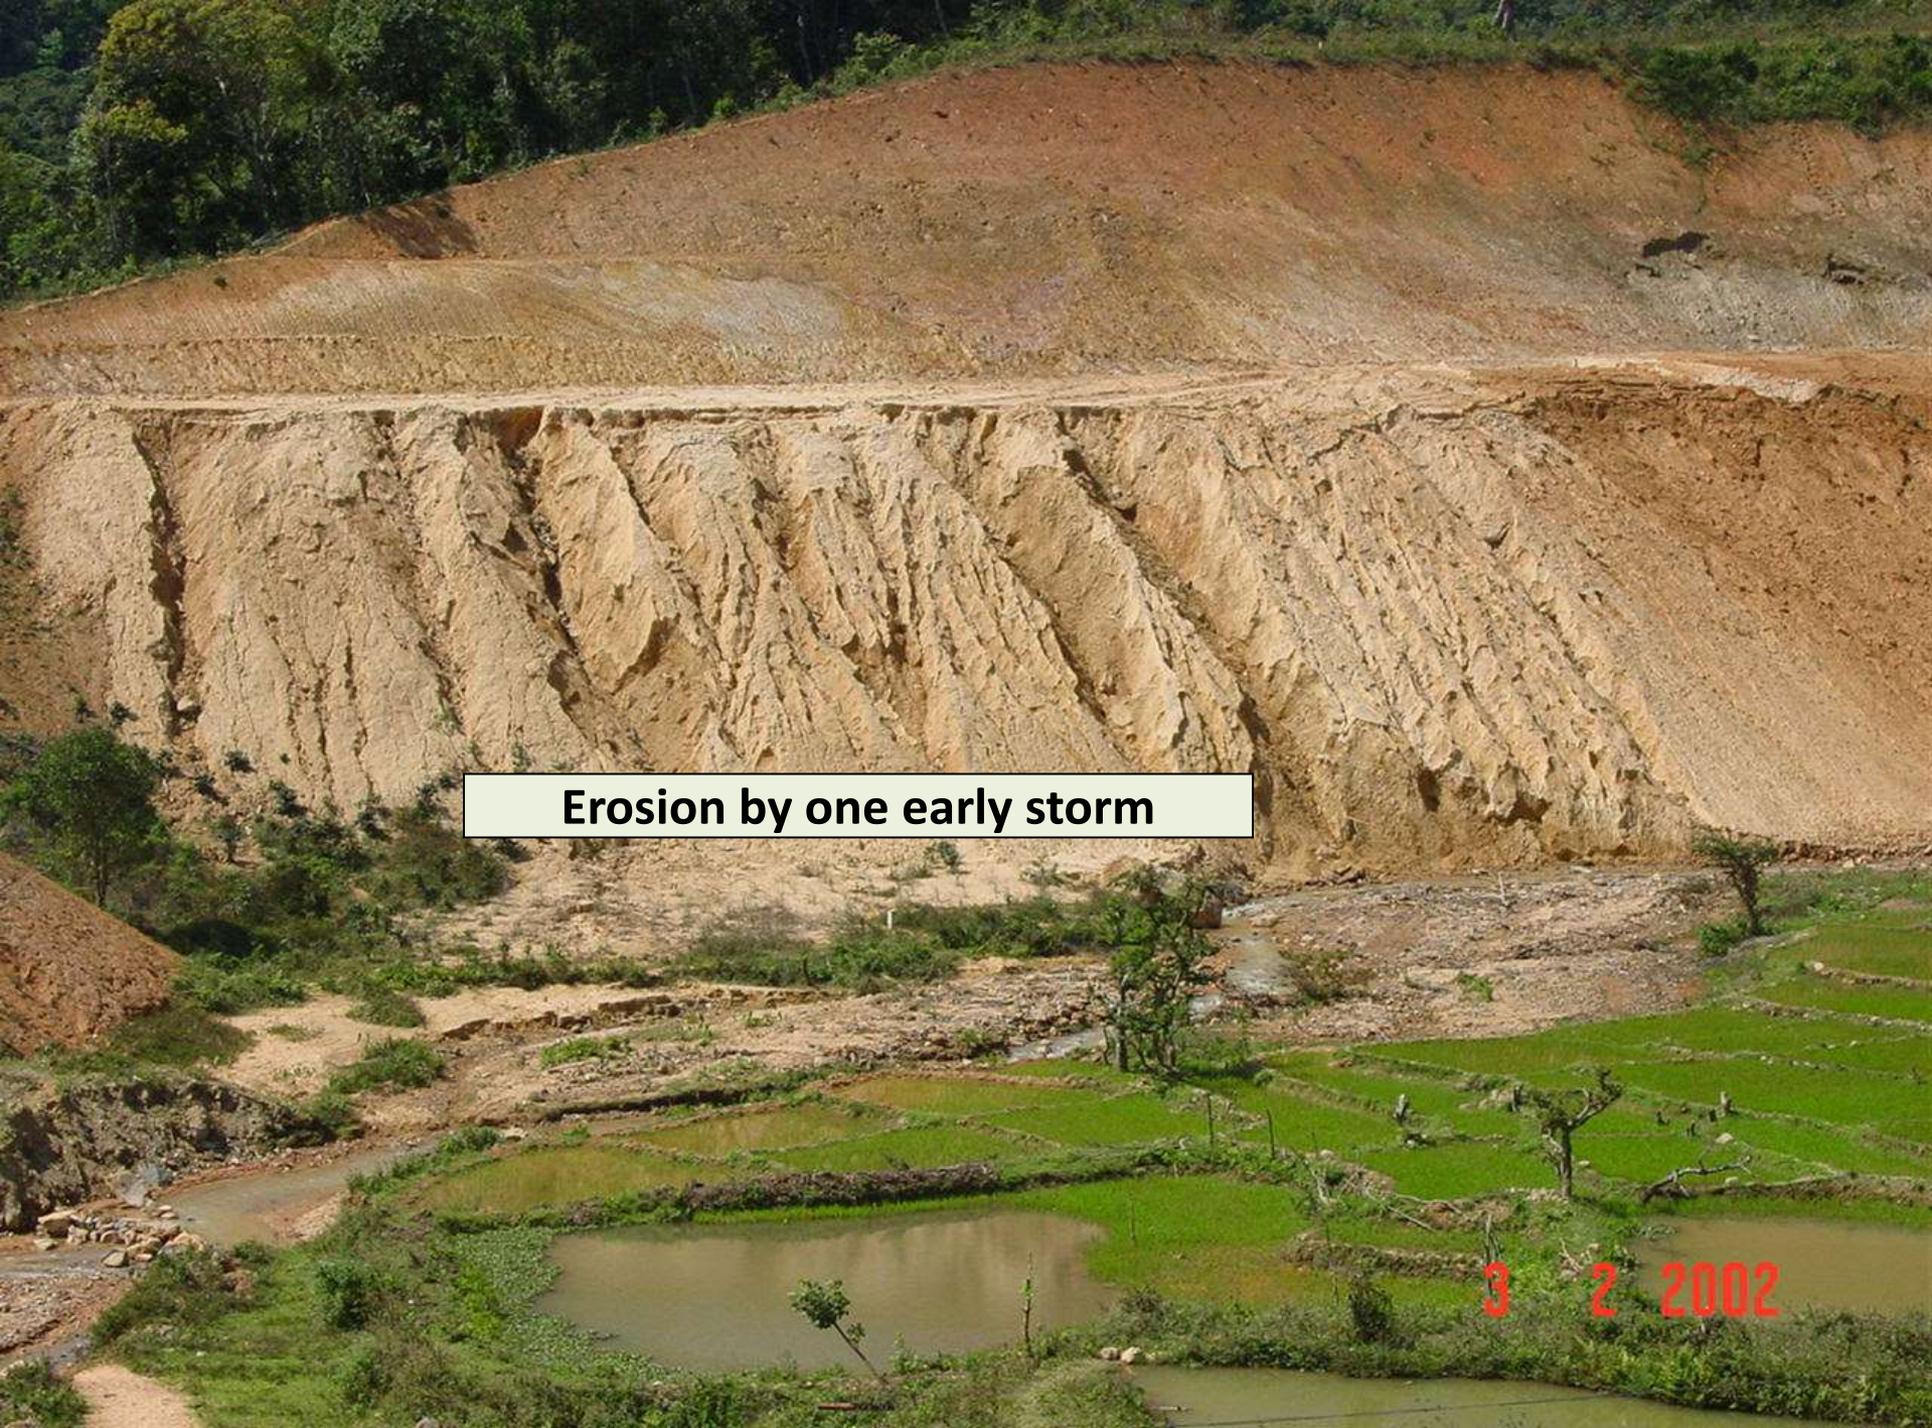
**Erosion by one early storm**

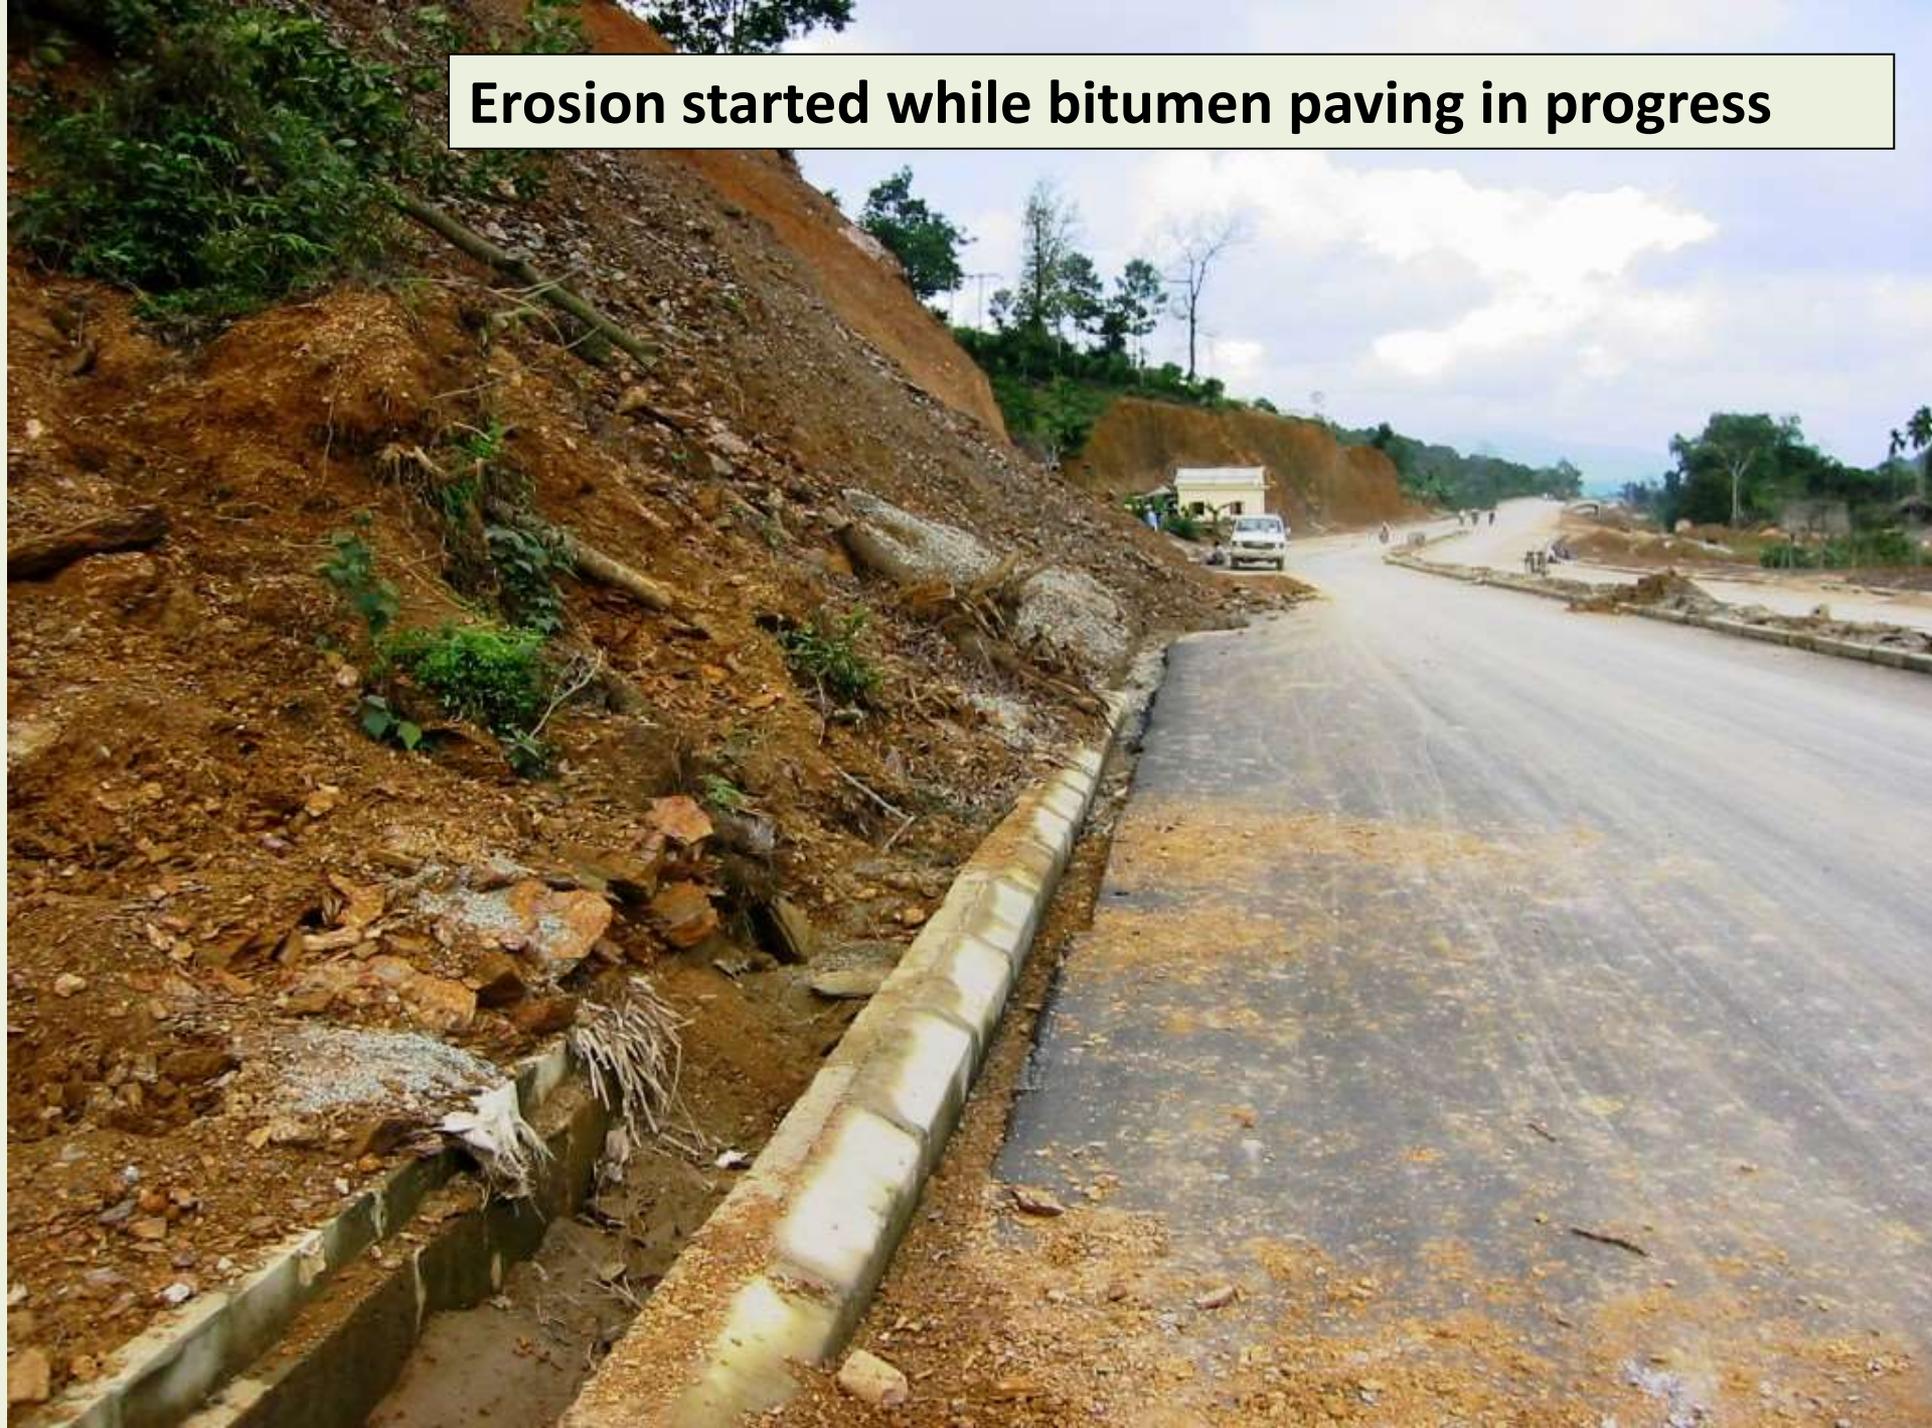
**Erosion started while bitumen paving in progress**

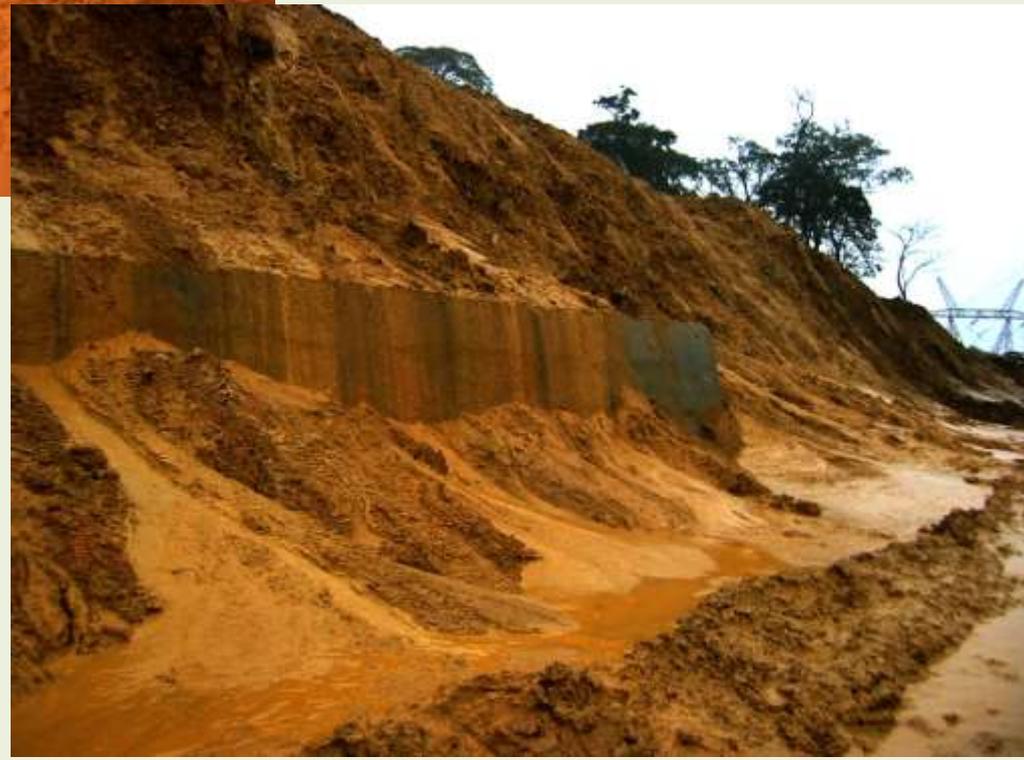
**But these massive and costly retaining walls by themselves did not stop erosion during the typhoon season**

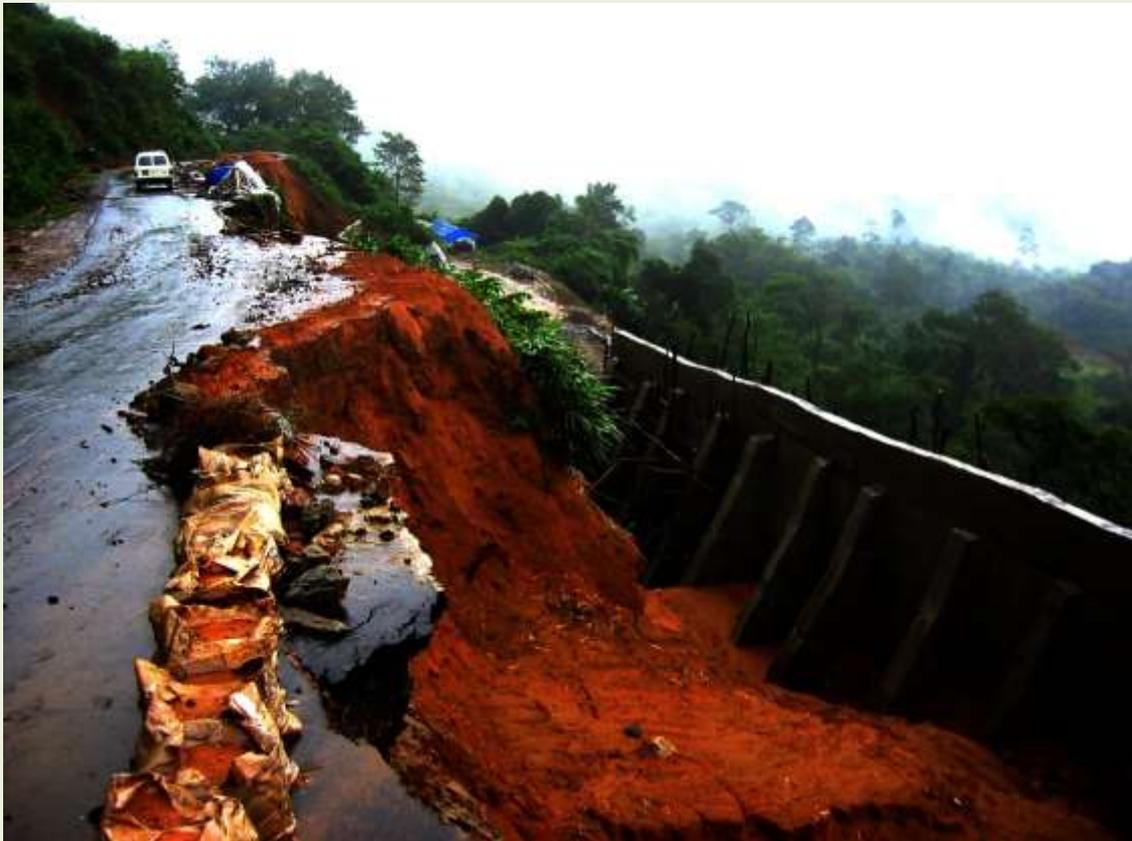
**If unprotected, this was what happened during the typhoon season**

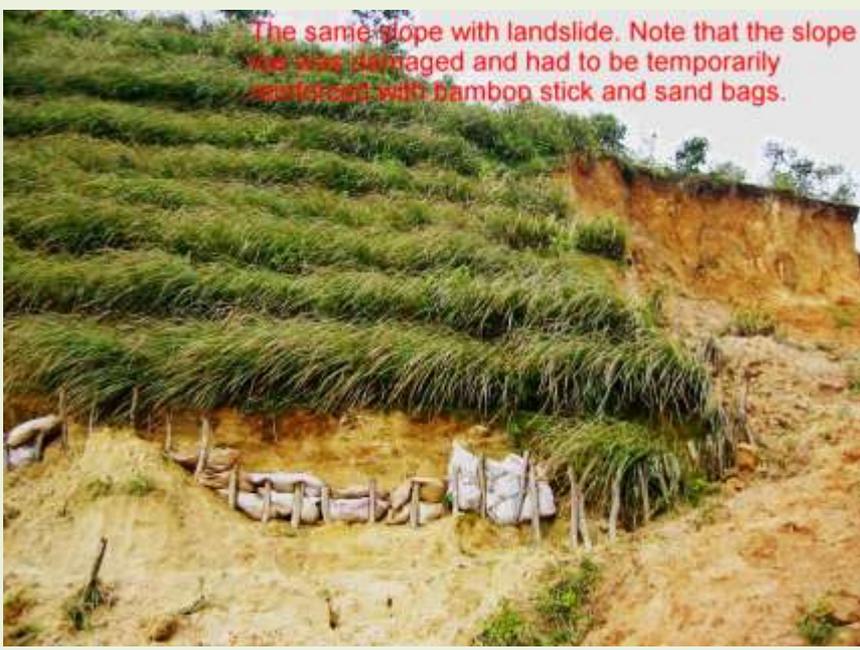
The slope toe was very steep when I was installed. The pre-Cambrian metamorphic bedrock was very strongly weathered into sandy mass, very susceptible to sliding.

**Ten month old planting, good growth but toe slope should be protected**

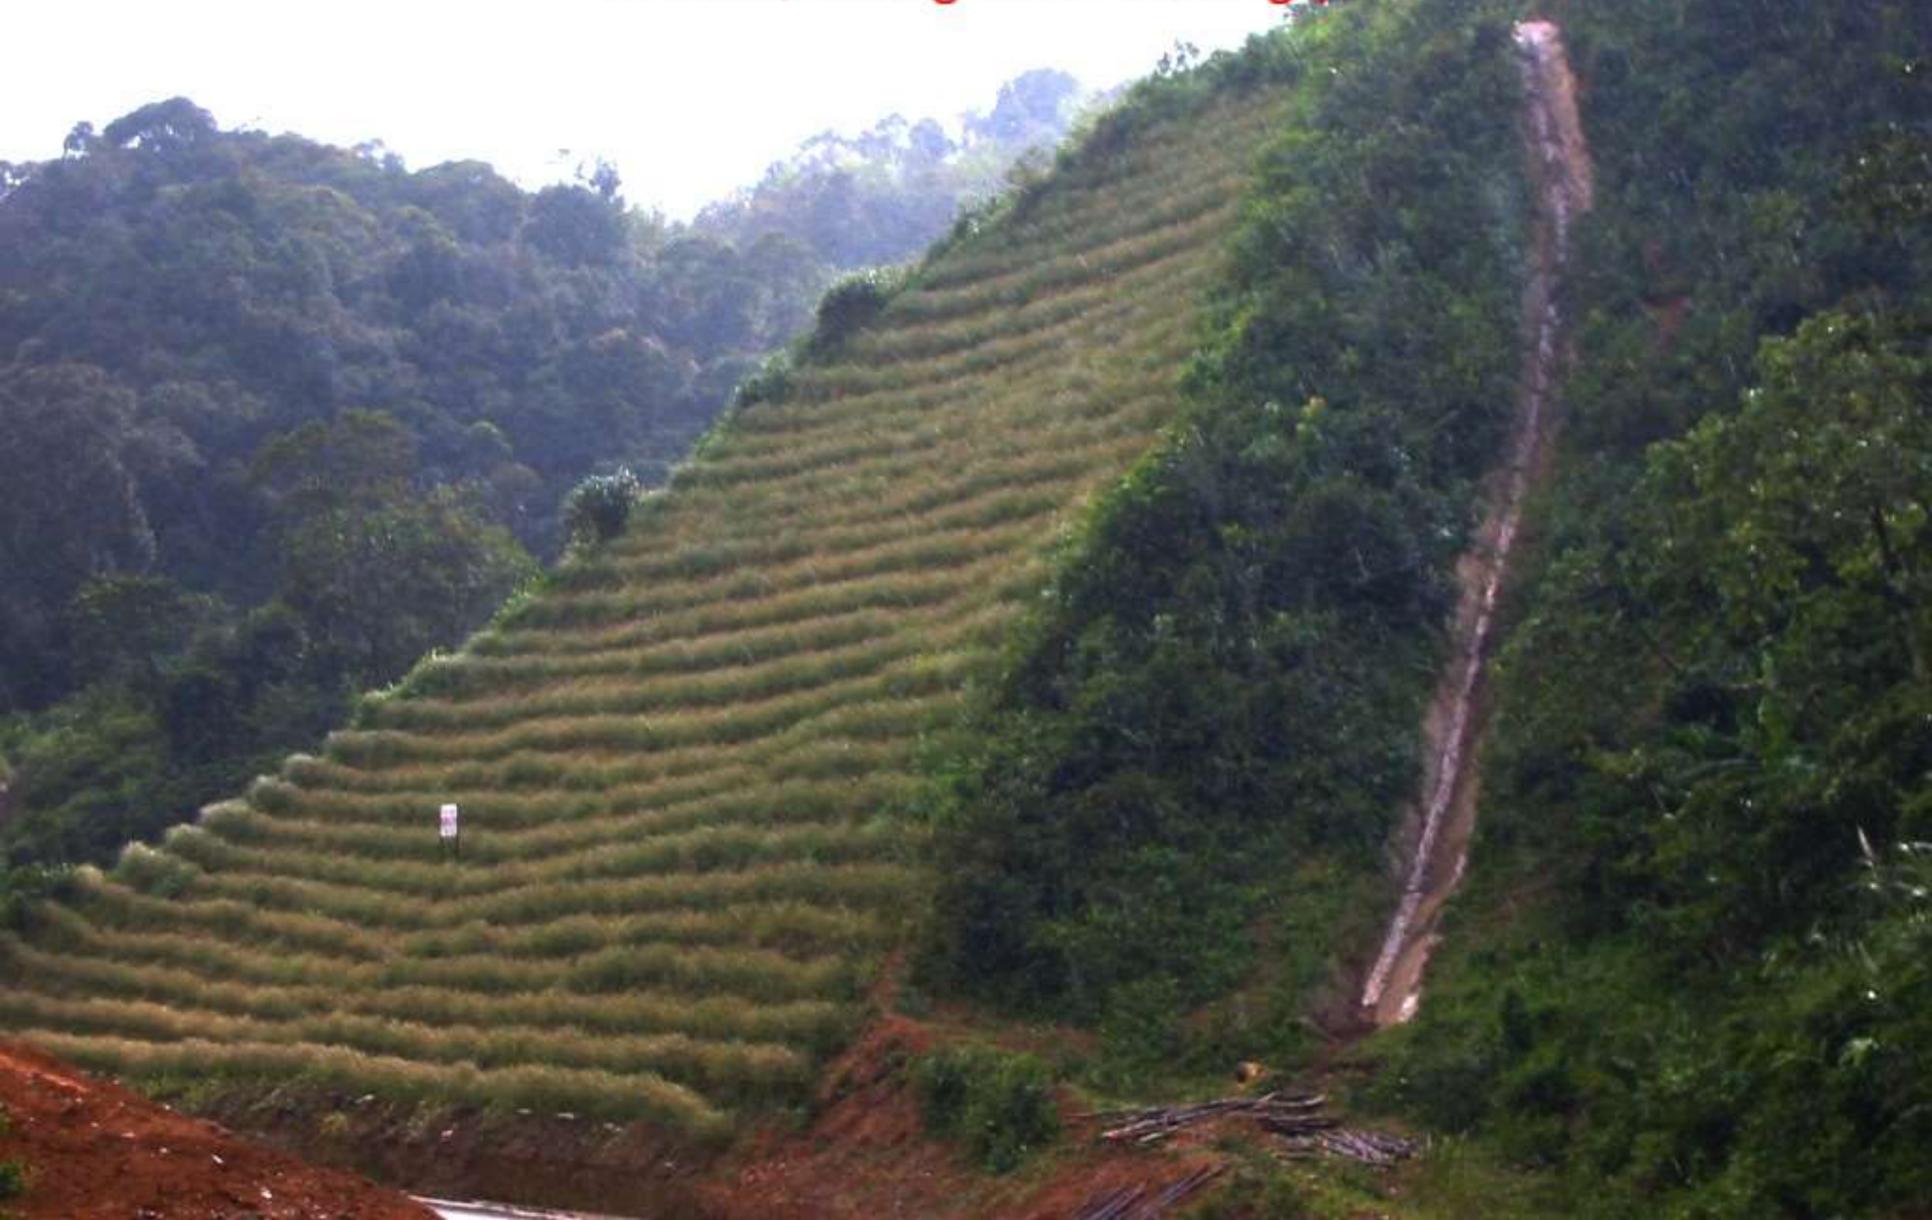
**Despite badly designed (no benching and Internal drainage), this very steep batter was successfully stabilized 3 years after planting. Survived several typhoons**

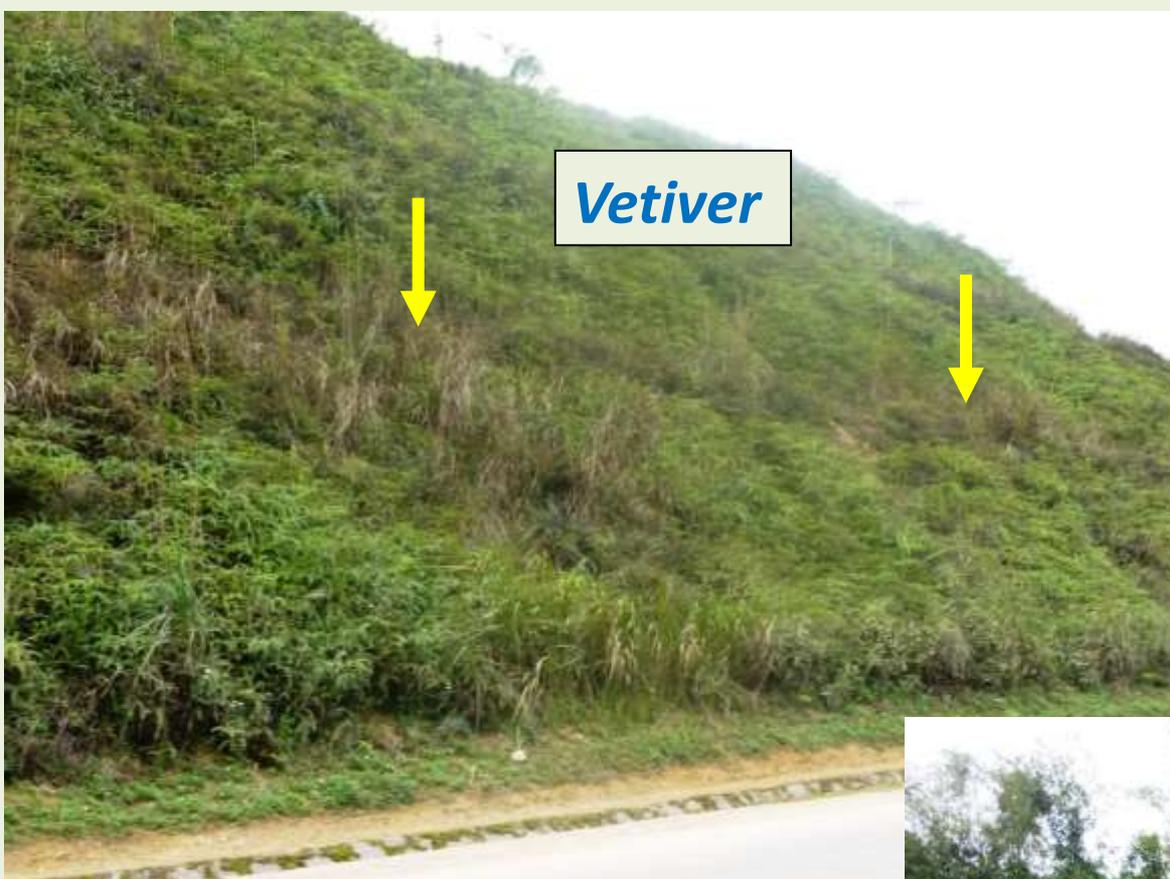
**In area where local species did not re-established, vetiver persisted and continue to provide protection**

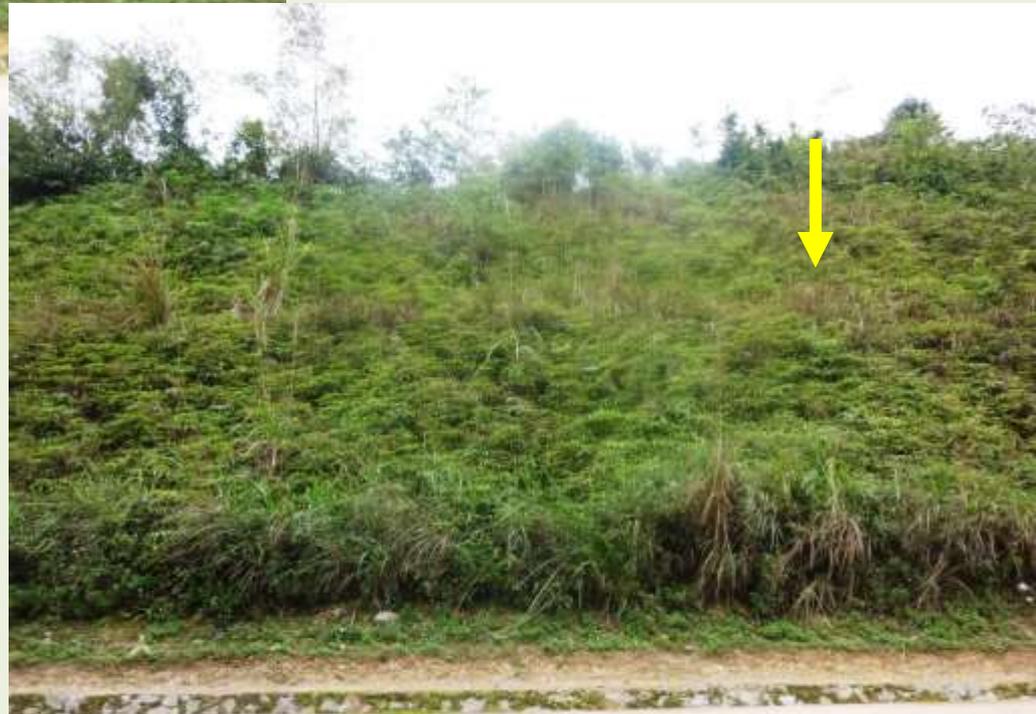
**Vetiver persisted  
and continue to  
provide protection  
to vulnerable area**

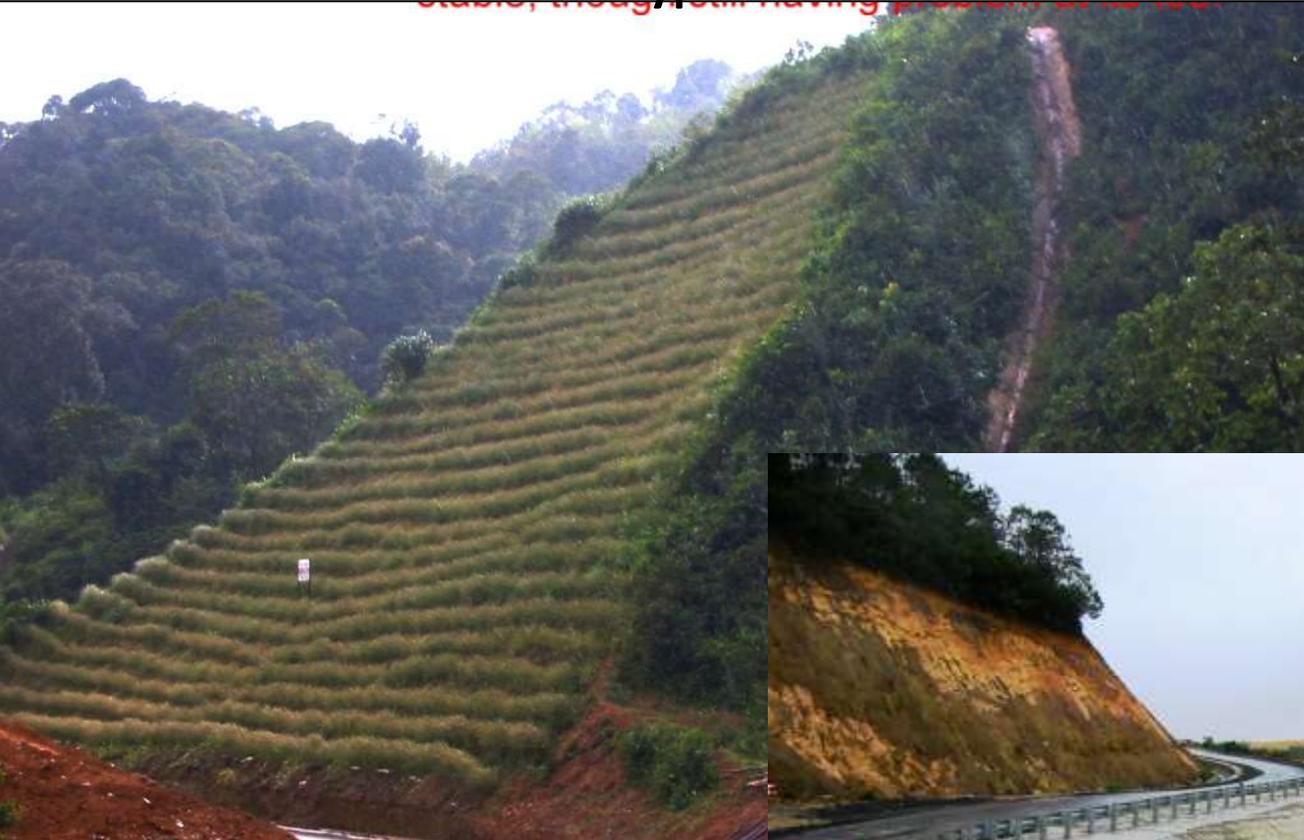
Despite badly designed this very steep batter has survived several typhoons
