02/2003. Large landslide in weak, clay rich, highly saturated soil at Da Deo Pass, one of the most problematic, about 1km long, section.

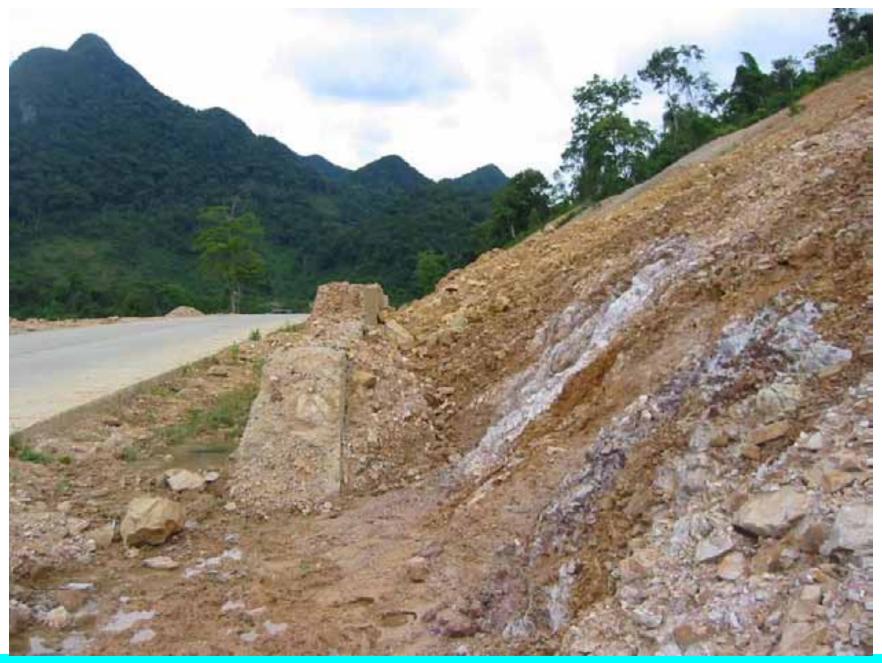
08/2004. Largely remained untreated. Note the slope angle and the darkened part by water seepage. The white colour is kaoline.

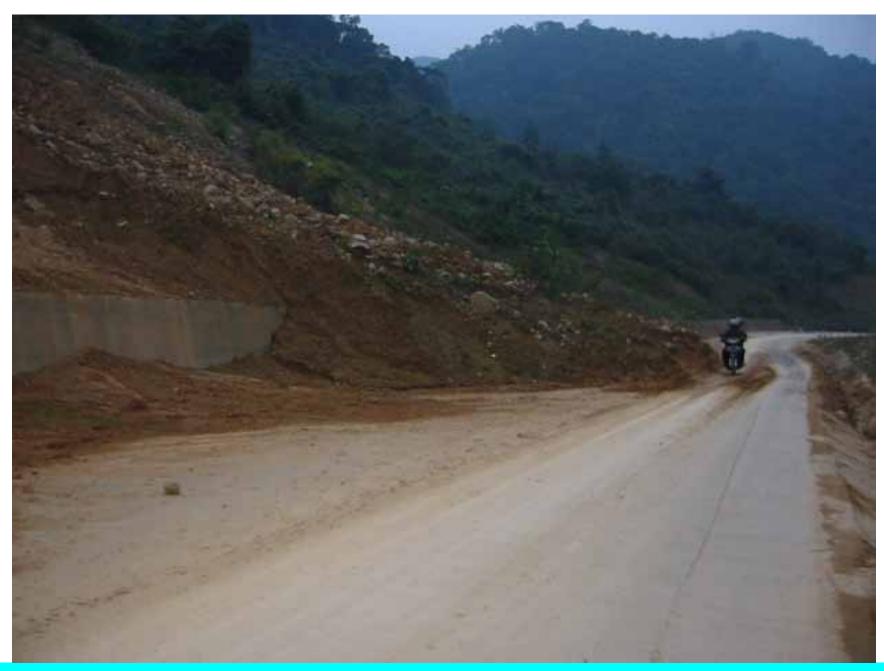
01/2005. Slides continued to occur.

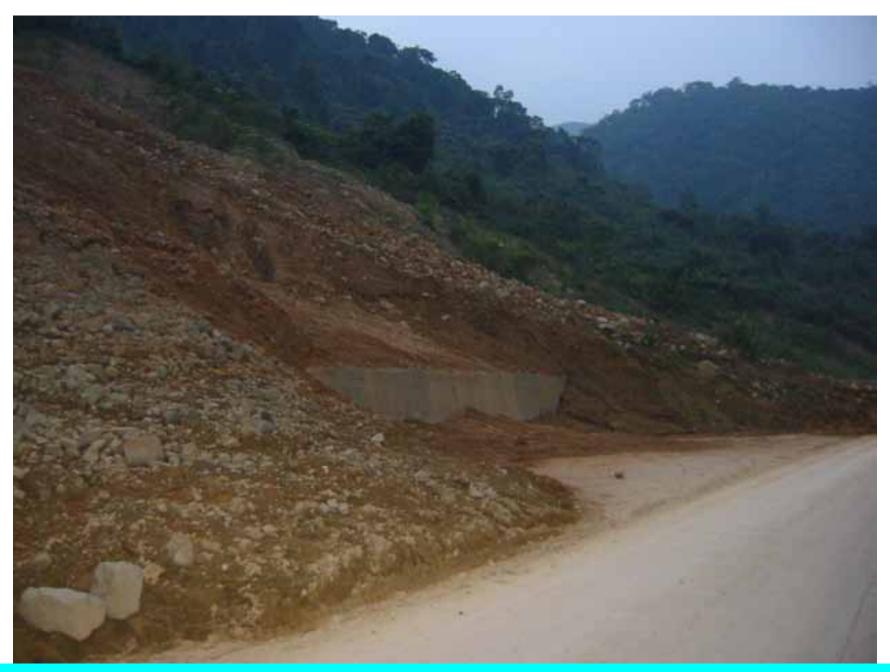
01/2005. Slides continued to occur.

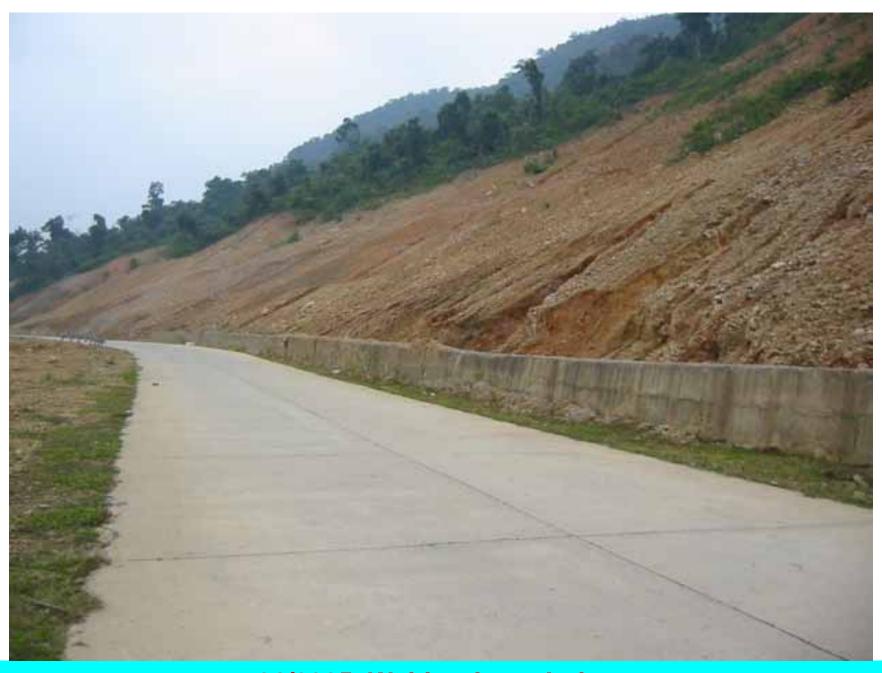
01/2005. Waiting for solution.

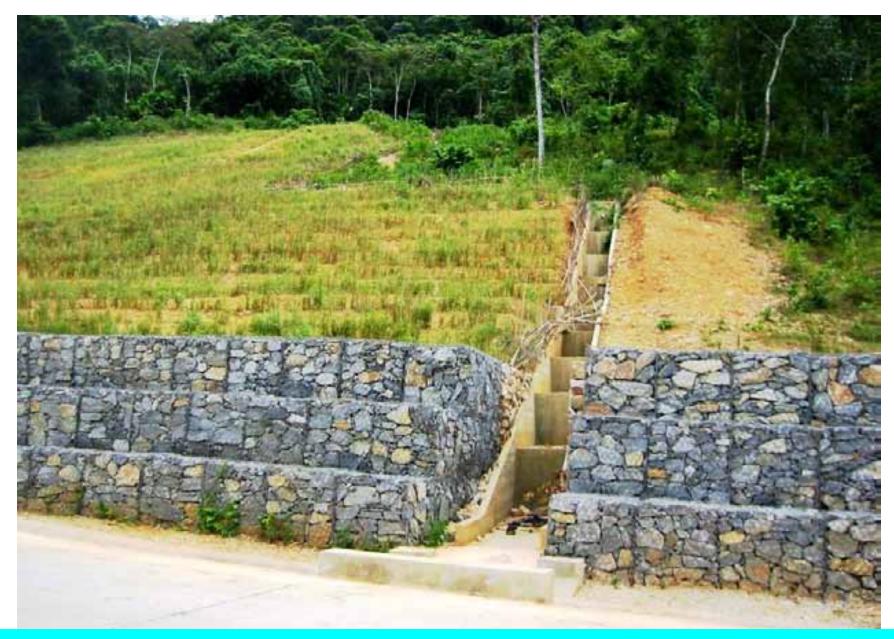
08/2004. One critical part was treated by gabions, drainage and Vetiver. The grass was planted 2 months before. But it was not mature enough and as the rainy season continued, a slow, retarded slide occurred.

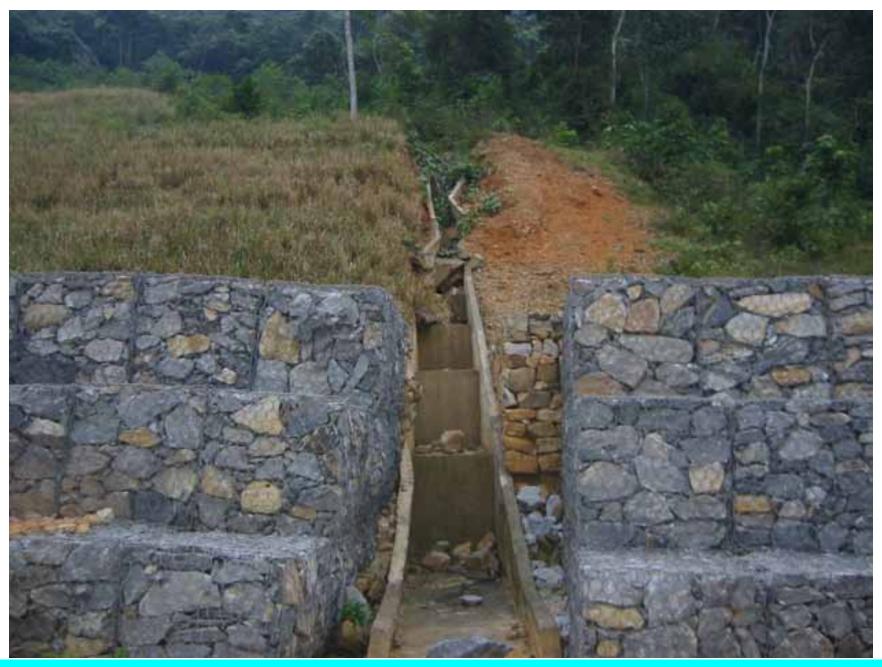
01/2005. The drainage path was damaged and the slide continued, although very slow. At the same time the grass became more mature.

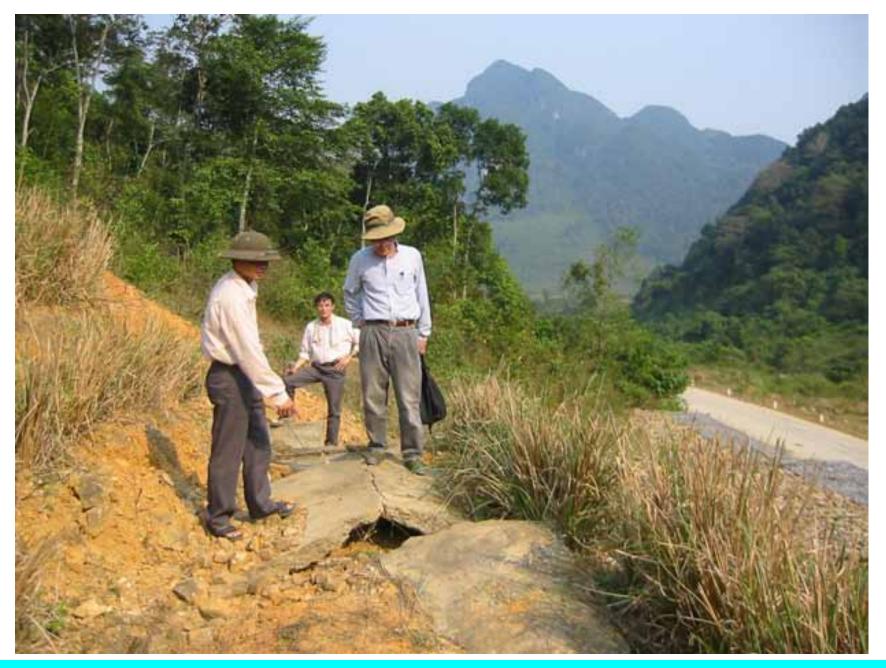
01/2005. The concrete plate was broken down by the sliding force while Vetiver grass continued to grow.

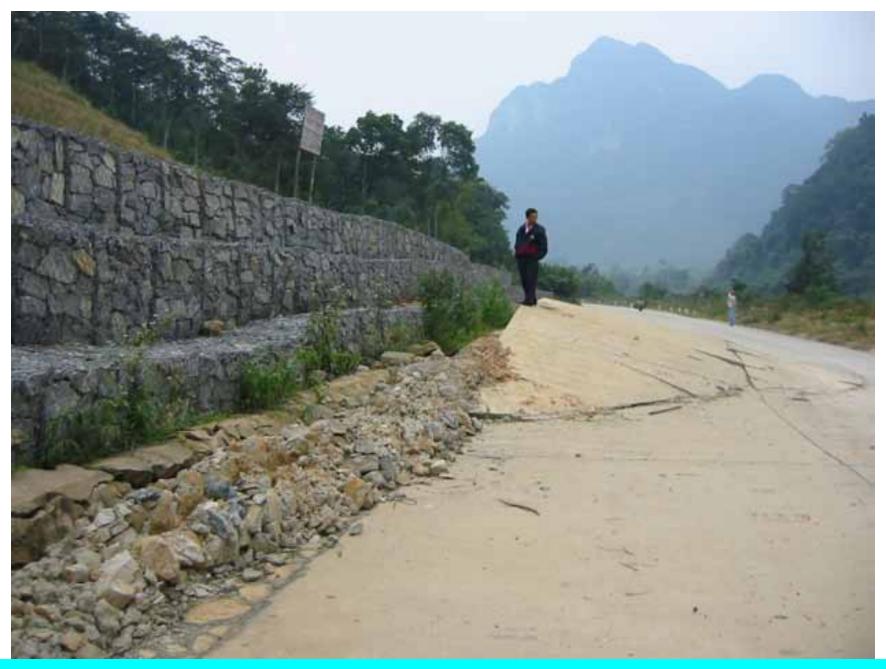
01/2005. At the toe of the slide the road was heaved up for about 1m despite the concrete cover of 20cm.

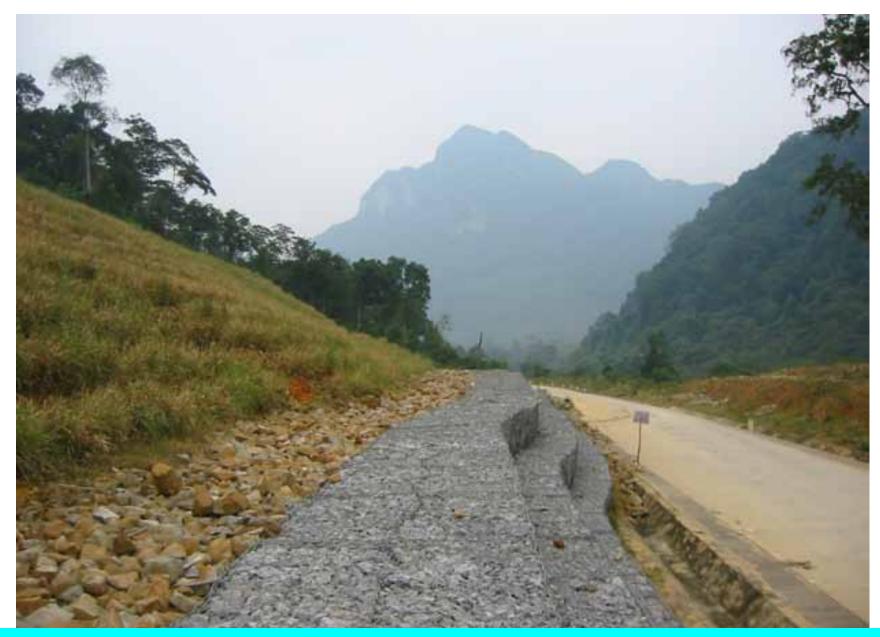
01/2005. The 3-layer gabion was displaced for about 1m. But the slide didn't continue as the grass became more mature. And the road was rebuilt a little bit to the right to continue its normal function.

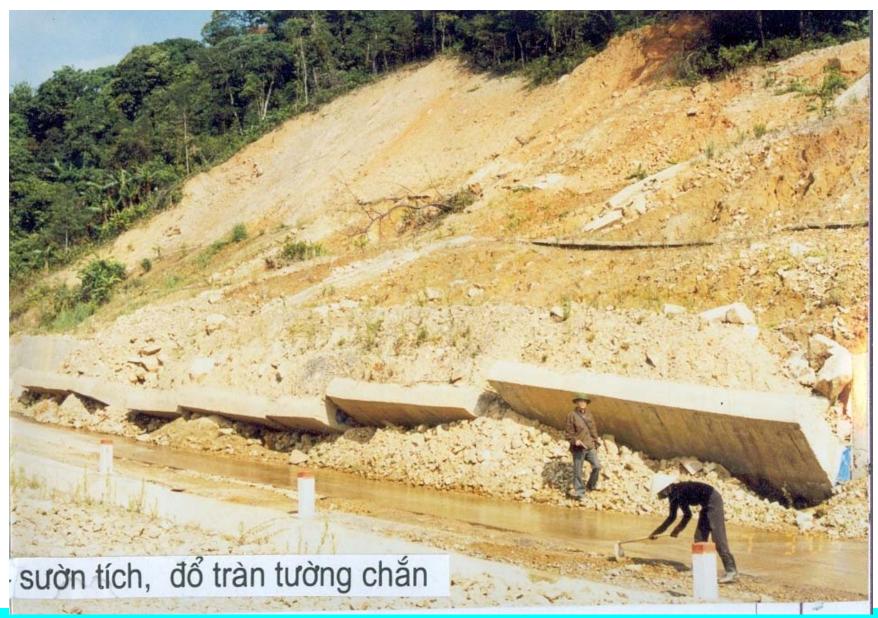
Another problem site. Thick weathering crust on granite is clay rich, becoming very weak when wet and the concrete retaining wall is useless.

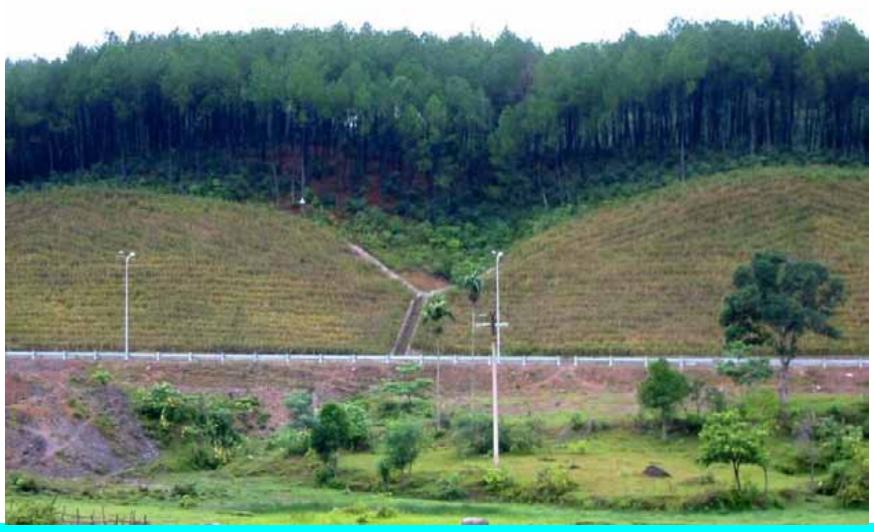
08/2004. Painting green the problem and it works. HCMHW, Vu Quang section in thin-bedded black schist, dipping 45° toward the road.

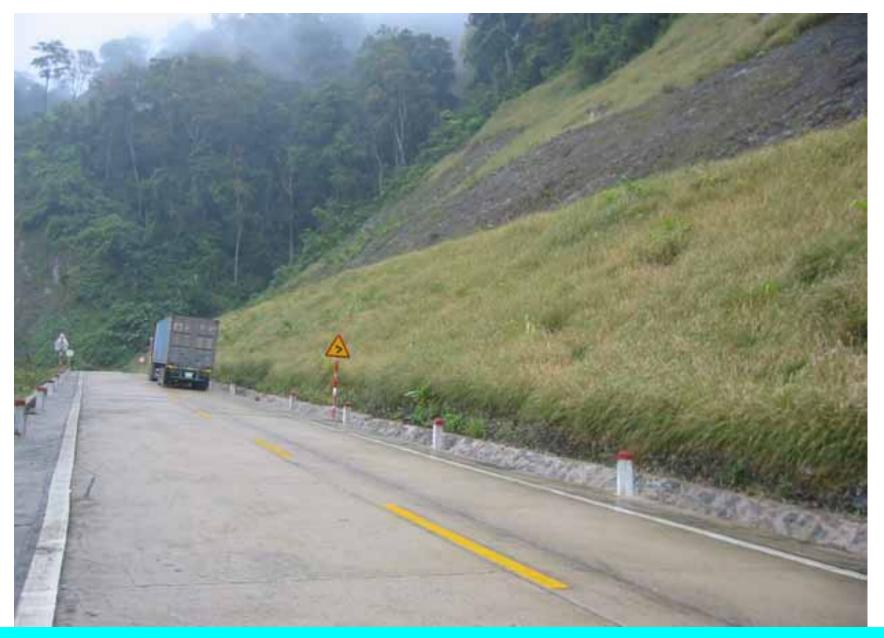
08/2004. Lo Xo (spiral) Pass. One of the most problematic section where a major fault runs through (in the road direction) the strongly crushed, clay rich and wet rock mass.
