The 6th International Conference on Vetiver (ICV-6)
5-8 May 2015, Da Nang, Vietnam

Application of Vetiver (*Vetiveria Zizaniodes*) as a Bio-technical Slope Protection Measure –Some Success Stories in Bangladesh

Dr. Mohammad Shariful Islam

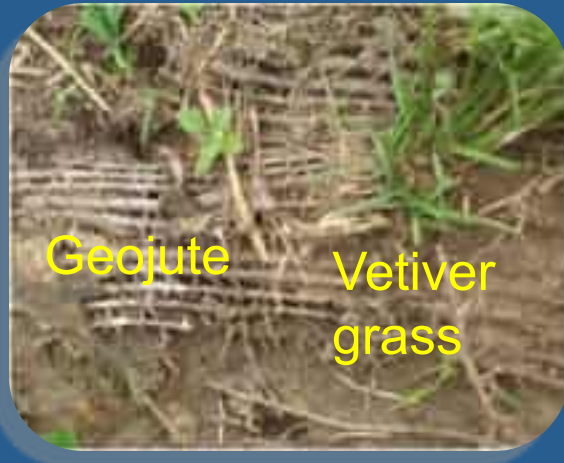
**WOVEN TYPE JGT
(OPEN MESH)**

- 500 gsm-750 gsm
- Opening area about 50%
- Moisture absorption is about 500% its dry weight
- Cost: Tk. 1.60 per sft for 500 gsm
- Durability: 2 years

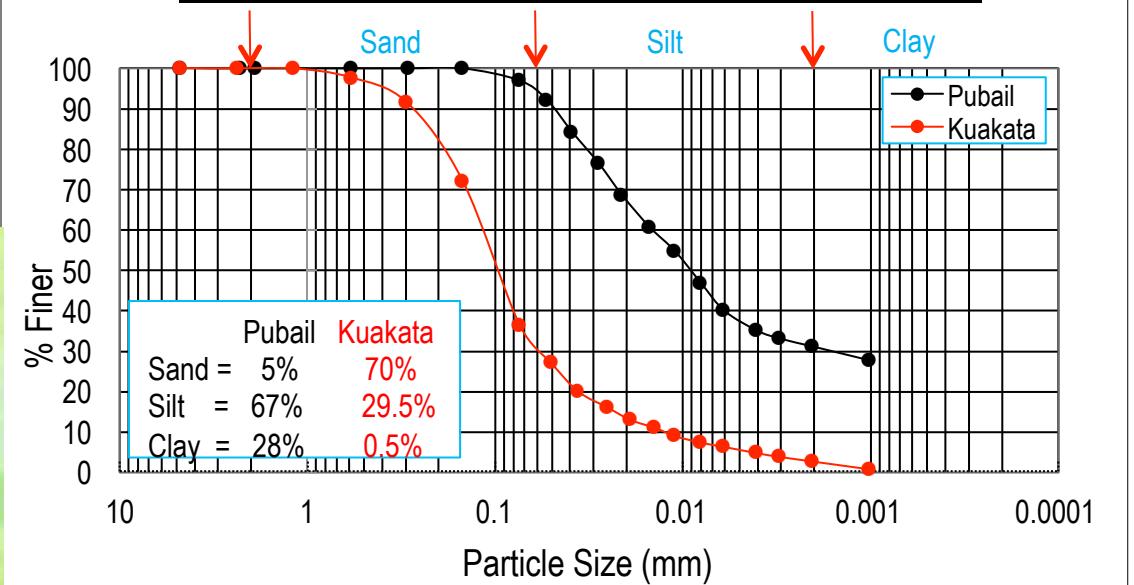
Grain size distribution of Pubail & Kuakata soil

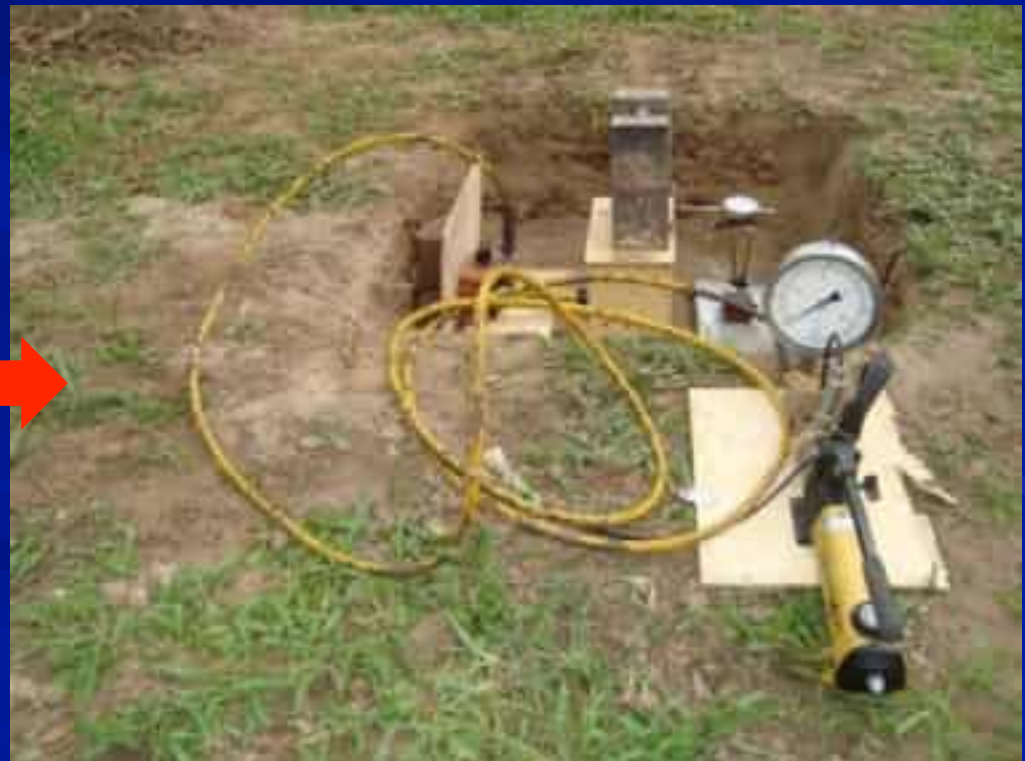
Test Set-up for
In-situ Shear Strength
Determination

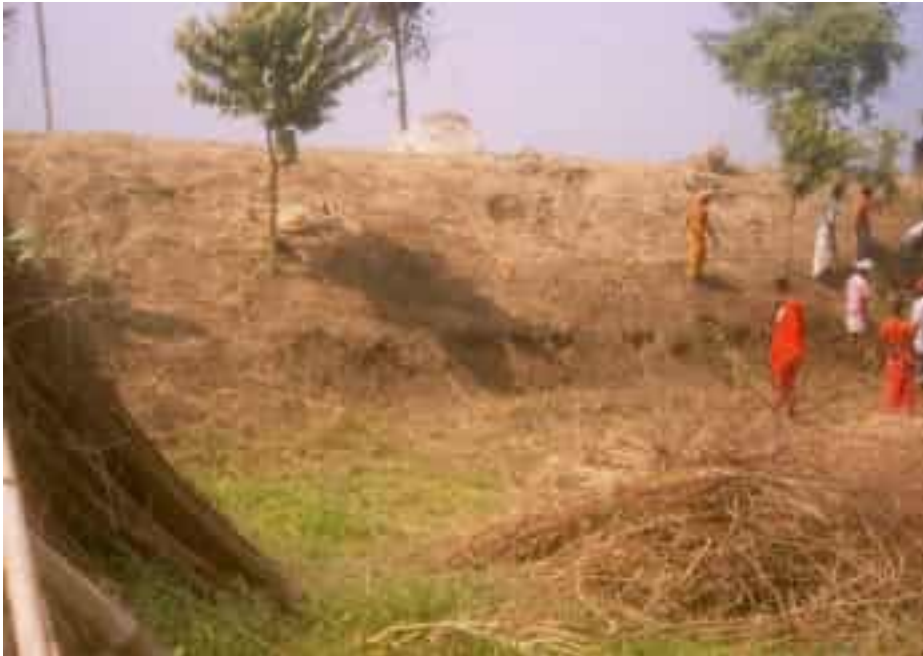
Grain Size Distribution of the Top-soil of the Road Side

Slope soil is susceptible to erosion

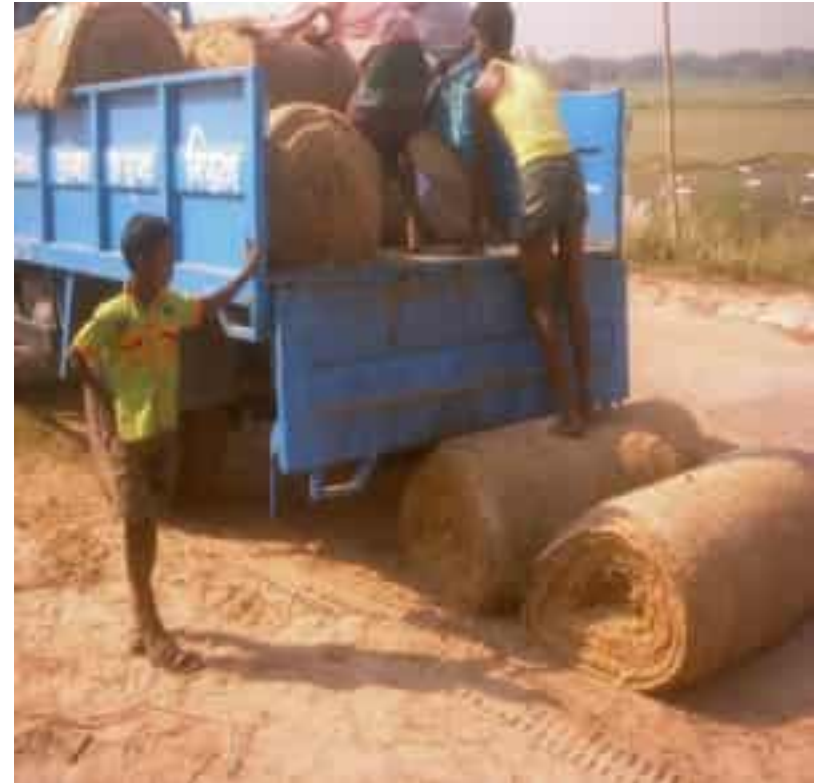
Work Started on 25/10/2011 (Winter)

Unit Mass: 700 gsm, Opening: 31 x 33 mm²
Tensile strength: 21092 N/m (x); 5886 N/m (y)
Absorption capacity: 2.75

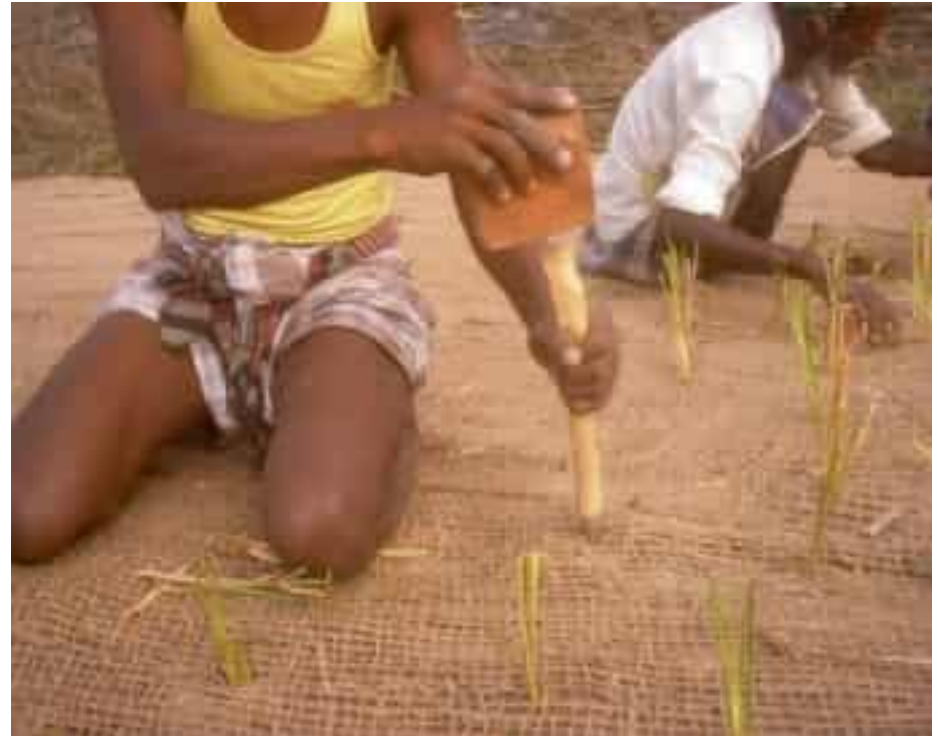
C) Vetiver plantation

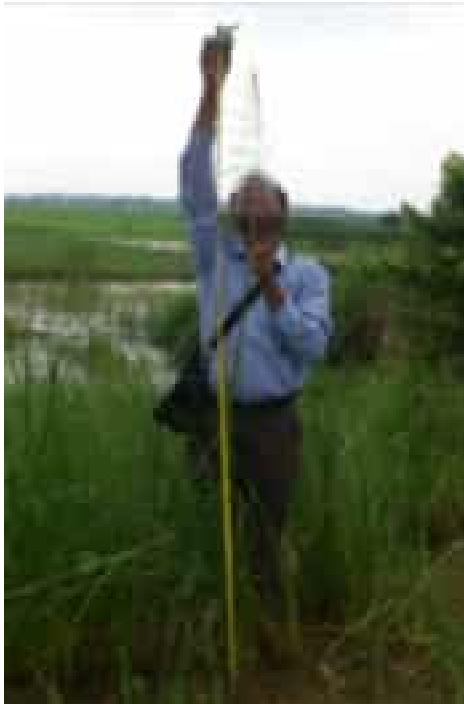
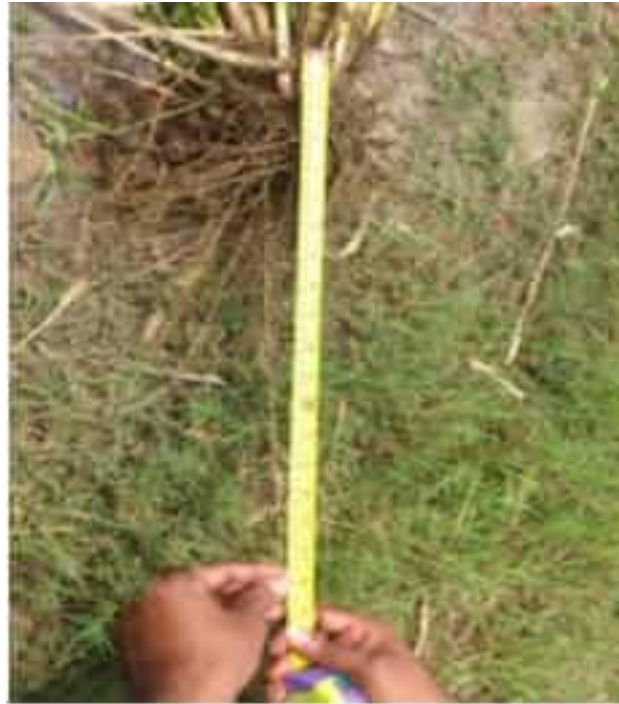
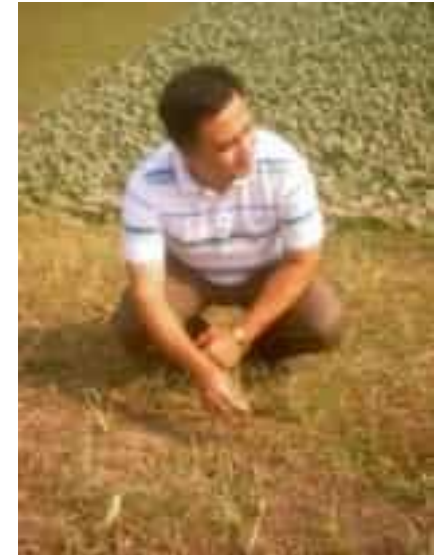
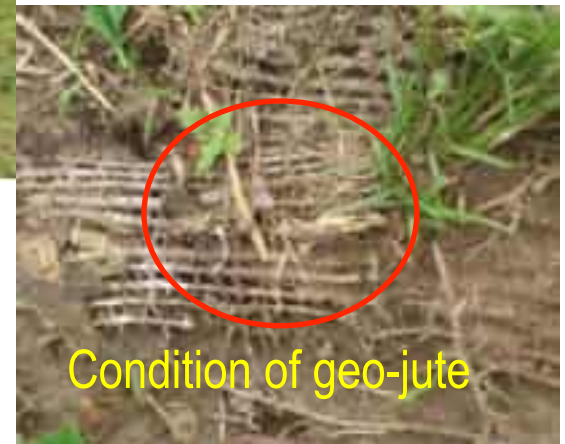
13/07/2012 More than 8 Months

Root length: 18 inch, Shoot: 6 ft
