Global Review of Contribution of VST in Alleviating Climate Change Disasters

Paul Truong

*ICV5 Fifth International Conference on Vetiver
28-30 October 2011, Lucknow, India*

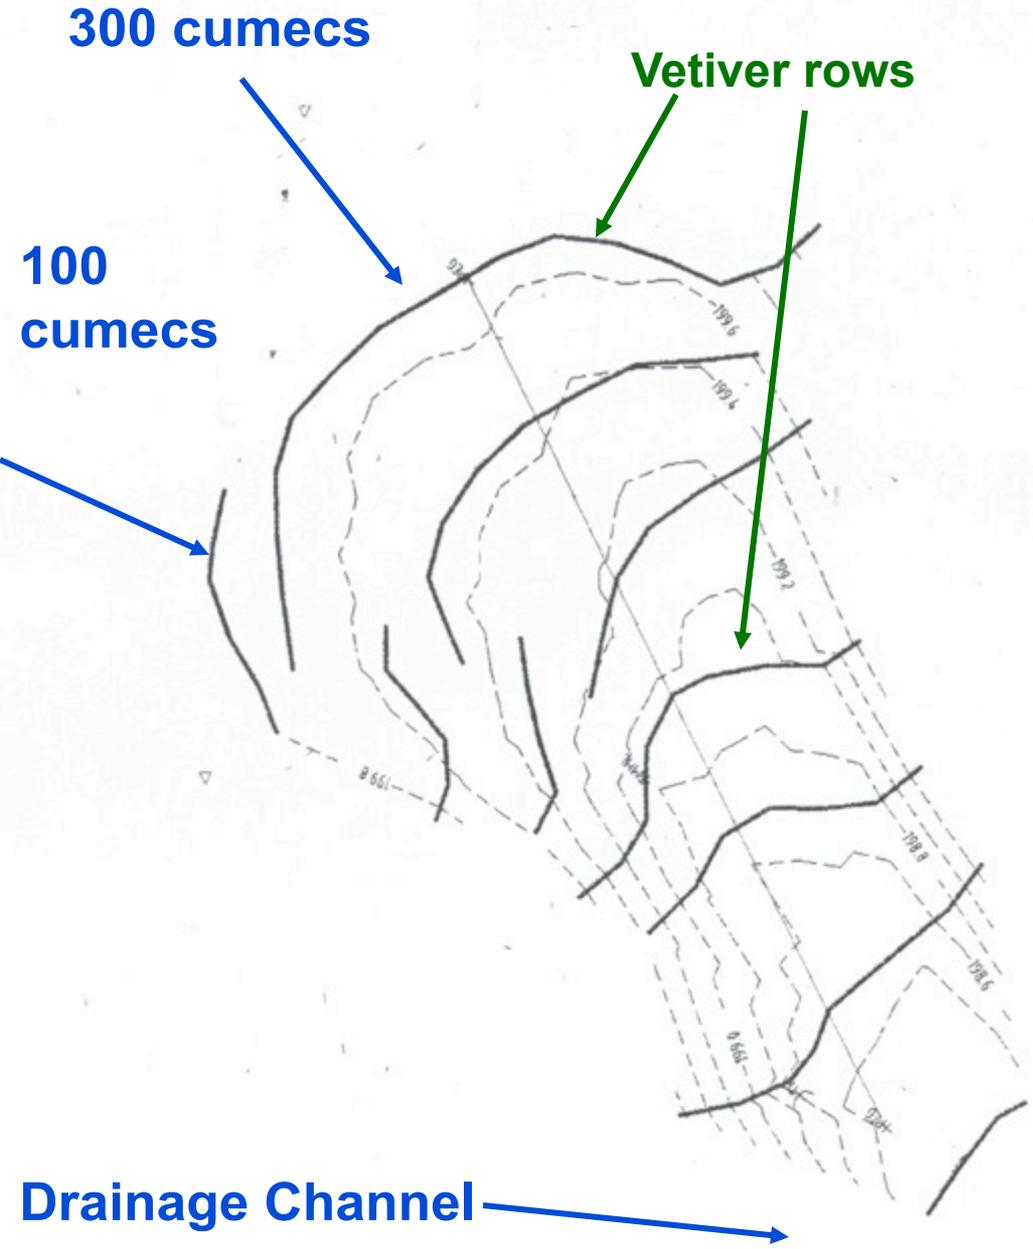
Flood erosion control in drainage channel at Laidley

Vetiver hedges were established to spread water out and also to divert water to the drain

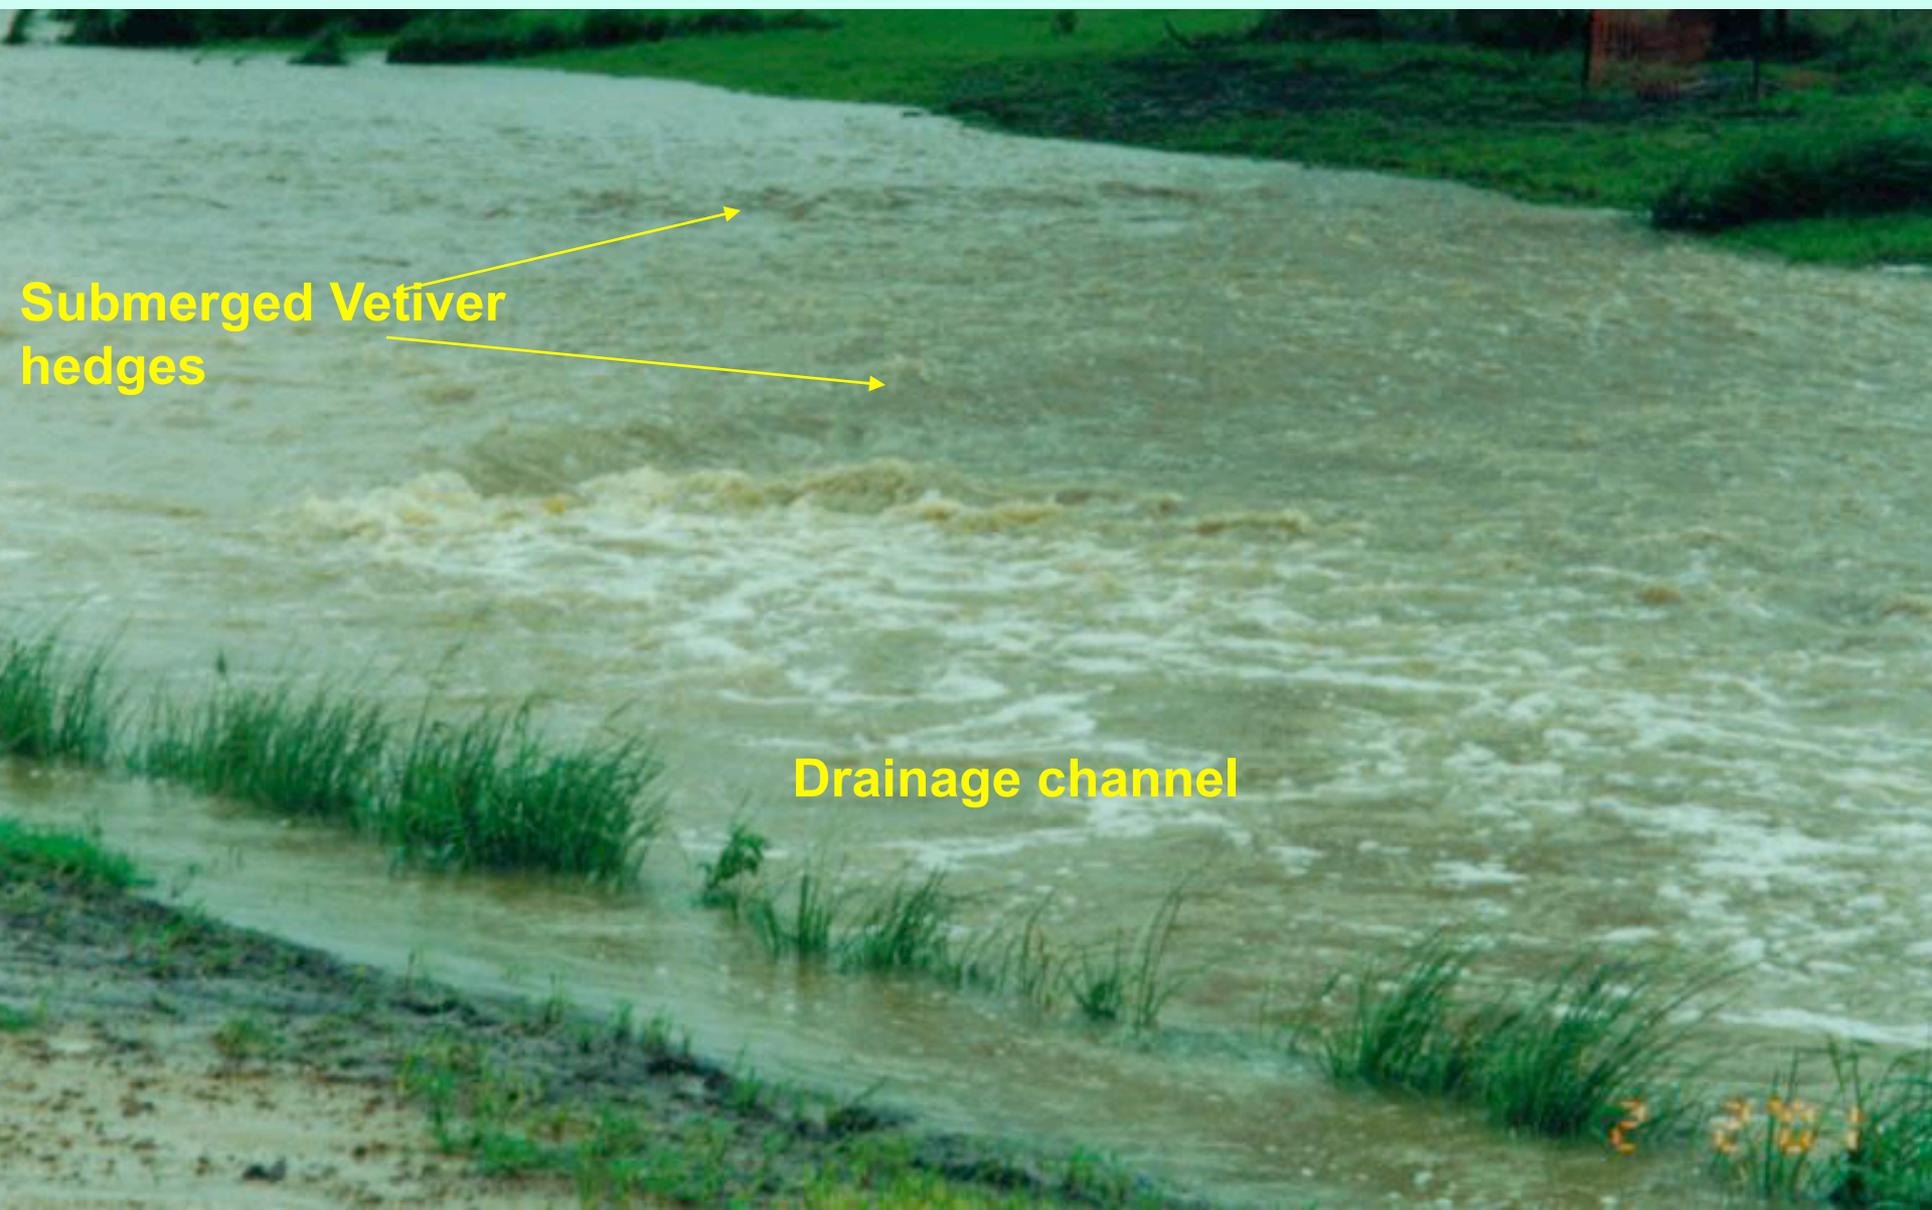
A big storm hit the area 3 months after planting and the whole site was flooded (Upper section)

Submerged Vetiver hedges

Drainage channel

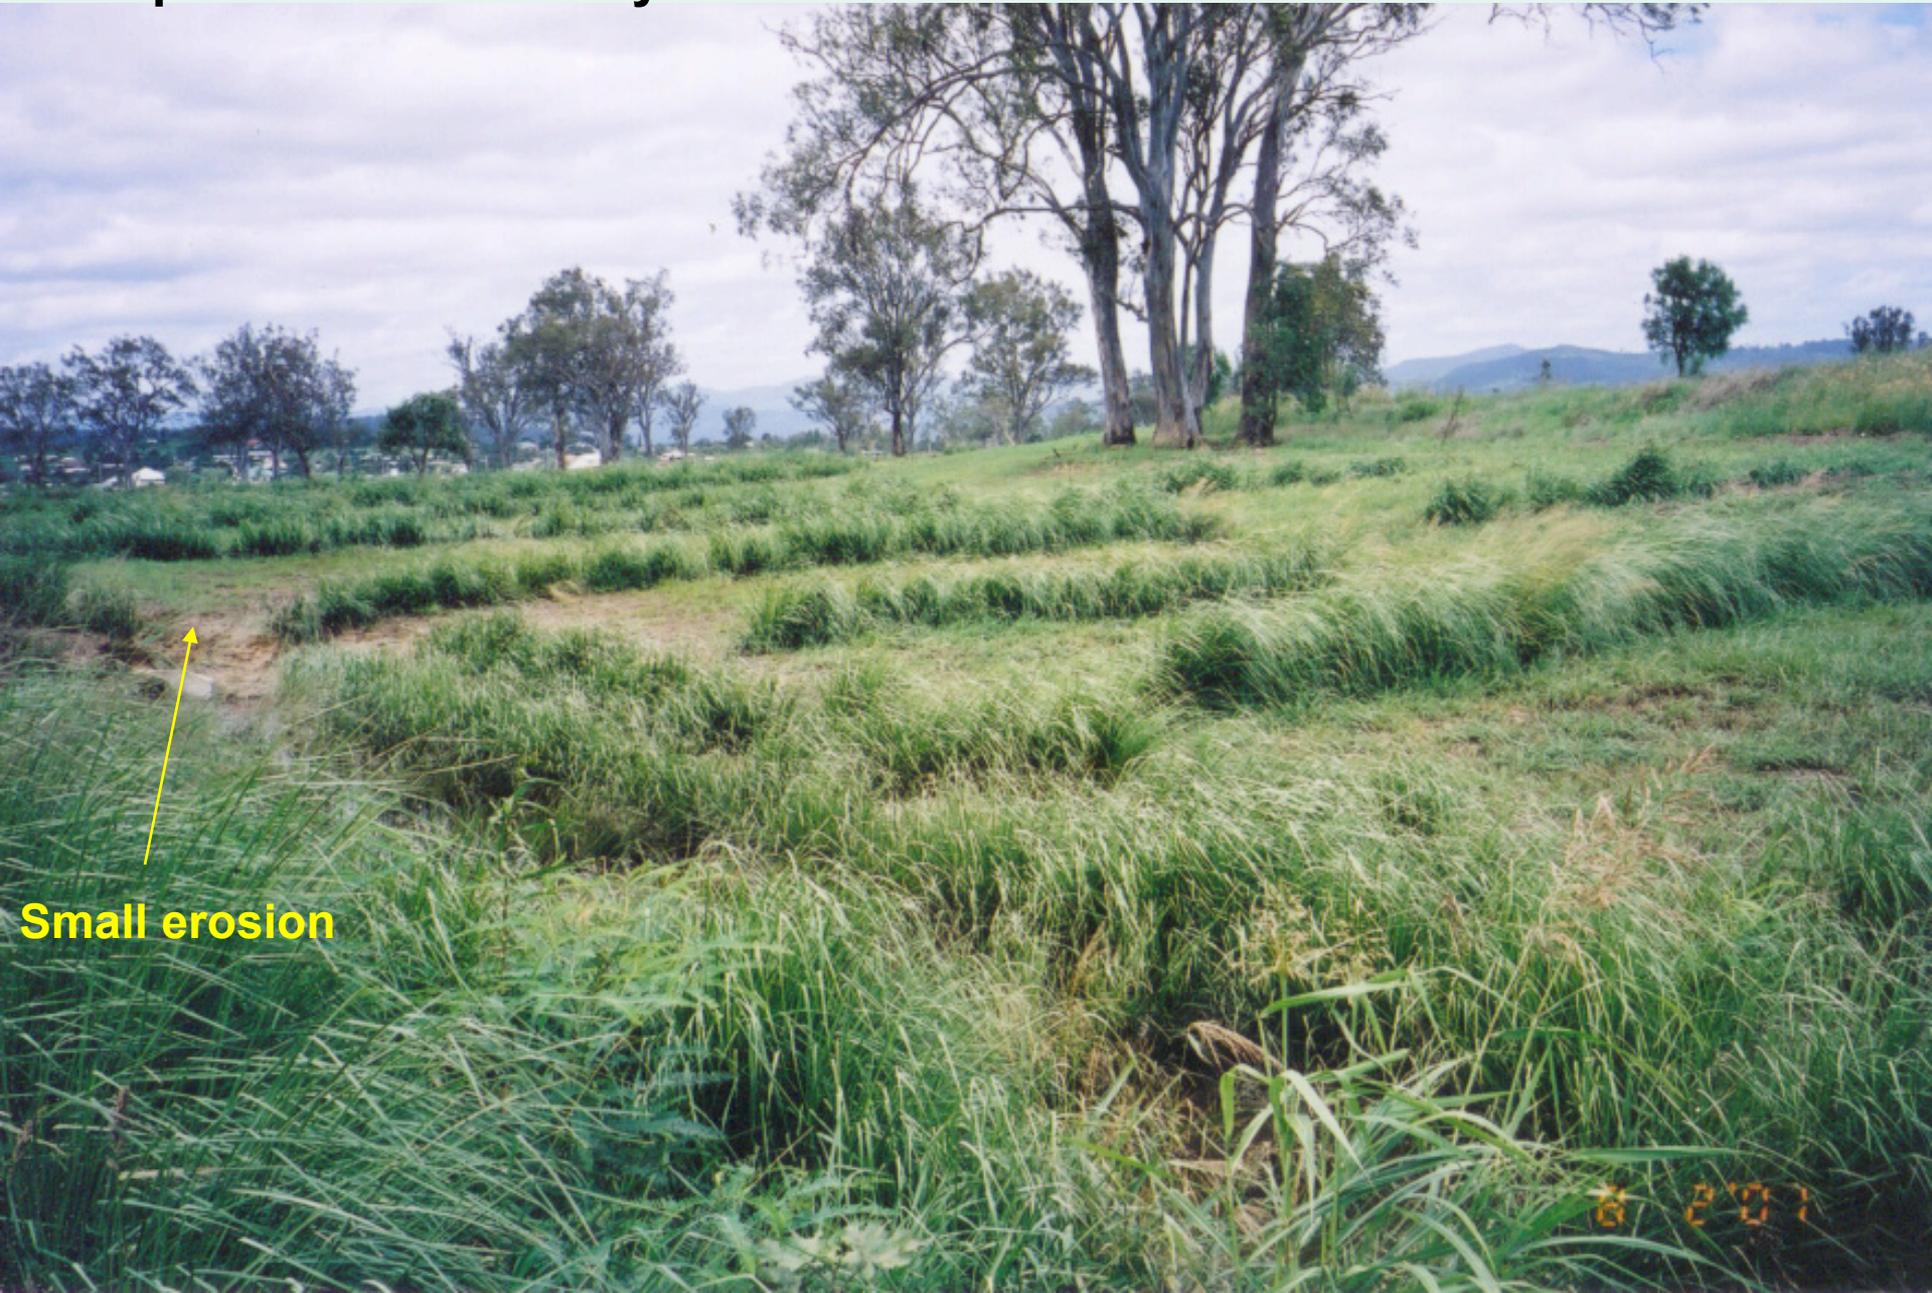
Although only 3 month old, the young hedges provide a very effective protection with only minimal erosion at the head of the channel

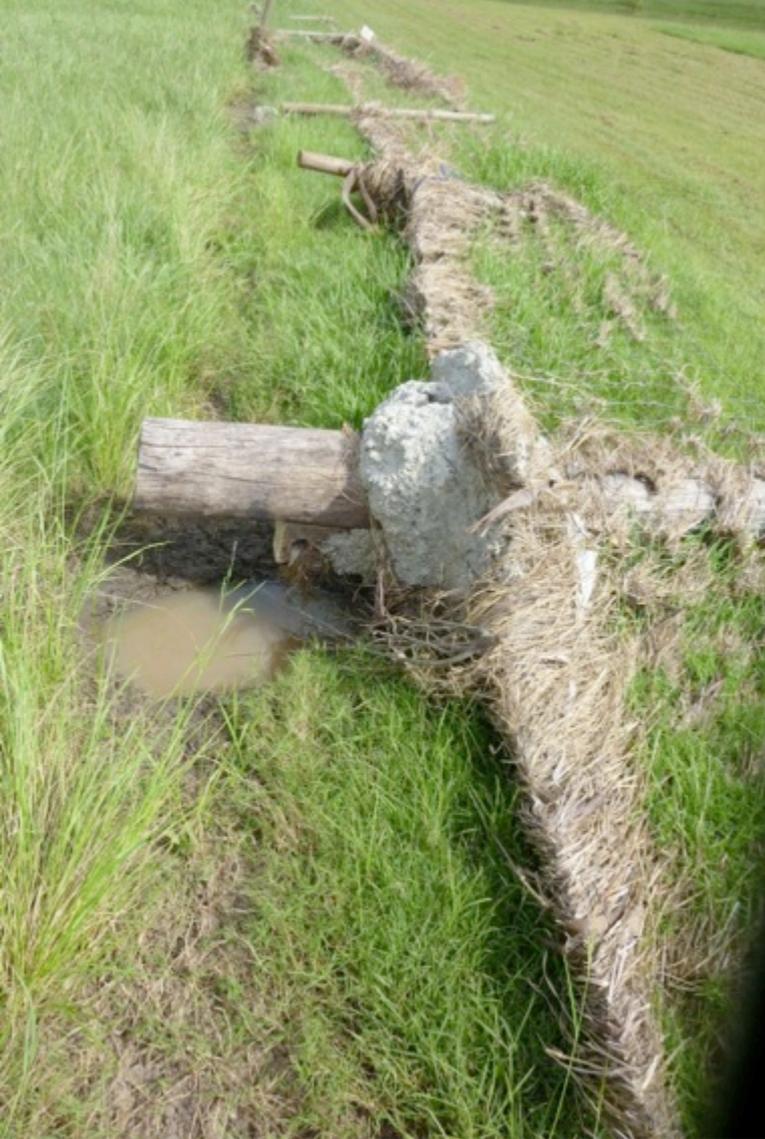
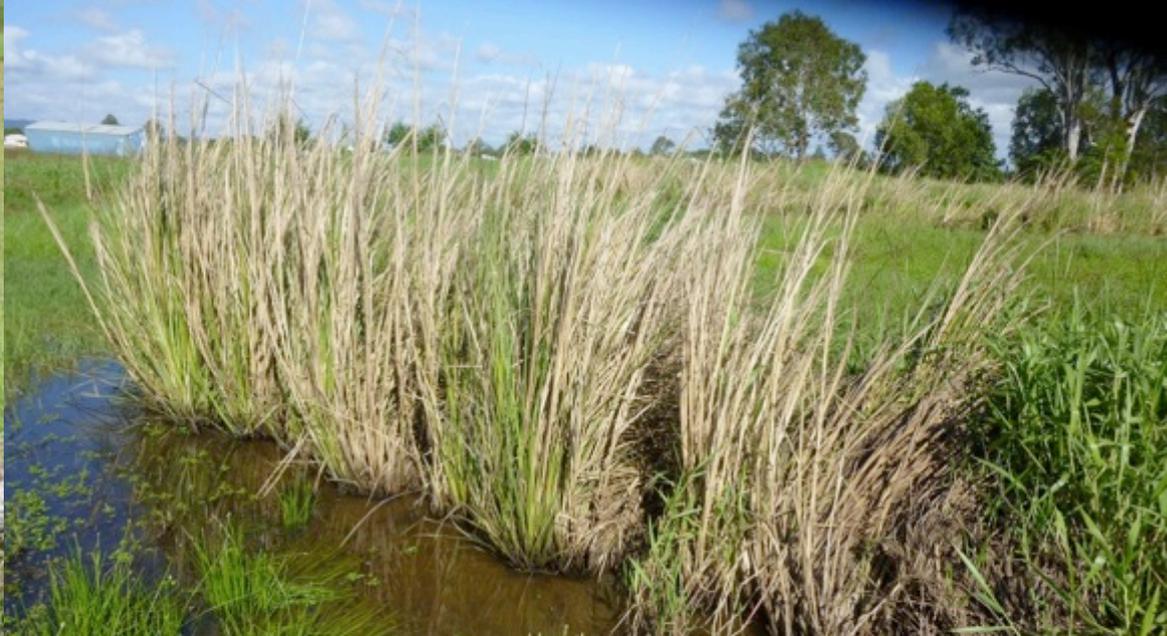
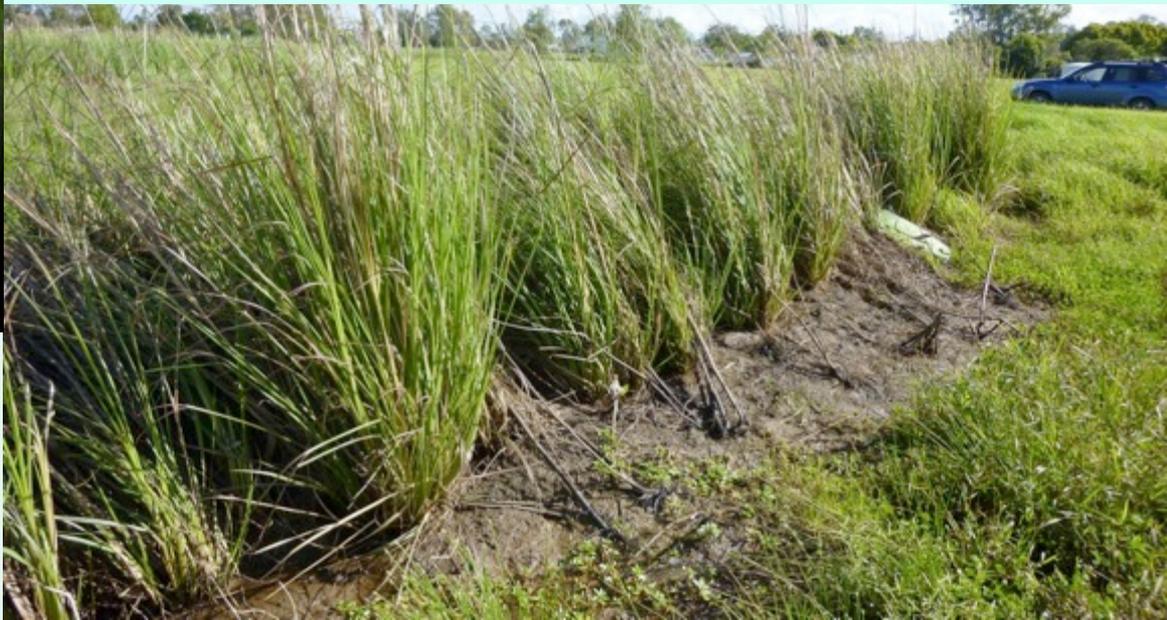
Shipping container from 23km upstream

While little damage to the vetiver, the fence posts were “uprooted”

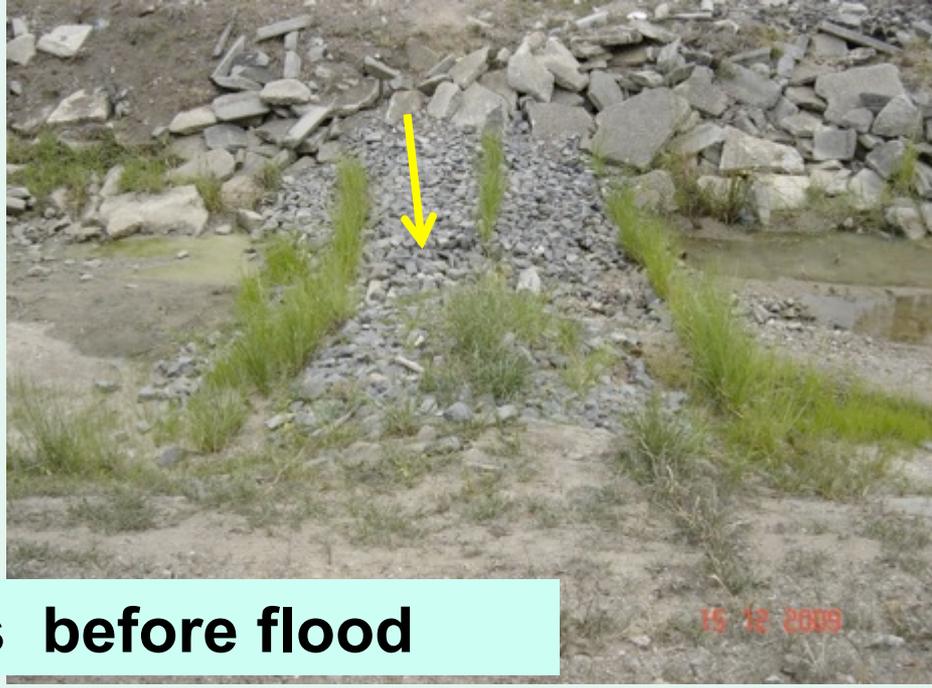
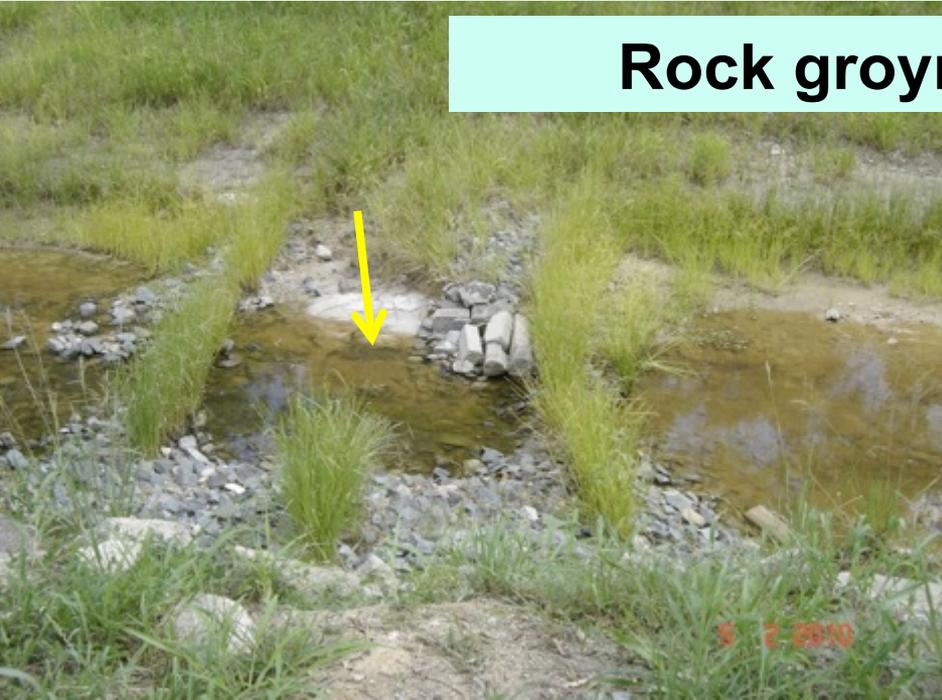
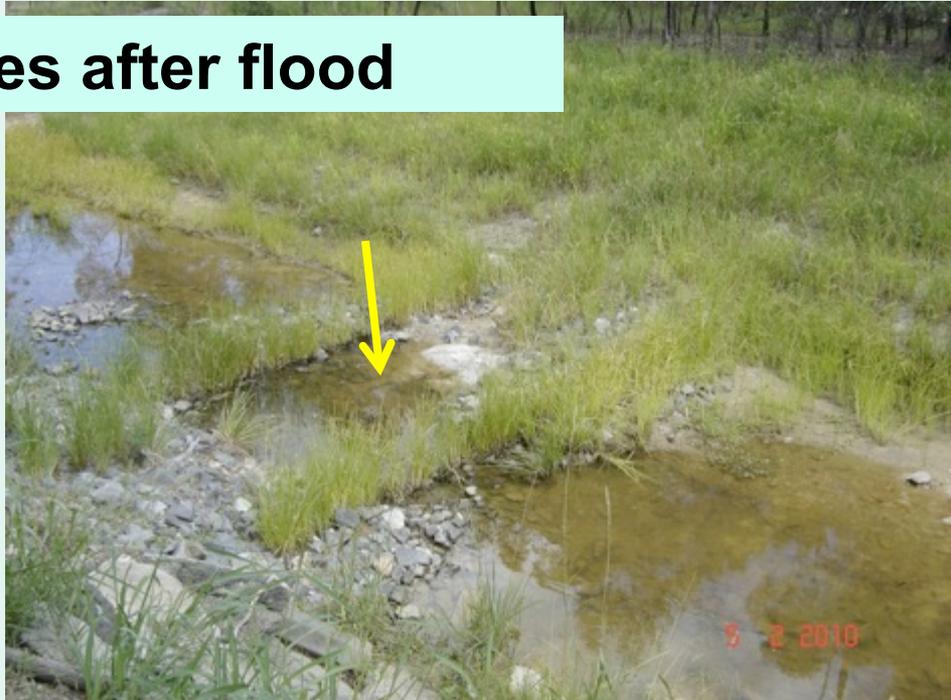
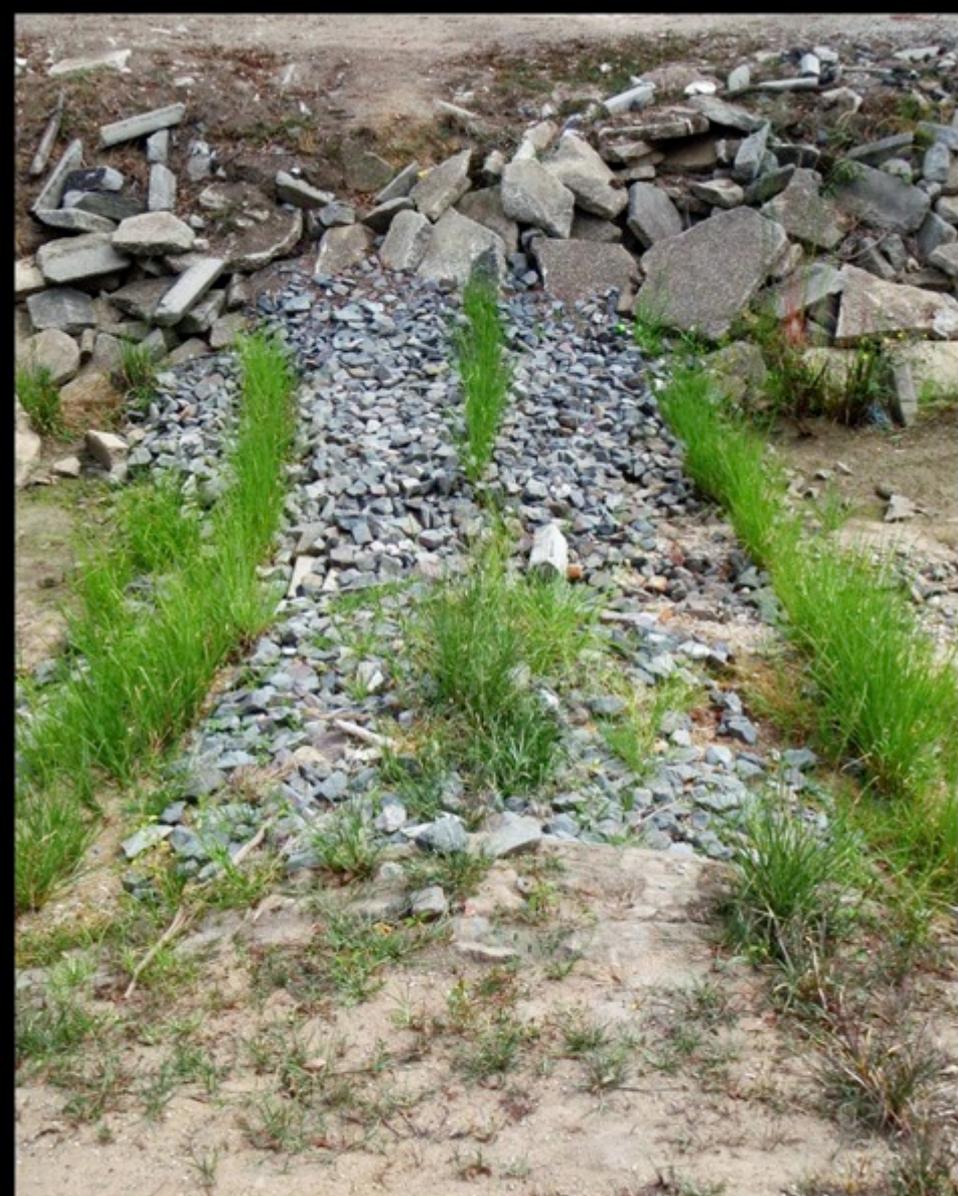
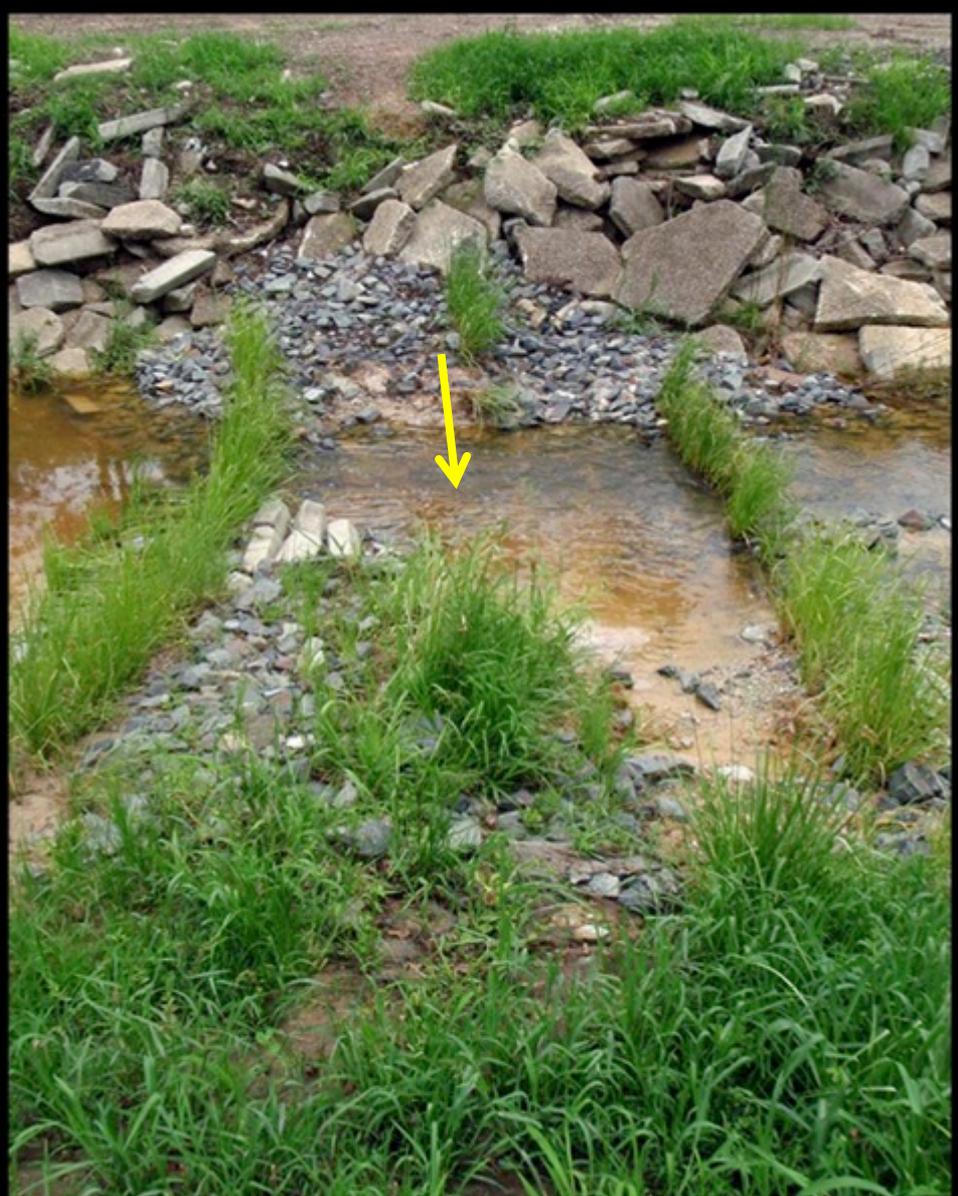
Rock groyne before flood

Rock groyne after flood

Vetiver rows on the edges of the groynes remained intact as its roots reached the soil base, the middle row on the top of the mound was damaged as its roots had not reached the ground

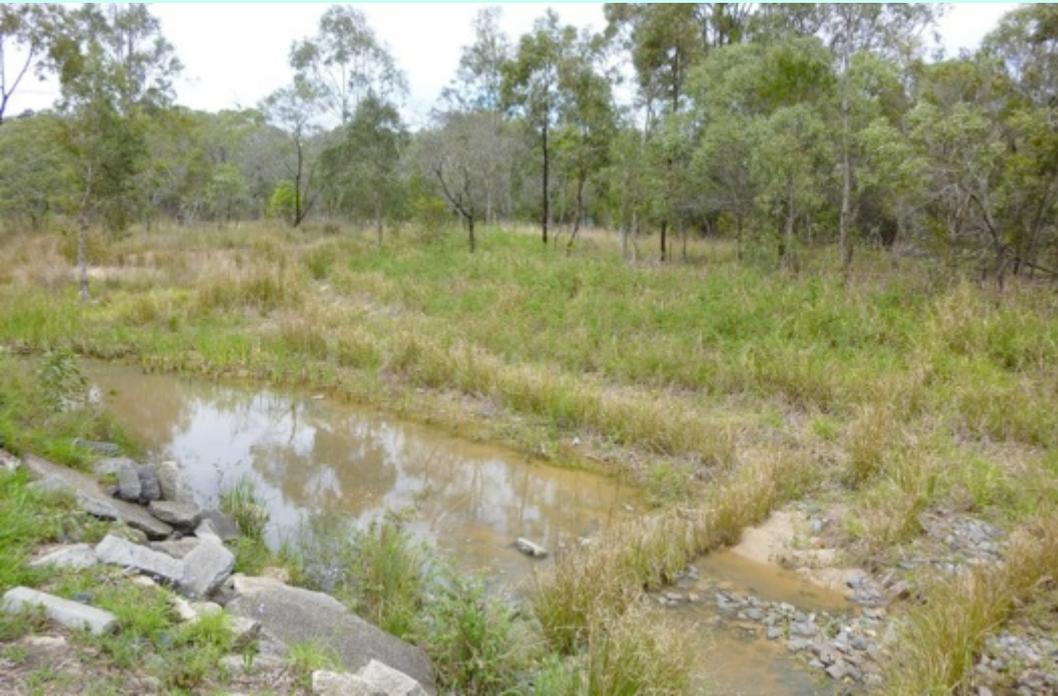
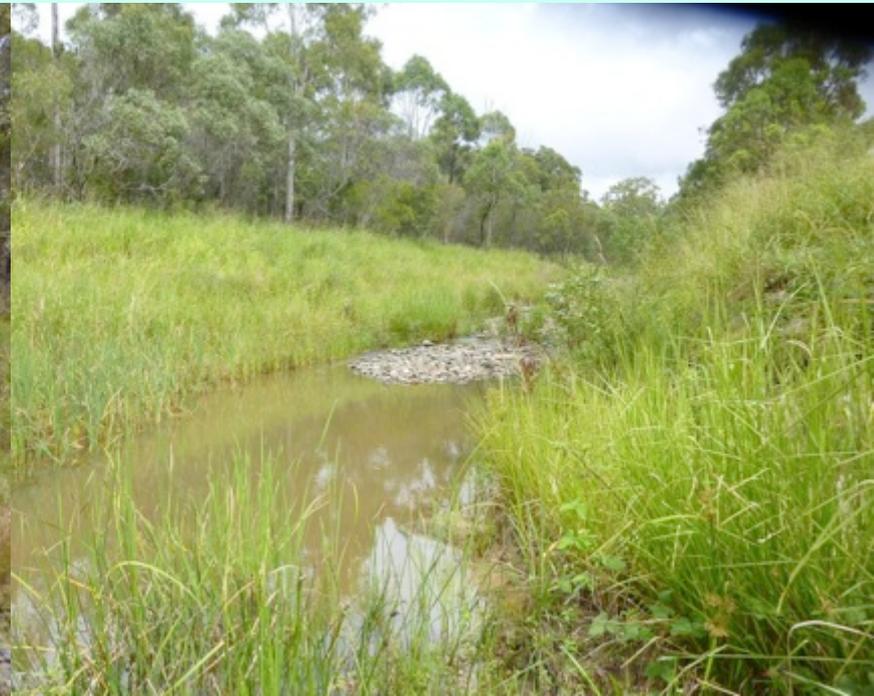
Drain before flood

Drain undamaged after flood

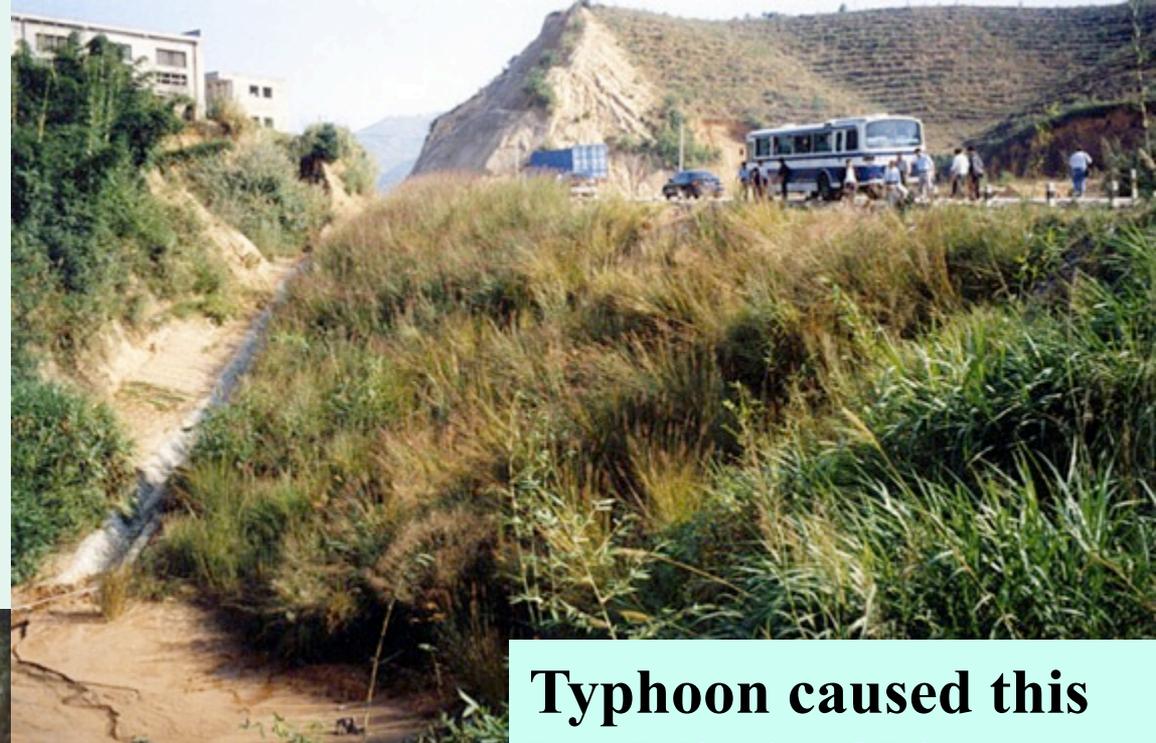
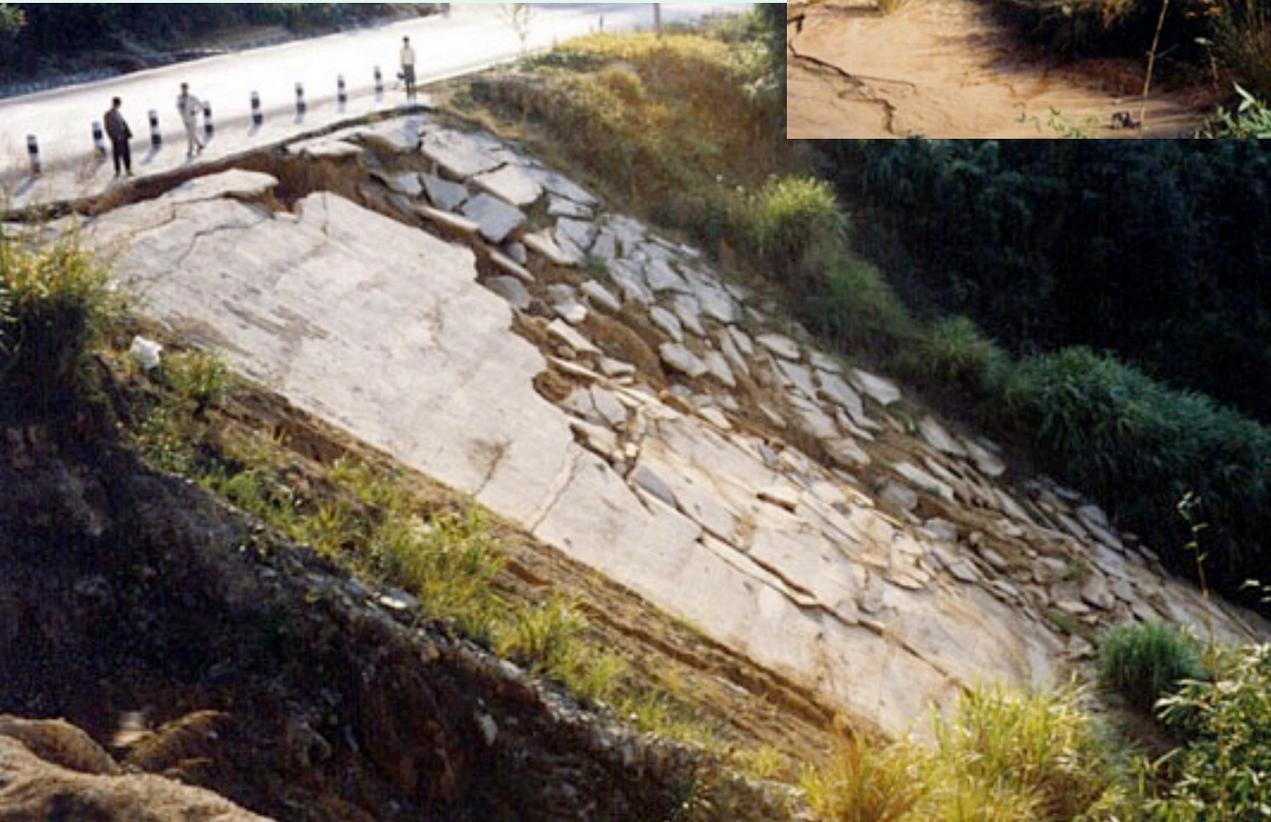
The deep, penetrating and extensive root system that binds the soil, and reinforces the soil structure is ideal for landslip control

Typhoon caused this landslip in China. This conventional cement-concrete engineering structure failed to protect this slope. Vetiver planting near this site provided full protection (above)

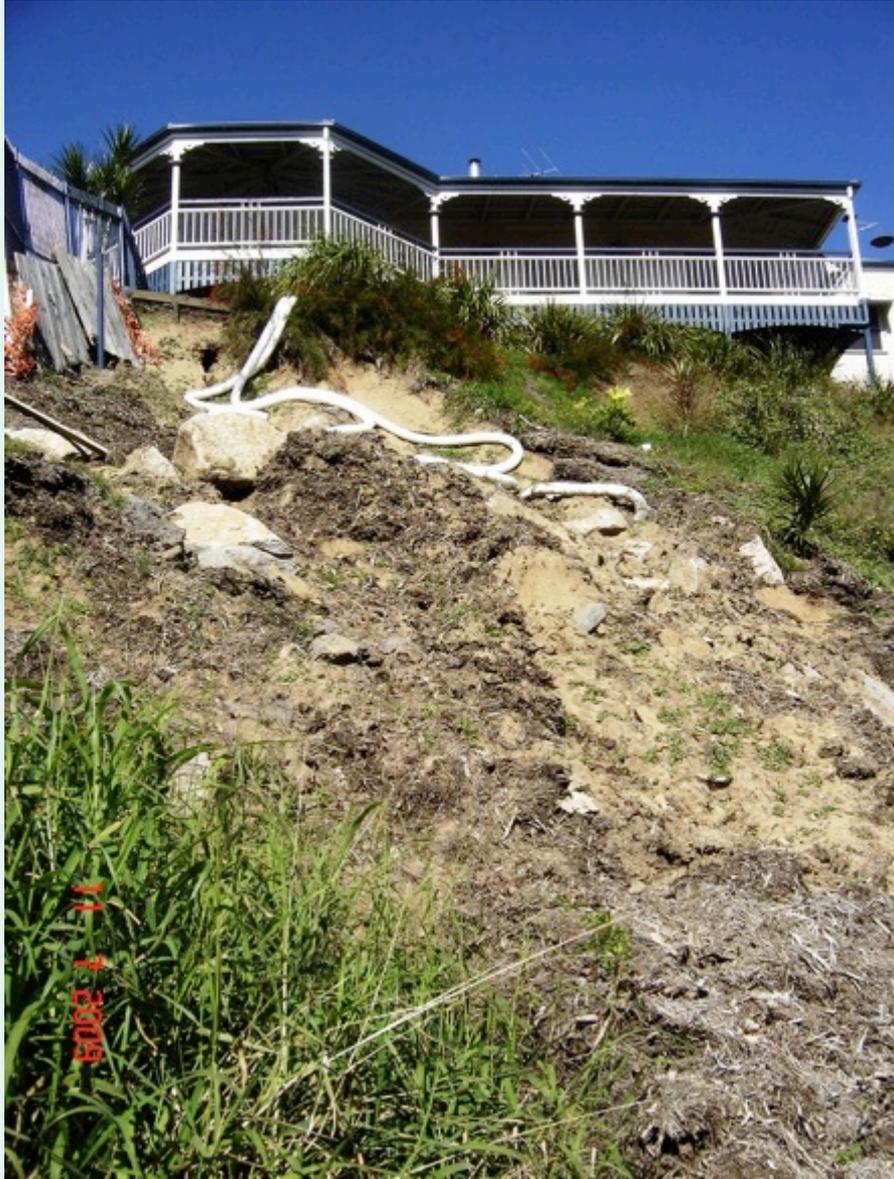
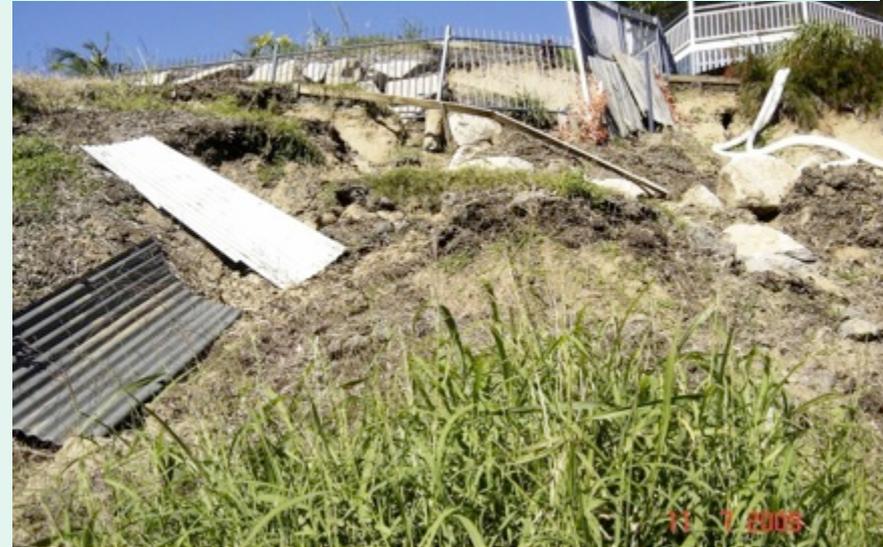
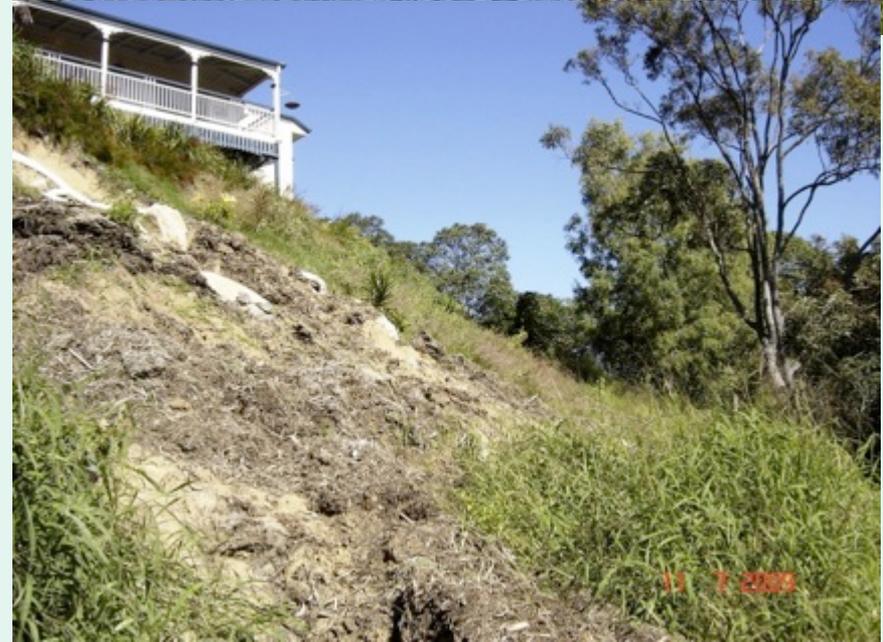
Landslide Prevention at Samford Valley

Landslide caused by a prolonged high intensity storm.

Site preparation and planting before the intense rain in Jan 2011.

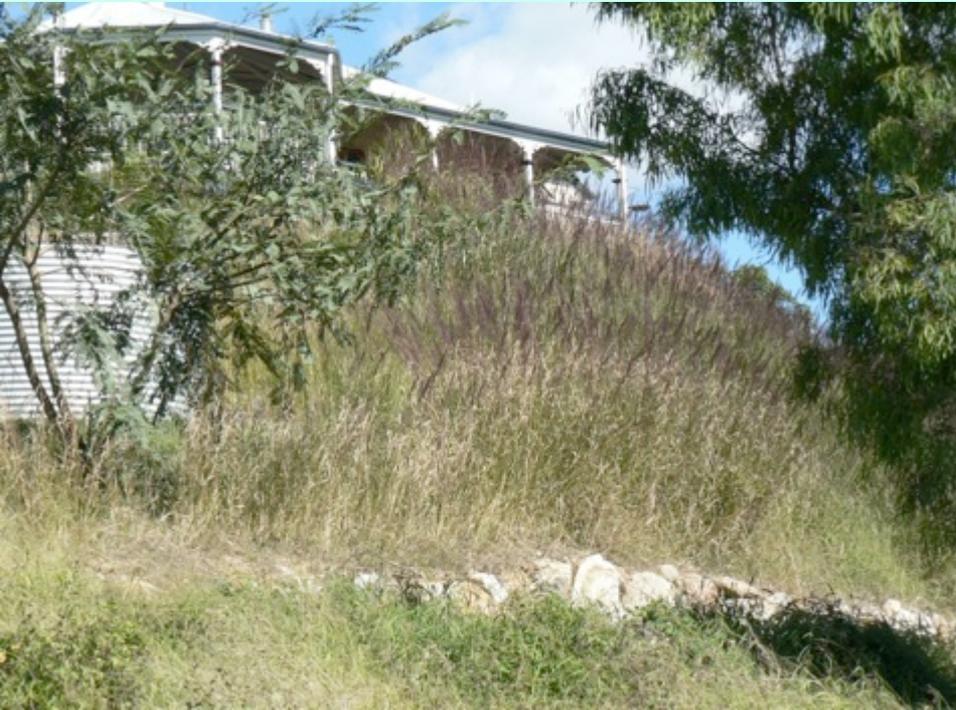
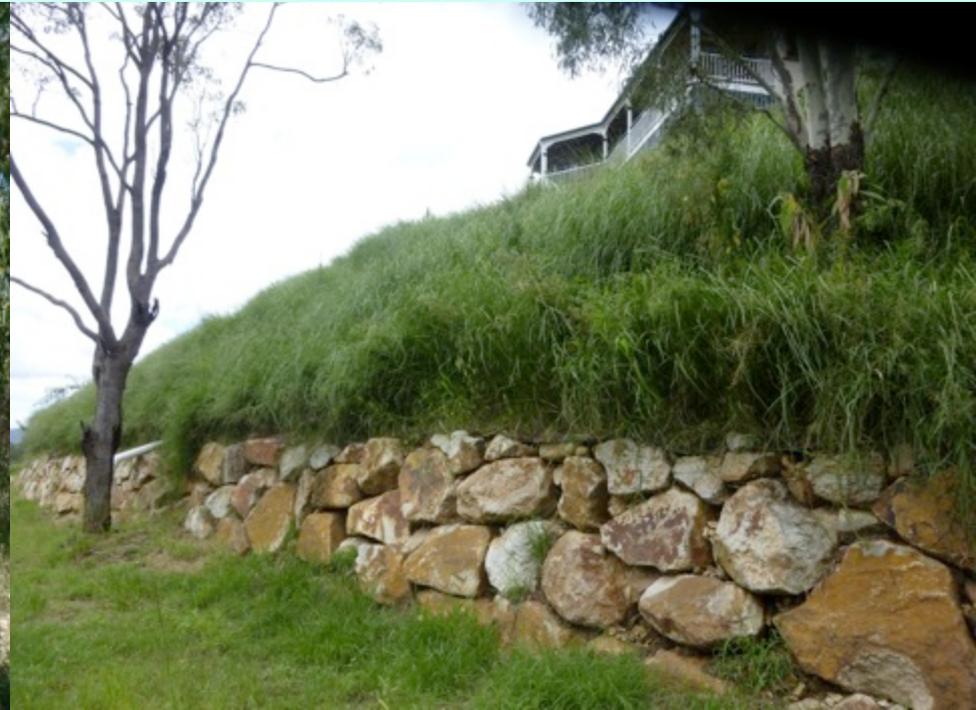
Undamaged by the same record breaking rain

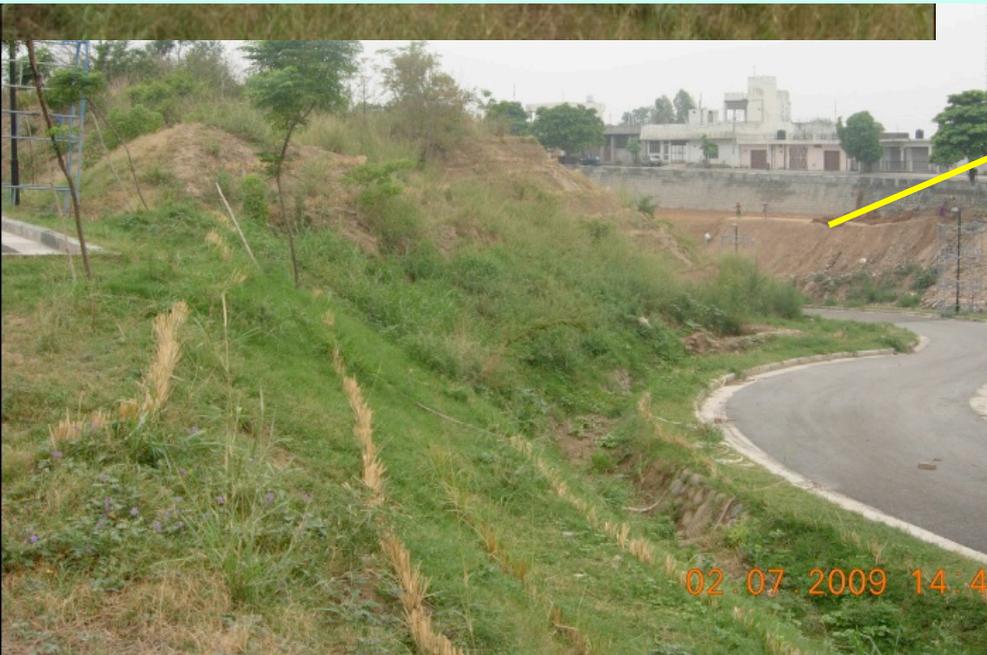
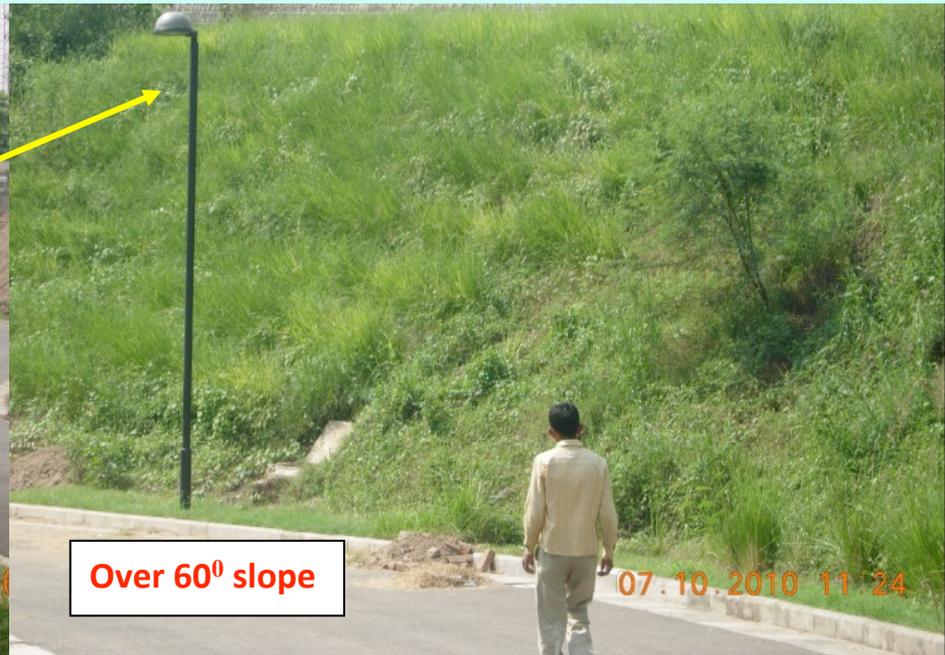
Before and after result of landslide erosion control

Over 60° slope

The site before and after vetiver planting at Noonmati

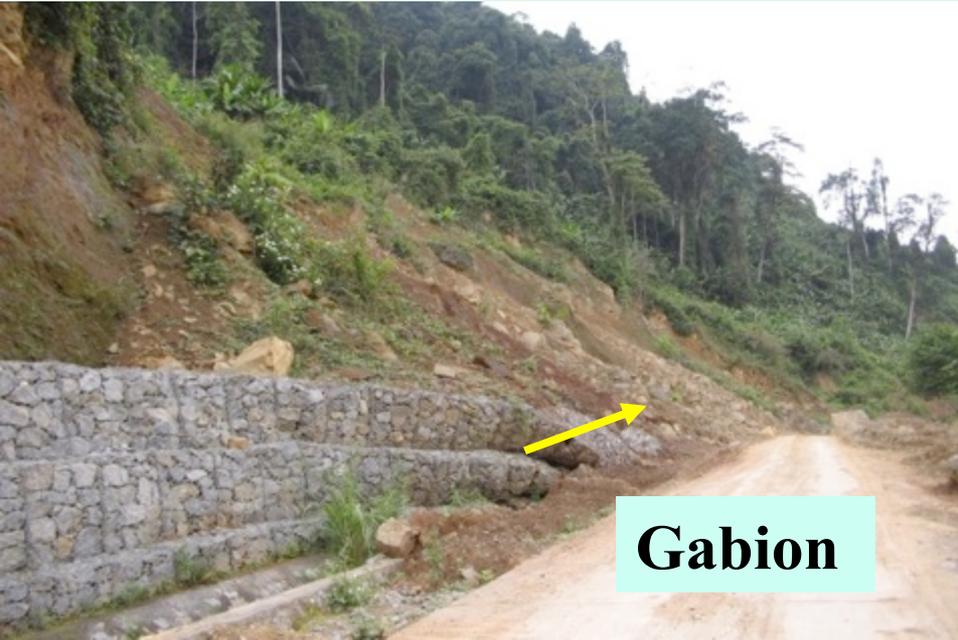
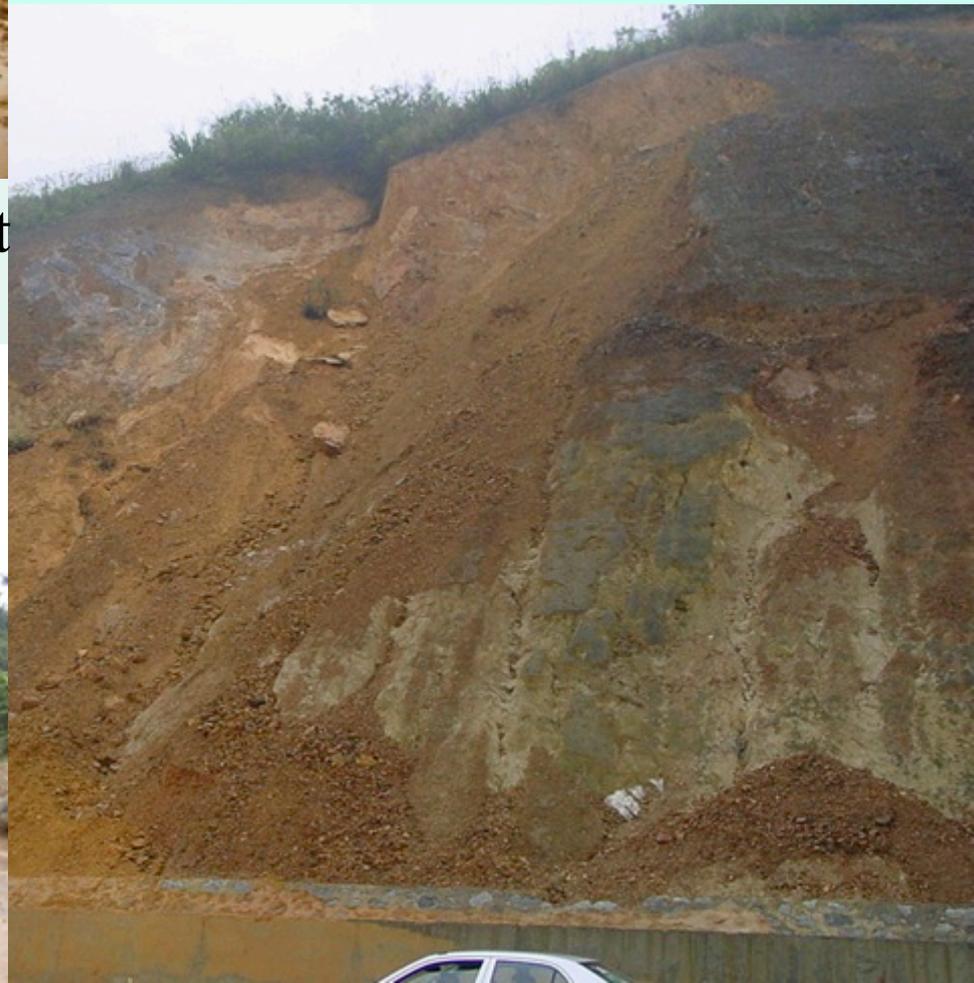
Concrete wall

Traditional rigid structures can not protect the slopes

Gabion
