Global Review of Contribution of VST in Alleviating Climate Change Disasters

Paul Truong

*ICV5 Fifth International Conference on Vetiver
28-30 October 2011, Lucknow, India*

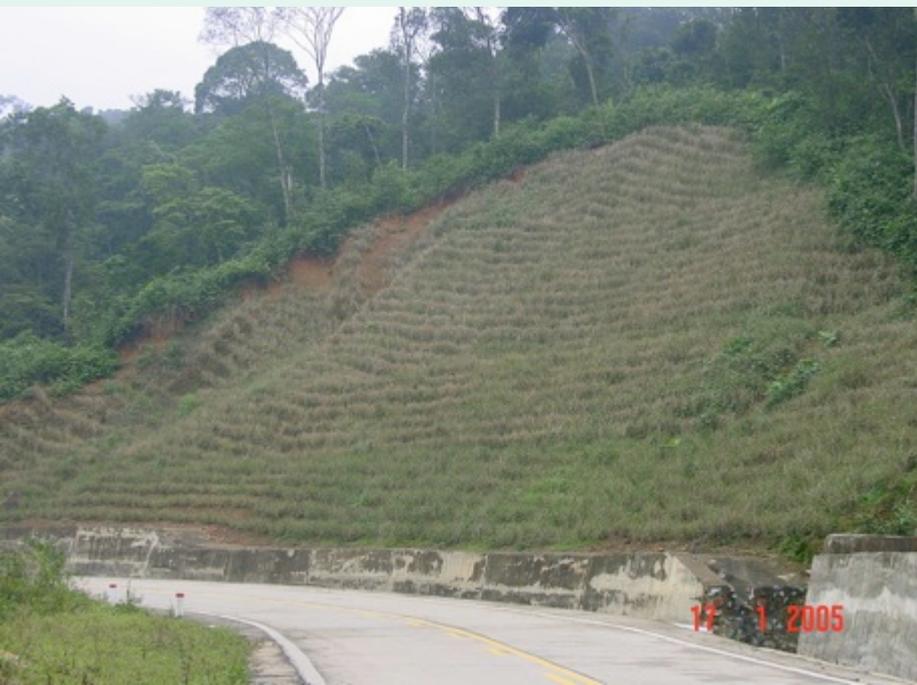
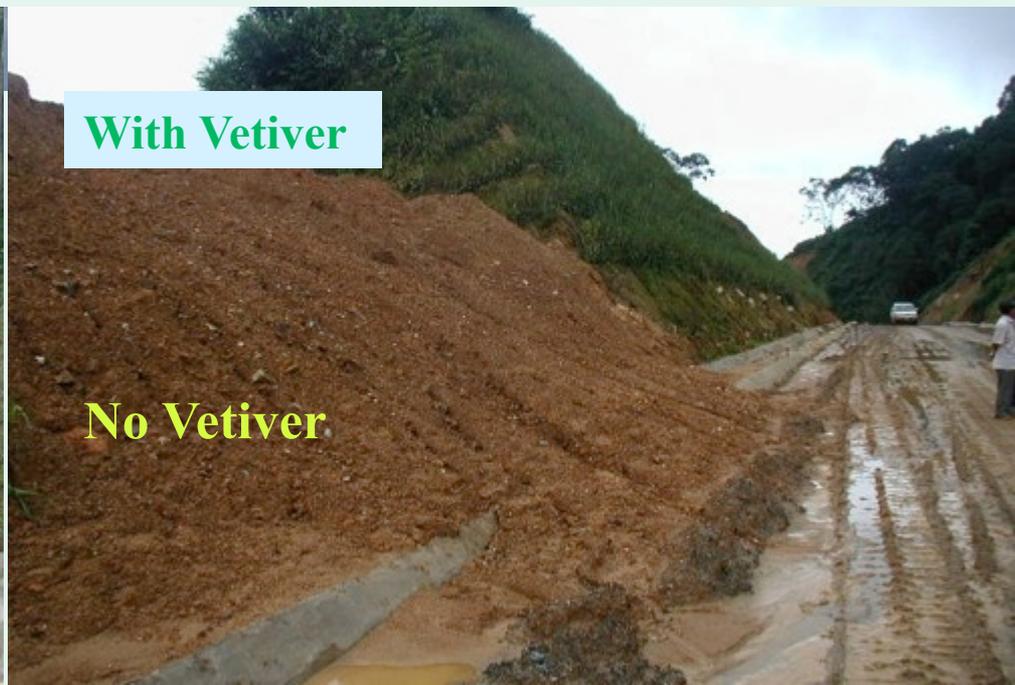
Vetiver is effective low cost to build and maintain

With Vetiver

No Vetiver

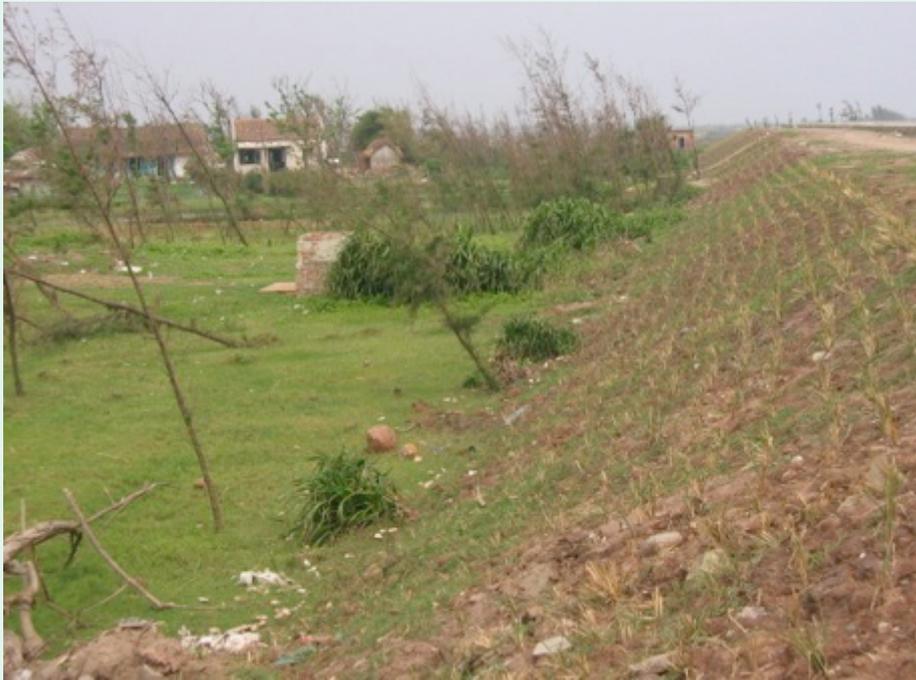
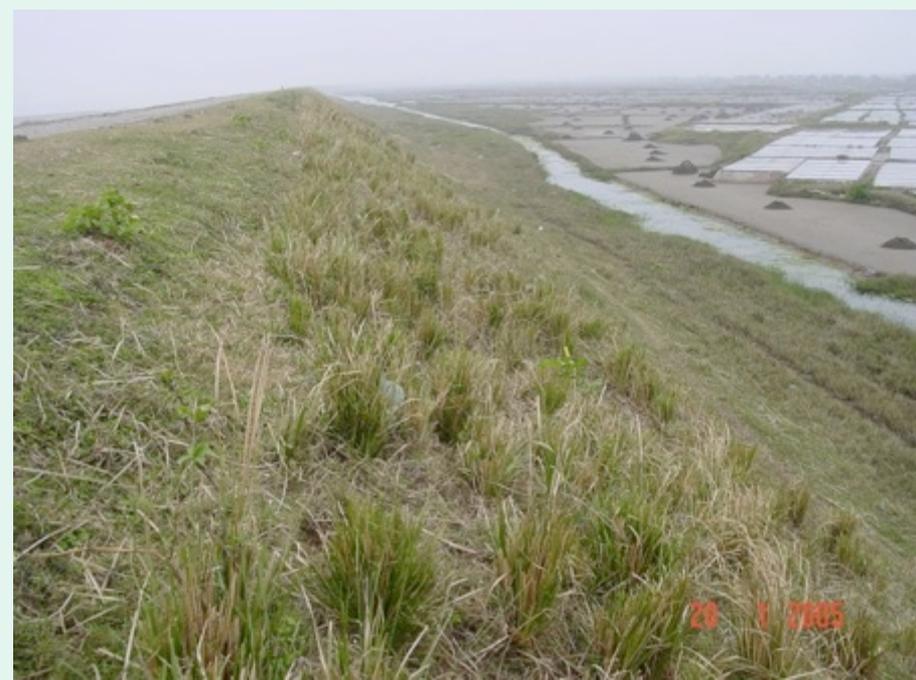
VIETNAM: Coastal sea dikes protection

Typhoon storm surges destroyed sea dikes and levees

Vetiver planting provided effective protection on a large sea dike

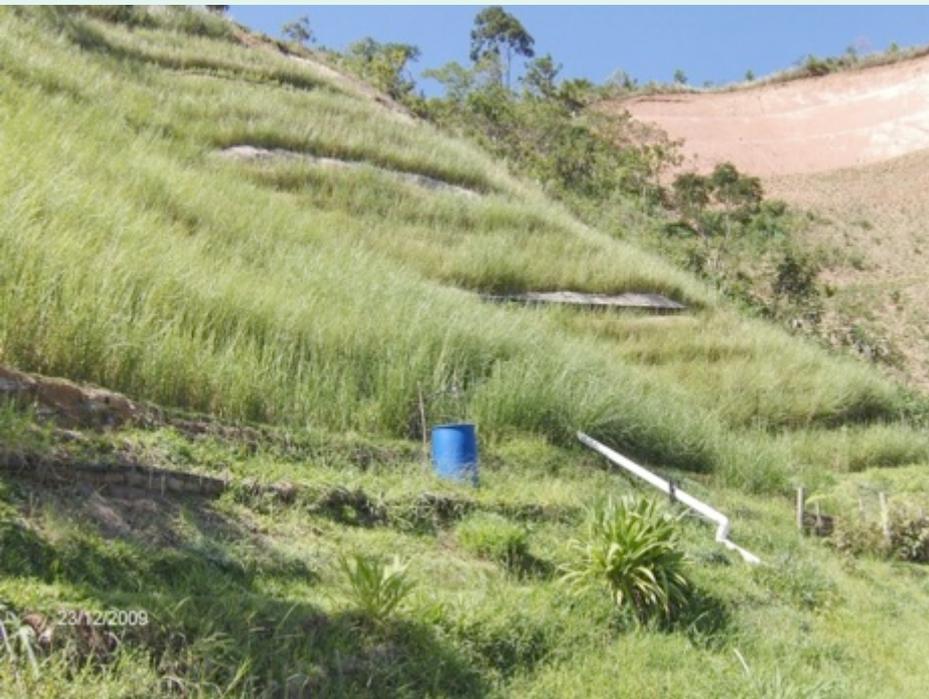
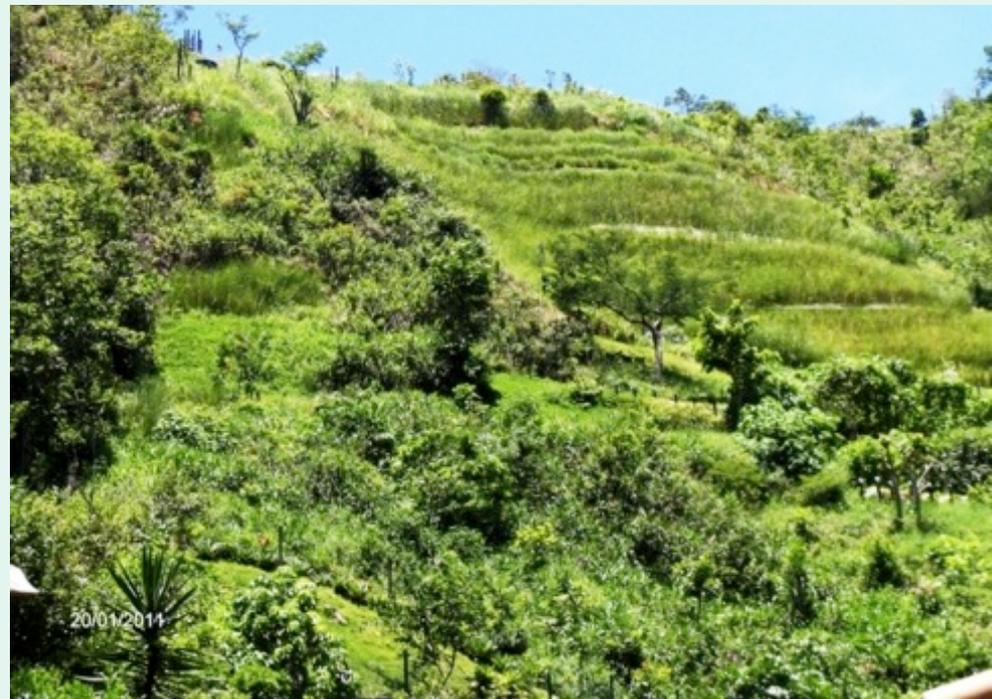
Brazil: Landslide at Itaipava, Petropolis, Rio de Janeiro

Vetiver planting has successfully stabilized this landslide

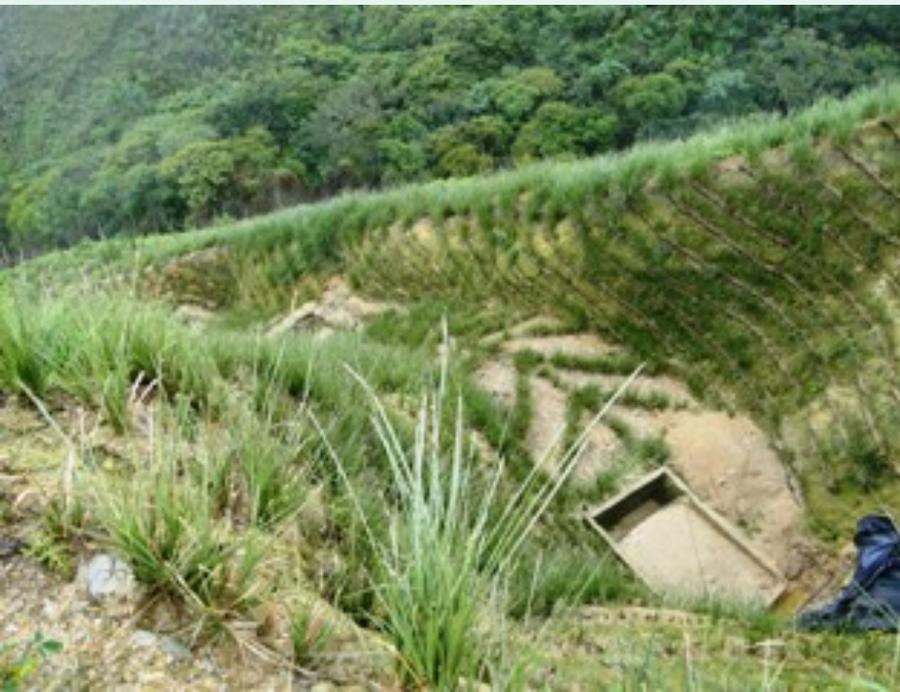
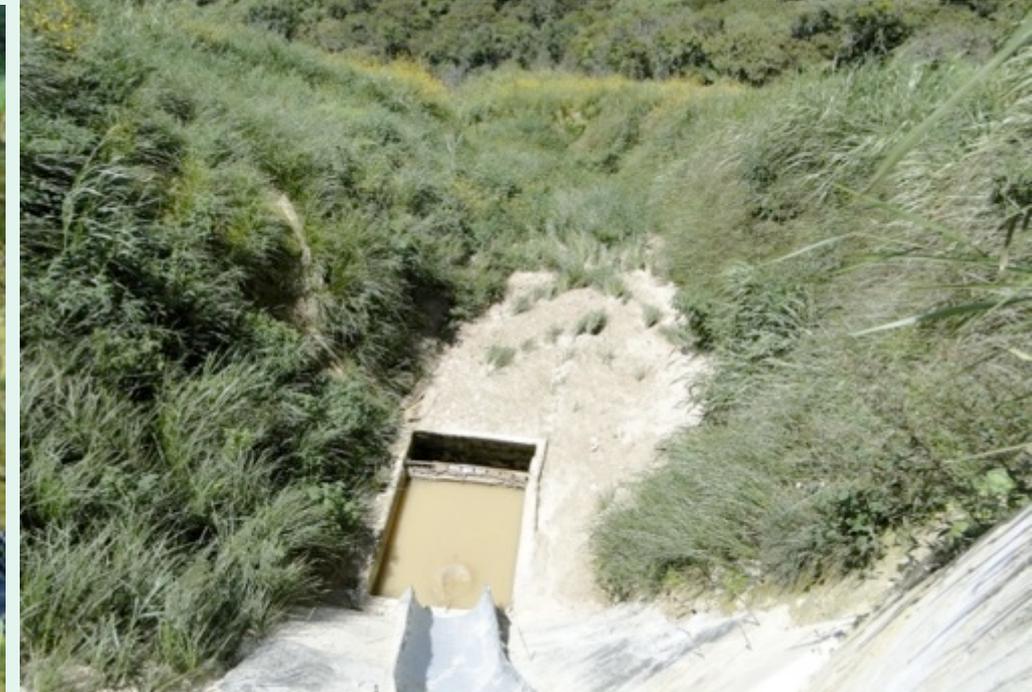
Venezuela: Landslide

Vetiver planting has successfully stabilized this landslide

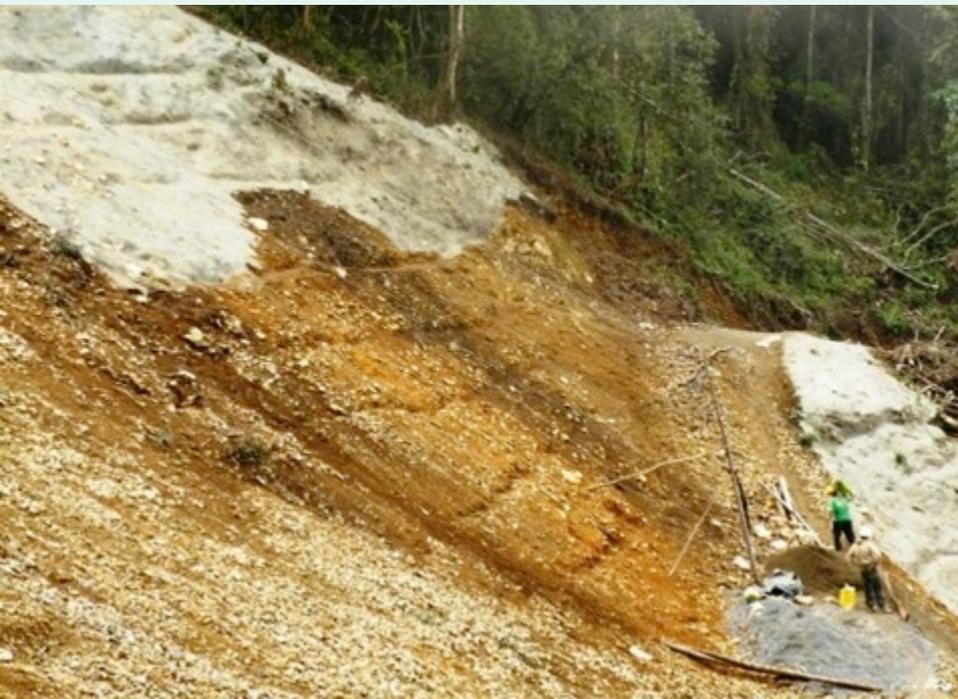
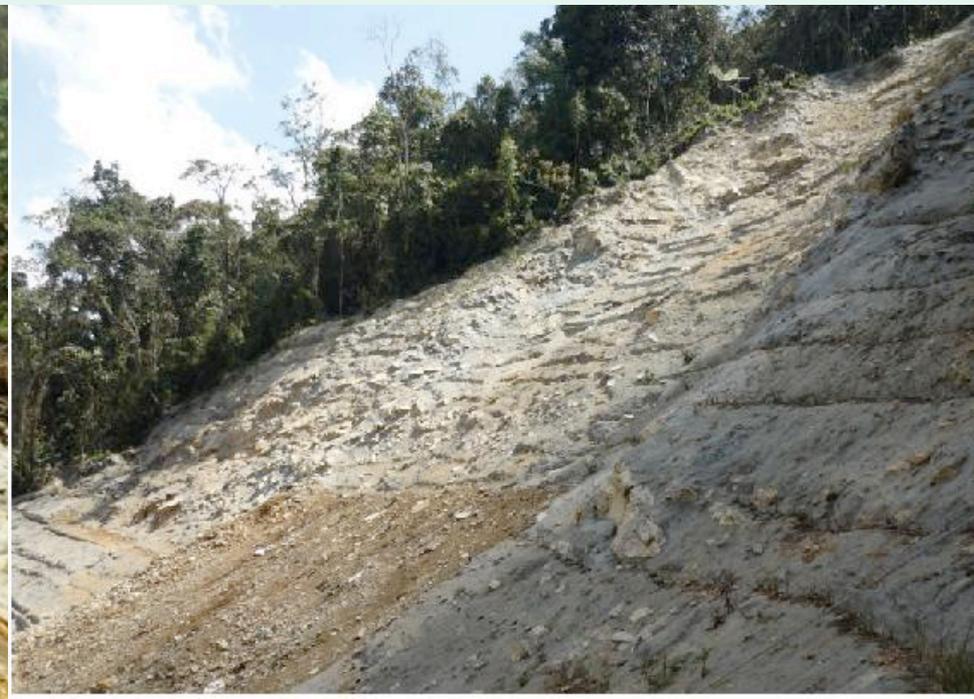
Colombia: Landslides rehabilitation using Ecomortar

Vetiver planting has successfully stabilized this landslide
