**Integration of the Vetiver System within Conventional Erosion Control
Technologies in Brazzaville, Republic of the Congo**
Alain N'Dona
Kinshasa, Democratic Republic of the Congo

Brazzaville, the capital of the Republic of Congo, has experienced worsening damage caused by soil erosion in the last decade.

To demonstrate this, three sites in the northern part of Brazzaville (Casis, Pylône and Boukeni) were chosen to test this new anti-erosion integrated approach. Thus, the combination of bioengineering techniques (planting of vetiver) and conventional techniques of erosion control (construction of drains, terramesh retaining walls, gabions, slope benching and reshaping, the use of sandbags etc...) provided a more effective anti-erosion control system as well as a means to protect the conventional engineering works.

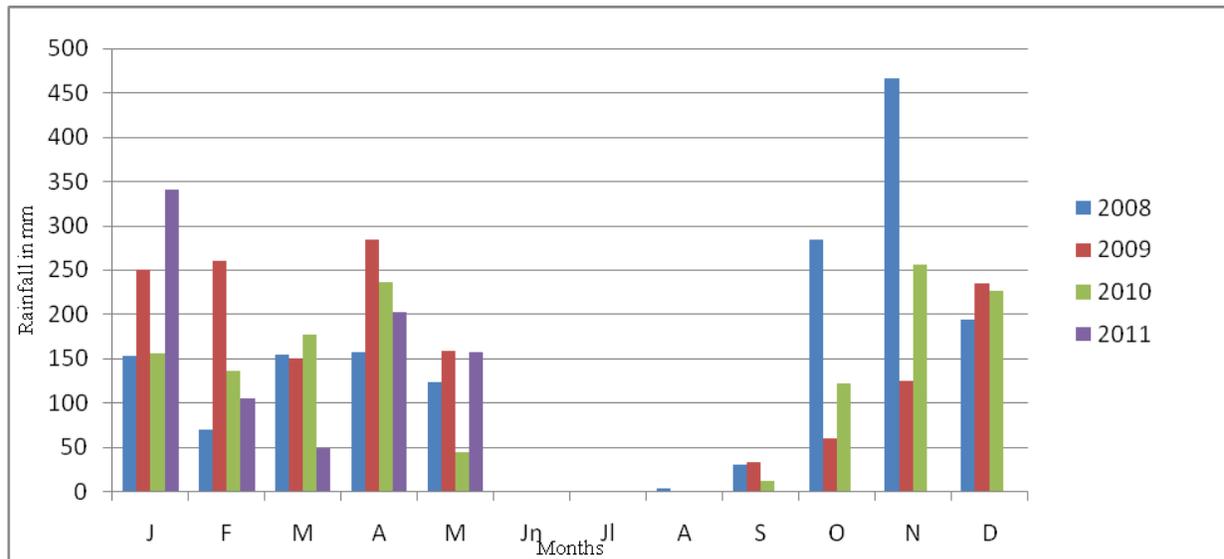
Figure I: Monthly rainfall, 2008 through May 2011

Regarding rains, the figure I below shows the monthly average rainfall in Brazzaville from 2008 through May 2011 (ANAC, 2008, 2009, 2010 and 2011).

The average monthly rainfall amounts as shown in the above graph do not give any indication of the rainfall intensity within each rainfall event capable of creating erosive damage. For this reason, Table II below shows for each year, the number of rain events with the corresponding quality of rainfall per event measured in millimetres (mm).

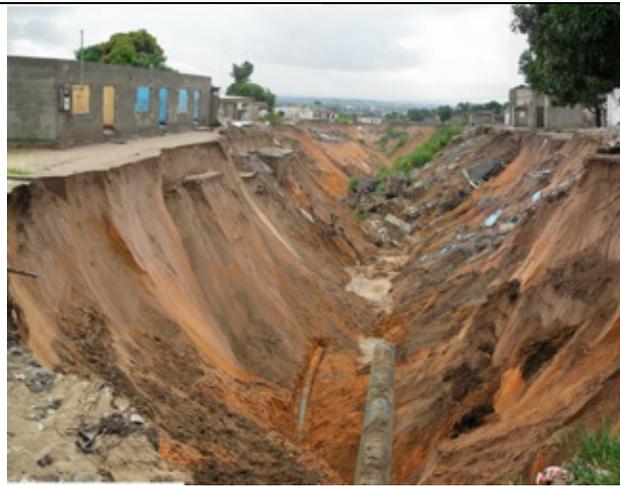
Photo 1: Initial status at the Boukeni ravine, before placing sandbags and planting vetiver

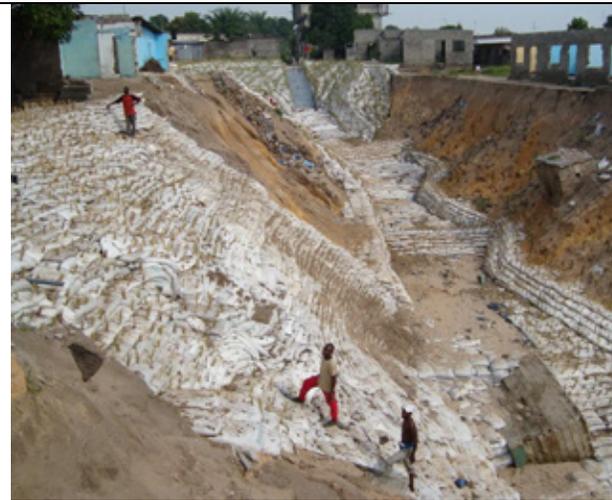
Photo 2: Placing bags containing topsoil and vetiver planting on the Boukeni site (February 2009)

From Table II the vetiver vegetative coverage of the slopes and embankments has significantly increased from 0 to 100% on all three sites beginning in the first quarter of the first year (2009) through the first quarter of the third year (2011). For the Boukeni site, coverage was very fast 2% at planting in the first quarter 2009 to 100% at the end of the 4th quarter of that same year. This is portrayed in Photos 2, 3 and 4 below.

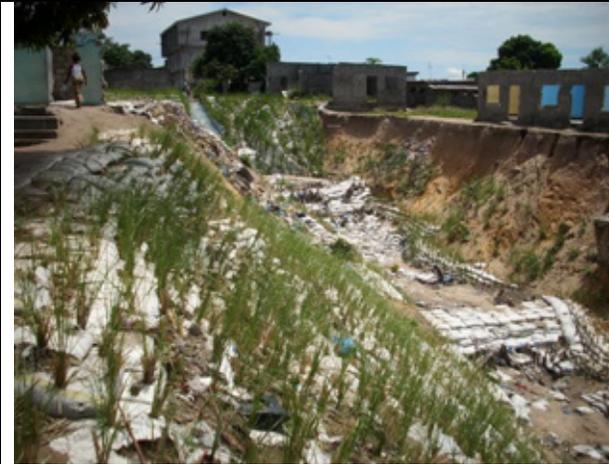
Photo 3: The Boukeni site 2 months after planting vetiver directly into the bags of topsoil (April 2009)

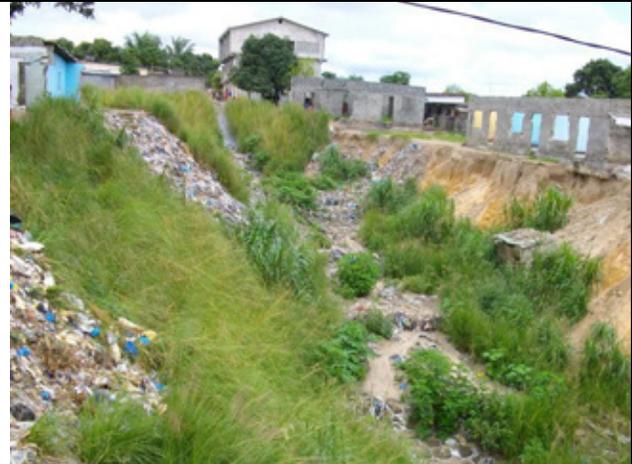
Photo 4: Status of the vetiver cover at Boukeni 10 months after planting (November 2009)

This rapid development compared to the other two sites is attributed not only to the fact that the Boukeni vetiver planting occurred earlier (in the middle of the first quarter of 2009) as compared to the other two sites (Pylône Q2 and Casis Q4), but also because of the presence of topsoil in the bags into which the vetiver slips were planted. There was also more organic matter after the decomposition of garbage that was frequently thrown into the ravine by Boukeni residents. The decomposition of such waste created humus of very good quality at Boukeni, unlike the very poor soils at both Casis and Pylône, both devoid of organic matter to a large extent. Indeed, a soil that is rich in organic matter and nitrogen allows for rapid vetiver development (Ndona et al., 2006, Ndona, 2009).

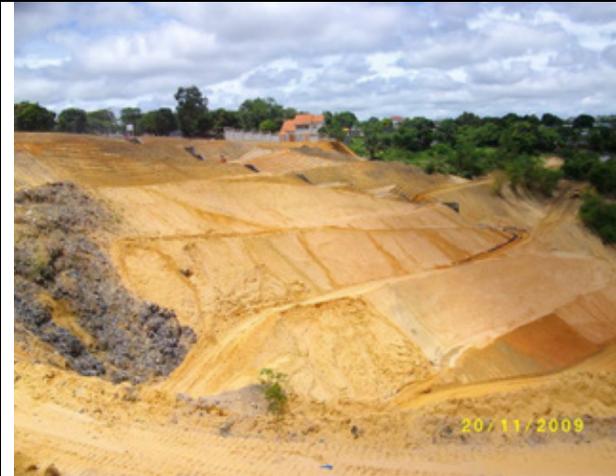
Photo 5: Planting vetiver at the Casis site Nov. 2009

None the less, despite the poor soil quality at Casis and Pylône, the plant cover development increased to 100% between Q1 2010 and Q1 2011 as shown in Photos 5, 6 and 7 for the Casis site and between Q4 2009 and Q1 2011 for the Pylône site, illustrated by Photos 8 and 9. It should be noted that the Casis and Pylône sites received fertilizer applications (NPK 17-17-17) and urea (46% N). This further confirms the recommendations made by Ndona et al. (2006) and Ndona, (2009) on the positive effects of fertilization on low fertility soils and the good vetiver response to these treatments with respect to biomass formation.

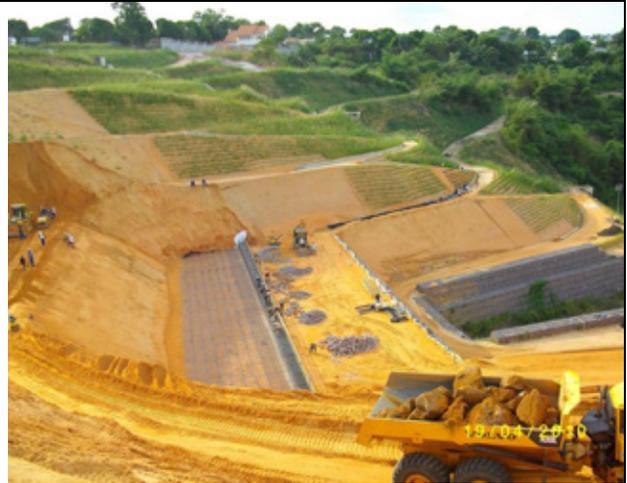
Photo 6: The Casis site five months after planting vetiver on part of the site (April 2010)

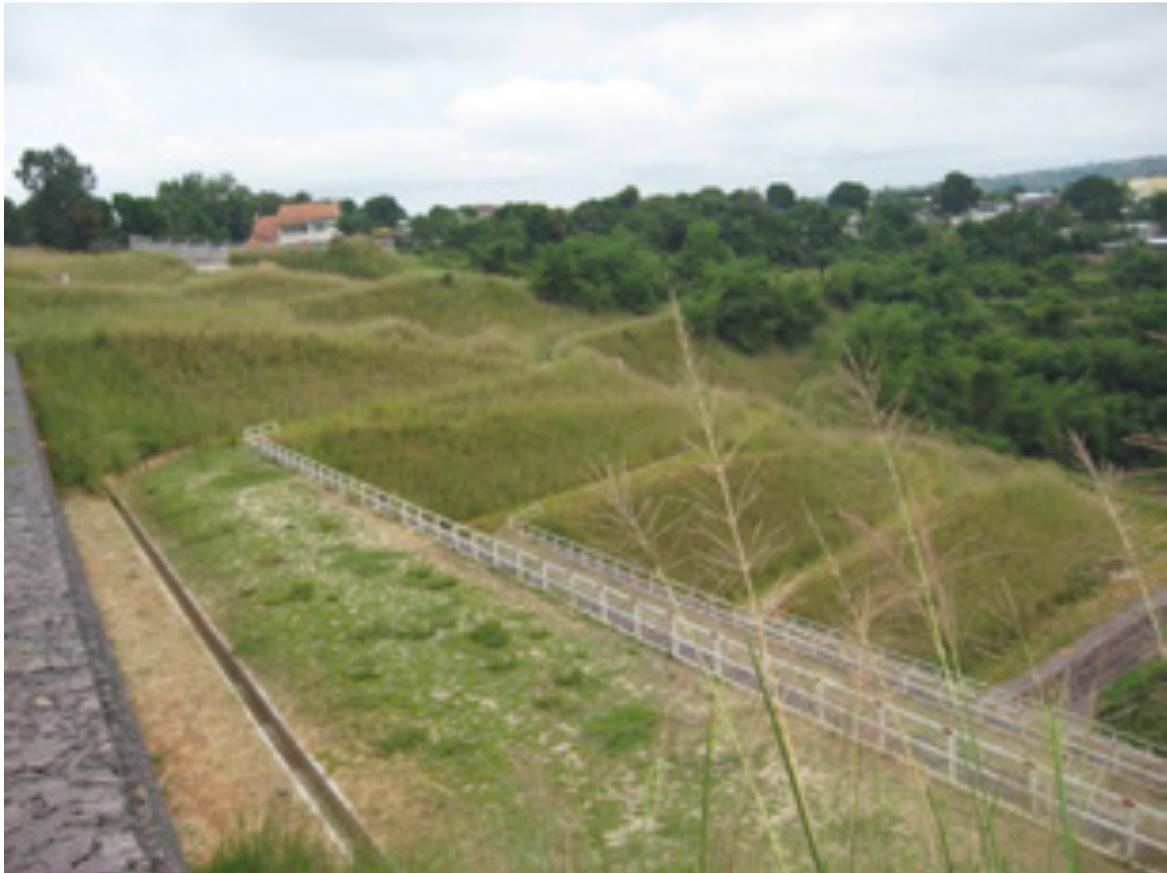
Photo 7. The Casis site 17 months after planting vetiver on parts of the site (May 2011)

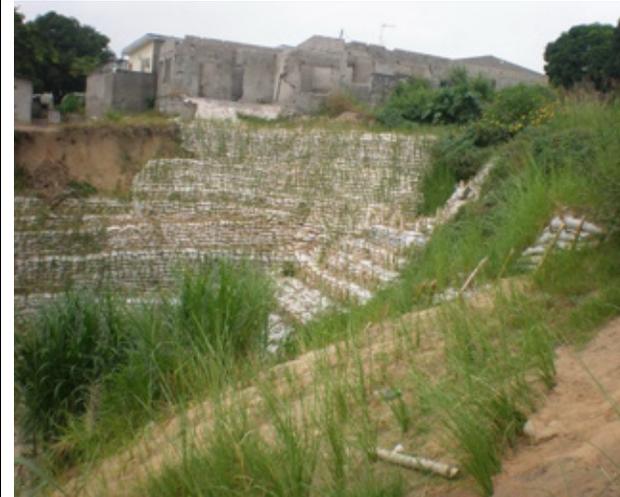
Photo 8: The Pylôn site two months after planting vetiver on parts of the site (June 2009)

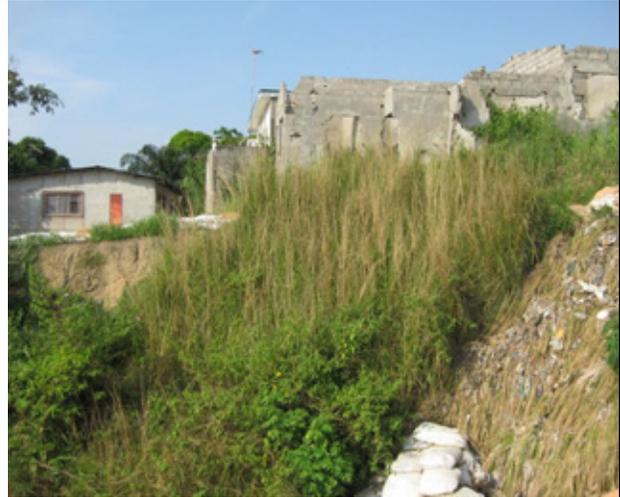
Photo 9: The Pylône site 23 months after planting vetiver (May 2011)

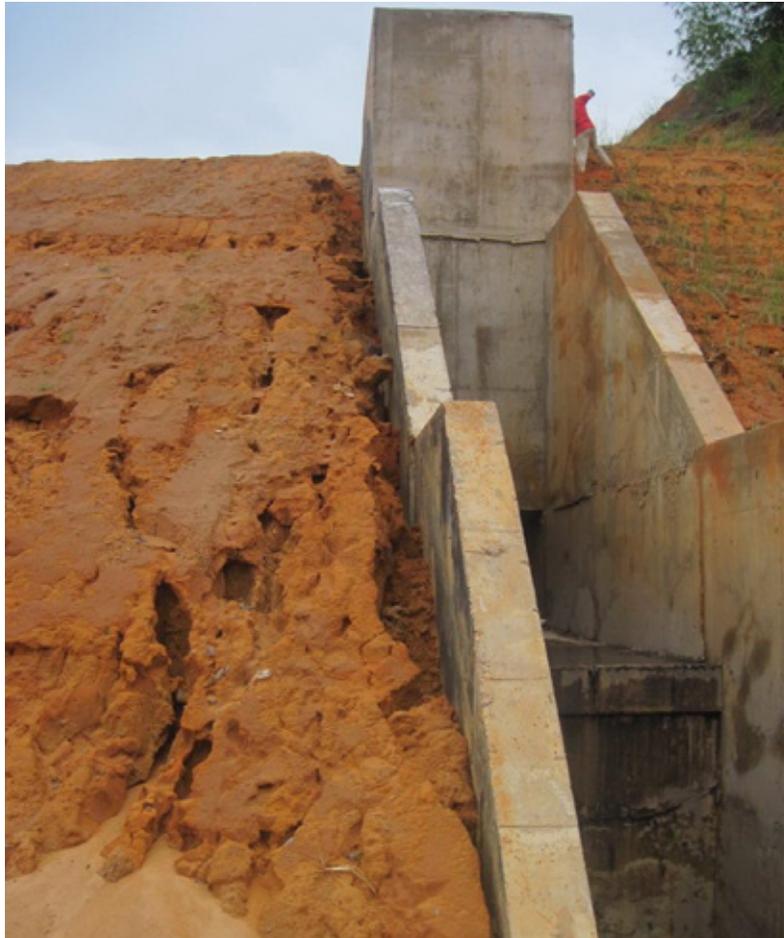
Photo 10: Damage on the slopes and embankments adjacent to the Casis drain site (Dec. 2009)

In view of the observations in Table III, all 4 rains with 30 to 50 mm caused runoff and stripping off of surface soils (C) and the creation of small channels (D). However at the Casis site, the 3 to 4 rain showers of 30-50 mm fell between November and December caused the formation of gullies ≥ 1 metre deep (E). During the same period (November and December 2009), only one rain occurred with over 50 mm and that rain caused all by itself the three categories of damage (C, D and E) and illustrated by the photograph 10 below.

This kind of damage occurred frequently and reoccurred during each rainfall event at Casis, because vetiver grass planting had just started, the cover was almost zero (2%) as shown in Photo 10 above and this cover was not yet able to provide effective protection of slopes and embankments at Casis.

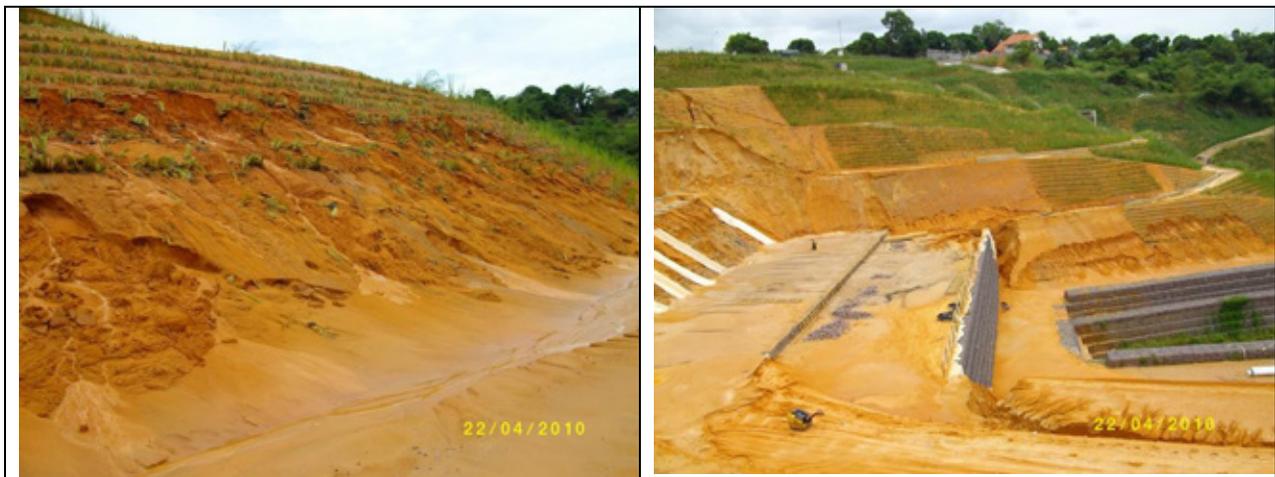
Photos 11 and 12: Damage on the slopes at the Casis site (April 2010)

It is however important to note that all the rain that caused Category C, D and E damage (as illustrated by the Photos 11 and 12 below), fell between the 1st and 2nd quarters of 2010, when the cover was not sufficiently developed. Table II shows that in this period the vegetation was estimated between 20 and 60% on this site, at which point the vetiver hedges had not yet formed a dense vegetative cover that can effectively protect the slopes and embankments of the site against erosion. To be effective in protecting against soil erosion and insuring the stabilisation of infrastructure, Greenfield (2008) mentions that vetiver must form very dense hedgerows.

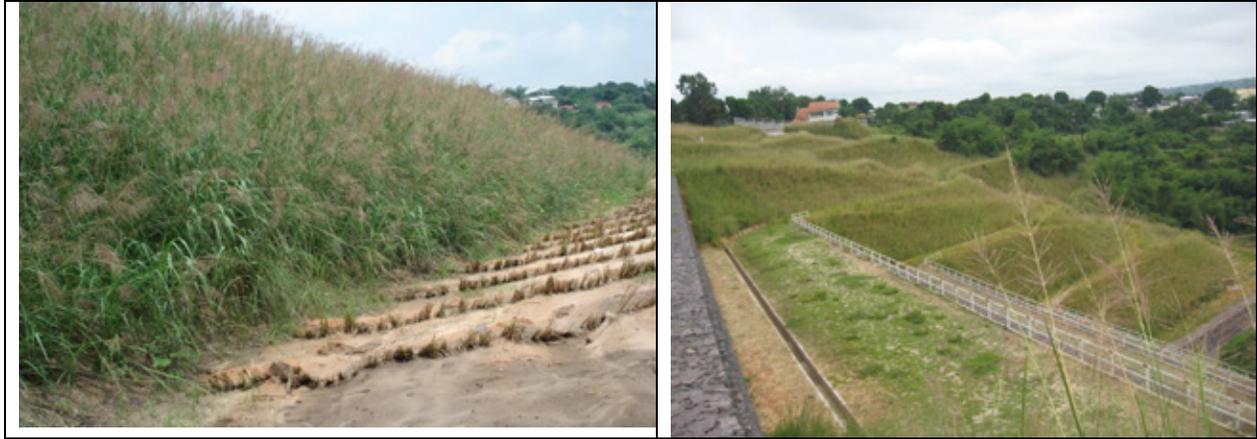
Photos 13 and 14: Same site as in photos 11 and 12 (May 2011), the vetiver hedges having prevented all erosion despite record rainfall exceeding 70 mm

In addition, despite an exceptional rainfall of 96 mm and three rains of 48, 46 and 56 mm that fell in December 2010 (ANAC, 2010), no damage was recorded, even in areas previously degraded by light rain in April 2010. These 4 rains did not even cause any runoff damage (see Photo 13), also the lack of damage is shown in Table III data, thanks to the improvement of the vegetative cover on this site from the end of fourth quarter 2010, up through 2011, as shown in Photos 13 and 14 below.

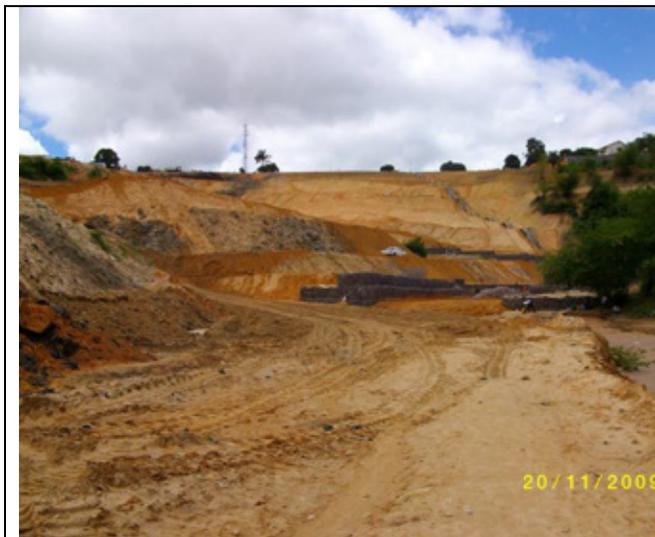
Photo 15. The Casis site during planting, Nov. 2009

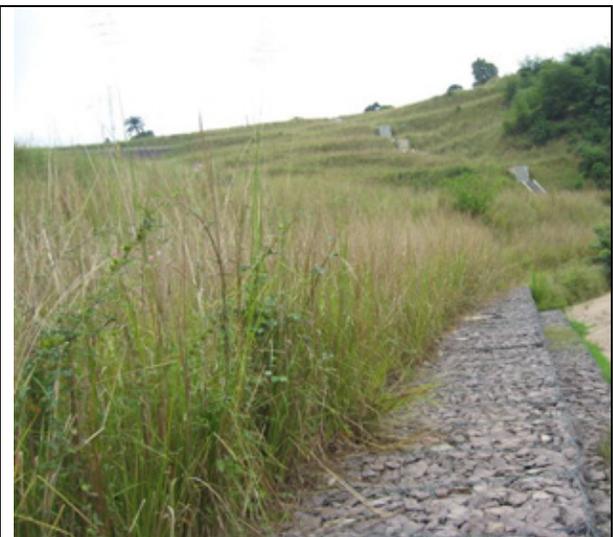
Photo 16. The same site 17 months later in May 2011

Thus, vetiver vegetative cover really demonstrated its effectiveness as no signs of runoff damage were observed due to greatly increased infiltration as a result of the development of abundant vetiver-based vegetative cover (Ndona et al., 2006, Paul Truong et al., 2008a).
