# WORKSHOP 6

## Contribution of VST in Alleviating Climate Change Disasters

Paul Truong

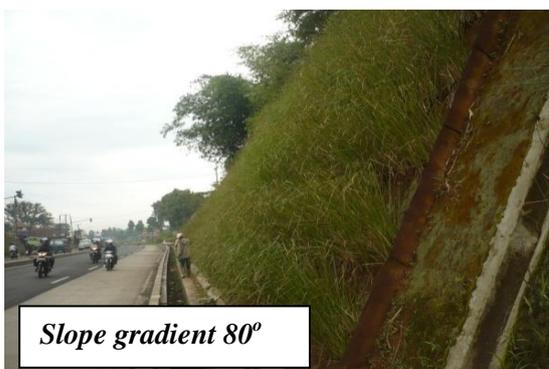
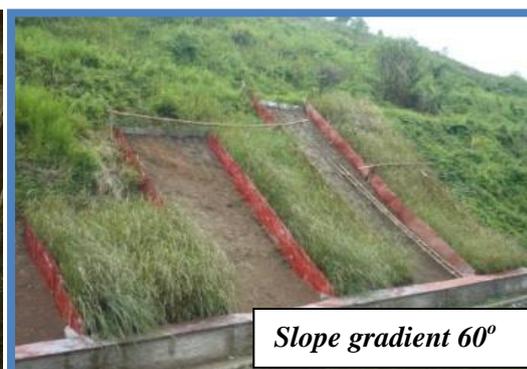
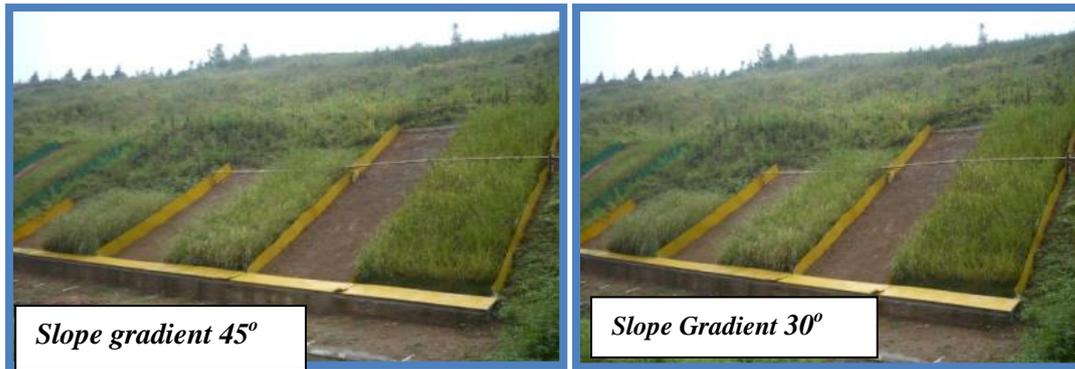
- VS can be used effectively to control surface erosion and shallow failure of road slope
- VS can be used effectively at slope 30° – 60°
- VS could be applied by road authority to cope with erosion and shallow failure of road slope
- At road slope > 60°, vetiver technology is not recommended to applied solely (must combined with mechanical method)

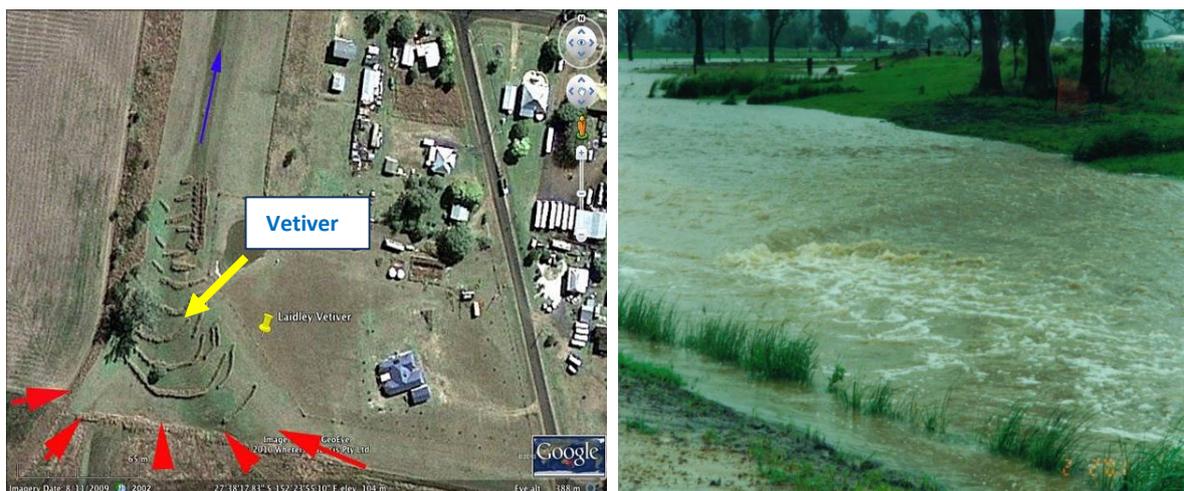
*Layout of vetiver rows at the head of the drain and flood flow at 5m/sec*

A major drainage channel that runs across the town of Laidley in Queensland. In summer this channel often flows at full capacity due high runoff (up to 400 cumecs) from the hills east of the town. This often results in flash flooding. At the head of the channel, runoff water is first concentrated in an area of approximately one hectare. This area received very high velocity flows during summer storms and in times of flash flooding severe erosion occurred after every major flooding event.

Following a severe erosion occurred during the last flood the Laidley Shire decided to use the Vetiver System instead of conventional engineering structures to control flood erosion damage as these structures are not only too expensive but also not very effective in the past. Site construction started in 2000 and since the vetiver planting has successfully protected this area from several major and flash floods, especially the flood erosion during the January 2011 massive flood, with water level over topping the banks by several meters.

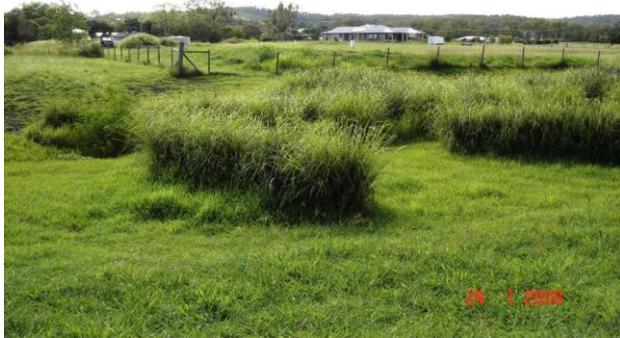
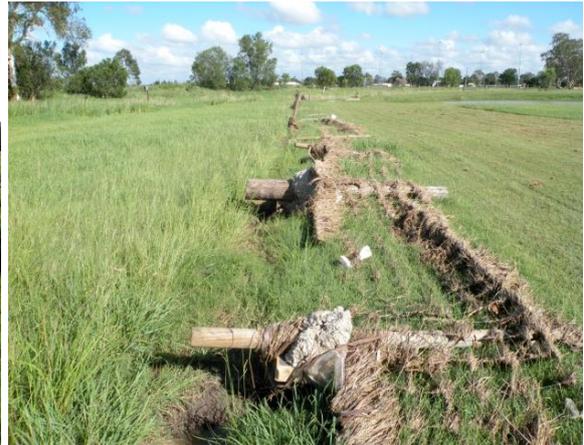
***Eight year old Vetiver hedges undamaged and fully protected the drain, while the concrete footed fence was ripped up by the big flood***

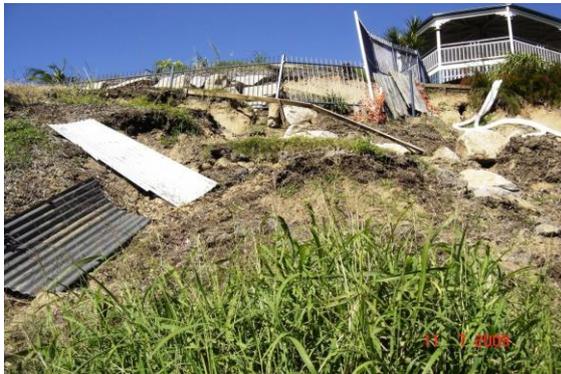
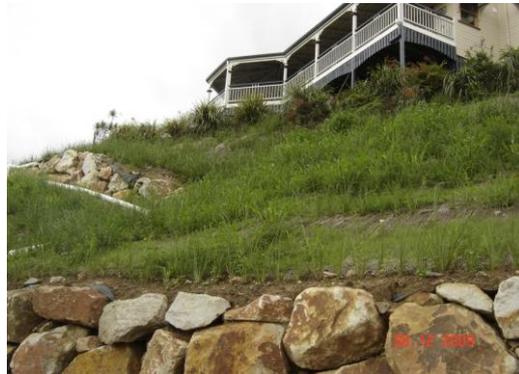
***Landslide threatened the foundation of this house on a very steep hill. The slope was repaired and vetiver planting provided full protection two years after planting***

A heavy down pour in 2008 caused this landslide on a house block on a very steep hill, vetiver was planted after repair work. Due to the steep gradient of the slope it was first protected by jutesh during vetiver establishment phase. Vetiver planting has successfully stabilised this very steep and difficult site and protected it from further erosion in the next two years despite periods of record rainfall. The slope remained stable during the very high and intense rains in January 2011.

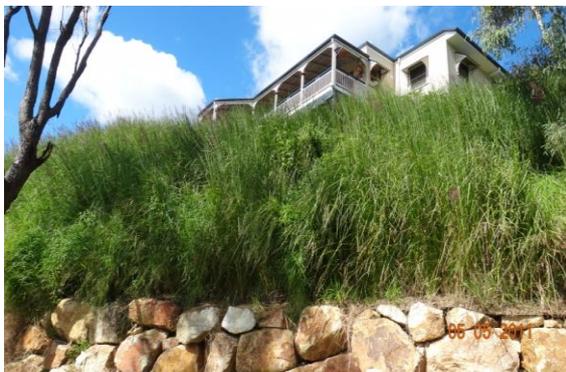
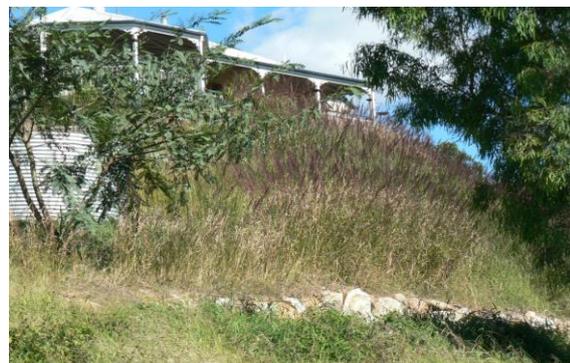
***The house was fully protected during the record breaking rain fall in January 2011***

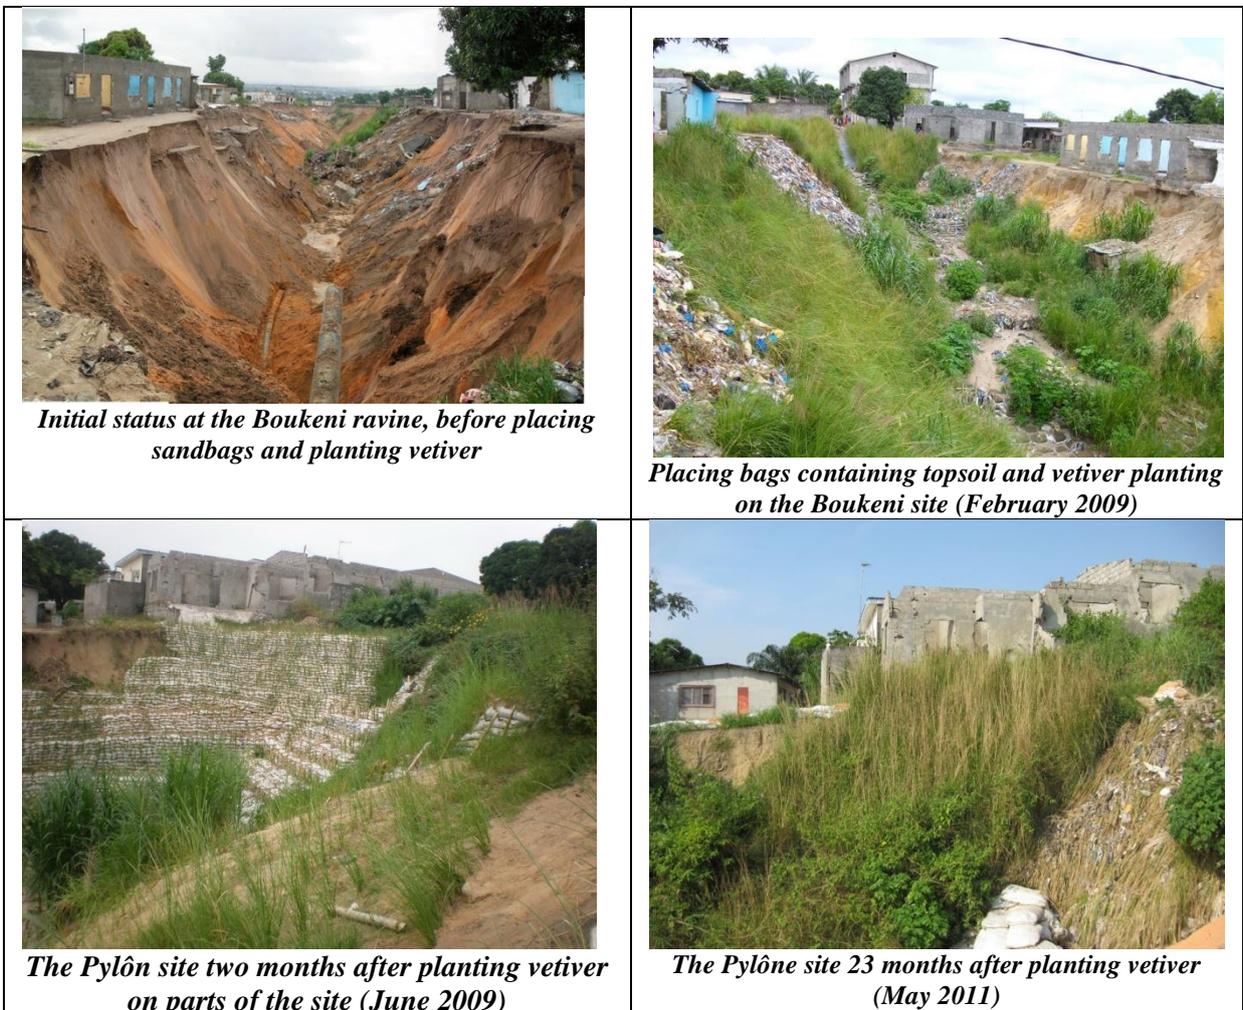
The results so far have been an outstanding success. The ravines remained stable and fully protected from tropical torrential rains on the last few years.

During the same period, conventional engineering efforts to halt erosion damage have remained ineffective. Given these difficulties, the idea of integrating bio-engineering technology, including the VST into the conventional technology. VST clearly demonstrated its effectiveness not only in erosion control, but will also ensure the protection and sustainability of conventional structures to be built in the future.

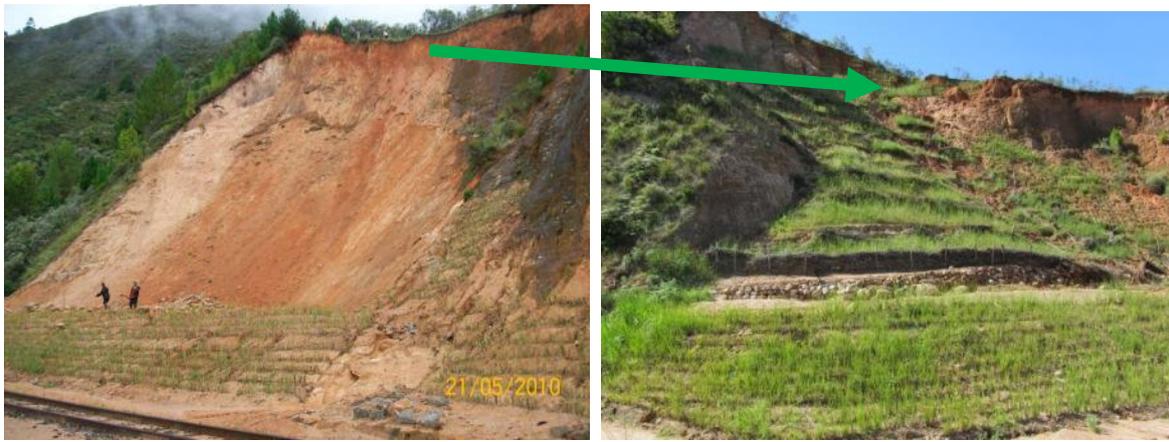
*Before and after result of Yoann Coppin's work on Lavaka rehabilitation*

Lavaka is a massive form of landslide very common in Madagascar due to the deep and highly erodible volcanic soil and high torrential rainfall. This erosion problem occurs on big steep slope, disrupted traffic and sometimes forces the railway lines to be relocated. Up to now there has been no effective and low cost solution. But Vetiver System Technology has provided the needed solution.

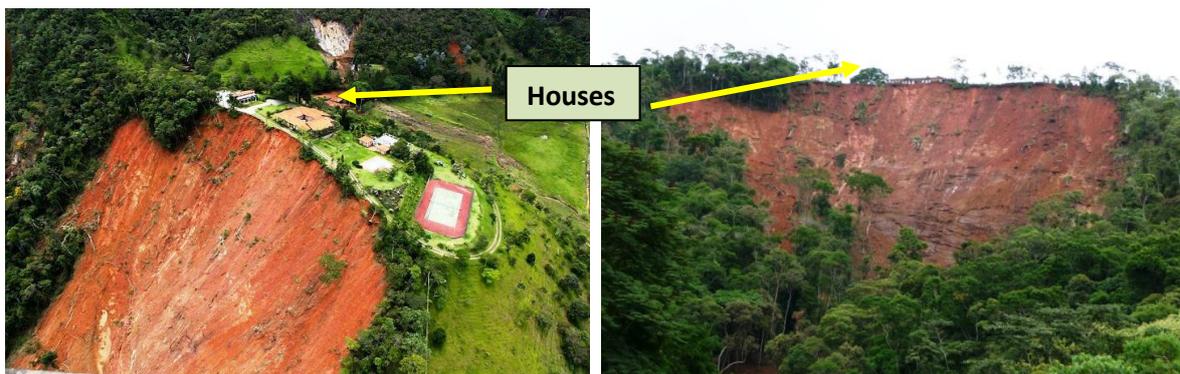
Brazil has suffered massive world-news landslides in recent years due to torrential rains. For example this is one of the many sites in Rio de Janeiro State.

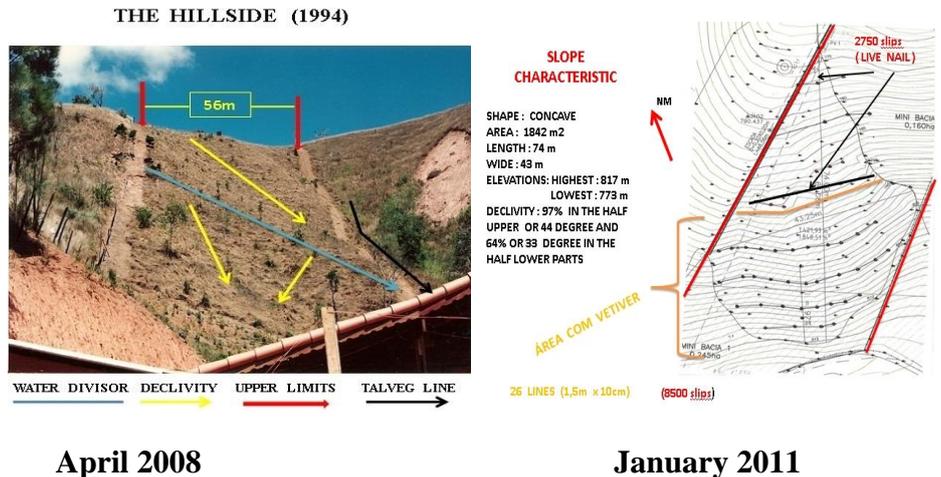
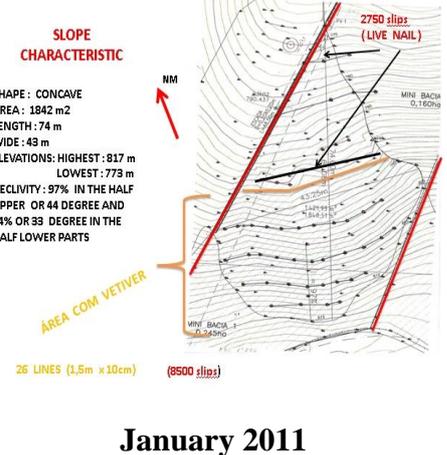
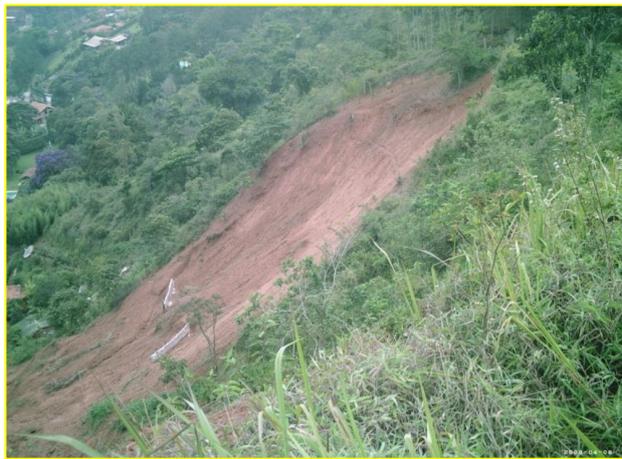
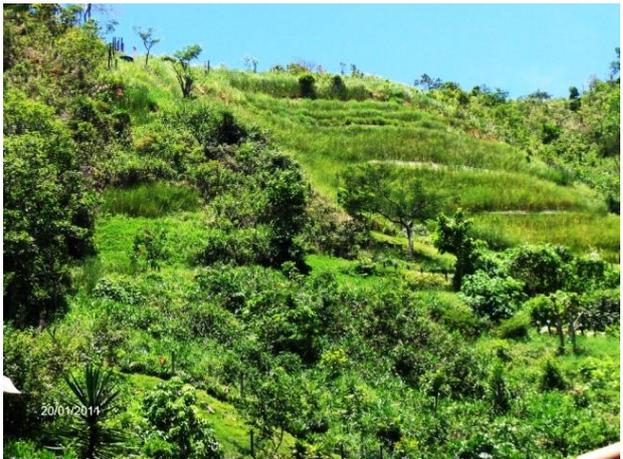
- VS is a cheap, effective and safe solution for the rehabilitation of landslides and reduction of landslids incidence in high rainfall region
- The VS will fail when not properly applied or not well maintained. The VS when installed and following the correct technical guidelines is a guaranteed success.
- Perhaps the only real defect of the Vetiver solution is: *Too cheap to be true, too cheap to believe when compared to heavy stone structures.*
- Here is the final living proof

On February 02, 2008 heavy rains and intense lightning occurred for about 3.5 hours, causing landslide on the ranch of João Eboli in Itaipava, district of Petrópolis. Before the landslide, the hill was covered with natural grass and native bushes (Fig.1). The landslide had the shape of a concave basin of 1840 m<sup>2</sup>, with a length of 74m and a width of 43m, funnel shaped towards the lower side, and vertical height of 47m (elevation of the highest point:817m and

lowest point: 770m). Right after the owner read about Vetiver grass, which is available in Brazil and appropriate for use in slope stabilization. He studied the plant characteristics and decided immediately to try and use it on his landslide area with the aim to provide long term slope stability. He planned, designed and implemented the stabilisation and rehabilitation of the slope with four employees.
