# VETIVER SYSTEM FOR FLOOD EROSION CONTROL

THE VETIVER NETWORK INTERNATIONAL

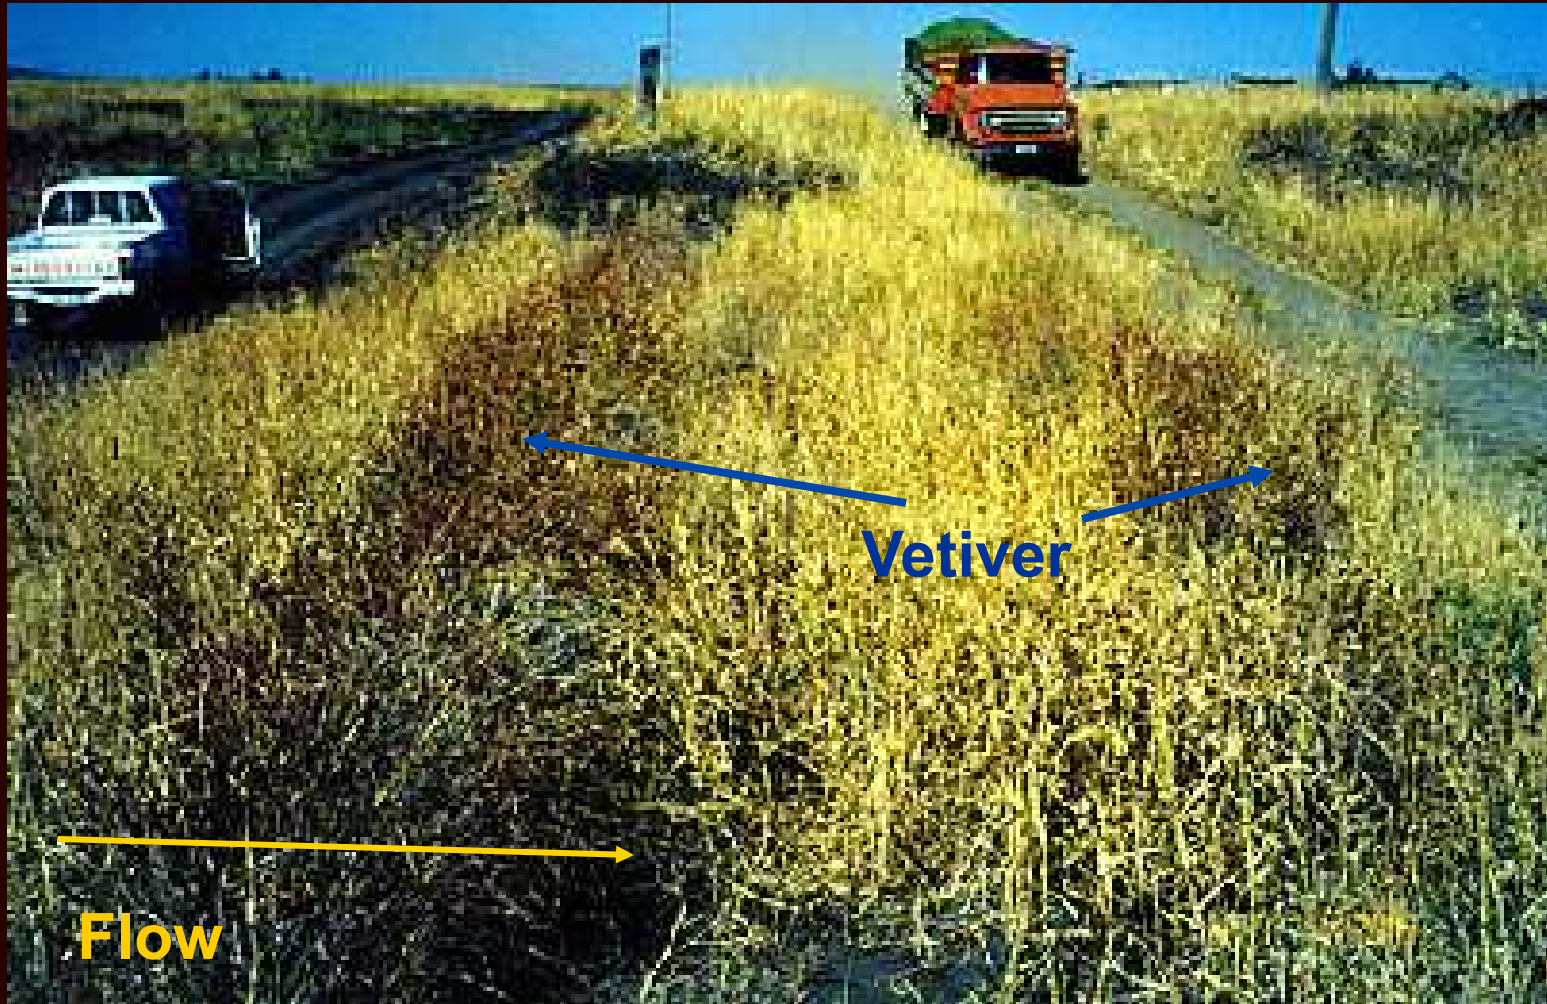
**Australia:** This concrete causeway on this farm road was often washed away by flood water which undermined the foundation of the concrete surface Two rows of vetiver planted upstream of the causeway.

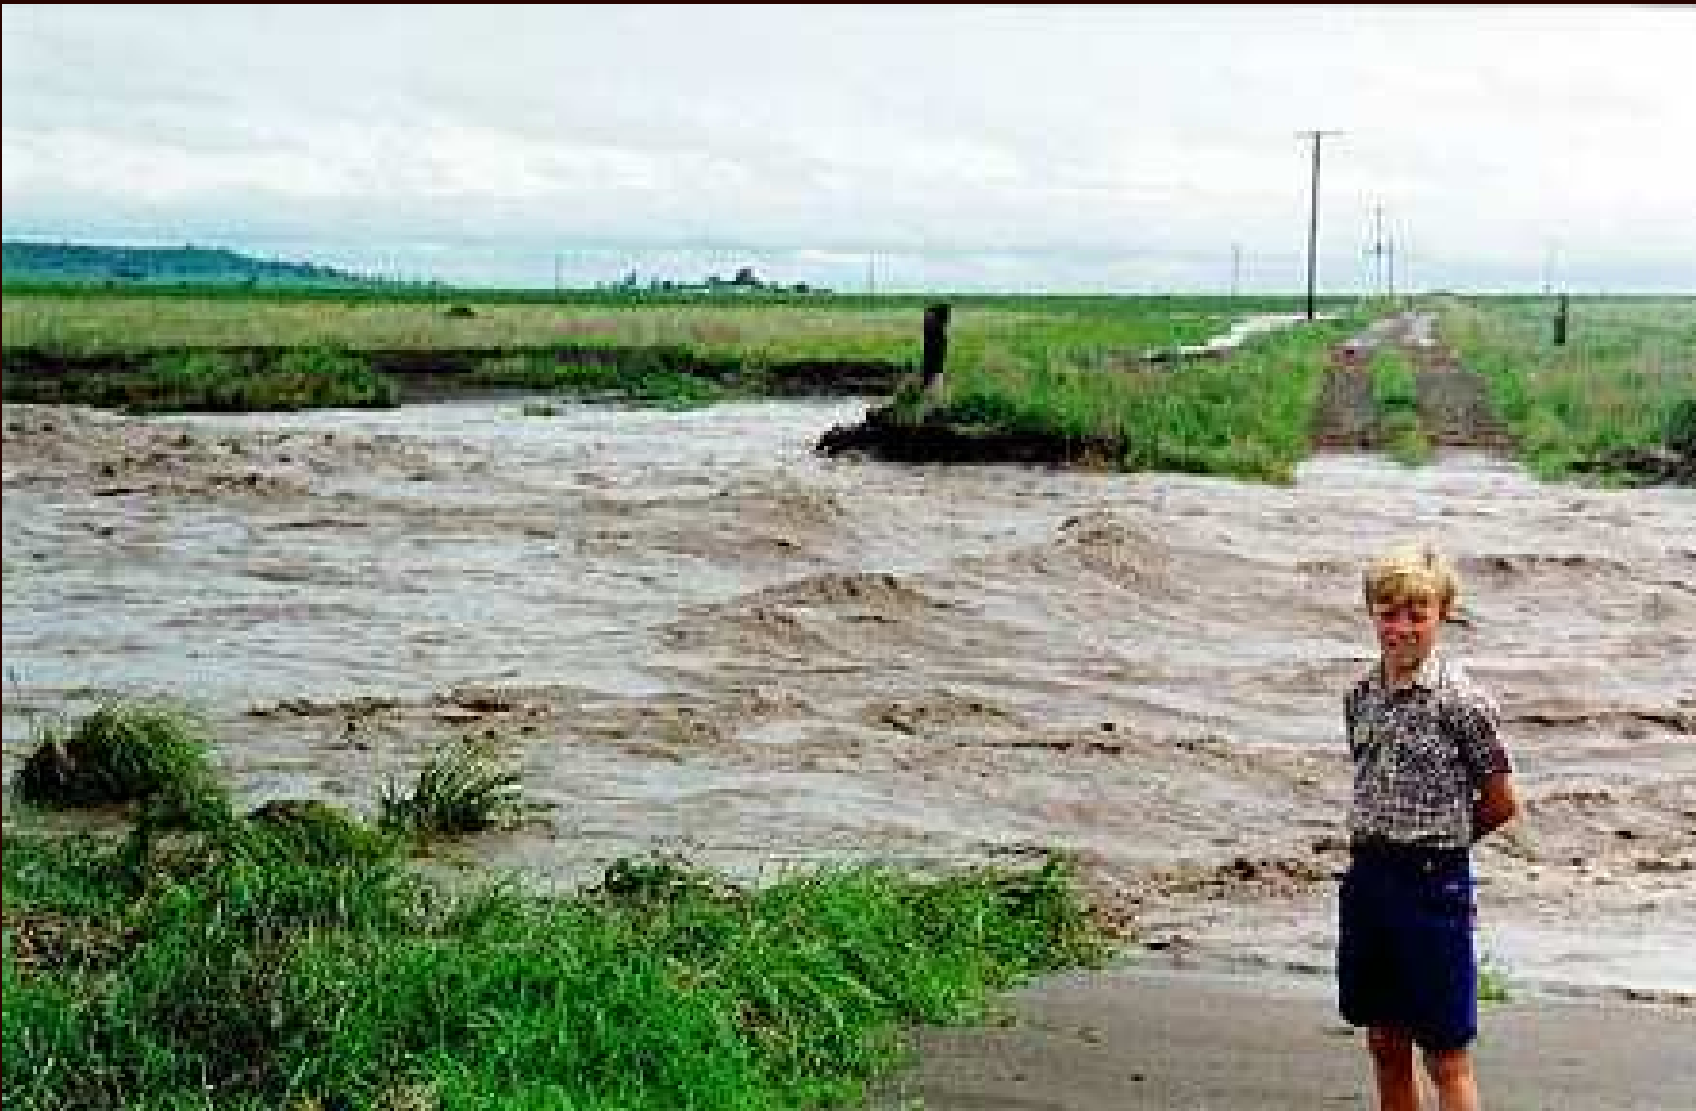
**A 3m deep flood swept through this causeway, completely submerged the vetiver rows**

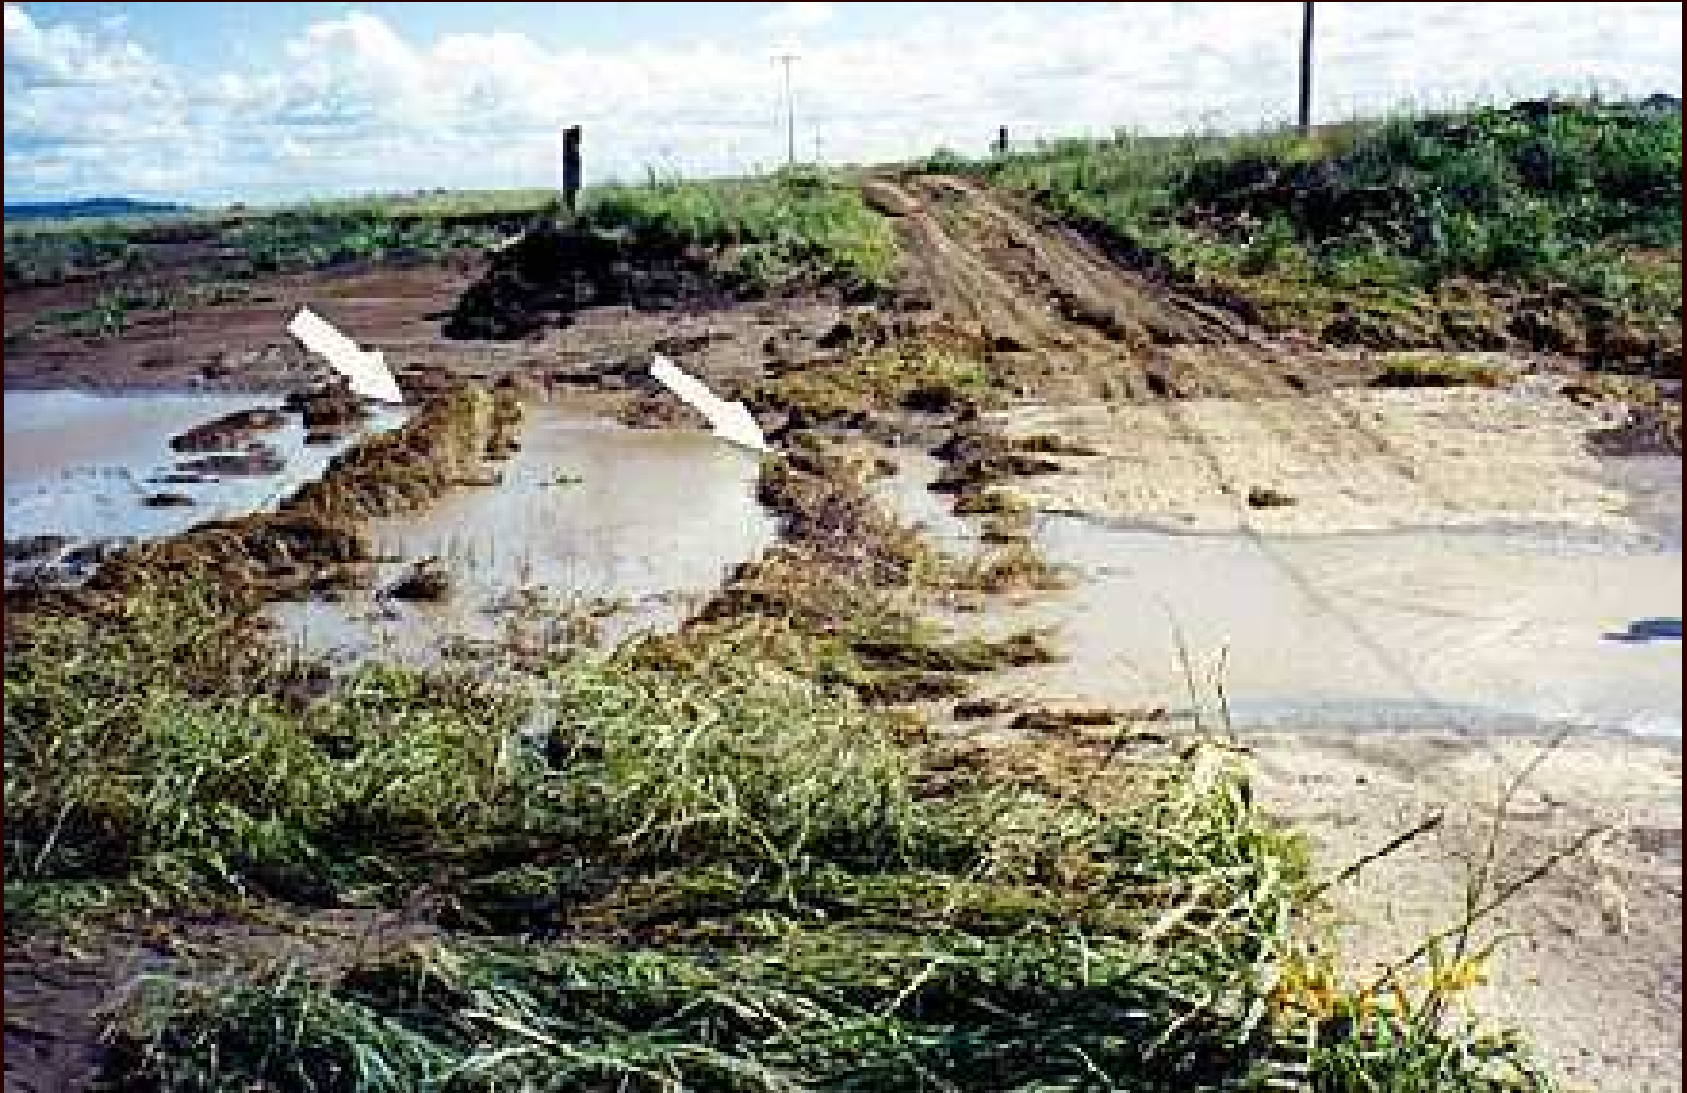
**Although badly battered, the vetiver hedges held firm during the flood, preventing the undermining of the concrete causeway**

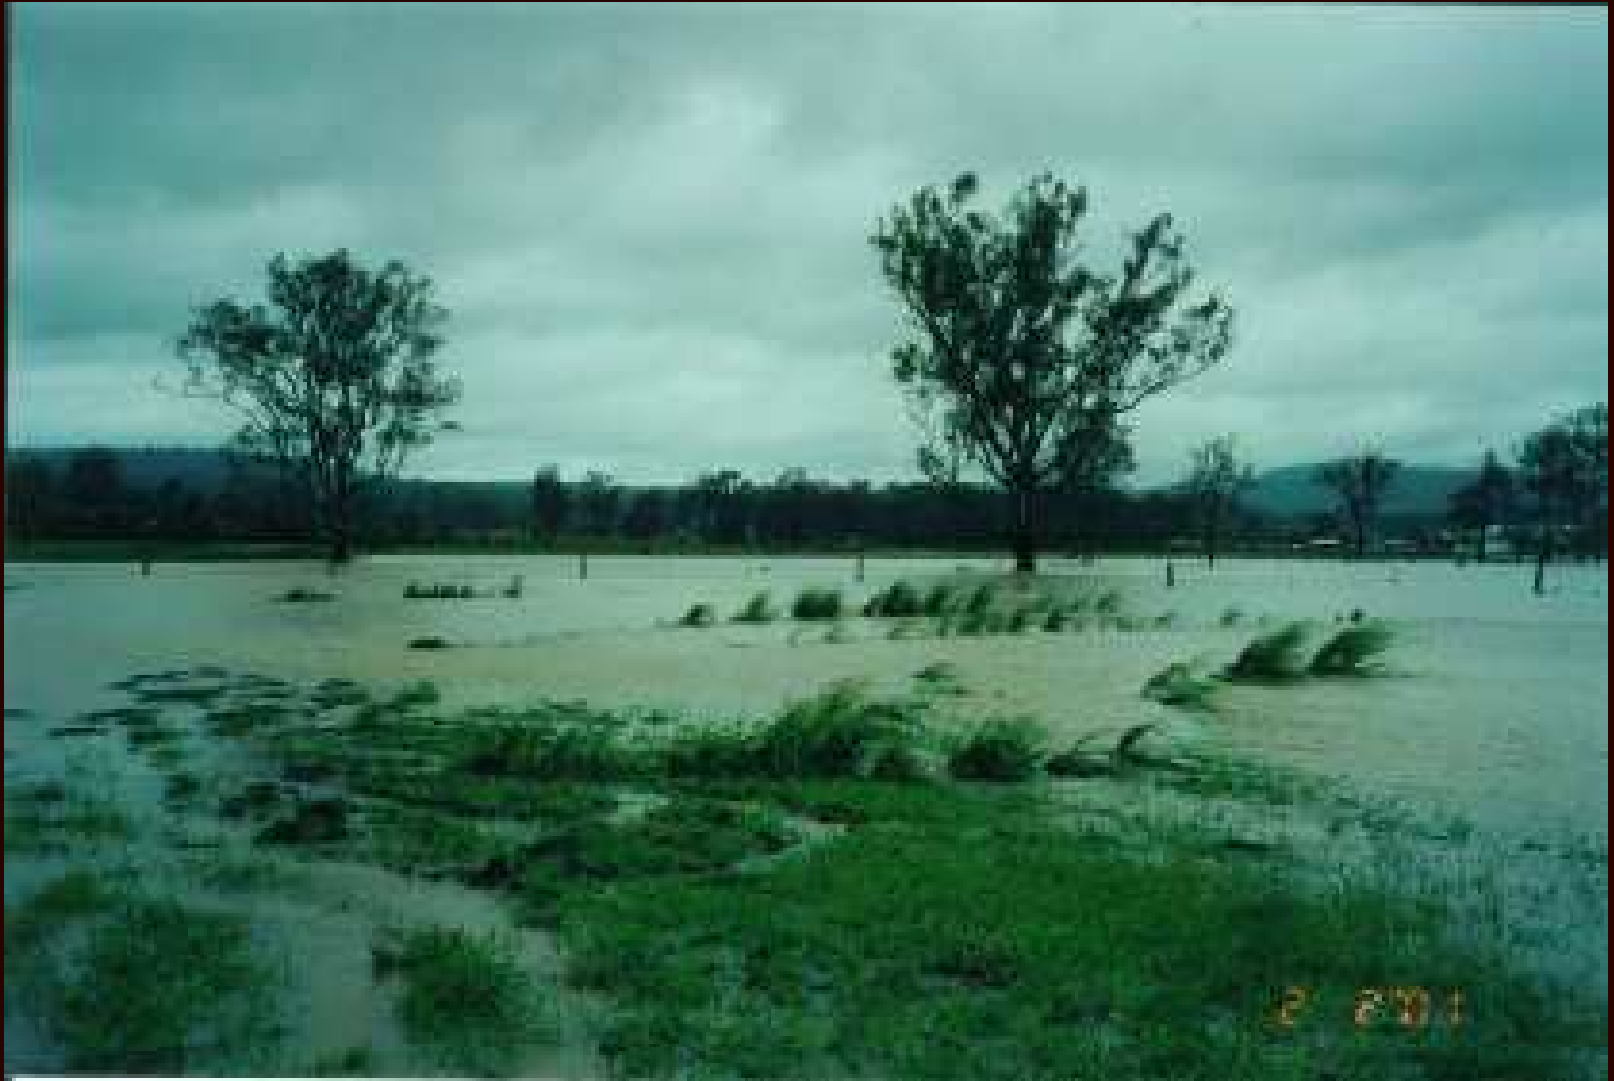
**Australia: This drainage channel is often damaged by flood, note that vetiver hedges bent under strong current**

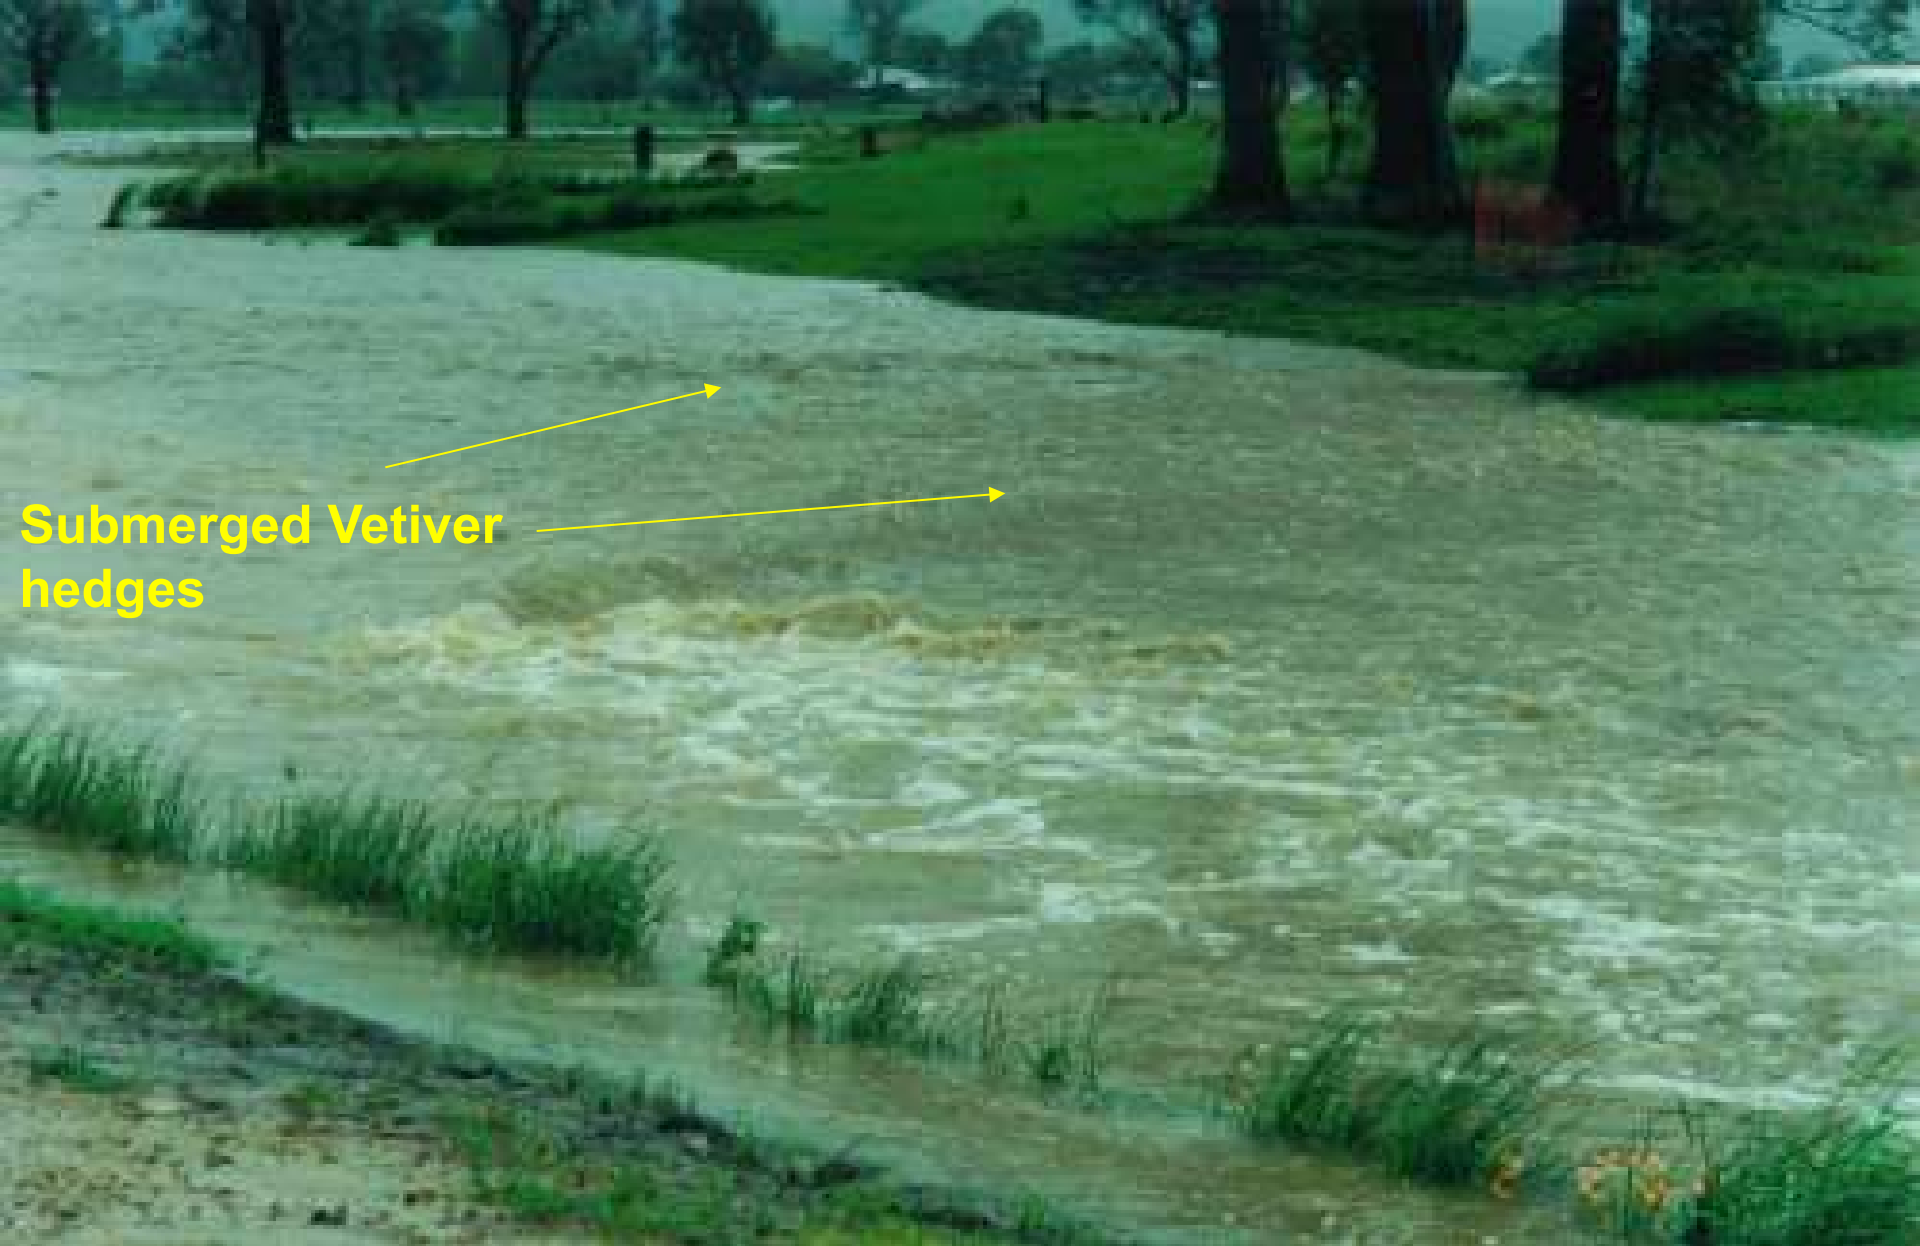
**Submerged Vetiver  
hedges**

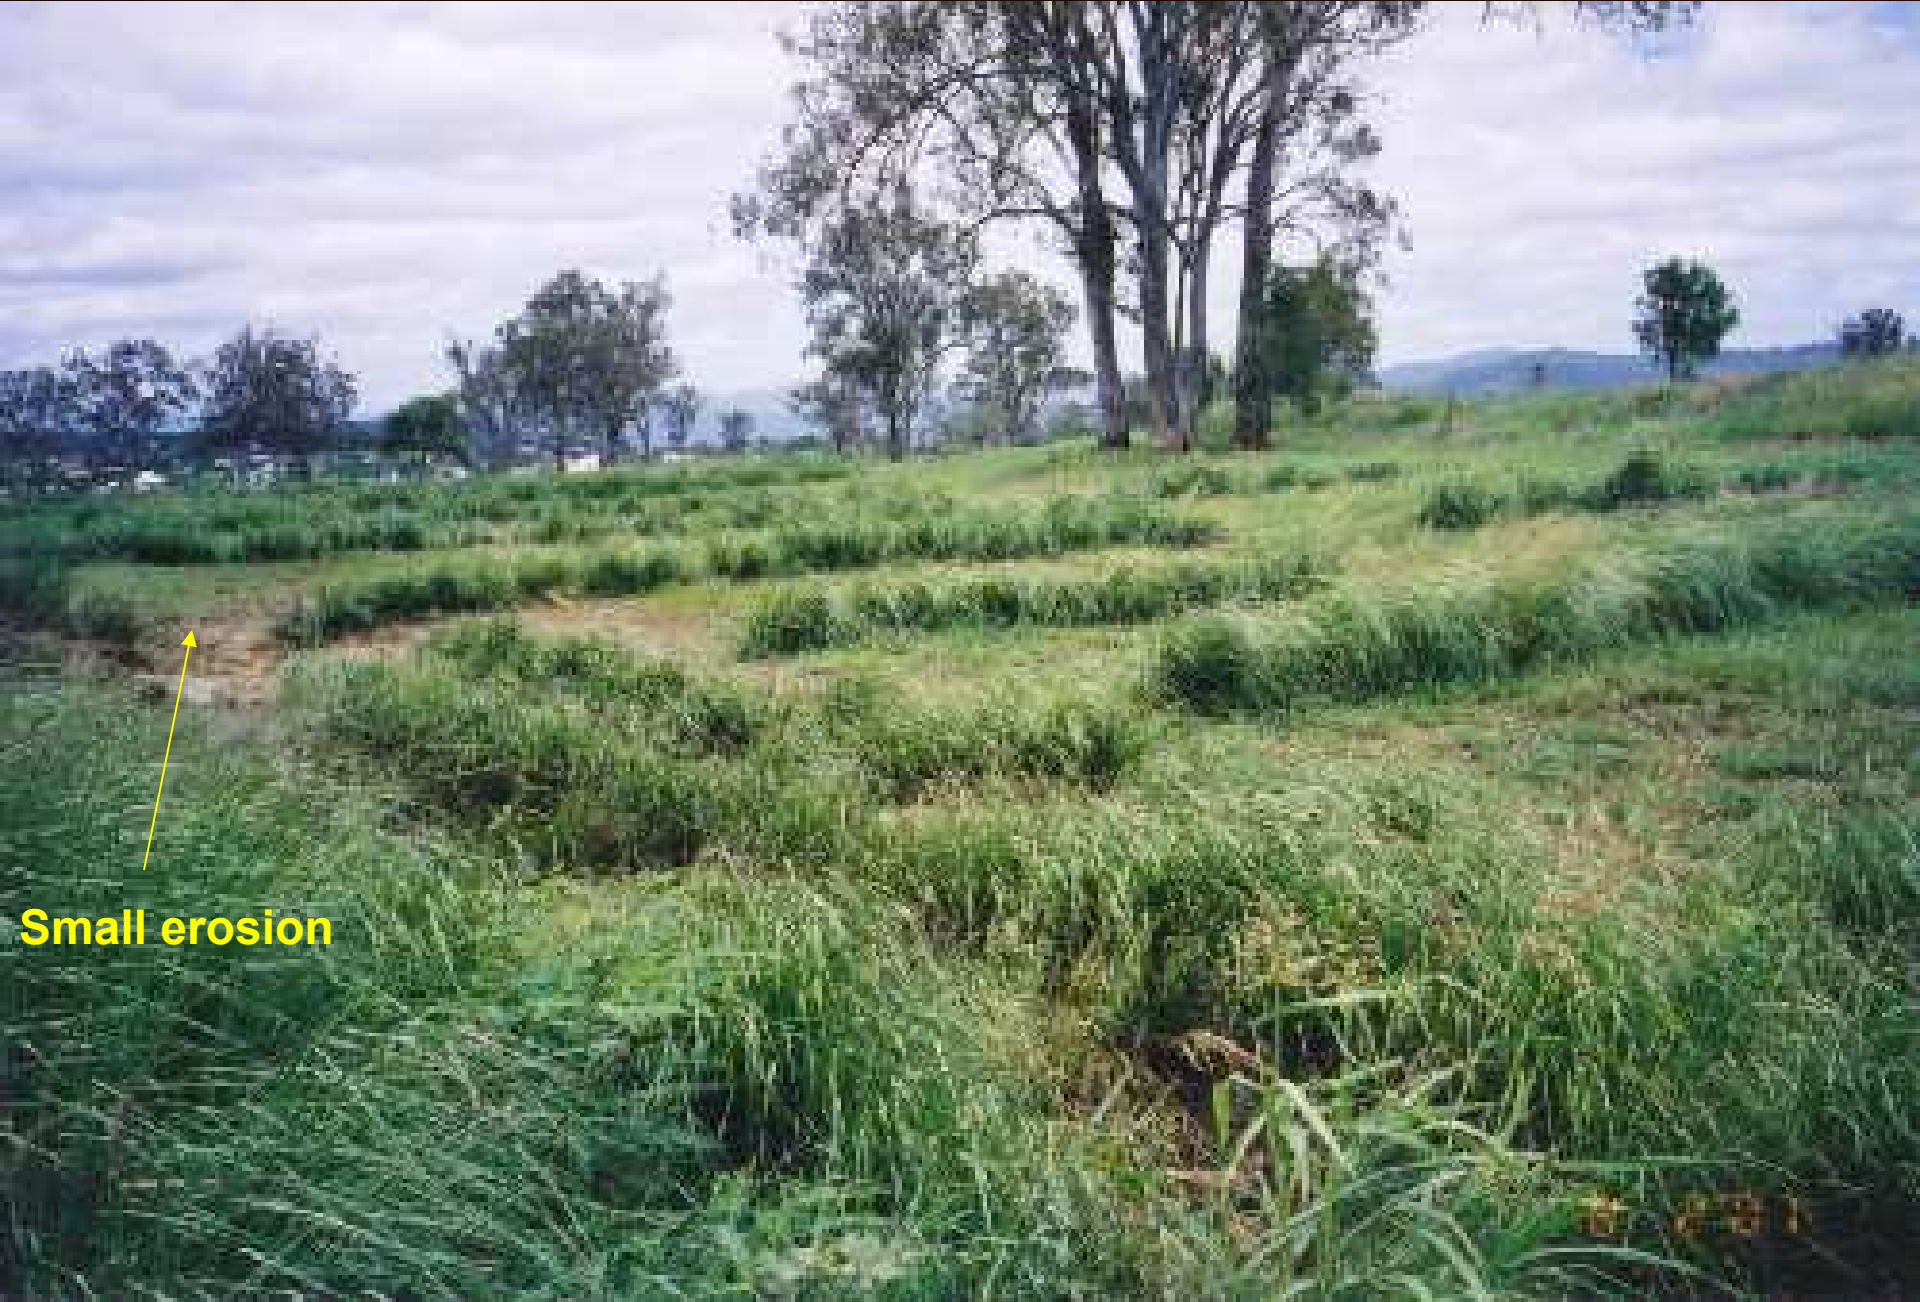
**Although only 3 month old, the young hedges provide a very effective protection with only minimal erosion at the head of the channel**

**Small erosion**

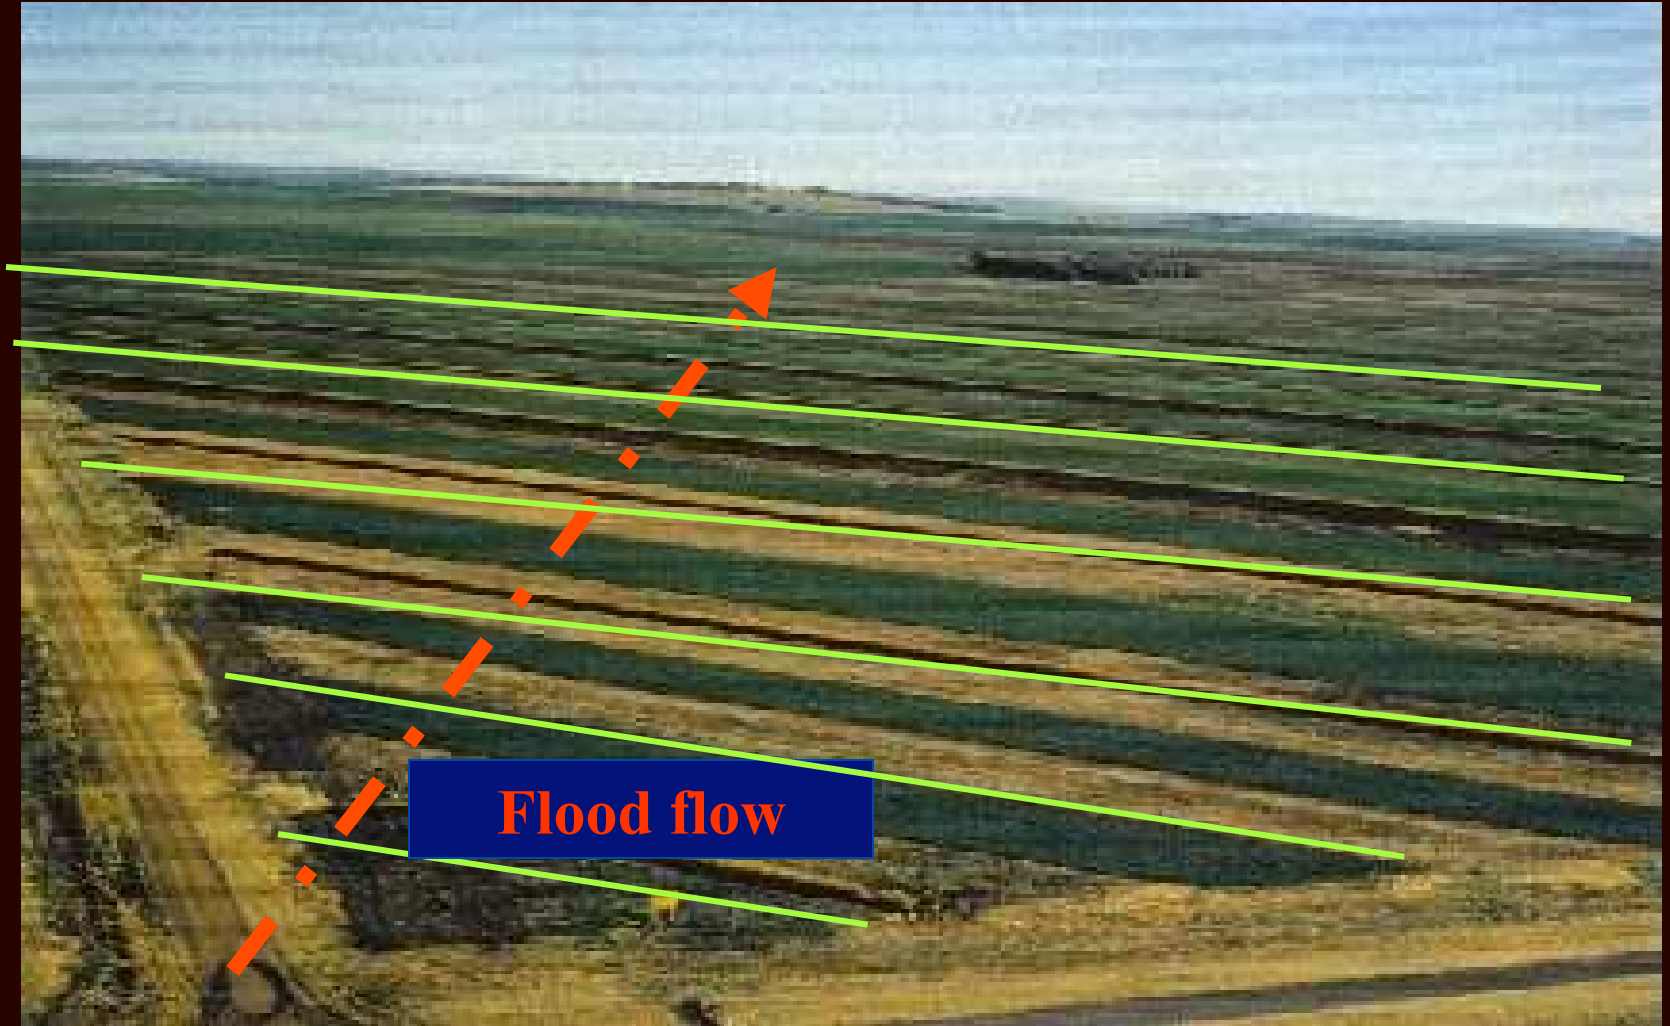
**Australia:** Flood erosion is often severe on the flood plain and this rich agricultural land is traditionally protected by strip cropping practice. Six rows of vetiver planted at 90m interval as an alternative flood erosion measure.

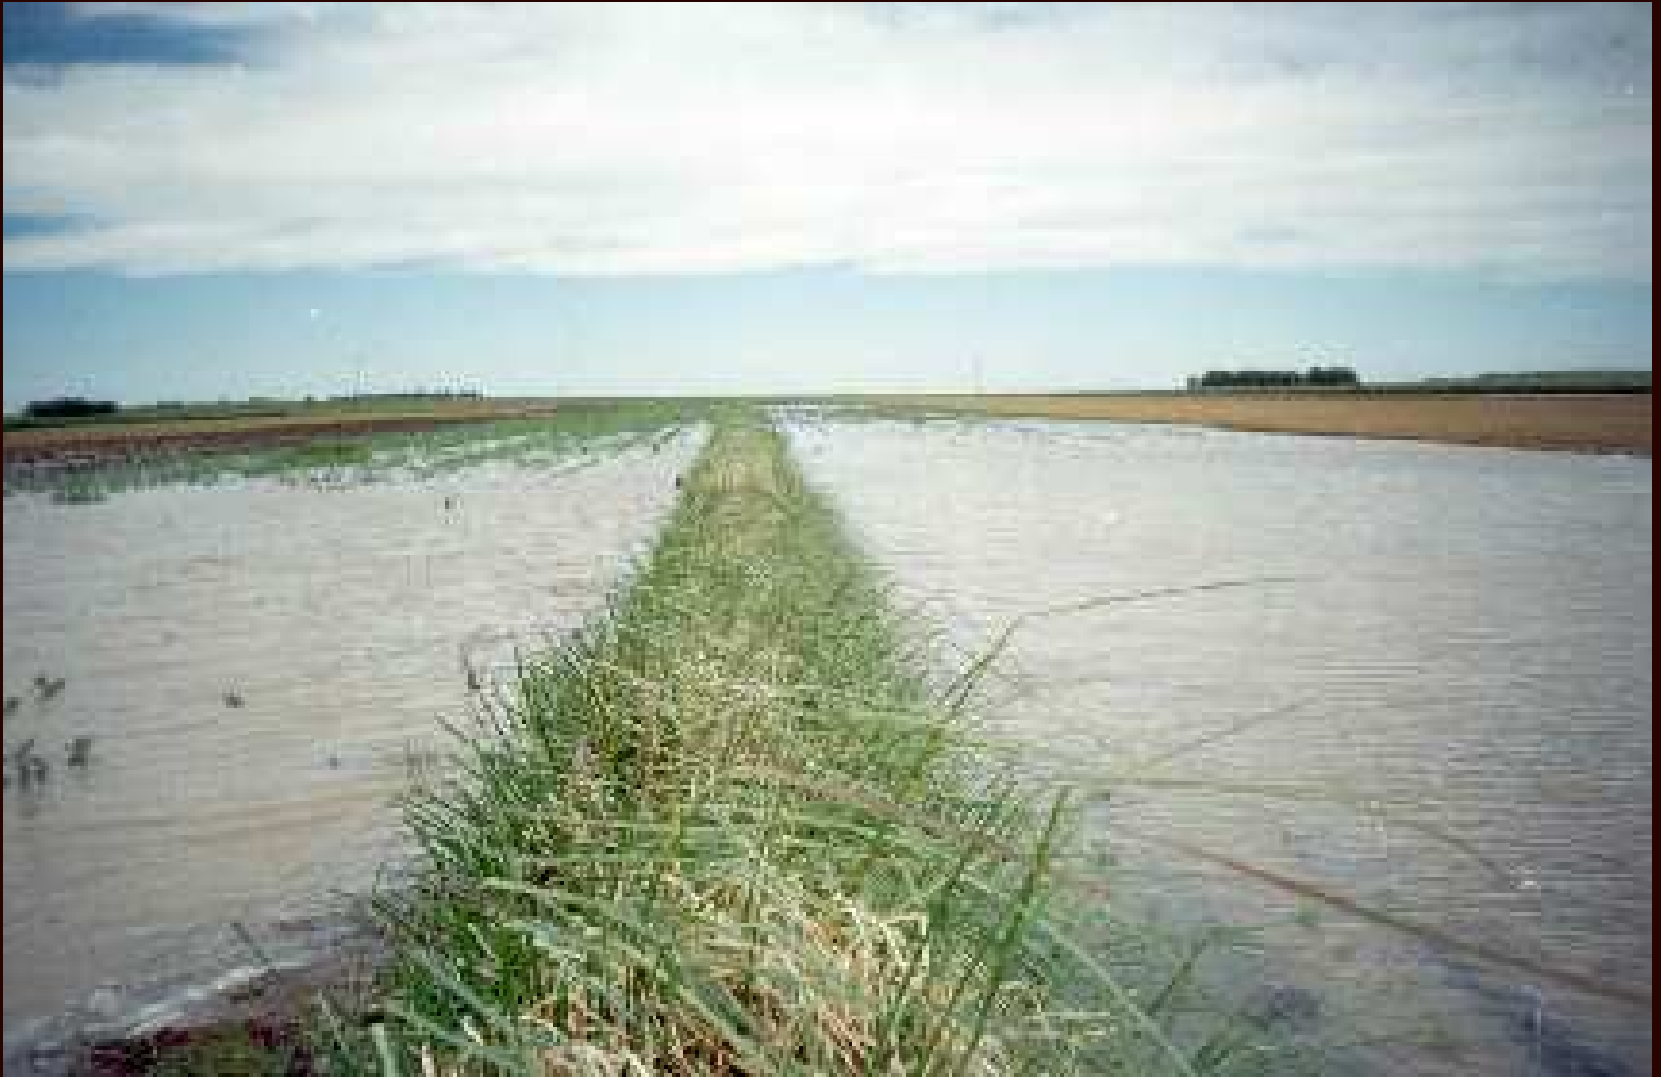
## A major flood event in 1996

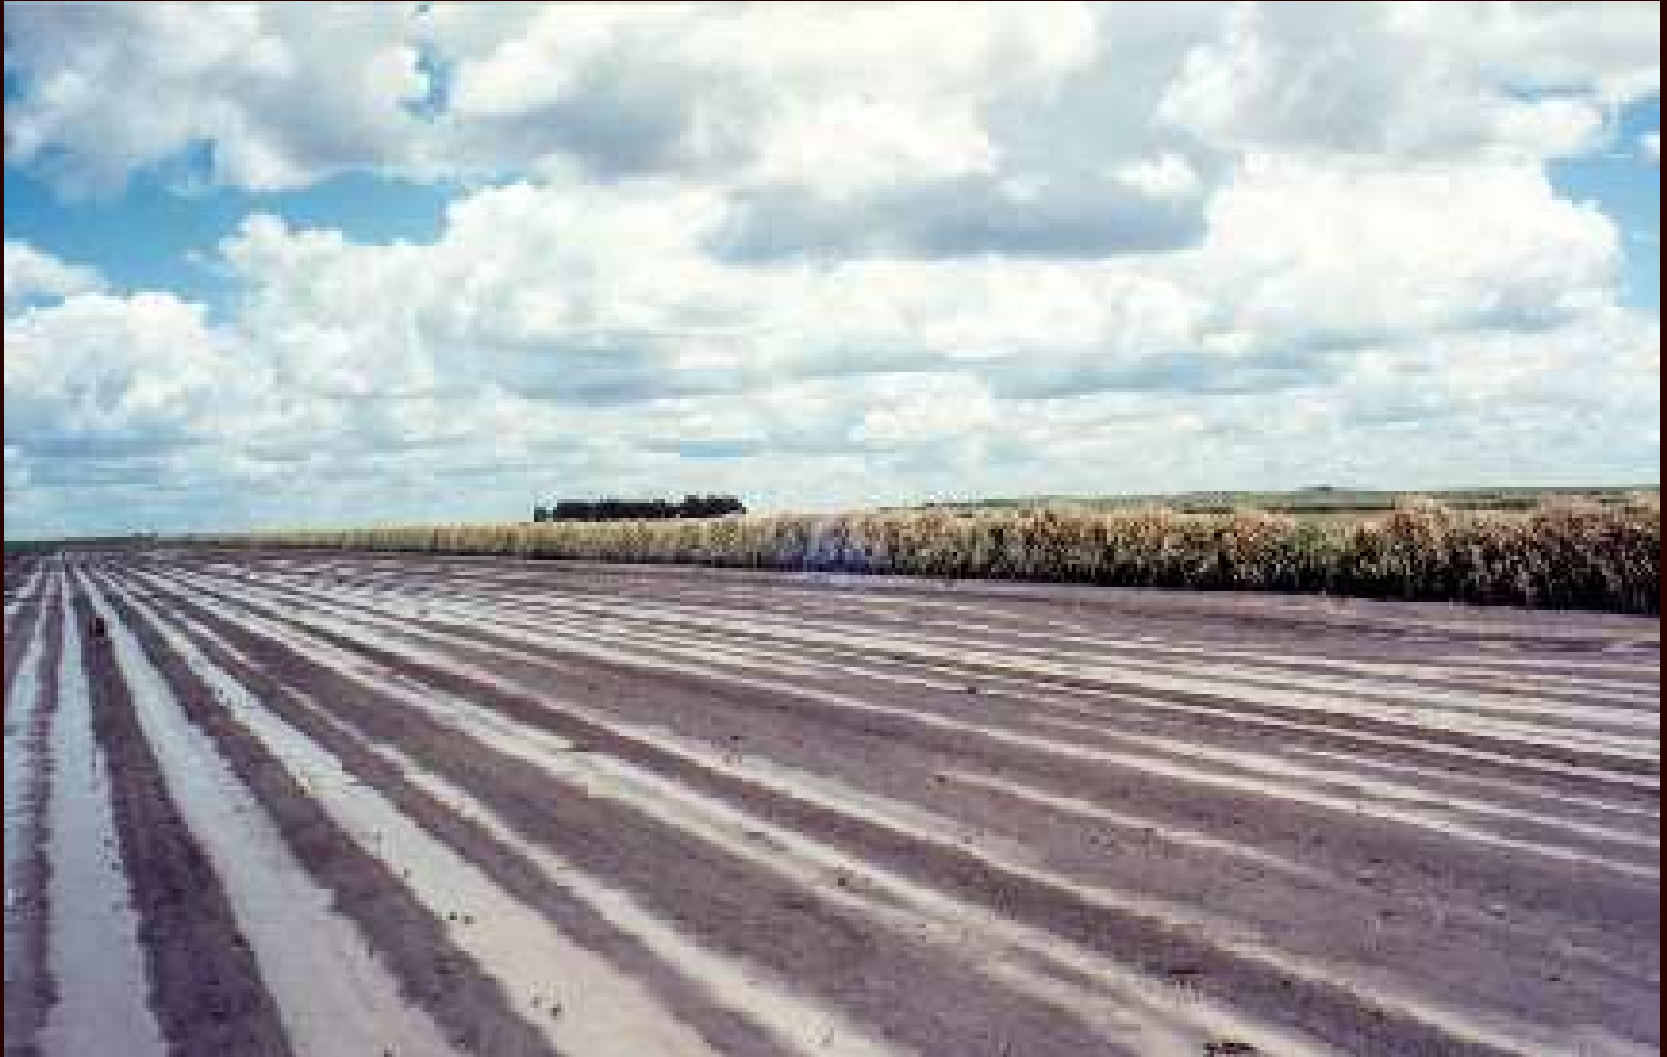
**No sign of rill and minimal surface erosion**

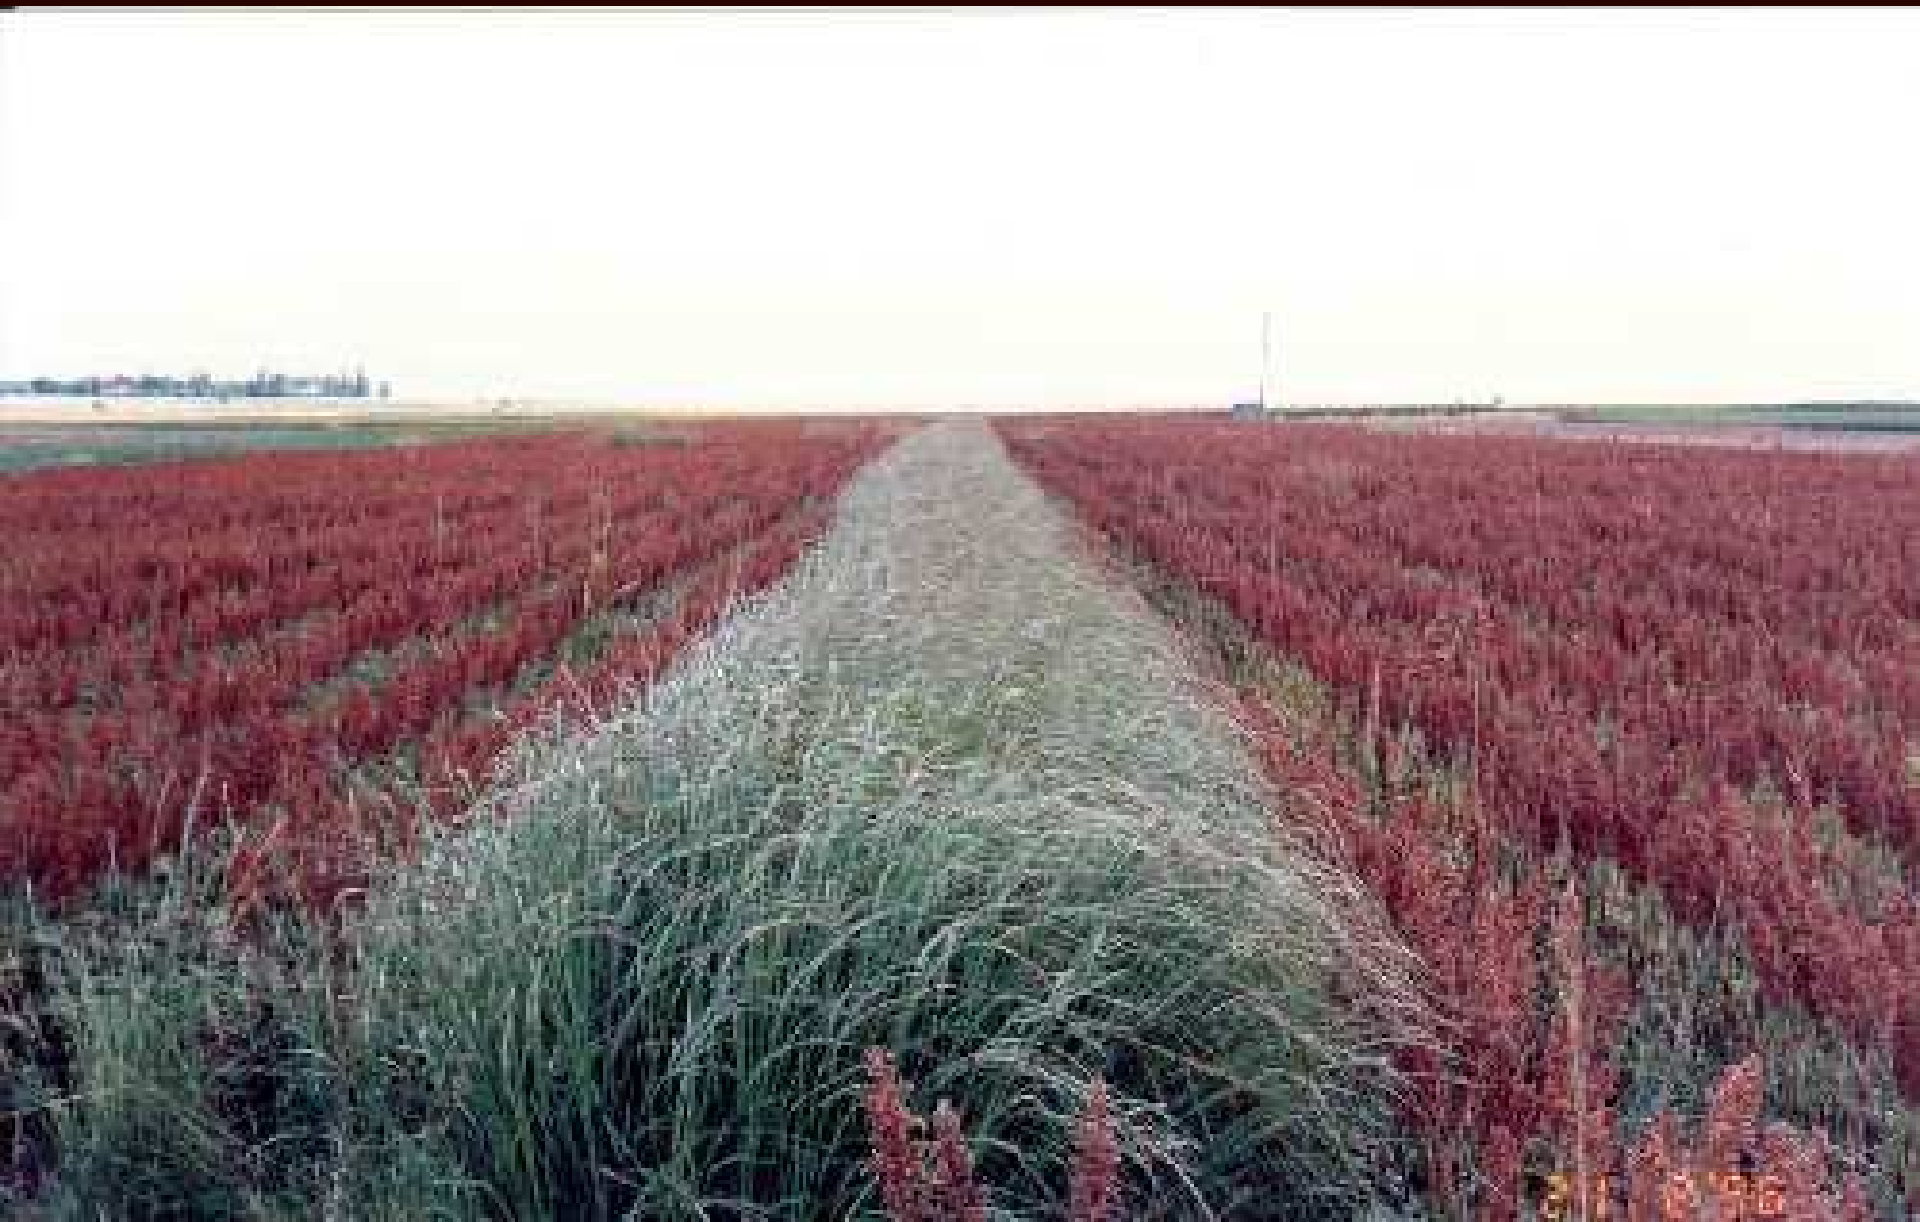
**No flood damage and excellent crop of sorghum**
