VETIVER SYSTEM FOR FLOOD EROSION CONTROL IN UPLAND AREAS

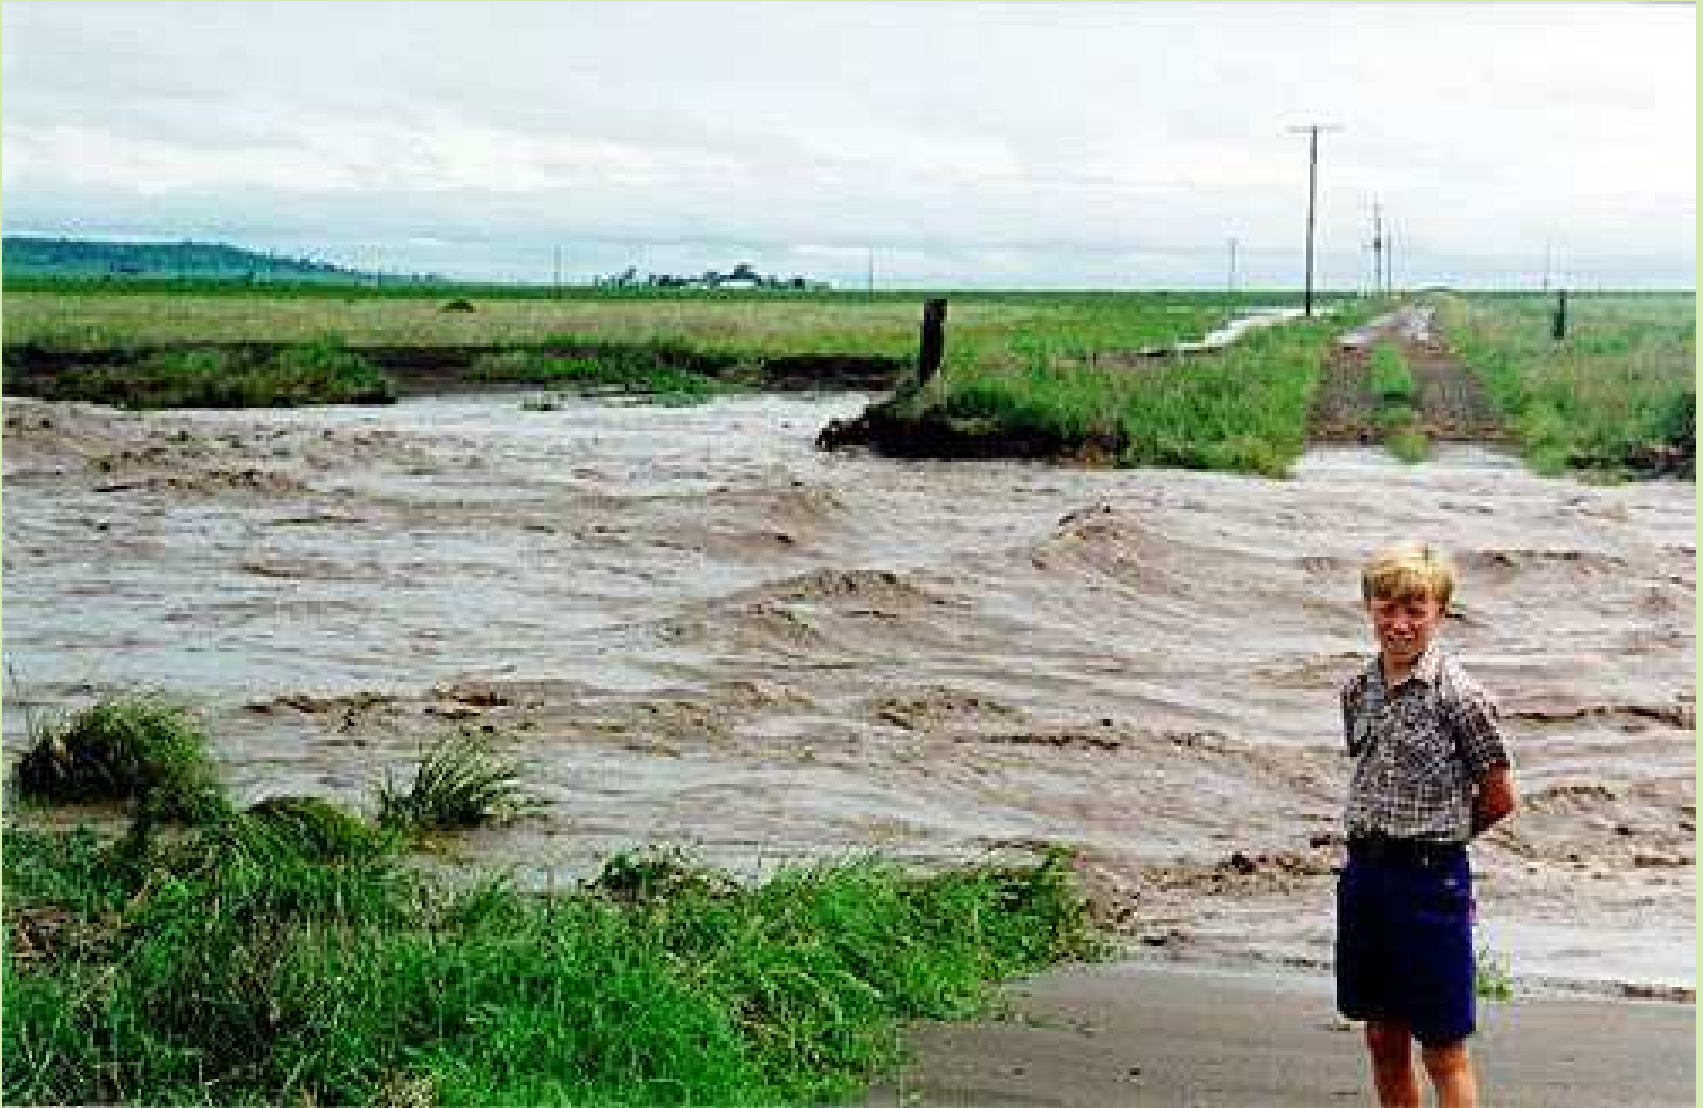
A 3m deep flood swept through this causeway, completely submerged the vetiver rows

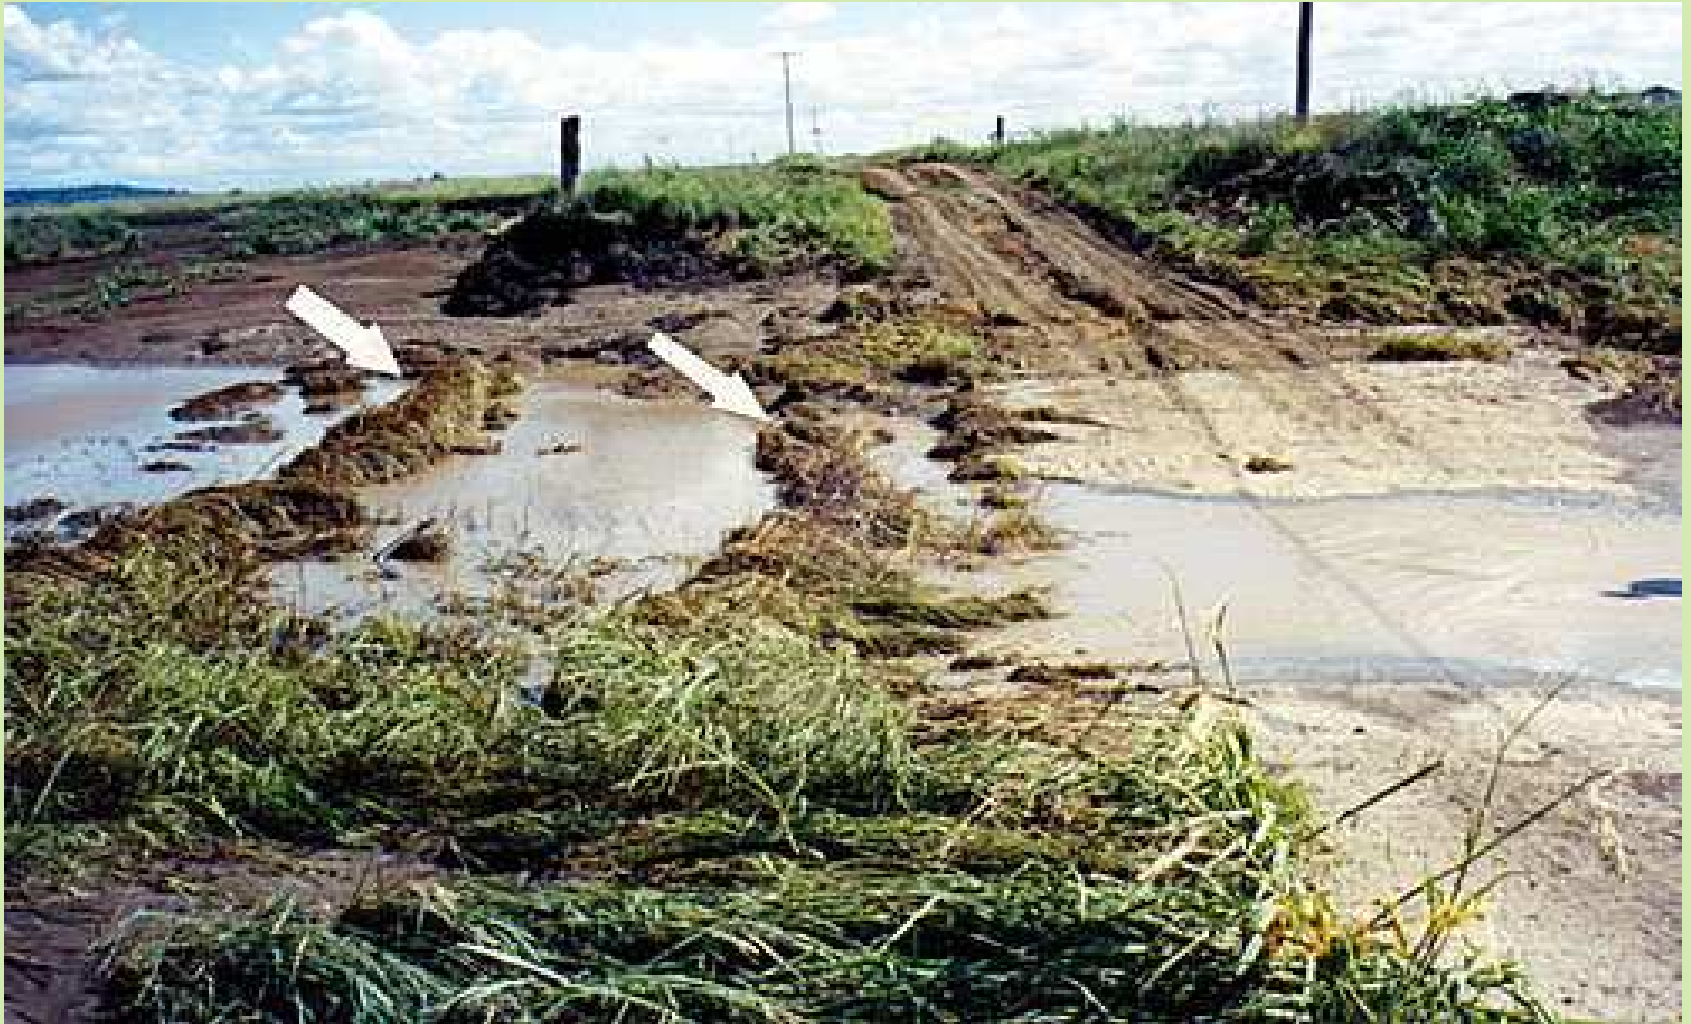
Although badly battered, the vetiver hedges held firm during the flood, preventing the undermining of the concrete causeway

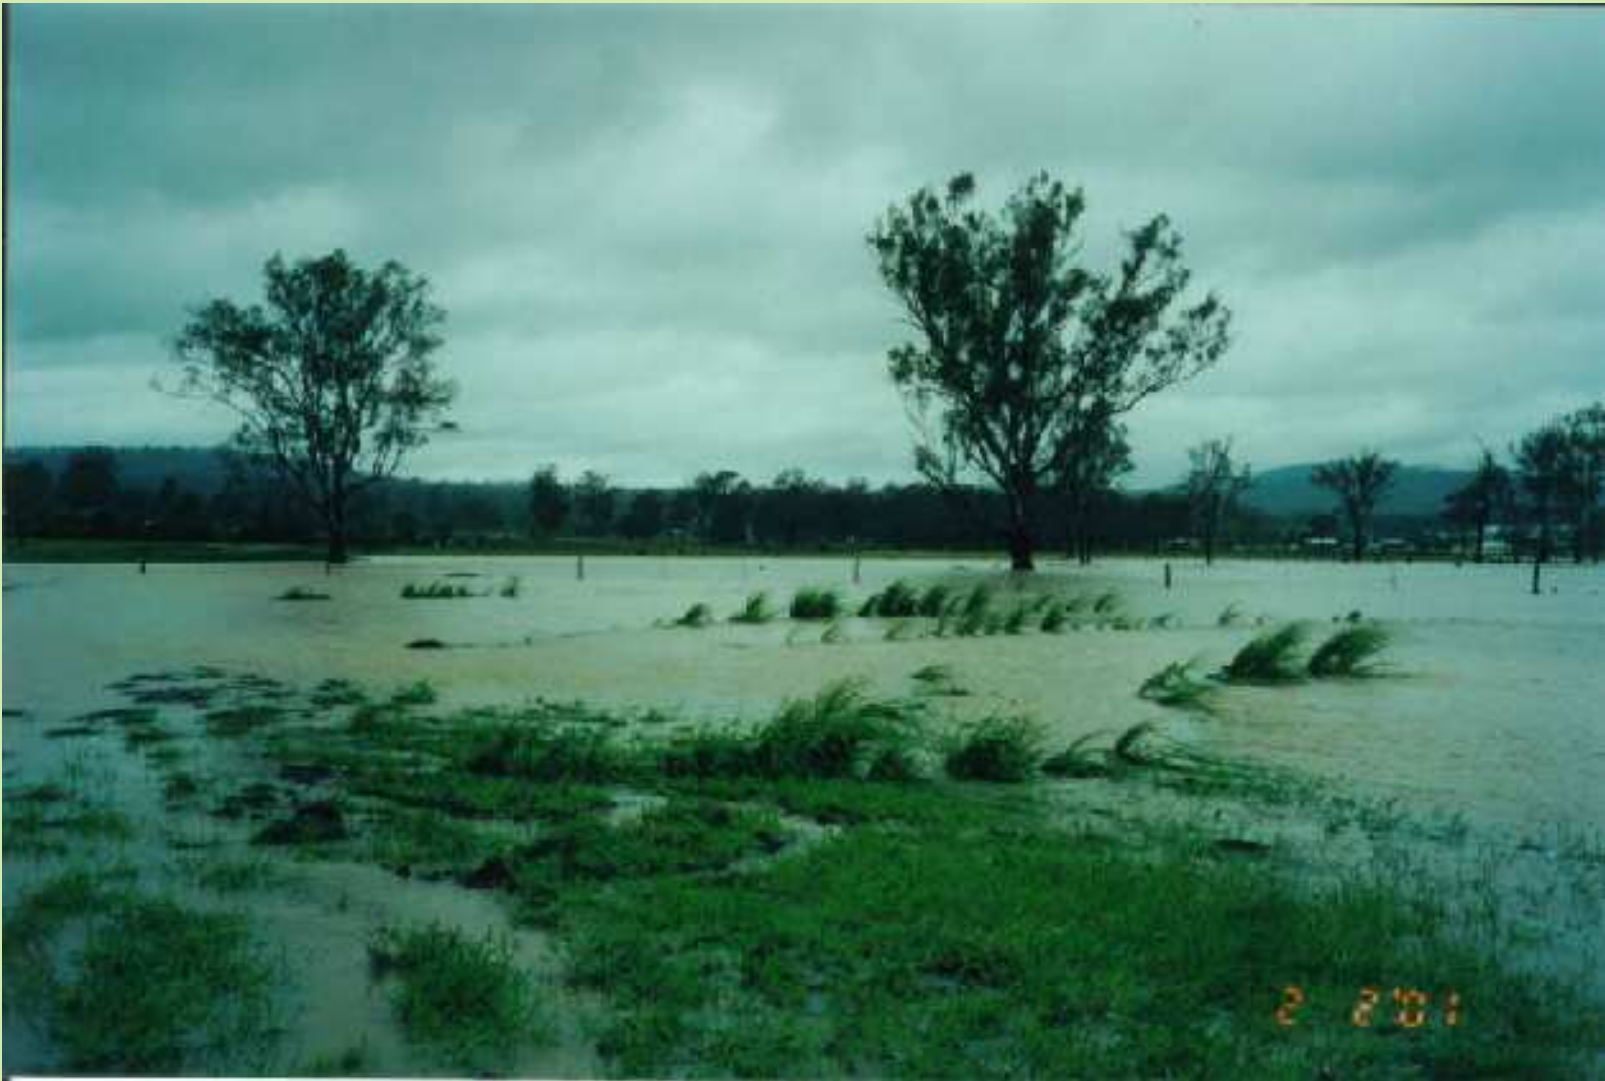
Australia: This drainage channel was often damaged by flood, note that vetiver hedges bent under strong current

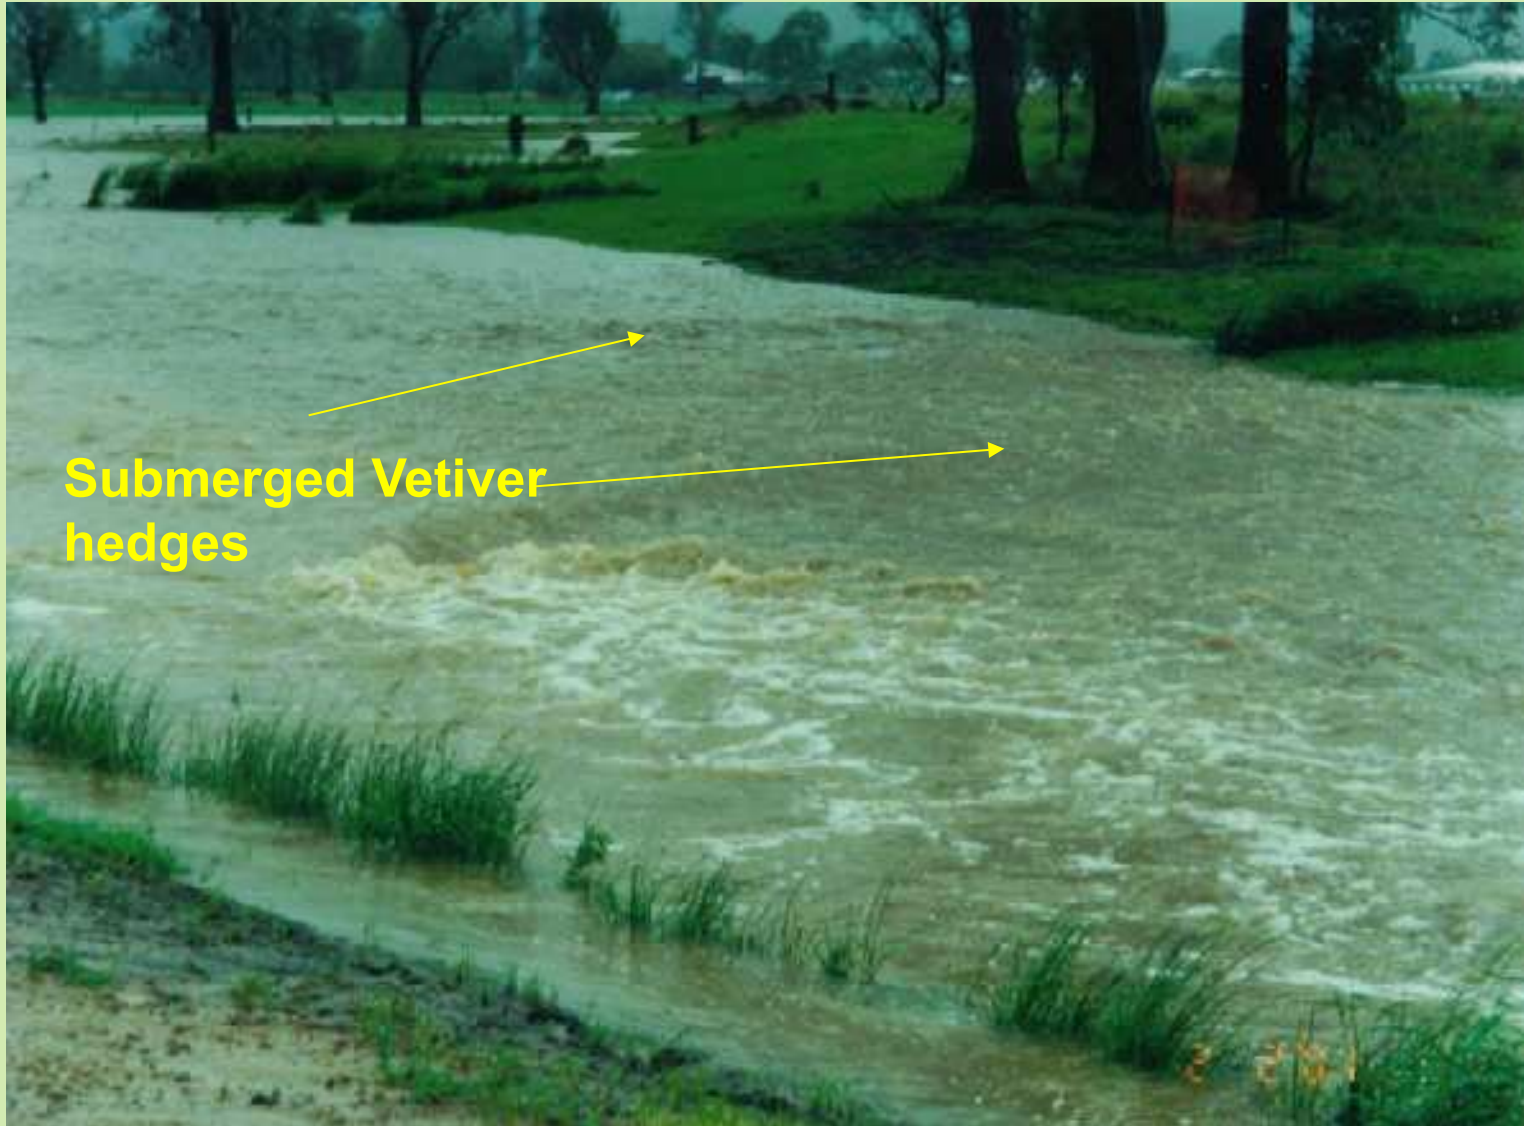
Submerged Vetiver hedges

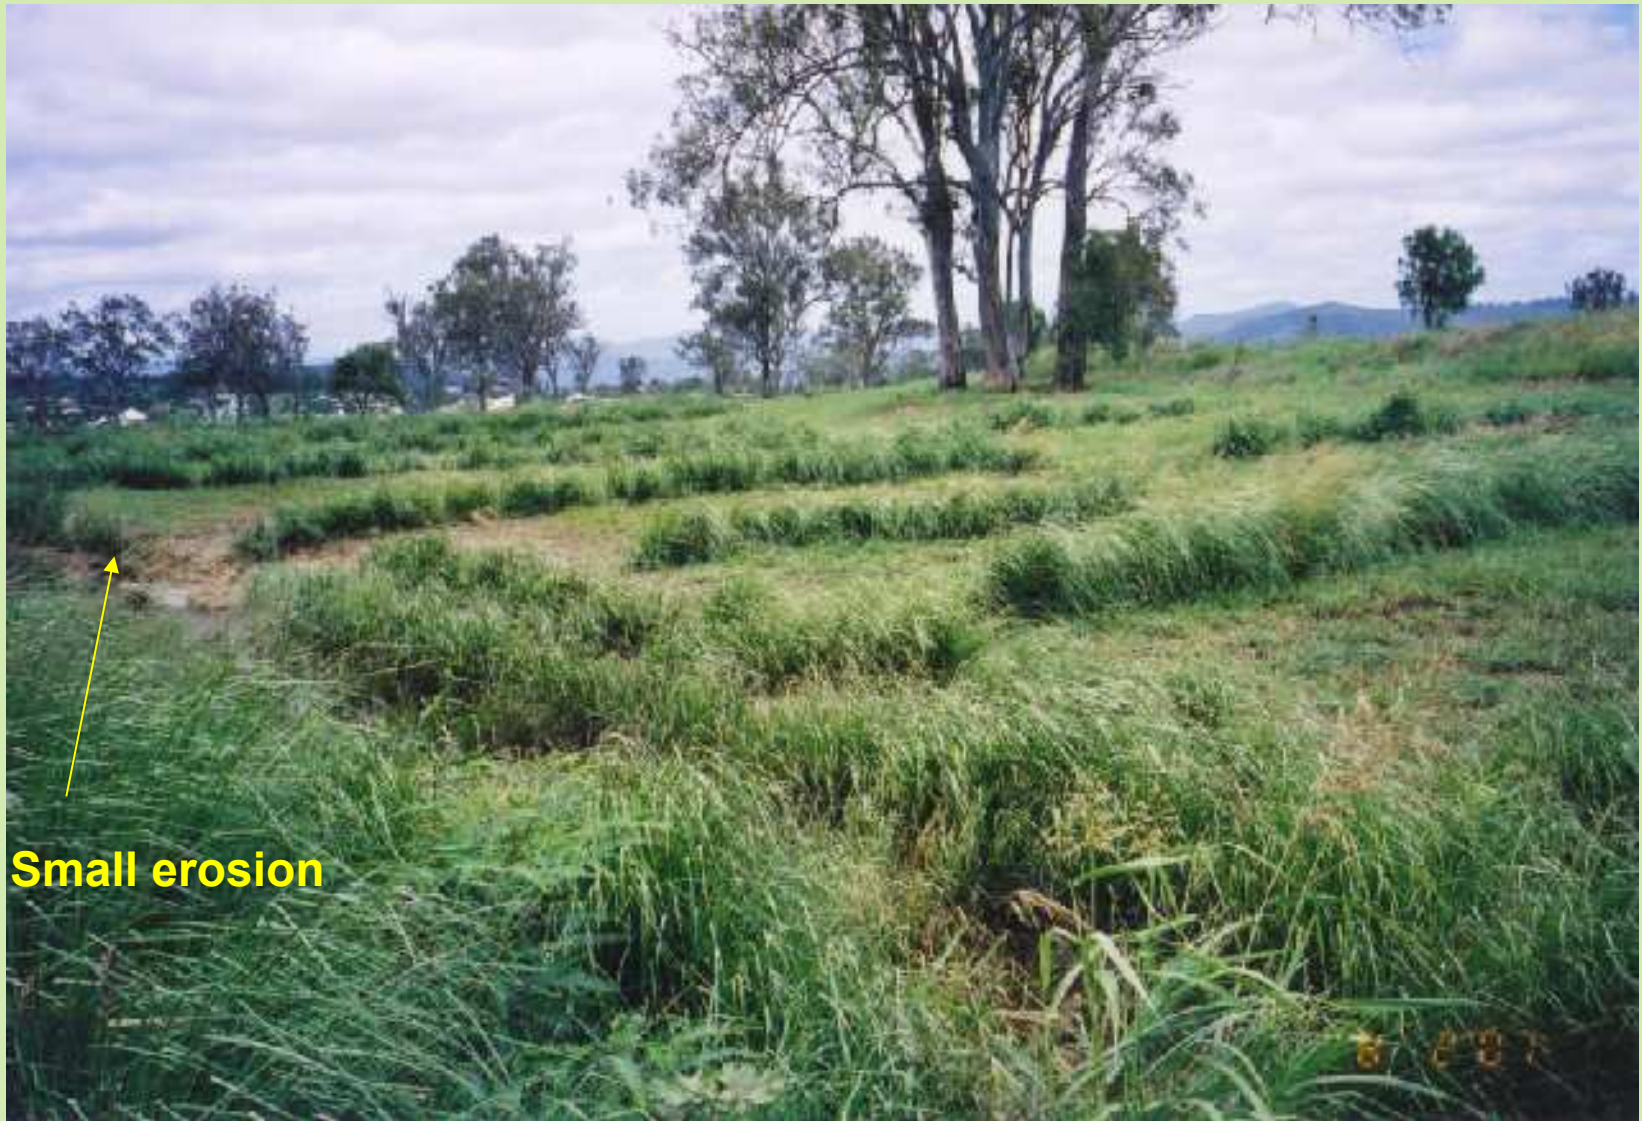
Although only 3 month old, the young hedges provide a very effective protection with only minimal erosion at the head of the channel

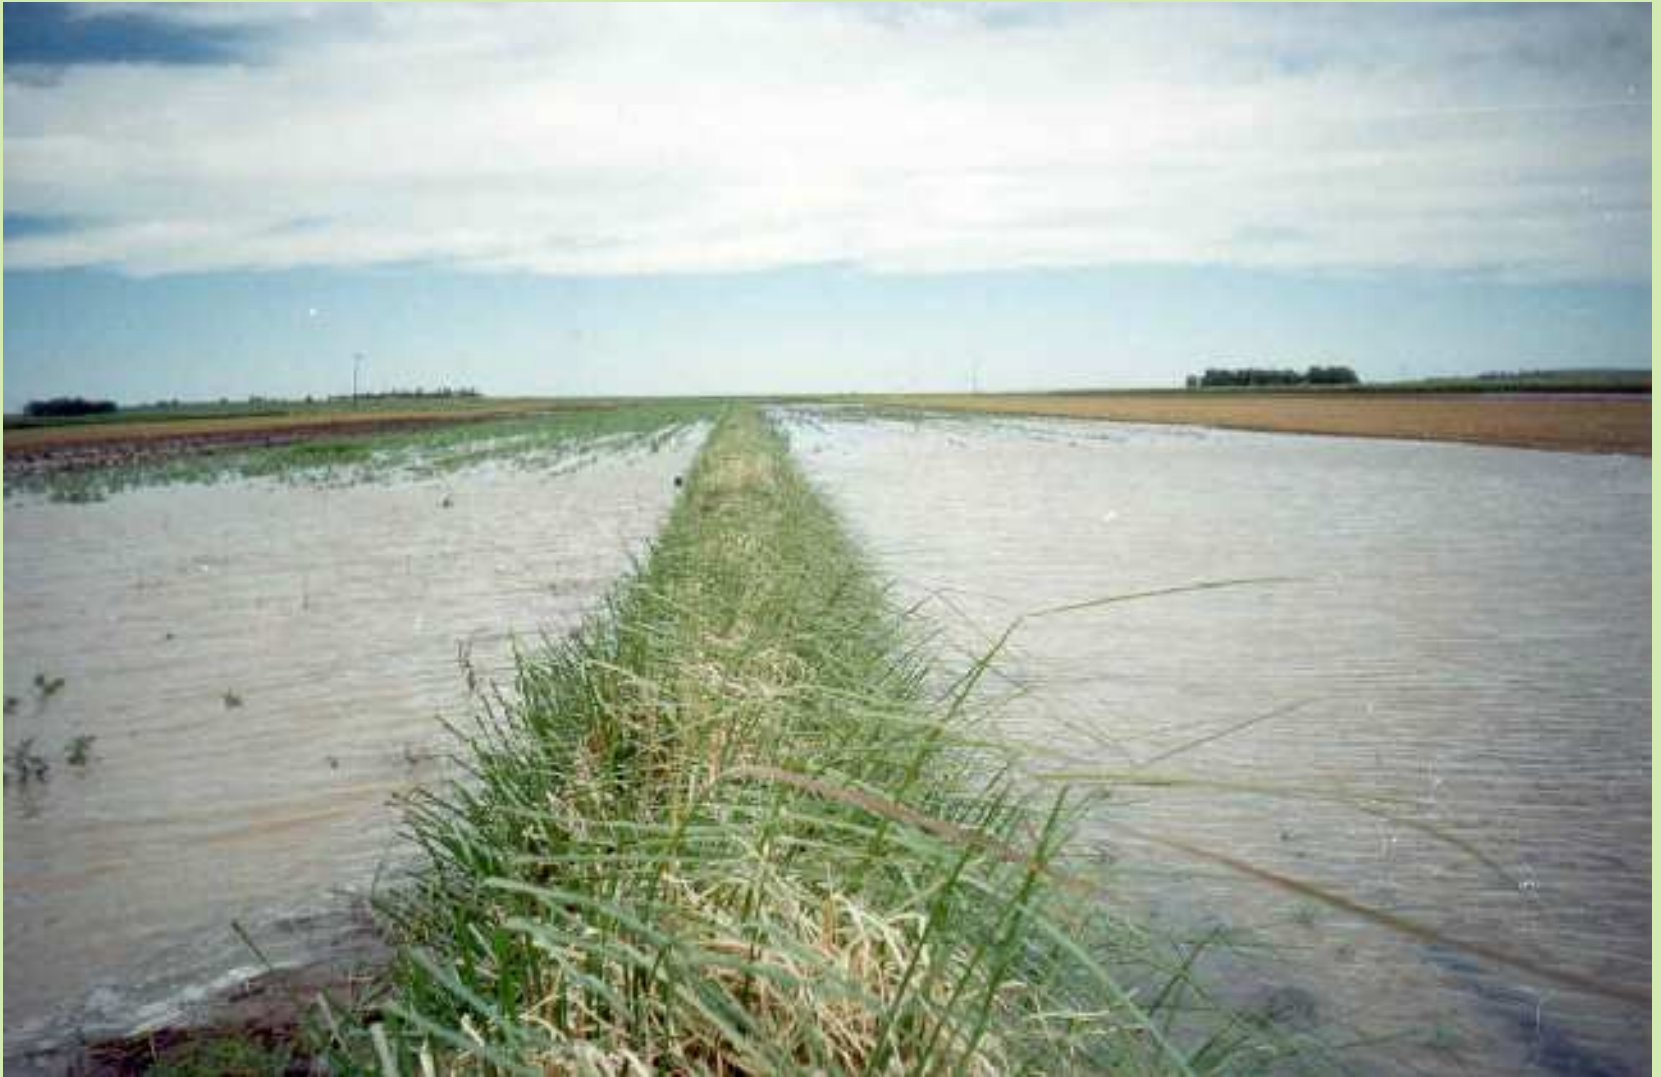
A major flood event in 1996

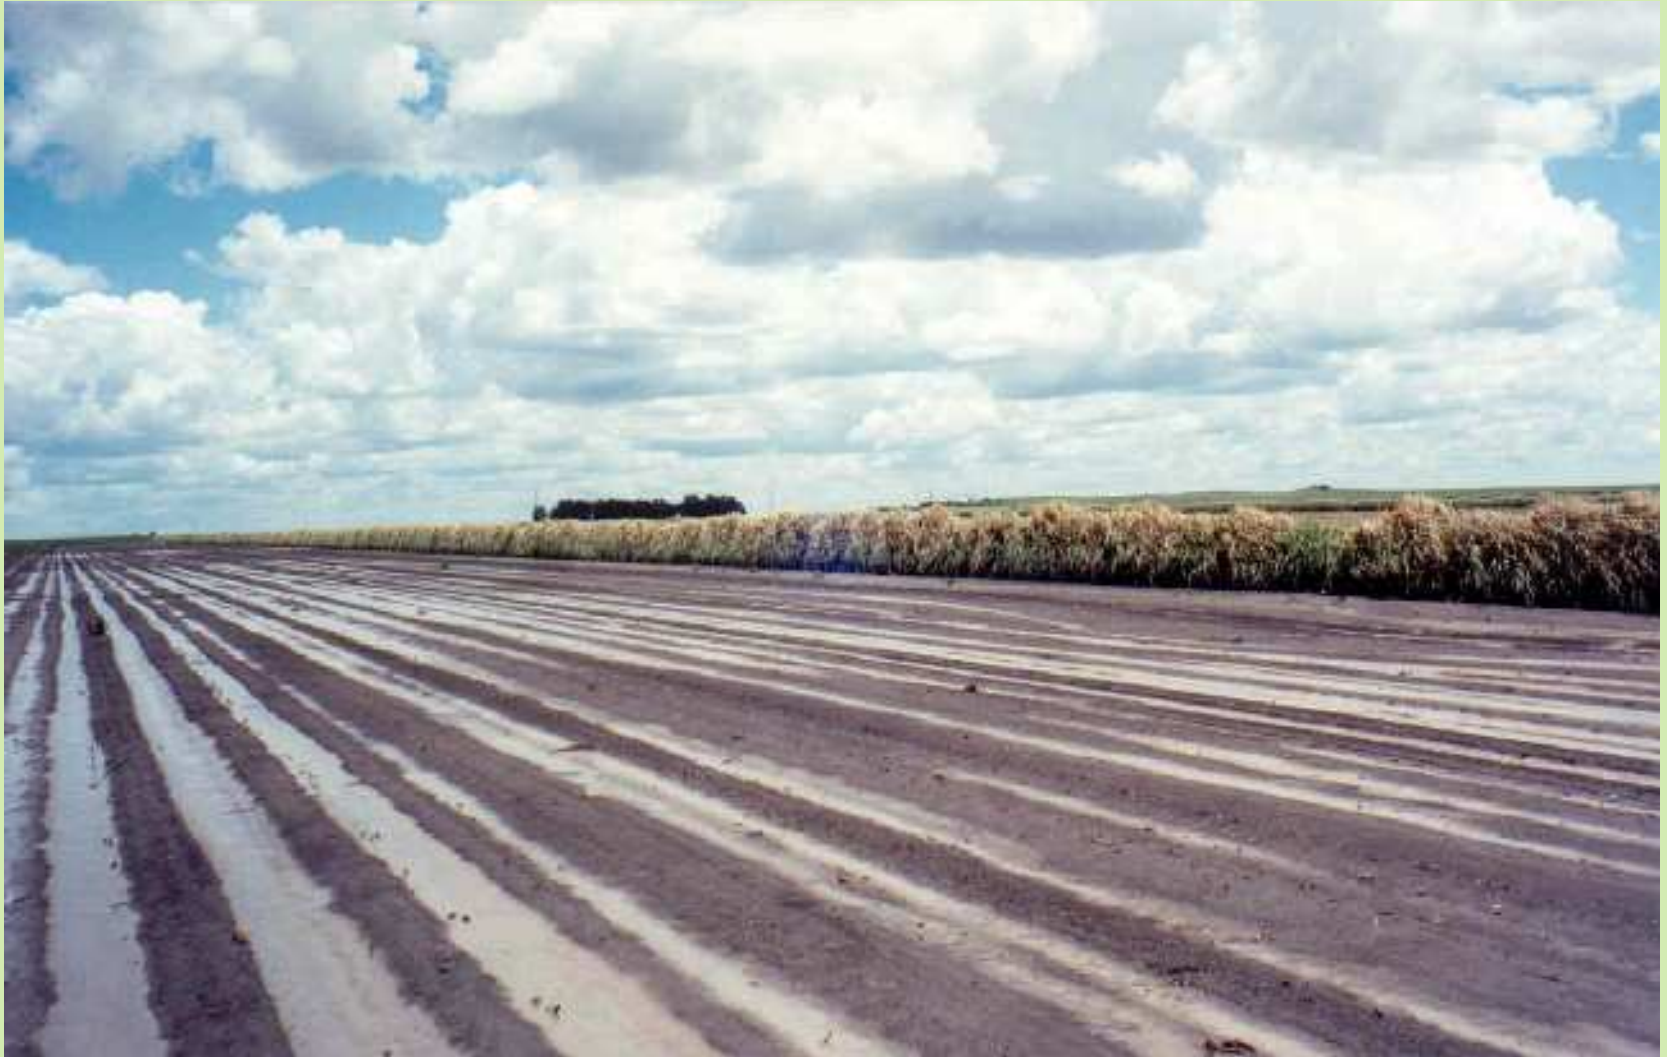
No sign of rill and minimal surface erosion

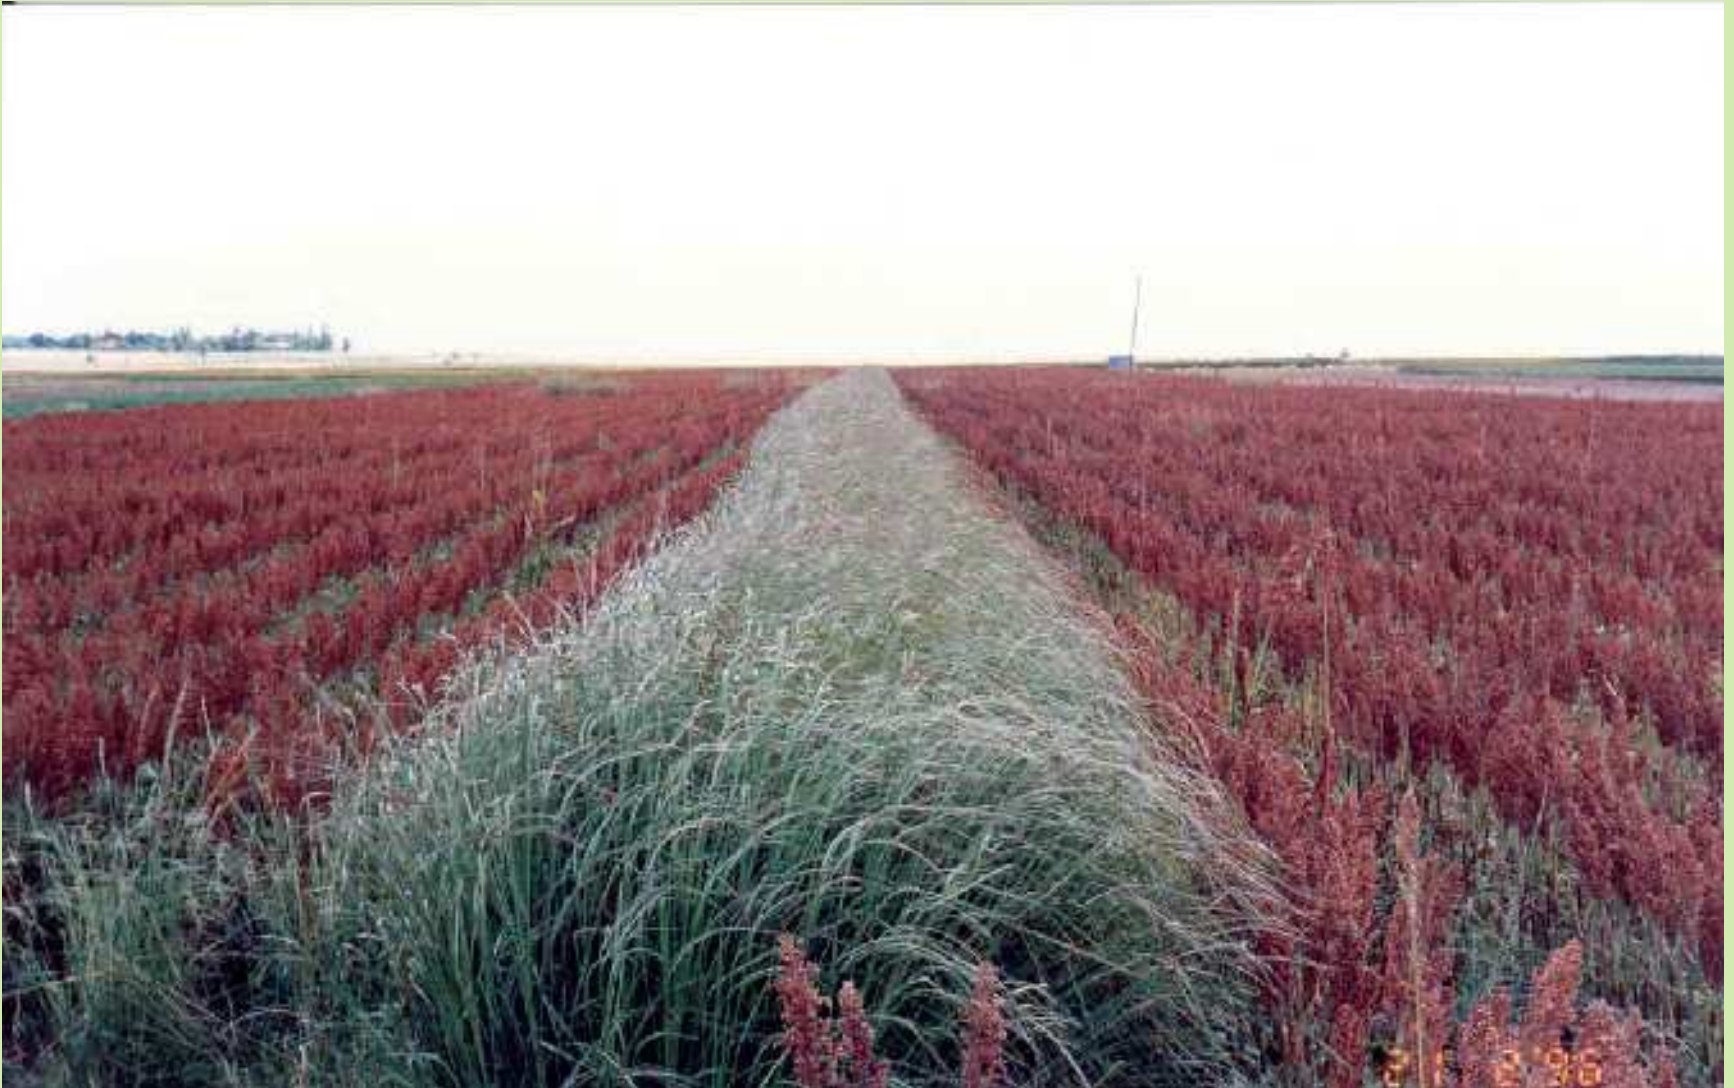
No flood damage and an excellent crop of sorghum
