Vetiver Grass used to protect road culverts in Bandera County – Texas
Jim Smyle

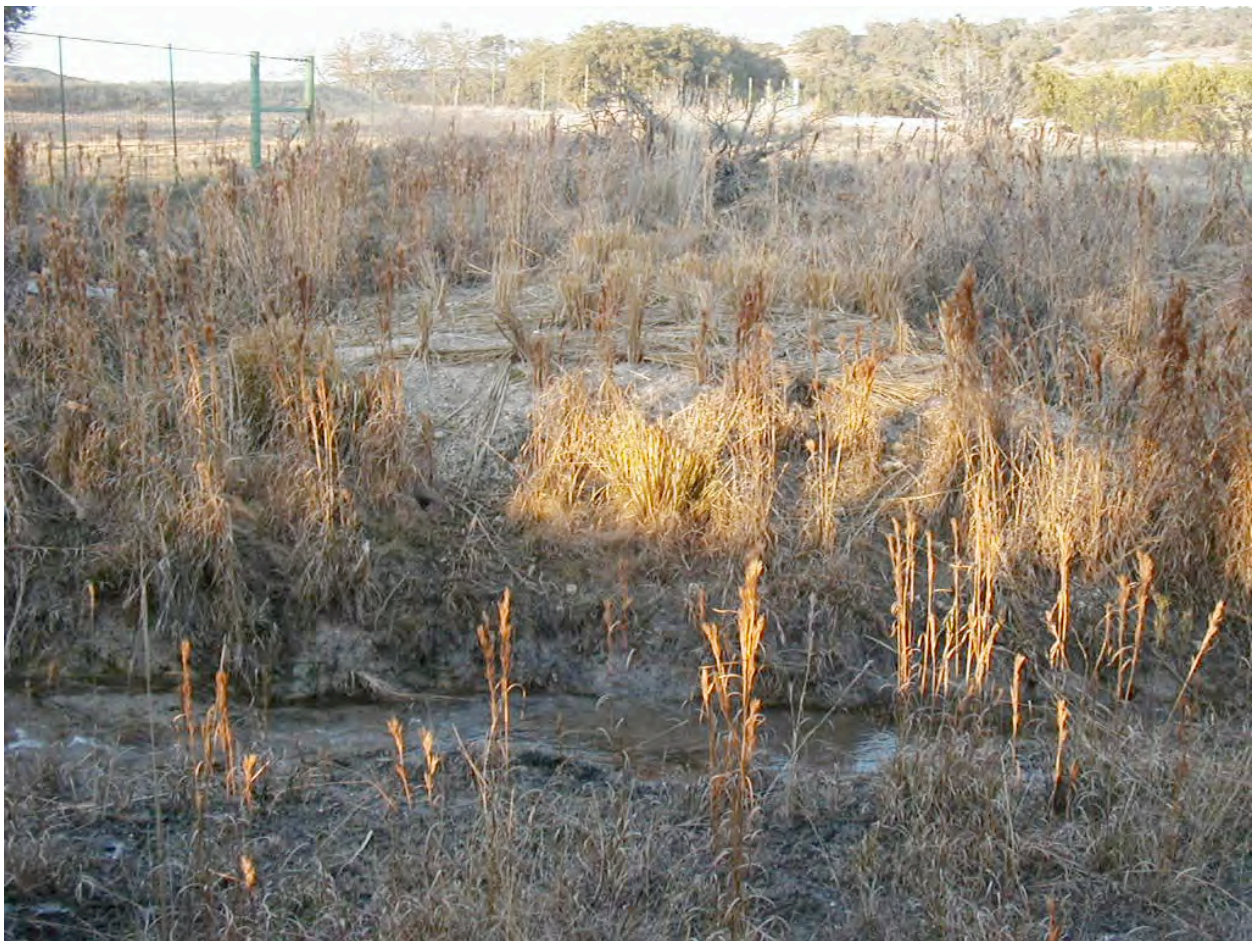
Photo 1. Informal nursery, with about 50 plants, in recent flood-deposited coarse gravelly sands.

Note, this picture and all the others were taken recently. Being winter, and having had below freezing temperatures in November and December, all the vetiver (and other grasses, shrubs and deciduous trees) are brown.

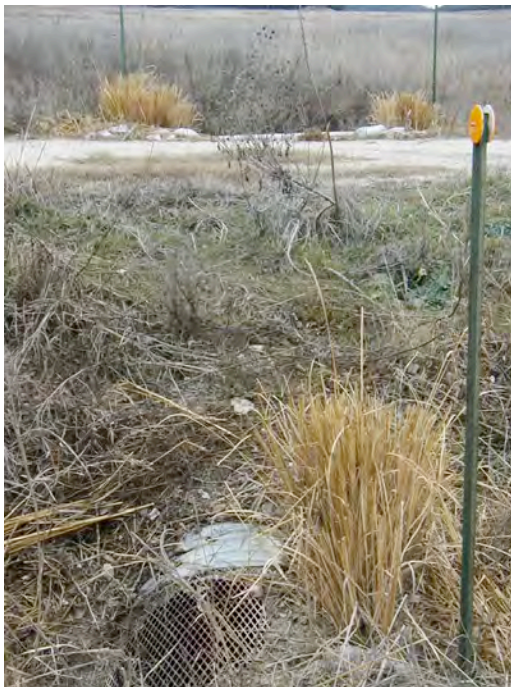
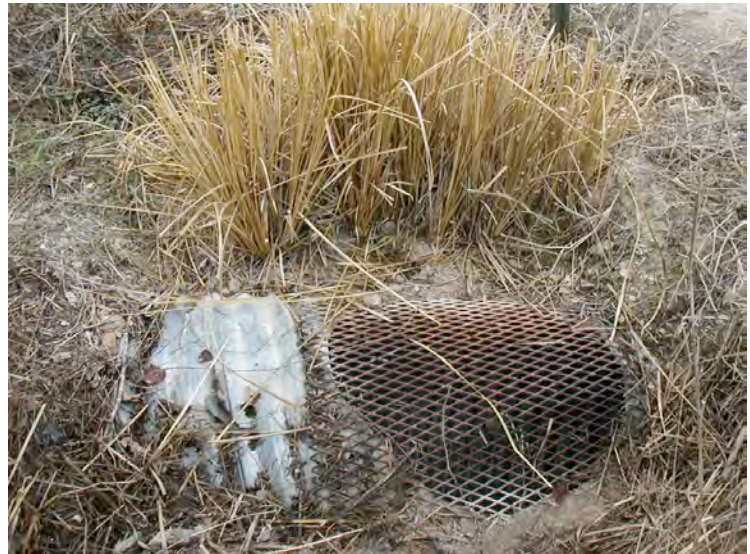
Photos 2 & 3. Culvert installed on our entrance road (far side, photo 2) and run to tie into culvert under county road. As the new culvert crosses the drain on the side of the county road, it was necessary to cut a drain hole into the culvert to allow the drainage from the county road to enter. A small hedge has been planted upslope to filter out debris and keep the screen from clogging.

In 2004 we had the dirt road coming into our property improved by grading, putting in cross-drainage, and surfacing (with caliche) on a critical section. During the floods of 2002, the nearby county road was washed out – the culverts were ripped out by the flood waters. Our neighbors used our entrance road to bypass the section of county road that was destroyed. Our section, which was parallel the county road and only 5 meters away, survived as we had protected that section with vetiver hedges. When we improved the road in 2002, we were forced to put in a culvert in that section as we had raised and surfaced the road bed due to it being a very sticky clay soil in that section. We tied our new culvert into the one going under the county road and have protected it with vetiver.

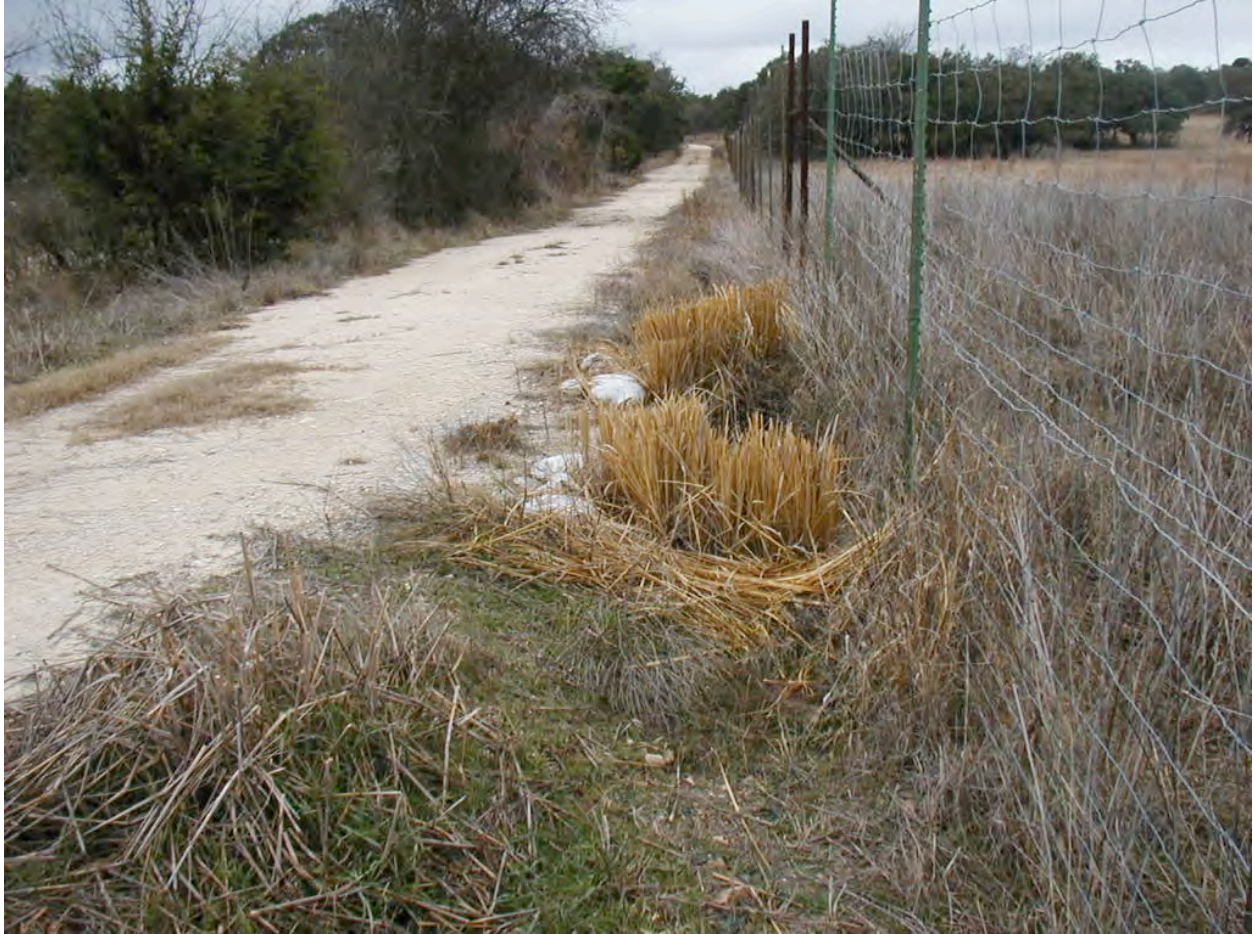
Photo 4. Vetiver planted to protect soil : concrete interface of culvert and to take velocity out of runoff in the road drains.

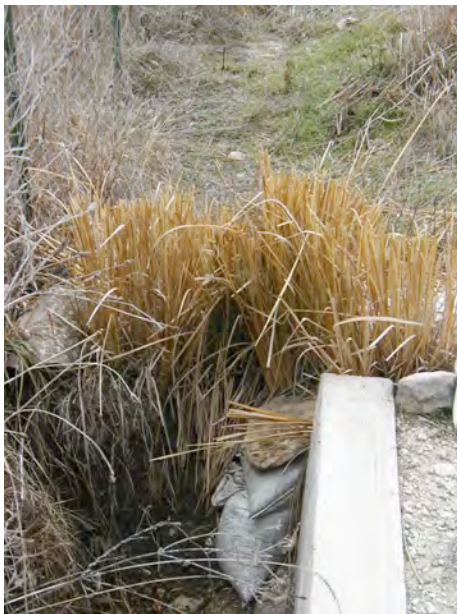
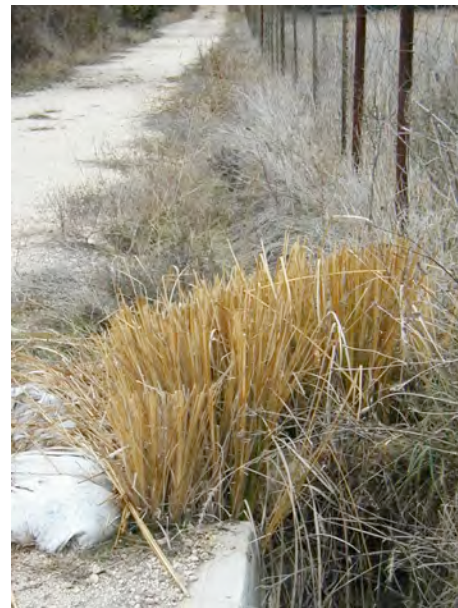
Photos 5& 6. Close-up of culvert protection plantings.

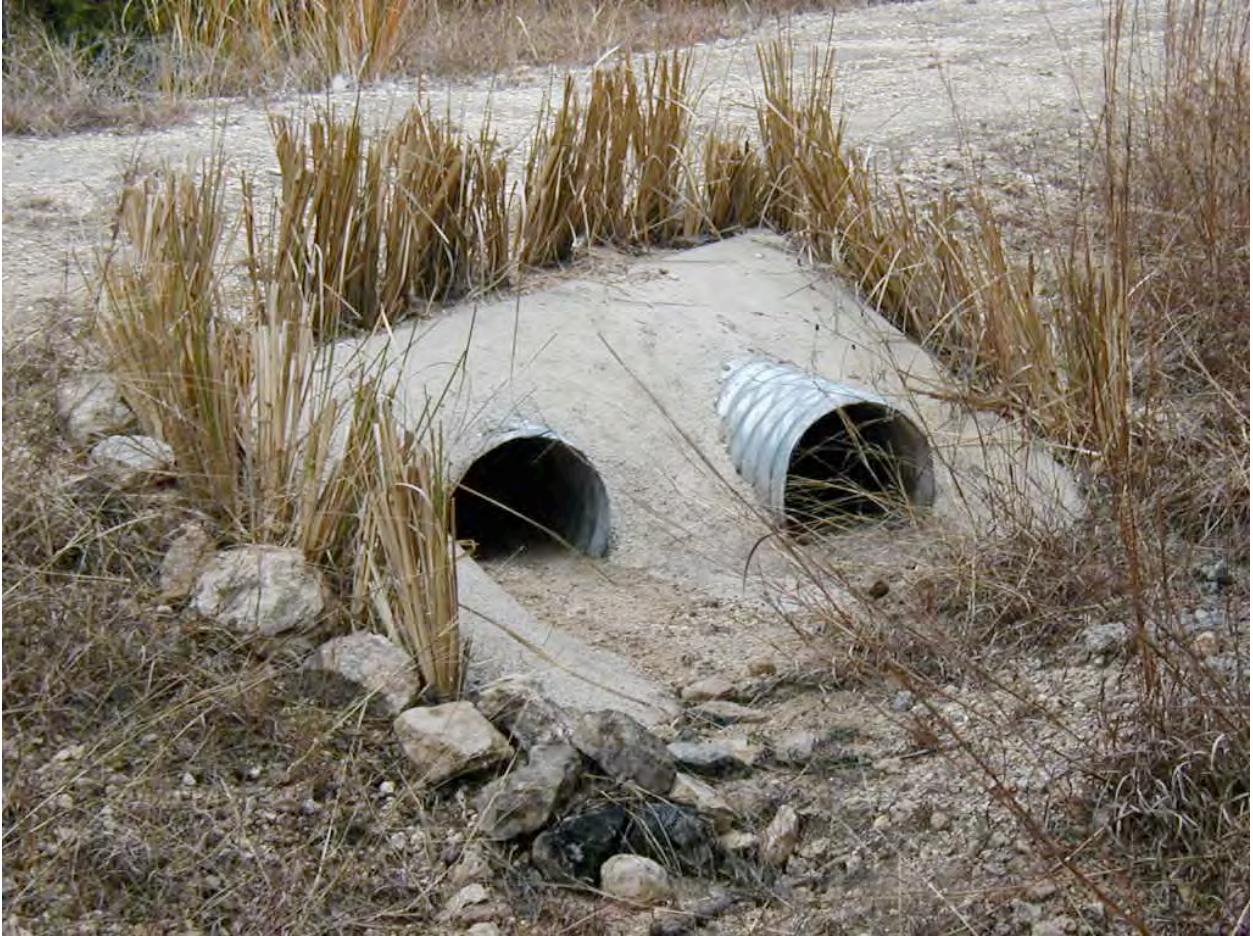
Photo 7. Another culvert that we have protected with vetiver.
