***Across the gulley or streams***

works of P Truong in Australia

***FLOOD EROSION CONTROL ON  
A LARGE URBAN DRAIN  
IN QUEENSLAND***

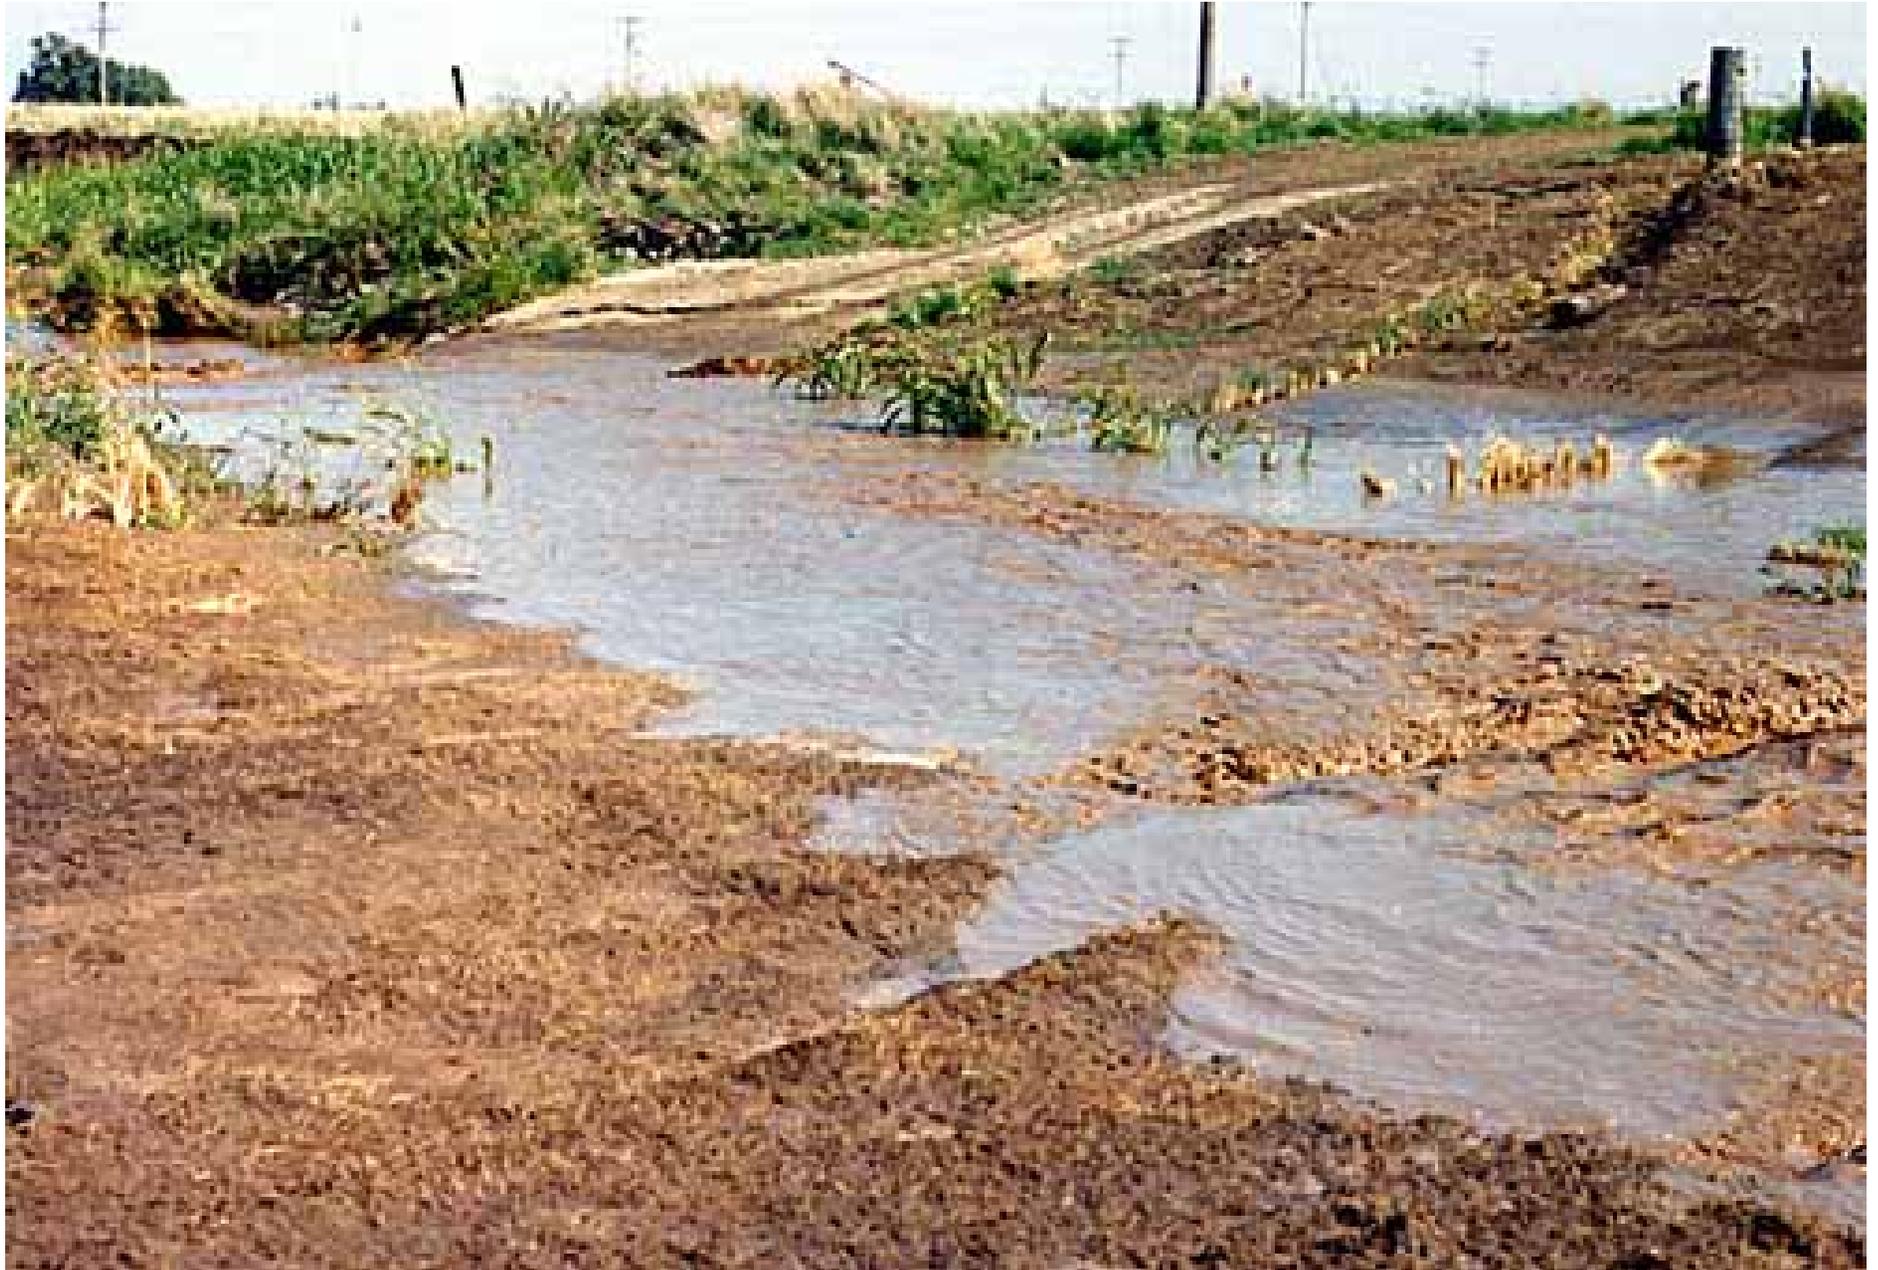
This concrete causeway on this farm road was often washed away by flood water which undermined the foundation of the concrete surface

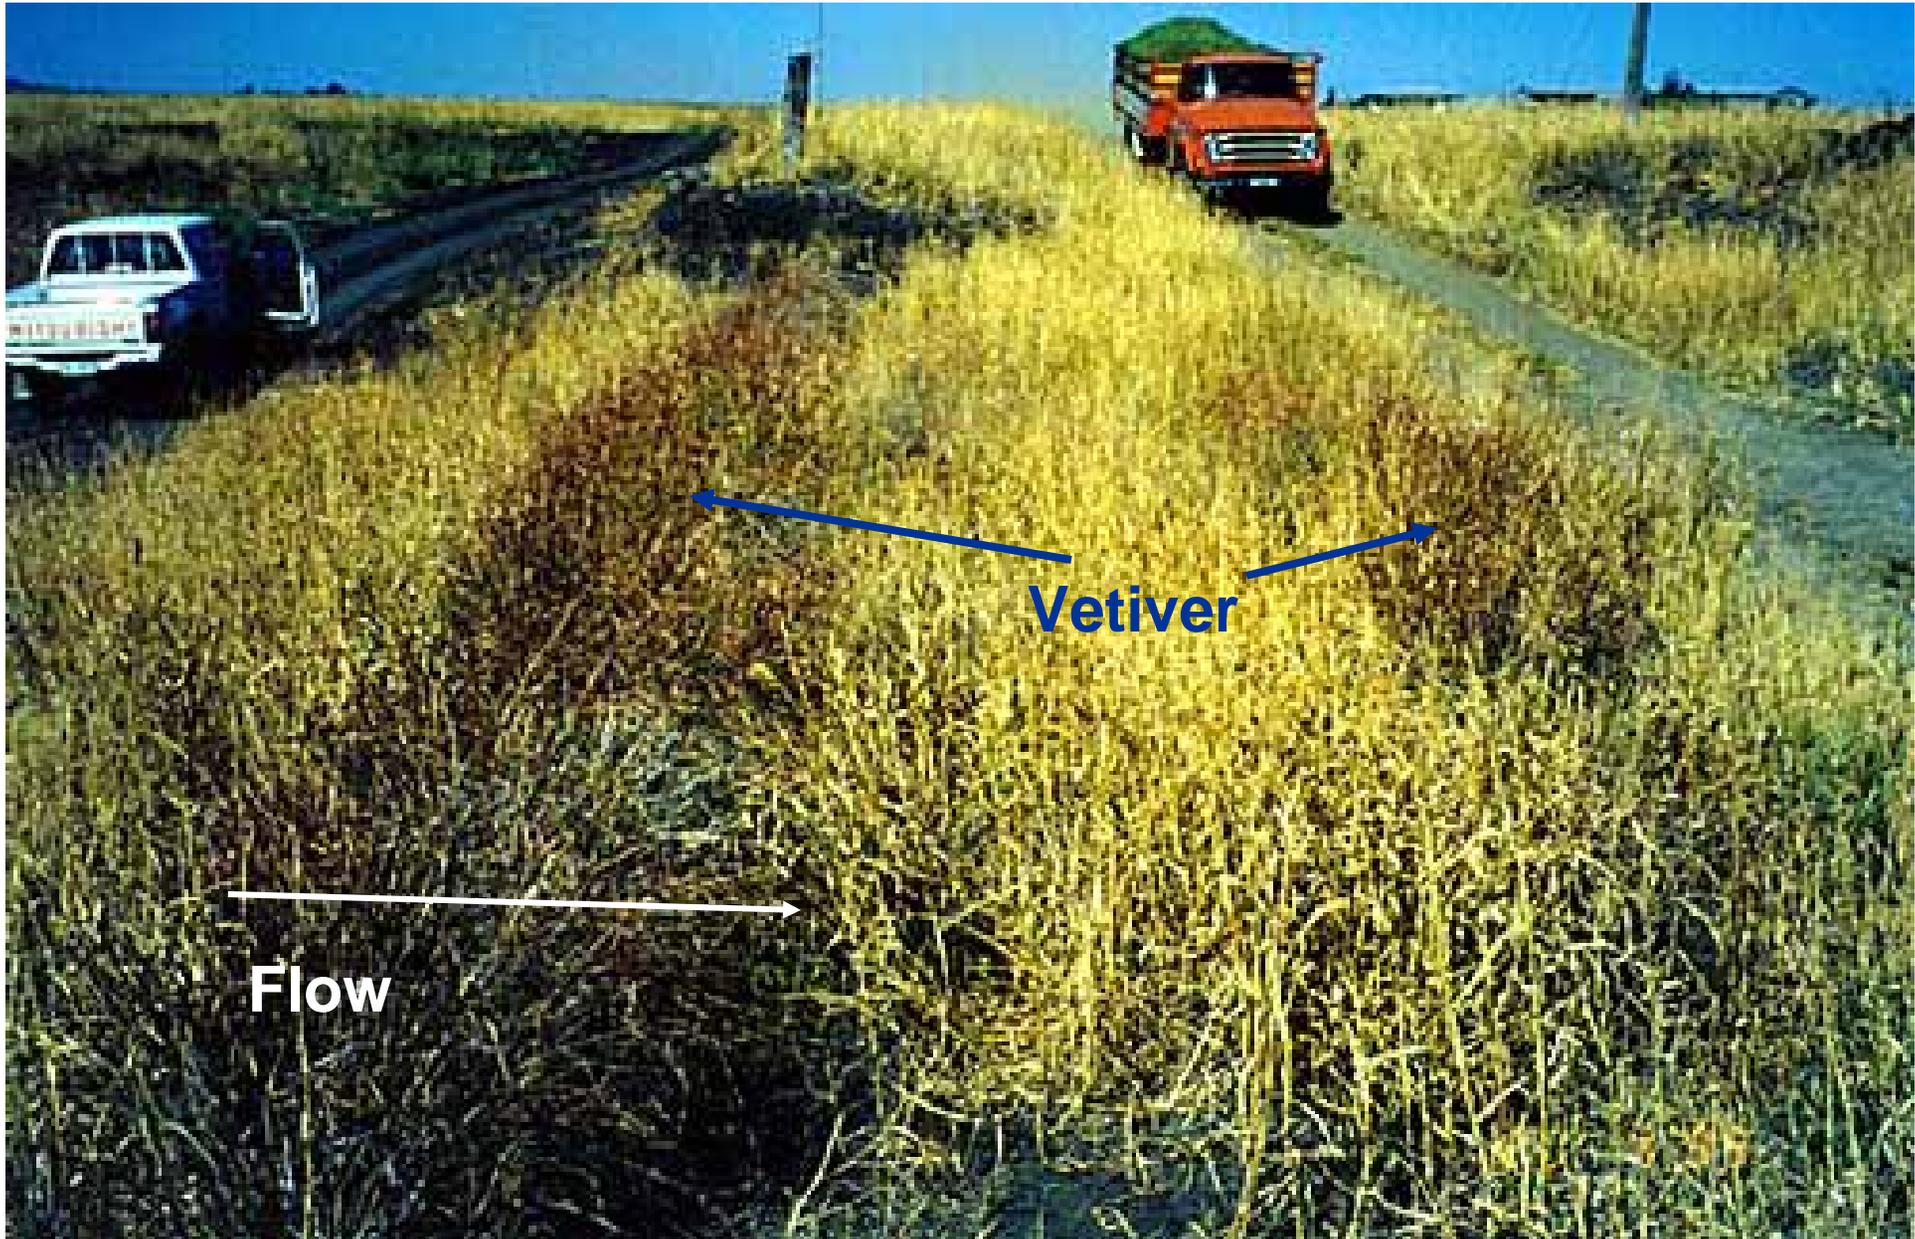
Two rows of well established and mature vetiver planted upstream from the causeway

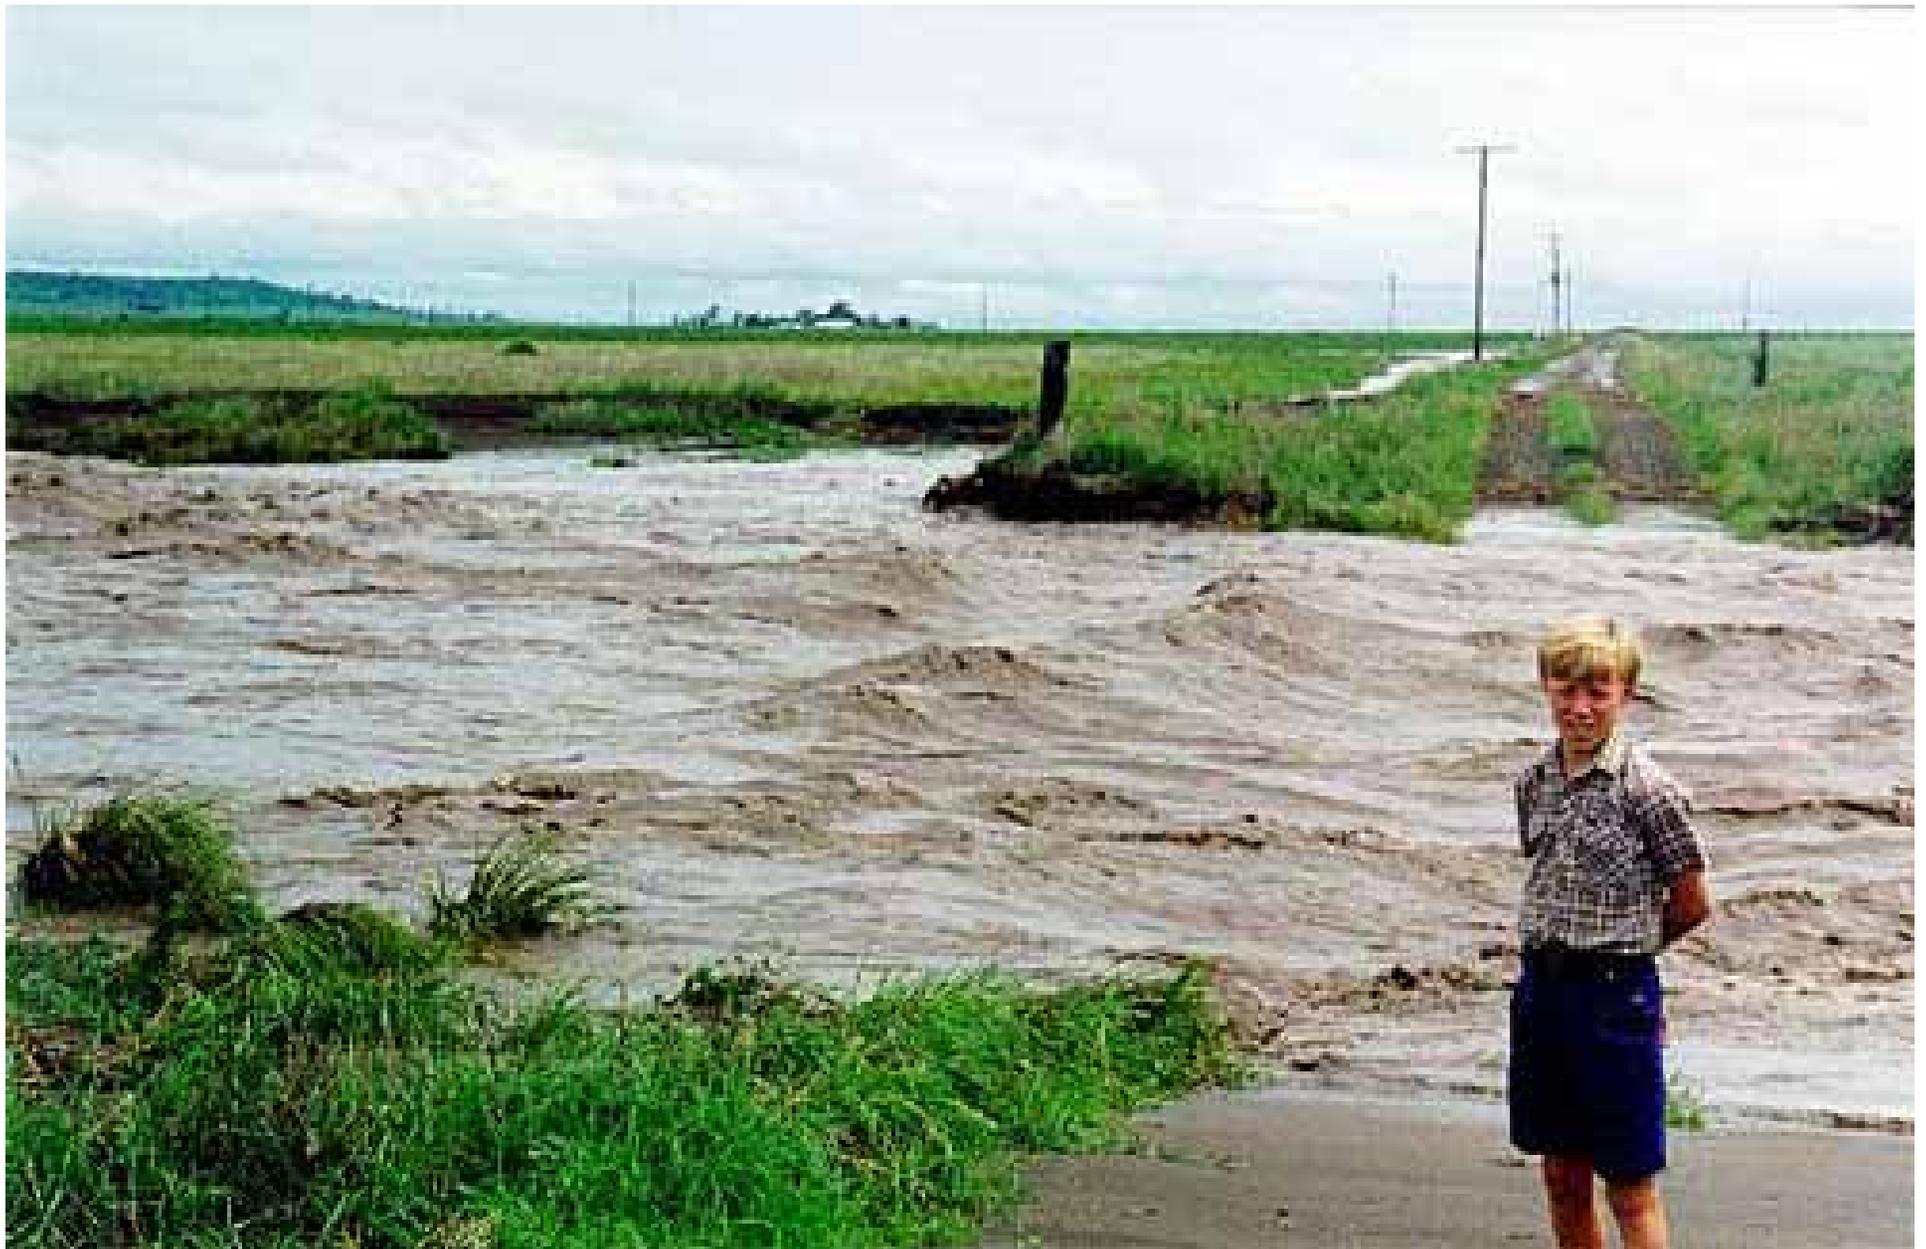
A 3m deep flood swept through this causeway, completely submerged the vetiver rows

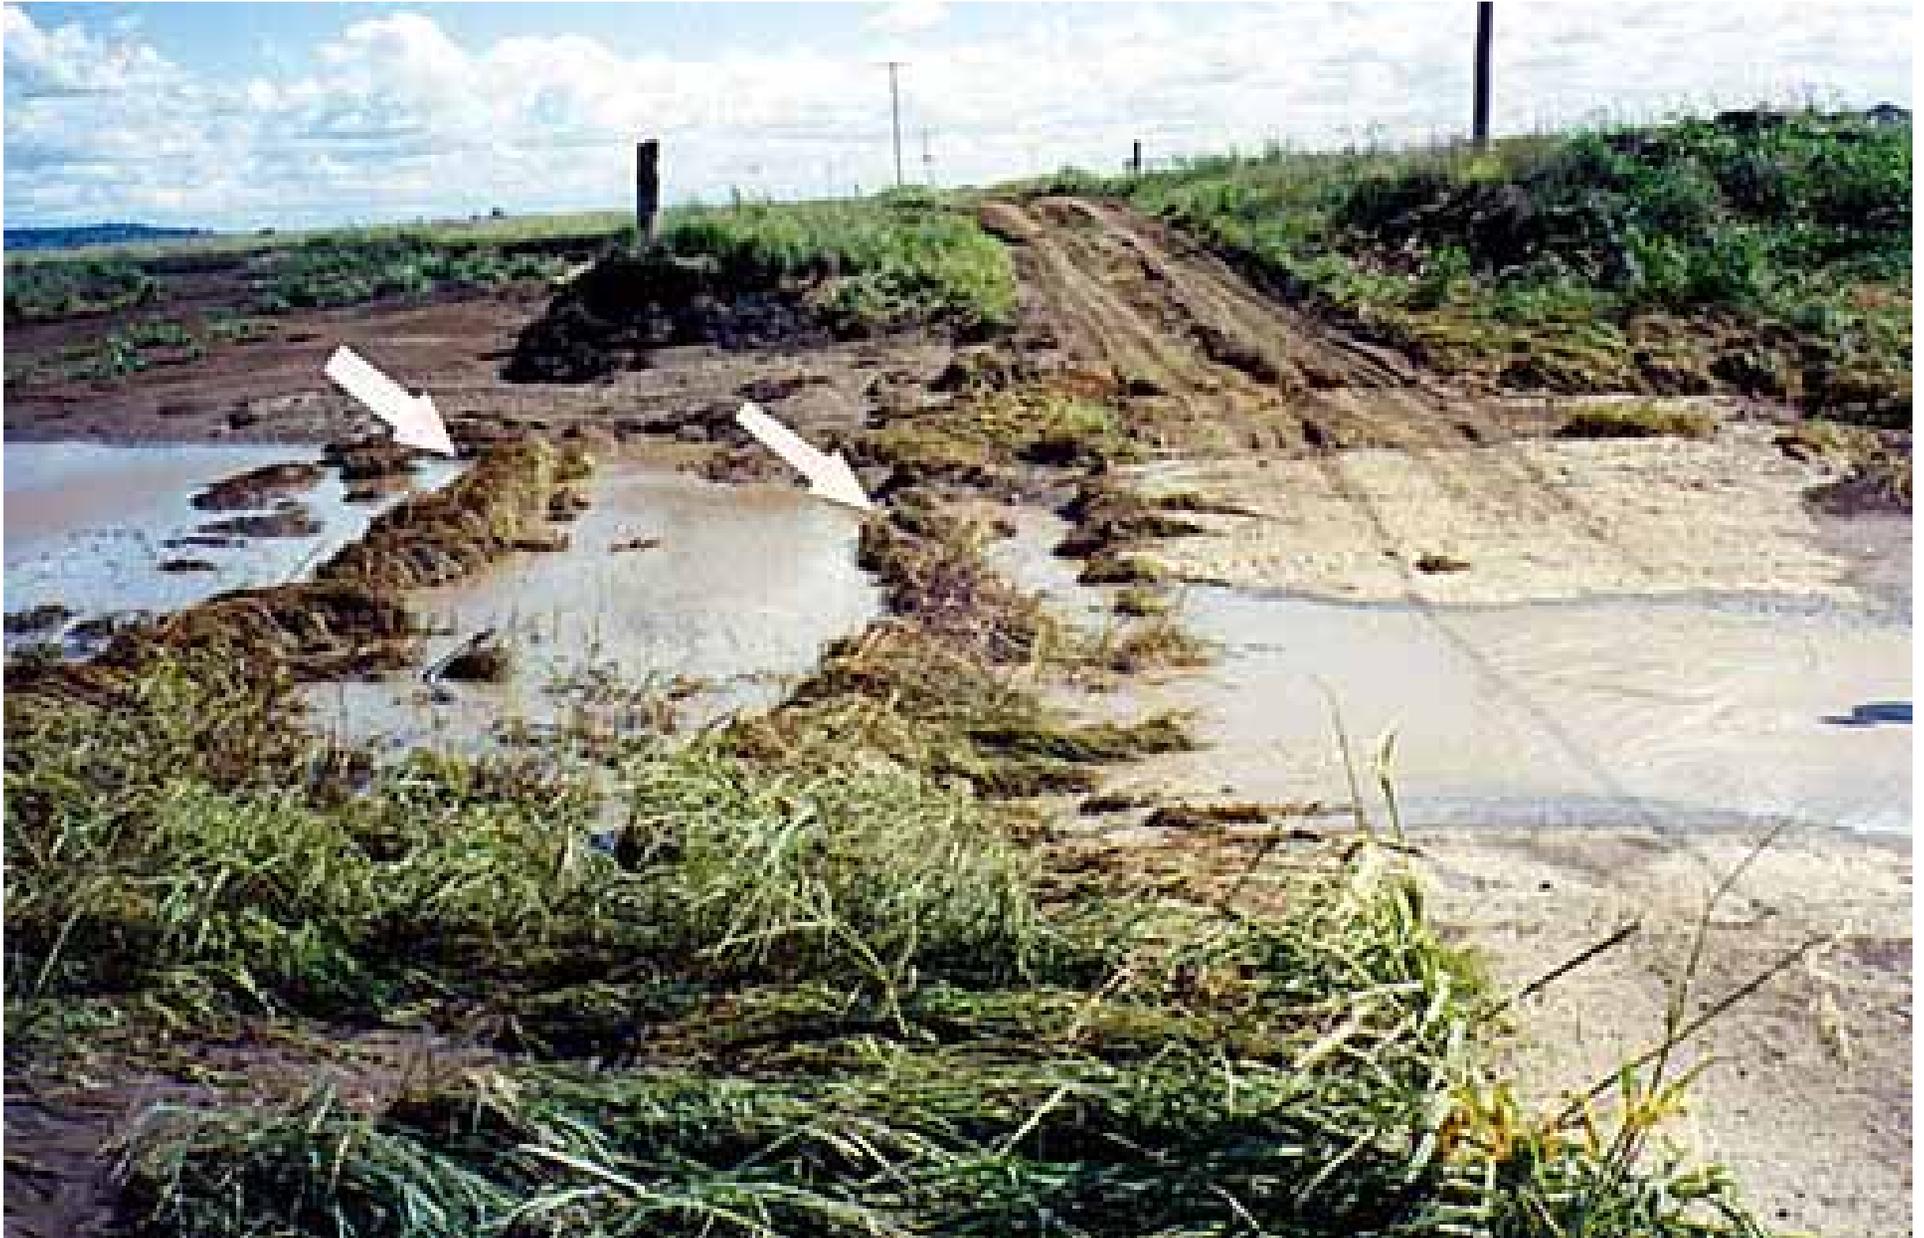
Although badly battered, the vetiver hedges held firm during the flood, preventing the undermining of the concrete causeway

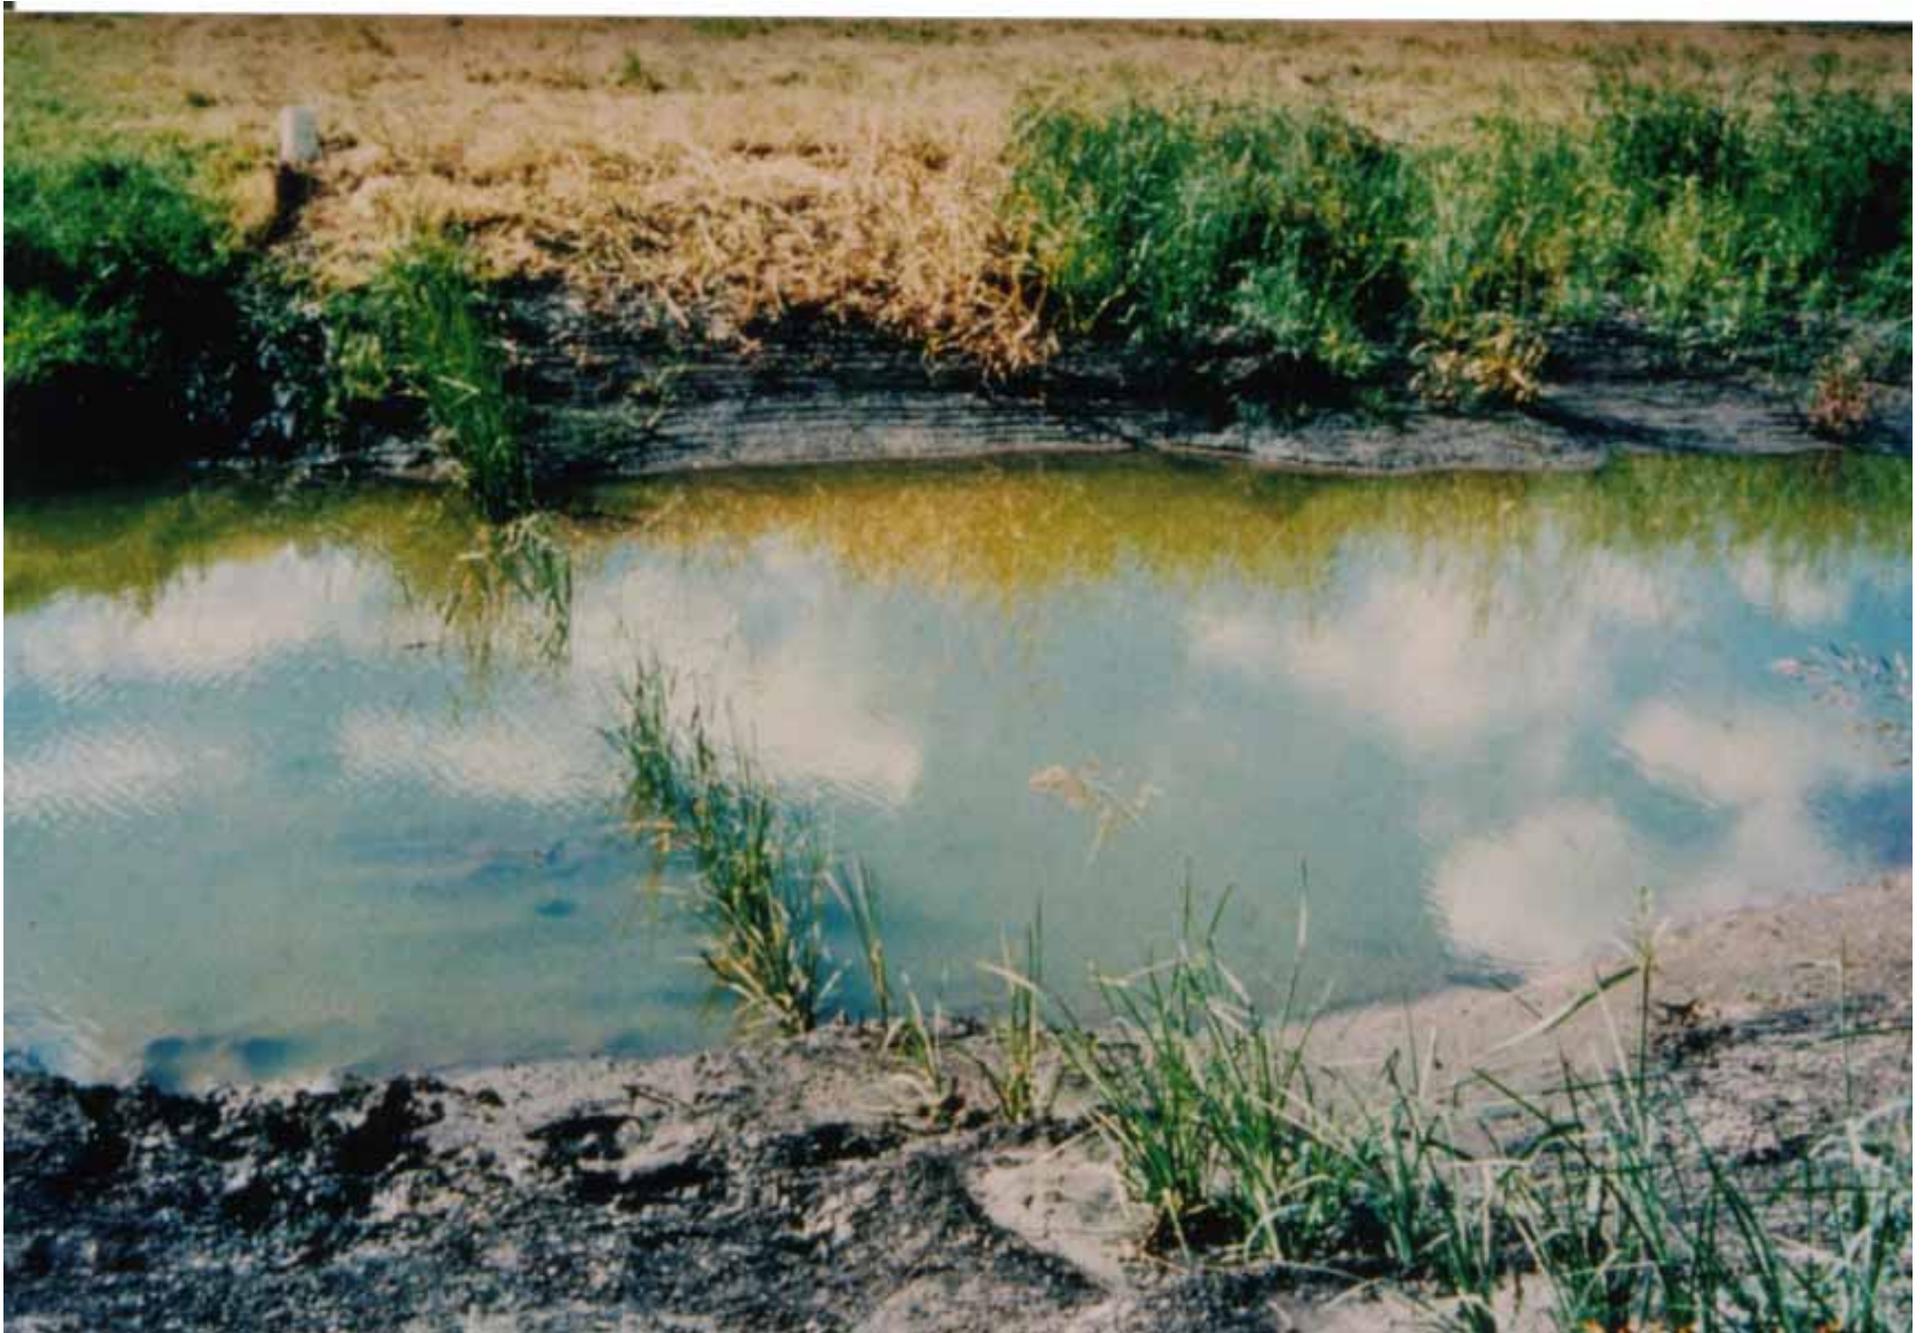
**Partially submerged under fresh water for at least 6 months on a farm waterway**

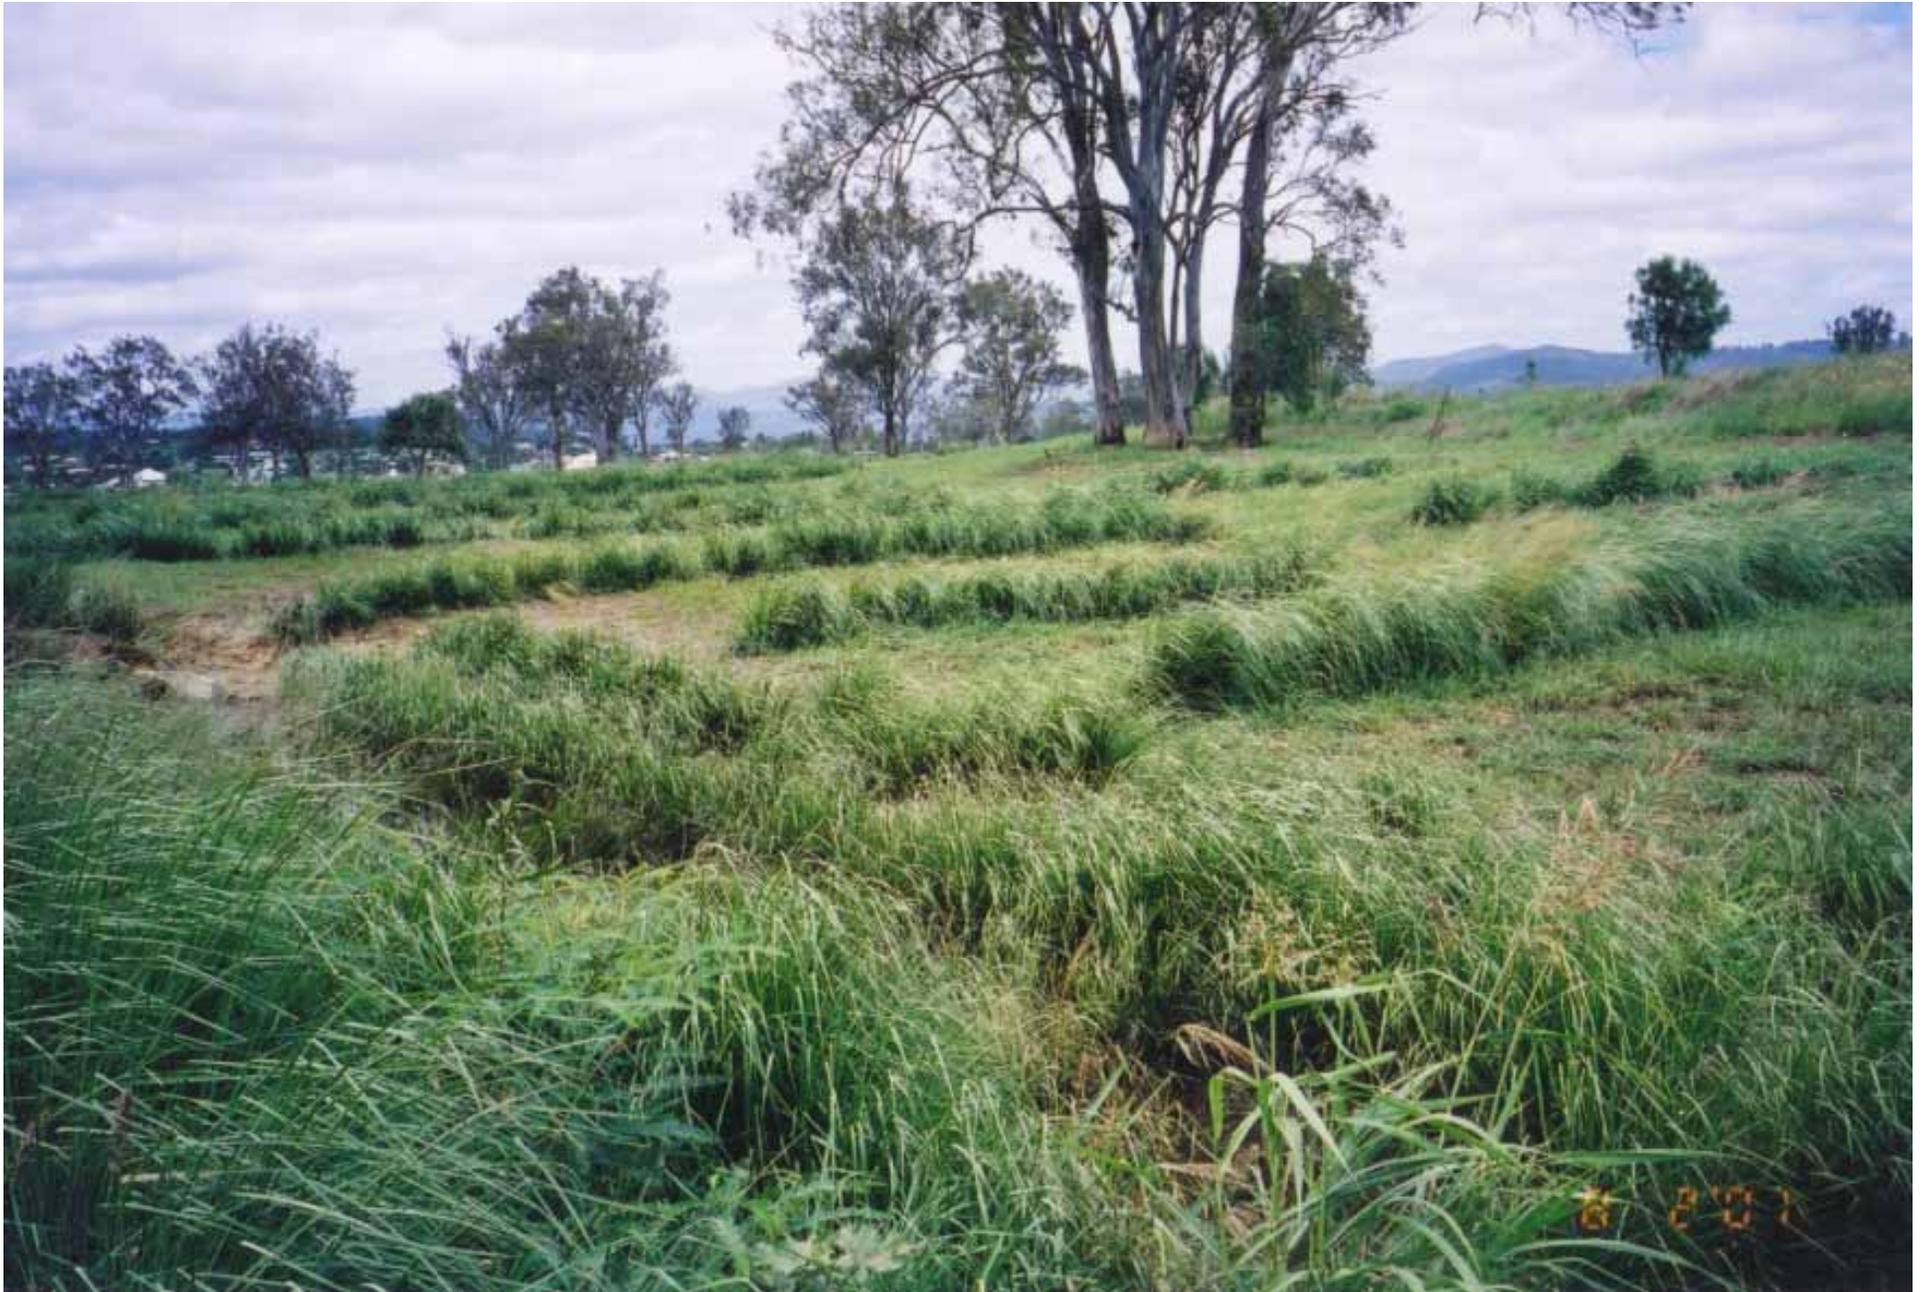
**VETIVER WAS PLANTED ON THIS LARGE URBAN DRAIN TO CONTROL FLOOD EROSION**

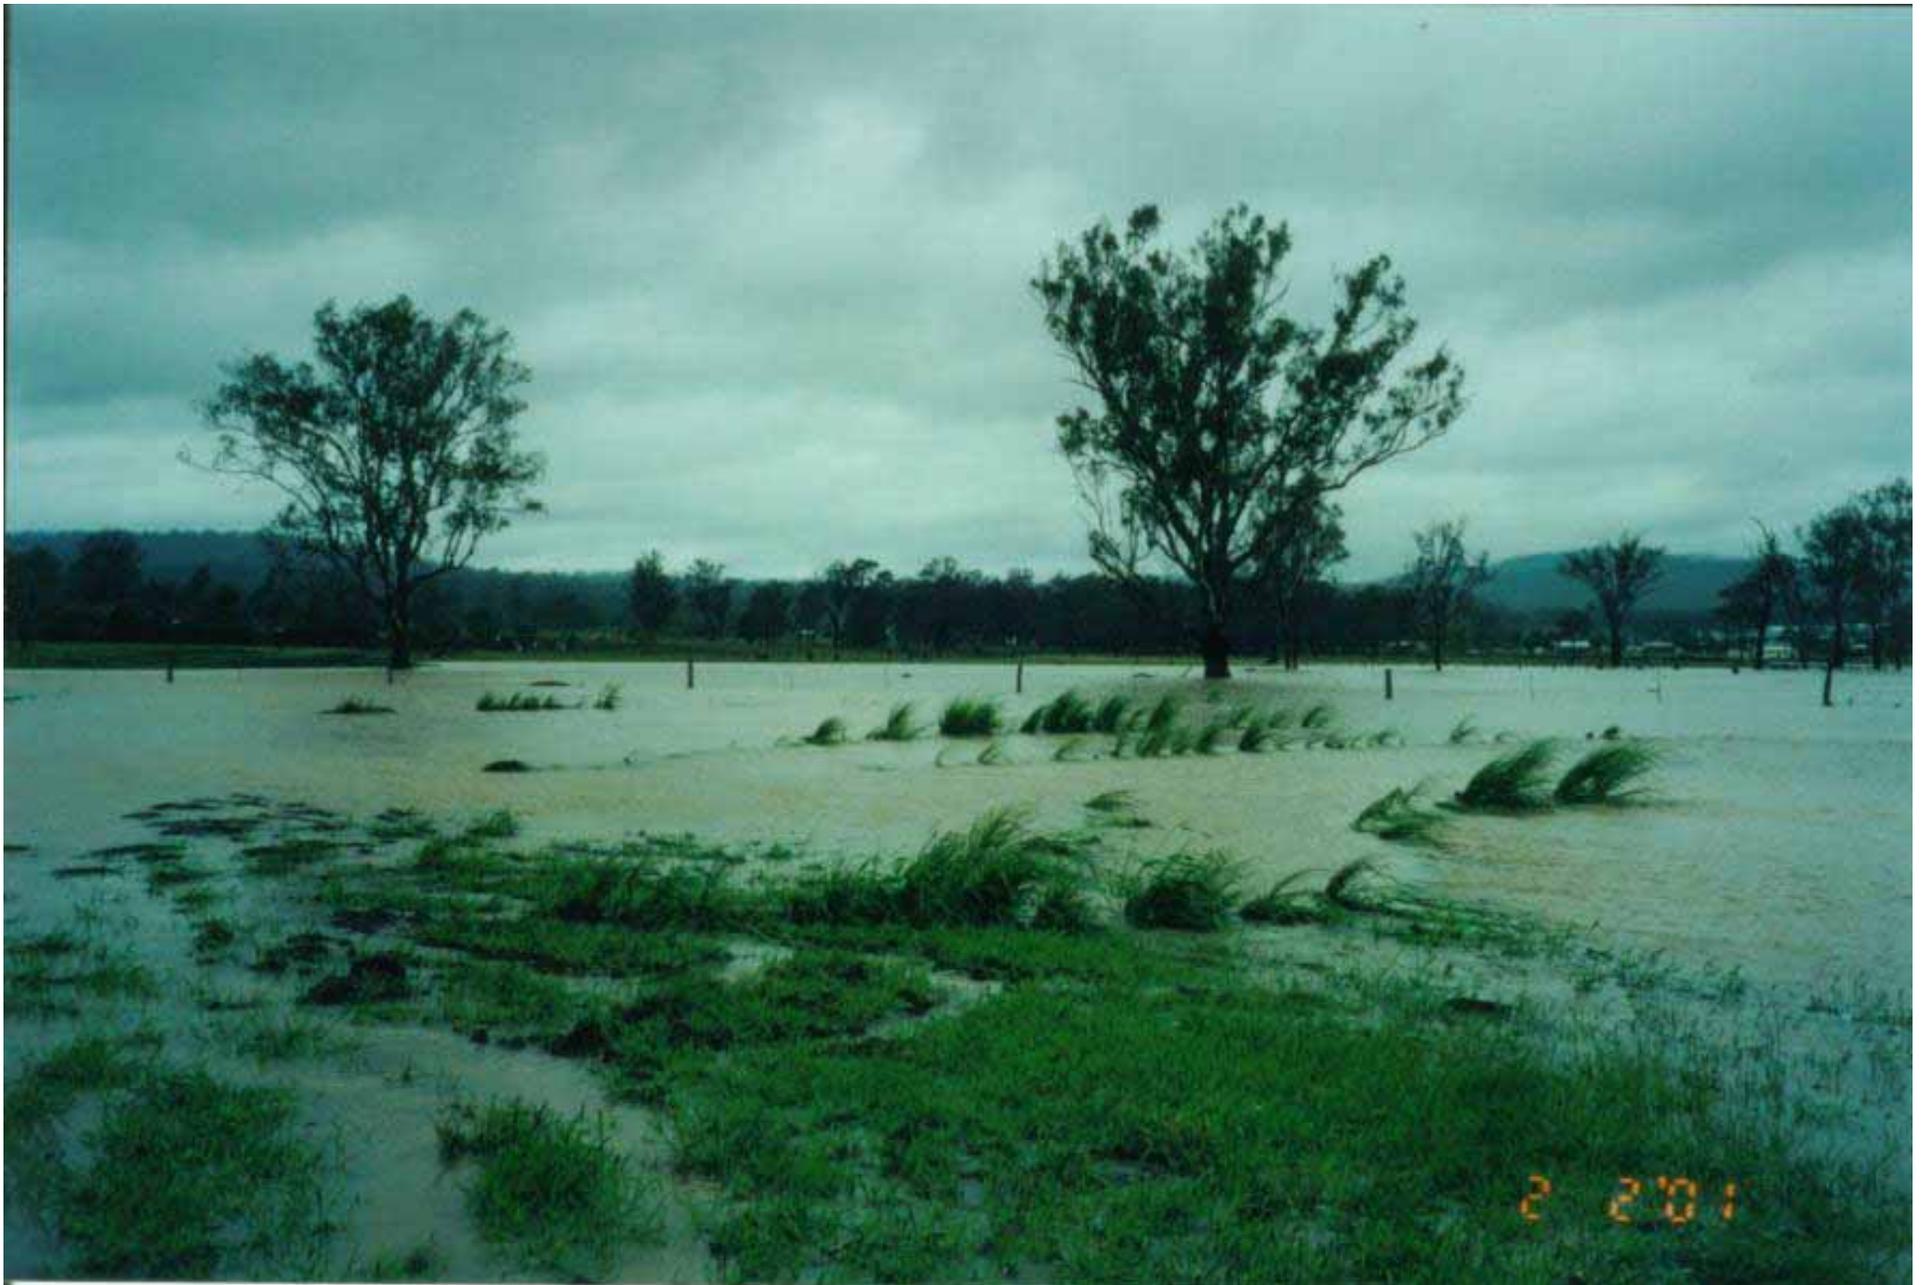
**A large flood hits the town 3 months after planting.**

**Middle section, note that vetiver hedges bent under strong current**

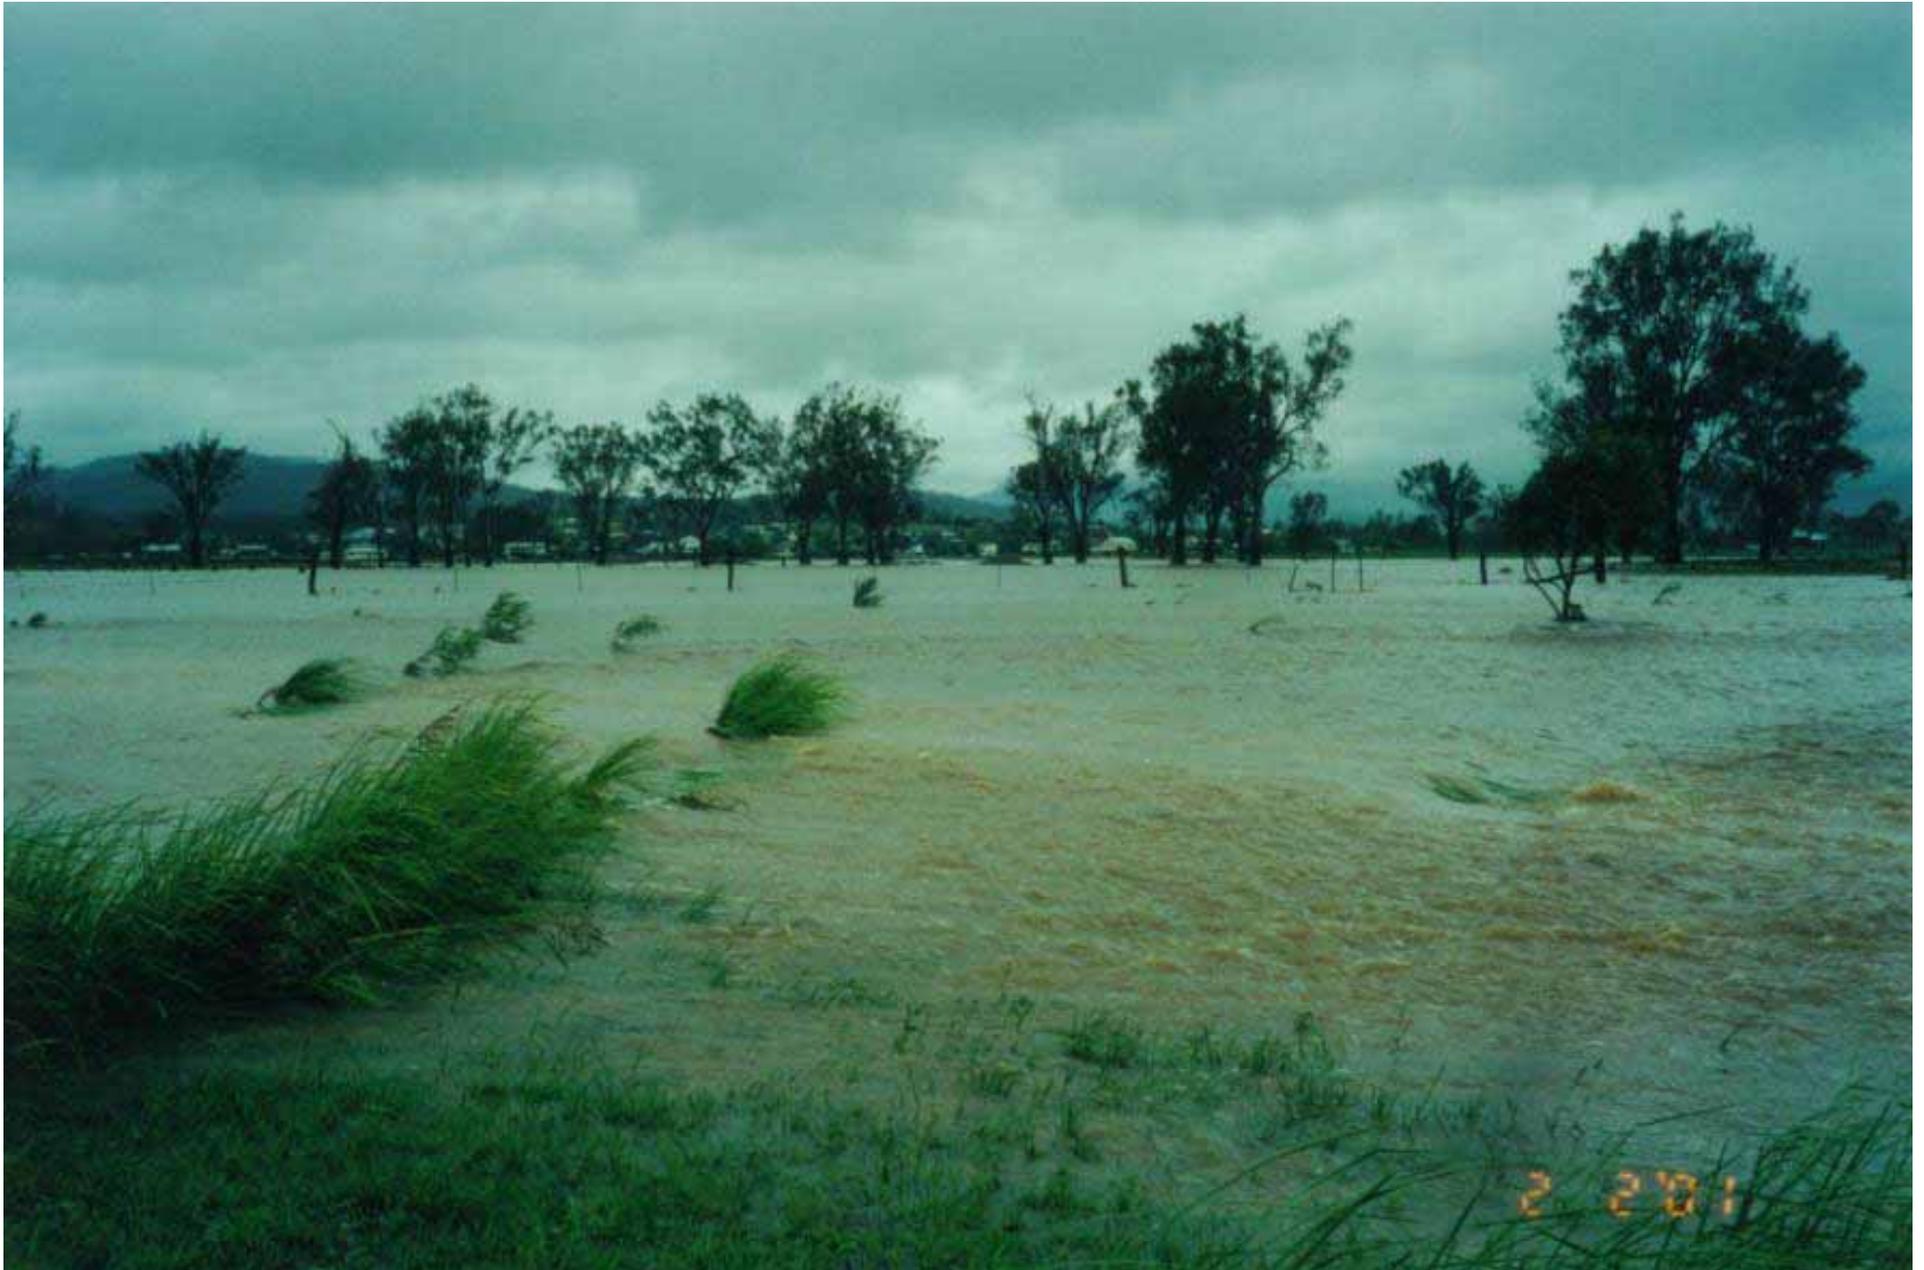
**Very fast flow flattened and inundated most of the hedges. The velocity was estimated up to 5m/sec in some areas**

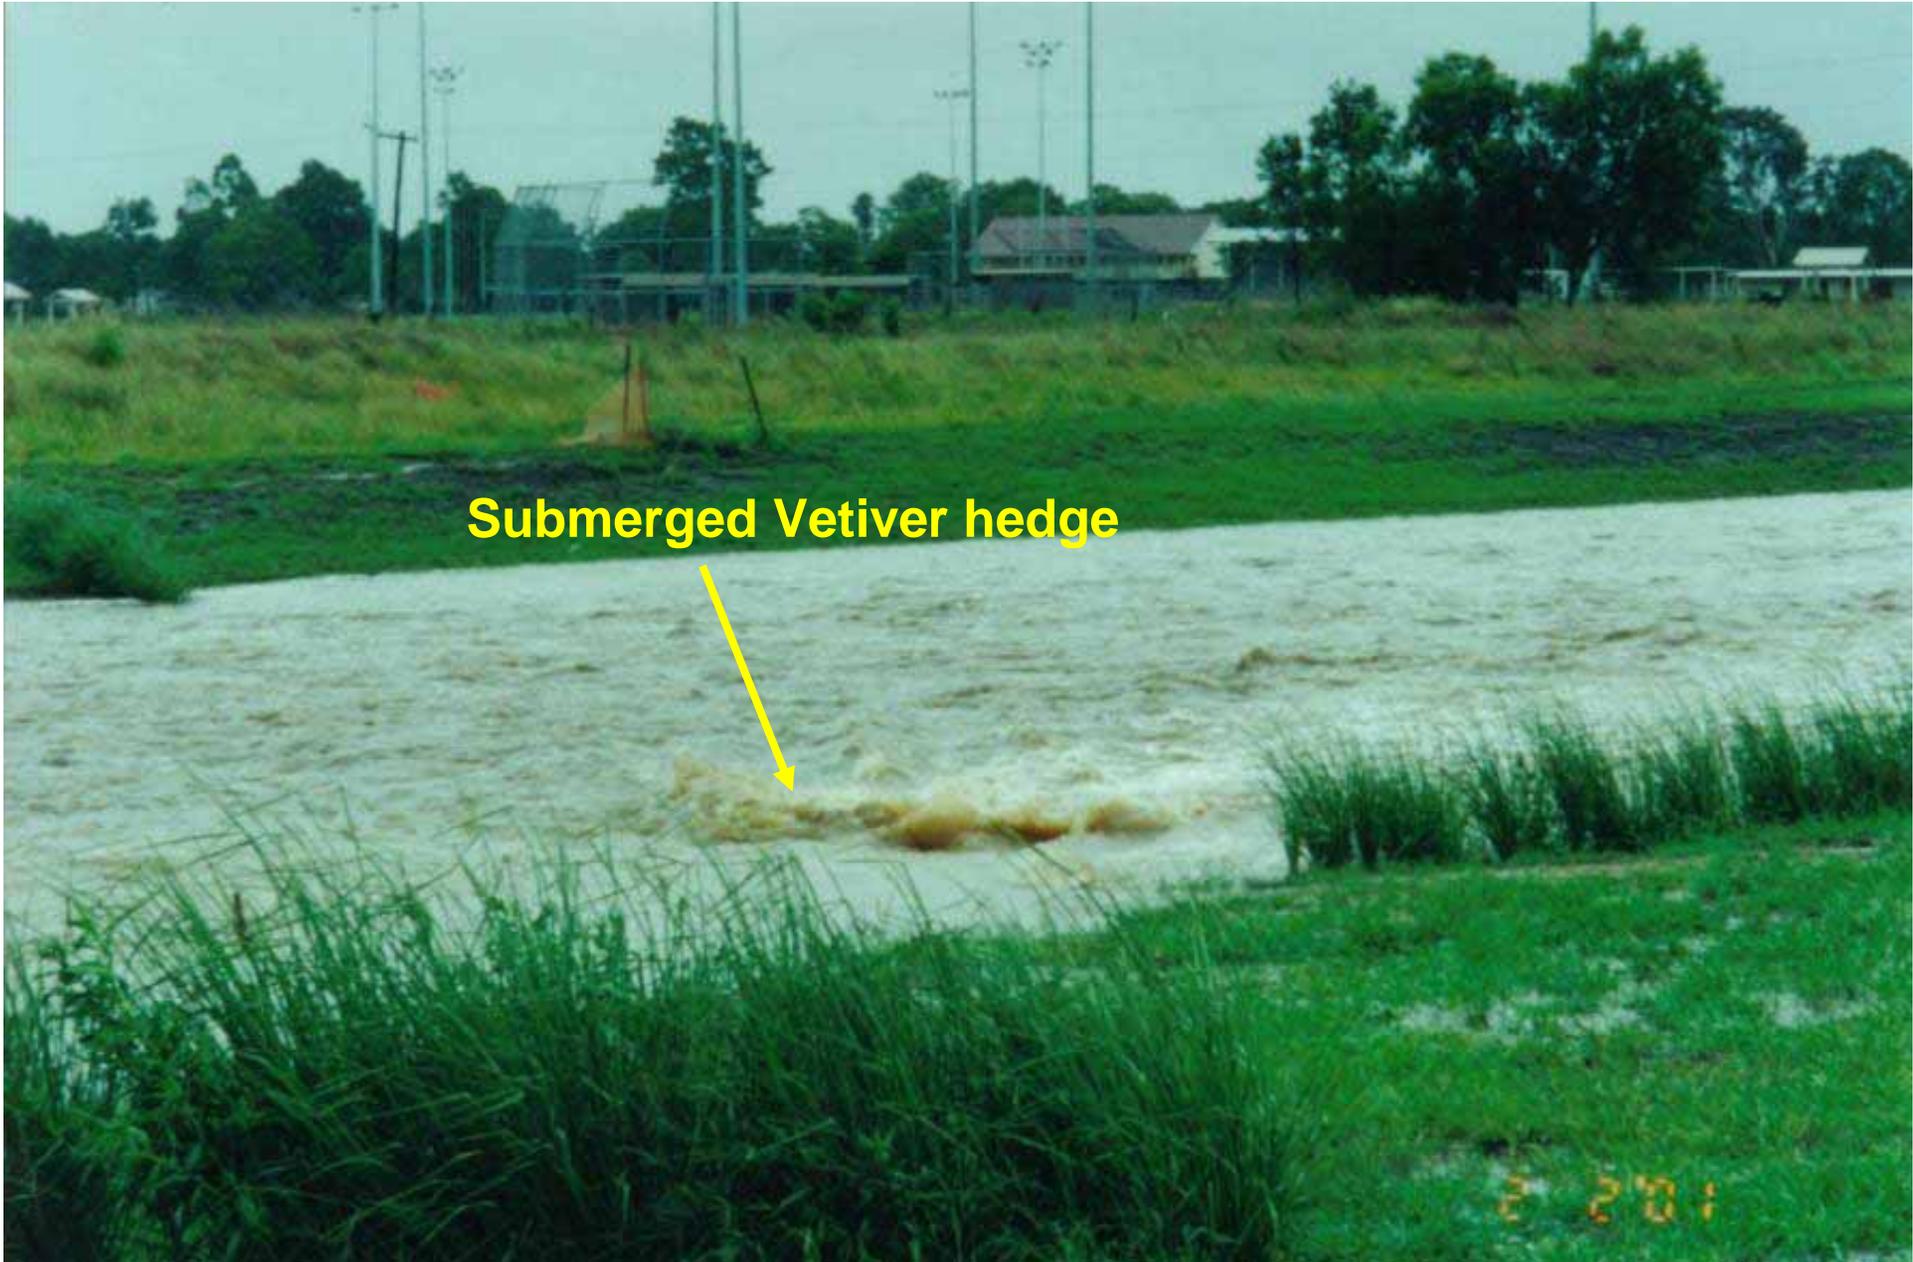
**Submerged Vetiver  
hedges**
