***Across the gulley or streams***

works of P Truong in Australia

***FLOOD EROSION CONTROL ON  
A LARGE URBAN DRAIN  
IN QUEENSLAND***

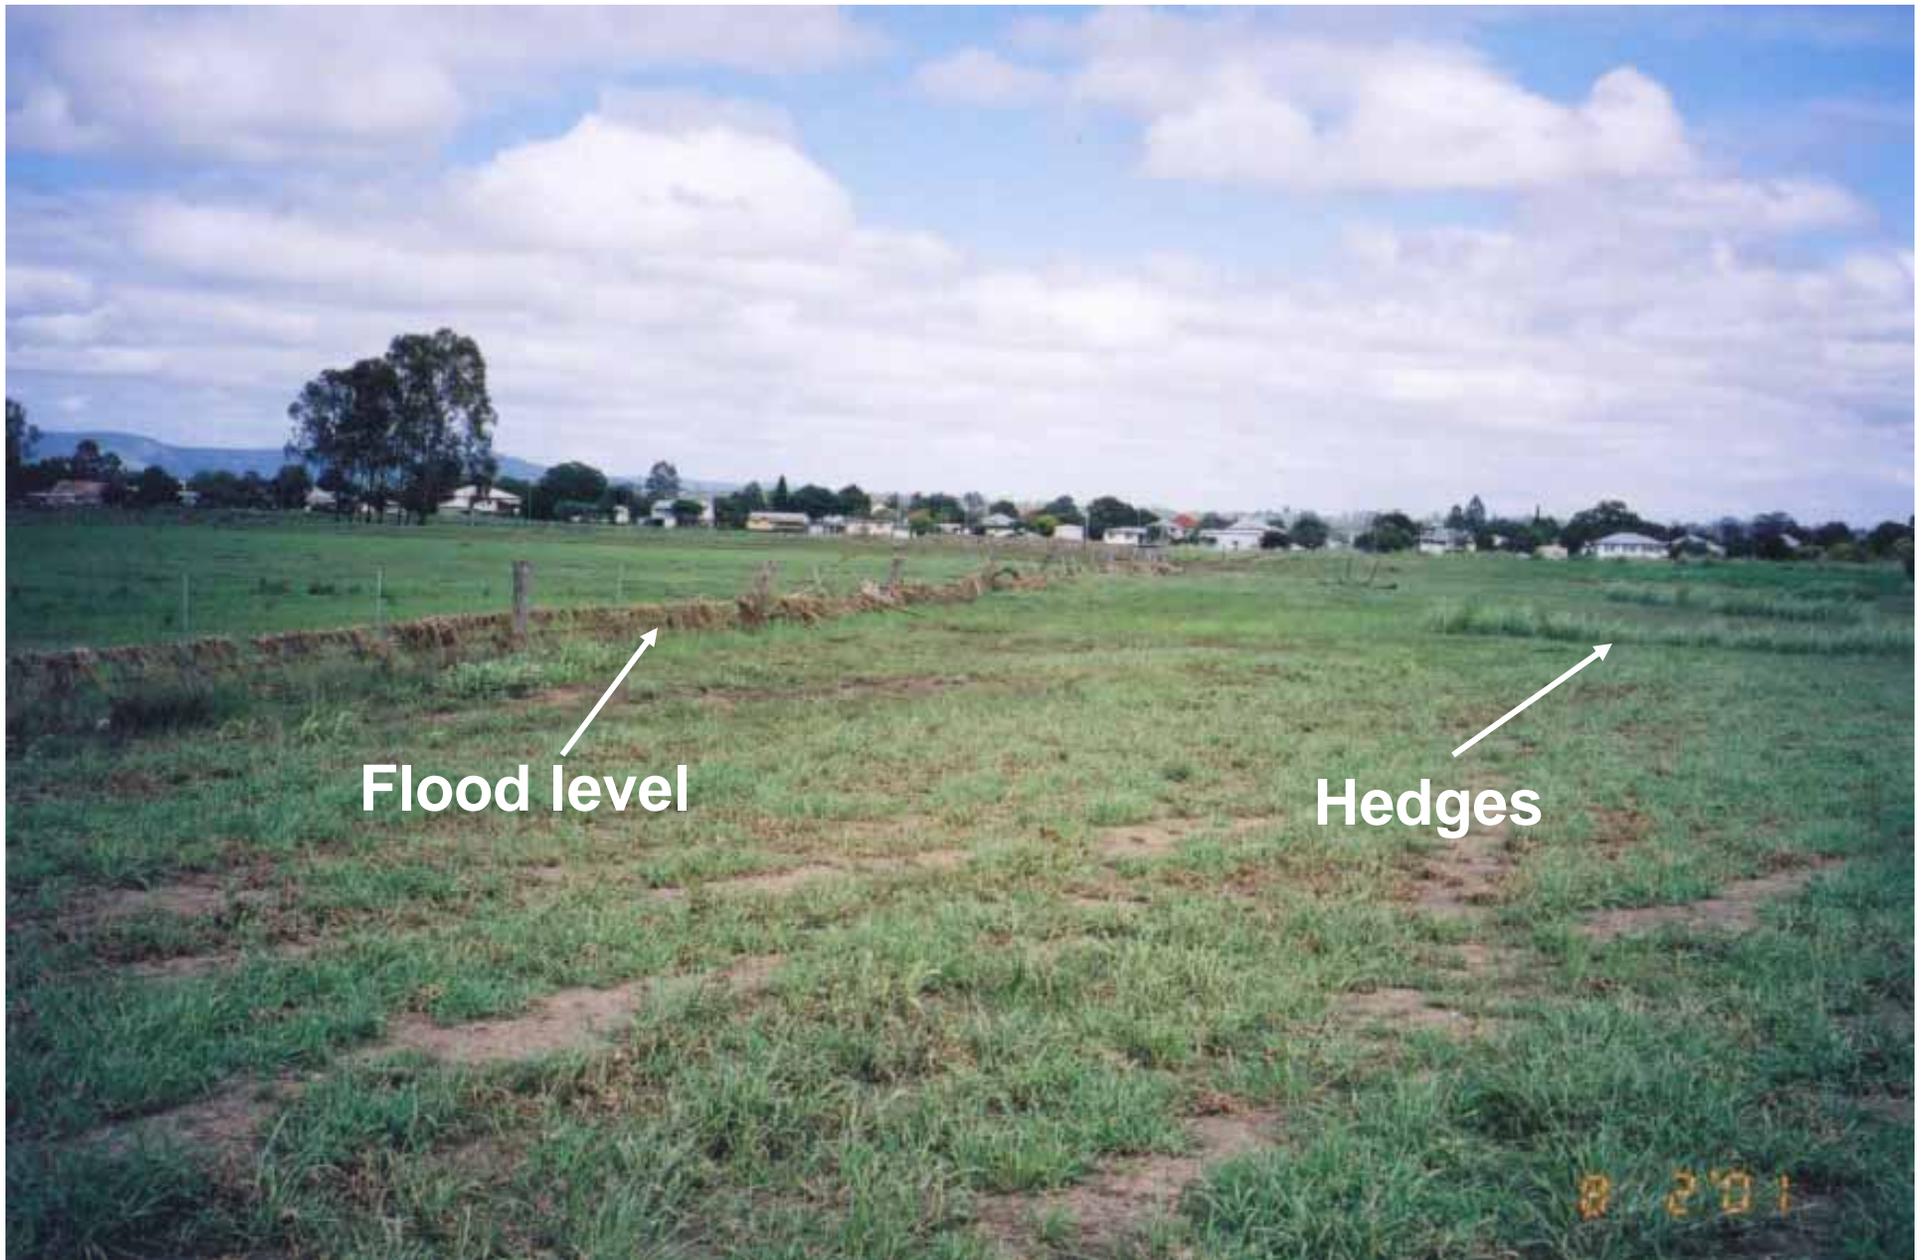
**Submerged Vetiver hedge**

# Six days after the flood, upper section

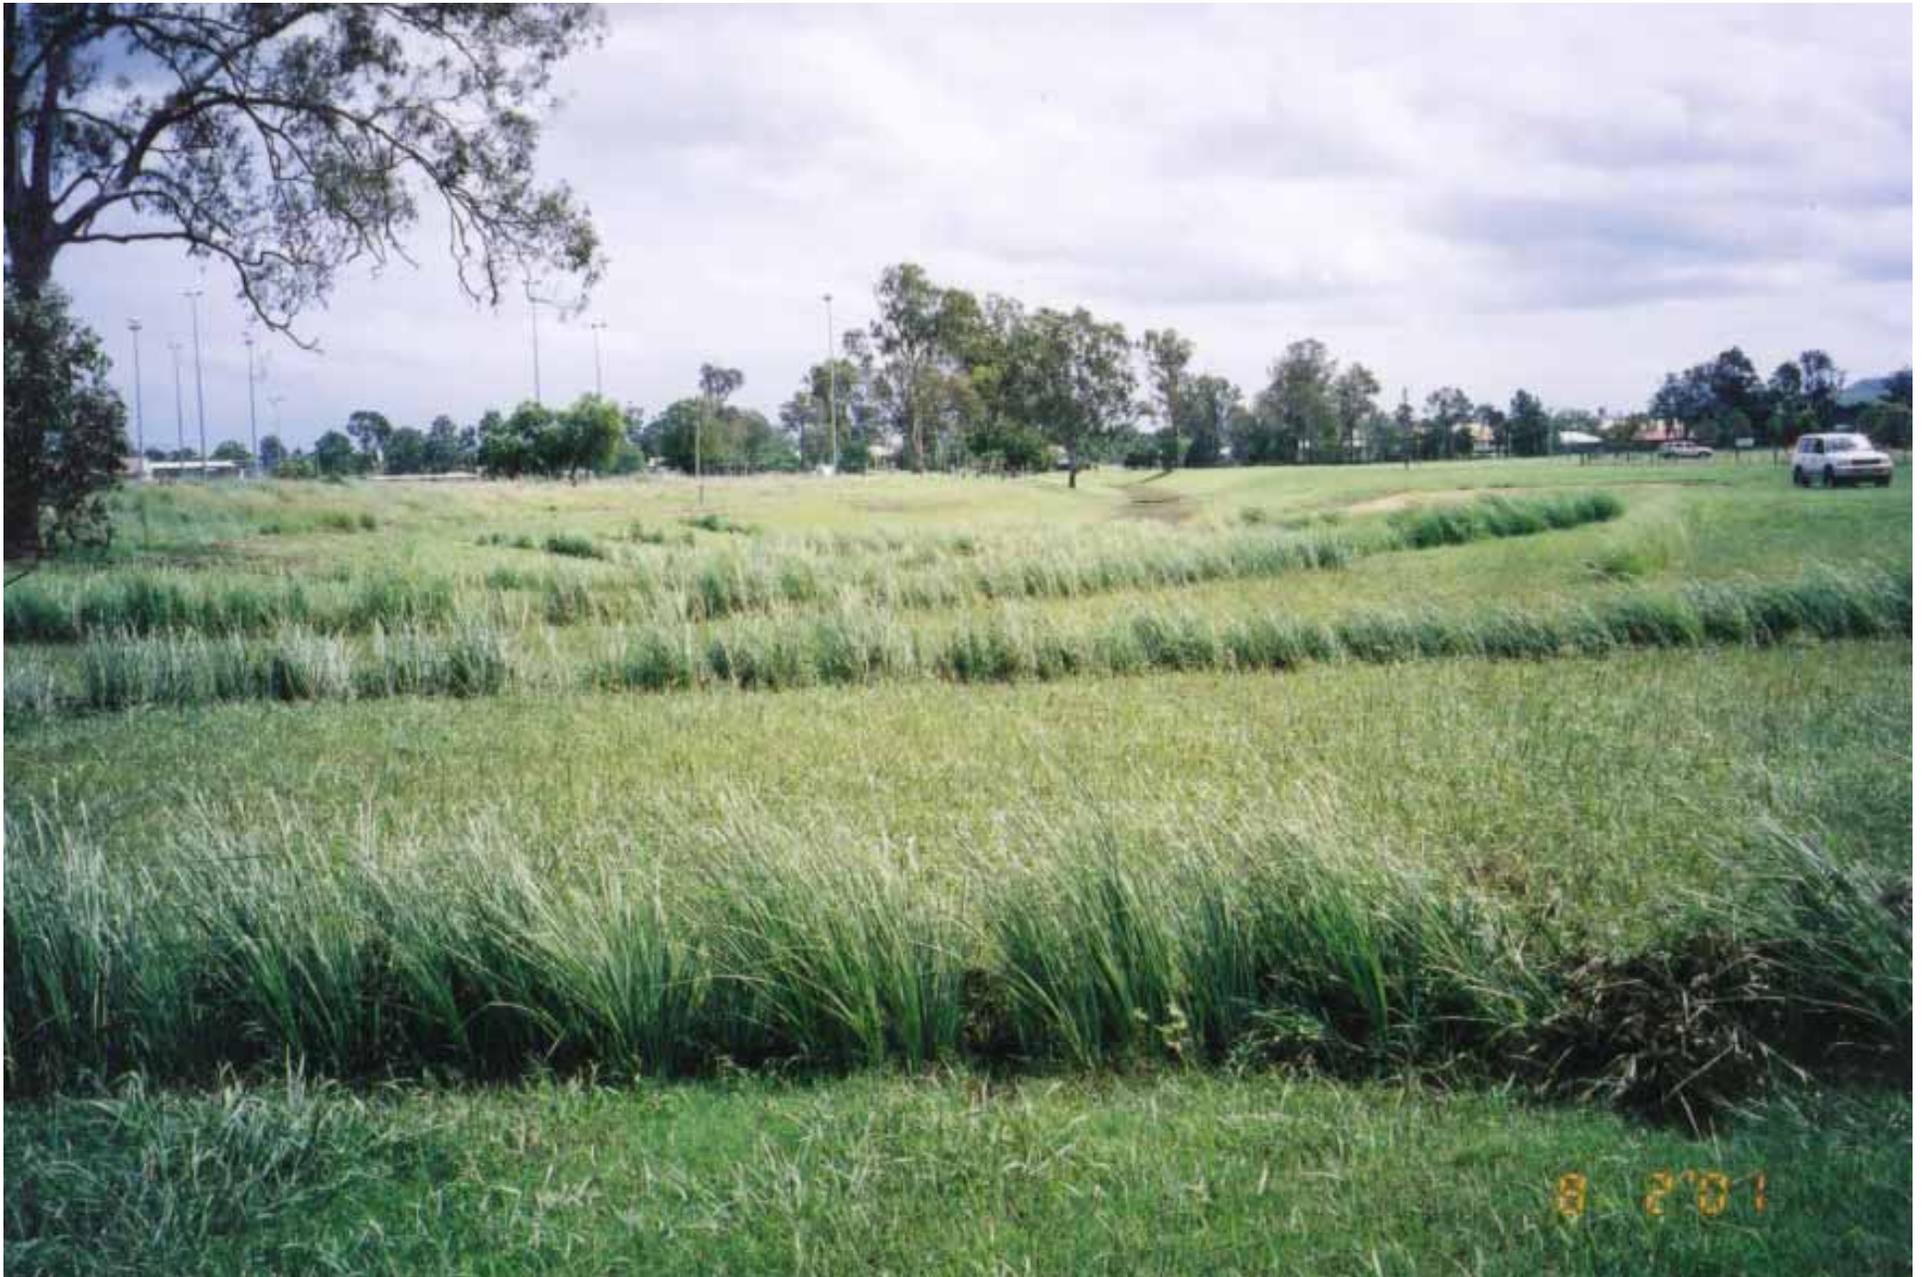
**Although only 3 month old, the young hedges provide a very effective protection with only minimal erosion at the head of the channel**

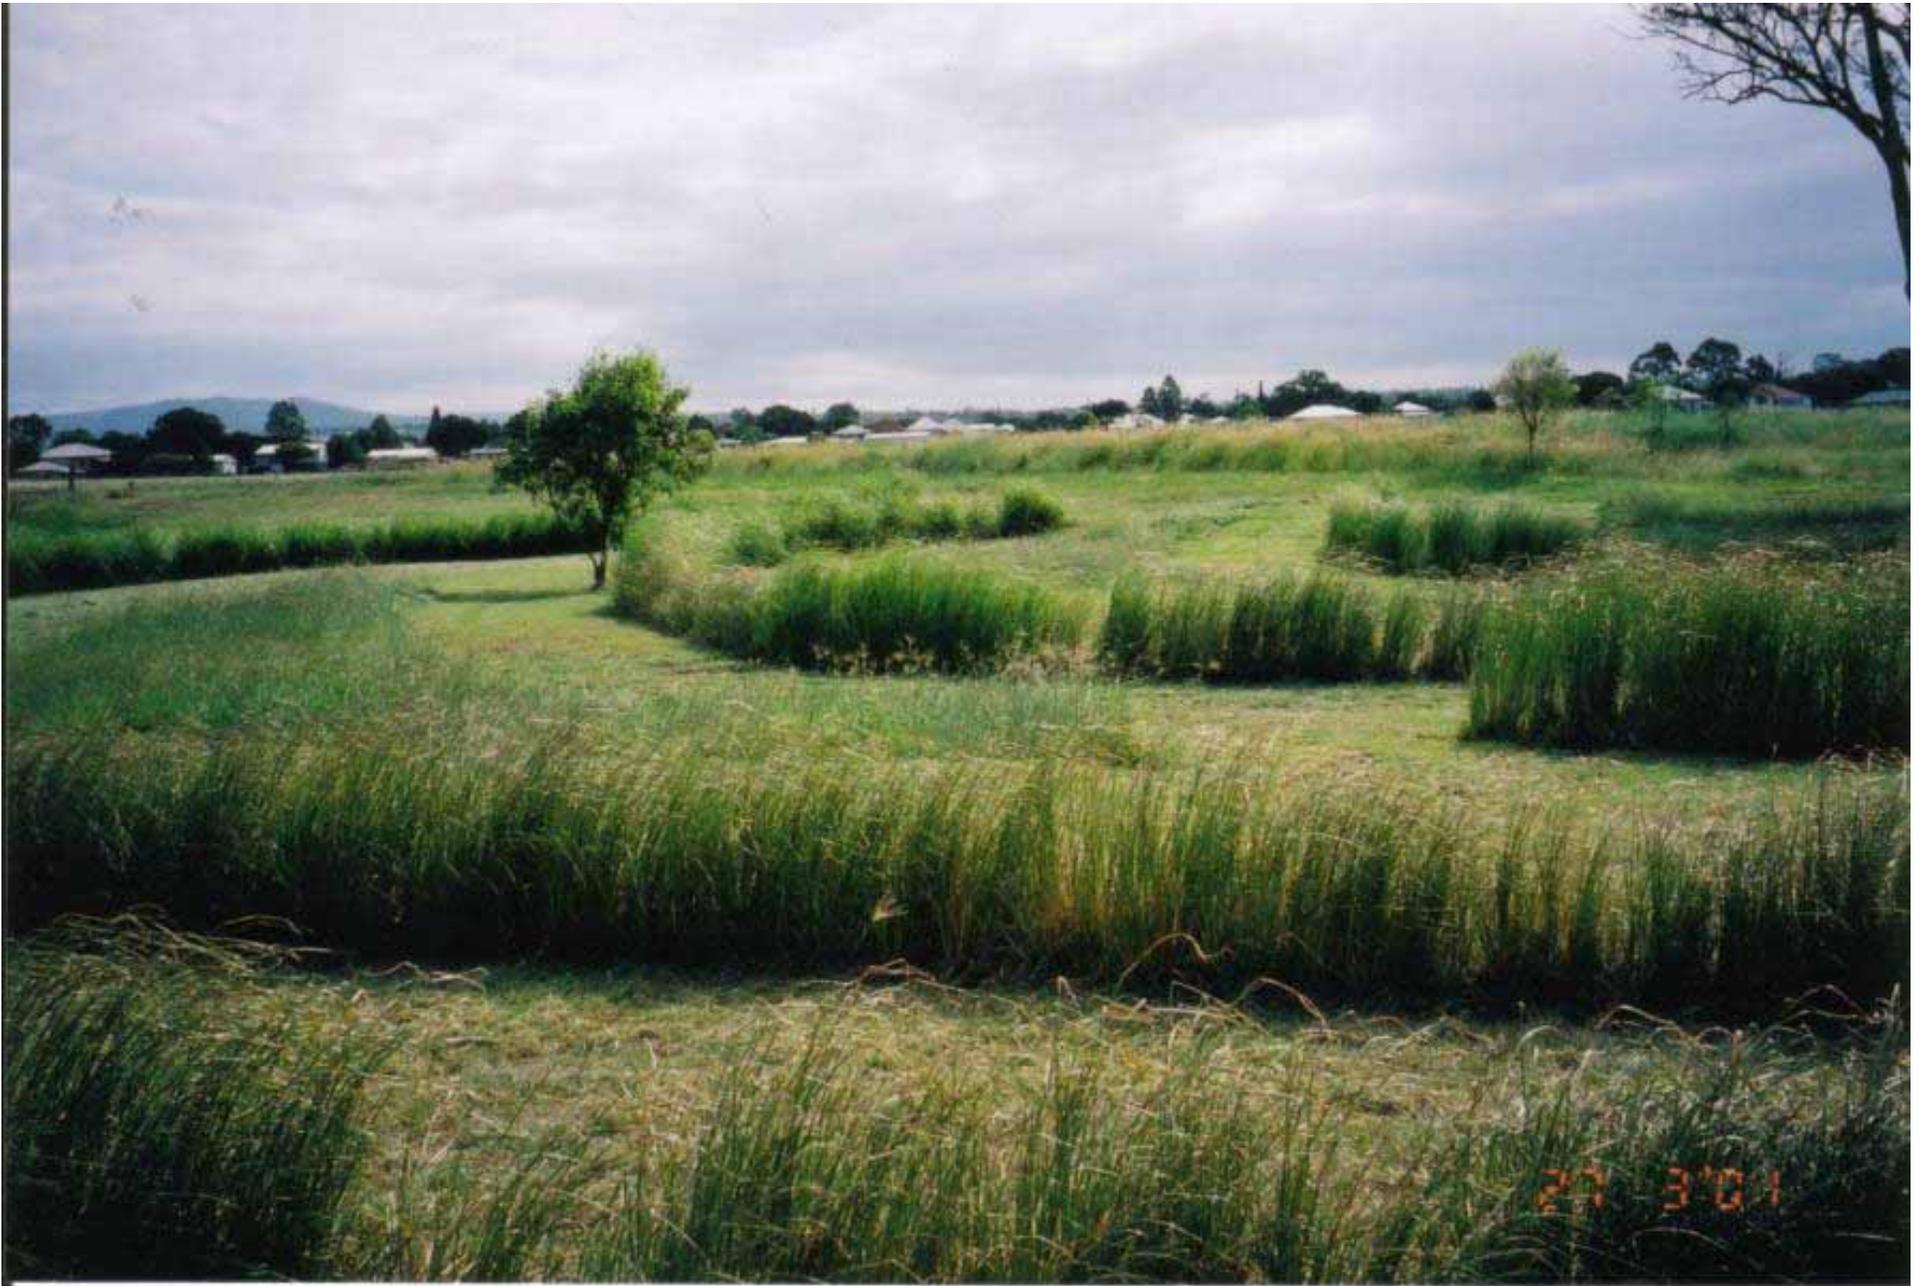
**The hedge fully recovered seven weeks after flooding**
