**BEAUDESERT LANDCARE
GULLY STABILISATION PROJECT
CRYNA ROAD**

Dr. Paul Truong

Veticon Consulting

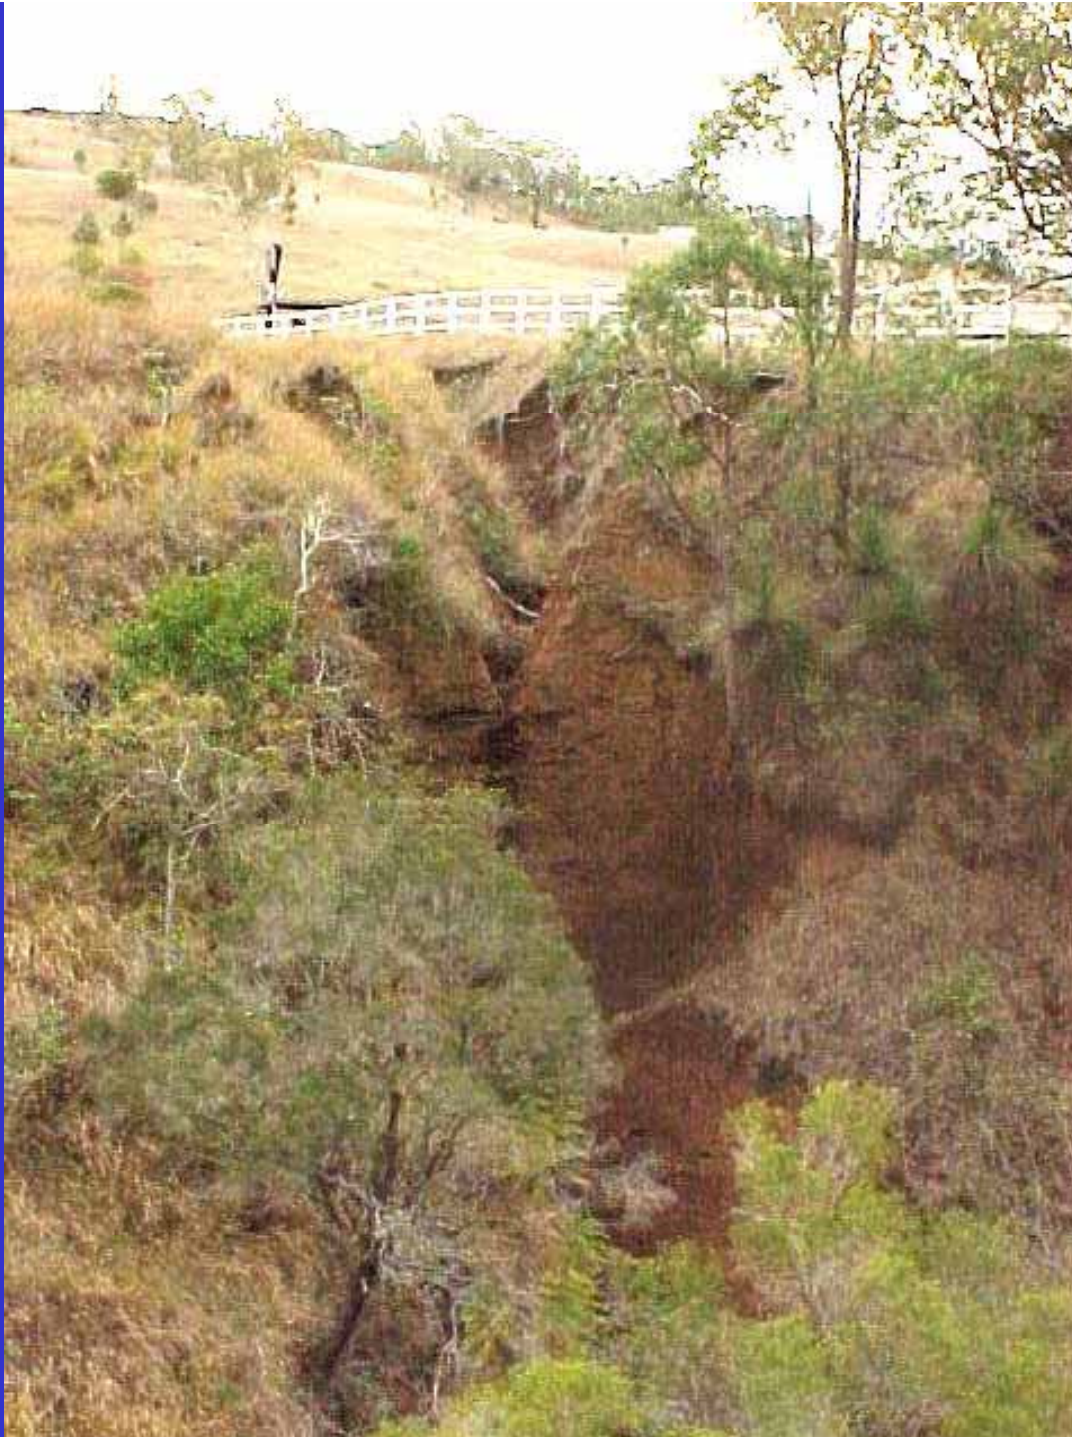
**A very deep and
narrow gully on a
highly erodible
loamy soil**

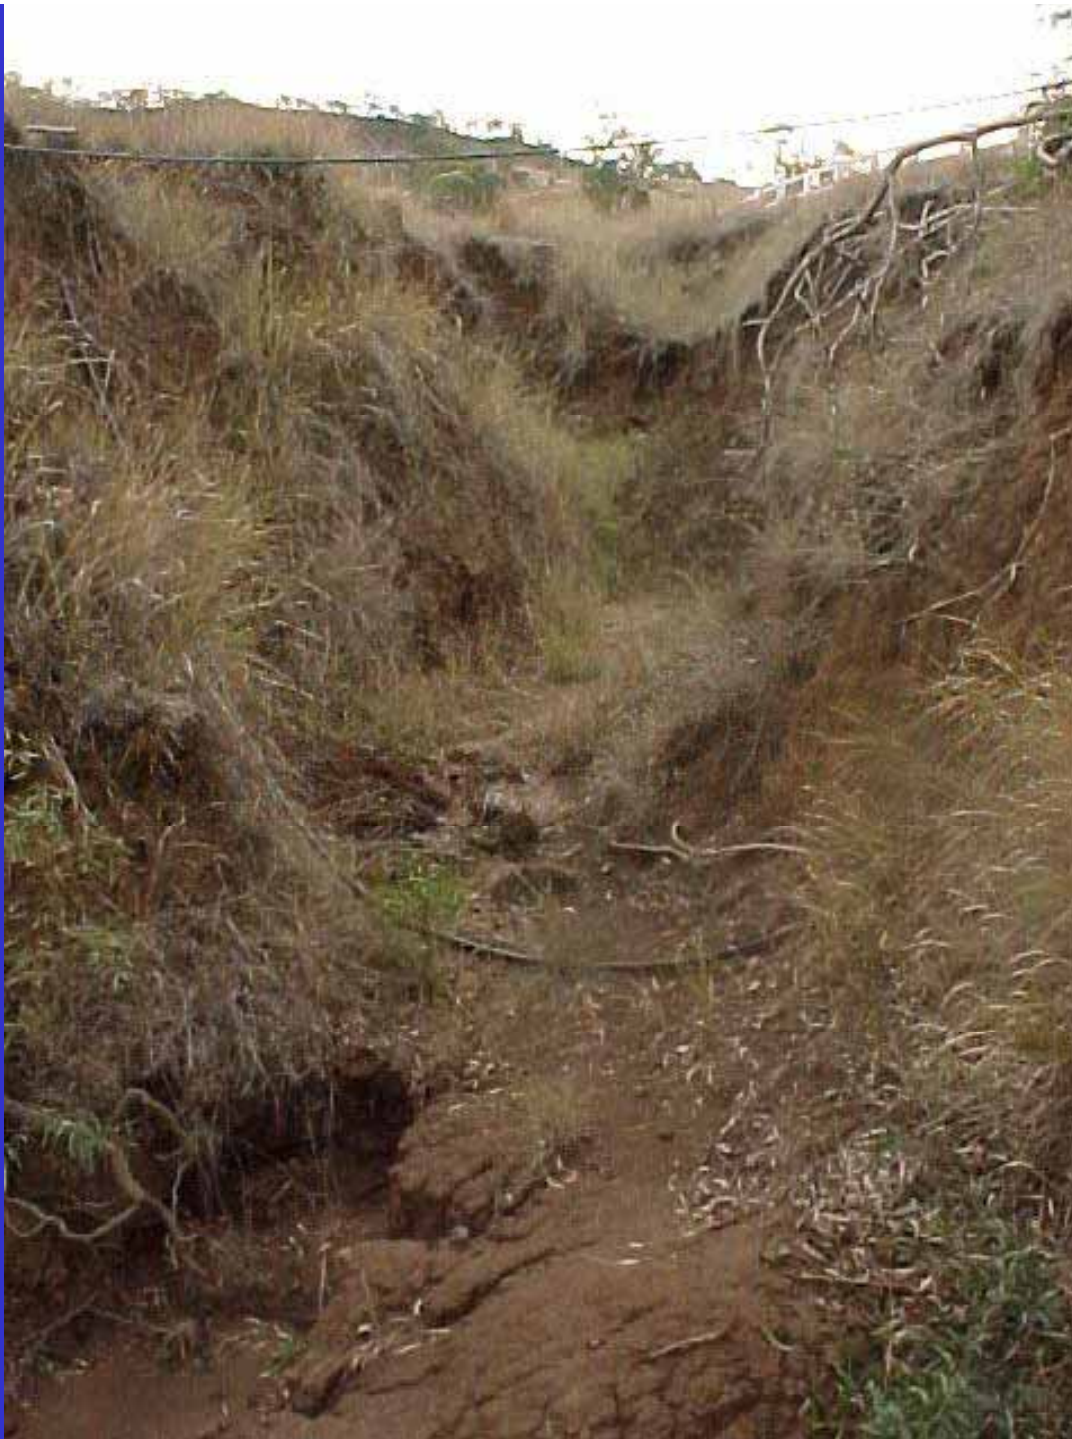
**Looking up, gully
head with vertical
drop of 6m**

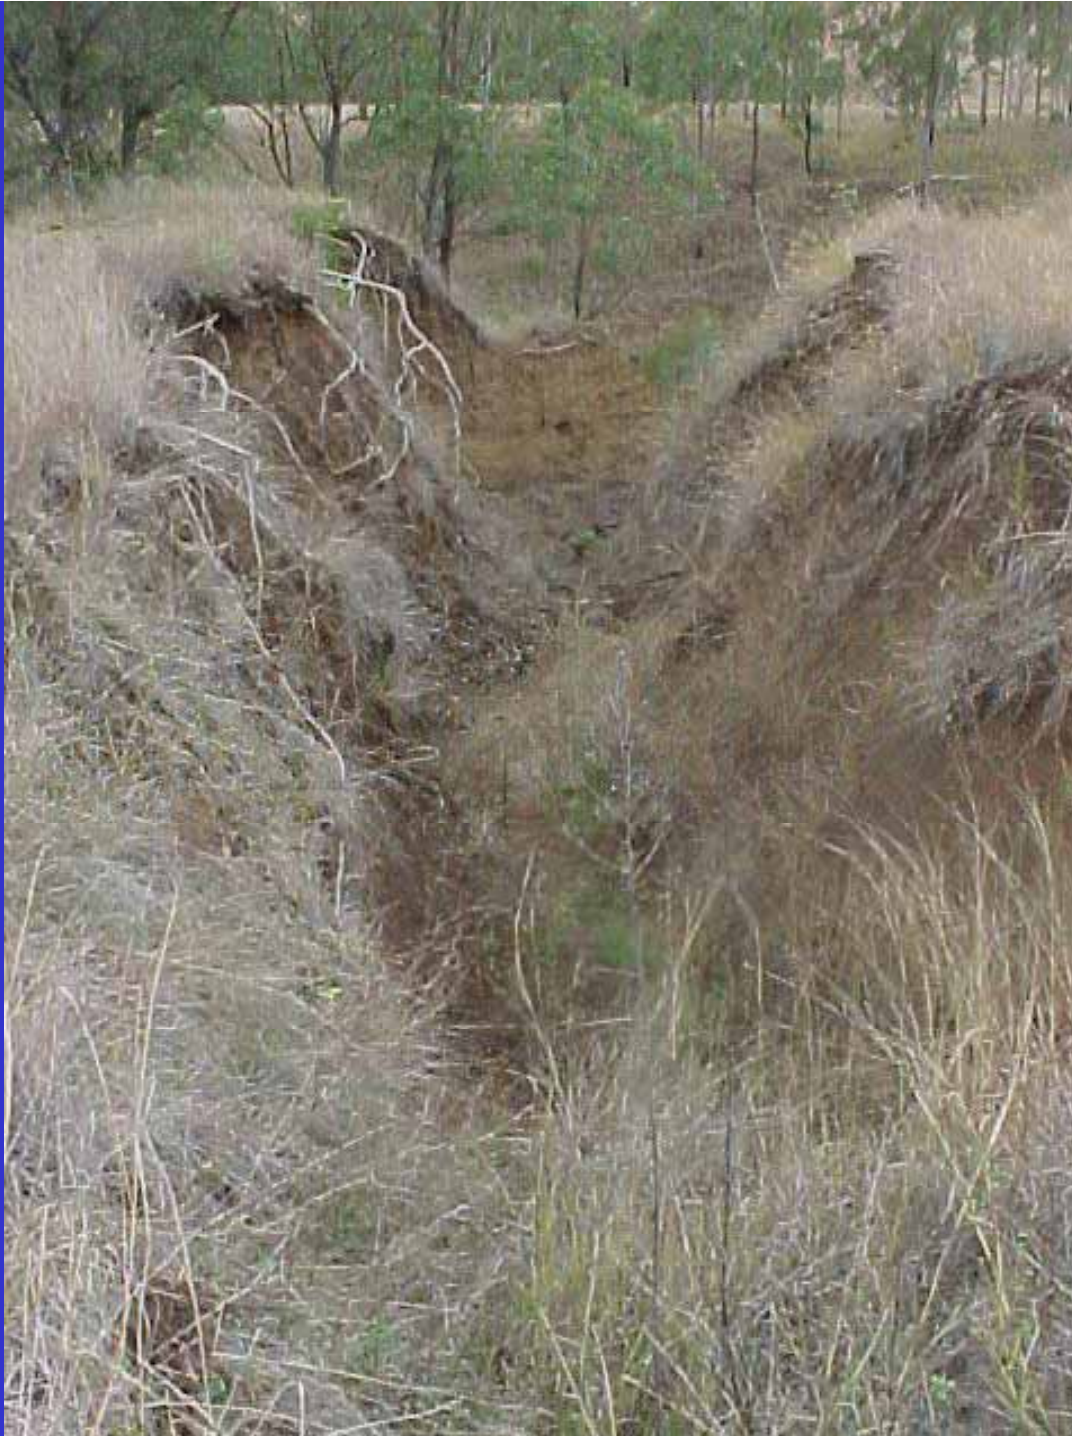
**Looking down
toward the creek**

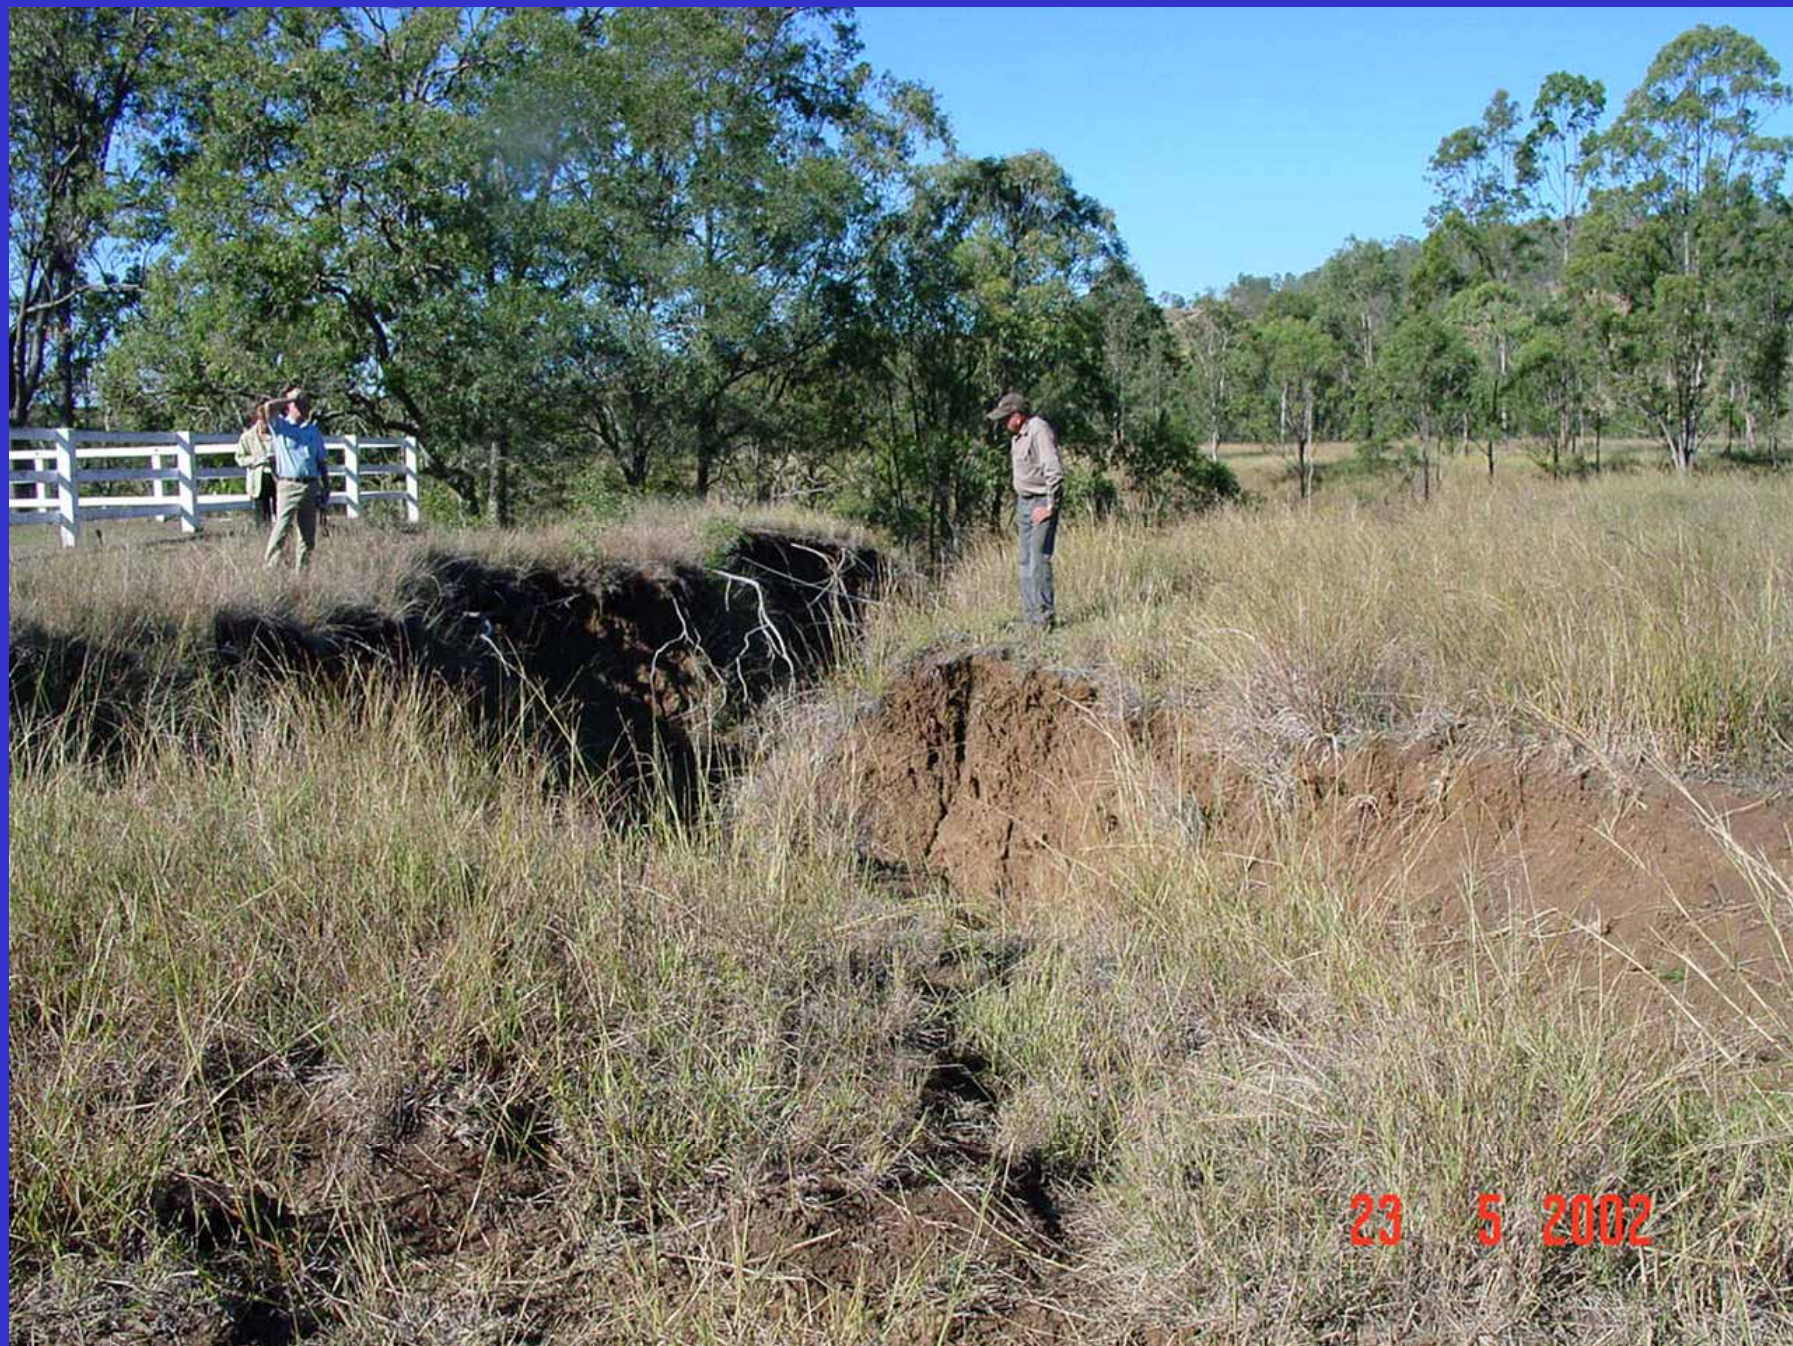
23 5 2002

Looking down from from gully head

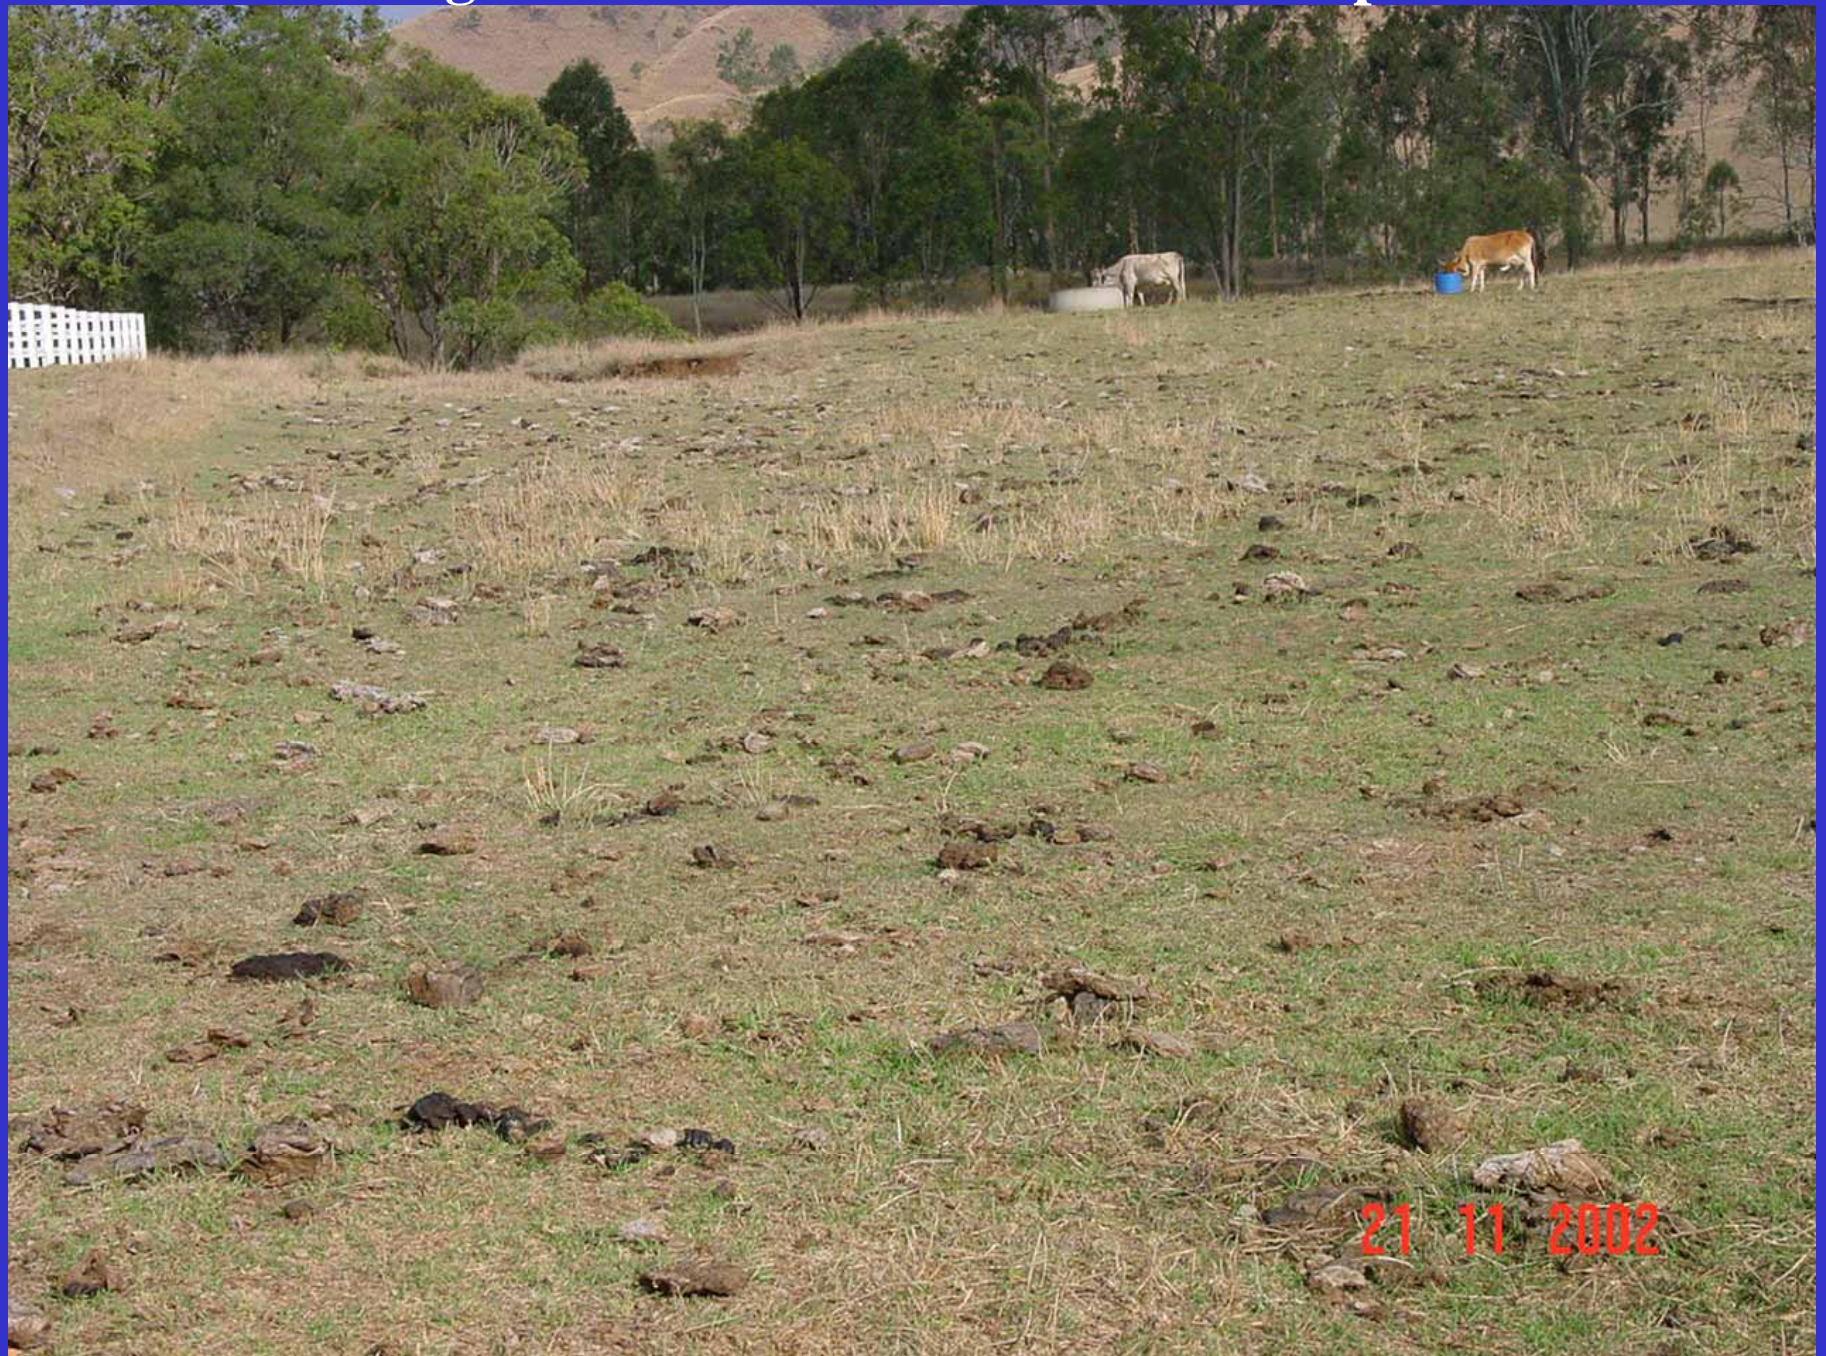
21 11 2002

Looking down toward creek from 30m upstream

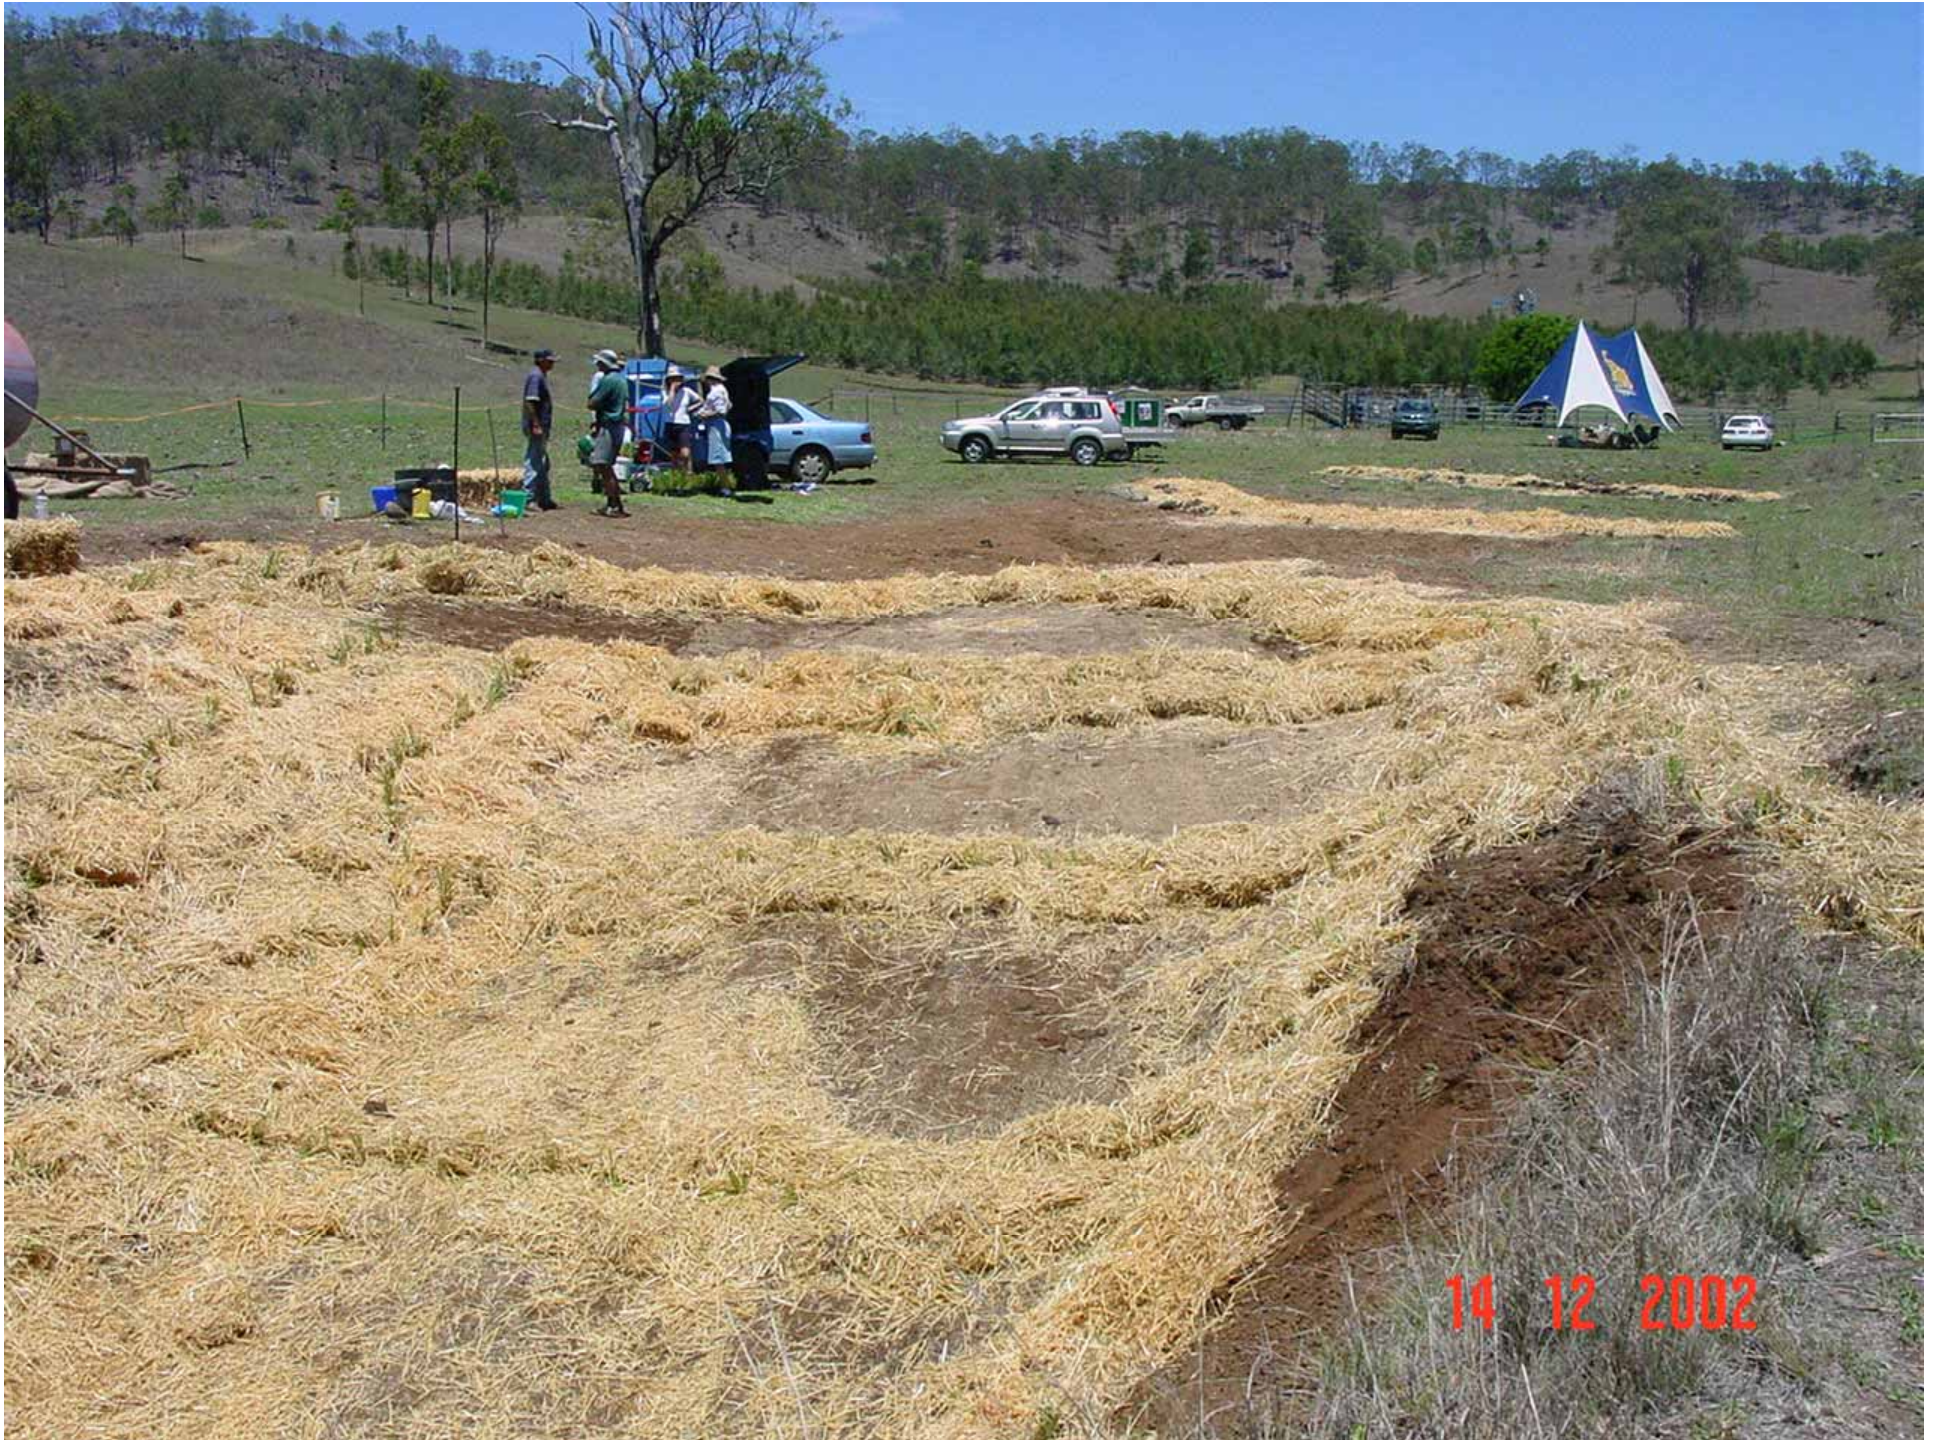
14 12 2002

One week after planting

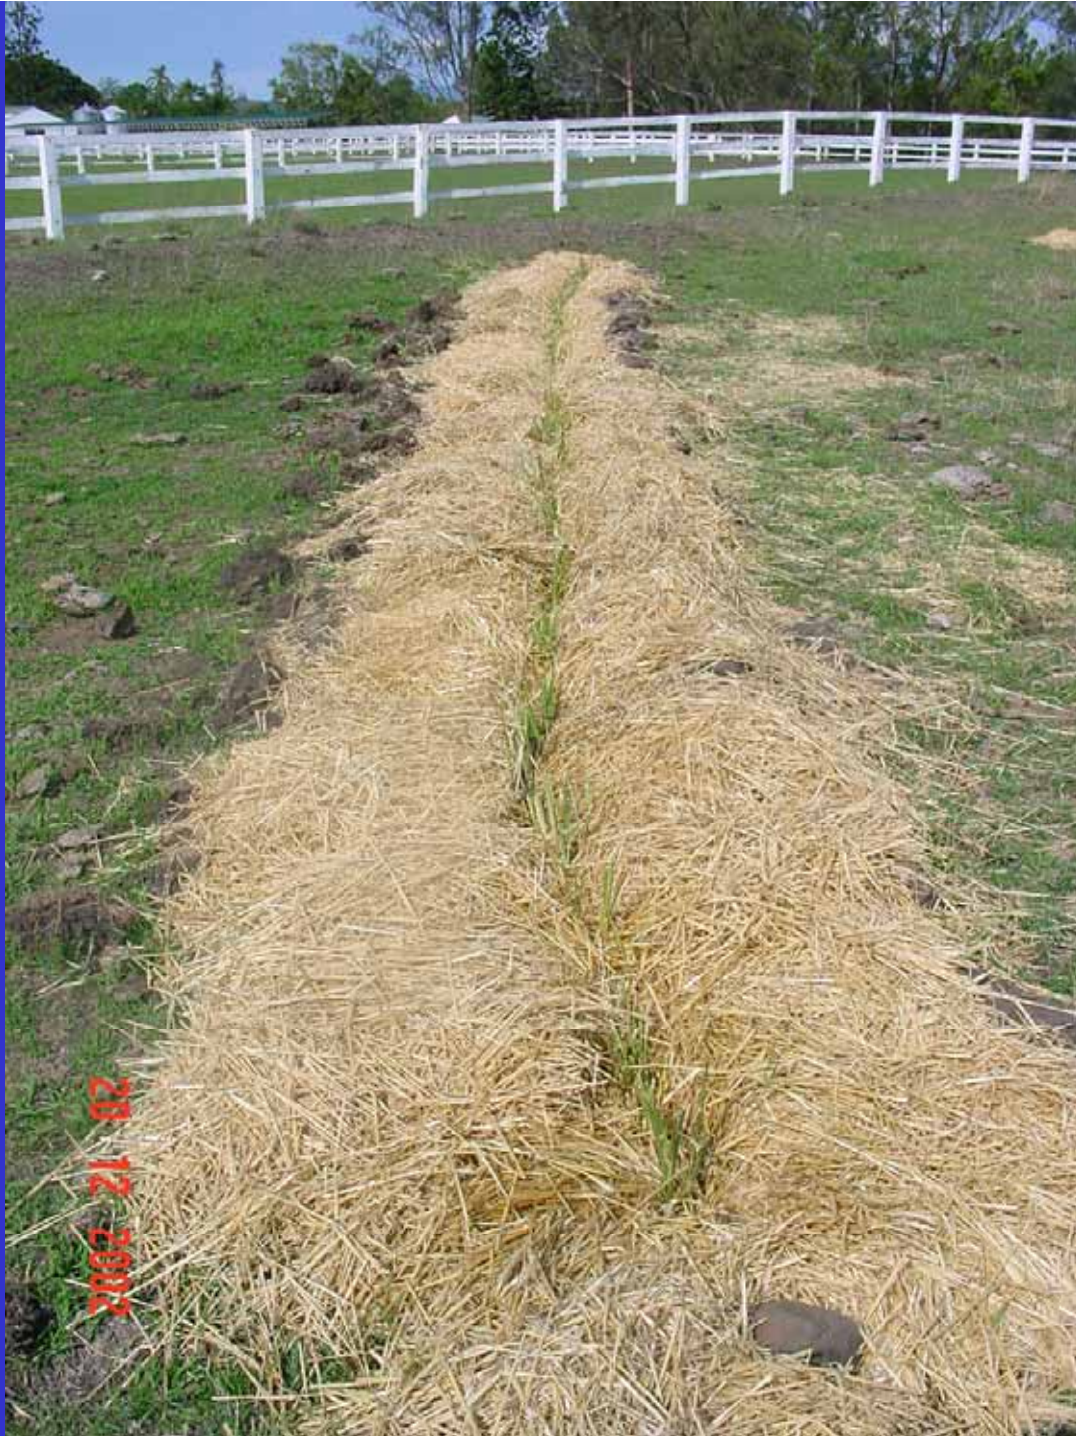
**One week
after planting**

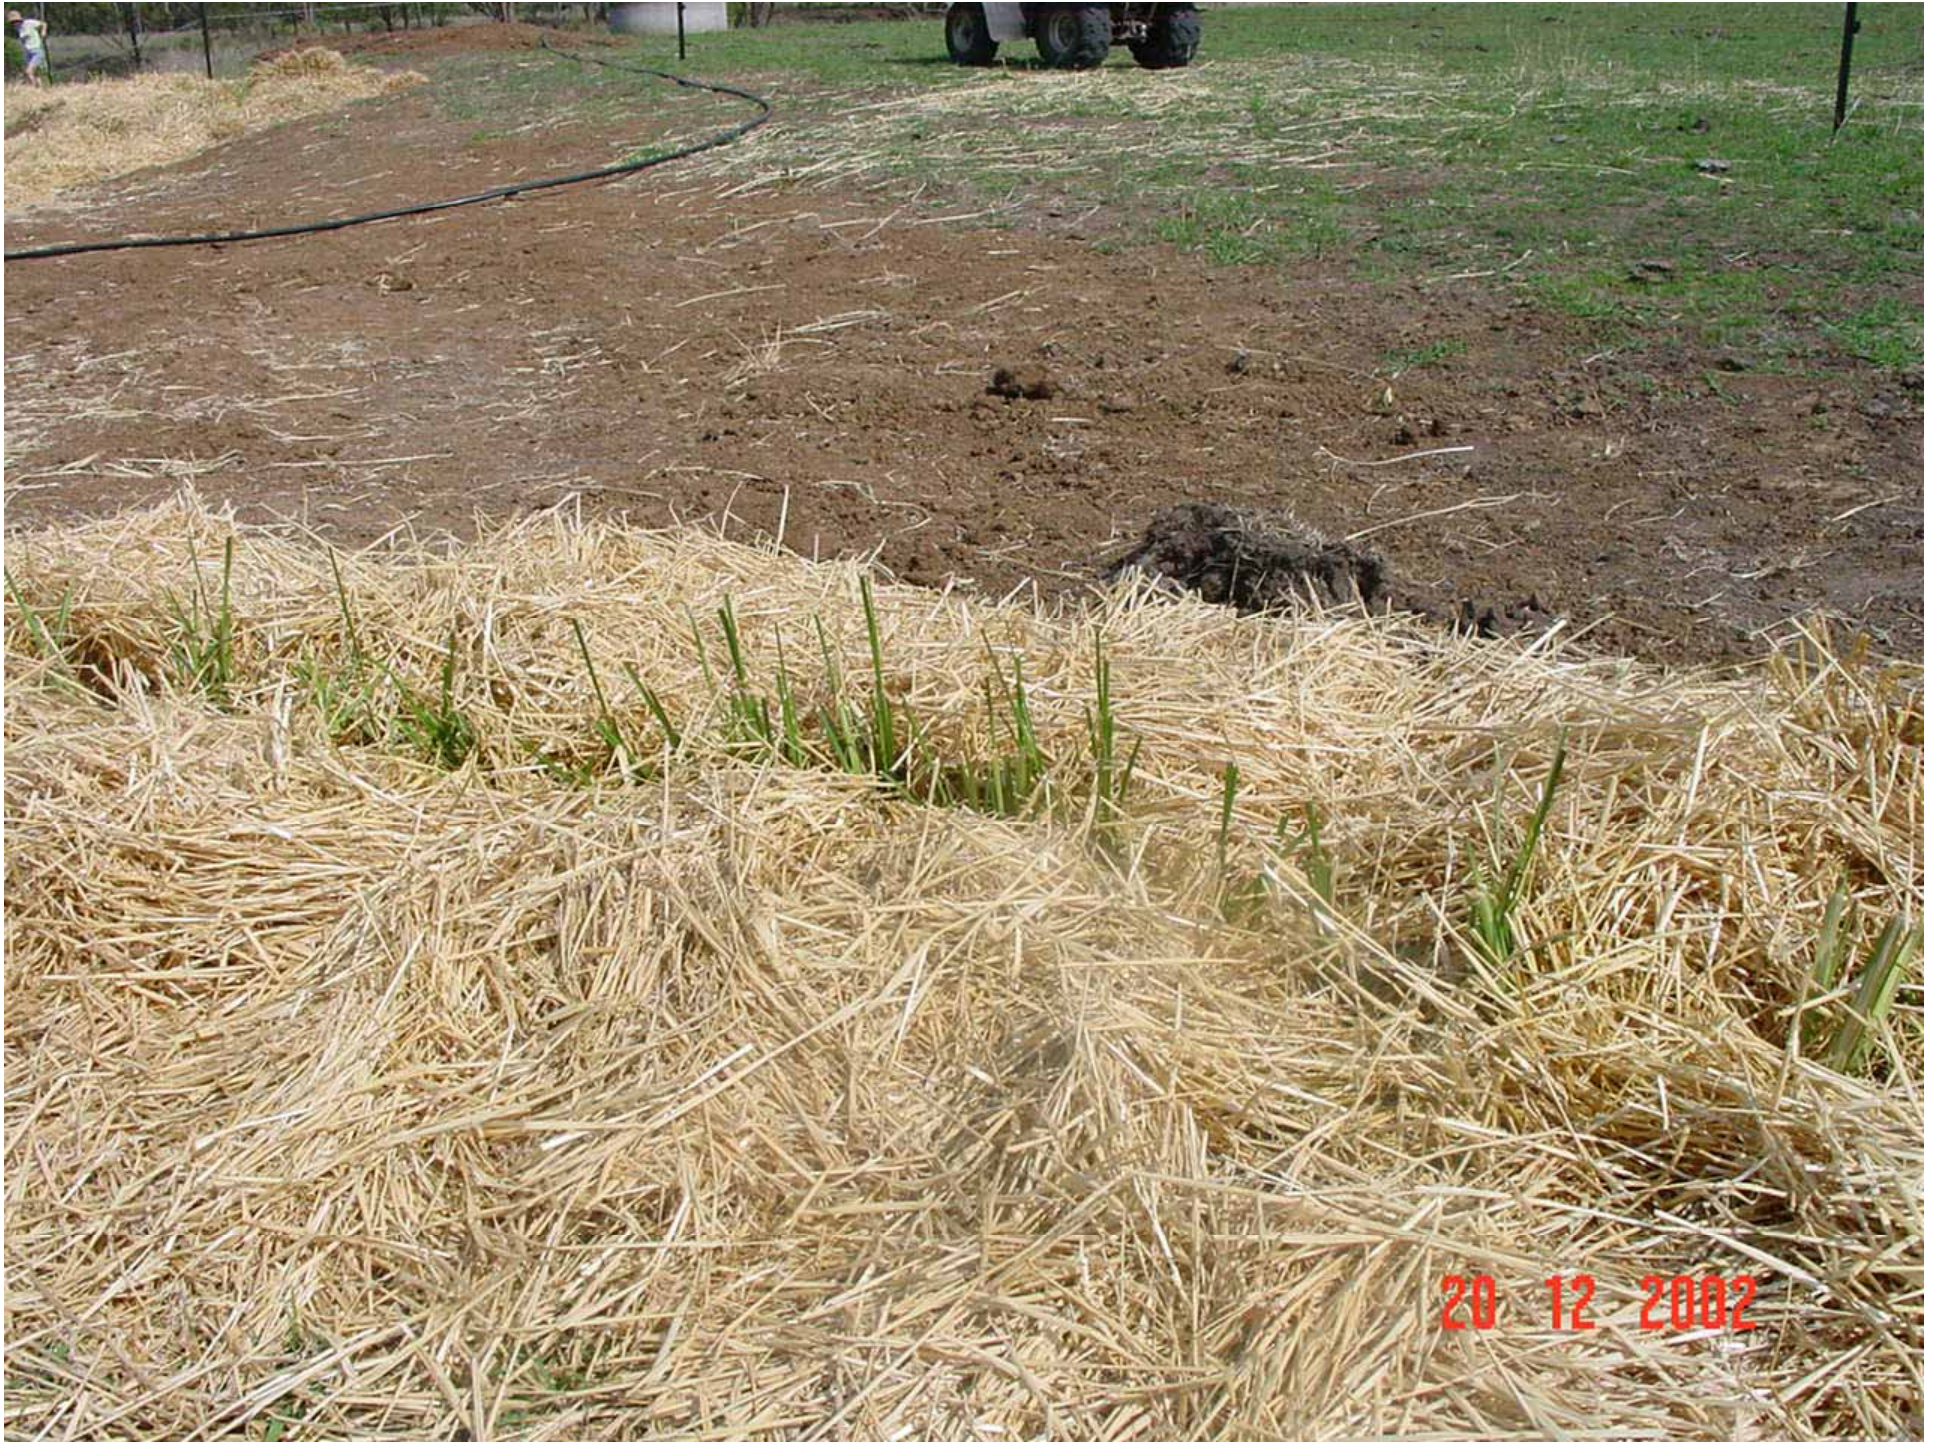
With good watering, new growth up to 15cm after two weeks

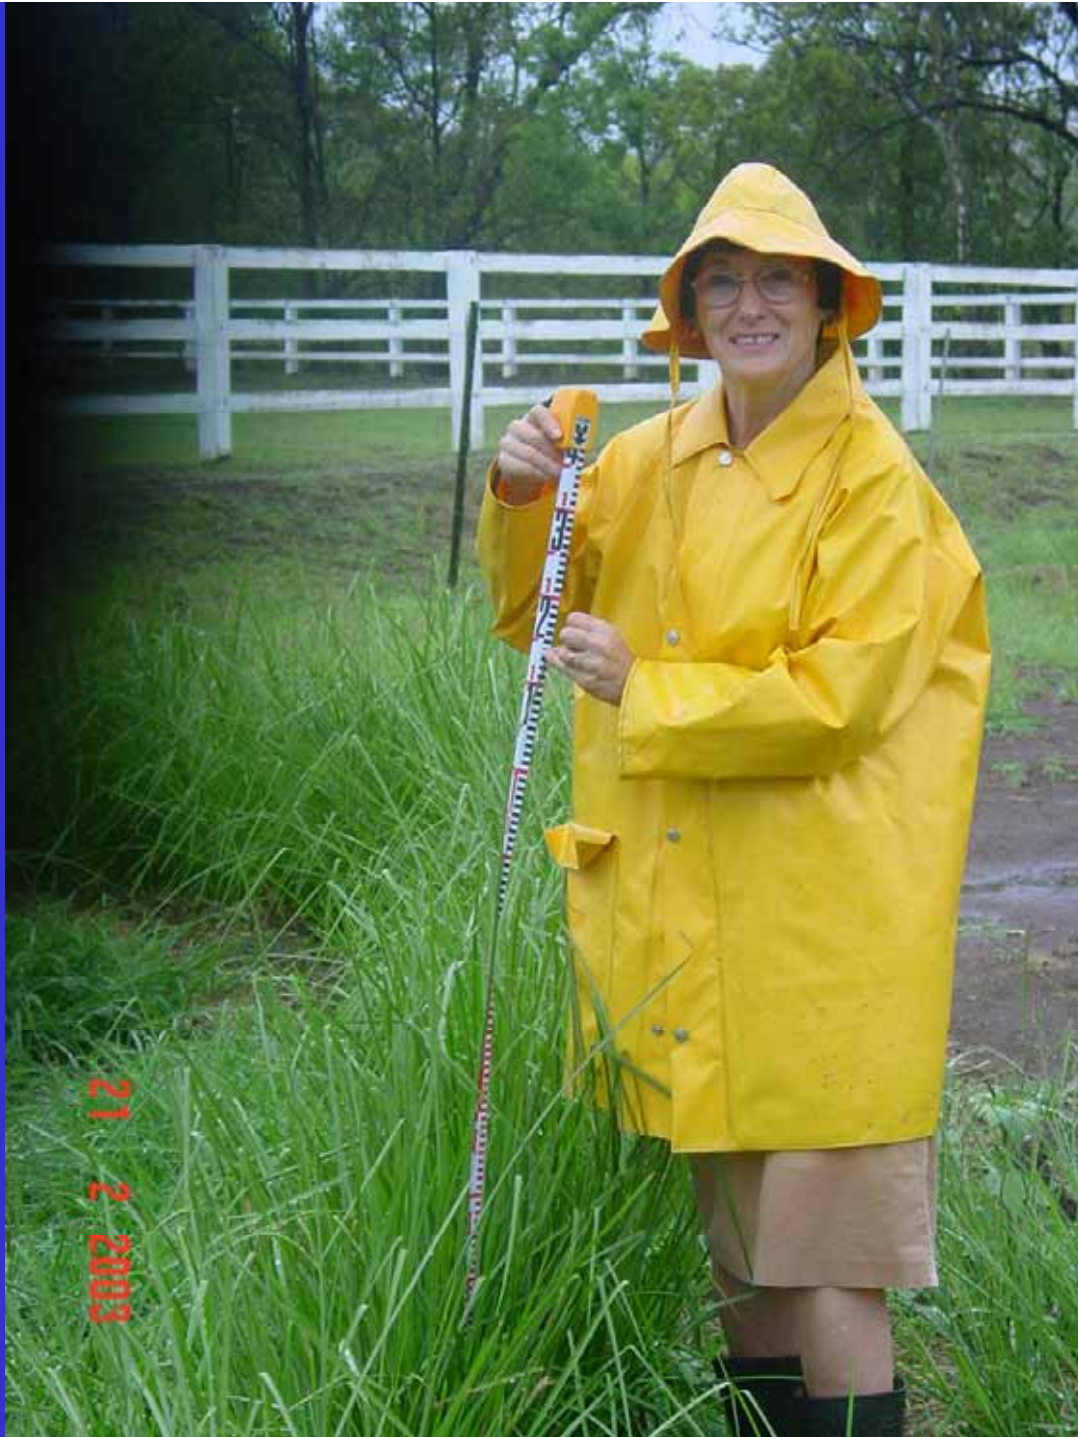
**2 months
later, 1.2m tall**

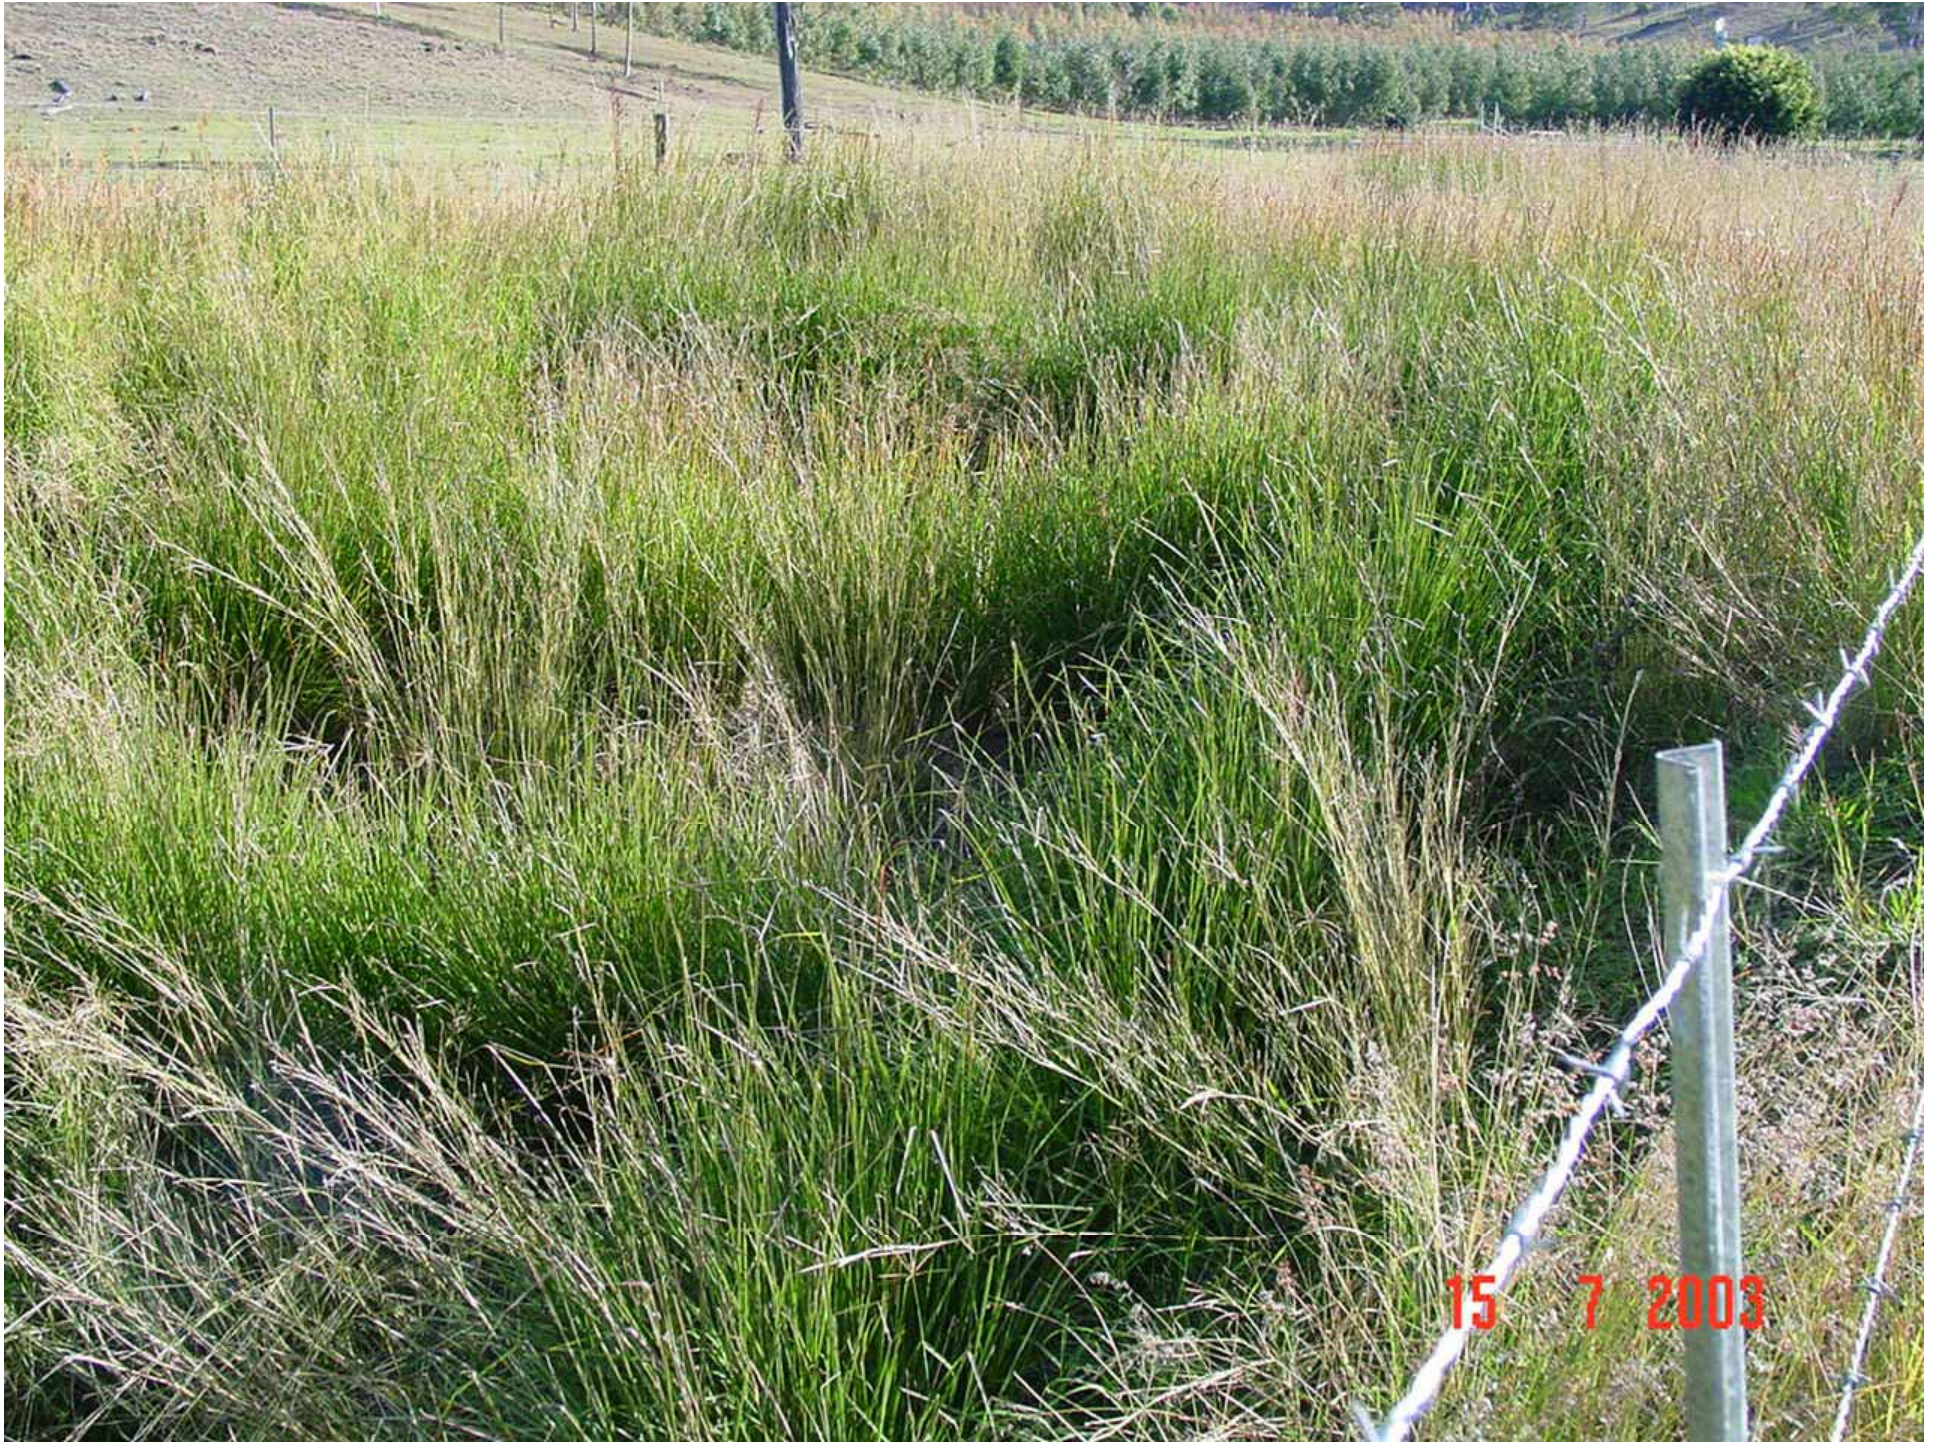
15 7 2003

6 months later, return of local tree species

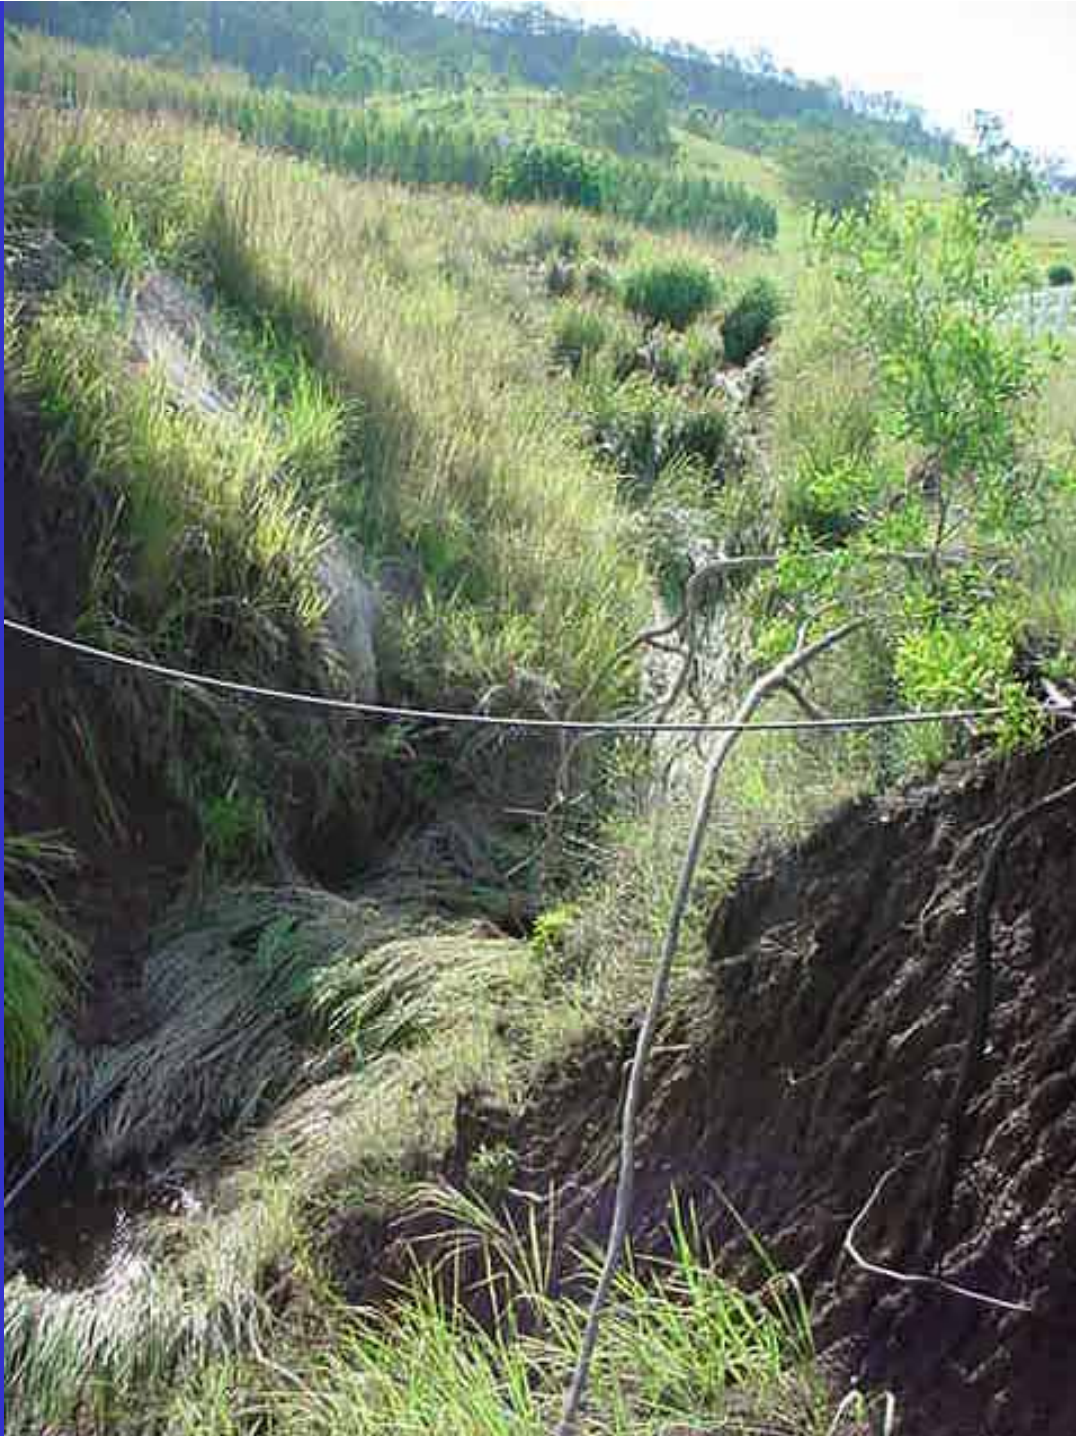
One year later
Following a
severe storm of
120mm in 1.5
hour
