**BEAUDESERT LANDCARE
GULLY STABILISATION PROJECT
CRYNA ROAD**

Dr. Paul Truong

Veticon Consulting

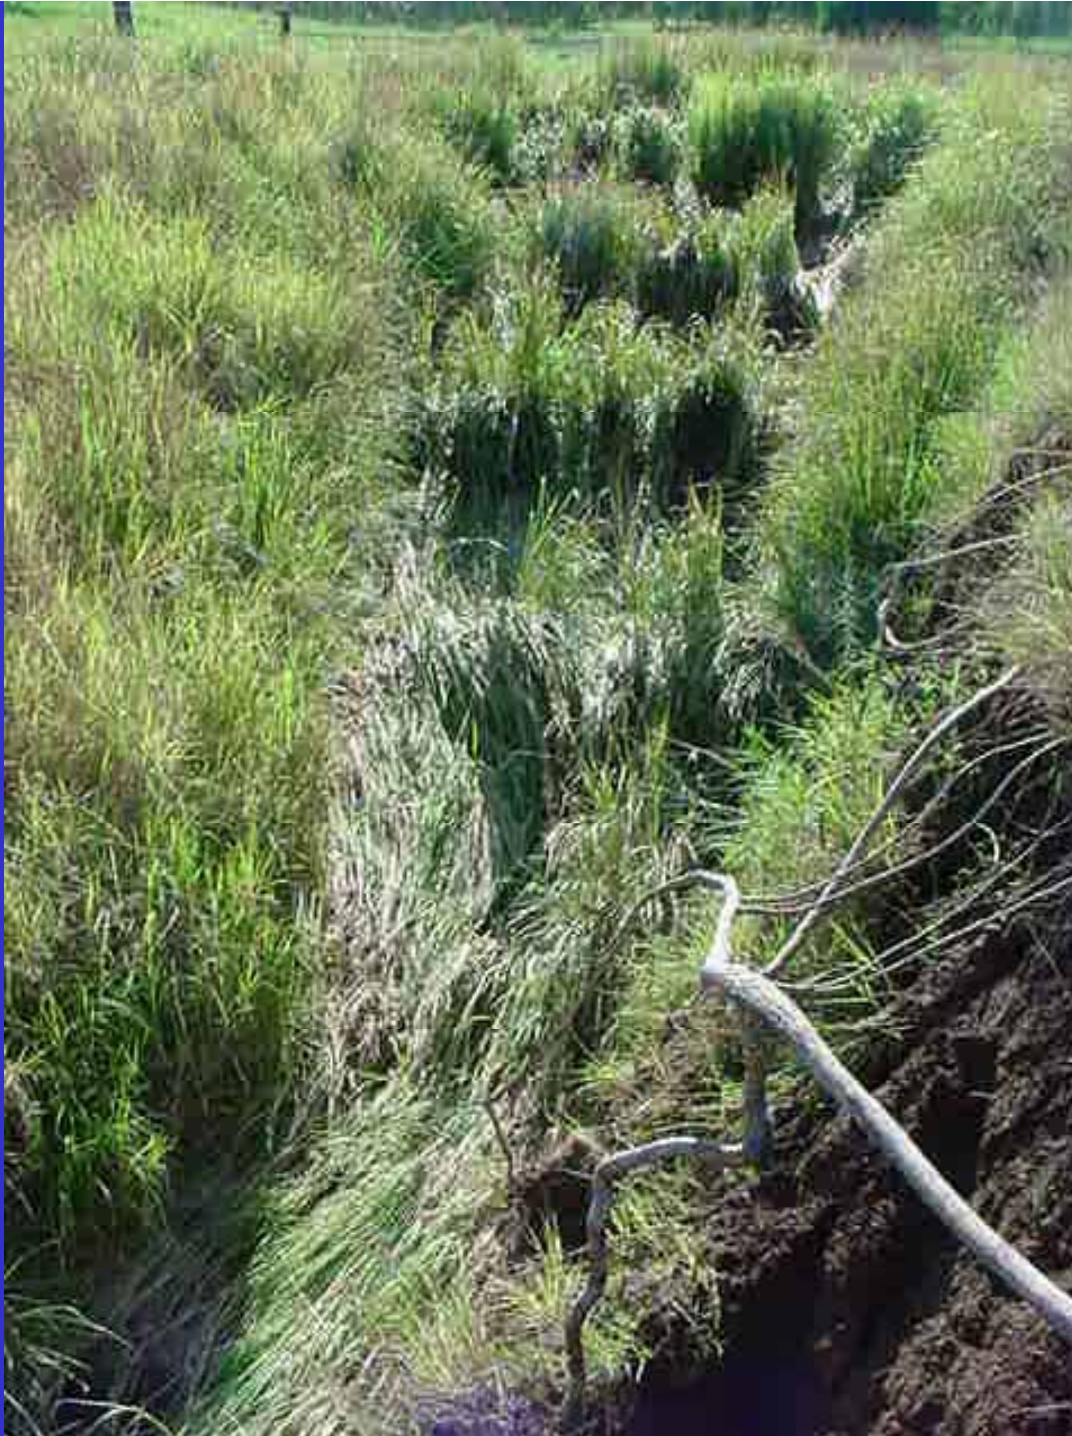
No Erosion:
Vetiver was
flattened but
holding firm
