# VS FOR EFFLUENT AND LEACHATE CONTROL

Stage 2

**Jacaranda Motel**

Grafton

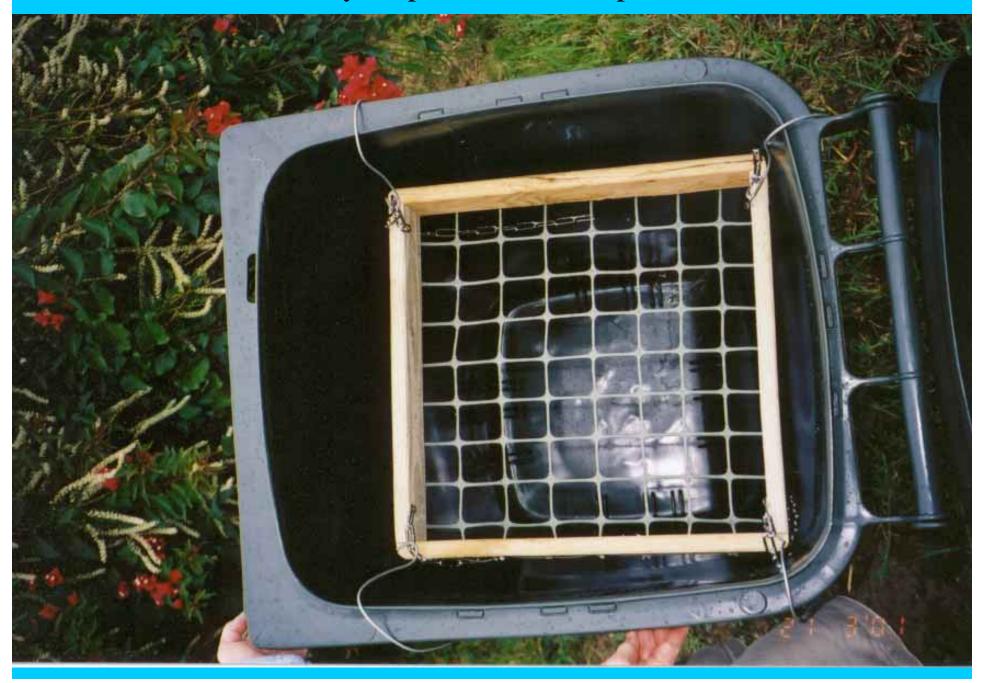
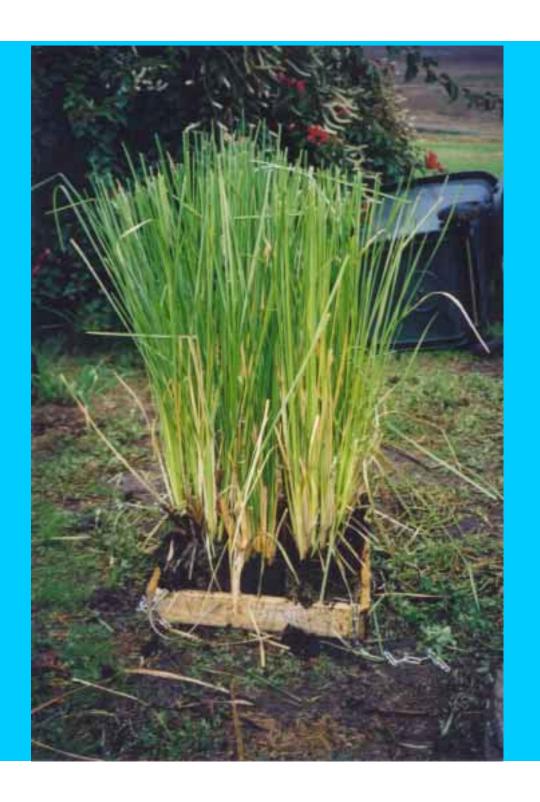
### Wire tray suspended in 200L plastic bin

Mature vetiver with well developed roots were packed in the tray

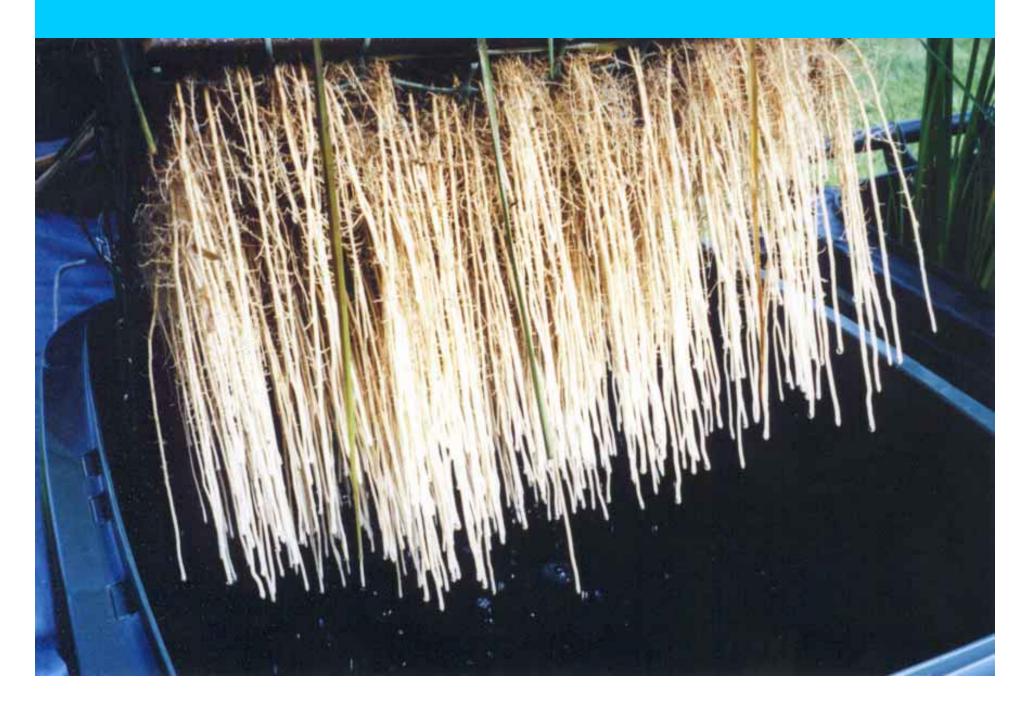
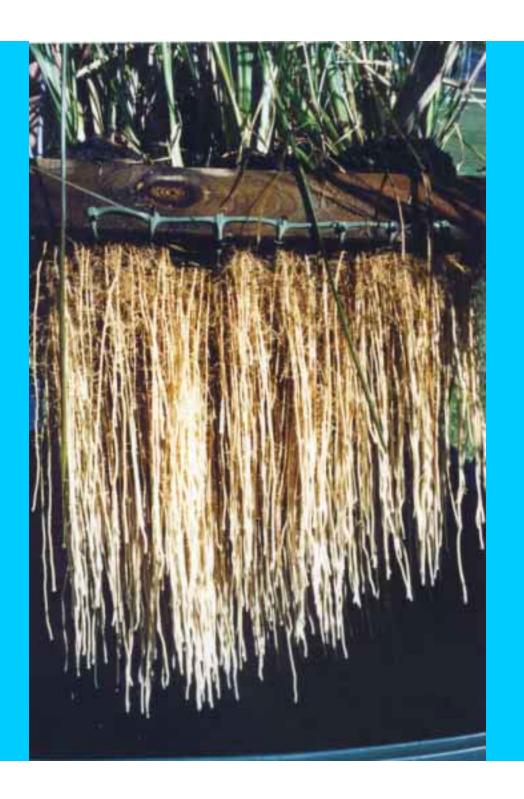
#### Root growth after 5 weeks in effluent (Hydroponics)

55 cm long

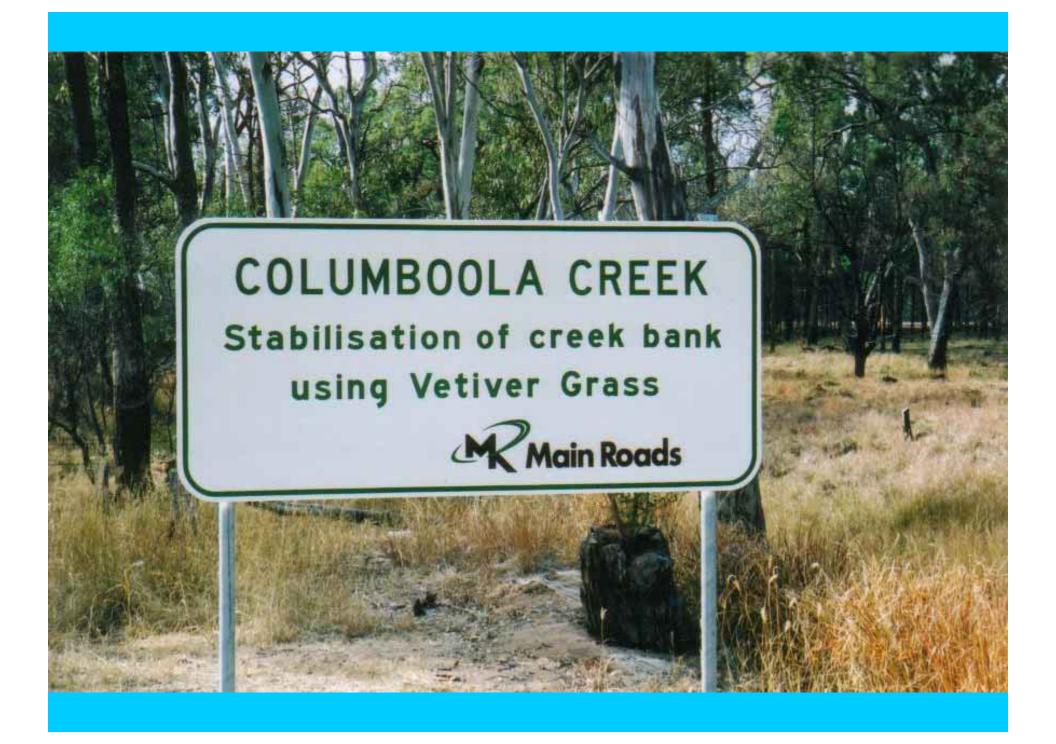
#### Columboolah creek, December 99

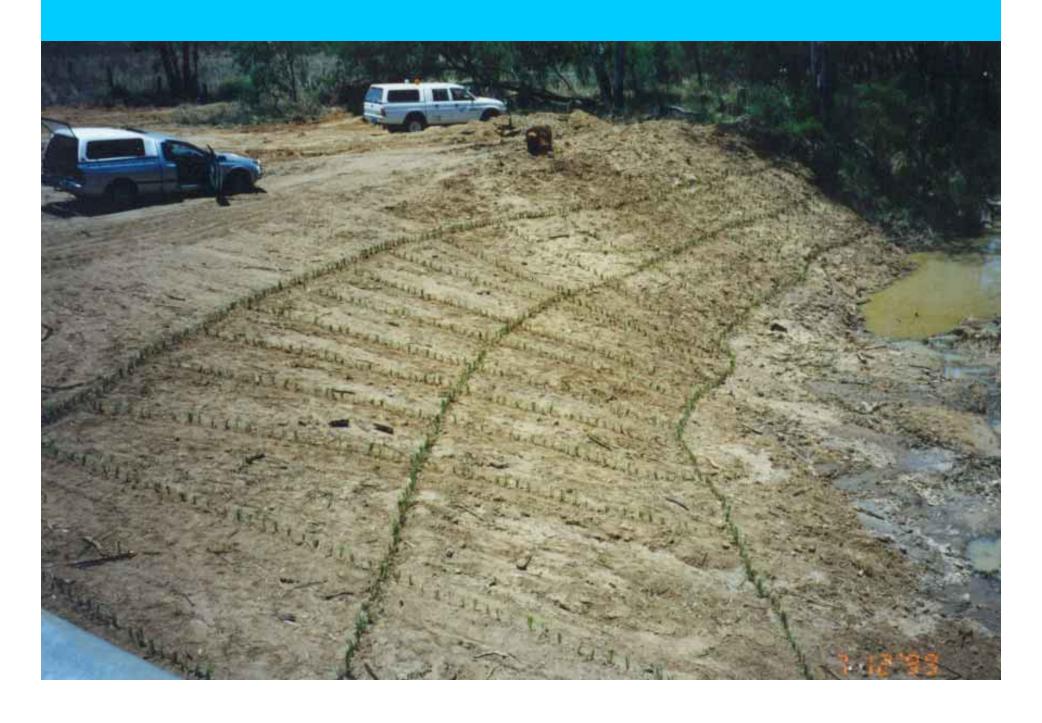
#### Same site seven months later, after a few floods

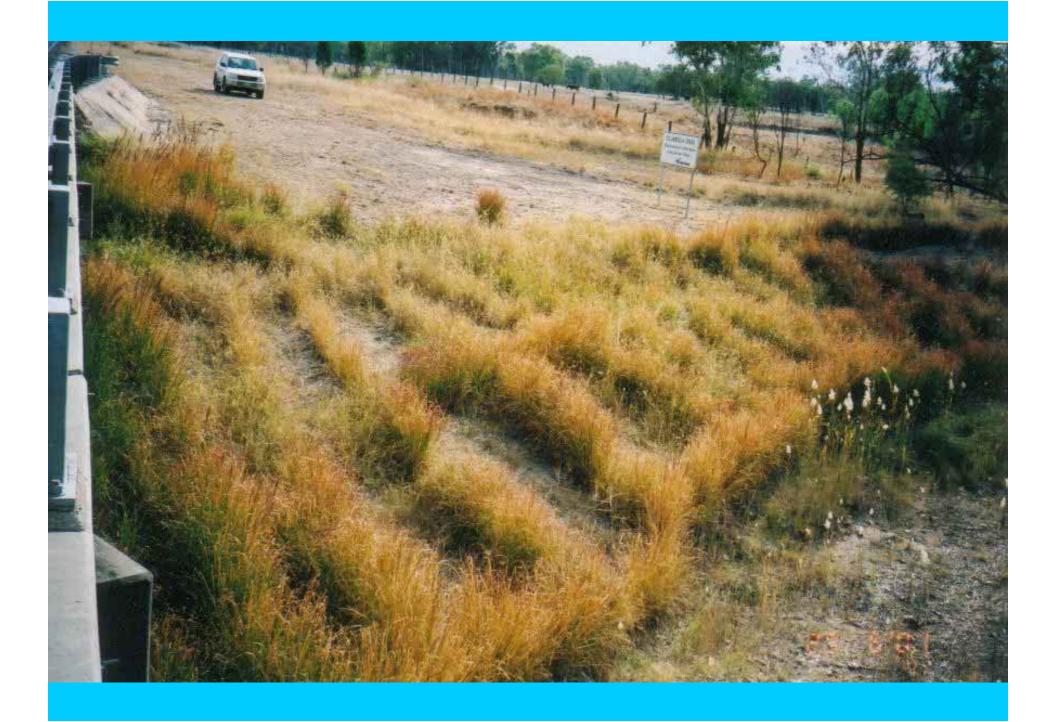
Note the bare area in between rows, due to drought and cold temp.

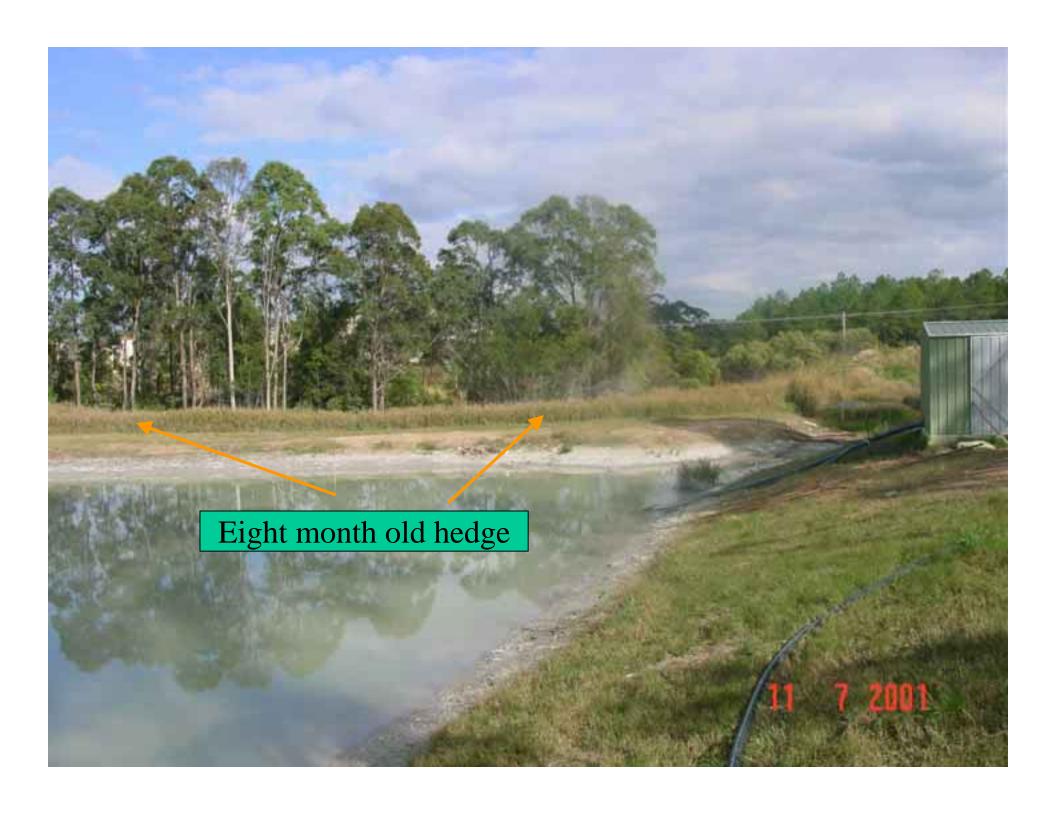
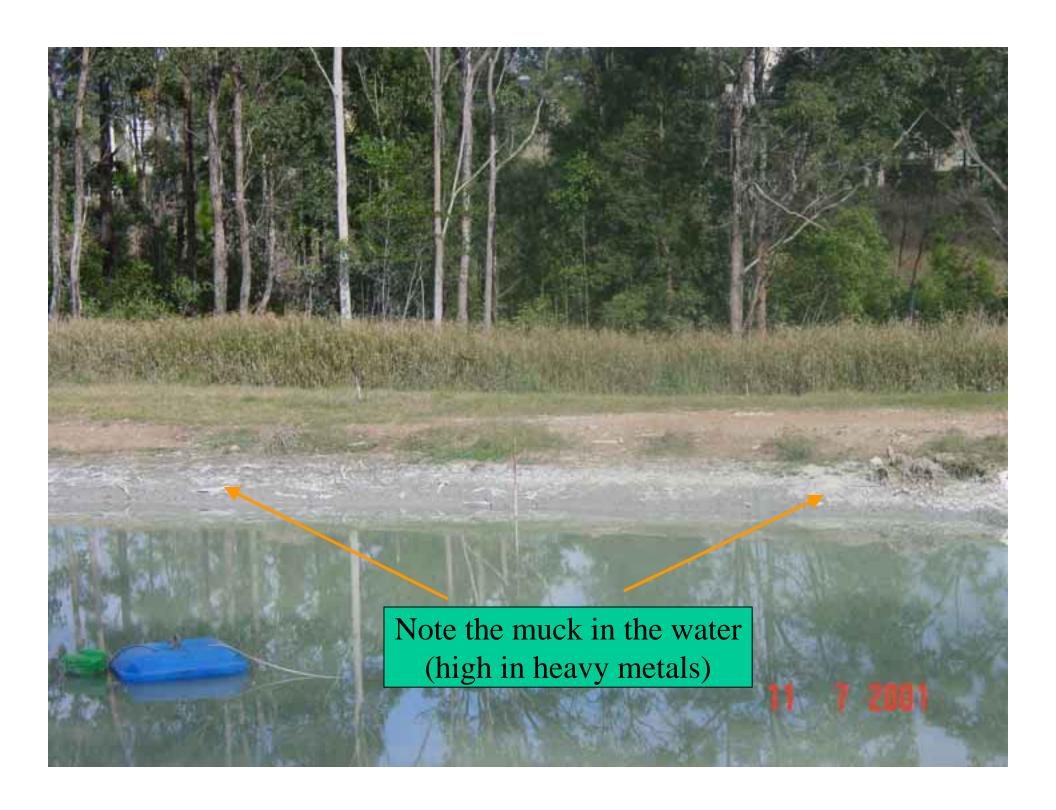
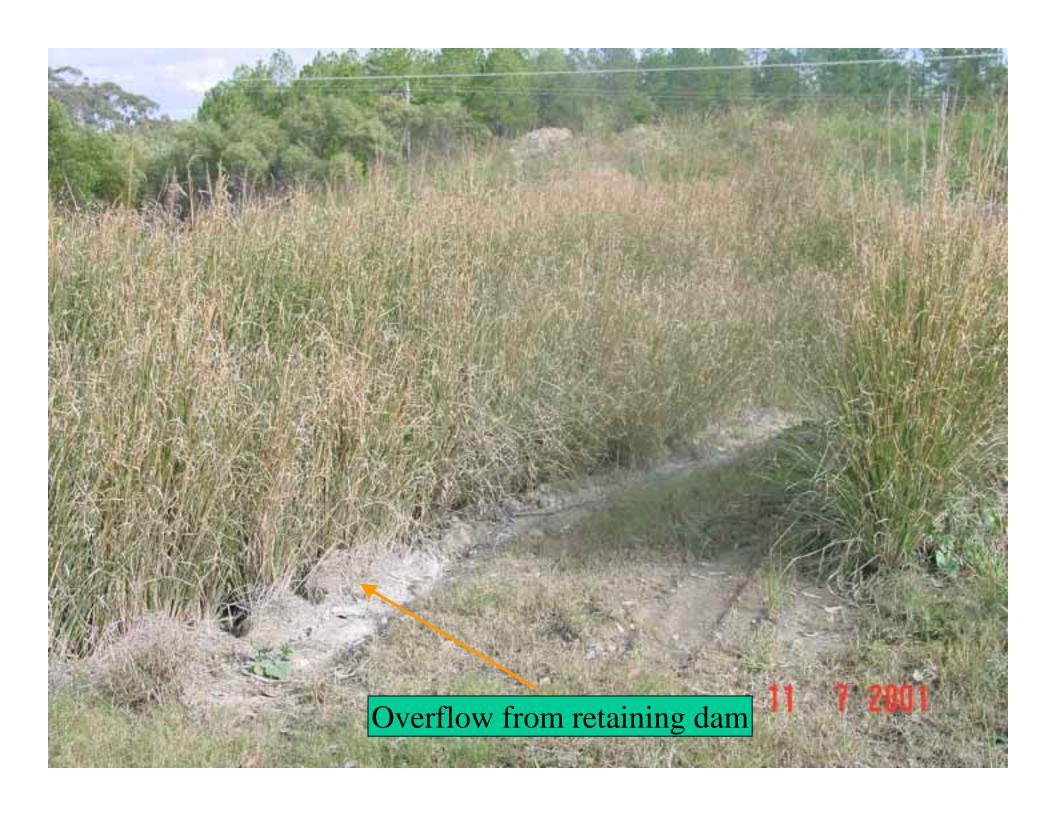
## Filter strips of gold mine tailings
