In-situ Shear Strength of Vetiver Grass Rooted Soil

M.S. Islam¹, Arifuzzaman² & S. Nasrin²

¹Associate Professor, Dept. of Civil Engineering, Bangladesh University of Engineering and Technology, Dhaka, Bangladesh
E-mail: msharifulislam@ce.buet.ac.bd

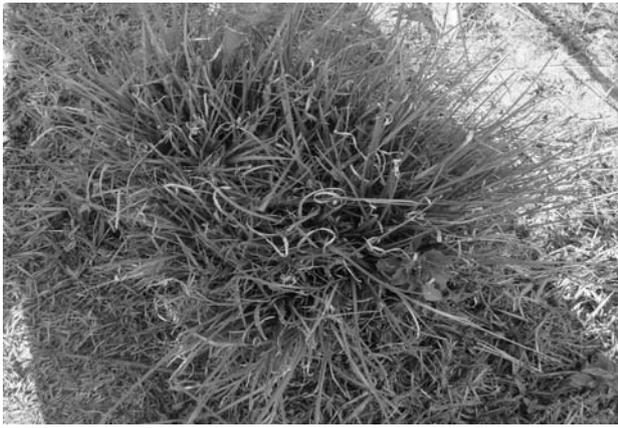
Figure 2: Naturally grown clump of vetiver grass at the study area Kuakata, Bangladesh

Mean annual rainfall varies from about 1500 mm in the southwest (Khulna district) to over 3750 mm in the southeast (Cox's Bazar) and about 2506 mm in Patuakhali district. The heaviest rainfall occurs in July and ranges from 350–875 mm (Islam, 2003). Soil Resources Development Institute assessed soil salinity status of Patuakhali and Barguna districts. The soil salinity varies from 2.0–10.0 dSm⁻¹ for most of the area where our study area is also exists. Therefore, it is clear that the local climatic and soil condition is suitable for vetiver grass to grow at the coast of Bangladesh. Hence, vetiver is considered in this research as a potential vegetation in protecting the coastal embankments against cyclonic tidal surge. Figure 2 shows a naturally grown clump of vetiver grass found at the study area, Kuakata. This means that it can be easily grown at the coast of Bangladesh.

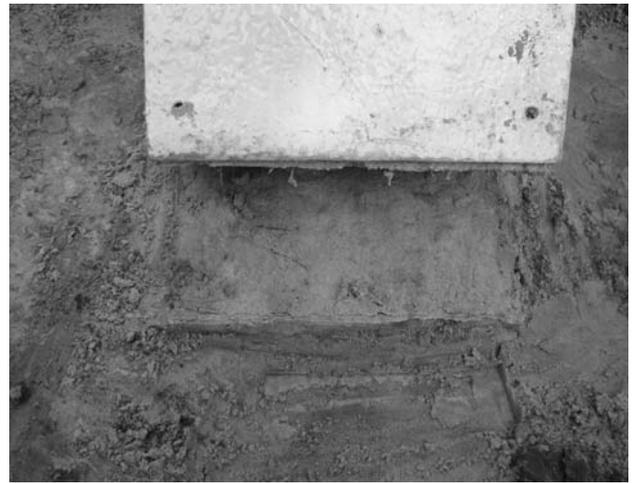
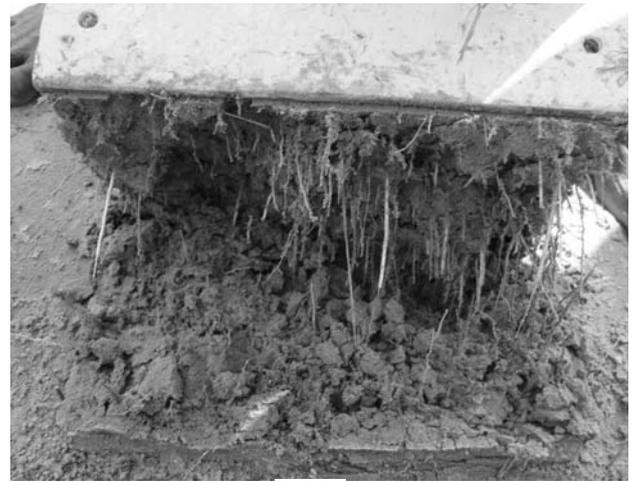
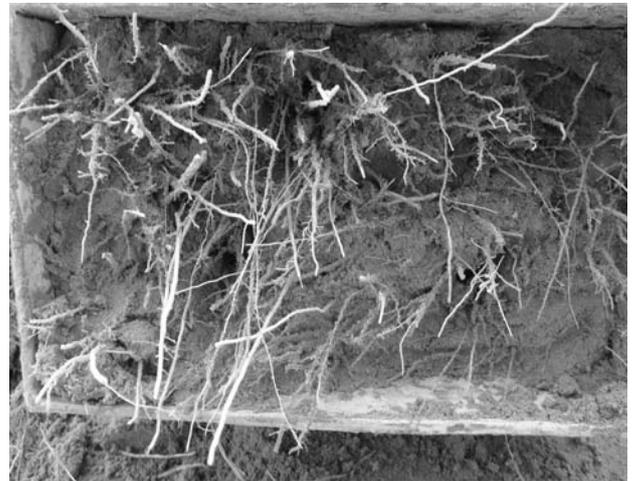
Figure 8: Failure pattern of samples: (a) soil sample without root; (b) vetiver rooted soil matrix and (c) massive root system of vetiver grass in soil matrix

Photographs of Figures 8a and 8b show failure pattern of the block sample without root and the vetiver rooted block sample. It is seen that the failure plane of soil without root sample is very smooth. There is no anchorage between the top and bottom part of the failure block sample. Therefore, it seems that it will be easily dislodged even under low velocity flows. On the other hand, in vetiver rooted soil matrix, the root system makes an anchor with the soil particles. This anchor bonding increases the shear strength of rooted soil matrix. Therefore, it is expected that it will be very difficult to dislodge the rooted soil matrix even under high velocity flows. Photograph of Figure 8c shows clearly the massive root system and anchor system between vetiver grass and soil sample.
