Slope Stabilization in Itaipava-Petropolis, RJ, Brazil Using Vetiver Solution - A Total Success.

*Paulo R. Rogerio, PE, Geotechnical Consulting Engineer
Pomerode-SC-Brazil email: prrog@terra.com.br*

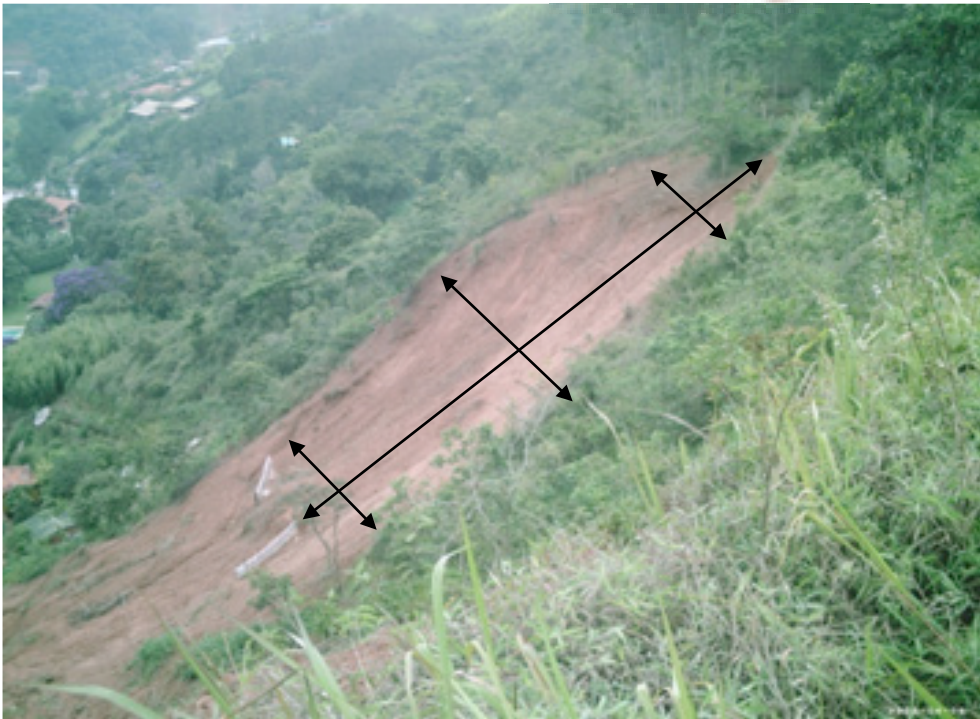
The landslide in neighbor's land

FIG. 2. The area where was planted about 8500 slips

The slipped slope was stabilized by making a channel to deviate the surface water acting from the head and laterals of the eroded basin; the soil was prepared manually, after which contour lines were plotted and vetiver hedgerows were installed, using about 8500 vetiver planting slips in order to prevent surface erosion and promote inside the basin a truly “live nail” pinning the soil to the subsurface “C” horizon. In addition around the boundaries of the slide area the plants were placed as 2/square meter.

The soil between the Vetiver hedgerows was totally covered with mulch (straw and sawdust — 0,5kg/m²) and jute bags meant to improve the soil roughness between the leveled lines.

The Vetiver slip was planted at 10 cm (4 inches) center to center and the lines varied between 1.0 and 1.5 meters.

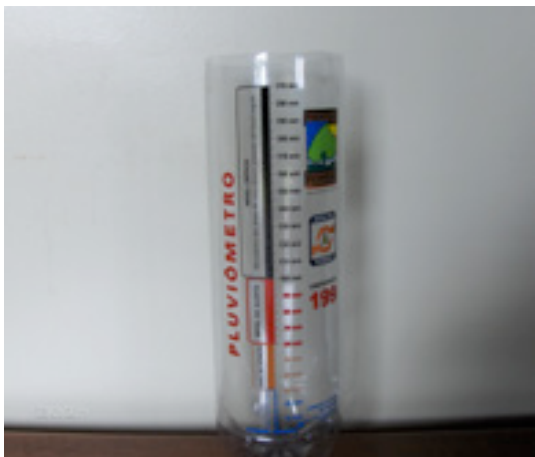
FIG. 3. Home made rain gage type.

In the year 2009 and 2010, 2300 additional slips of Vetiver were planted. The surface drainage was also completed in September 2009 and a rain gage (fig.3) was made available in the area studied

The ultimate test was on the 11 and 12 January 2011, when after an initial 18 mm it rained 95 mm over a two and half hour period. Altogether a precipitation of 113 mm in less than 24 hours was measured by rain gage placed at the house.

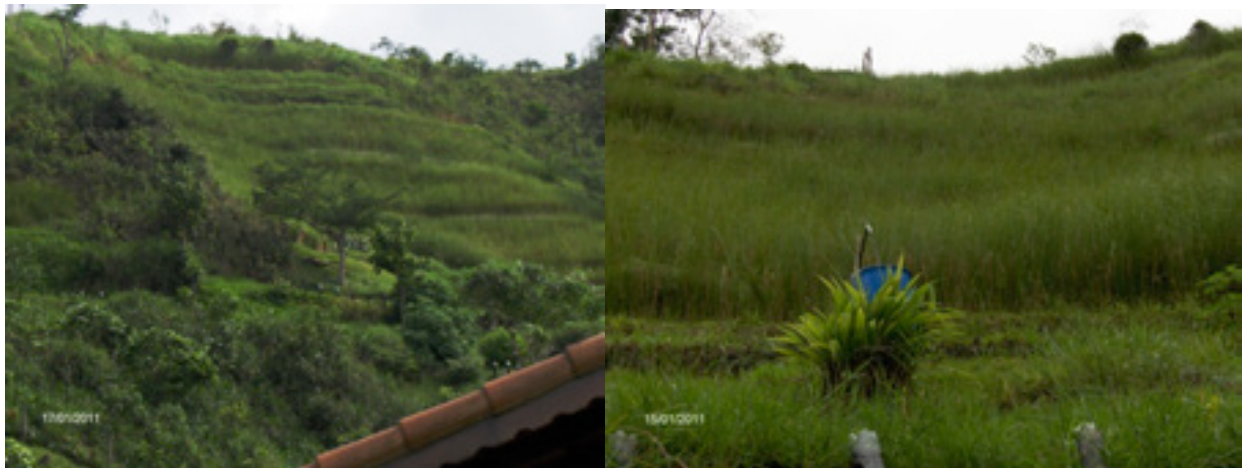
After three years since the landslide, although suffering strong winds and heavy rains, the hill slope is fully intact with the help of the Vetiver that is now fully developed and firmly holding the soil.

See the figures (4) and (5). The photos were made after the recent 2011 rainfall events

This effective slope stabilization and the much reduced sediment runoff provides a real life testimony for Vetiver which thus far remains in great condition

The soil on the hill has remained stable and the water discharged into the public drainage line is clean, with no dirt in it.

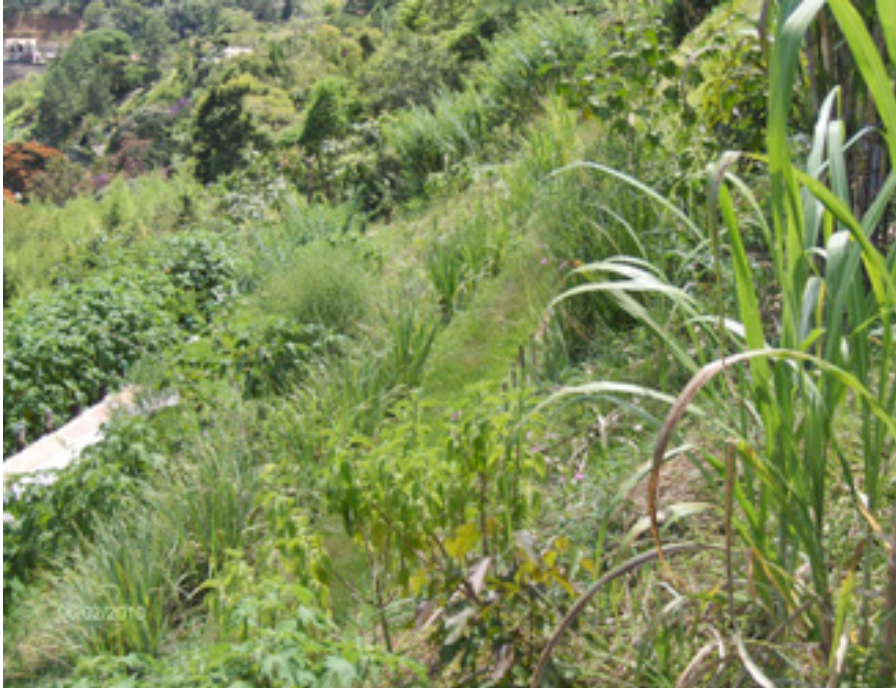
Partial view of lower portion of the slope. Fig. (6)

On the lower part of the slope, in addition to the Vetiver planted as a “live nail”, some leguminous plants, shrubs, fruit trees, grass, were planted and today 95% of the area is fully covered with vegetation.
