VETIVER SYSTEM FOR ENVIRONMENTAL PROTECTION OF OPEN CUT BAUXITE MINING AT “LOS PIJIGUAOS” –VENEZUELA.

Keywords: Bauxite, phyto-technology, bioengineering, slope stabilization, erosion control, gullies

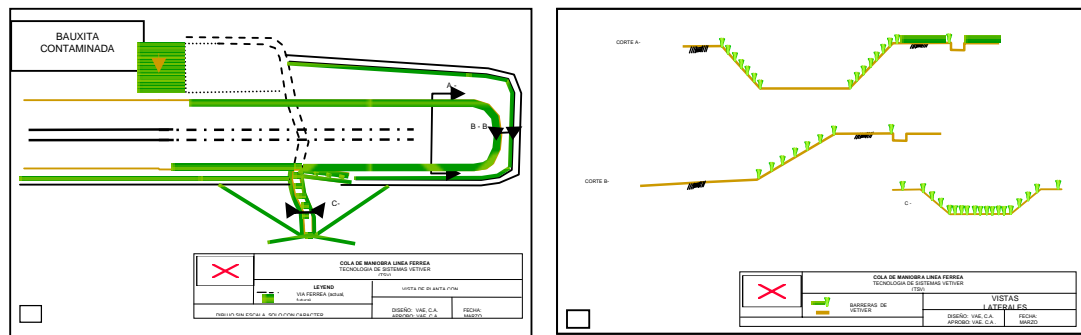
Fig 1: Design drawings

After doing an evaluation from the sites to recover, soil samples are taken for its analysis; there are observed factors like: ways of water presence in the area of the zone to treat, stability of the soil, slopes of the land and which will be the use of the barrier; with all this information is determined the Vertical Interval (VI) to apply, which generally is located between 0.80 m and 1.00 m. Subsequently proceeds to design the barriers (fig. 1)

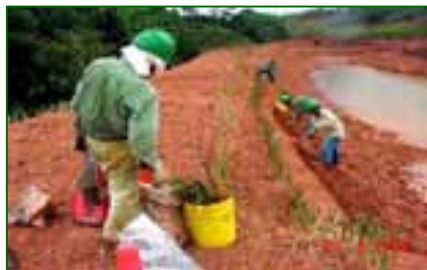
photo 1

With the sowed of vetiver plants (photo 1) the phenomenon of erosion in the slopes has been controlled; achieving besides to reinforce the structure of the dike, thanks to the net of roots which moor the ground. The barriers formed by their leaves offer an additional over elevation, due to they behave like a porous wall (photo 2) that allows the lagoon to release water through its crest, when rains of great dimensions fall; simultaneously they captures the sediments suspended in the waters that pass through them.

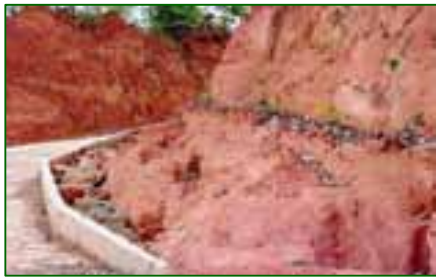
photo 3

One of the problems that commonly appears in engineering is the erosion of the transition areas between the concrete and the ground; very particularly in the zones by which the rainwater drains (photo 3). The VS was applied in curbstones of a hard pending road of 1.200 m that leads to “the adduction”. Although the road was in its first year, in some sites the curbstone presented deep furrows; even though as prevention a poor concrete mantle had been applied, the action of waters continued eroding and the damage in the referred zone persisted before the planting.

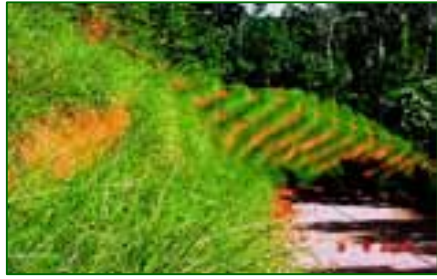
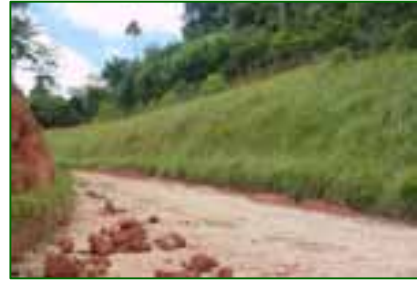
The slope is stable and the barriers are strongly developed (photos 7 and 8). Additionally the presence of pioneering vegetal species for the recovery of the original forest has been observed in it.

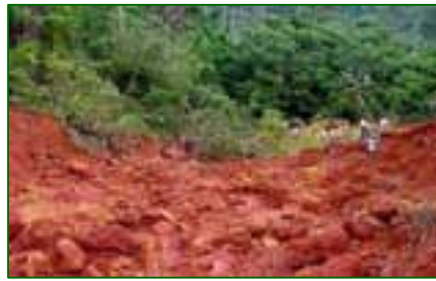
photo 9

This was a gully of 95 meters in length, (photo 9) formed by vertical walls with unevennesses up to -5,00 m, that reached up to 15,90 m wide. It had been repaired in diverse occasions but also continue failing; later a torrent flood of concrete was constructed to lead waters, nevertheless, the visual contamination and the risk that which waters looked for their previous course continued.

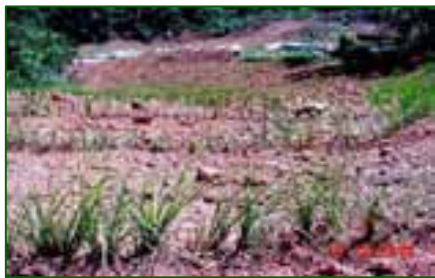
photo 10

For the application of the VS a machine conformation of the land was made, previous to the planting of vetiver (photo 10). Seed was made at the end of the cycle of rains and it limited the formation of the barriers in its totality. Although irrigation workings were not made, and the summer in the region is strong; the plants of vetiver stayed in a latency state until the rains restart, five months later. In the 2.004 took place a reseed in some failed points; in that occasion all the plants grew vigorous (foto11).

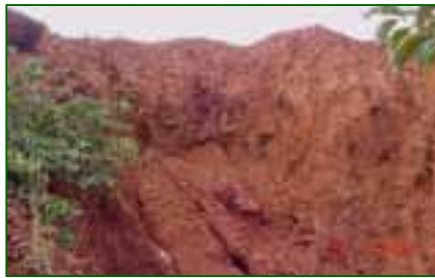
photo 12

- One of 15 mts of depth with an inclination of 80° (photo 12). Formed by the rupture of the dock of a sedimentation lagoon that was constructed near a depression, according to previously used criteria today discarded. It was required to seed by points, that is to say, it was not possible to open ditches due to the instability of the land (photo 13). During the phase of establishment of the plants three focused slidings happened, caused by the rains. These were reseeds in each occasion. At the moment the recovery is total.

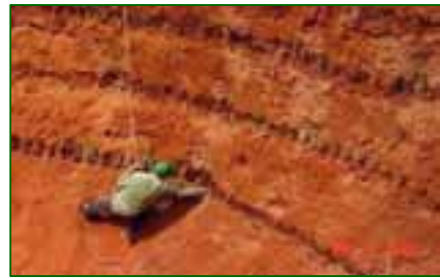
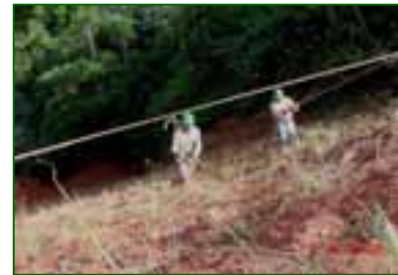
In the execution of both cases, the workers moor themselves using technical similar to rappel (photos 13 and 15).

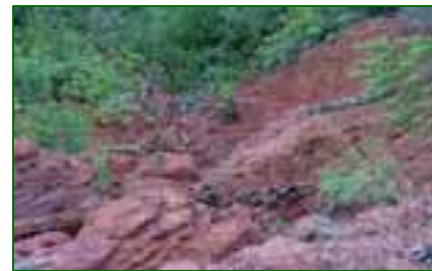
photo 14

- The other had a depression of approximately 40 m of depth and an inclination of 60° (photo 14). Of a similar origin to the previous one, it was modified by the action of works made in the lagoon that produced it. The overturning of the material formed a very unstable slope caused by filling without compacting; to it was added the filtration of the lagoon through the inferior part of the slope; all these elements were conjugated so a sliding happened after to have seeded. The works of repair were undertaken the following year. Today it is stable and also there is presence of other pioneering vegetal species.

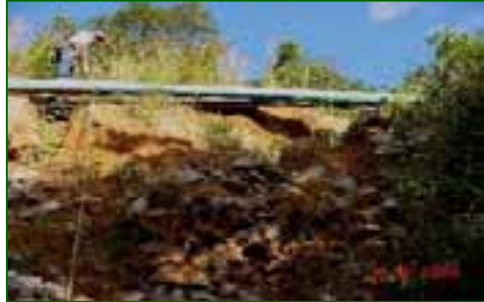
photo 16

At km 4 of the road that leads to the mine happened a sliding that considerably deteriorated a stone wall that was in the area, leaving in addition without support a pipe section that leads potable water to the residential camping (photo 16). The security's department of Bauxilum declared an emergency in front of the possible rupture of this pipe which represented a double risk:

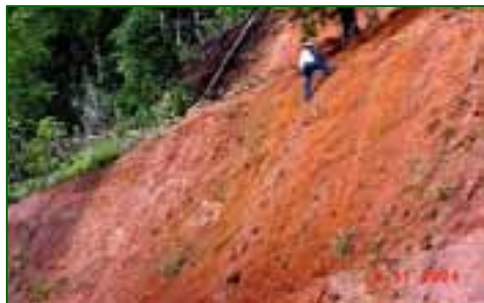
photo 18

In km 10 from the route to the mine two slidings took place in slopes of cut with a high of 15 m and 25 m respectively, and an inclination of 75° (photo 18). The slopes are located in the East face of the mountain; across (at the West) a leafy vegetation exists; this situation restricts the incidence of light in the zone to few hours of the day.

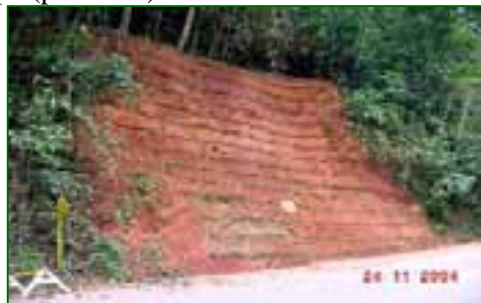
photo 19

The growth and development of the plants were very poor due to the little incidence of solar light, to the point that at the date, two years later, the presence of them is hardly noticed. Nevertheless the slope stays stable; perhaps by the absence of the waters that were turned aside to another slope (photo 19).

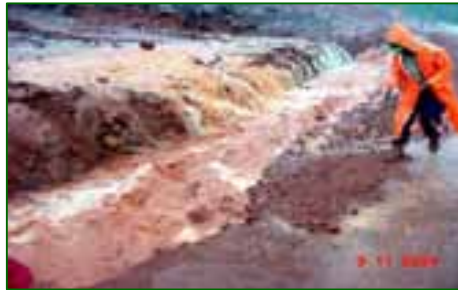
photo 20

Due to the strong currents that moves through those drainages (photo 20), sometimes is required to install provisional barriers with sand bags, rocks or wood, previous to the vetiver planting to avoid that the plants be dragged before they root in the ground. In other cases we have worked with barriers preformed in the nursery anchoring them with the use of steel treenails and mooring them strongly.

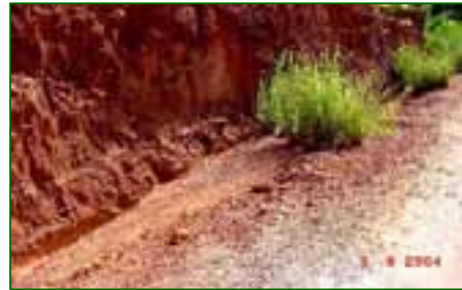
photo 21

The establishment of barriers of vetiver as sediment filter not only has fulfilled that intention but also the process of erosion when filling up has reverted and to form terraces in the located areas above waters (photo 21).

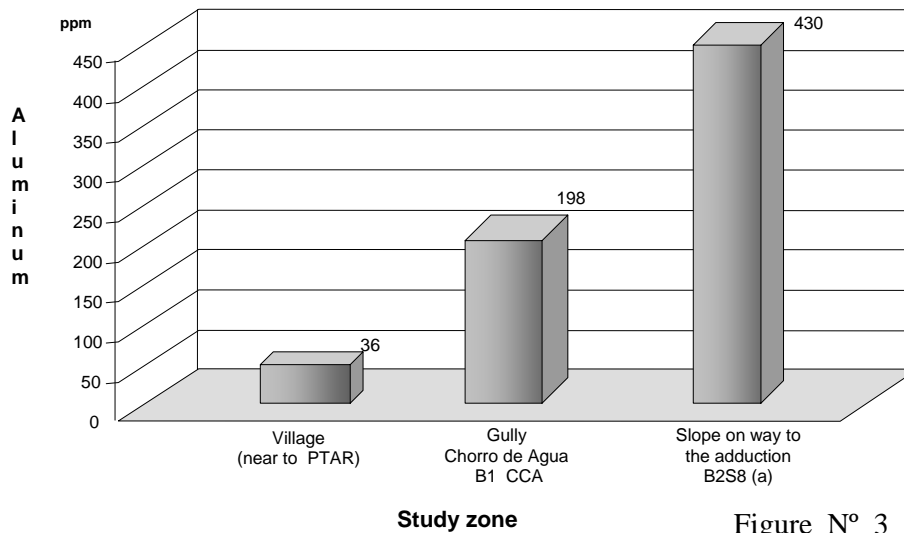
Figure N° 3

On the other hand, the table N° 2 shows the aluminum levels contained in the leaves of the sampled plants, which are compared graphically in figure N° 3.

ALUMINUM ABSORPTION IN VETIVER PLANTS (LEAVES)

From the result of the analysis made in samples of Vetiver plants (leaves); as well as in those of the ground of the planted area, the following concludes:

- From the samples obtained to determine the aluminum content present in the plant, were obtained the biggest results (values) in the plants established in the slope of the route to the adduction of the mine (B2S8a), presenting 430 ppm of accumulated aluminum 34 months after the planting. Next, appear values of 198 ppm in the plants established in the gully of the stream “Chorro de Agua” (water spurt) (B1 CCA), with a time of planting of 26 months. Both groups of plants established in the areas in recovery process.
The lowest values of 36 ppm correspond with the species established in the proximities of Served Waters Treatment Plant (PTAR by its acronym in Spanish) that is located in the Populated Center; and therefore they are not associated neither to the process of operation of the bauxite mineral, nor to grounds derived from this type of mineral.

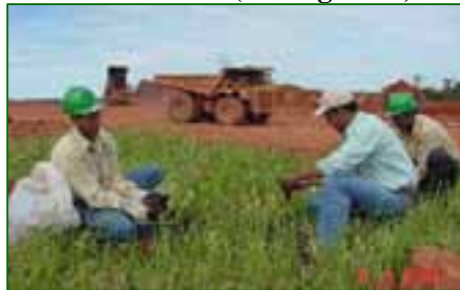
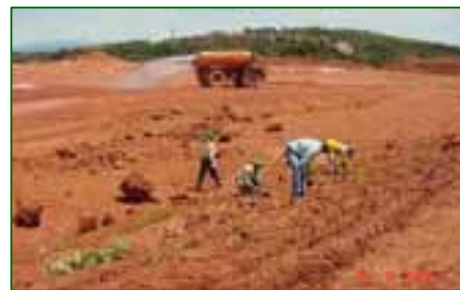
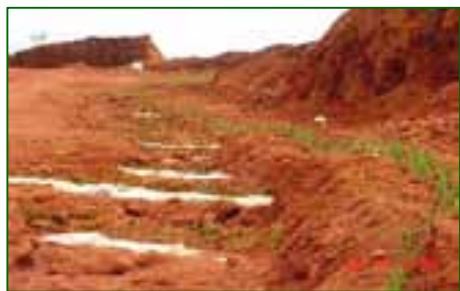
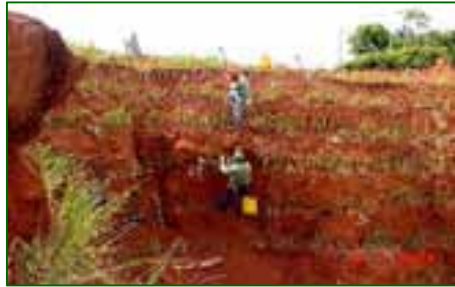
Preparation and planting of vetiver in a lagoon border, near to the deposit patio of bauxite (photos 24 and 25). Barriers provisionally installed, while vetiver consolidates (photo 26). Rain fell 2 weeks after seeding in the roadside ditch (photo 27). Sediments retained by barriers in formation (photo 28) and established (photo 29). Erosion in curbstones before the planting (photo 30). Effect of the shade in the growth of the plants (foto31). Repairing damages caused by the rain in one gully during the establishment phase (photo 32). Our human equipment (photo 33)
