Vetiver Solution

A Total Success in Landslide Stabilization at Itaipava, Petropolis, Rio de Janeiro, Brazil

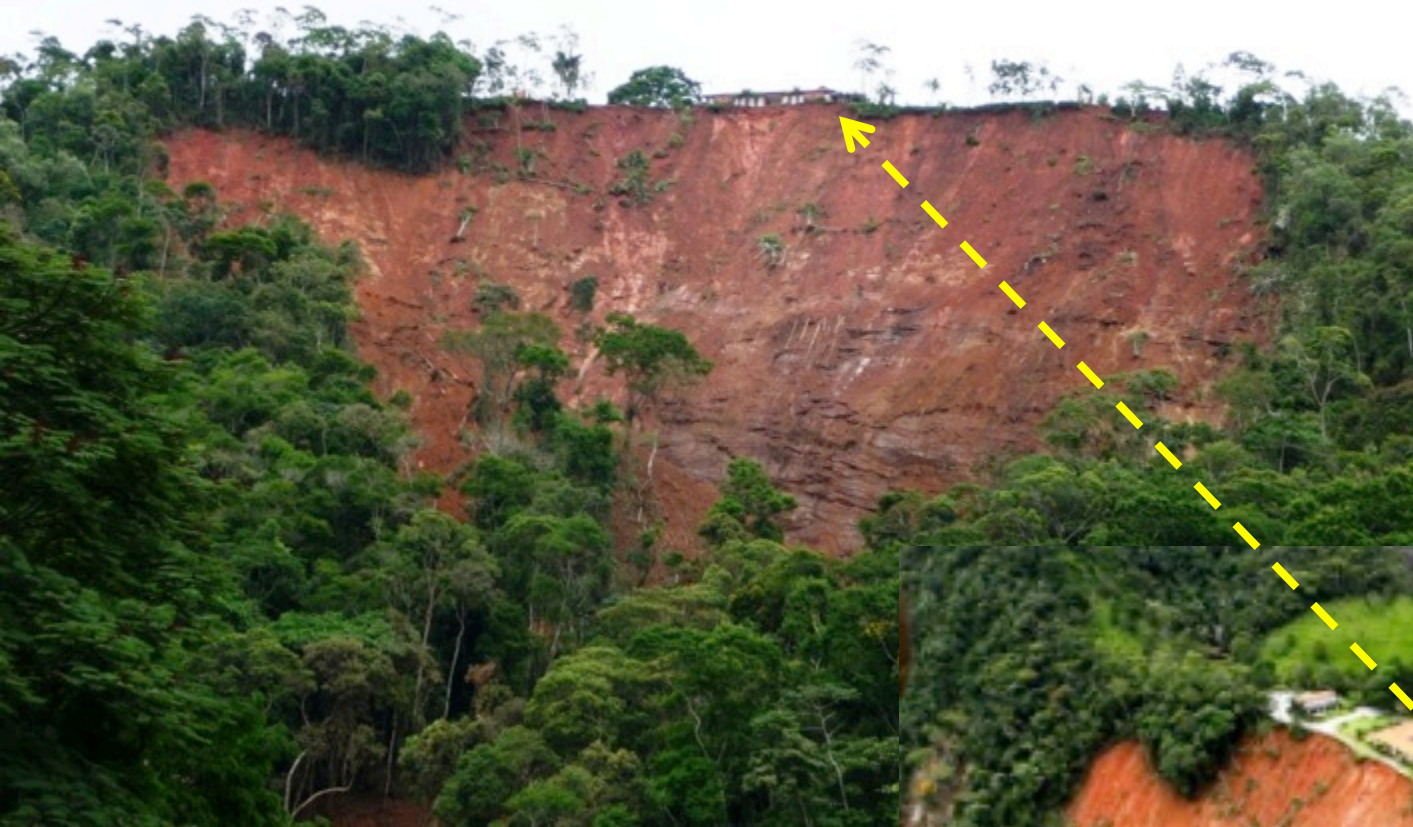
Landslide like this is common in Brazil due to highly erodible soil and extreme weather

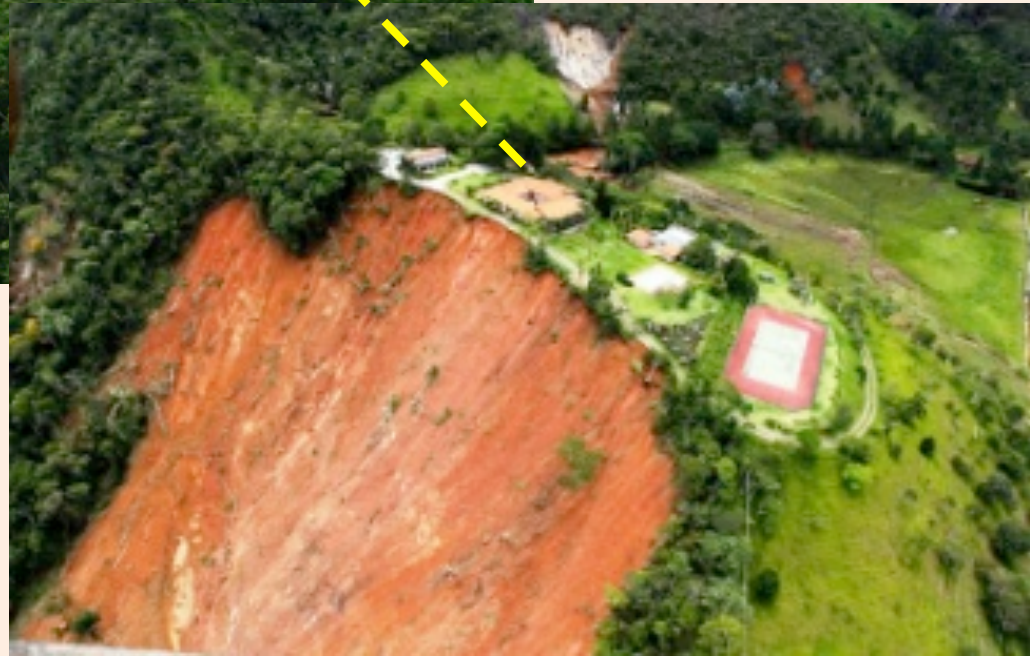
Landslide at Itaipava, Petropolis, Rio de Janeiro

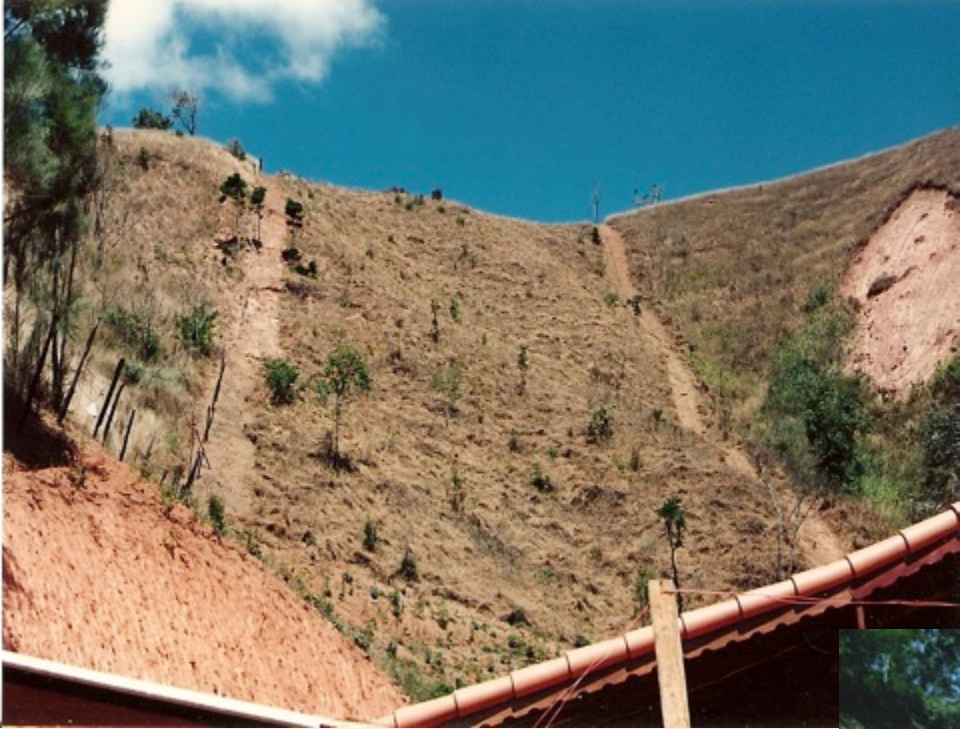
Site before Landslide

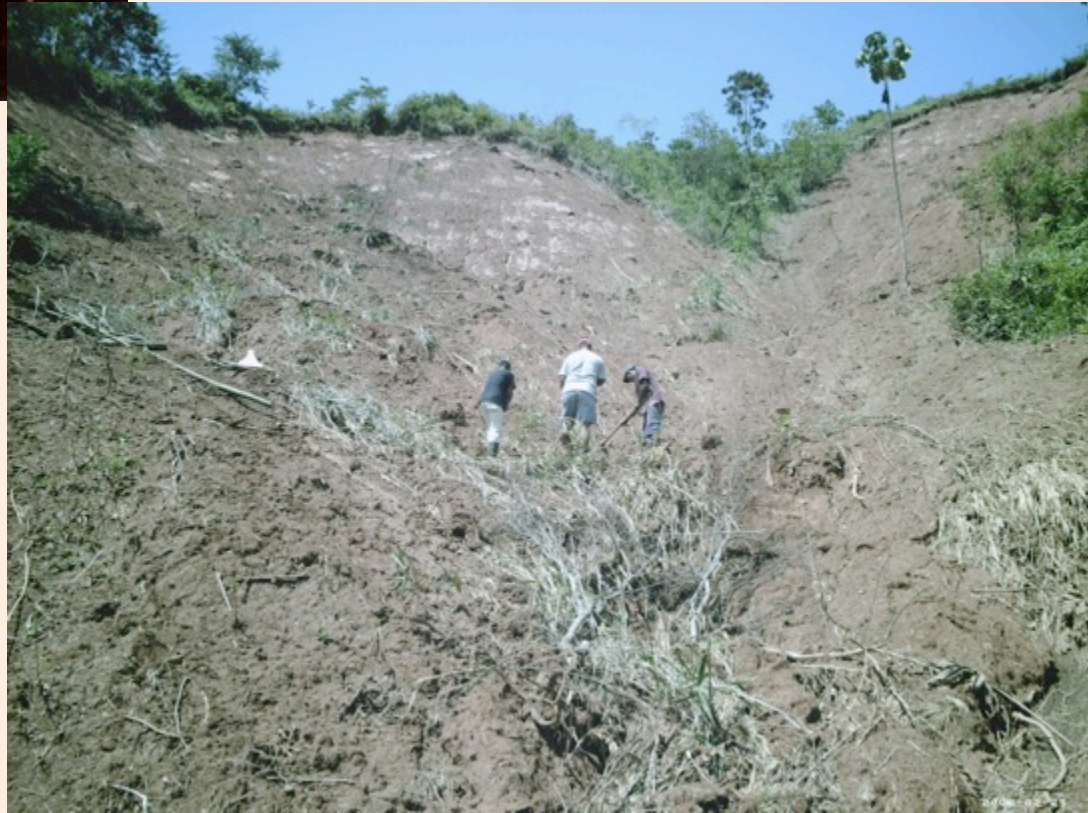
Site after Landslide

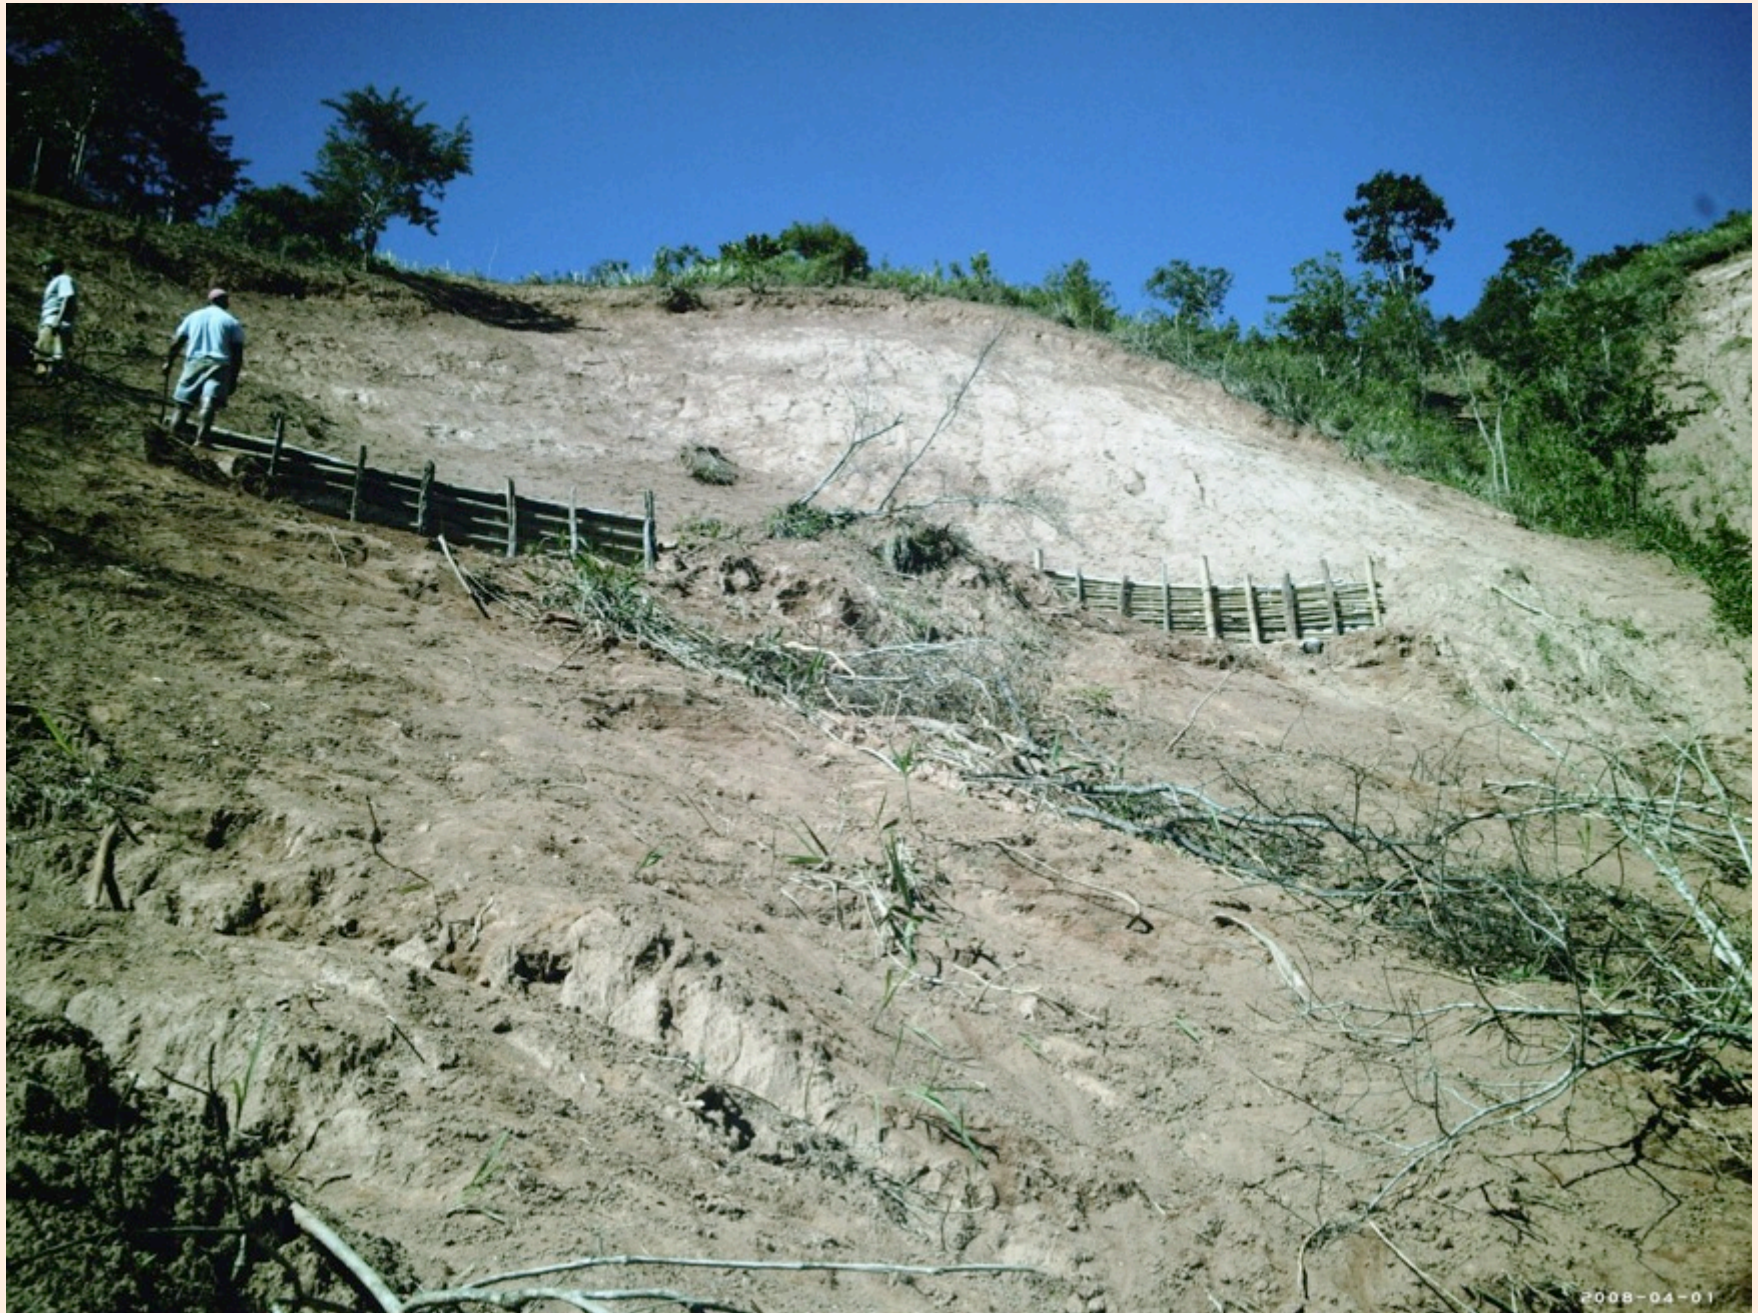
Landslide direction

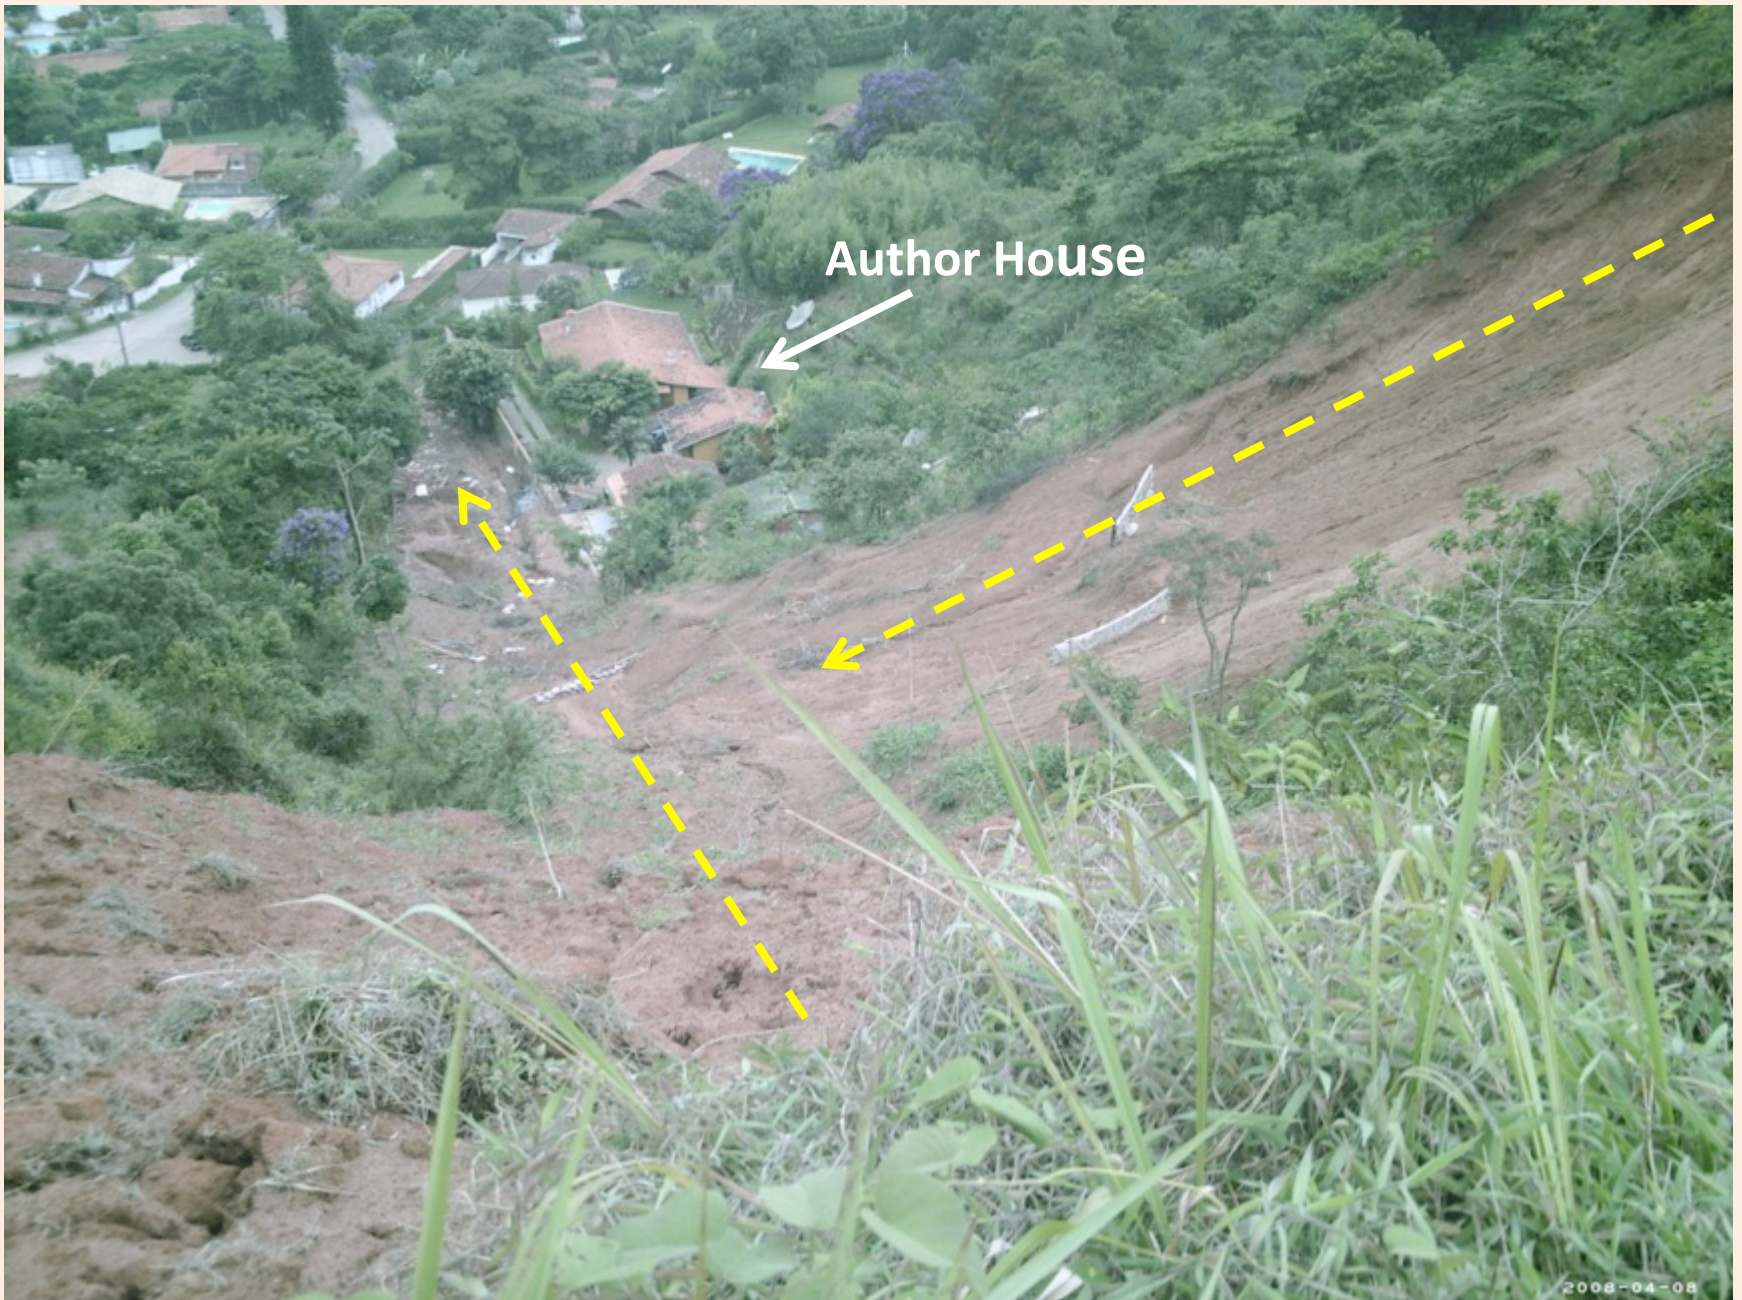
Site steep gradient (66%-97%) and planting layout

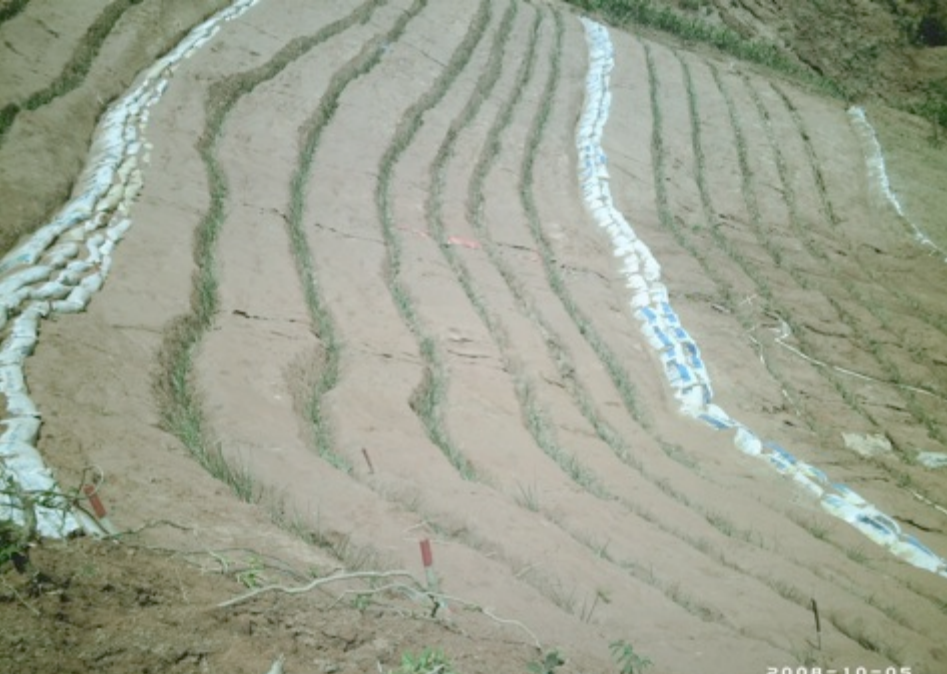
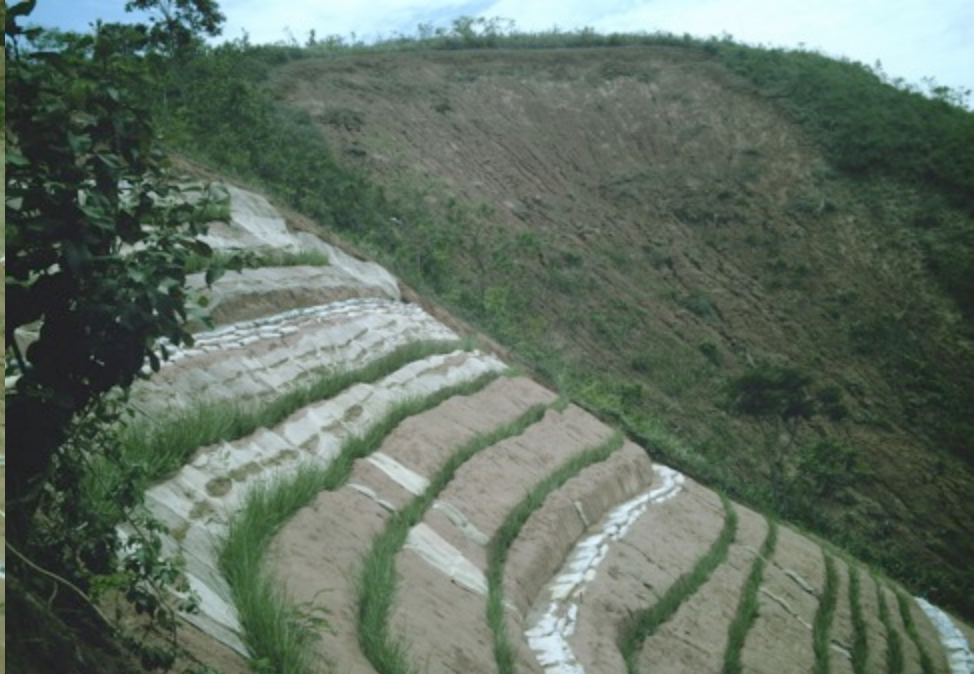
Planting on contour lines ay 1m Vertical Interval

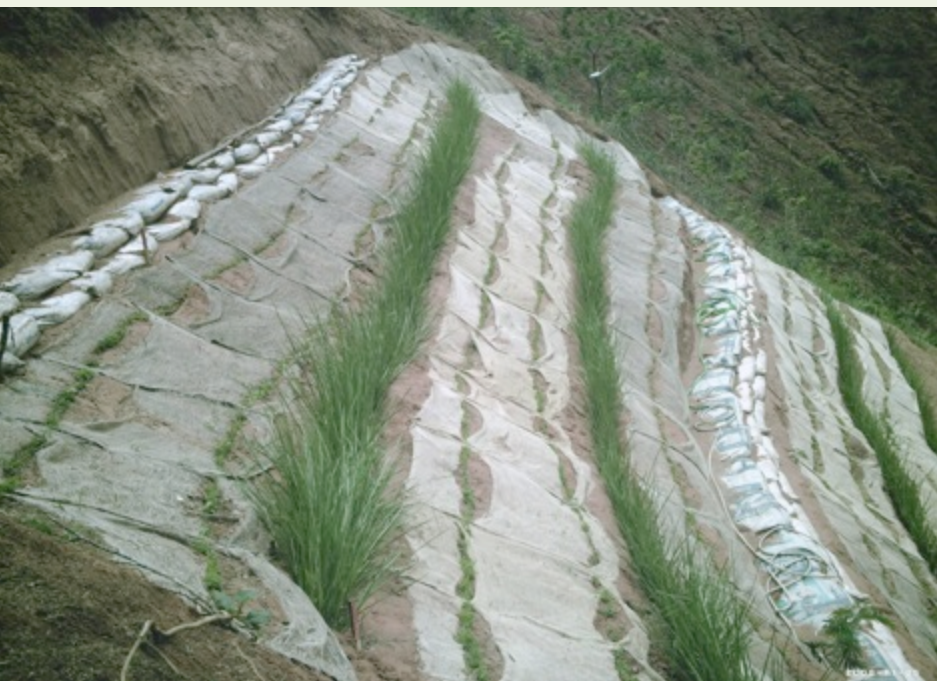
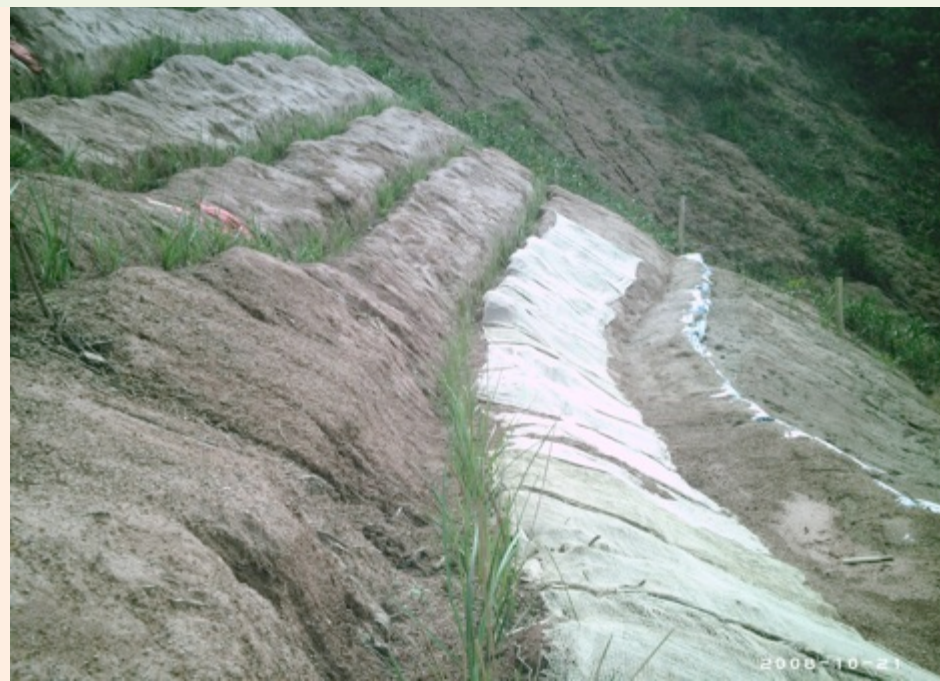
New planting overview

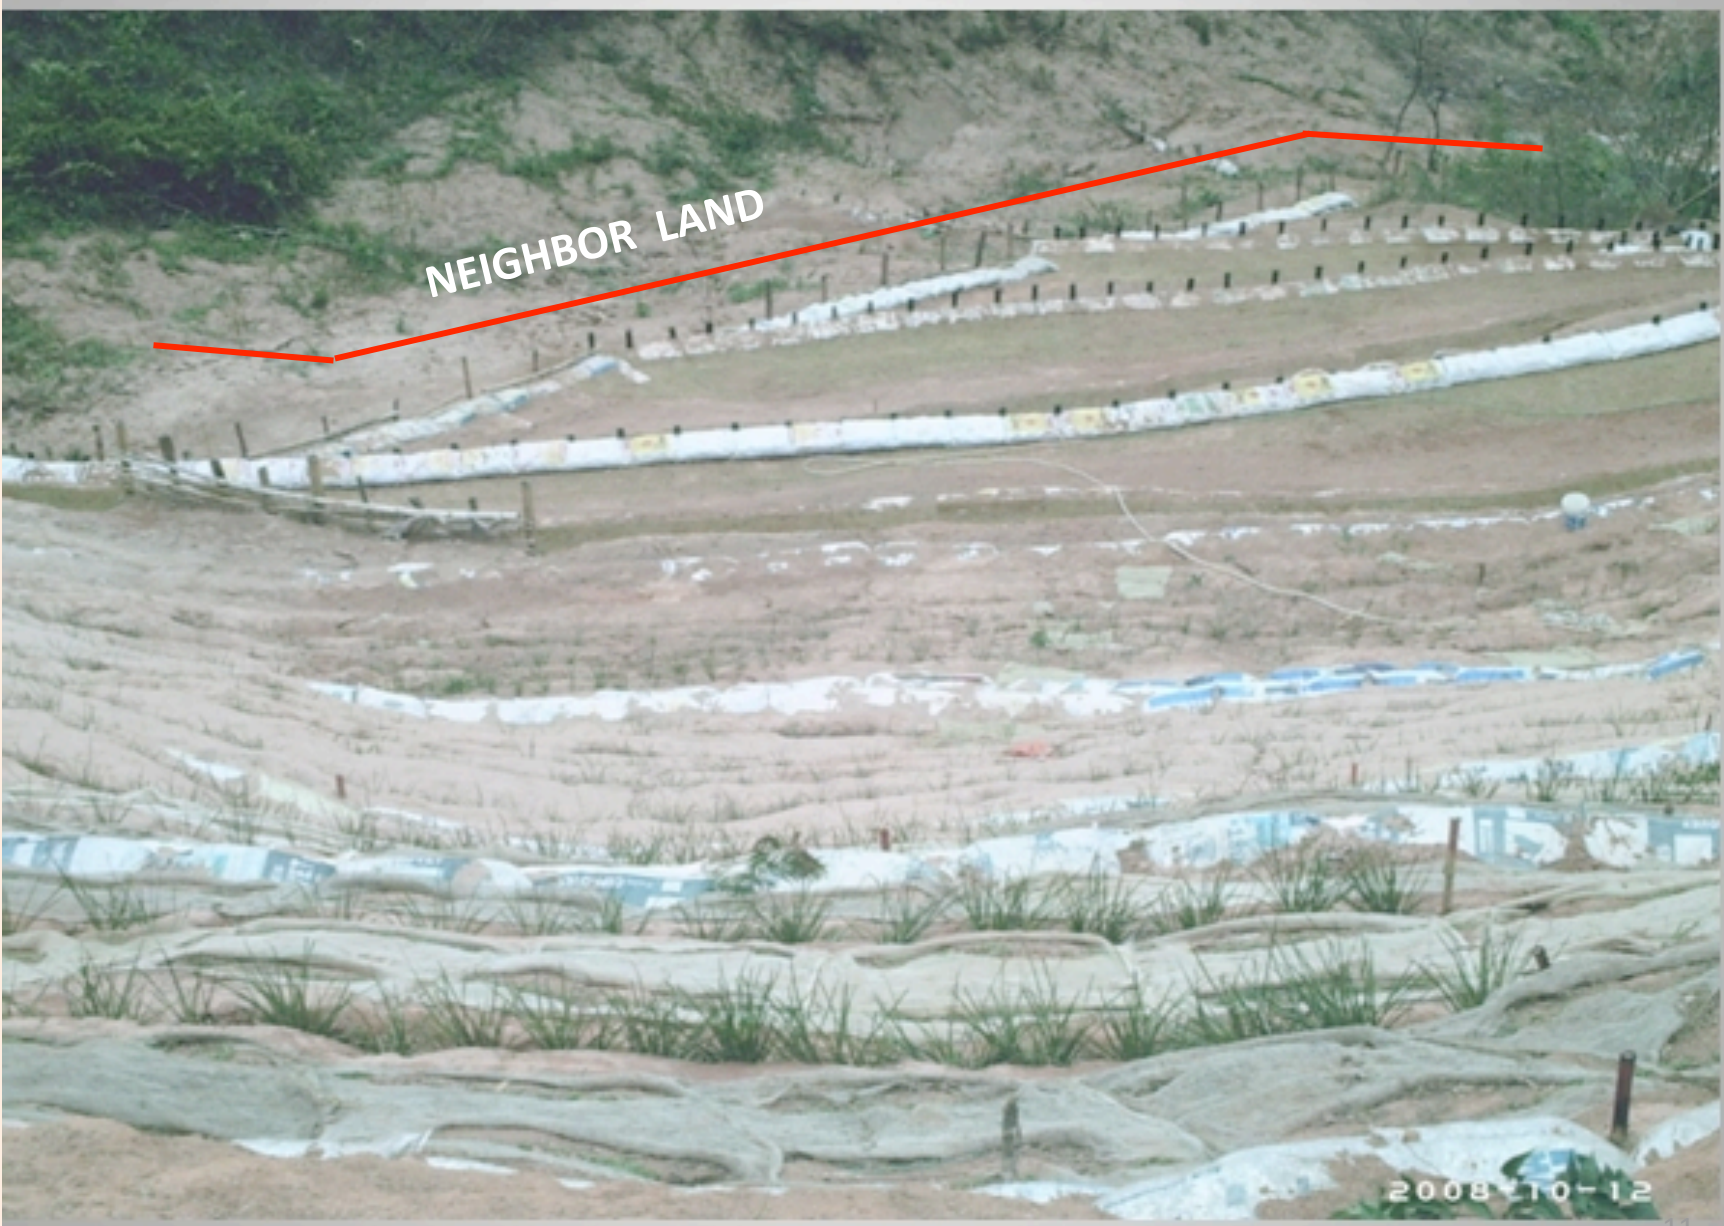
Steep slope planting overview

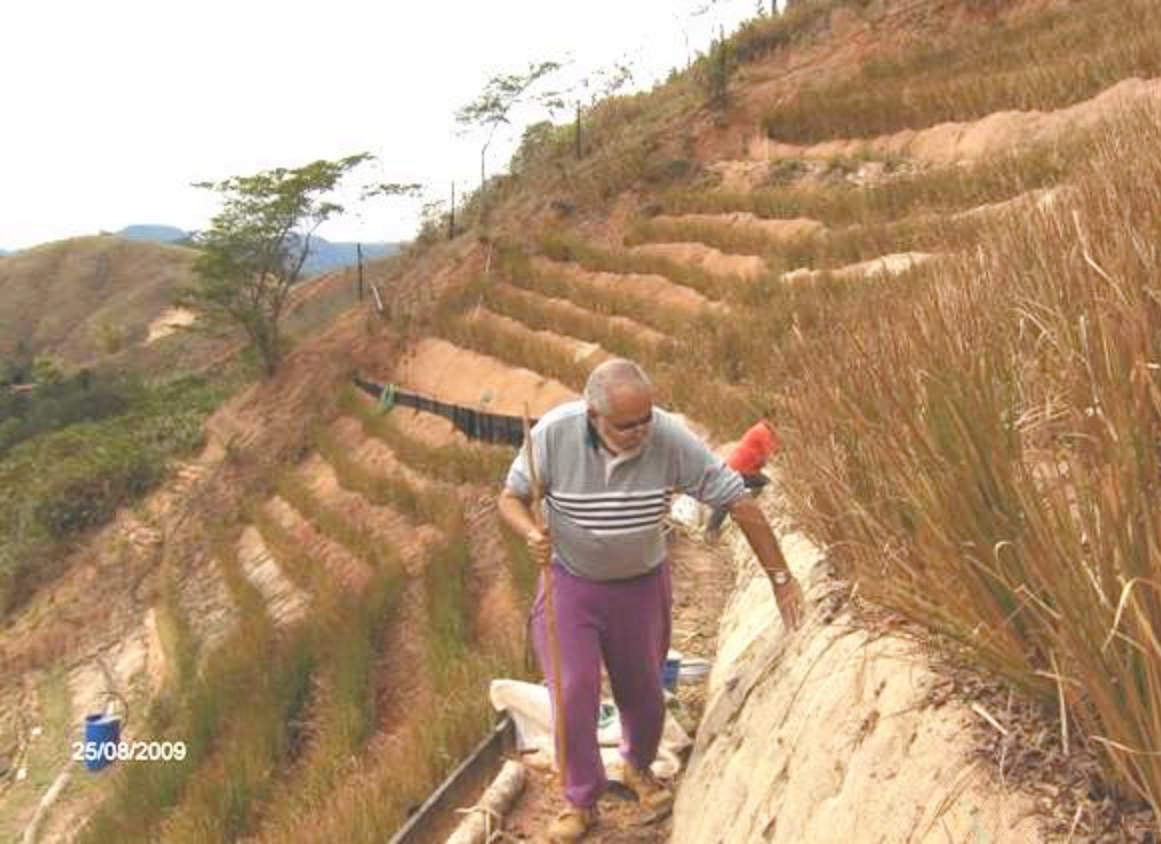
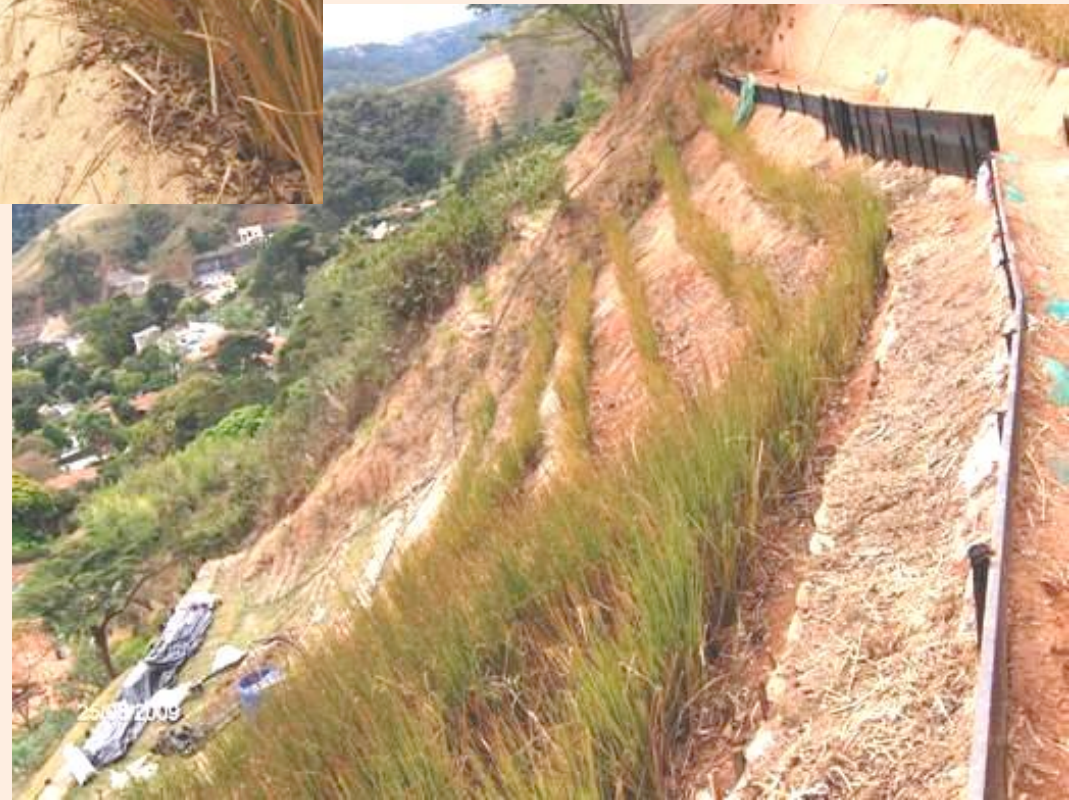
One year after planting

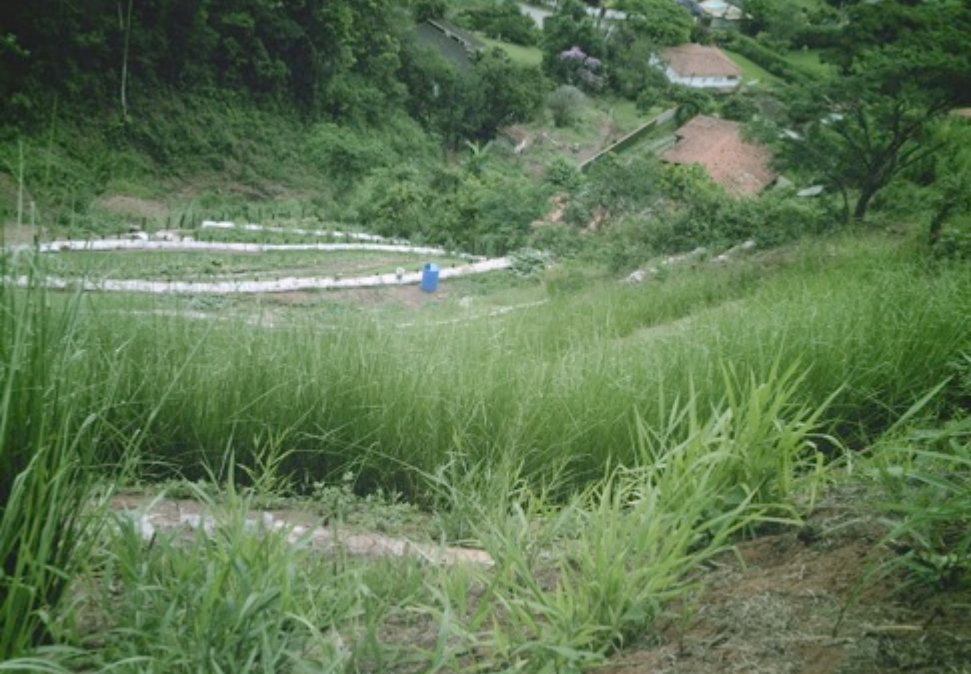
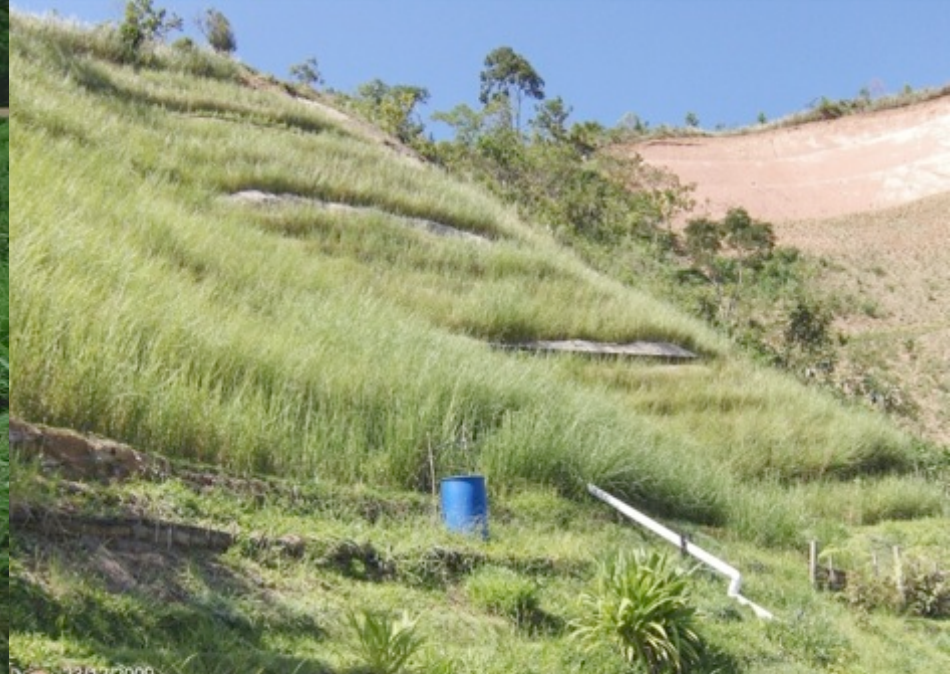
Three years after planting and withstood several intense storms

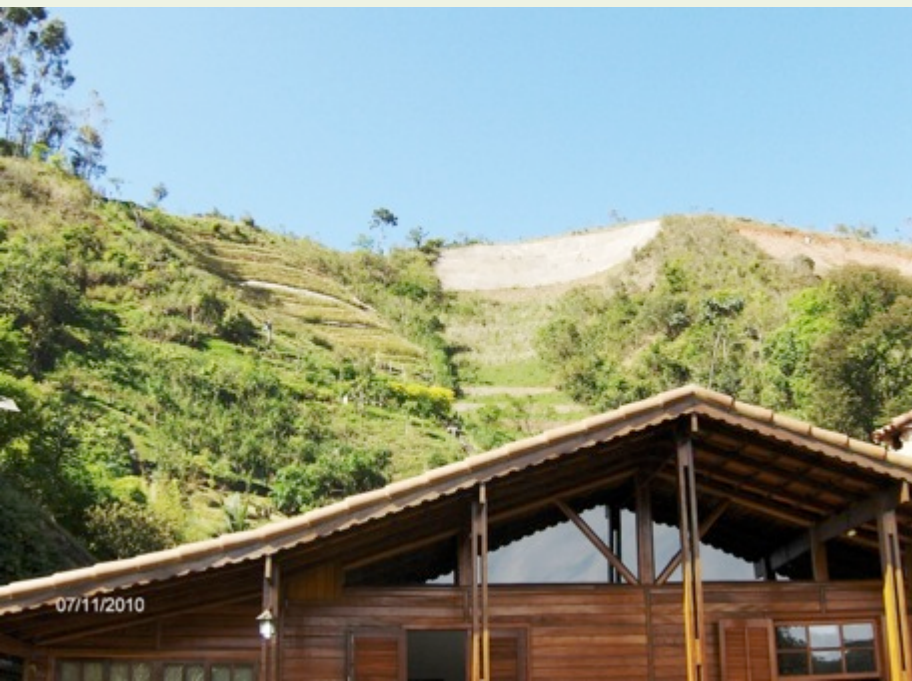
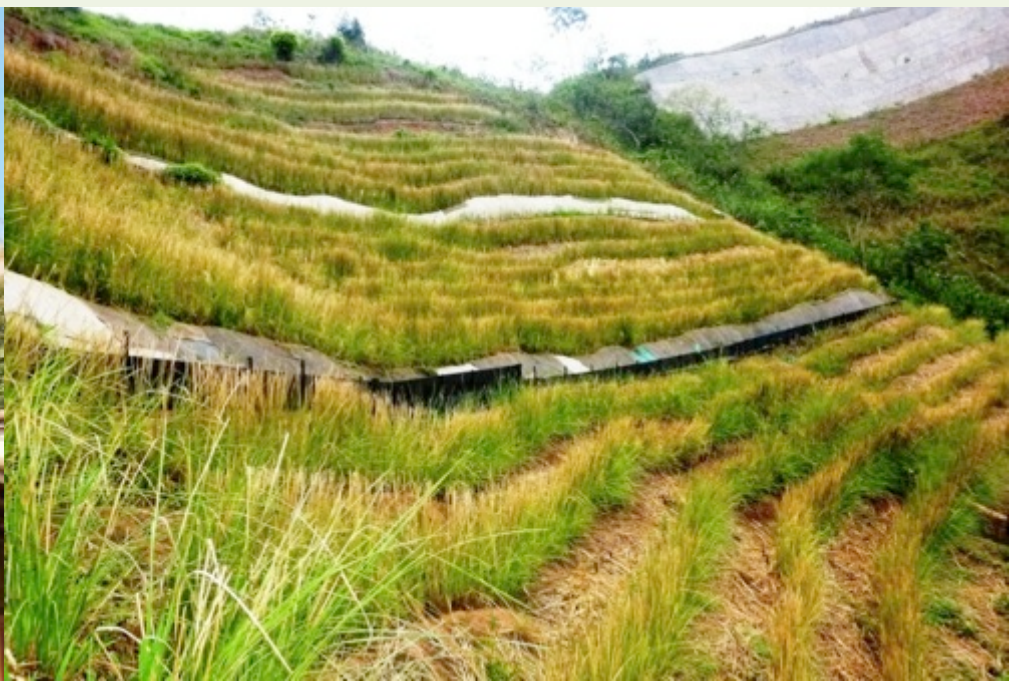
Supporting Materials: Logs from vetiver leaves

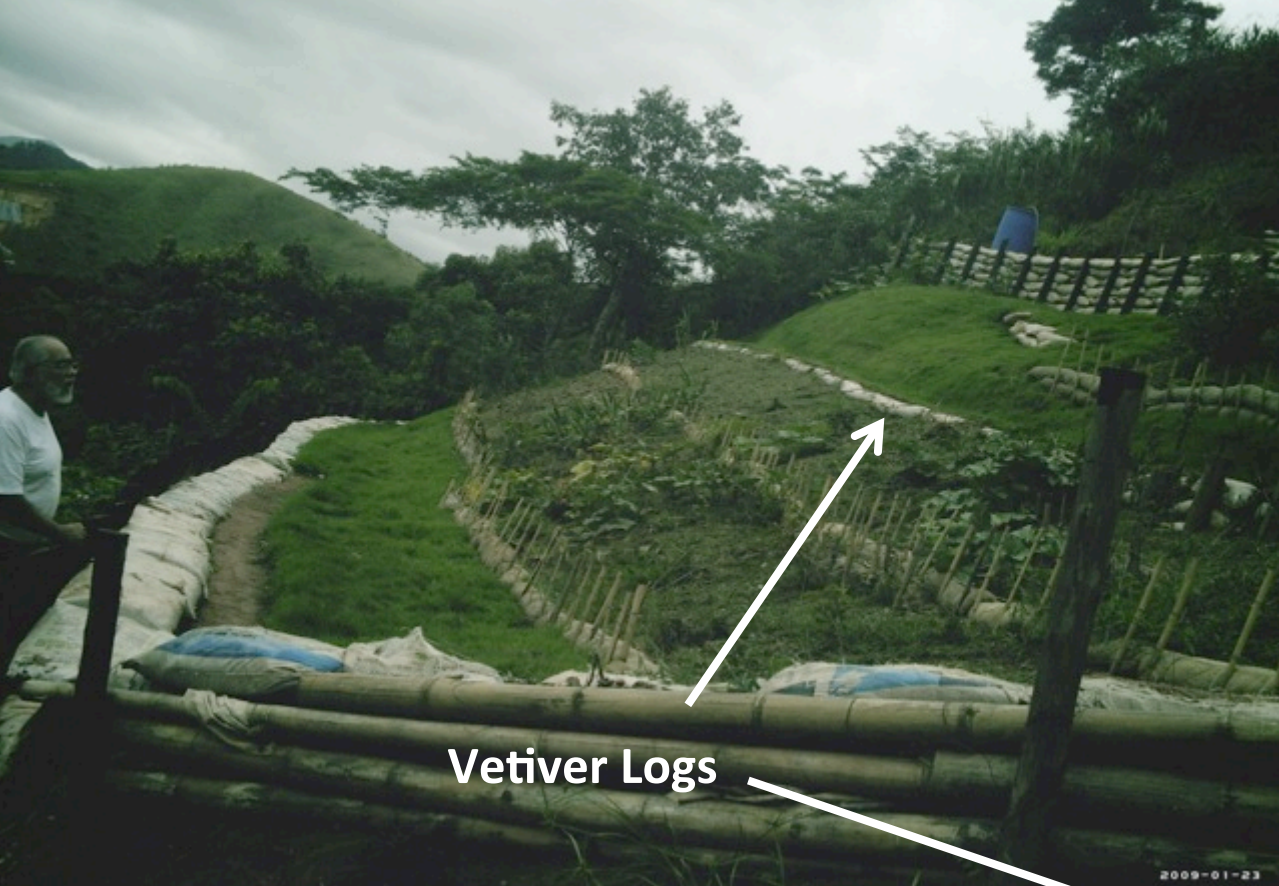
2009-01-23

Vetiver Logs

**Vetiver Logs
trapped
sediment and
enhanced
growth**

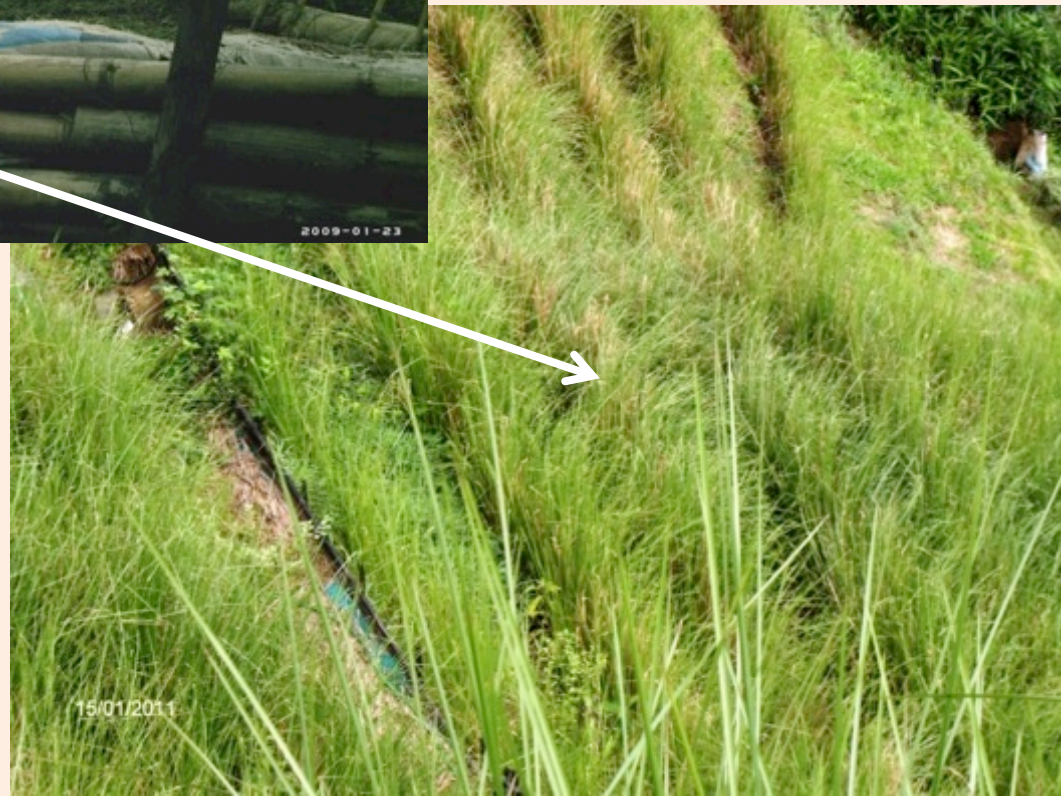
15/01/2011

Supporting structures: Terraces with soil bags

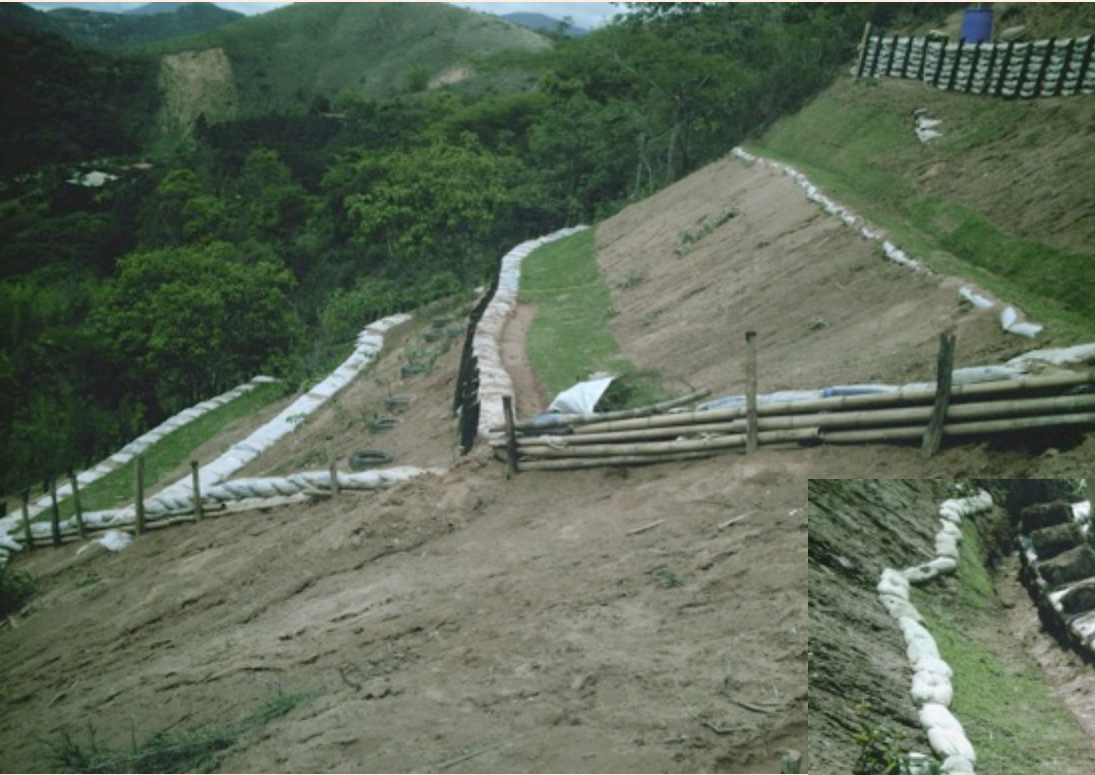
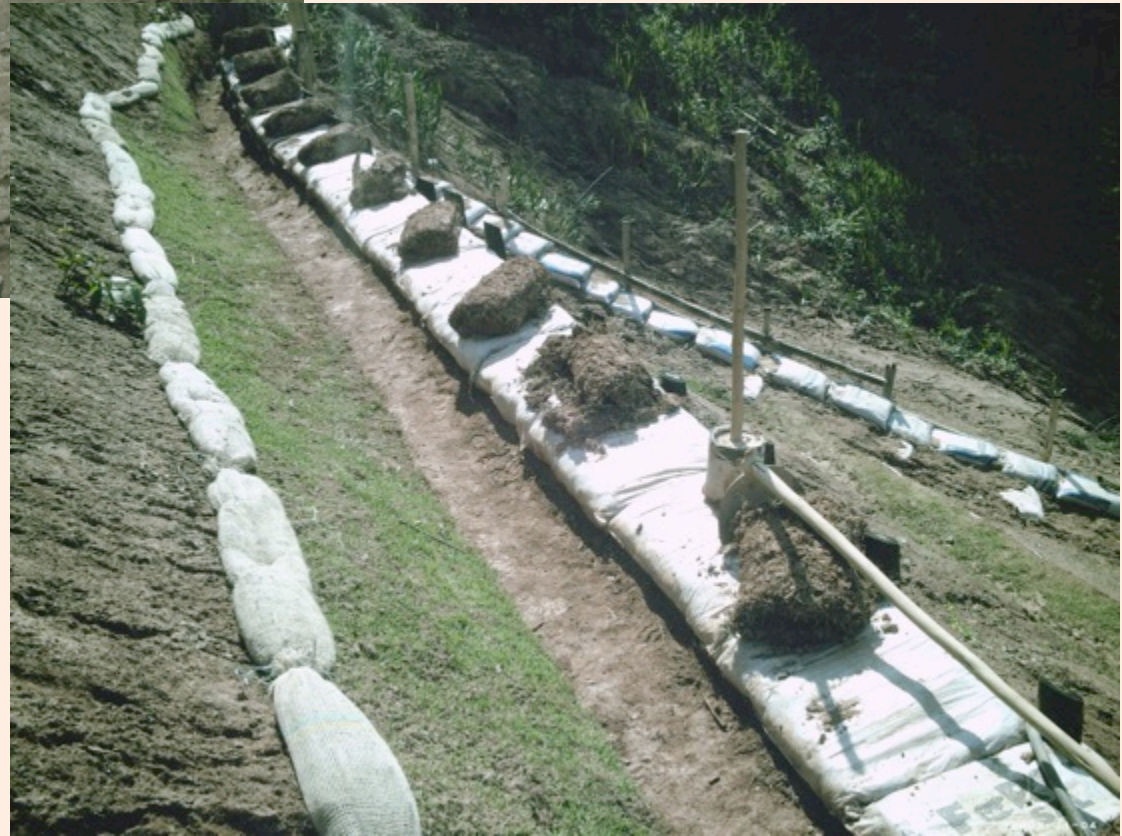
Supporting plants: Pintoi peanut to improve soil fertility

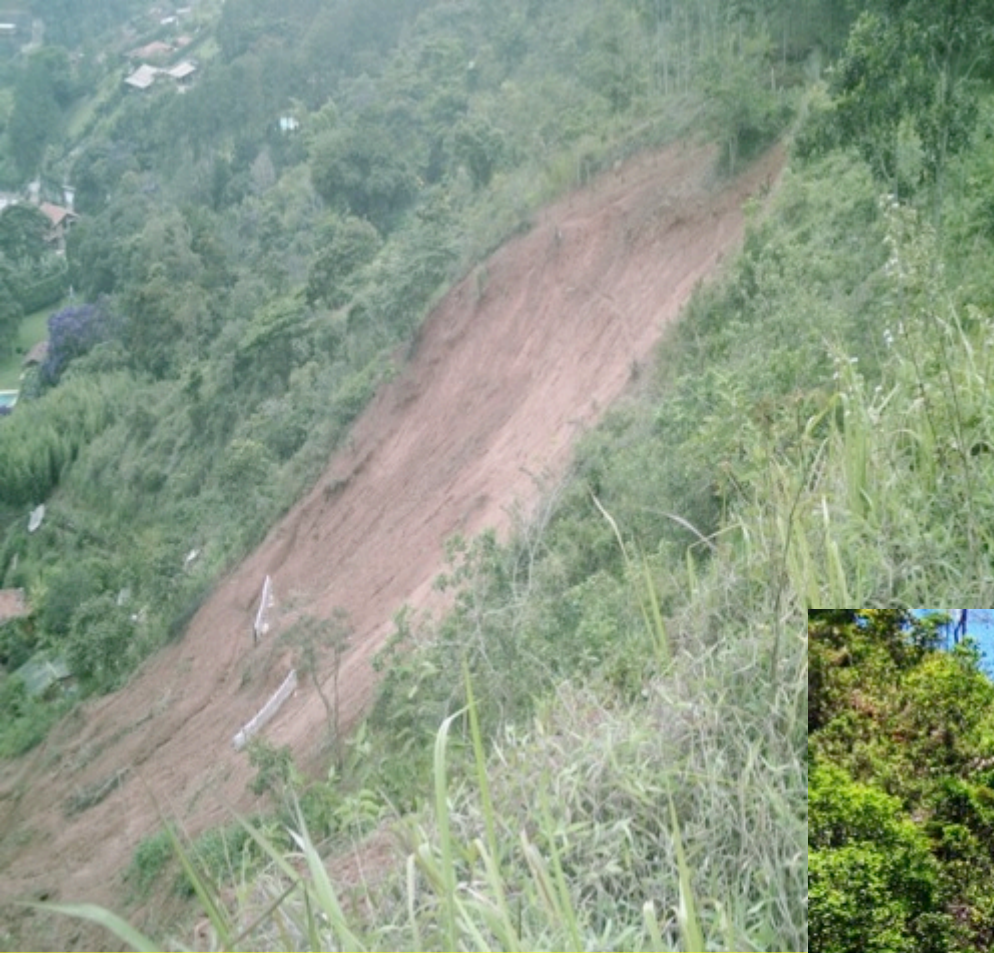
A green solution: Four years later

- After four years the slope has maintained its integrity demonstrating and proving that Vetiver grass can rehabilitate and maintain slopes affected by landslides.
- The use of VS for the stabilization of slopes not steeper than 1:1
- The VS will fail when not properly applied or not well maintained.
- The Vetiver when installed and following the correct technical guidelines is a guaranteed success
