Integration of Vetiver System within Conventional Erosion Control Technologies in Brazzaville, Republic of the Congo

Alain NDONA

ICV5, Lucknow, India, October 2011

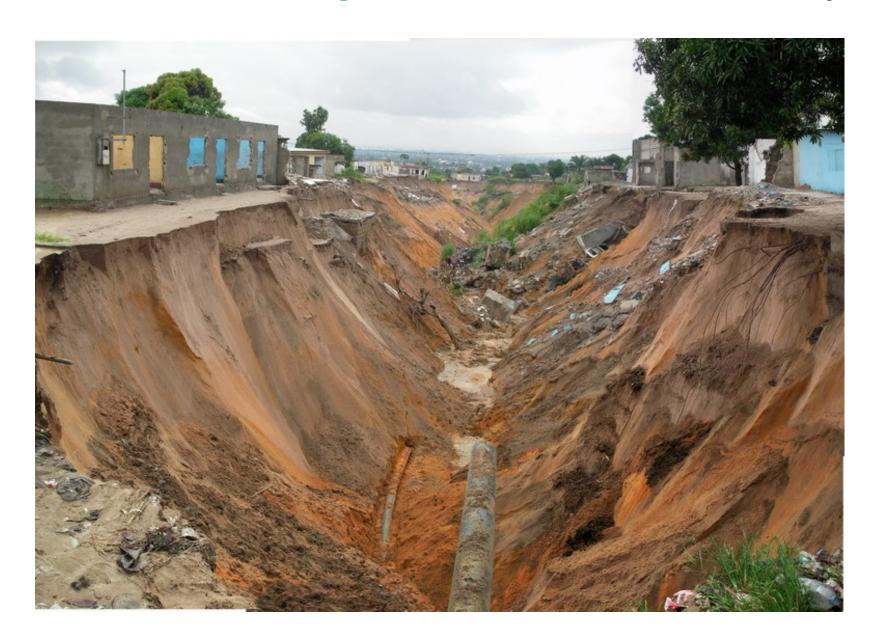
Some rainfall damages in Brazzaville: Boukeni Gully

Unfortunately, conventional engineering efforts to halt erosion progress have remained ineffective as the following pictures show.

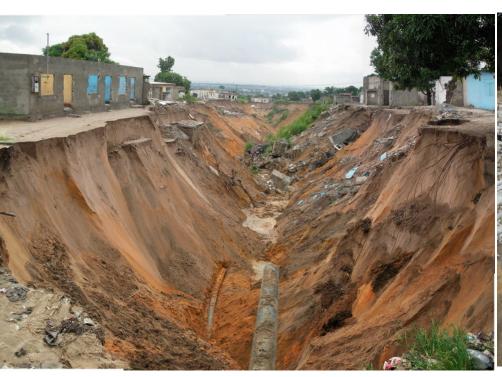
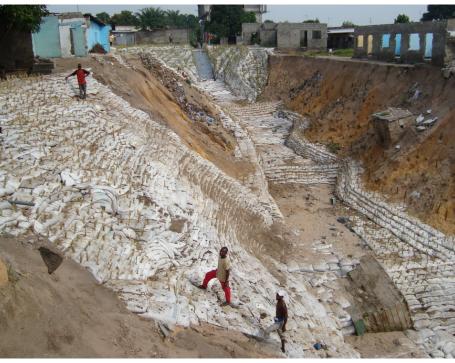
I. Boukeni site, February 2009

Initial status at the Boukeni ravine, before placing sandbags containing soil and planting vetiver

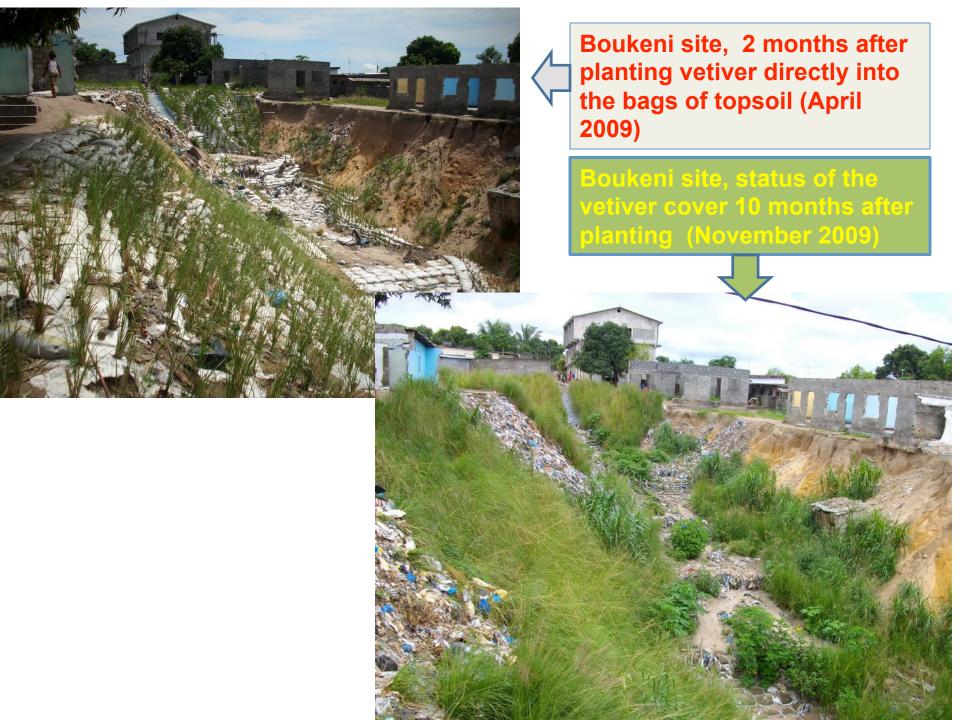
Placing bags containing topsoil and vetiver planting on the Boukeni site

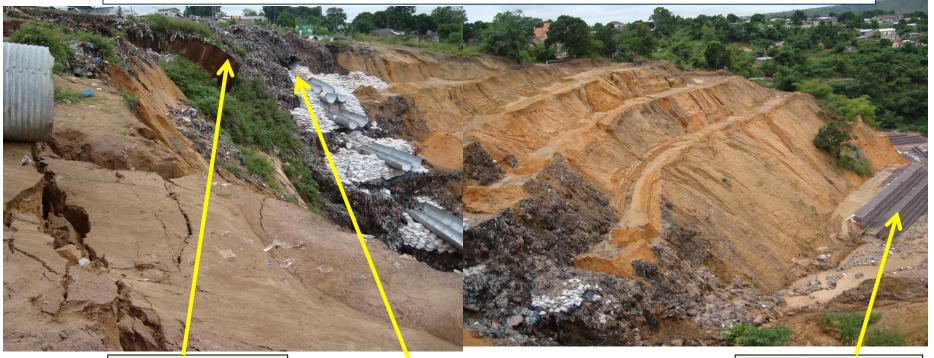
II. Casis site: Initial status, failure of certain conventional engineering techniques

Palplanche or sheet piling wall

Unprotected outlet

Gabion wall

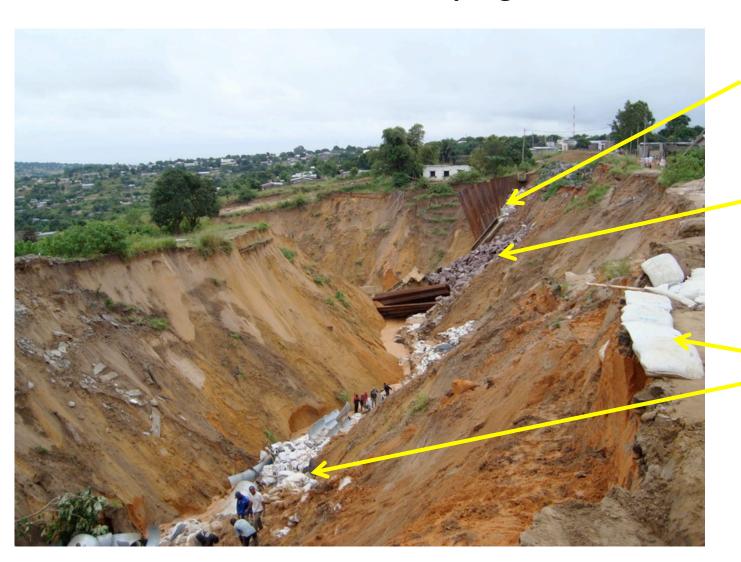
Failure of certain conventional engineering techniques:

Palplanches, rocky protection, soil bags, etc... were not efficient to halt erosion progress

Palplanche s or sheet piling wall

Rocky protection

Soil bags

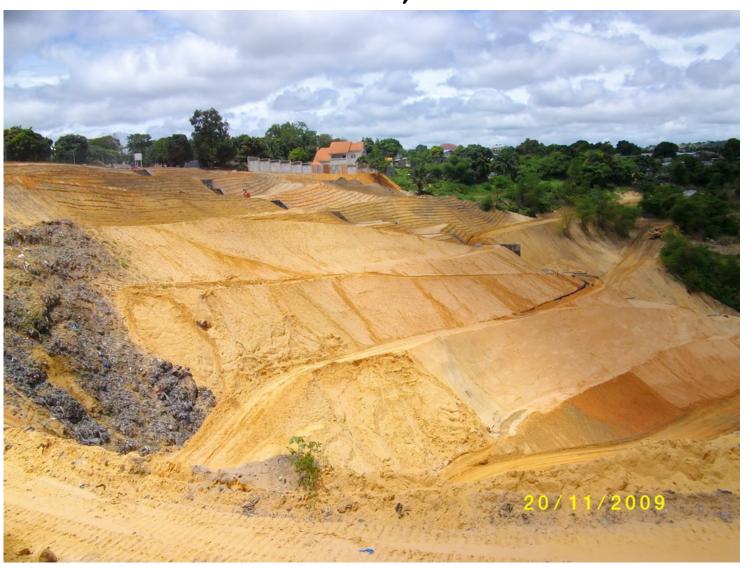
Gully slope reshaping and vetiver planting at the Casis site November, 2009

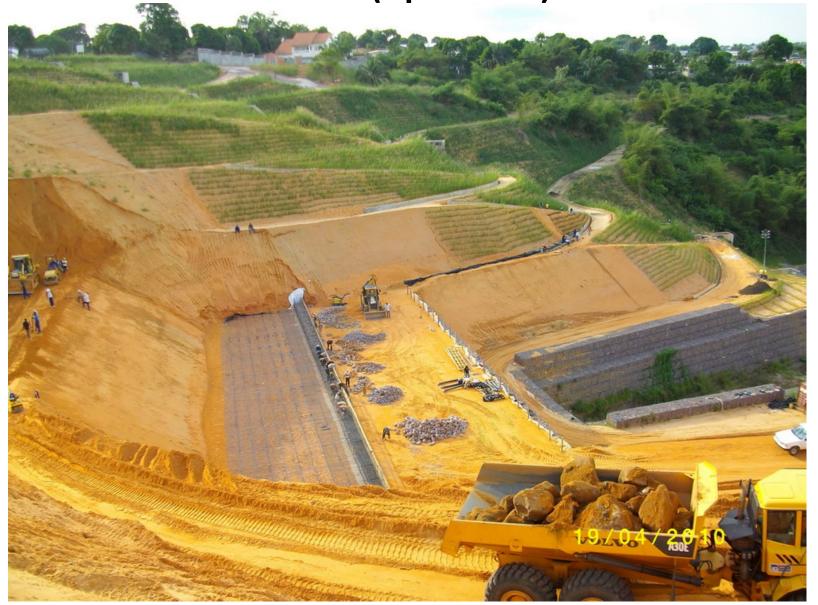
Casis site, five months after planting vetiver on part of the site (April 2010)

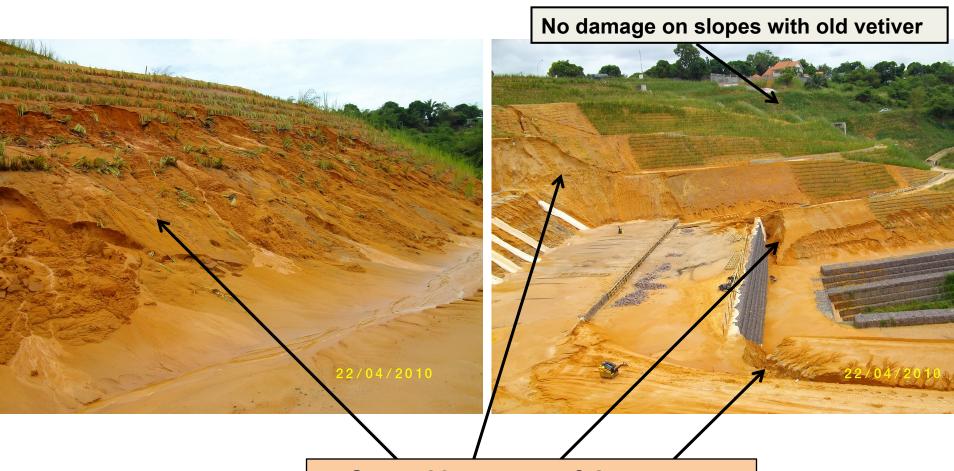
After rainfall events, the site has been damaged on several unprotected slopes and on slopes recently planted with vetiver, but no damage was seen on slopes protected with old vetiver.

Several instances of damage on unprotected slopes and on slopes recently planted with vetiver

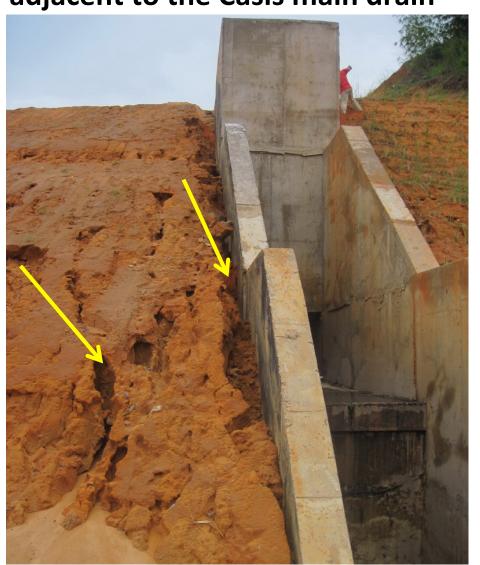
Therefore, close to the main drain, visible damage has been recorded on the unprotected slopes and embankments adjacent to the Casis main drain

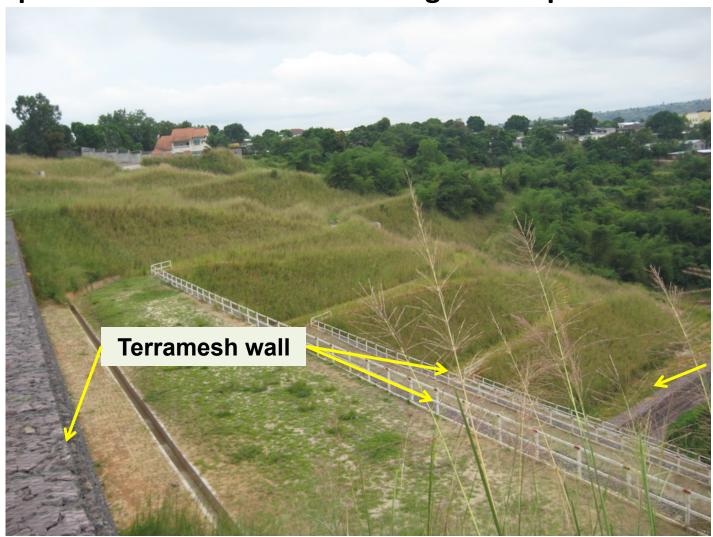
Casis site 17 months after planting vetiver:

Completely stabilized and no damage has been recorded despite of record rainfall exceeding 70 mm per rain event

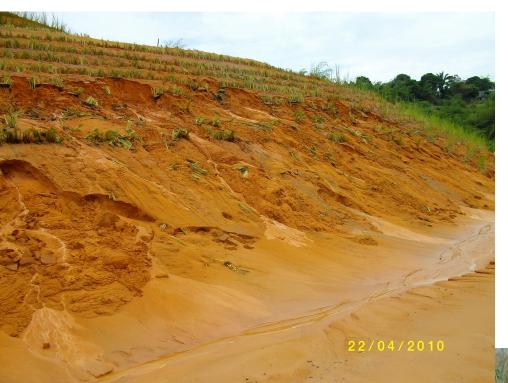
Comparison status

The same place one year later, well established vetiver grass and no damage was seen, despite of record rainfall exceeding 70 mm per rain event

Damage was recorded during rainfall events, before vetiver was growing on the slope

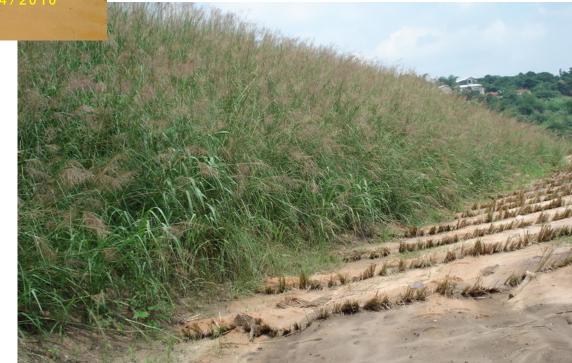
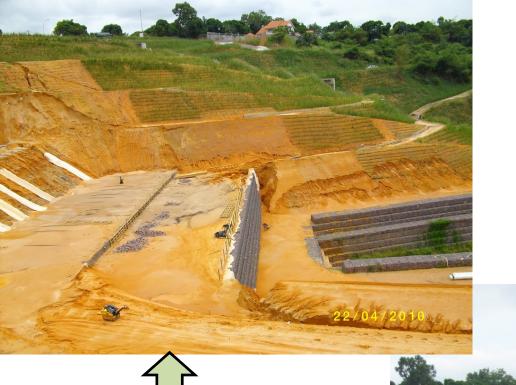
Comparison status

The same place one year later, well established vetiver grass and no damage was seen, despite of record rainfall exceeding 70 mm per rain event

Damage was recorded during rainfall events, before vetiver was well established on part of the slopes

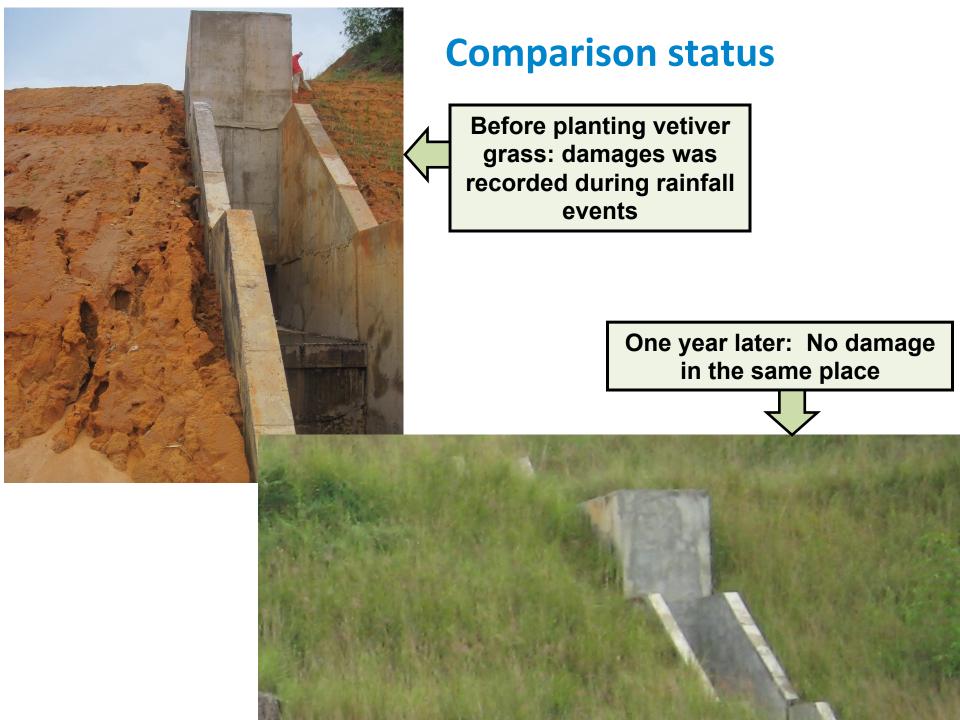
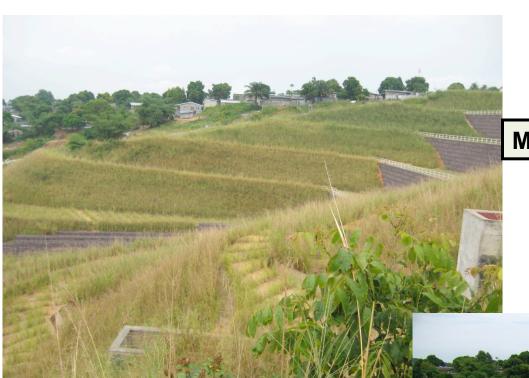
Comparison status as seen from afar

May, 2011

April, 2010 22/04/2010
