COASTAL EROSION CONTROL AND LANDSCAPING USING VETIVER GRASS

Luiz Lucena*, Paula L. Pereira** and Debora T. Assis***

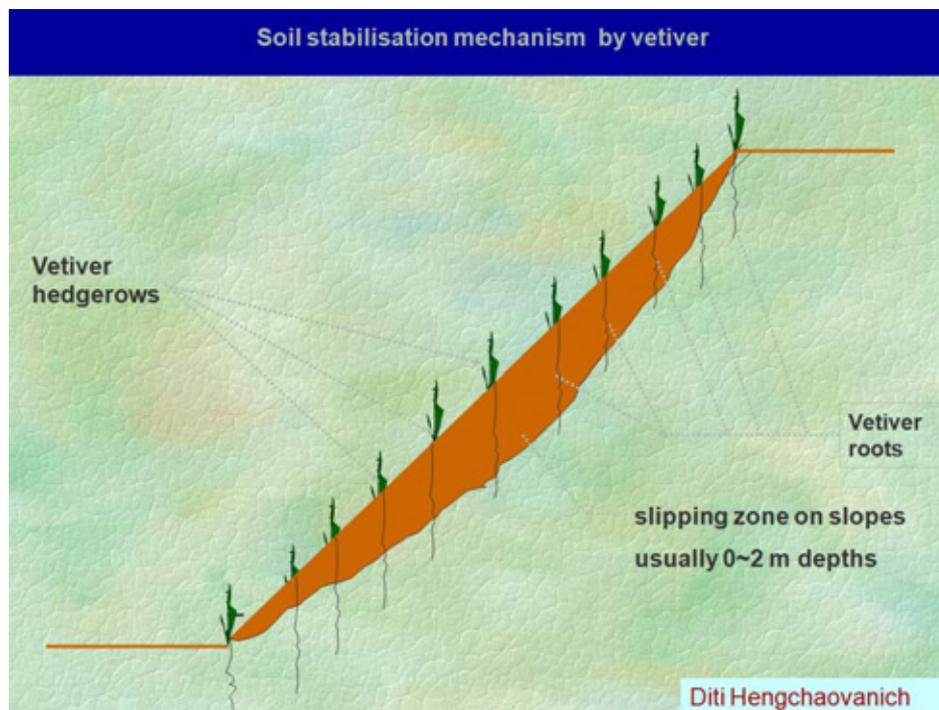
Figure 1: Soil stabilization mechanism by Vetiver
Source: Diti Hengchaovanich

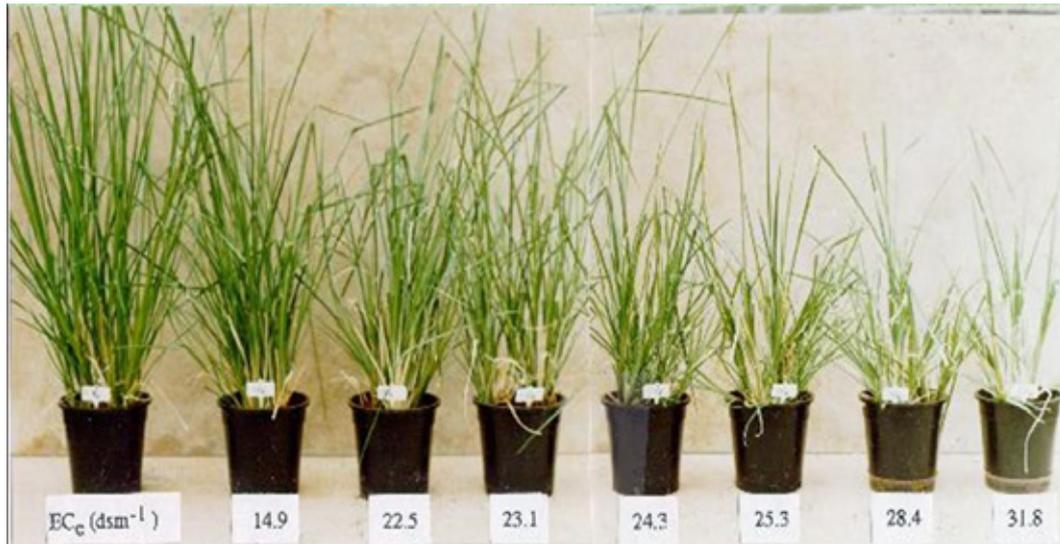
Figure 2: Vetiver tolerance to salinity.
Source: Paul Truong

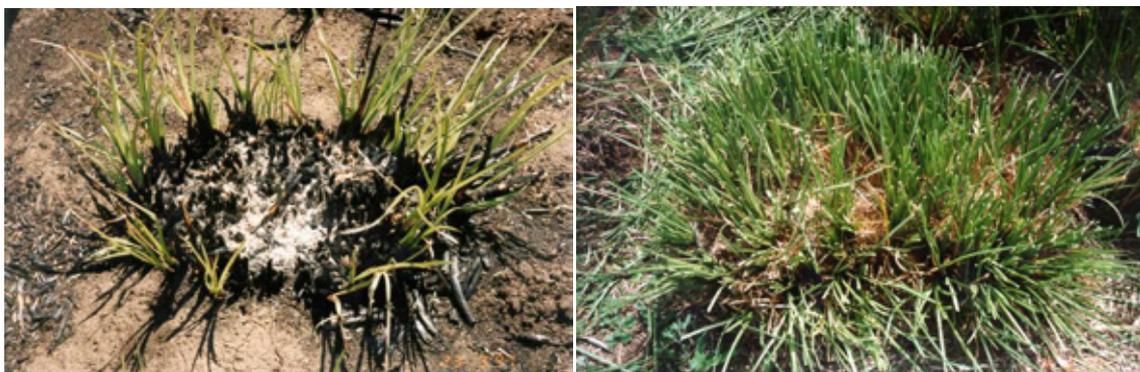
Figure 3: Vetiver tolerance to fire
Source: Paul Truong

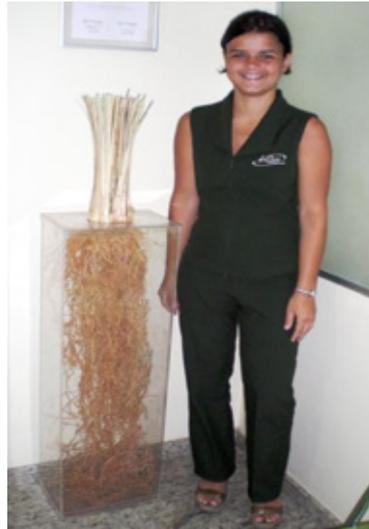
Figure 4: Roots of a young dehydrated Vetiver Grass compared to a 1.60 m tall person.
Source: Deflor bioengineering / Luiz Lucena.

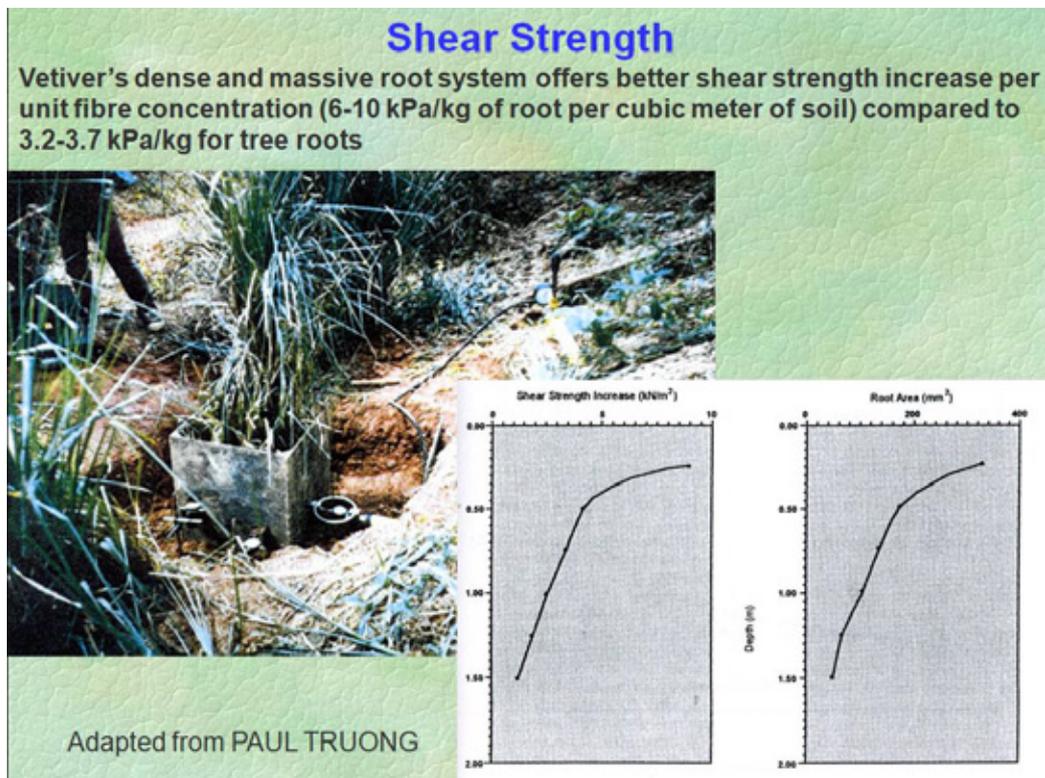
Figure 5: Vetiver shear strength resistance.
Source: Paul Truong

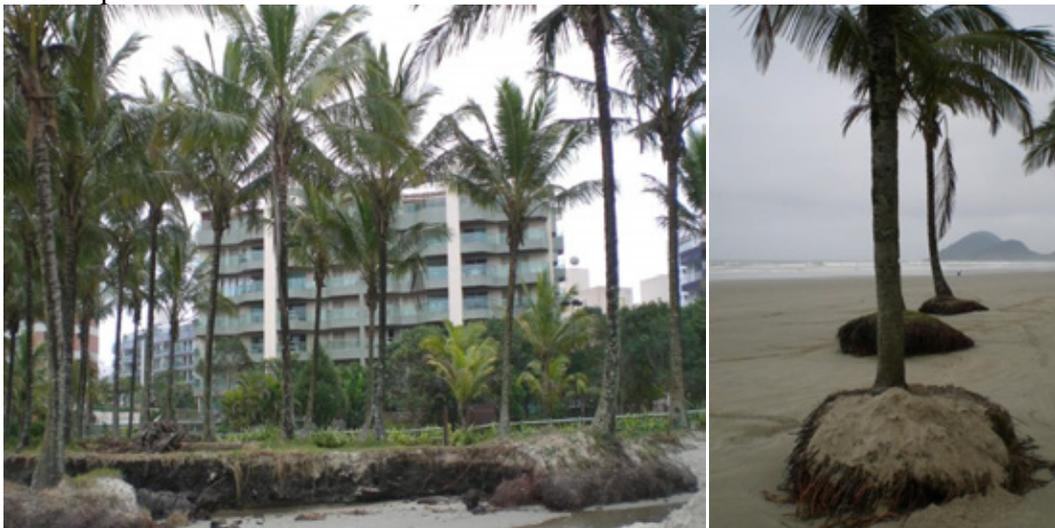
However, this procedure was not efficient to promote soil protection and stability. During the storm surge that occurred in the years 1995 to 1997, sweet grass’ root system of was not deep or resistant enough to protect soil against surf and the impact of waves during high tides, resulting in the undermining of the embankment formed by *Jundu*, as can be seen in Figure 9. Several coconut trees fell down and a severe erosion process was evidenced.

Figure 8: Coastal erosion caused by storm surges and tidal changes.

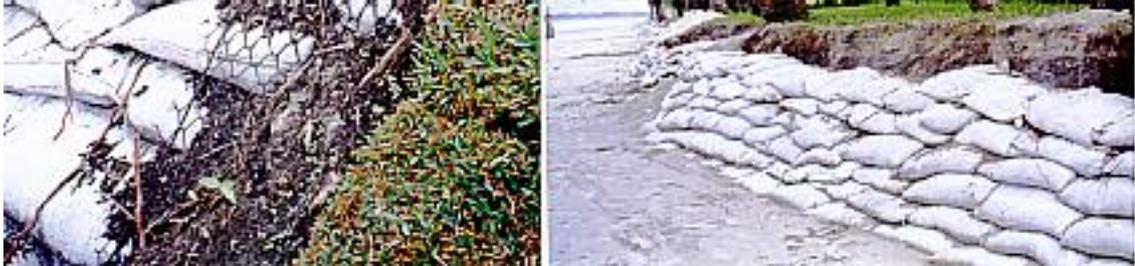
The initial solution set in 2008 was to build a rip rap using raffia bags previously filled with a mixture of soil-cement in the proportion of 12% cement and 88% soil extracted from the vegetation removal stage. The bags were conveniently

arranged in the shape of pyramid and covered with a geogrid - high density polyethylene extruded plastic screen to minimize the effects of wave breaking and allowing the deposition of sand from the return of the waters in which the new vegetation was planted, resulting in an enhanced carpet and homogeneous surface ensuring stability, Figure 10.

Figure 9: raffia bags to resist surf erosion.

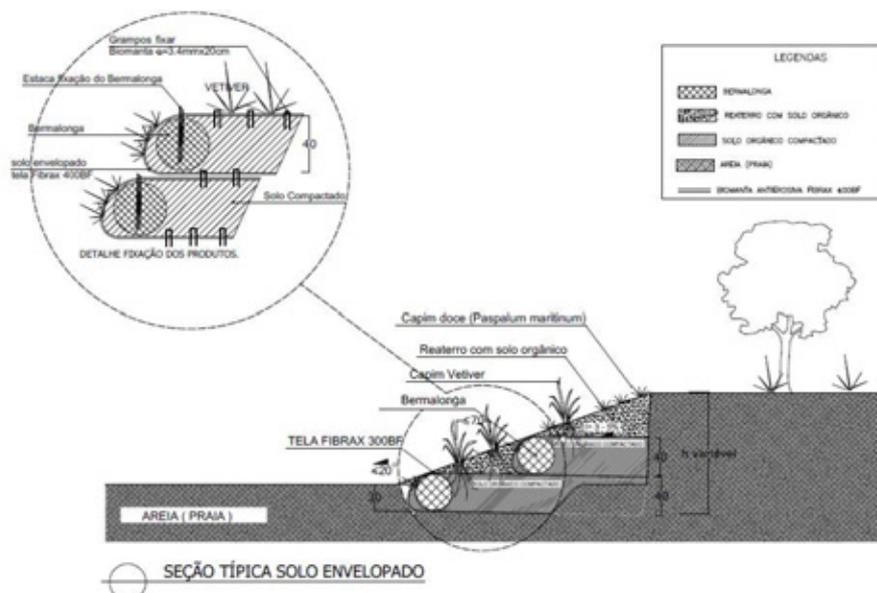
Initially it consisted in the construction of the slopes with the original geometry (1:3), using soil rapping reinforcement, sediment retainers (Bermalonga / wattles) to guarantee soil anchoring and filtering of water flows from and to the ocean and Vetiver Grass to work as energy dissipaters. Figure 10.

Figure 10: Project concept.

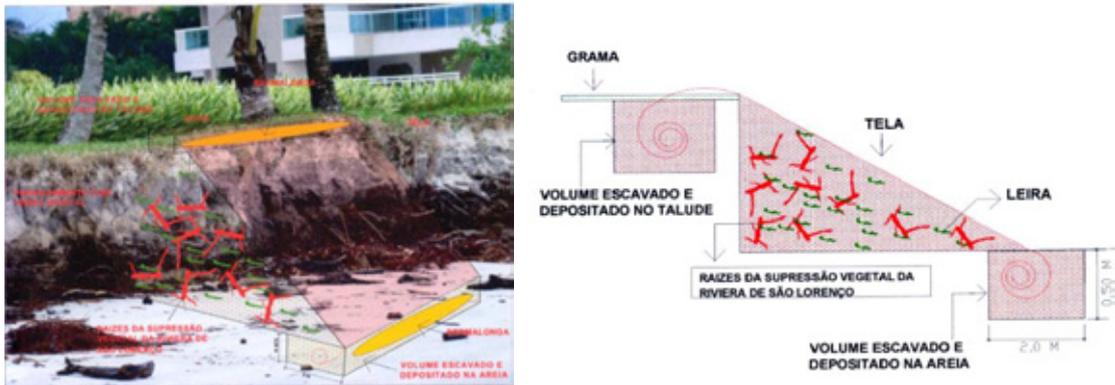
Figure 11: Schematic representation of the slopes of the project being developed.
Source: Gaia Environmental Consulting

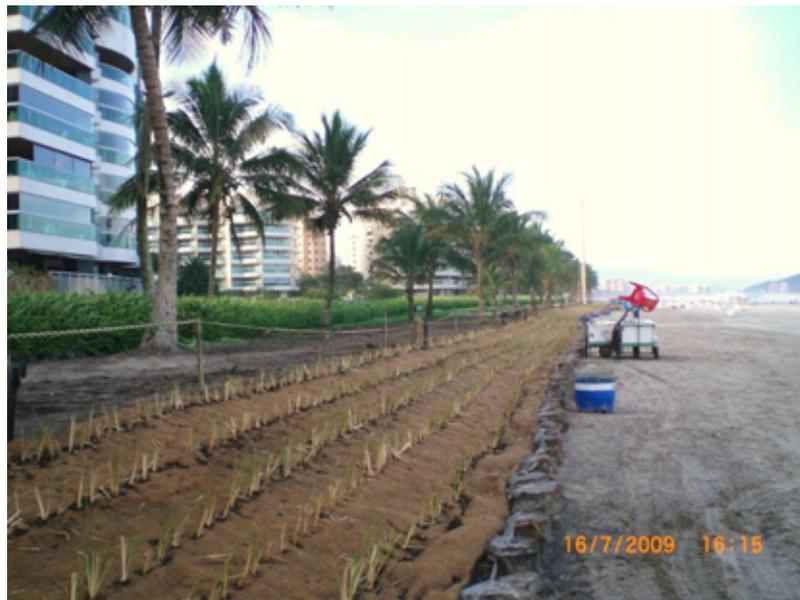
Due to the concern regarding to a possible increase in the sea level in the near future, designers decided to add a wood palisade separating the sand from the landscaping area in order to increase security factor of the structure. The palisade was designed to use part of the wood stored during development of the urbanization project and the slopes incorporated biomass that was also stored and had to be used within the limits of the project and could not be burned according to Brazilian environmental regulations (DPRN Authorization No. 29/2005). Figure 12.

Figure 12: Final Project executed: palisade, erosion control blanket and Vetiver hedgerows.
Source: Luiz Lucena.

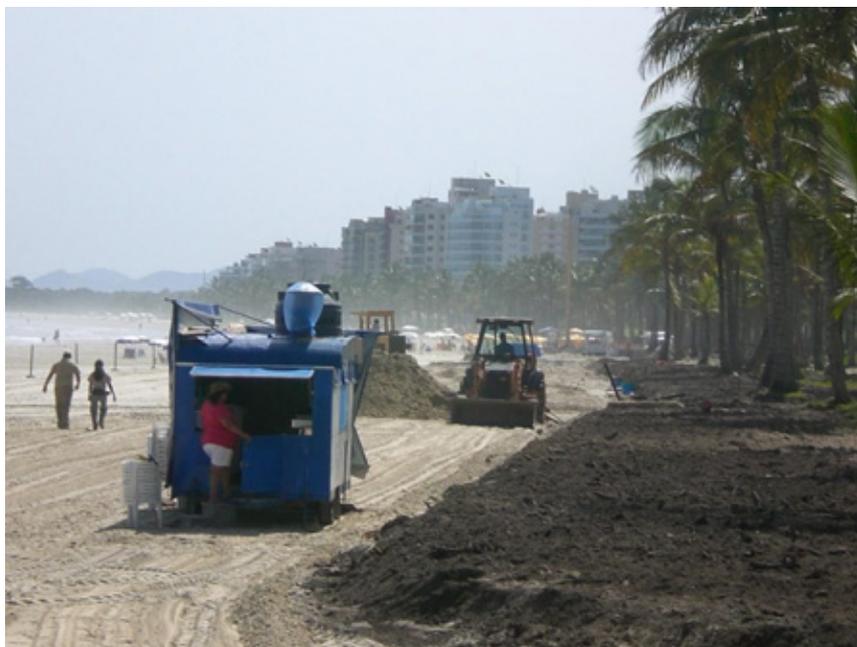
The first stage of the project, held by the Association of Friends of the Riviera de Sao Lourenco was the site preparation through the construction of the trench, palisades and deposition of organic material using heavy machinery such as hydraulic backhoe and bulldozers, as shown in Figure 13.

Figure 13: Preparation of land with the deposition of organic material.

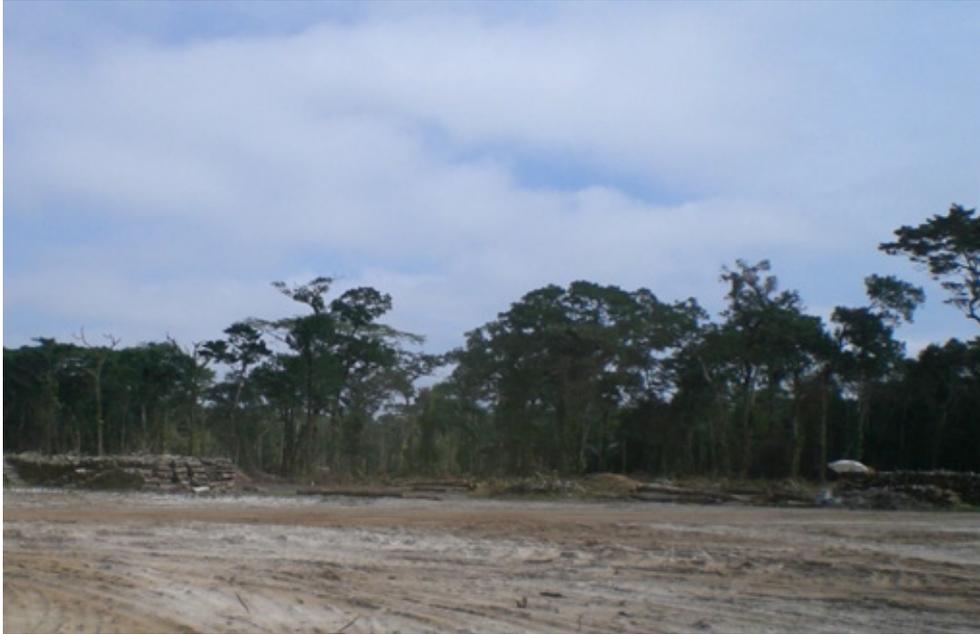
Figure 14: Storage of material from deforestation process.

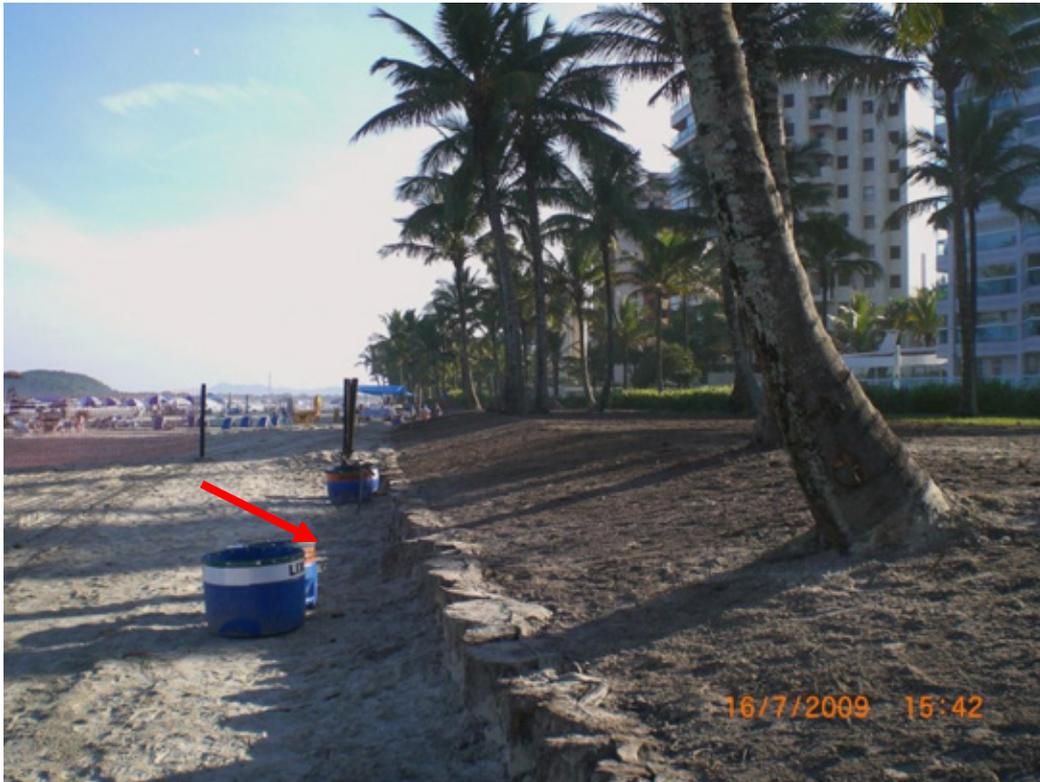
Figure 15: Detail: palisade and slope ready for erosion control blanket installation.

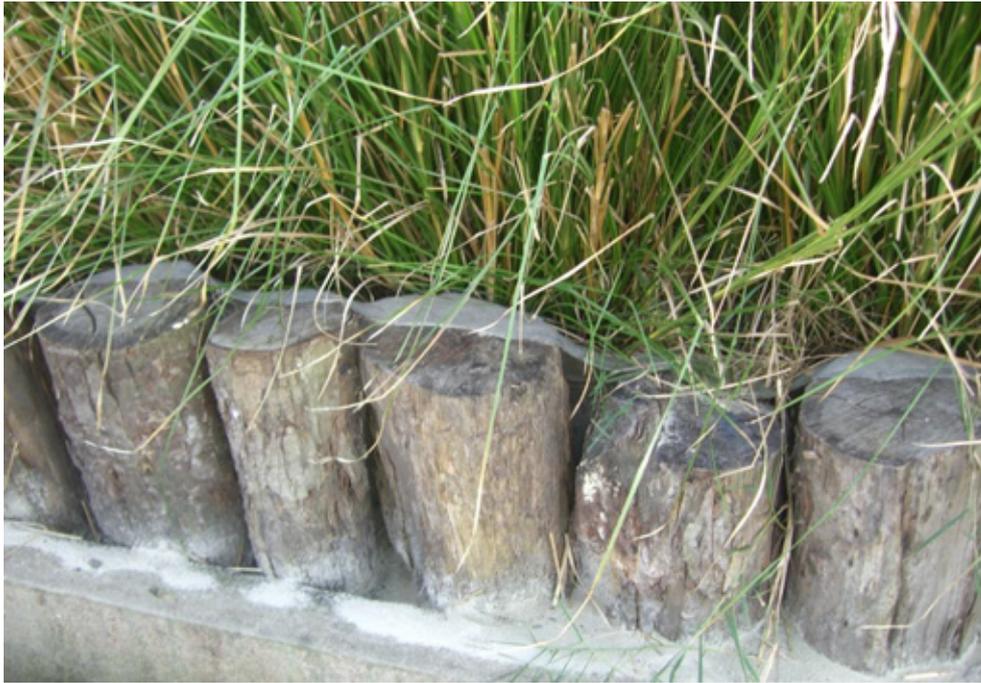
Figure 16: Detail: palisade, geotextile and Vetiver.
Source: Luiz Lucena

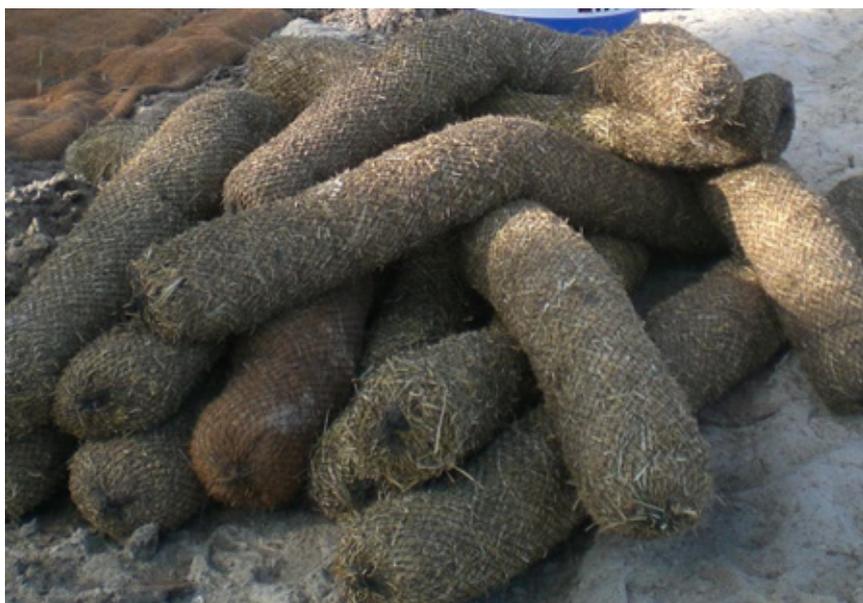
Figura 18: Sediment retainers 0,30 m diameter - Bermalonga[®] D30
Source: Luiz Lucena

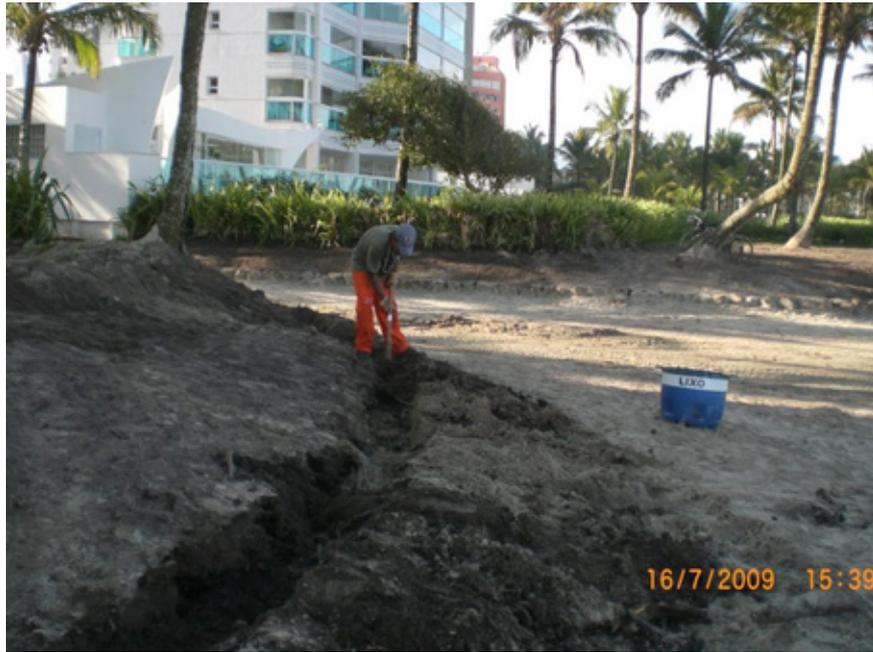
Figure: 19: Trench excavation for sediment retainer installation.
Source: Luiz Lucena

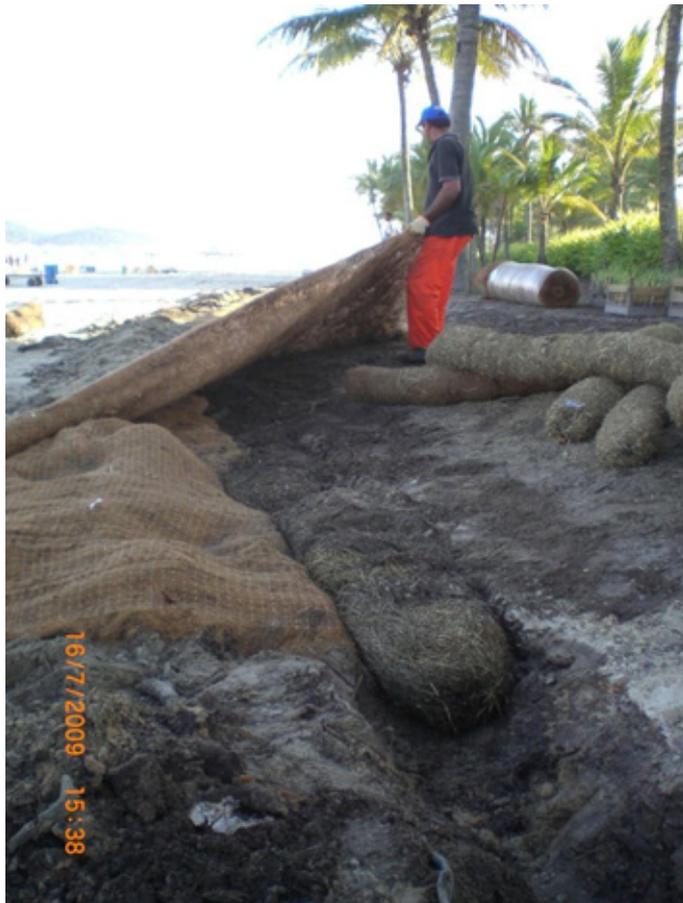
Figure: 20: Installation of erosion control blanket..
Source: Luiz Lucena

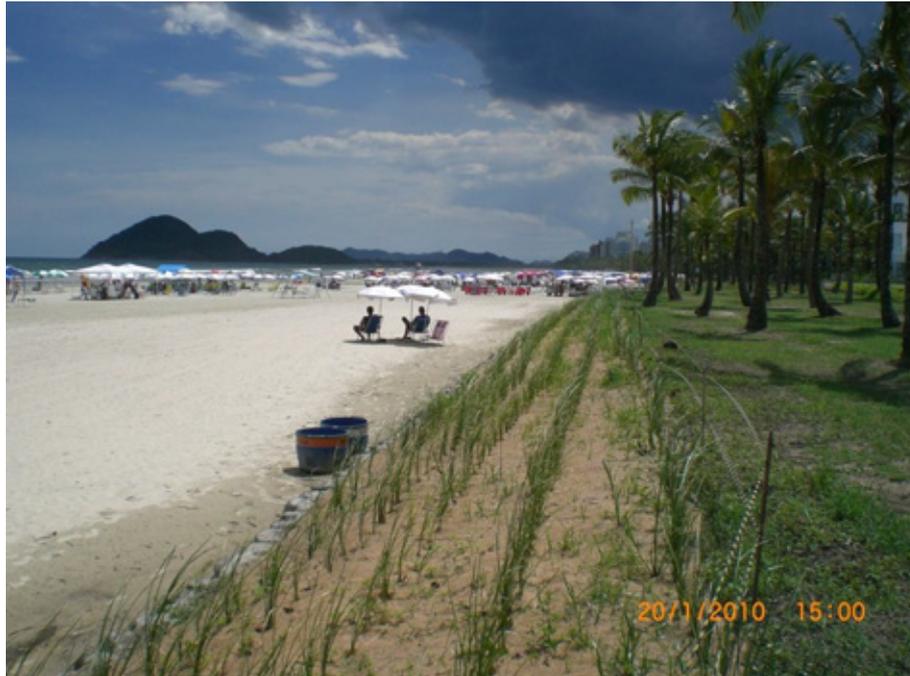
Figure: 21: Beginning of Vetiver development.

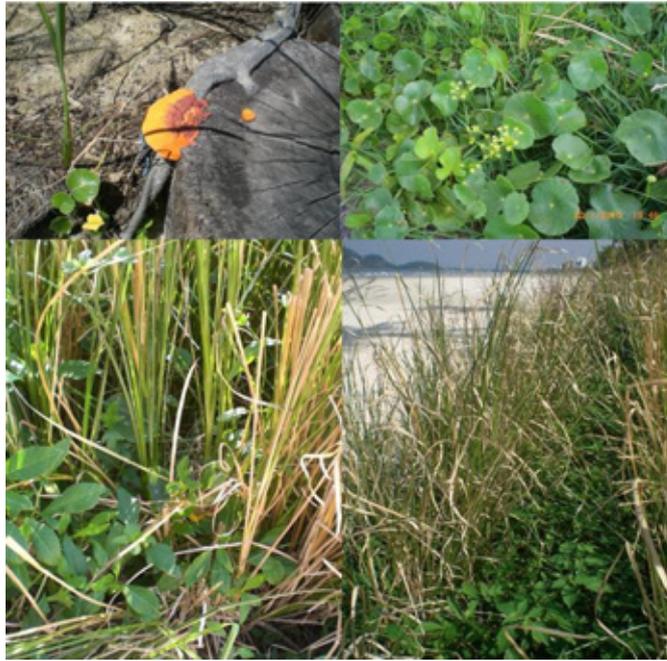
Today, after two years of the initial phase of this restoration project, there is the occurrence of recolonization of native vegetation of herbaceous and grasses and also species of fungi, which shows the quality of the recovery process of the site, with soil biodiversity and stability (Figure 22).

Figure: 22: Recovery quality indicators: fungi and several species from native Jundu.
Source: Luiz Lucena

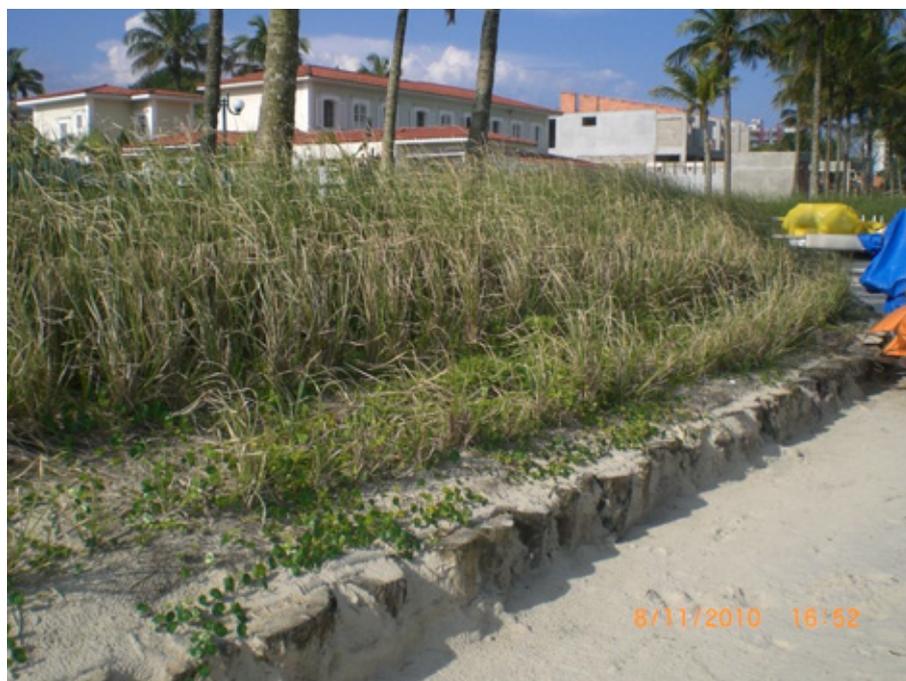
The highest tides in Brazilian coast occur usually during the months of August and September. In September 2009, there were some sea storm surge events, leading to strong surf and wave hitting the system just one month and fifteen days after completion of installation part one. The consequence of this natural phenomenon was that the first Vetiver hedgerow was bent and recovered without maintenance.

Figure: 23: First Vetiver hedgerow bent after strong surf and wave hit.
Source: Luiz Lucena

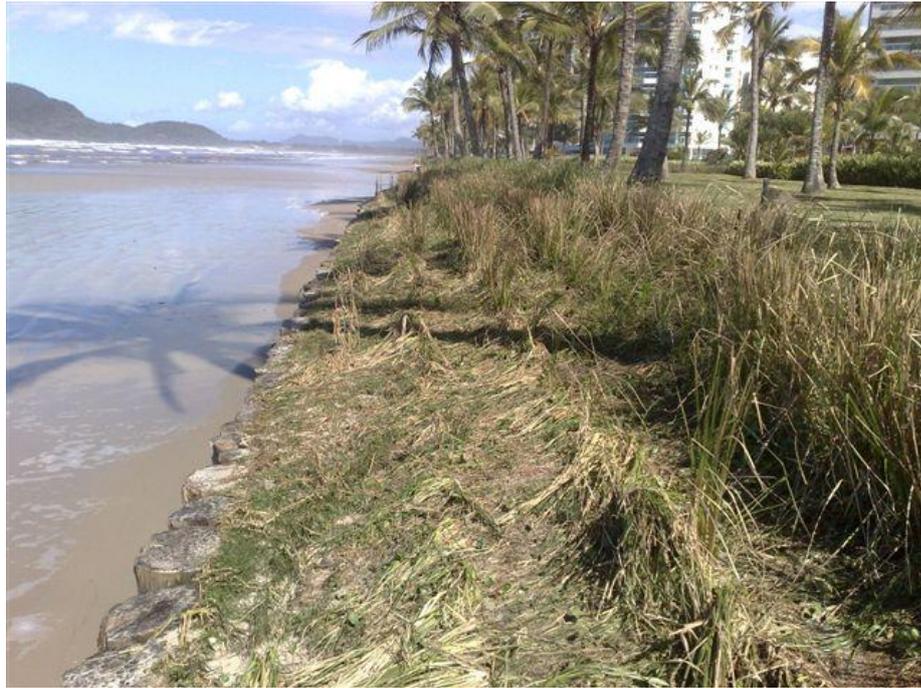
Figure: 24: First 3 Vetiver hedgerows at the worst spot where wave hit and no soil loss observed.
Source: Luiz Lucena

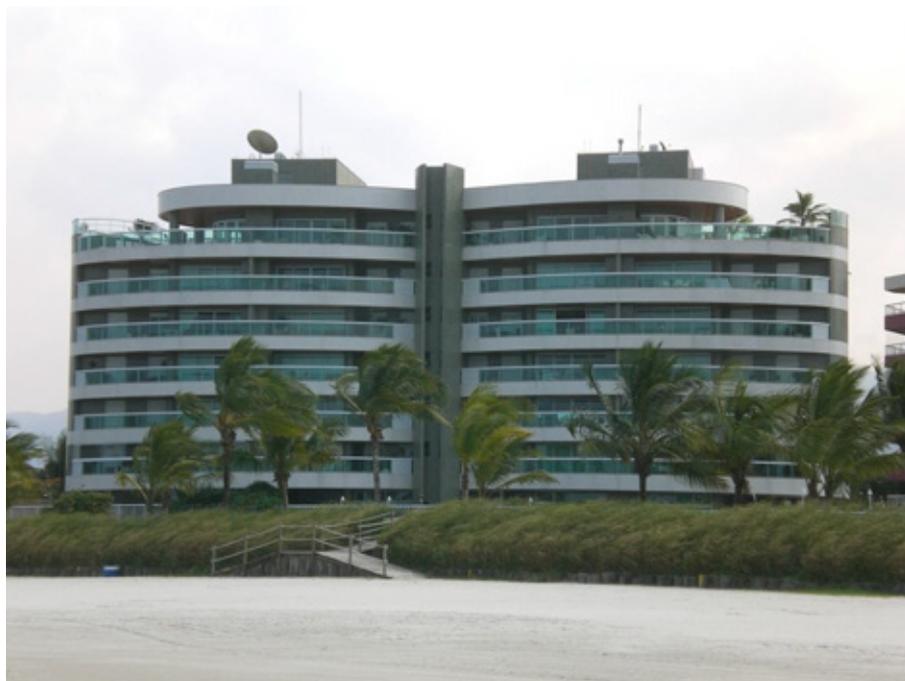
Figure: 25: Frontal view of the beach showing Vetiver completely integrated to landscaping.
Source: Luiz Lucena

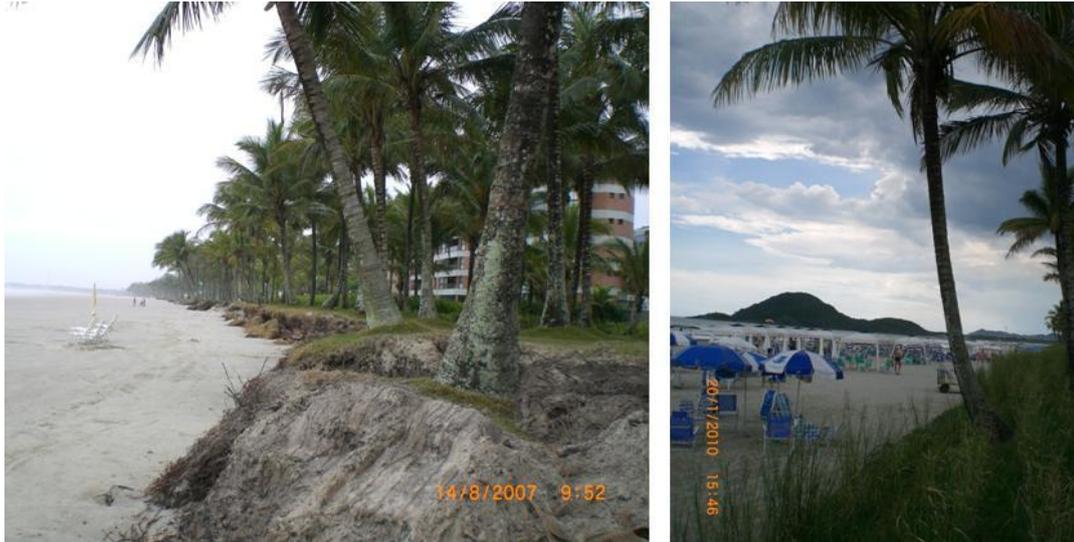
Figure: 26: Before and after pictures of the Riviera de Sao Lourenco beach.
Source: Luiz Lucena
