evelopment of Eco-Guide Post for Road Traffic Safety in Rural Areas by Using Vetiver Clay Composites

R. Parichatprecha, T. Luengkulyanakun, T. Hengsadeekul, and P. Nimityongskul

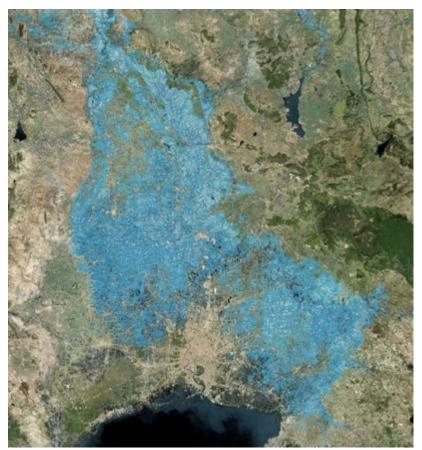
- In 2011 More than 12 Storms Attacked
- In October 2011 Worst Flood About 17,000 Million Cubic Meters Overwhelm from Northern to Bangkok
- More than 20 Provinces were swamped Including Bangkok
- Approximately 6.5-7.0 Billion US\$
 Damaged

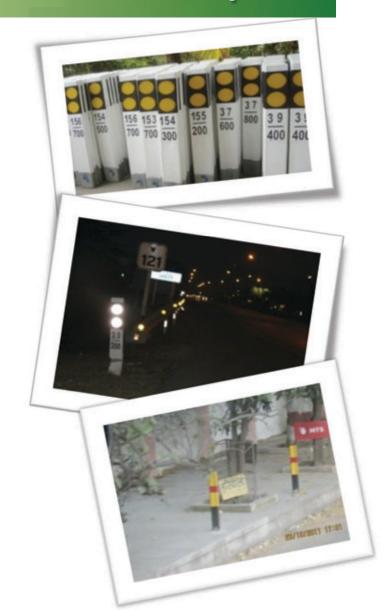
แบบแปลนแสดงหลักนำโด้ง (GUIDE POST) บริเวณโด้งทางราบ

- The posts used to mark the edge of the road carriageway
- It assists the road users by indicating the alignment of the road ahead
- Almost all of guide posts in Thailand's highway are made from very stiff materials such as reinforced concrete
- Approximately one million are required along the roads side in Thailand, however only 30% were installed

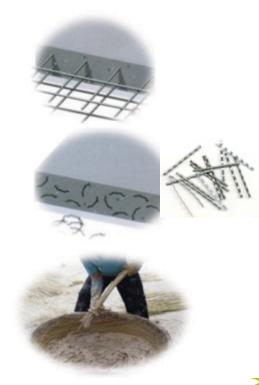
4 Approaches for application of Vetiver and Bamboo Sticks as Fibers and Reinforcing Bars

Hybrid vetiver fibers and vetiver clay bundle

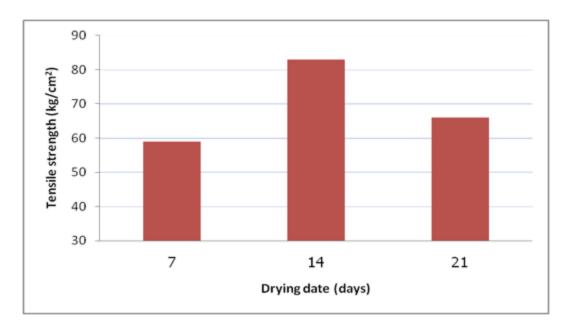
The relationships between drying date and average tensile strength of vetiver grass

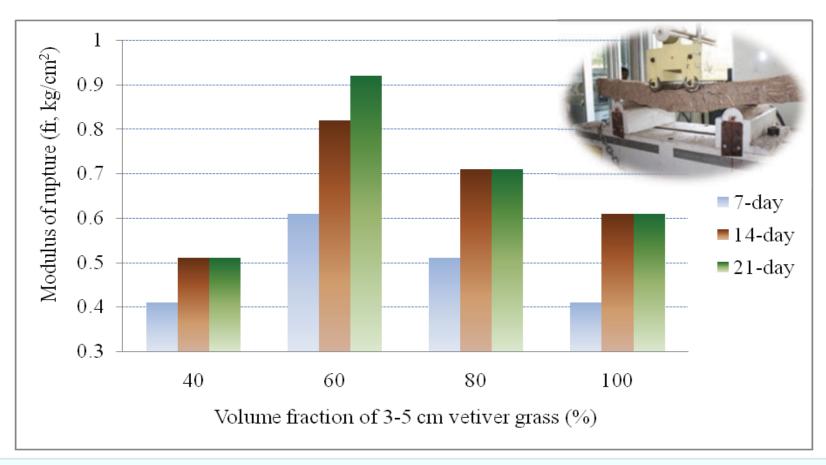
Mechanical Property

- The 60% vetiver grass at 21-day drying gave a highest modulus of rupture of 0.91 kg/cm².
- The suitable volume fraction of 3-5 cm. vetiver grass with more than 14-day drying period can be improved the flexural strength of eco-guide post.

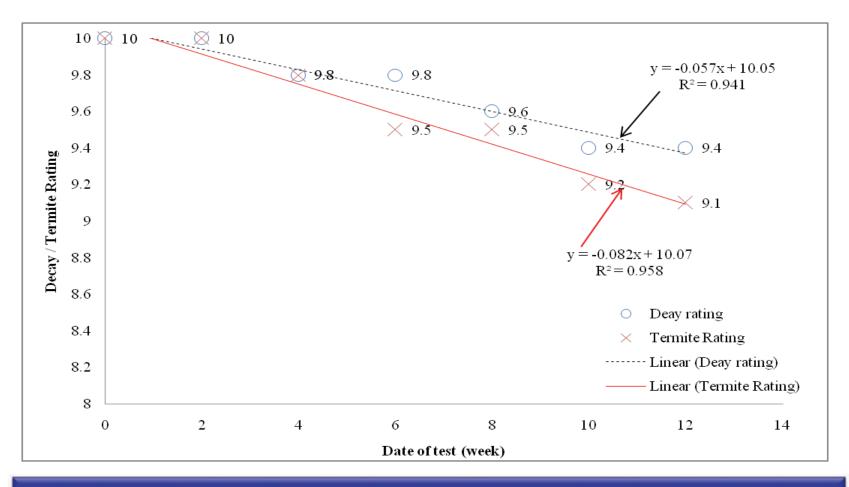
American Wood Protection Association (AWPA E7-09) standard was applied to investigate the durability of 20 samples (Model 8 with 60% of short fibers) in terms of decay and termite rating.

It can be summarized that the durability of eco-guide post in terms of decay and termite rating index along 3 months period was found to be sound condition

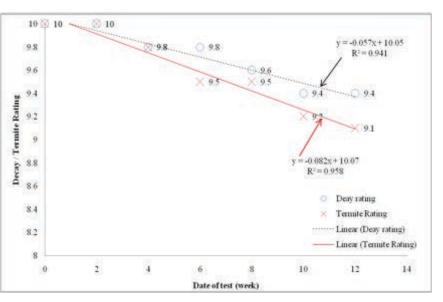
Prediction of Service Life of Eco-Guide Post

Linear Regression

Decay Index = -0.057(Date of test, weeks) + 10.05; $R^2 = 0.94$

Termite Index = -0.082(Date of test, weeks) + 10.07; R² = 0.96

The limited condition for serviceability of guide post was setting at 30-50% cross sectional area affected and the index for both rating was 6. By using this condition and best fit equations, the service life of eco-guide post in this study was approximately found to be 12 months.

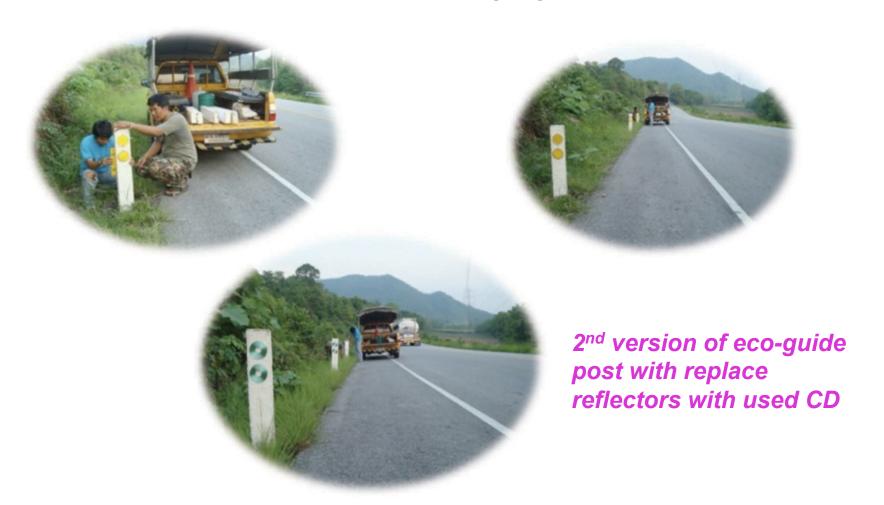
Application of eco-guide post on road number 104 in Wangchao-Tak region and road number 1090 in Maesord-Umphang region, Tak Province, Thailand

- ☐ The guide posts developed have now been installed at roadside on road number 104 in Wangchao-Tak region and road number 1090 in Maesord-Umphang region, Tak Province, Thailand.
- The transferring technology of this research to the related communities has launched by conducting the training programs and distributed to the several areas on the northern and the northeast regions of Thailand.
