THE VETIVER SYSTEM FOR SAND DUNE STABILISATION & POVERTY ALLEVIATION IN MADAGASCAR

Roley Noffke* and Yoann Coppin**

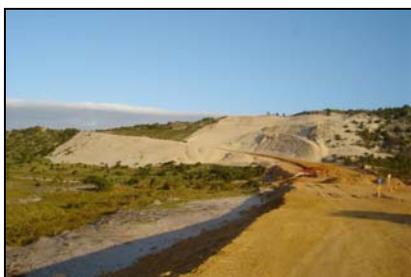
November 2006
Eholo dune cut during construction phase – An area of 5 hectare in extent had to be stabilized.

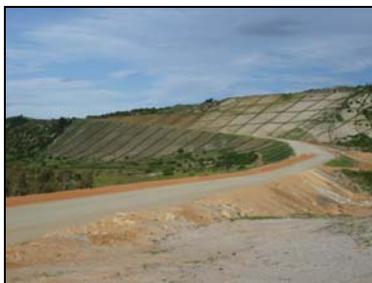
April 2007
Wind Barrier Netting erected and Vetiver grass planting completed

A visit to site during August 2010 showed that the Vetiver grass rows had remained intact on areas exposed to heavy sand deposition caused by the prevailing winds particular through the dune cut corridor, where the sand build-up had exceeded 700mm meter in height. This can be seen by the remaining section (\pm 500mm) of the wind barrier netting that was initially 1.2 metre in height.

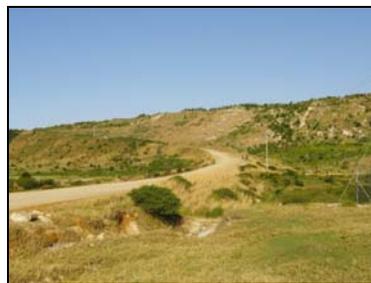
August 2010
Stabilised dune cutting showing native specie diversity

The Vetiver grass rows had receded in the sections where the Eholo Dune cut was protected from the impact of the prevailing winds and deposition and was replaced by native grass and shrub species. In places little or no Vetiver grass could be found.

The planting of Vetiver grass on the project not only stabilised drift sand on the dunes but also created a “micro-climate” where native vegetation was able to establish.

The Vetiver plants receded as the native species through succession developed a strong canopy cover.
