The Vetiver System in Panama

❖ **Part I:** Rehabilitation of Major Landslide in Finca Isabel, using The Vetiver System

❖ **Part II:** Introducing The Vetiver System to La Mina de Cobre (Copper Mine) in Panama ~ Construction Phase

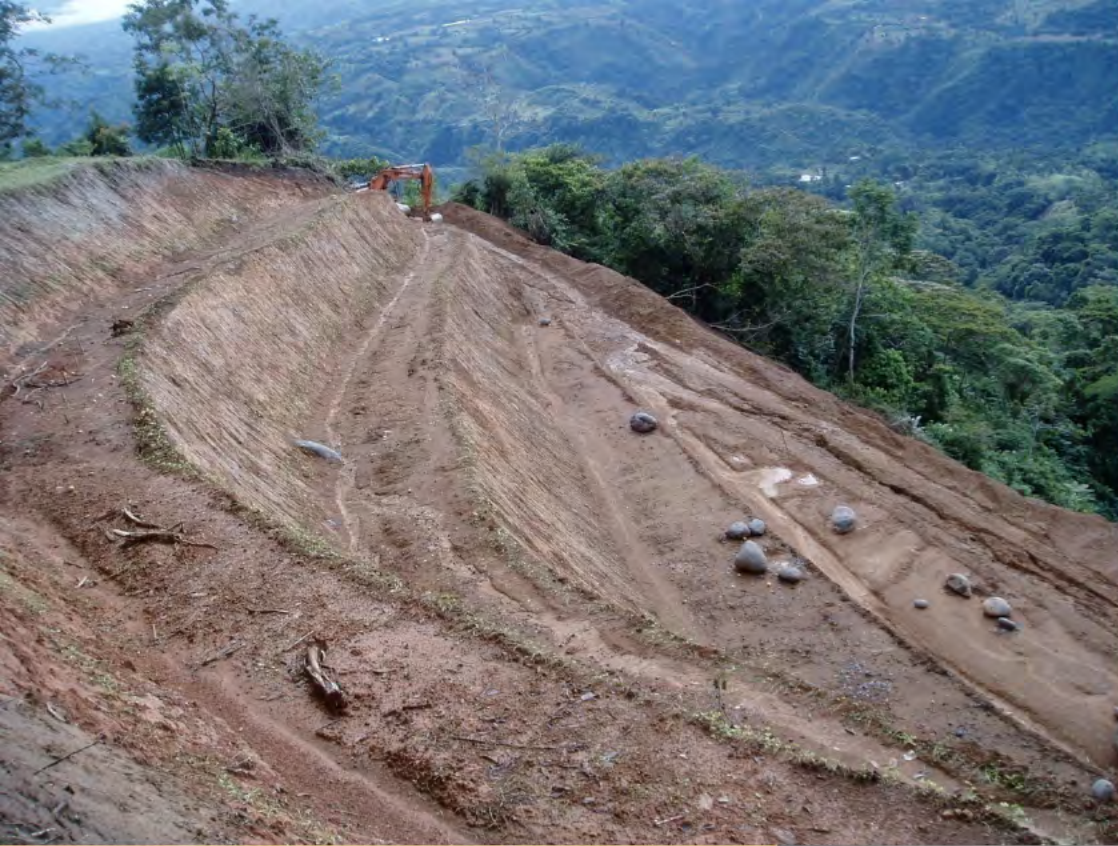
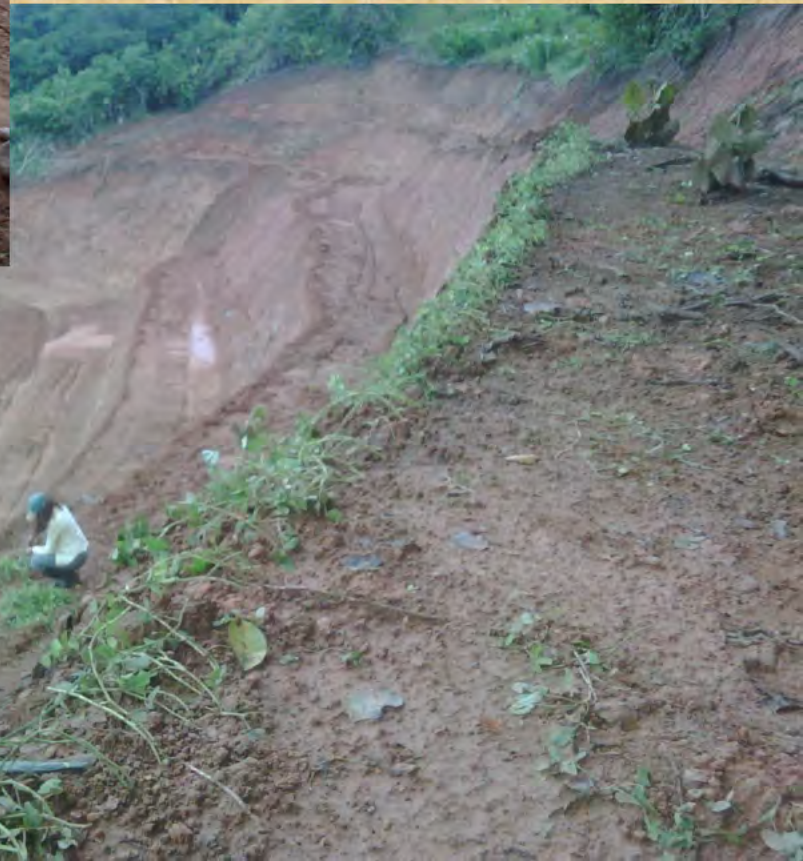
Construction and conformation of slopes (2009)

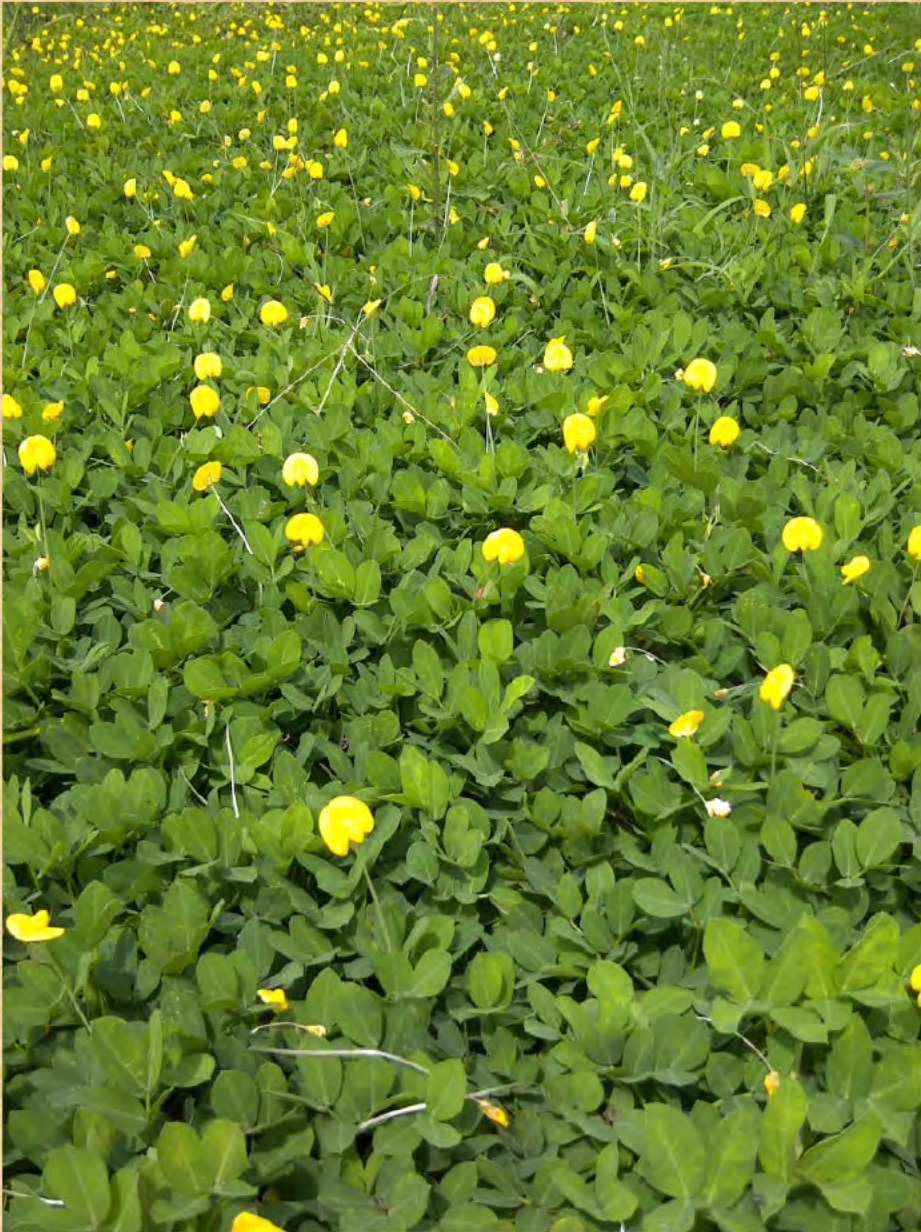
Mani Forrajero
(*Arachis Pintoi*)

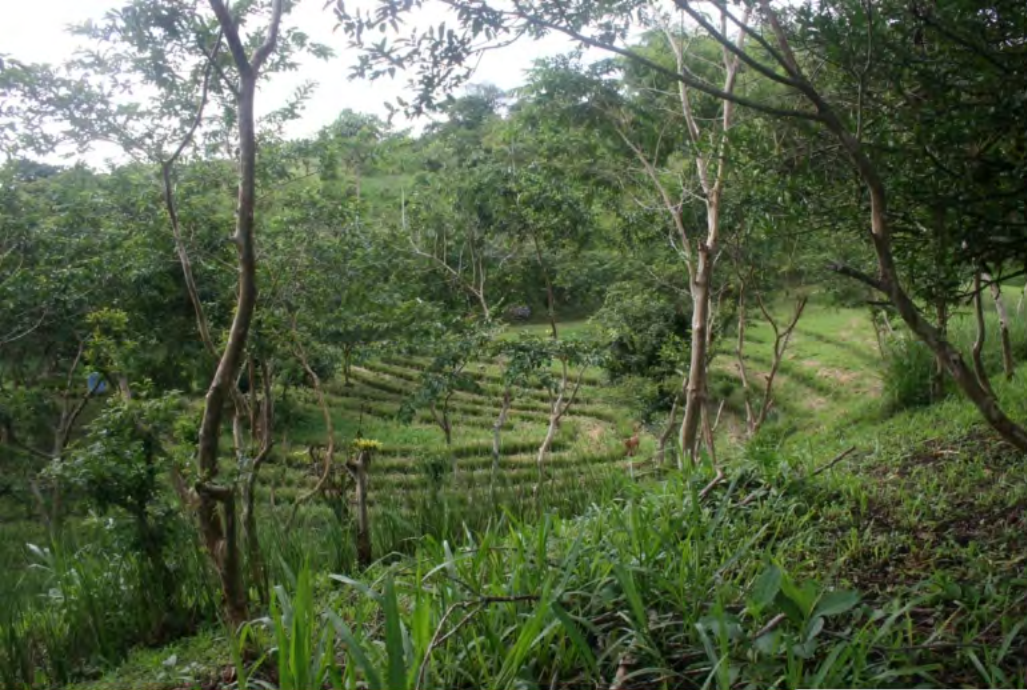
Nursery areas in Finca Isabel

Among the guava
trees

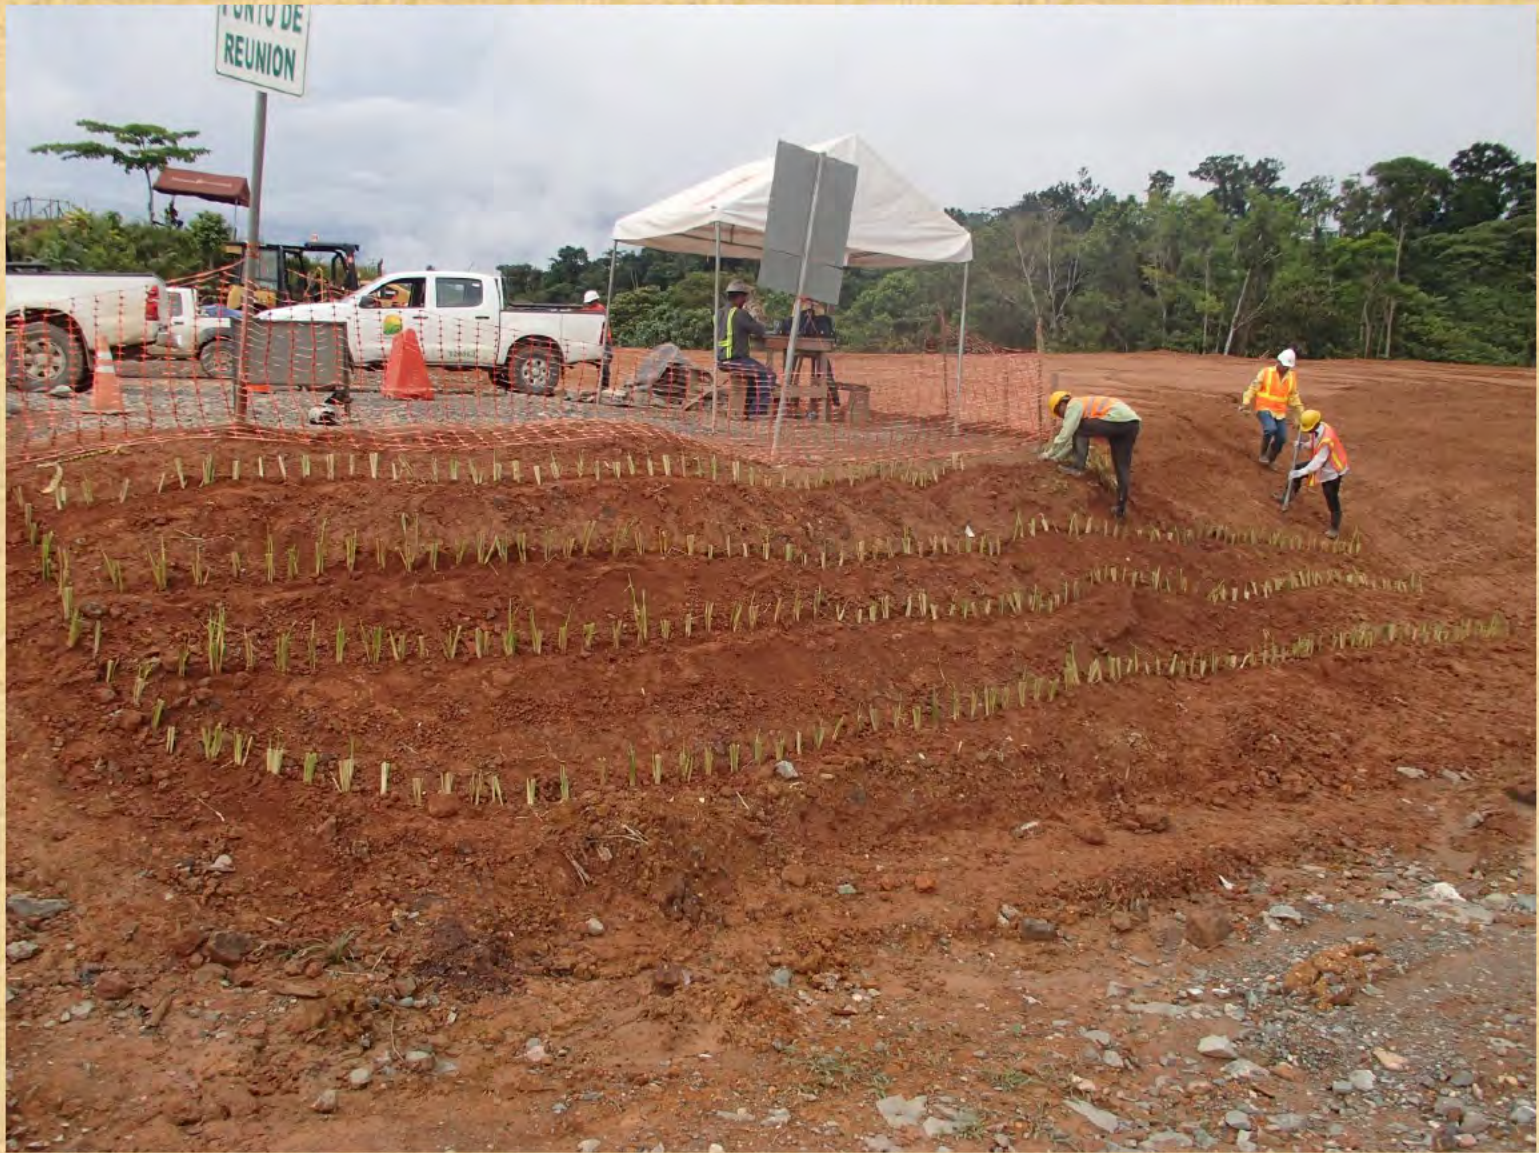
- Personnel from landscaping company had no previous training, were trained on site following techniques I obtained in the Vetiver Manuals. No harnesses used, slopes approximately 1.5H:1V.
- Slips brought to site cut about 15 cm long, in back of pick-up truck, and planted the same day. Some slips were pre-soaked several days. It was found that pre-soaked slips had almost 100% survival rate, whereas un-soaked slips had about 80% survival.
- Successful planting over a period of about 6 weeks, however no watering system in place, and a 2-week dry spell caused some of the first plants to fail.
- After this dry spell, rainfall was pretty consistent. In one area, very poor water management caused major erosion within 2 days of planting, and major slope destruction and slip washout.

No Water Management on upper platform considered. Major erosion and slips washout within 2 days of heavy rains

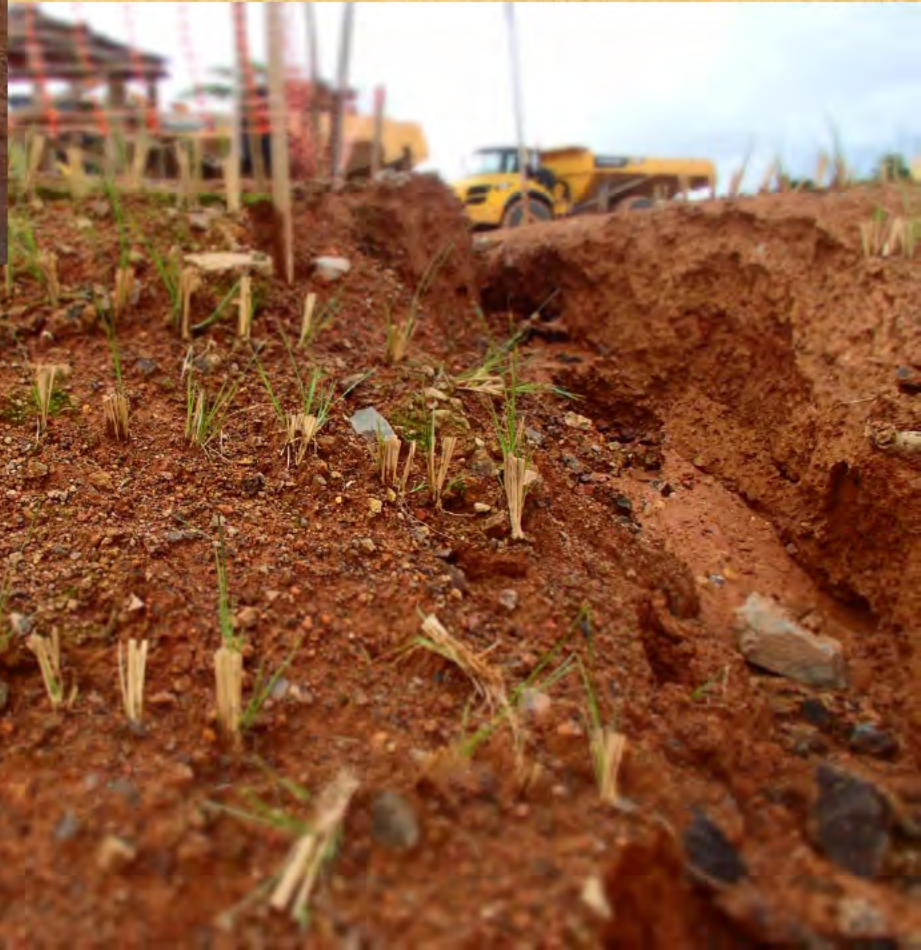
However, remaining Vetiver grew well and performed its function.

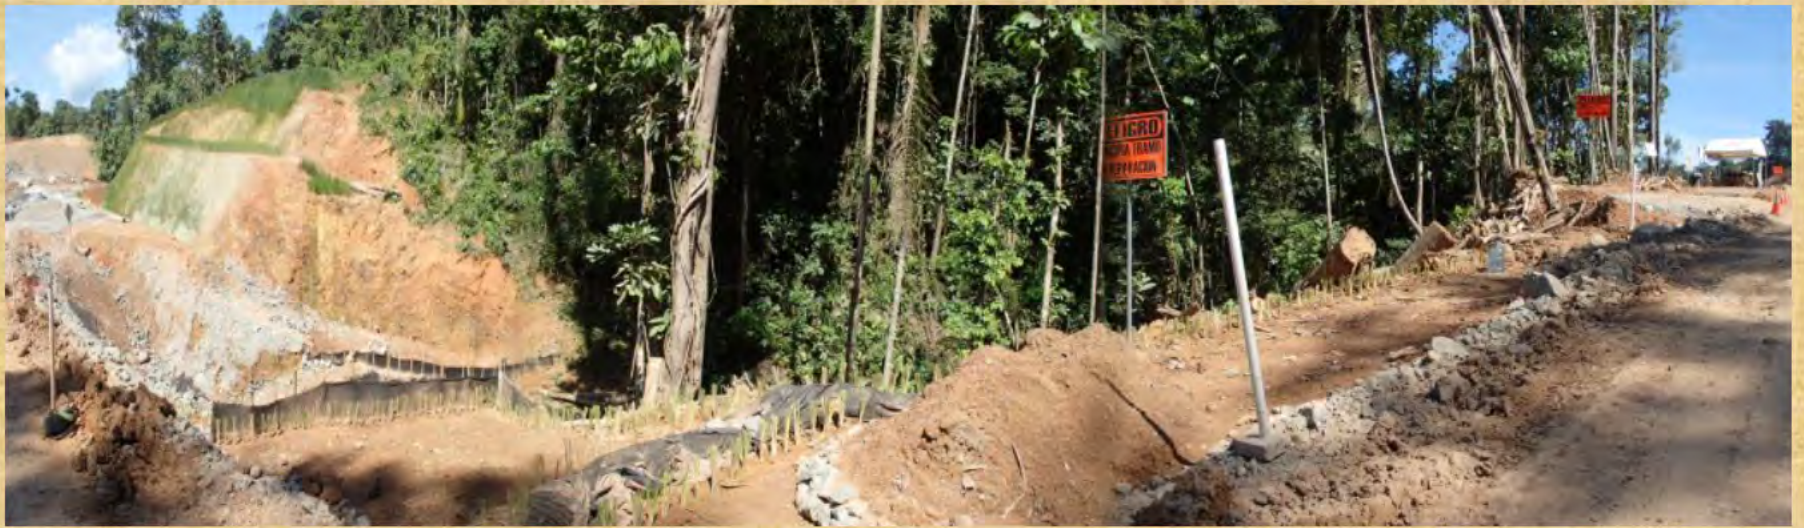
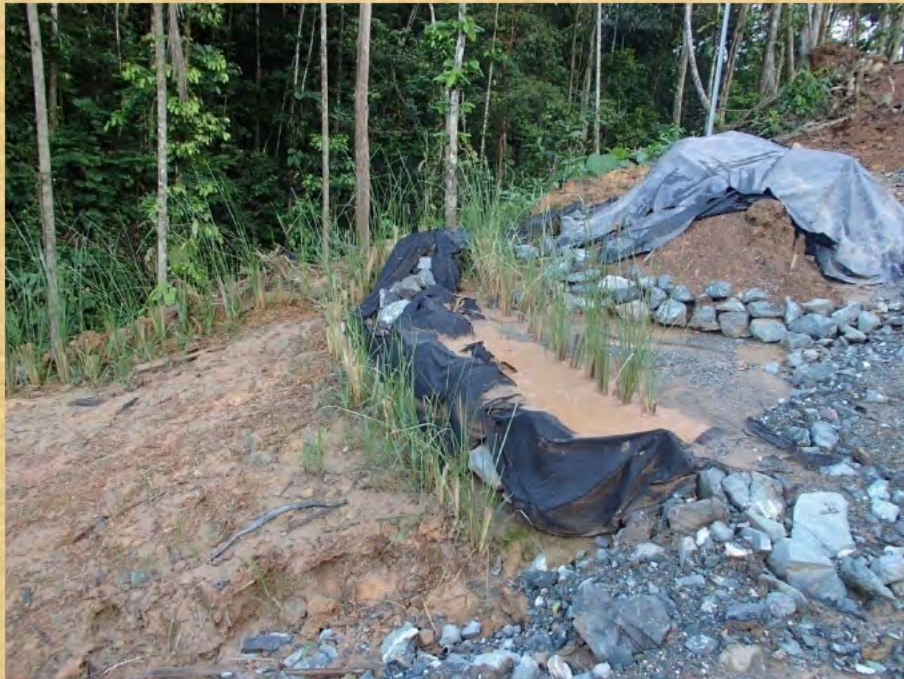
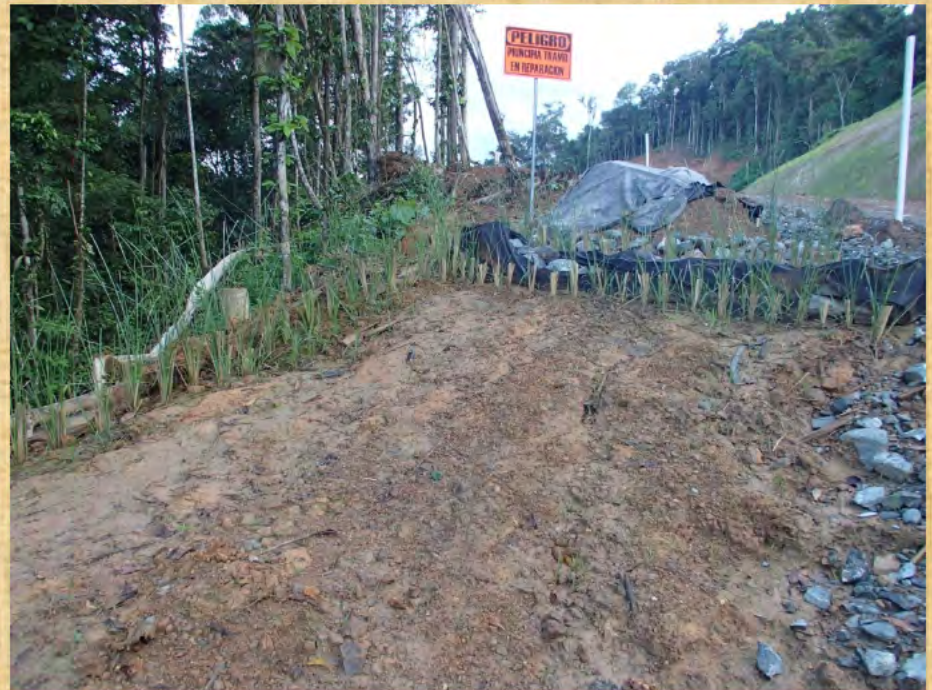
■ One of the slopes planted well following The Vetiver System did undergo partial failure. This was a fill slope, with gradient about 1.5H:1V. This may be in cause due to poor water management, and saturation of the slope.

- During the first few weeks to about 3 months, the failure is primarily governed by the short term stability of the slope itself due to its geotechnical properties. High saturation increases the risk of failure in most cases. Excellent **water management and water diversion** at the moment of construction is critical to reducing slope failures.

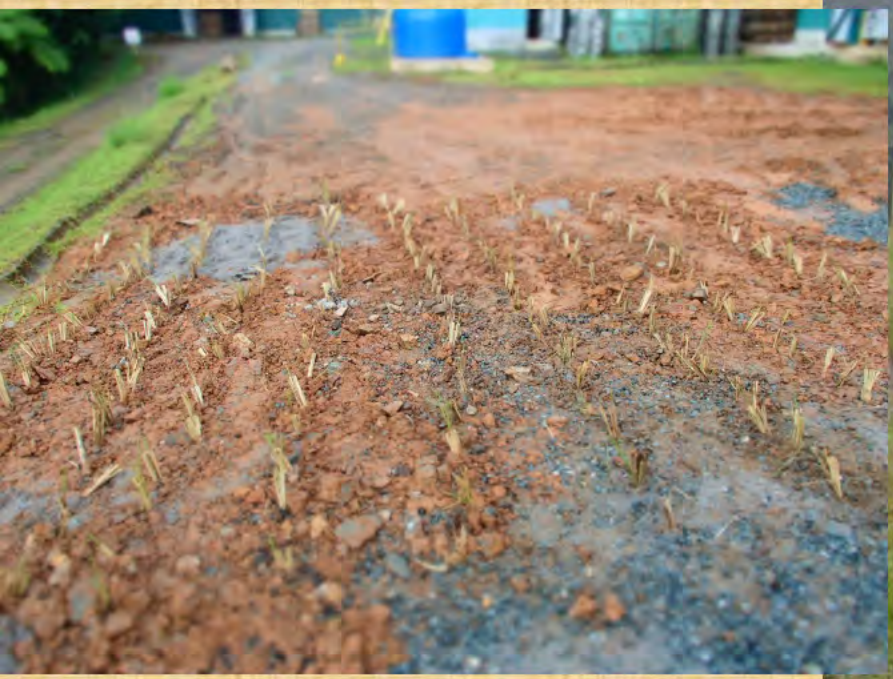
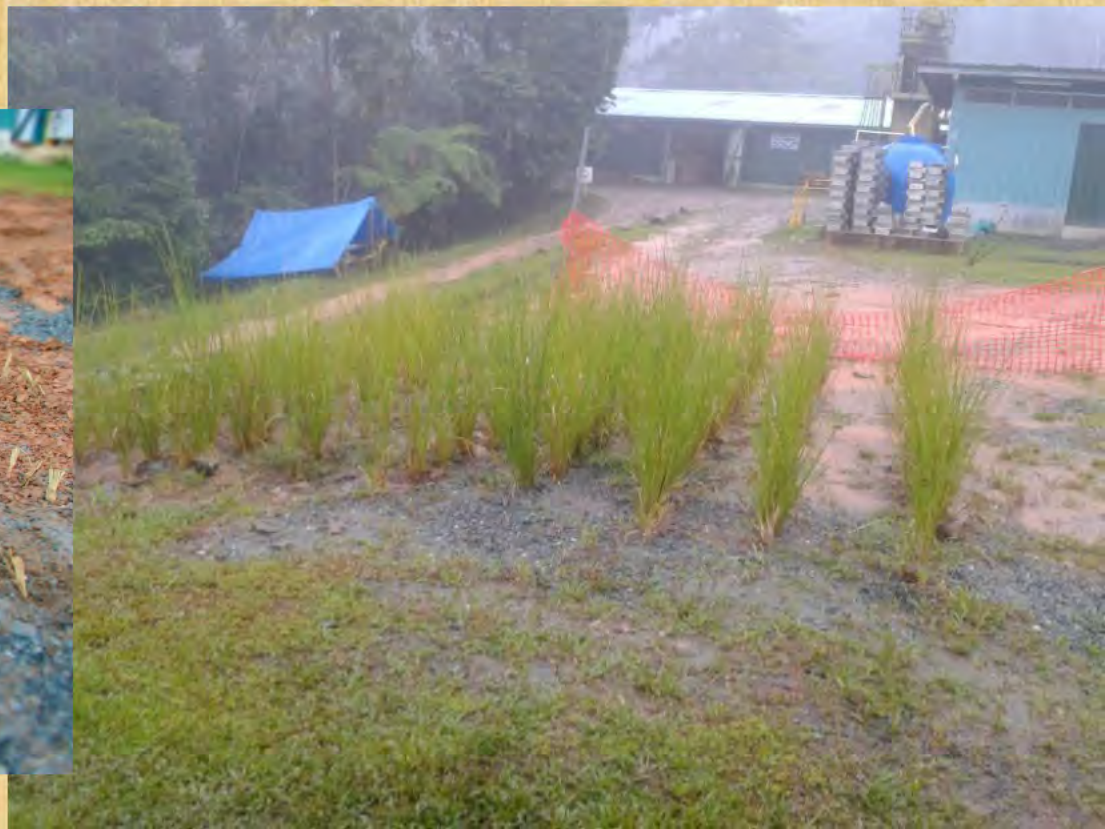
- The concept of Vetiver for waste water treatment and contaminated land rehabilitation was introduced to the client.
- Vetiver grass was planted as secondary treatment to traditional waste water treatment systems
- Below photos: Vetiver planted over gravel/rock filter, downstream of biodigester, for laundry grey water
- Potential for future use in mine waste water and tailings clean-up.
