# Contribution of VST in Alleviating Climate Change Disasters

**Paul Truong**  
*TVNI Technical Director*  
*Director for Asia and Oceania,*  
**Brisbane, Australia**

# CASE STUDY: Flood erosion control in Australia

## Flood erosion control in drainage channel at Laidley

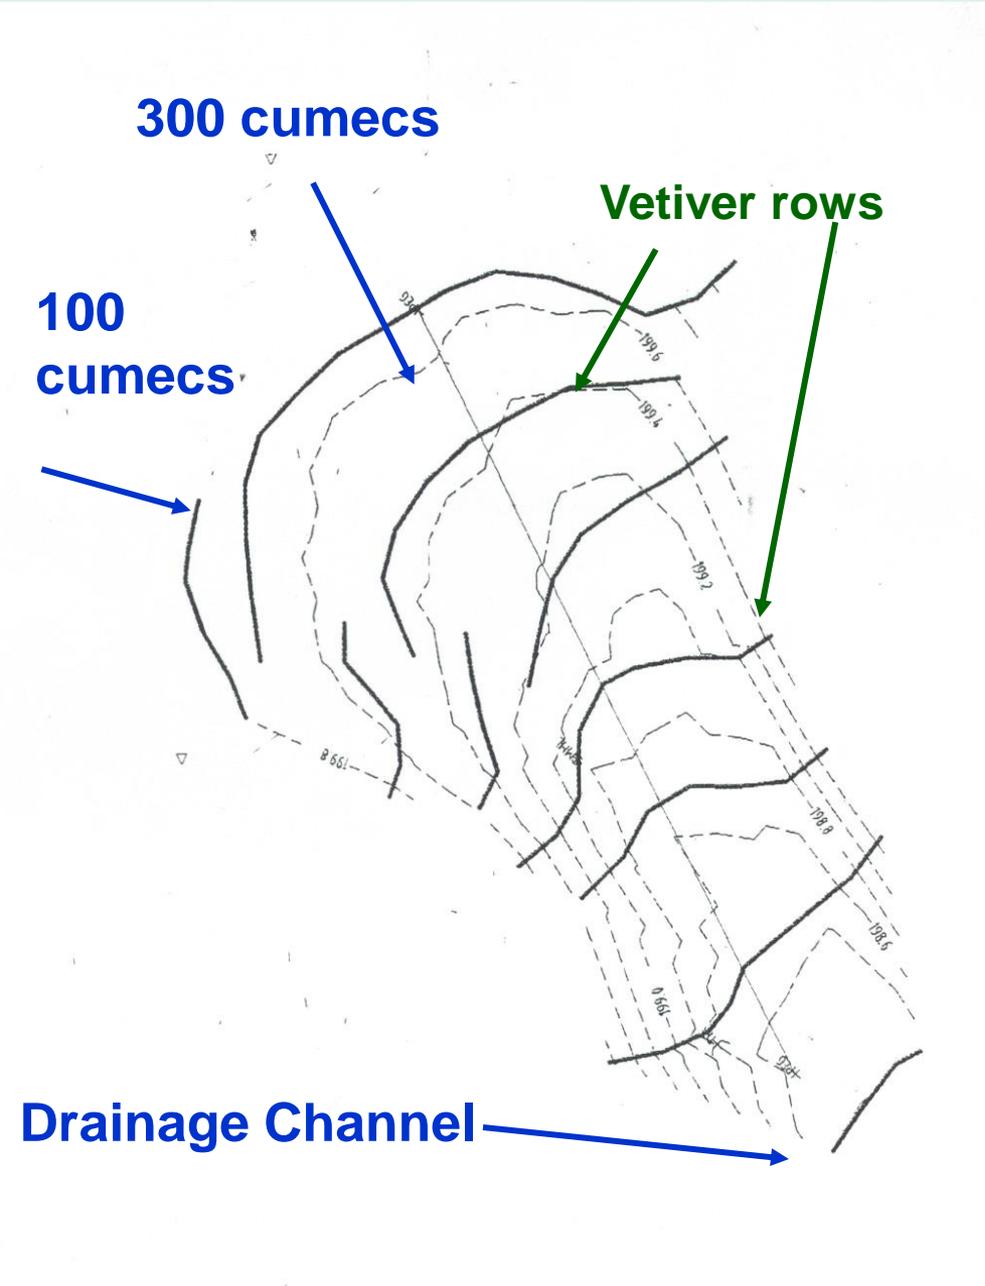
Vetiver hedges were established to spread water out and also to divert water to the drain

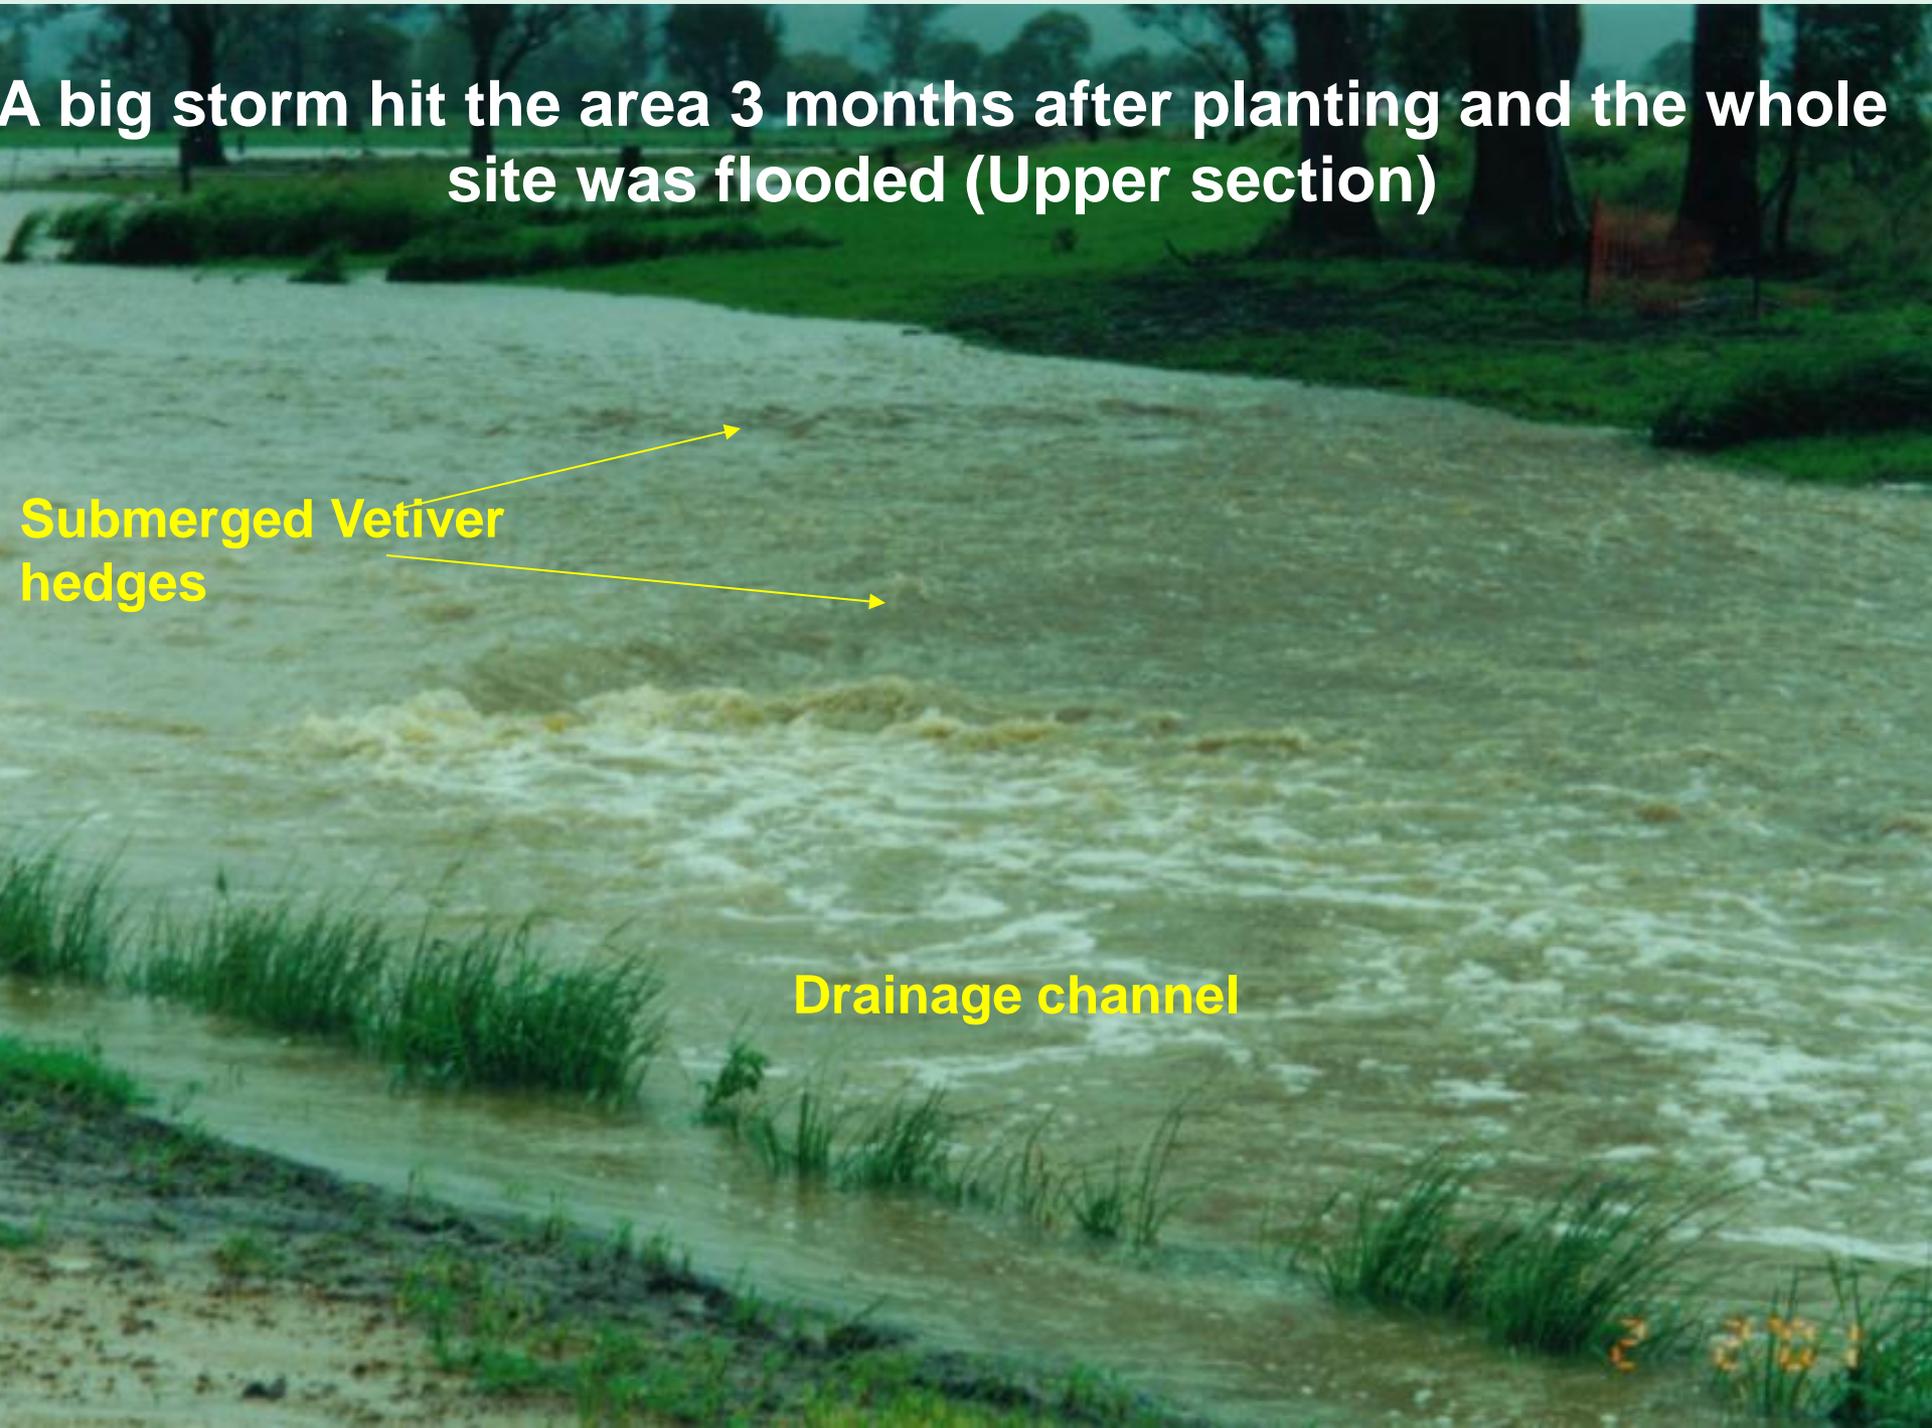
**Flow direction**

**A big storm hit the area 3 months after planting and the whole site was flooded (Upper section)**

**Submerged Vetiver hedges**

**Drainage channel**

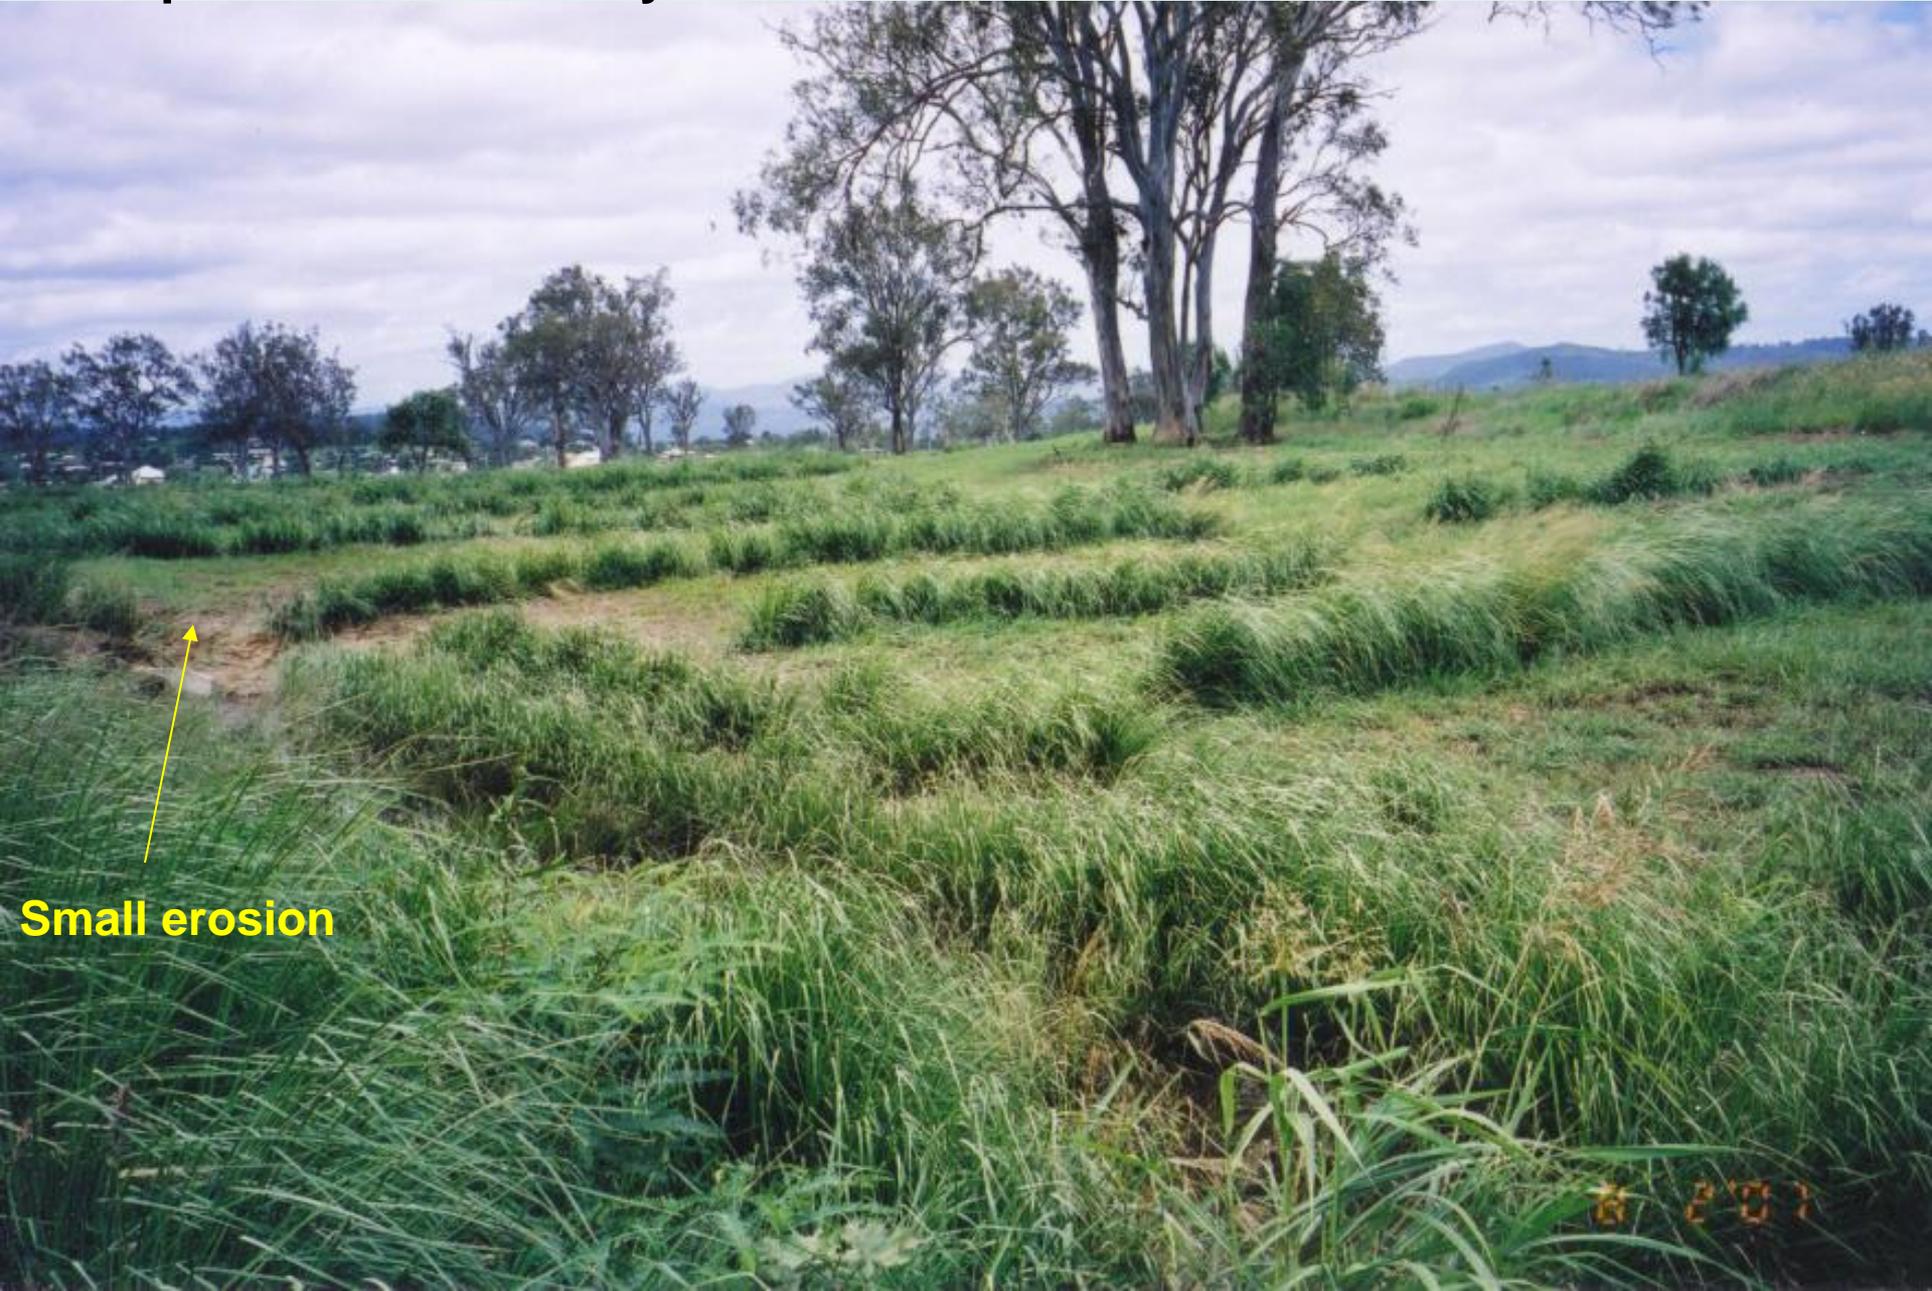
**Although only 3 month old, the young hedges provide a very effective protection with only minimal erosion at the head of the channel**

**Small erosion**

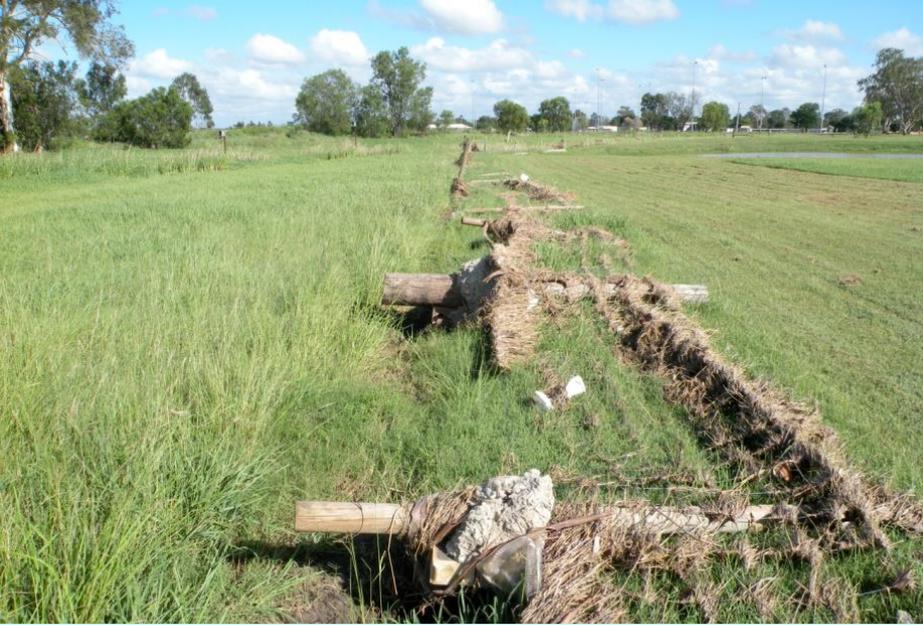
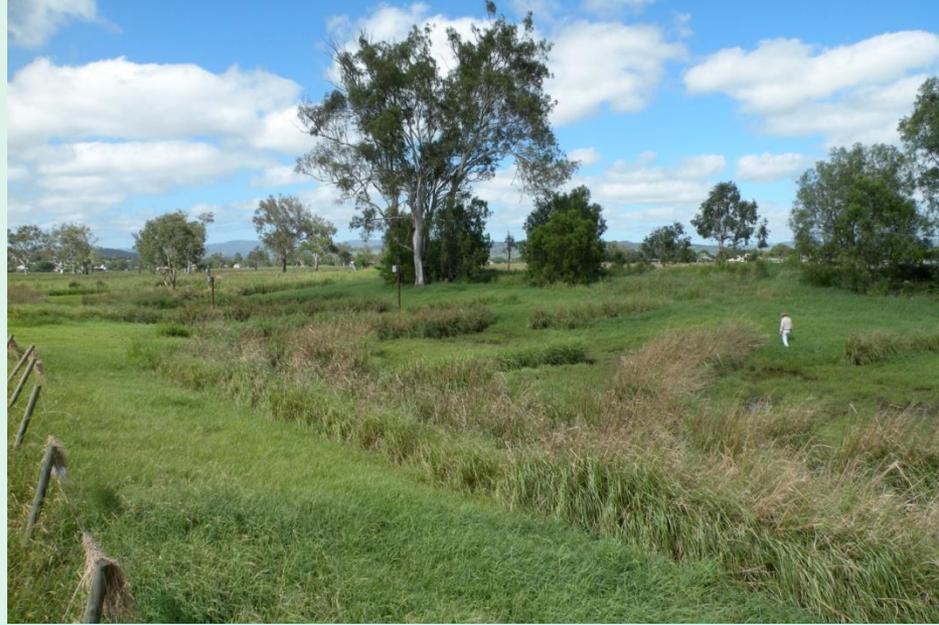
**Vetiver hedges after flooding**

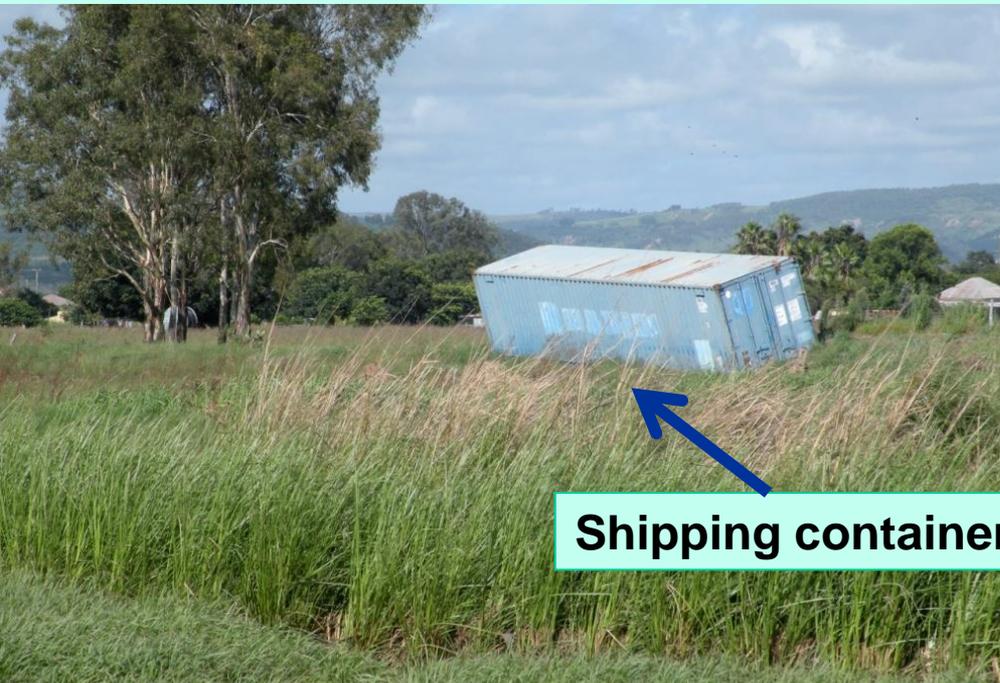
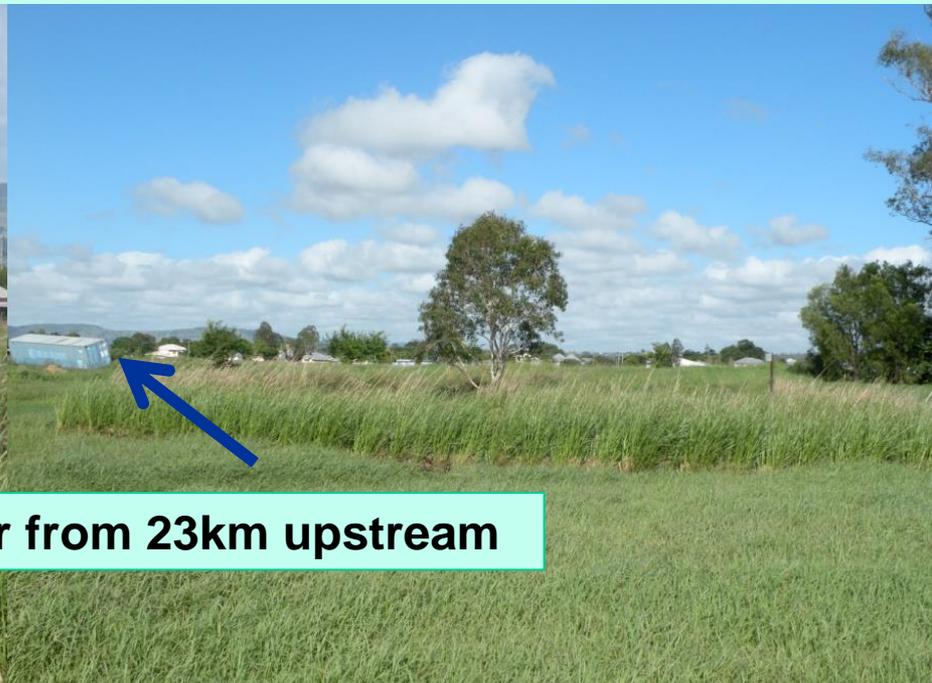
**Shipping container from 23km upstream**

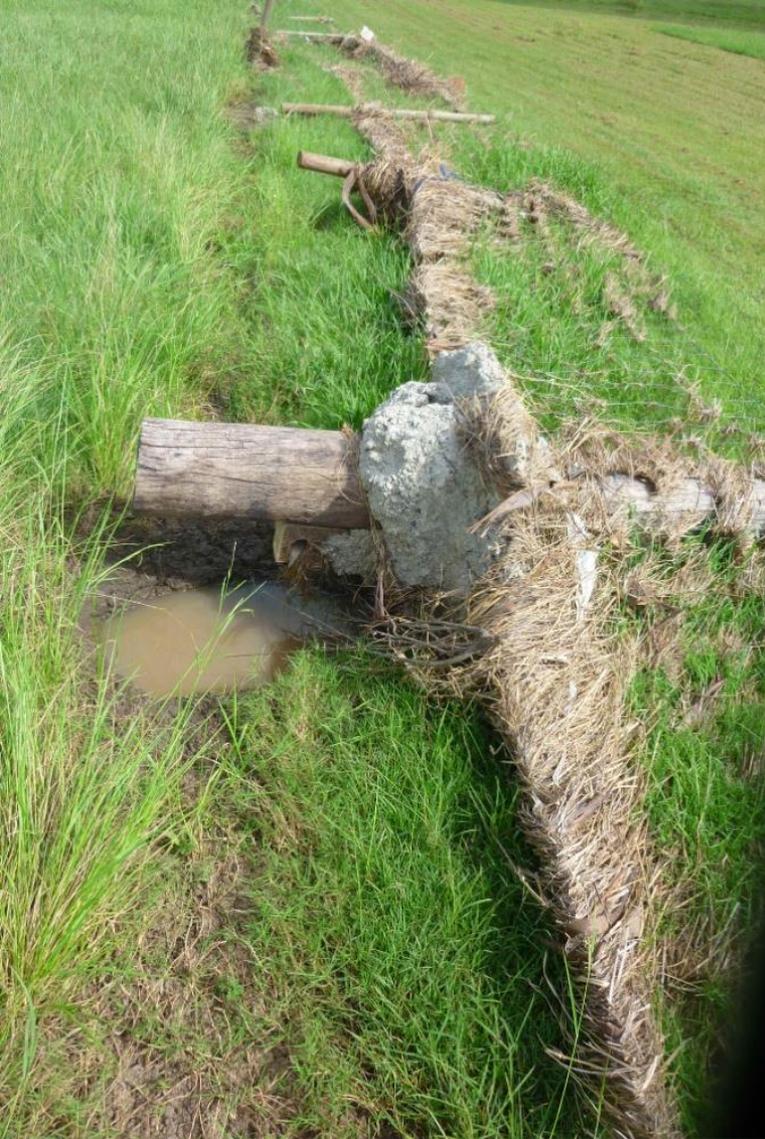
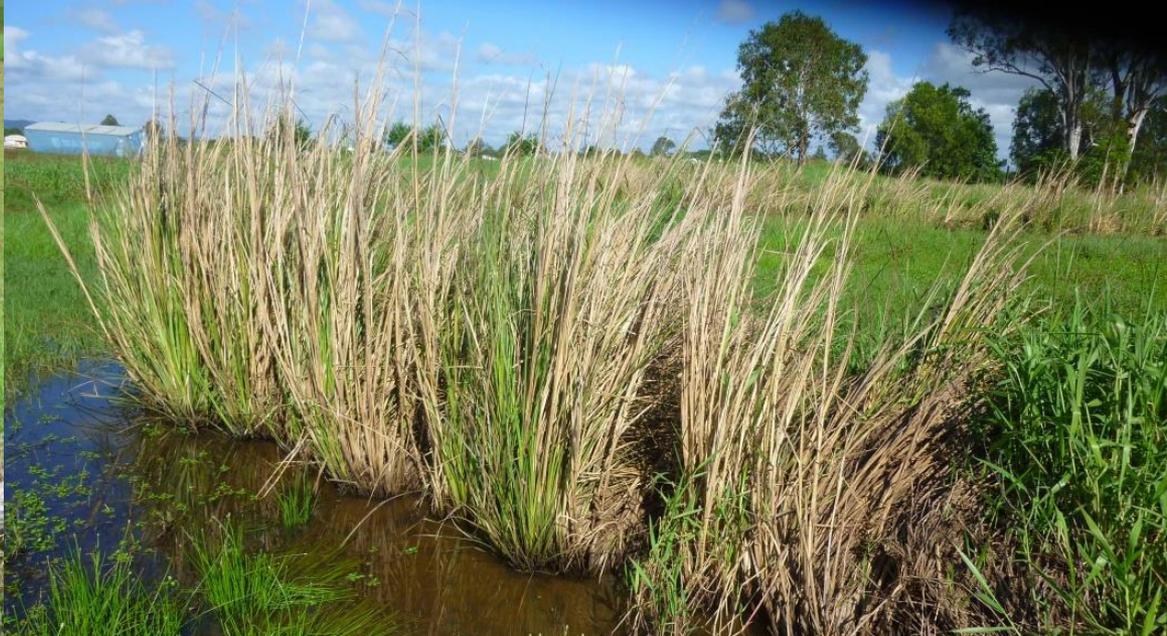
**While little damage to the vetiver, the fence posts were “uprooted”**

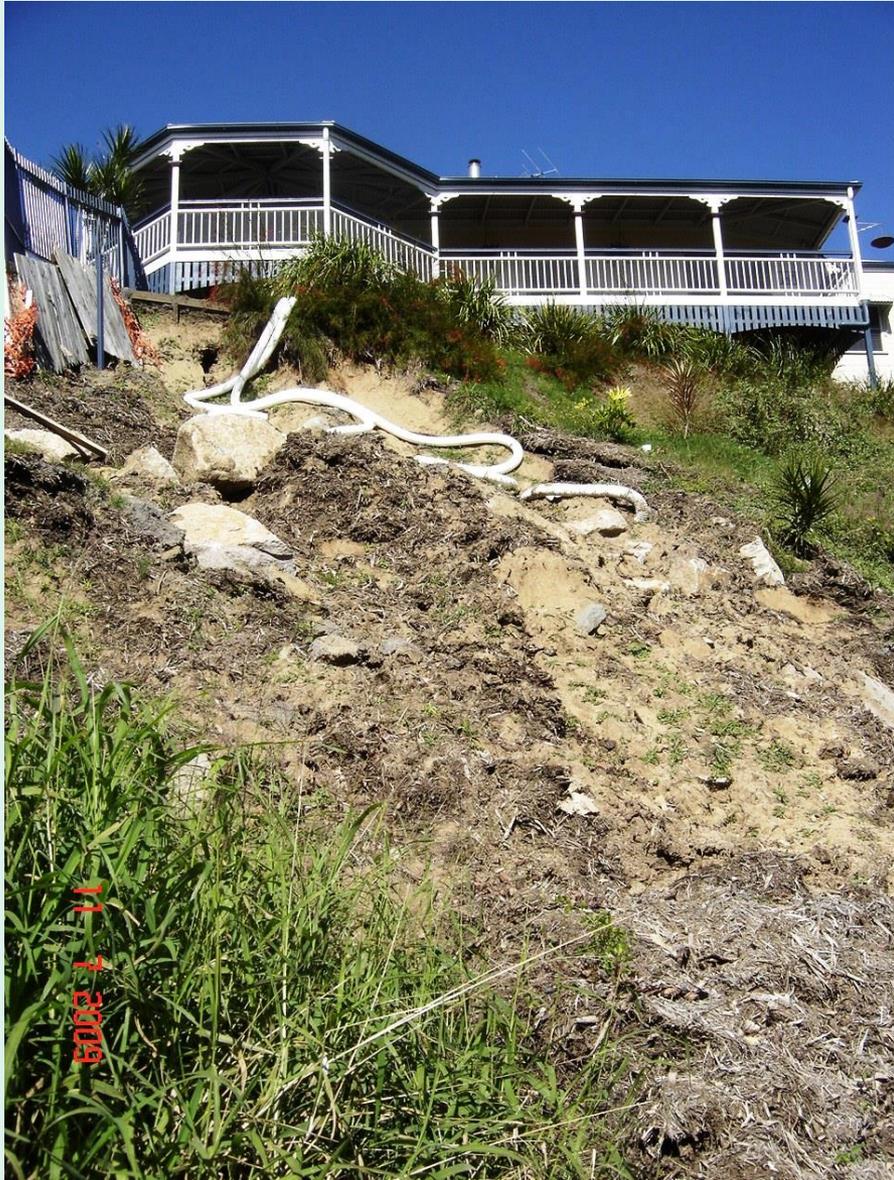
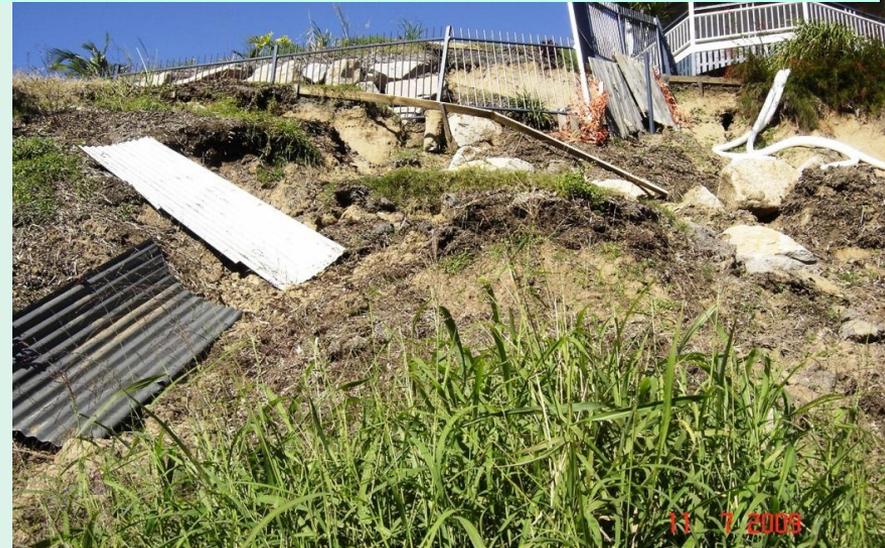
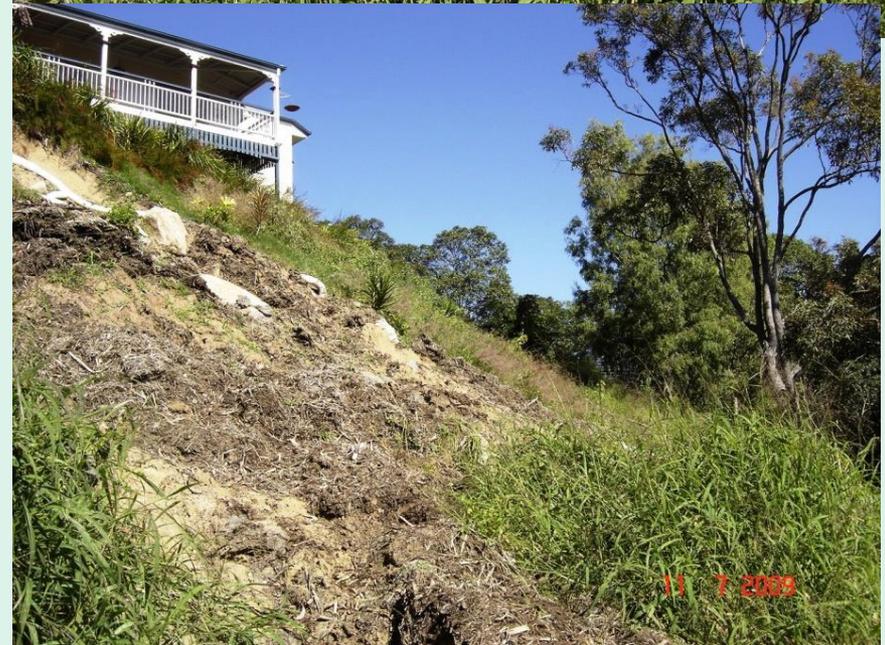
Landslide caused by a prolonged high intensity storm.

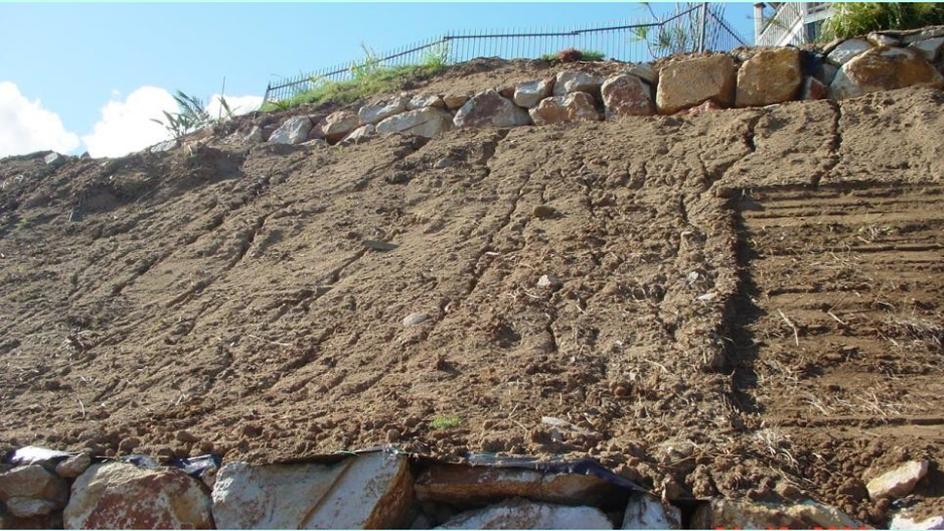
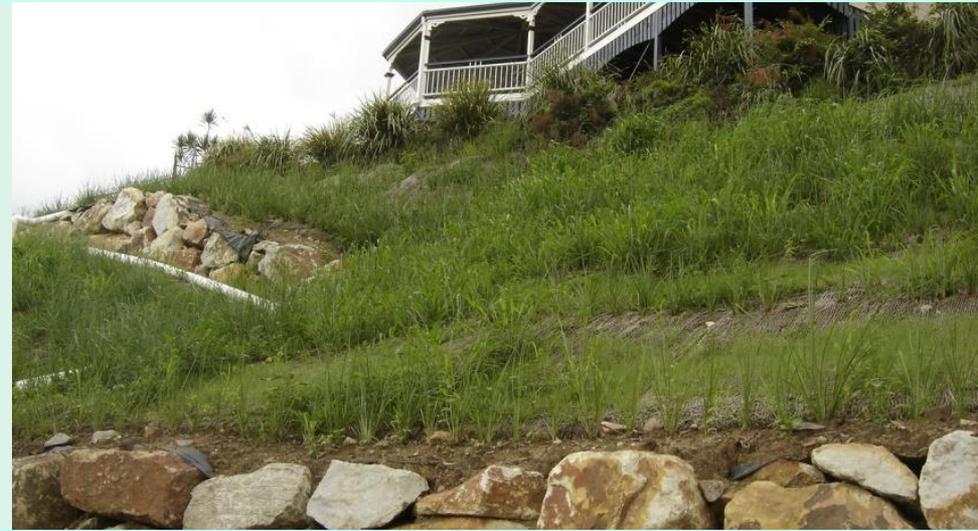
# Site preparation and planting before the intense rain in Jan 2011.

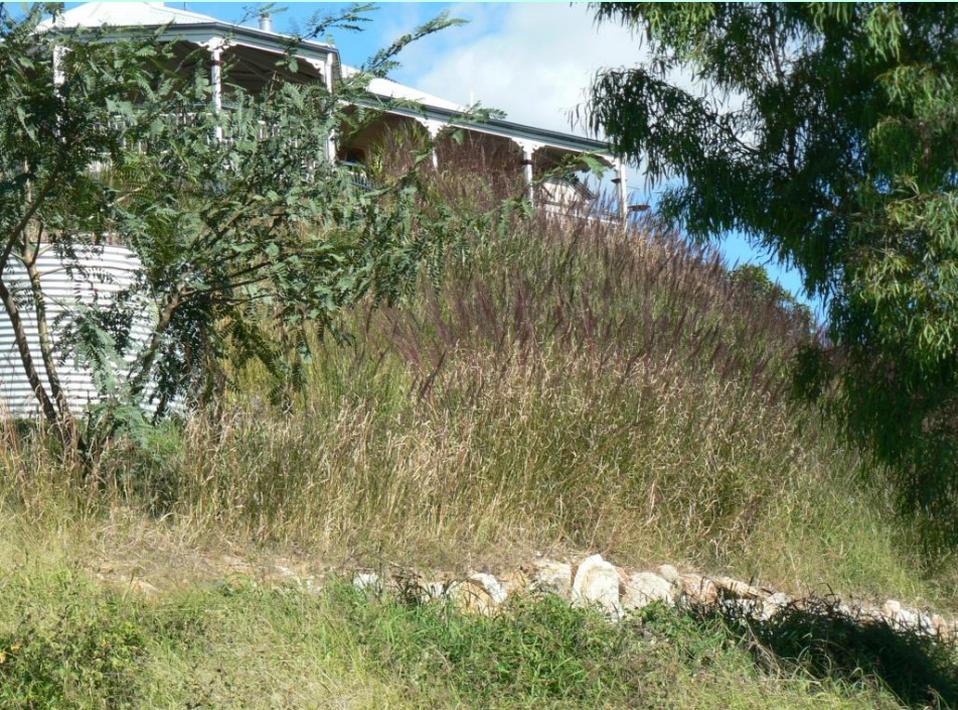
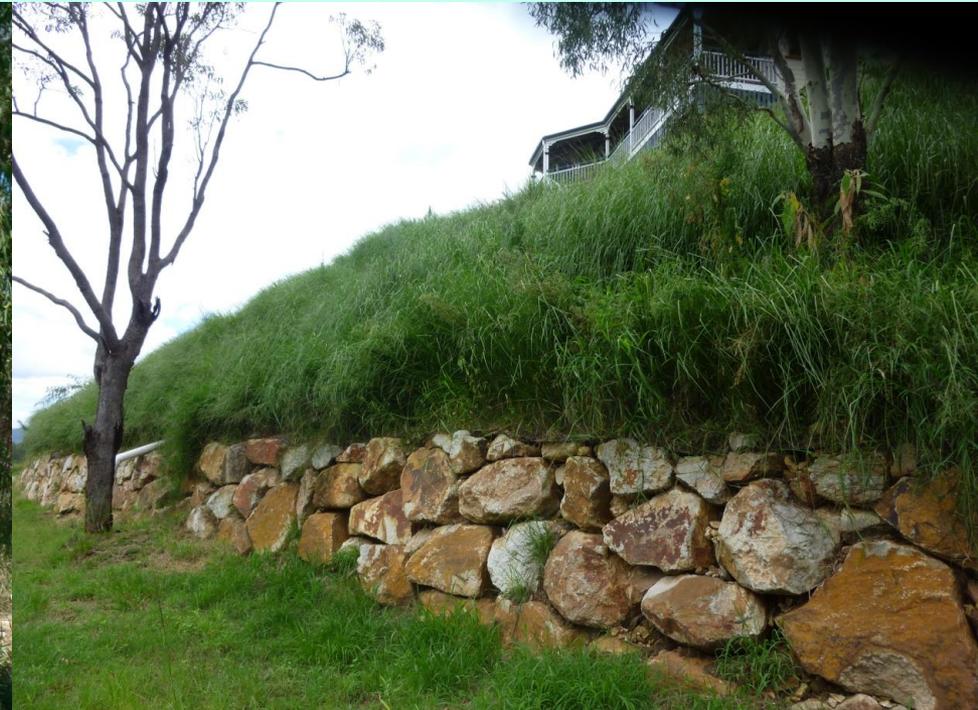
**Undamaged by the same record breaking rain**

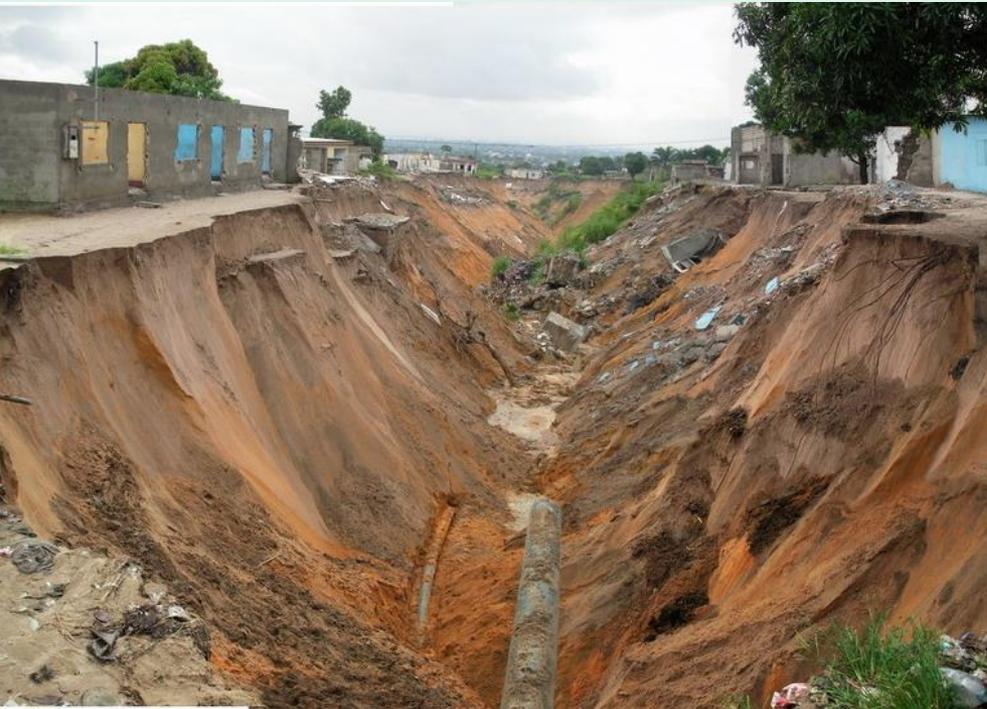
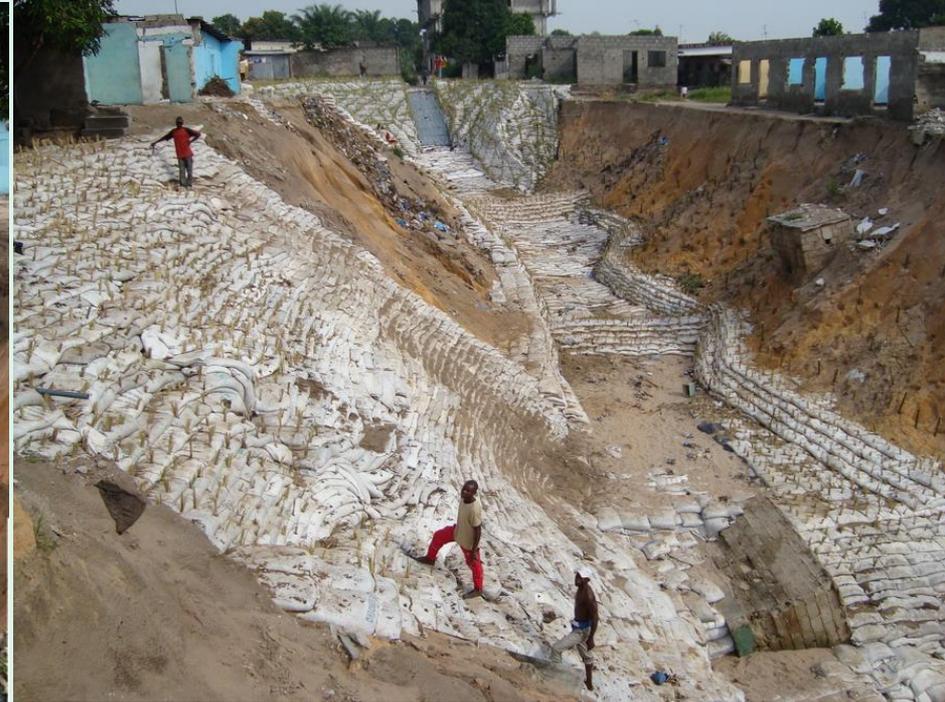
## **Boukeni site, February 2009**

**Initial status at the Boukeni ravine, before placing sandbags containing soil and planting vetiver**

**Placing bags containing topsoil and vetiver planting on the Boukeni site**

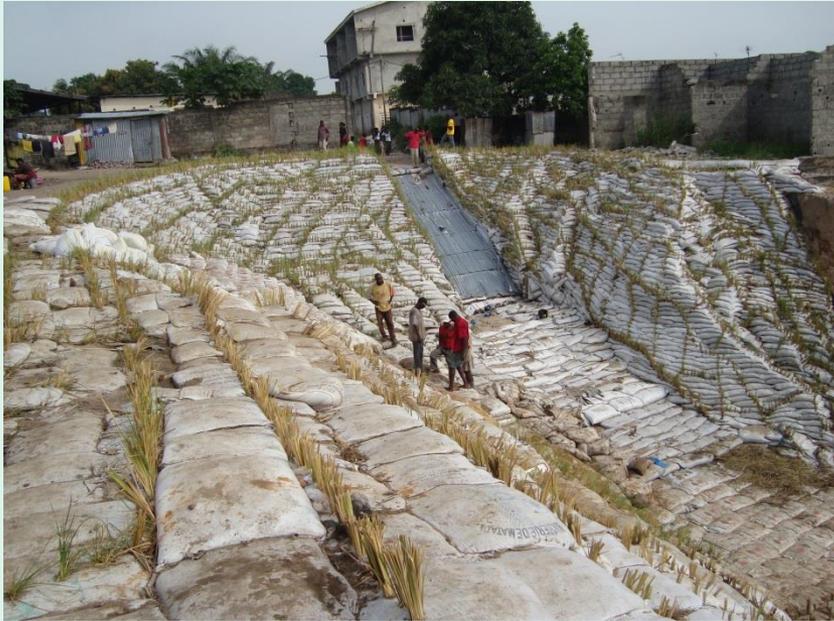
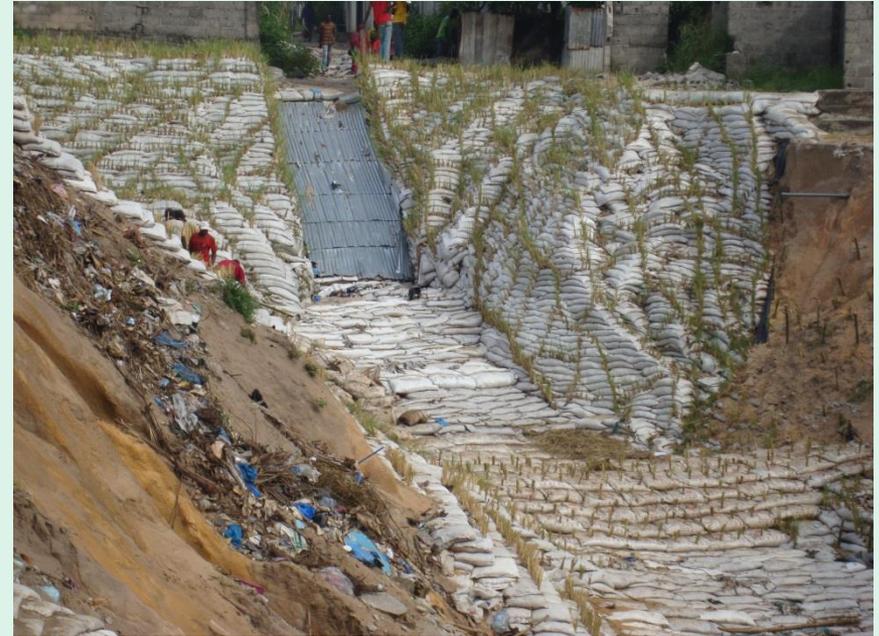
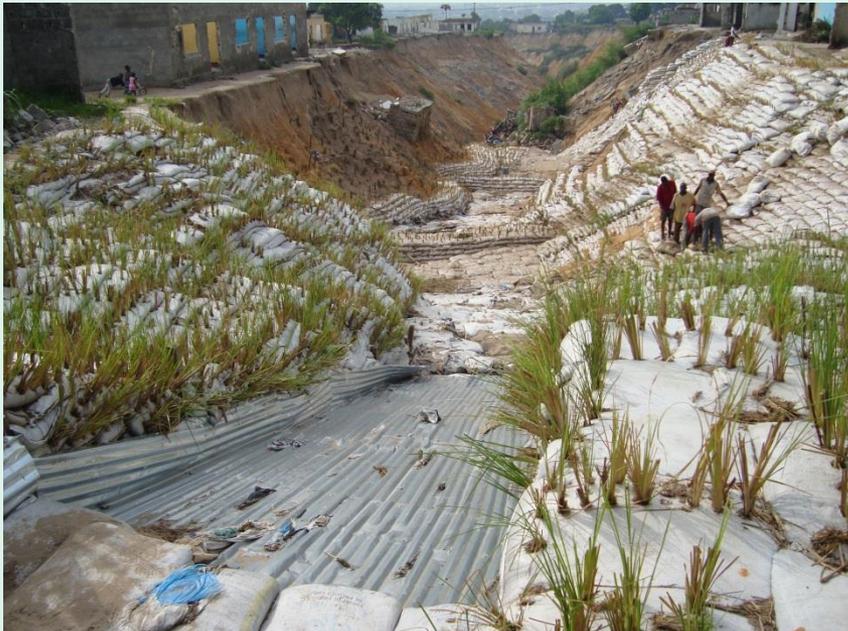
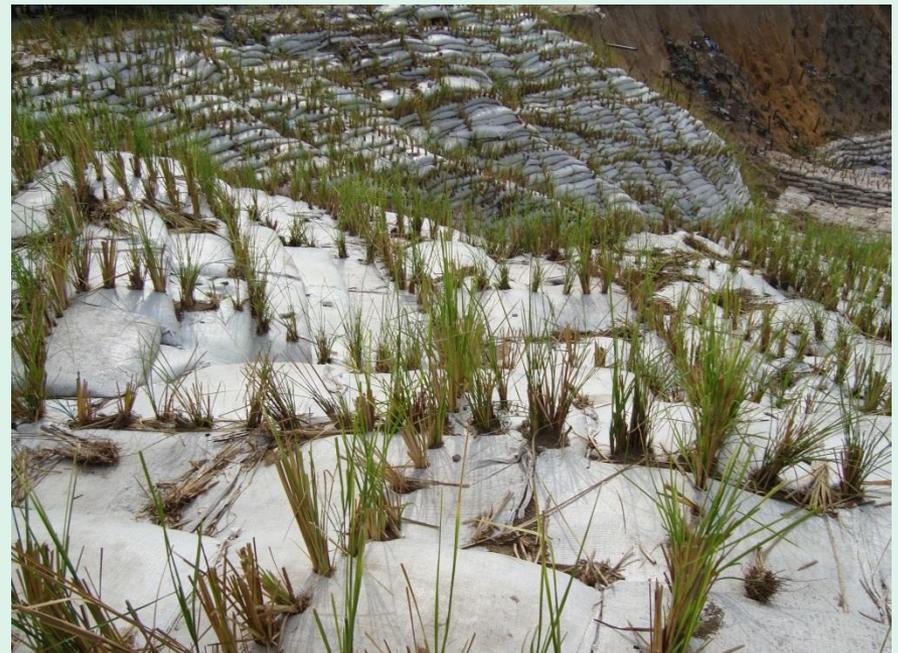
# Sandbag installation and vetiver planting

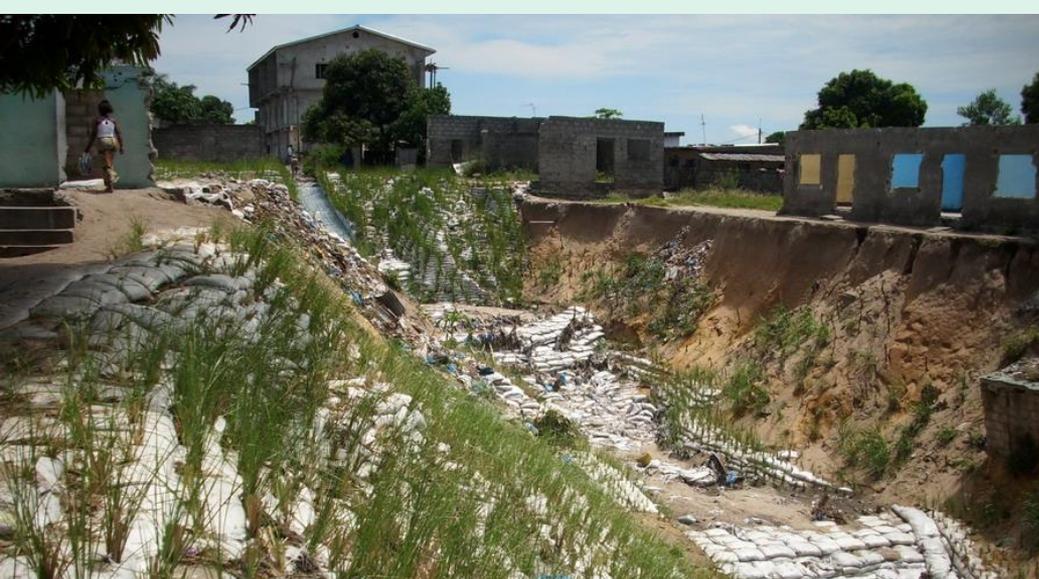
**Boukeni site, 2 months  
after planting vetiver  
directly into the bags of  
topsoil (April 2009)**

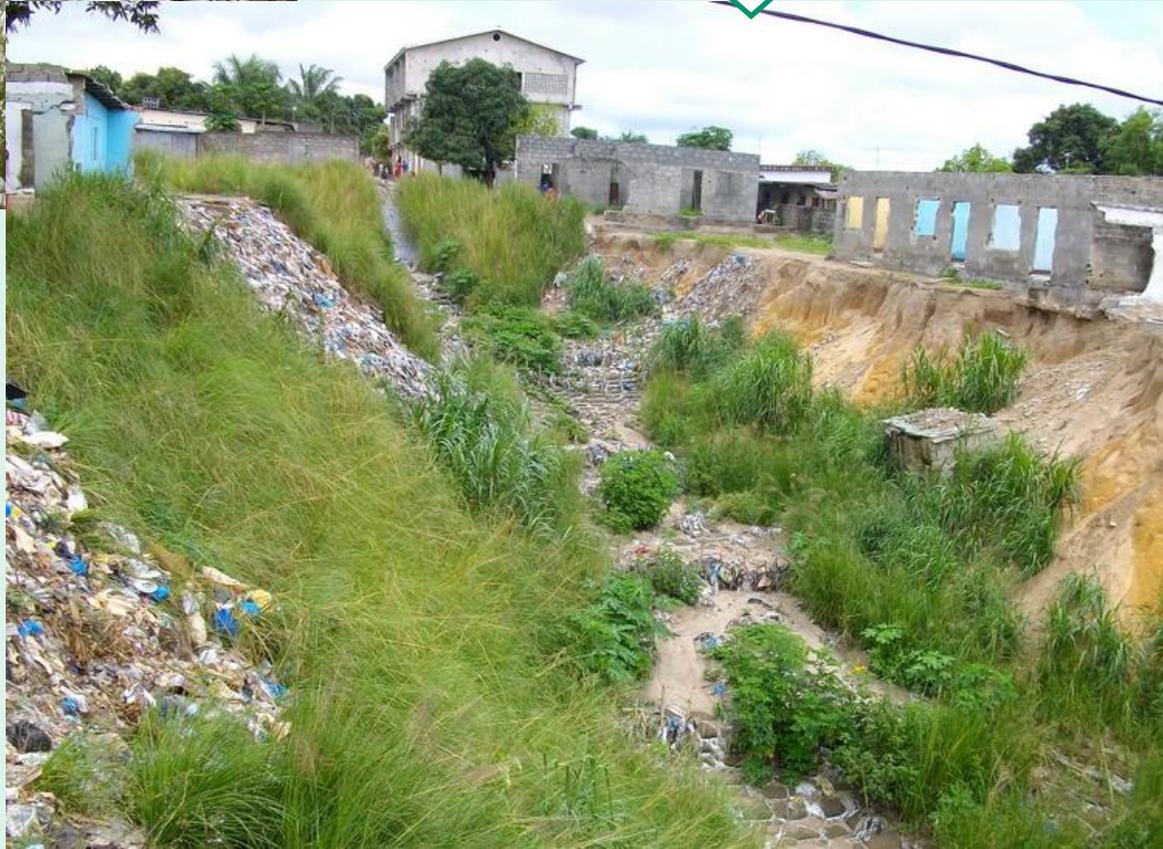
**Boukeni site, status of  
the vetiver cover 10  
months after planting  
(November 2009)**

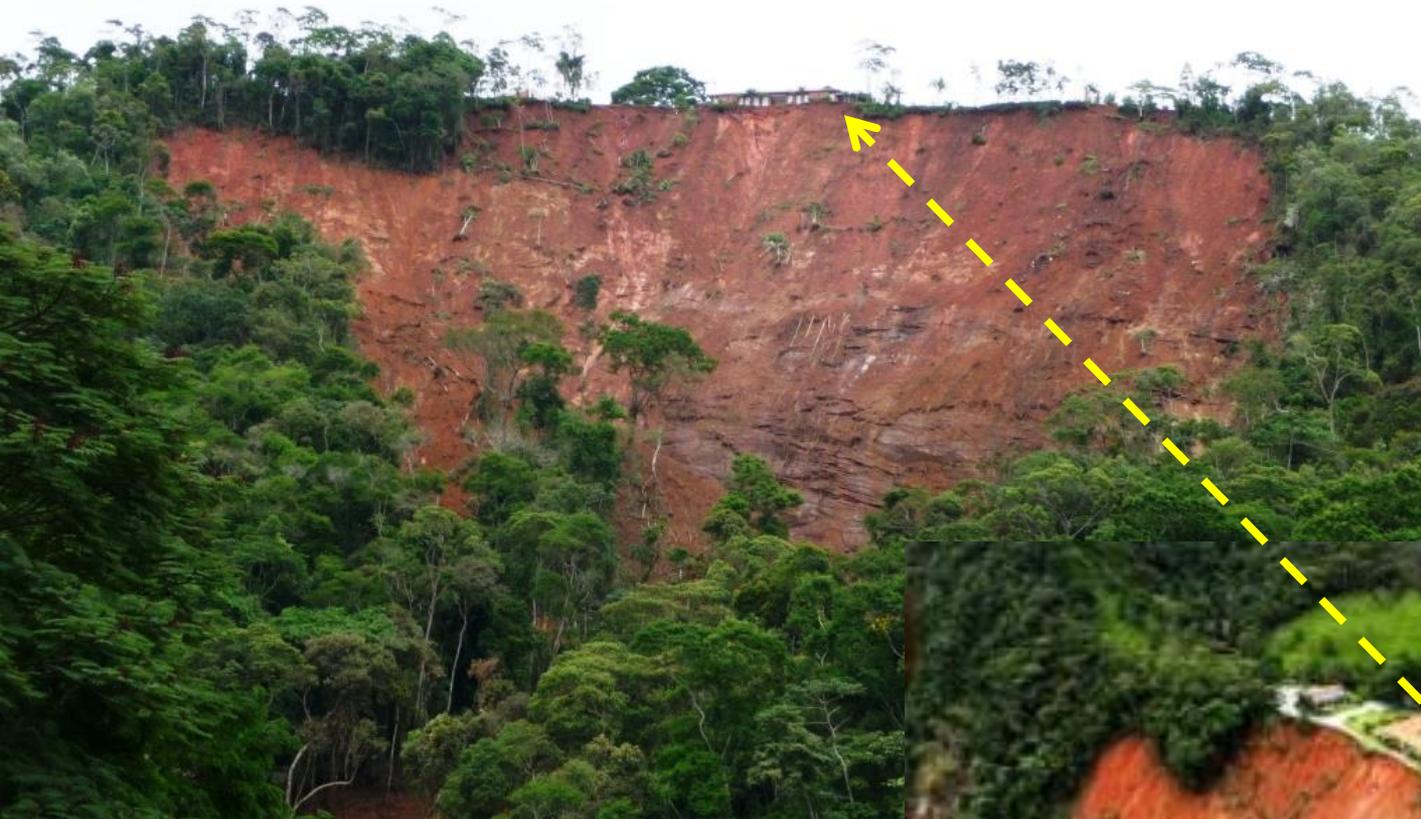
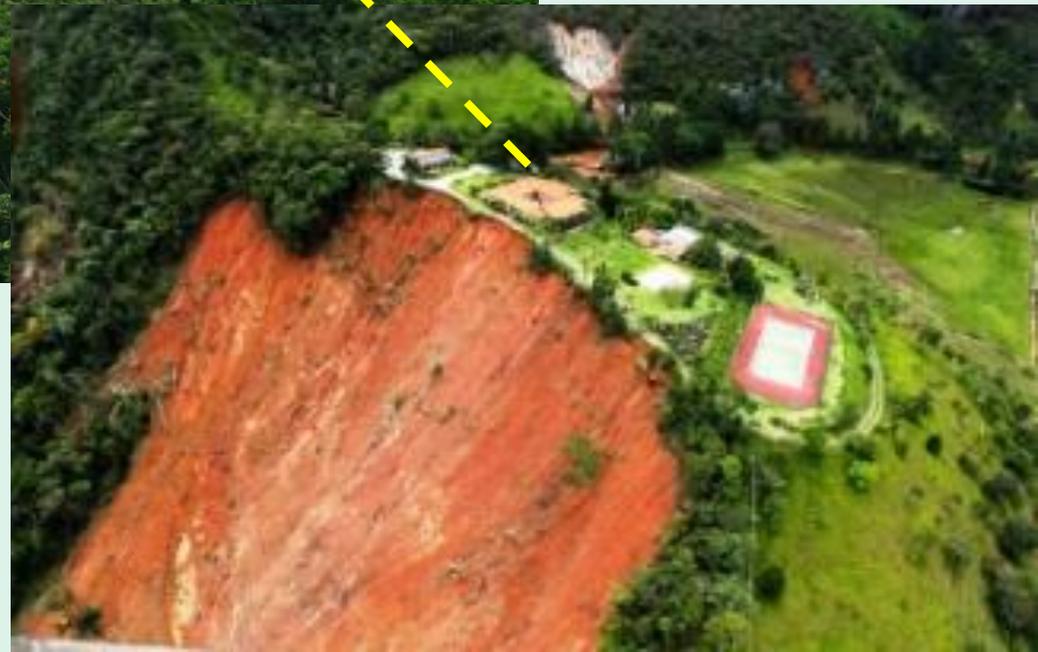
**Landslide like this is common in Brazil due to highly erodible soil and extreme weather caused by climate change**
