# Contribution of VST in Alleviating Climate Change Disasters

**Paul Truong**  
*TVNI Technical Director*  
*Director for Asia and Oceania,*  
**Brisbane, Australia**

# CASE STUDY: Flood erosion control in Australia

## Flood erosion control in drainage channel at Laidley

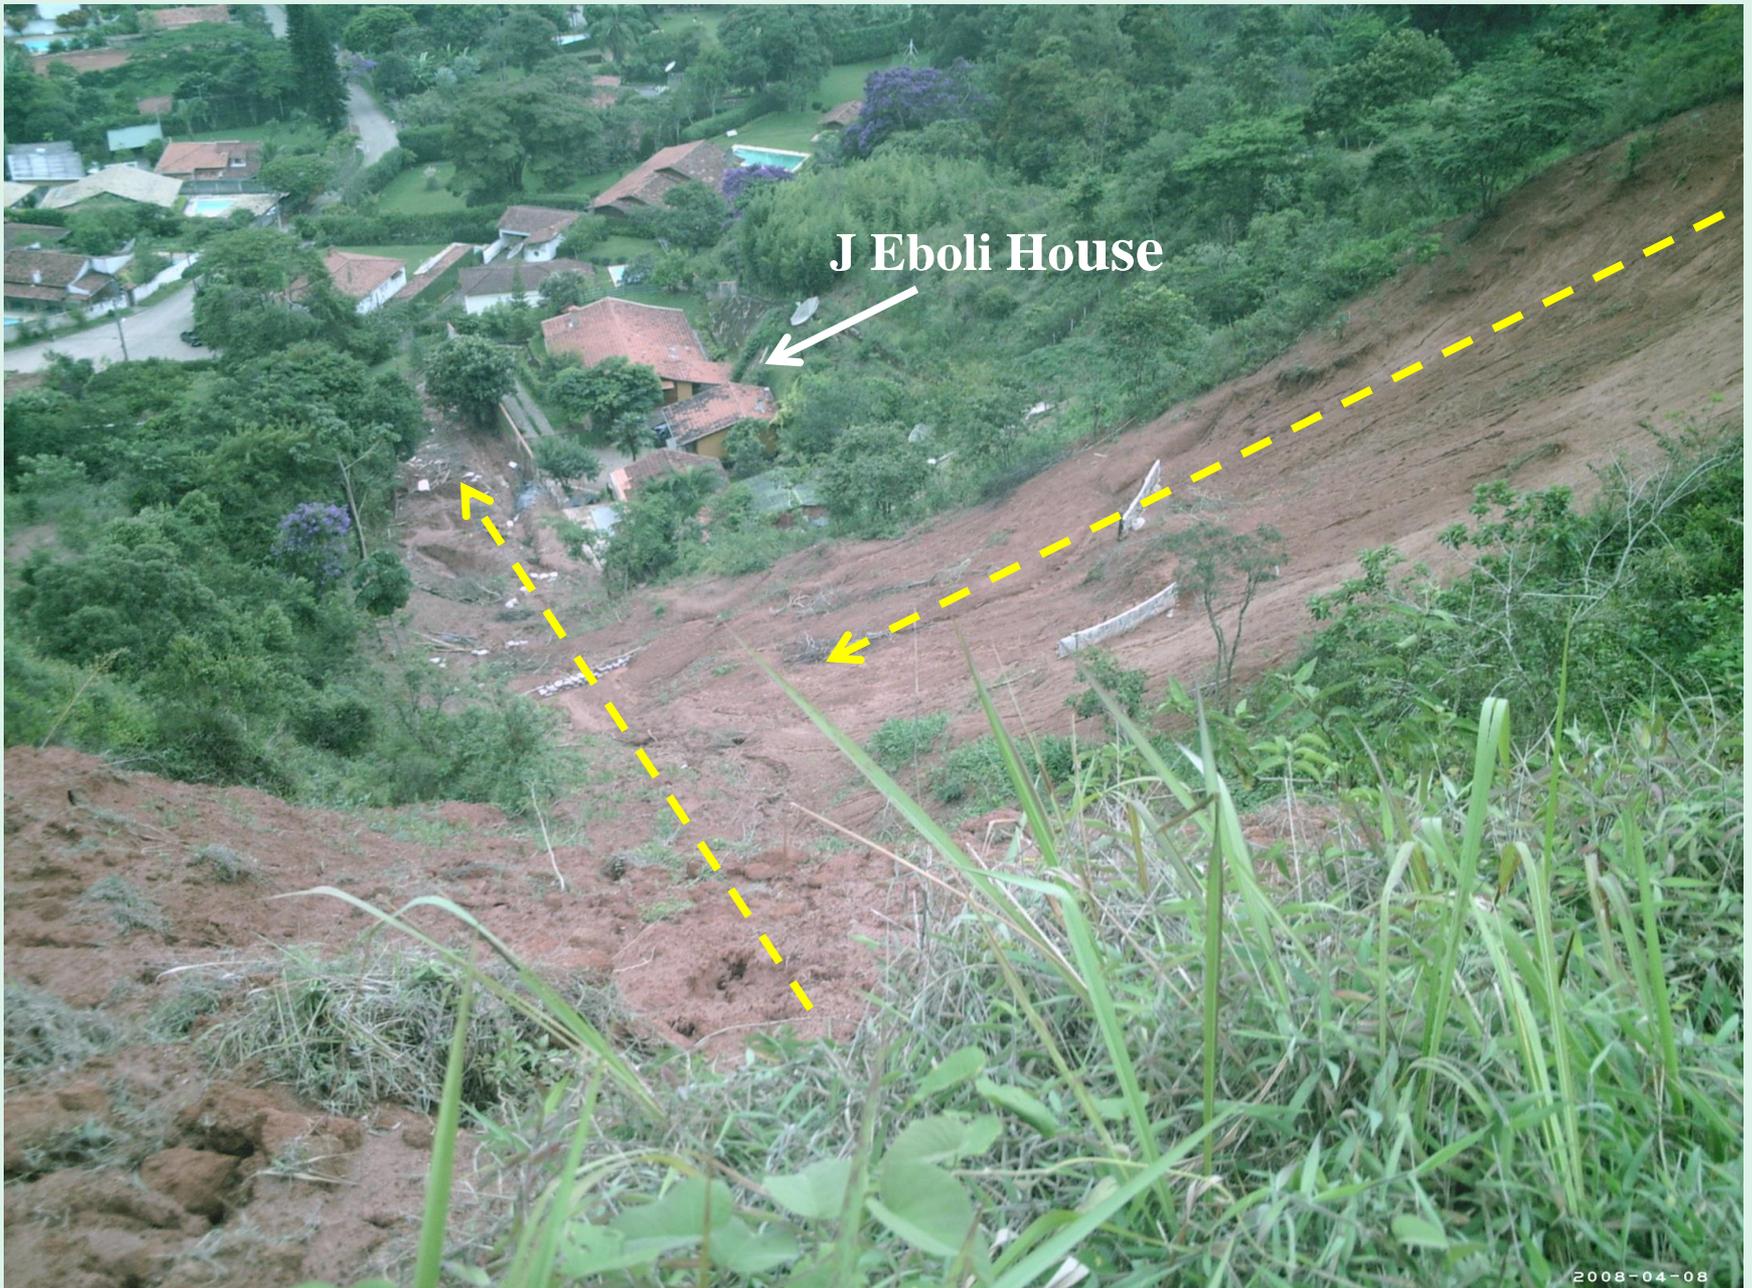
# Site steep gradient (66%-97%) and planting layout

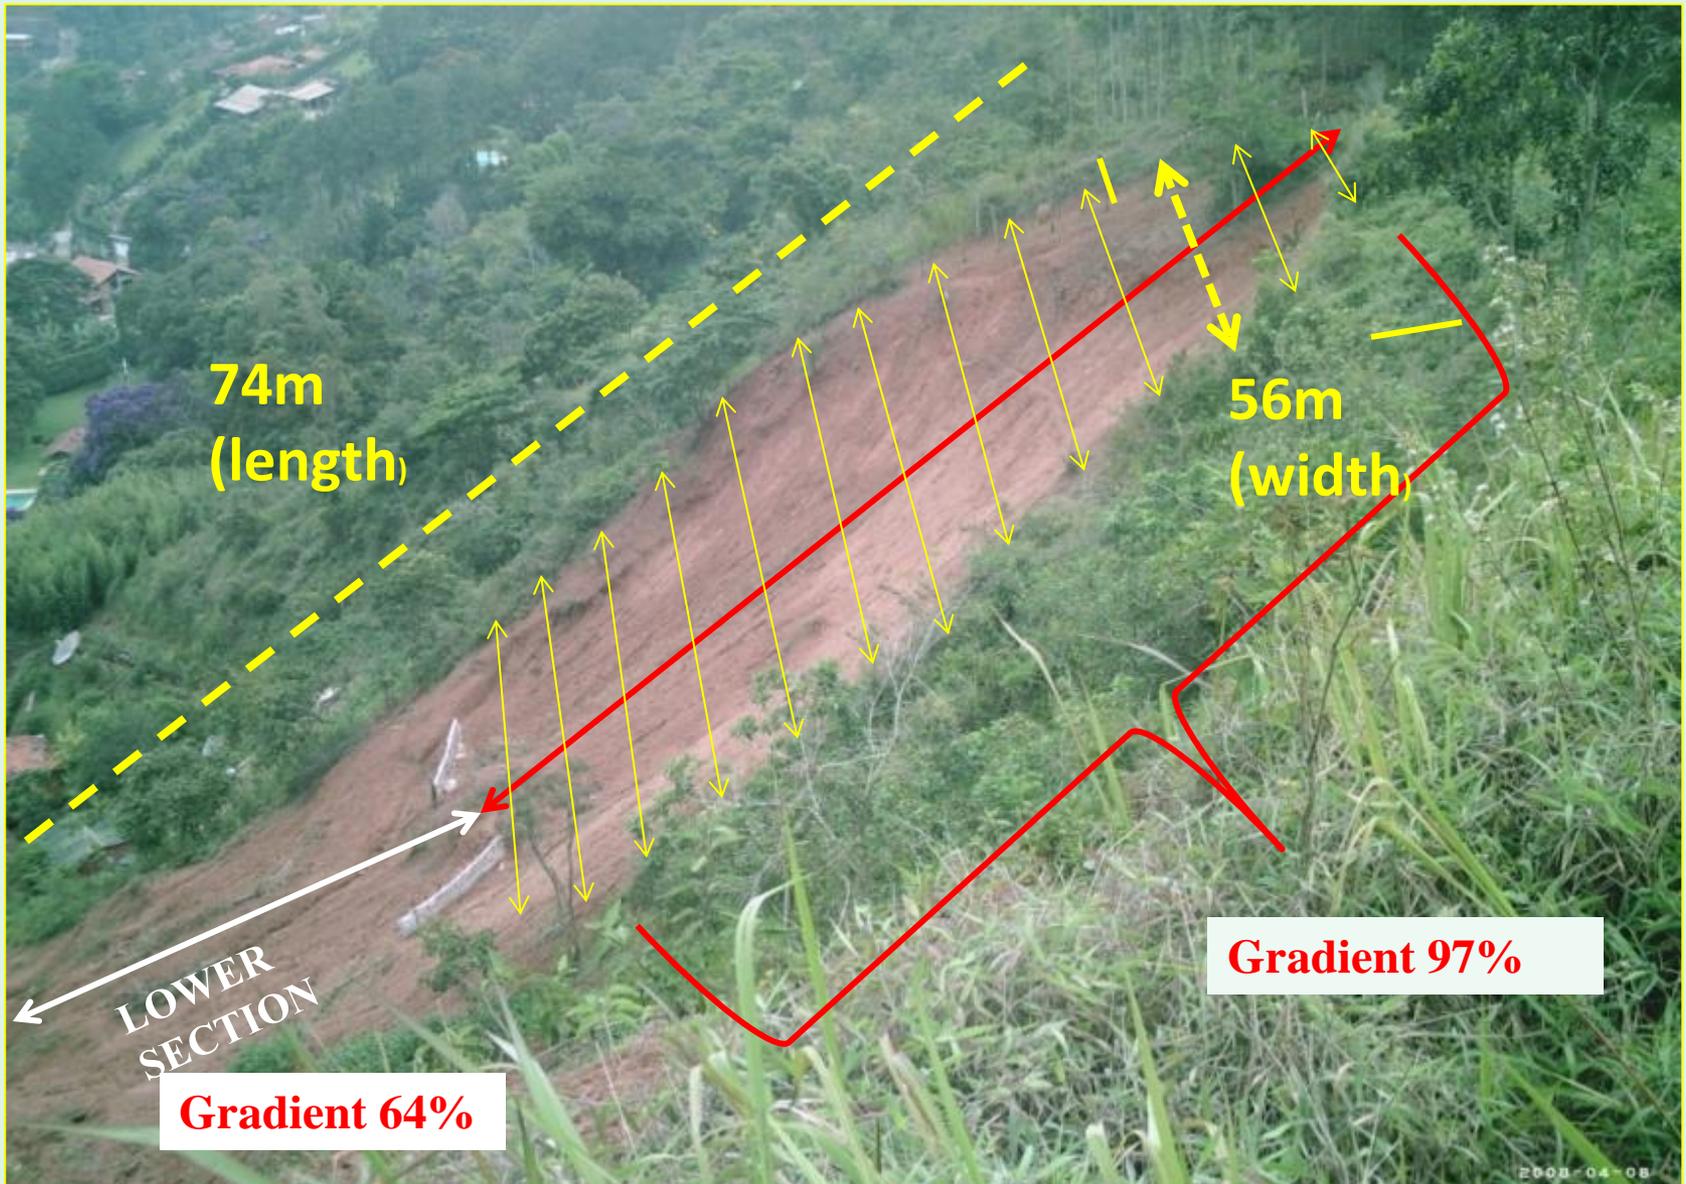
# Site clean up and preparation for Vetiver planting

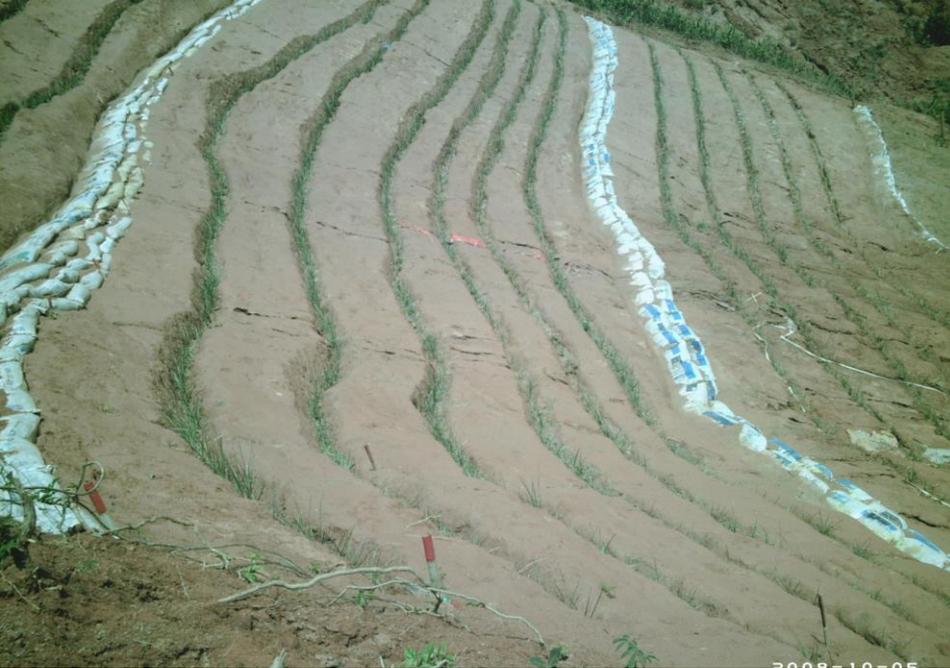
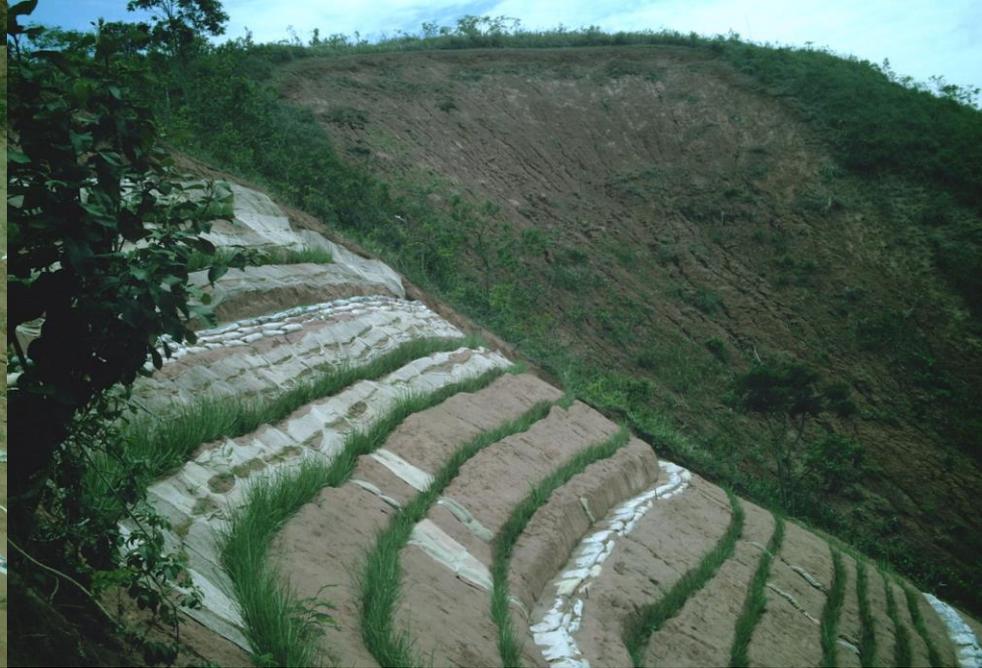
**Planting on contour lines ay 1m Vertical Interval**

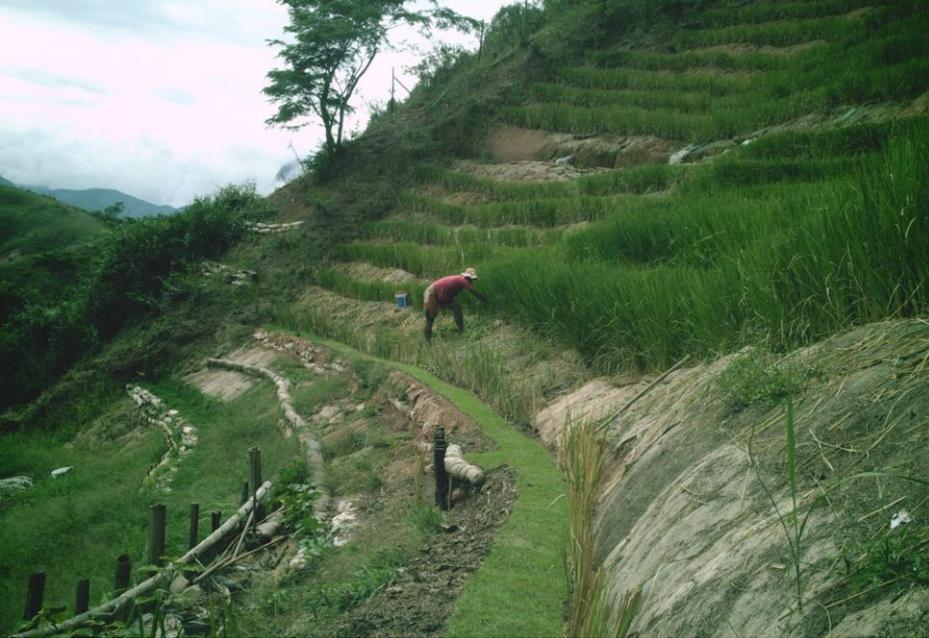
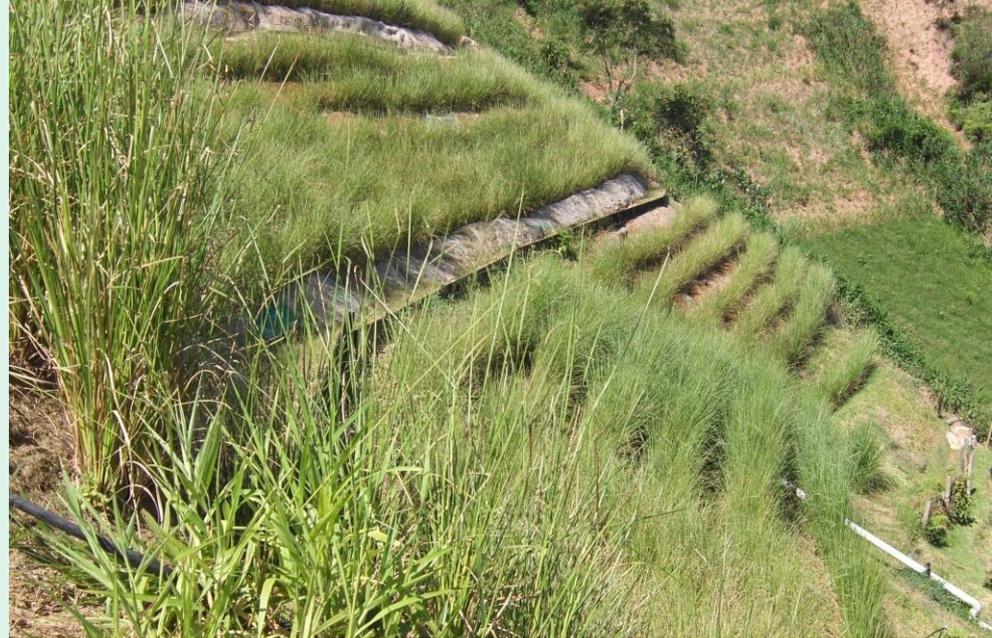
**Vetiver planting has successfully stabilized this landslide**

- After four years the slope has maintained its integrity demonstrating and proving that Vetiver grass can rehabilitate and maintain slopes affected by landslides.
- The use of VS for the stabilization of slopes not steeper than 1:1
- The VS will fail when not properly applied or not well maintained.
- The Vetiver when installed and following the correct technical guidelines is a guaranteed success

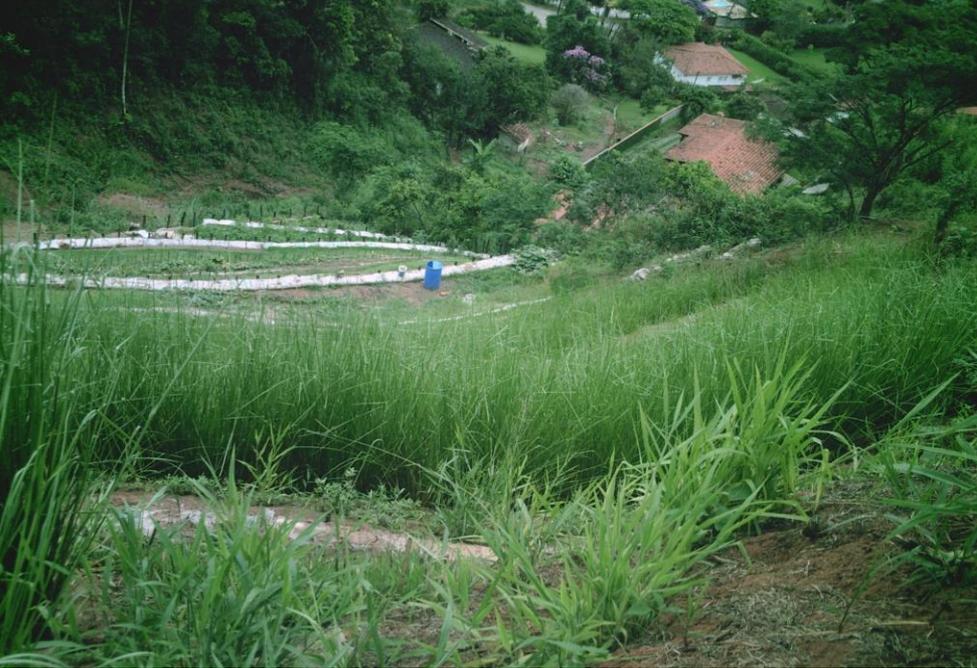
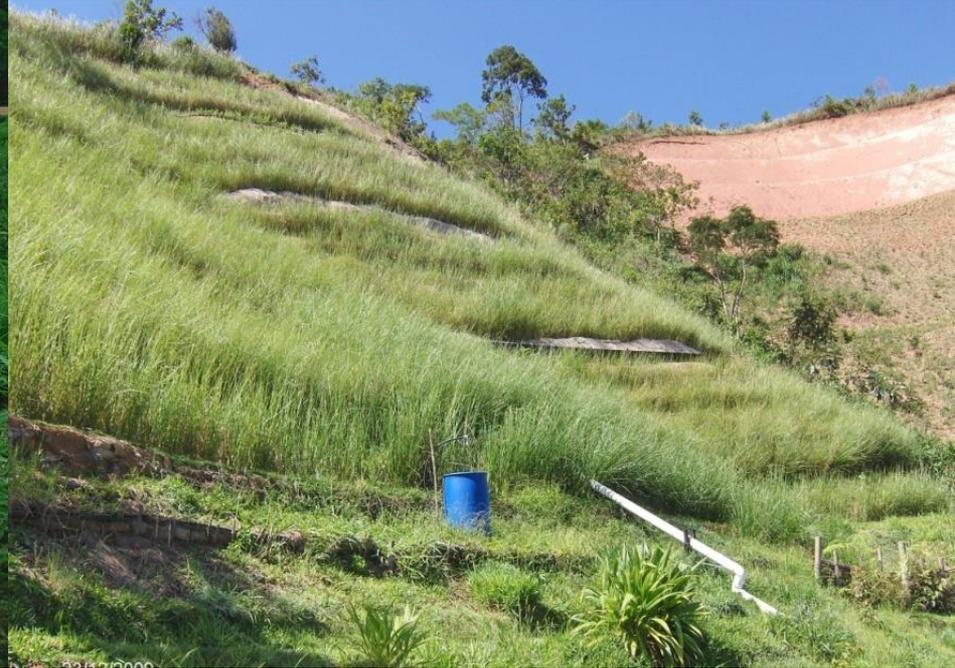
**Three years after planting and withstood several intense storms**
