# VETIVER SYSTEM FOR BEACH EROSION REHABILITATION

**Paul Truong - *TVNI Technical Director***

# Brazilian Beach

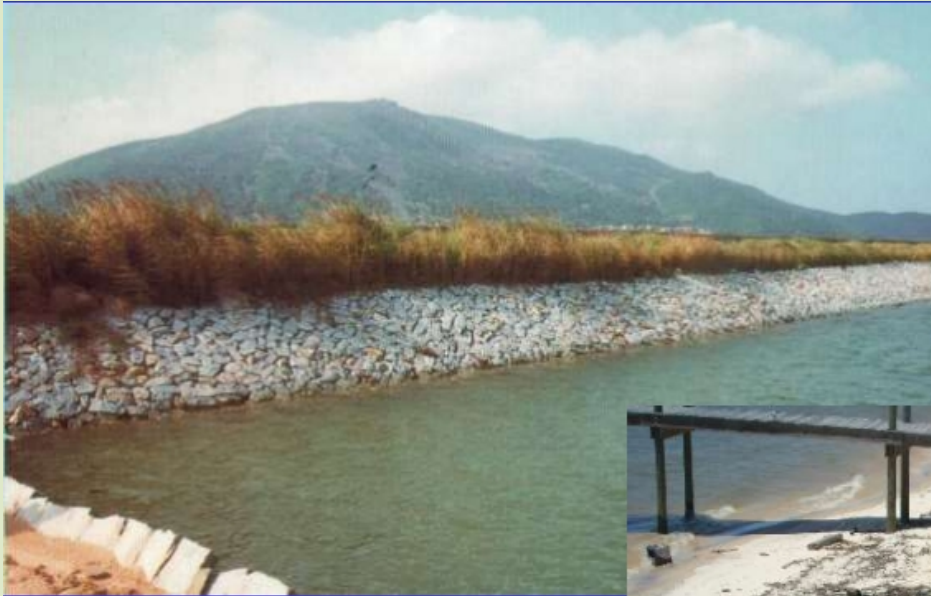
Left: China, Sea wall protected by vetiver - 100% salt water fish pond. Where planted there was no breaching by cyclones

Right: Vetiver protected this beach cliff interface on Alabama Bay (brackish water), USA

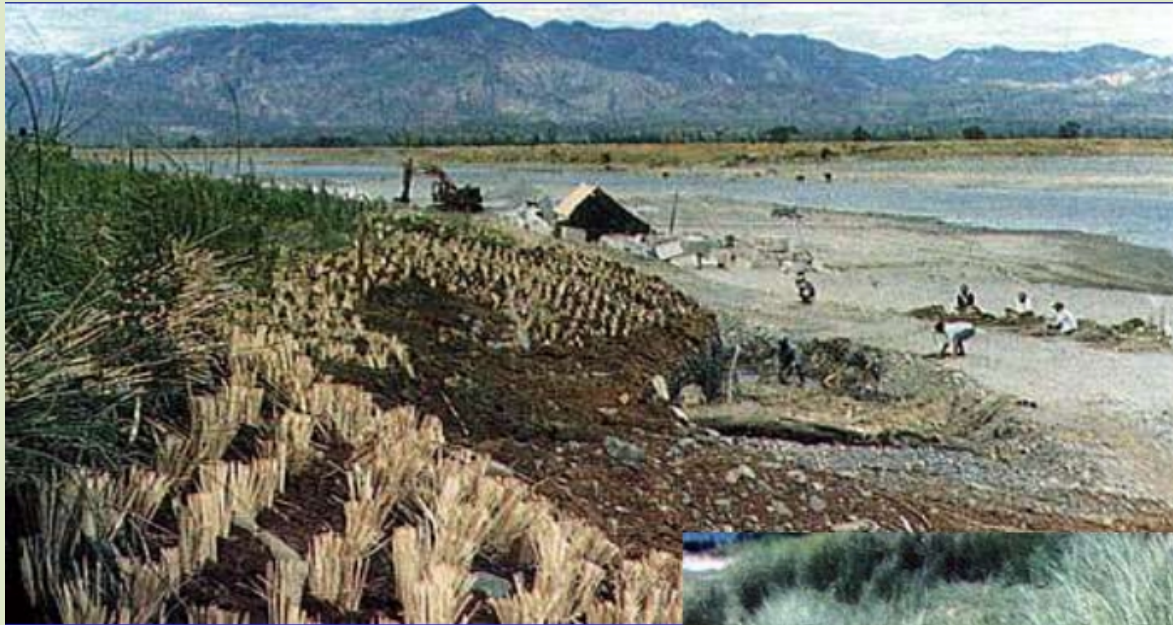
# Philippines: Vetiver planting to protect the bank of Abra River estuary against flood erosion and tidal surge

**One year after planting,  
the bank was  
successfully stabilised**

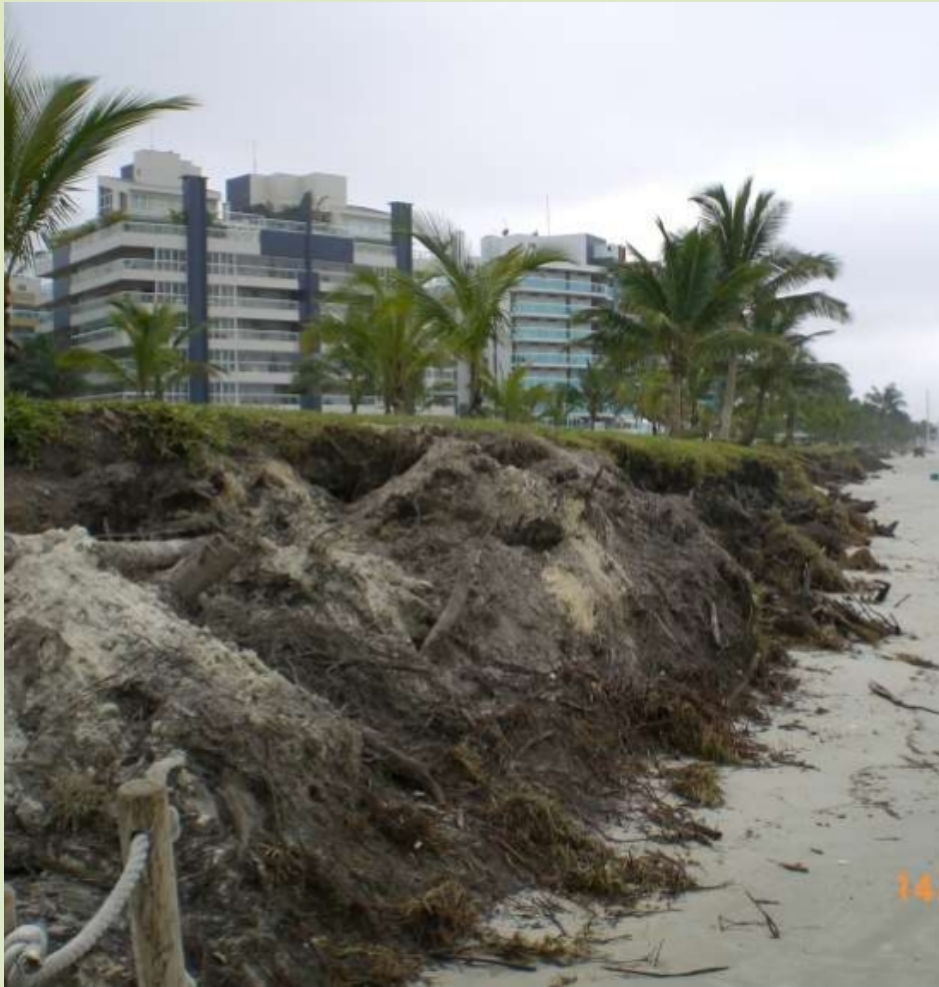
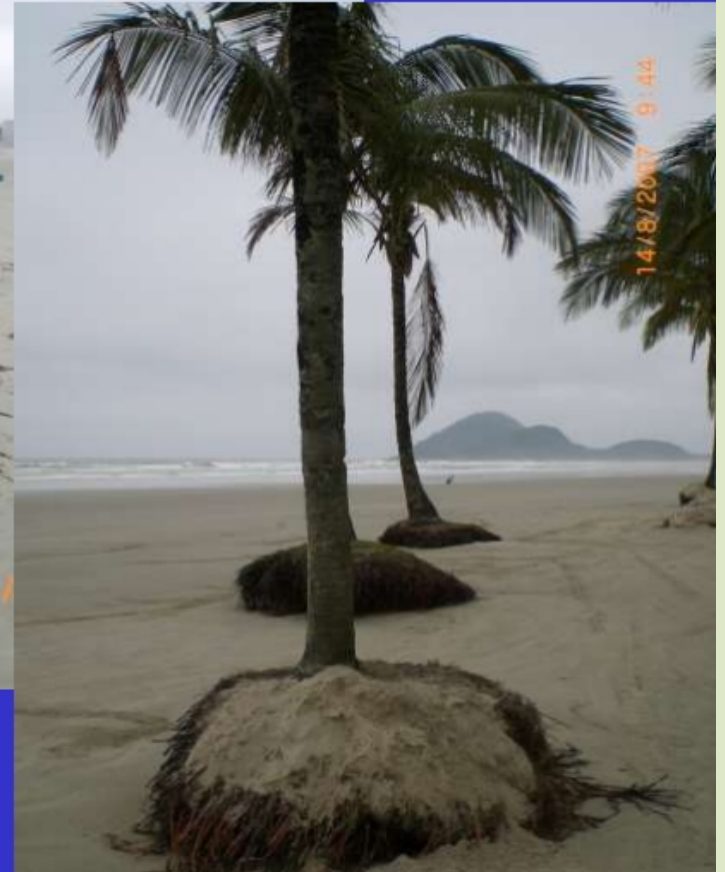
Erosion of beach dune protected by “Sweet Grass” - *Paspalum maritimum* .

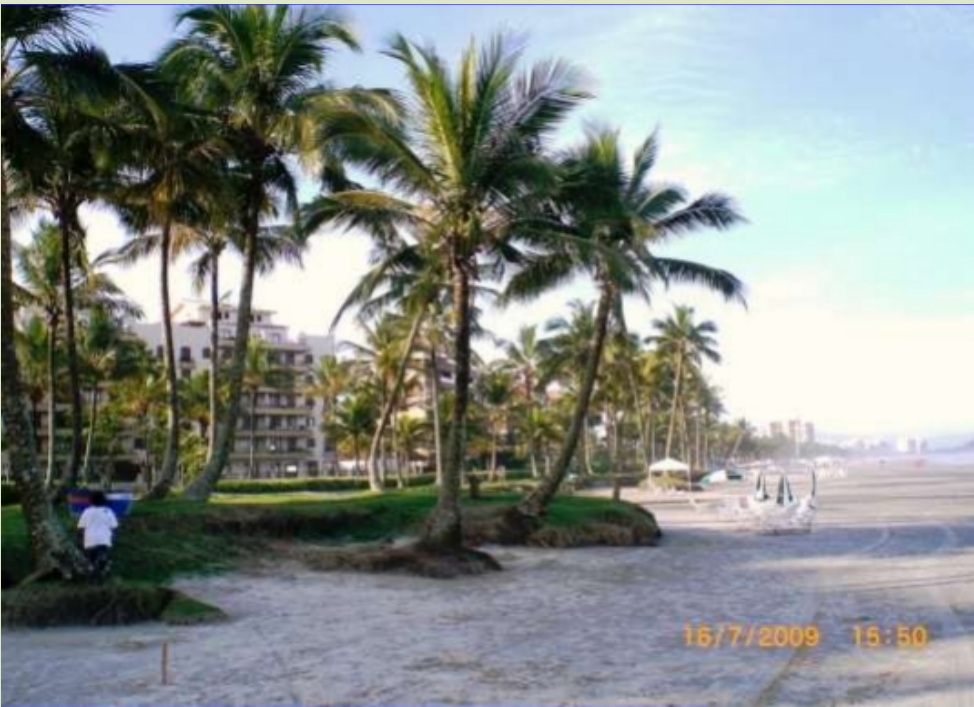
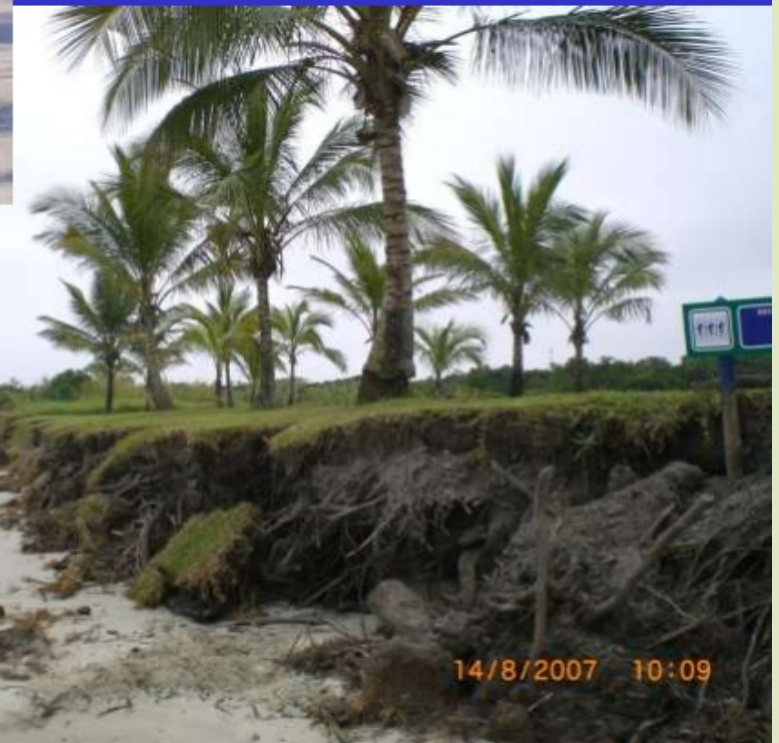
Erosion of beach dune protected by “Sweet Grass” - *Paspalum Maritimum*.

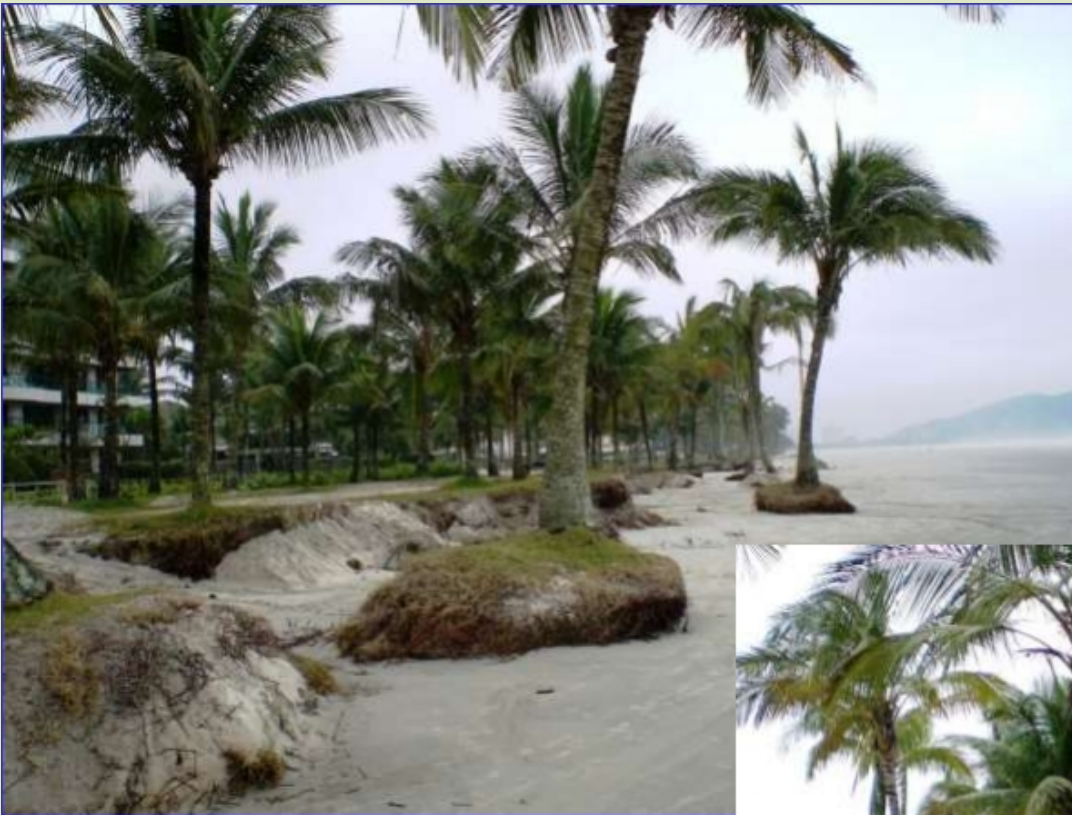
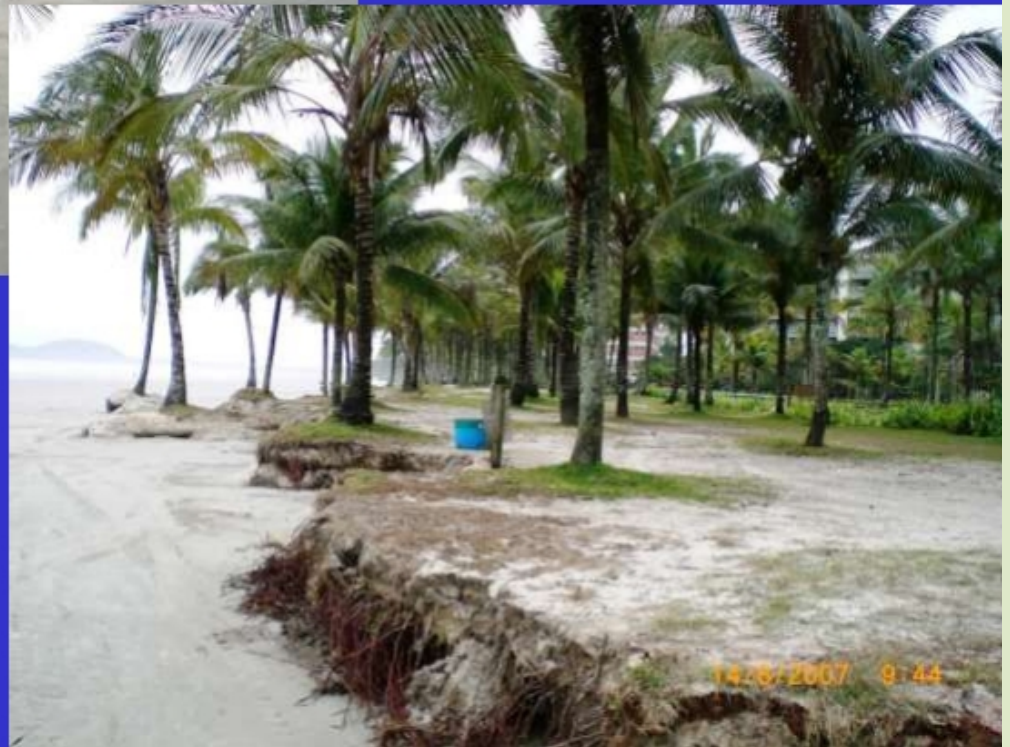
Erosion of beach dune  
protected by “Sweet  
Grass” - *Paspalum  
maritimum* ,

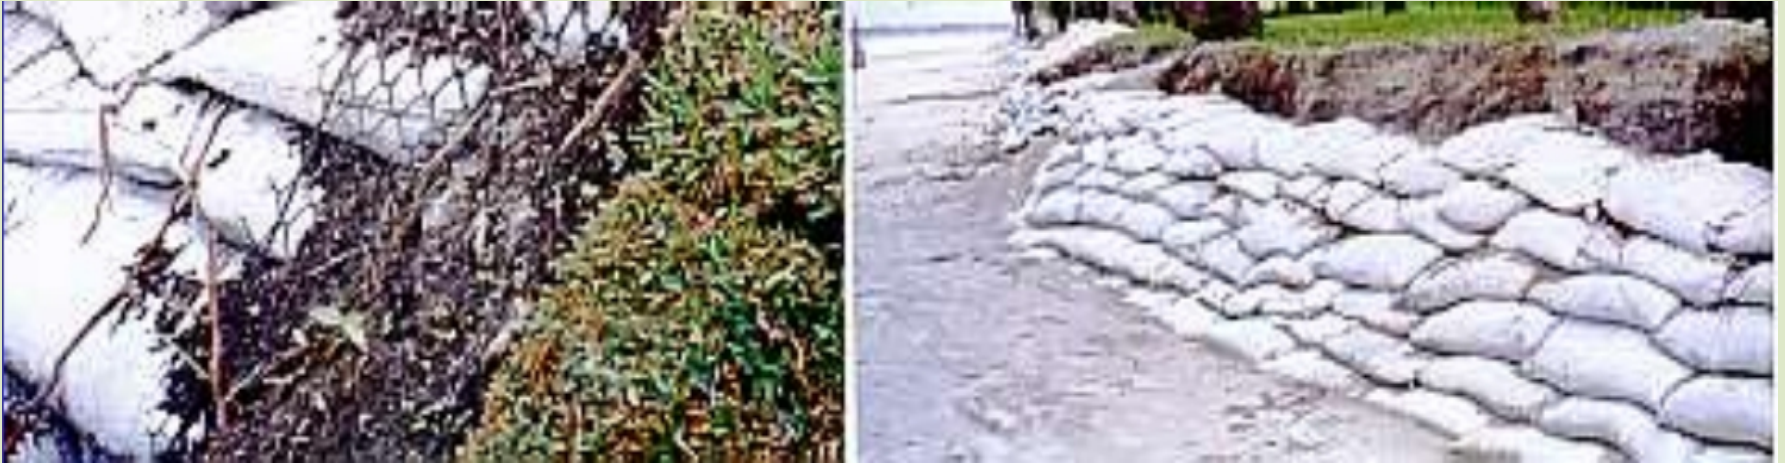
**In 2008 the initial solution was to build a rip rap using raffia bags filled with a mixture of soil-cement in the proportion of 12% cement and 88% of local soil**

**Although this measure worked partially, it had very low landscape appeal for an urbanized condominium settlement on Brazil number one beach. Eventually, due to concerns of the local Community Association and environment authorities, who wanted a most environmentally friendly method for the region, which lead to the search of a new concept of beach protection combined with landscaping .**

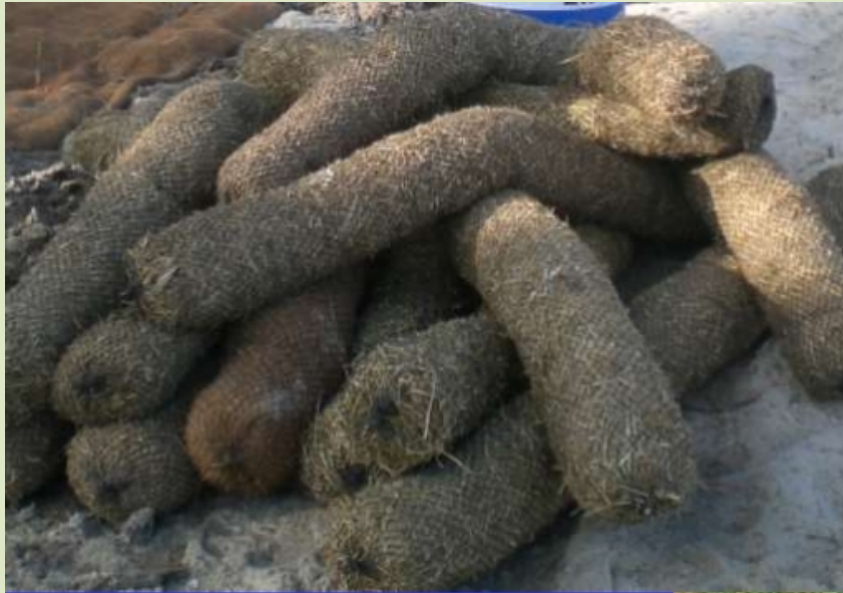
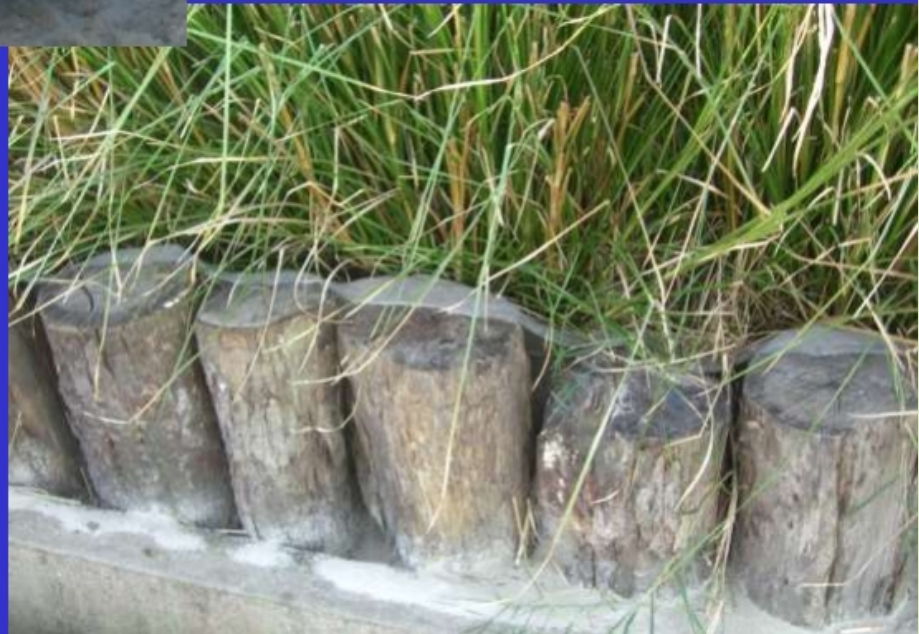
**Cocologs in low risk area**

**Wooden palisade in high risk area to increase security factor of the structure anticipating sea level rise in the future.**

**Bio-engineering with Vetiver grass: Using Cocologs in low risk area and wooden palisade in high risk area to increase security factor of the structure anticipating sea level rise due to climate change in the future.**

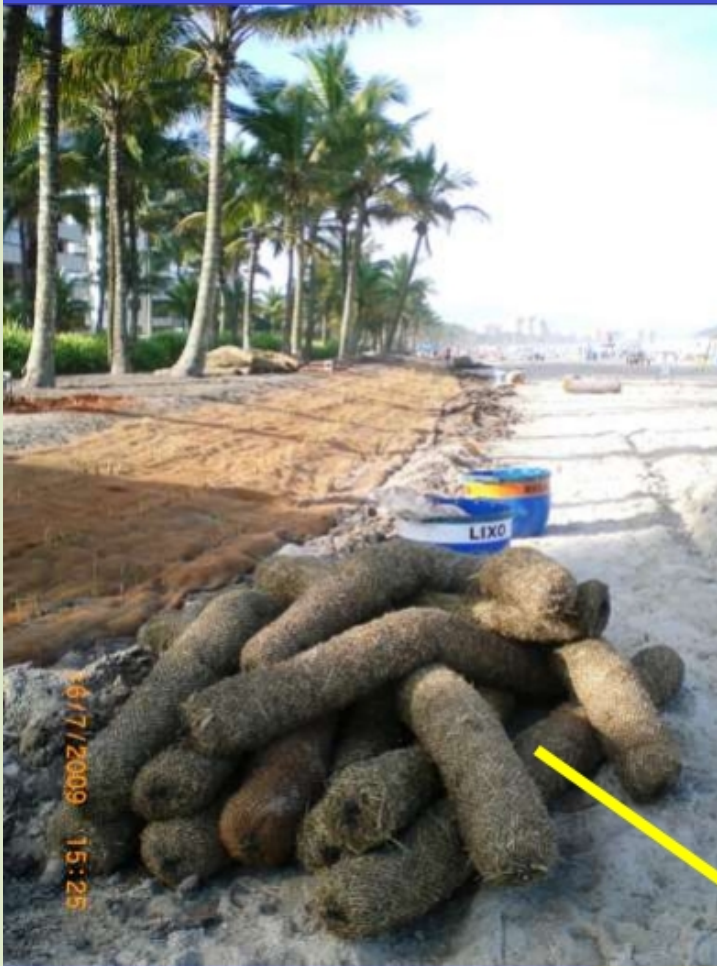
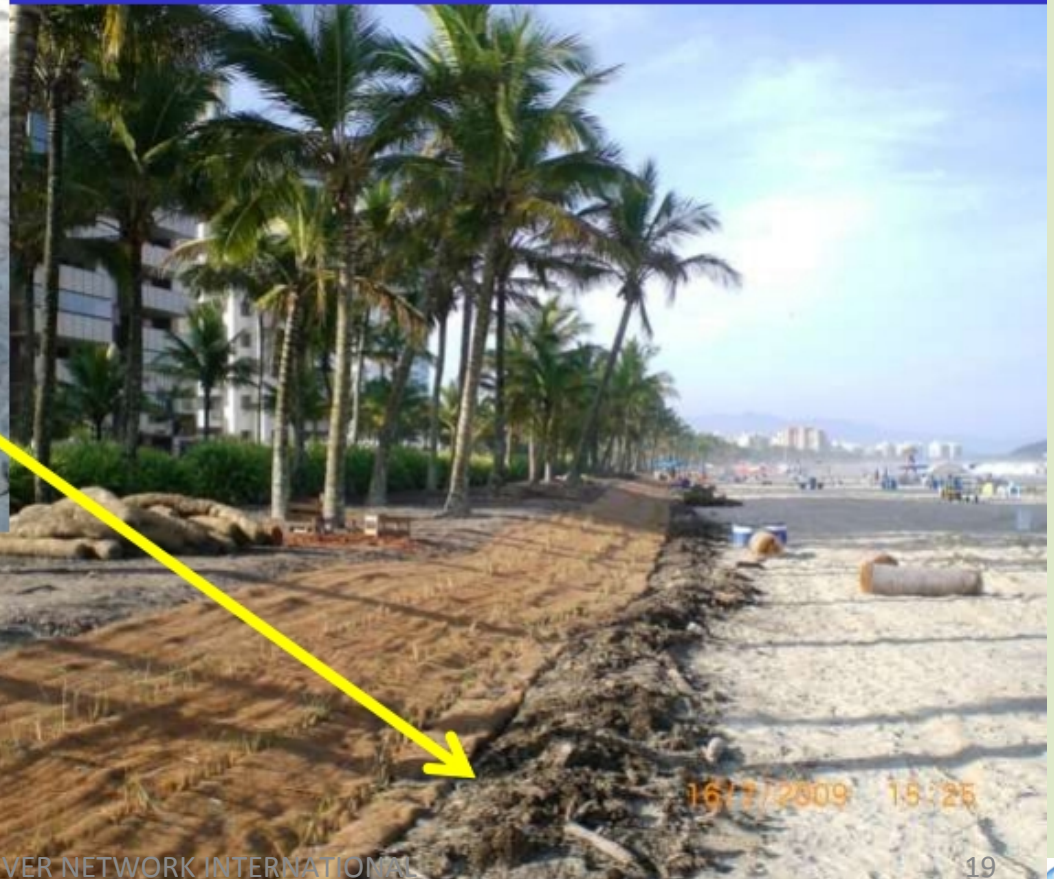
Cocologs in low risk area, with biodegradable jutemesh to protect sand surface during vetiver establishment phase

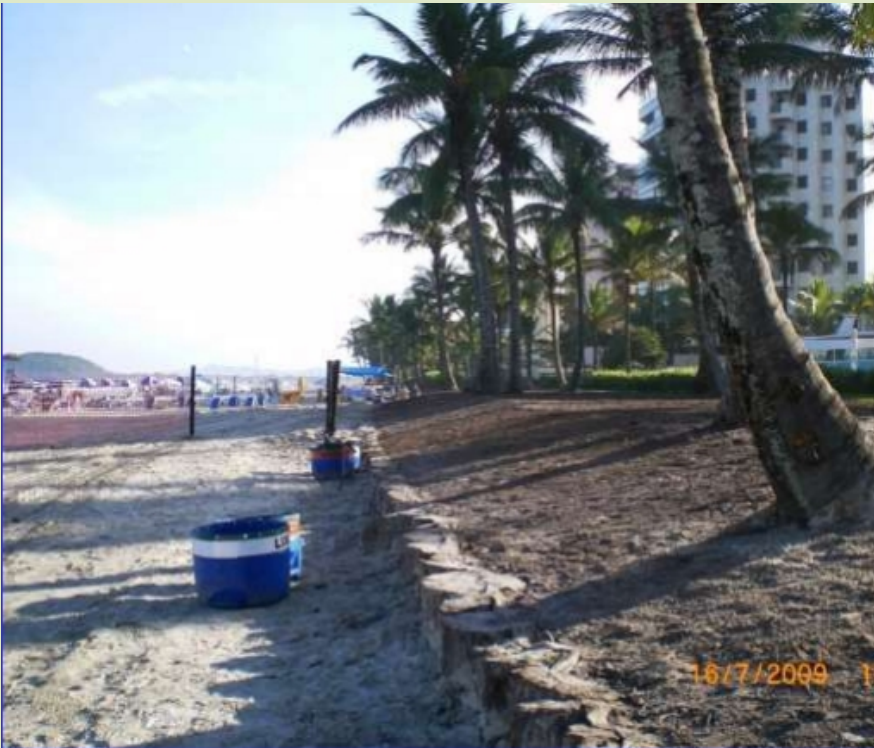
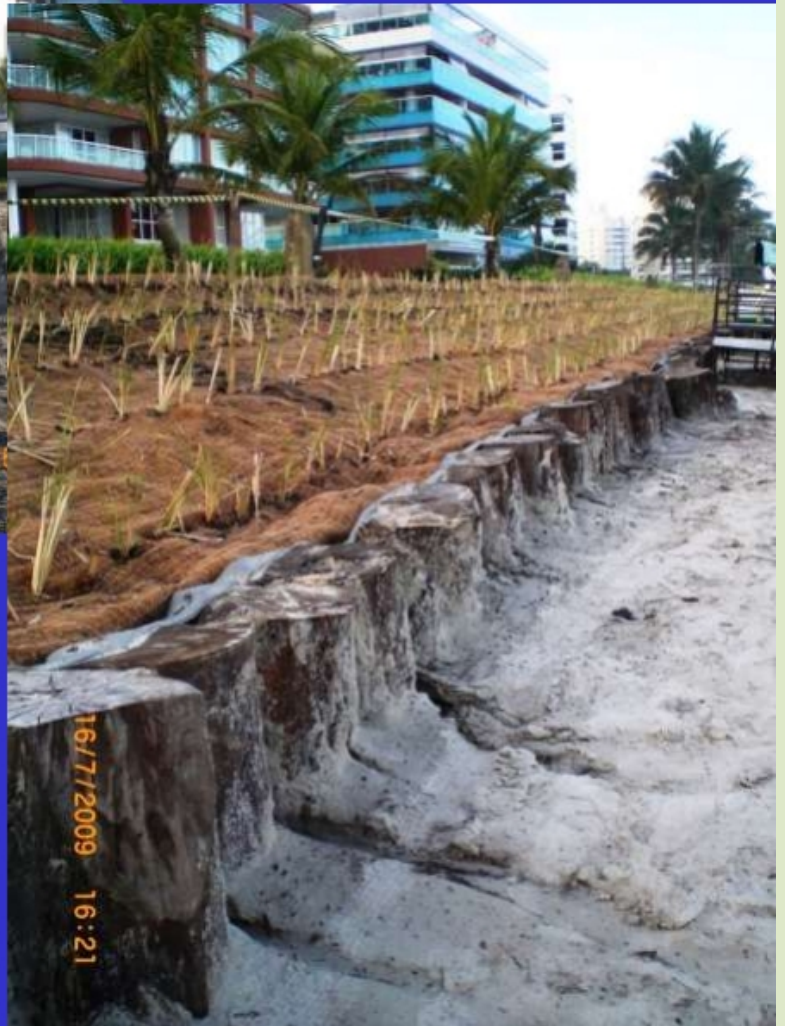
**Wooden palisade in high risk area,  
before and after biodegradable  
jutemesh installation.**

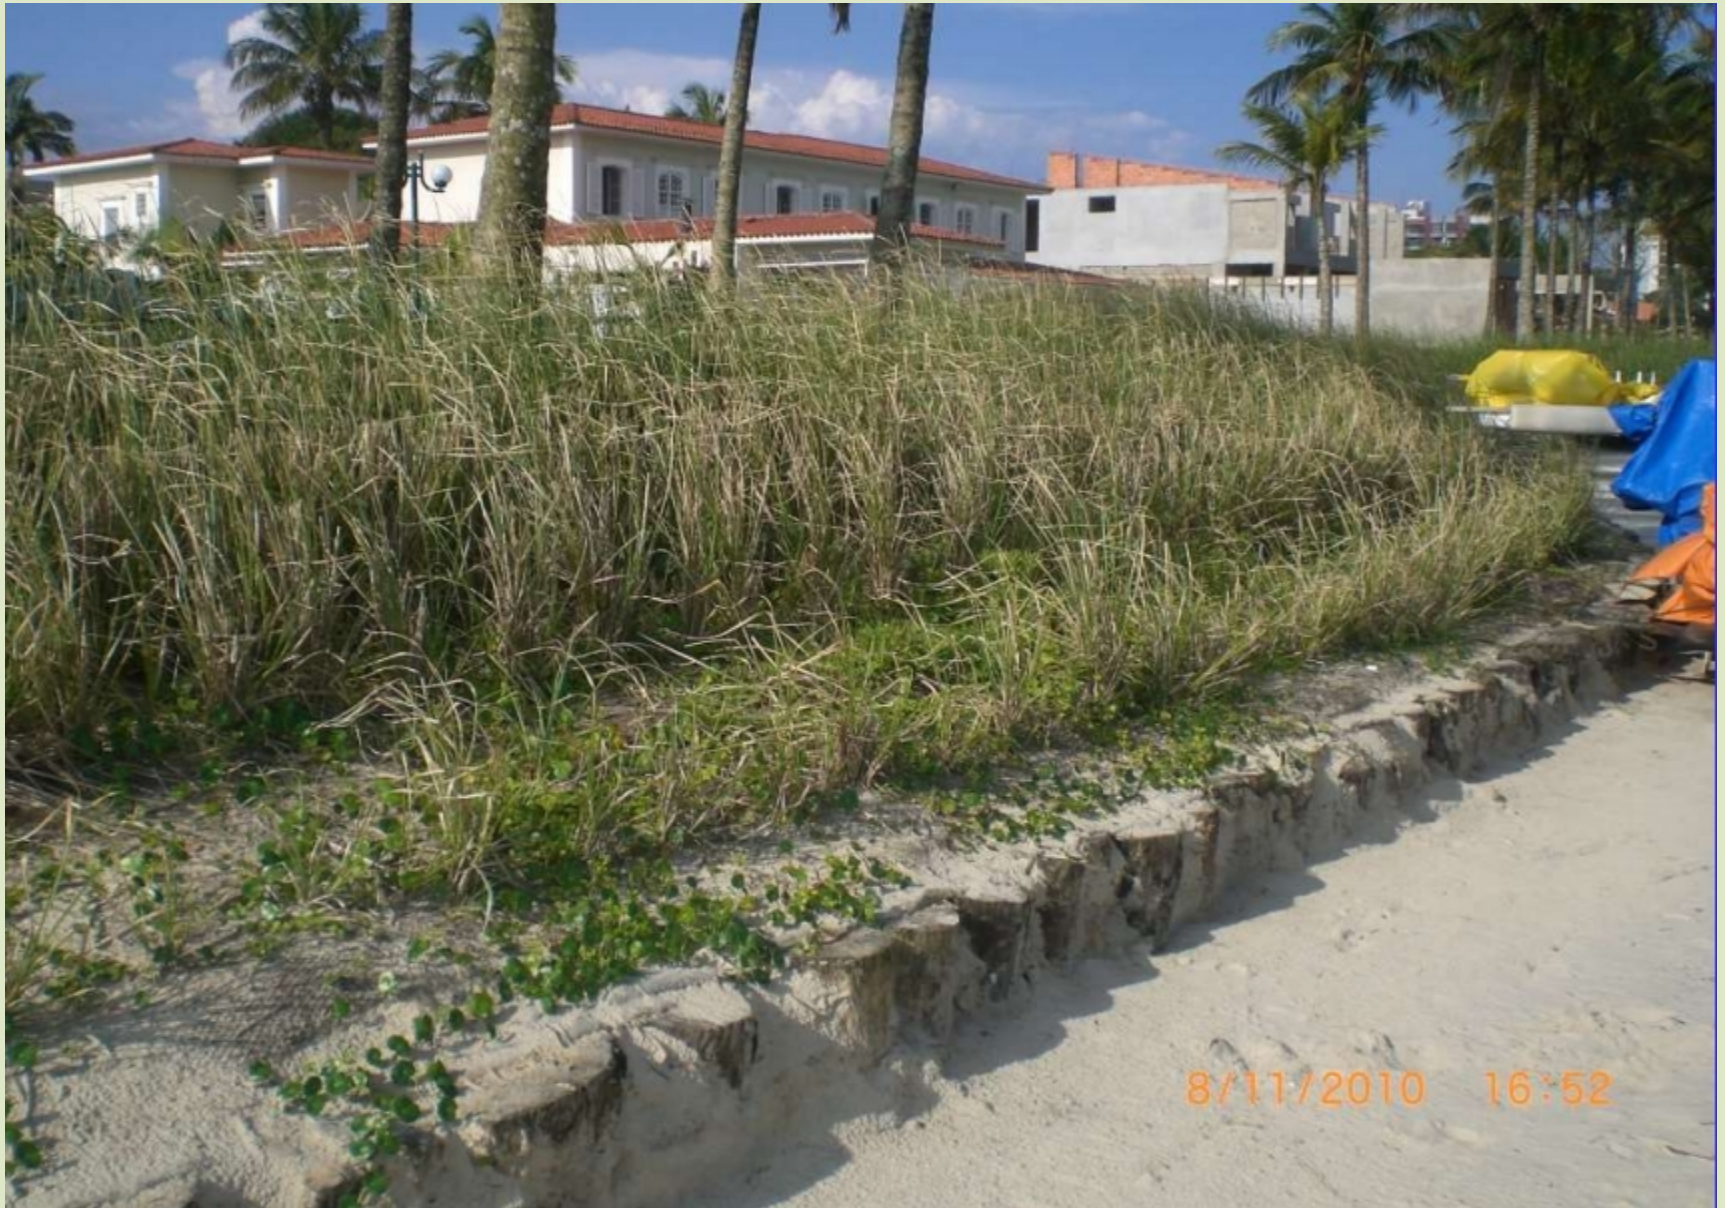
# Strong surf and wave bent the first few Vetiver hedgerows

**Badly damaged  
Vetiver plants in the  
front rows but they  
recovered naturally.**

**The highest tides in Brazilian coast usually occur during August and September. In September 2009, there were some major sea storm surges leading to strong surf and wave hitting the site just six weeks after the installation of stage one.**

**These storm surges badly damaged Vetiver plants in the first hedgerow but they recovered naturally.**

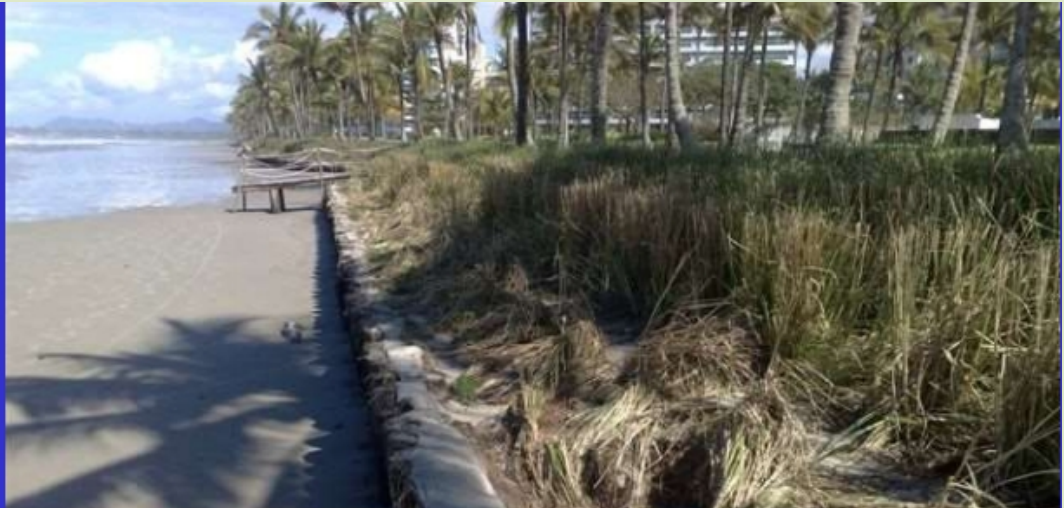
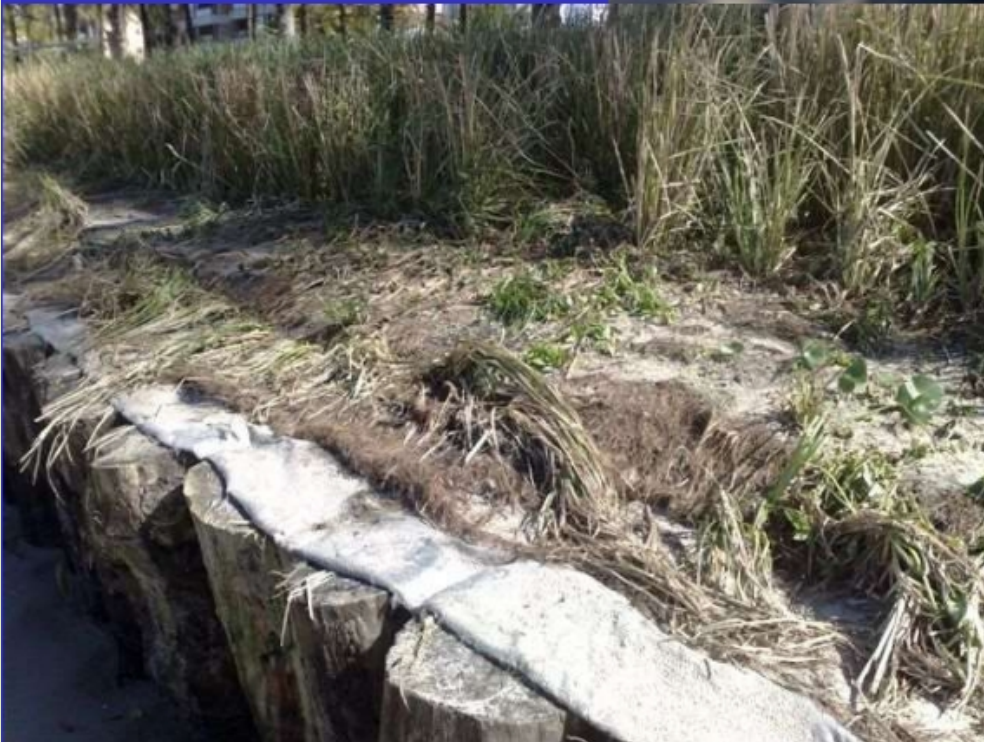
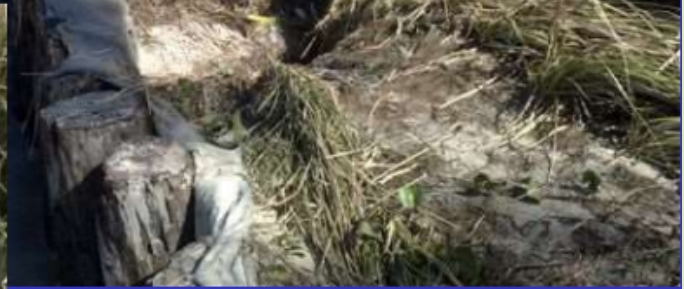
**No soil loss occurred in the first 3 Vetiver rows at the worst area where the waves hit**

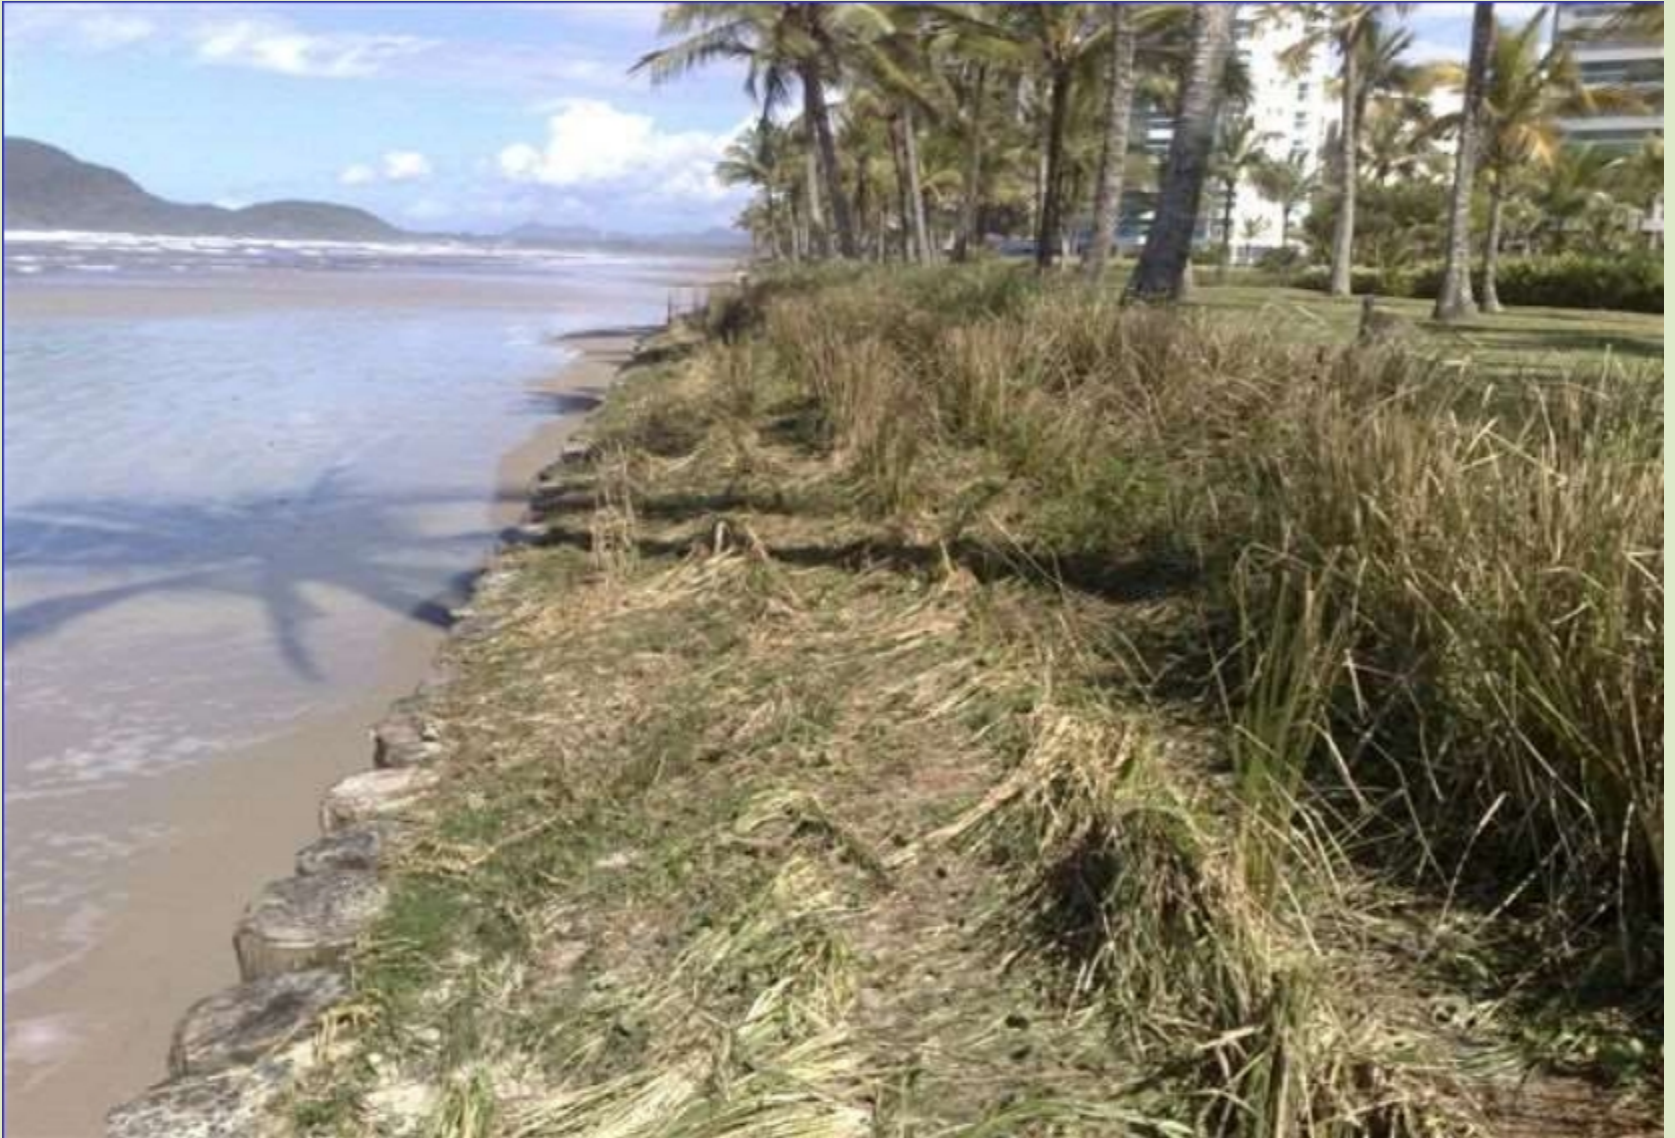
# Frontal view of the beach showing Vetiver integrated completely to landscaping.

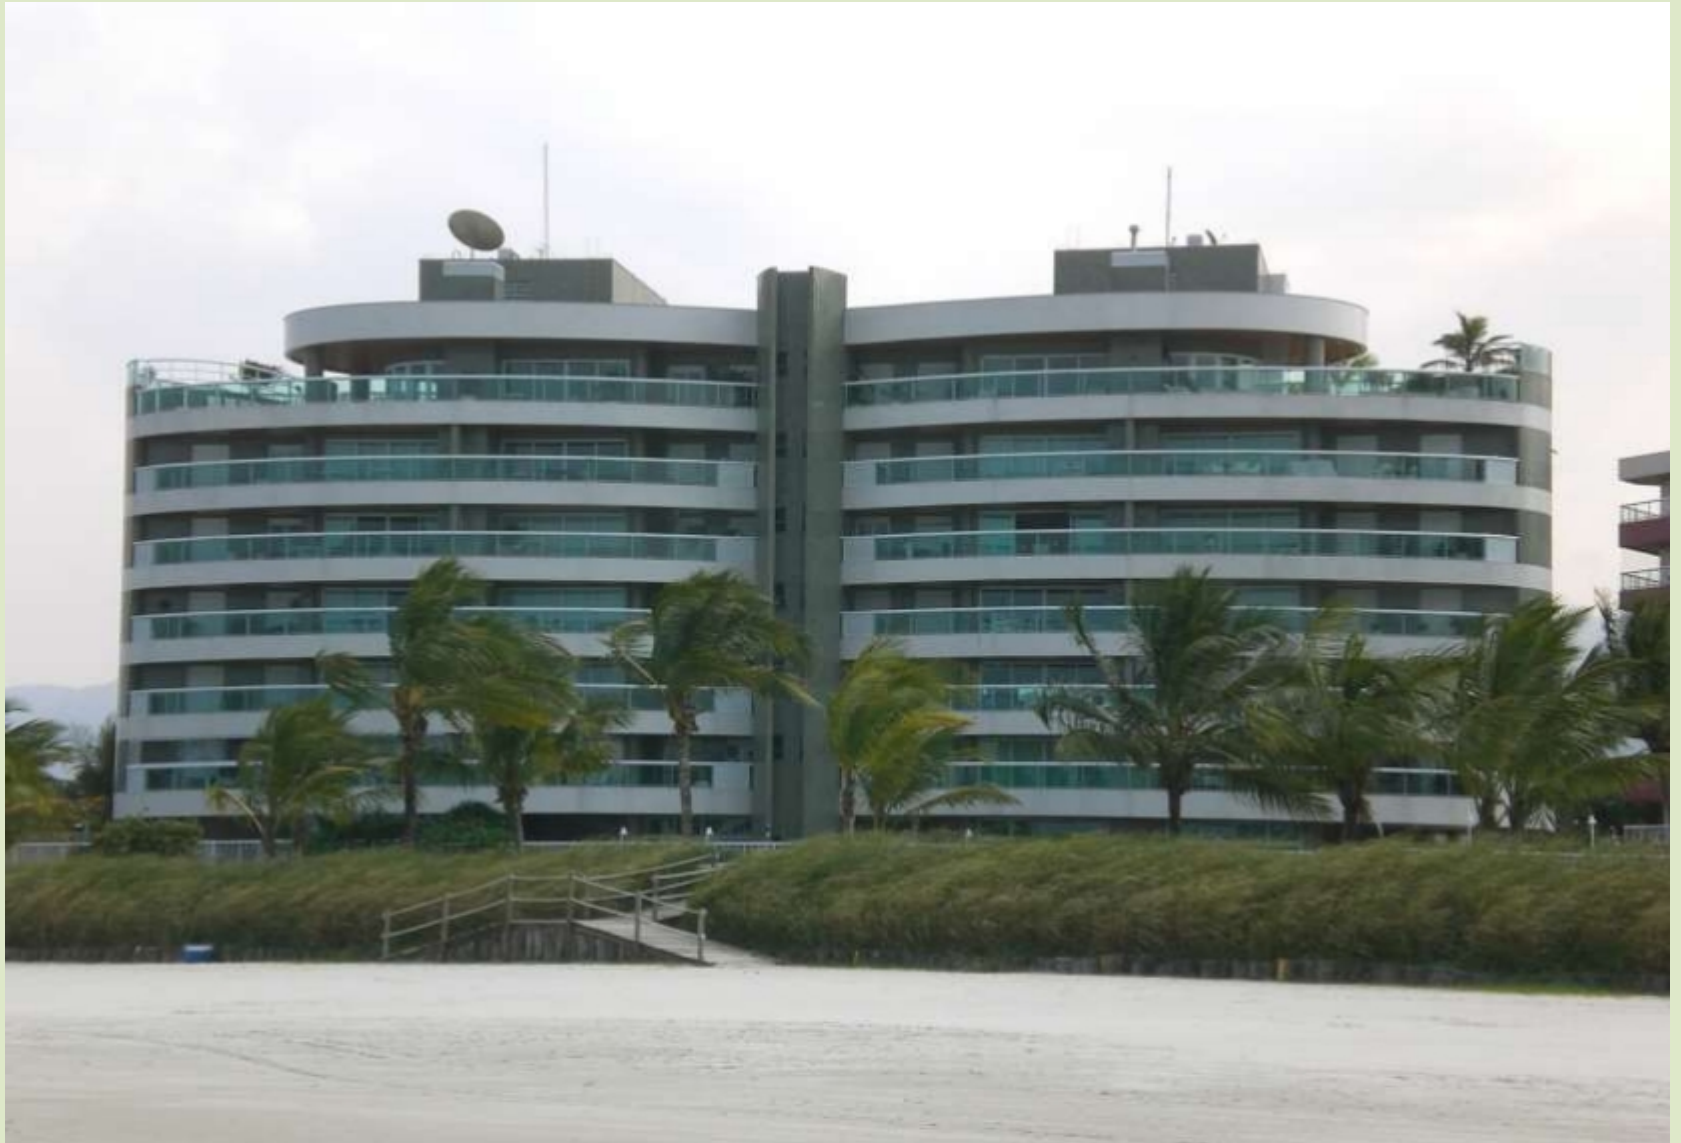
# Beach view showing Vetiver completely integrated to landscaping.
