# VETIVER SYSTEM FOR EROSION CONTROL OF LEVEE BANKS AND SEA DIKES IN LOW LYING FLOOD PRONE AREAS

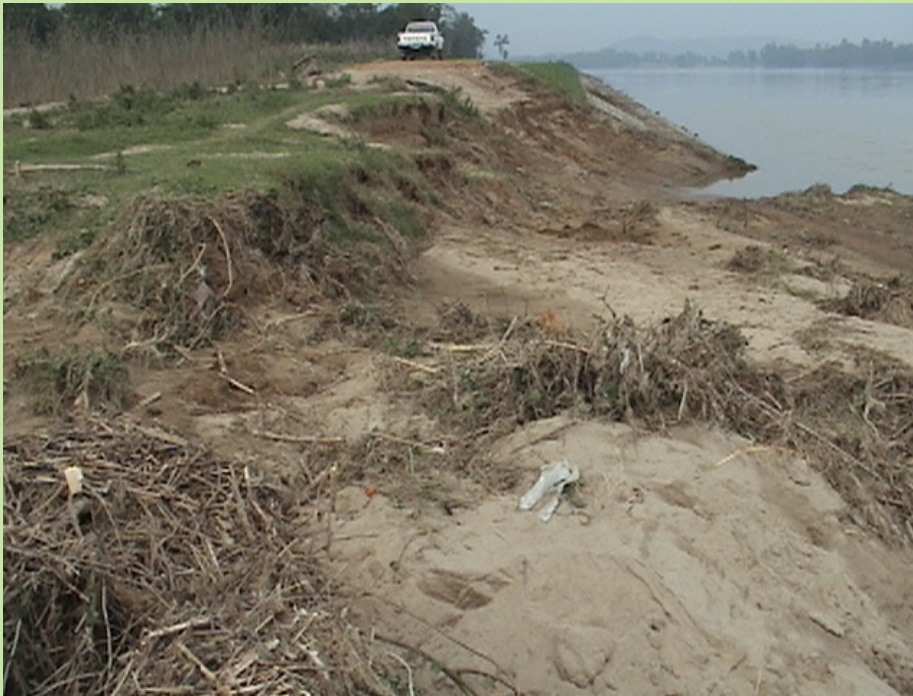
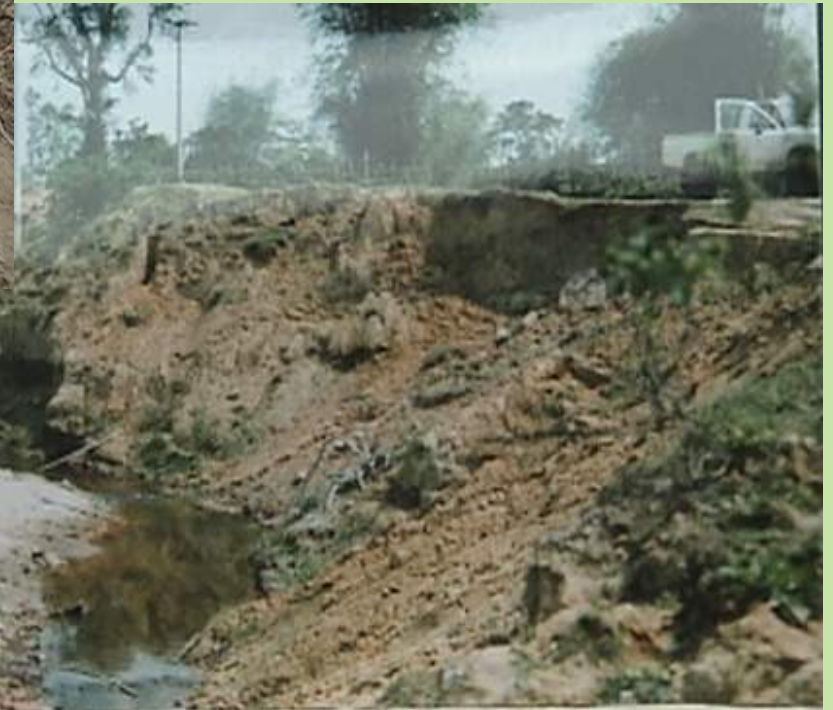
# Flash flood caused enormous damage to infrastructure such as levee banks in the central coastal provinces of Vietnam

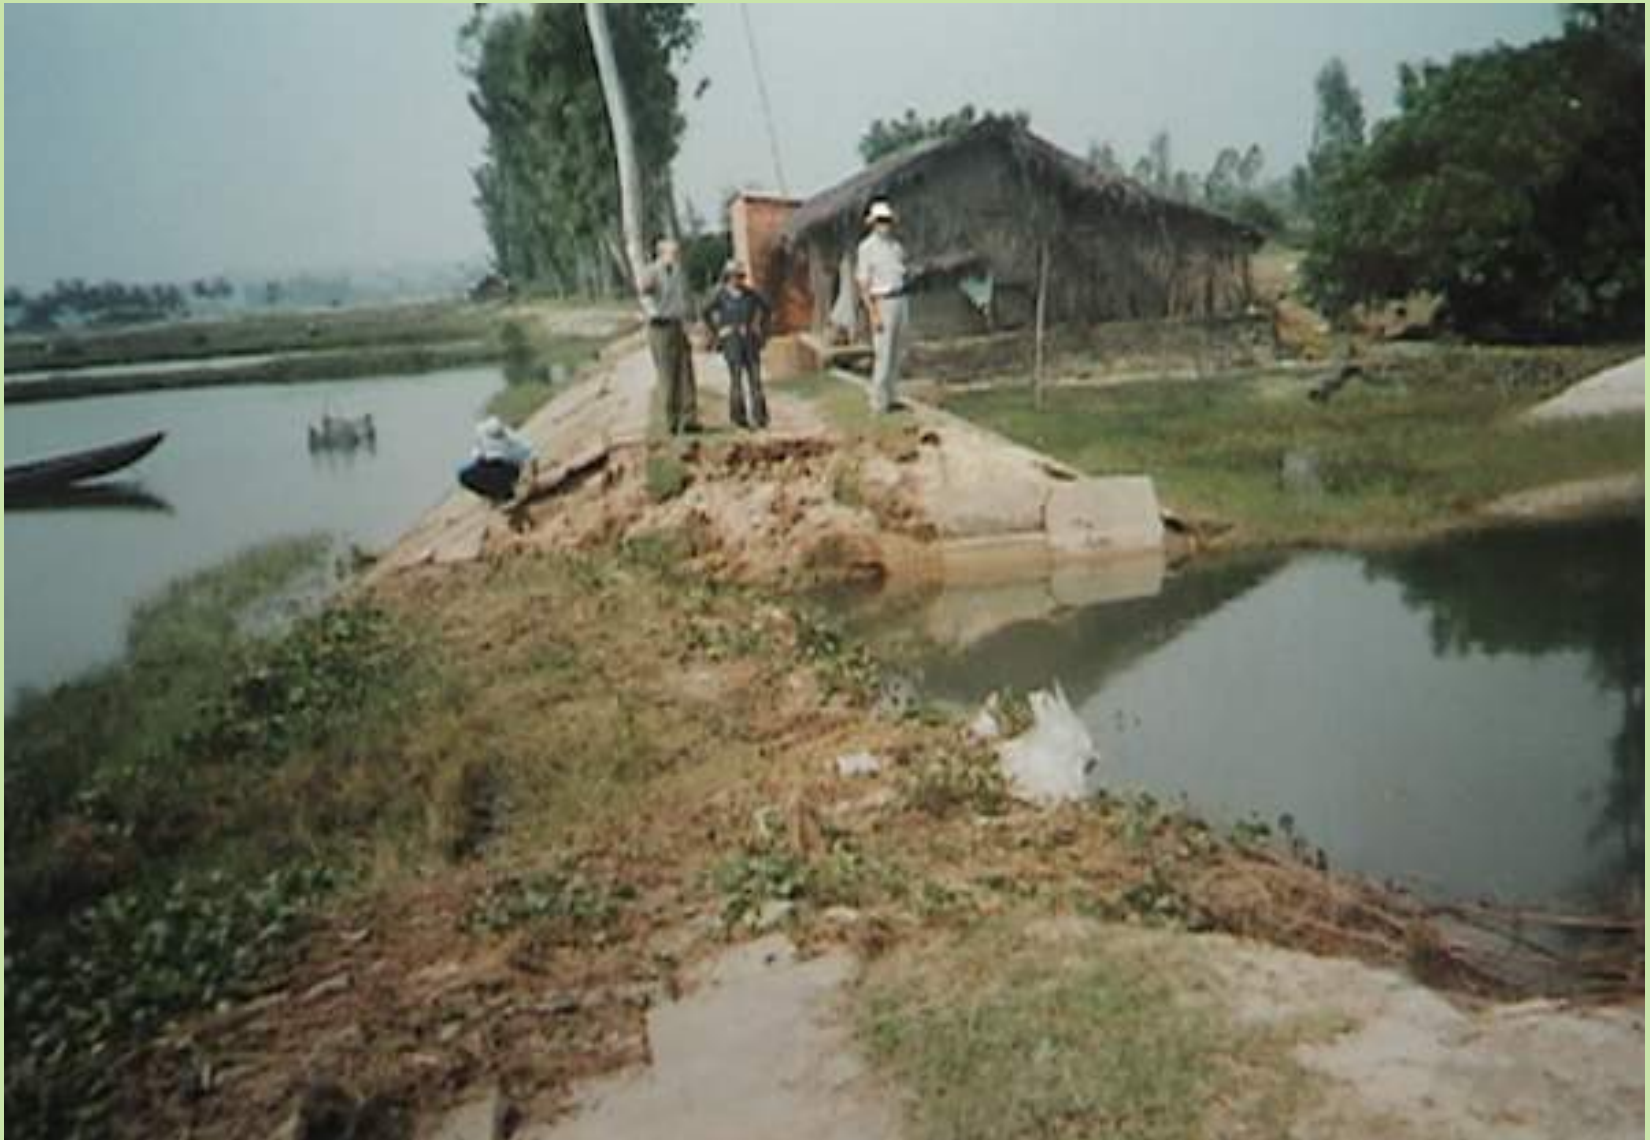
## Severe damage to rural roads

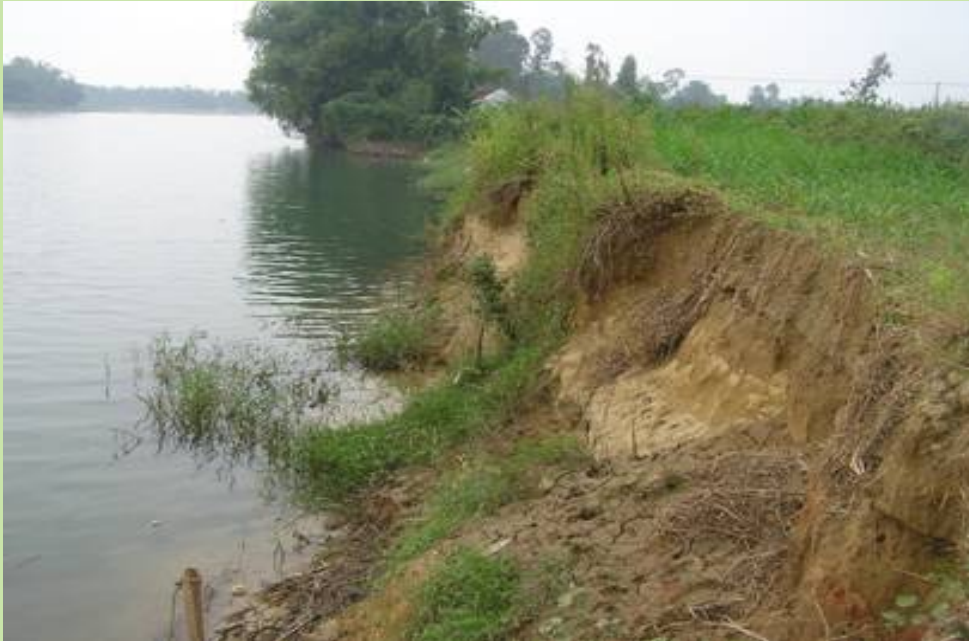
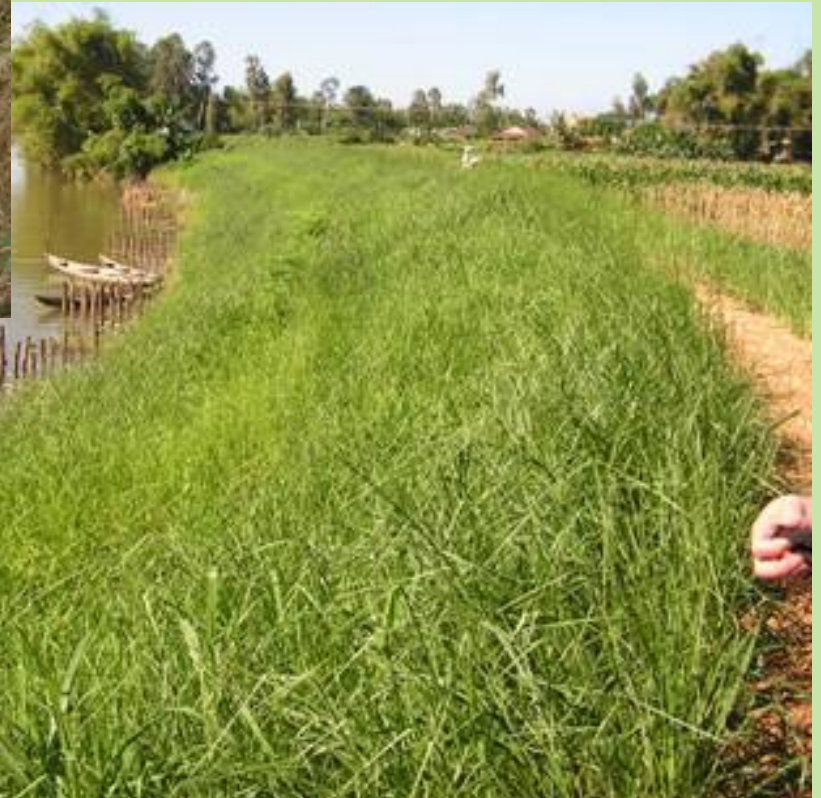
# Vetiver stabilisation of river bank before and after vetiver protection

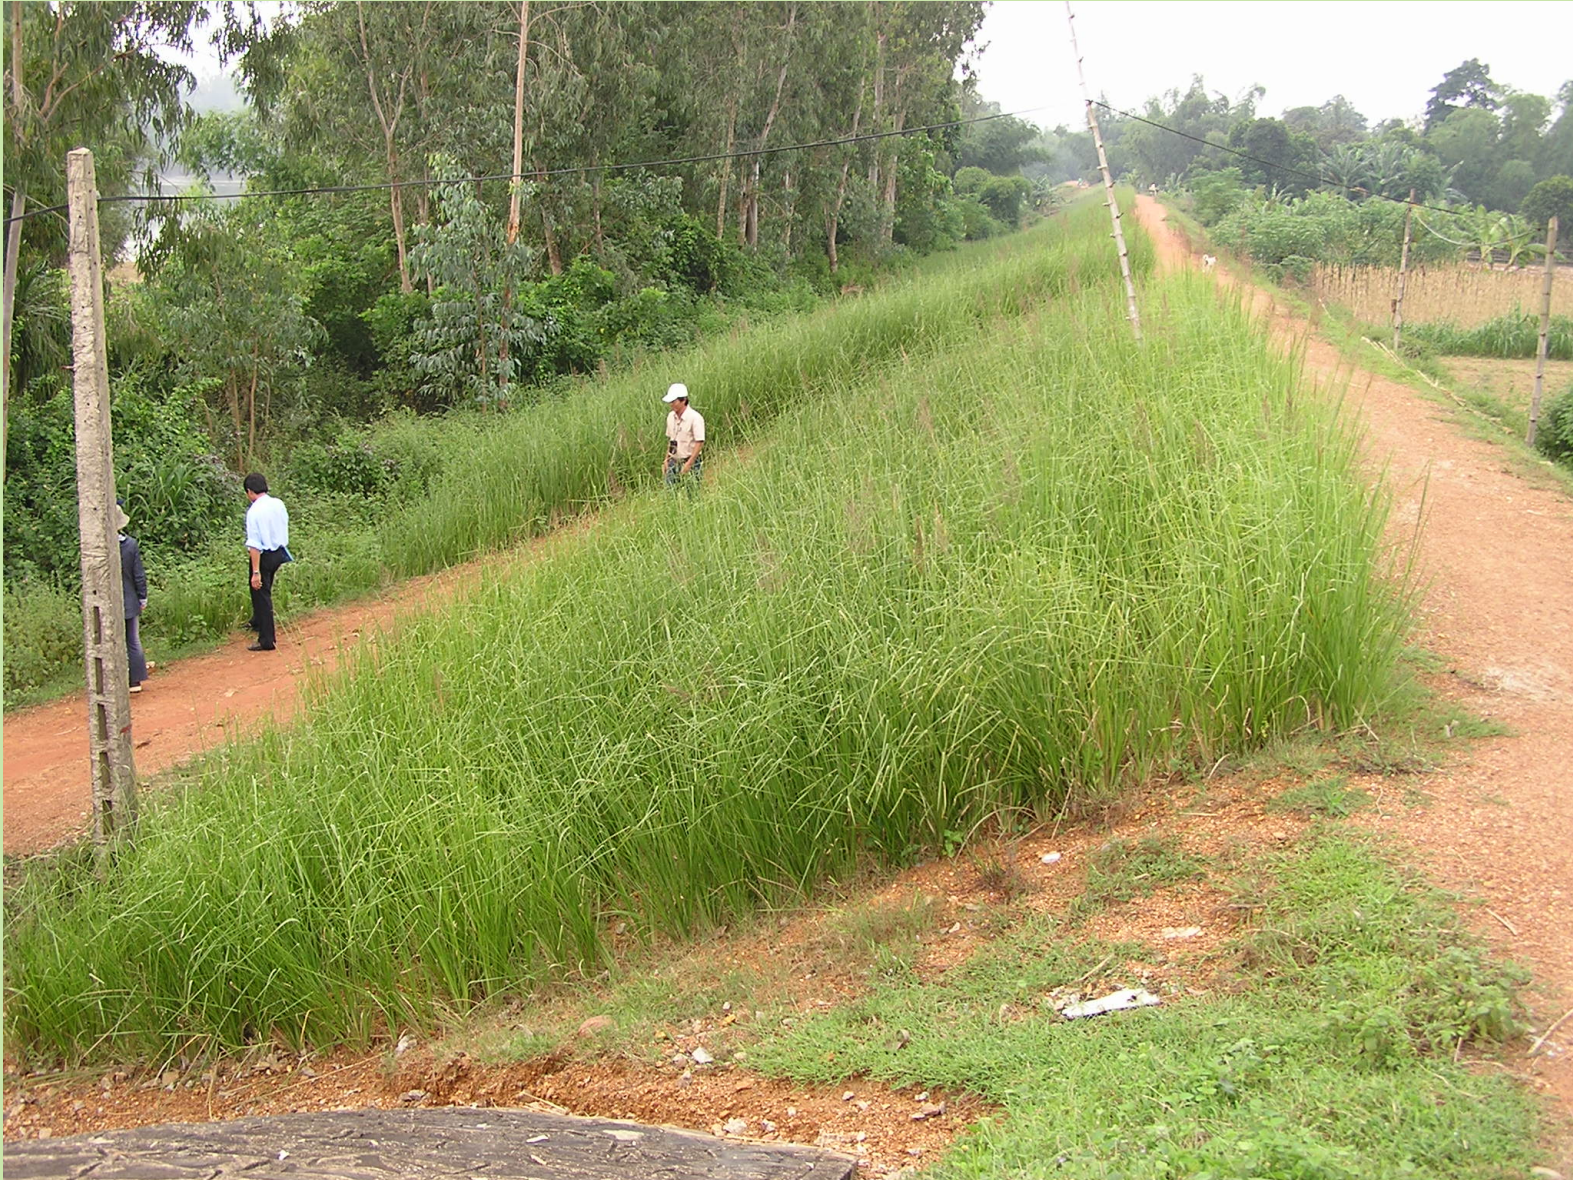
# Vetiver stabilisation of a large levee bank

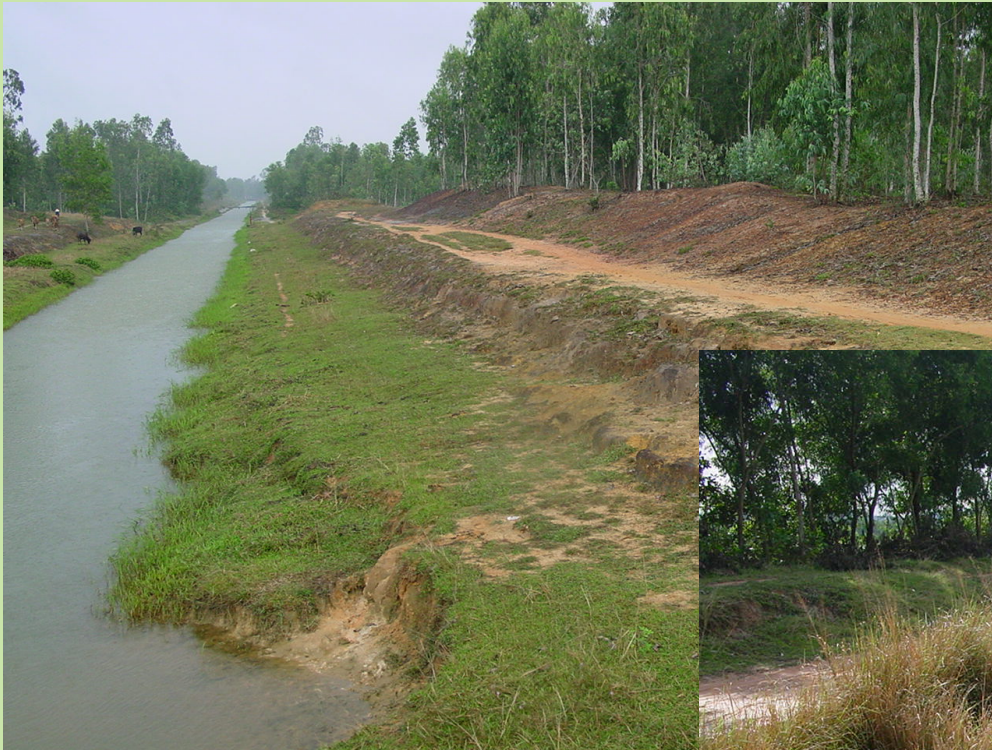
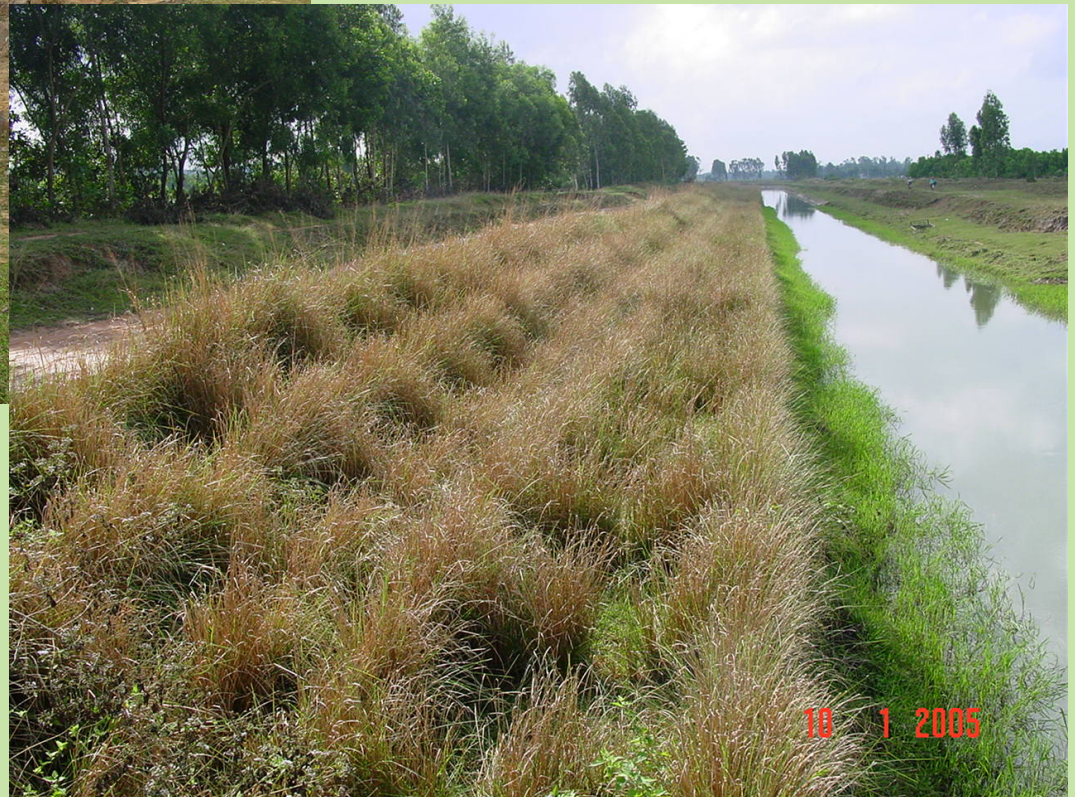
# Vetiver stabilisation of drainage channel bank before and after

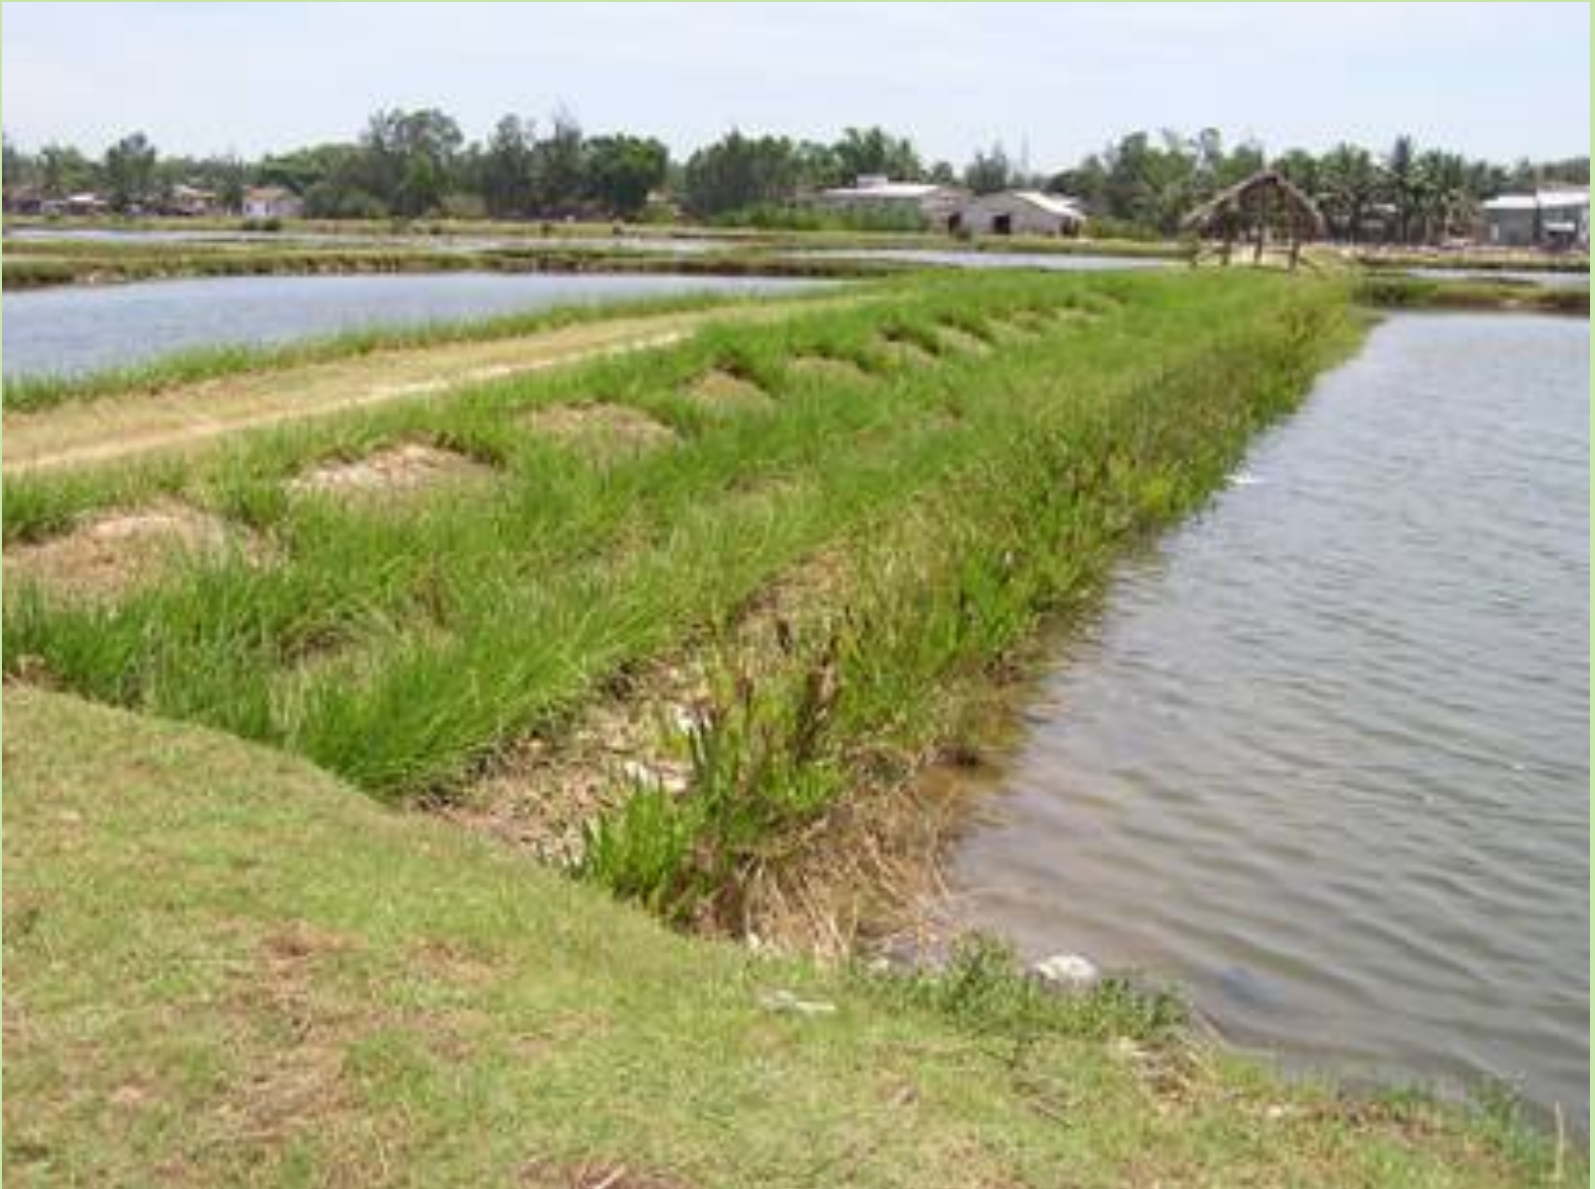
# Stabilisation of aquaculture infrastructure

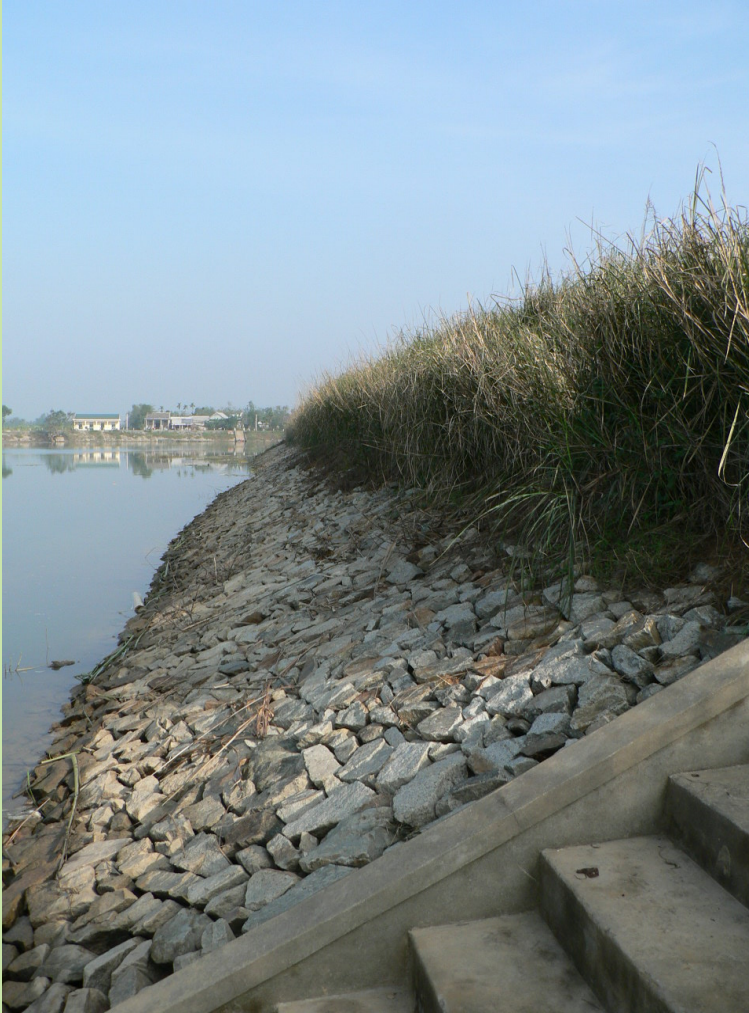
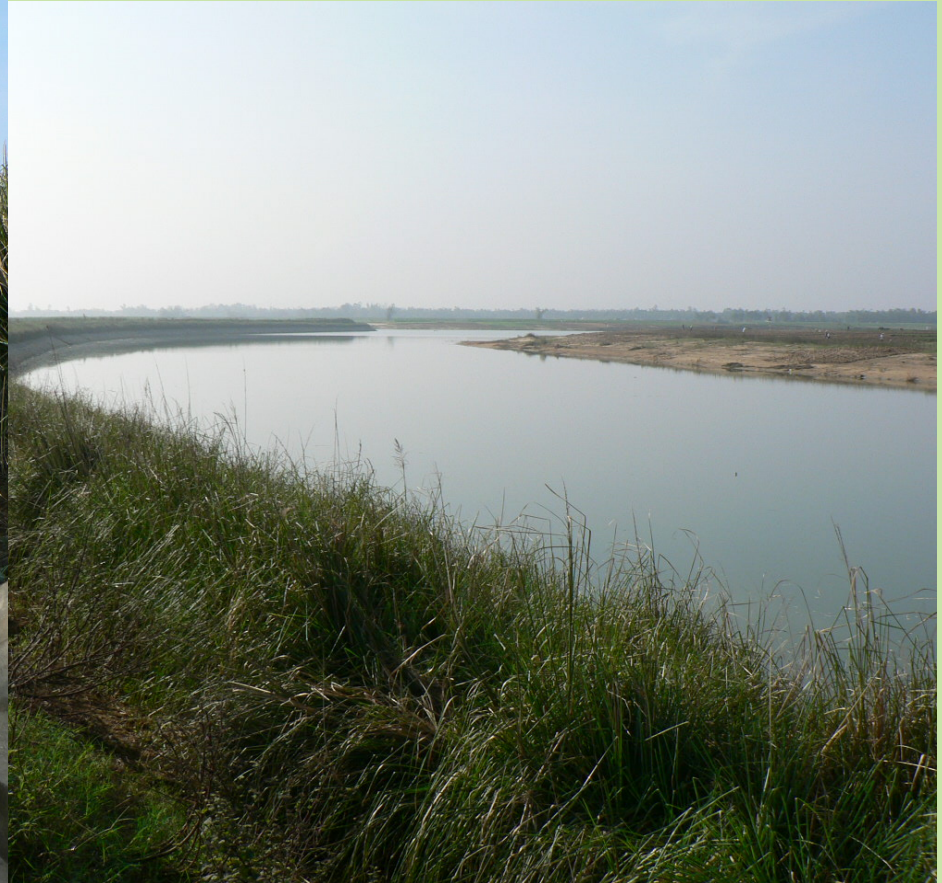
# Re-enforcing and protecting hard structure of a river bank in Vietnam

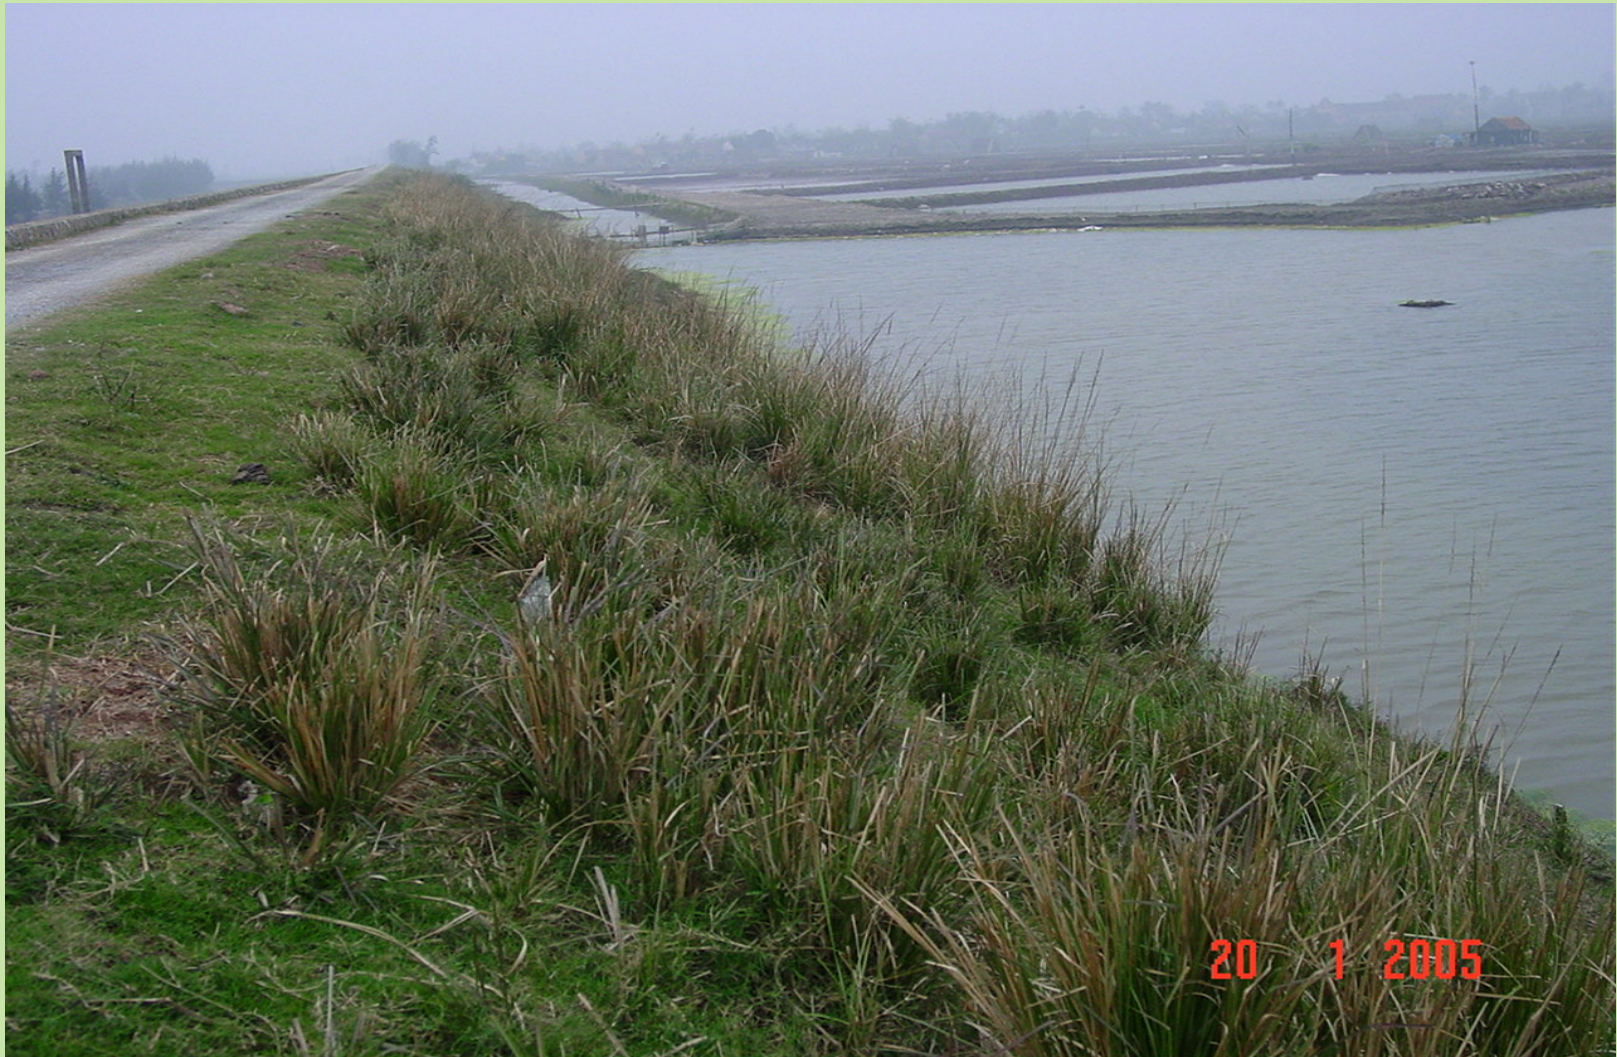
# Stabilisation of the inner wall of a sea dike in Nam Dinh province, Vietnam

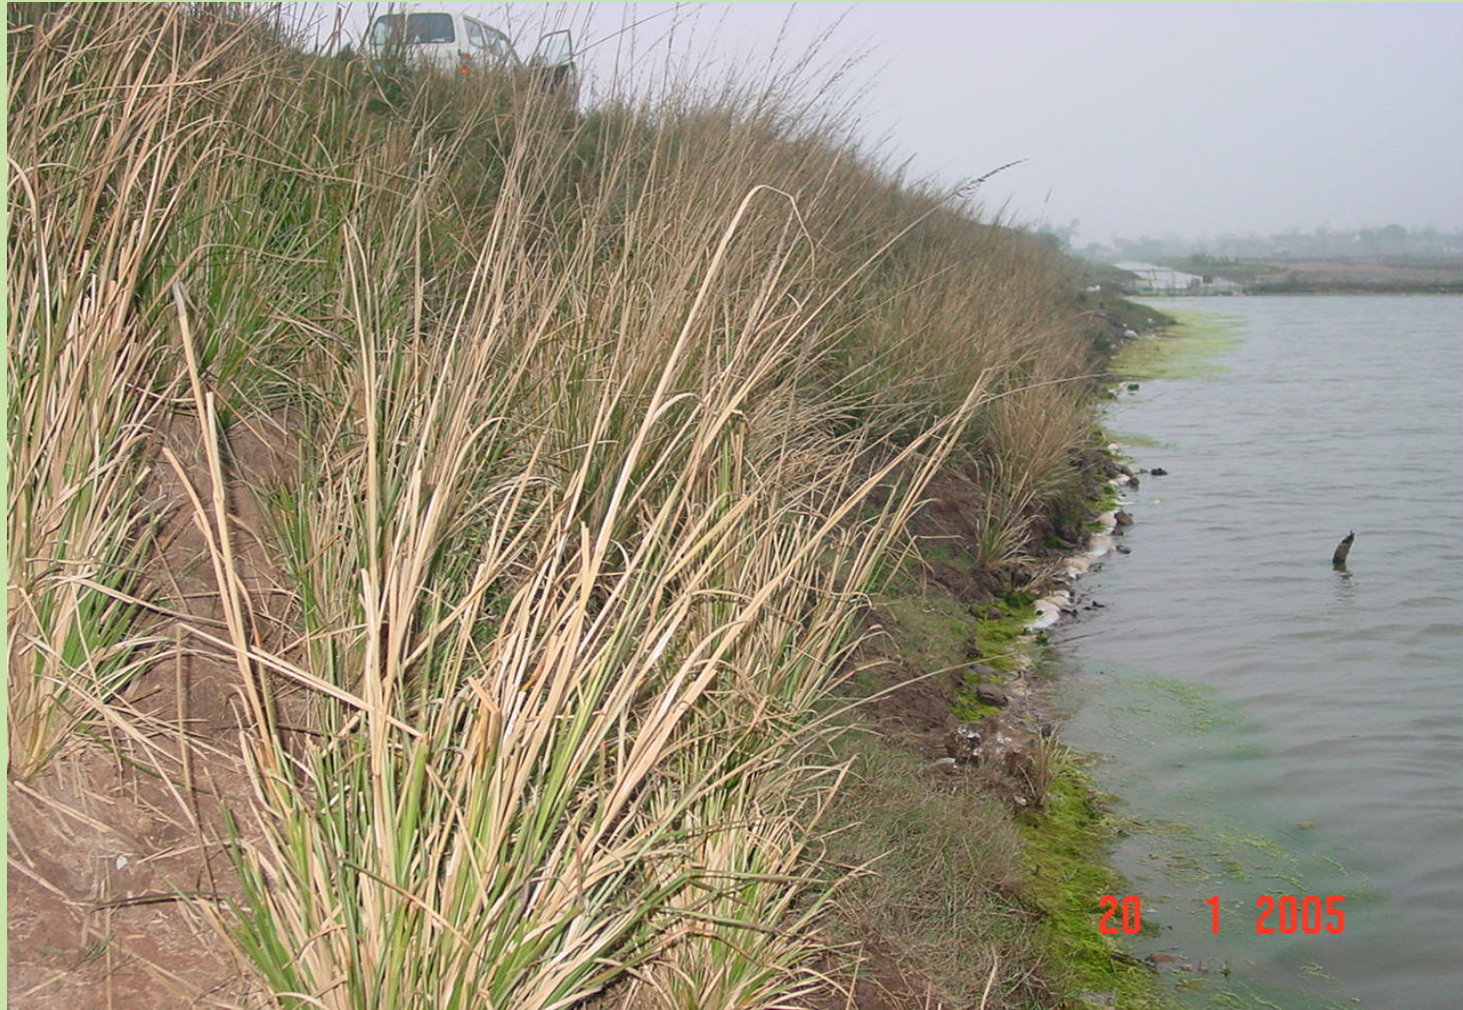
**When this dike was over topped by a recent typhoon, the unprotected part of the dike was washed away, while the vetiver planted section remained intact.**

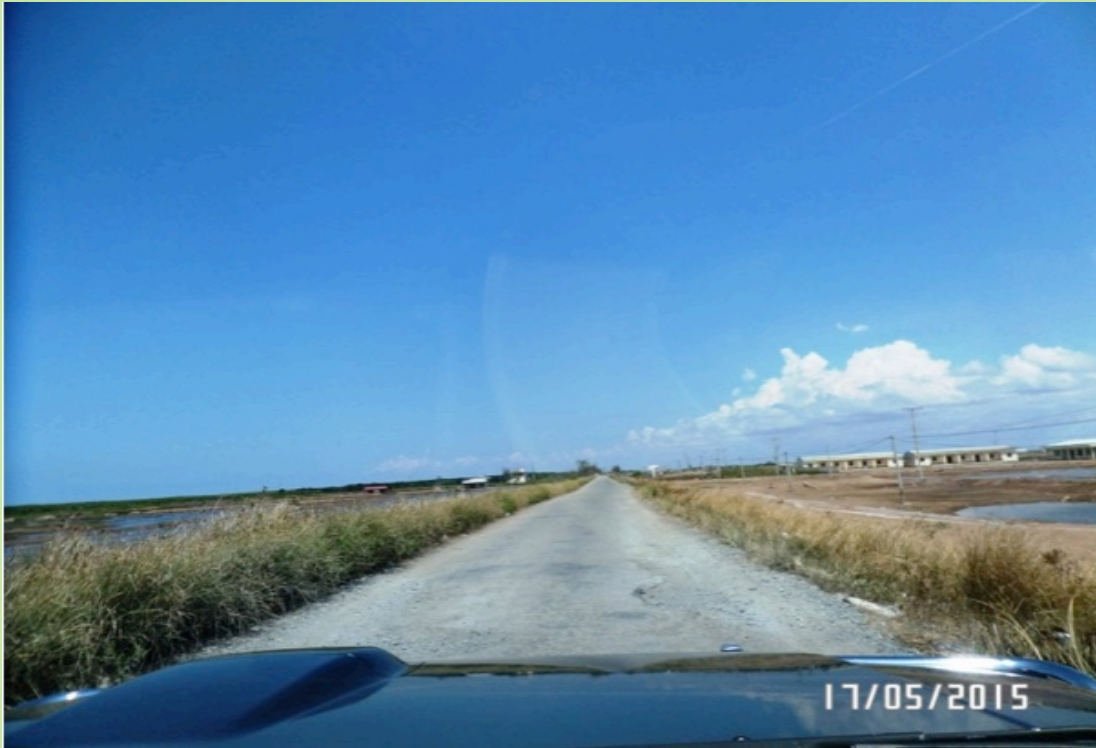
**Vietnam, Mekong Delta –  
eight year old vetiver  
stabilizing dike road**

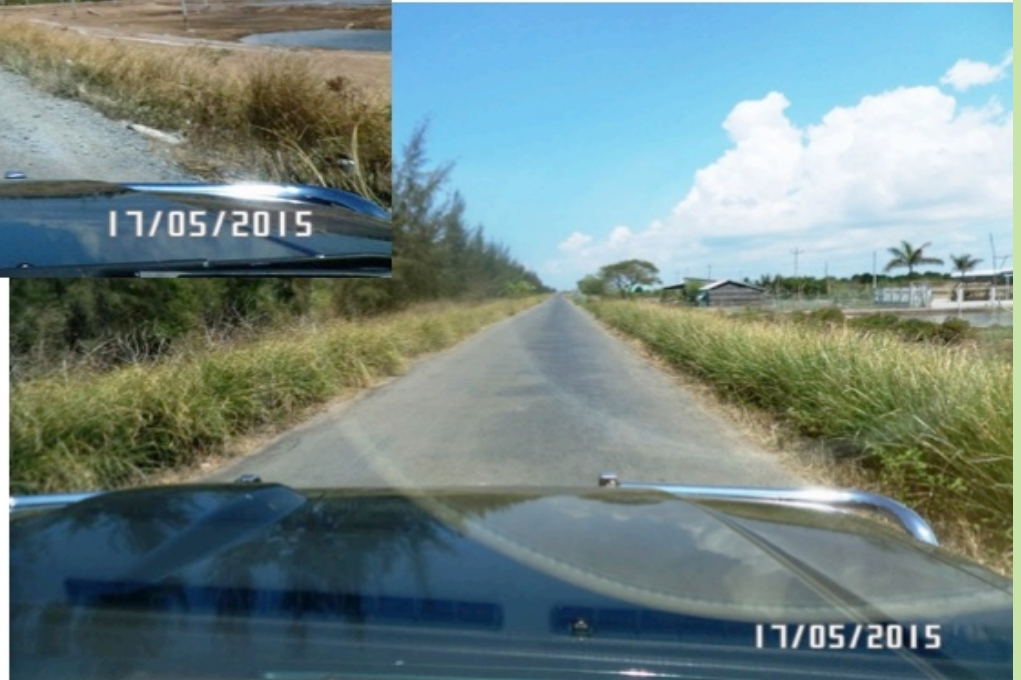
**Note: no erosion evident  
on road shoulder. Much  
lower road maintenance  
costs.**

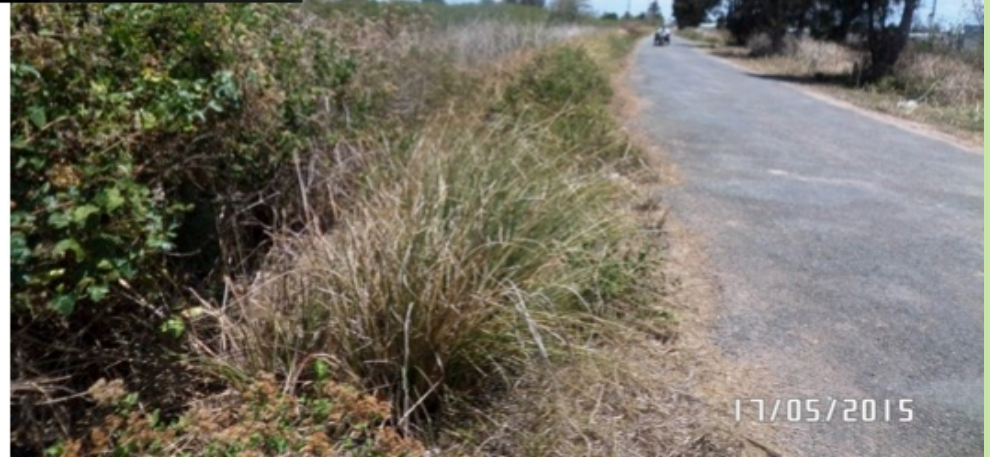
**Excellent vetiver  
growth on both  
inside and outside  
batter on this  
Mekong Delta dike**

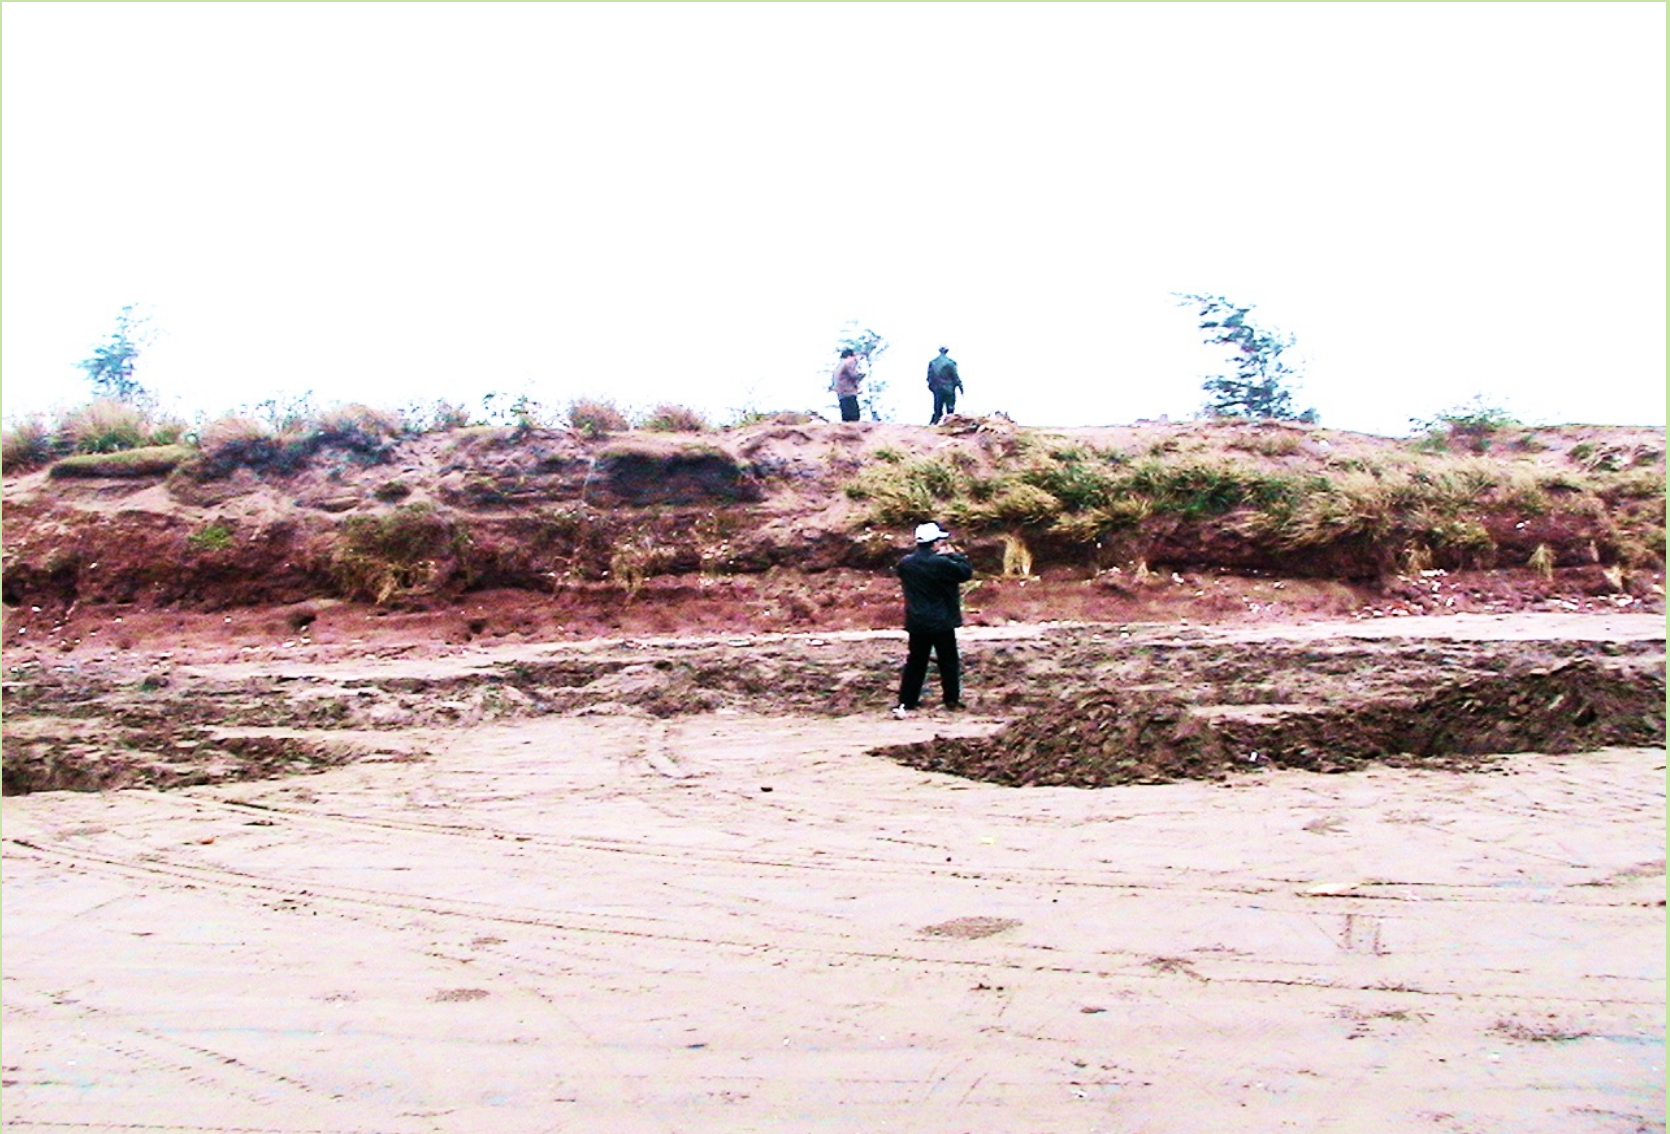
**The sea-facing wall of this dike was badly damaged (left) while the right side, planted with vetiver remained fairly stable**
