VETIVER SYSTEMS FOR LAND REHABILITATION

LANDSLIP CONTROL MECHANISM BY VETIVER

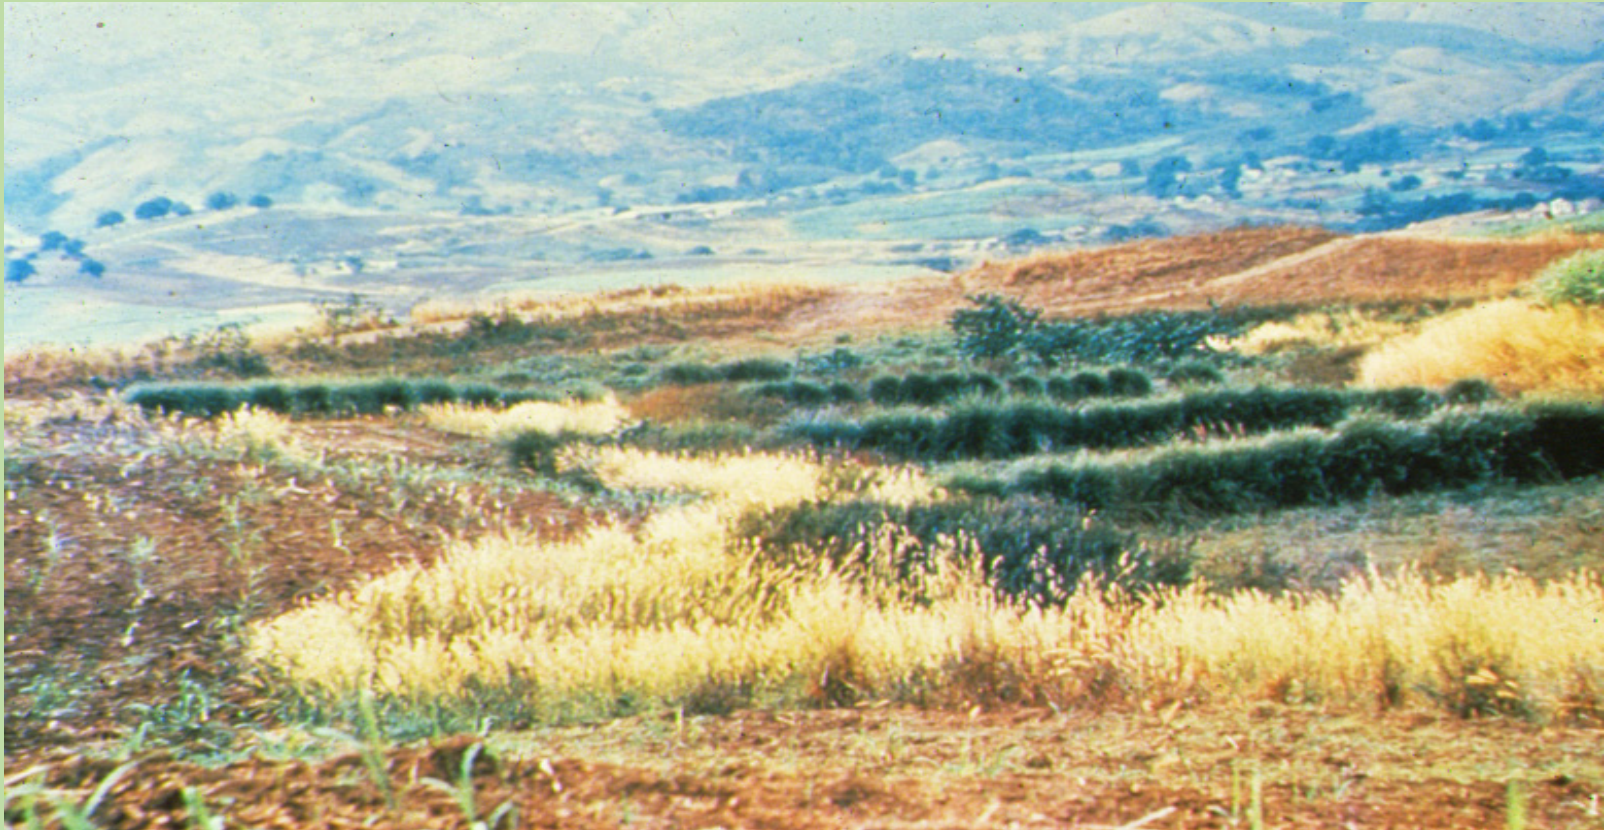
This drainage line in Fiji has been stabilized with vetiver for more than 30 years. It used to be barren and gullied. Note the color difference between vetiver and native species.

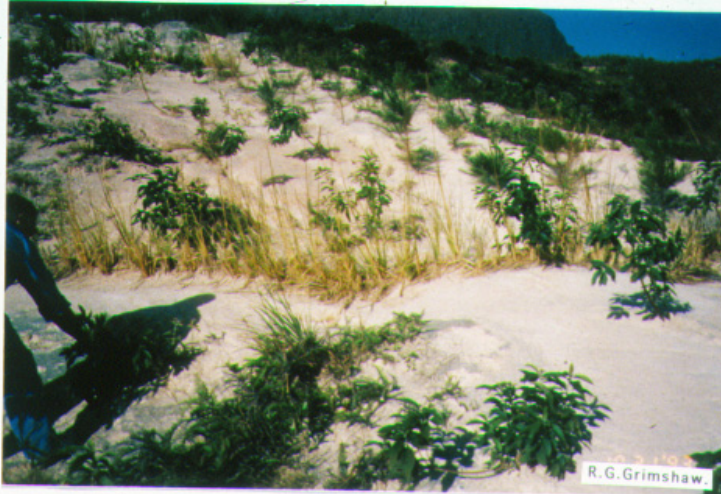
Hong Kong - Kowloon. Above, vetiver hedgerows and *Acacia mangium* planted on heavily eroded granite surface on hills behind airport. Below, similar site two years after treatment. Photo credit - R.G. Grimshaw.

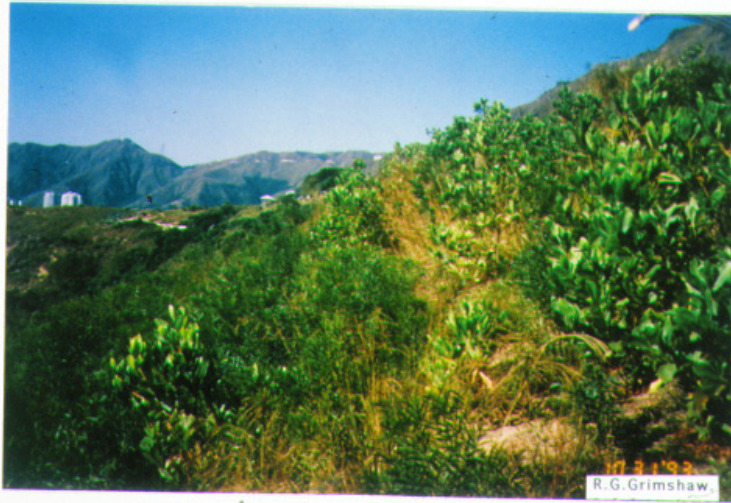
Degraded hill park in Hong Kong was planted to vetiver and Gmelina trees. The result was startling. Vetiver hedgerows acted as a pioneer system that improved soil moisture by reducing runoff on these steep hillsides. Native species colonized the slope between the hedgerow and the trees grew very well. This is typical of what the Vetiver System will do.

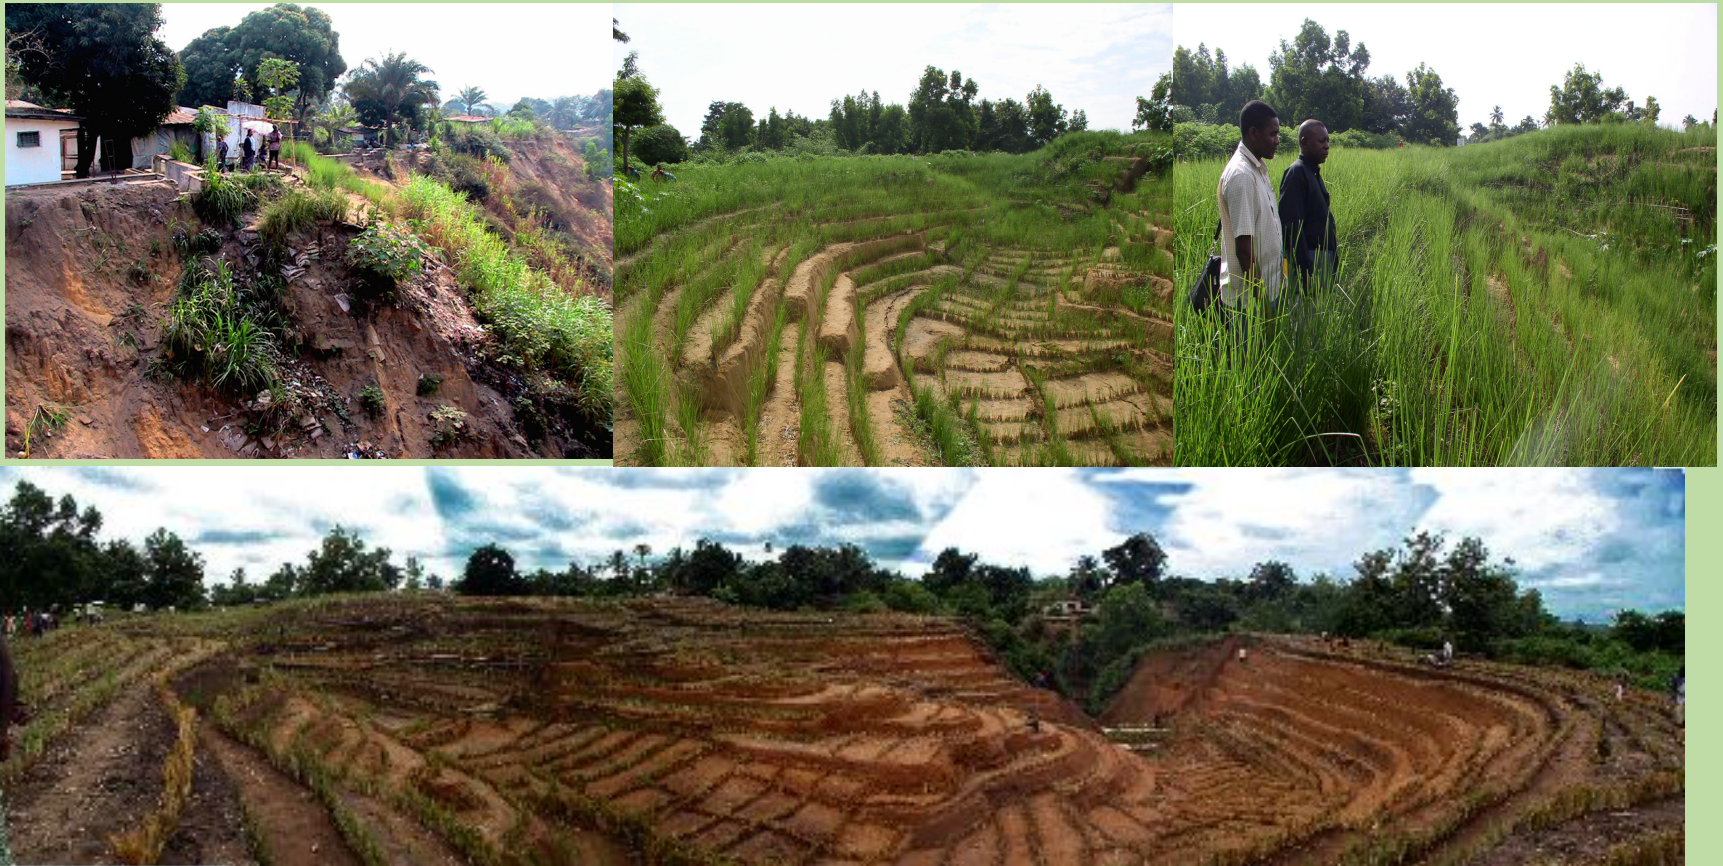
A common feature in many West African countries is the occurrence of enormous gullies (ravines) that are cutting back into urban areas. In the Congo (DRC) this huge gully was cutting back into the city of Kikwit. With the support of USAID and The Vetiver network a community project was undertaken with the local people reshaping the gully and planting it to vetiver. Top left - a huge gully near Kinshasa, the home owner had planted a little vetiver which gave some protection. Bottom - a panorama view of the reshaped gully. Top center - planted with vetiver. Top right the gully well covered 4 months after planting.

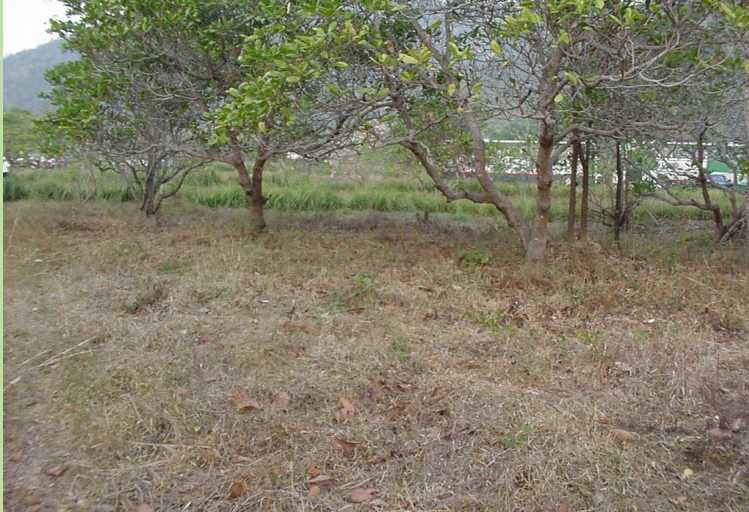
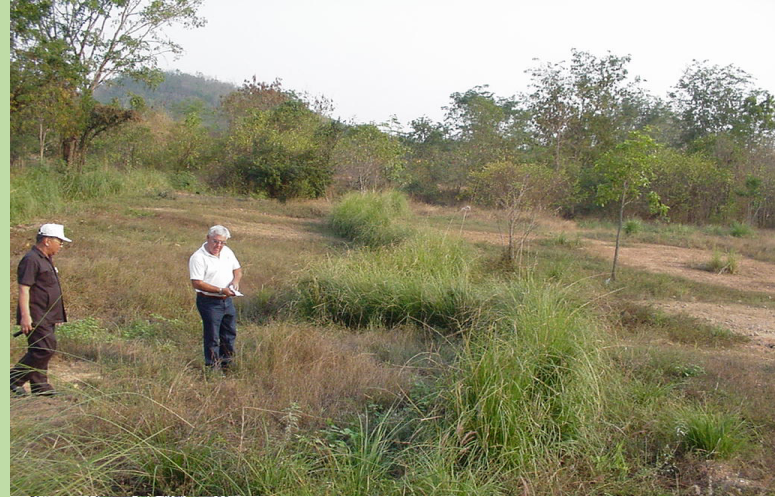
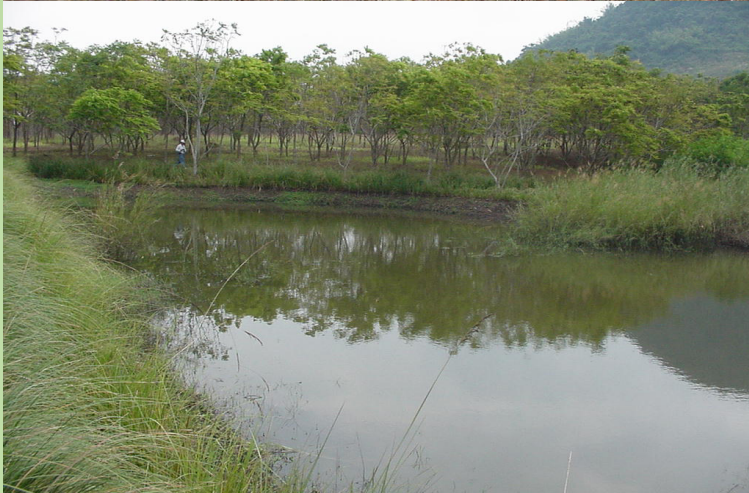
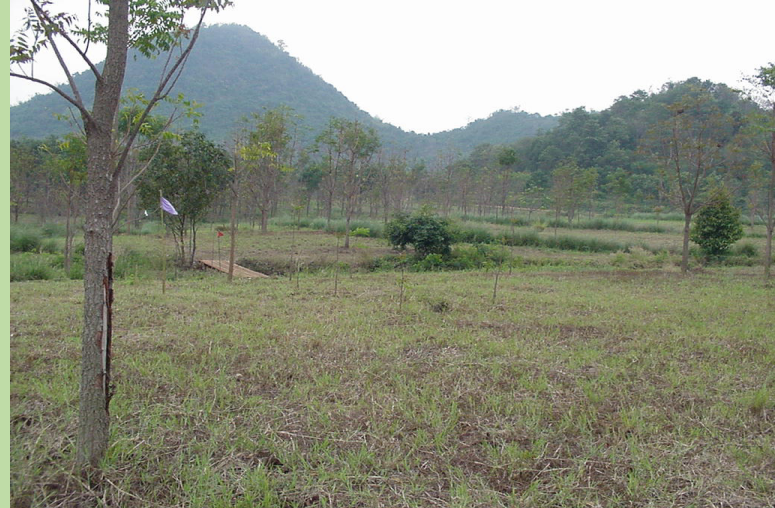
Five years previously this land was heavily eroded pineapple plantation in Thailand. With the help of vetiver it has been rehabilitated into open parkland. Note in top right how native grasses are growing vigorously in the silt deposit behind the hedgerow where the man in the white shirt is standing

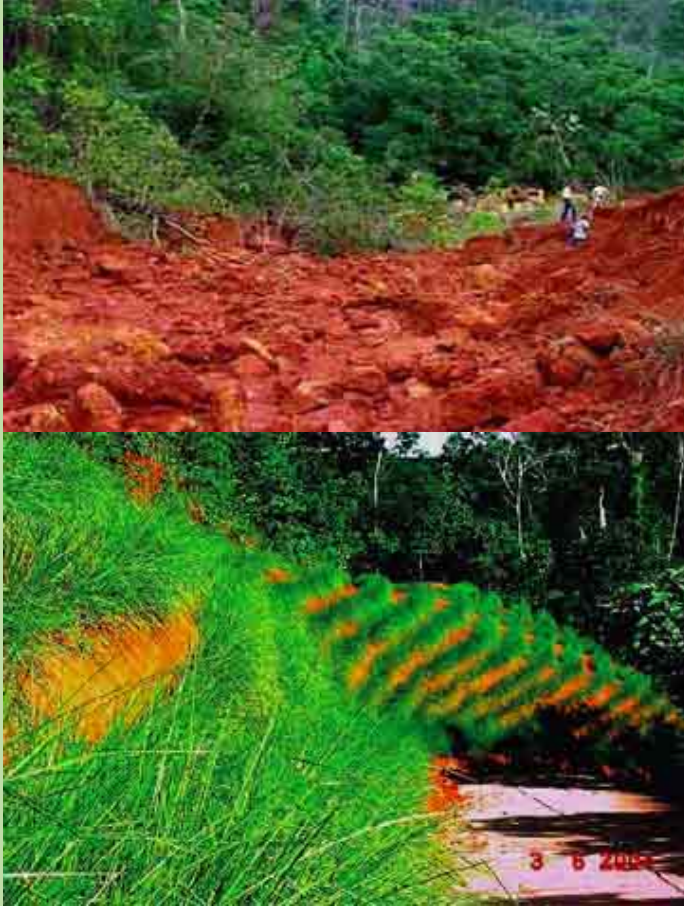
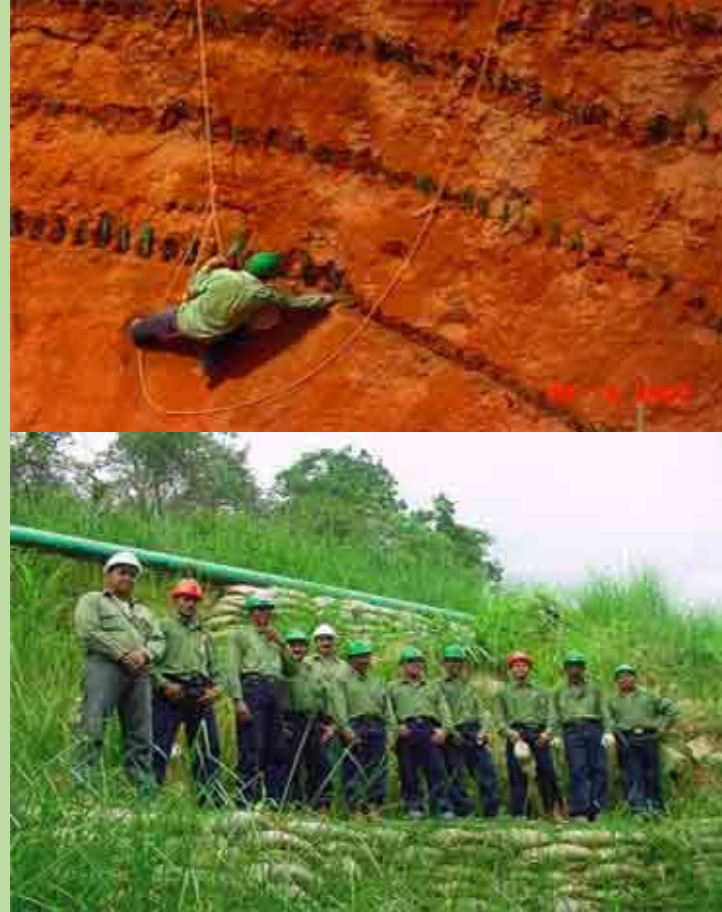
This bauxite mine tailings in Venezuela were rehabilitated using Vetiver System by a local environmental cooperative. Native species will colonize between the vetiver rows. This is a typical point source site for sediment and toxic leachates that if not for vetiver would end up in down stream drainage

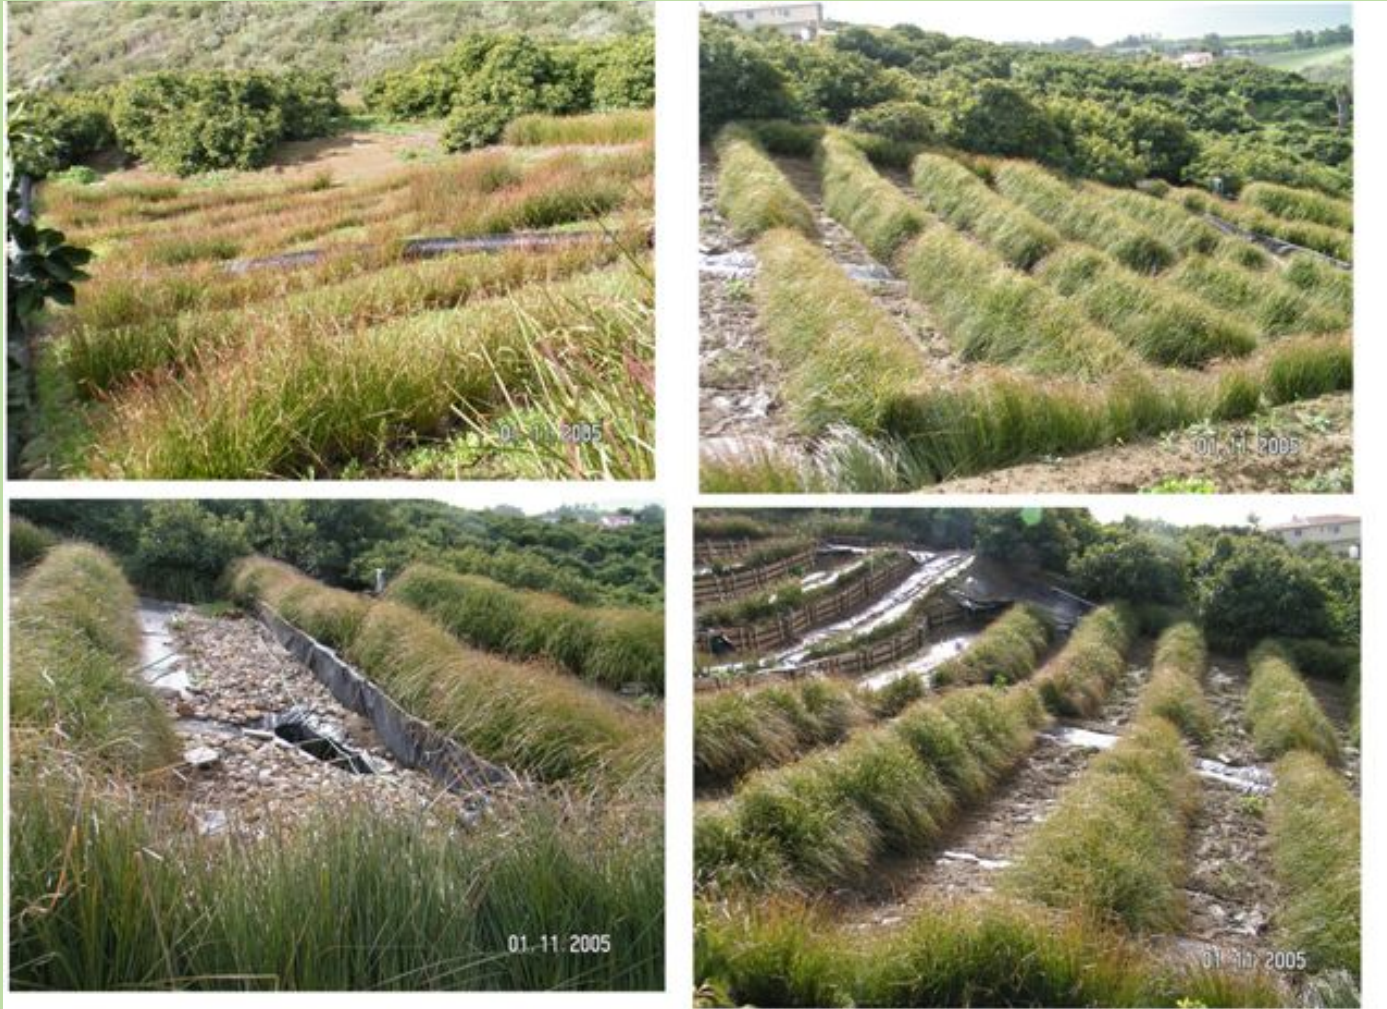
This orchard land near Santa Barbara, California was sliding down the hill. The engineered system was not working. Vetiver was planted and the slide was halted. The owner rates vetiver at A+++

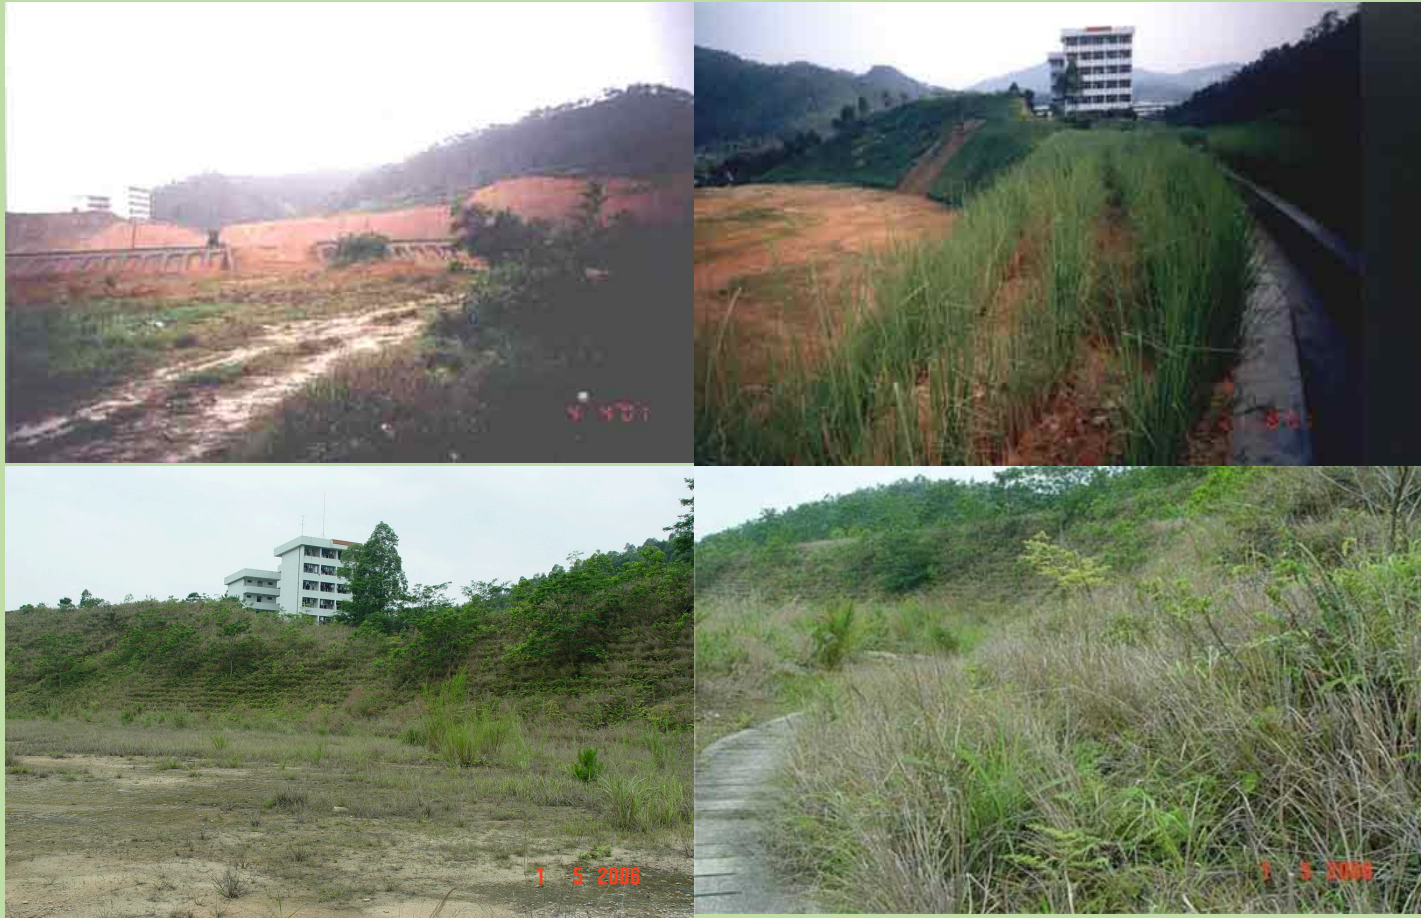
This College campus in south China was in need of land rehabilitation. Vetiver System was applied (top right). The two bottom photos show how the landscape has been protected and stabilized and how native plants have colonized the vetiver

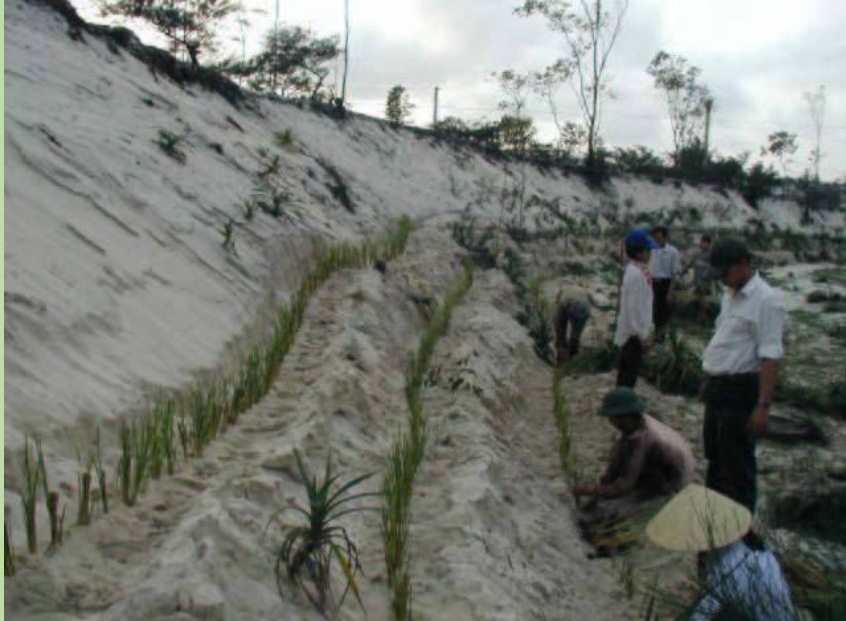
Trial of Vetiver grass for protecting sand dunes in Quang Binh. Establishment of the demo site.

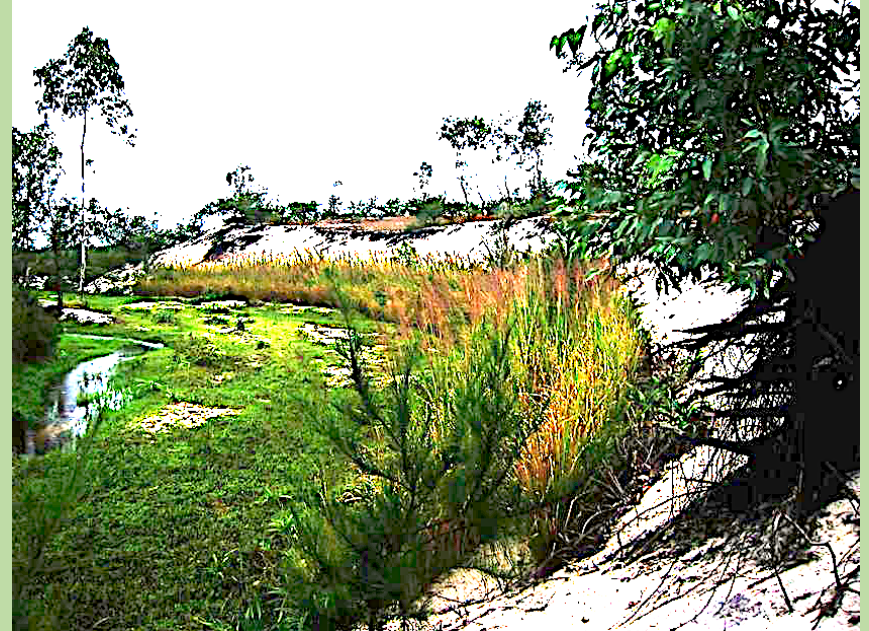
The sand dune is fully stabilized after one year, favoring the growth of other trees.

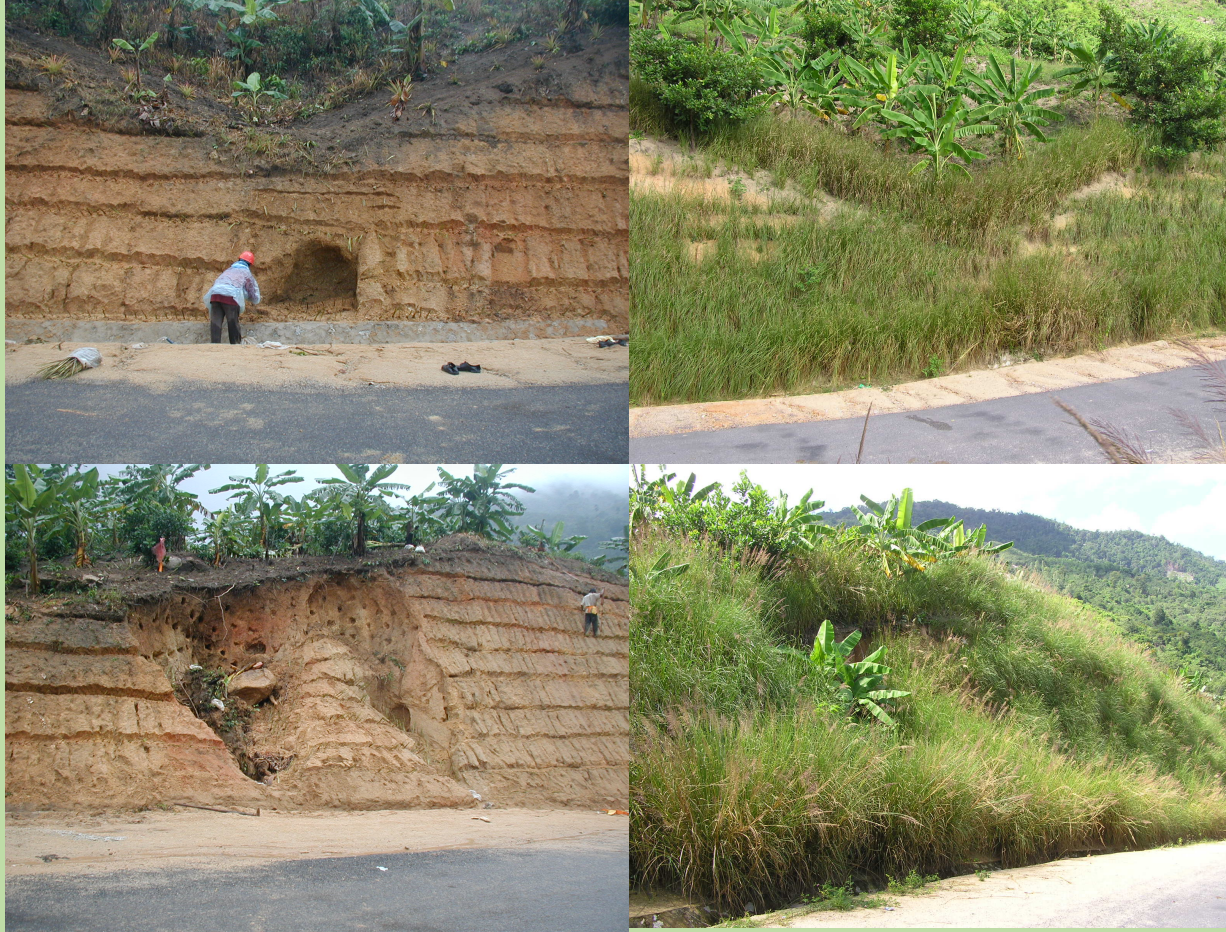
A degraded slope in Vietnam. Before treatment (left), two years later (right)

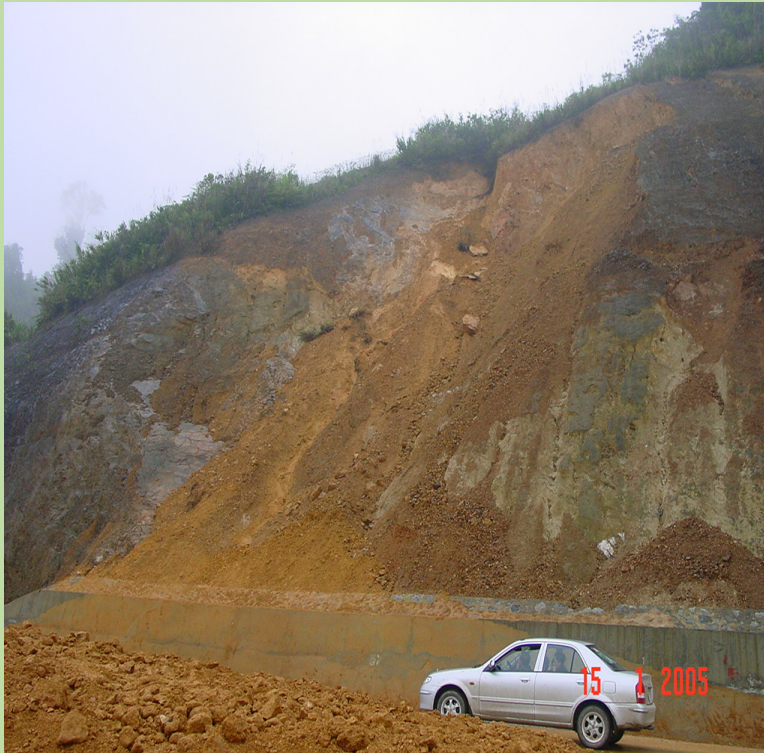
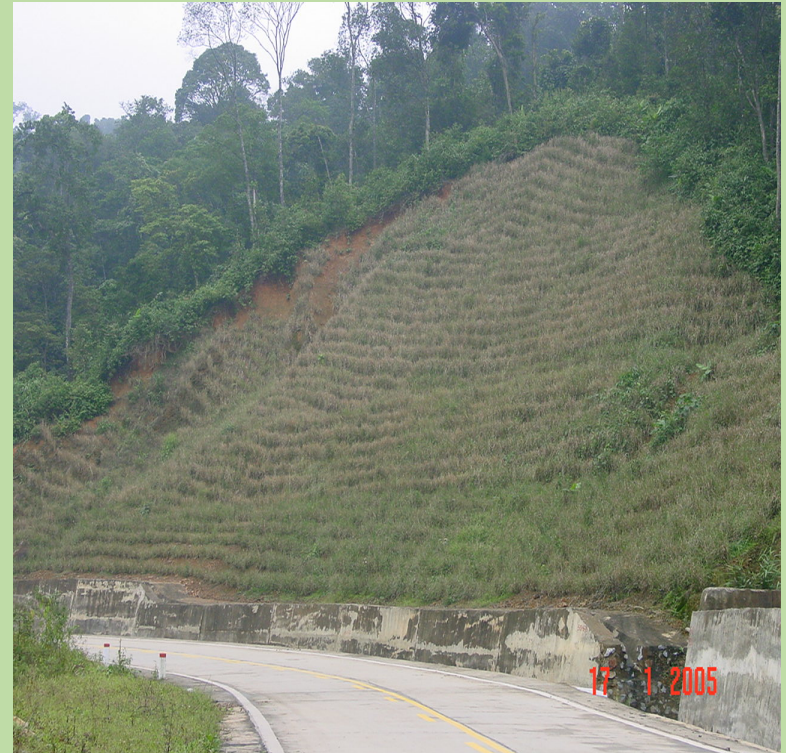
Slopes like this (left) on the Ho Chi Minh highway can be stabilized successfully with Vetiver (right). If the slope on the left is not stabilized it will slide. This is typical of land slides that occur after steep slopes have been cultivated. Vetiver can be used to protect and stop future slides

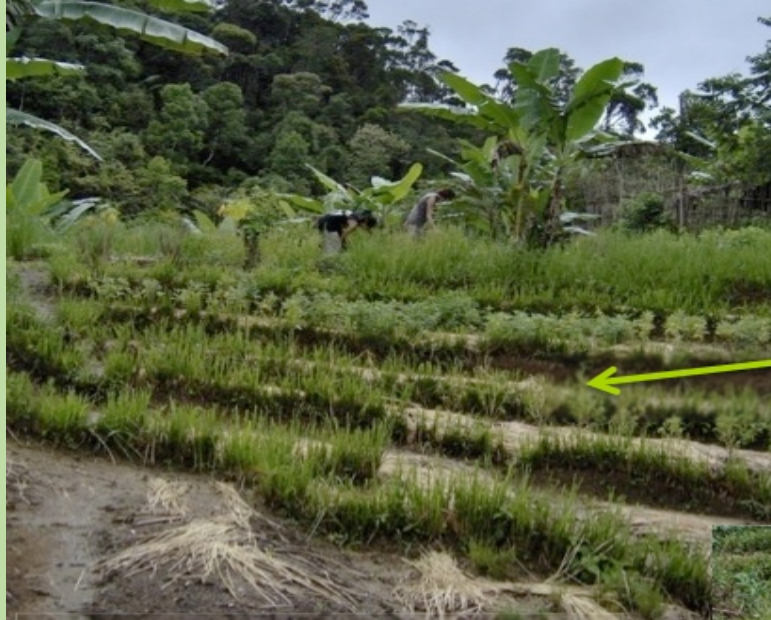
These terraces are established only by VS action, planted few years ago for vegetable culture

Results: sustainable agriculture with better fertility and moisture, mulching, no soil loss

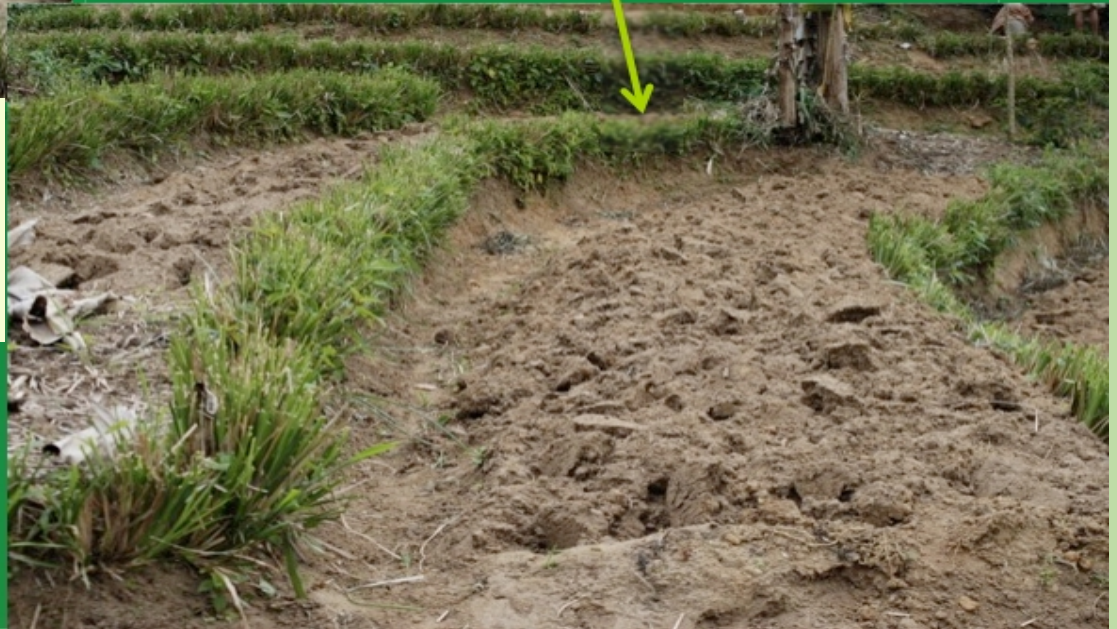
Erosion, gully erosion (lavaka) and sediments due to lack of protection in Madagascar.

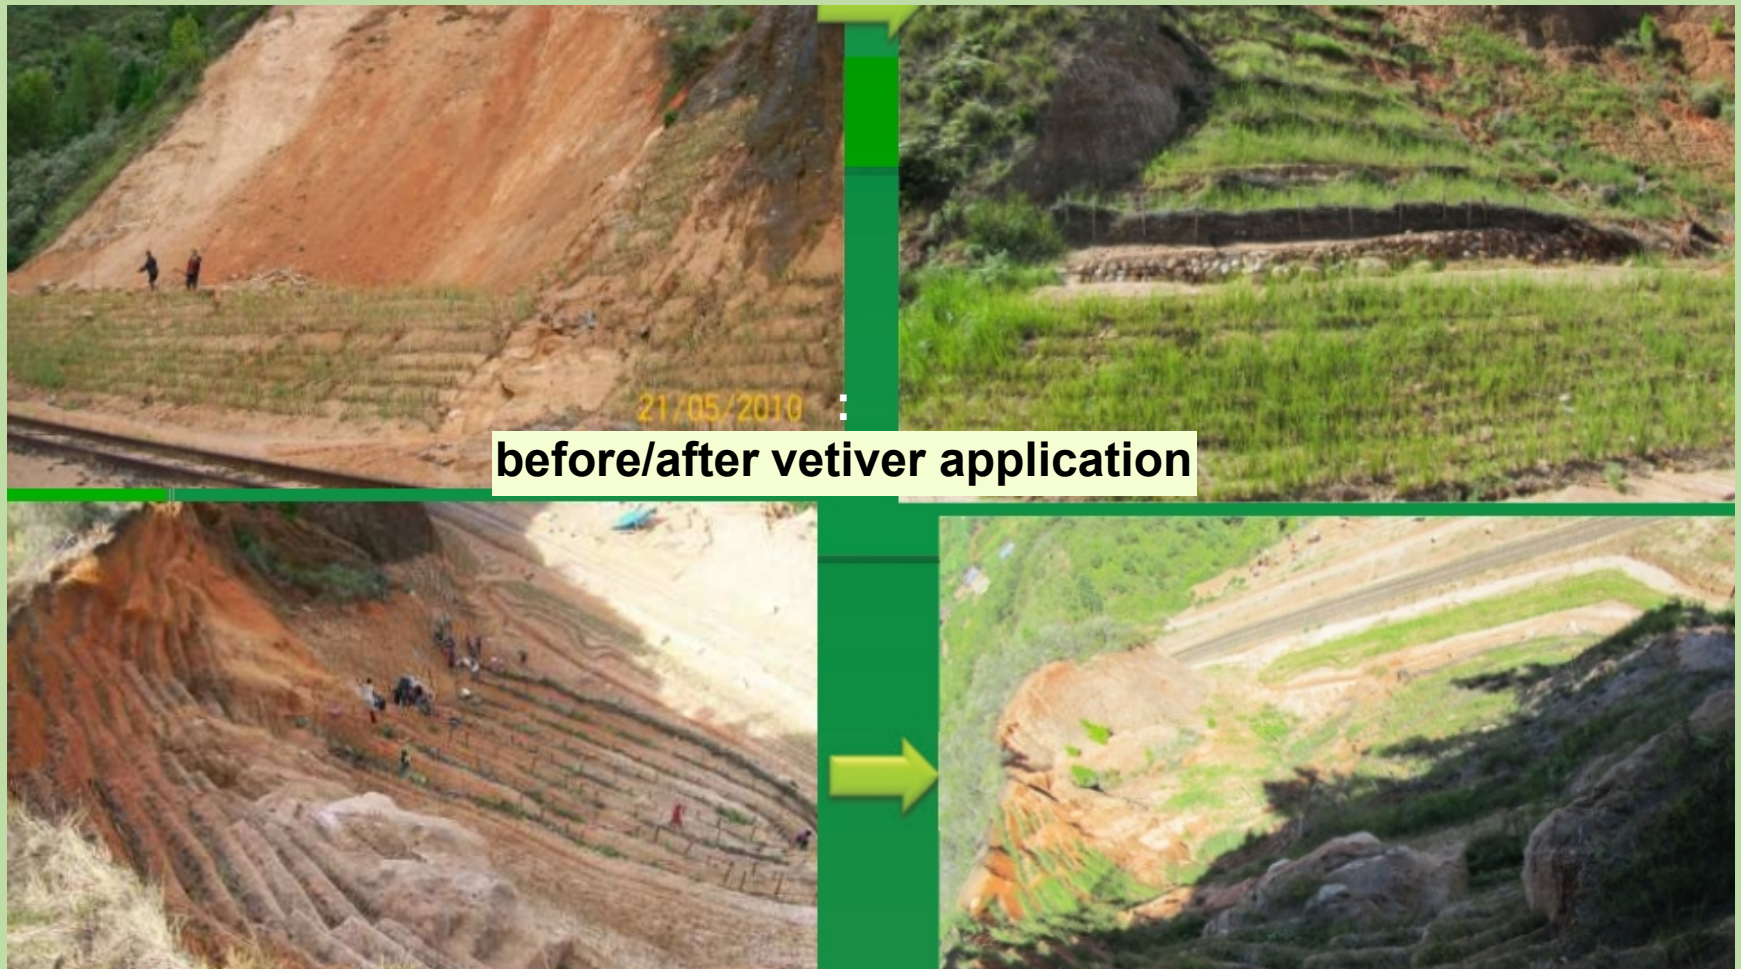
Vetiver System Application for infrastructure stabilization (railway)

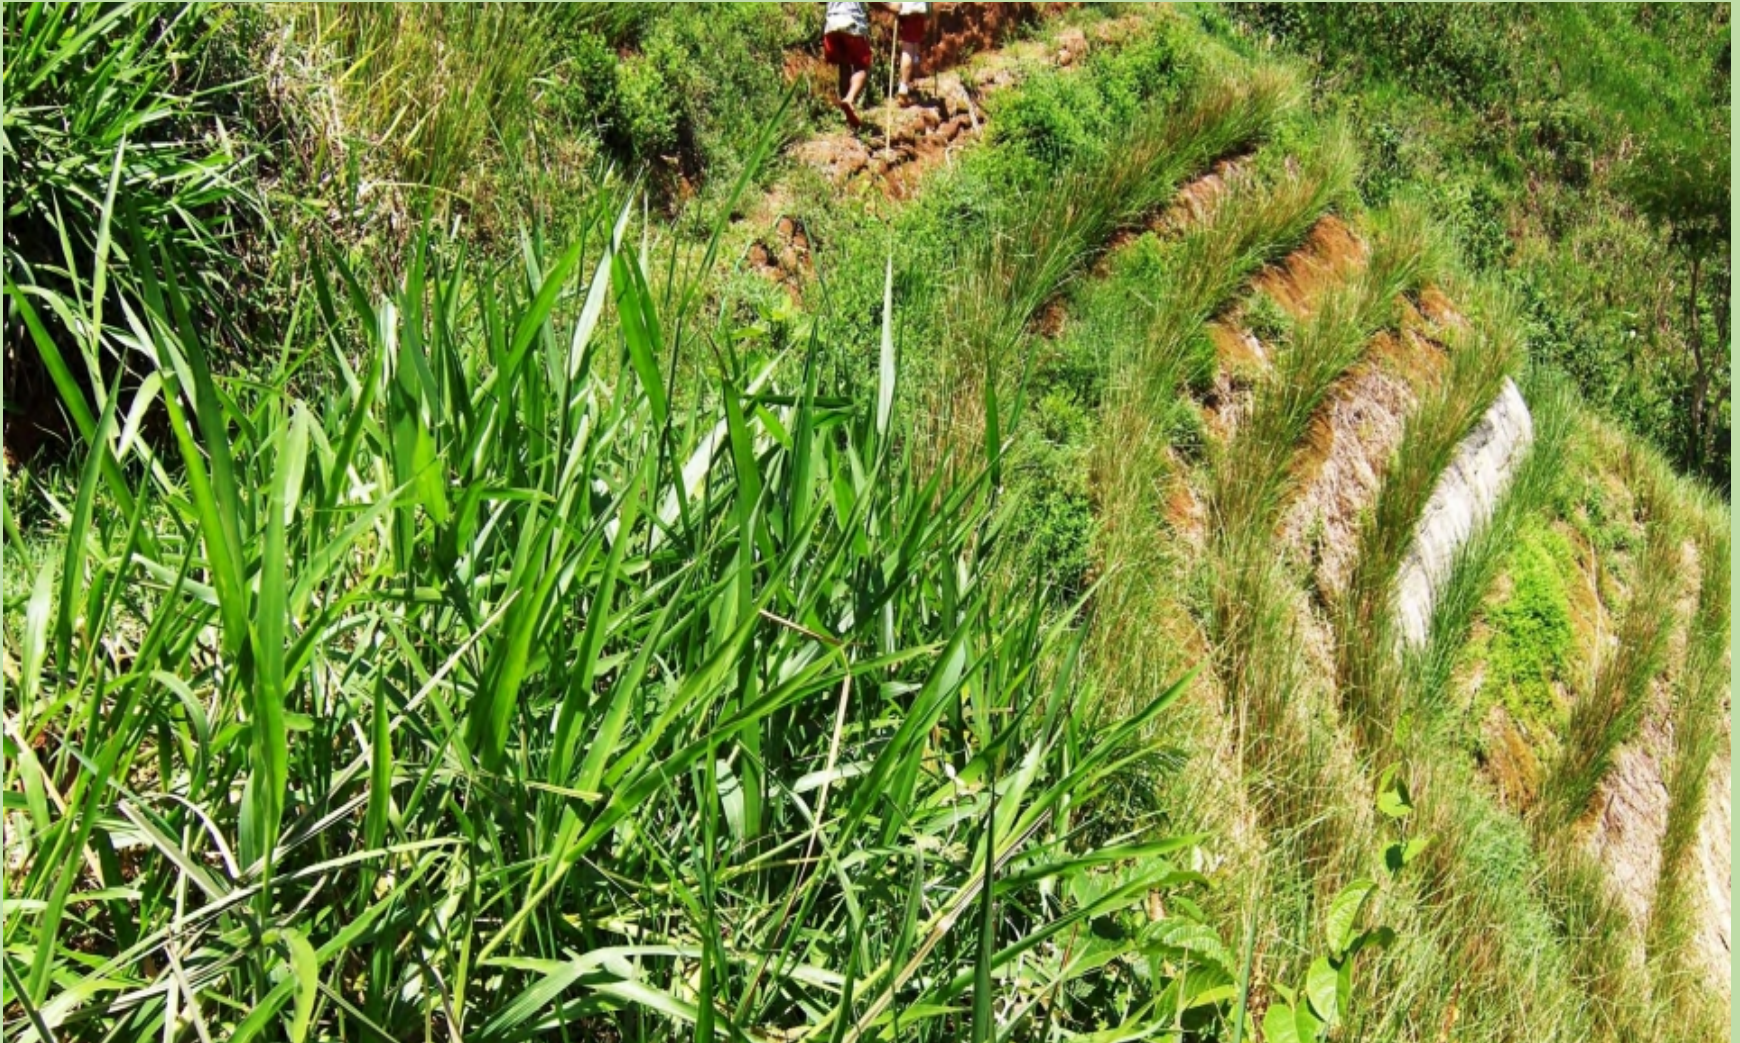
Completed and stable slide slope

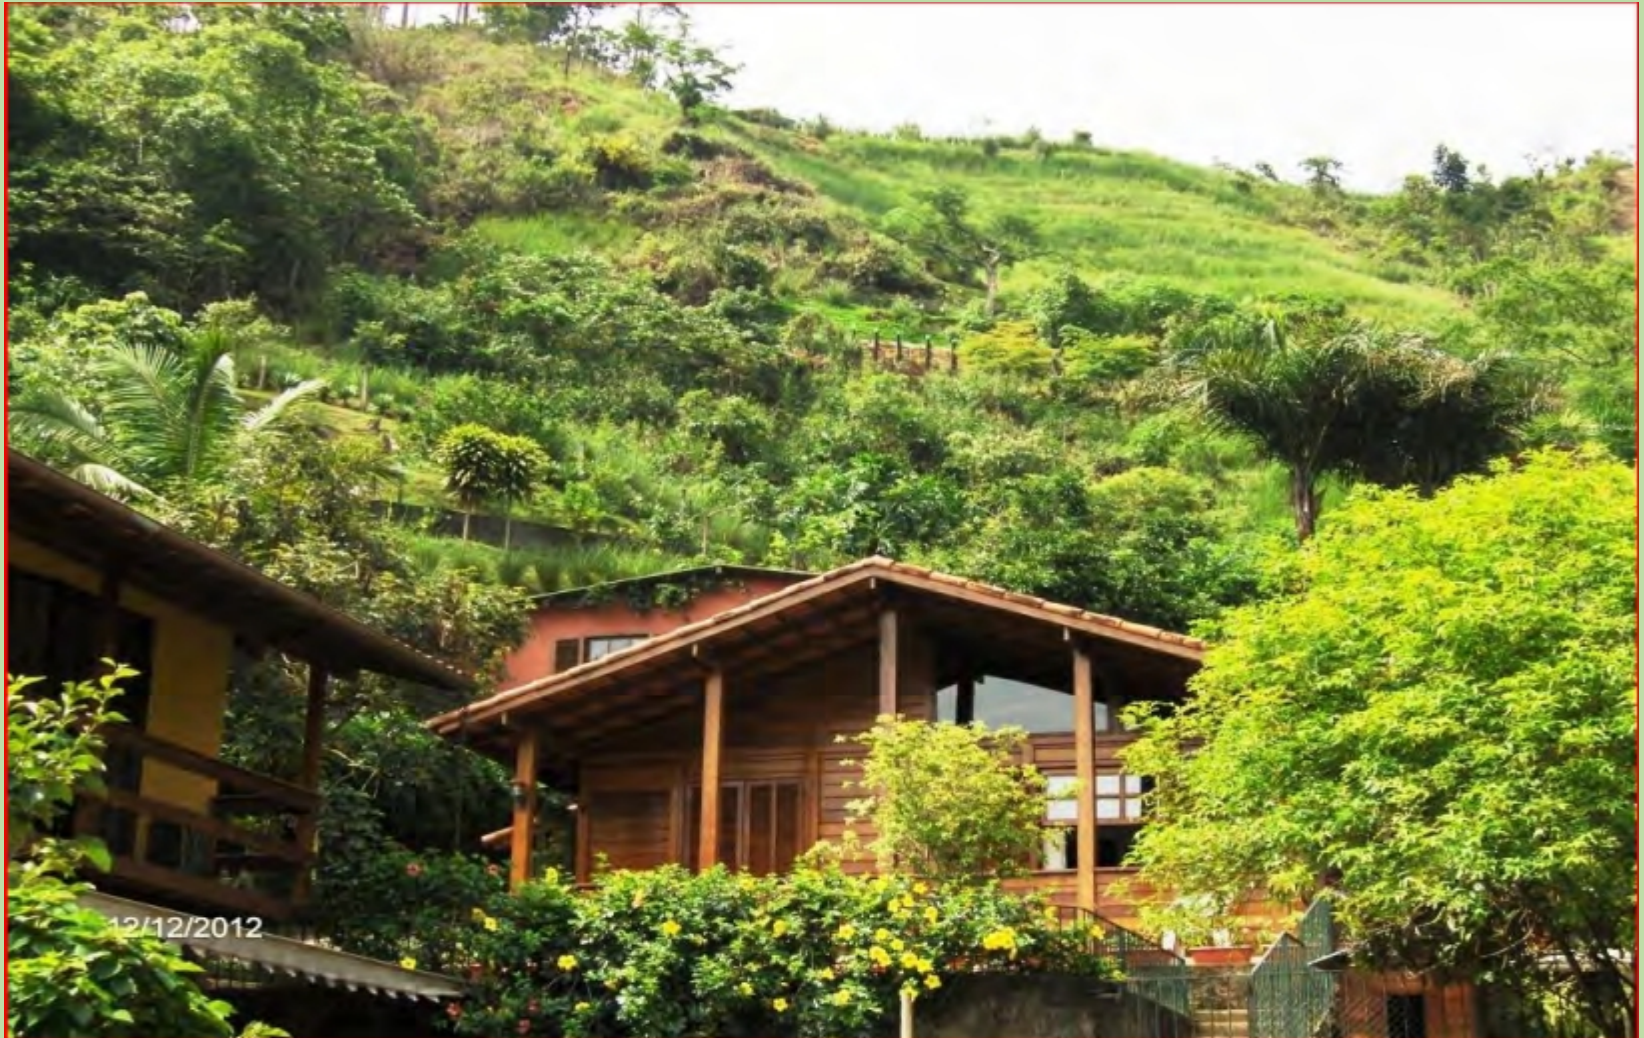
Restored, safe and revegetated thanks to Vetiver System

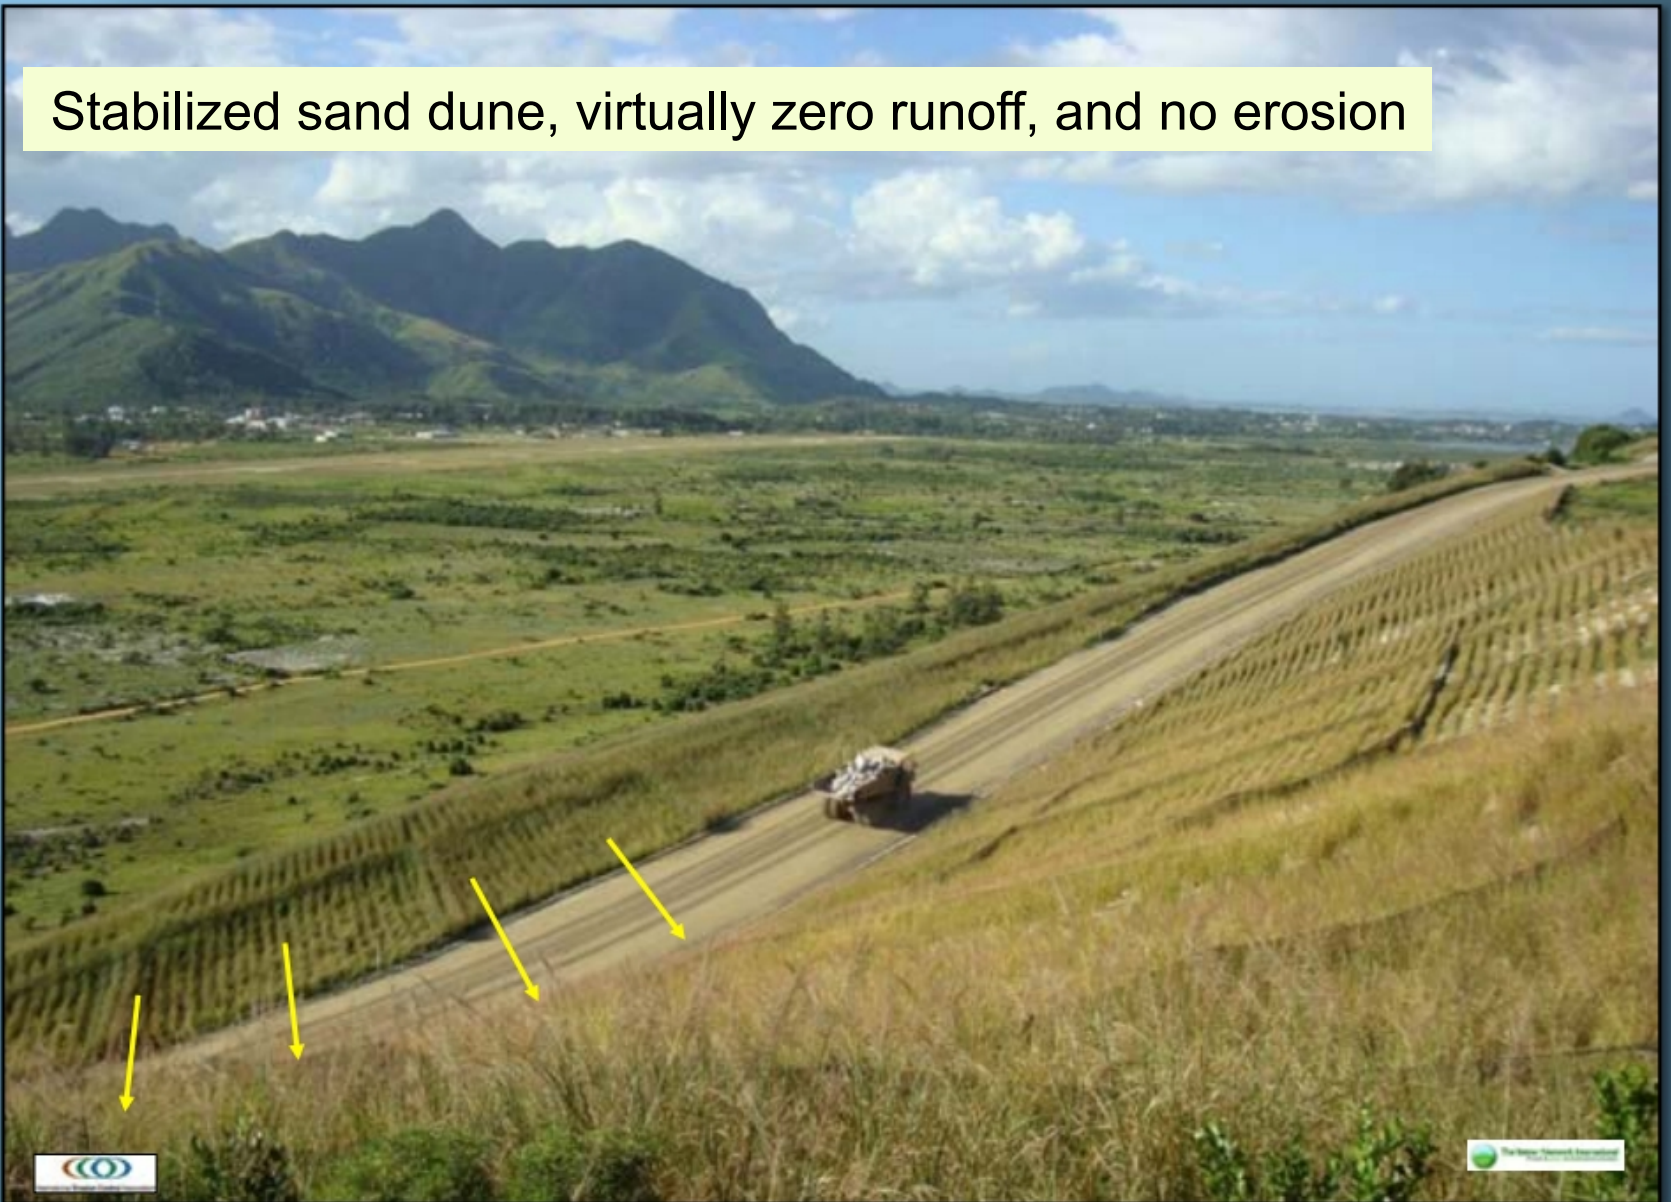
Stabilized sand dune, virtually zero runoff, and no erosion
