VETIVER SYSTEMS FOR LAND REHABILITATION

LANDSLIP CONTROL MECHANISM BY VETIVER

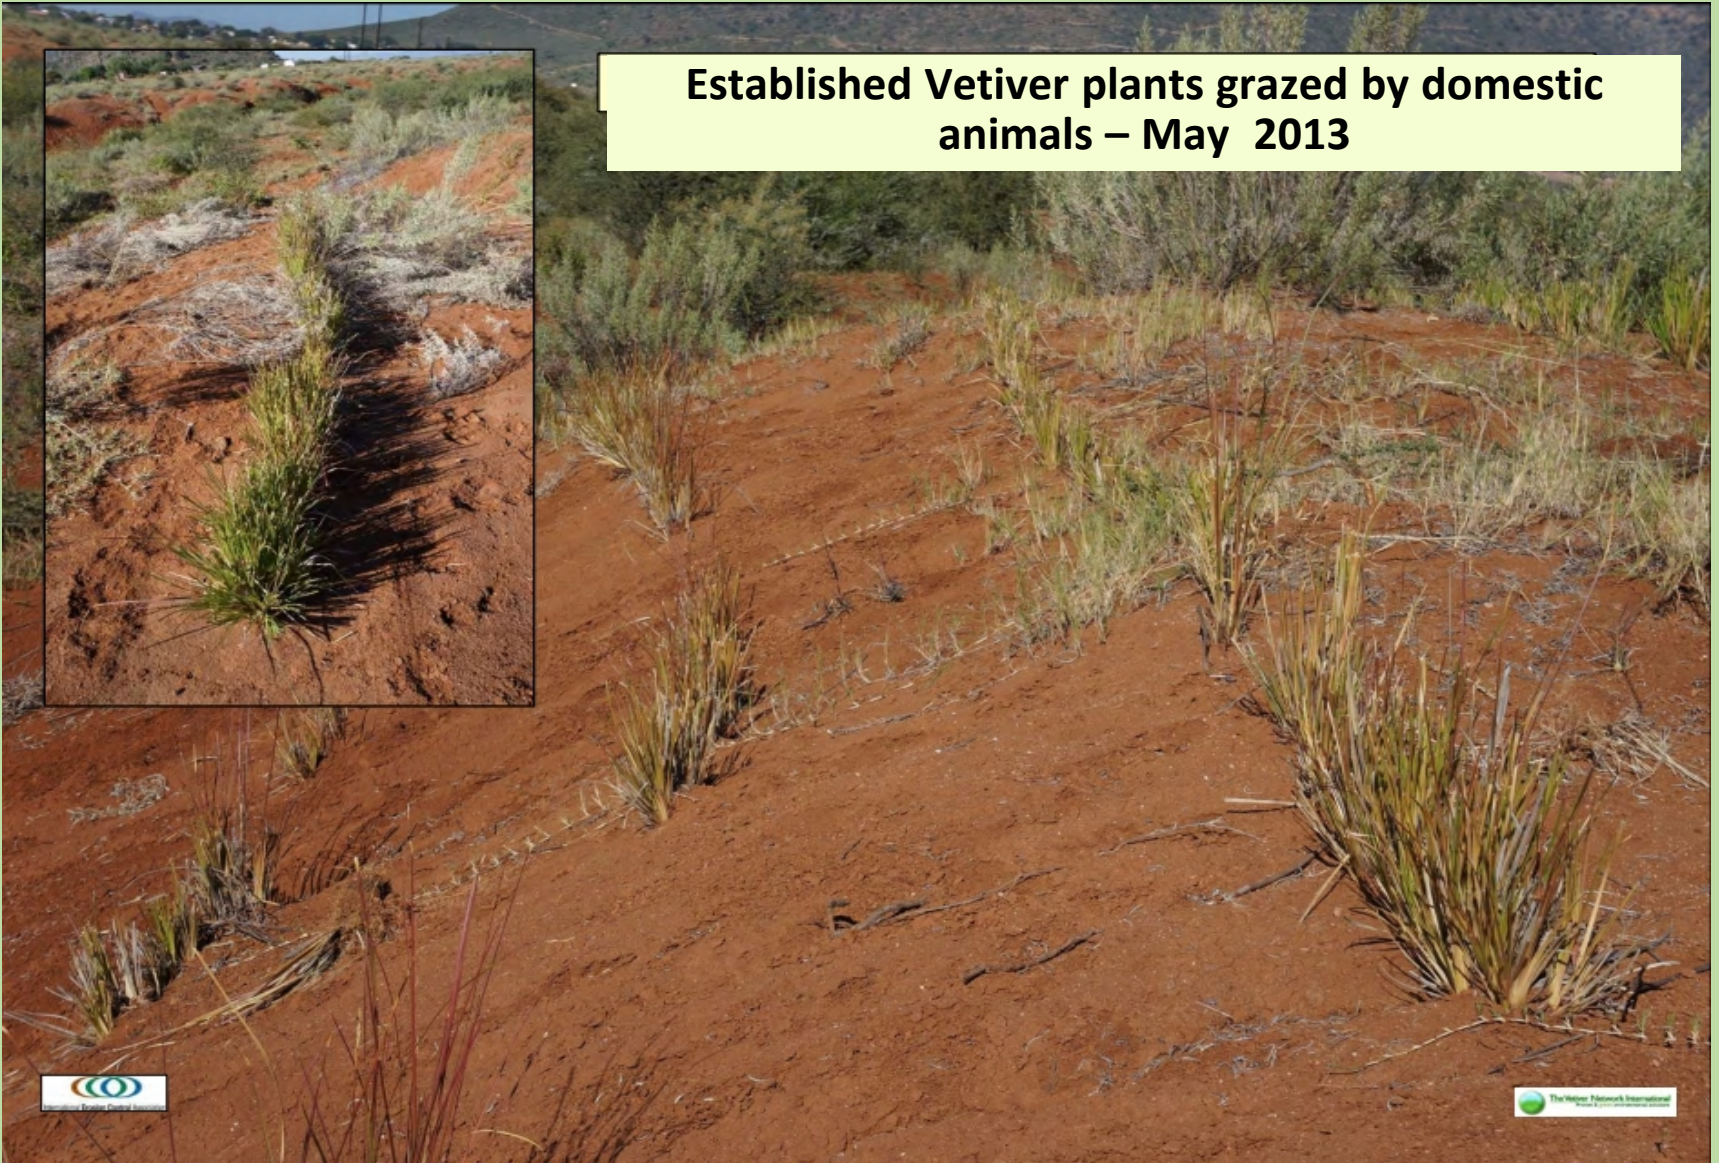
Established Vetiver plants grazed by domestic animals – May 2013

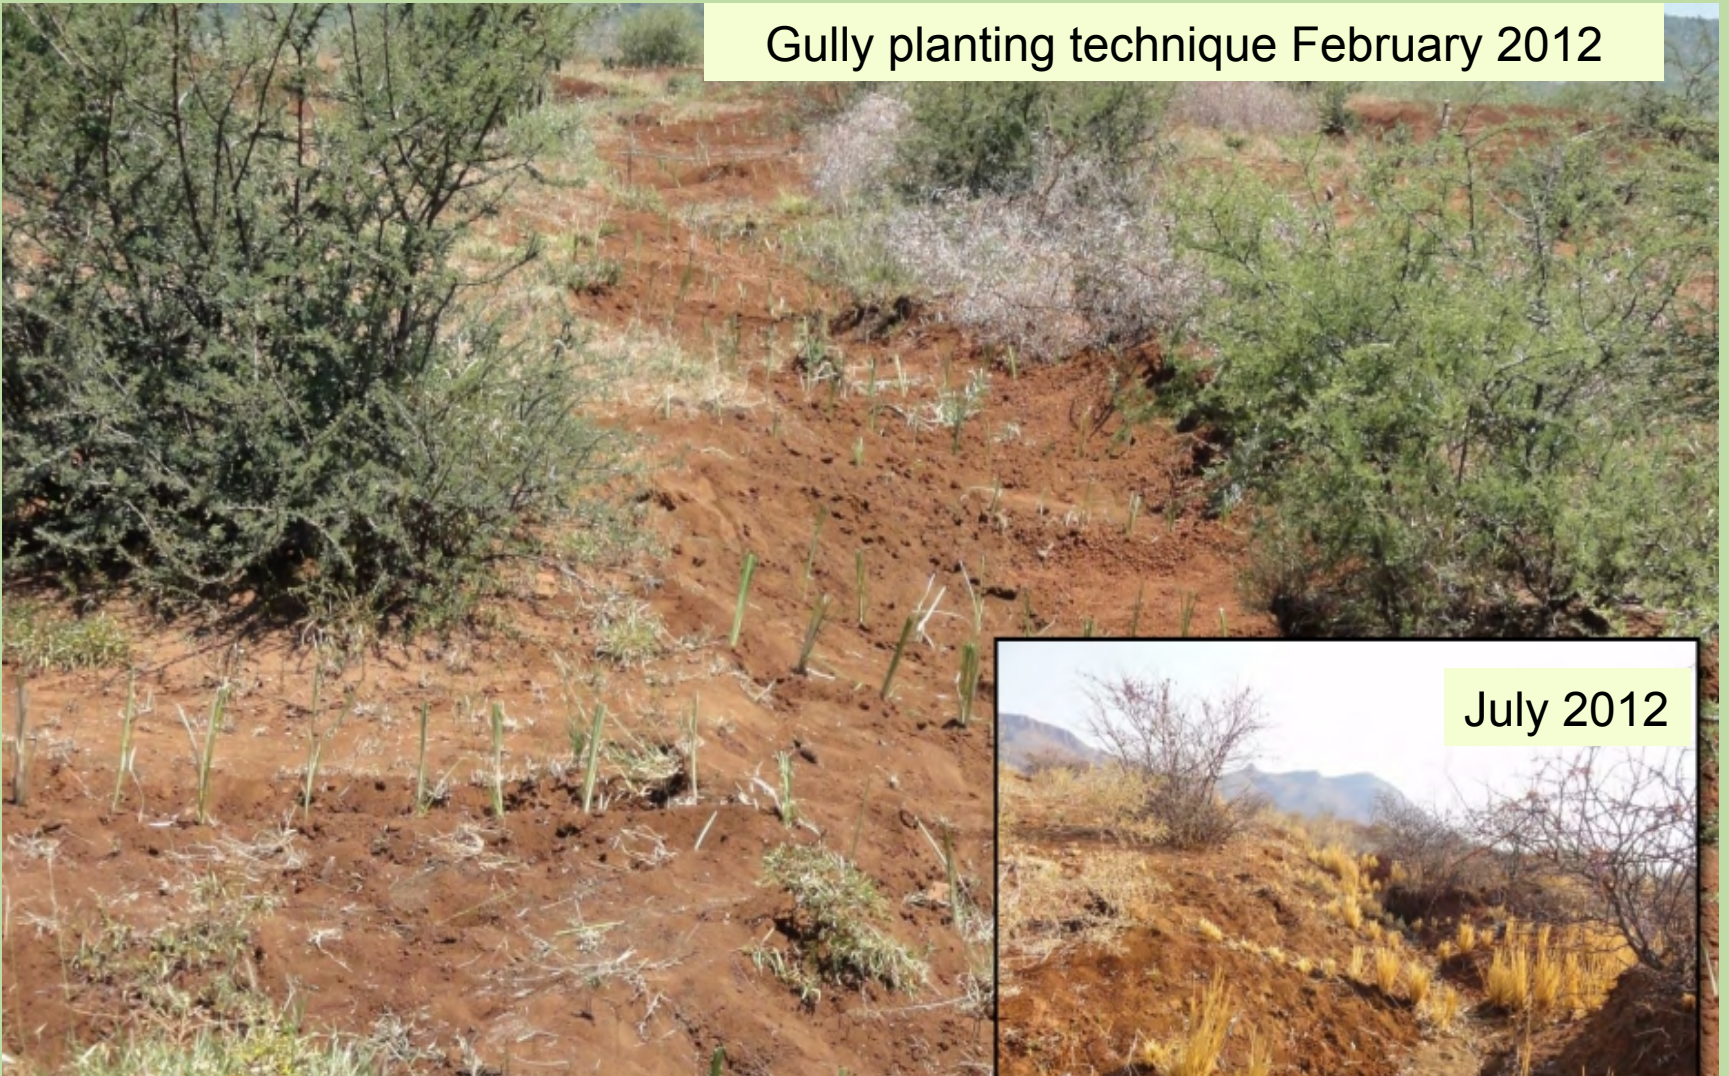
Gully planting technique February 2012
