# **VETIVER SYSTEM FOR RIVER AND CANAL BANK STABILISATION**

# Principles of the Vetiver System for River Bank Stabilisation

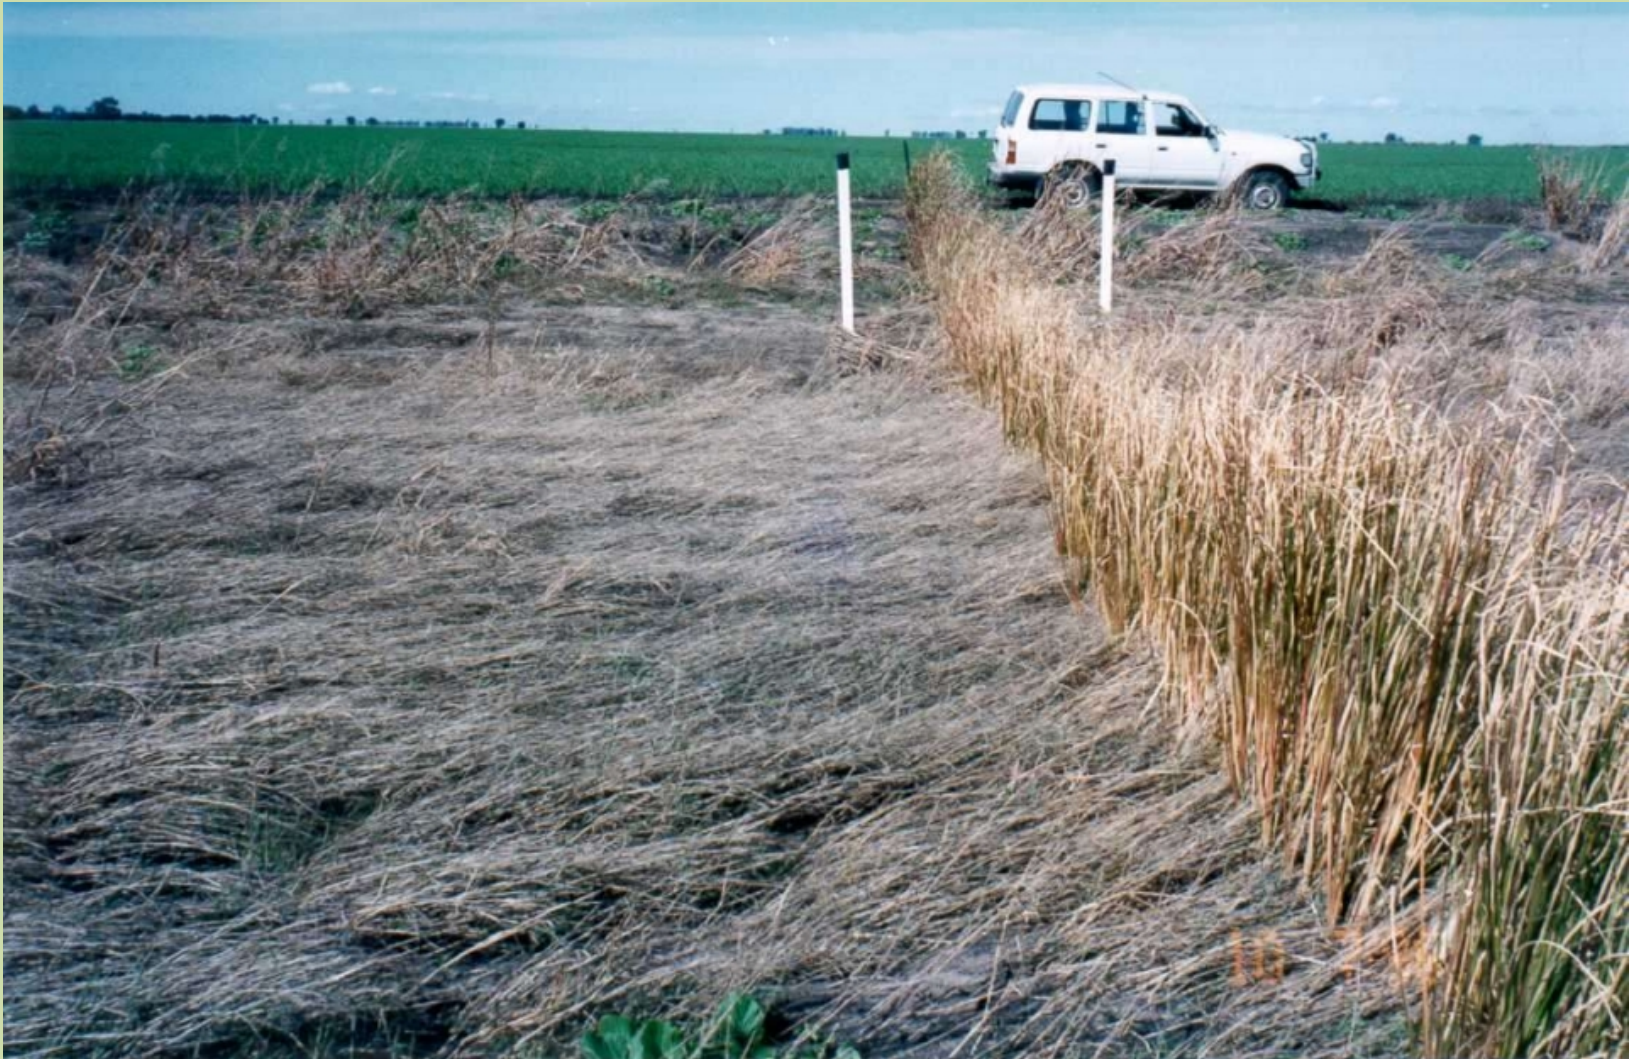
# **Strong current flattened the native grass but not vetiver on this waterway**

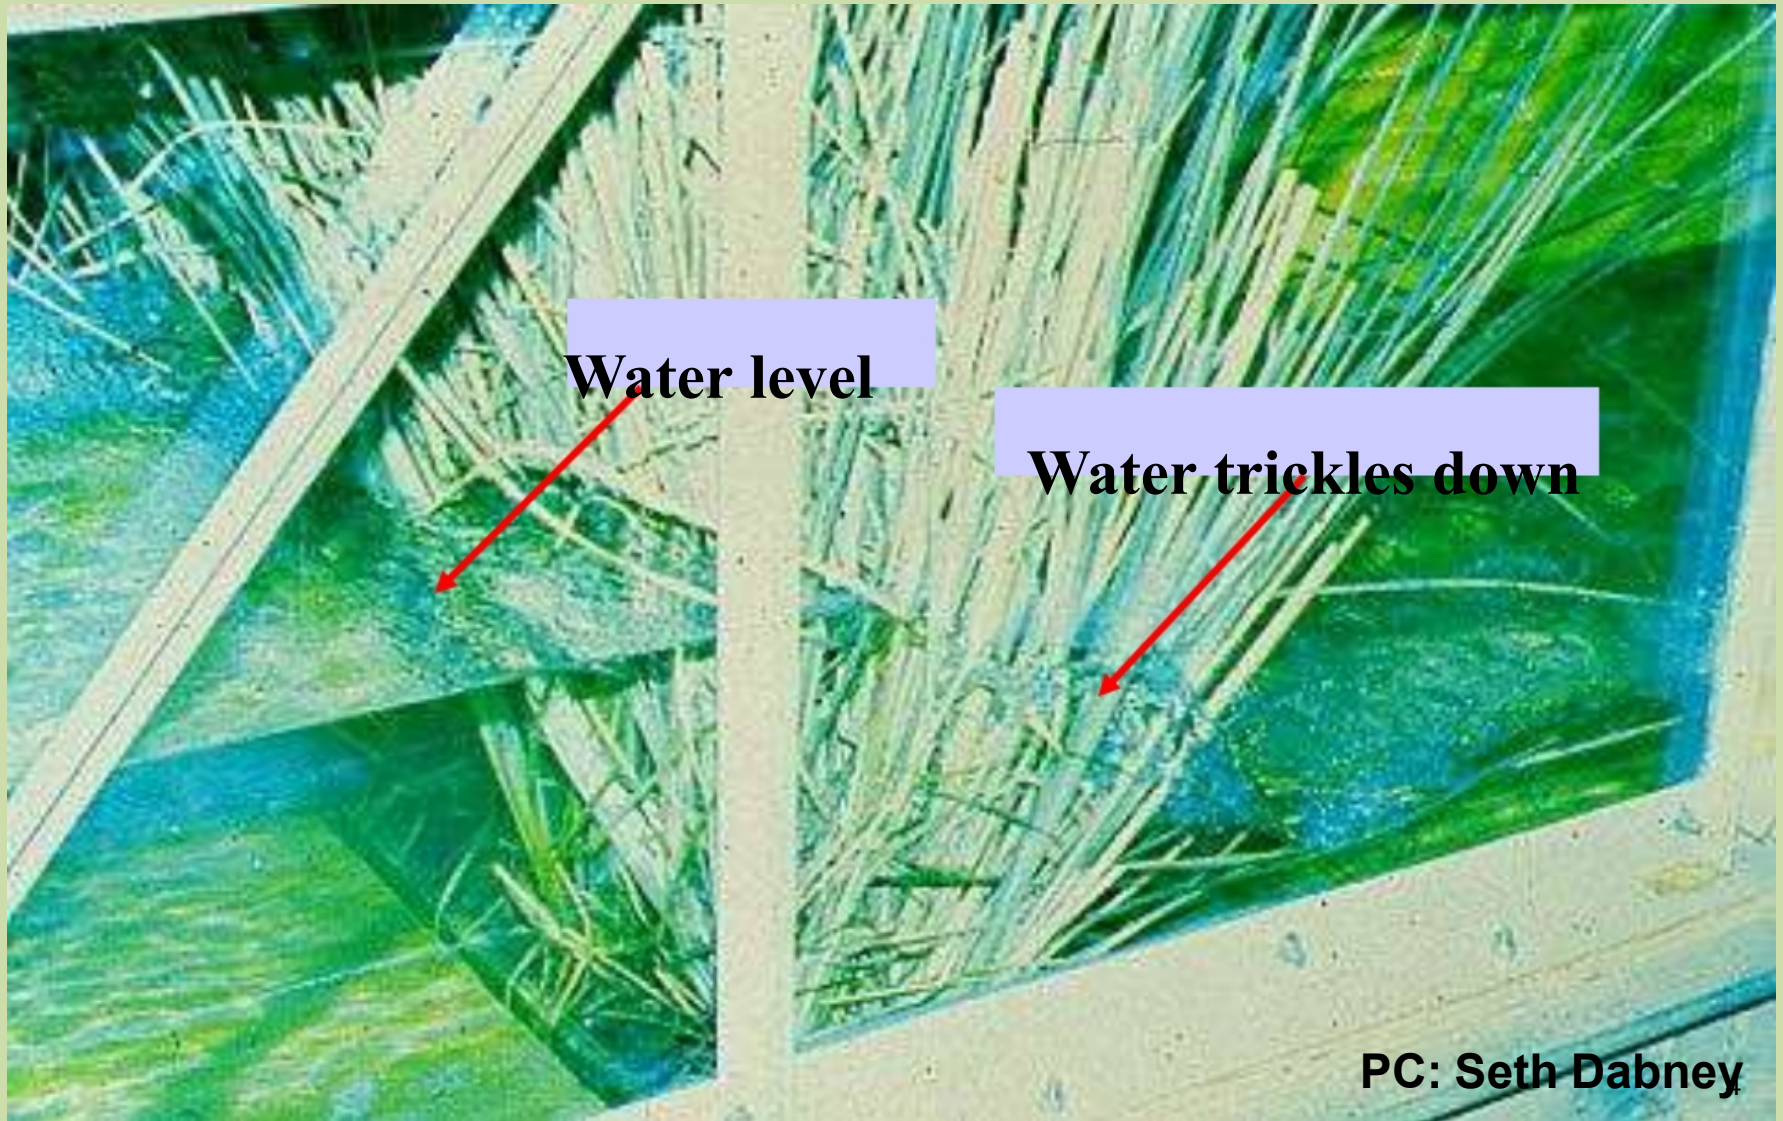
# Indoor flume test

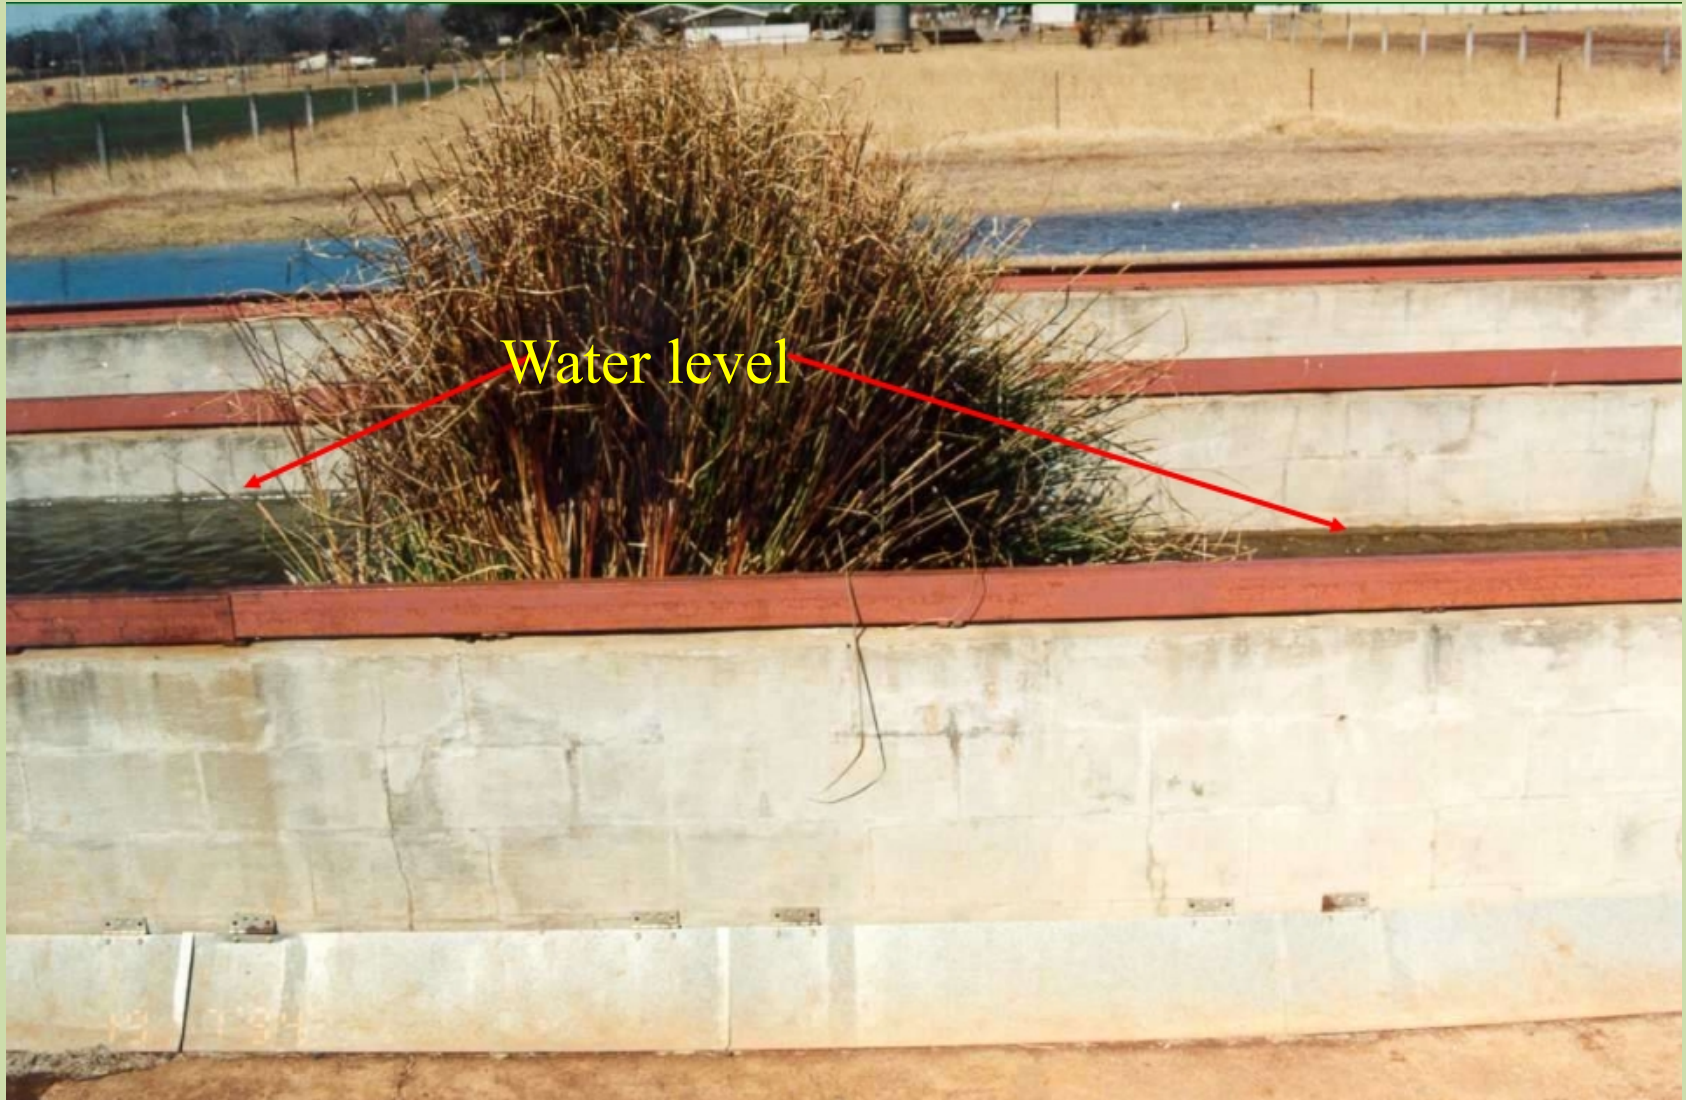
# In flume test a mature hedge can bank up water to 600 mm depth

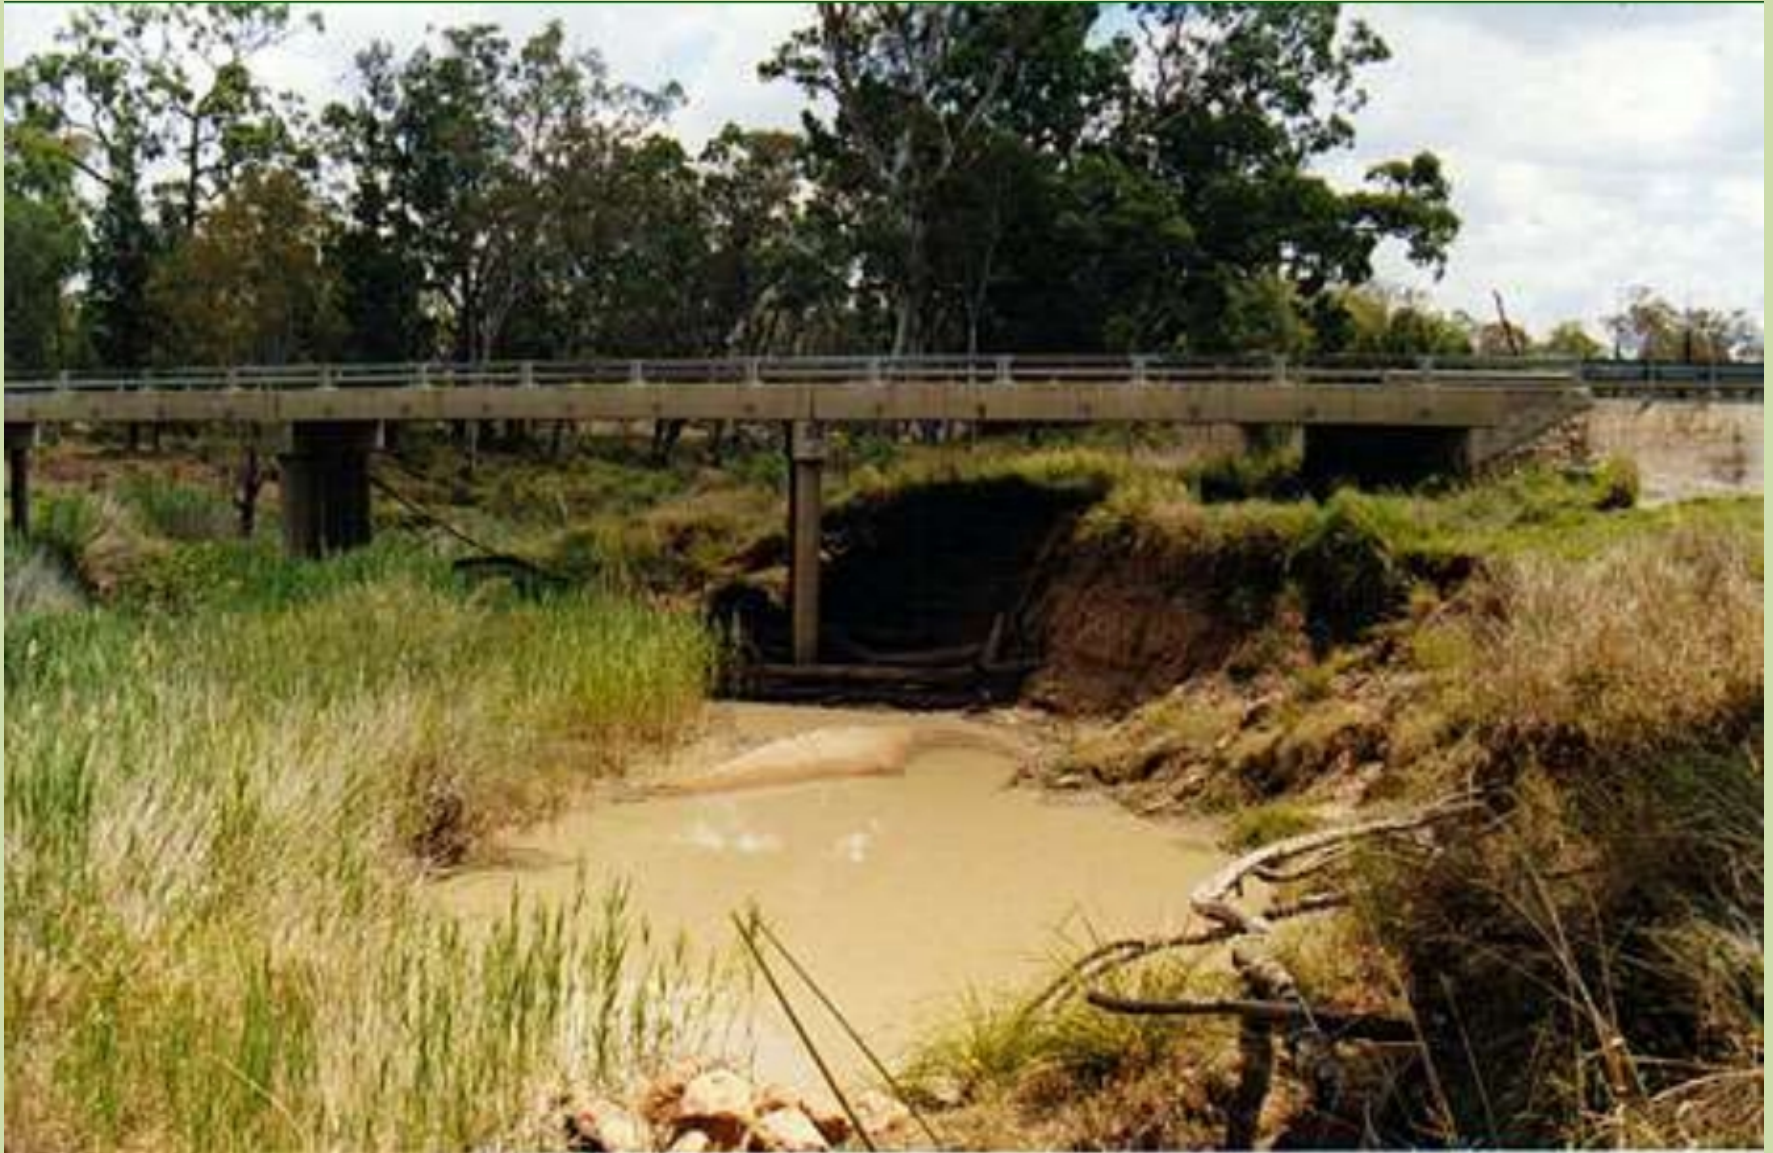
# Severe erosion on the abutment of the Coolumboola Creek bridge near Miles

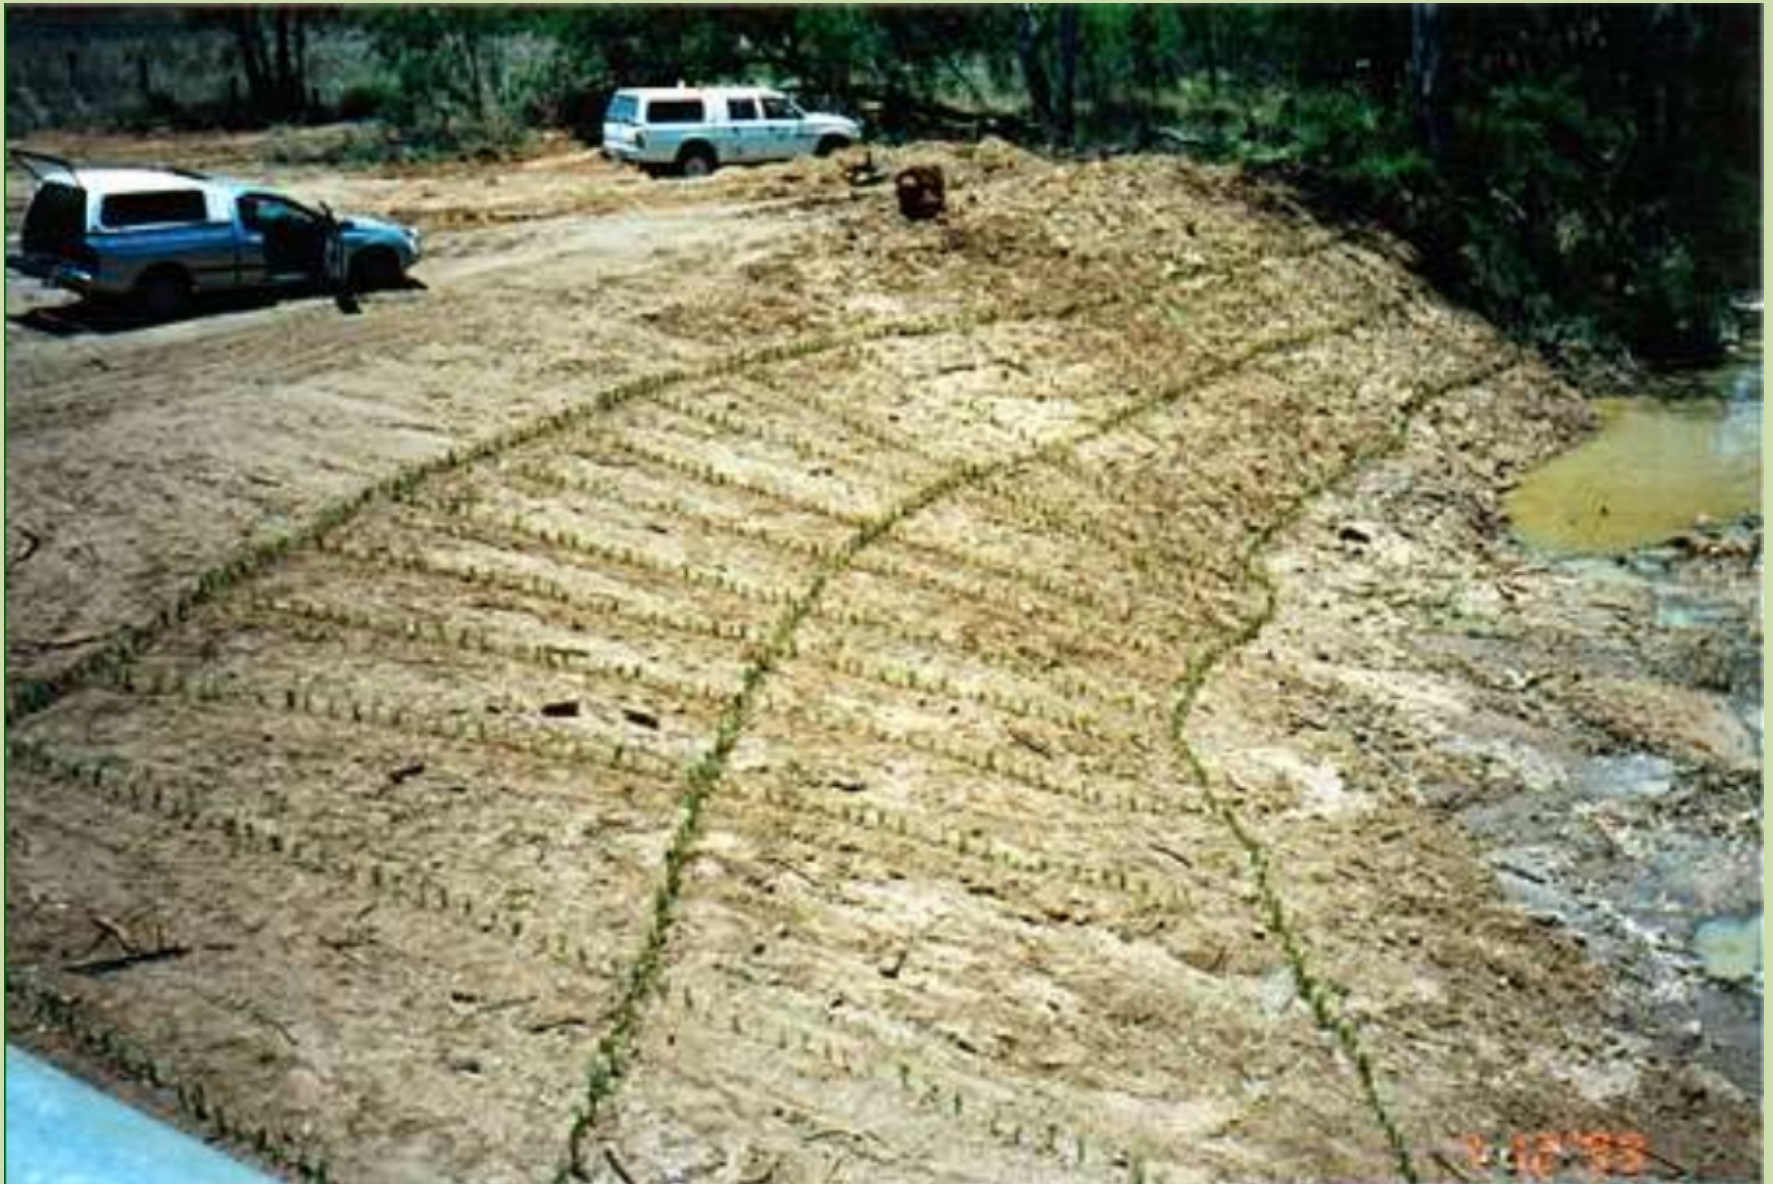
# Vetiver planting following repair of bank.

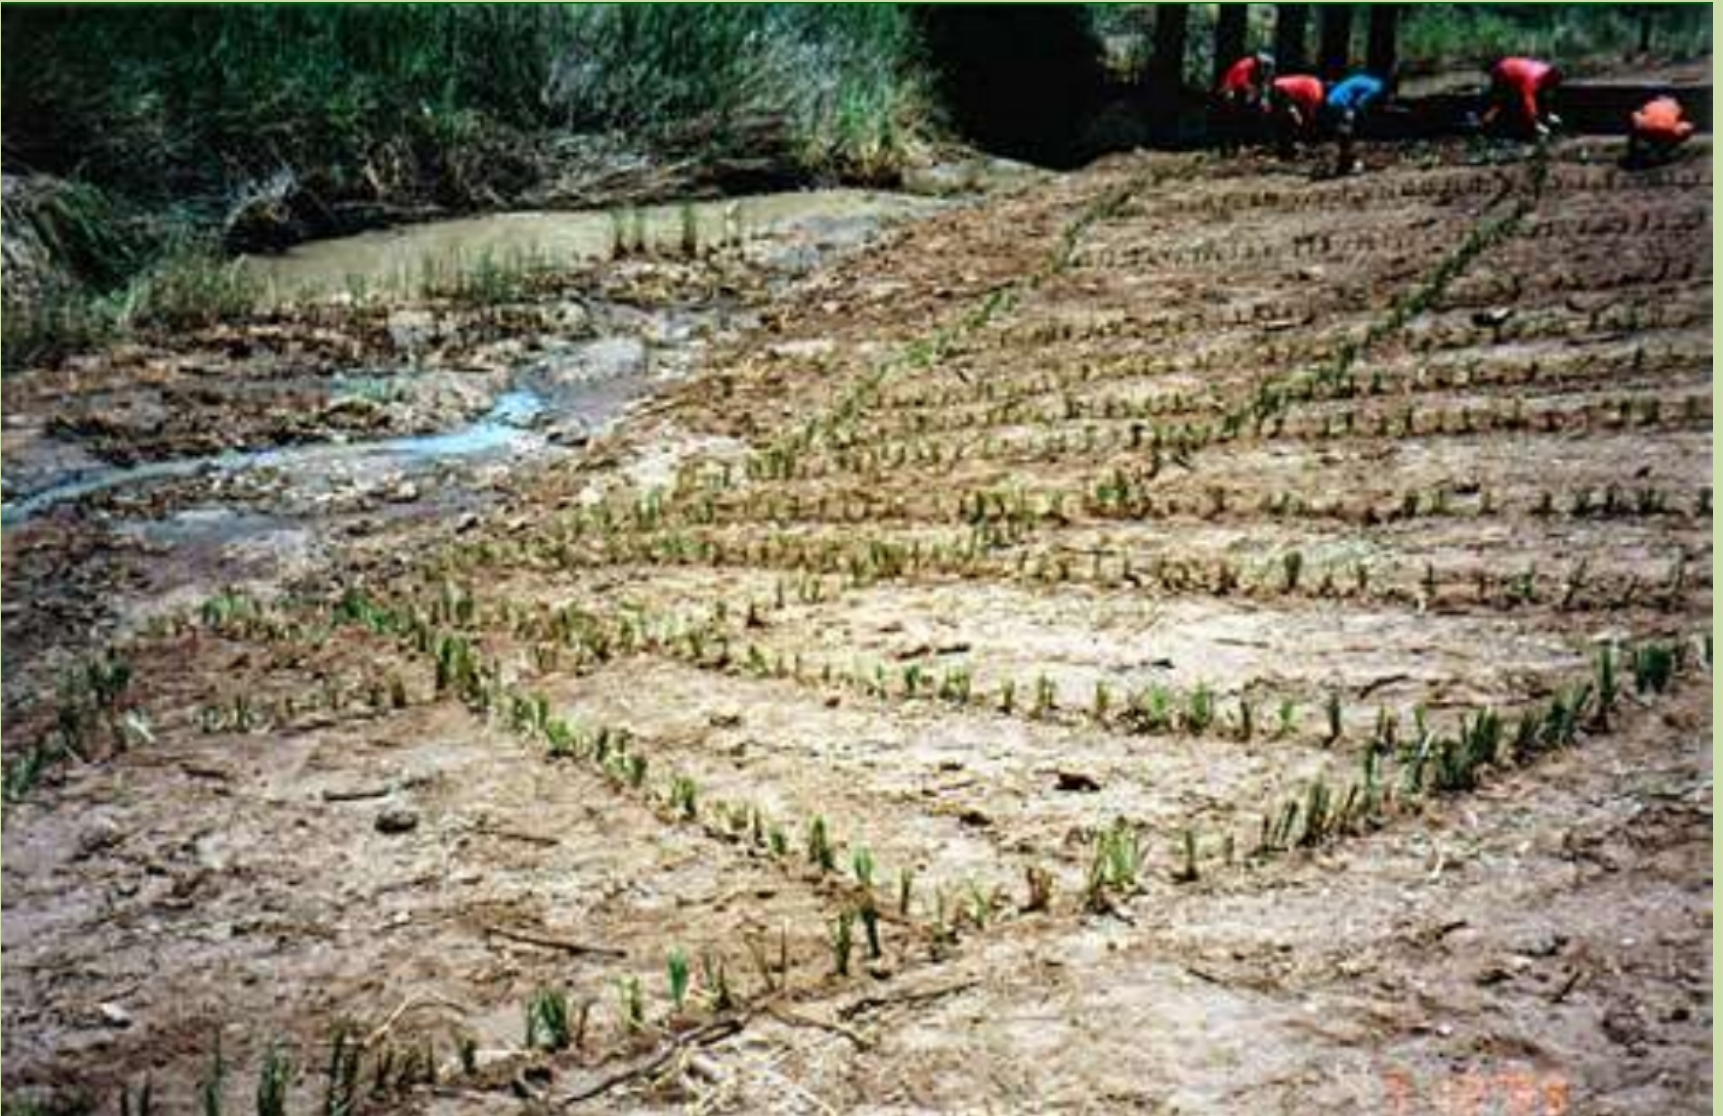
# Cross rows are most effective when planted right angle to flow direction

- To stabilise the bank steep gradients, horizontal rows planted on approximate contour lines
- To reduce flow velocity of the strong current therefore preventing scouring from the strong flow, planting of cross rows is needed.
- For maximum effect, the cross rows are orientated at right angle to the flow direction.
- *The spacing of both horizontal and cross rows varies with slope gradient and length, soil type, flow velocity and depth .*

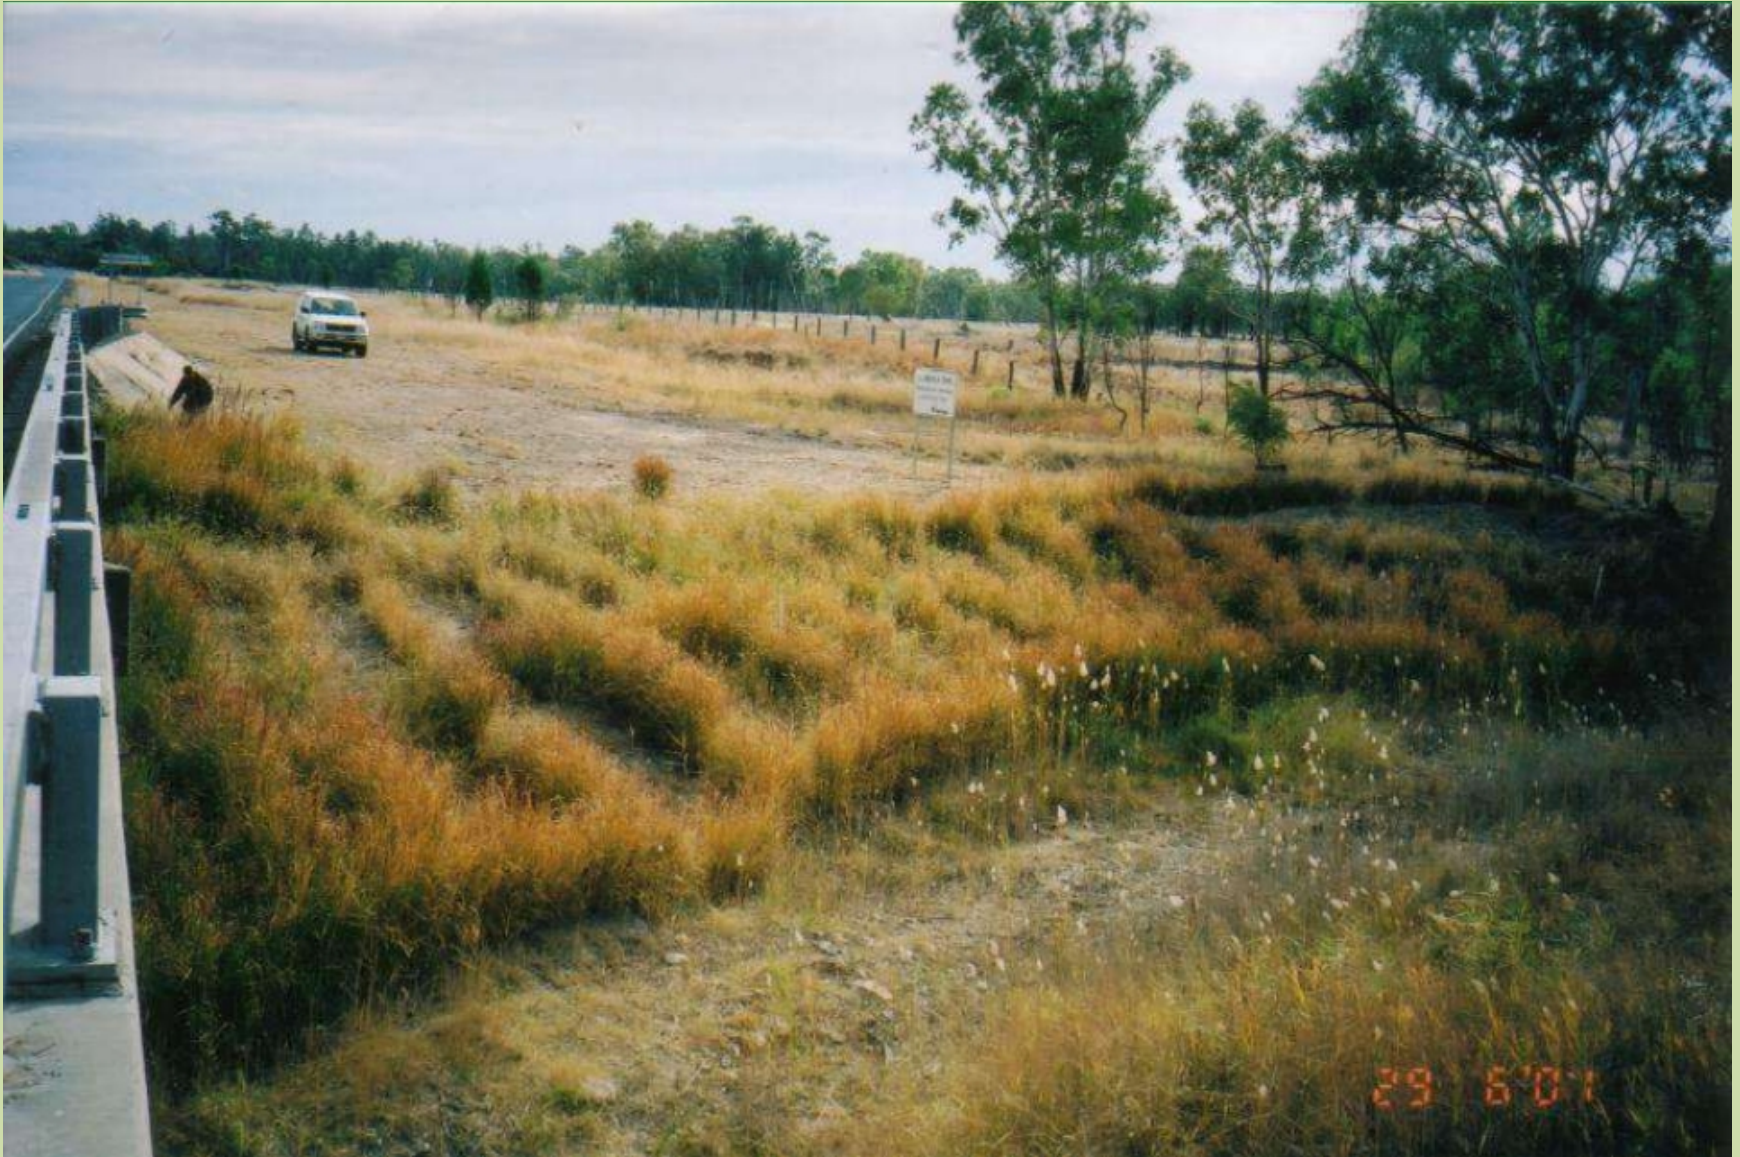
**There were several big flows during the first summer and no damages were noted. This abutment is now well protected by these mature vetiver.**

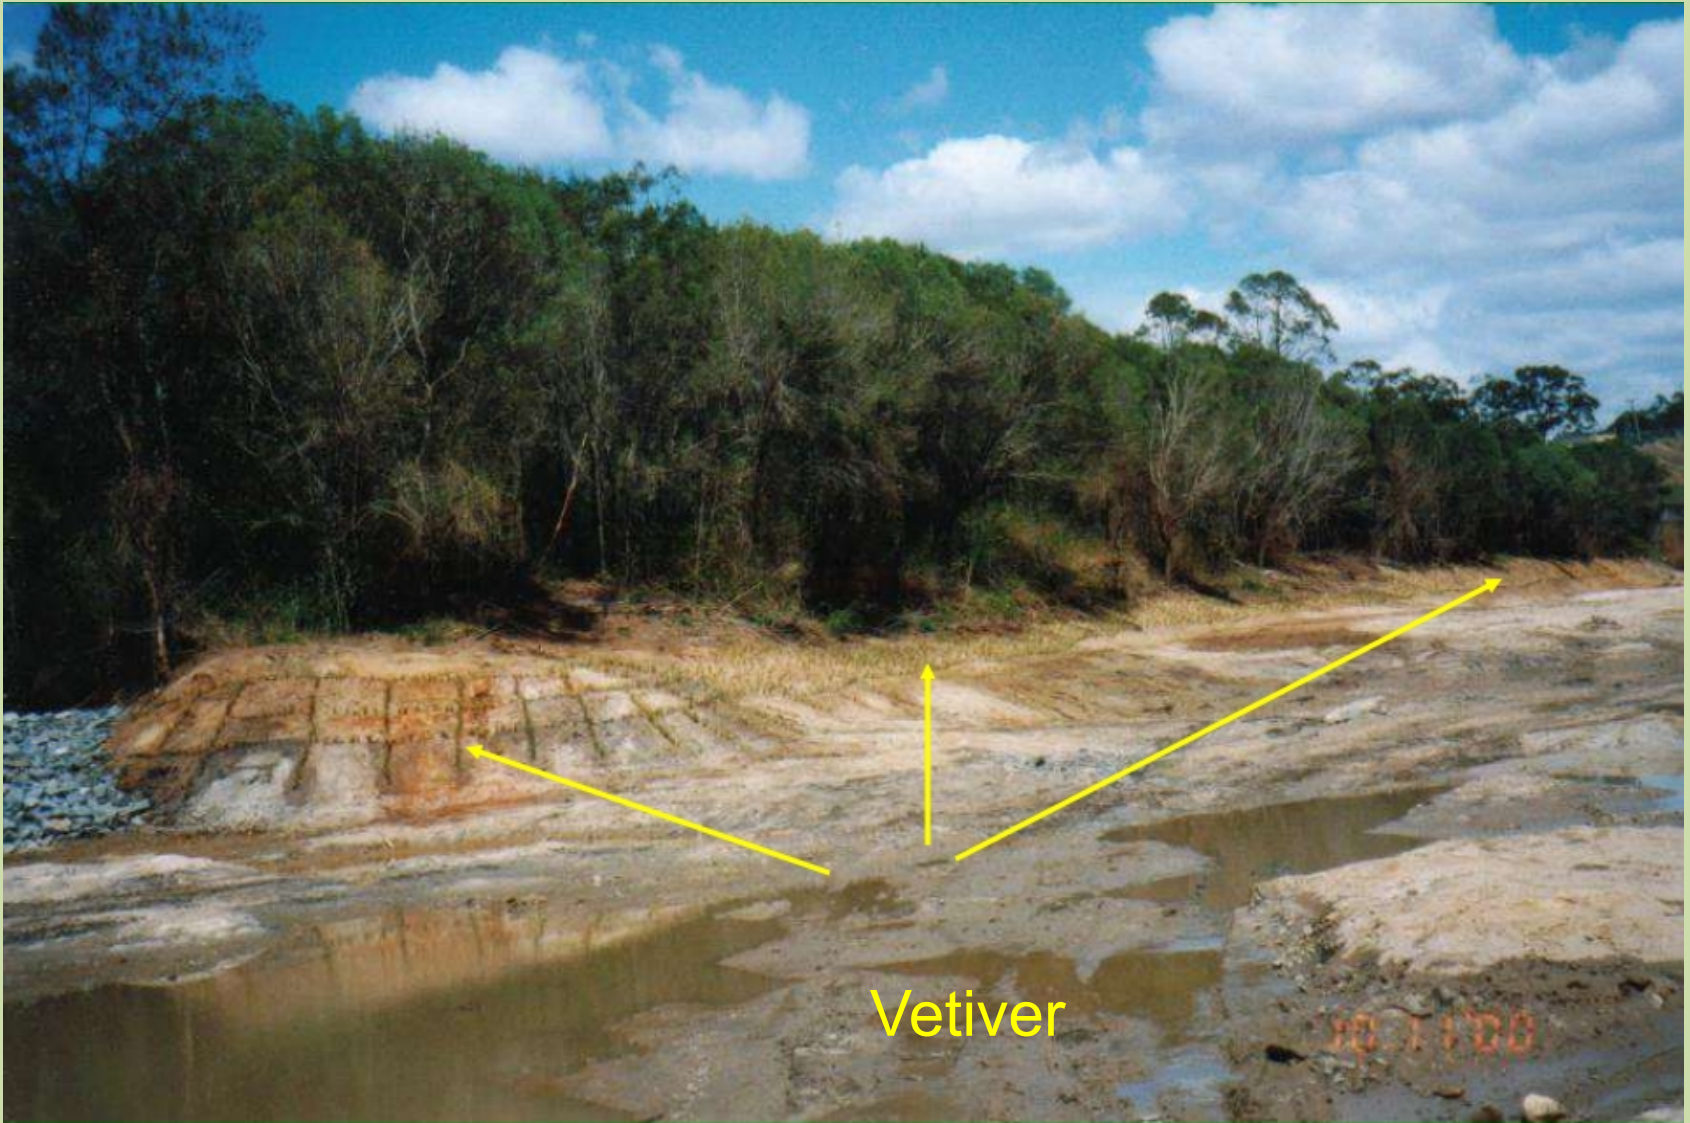
# Dam spillway protection

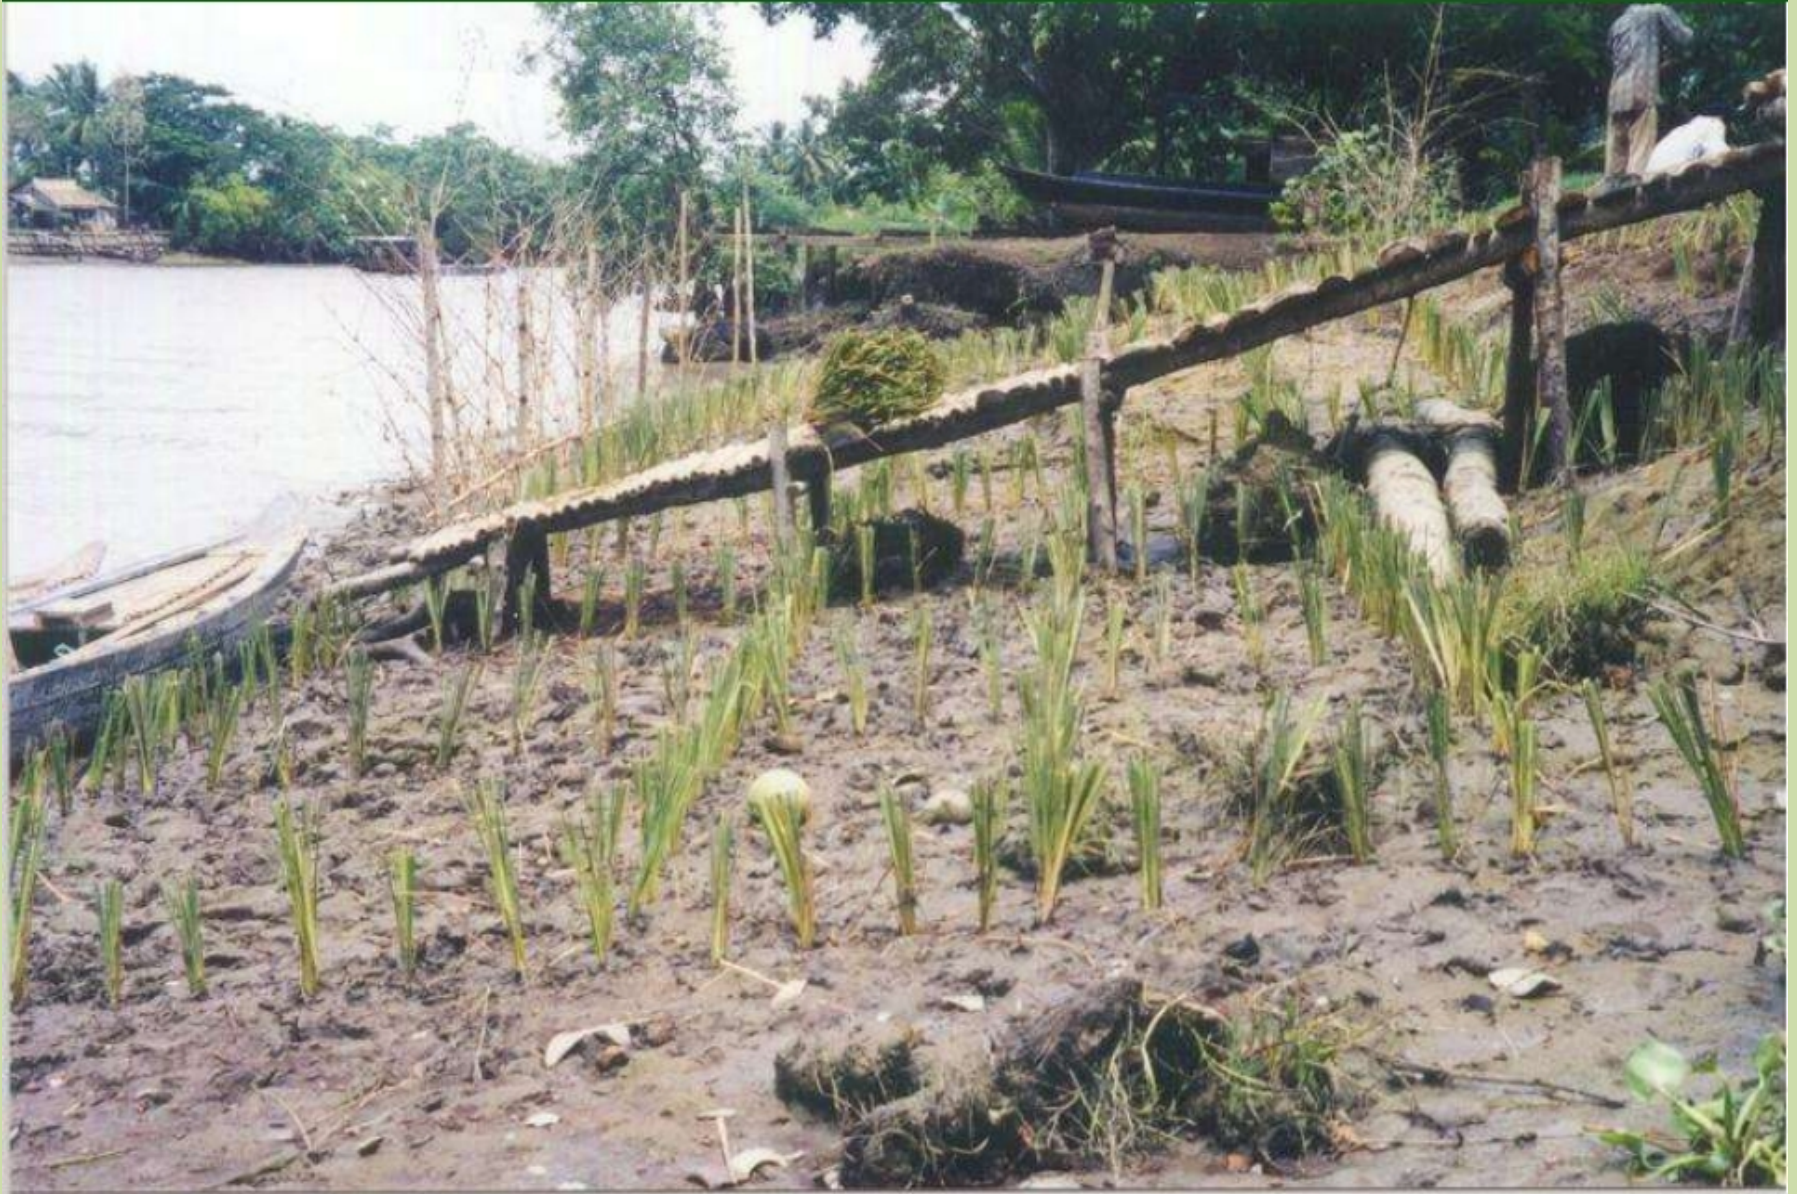
# Mekong Delta Vietnam: Protecting bank against wave erosion

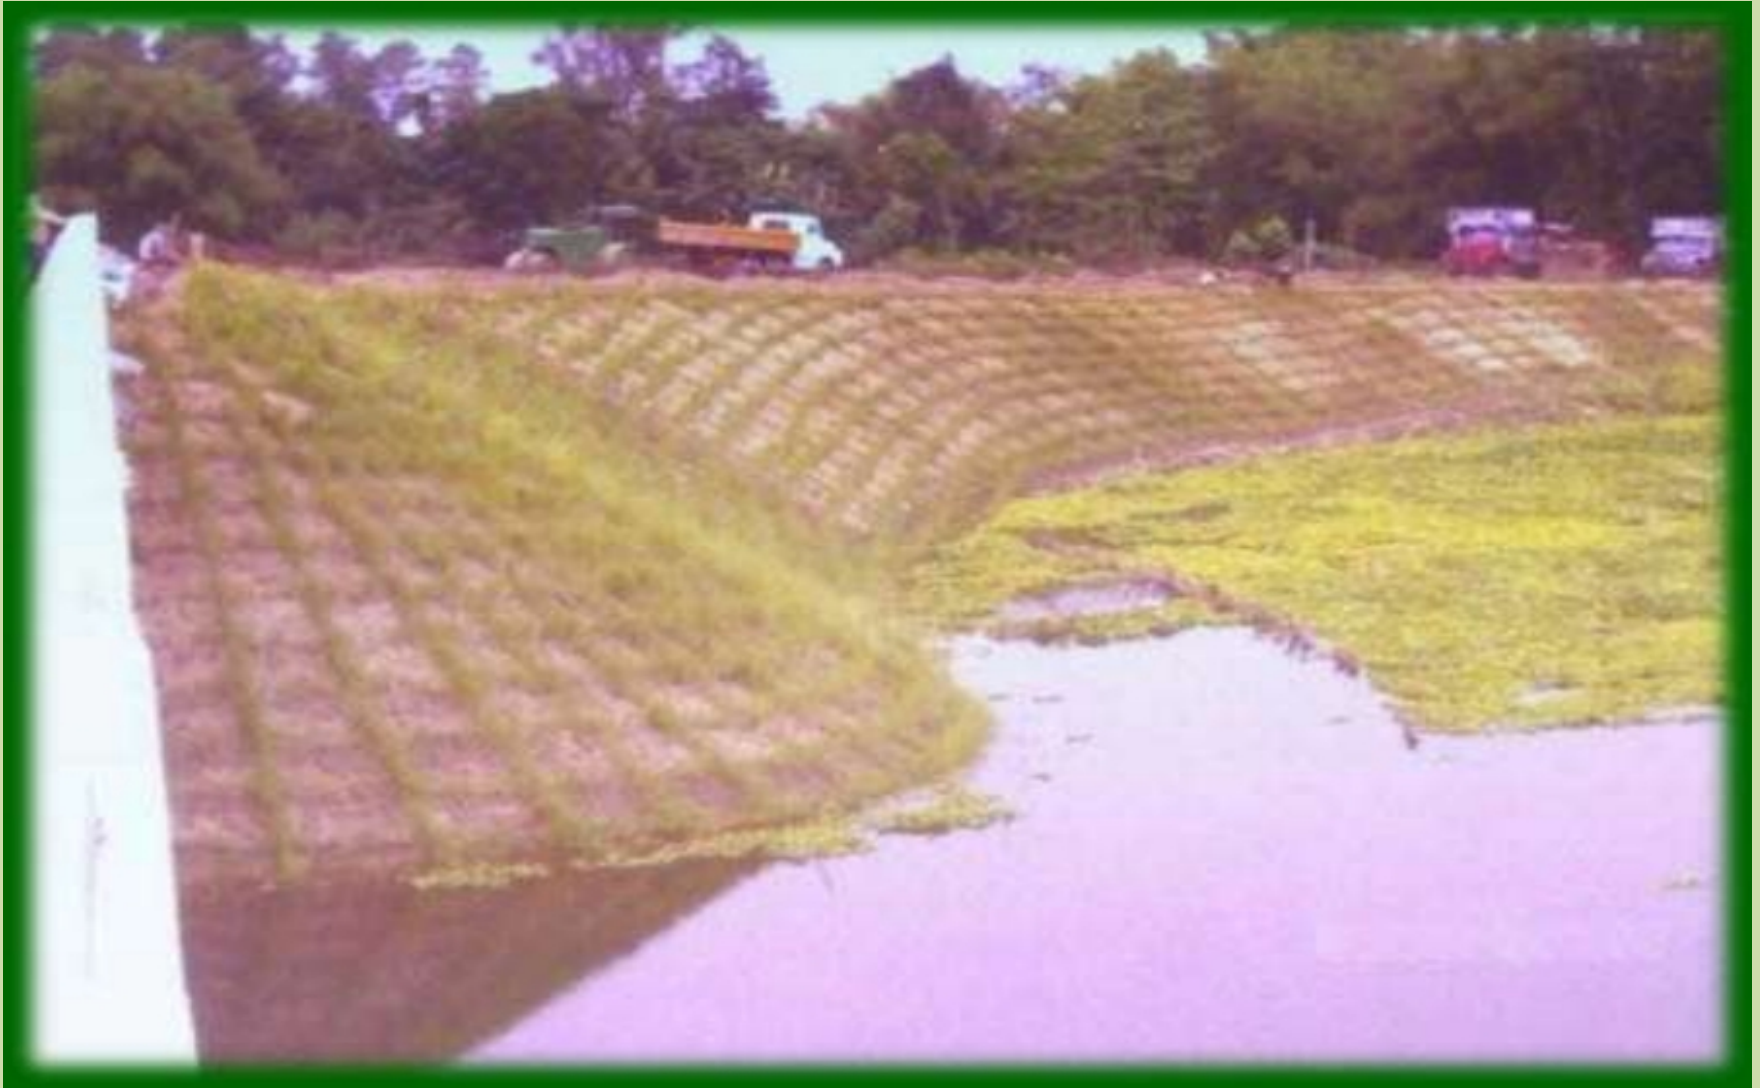
# Assam, India : Doria Bridge approach, Note: grid pattern

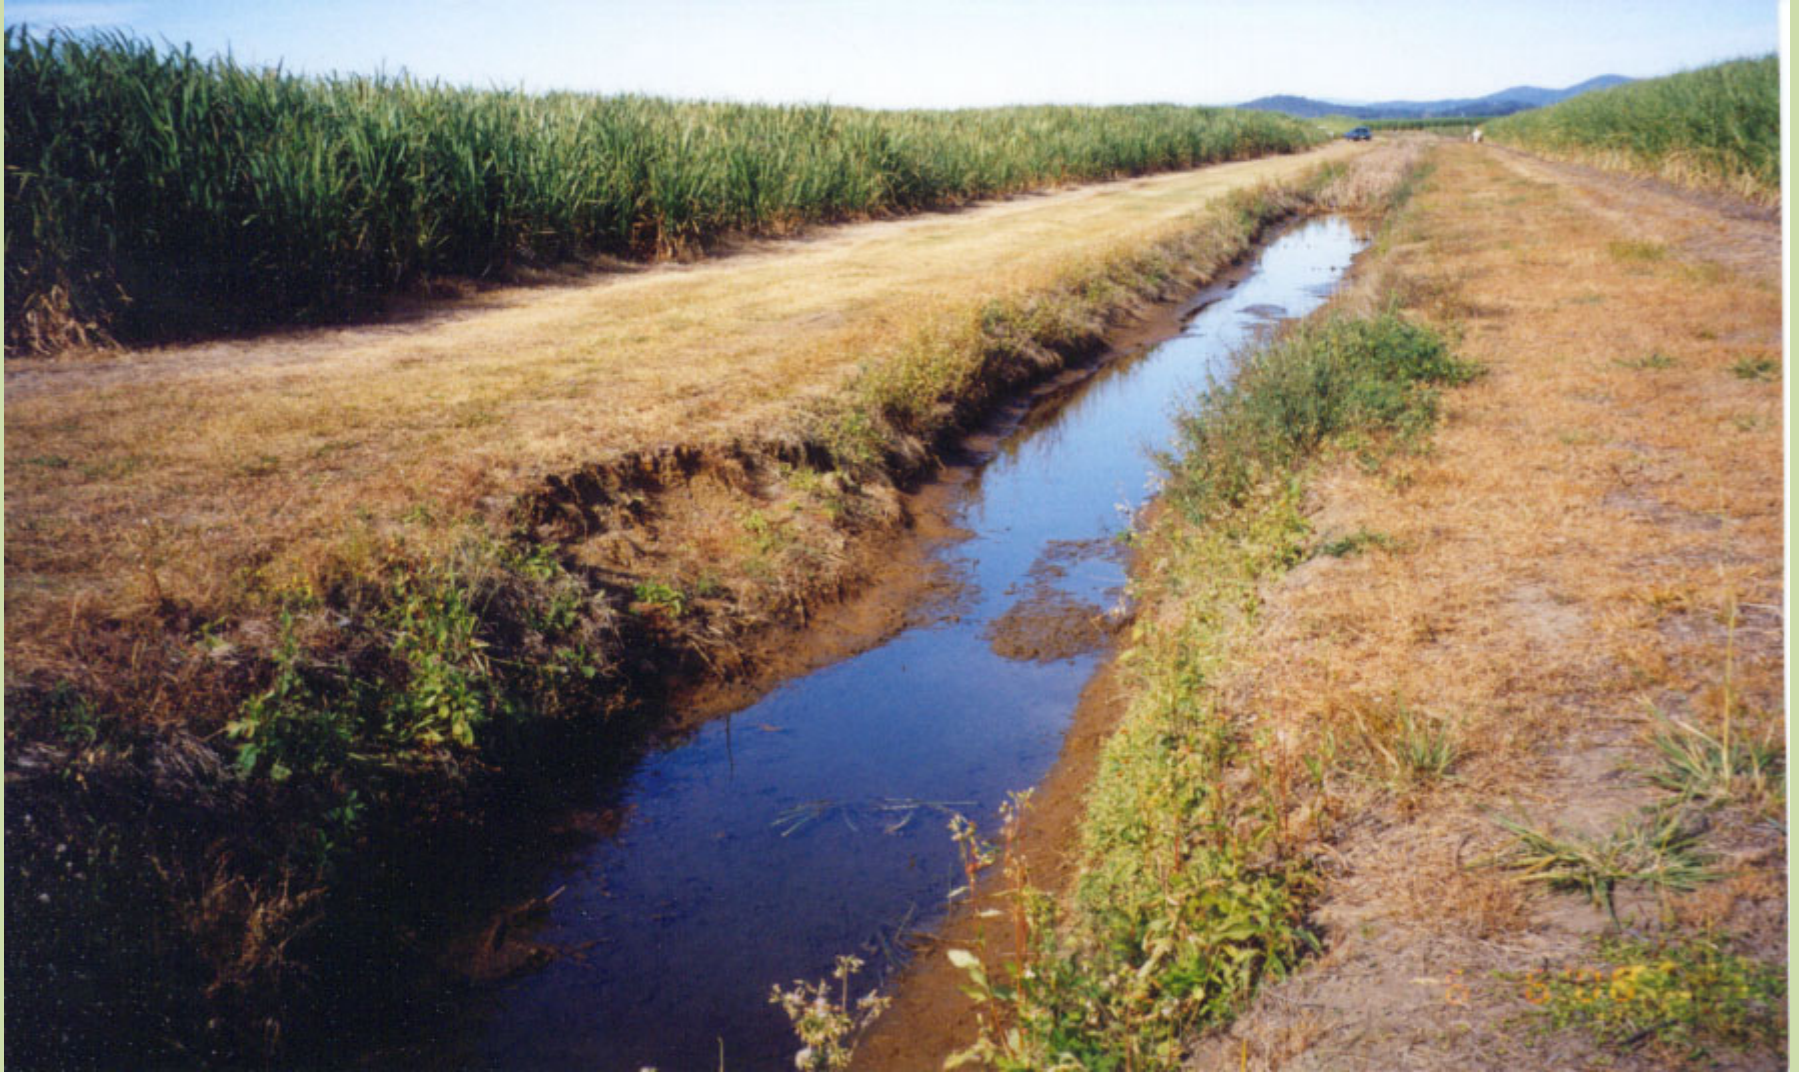
# Australia - Badly eroded drainage channel on acidic sulfate
