# **VETIVER SYSTEM FOR RIVER AND CANAL BANK STABILISATION**

# Principles of the Vetiver System for River Bank Stabilisation

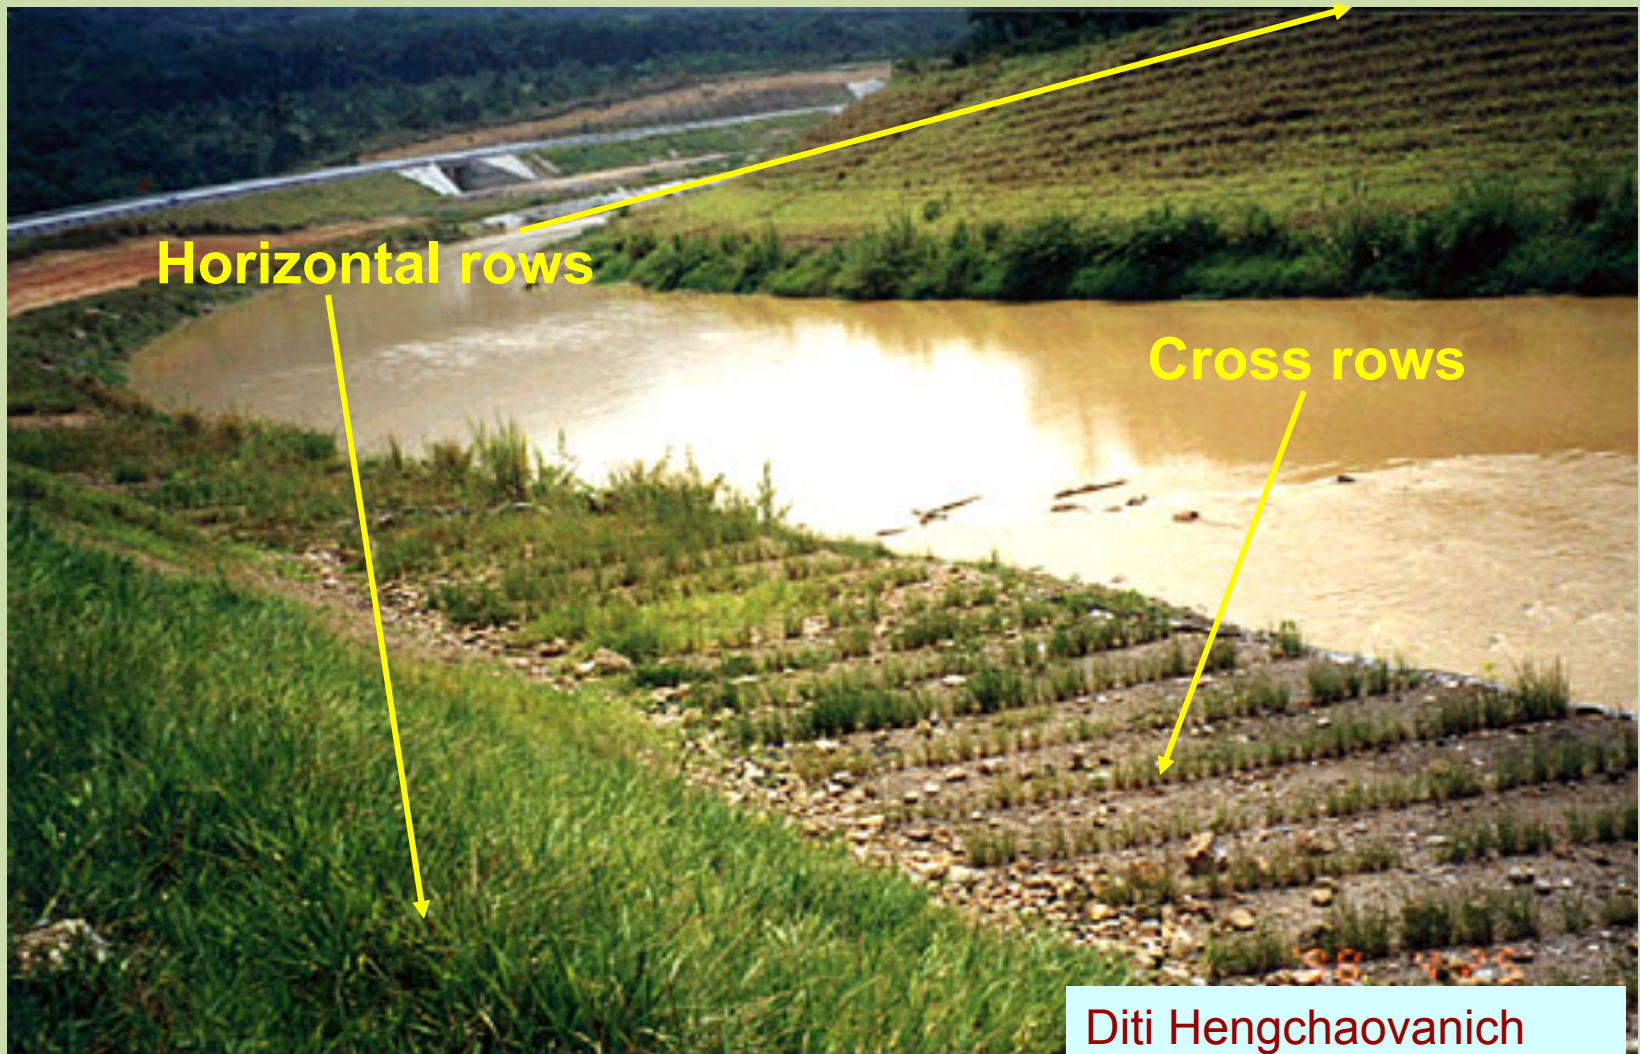
# Malaysia: An outstanding success, several floods did not damage this river

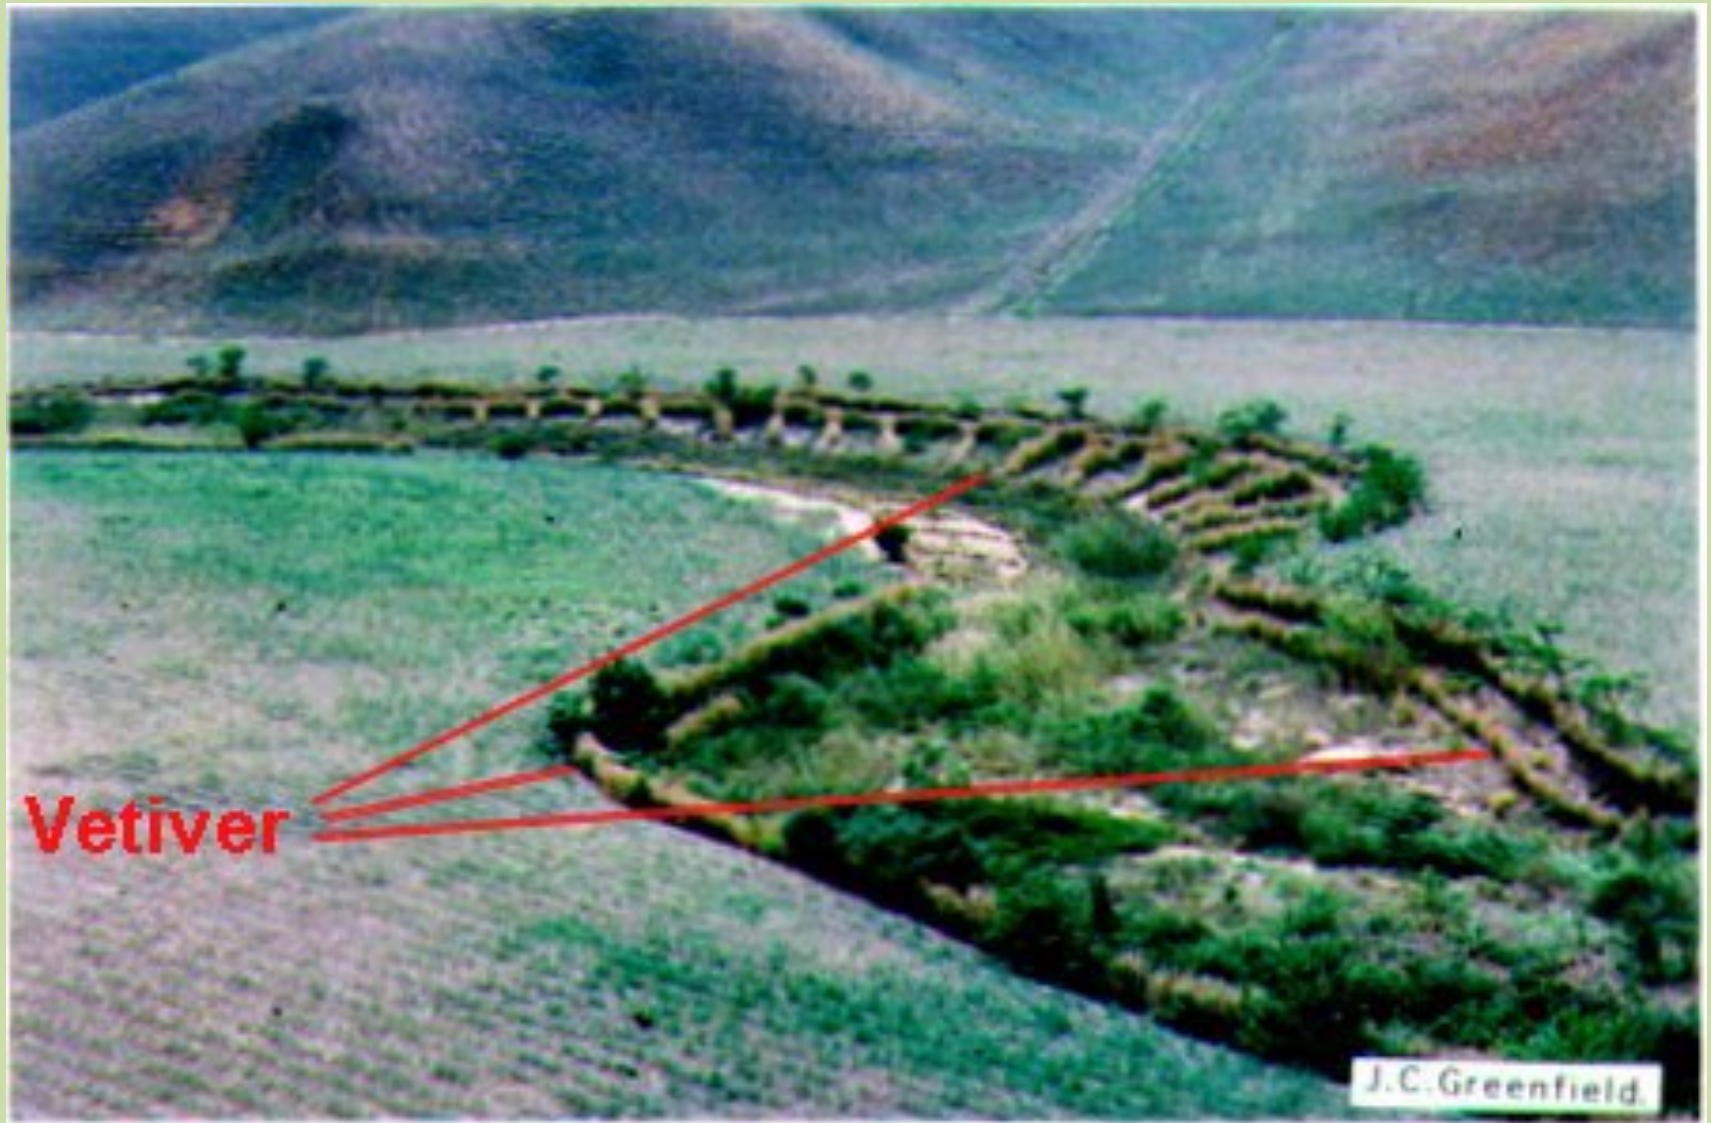
# South Africa: A very well layout provided complete protection against erosion
