VETIVER SYSTEM FOR BEACH EROSION REHABILITATION

Paul Truong - *TVNI Technical Director*

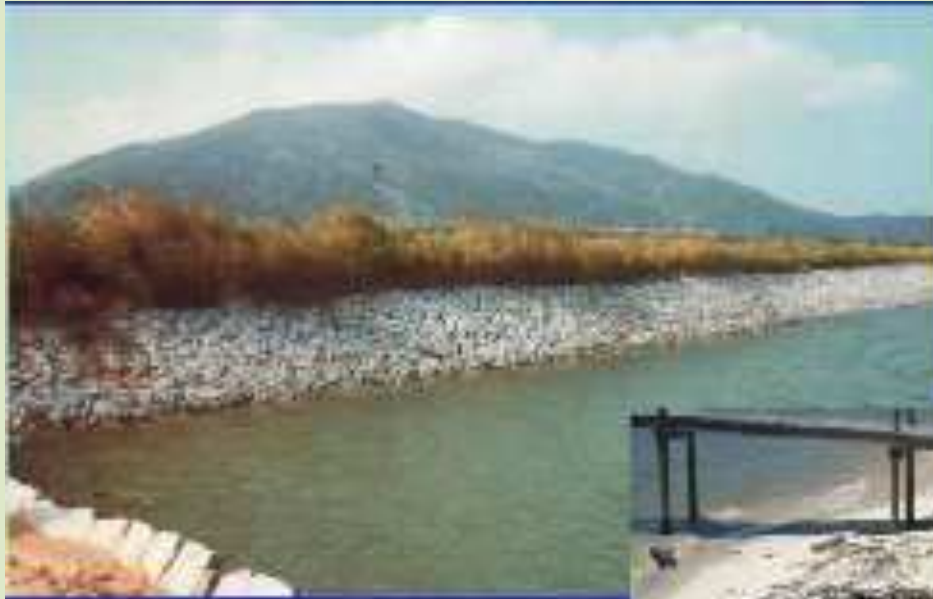
Left: China, Sea wall protected by vetiver - 100% salt water fish pond. Where planted there was no breaching by cyclones

Right: Vetiver protected this beach cliff interface on Alabama Bay (brackish water), USA

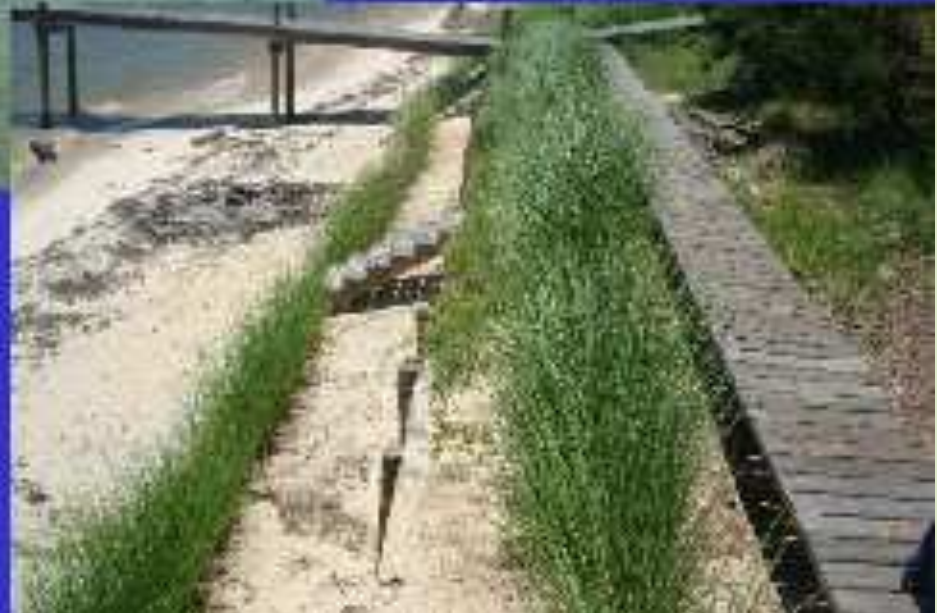
India: Chennai Beach Resort Landscaping and sand blast control

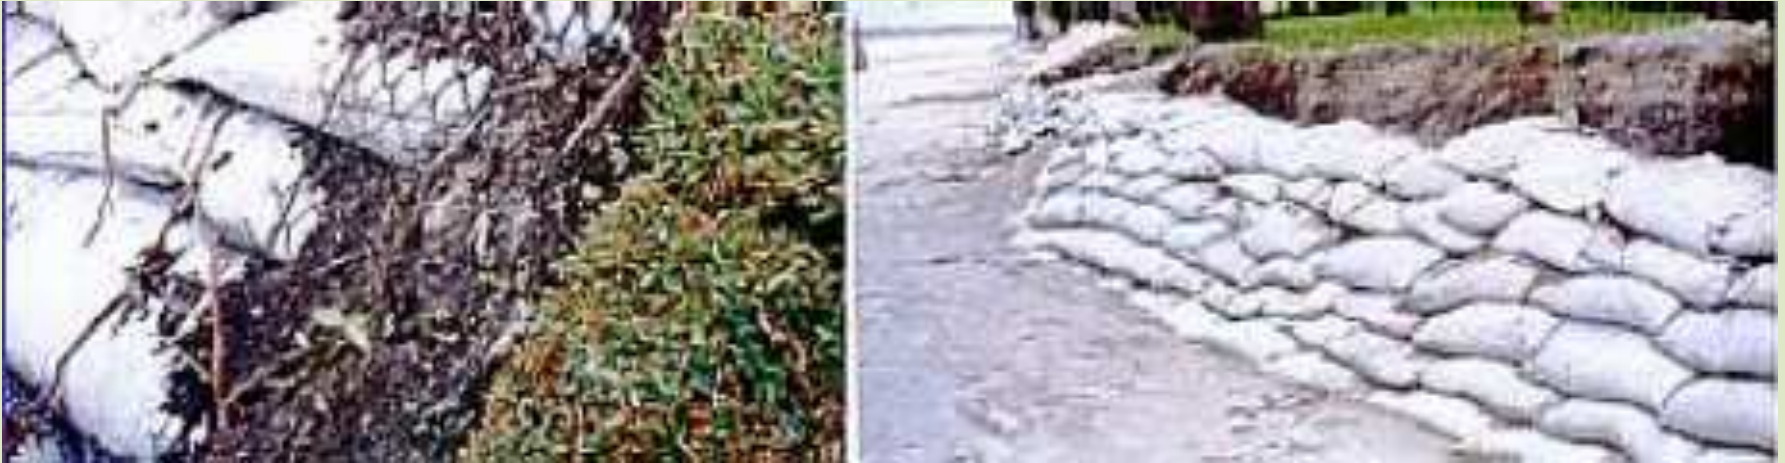
Traditional Solution

In 2008 the initial solution was to build a rip rap using raffia bags filled with a mixture of soil-cement in the proportion of 12% cement and 88% of local soil

Although this measure worked partially, it had very low landscape appeal for an urbanized condominium settlement on Brazil number one beach. Eventually, due to concerns of the local Community Association and environment authorities, who wanted a most environmentally friendly method for the region, which lead to the search of a new concept of beach protection combined with landscaping .

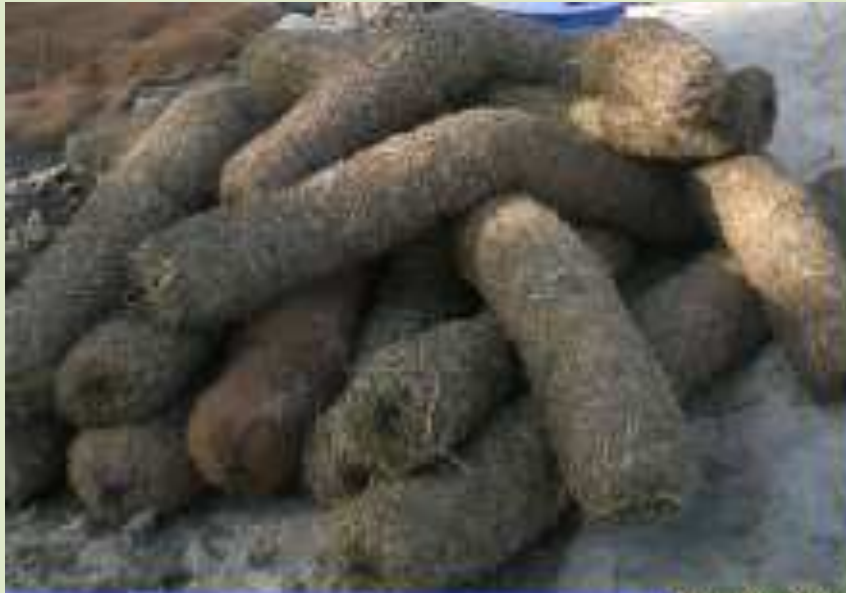
Cocologs in low risk area

Bio-engineering with Vetiver grass: Using Cocologs in low risk area and wooden palisade in high risk area to increase security factor of the structure anticipating sea level rise due to climate change in the future.

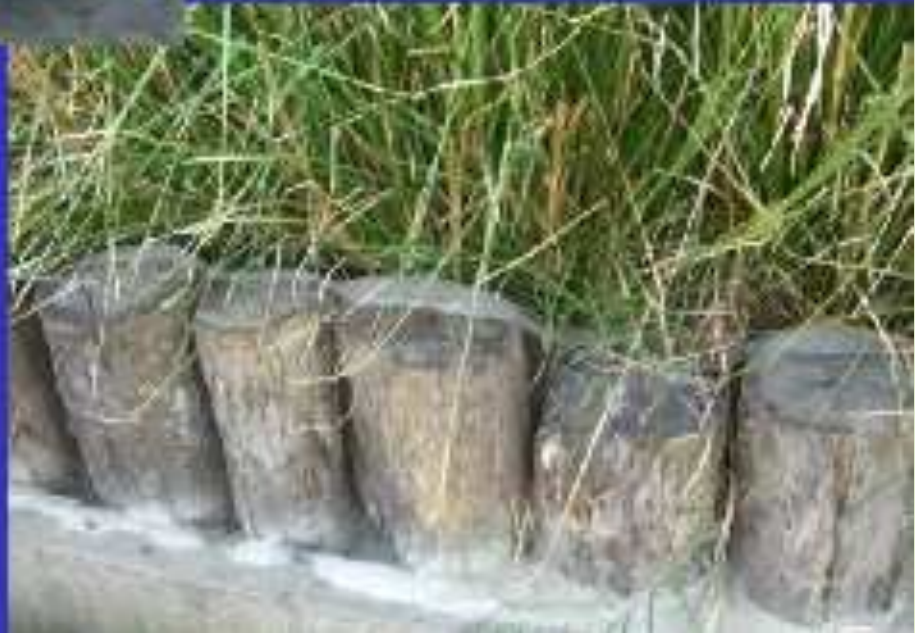
Wooden palisade in high risk area to increase security factor of the structure anticipating sea level rise in the future.

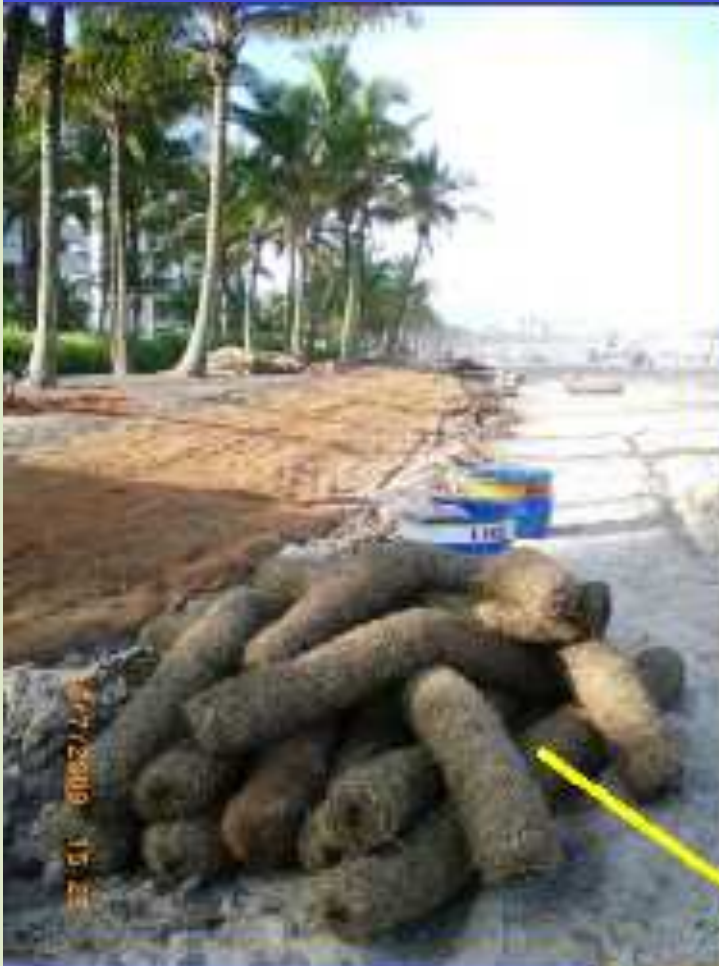
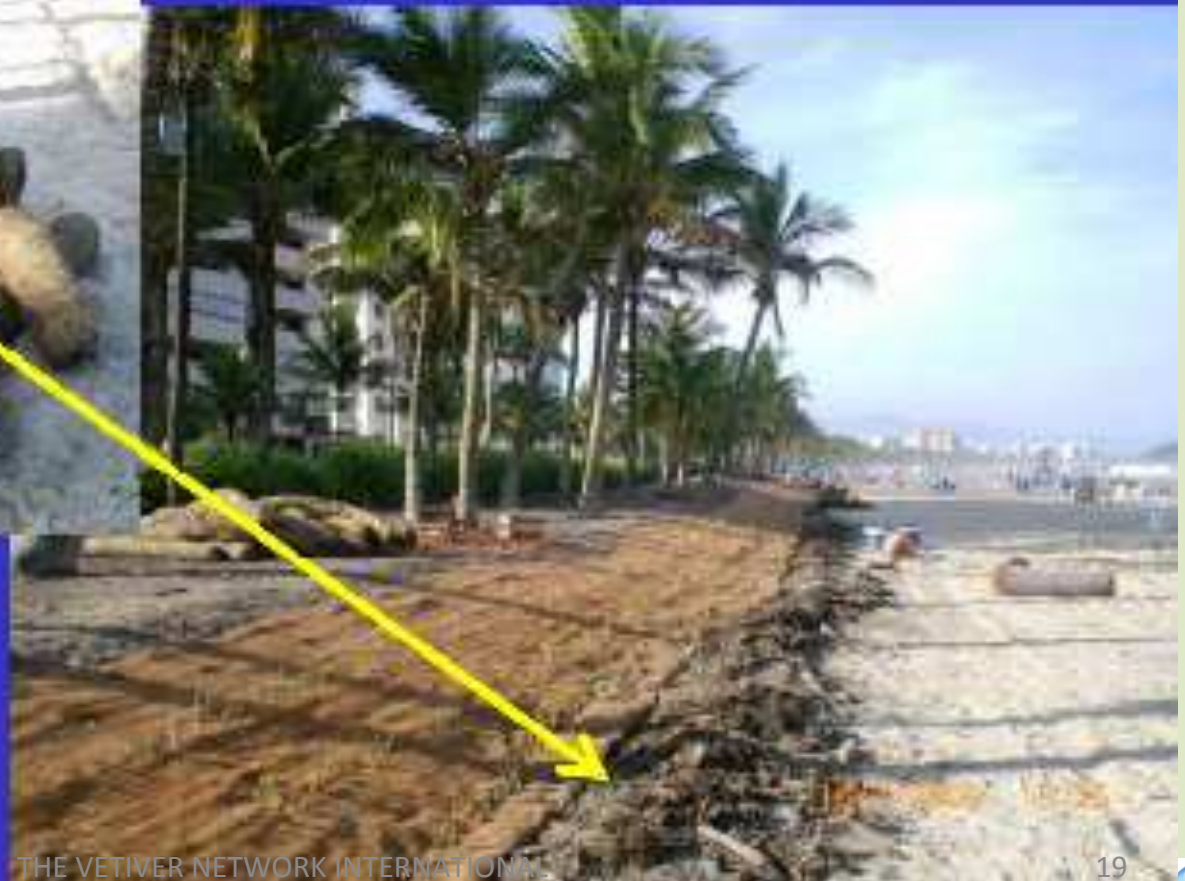
Cocologs in low risk area, with biodegradable jutemesh to protect sand surface during vetiver establishment phase

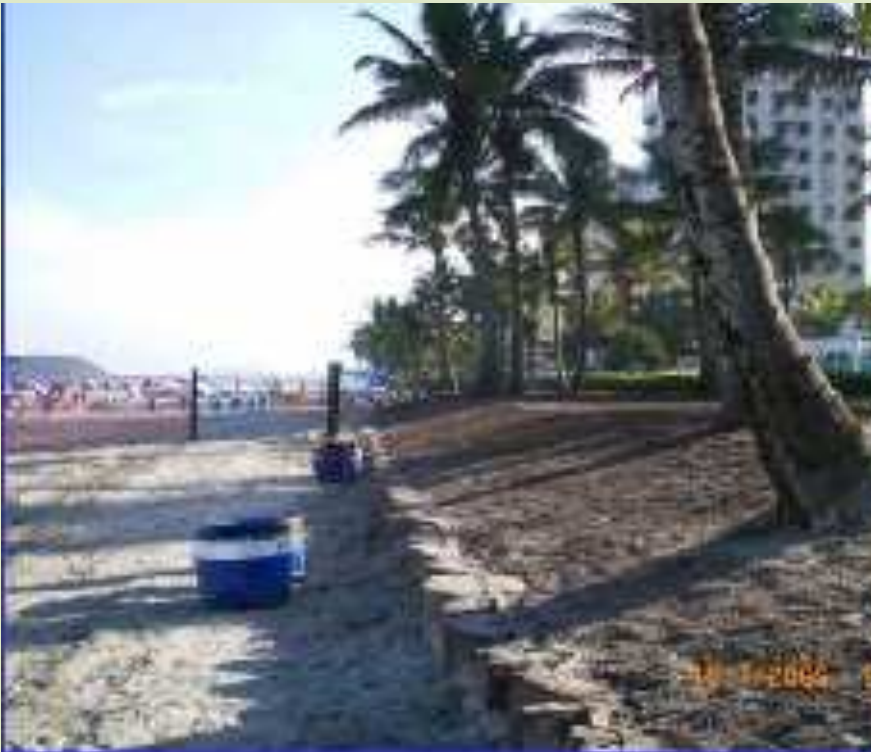
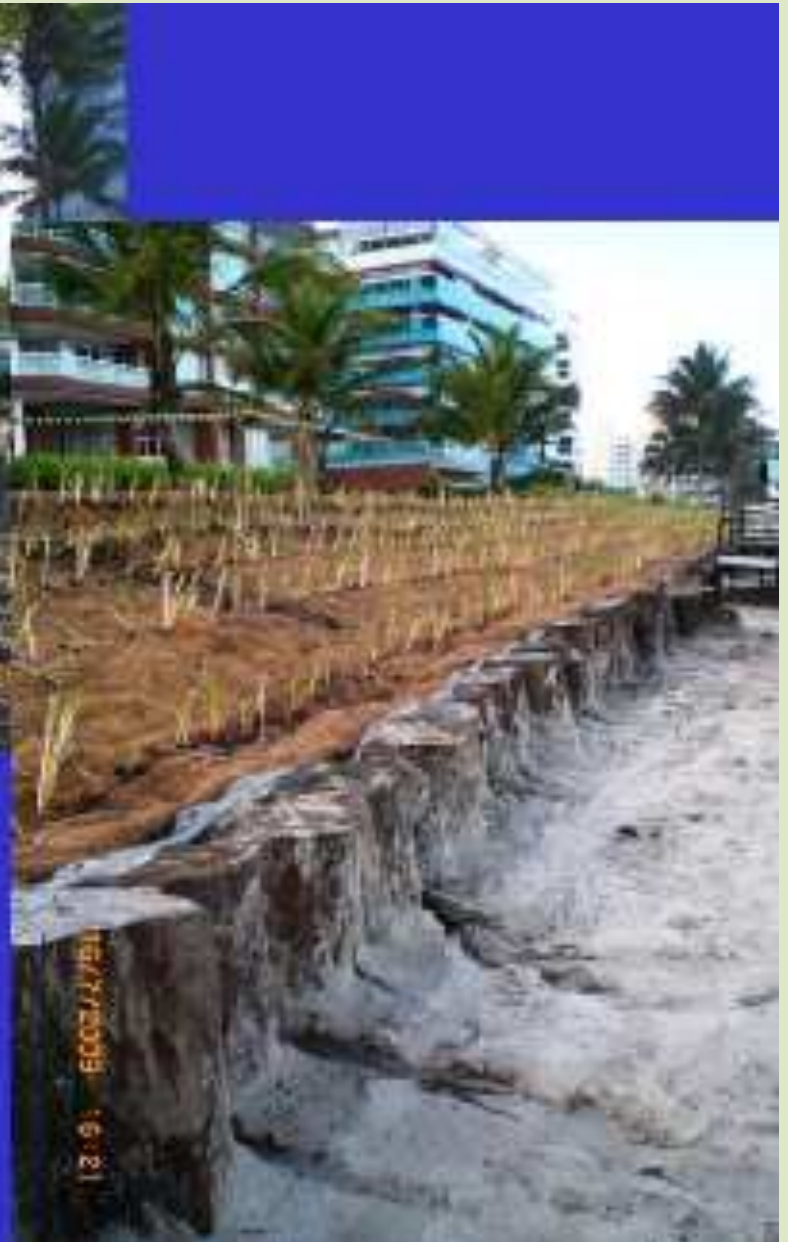
**Wooden palisade in high risk area,
before and after biodegradable
jutemesh installation.**

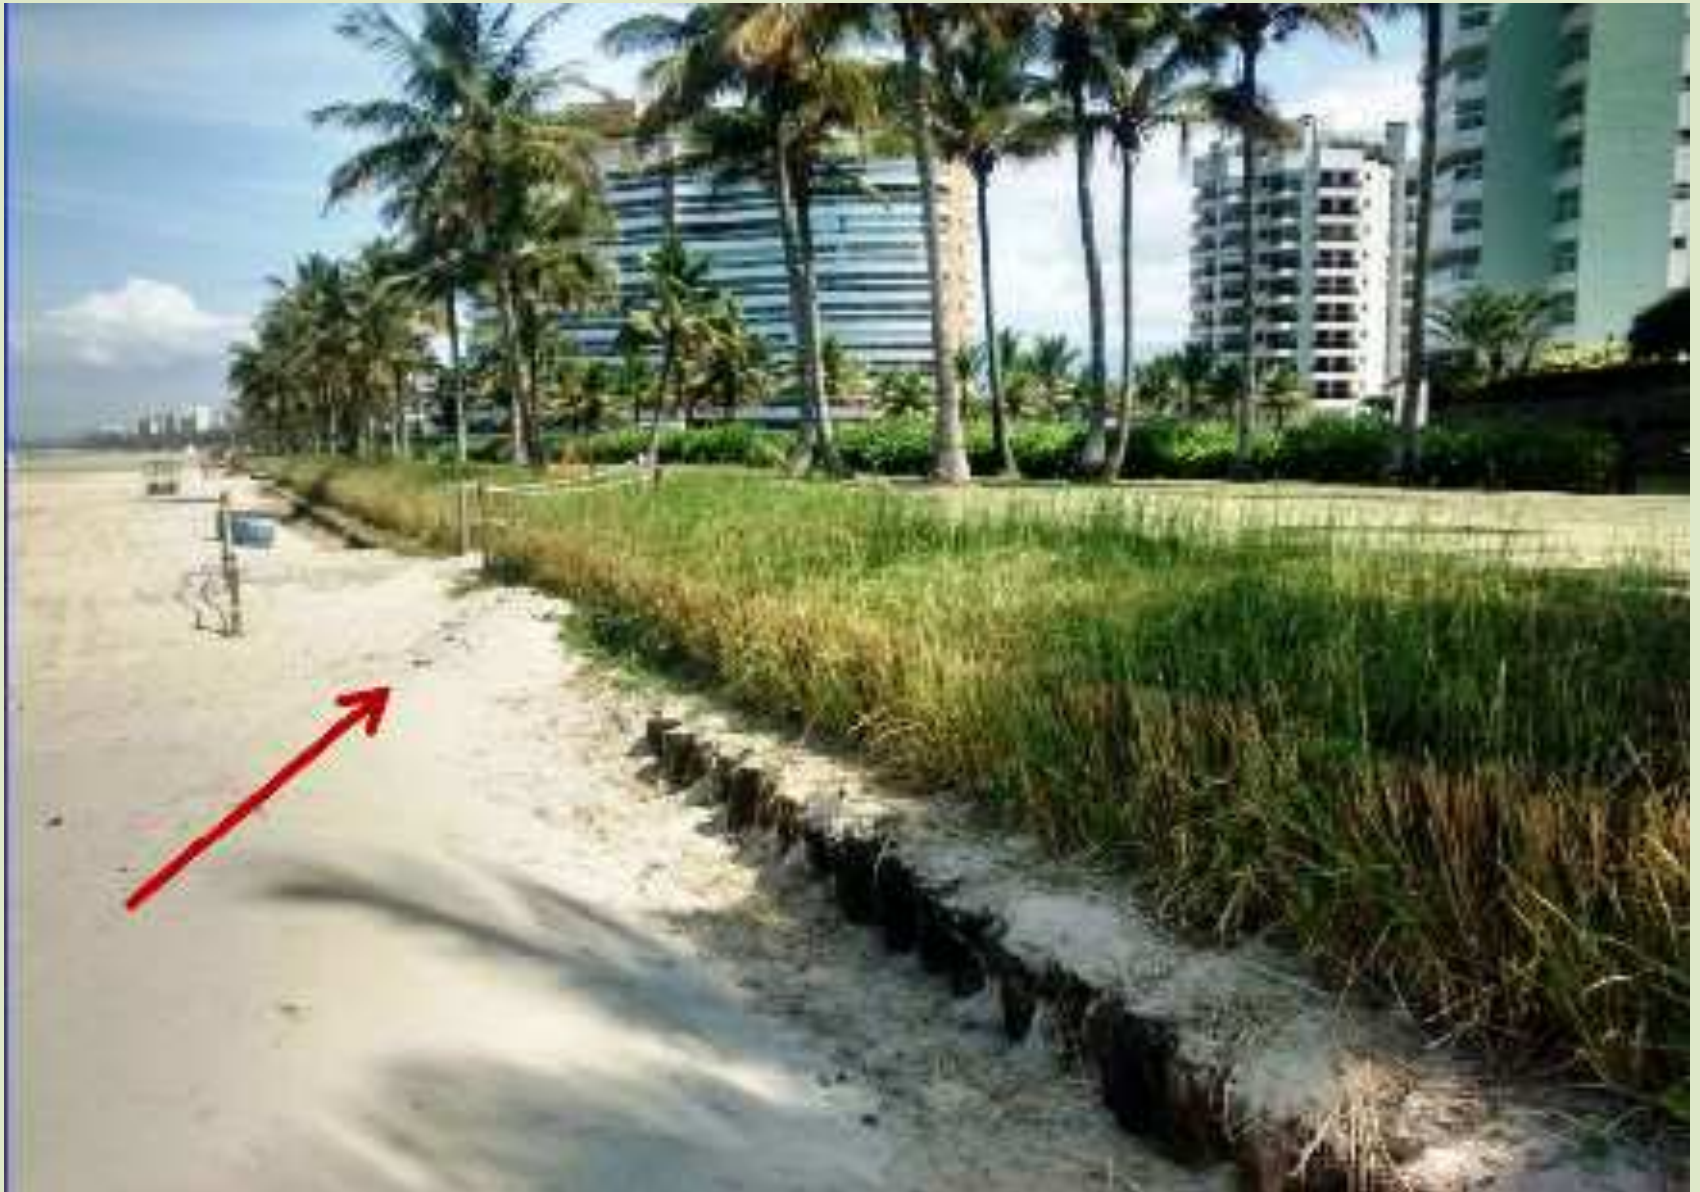
Additional benefit : Control of sand drift

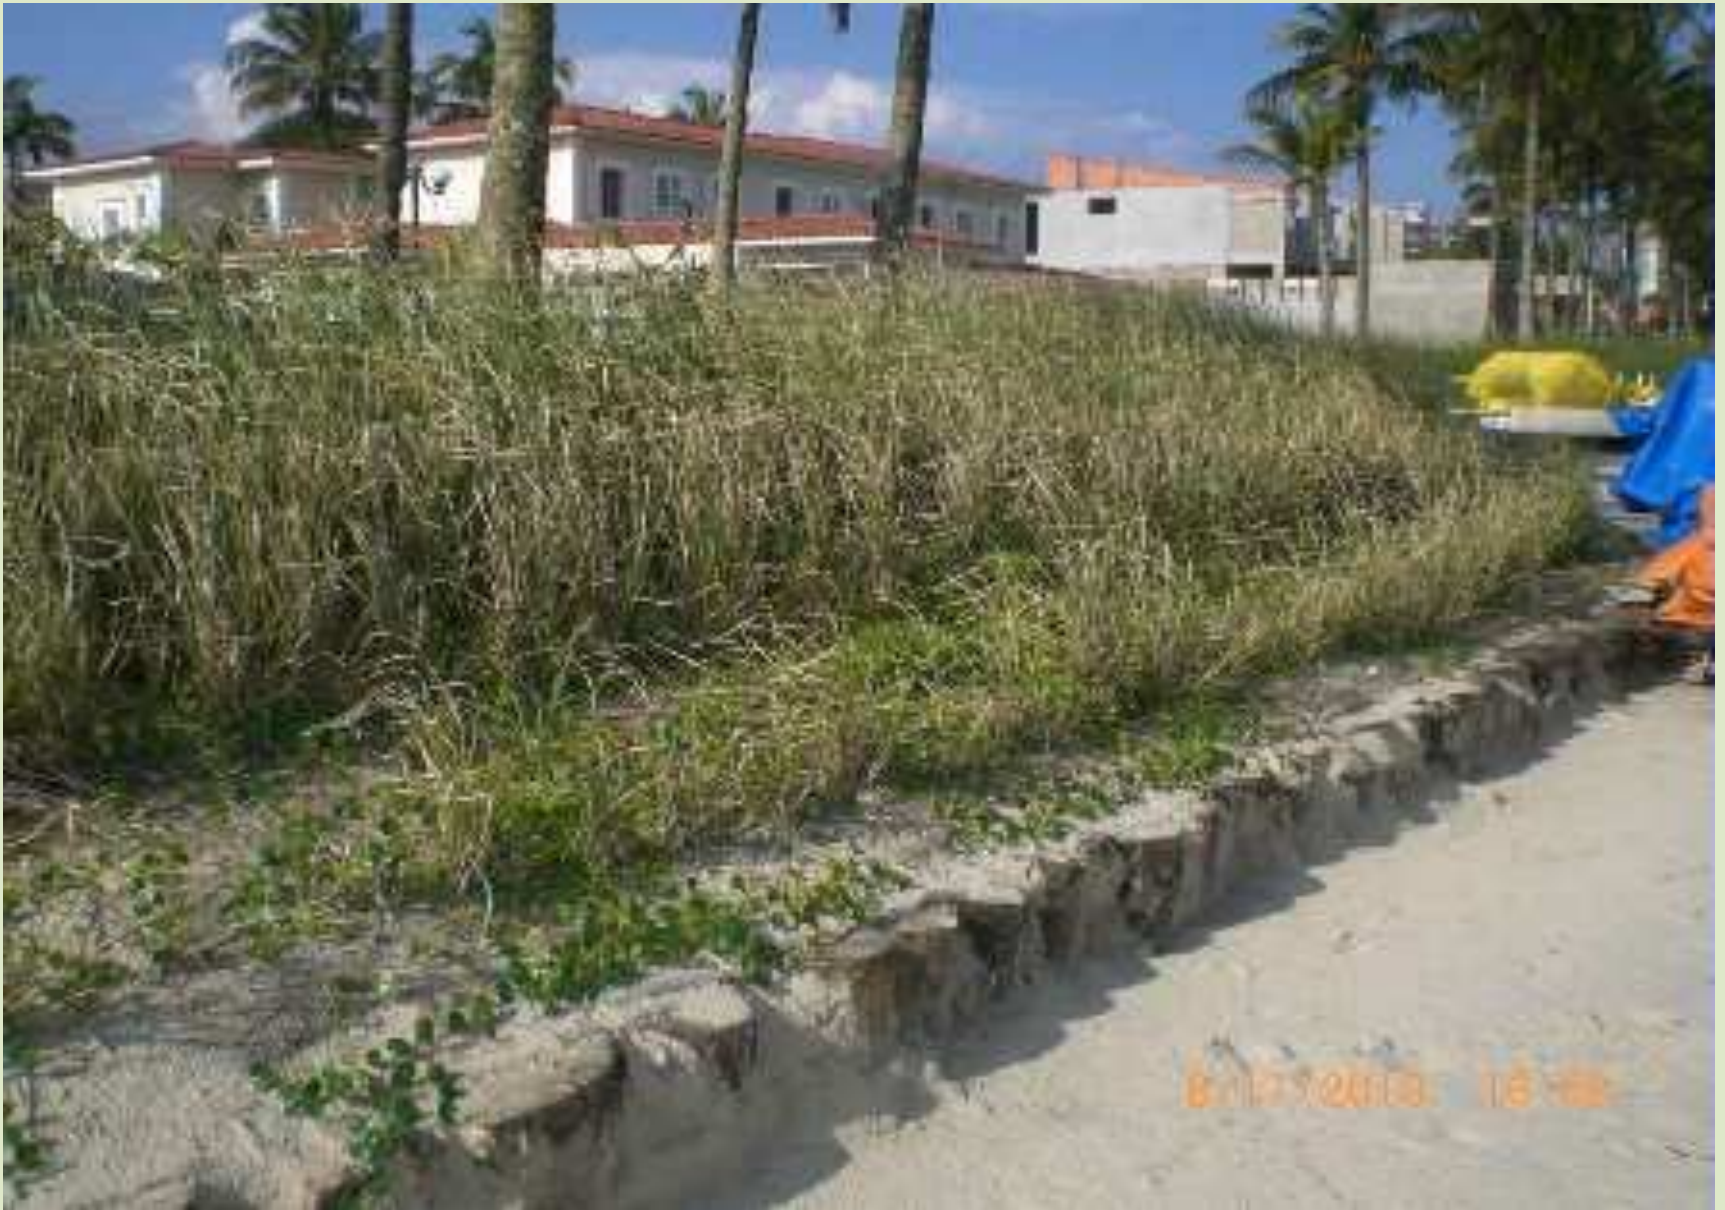
Strong surf and wave bent the first few Vetiver hedgerows

The highest tides in Brazilian coast usually occur during August and September. In September 2009, there were some major sea storm surges leading to strong surf and wave hitting the site just six weeks after the installation of stage one.

These storm surges badly damaged Vetiver plants in the first hedgerow but they recovered naturally.

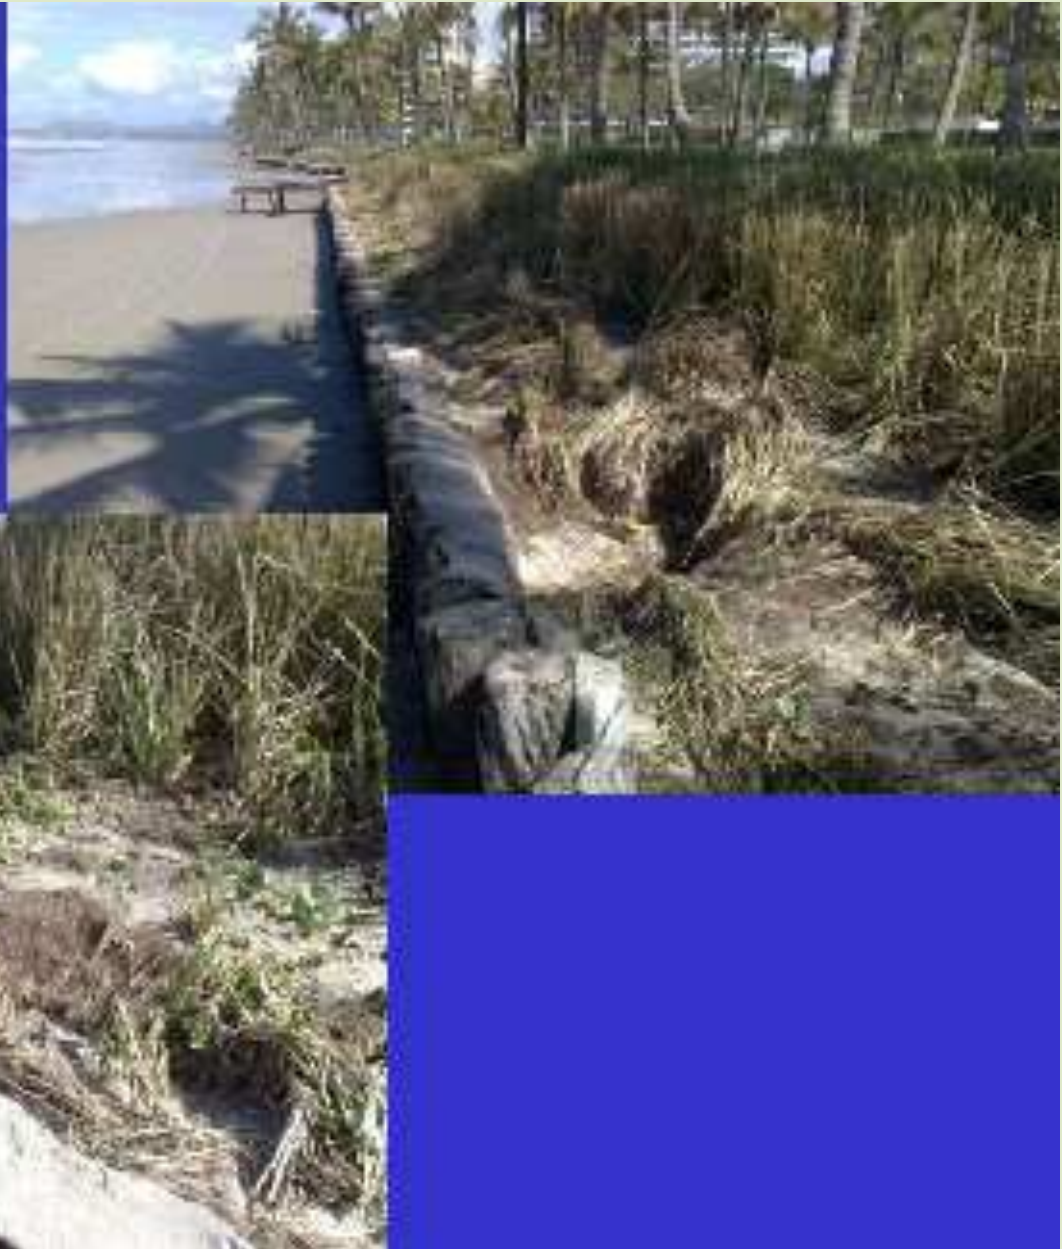
**Badly damaged
Vetiver plants in the
front rows but they
recovered naturally.**

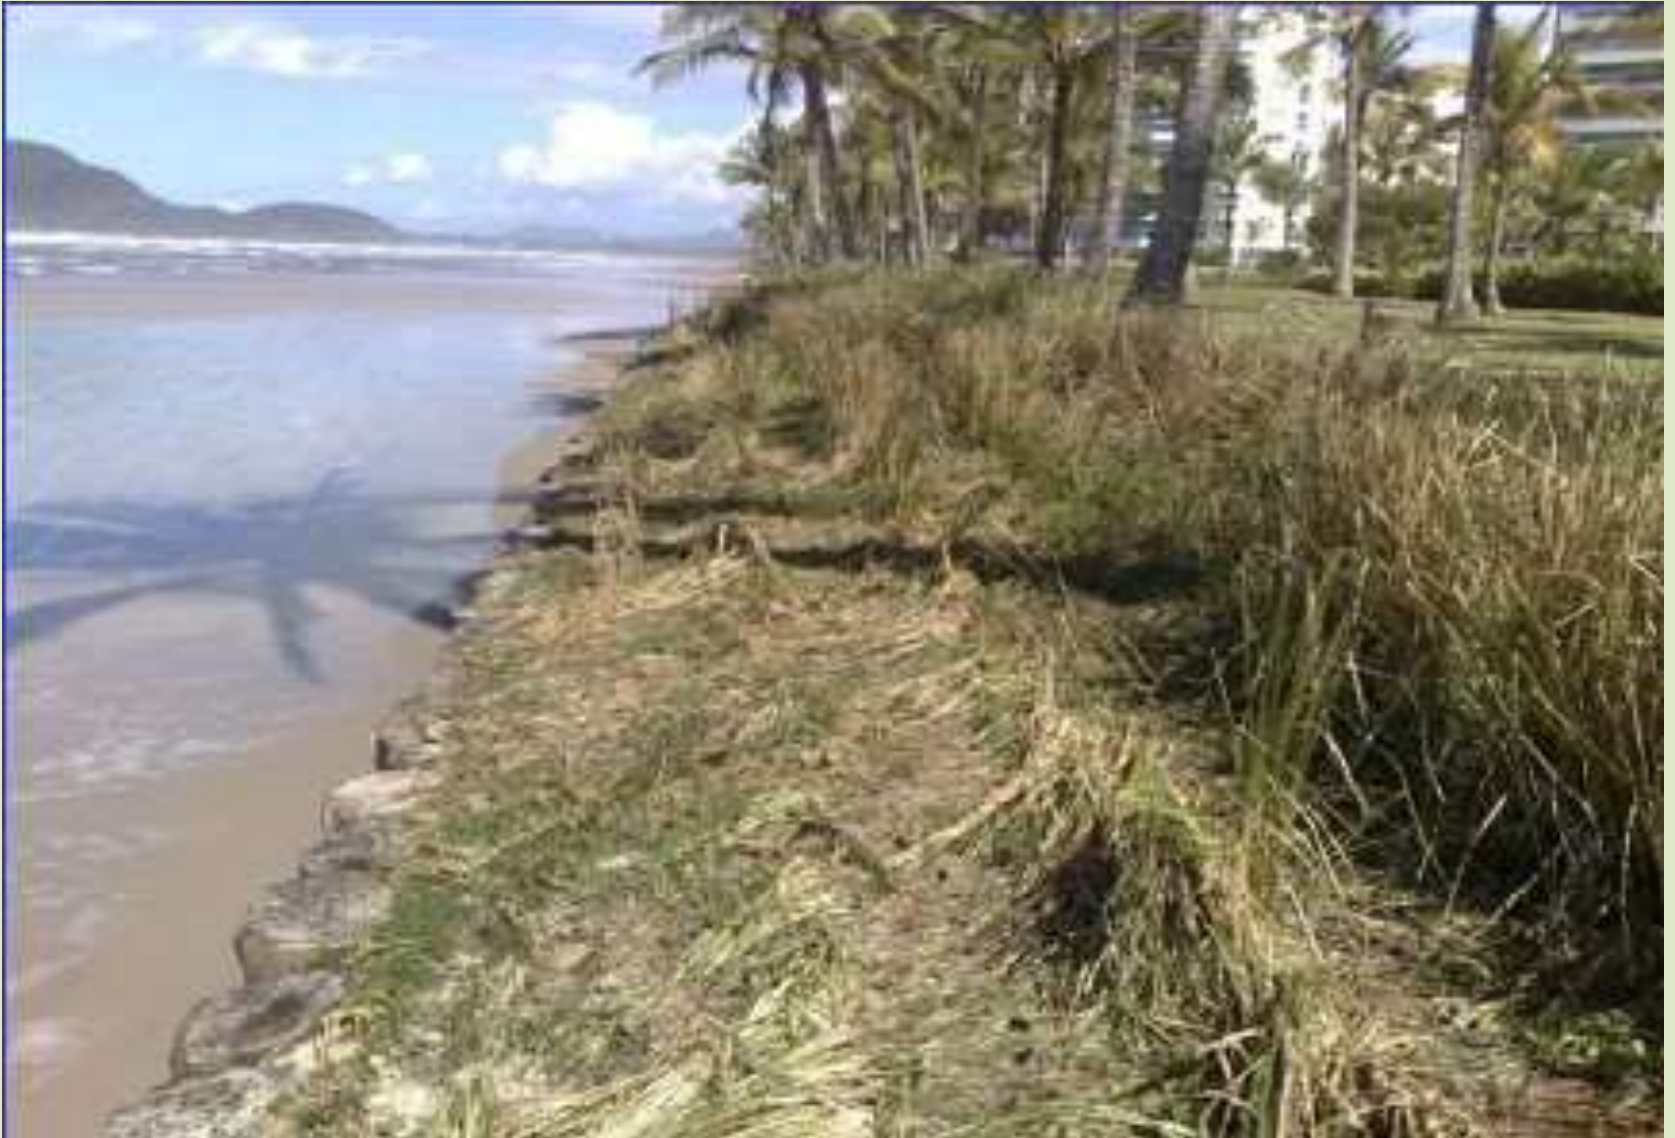
No soil loss occurred in the first 3 Vetiver rows at the worst area where the waves hit
