# California, Vetiver System, and Drought

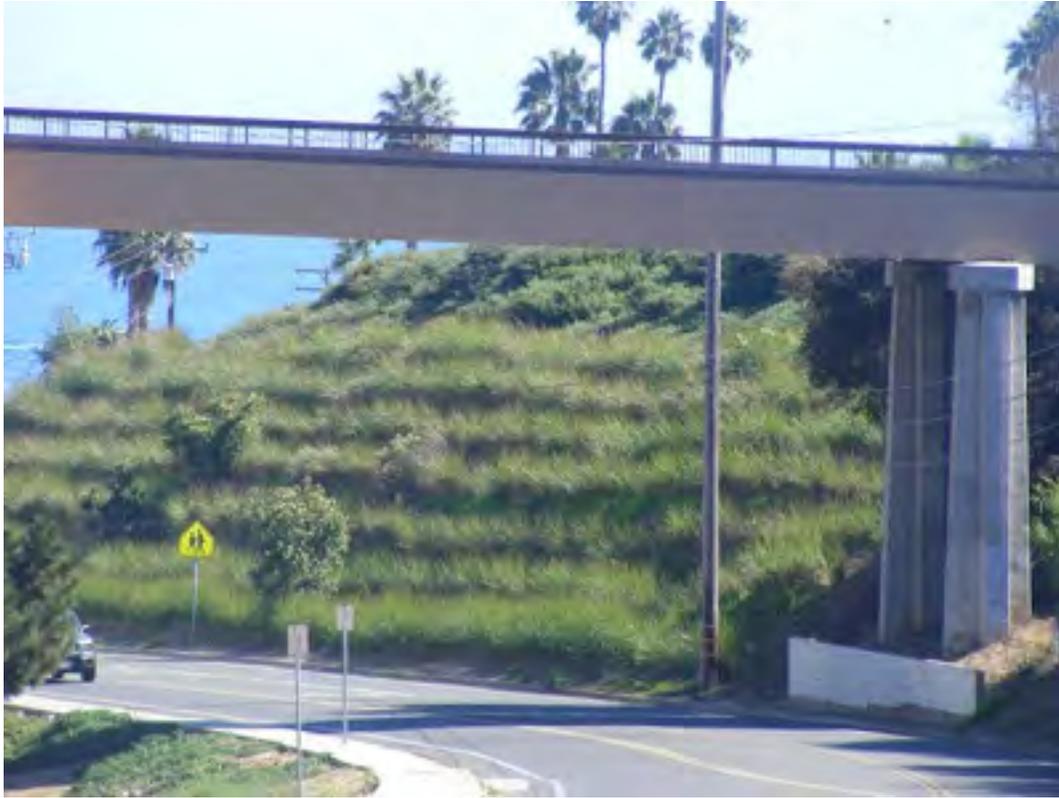
Doug Richardson (a landscaper who uses vetiver and native plants in landscape design) planted the slope in the photo above at the Santa Barbara City College (California) in 2000. Before Vetiver was planted there was mud and rock in the street after every major storm. **There have been no problems since.**

Native plants have **voluntarily** established themselves. The image shows this slope protected with vetiver, along with the volunteer trees and shrubs that include: the tree - Toyon (*Heteromeles arbutifolia*). Also you can also make out a number of smaller shrubs native to this area including Coastal Sage (*Artemisia californica*), and Chaparral Broom (*Baccharis pilularis*) both of which are growing well with the Vetiver. The native Blackberry is also growing with the Vetiver but is harder to see in this photo.

Doug (who was Chairman of the Environmental Horticulture Department at Santa Barbara City College) says that experience in California is that after a season of irrigation to establish Vetiver no further irrigation is required to assure its survival. Fires are a serious problem in California. He has found that Vetiver outperforms the native grass *Leymus Condensatus* in maintaining green less flammable foliage in drought conditions. This does not mean that vetiver does not burn once ignited, but it produces flames that are about 6 to 8 ft high, compared to native chaparral species (like most of the Sages) which can be quick to ignite, burn at higher temperatures, throw flames 50'-100' in height (*Ceanothus*, *Manzanita*, *Adenostoma*, etc.) and throw embers which are large and persistent. Vetiver, as a grass with high moisture content, has less actual biomass and density than the woodier species. Vetiver sprouts quickly from its roots if burned, and this is a huge plus for subsequent erosion control not to mention the preservation of the original costs and investment that went to getting it established.

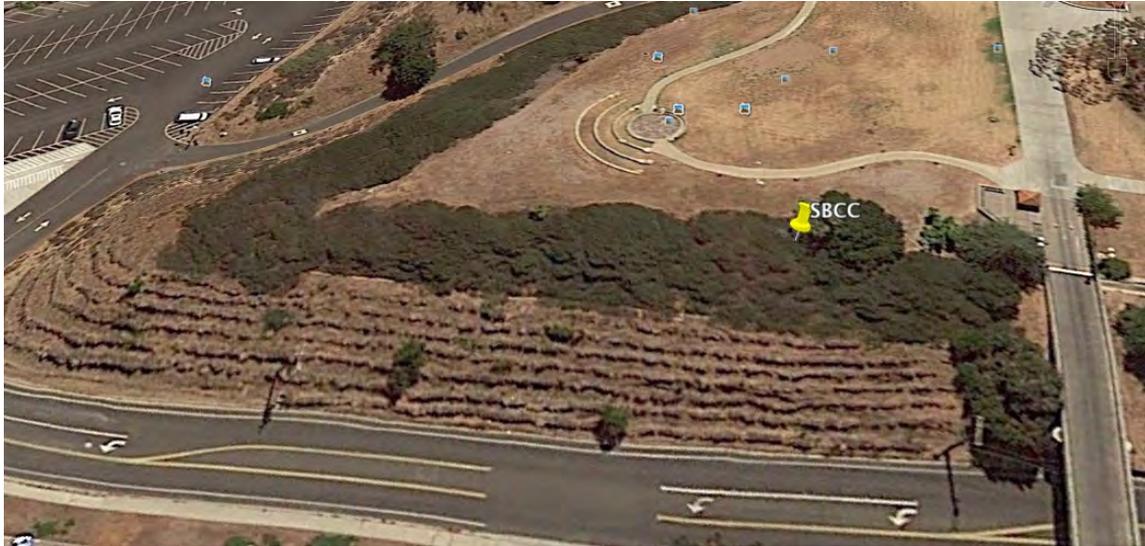
Over the past 15 years this planting at The Santa Barbara City College has received very little maintenance and has survived the current four year drought well (6 to 8 inches of rain per year). Here are a couple of images from Google

Earth (imagery date May 1 2015) of the site. One is a traditional GE image showing clearly these 15 year hedgerows, the other is from GE Street View (a remarkable image that clearly shows the current state of the vetiver hedgerows – a bit ragged – but still very effective. Doug tells me that the college will shortly order a “tune up” of the vetiver – including pruning, and he expects a rapid recovery to fuller hedgerows. Note even there may be “holes” in the

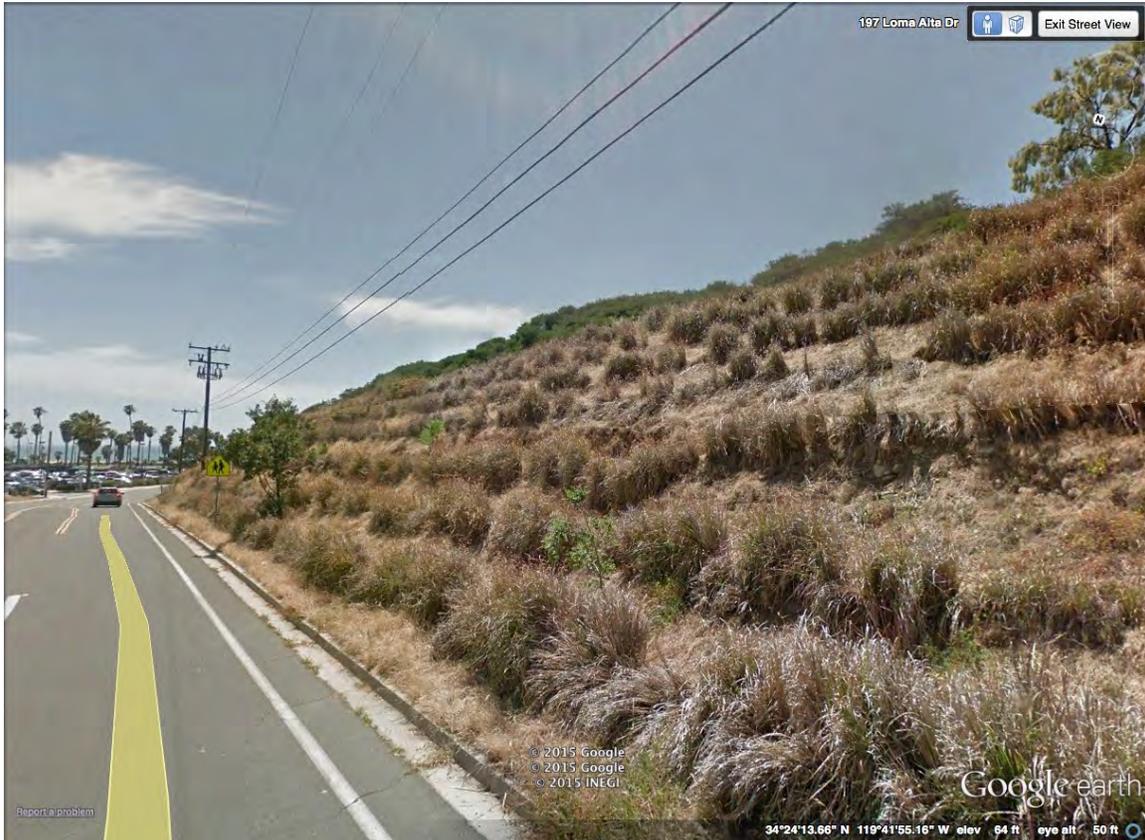
hedgerows the root systems will be well established throughout the slope to provide the added shear strength to prevent slippage. Note the local species between hedgerows don't look very happy after prolonged drought. Although there has been some damage from gophers, it does not appear extreme
