# **Sea dike erosion on coastal zone in North Vietnam**

**These dikes are built to protect fertile agricultural land inside**

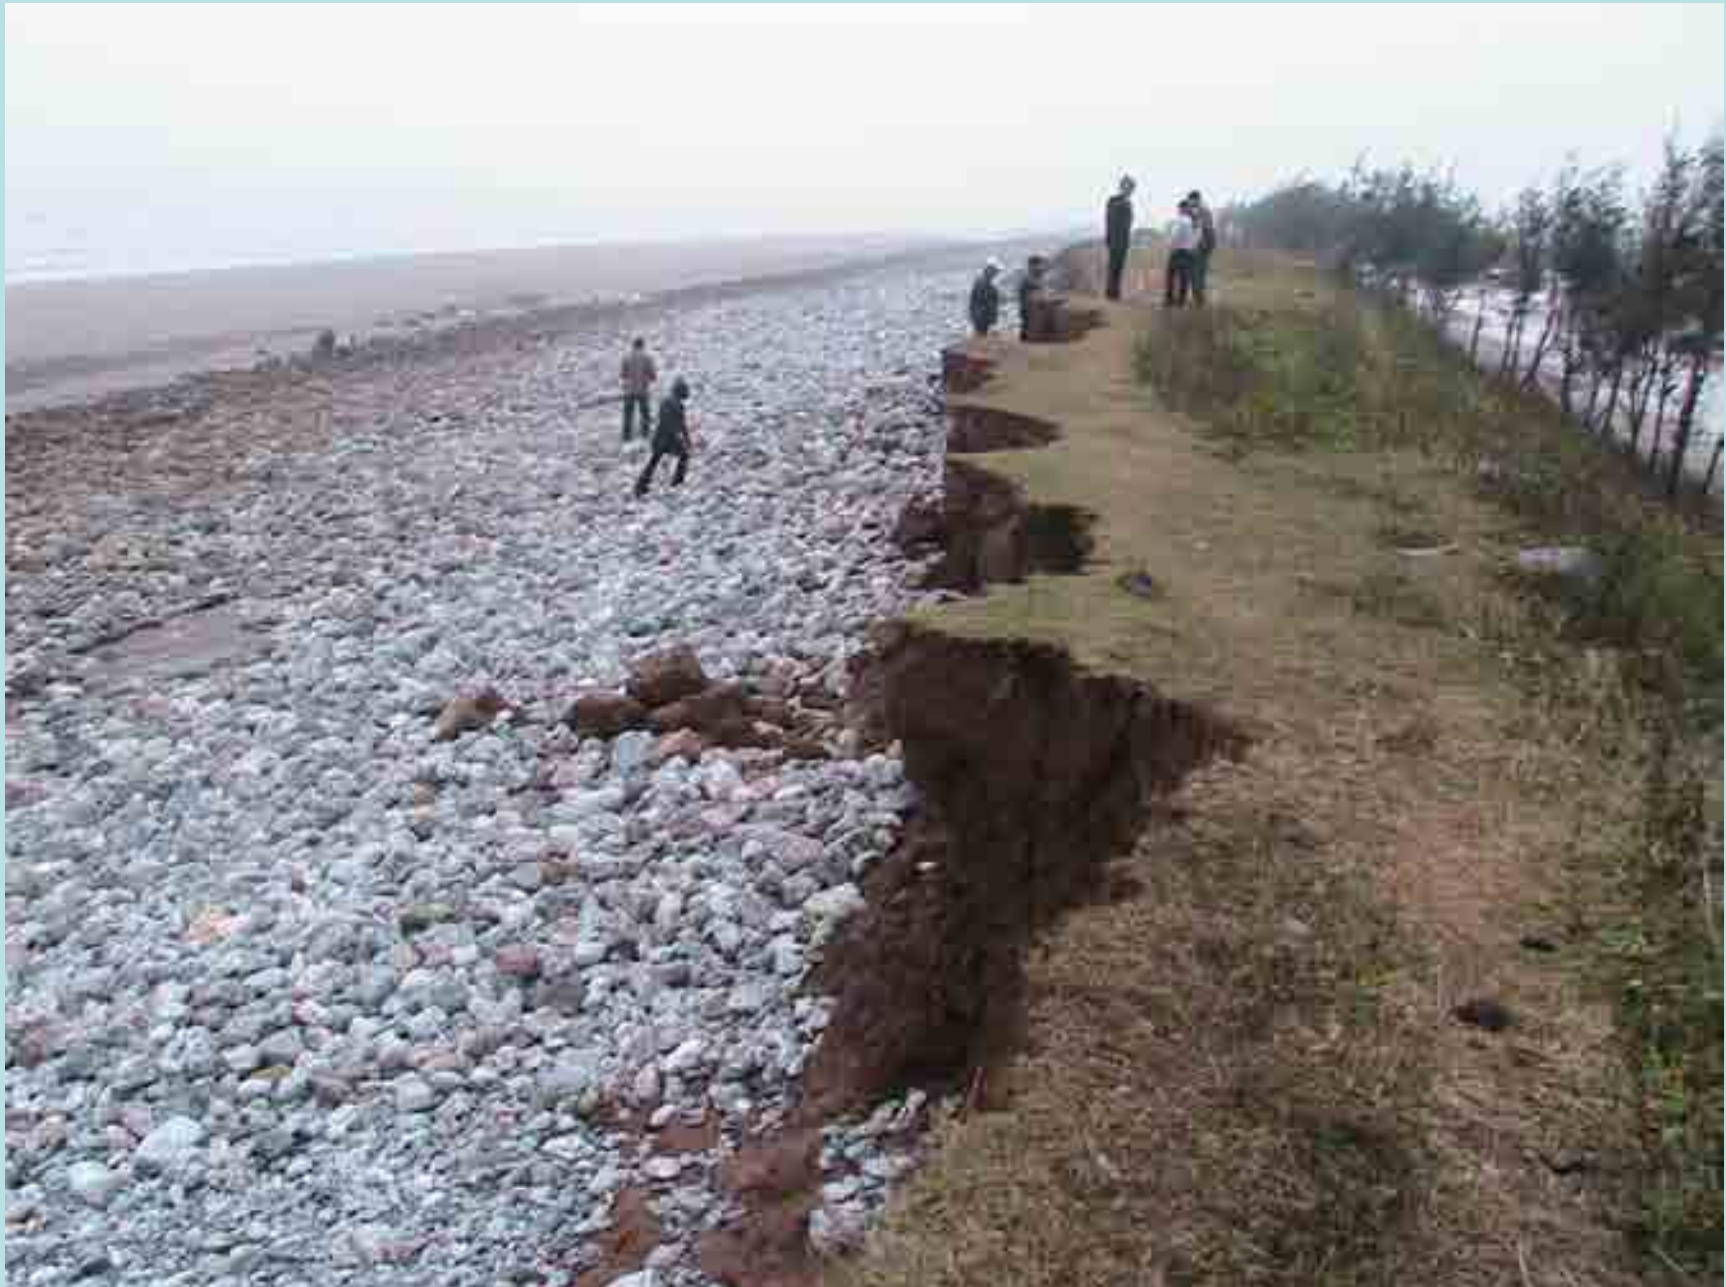
**Typical erosion on the sea facing batter of an old dike along the coastal zone facing Ha Long Bay. Note the collapse of the gabion/rock basket armour**

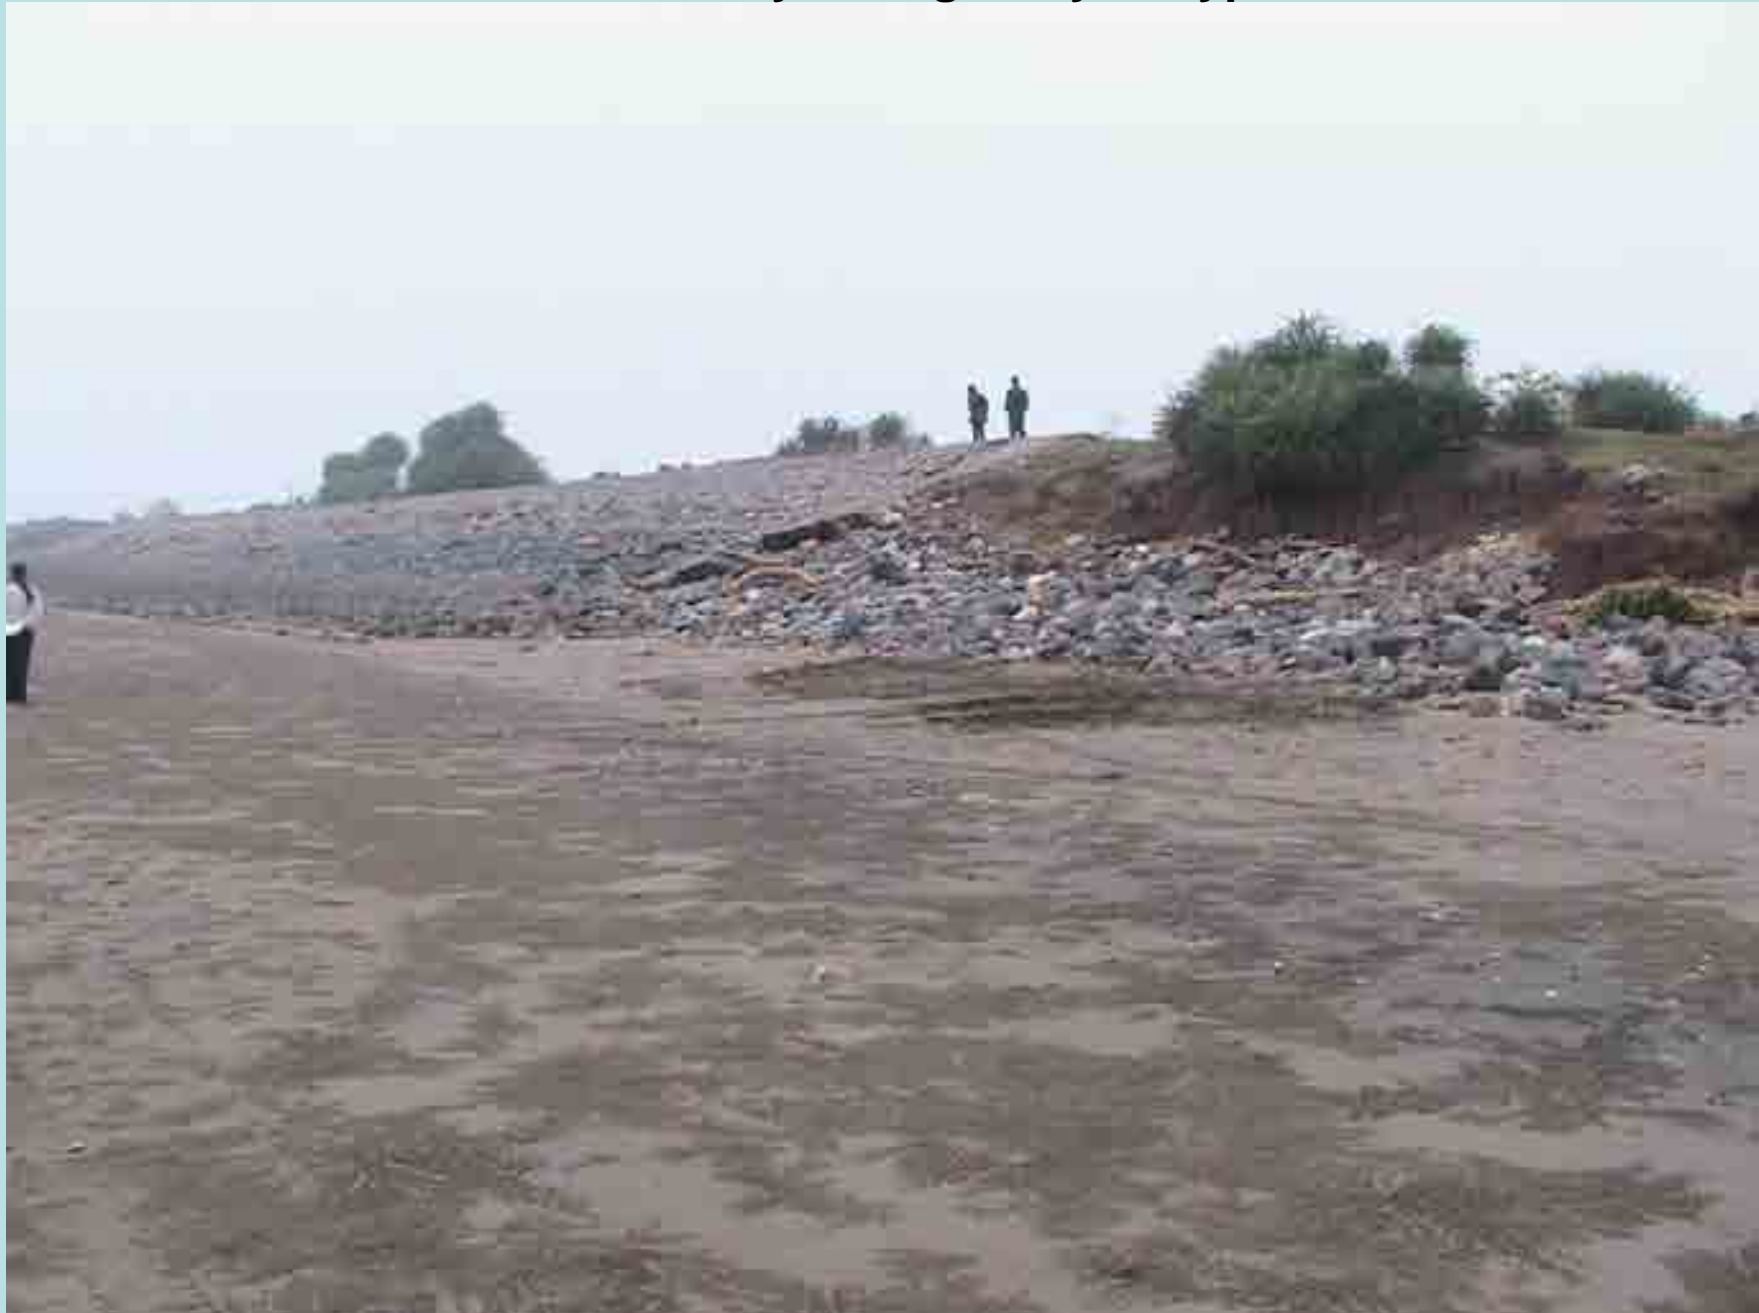
**Erosion has started on another old sea dike, despite the rock armour and this old dike was washed away during last year typhoon season**

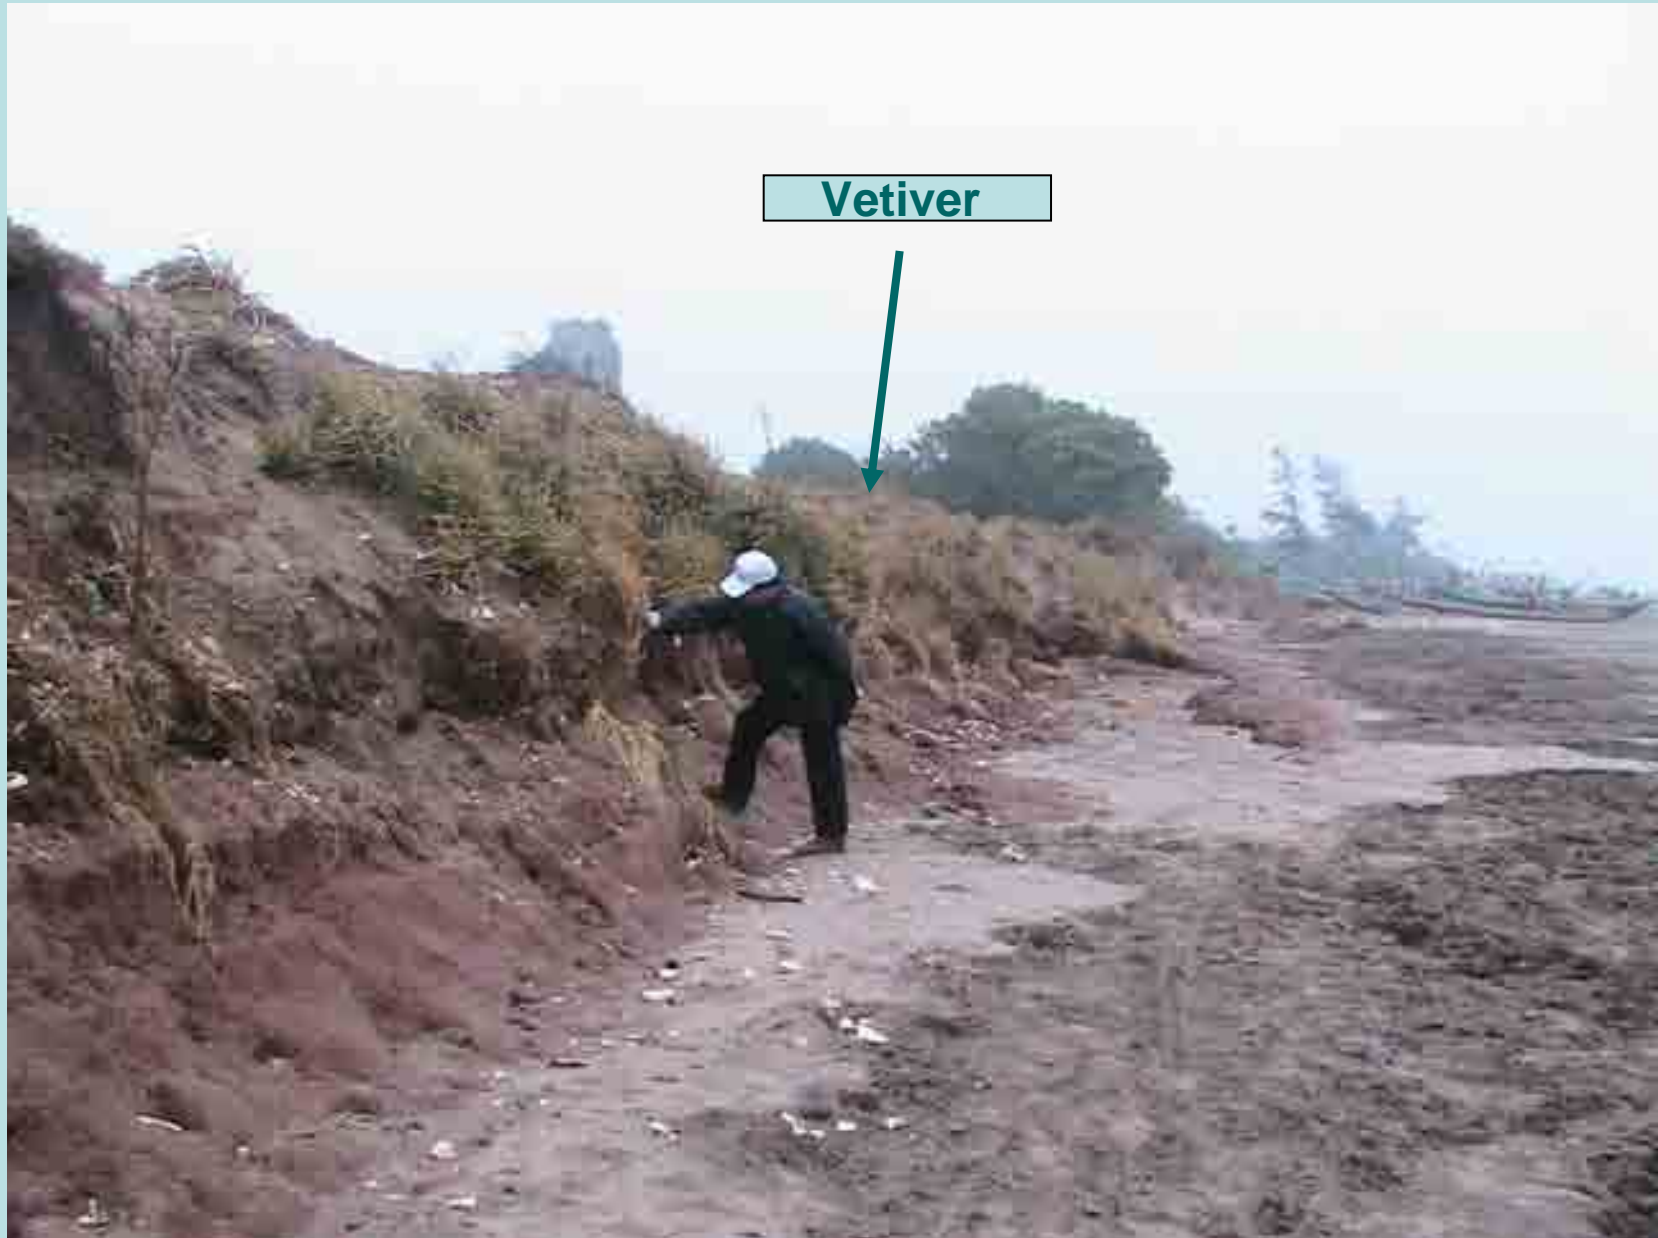
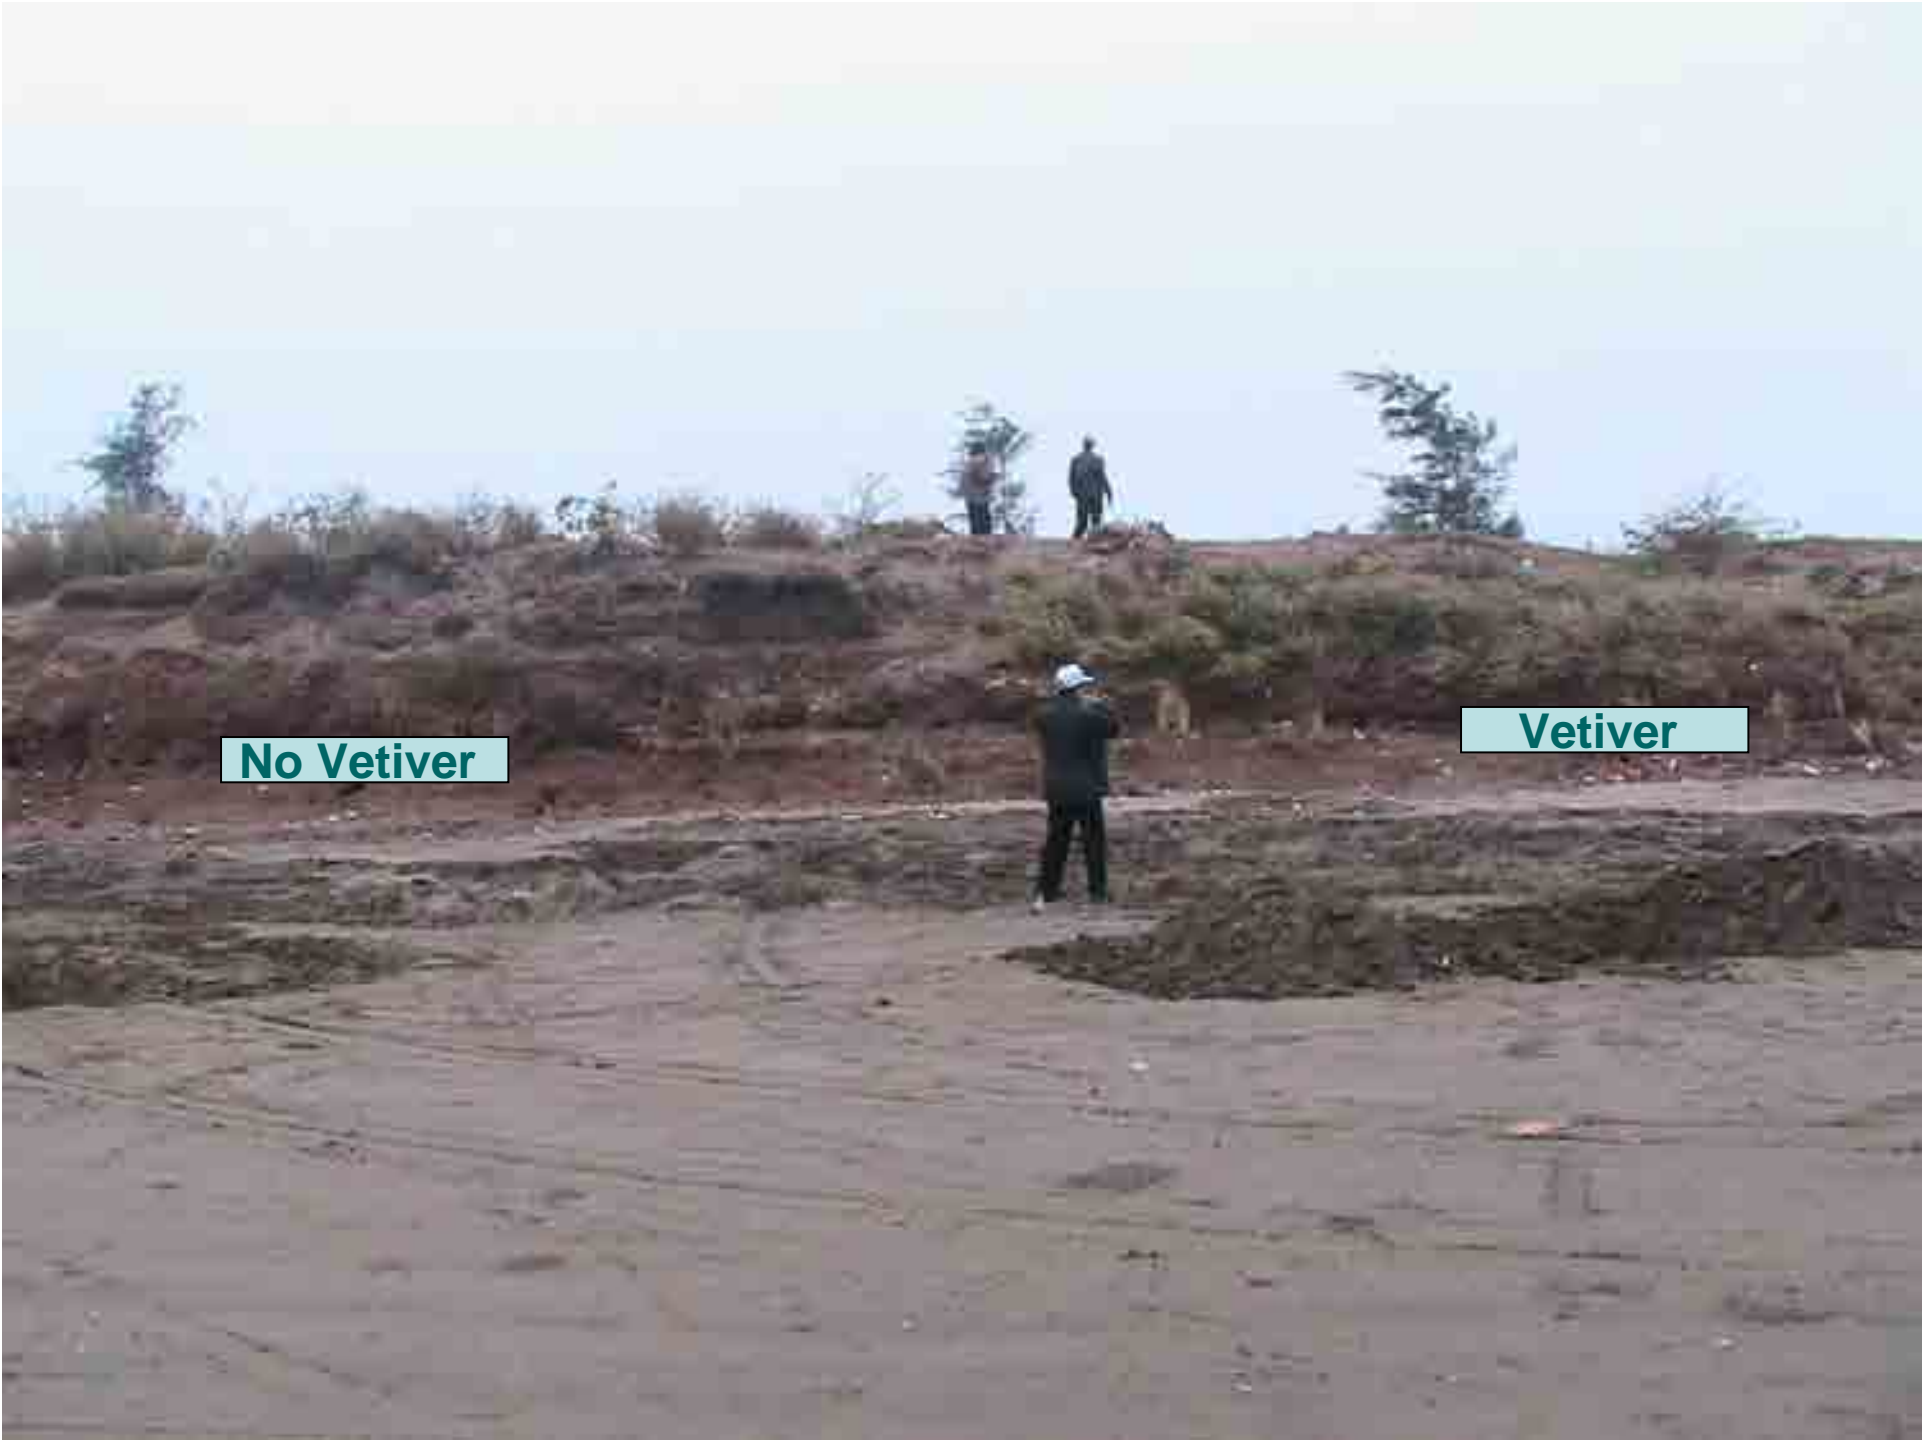
**On a badly eroded section of this dike, Vetiver provided some protection on the sea facing batter, but this was not enough to protect this dike during last year typhoon season, all washed away**

No Vetiver

Vetiver

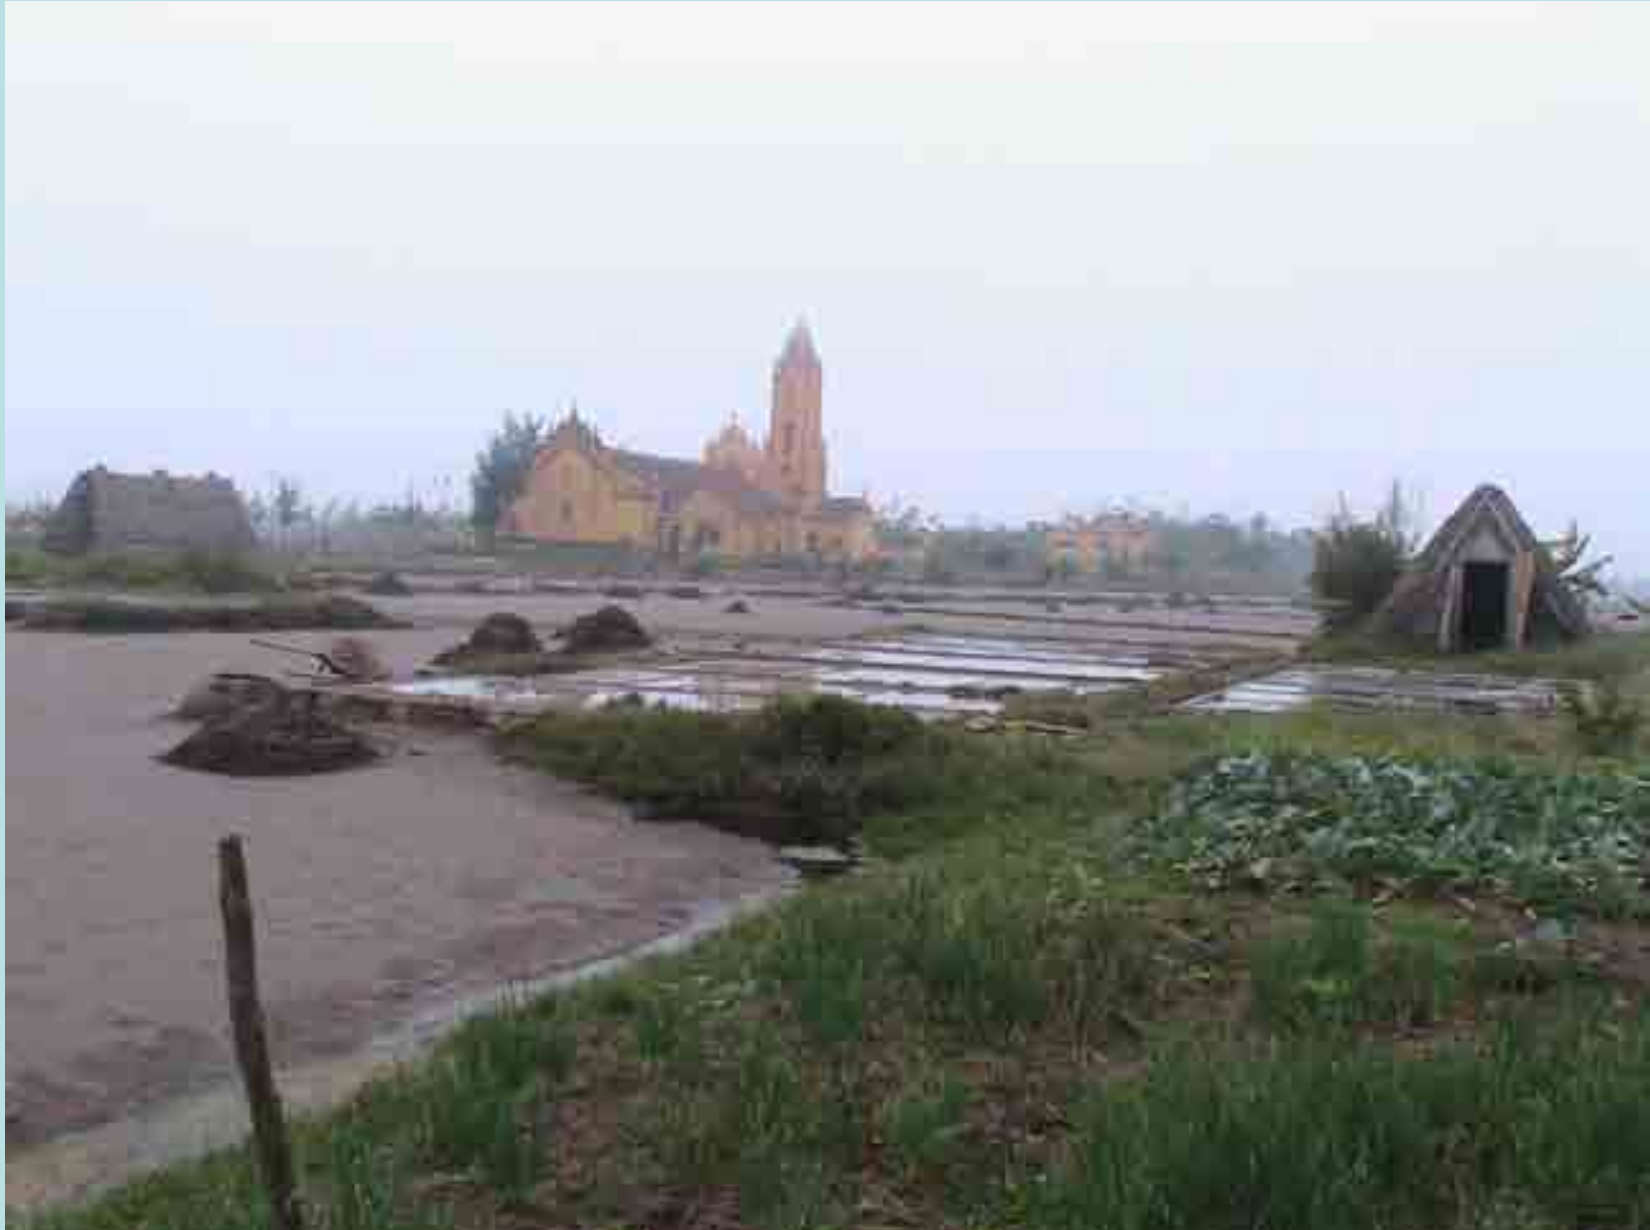
**Abandoned and lost fertile agricultural land to poor local farmers forever who only has only a very small farm for their subsistent living, as the government does not compensate for their lost of livelihood.**

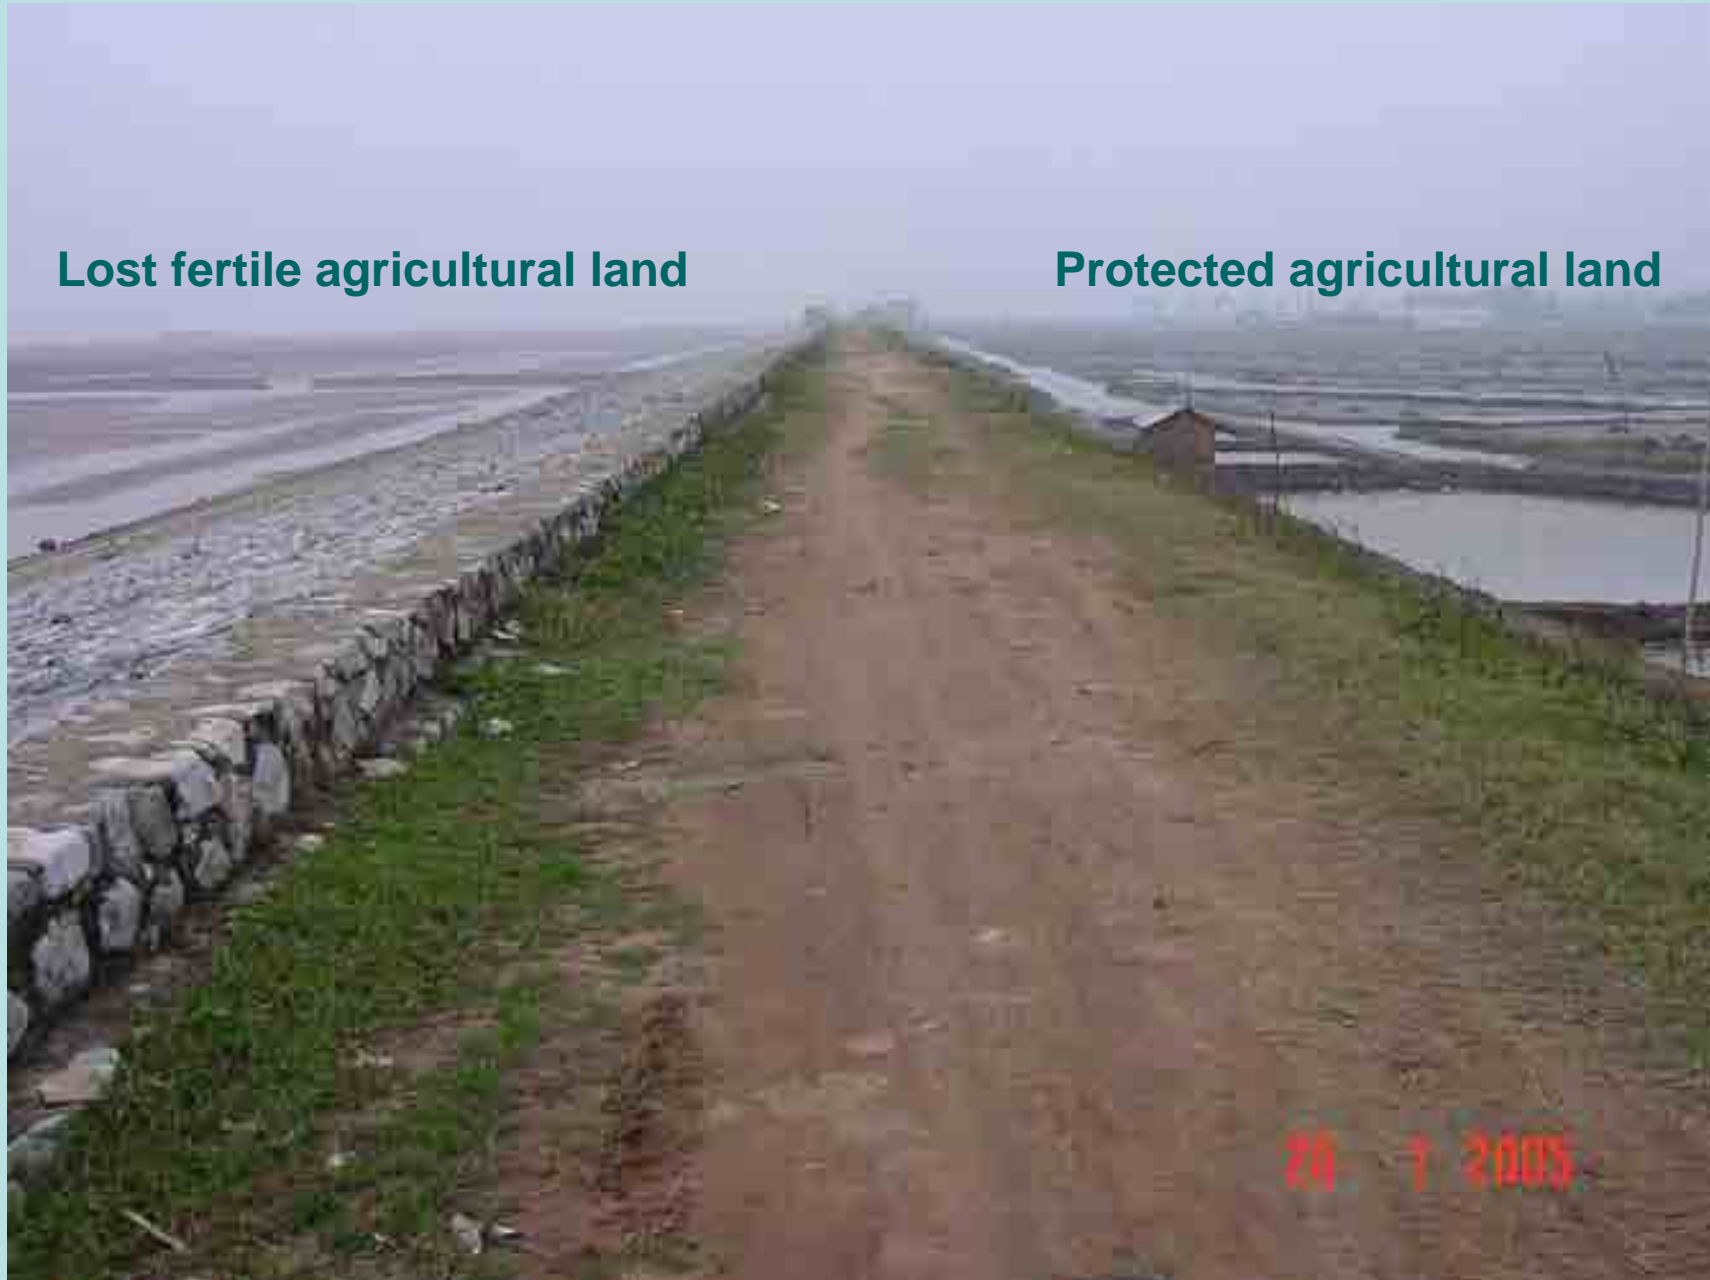
**This is an new dike, about 1 000m inland, built to replace the old dikes shown previously, which were all washed away this year**

**Lost fertile agricultural land**

**Protected agricultural land**

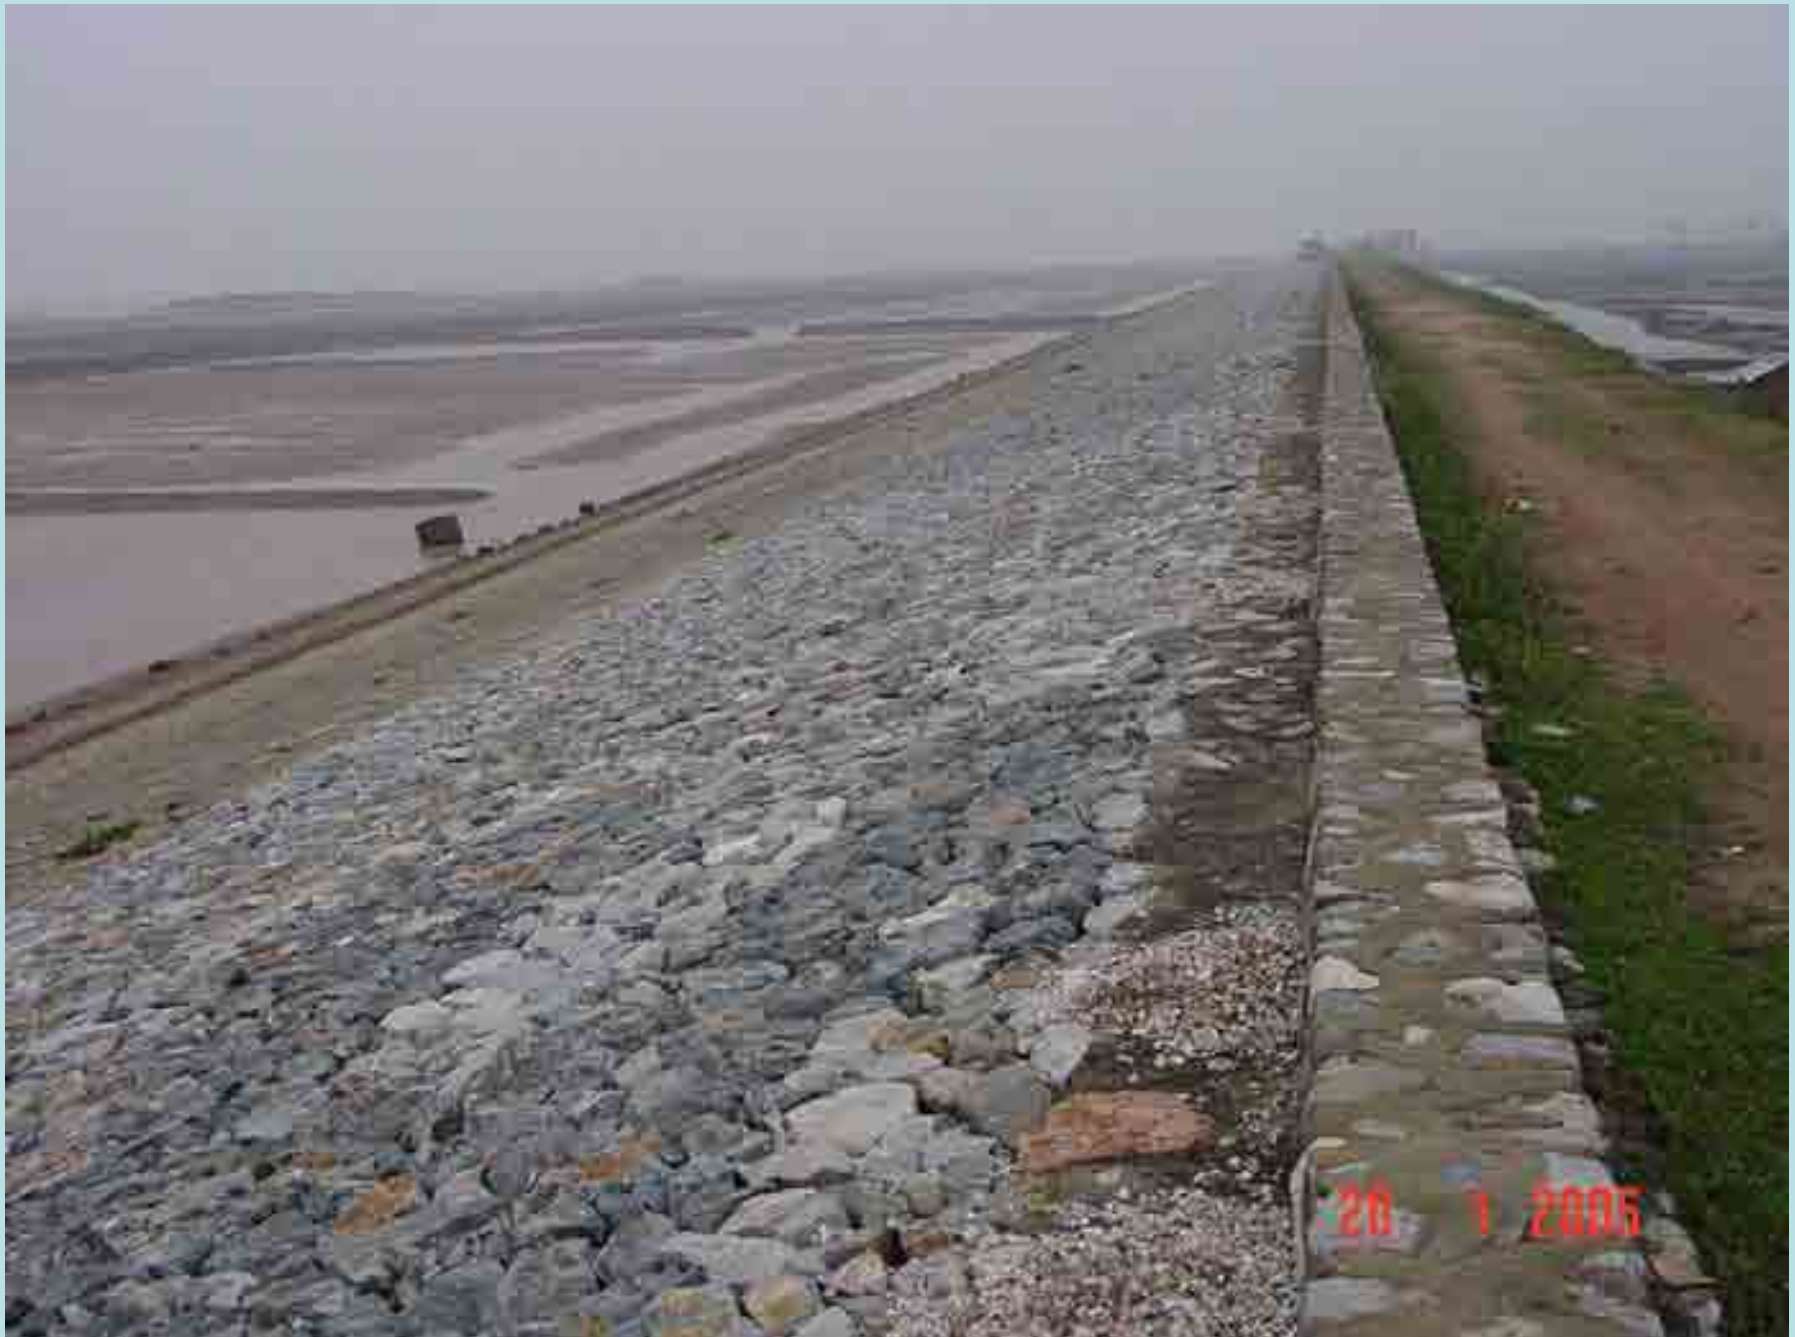
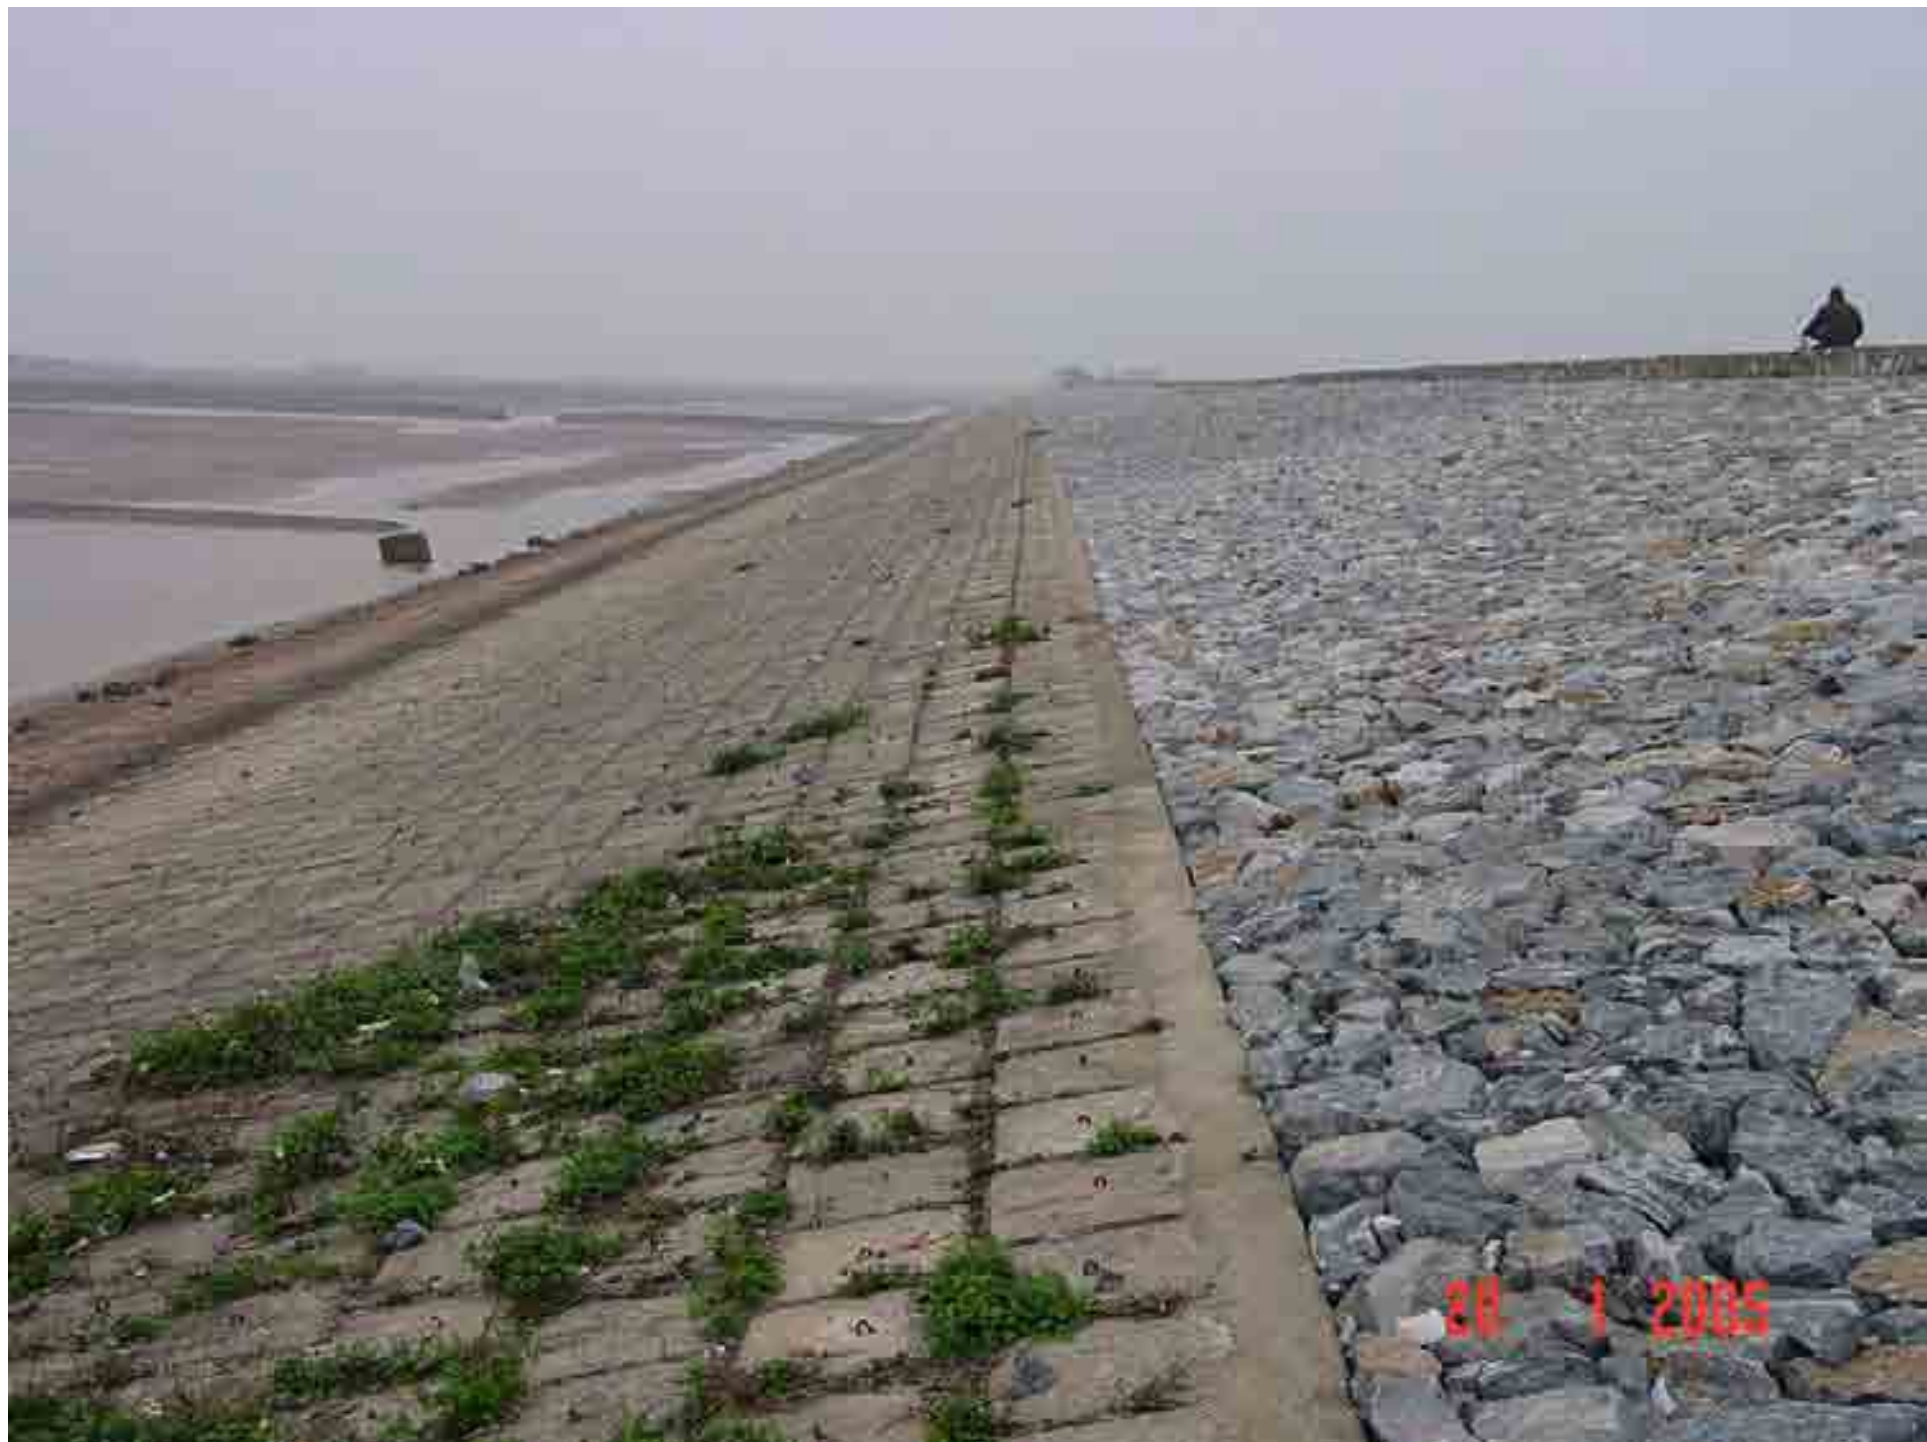
**This new dike, heavily protected by the extremely expensive rock armour**

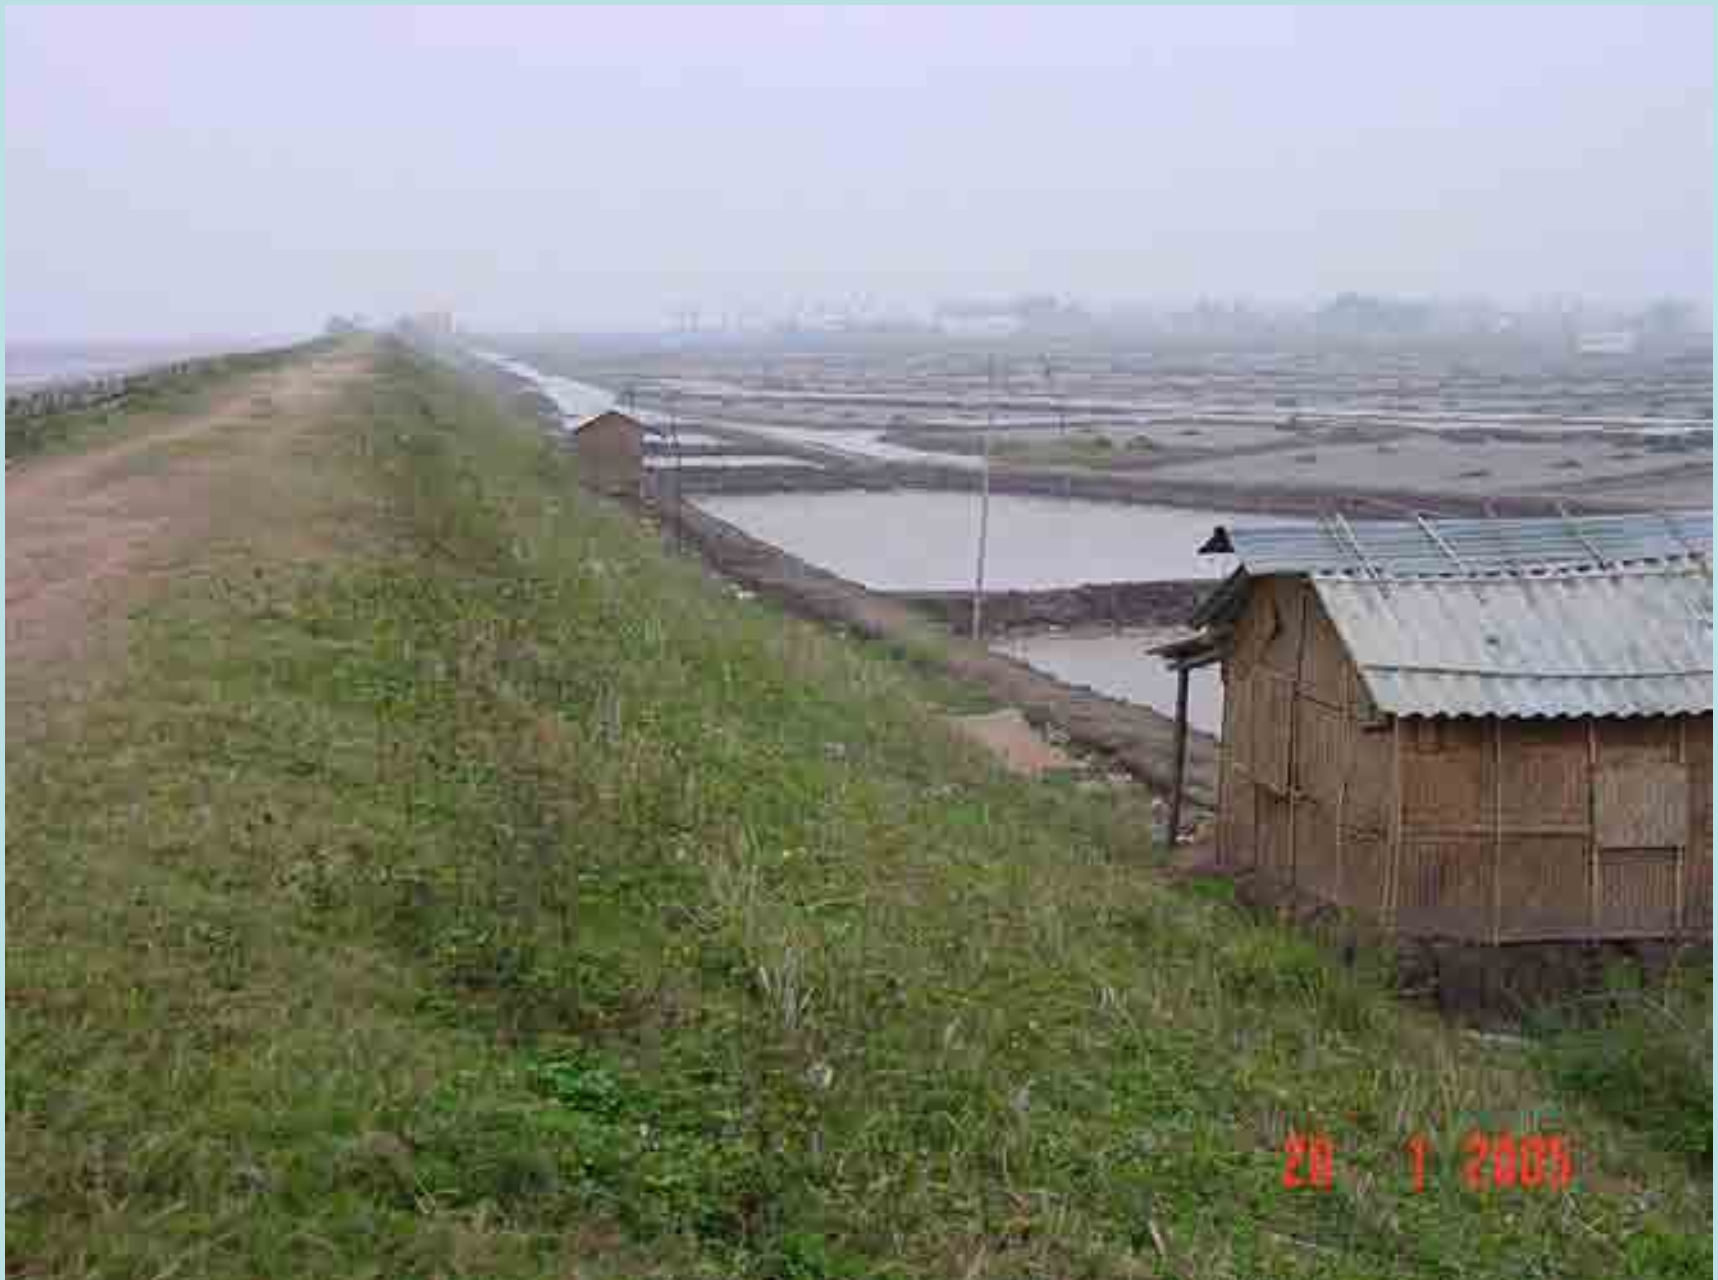
**But this new dike, heavily protected by the extremely expensive rock armour, its inside batter was not protected, cover only by local vegetation, mostly weeds**

- Although the local Dike Department officials noted that severe erosion often occurred on the inside batter of the wall due to surface runoff from the dike surface. That was the reason why they planted vetiver as shown before to protect the inside batter of the wall from this erosion

- With full confidence of their armour plated new dike the Head Office of the Dike Department ignored the local concern and left the inside batter unprotected.

- But the unexpected phenomenon happened during the 2005 typhoon season, the worst in 60 years, with huge storm surge during typhoon number 7, the dike was overtopped by sea water. Although the dike stay intact but its inside batter was badly damaged except on the section where vetiver was planted.
