# **Sea dike erosion on coastal zone in North Vietnam**

**These dikes are built to protect fertile agricultural land inside**

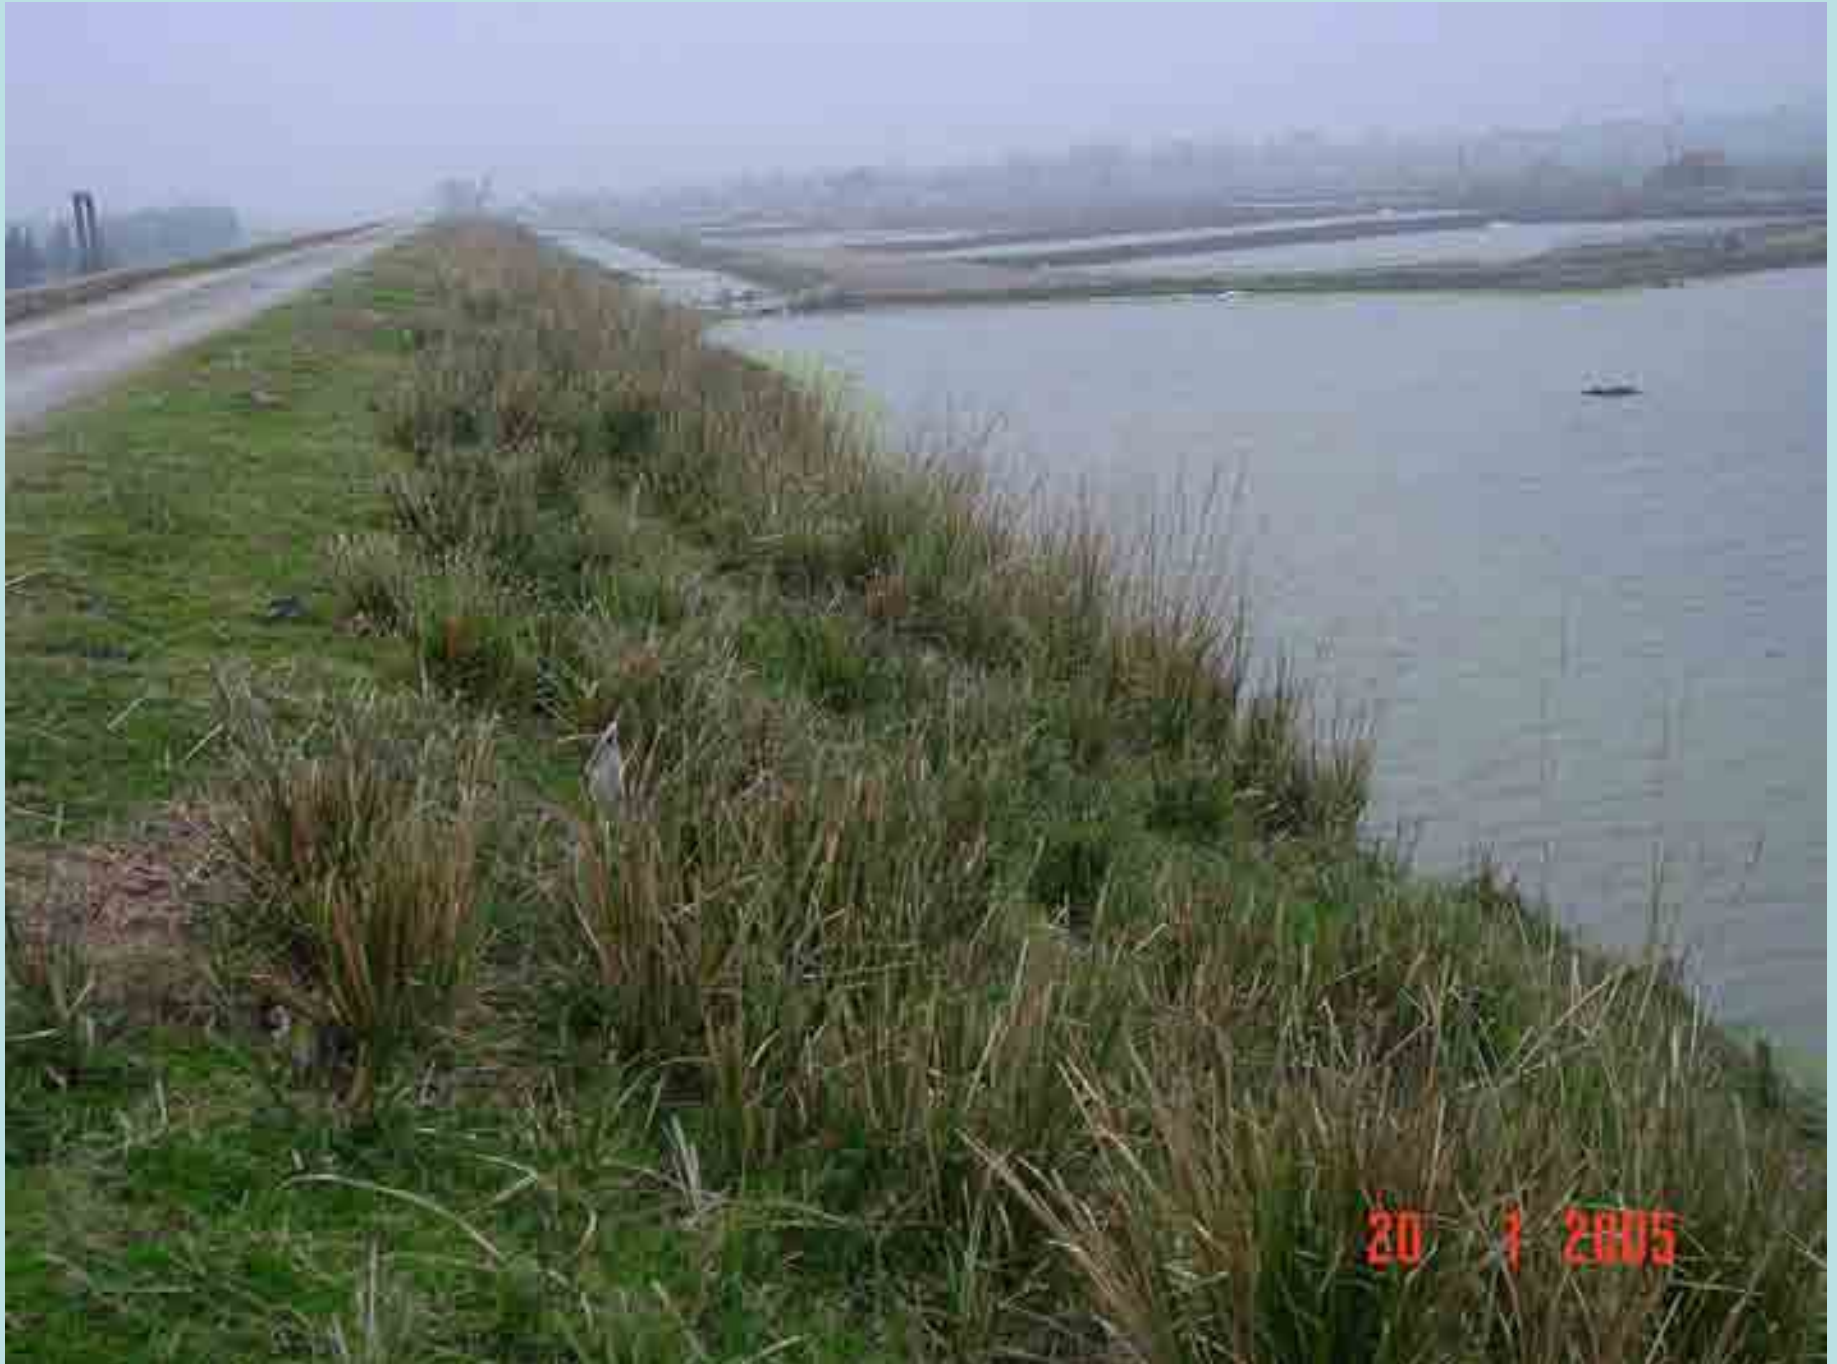
On a section of about 2km long, vetiver was planted to protect the inland batter

- Now the Dike Department has taken notice and ask VNVN to help them both technically and financially if possible to plant vetiver on these badly eroded section of the dike

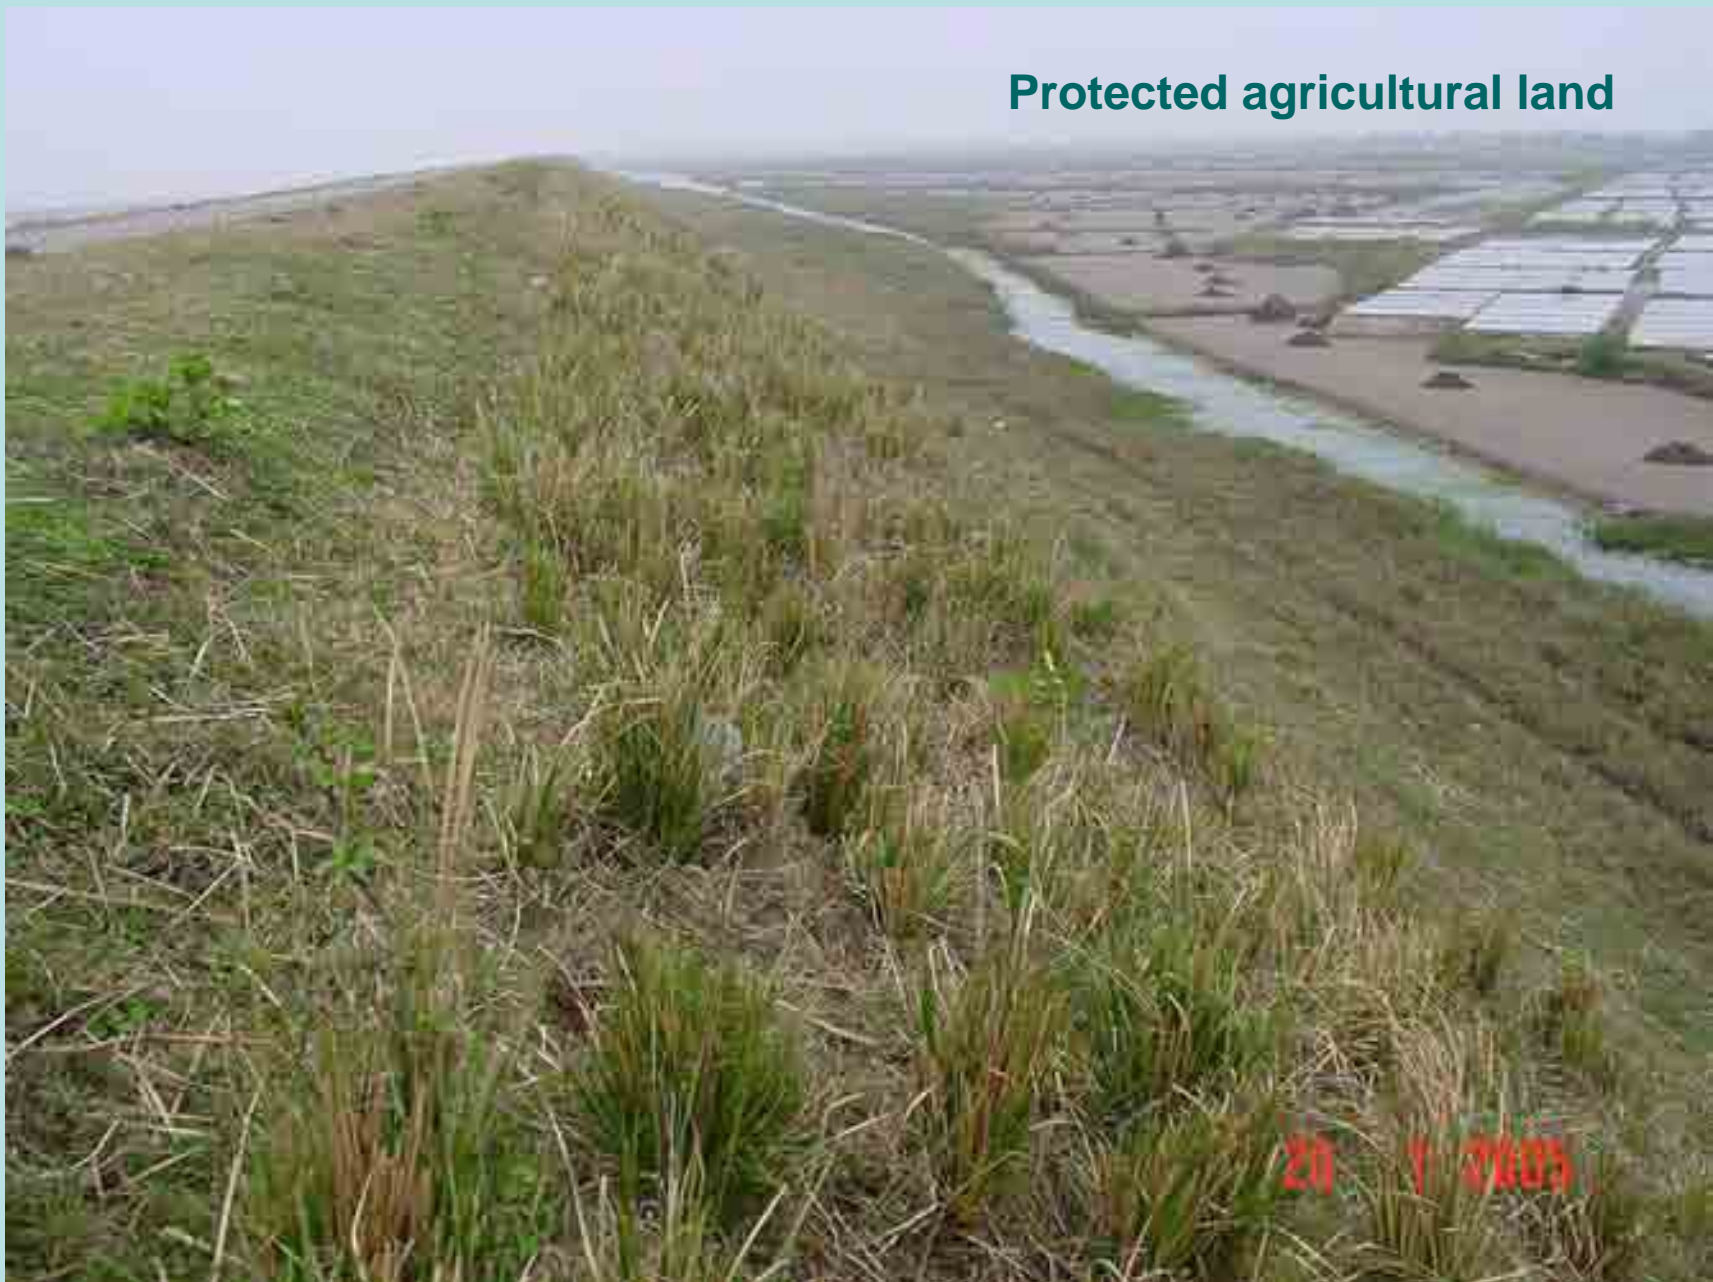
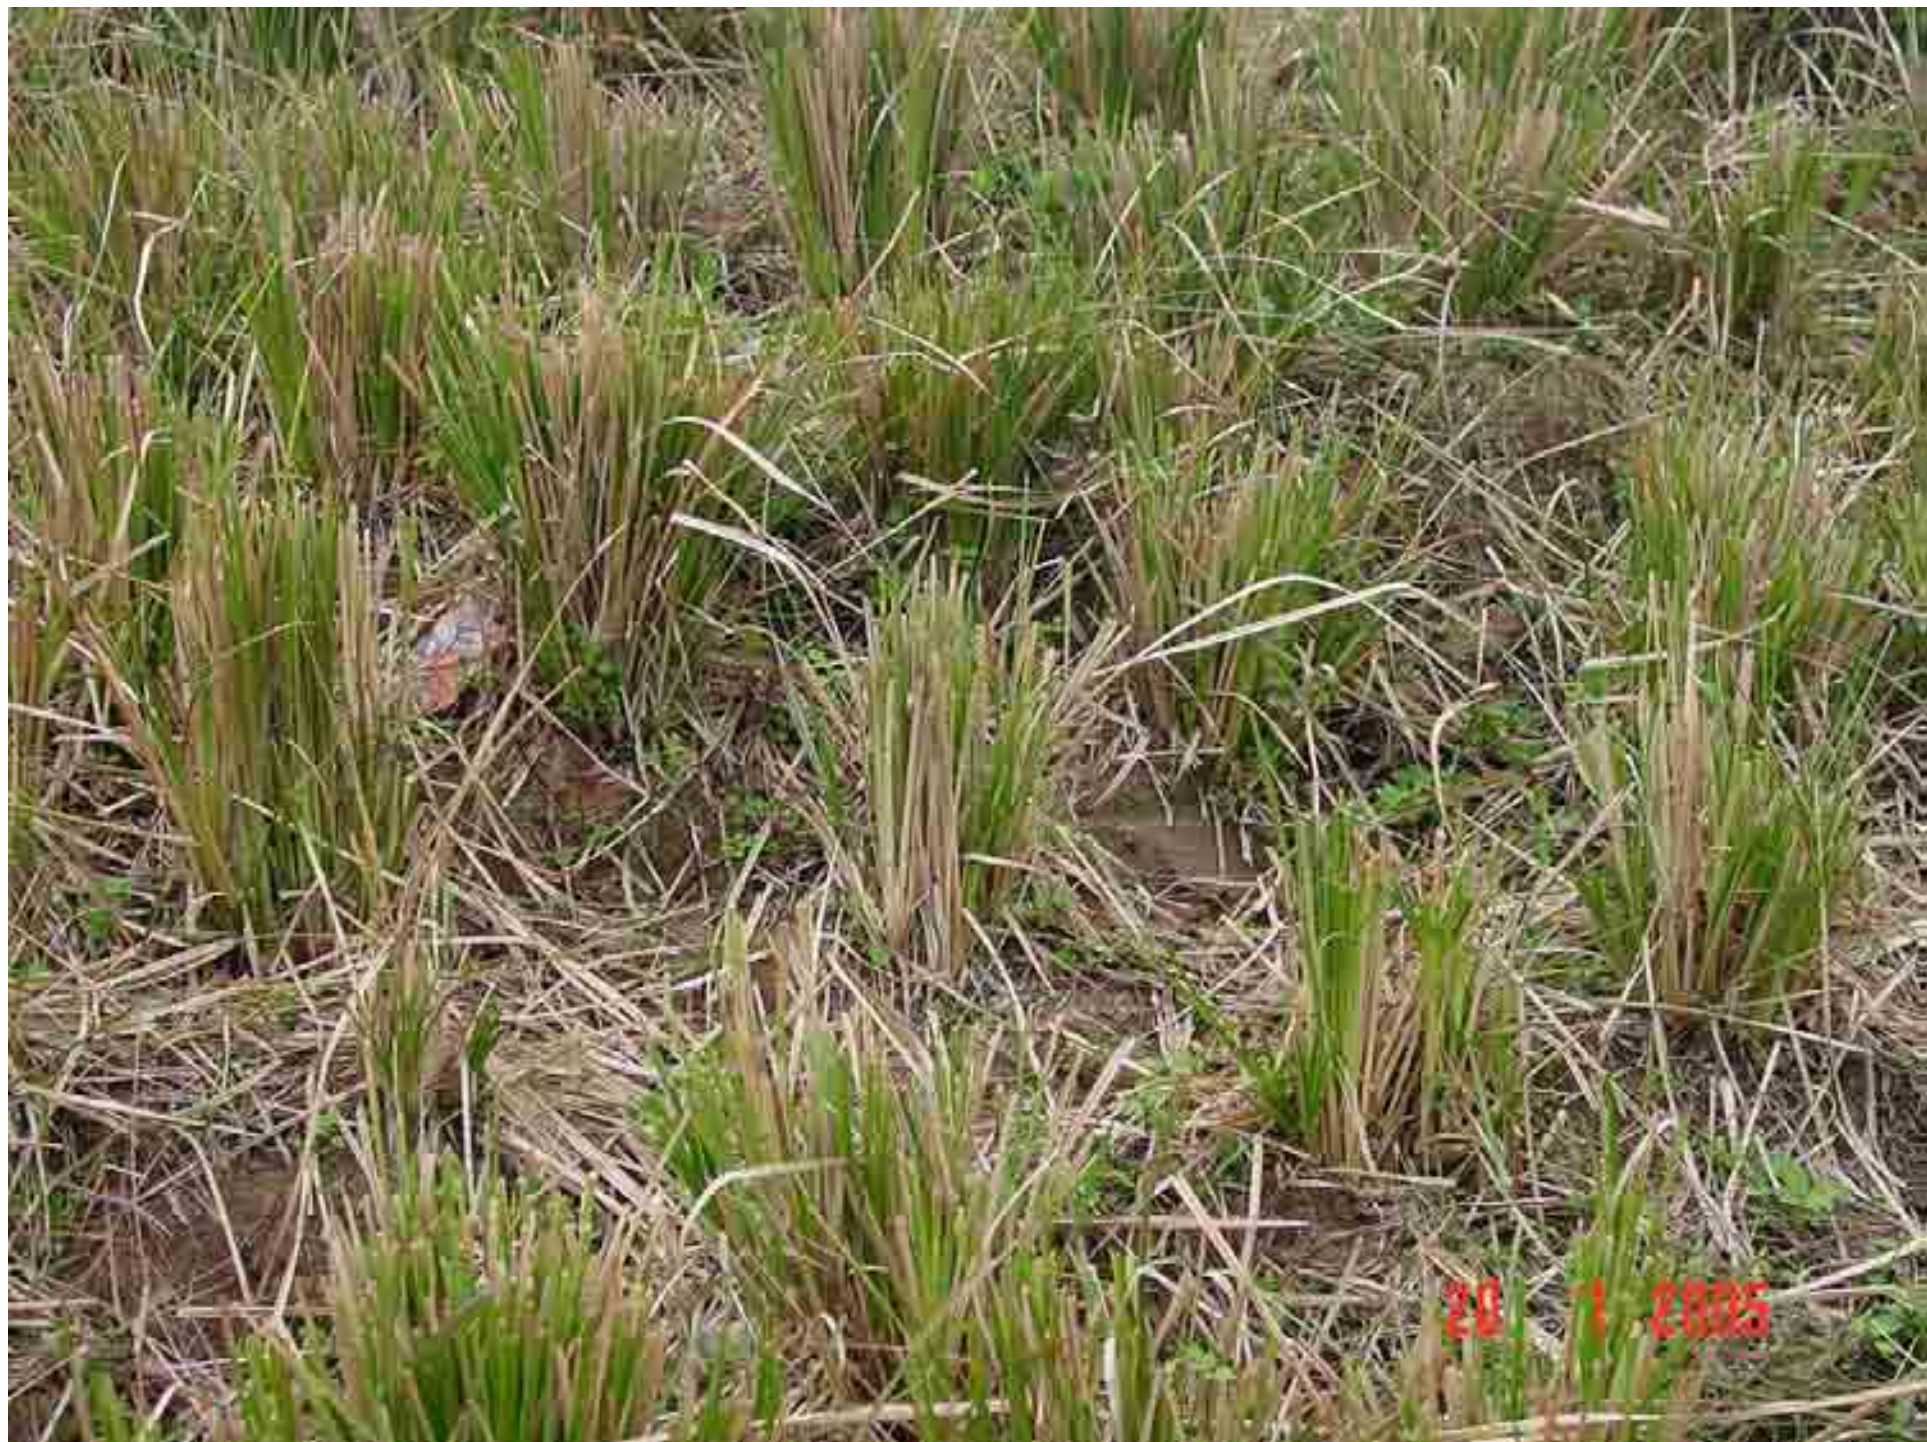
**Much appreciated by the farmers who graze the vetiver planting regularly. This is the only feed source for their livestock during the wet and cold winter season**

**Protected agricultural land**

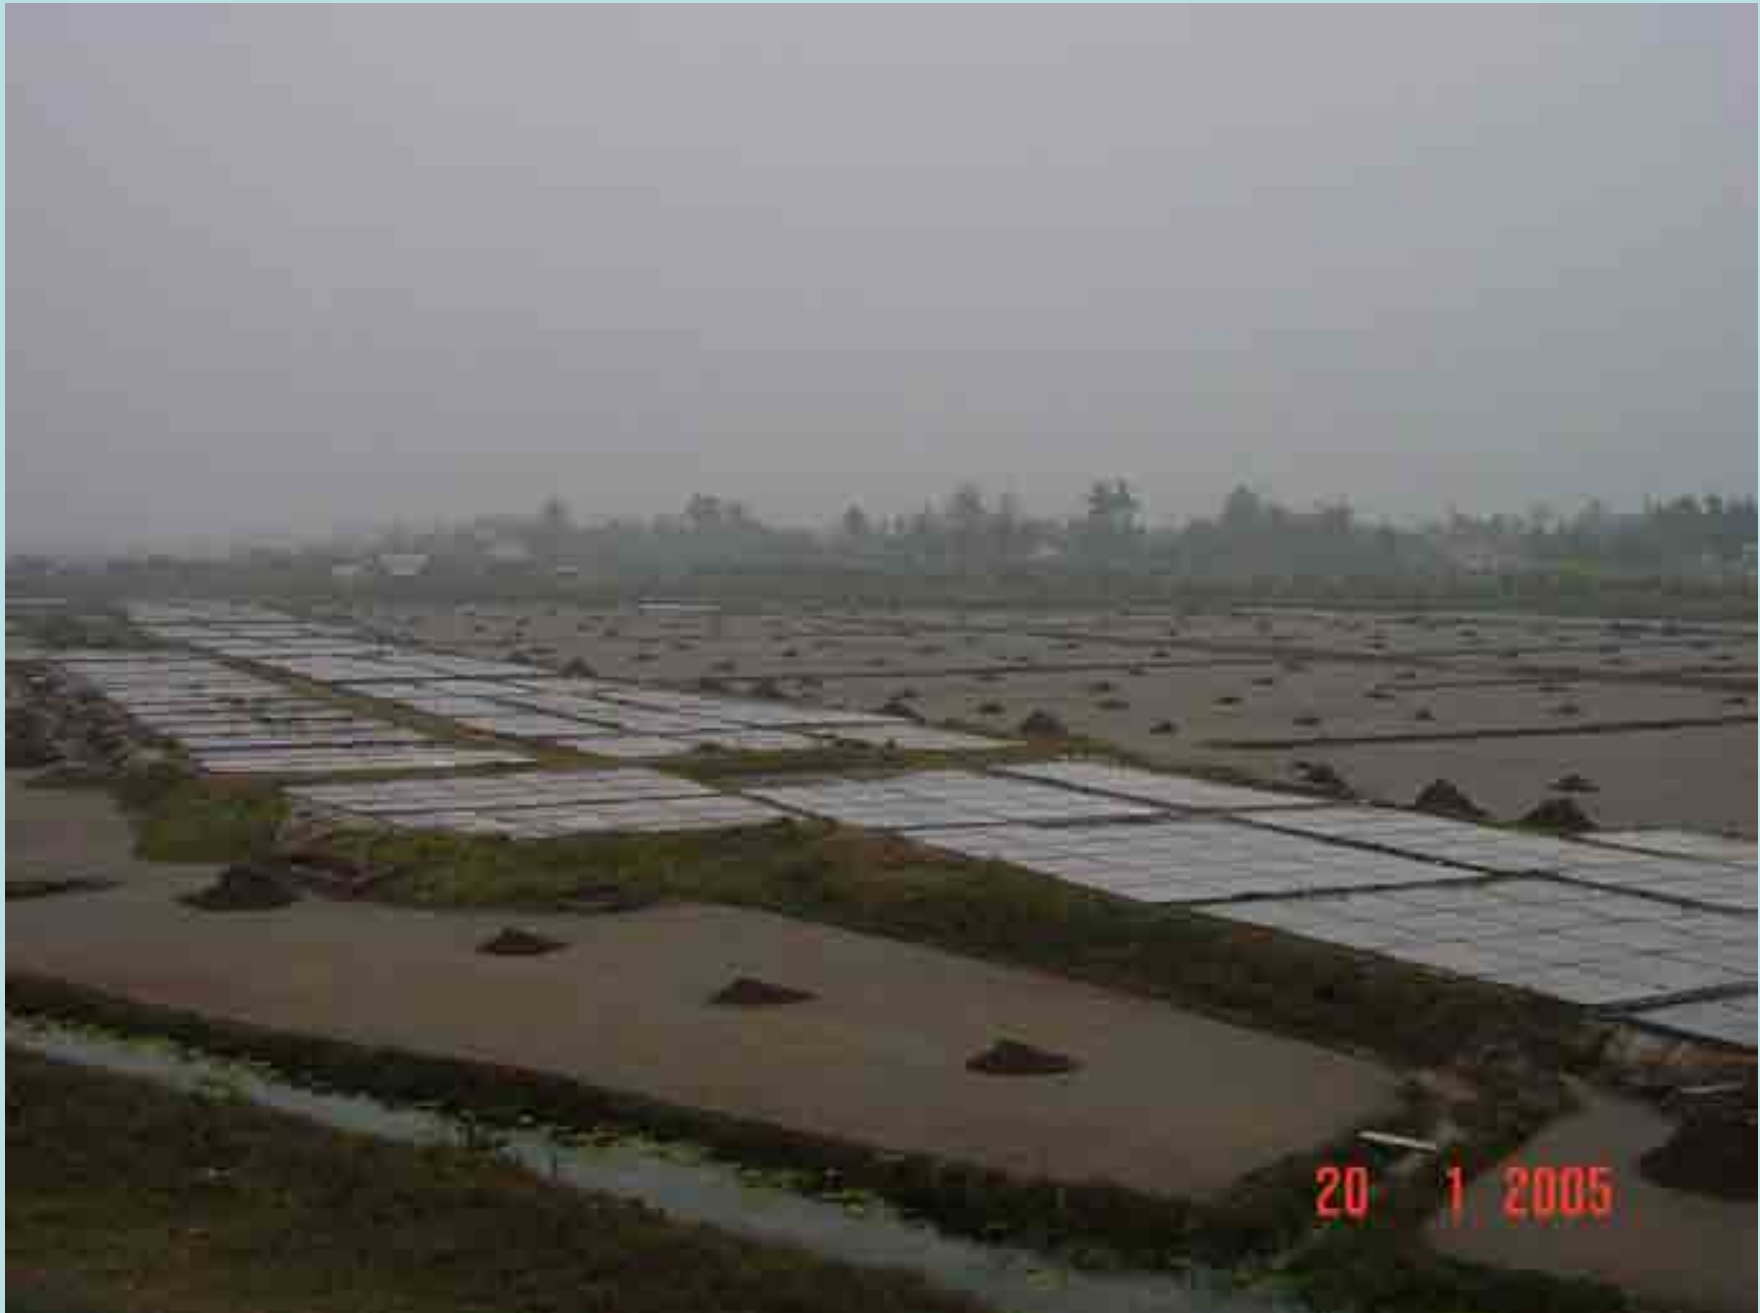
**Newly protected agricultural land, inside the new dike, but for how long??**
