Keeping Sediment Off The Reef

A project using vetiver grass to trap sediment and re-establish indigenous forest - Aneityum Island, Vanuatu

The Aneityum Erosion Control Project

A brief retrospective 6 years after NZAID funding ceased

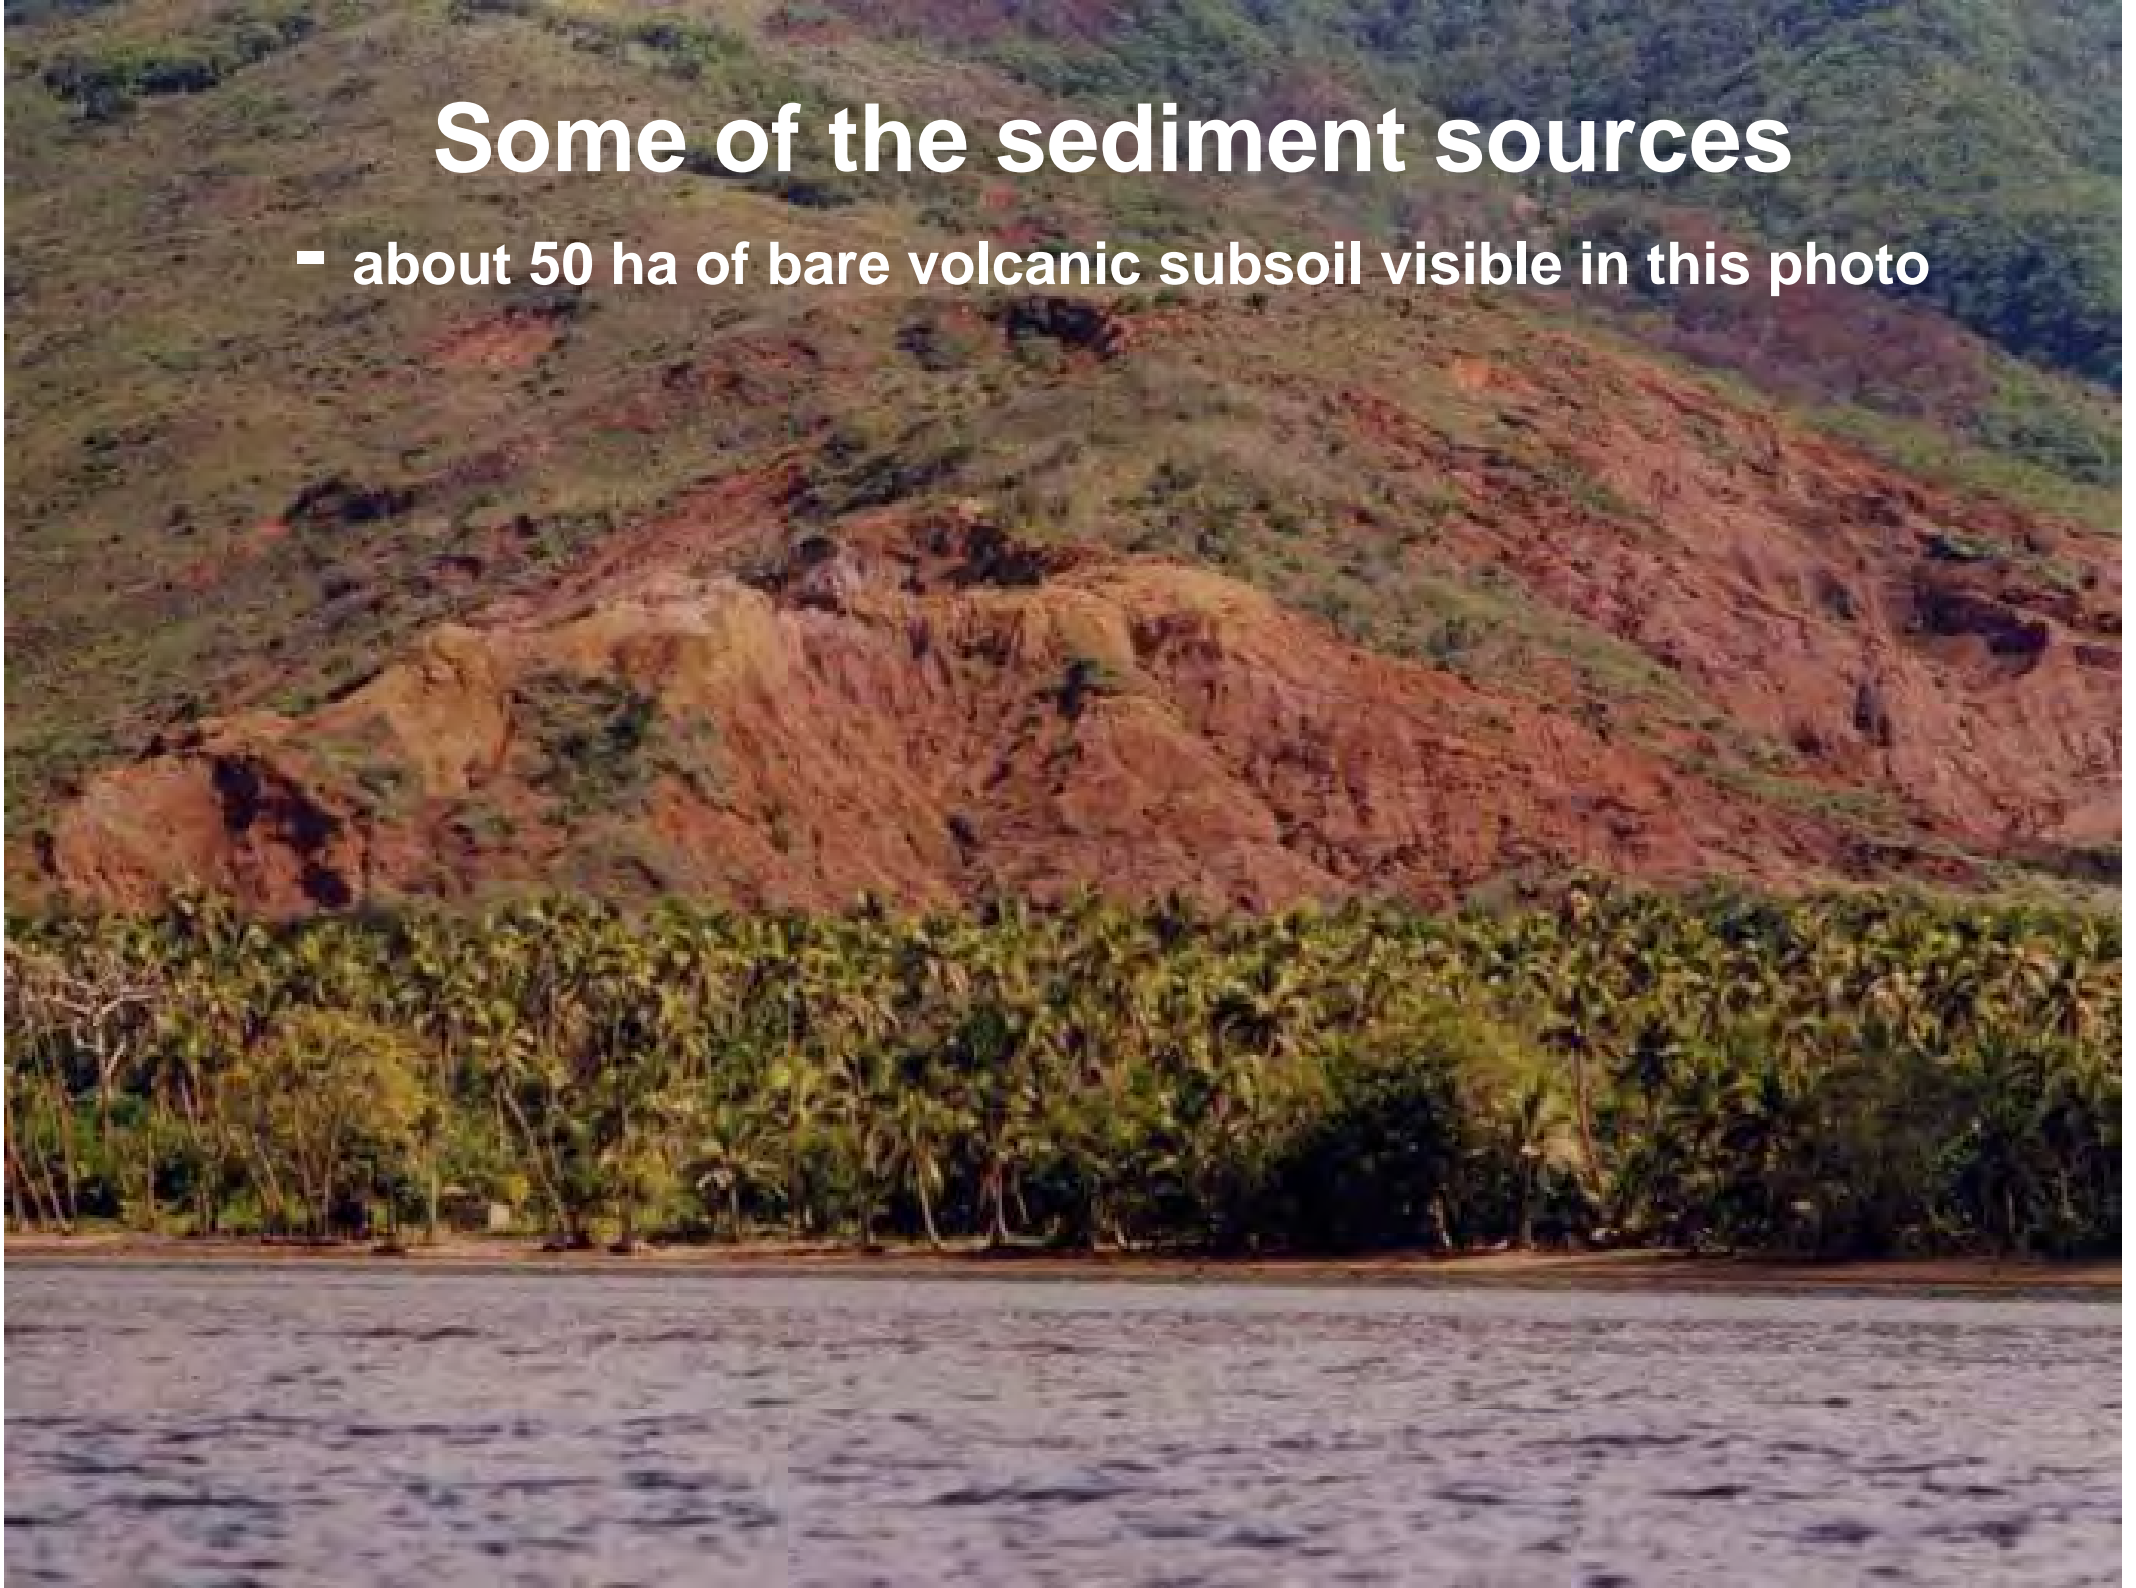
A major source of sediment

5000 gal water tank gives scale

“Chalk Hill” 1995

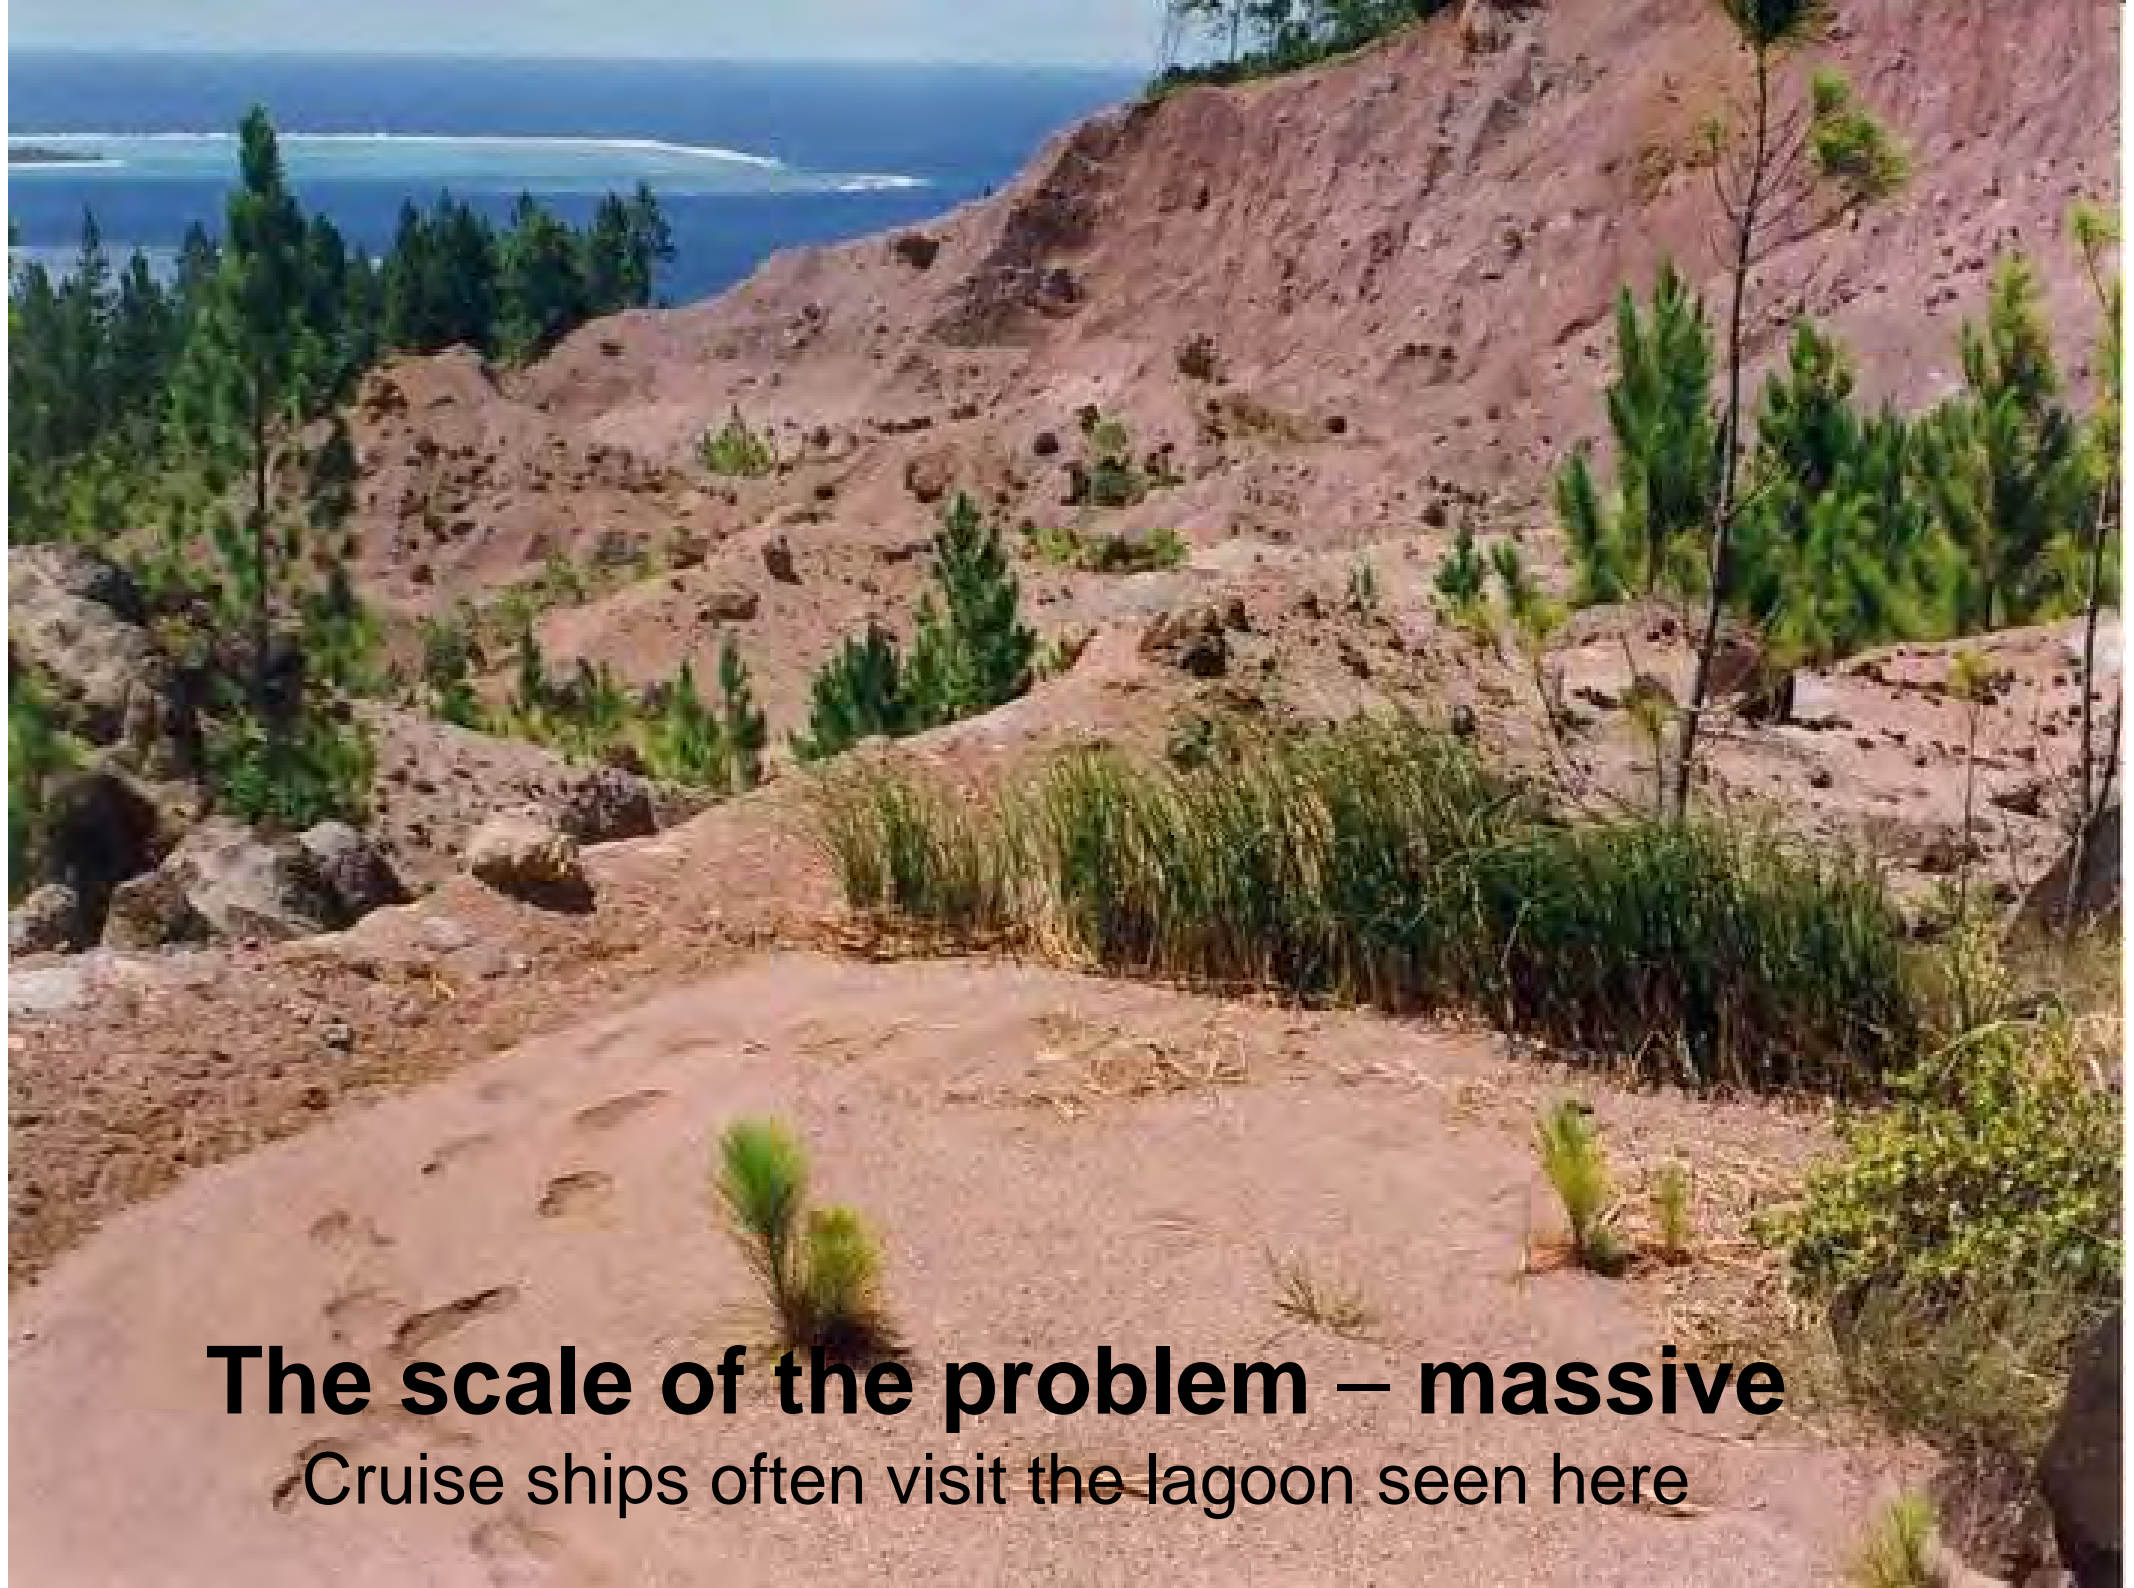
The scale of the problem – massive

Cruise ships often visit the lagoon seen here

Large areas of gullies like this

- Soft volcanic rock that even pines won't grow in.
- Low pH, high Mn and high available Aluminium %
- Very high rates of weathering
- High annual volumes of acid sediment

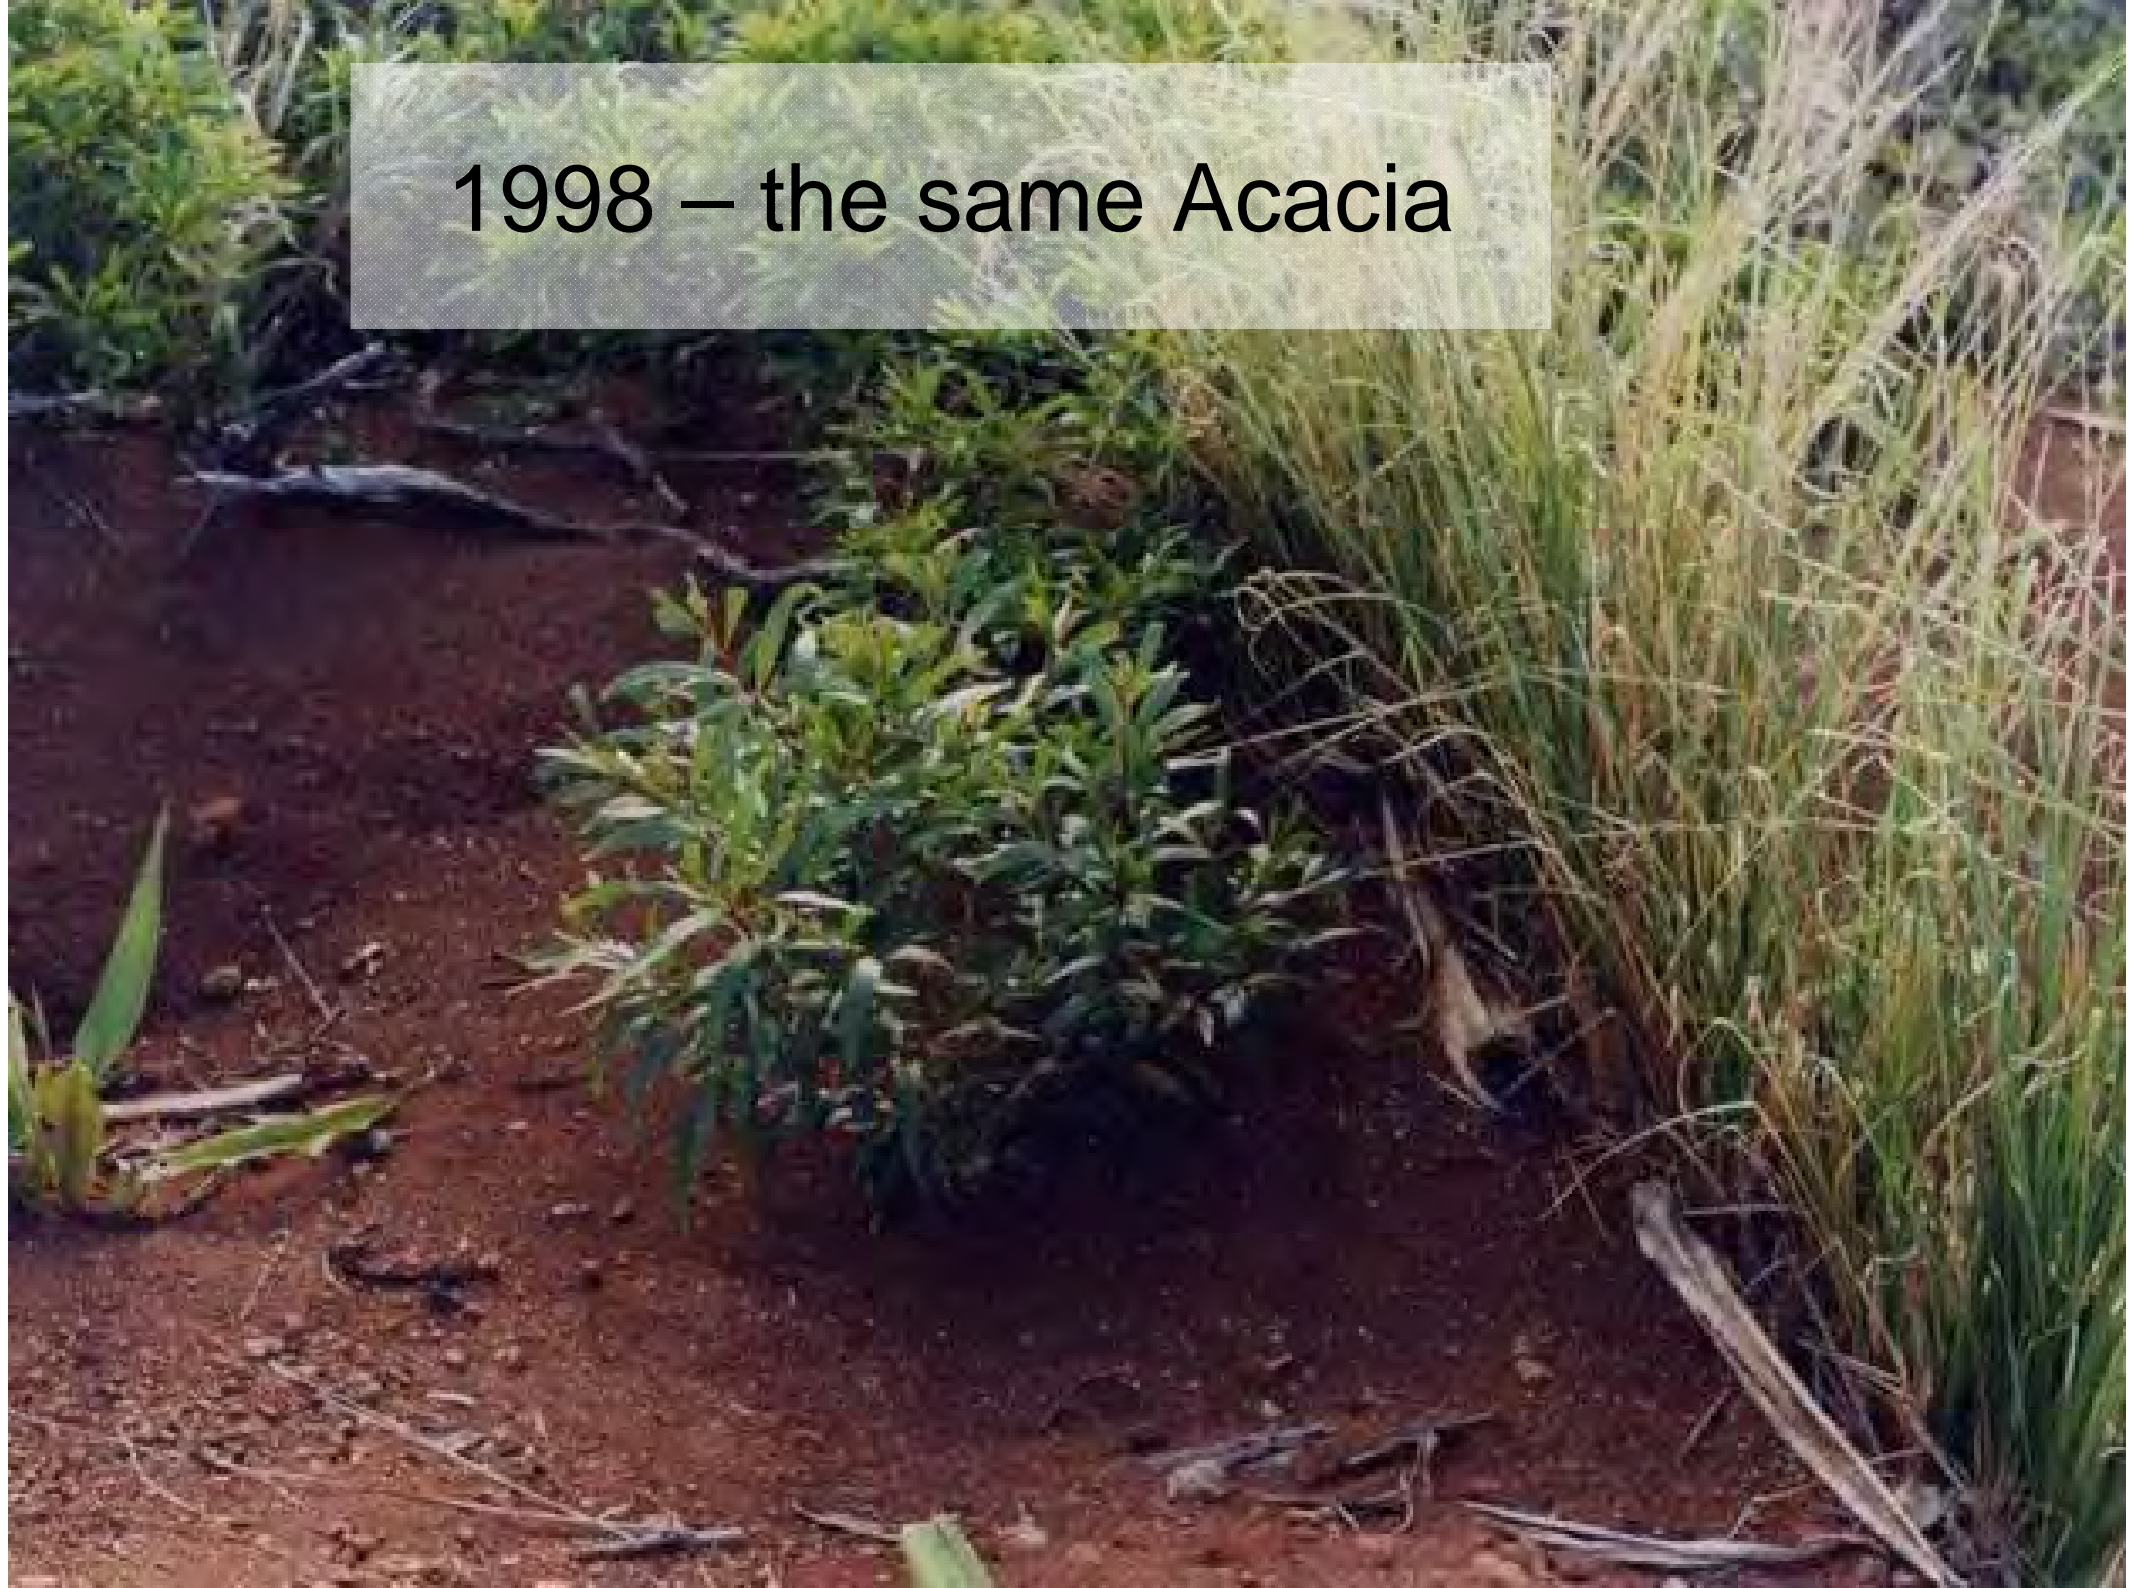
1998 – the same Acacia

- Vetiver grass continues to trap sediment
- *Acacia spirorbis* shades soil and provides nitrogen and leaf litter

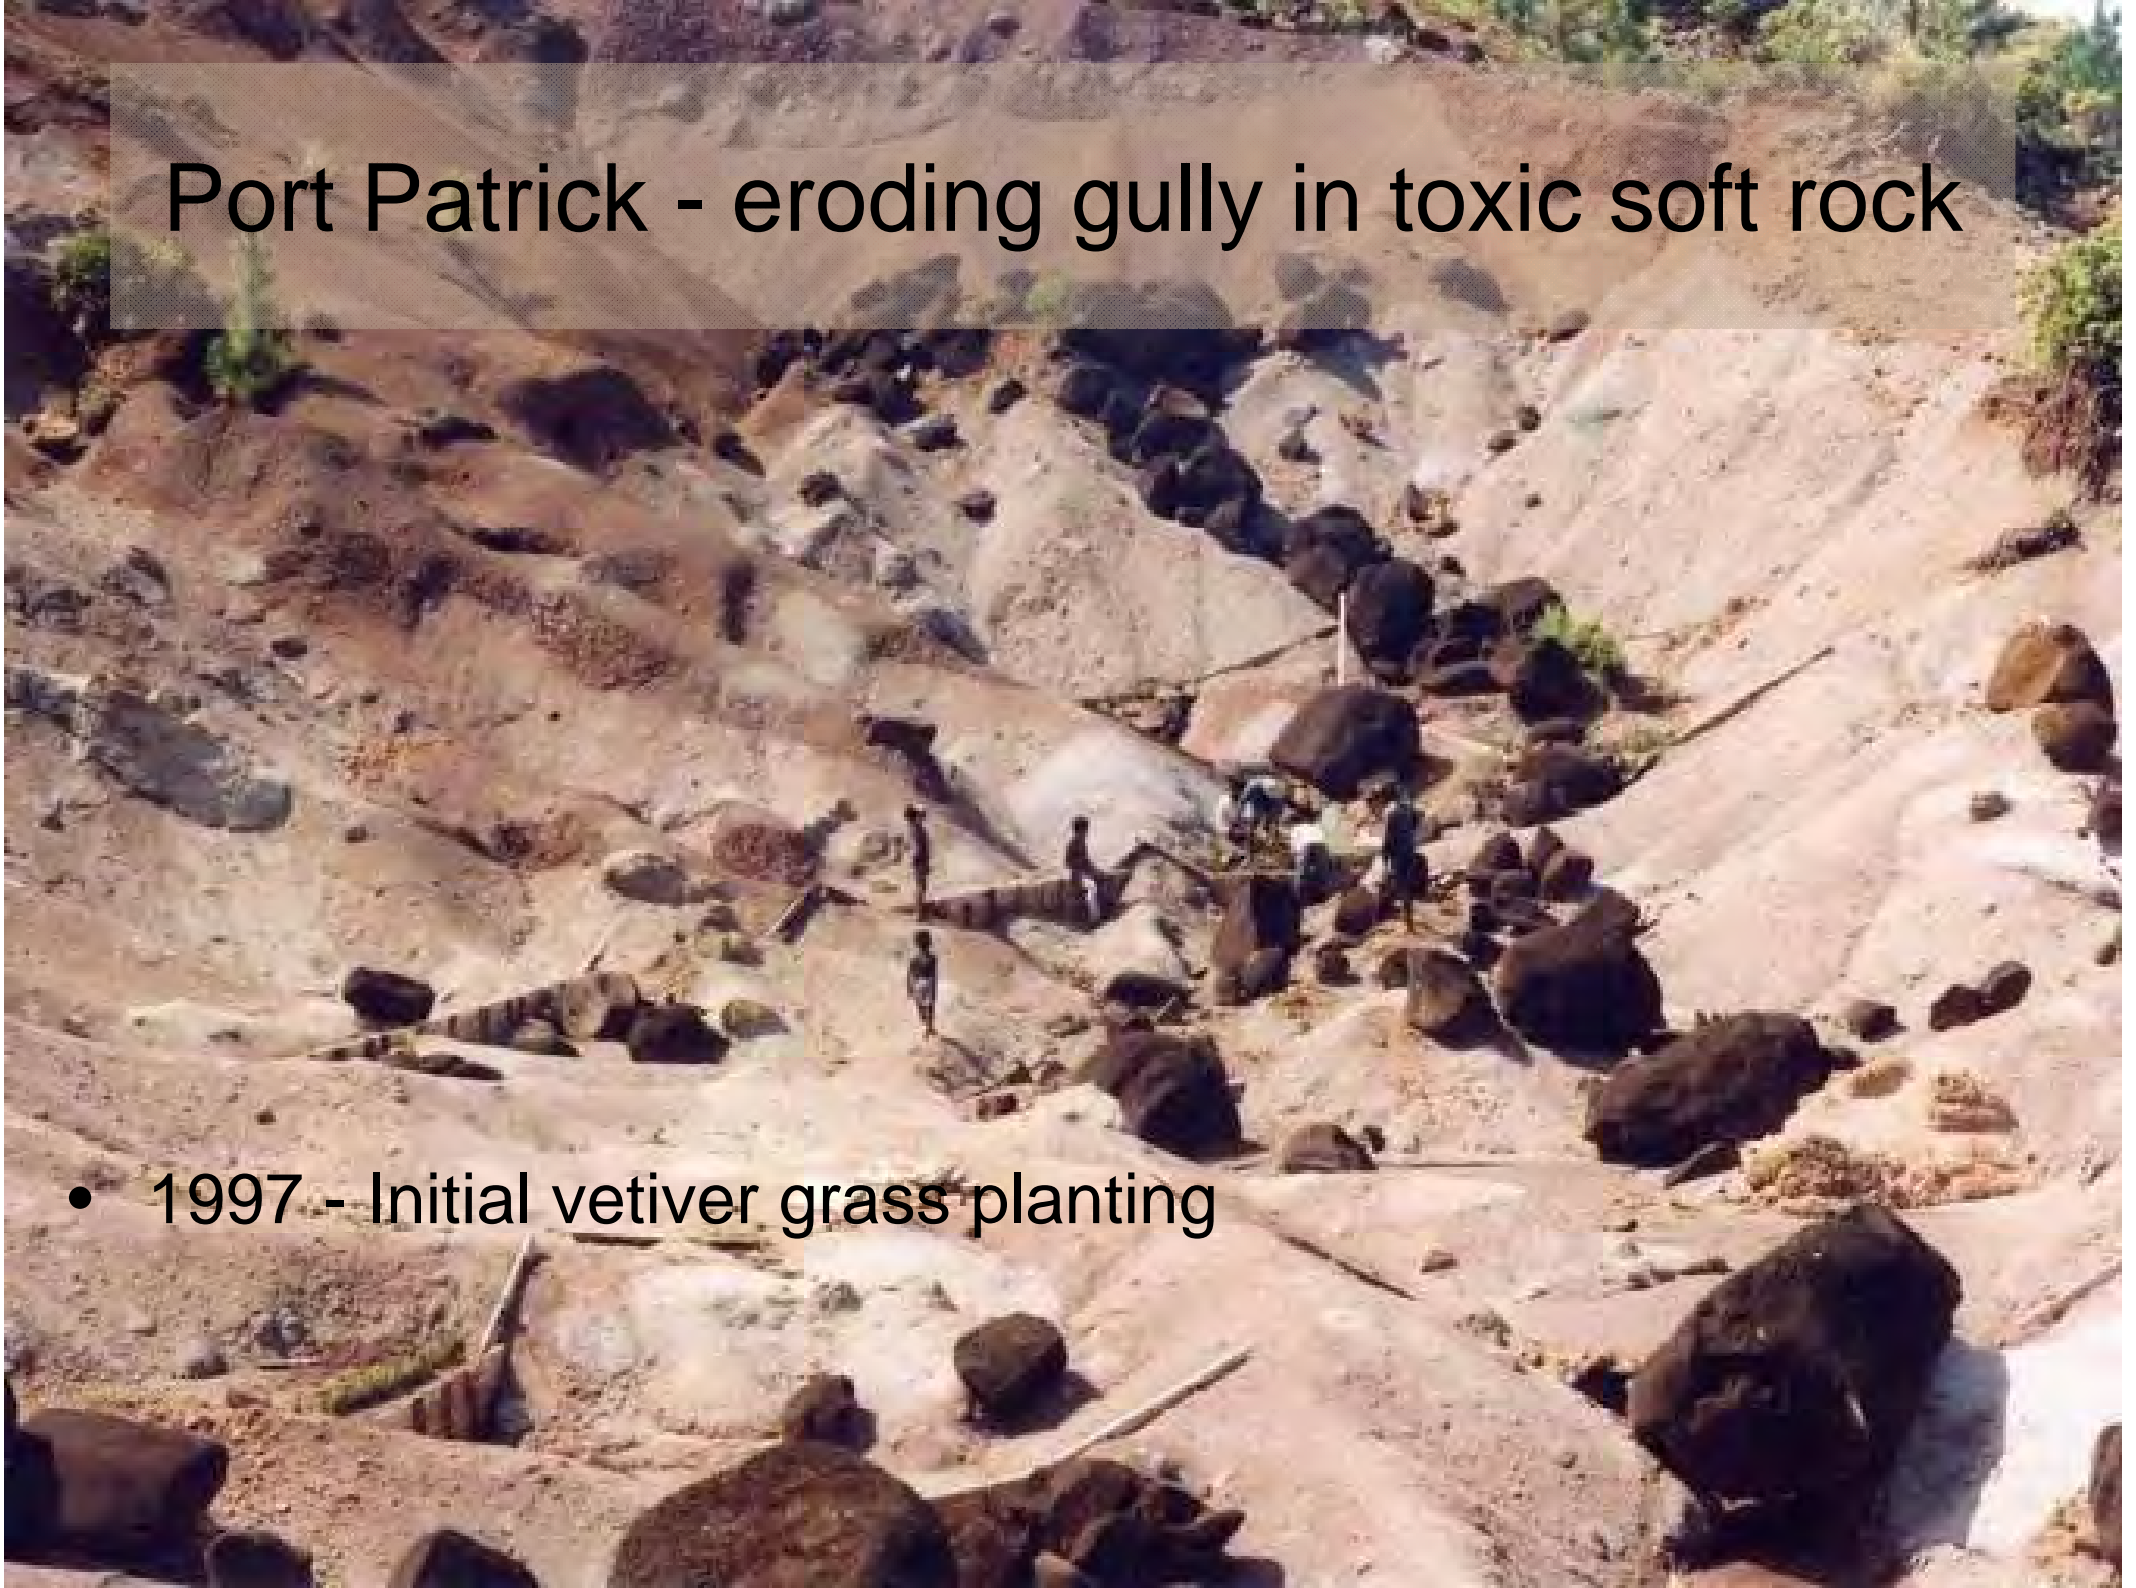
Port Patrick - eroding gully in toxic soft rock

- 1997 - Initial vetiver grass planting

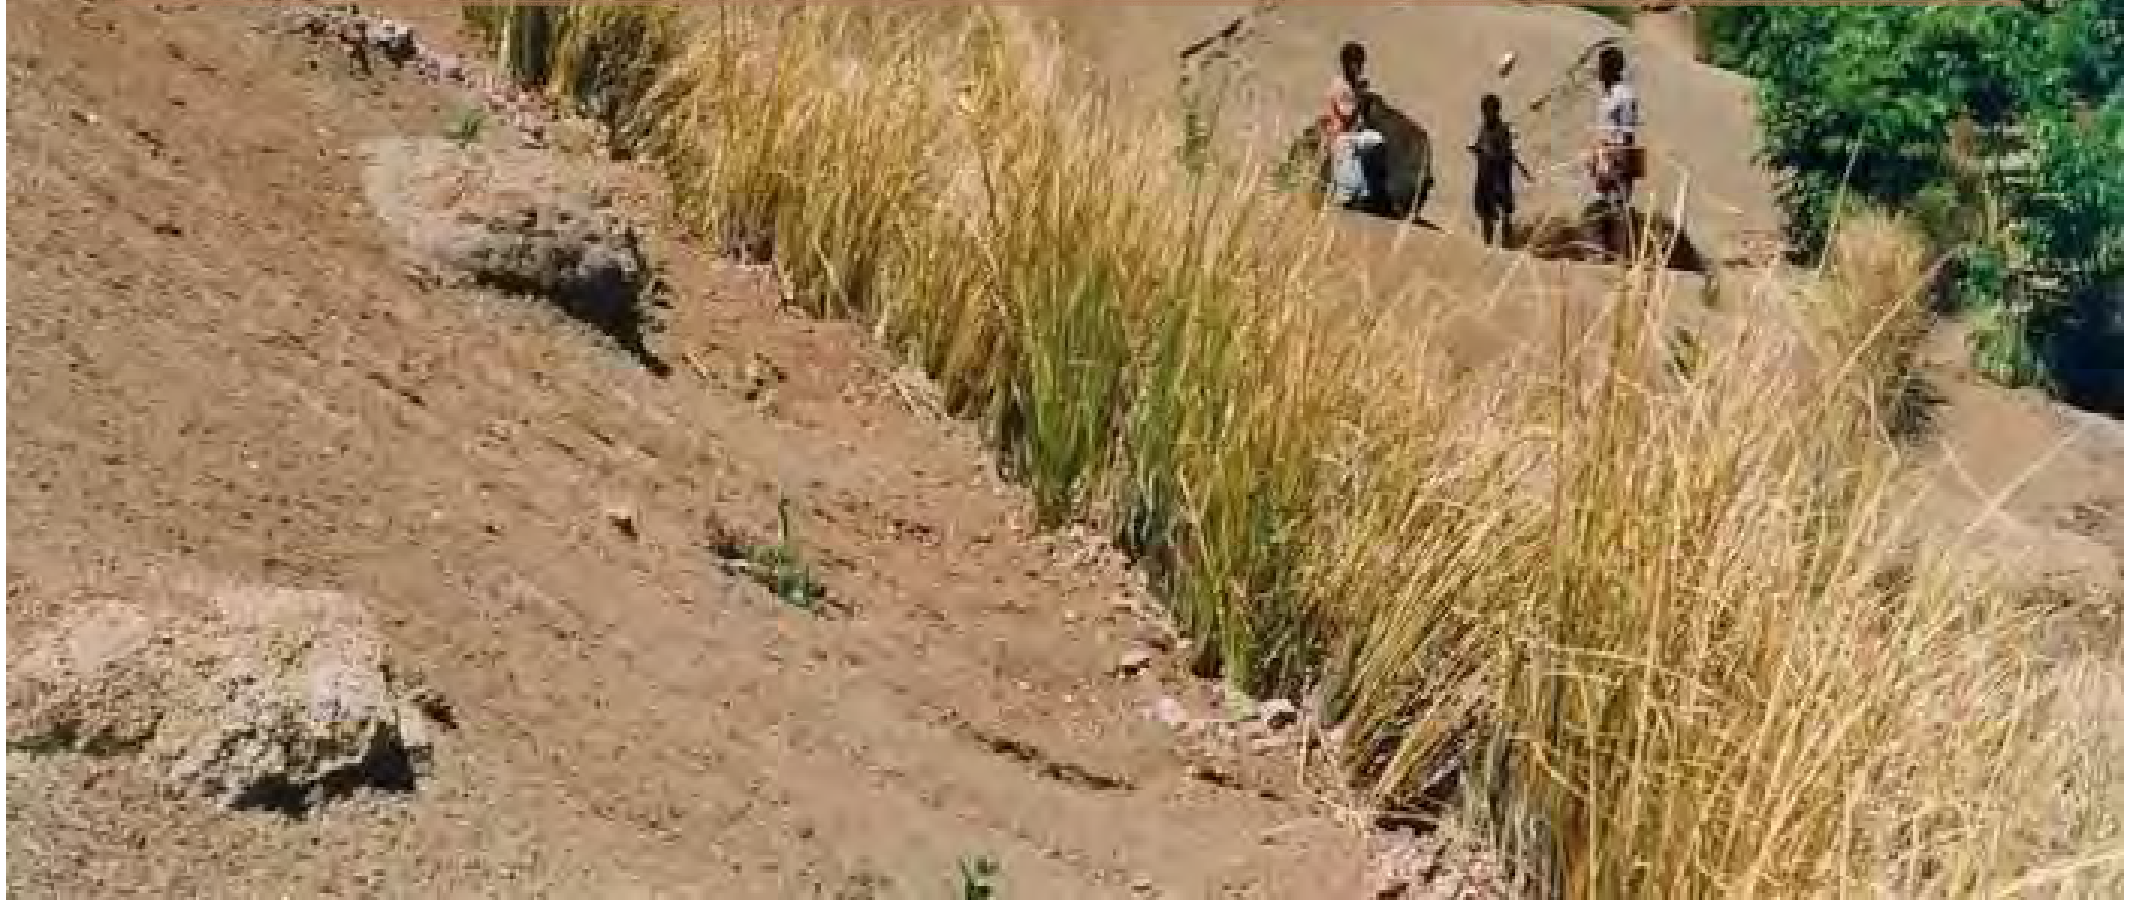
A major source of sediment in 2001

- This soft volcanic rock loses about 50 mm of weathered material per year.
- Note sediment retained above the young vetiver grass hedge.

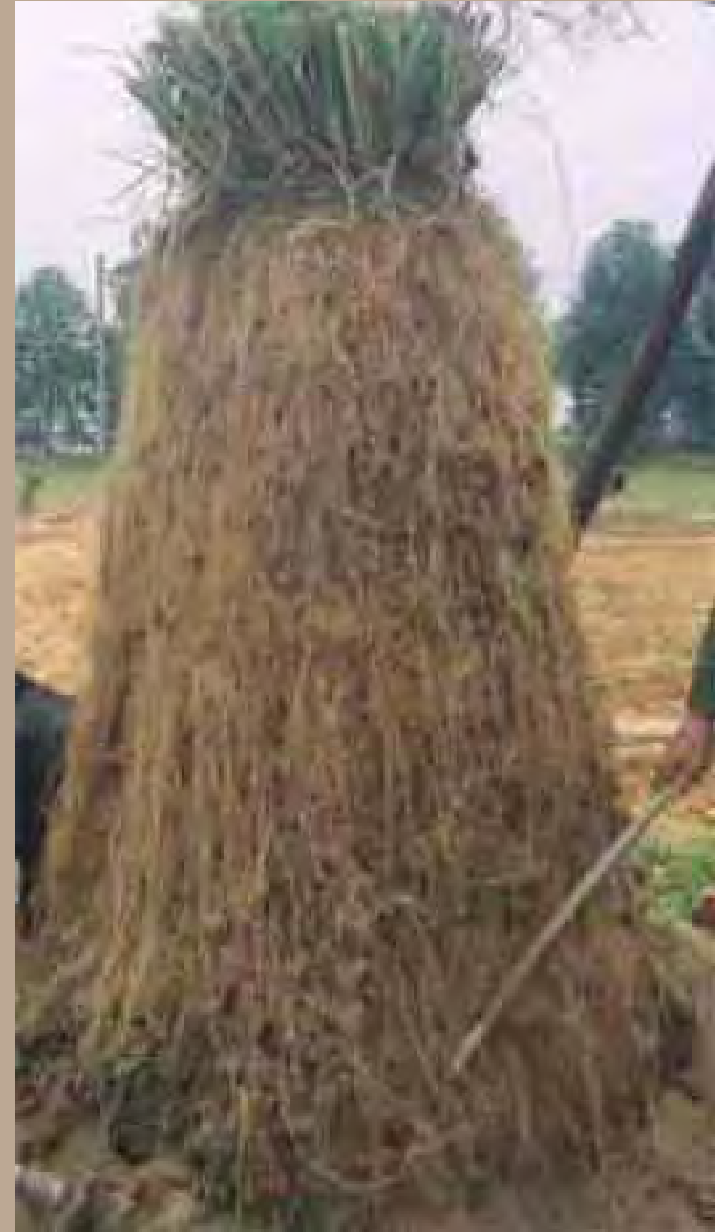
Vetiver can have a massive root system

In deep soils root depths of 2 metres are common.

These roots allow the grass to survive drought and resist scour in stream channels.

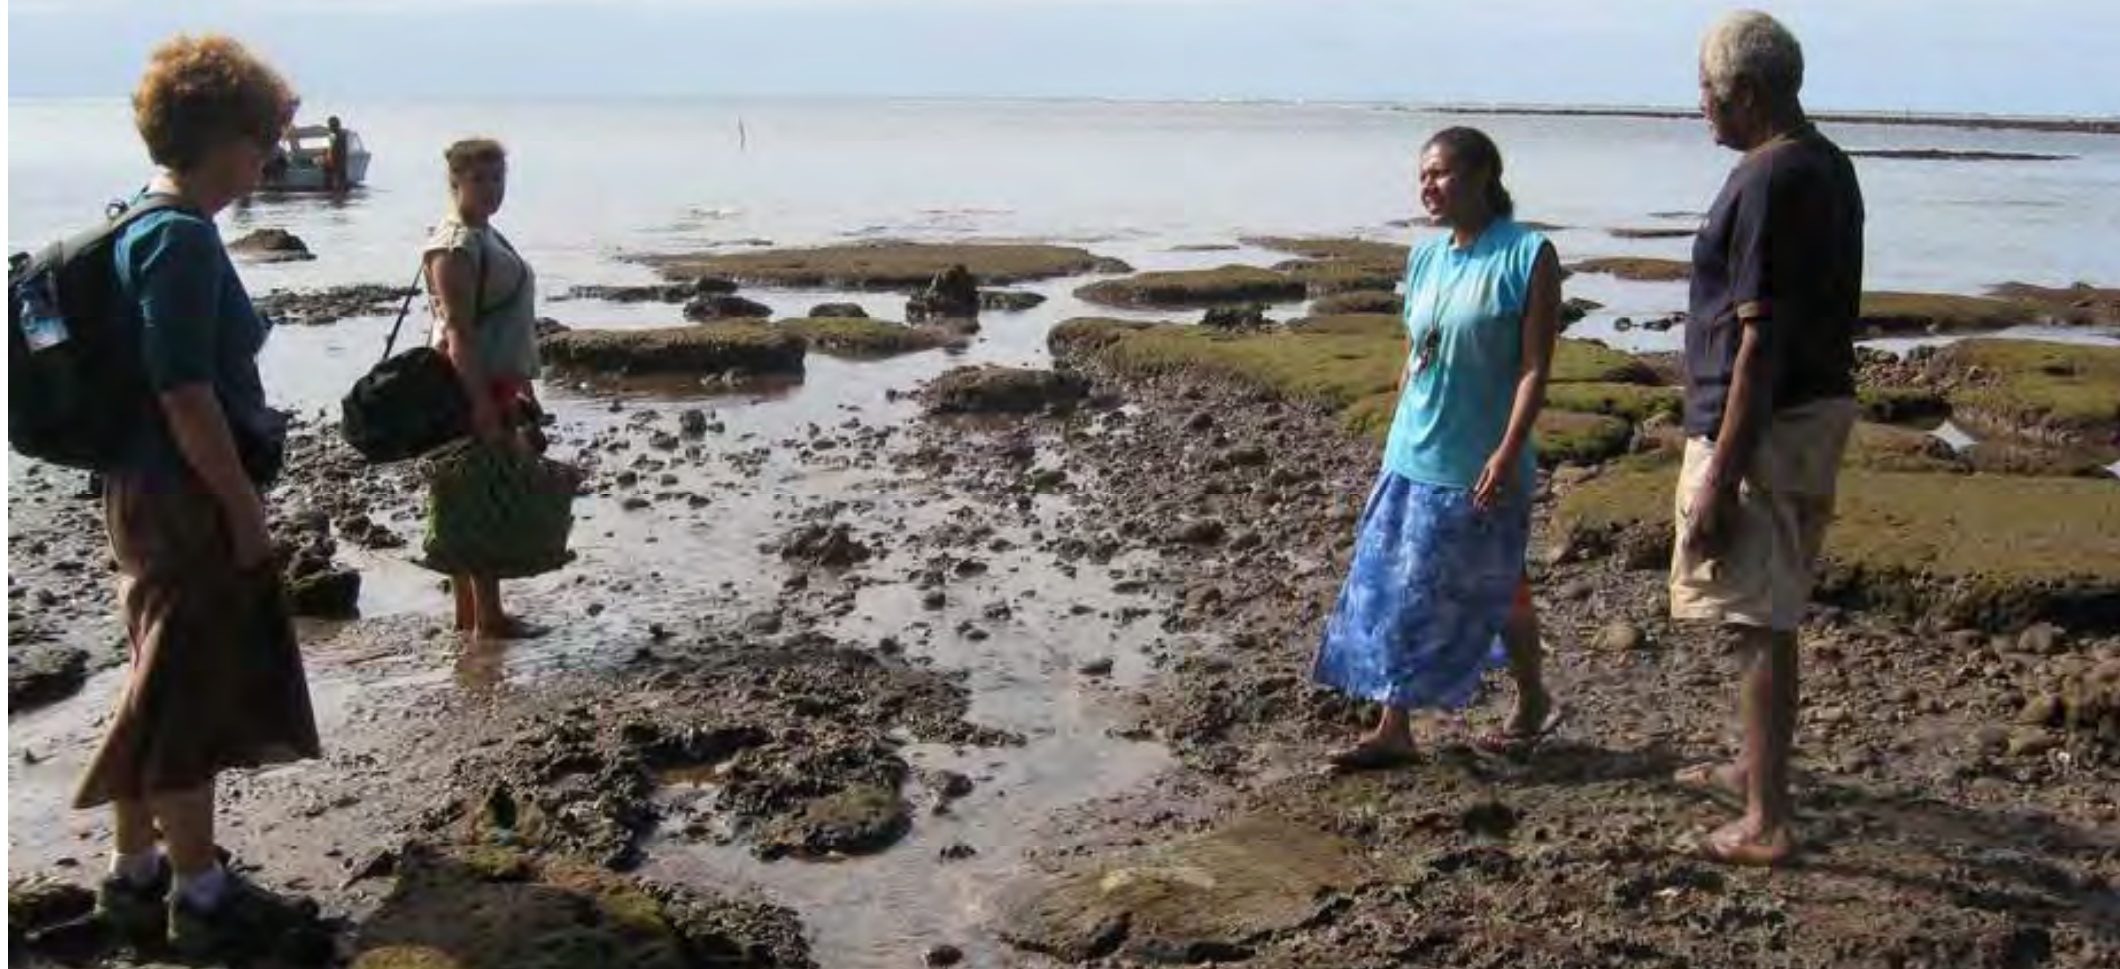
The same location - 2008

- Thick red mud covered much of this uplifted reef in 1995 – A footprint at Port Patrick

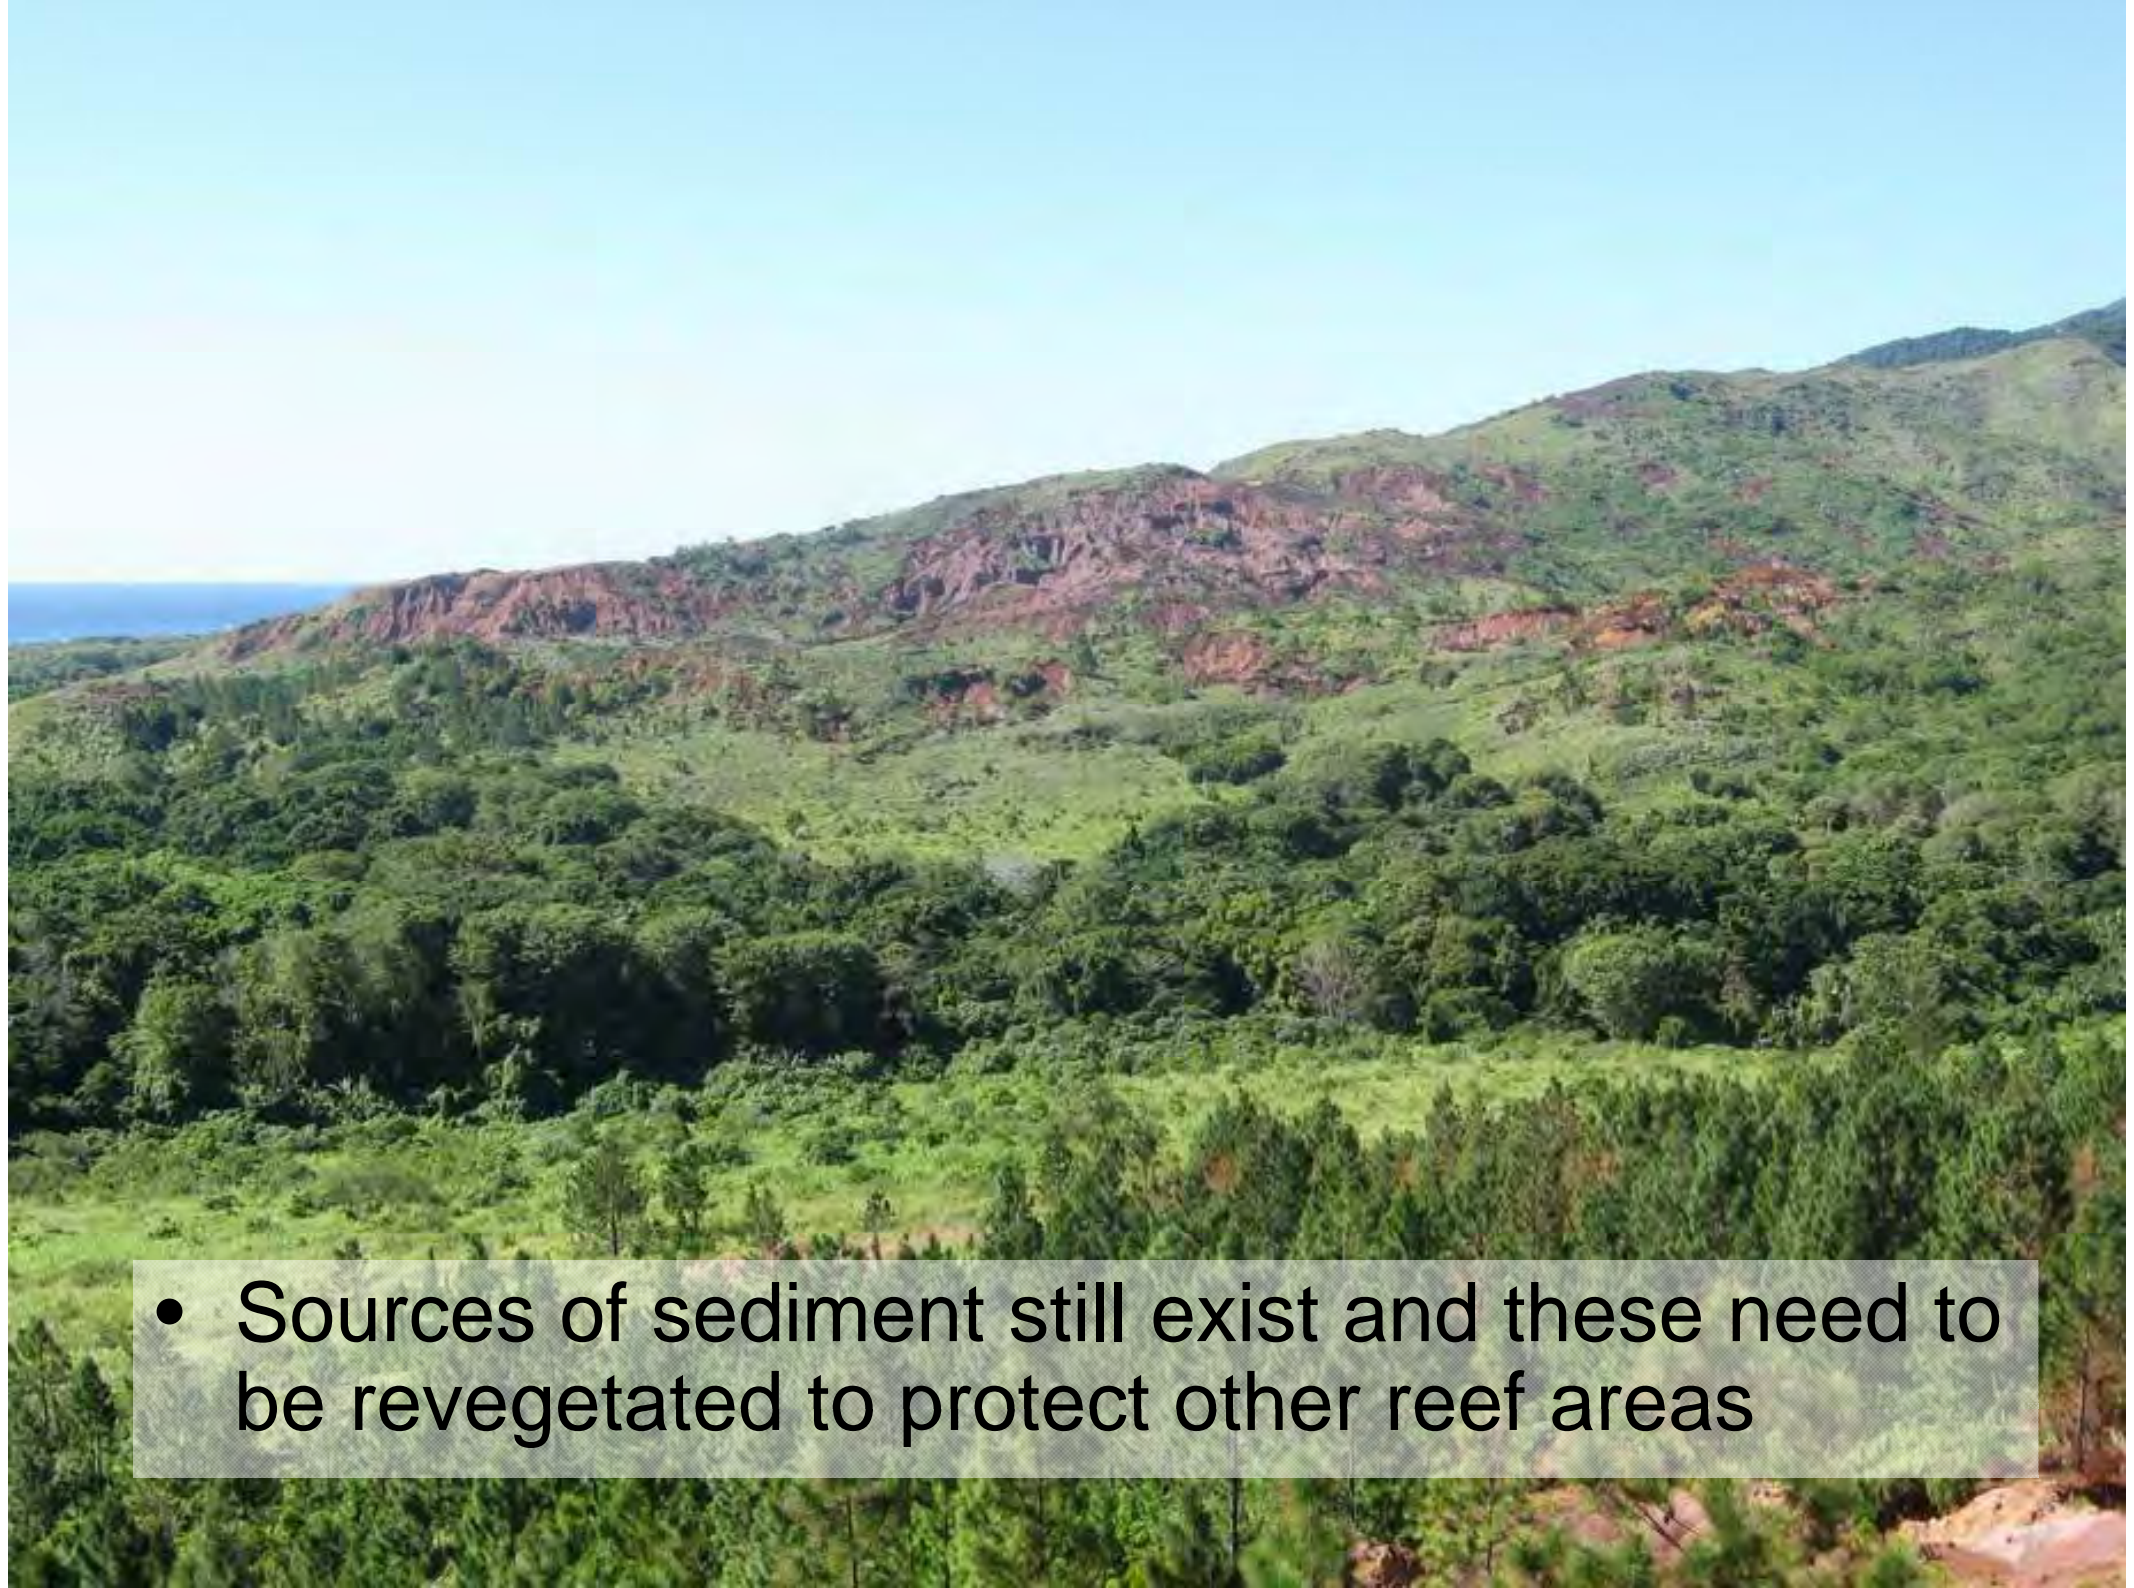
- In some areas too much red sediment is still reaching the sea – (“upstream” from Port Patrick)

- Sources of sediment still exist and these need to be revegetated to protect other reef areas
