Keeping Sediment Off The Reef

A project using vetiver grass to trap sediment and re-establish indigenous forest - Aneityum Island, Vanuatu

The Aneityum Erosion Control Project

A brief retrospective 6 years after NZAID funding ceased

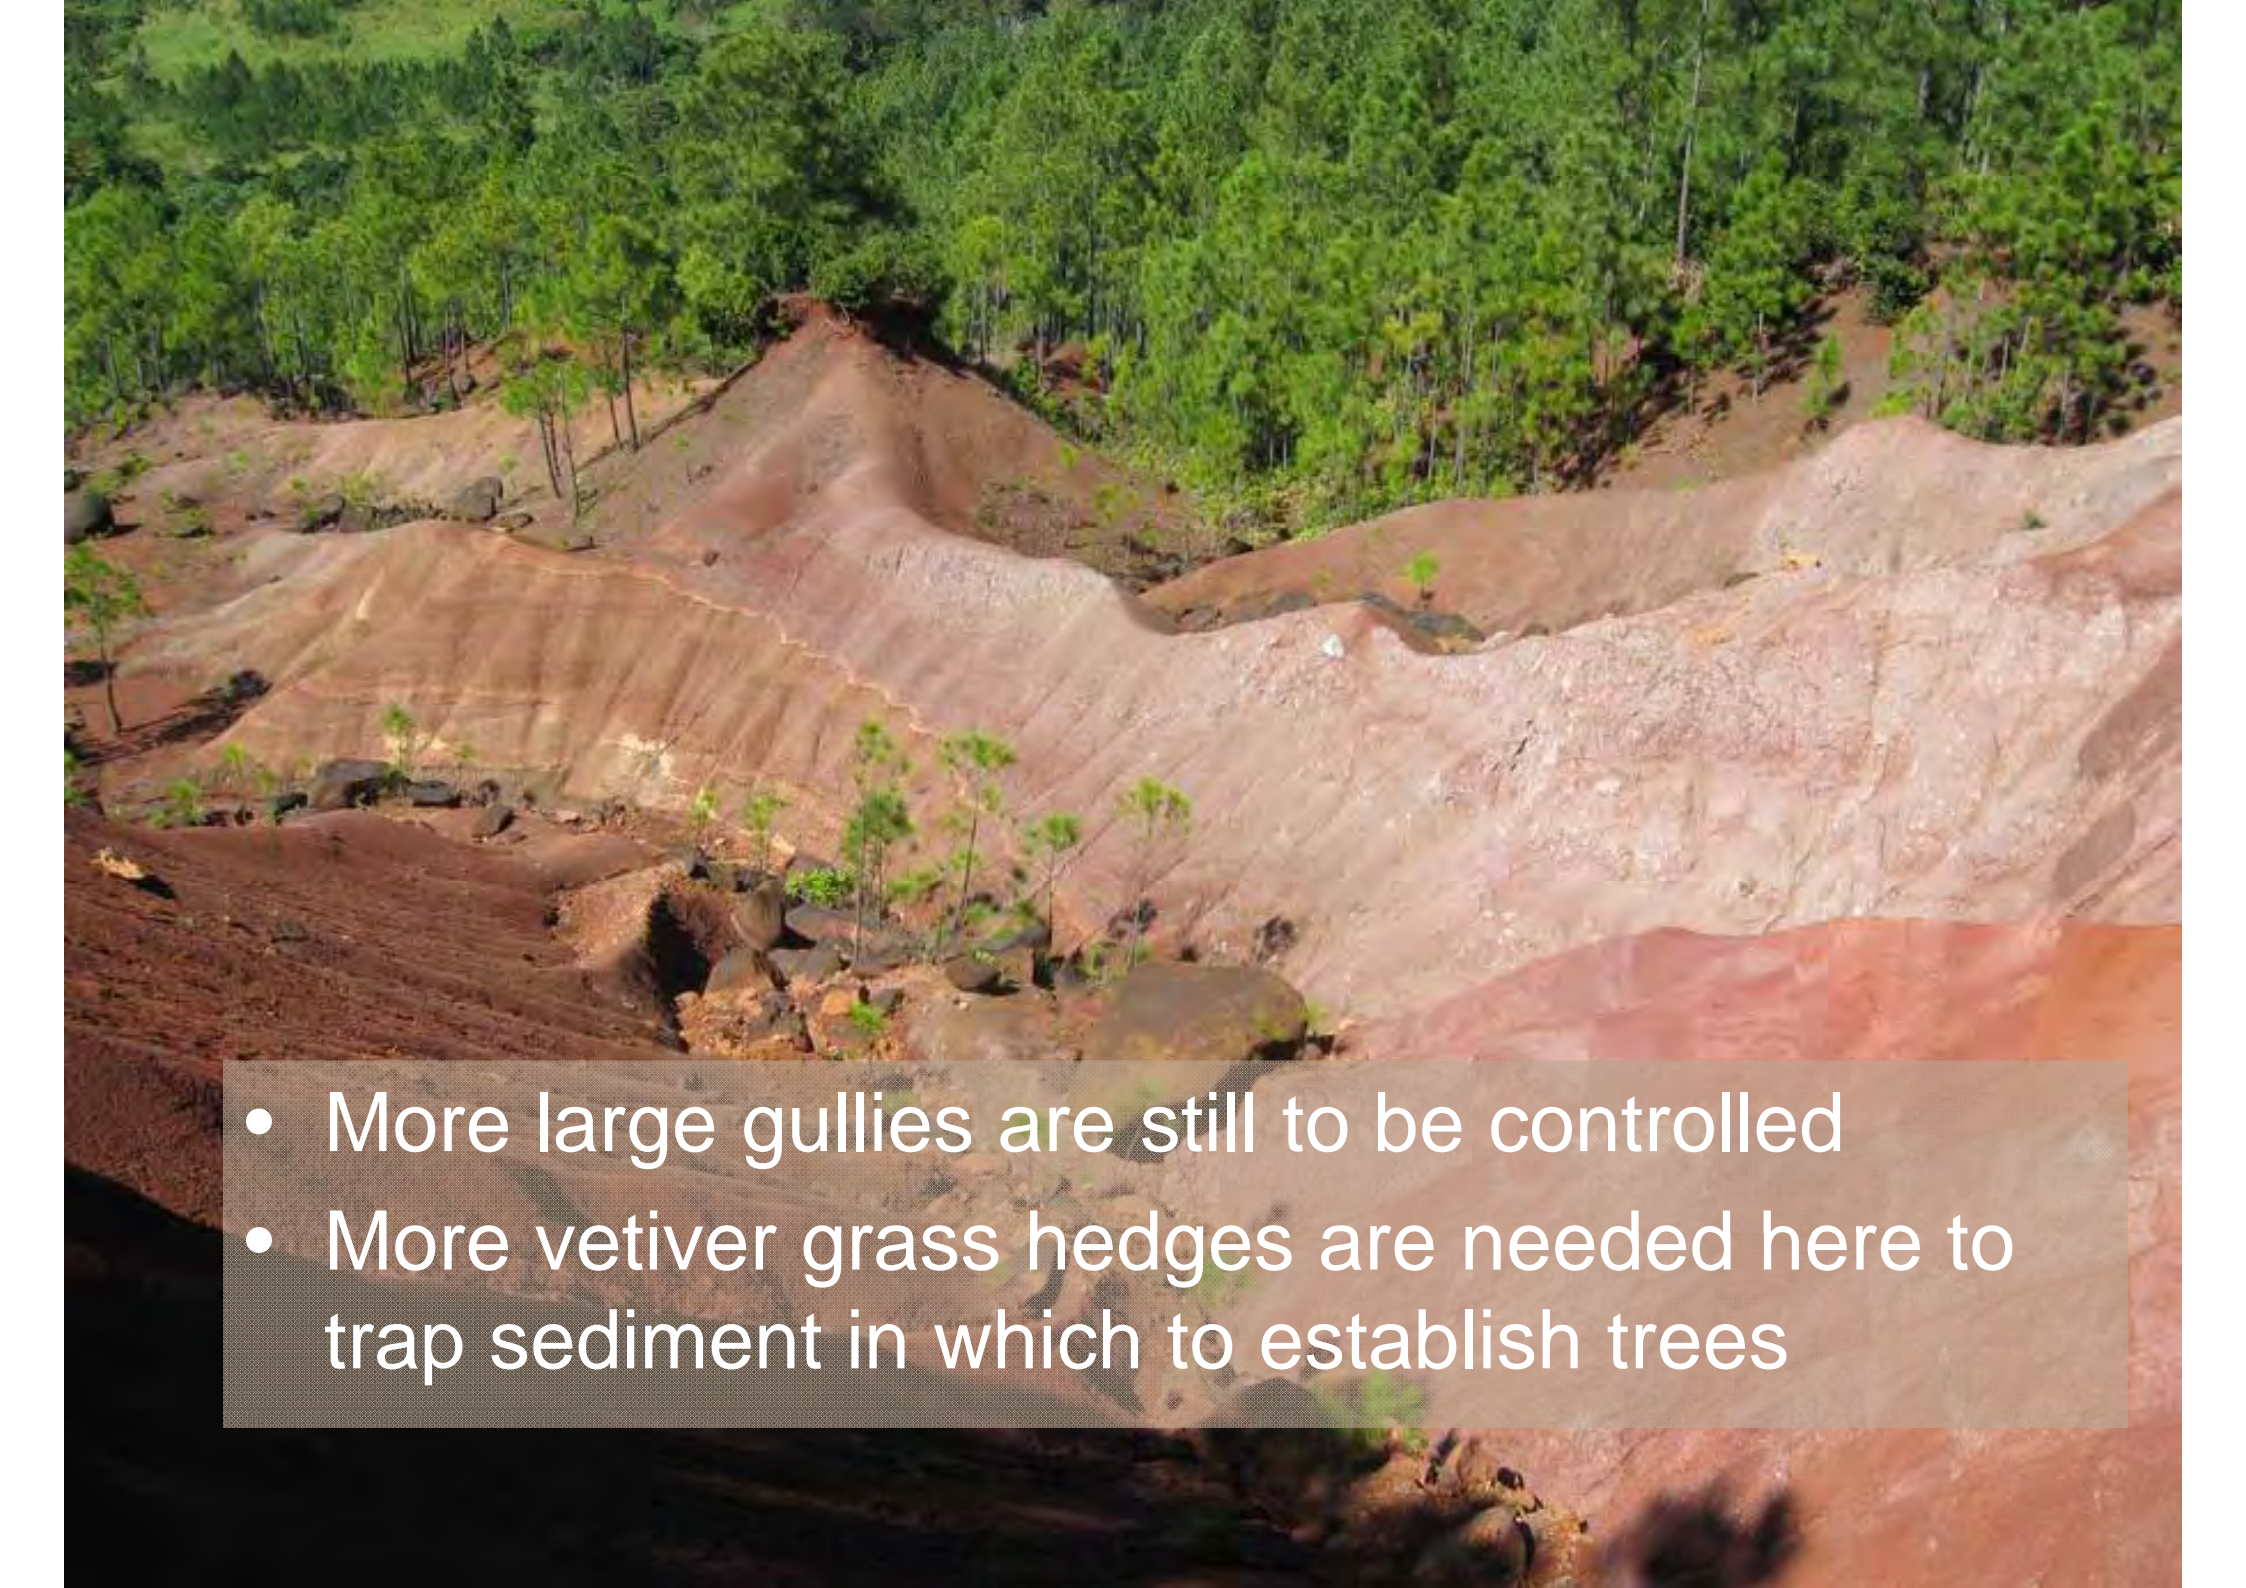
- More large gullies are still to be controlled
 - More vetiver grass hedges are needed here to trap sediment in which to establish trees
