EXPERIENCES IN THE STABILIZATION OF A LARGE GULLY AT SPRINGS AREA PROPERTY FROM AGUA MINALBA VENEZUELA.

Keywords: gully, bioengineering, erosion, embankments.

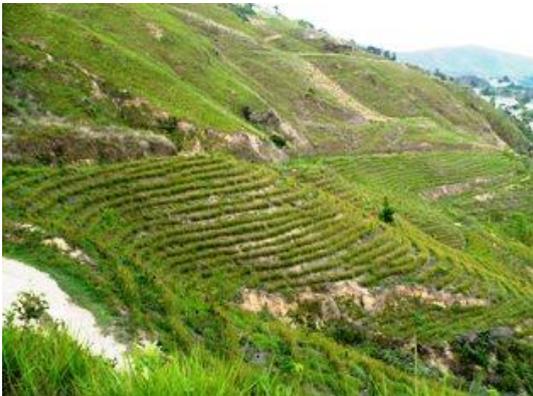
Photo 1: Vetiver on the site of AGUA MINALBA

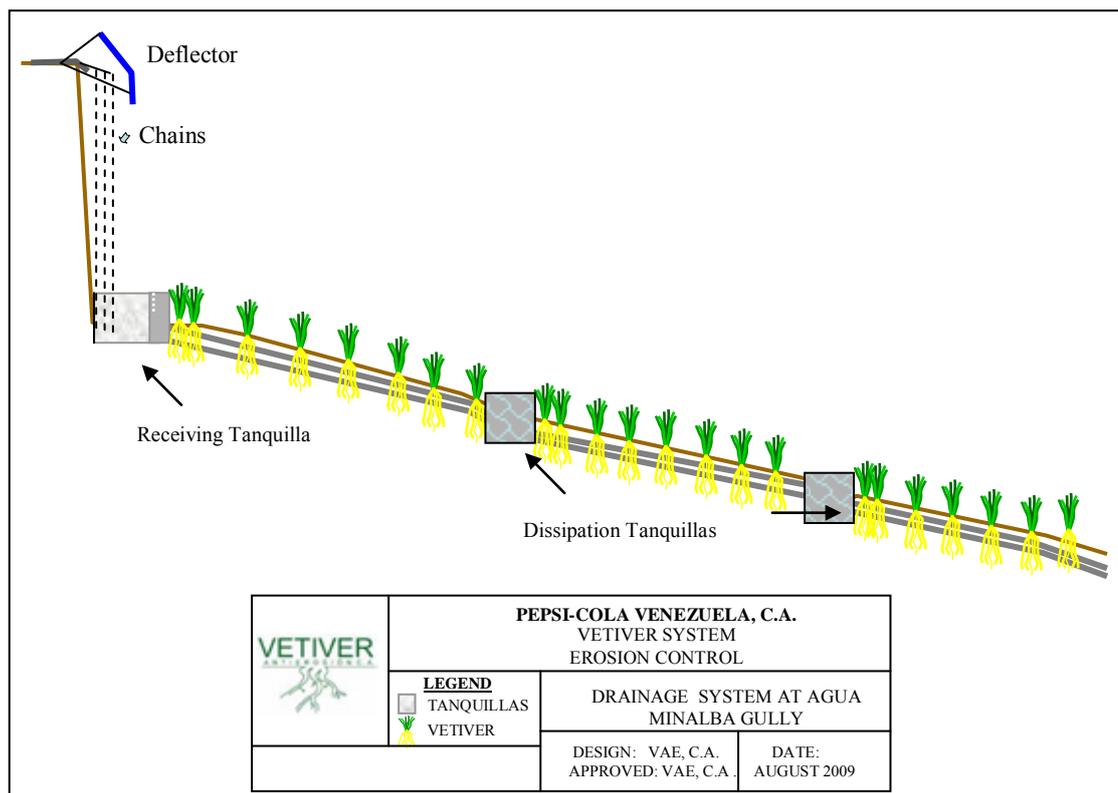
The original project included a baffle placed over the slab from the upper channel where a battery of steel chains 1 / 2 "will dissipate waterfall forces. This phase was never concluded because an earthquake occurred during the construction phase and the channel and slab collapsed. The new scenario led to the construction of a channel of corrugated galvanized pipes delivering water into the receiving tanquilla.

Figure 2: Original design

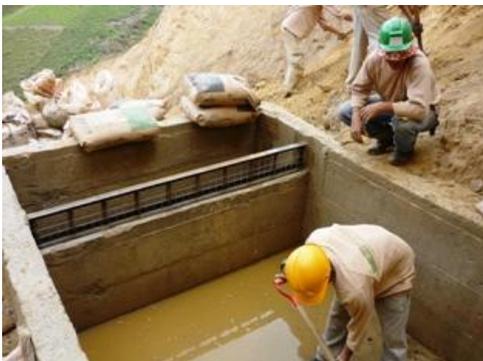
The receiving tanquillas has a grid to prevent objects larger than the diameter of the hoses to pass into and obstruct them. (Photos 7 and 8).

Photo 7 Receiving Tanquilla

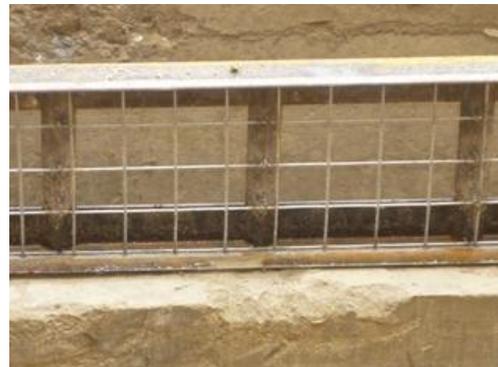
Photo 8 Detail Grid

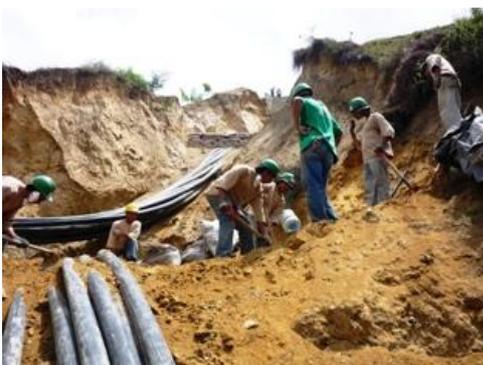
The tanquillas are connected to a battery of 16 4-inch HDPE pipes; they lead the water to the disposal site (Photos 9 and 10).

Photo 9 Piping system

Given the experience of the difficulties taken for installation of the hoses and the collapse of these system we recommend:

- Repair the drainage system.
- Use rigid pipe with a high roughness index, the more effective diameter and length not exceeding 6 meters.
- Replace the 16 lines HDPE Hose 4 "by 2 rigid pipe 16."
- Set the final drainage system, with both dissipation tanquillas built in reinforced concrete.

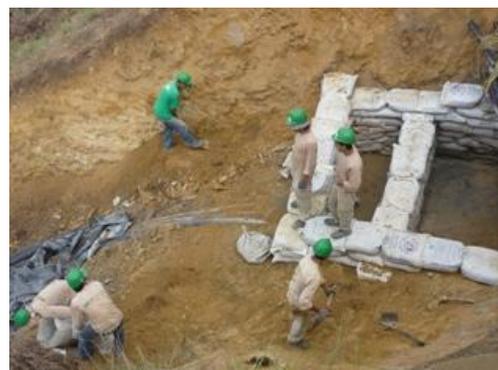
Photo 10 Transition Tanquilla and hoses

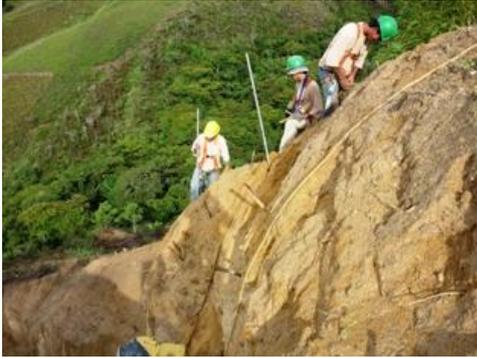
Once the previous phase of work conclude, it was started the reshaping of all sides of the slopes of the gully in order to eliminate the sections of soil surface that had fractures and / or irregularities in its geometry. To this end, workers tied with a nylon rope harness and anchor them to points well assured (Photos 11 and 12). Then, with appropriate tools began to work by sections from the upper east side, until they reach the lower part. Continued through the front (north side) and then applied the same methodology to the west side.

Photo 11 Start the reprofiling

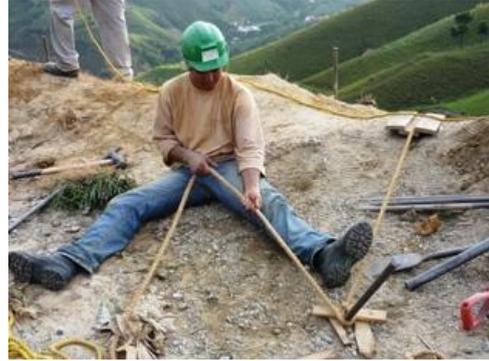
Photo 12 Securing the fall of a worker

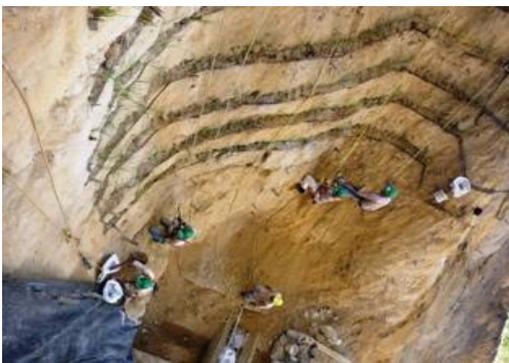
The work was executed planting horizontal strips starting from the top of the walls (Photo 13). In the first instance, it is made a little dig at each planting point (Luque et al, 2006), there was placed a portion of diammonium phosphate, it is covered lightly and then placed a substrate consisting of a mixture of wood chips and horse manure, which was selected because the chip size did not allow their passage through the mesh grids. 9 plants / m were planted (Photo 14).

Photo 13 Planting in horizontal stripes

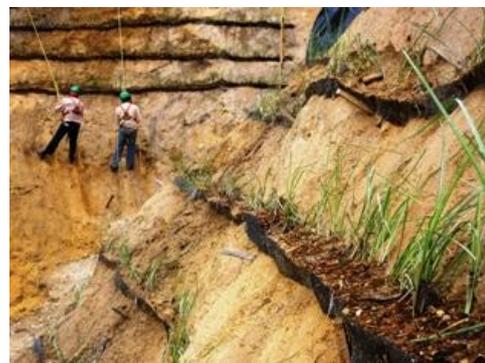
Photo 14: Retained by the mesh substrate

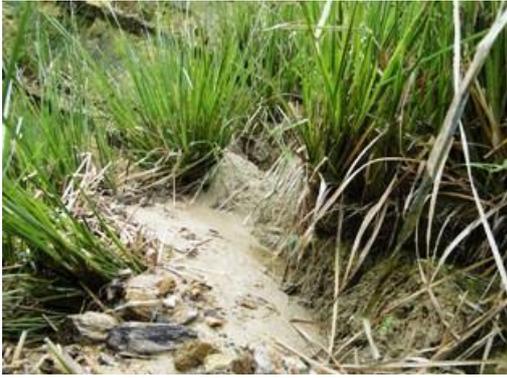
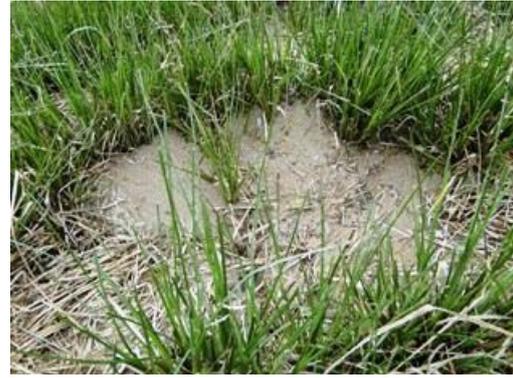
- After controlling the worm it was found that the attack caused no significant damage in the crop, except in some young plants.
- Between October 2010 and early May 2011, the VS work without erosion evidences in the gully, on the contrary, trapped sediment was found behind the barriers. Vetiver handled well, both the water flows in the microbasin, as well as that entered through the external drainage system. During that time, sediments were observed trapped in bed (photos 21, 22).

Photos 21 and 22 sediment trapped by the barriers placed in the bed of the gully (May 2010)

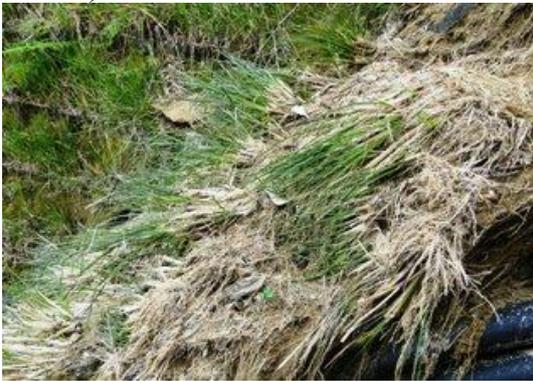
- An important fact to note is that the abundant presence of vetiver roots in the gully did not allow the collapse of the bed. It was observed some of them anchored within schists, which supports research by Hengchaovanich, on the ability to penetrate rock (photos 28 and 29)

Foto 30 Abundance of roots

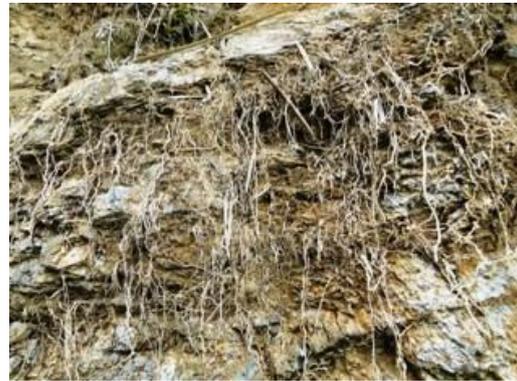
Foto 31 Roots anchored in shale
