Pearl River Embankment Protection Nansha District Section Guangzhou City, China

SUMMARY

Project name: Embankment protection of Pearl River in Nansha District, Guangzhou

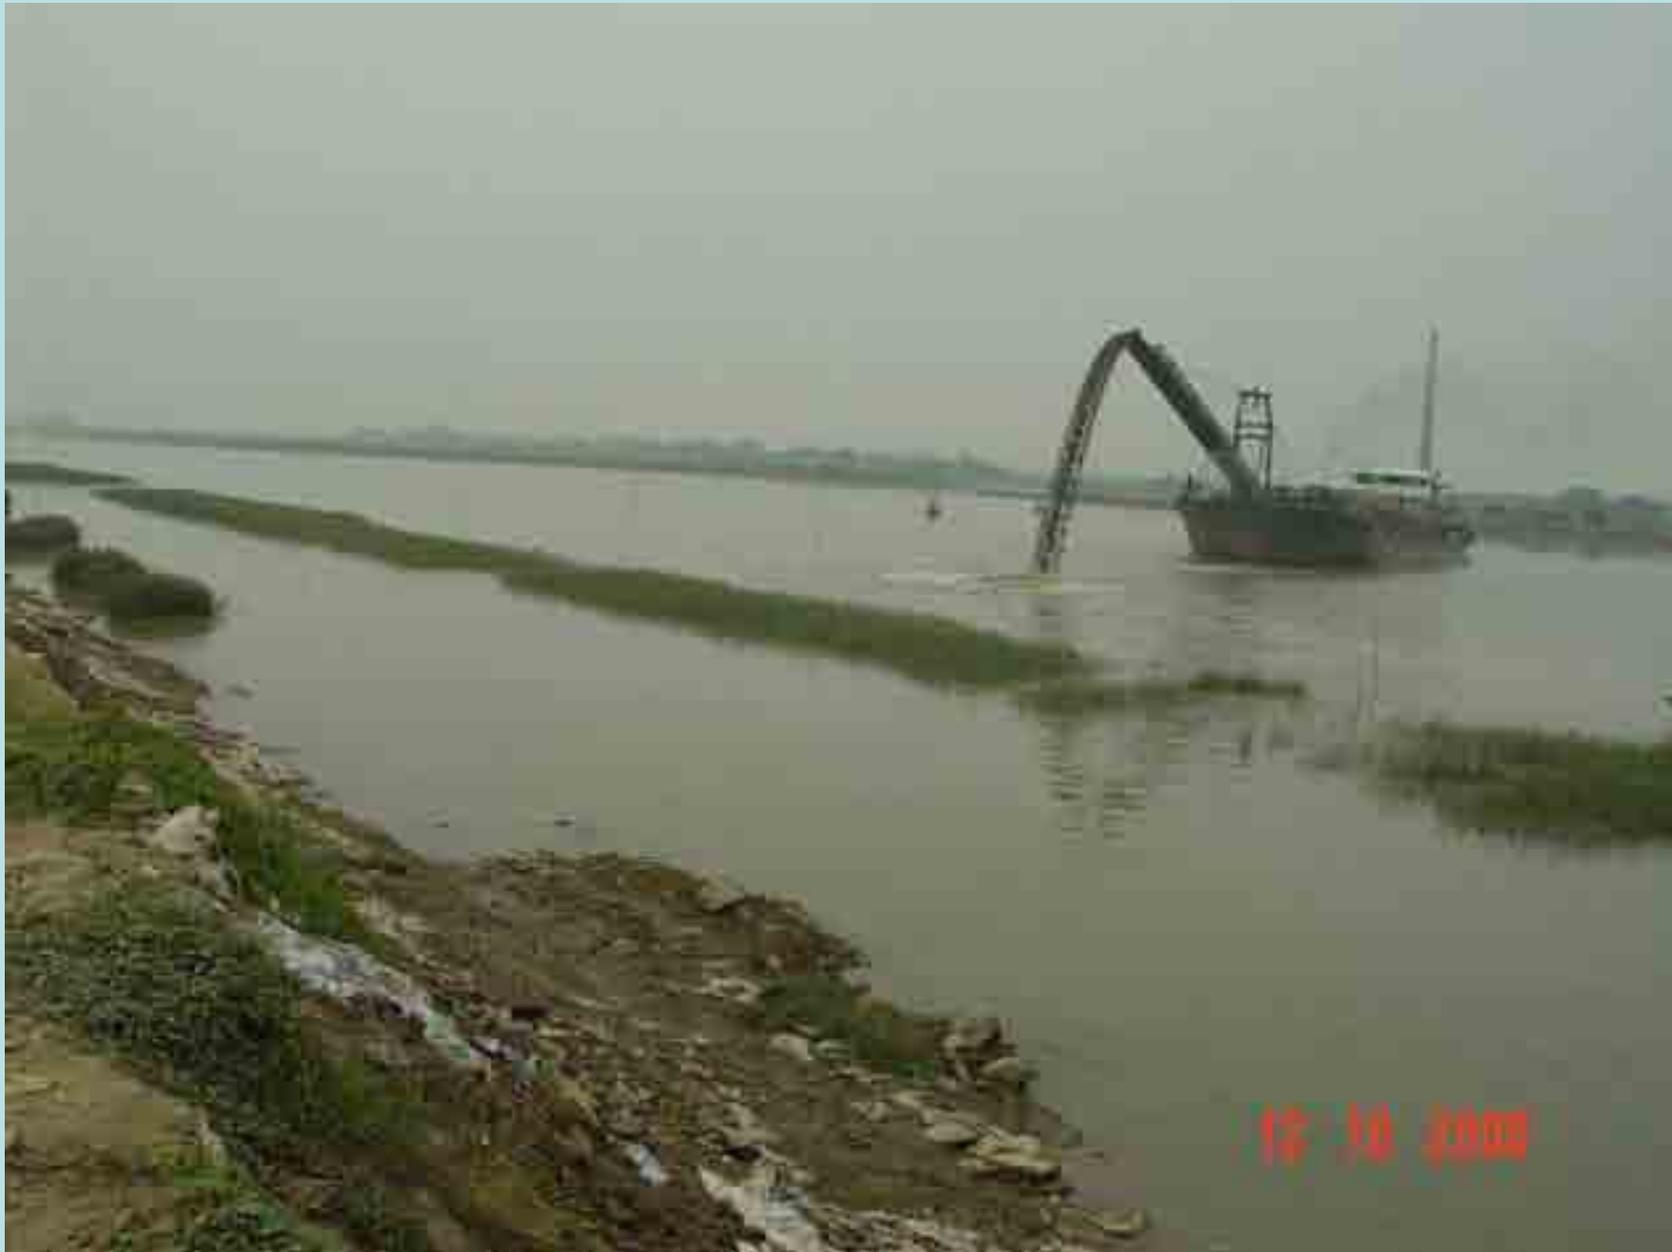
The original embankment was badly eroded, dirty and poorly resistant to floods and waves

The original embankment was quite eroded, dirty and poorly resistant to floods and waves. The construction procedure was as follows:

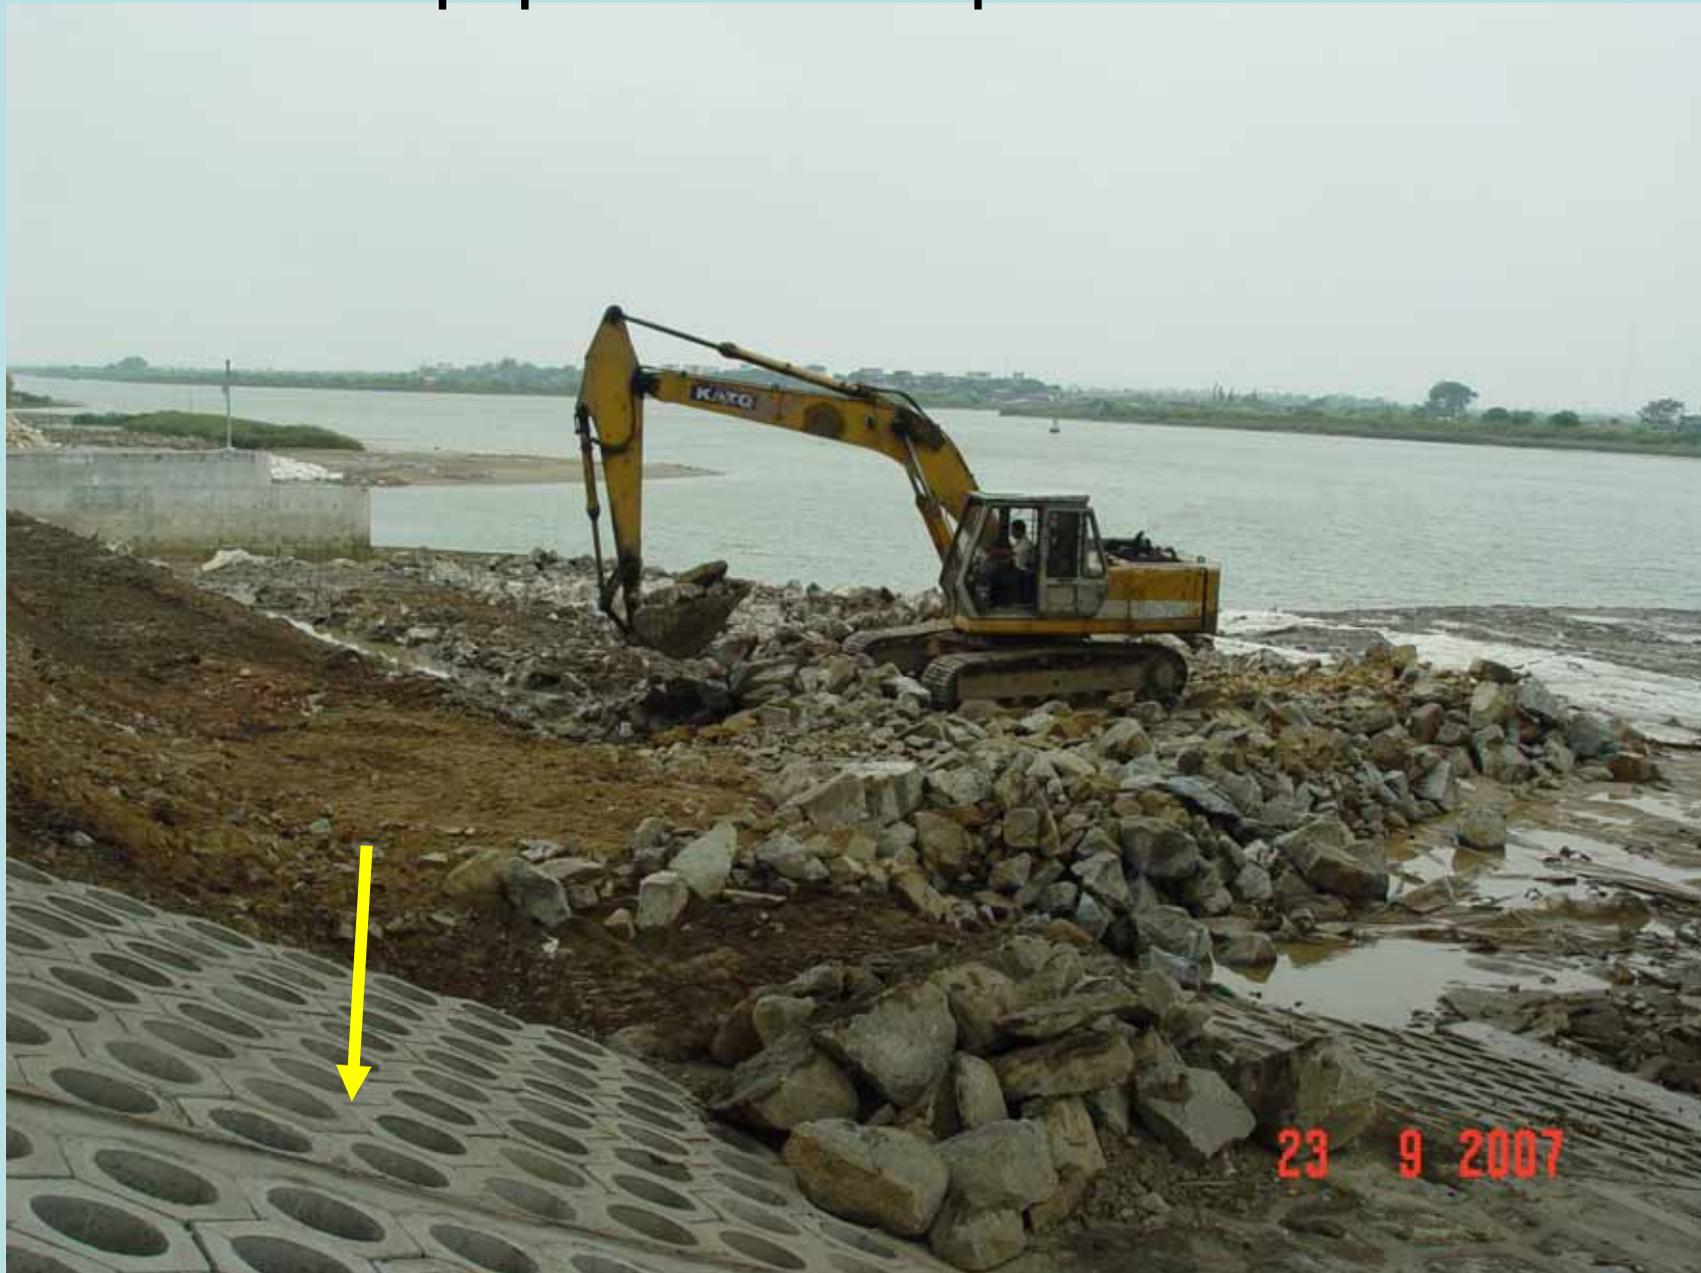
First the slope of the embankment was reshaped, the mud flat covered with riprap rock and the slope with hollow bricks

- First the slope of the embankment was reshaped and then divided into 2 sections with a large bench in the middle.**
- Then the bank was paved and hollow nut-shaped bricks were laid on the slopes. The diameter of brick's holes is 25 cm and two different depths were tested: 10 cm and 25 cm.**
- After the physical engineering was finished, the biological engineering began. The brick's holes were first filled with fertile soil then planted.**
- Since high tides came up twice a day, resulting in submergence in sea water the lower part of the bank; so the selected plants must have strong resistance to salt and flood. (Continued)**

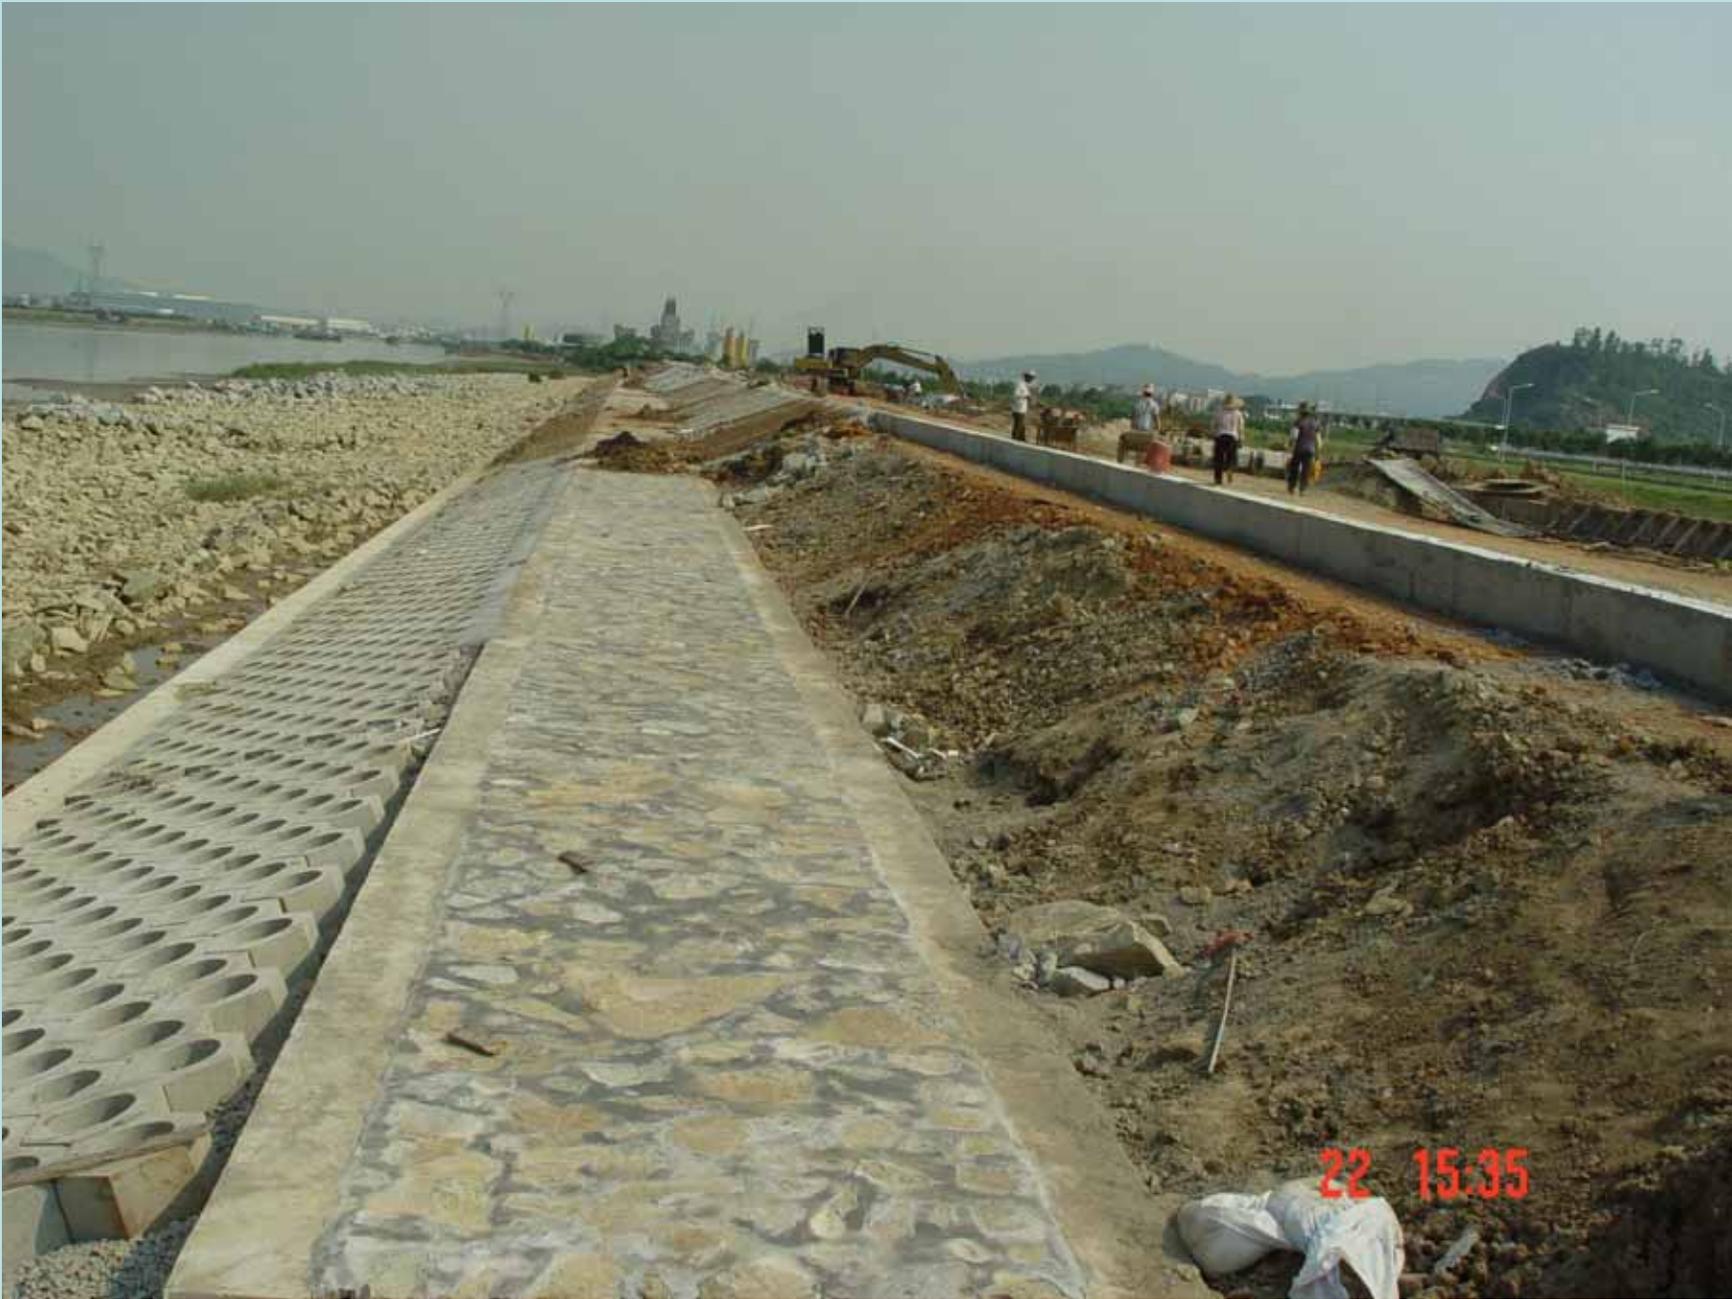
The slope was separated into 2 sections with a large bench in the middle

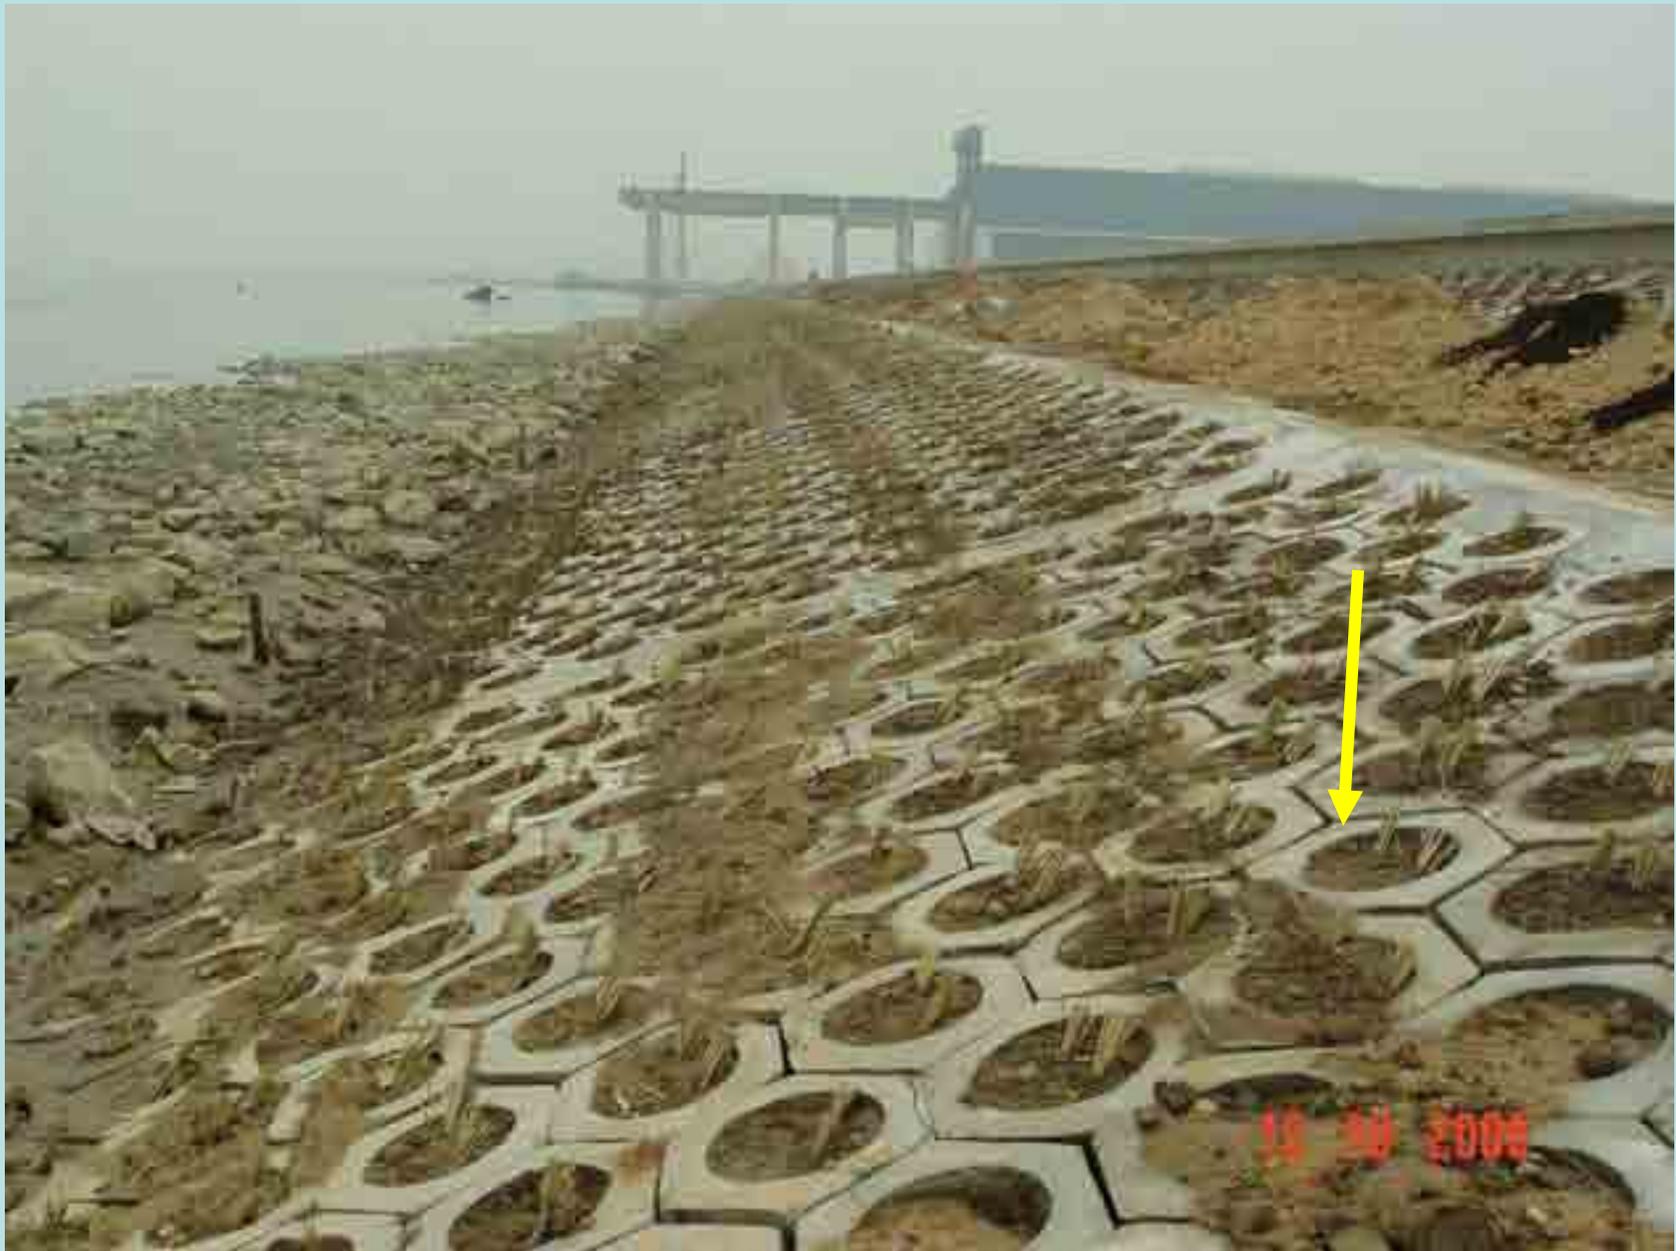
**Both sections were paved with hollow bricks with 25 cm diameter holes.
One set is 10 cm deep and the other 25 cm**

- However, plants grown in the brick with 10 cm deep brick holes grew much poorer. This is because the soil layer is too thin, and plant roots could not penetrate through the dense layer under the bricks. Therefore they could not reach nutrients and moisture that plants need for their normal growth.

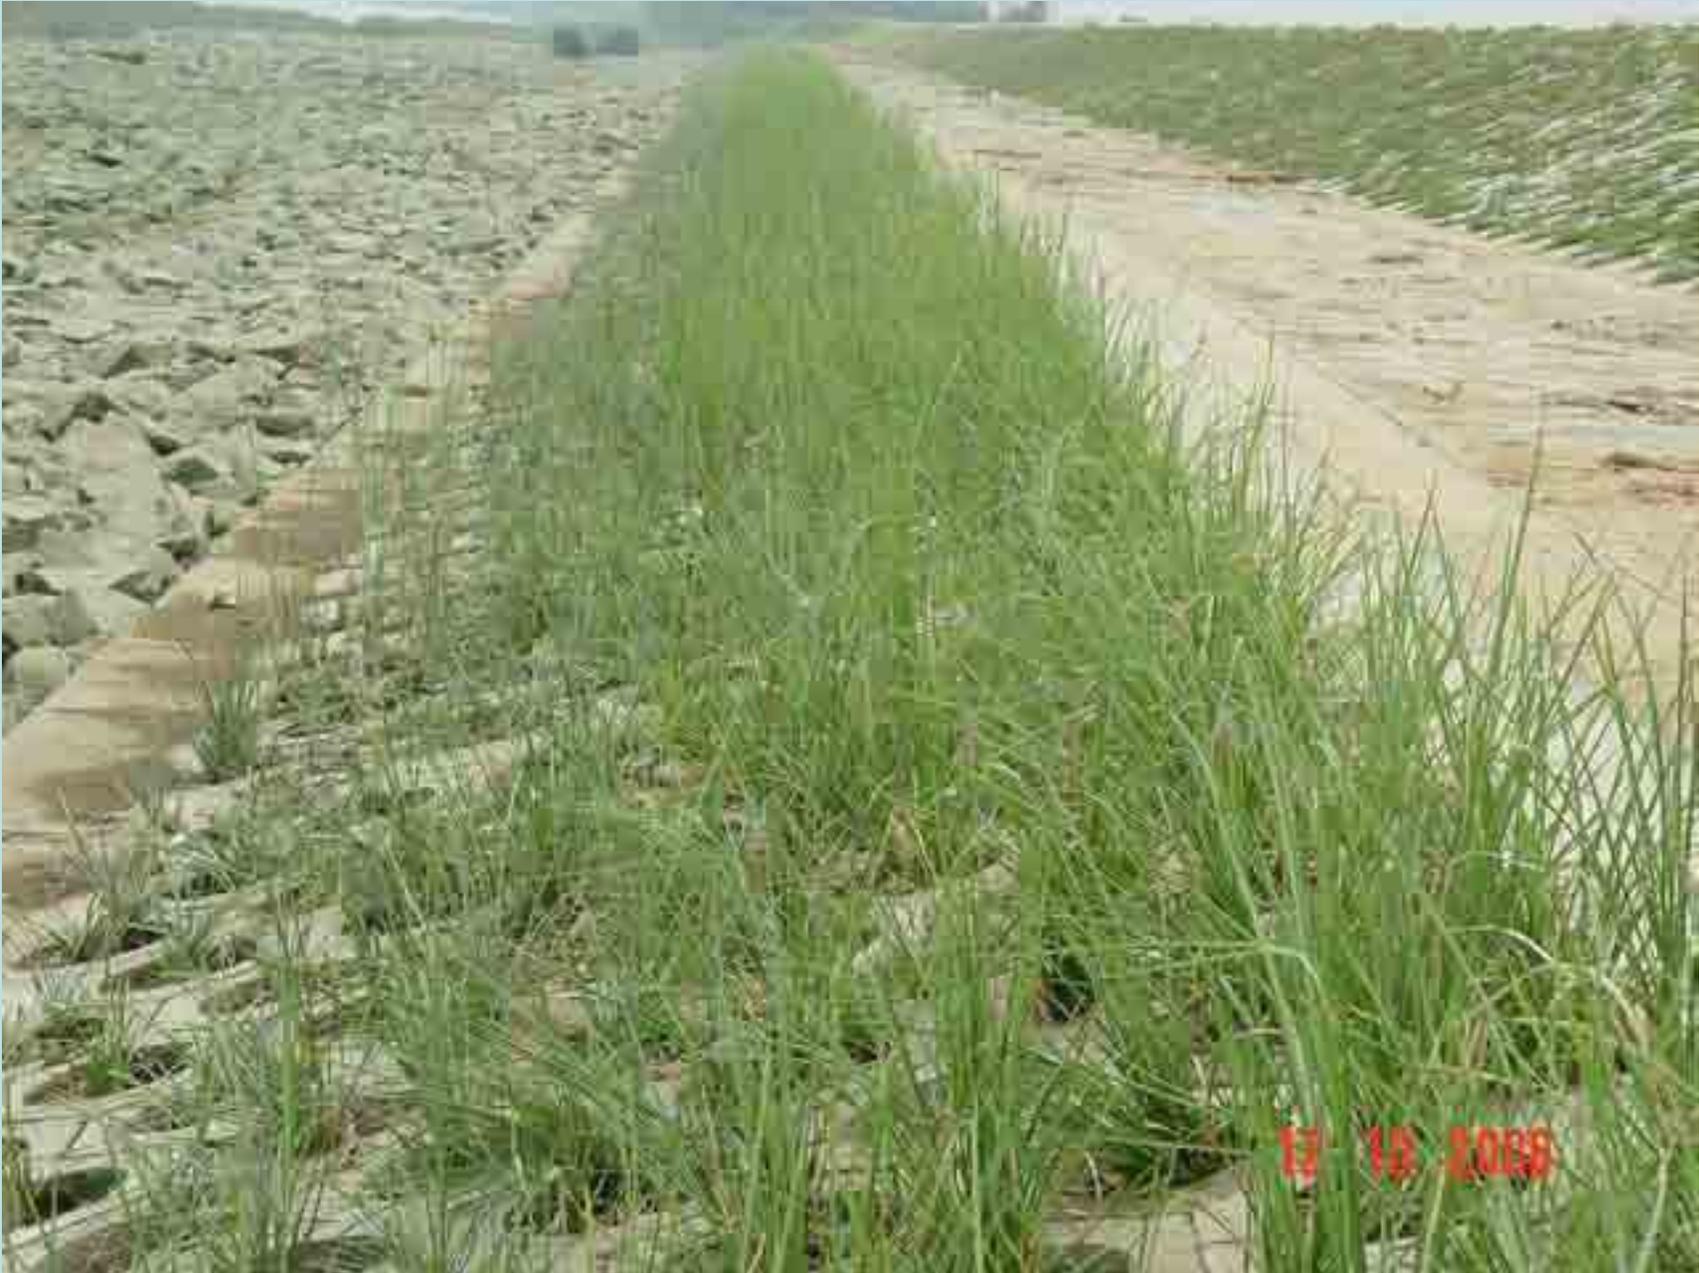
Vetiver grass 40 days after planting

The ecological benefits are quite obvious. The bank was covered with green color 40 days after vetiver was planted, and vetiver became very dense and exuberant one year later and Bahia grass also grew quite lush.

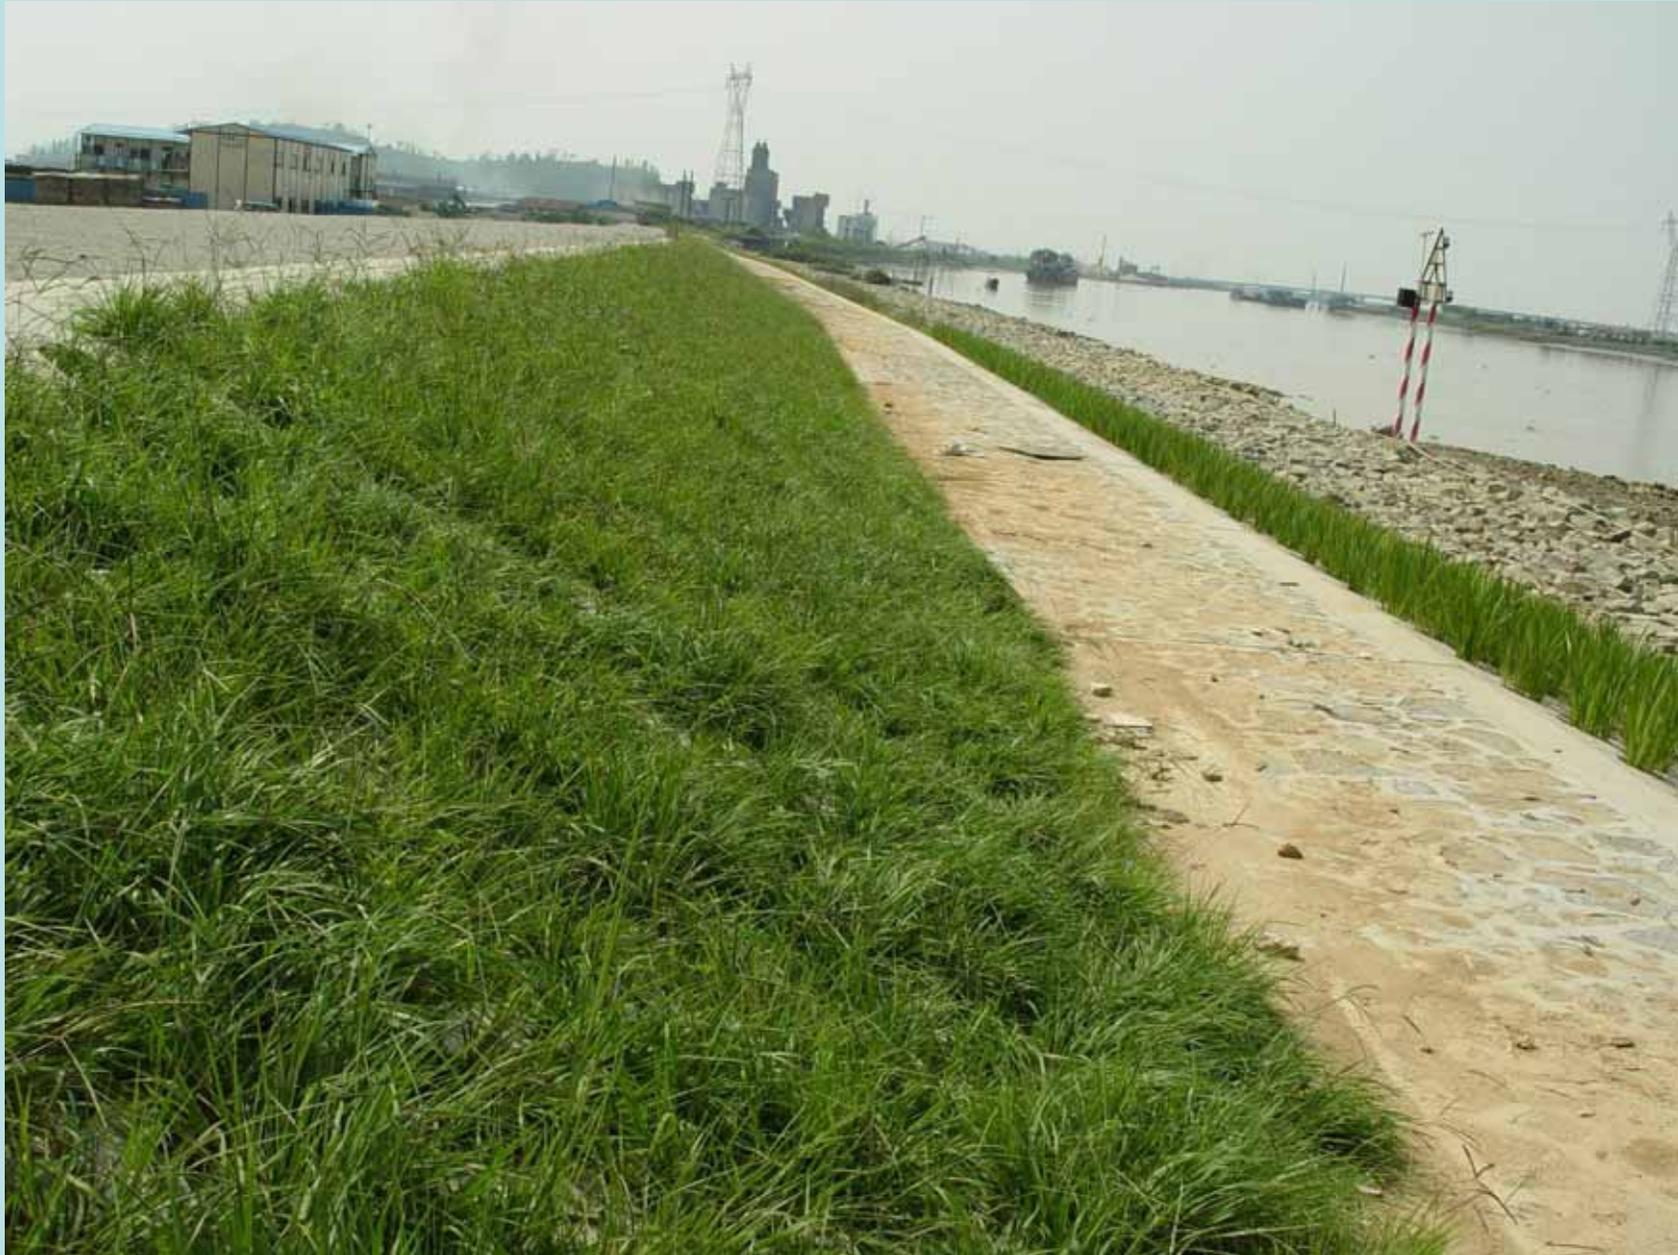
Bahia grass (*Paspalum notatum*) 40 days after planting

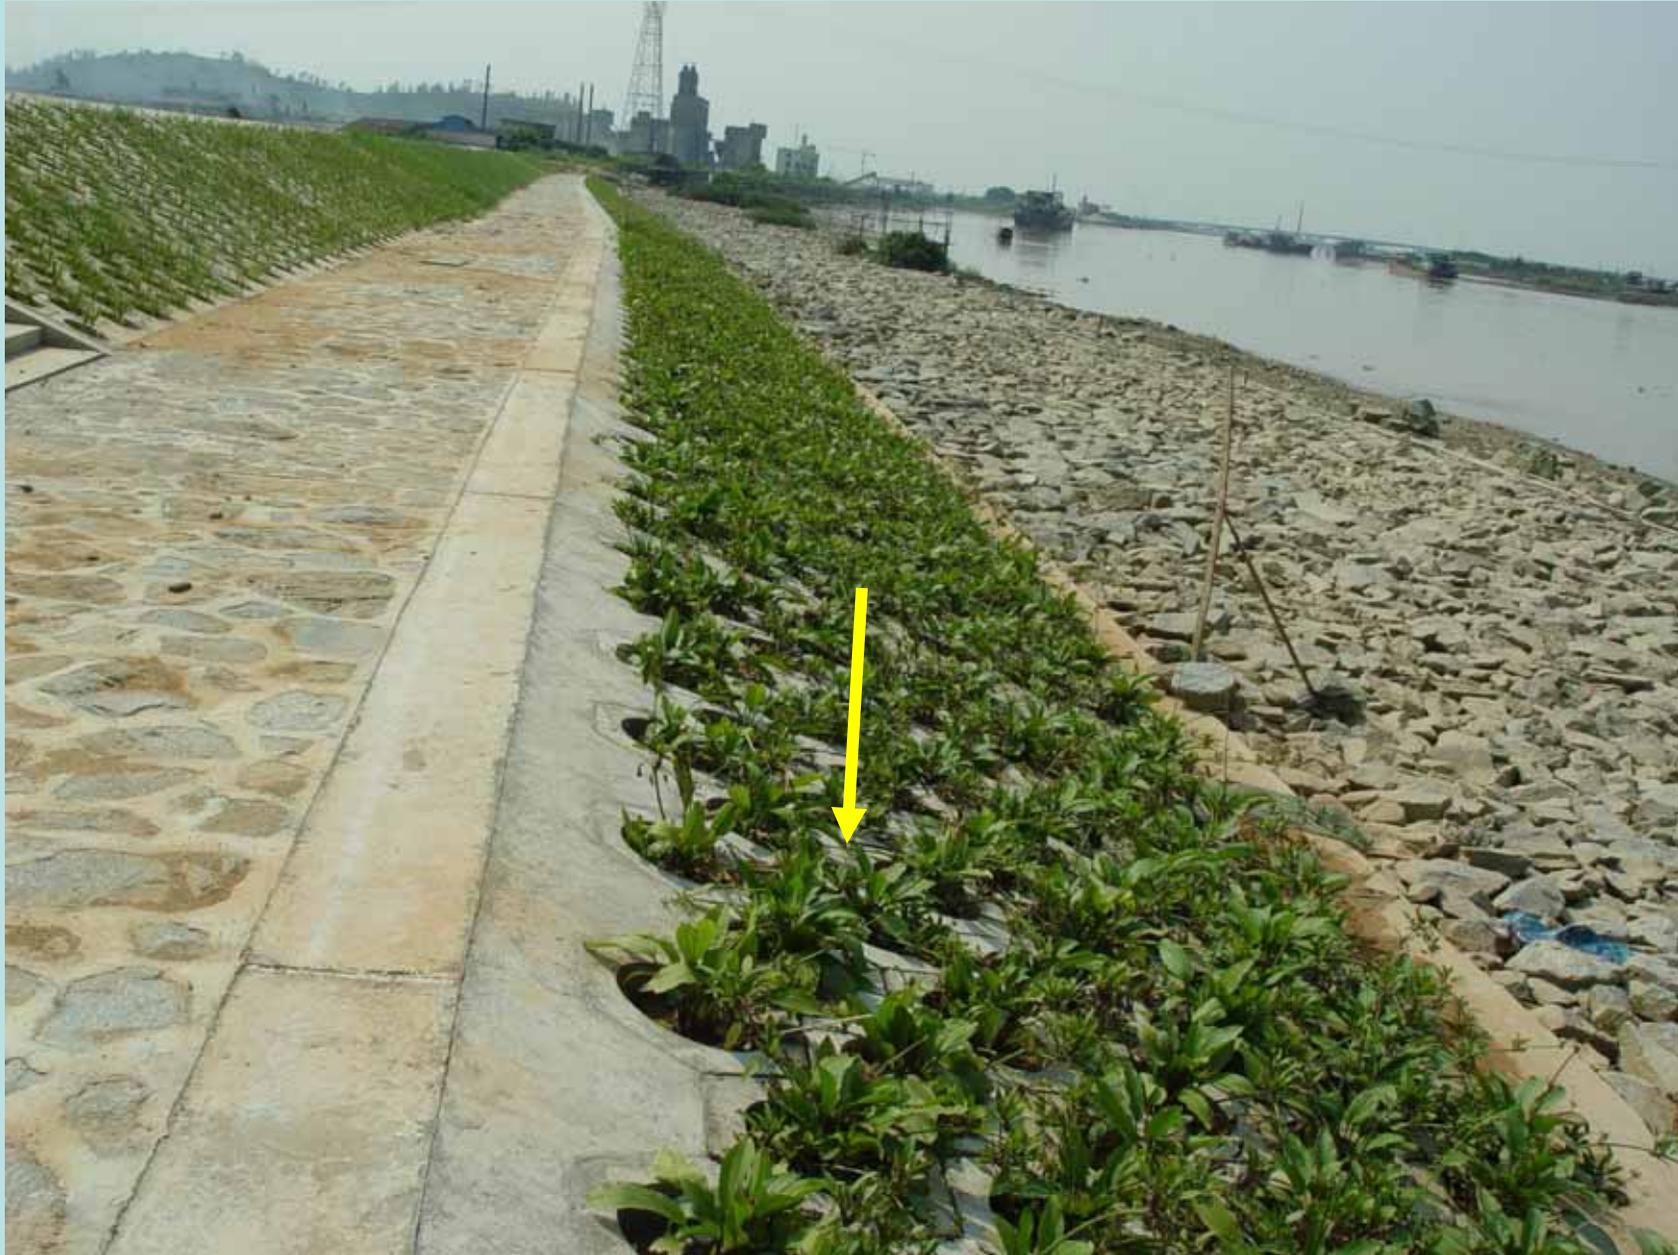
***Caldesia grandis* 40 days after planting**

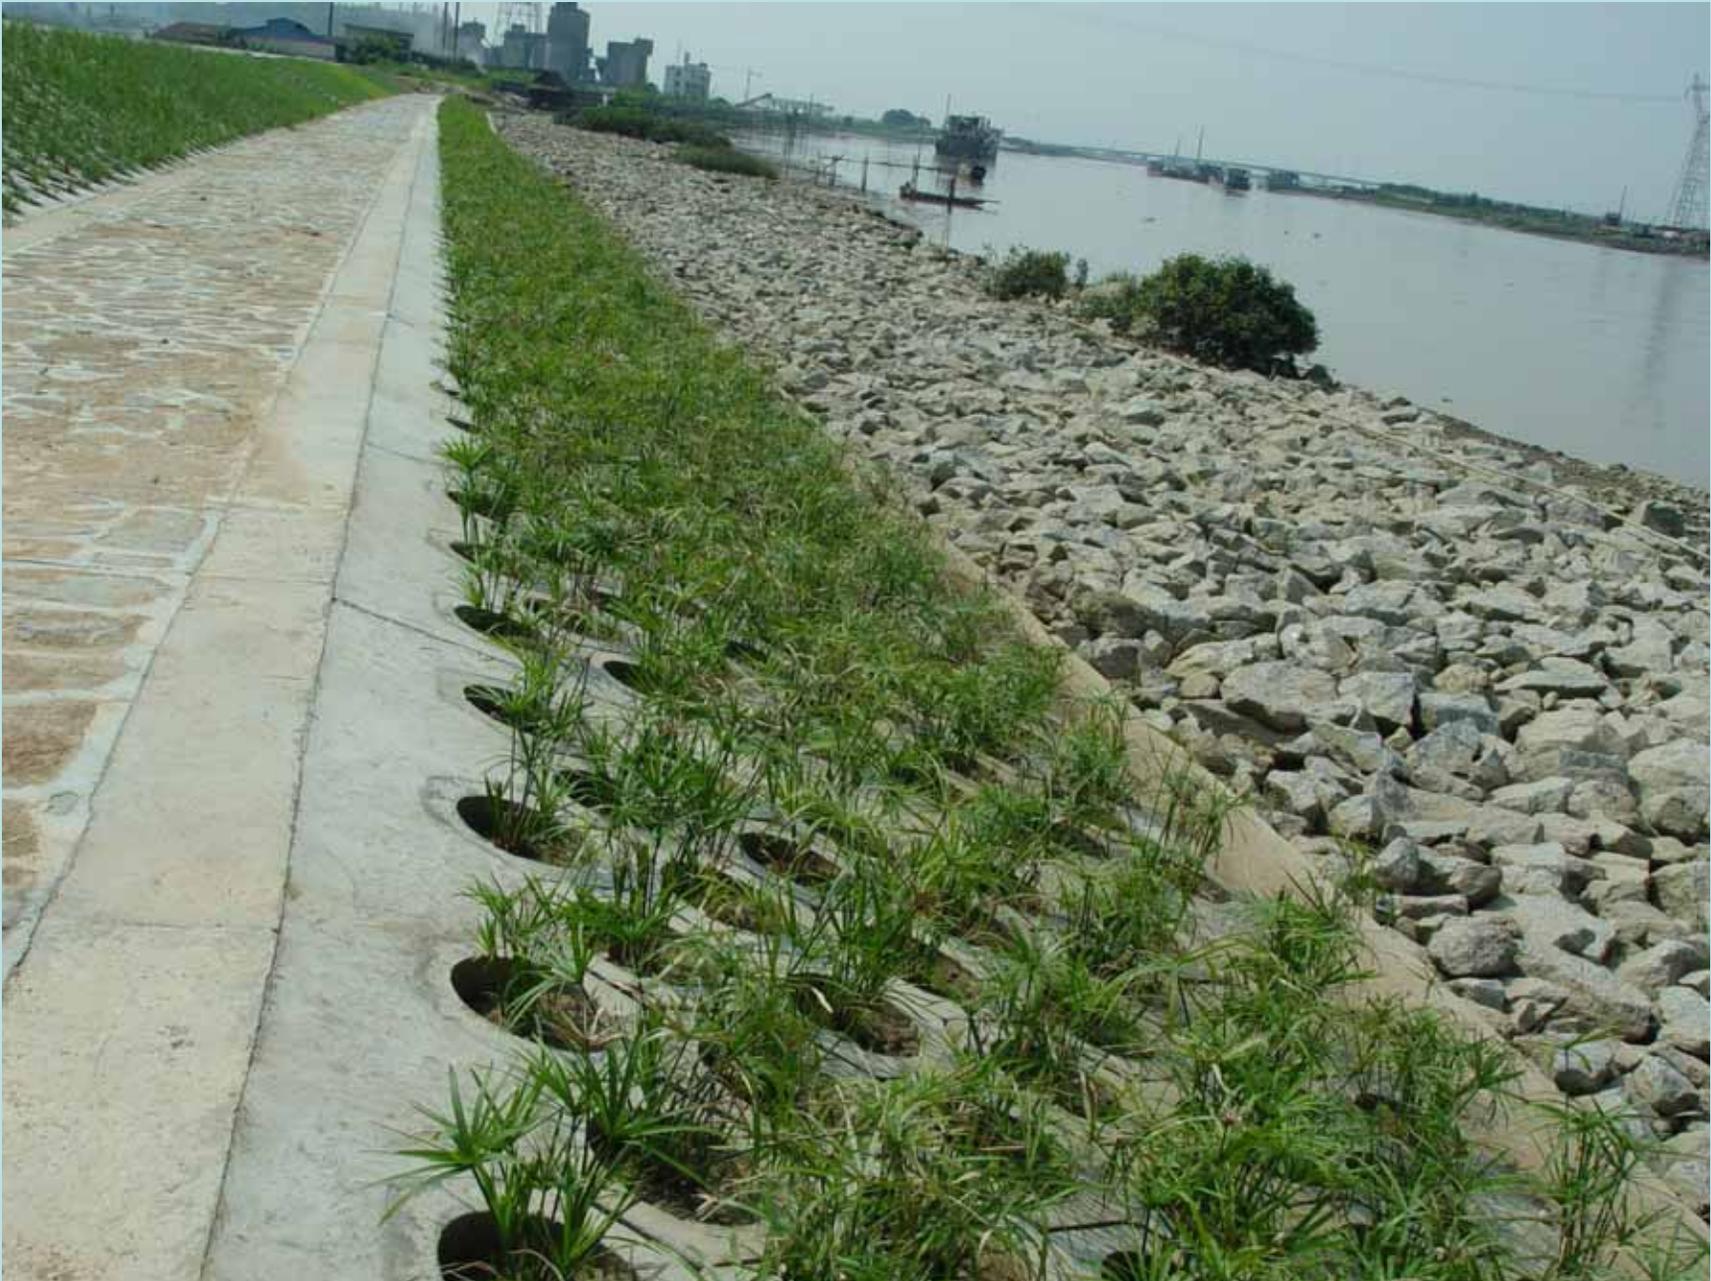
***Cyperus alternifolius* 40 days after planting**

- Two months after planting, the results showed that vetiver grass grew best on the lowest section of the slope, and *Cyperus alternifolius* second; bahia grass grew best on the higher part of the slope.

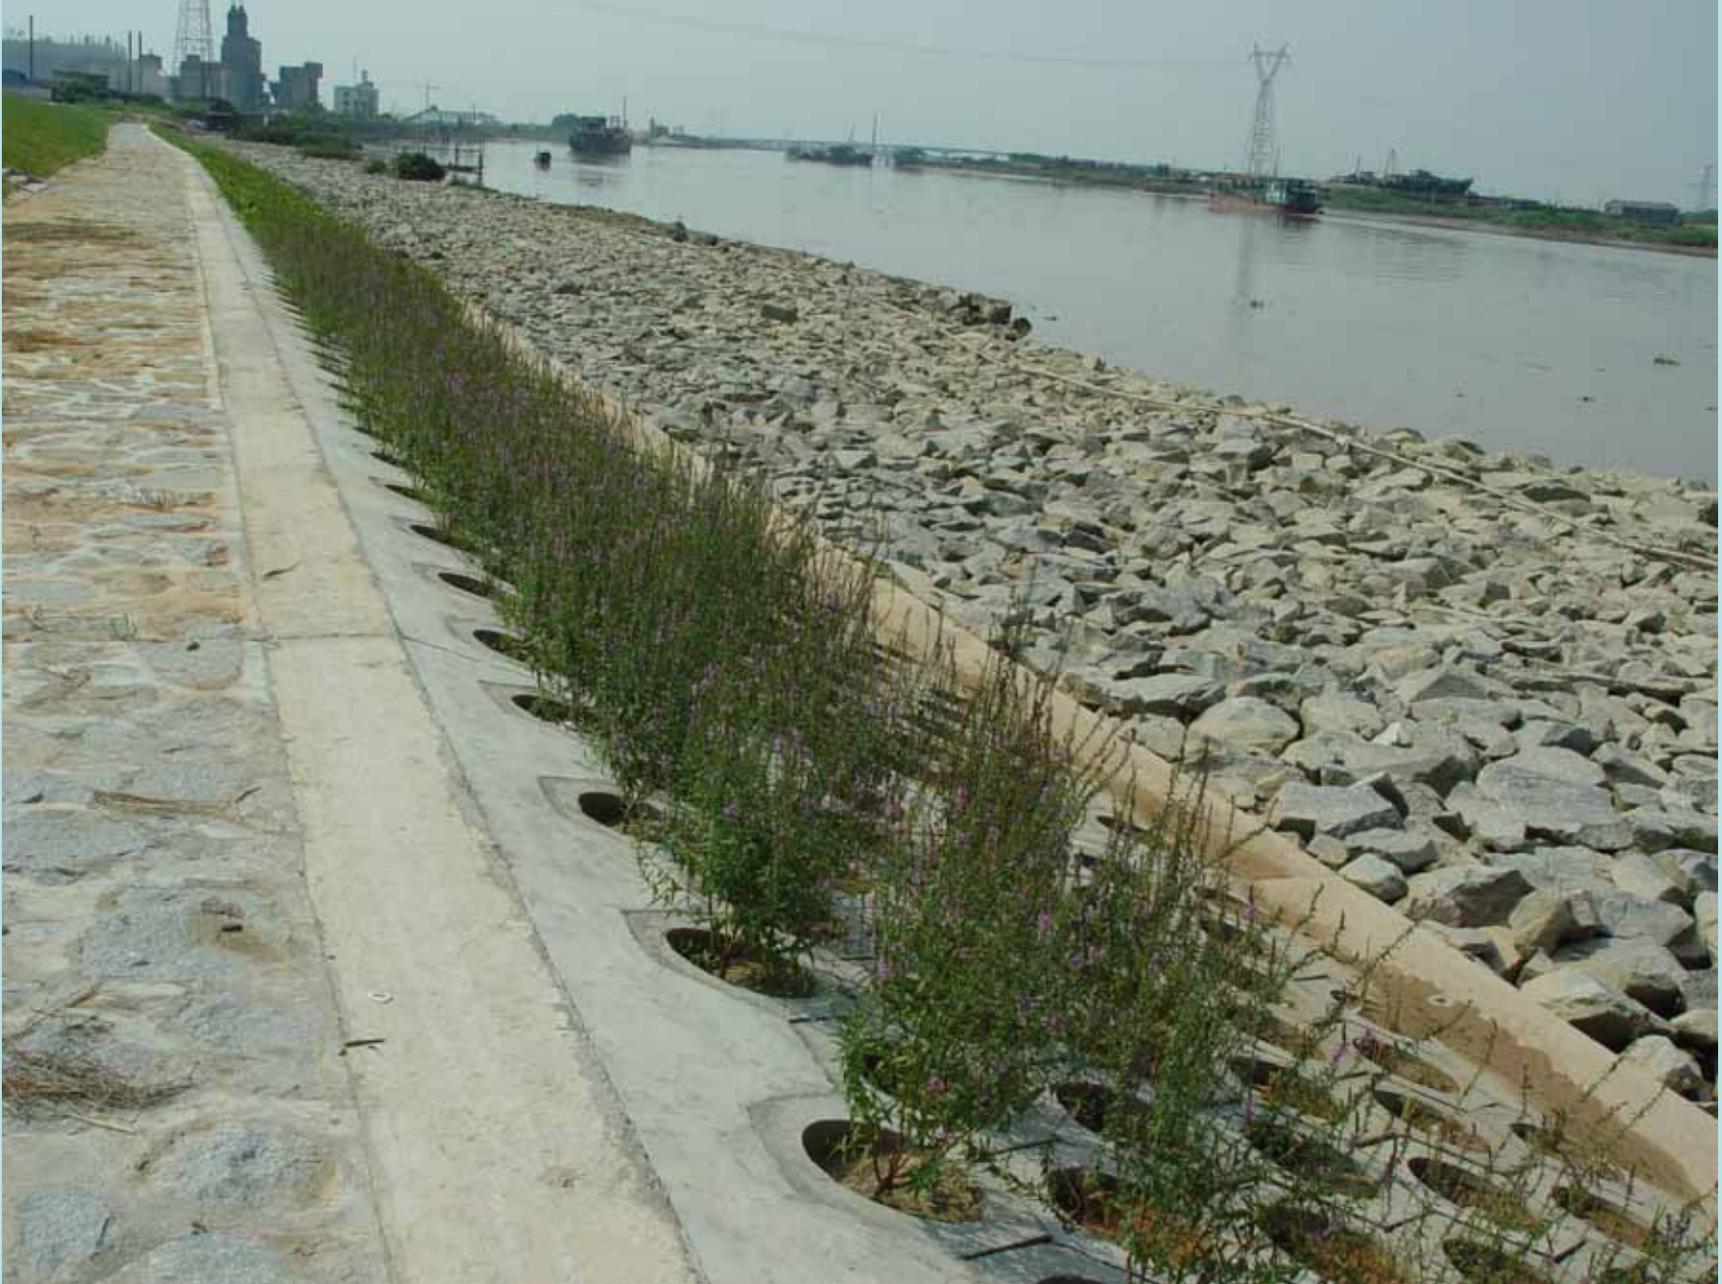
***Lythrum salicaria* 40 days after planting**

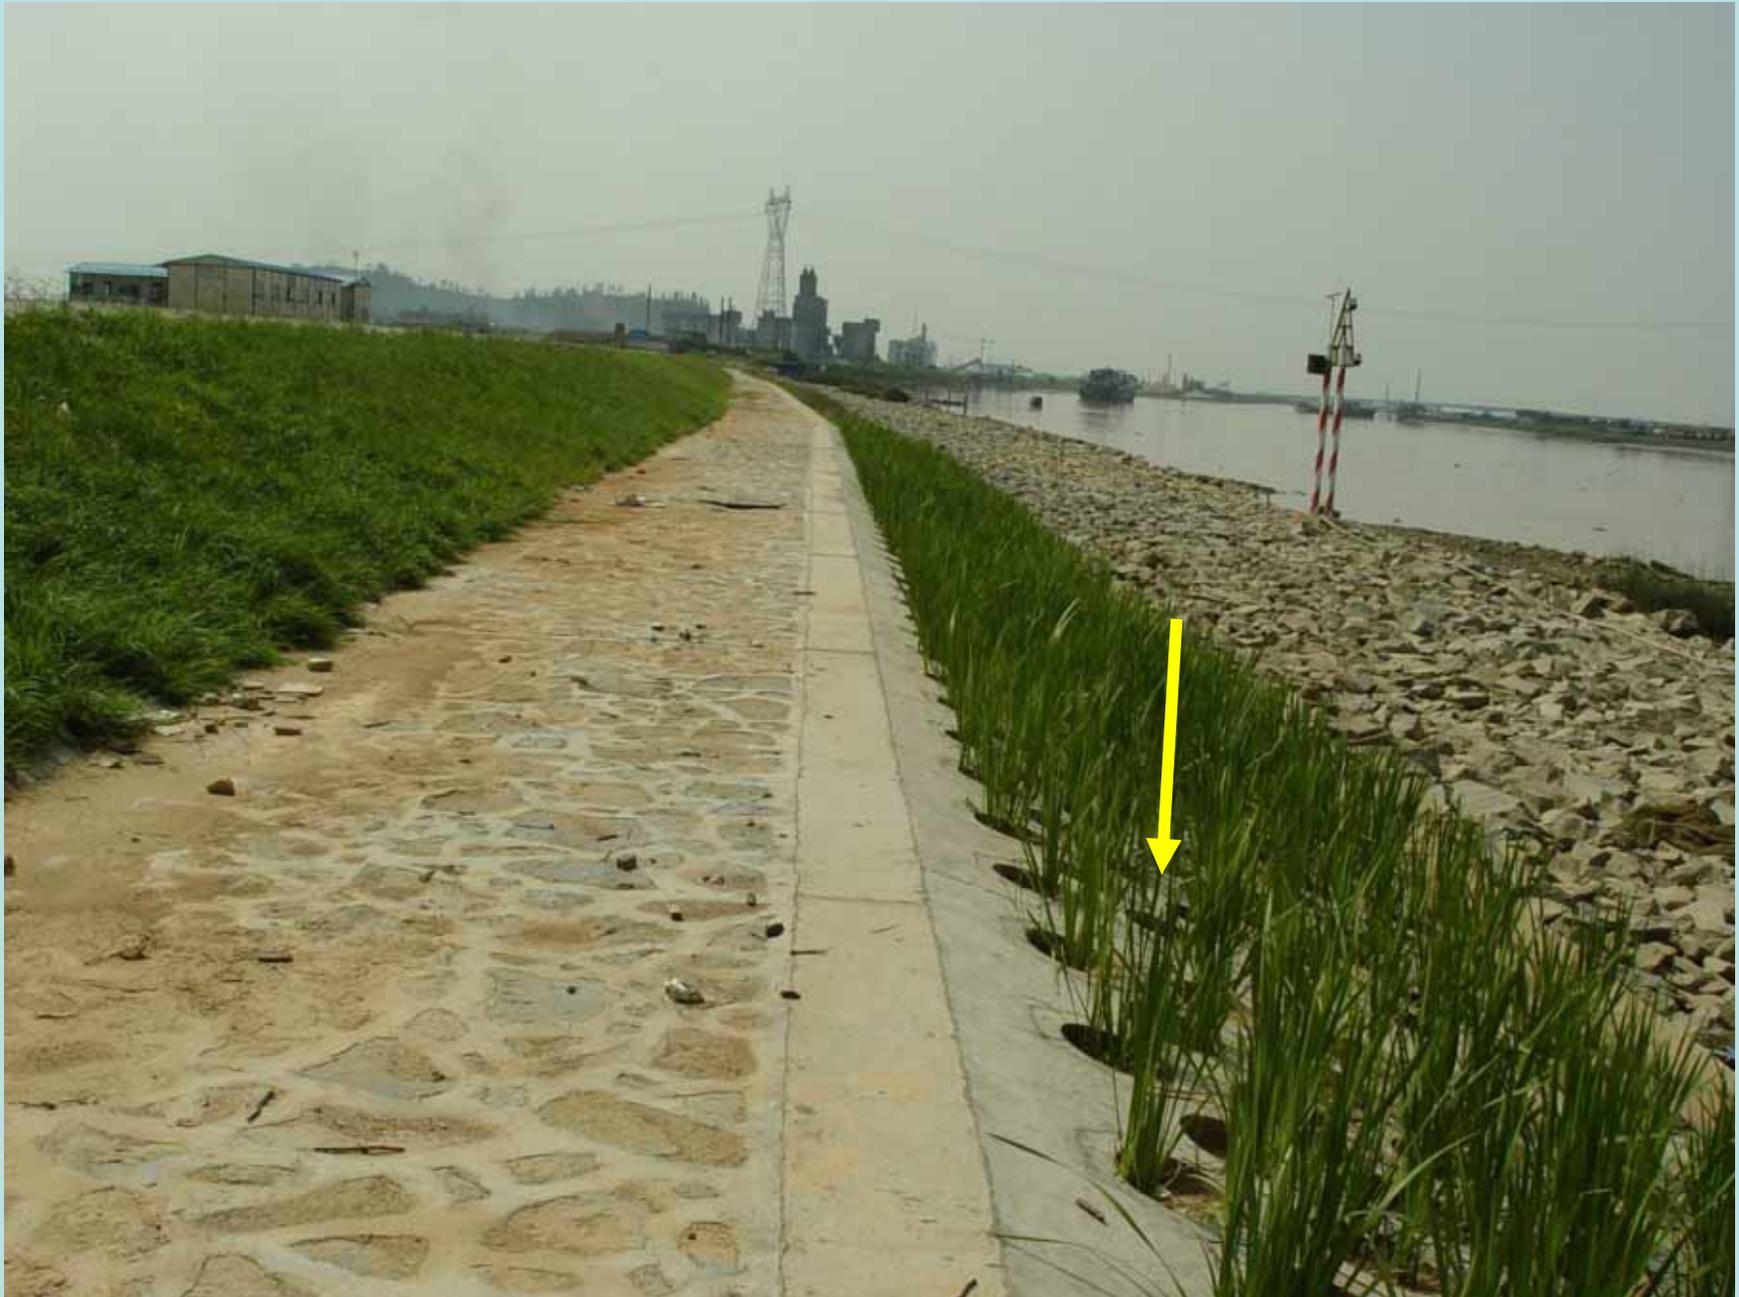
***Acorus calamus* 40 days after planting**
