Pearl River Embankment Protection Nansha District Section Guangzhou City, China

SUMMARY

Project name: Embankment protection of Pearl River in Nansha District, Guangzhou

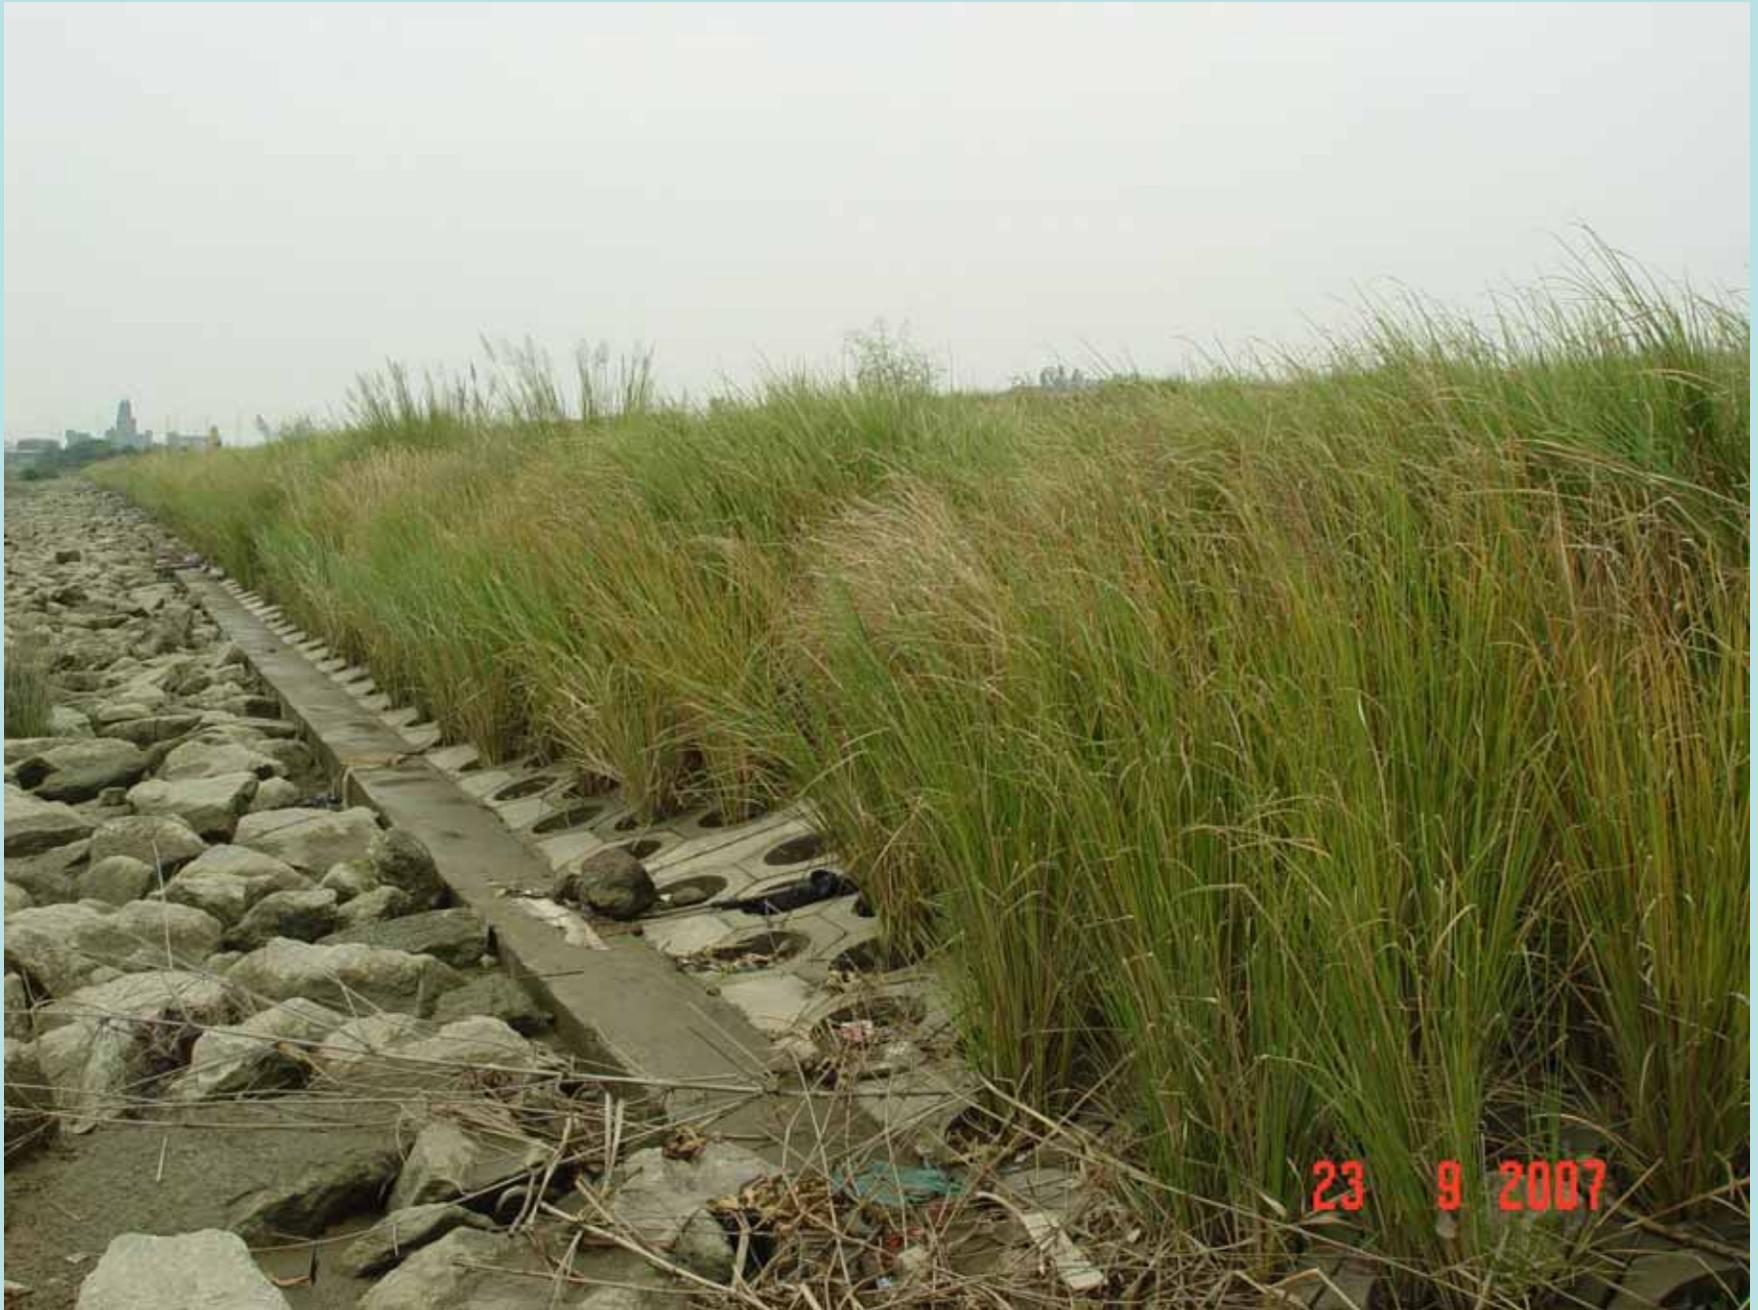
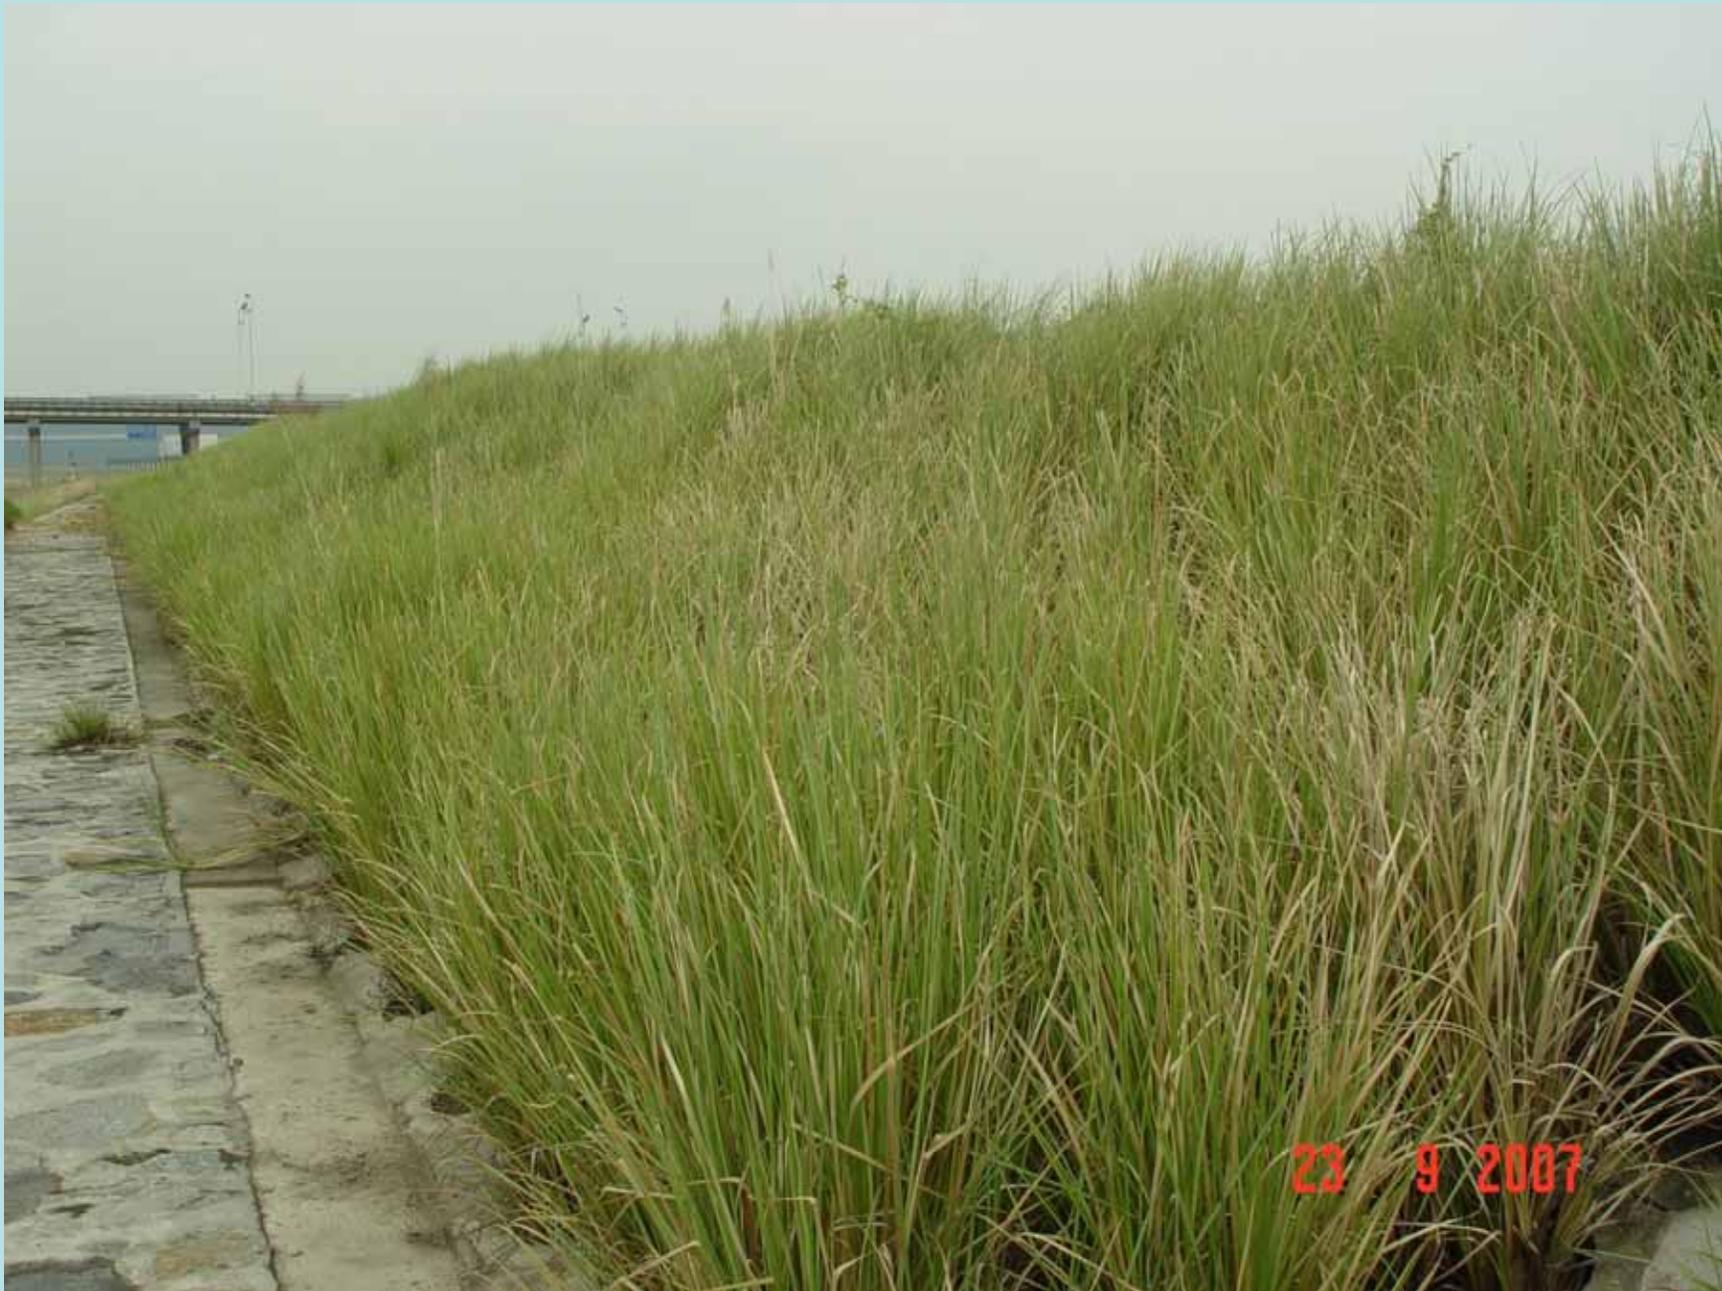
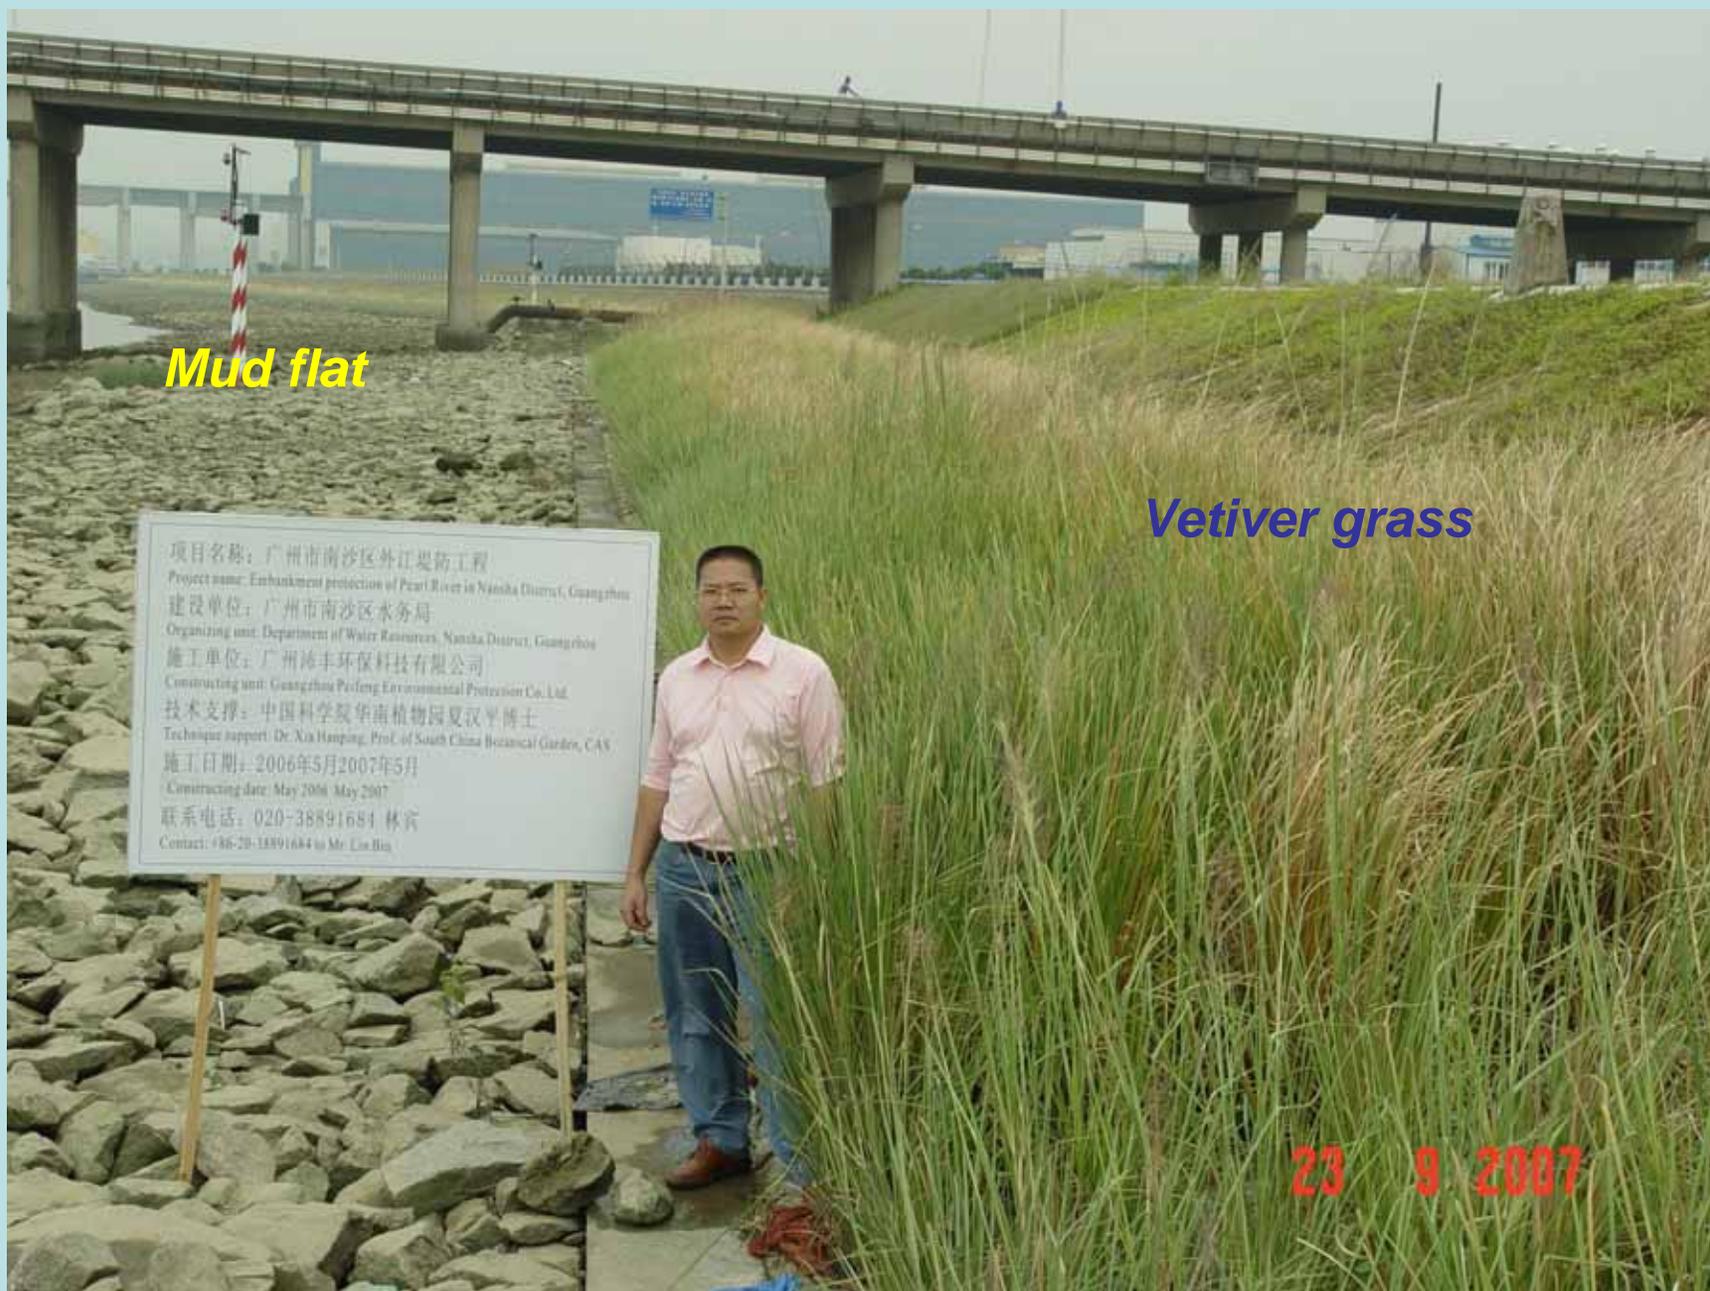
Vetiver grass one year after planting

The ecological benefits are quite obvious. The bank was covered with green color 40 days after vetiver was planted, and vetiver became very dense and exuberant one year later and Bahia grass also grew quite lush.

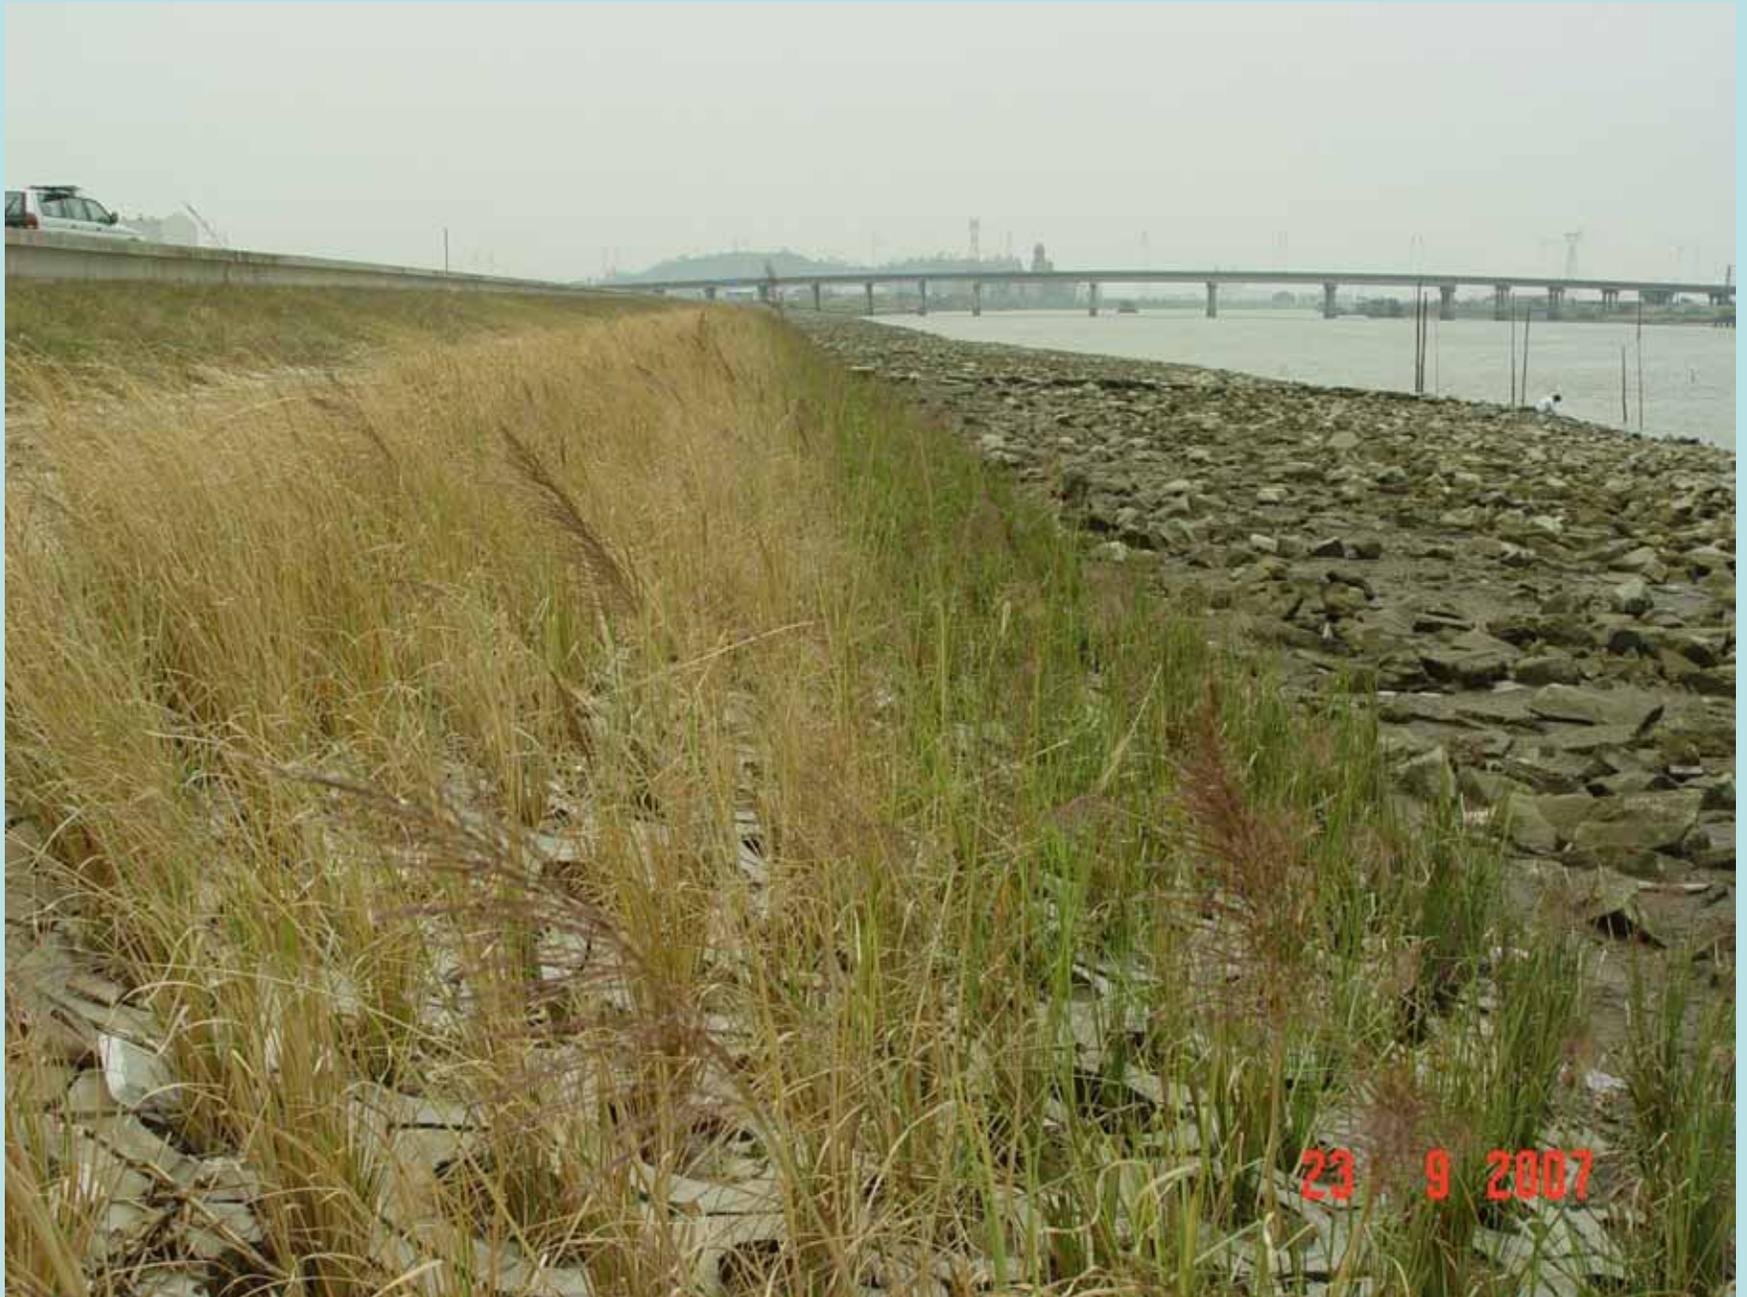
Poorer Vetiver growth due to shallow soil in the holes

- However, plants grown in the brick with 10 cm deep brick holes grew much poorer. This is because the soil layer is too thin, and plant roots could not penetrate through the dense layer under the bricks. Therefore they could not reach nutrients and moisture that plants need for their normal growth.

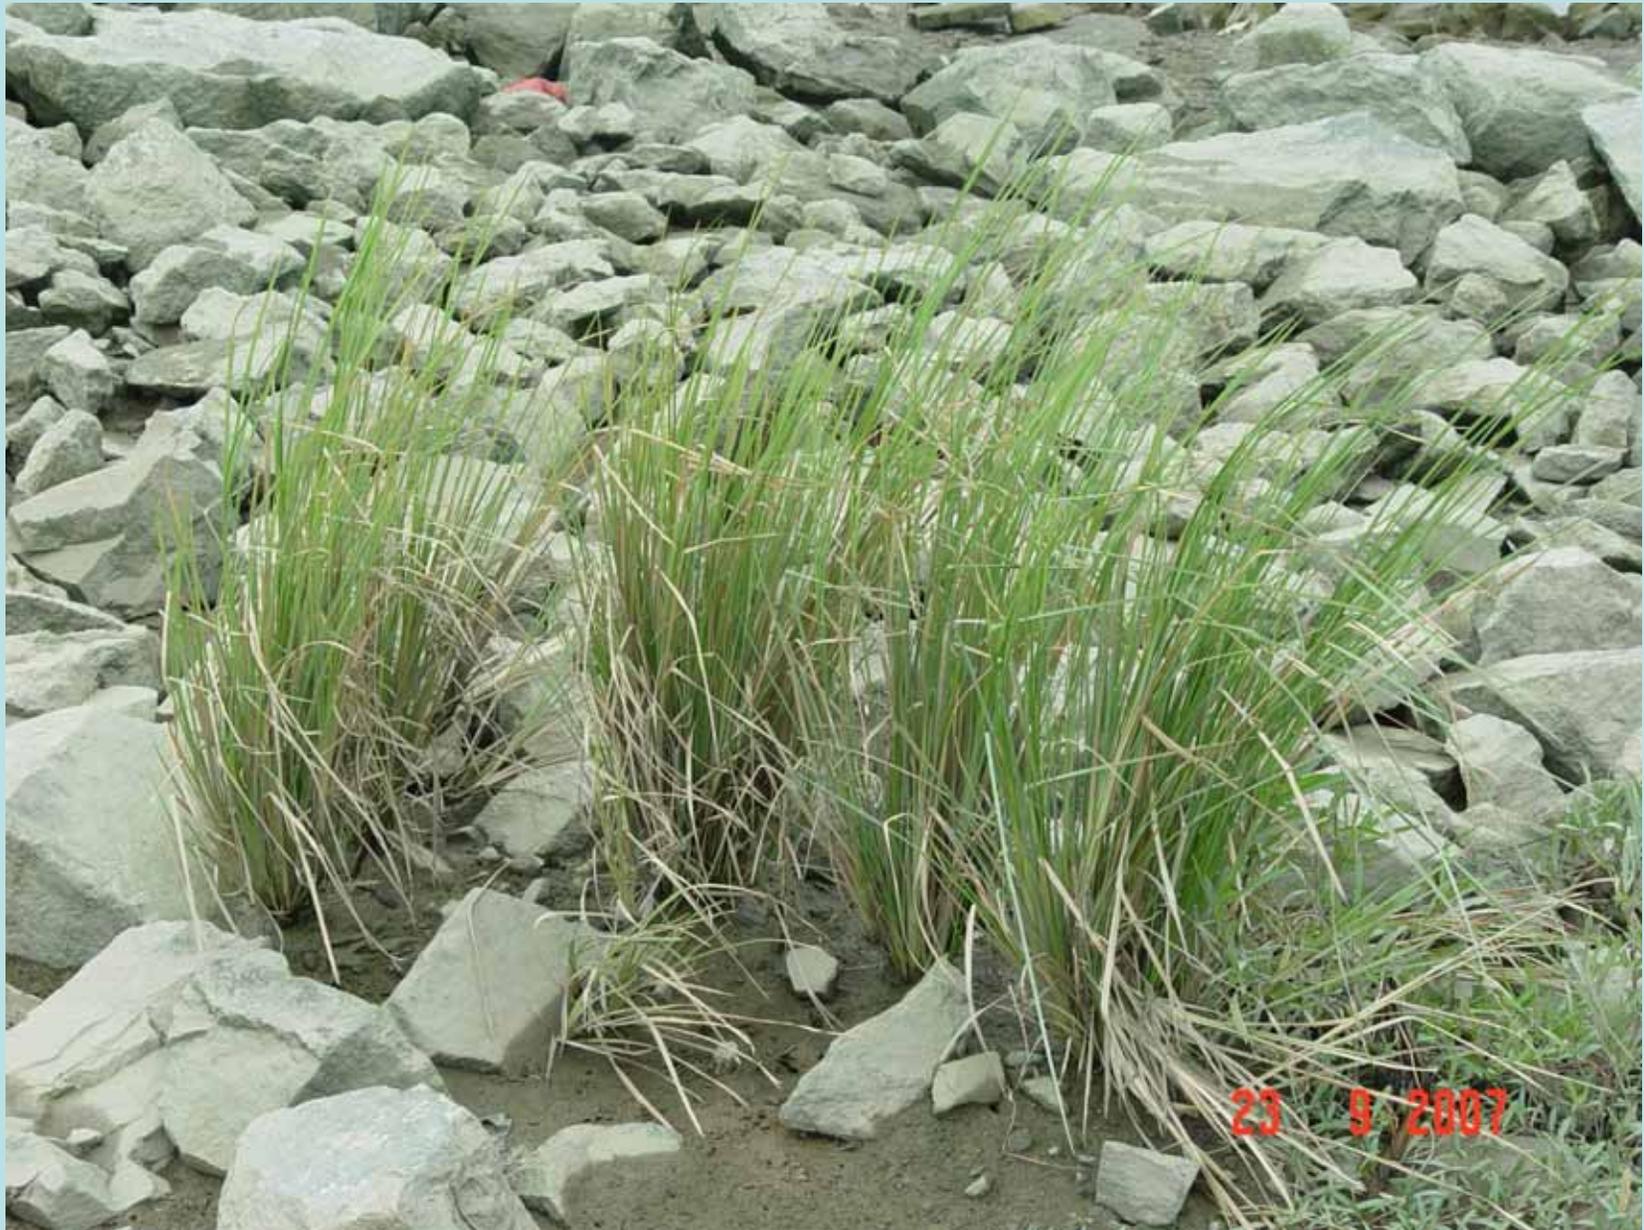
**An one year old stand of Vetiver grass planting on the mud flat on site,
which is submerged twice daily during high tide**

One particularly important point worth mentioning: Vetiver grass showed quite a strong tolerance to salt, flood, heat, and drought. For example, when several clumps of vetiver were planted on the riverbed; they have been submerged during high tide every day, but have thrived vigorously.

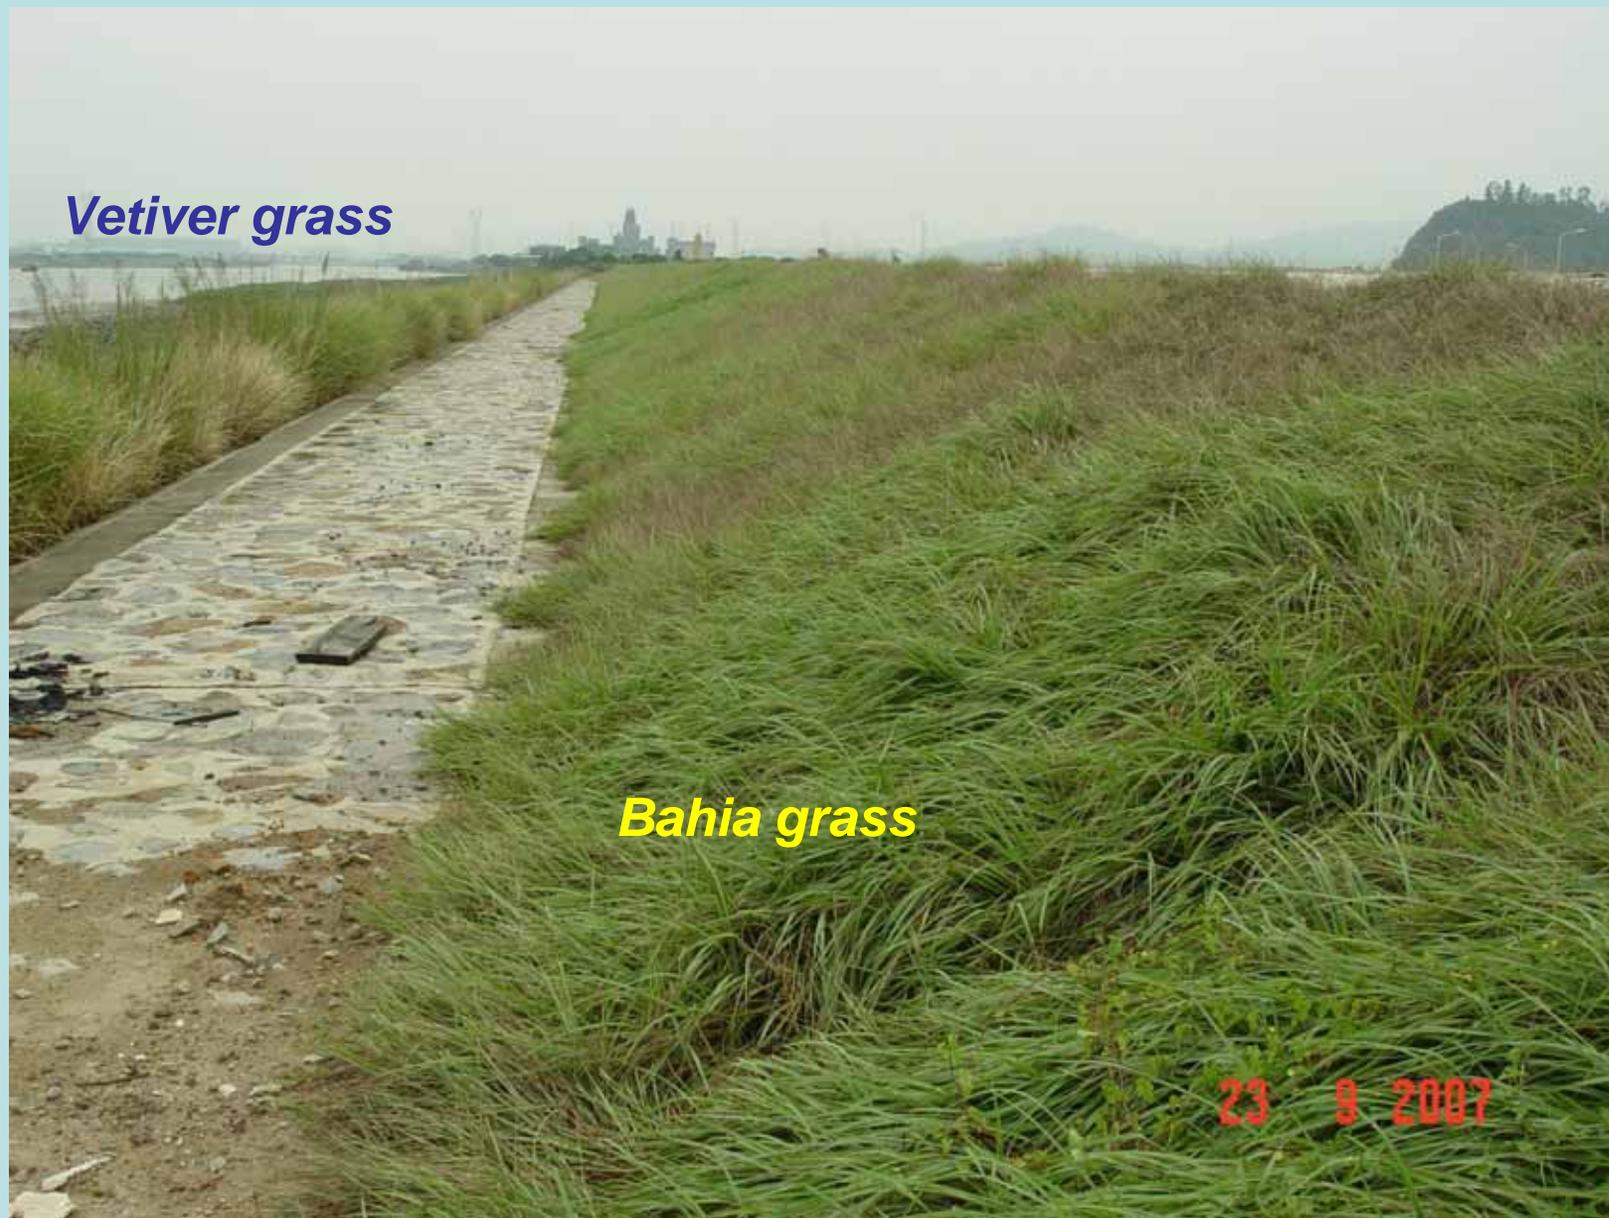
Best combination, Vetiver on lower ground and Bahia on higher ground

- As a result, the designer finally chose to plant vetiver grass on the lowest part of the slope and bahia grass on the higher part of the slope with 25 cm deep bricks.
