Black Cotton Soils and the Vetiver system

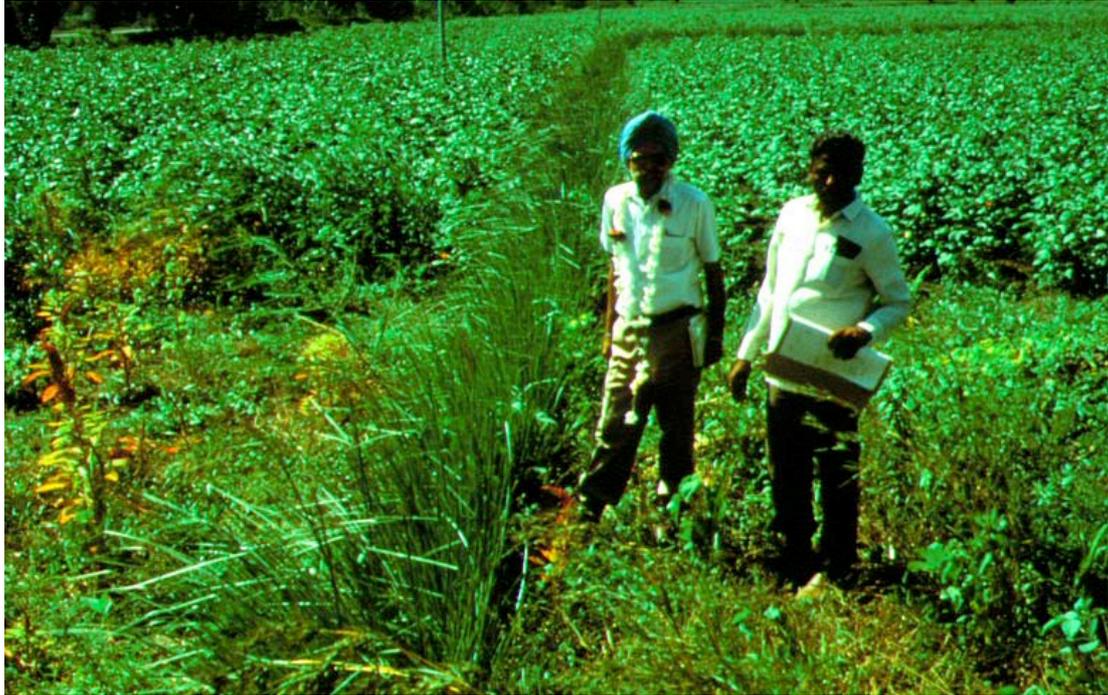
Photo BB18 - This photo was taken in the same field on the same day, here the cotton crop had been protected with a vetiver hedge. As can be clearly seen, the cotton is thriving. The vetiver hedge is not effected at all by the gilgai movement of the Vertisol as the hedge 'moves' with the soil, there was no ponding of runoff and the yield of cotton was high.

rush through it causing the erosion gap the extension worker is standing in. In both photos BB01 and BB02, a lot of farm land was necessary to build the banks - In BB01 with a 5 meter base, 1 km of bank takes half a hectare of land out of production. In the case of BB02 with a 10 meter base, 1 km of bank takes one hectare of land out of production. Where as the vetiver hedge in photo BB18 has a base of only 50cm and 1 km of this hedge only uses 1/20 of a hectare.

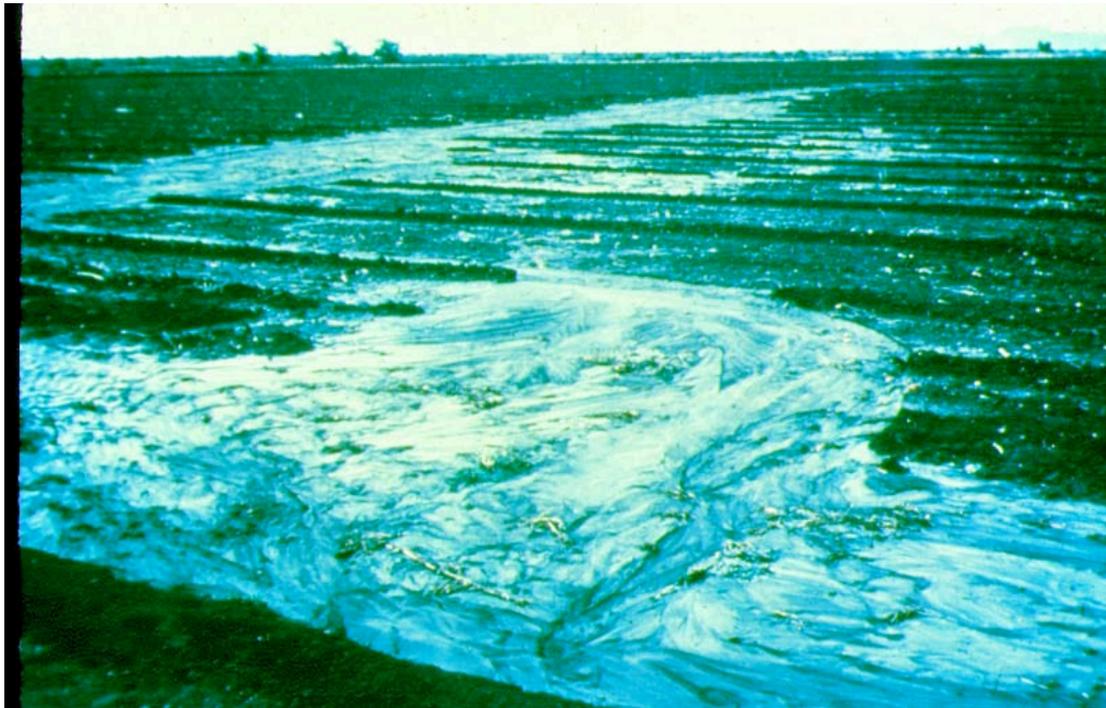
Photo BB03 Shows a typical runoff event on the vertisols, which the constructed bunds have proven incapable of controlling. The runoff has taken its own path despite the bunds, this could not happen with vetiver hedges with their roots down meters in the soil beneath them anchoring the hedges in place and making breaches impossible.

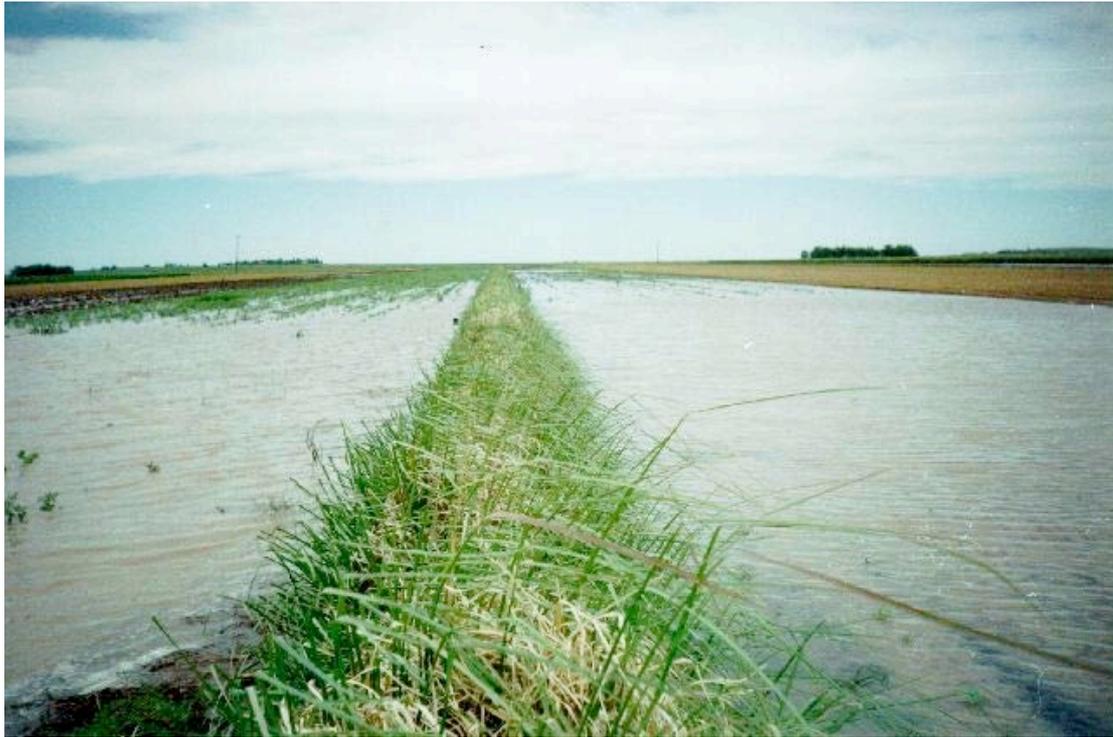
Photo BB47 Shows a vetiver hedge in the Darling Downs Australia containing a massive runoff event, taking the power out of it, the hedge standing up, not breached along its length and protecting crops planted near it. The inundation will not effect the vetiver grass at all, nor the integrity of the hedge.

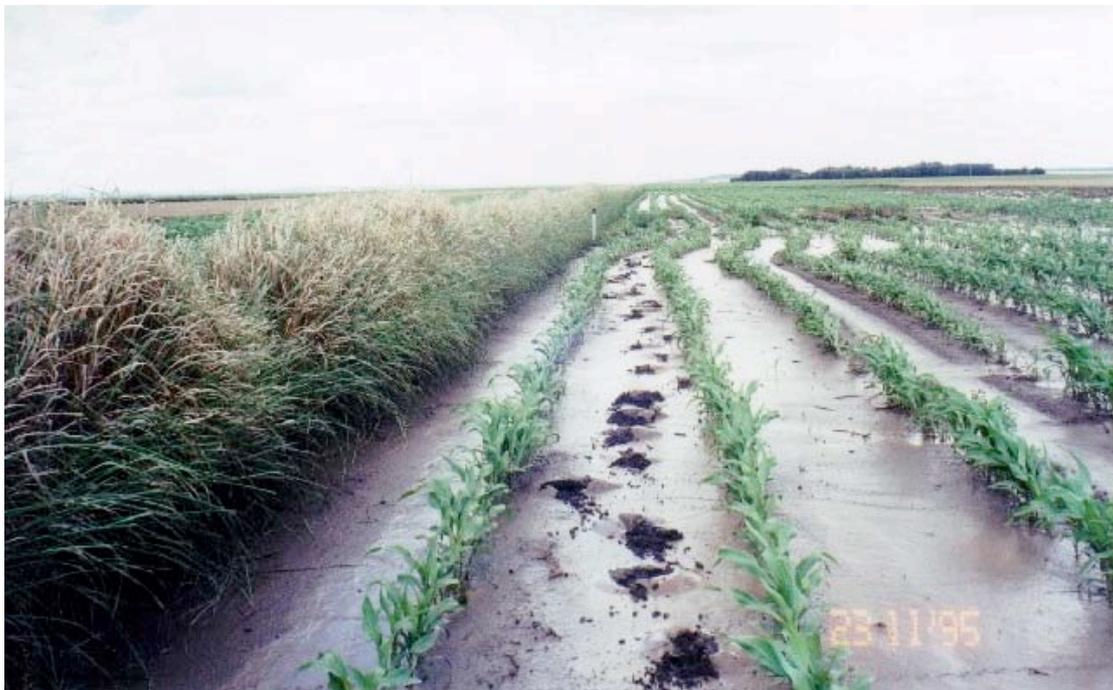
Photo BB35 Shows once the water has receded the crop has been protected from lodging caused when water flows at speed over an unprotected crop. It also shows silt that would have been eroded out of the area, has been retained behind the hedge

filling a low spot, thus levelling the field for greater ease of cultivation and spread of future rainfall.

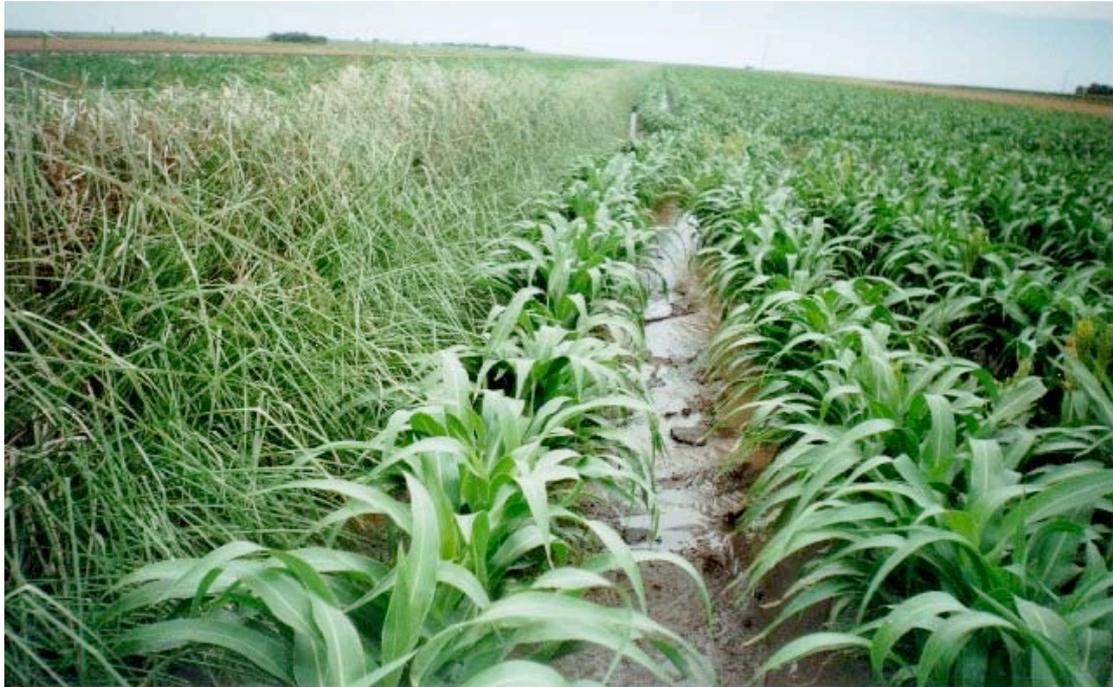
Photo BB37 Shows the crop thriving after inundation and not showing any signs of competition from the vetiver hedge. The reason the crop is still standing is that the hedge took the “power” out of the water flow. No constructed ‘bund’ or bank would have offered the same protection to the young crop.
