VETIVER SYSTEM - RAILROAD PROTECTION AND STABILIZATION

THE VETIVER NETWORK INTERNATIONAL

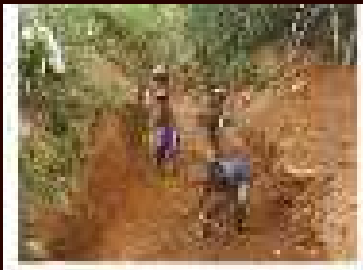
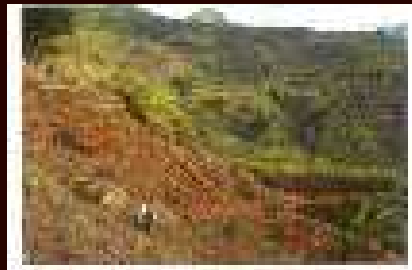
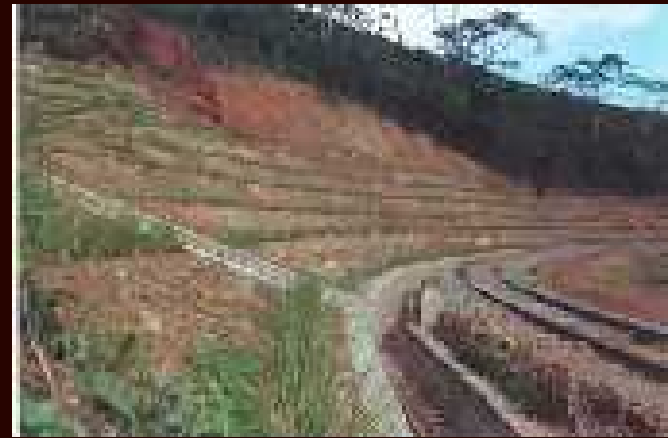
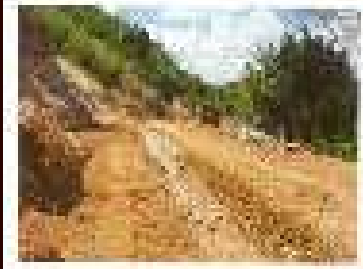
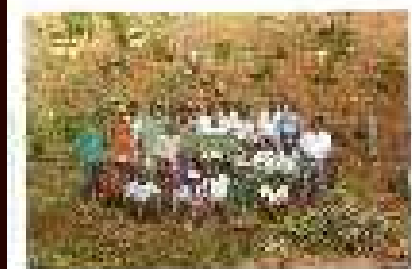
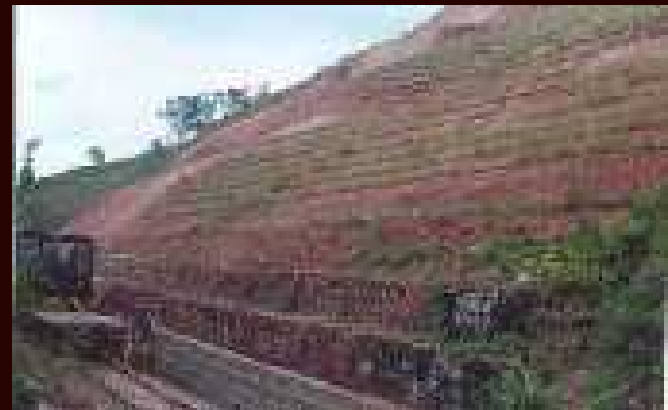
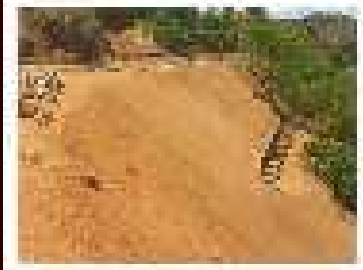
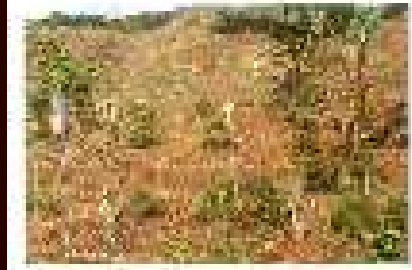
This 200 km railway was devastated by cyclone caused, lack of maintenance and cultivation. A plan linking the railway, farmers and vetiver was put in place, with a result that the railroad is now stable, operates without slope failure, and the farmers have better incomes

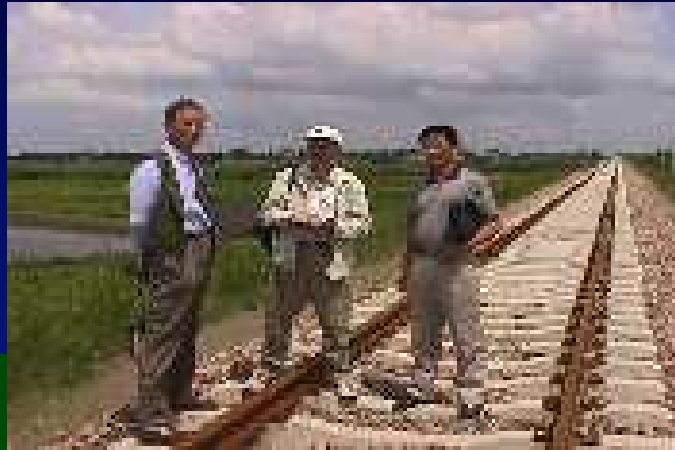
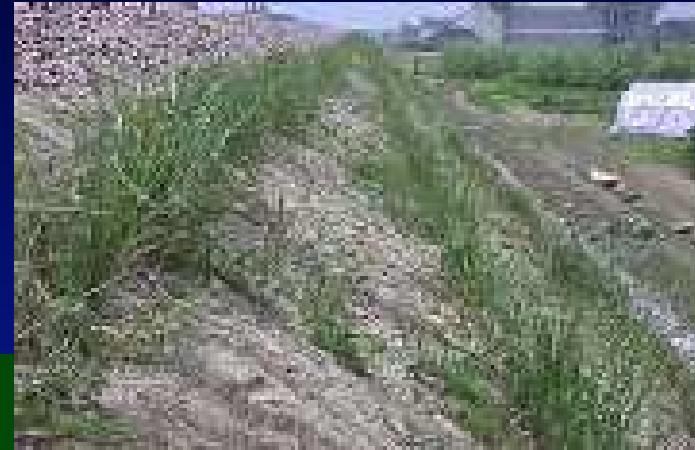
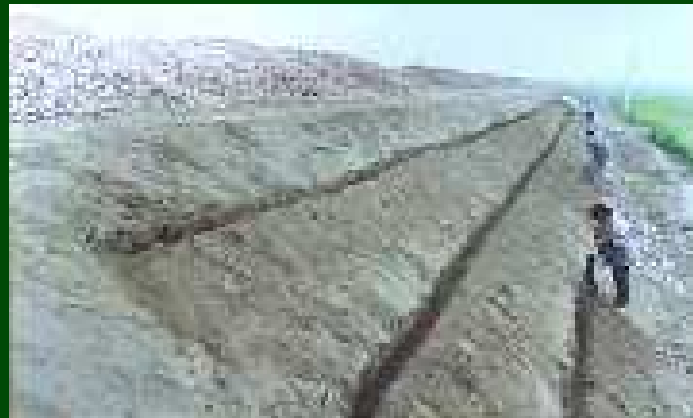
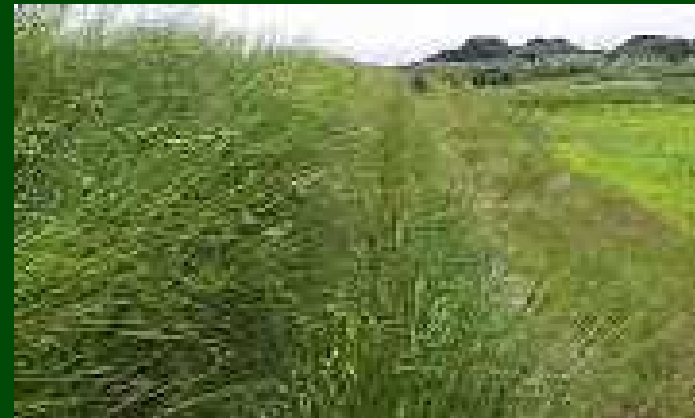
The China Vetiver Network and the China Railways worked together to stabilize this very sandy and unstable fill embankment. Bottom left - three years after planting. Stable railroad track.

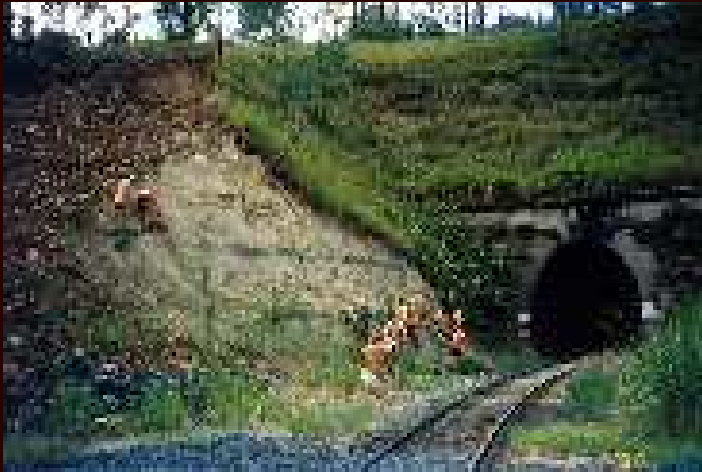
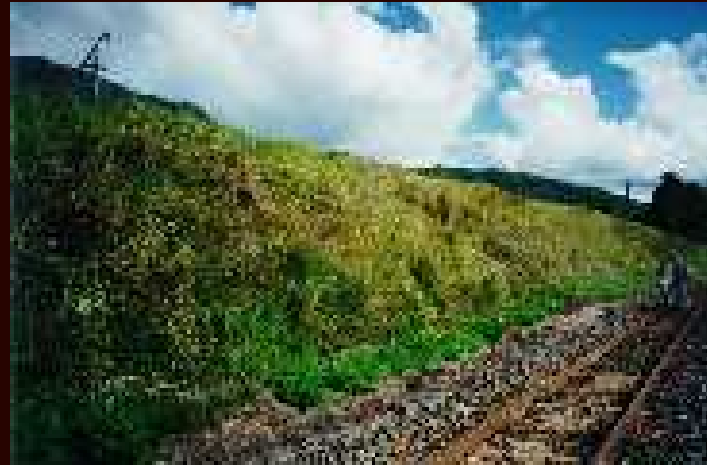
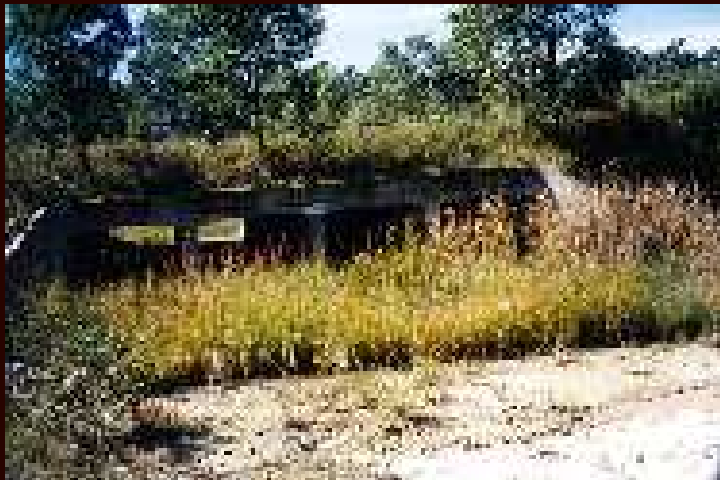
Australia, Queensland. Railroad tunnel entrance, drain underpass and railway batter cut all stabilized with vetiver grass hedgerows at 1/20 of the cost of standard practices.
