Vetiver System for Sand Dune Stabilization

A Vietnamese Experience

Dr Tran Tan Van, Ir Elise Pinnars and Dr Paul Truong

Vetiver Network Vietnam

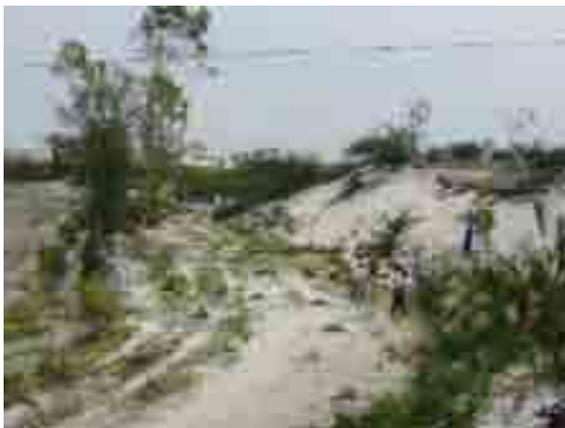
Fig. 1. The site in early March, 2002 - a dry river at the foot of a bare sand dune.

This particular pilot site so selected was along a sand dune on the bank of a small river. The river in fact is a natural boundary between a Forestry Enterprise and a commune. During the dry season, the river bed is leveled off and used by the Enterprise's workers as a nursery, but it is full with both water and sand during the rainy season. As the river gradually undermines its sandy bank during rainy season, the sand dune was retreating several meters year by year, making the commune people very unhappy. They thought it was the Forestry Enterprise to blame for their nursery activities. Several attempts were made for fixing the dune but all failed while the conflict was mounting, requiring an immediate solution.

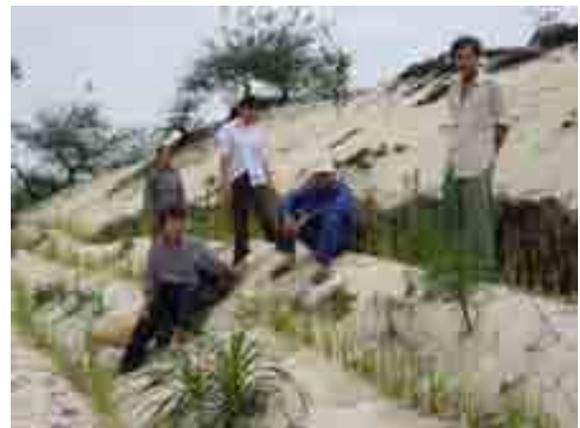
Fig. 2. Early April - one month after planting. Note the mulching above the uppermost row.

Establishment: The foot of the sand dune was prepared and 3 rows of Vetiver grass were planted, each 60 m in length. These rows were divided in two trials; on the left side (30 m) only bare root slips were used; on the right side (30 m) pots were used in the upper line, and 5m on-off in the 2nd and 3rd lines. Planting distance was adopted equally at 10 cm.

Maintenance and monitoring: Also during the dry season, the dry sand on the slope easily moved down with the wind, sometimes half burying the young grass, sometimes even washing it away. The farmers taking care of the trial were very creative in making a long and narrow ditch right above each row and putting in there dry Casuarinas leaves and mulches. In so doing they reduced the flow of dry sand and at the same time ensure a better watering. The first author of this paper visited the site once a month to measure the growth of the grass and give further instructions on any incurred technical problem.

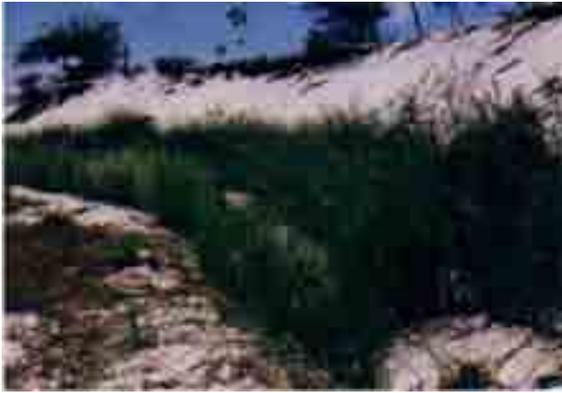
Fig. 3. Early July - 4 months after planting - very good growth to form dense hedgerows.

All fertilization schemes also appeared to give similarly good growth results. After 4 months dense hedgerows established, which effectively stabilised the sand dune. The Forestry

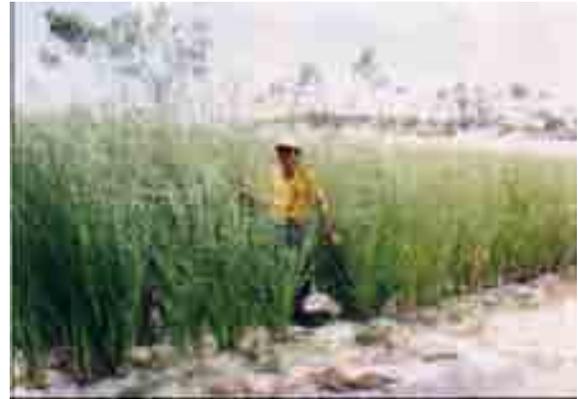
Fig. 4. The nursery after 4 months. More than 1.7 m high grass.

Nursery: A small nursery was set up at the same time nearby, on a flat sandy ground with better moisture condition. The spacing was selected at 0.5 m apart. The purpose of this nursery was to supply the mass planting phase a few months later.

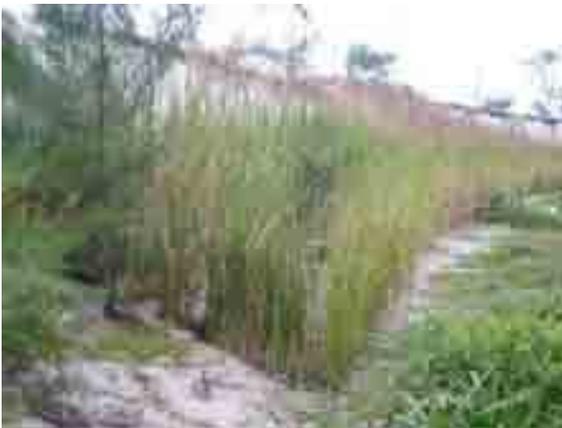
Fig. 5. Mid-October 2002 - The pilot site. Note the flowering, the dry leaves and the growth of Casuarinas in between Vetiver rows.

The grass grew very well both in the nursery and at the pilot site. Initially plant from the pots grew better, but after a while there was almost no difference between bare roots and pots. The grass then flowered but did not spread wild while its leaves become dry, replaced by younger tillers from the crown.

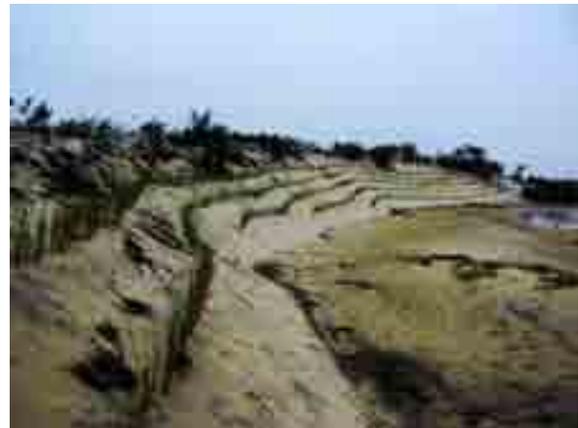
Fig. 6. Mid-October 2002 - One month after mass planting at a similar site. The "river" is quite wet.

Mass planting with 2 km run was carried out in October 2002, at the end of the rainy season. This was to avoid some heavy rains that could wash away the seedlings and at the same time to ensure adequate moisture in the sand before the next winter comes in December-January.

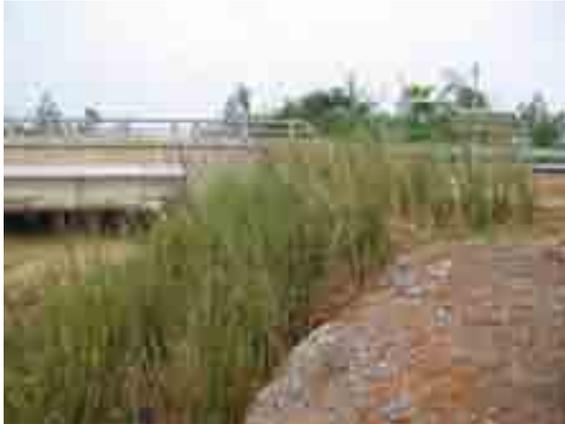
Fig. 7. Local initiative - Vetiver grass for protection of bridge abutment along the No. 1 National Highway. Note the sand transported by the flow, only 1 m below the bridge.

Enterprise was so happy with the results that, apart from some sand dunes planned by the project, it decided to mass plant the grass itself on other sand dunes. The Forestry Enterprise director even order to uproot a few hundred mature clumps to replant at a bridge abutment along the National Highway. Although technically it was not properly designed, but as the 2002 flood season was not so severe, the bridge abutment was also stabilized.

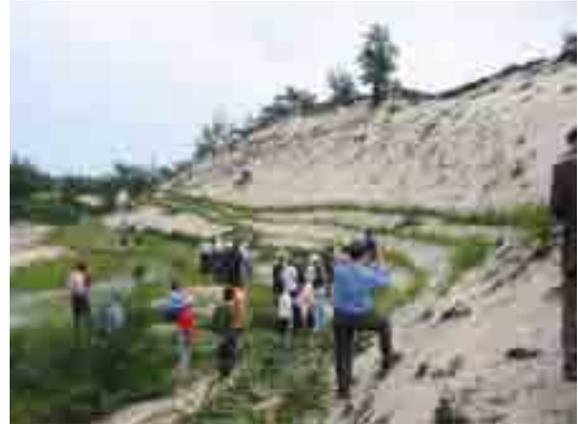
Fig. 8. Mid-February 2003 - Post-workshop field trip. The grass looks green even after the coldest in 10 years winter.

third replanting succeeded. Local grass also died because of the cold weather and the local farmers reported their Vetiver nurseries were cut by strangers for feeding cows. The mass planted Vetiver grass, however, survived and they looked quite green in February 2003, when a regional workshop was organized. After 2 years, at the first pilot site the grass has helped local varieties such as Casuarinas, wild pineapple etc. to re-establish. The vetiver grass growth was reduced under the shade of these trees but by then it has accomplished its mission.

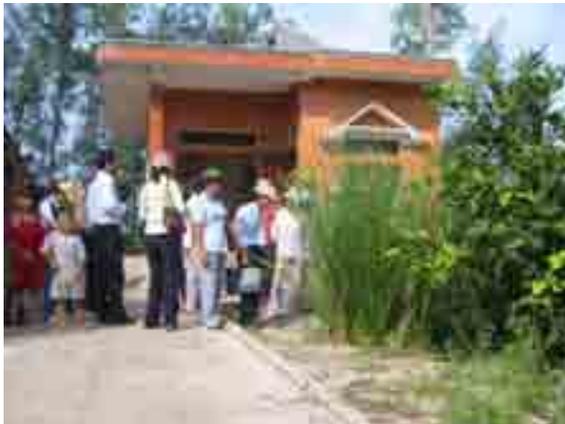
Fig. 9. June 2003 - Nursery at home. A World Vision Vietnam-sponsored field trip for farmers from the neighbouring Quang Tri province.

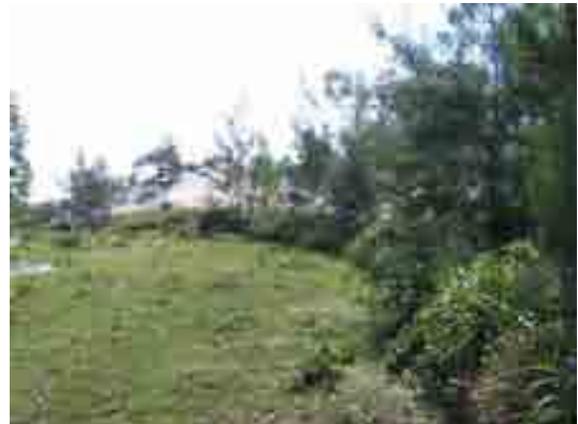
Fig. 10. Dec. 2004. Local species establish to completely fix the sand dune. Vetiver grass is fading away under the shade of these trees but it has accomplished its mission.
