# VETIVER GRASS TECHNOLOGY FOR REHABILITATION OF MINING WASTES AND TAILINGS

**Paul Truong**  
*TVNI Technical Director*  
*Director for Asia and Oceania,*  
**Brisbane, Australia**  
[p.truong@veticon.com.au](mailto:p.truong@veticon.com.au)  
[paultruong@vetiver.org](mailto:paultruong@vetiver.org)  
[www.vetiver.org](http://www.vetiver.org)

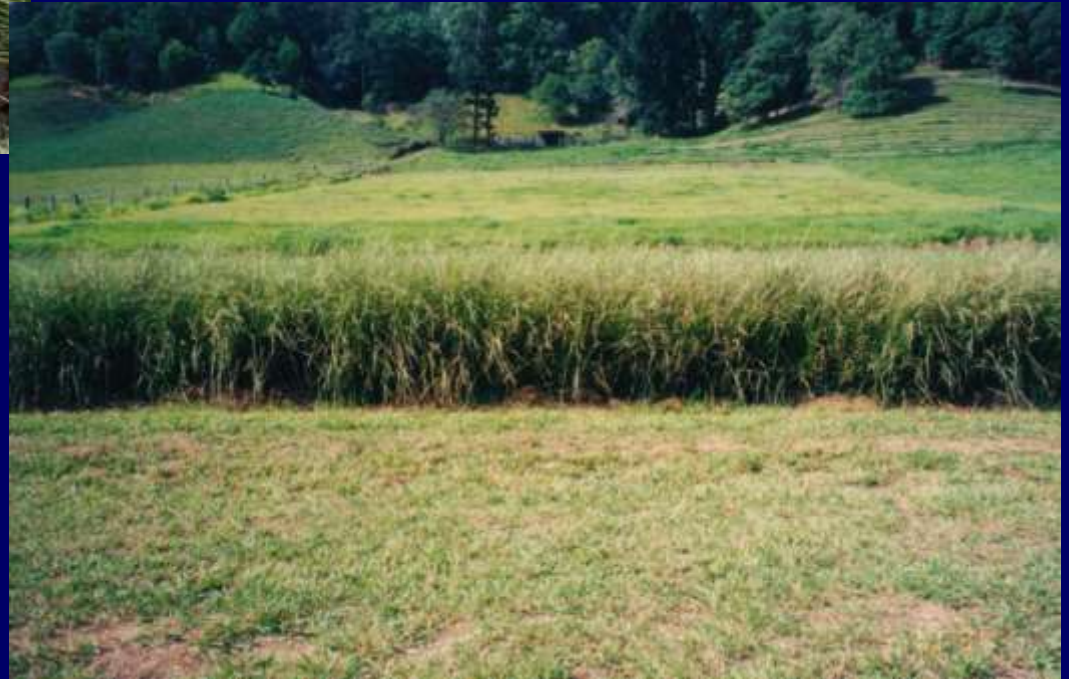
**Stiff and erect  
stems:**

**Erect stems up  
to 1.8m tall and  
over 2m with  
flower head**

**Forming a thick  
hedge when planted  
in row which can  
spread and slow  
down runoff water**

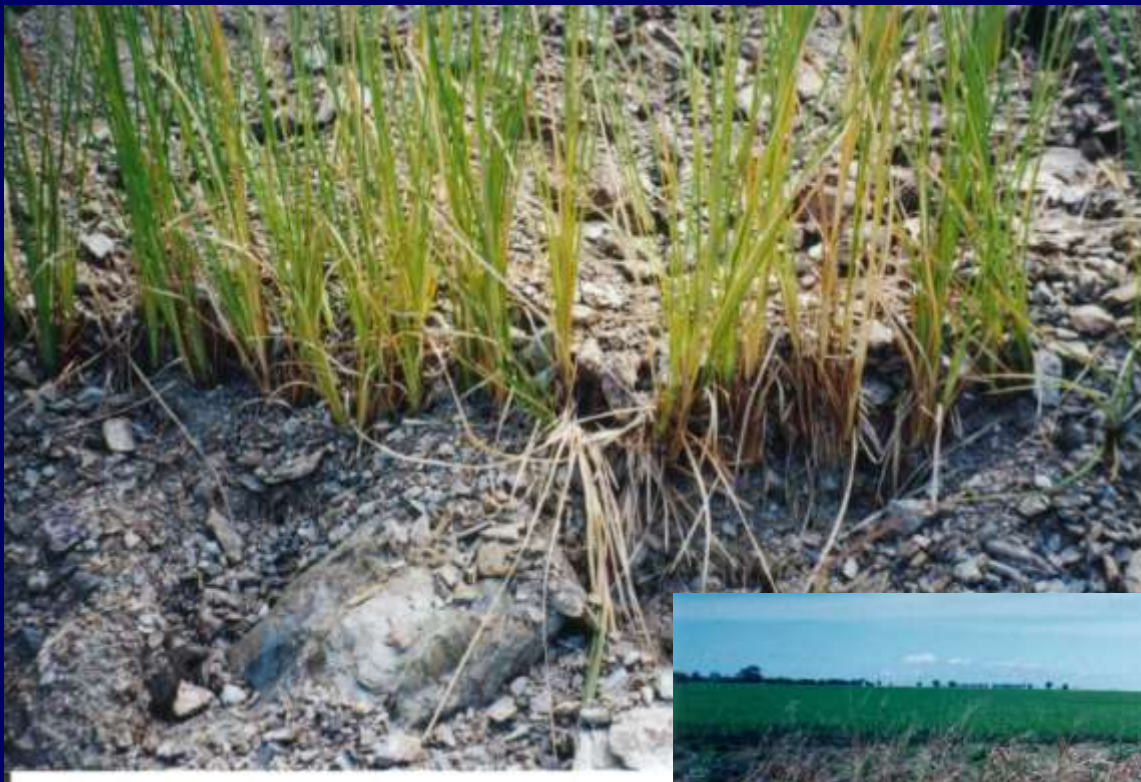
**Even at this young age  
the stiff stem is strong  
enough to trap large  
size gravel**

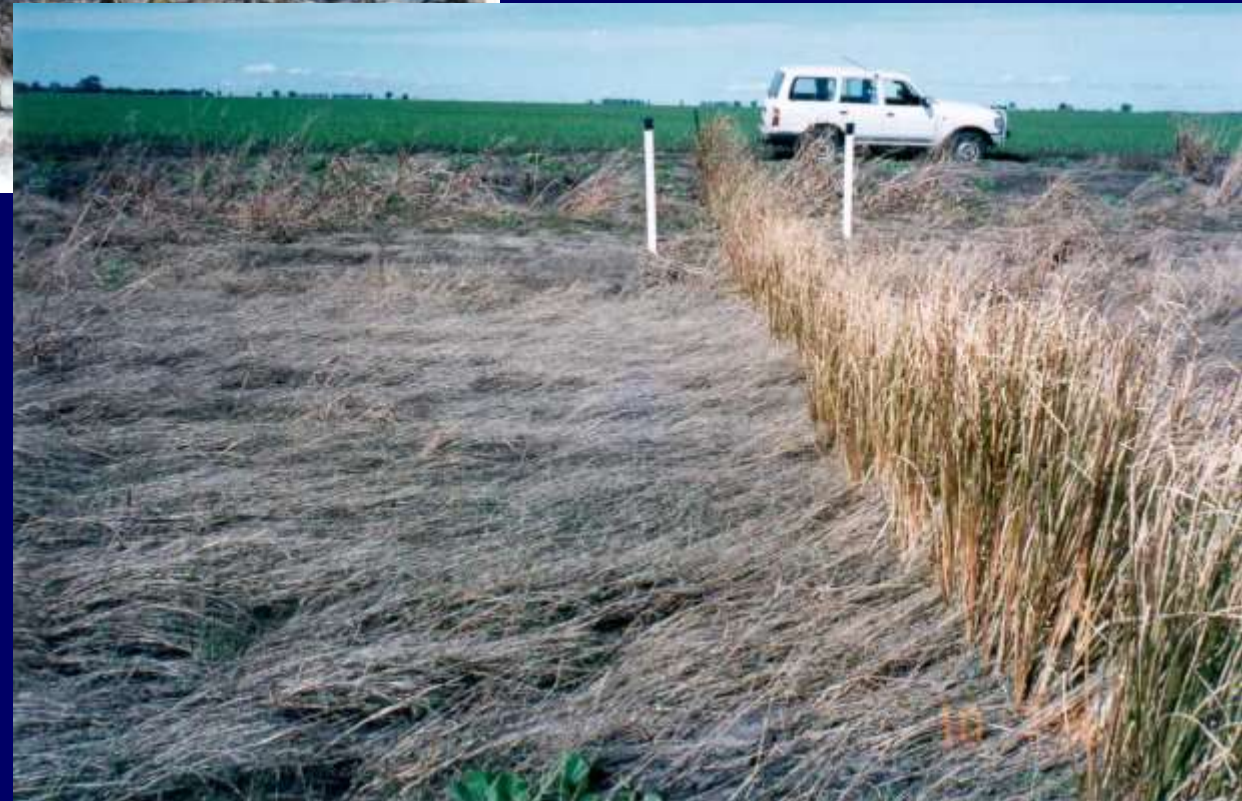
**Strong current  
flattened the native  
grass but not vetiver  
on this waterway**

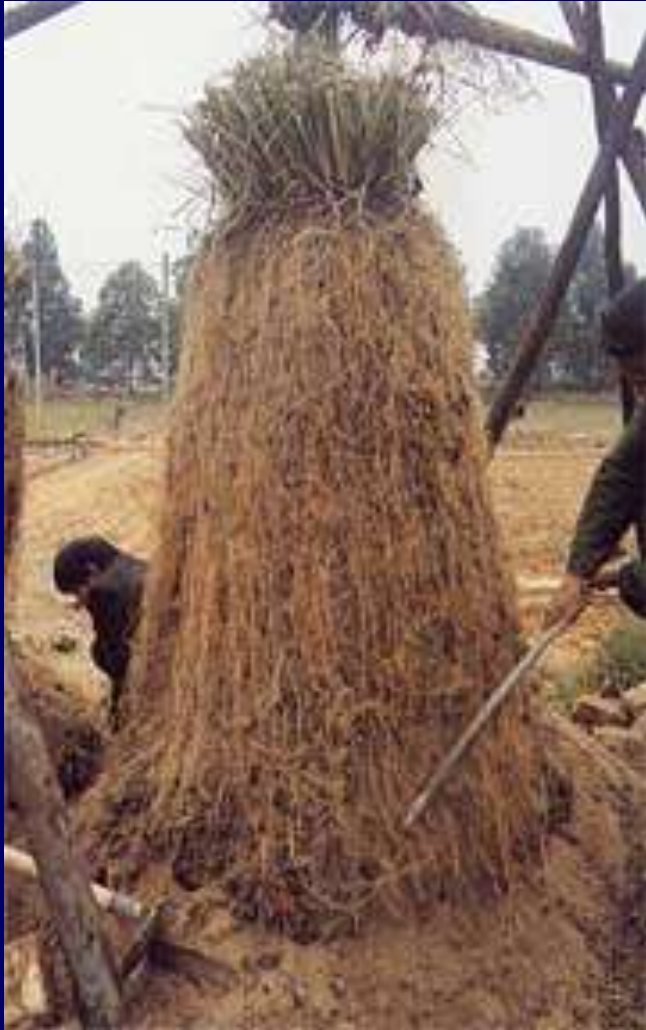
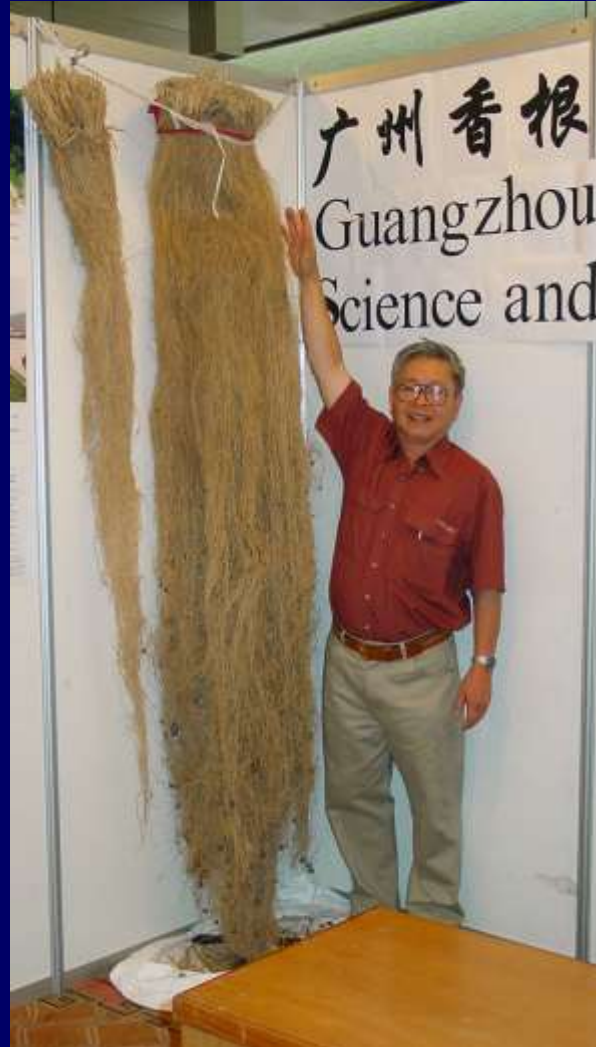
**China: One year old with 3.3m deep root system**

**Vietnam: Agriculture &  
Forestry University,  
Saigon**

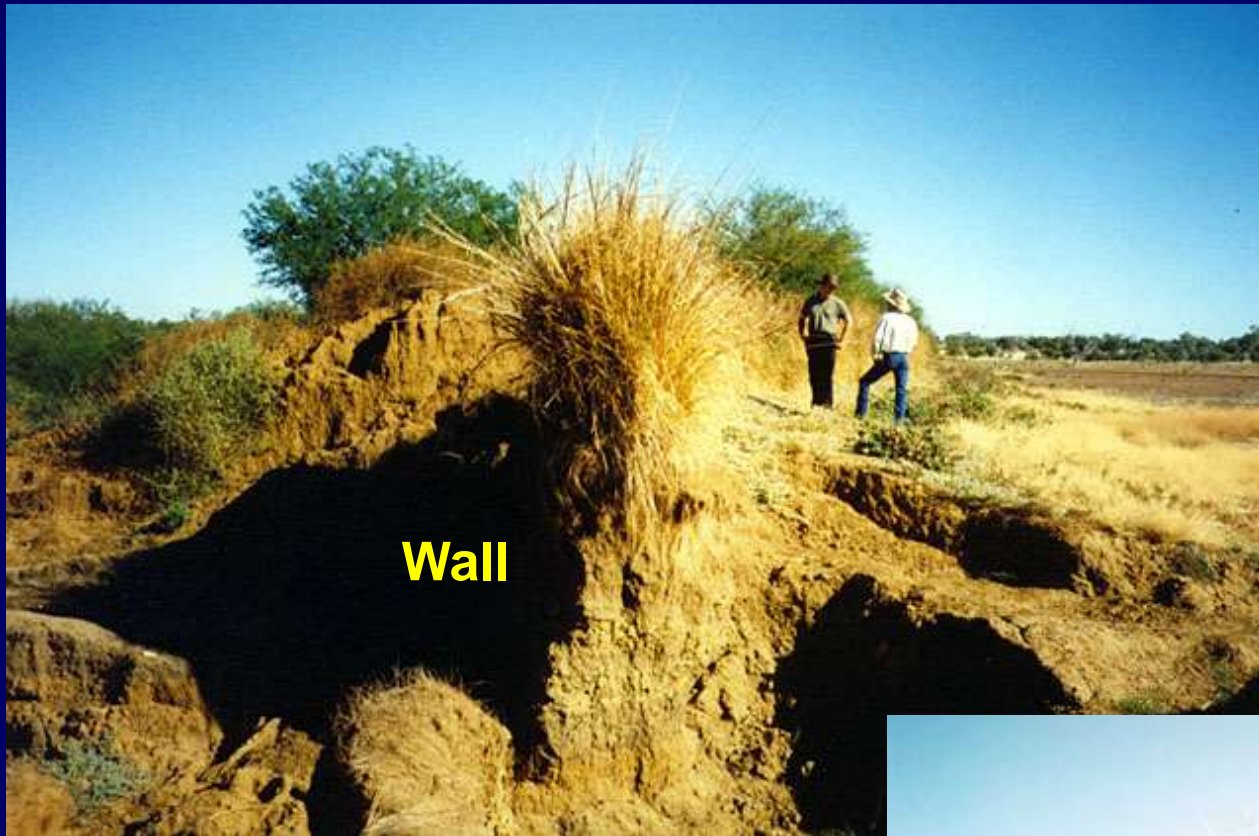
**Strong root  
reinforcement  
holding up this wall  
of soil against water  
erosion**

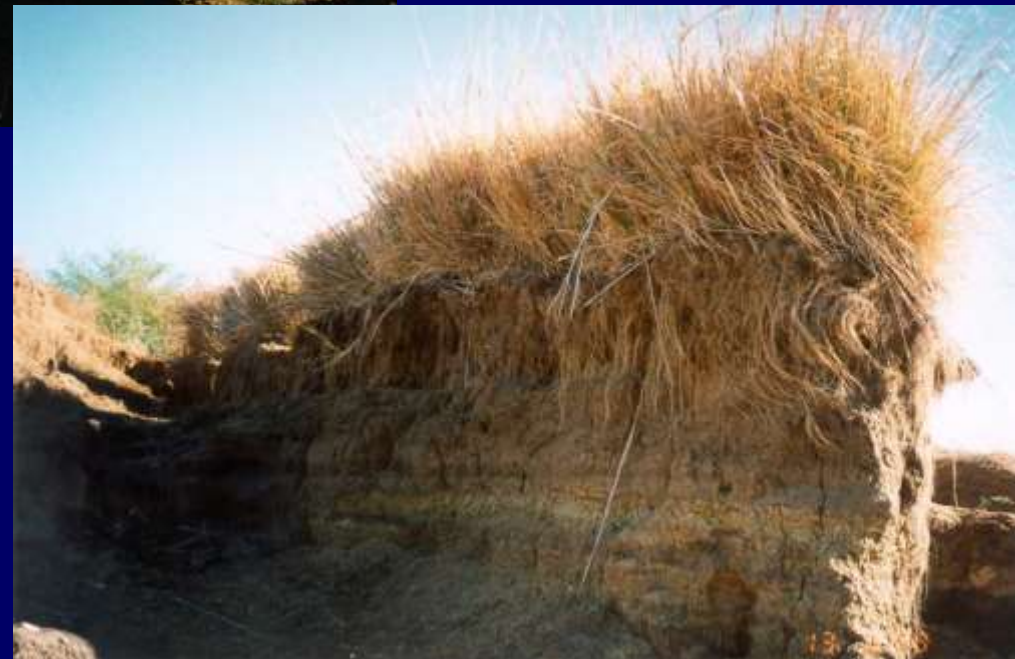
**Wall**

**Solid wall  
reinforced by  
vetiver roots**

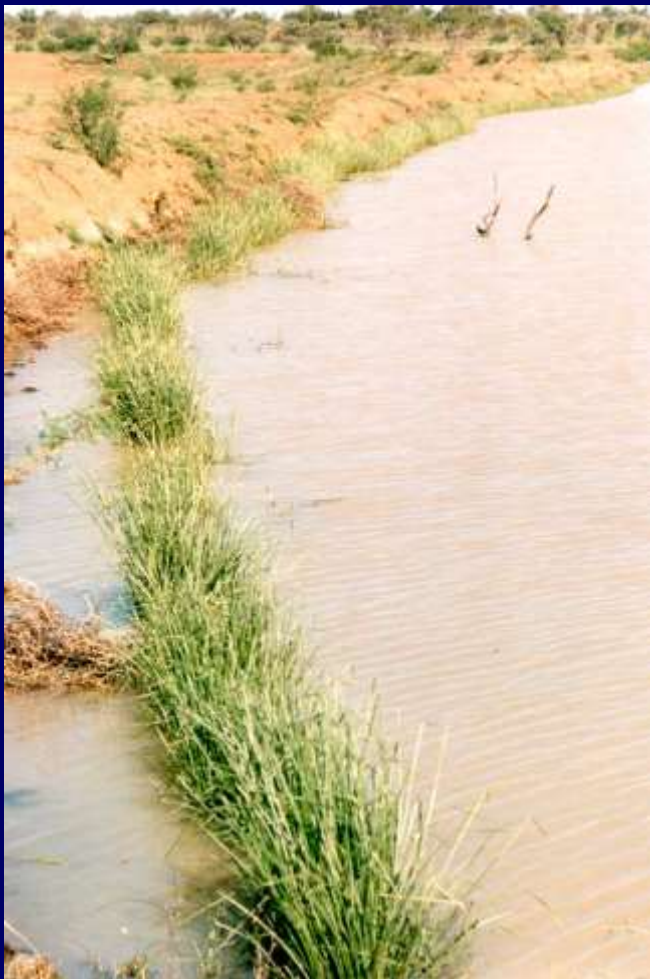
**Growing vigorously in water.**

**Tests conducted in China found that when completely submerged, vetiver survived for 54 days.**

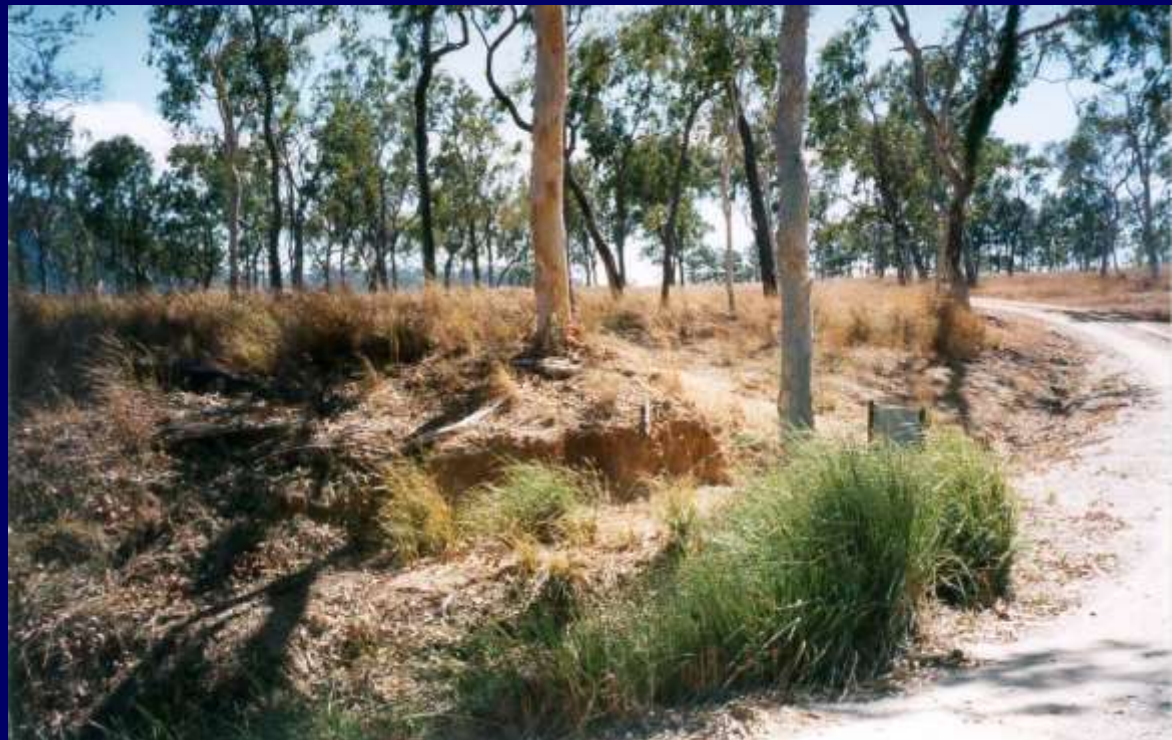
**Vetiver remained green but all native grasses were brown off under semi arid conditions in western Queensland .**

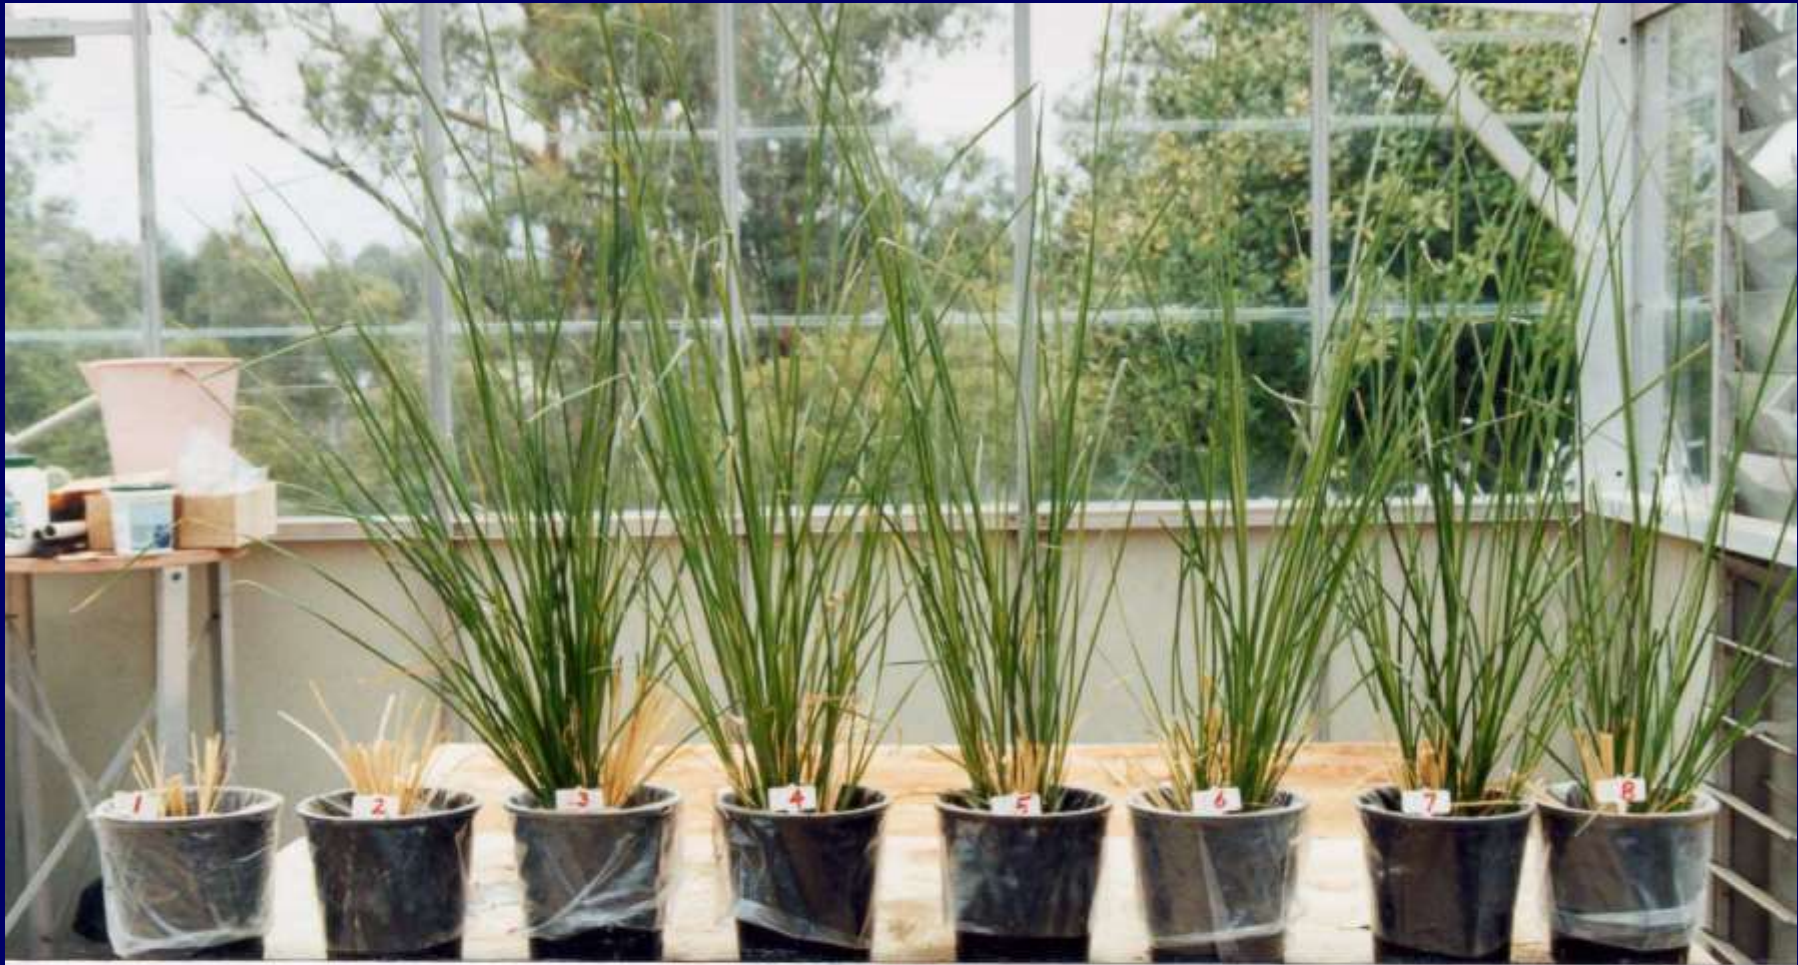
**Vetiver thrives at soil pH=3.8 and Al saturation percentage of 68% and 87% under field conditions**

pH	2.0	2.2	3.8	4.4	4.8	5.5	7.3	7.6
Al%	90	90	68	36	11	2	trace	trace

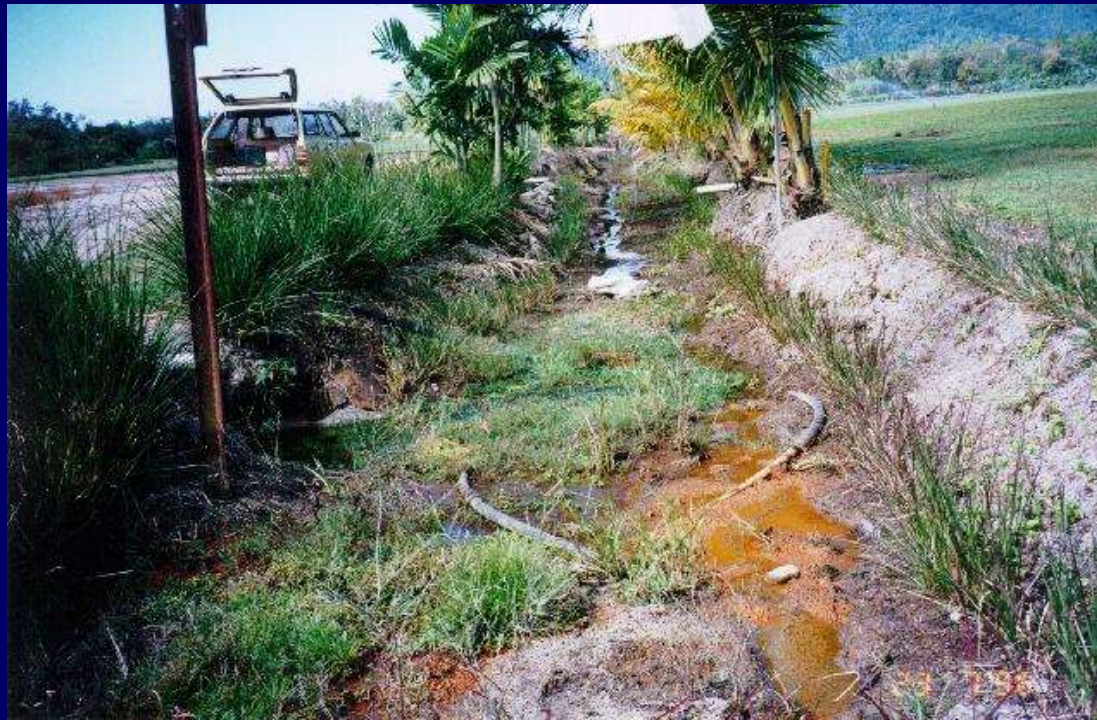
**Highly erodible acid  
sulfate soil (pH 3.0)  
in coastal Australia**

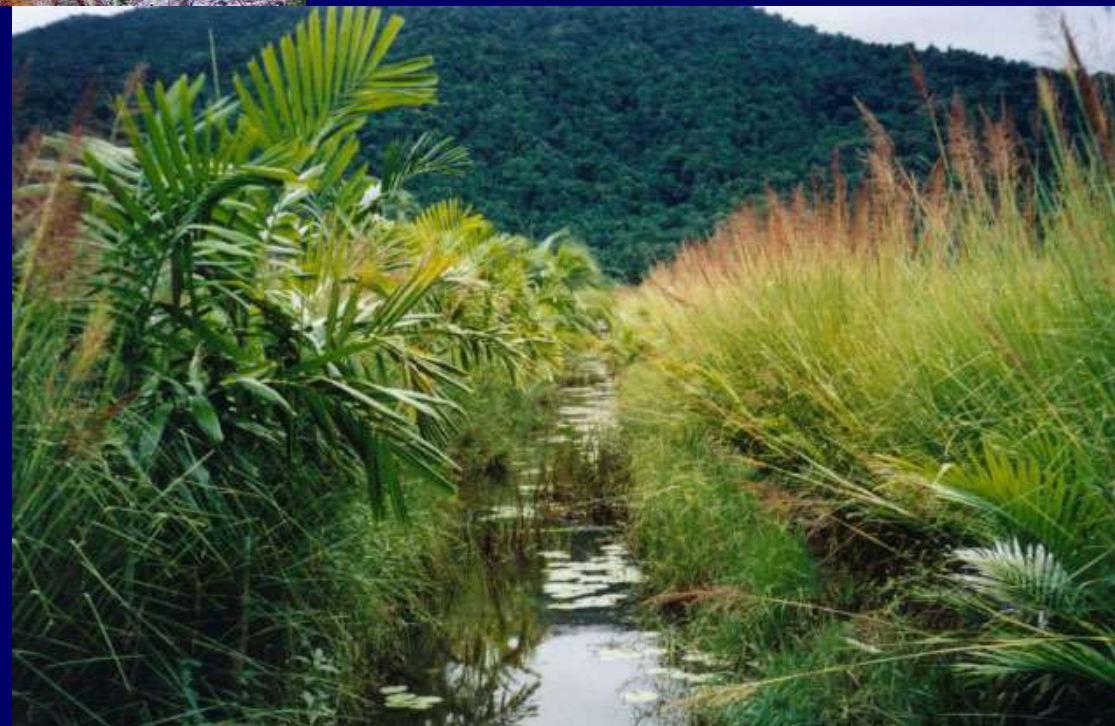
**One year after planting**

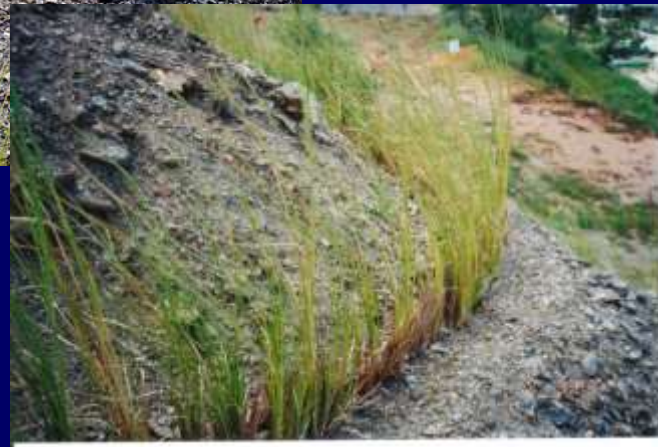
Highly erodible alkaline  
and sodic overburden of  
open cut coal mine in  
central Queensland

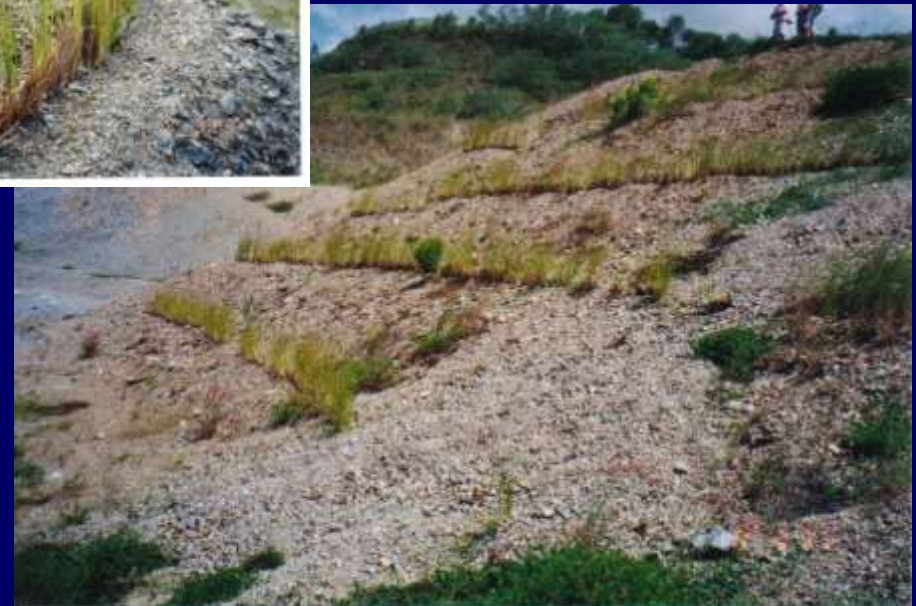
Vetiver planted on contour  
line to conserve soil  
moisture and stabilising  
loose surface materials

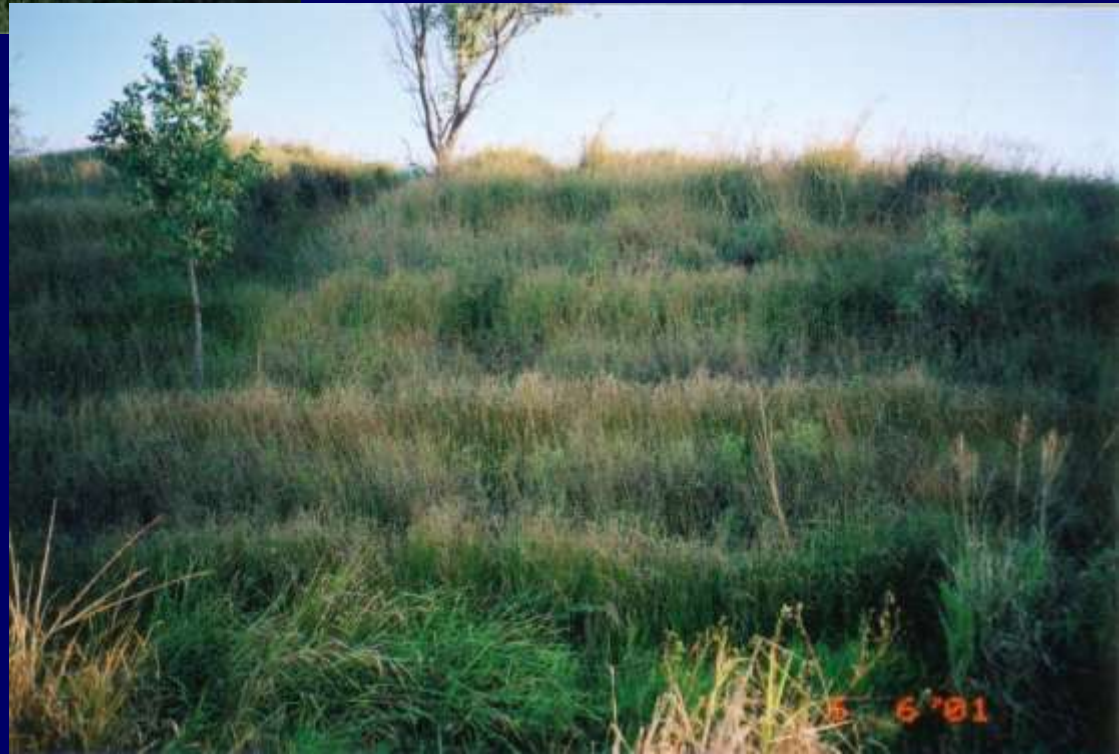
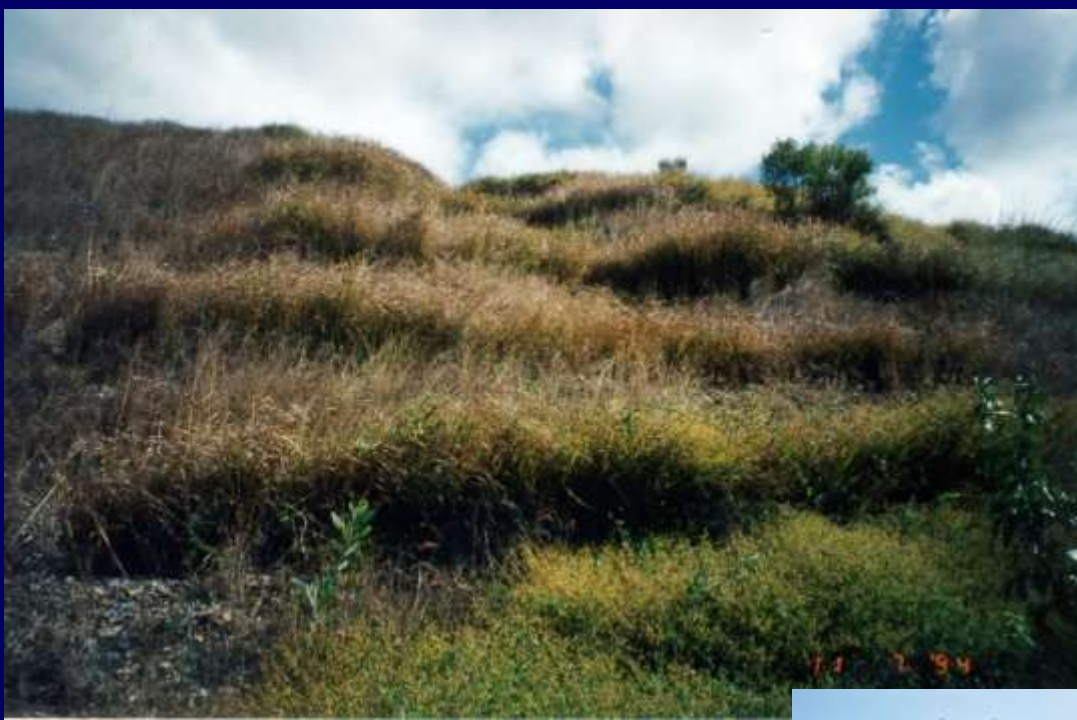
**Eighteen months  
after planting**

**Nine years after  
planting, note the  
return of native trees**

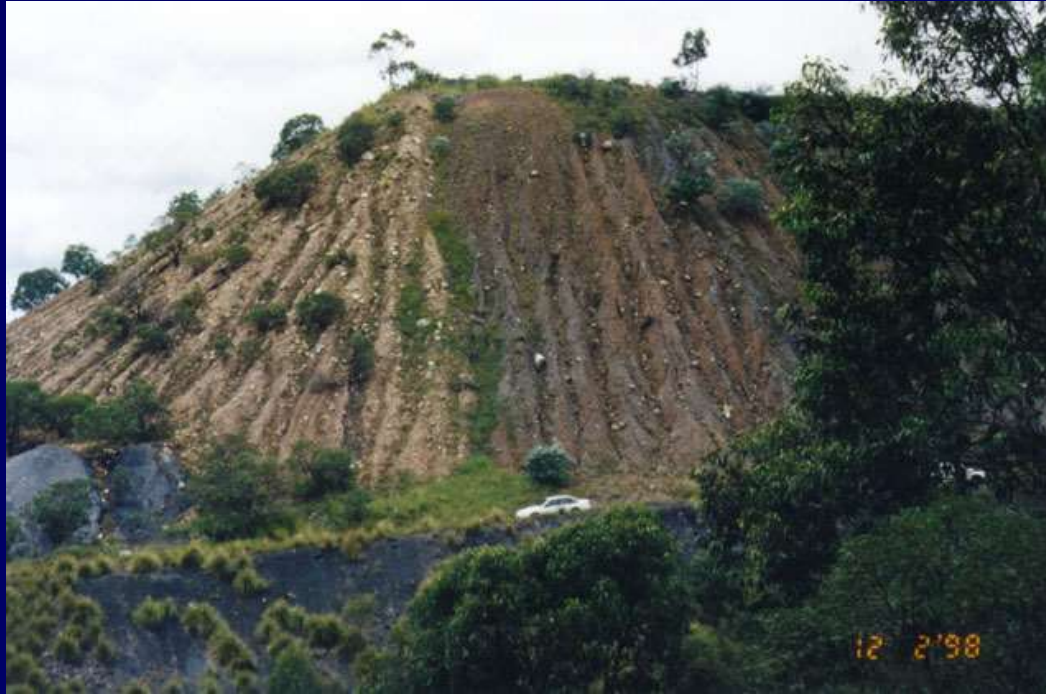
**This coal mine waste rock  
dump remained barren after  
50 years**

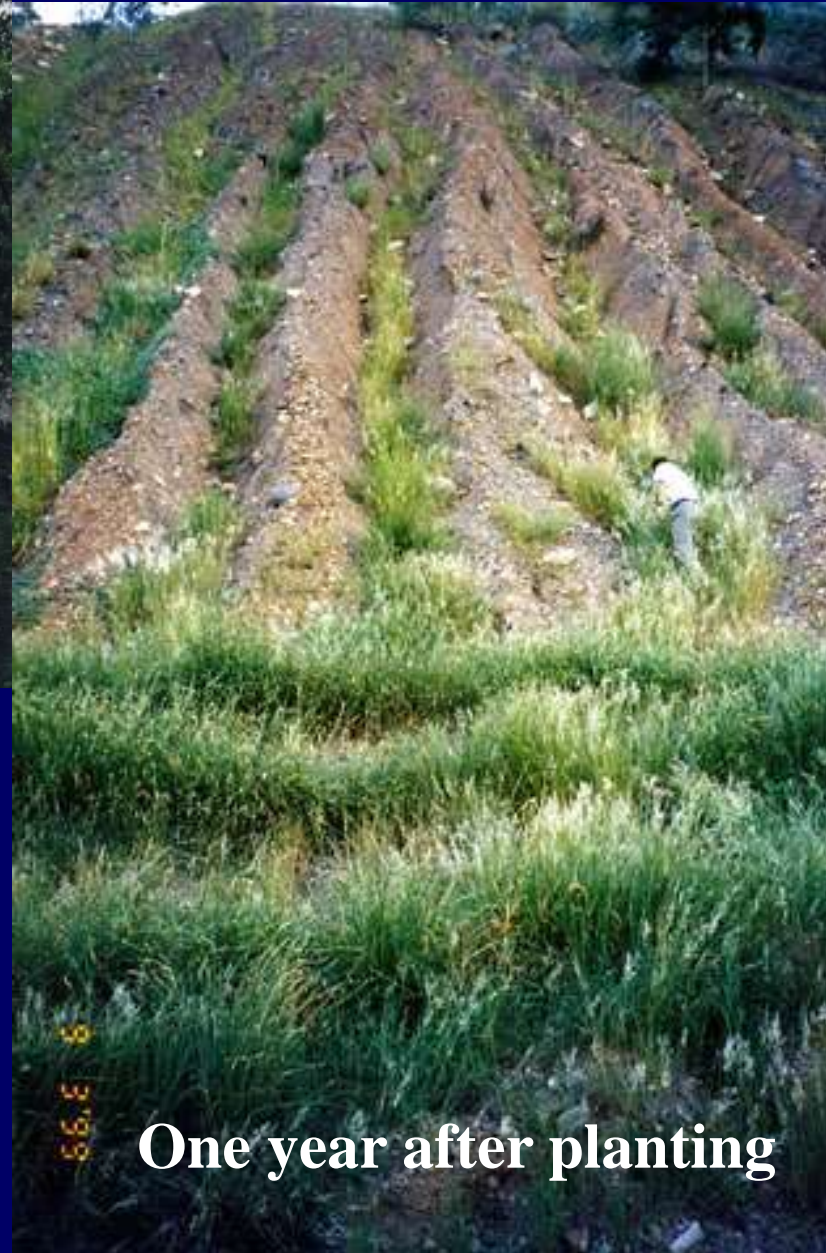
**Vetiver planting to stop gully  
erosion and trapping sediment**

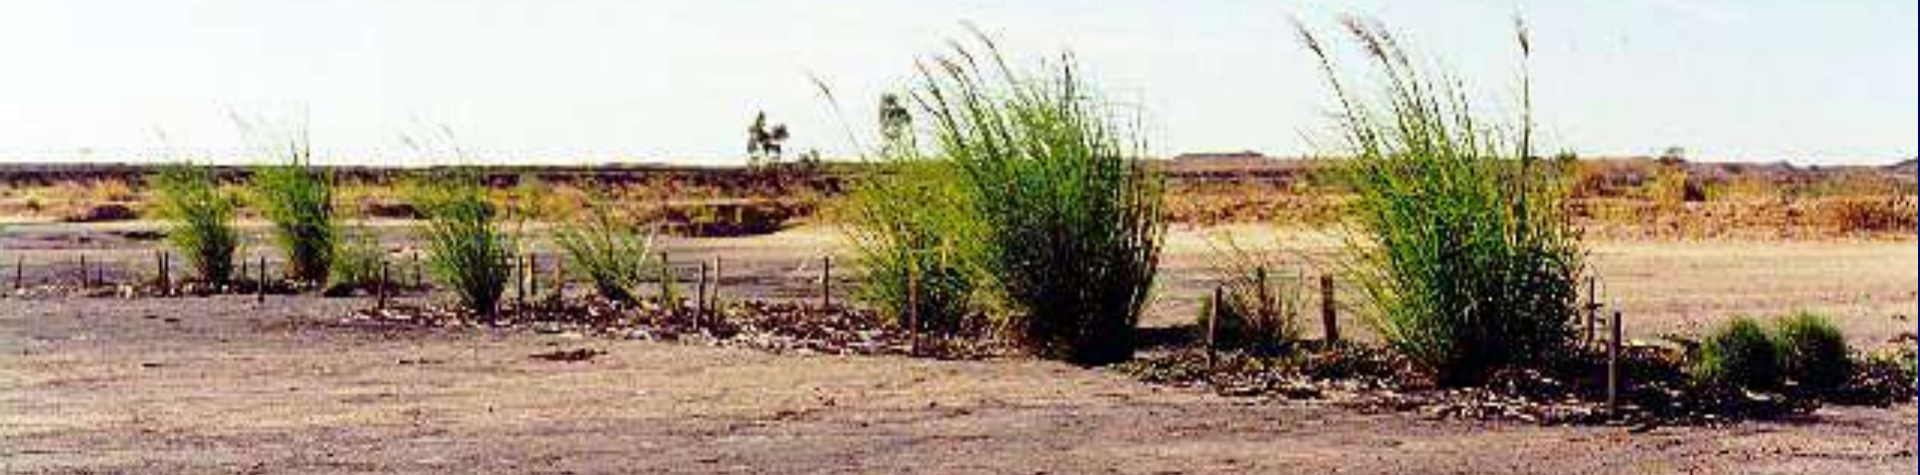
The tailings was saline, highly sodic, high levels of soluble S, Mg, Ca, Cu, Zn and Fe but extremely low in N and P.

Five salt tolerant species were used: vetiver, marine couch (*Sporobolus virginicus*), common reed grass (*Phragmites australis*), cumbungi (*Typha domingensis*) and *Sarcocornia* spp.

Complete mortality was recorded after 210 days for all species except vetiver and marine couch. Vetiver's survival was significantly increased by mulching but fertiliser application by itself had no effect.

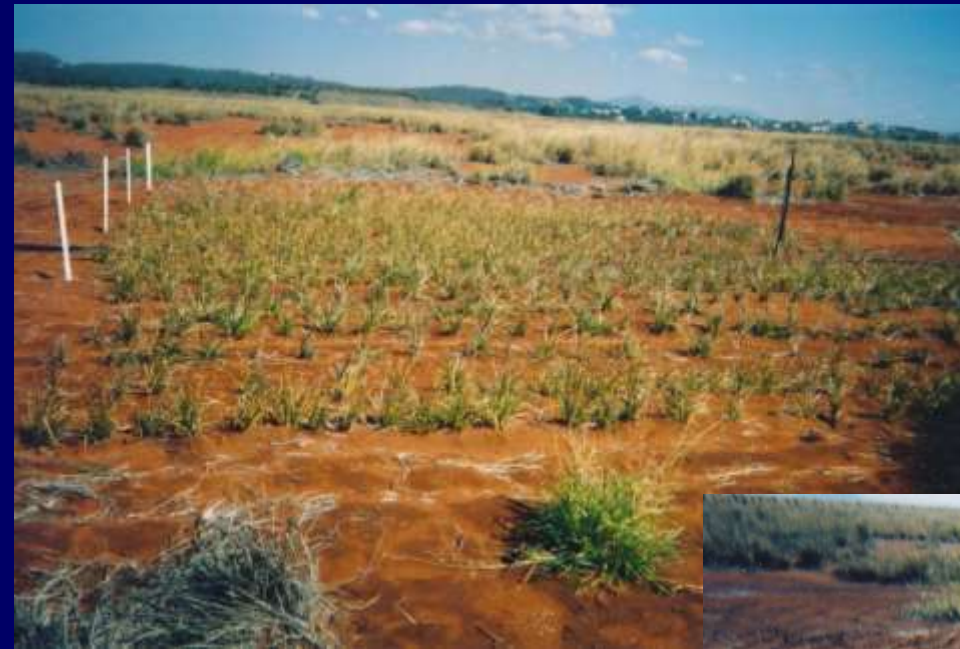
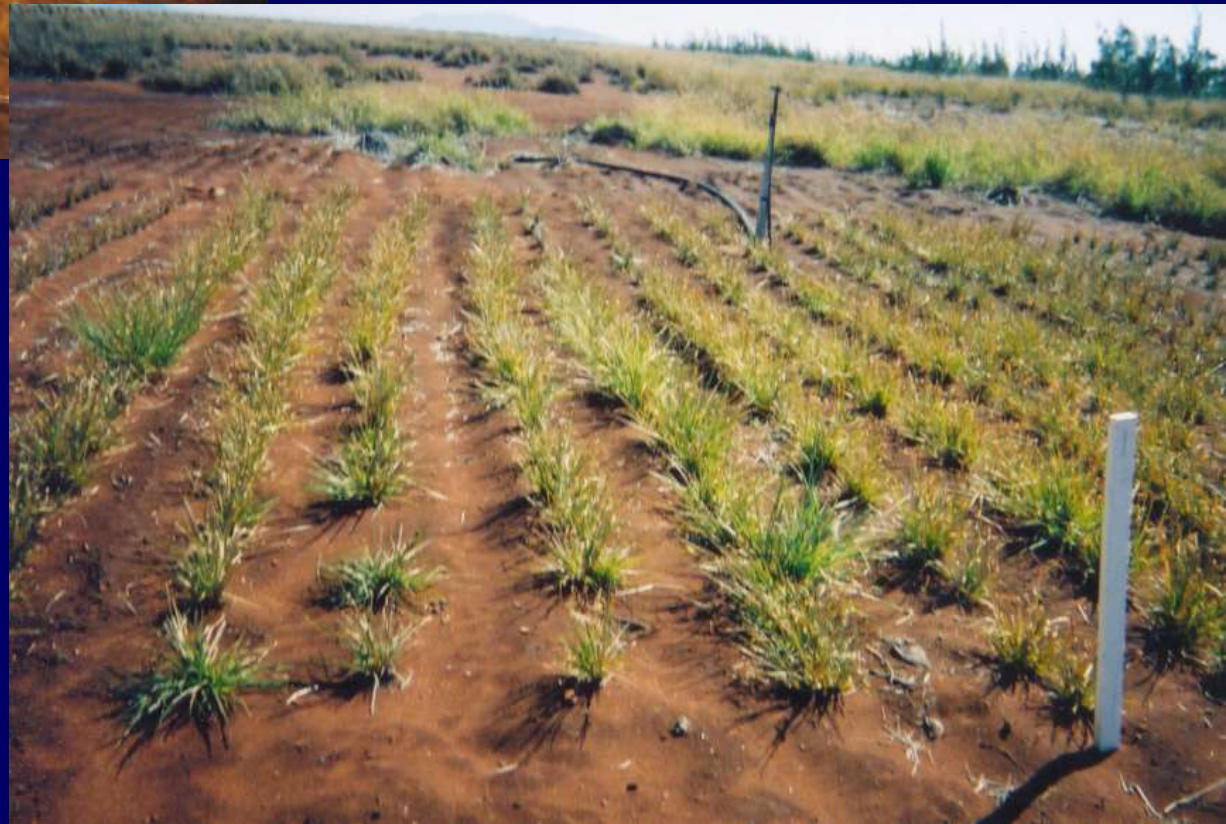
Three week after planting  
with only N and P fertilizers

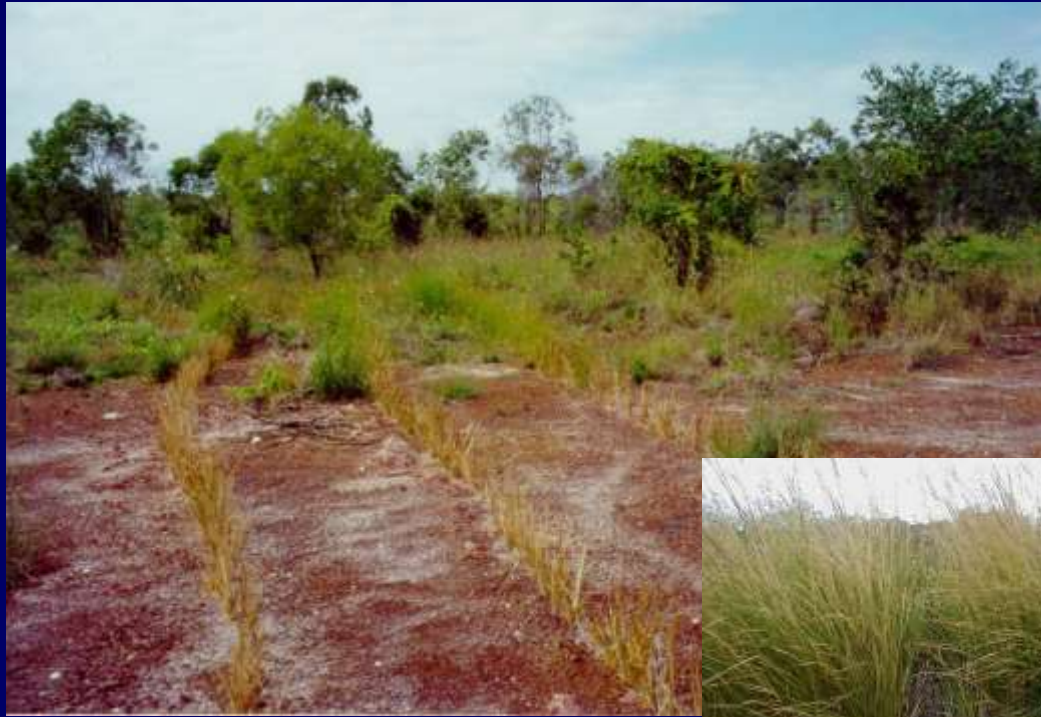
**New planting on highly caustic old residue sand**

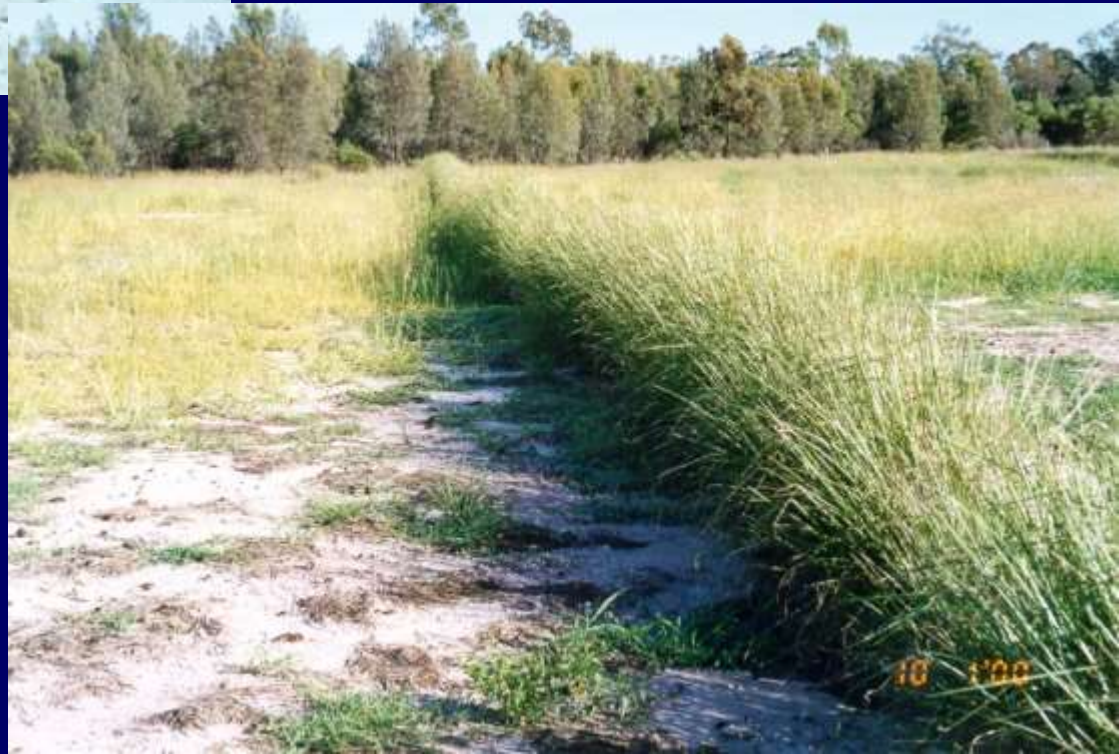
**This Bentonite mine tailings dump is barren with an extremely erodible surface which has low water infiltration and high runoff rates.**

**Fourteen months after planting, note the growth of other species**

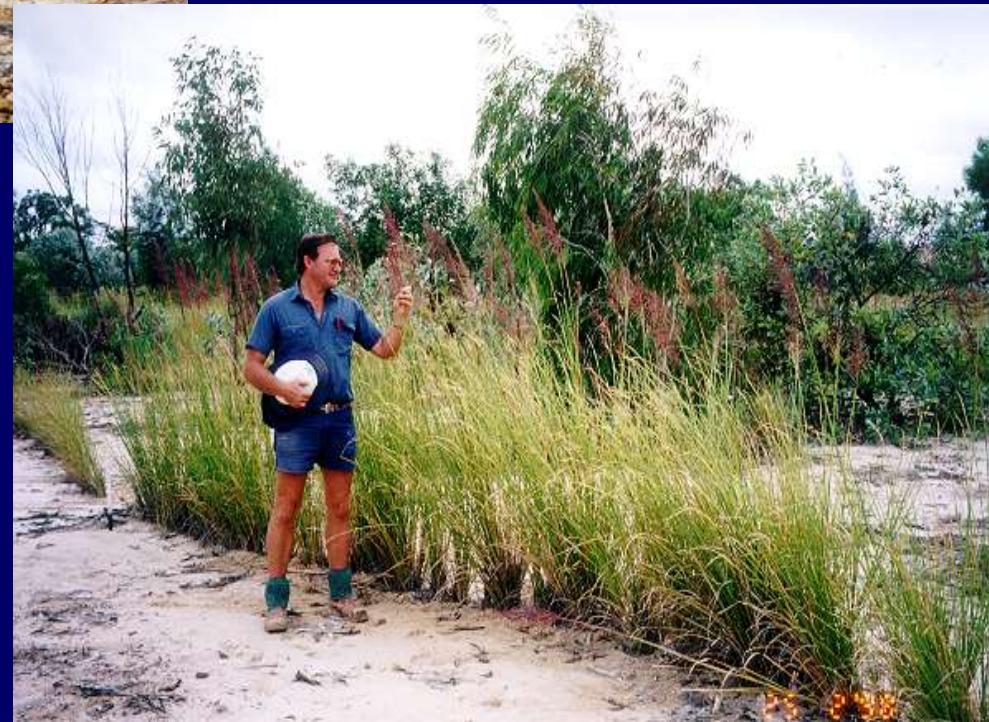
**Good establishment and growth with lime and fertiliser application on this site**

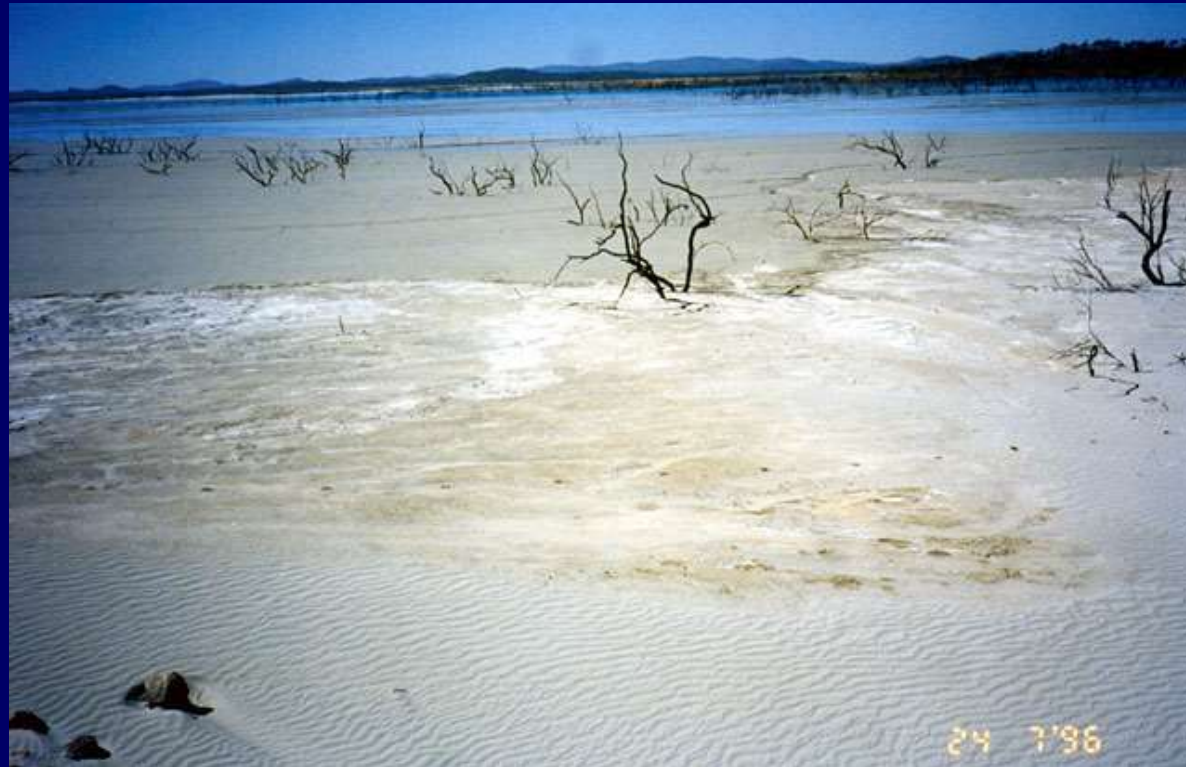
**Kidston mine large fresh tailings pond, typical of a big gold mine**

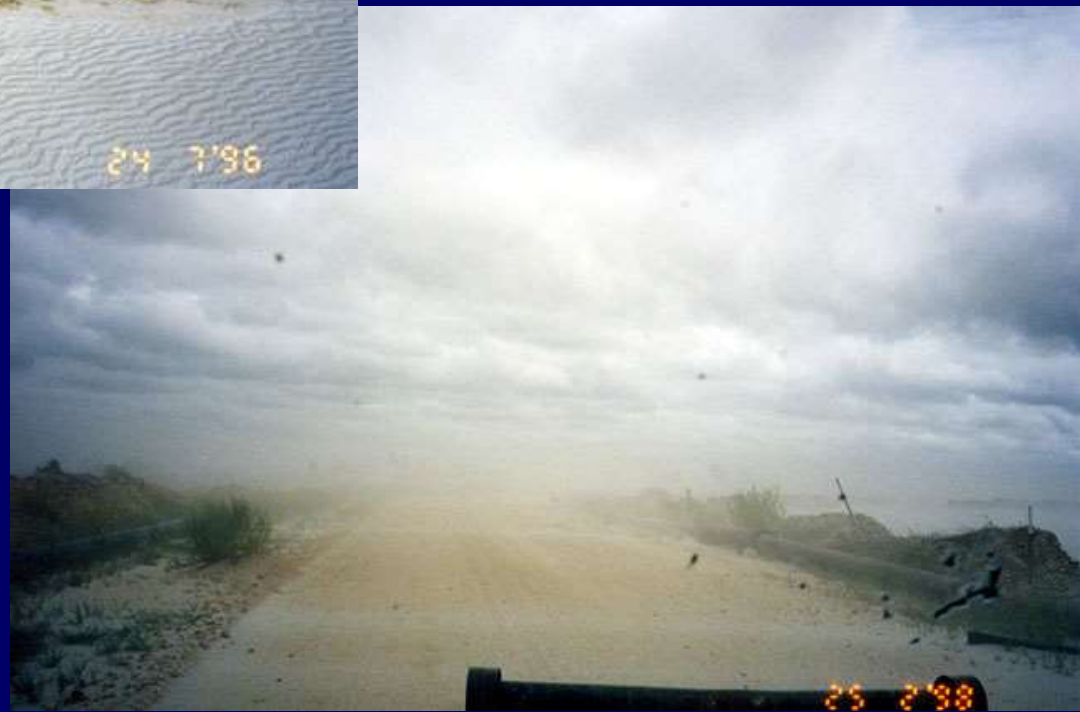
**Strong wind causes dust storm, which is highly contaminated with heavy metals such as Arsenic, Copper etc**

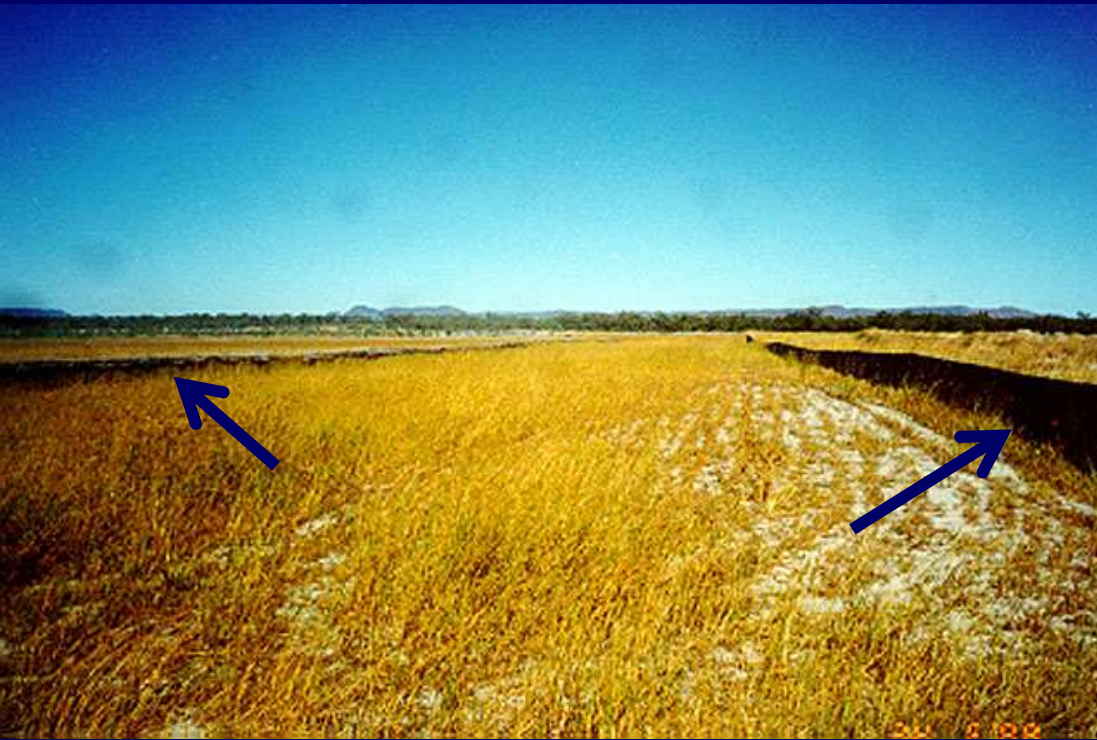
**Conventional measure  
is to plant a surface  
cover crop and to build  
fences to control wind  
erosion promoting crop  
establishment**
