# VETIVER GRASS TECHNOLOGY FOR REHABILITATION OF MINING WASTES AND TAILINGS

**Paul Truong**  
*TVNI Technical Director*  
*Director for Asia and Oceania,*  
**Brisbane, Australia**  
[p.truong@veticon.com.au](mailto:p.truong@veticon.com.au)  
[paultruong@vetiver.org](mailto:paultruong@vetiver.org)  
[www.vetiver.org](http://www.vetiver.org)

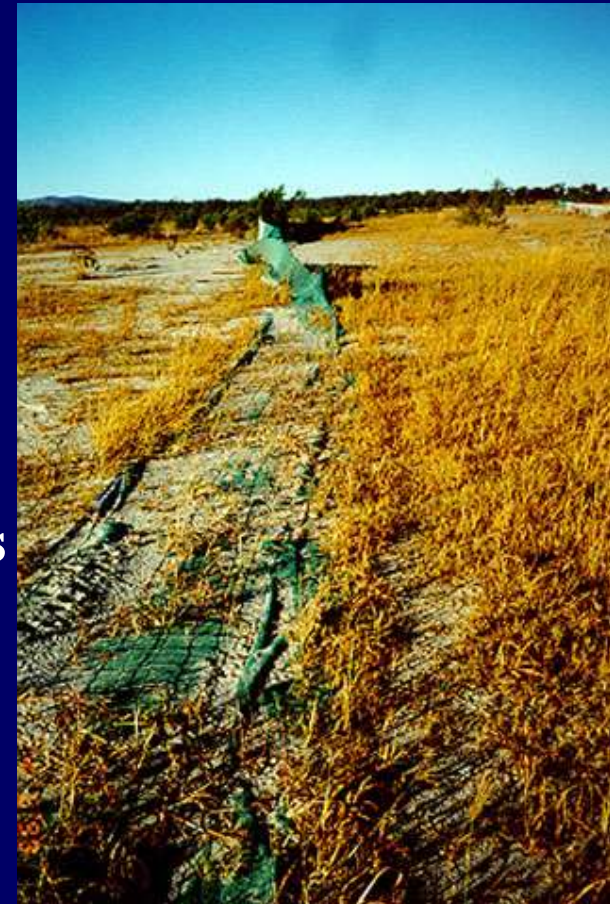
**Despite its very  
solid  
construction,  
these rigid and  
expensive fences  
are also  
vulnerable to  
high wind  
velocity**

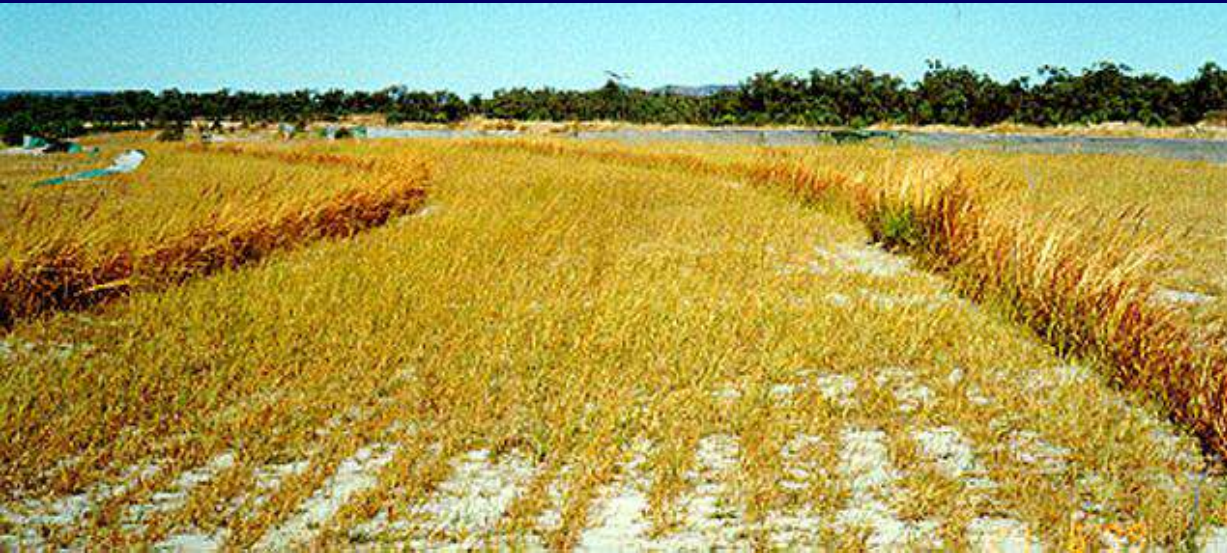
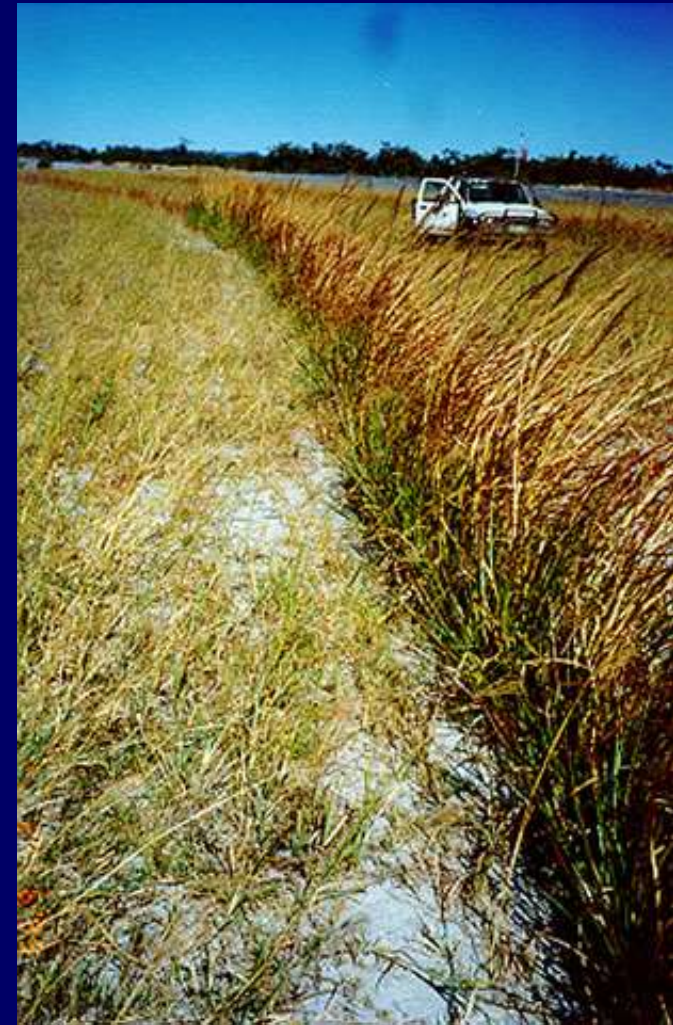
**The flexible Vetiver hedges provided a low cost and permanent wind barrier unaffected by strong winds, provided excellent protection for crop establishment (2 years after planting)**

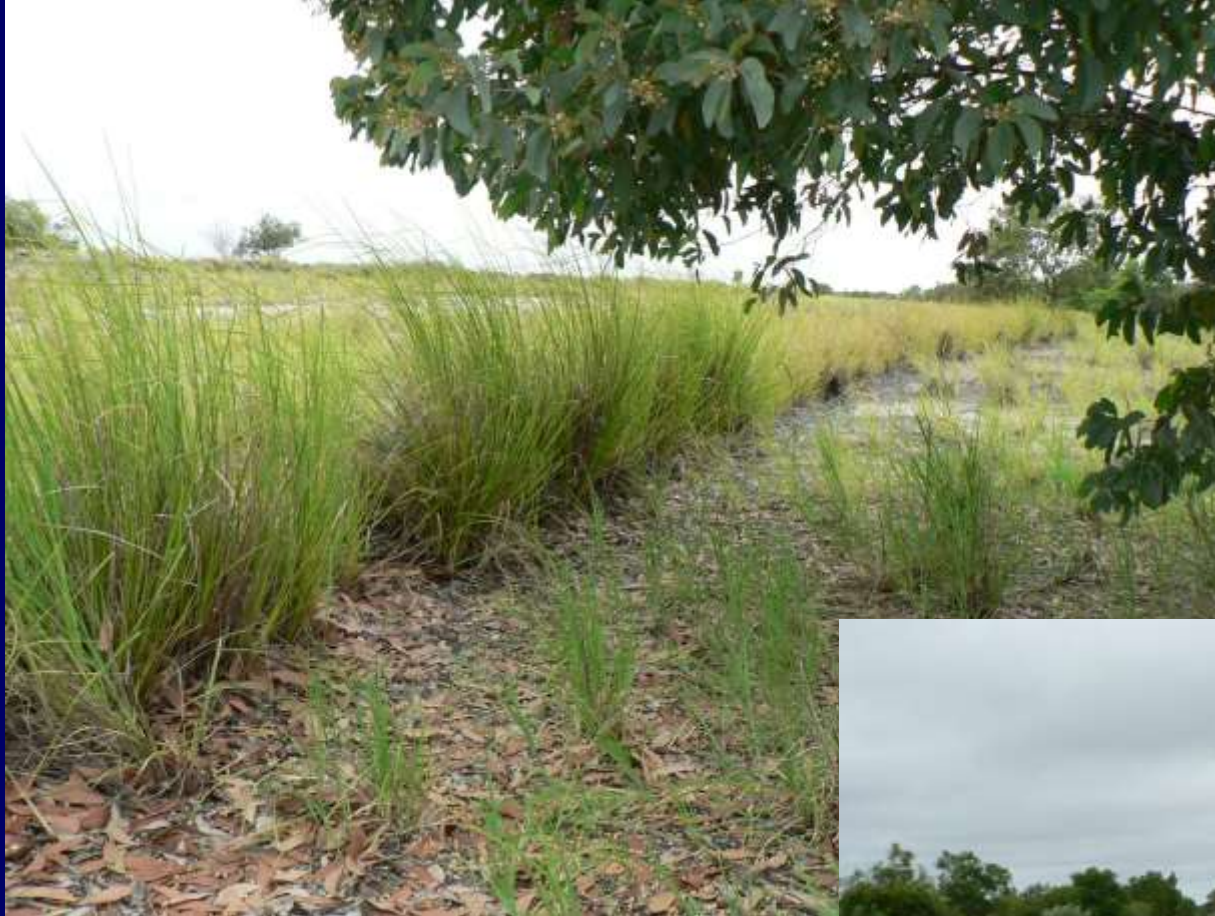
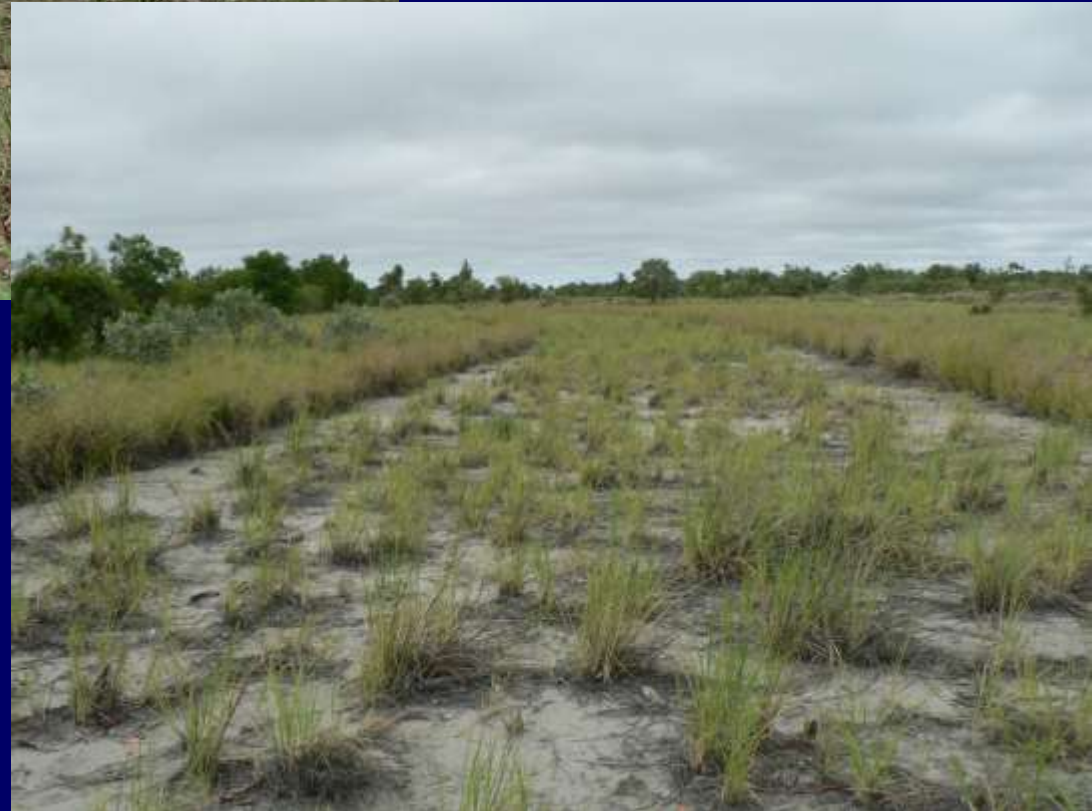
**Ten years after  
planting, no  
fertilizers and  
occasional  
grazing**

**Ten years after planting, no  
fertilizers and heavy  
grazing**

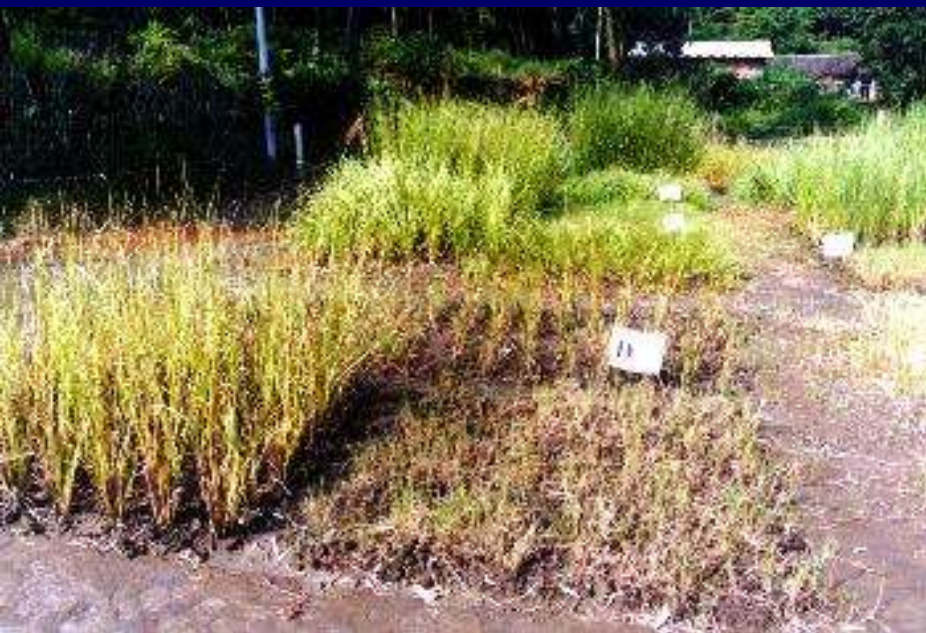
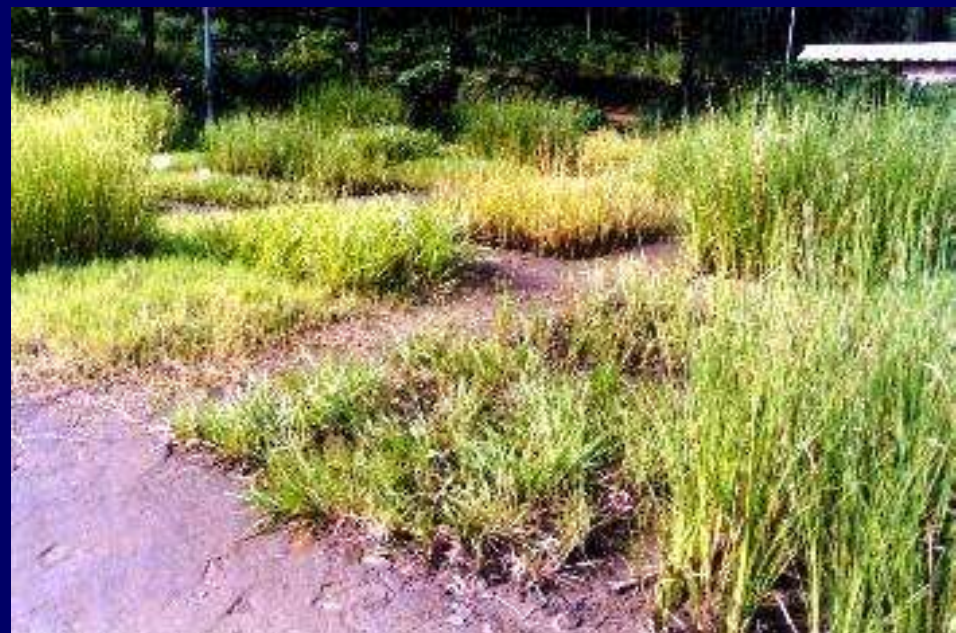
**With biosolids**

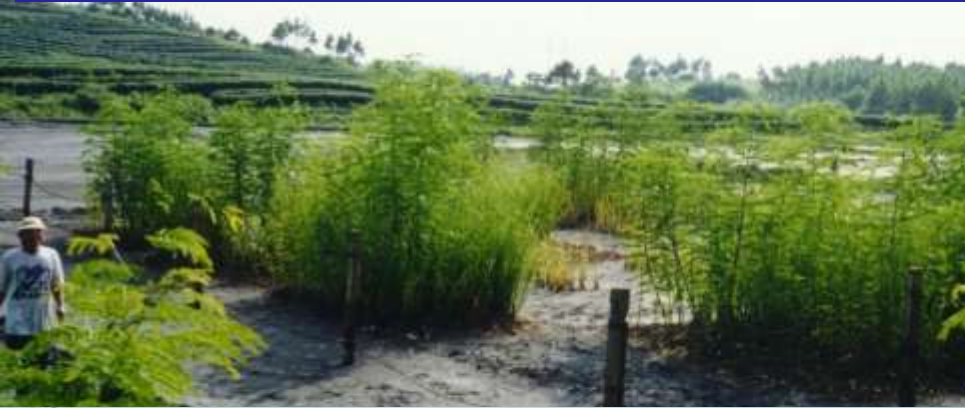
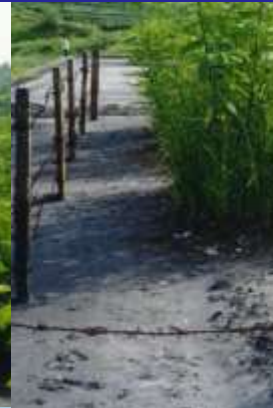
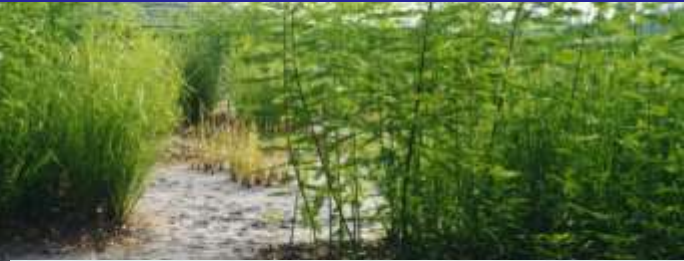
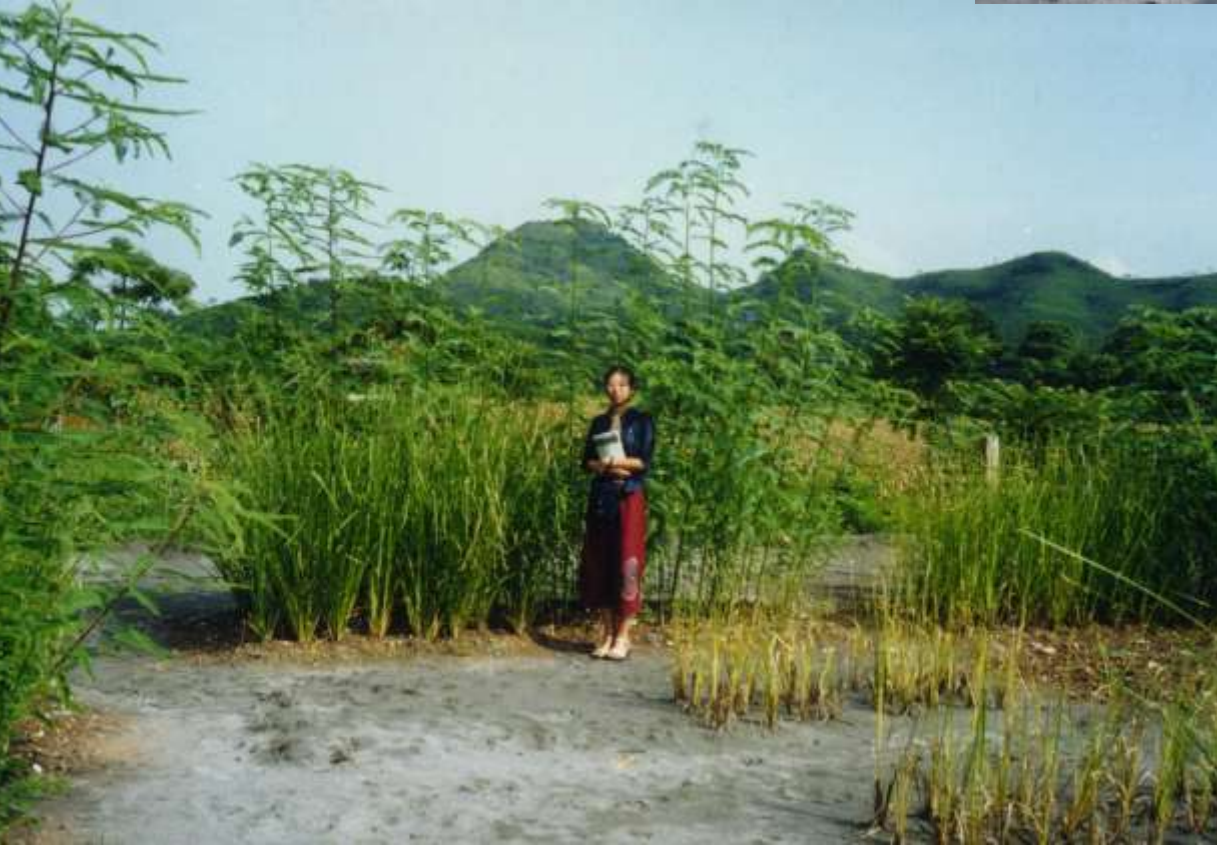
**Research:** Vetiver had the highest tolerance and accumulated the lowest concentrations of heavy metals in shoot.

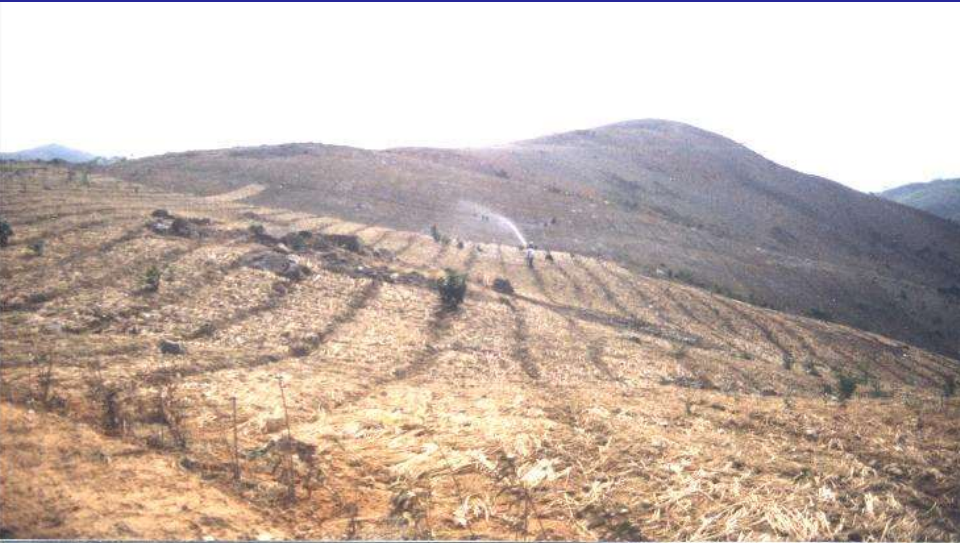
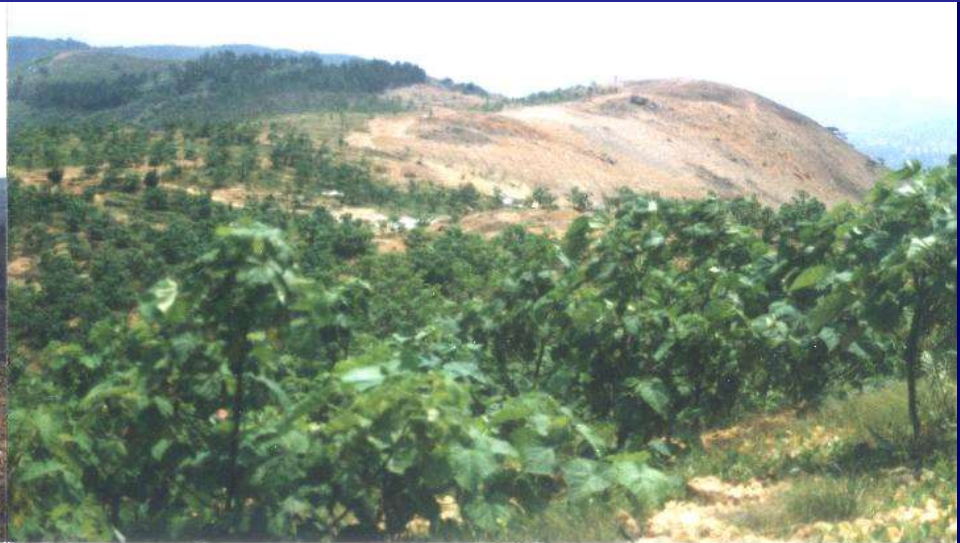
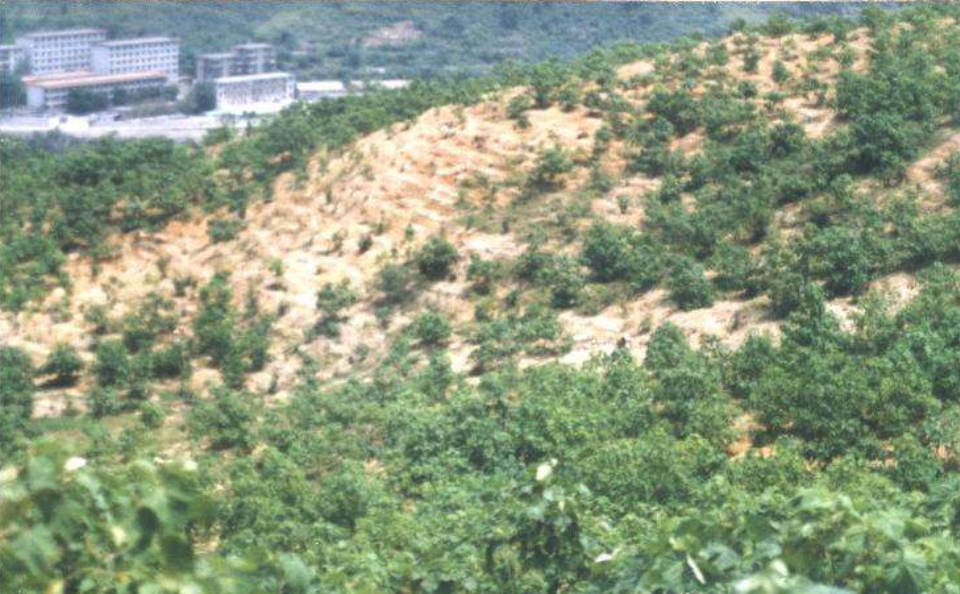
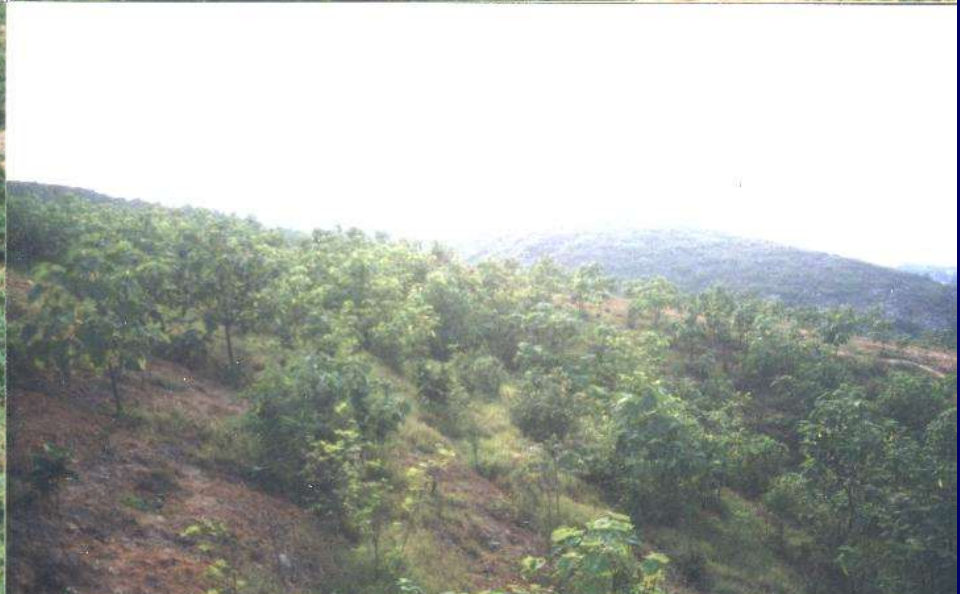
**Application:** The land around the smelting factory was severely contaminated by heavy metals. Many efforts were failed but Vetiver was well established after 5-months

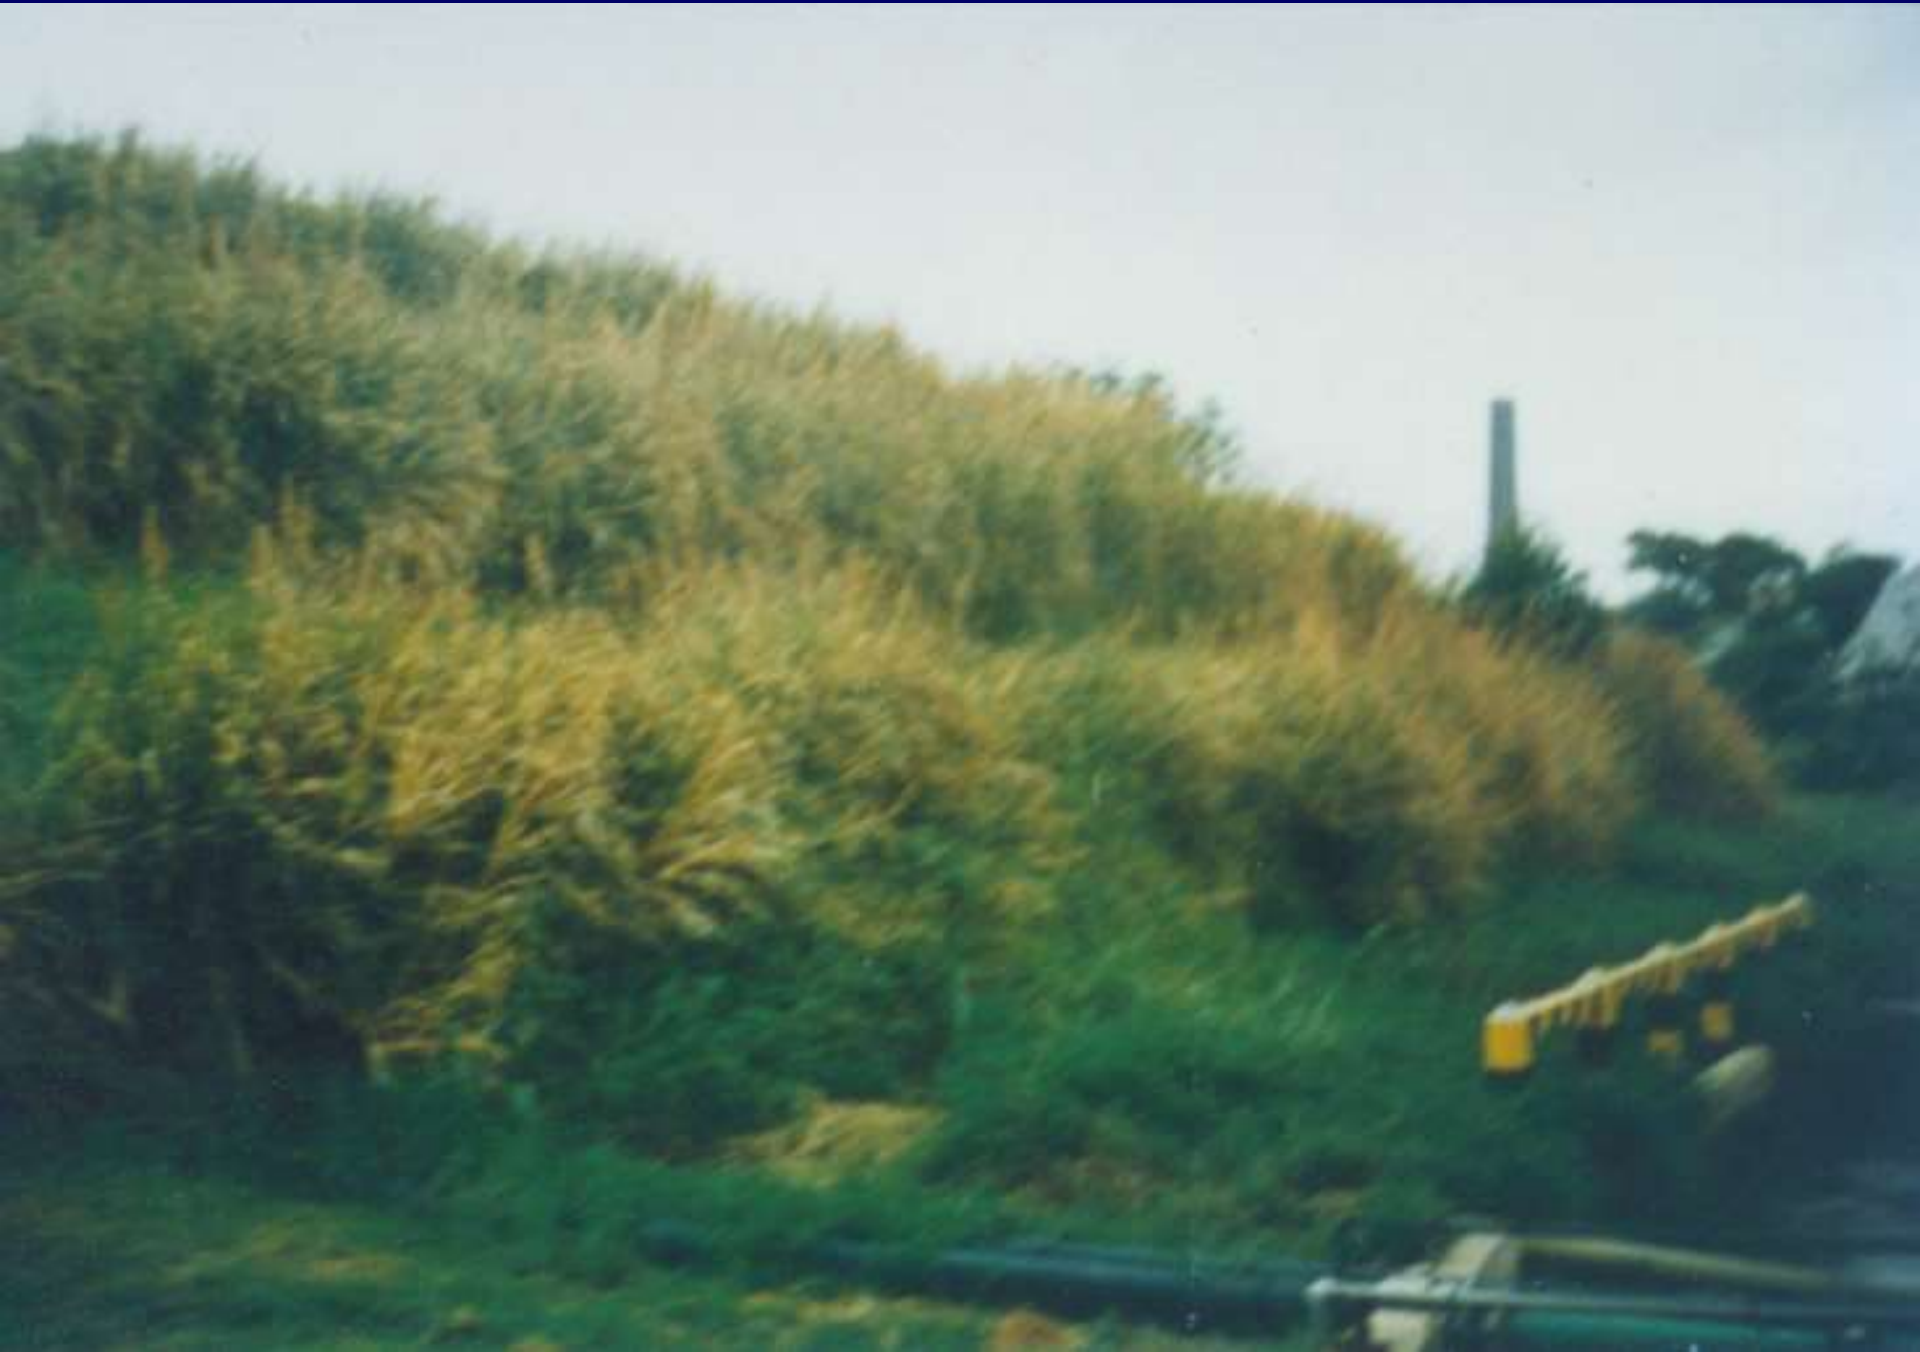
**Same tailings dam wall, 3 year later**

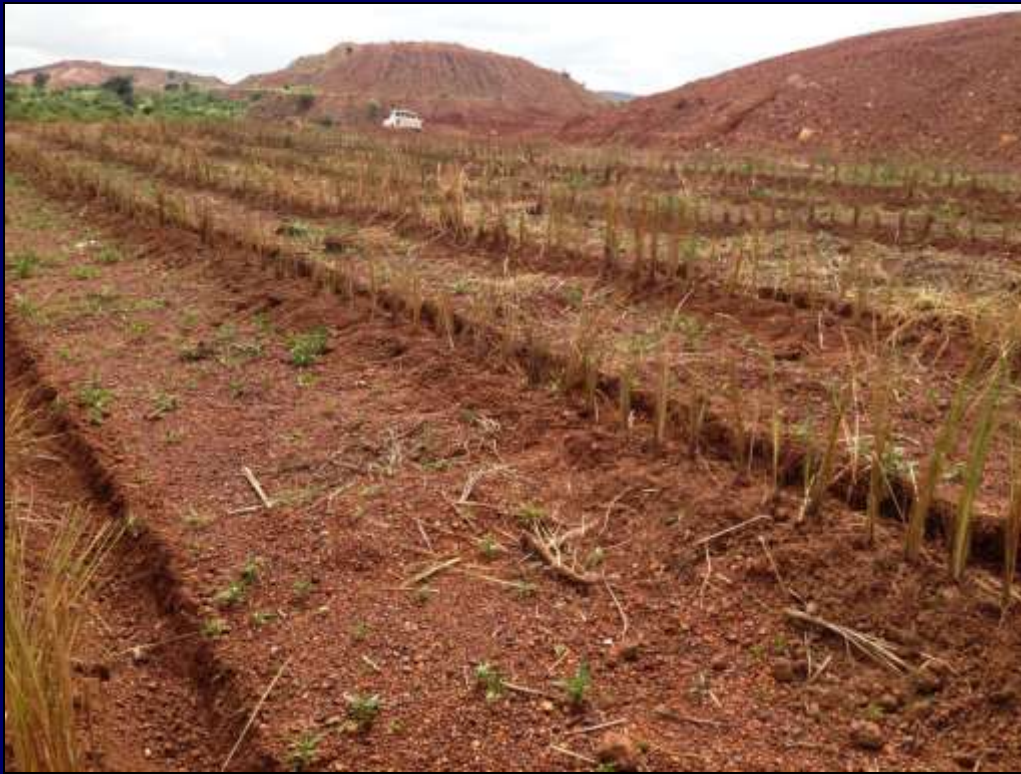
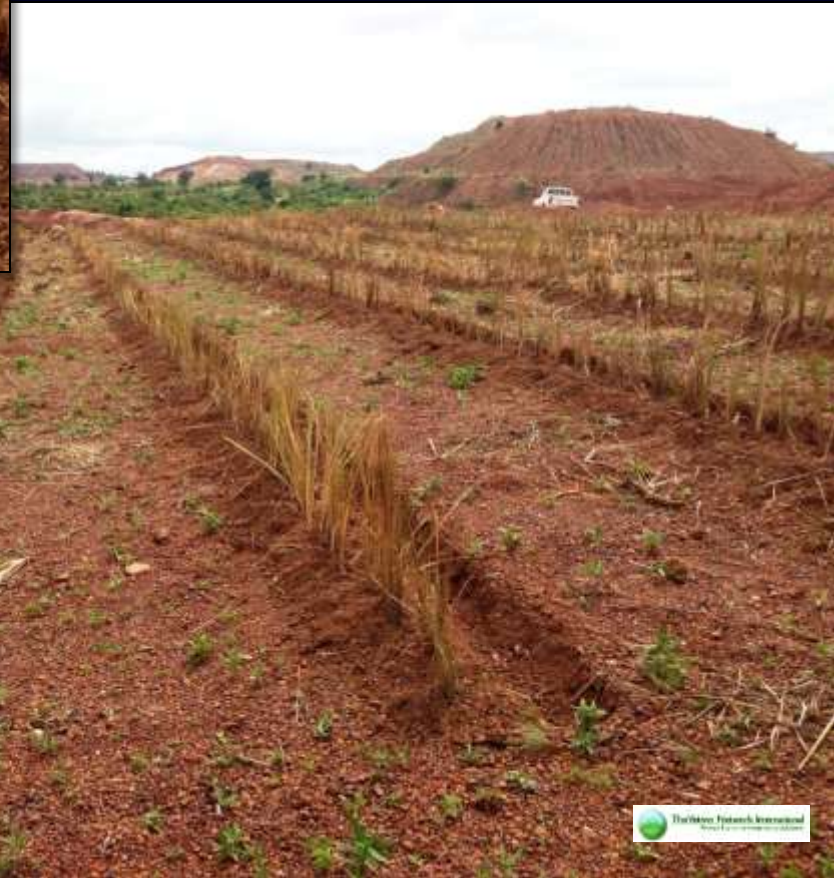
**Vetiver Grass Slips  
planted in contour  
furrows and  
hydromulched at  
Anglo Ashanti Gold**

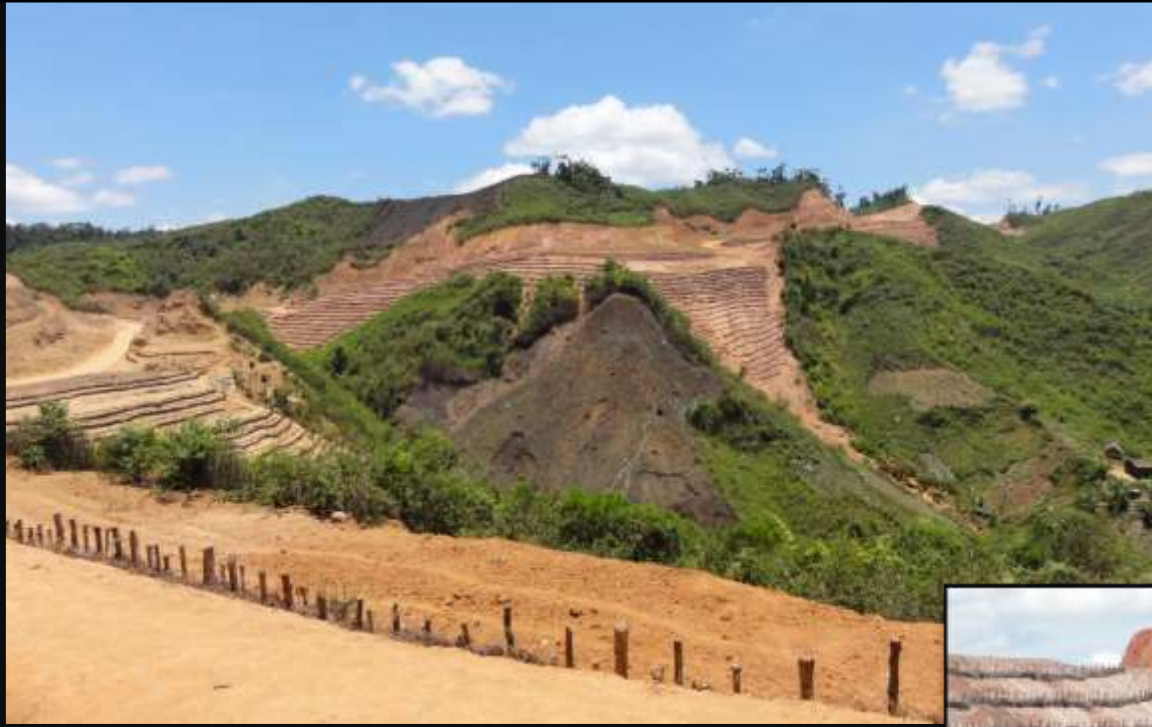
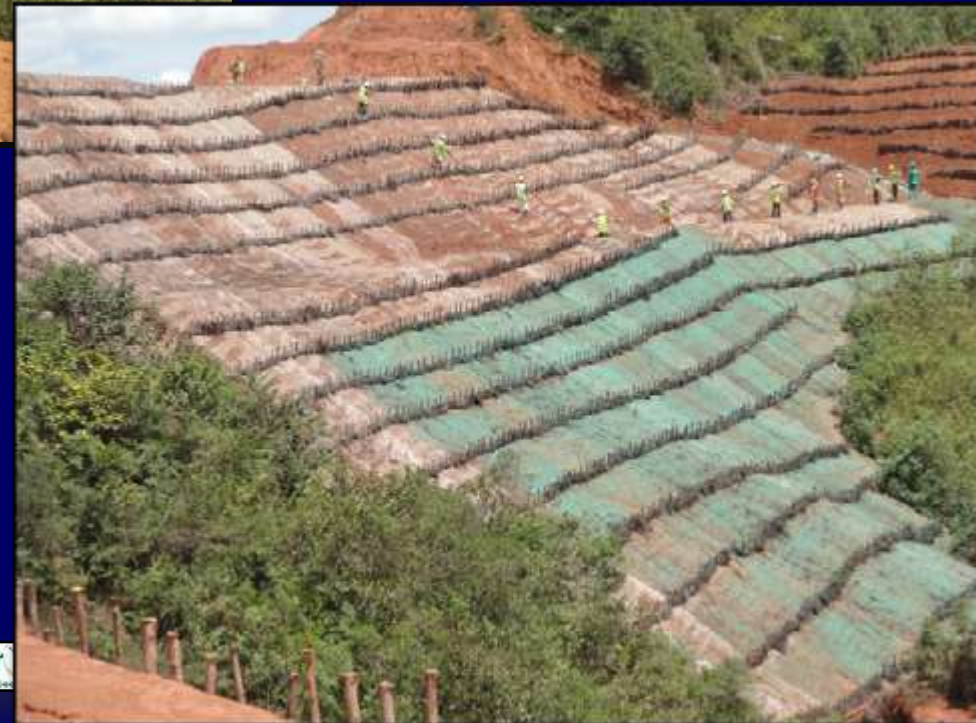
- **Length of rows: 220 km**
- **Area rehabilitated: 550ha**
- **Rehabilitation period: 3 years**
- **Vetiver plants & fascines sourced from local communities**

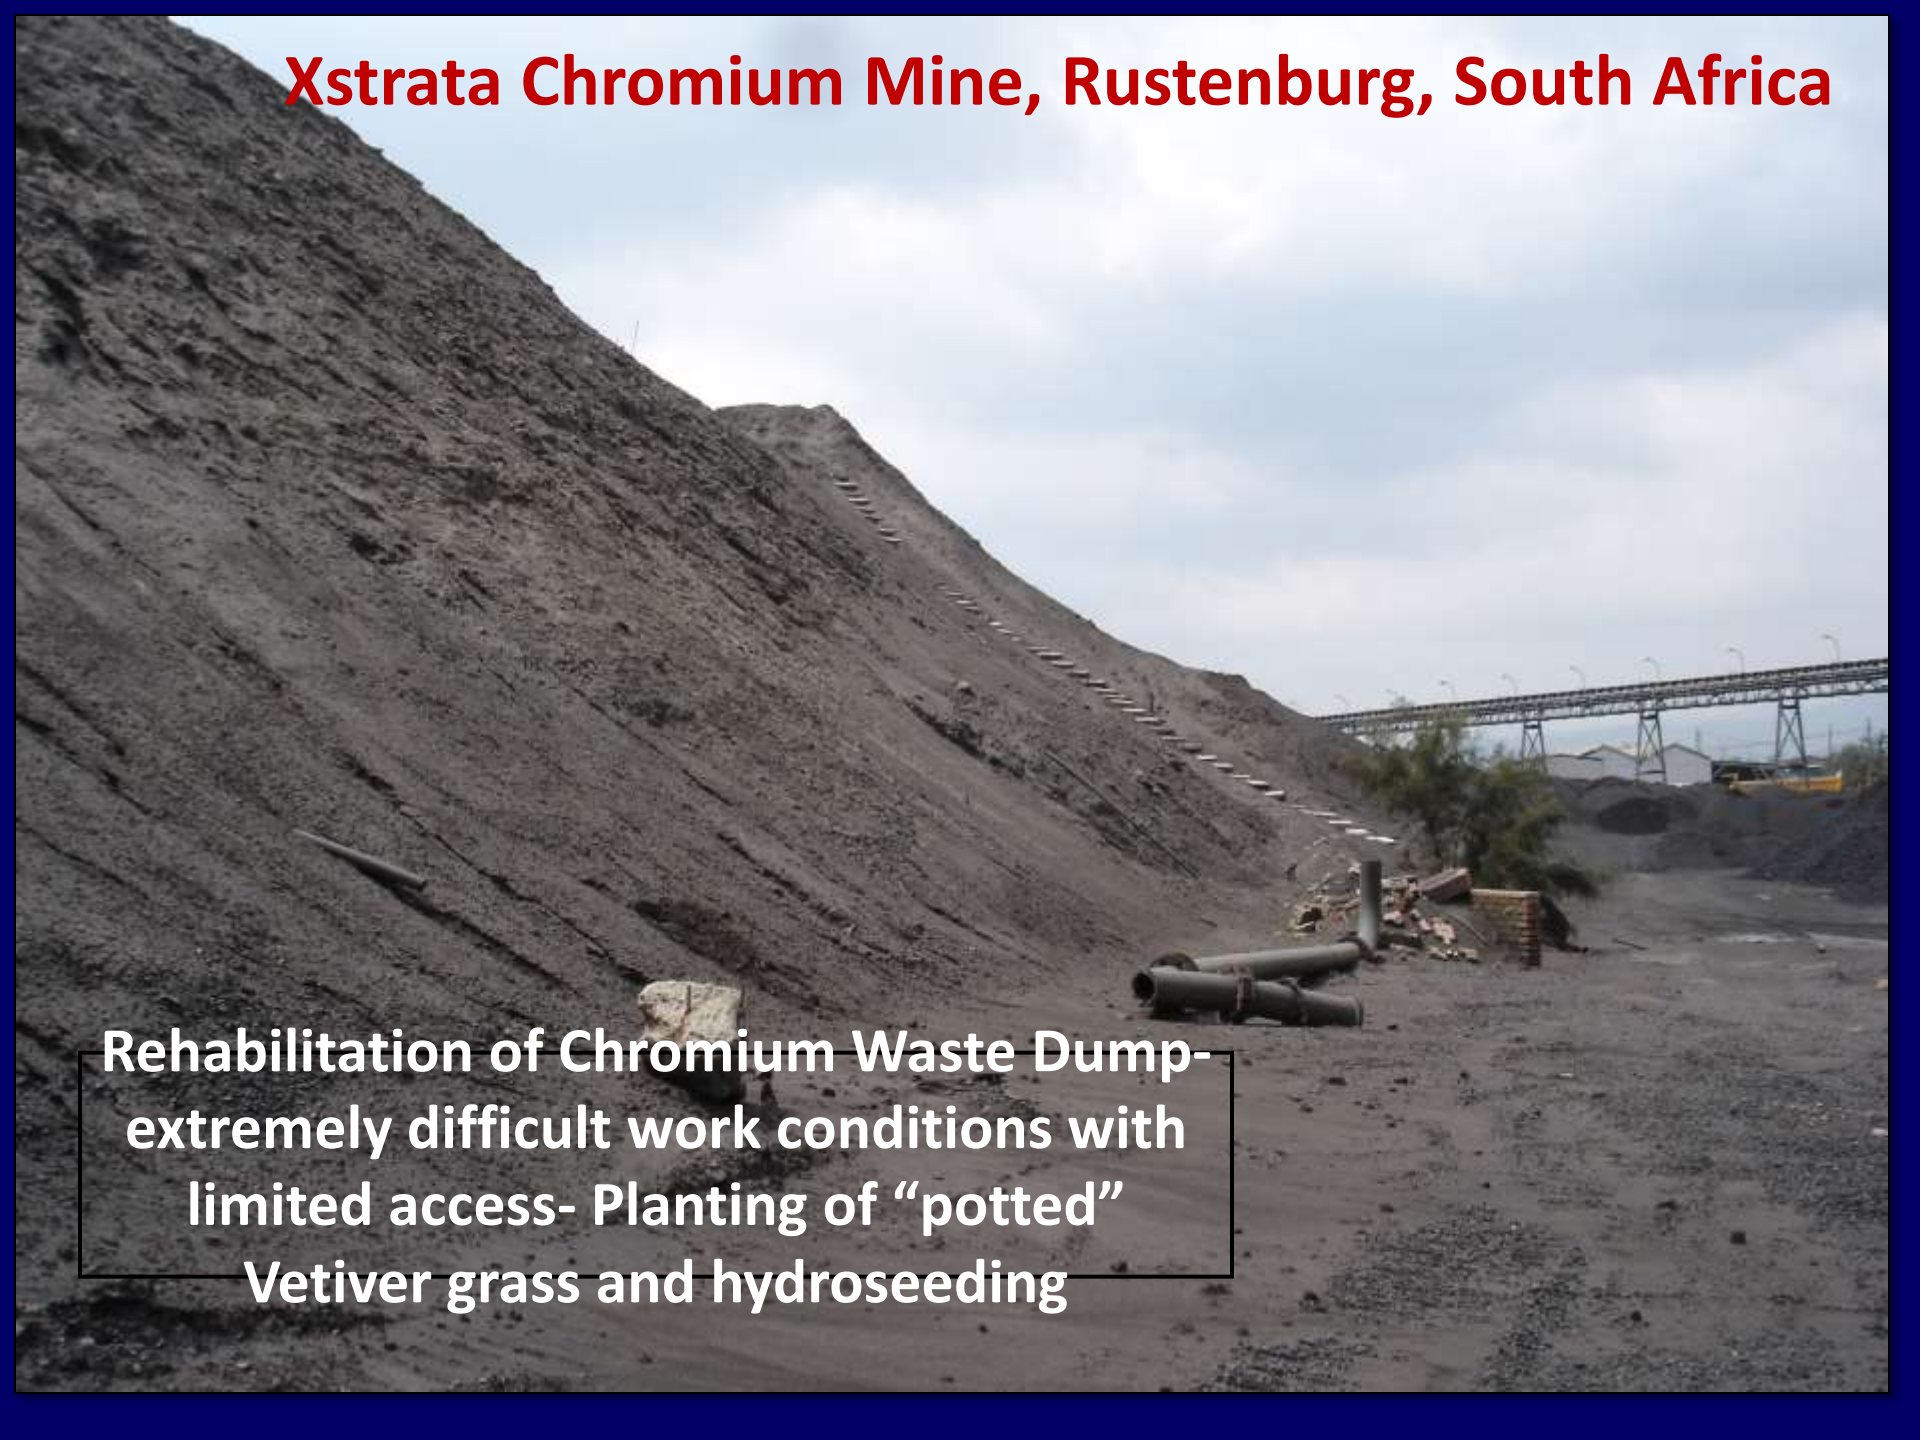
Rehabilitation of Chromium Waste Dump-  
extremely difficult work conditions with  
limited access- Planting of “potted”  
Vetiver grass and hydroseeding

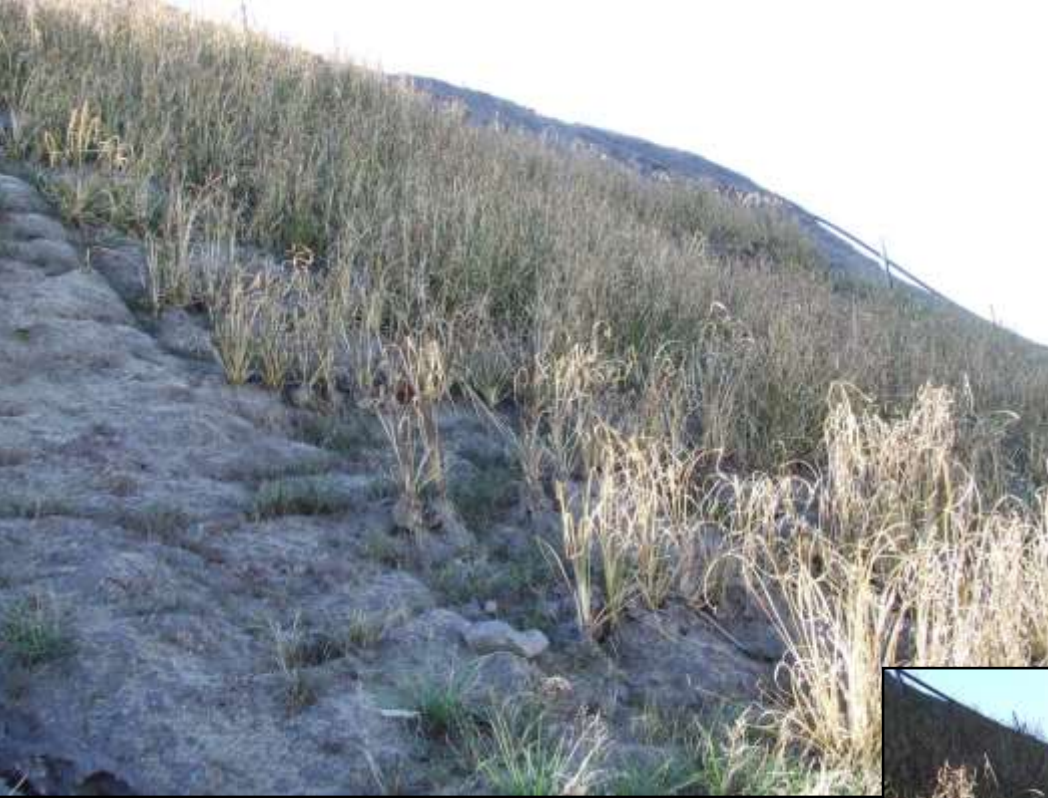
**Vetiver planted in rows 1 meter apart at intervals of 250mm. Areas between rows of Vetiver scarified and hydroseeded with native grass species**

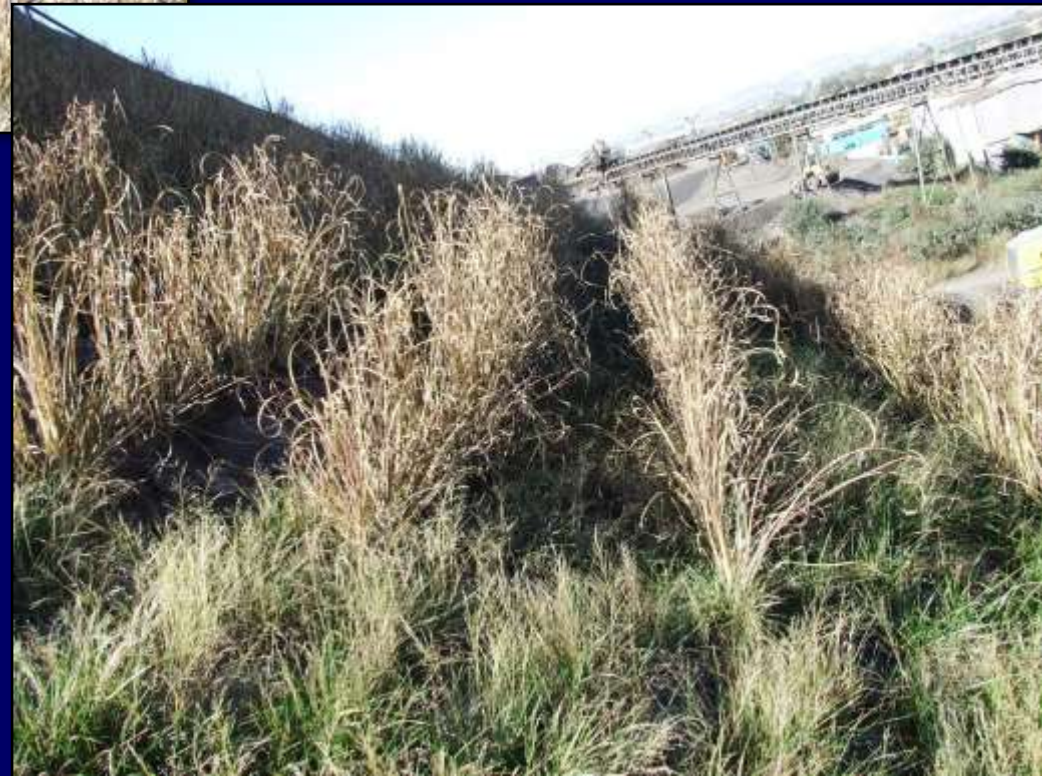
**Vetiver turned brown due to winter frost, will regrow in spring**
