# **VETIVER GRASS TECHNOLOGY FOR REHABILITATION OF MINING WASTES AND TAILINGS**

**Paul Truong**  
*TVNI Technical Director*  
*Director for Asia and Oceania,*  
**Brisbane, Australia**

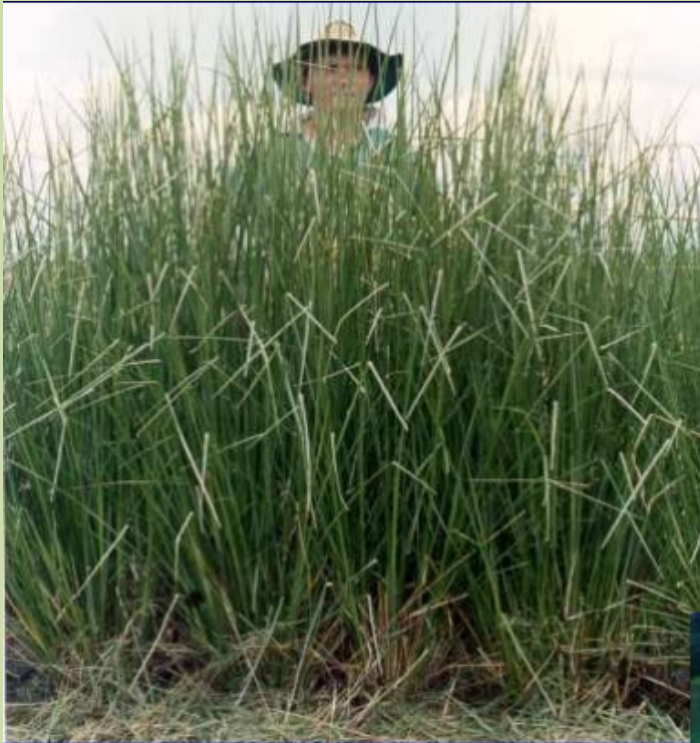
**Stiff and erect  
stems:**

**Erect stems up  
to 1.8m tall and  
over 2m with  
flower head**

**Forming a thick  
hedge when planted  
in row which can  
spread and slow  
down runoff water**

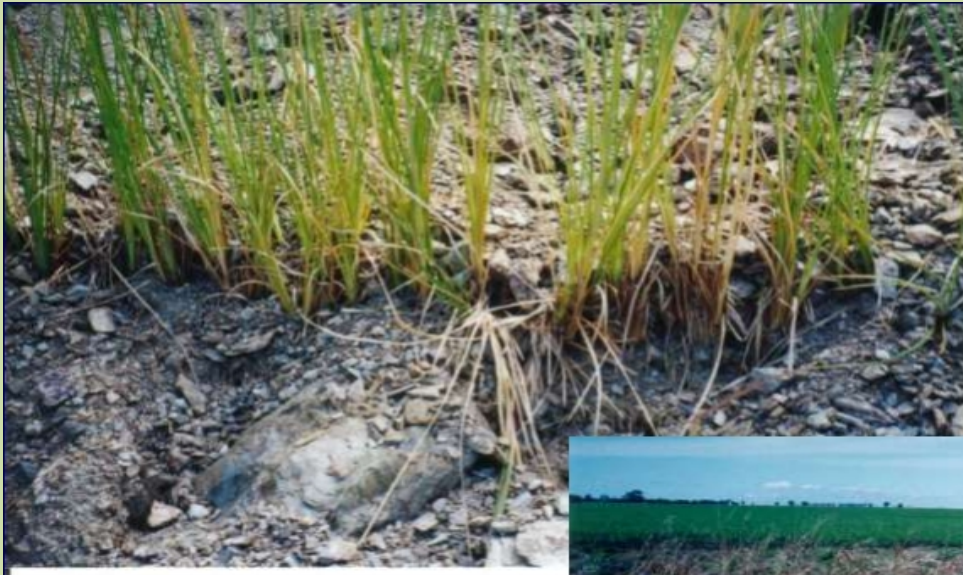
**Even at this young age  
the stiff **stem** is strong  
enough to trap large  
size gravel**

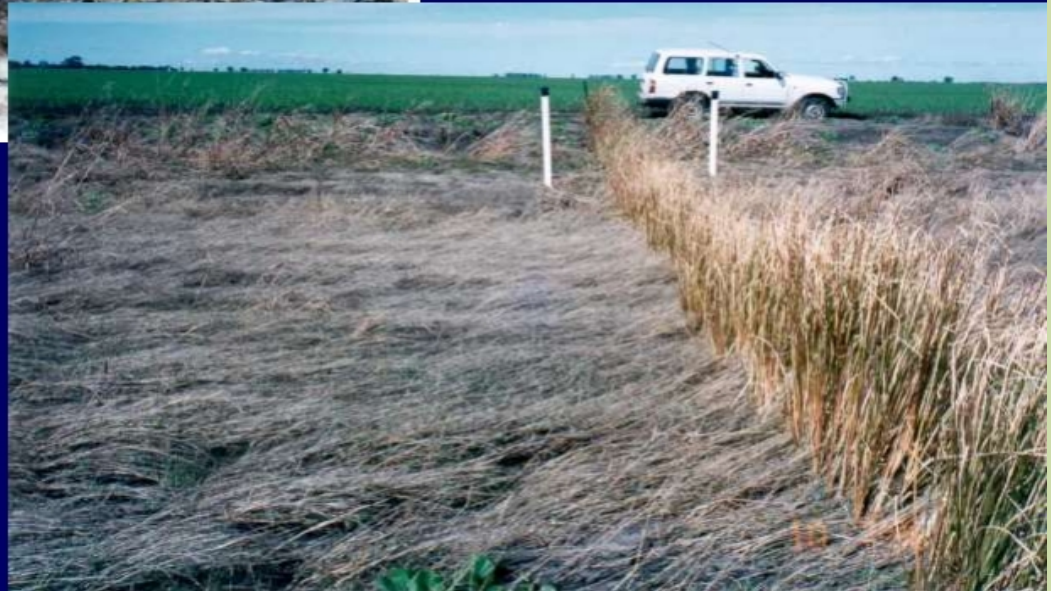
**Strong current  
flattened the native  
grass but not vetiver  
on this waterway**

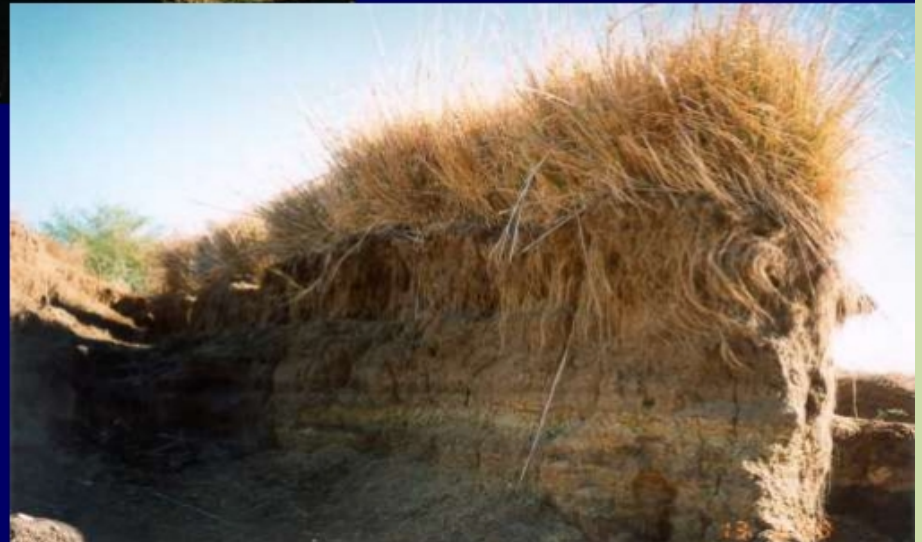
**Strong root  
reinforcement  
holding up this wall  
of soil against water  
erosion**

**Solid wall reinforced  
by vetiver roots**

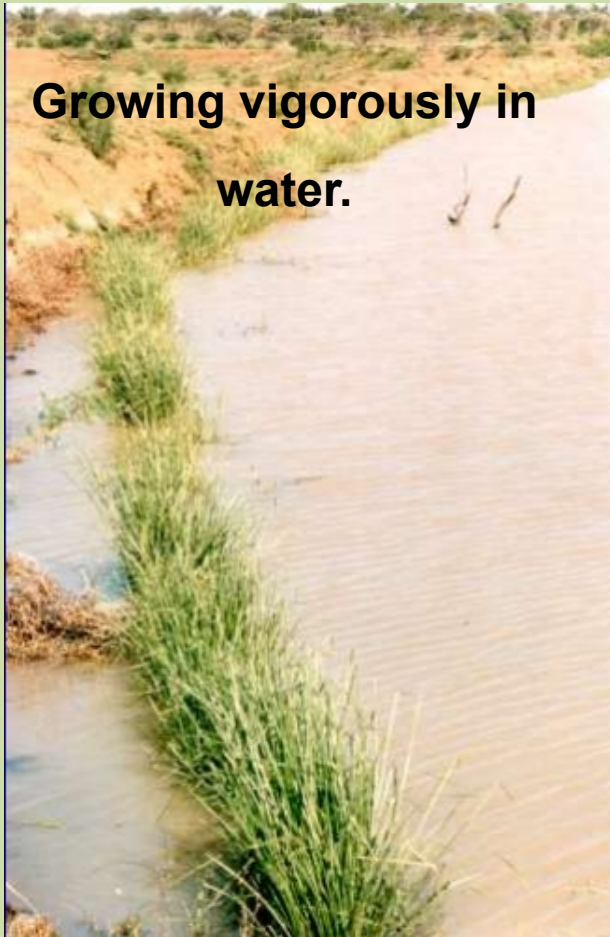
**Tests conducted in China found that when completely submerged, vetiver survived for 54 days.**

**Growing vigorously in water.**

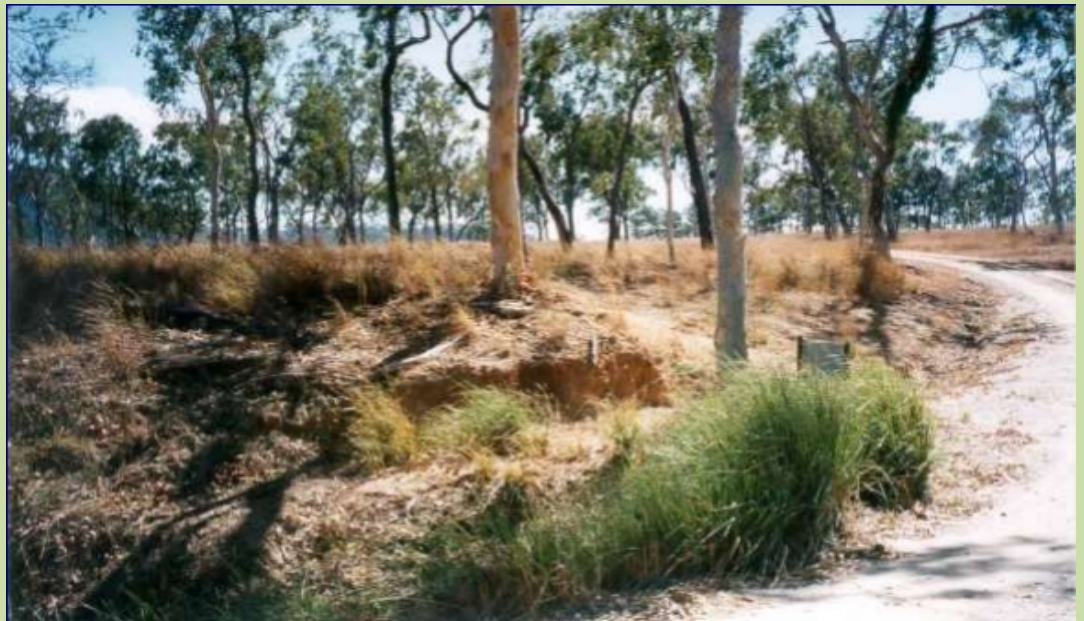
**Vetiver remained green but all native grasses were brown off under semi arid conditions in western Queensland .**

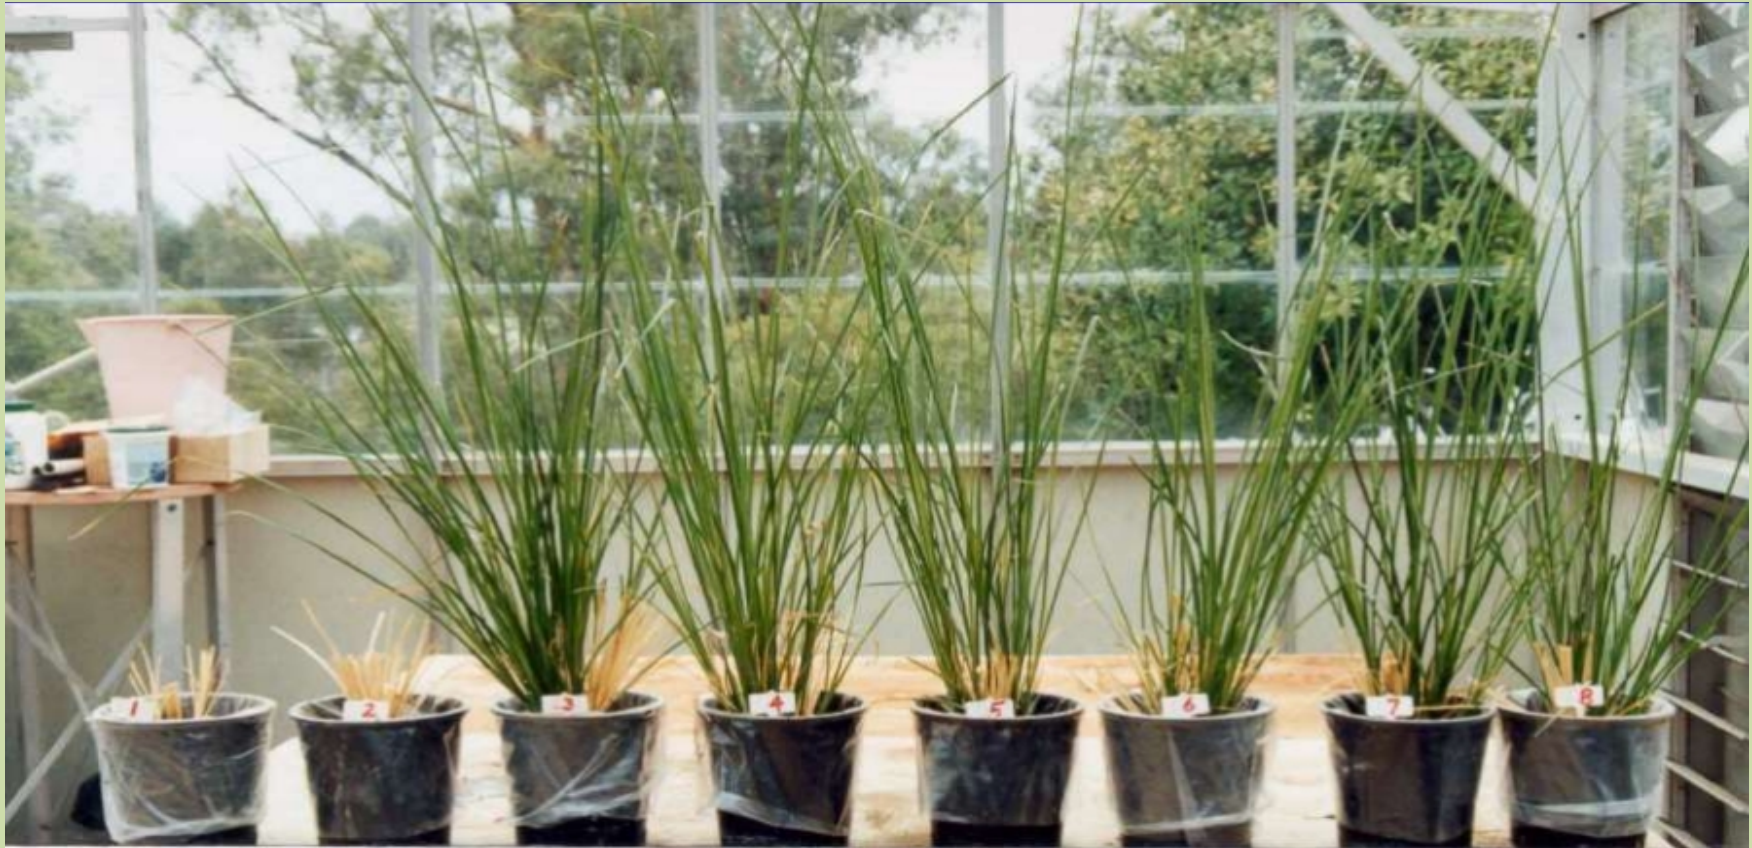
**Vetiver thrives at soil pH=3.8 and Al saturation percentage of 68% and 87% under field conditions**

pH	2.0	2.2	3.8	4.4	4.8	5.5	7.3	7.6
Al%	90	90	68	36	11	2	trace	trace

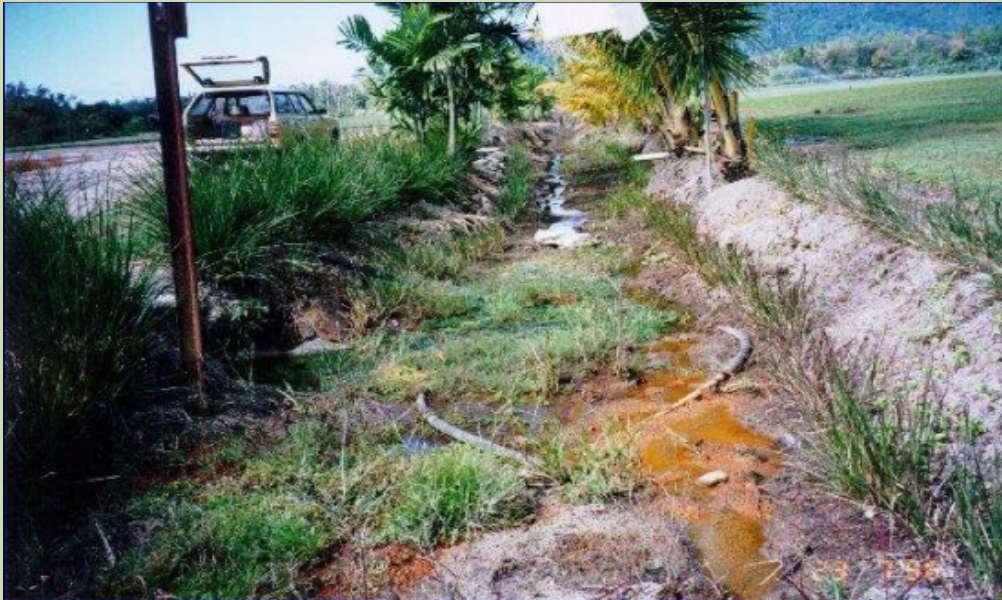
**Highly erodible acid  
sulfate soil (pH 3.0)  
in coastal Australia**

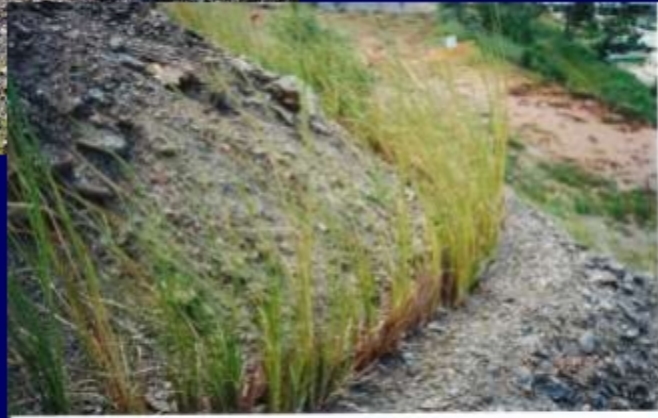
**Highly erodible alkaline  
and sodic overburden of  
open cut coal mine in  
central Queensland**

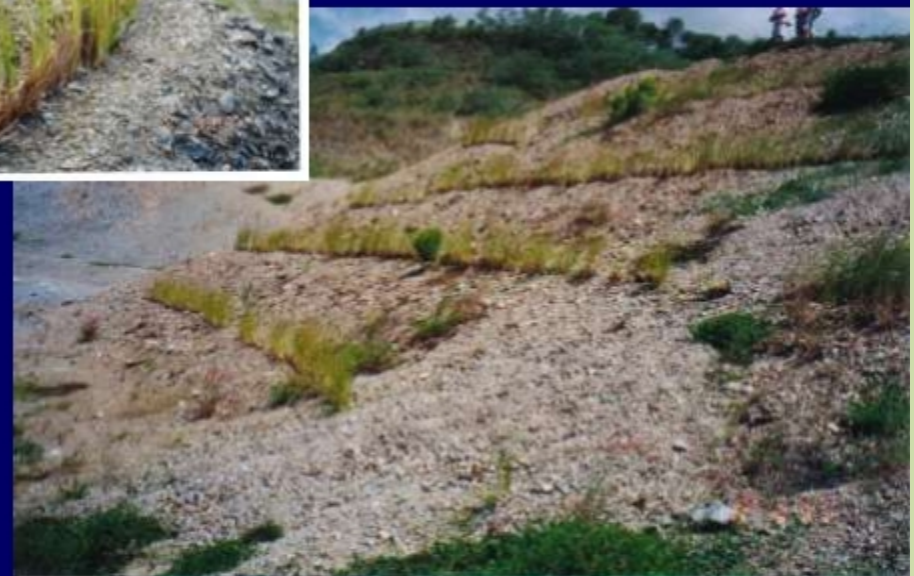
**Vetiver planted on contour  
line to conserve soil  
moisture and stabilising  
loose surface materials**

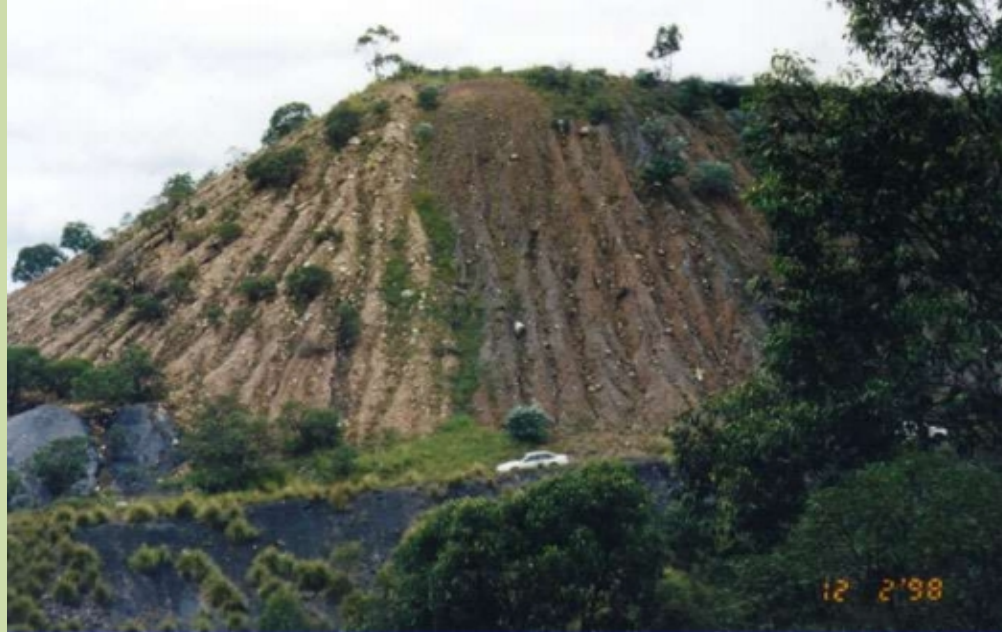
**This coal mine waste rock dump remained barren after 50 years**

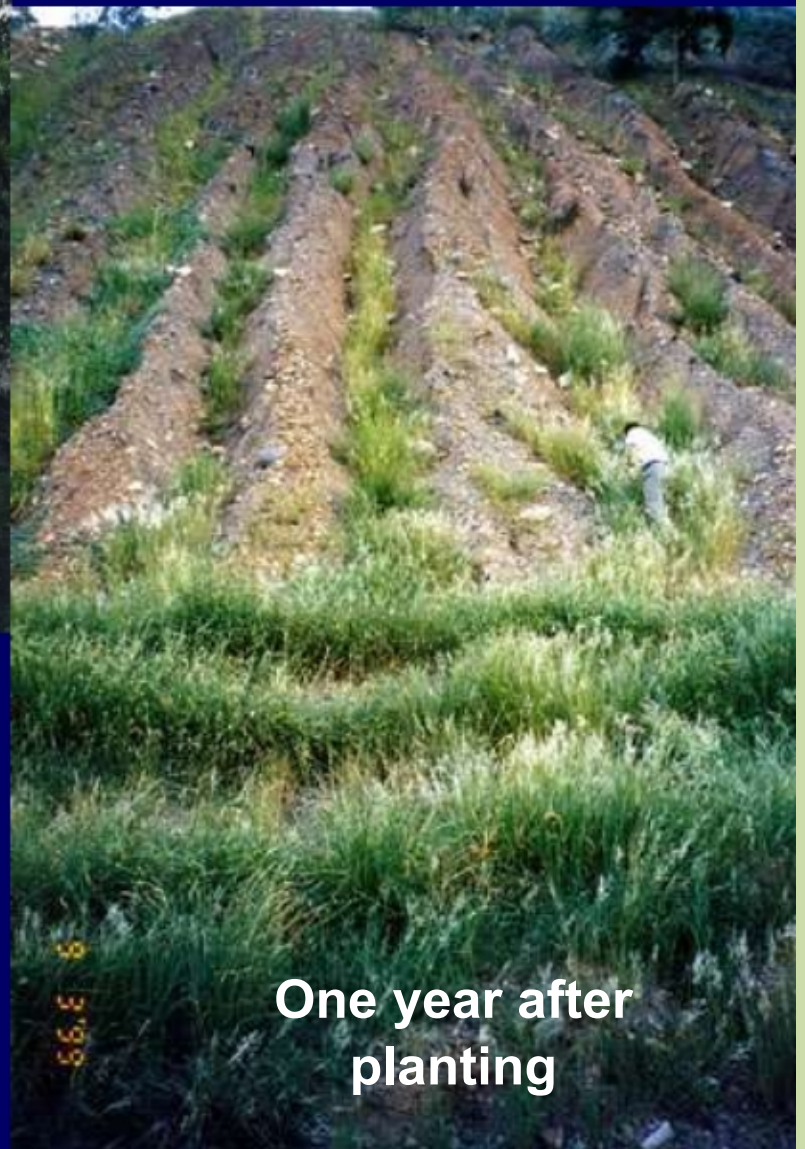
**Vetiver planting to stop gully erosion and trapping sediment**

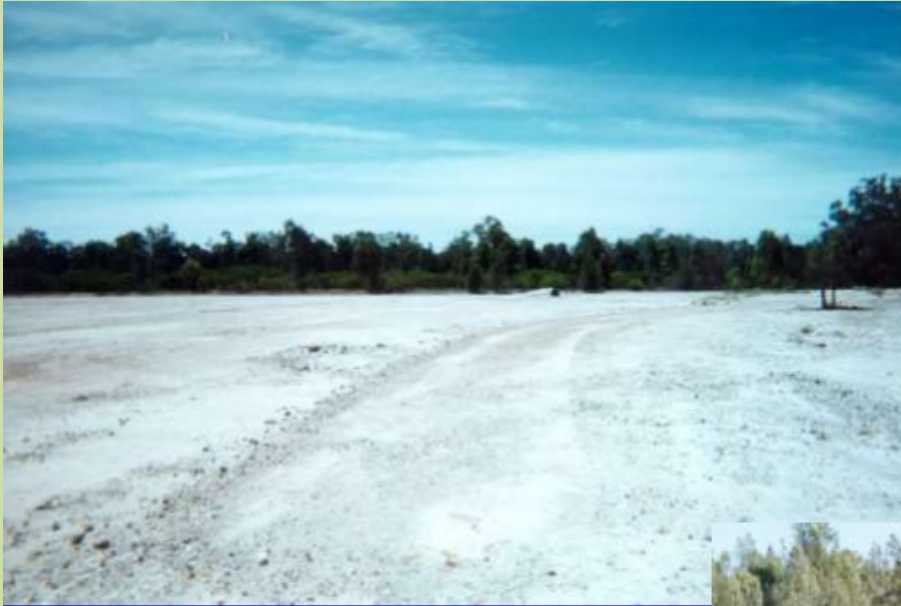
**This Bentonite mine tailings dump is barren with an extremely erodible surface which has low water infiltration and high runoff rates.**

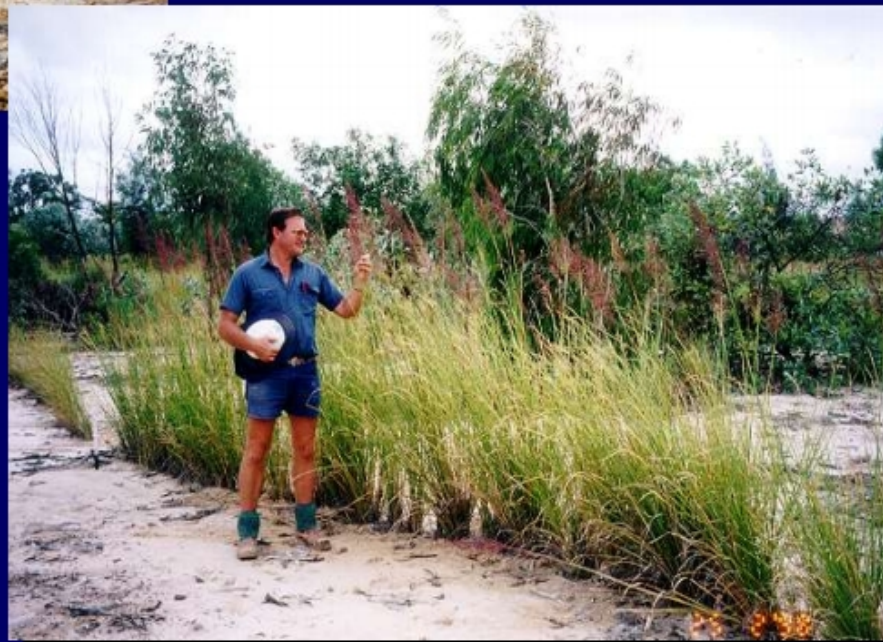
**Good establishment and growth with lime and fertiliser application on this site**

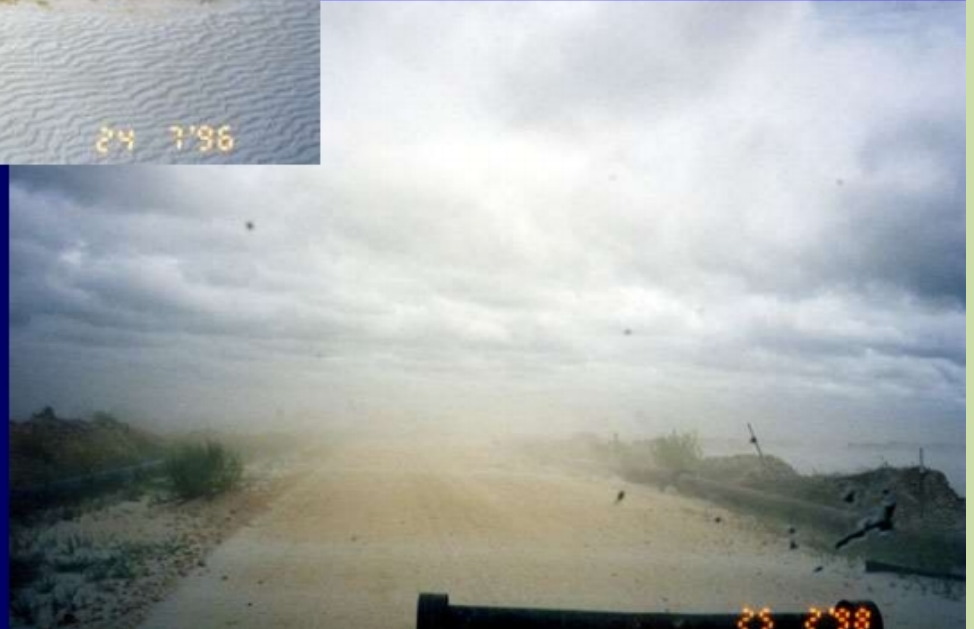
**Strong wind causes  
dust storm, which is is  
highly contaminated  
with heavy metals such  
as Arsenic, Copper etc**

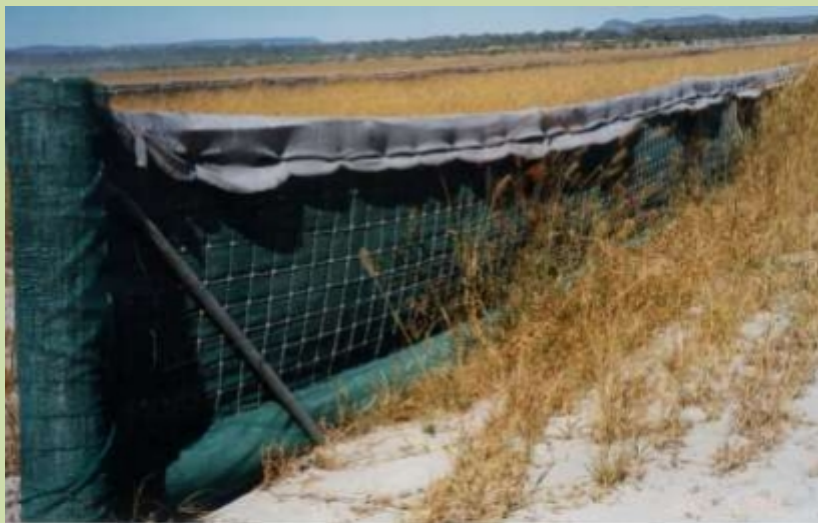
**Conventional measure  
is to plant a surface  
cover crop and to build  
fences to control wind  
erosion promoting crop  
establishment**

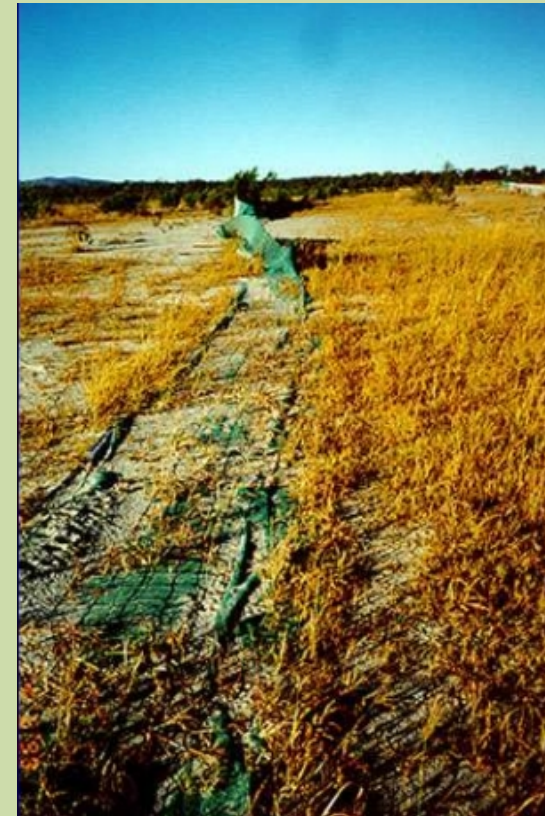
**Despite its very  
Solid construction,  
these rigid and  
expensive fences  
are also vulnerable  
to  
high wind  
velocity**

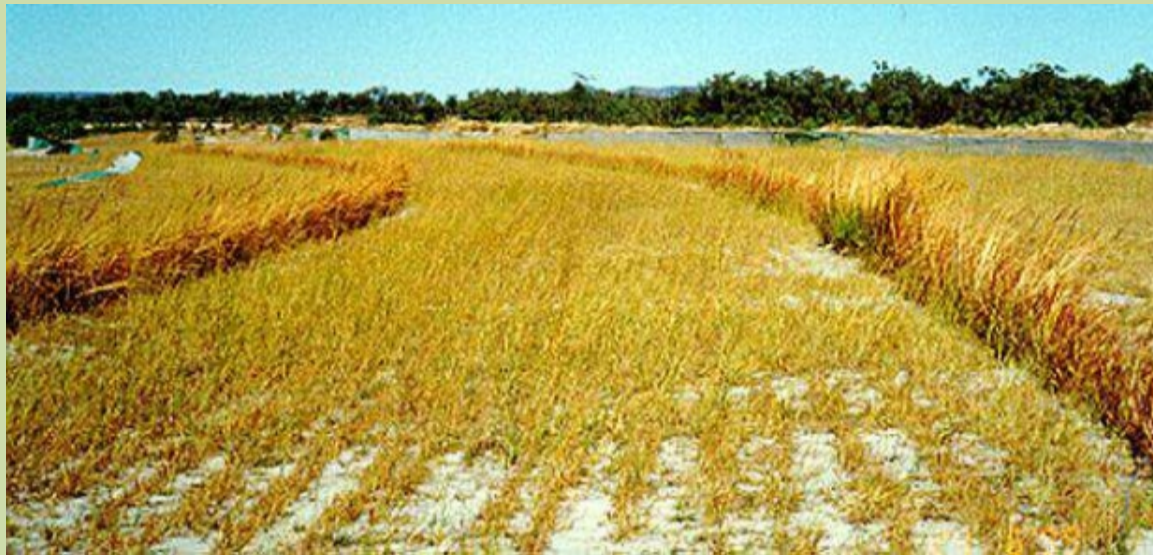
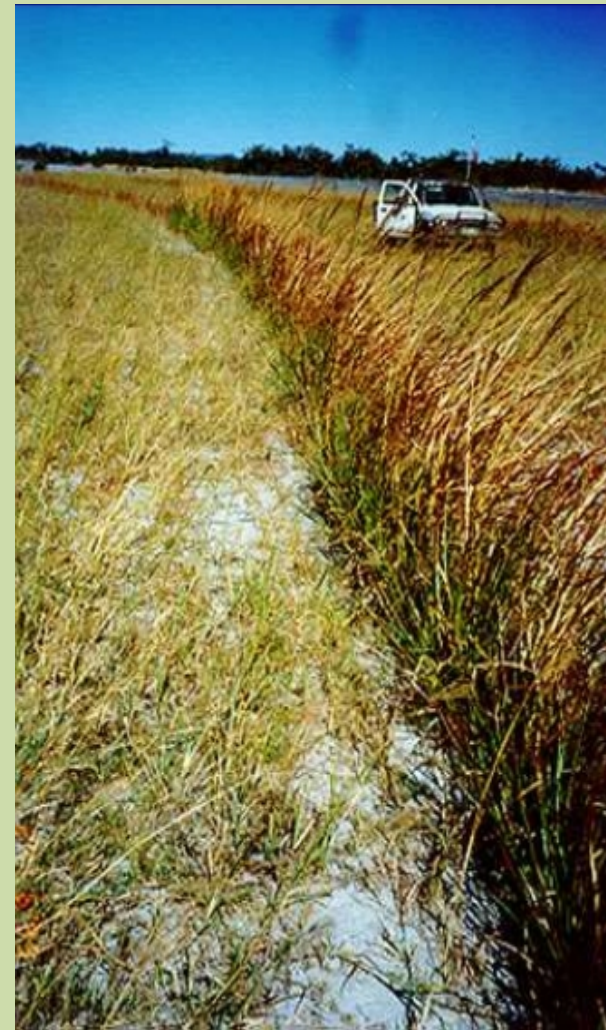
**The flexible Vetiver hedges provided a low cost and permanent wind barrier unaffected by strong winds, providing excellent protection for crop establishment (2 years after planting)**

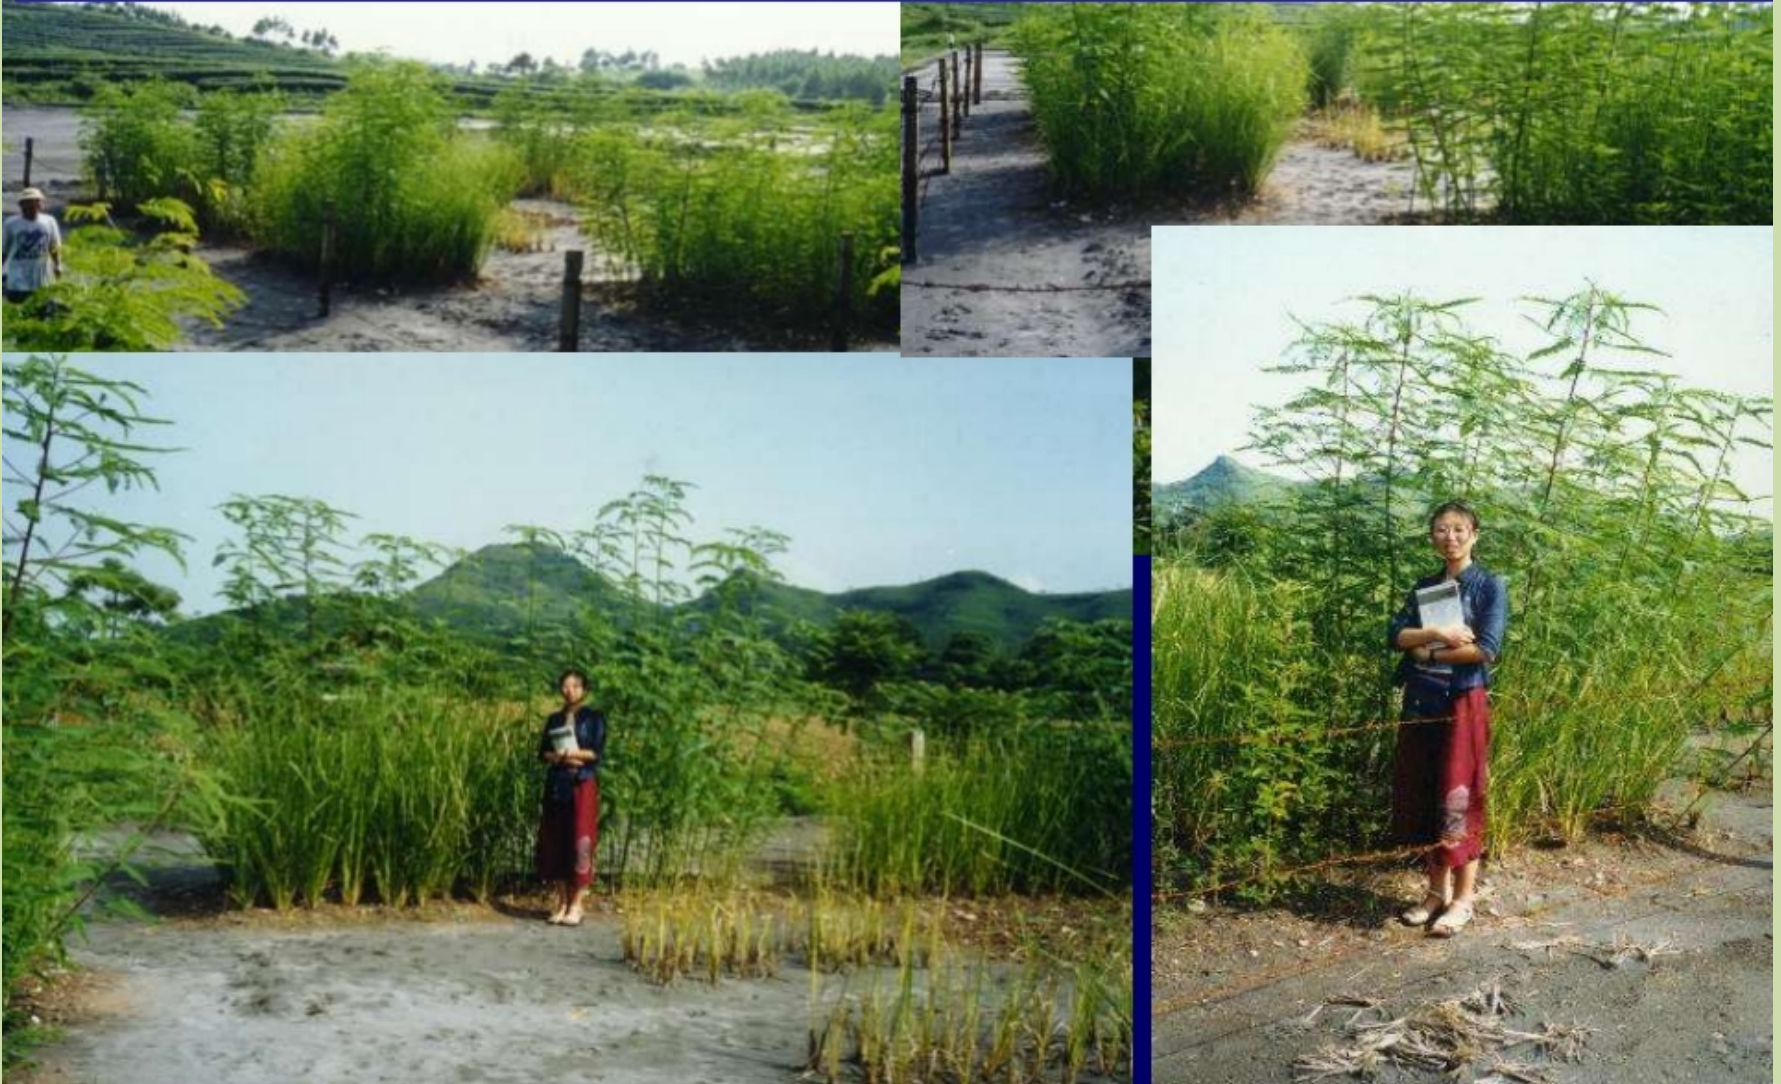
**Research: Vetiver had the highest tolerance and accumulated the lowest concentrations of heavy metals in shoot.**

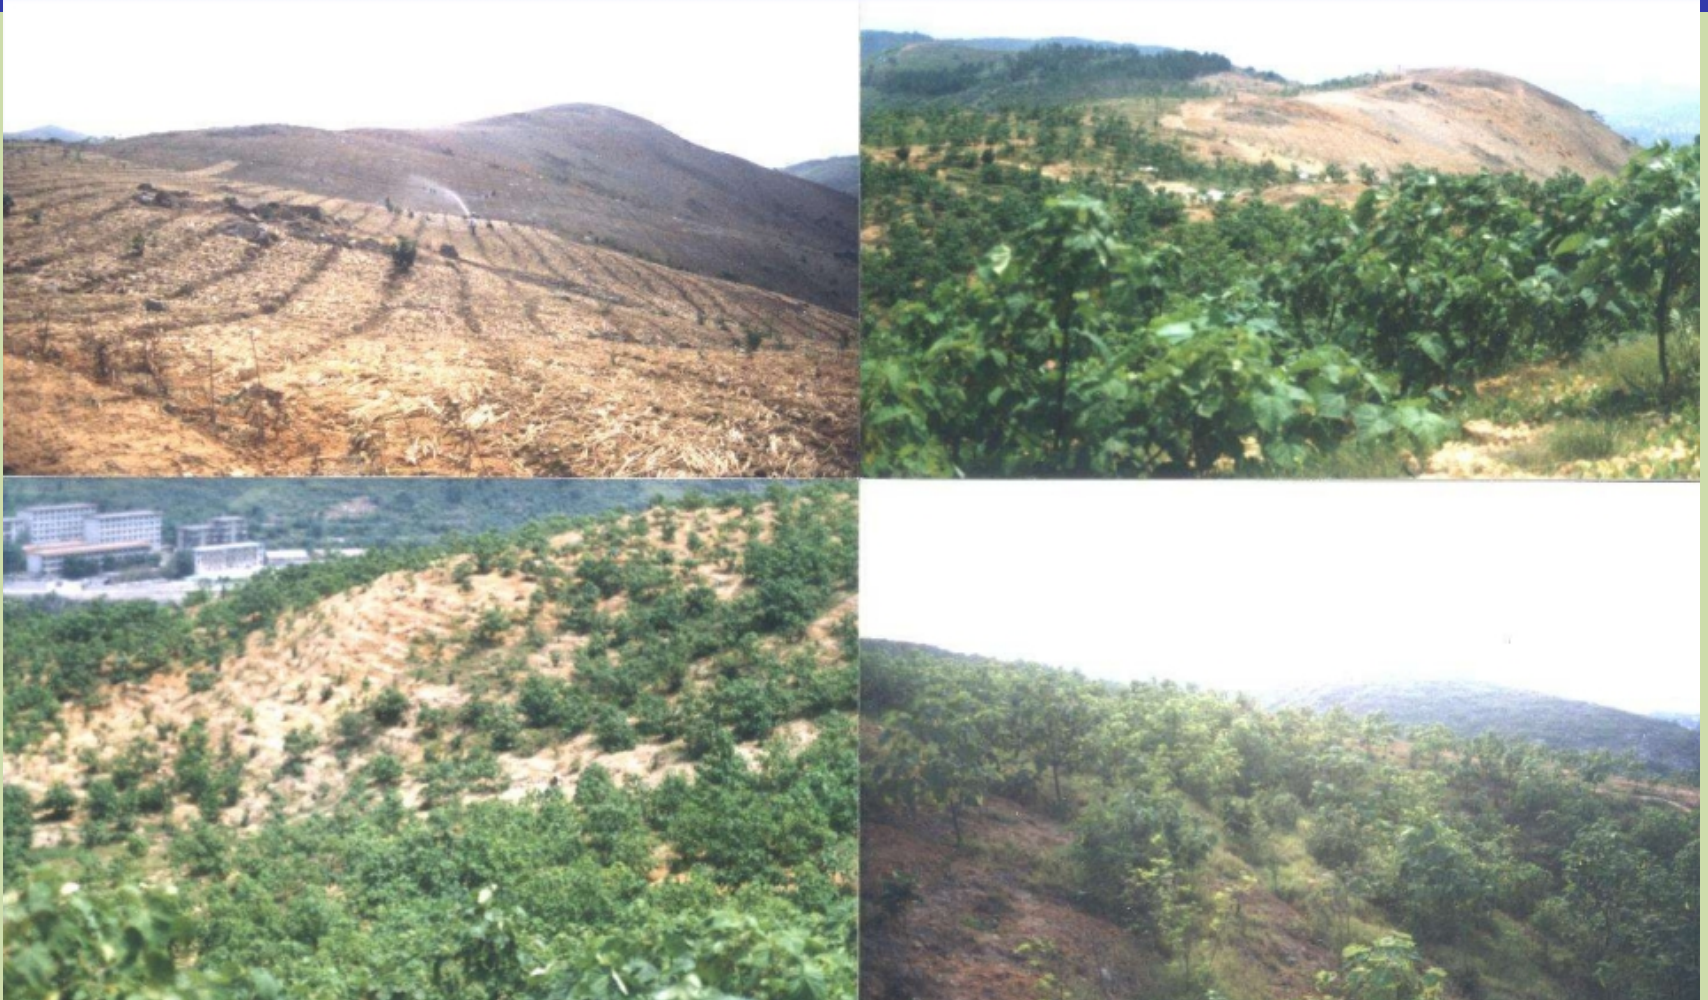
**Application:** The land around the smelting factory was severely contaminated by heavy metals. Many efforts were failed but Vetiver was well established after 5-months

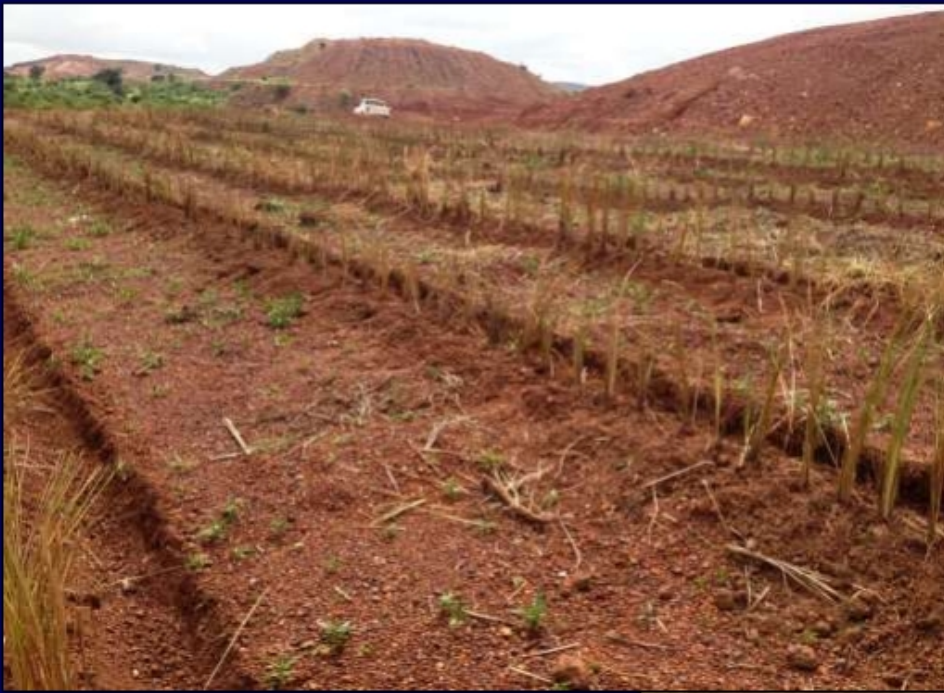
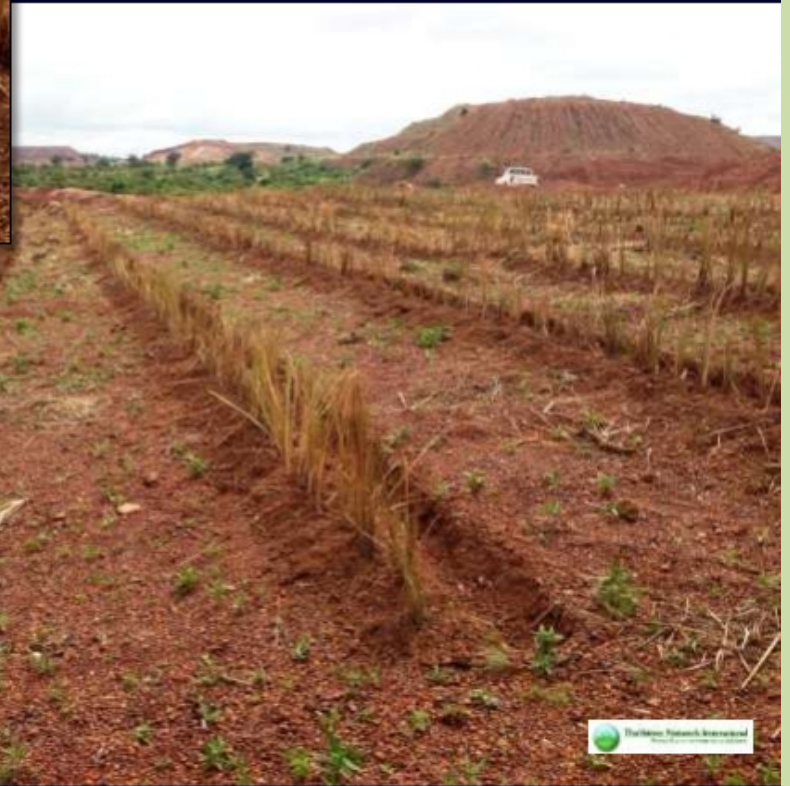
**Vetiver grass slips  
planted in contour furrows  
and hydromulched at  
Anglo Ashanti Gold, Ghana**

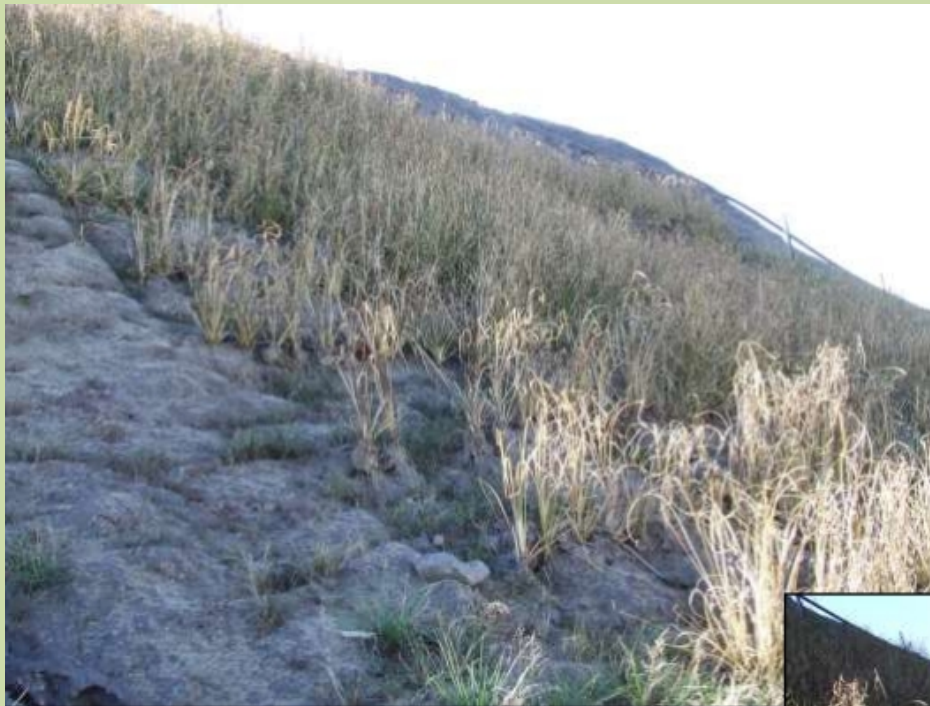
**Vetiver planted in rows 1 meter apart at intervals of 250mm. Areas between rows of Vetiver scarified and hydroseeded with native grass species**

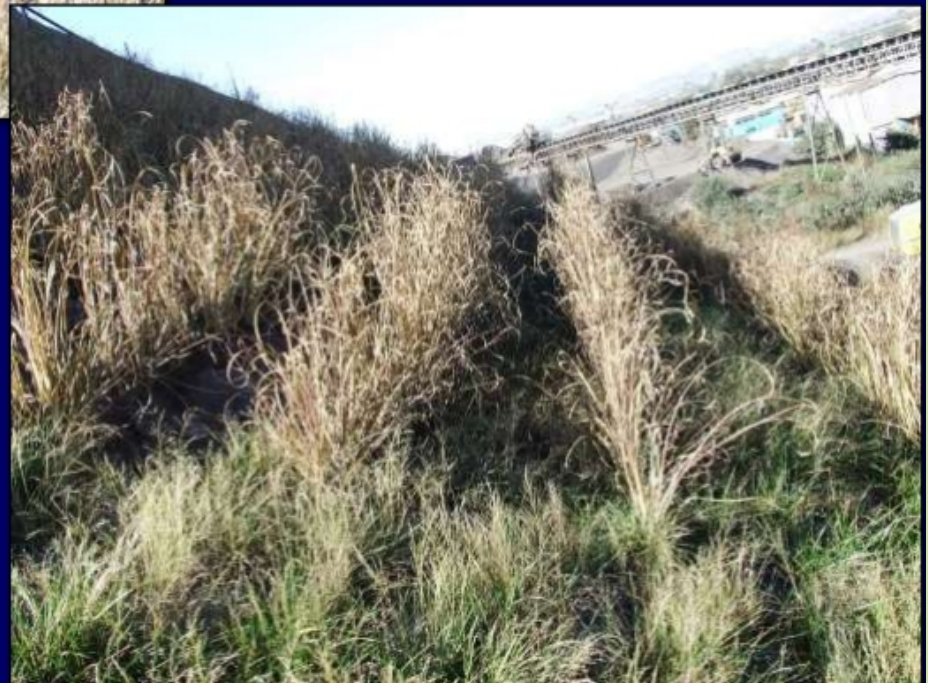
**Vetiver turned brown due to winter frost, will regrow in spring**
