Mine & Associated Rehabilitation Projects in Africa & the Indian Ocean Islands at Large Industrial Scale Application

Roley Nöffke

Hydromulch (Pty) Ltd

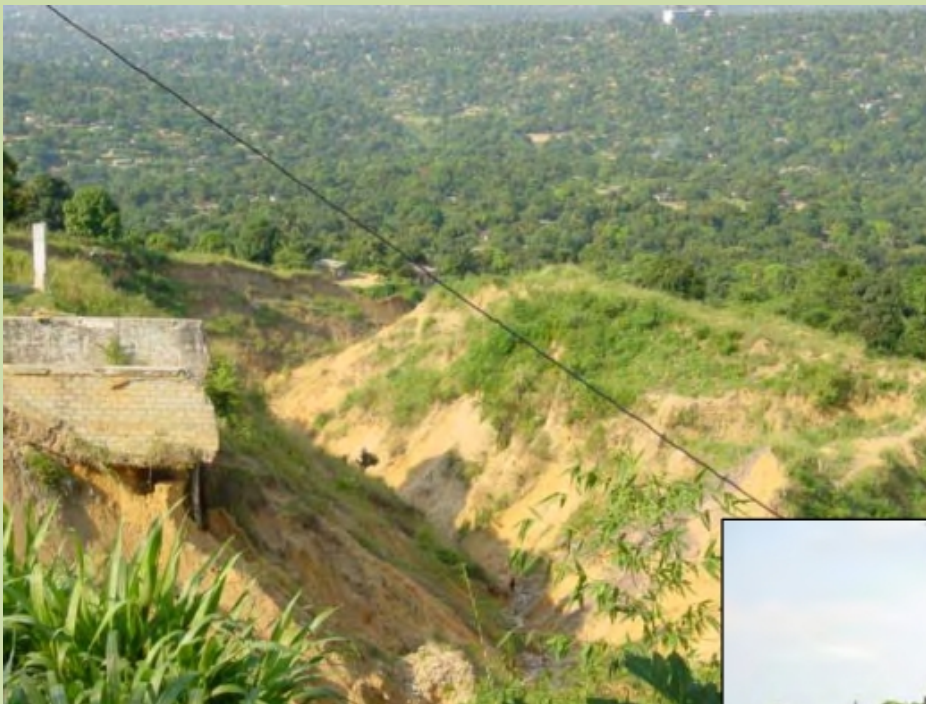
Collapsed bridges and urban roads preventing access to properties

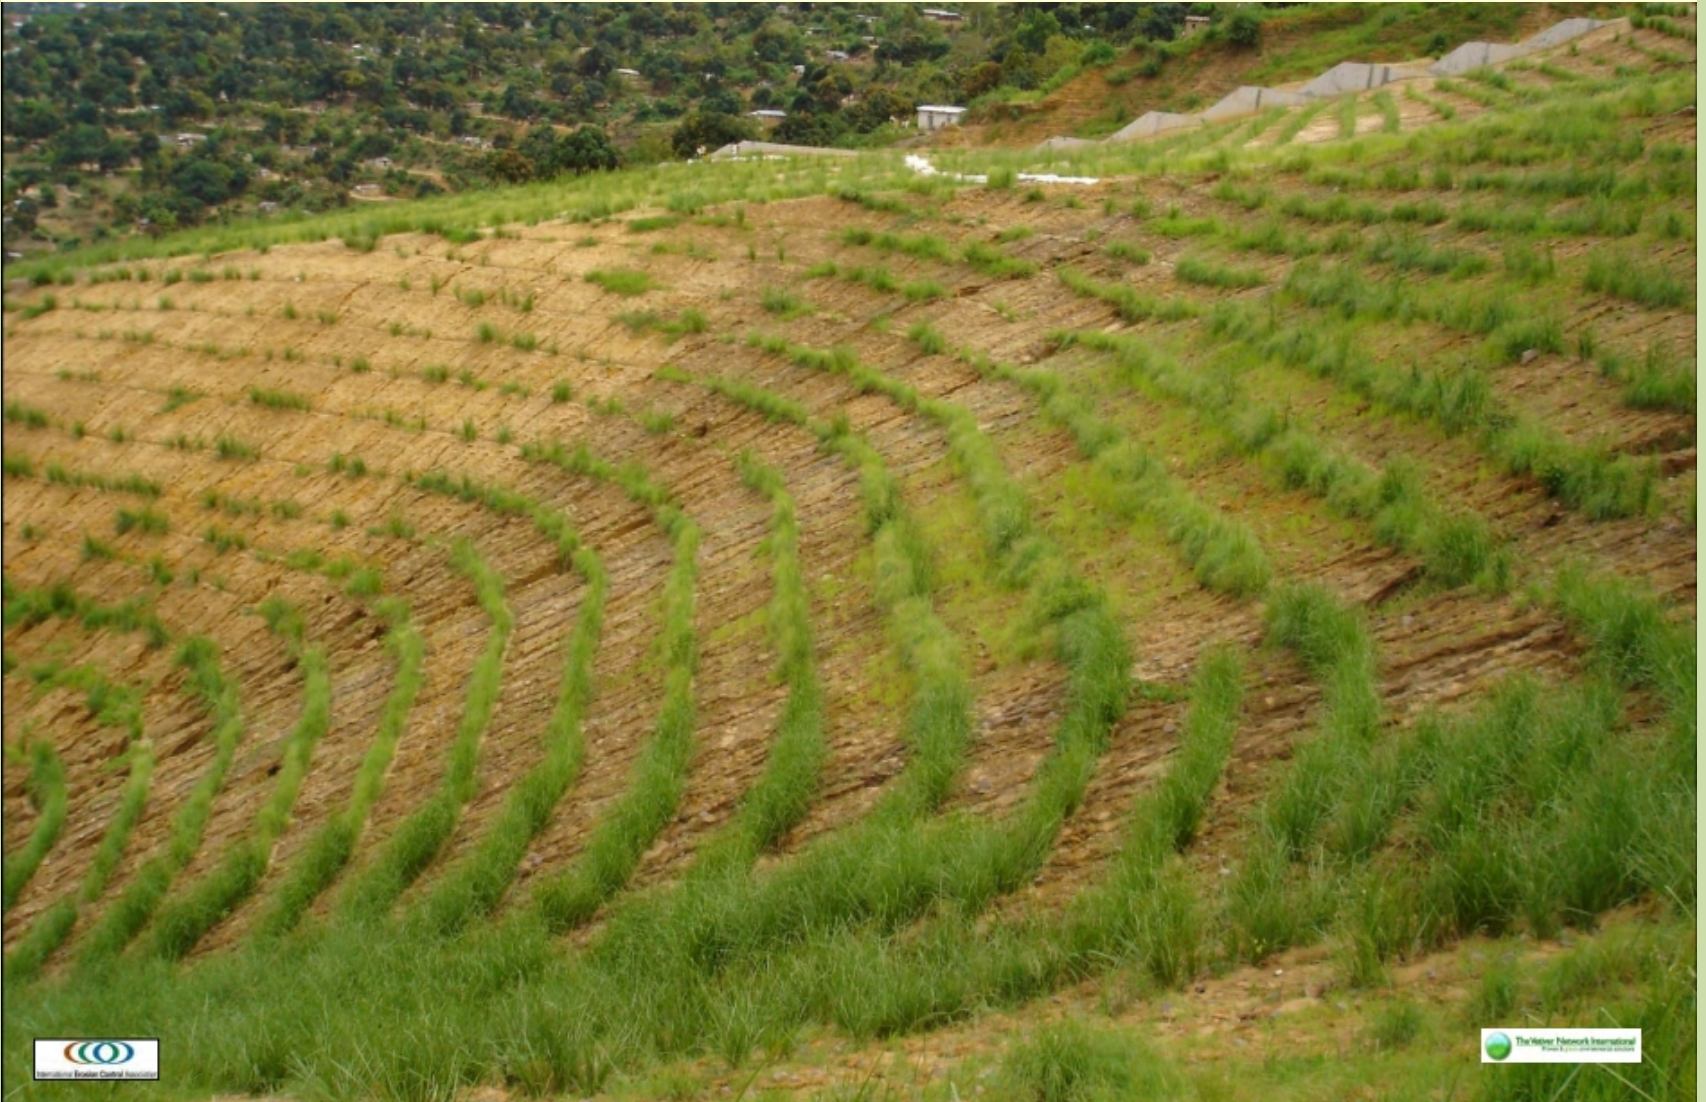
Excessive erosion of the drain in the primary catchment area as a result of under-designed collector drains silting up and displacing storm water directly onto the unprotected side slopes

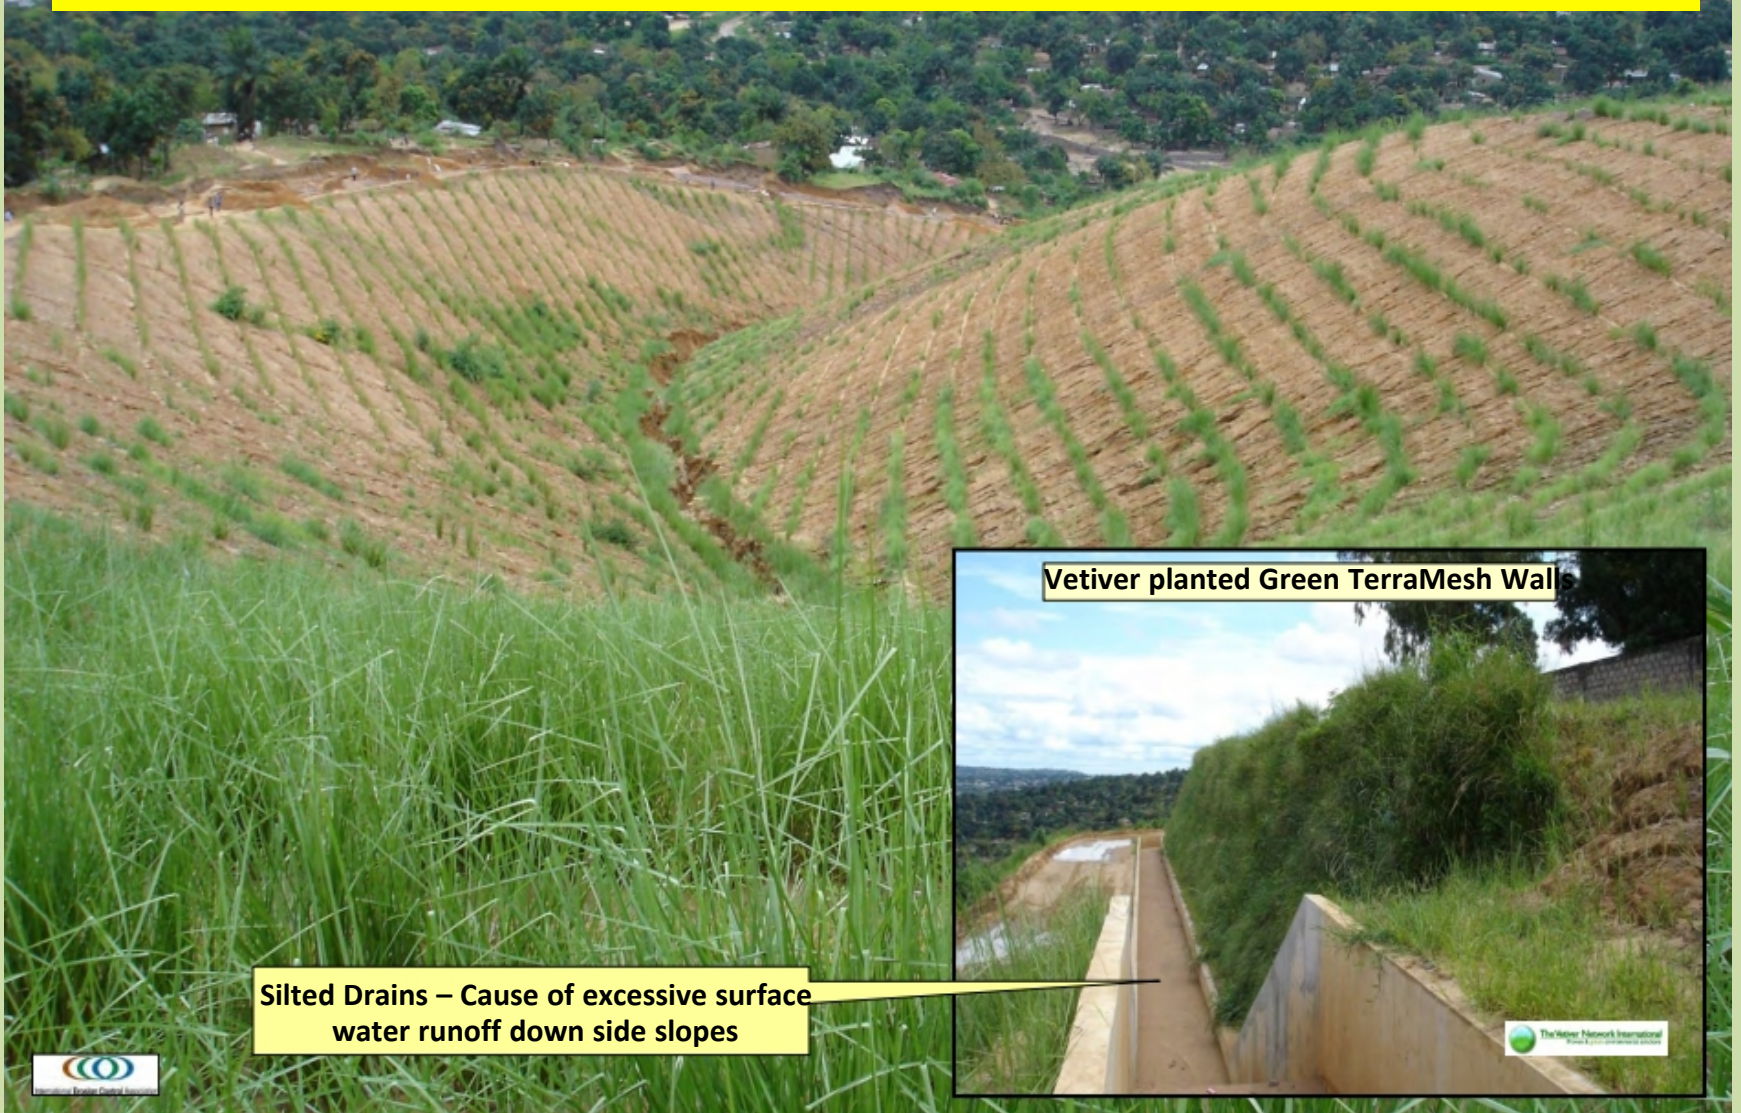
Vetiver planted Green TerraMesh Walls

Silted Drains – Cause of excessive surface water runoff down side slopes

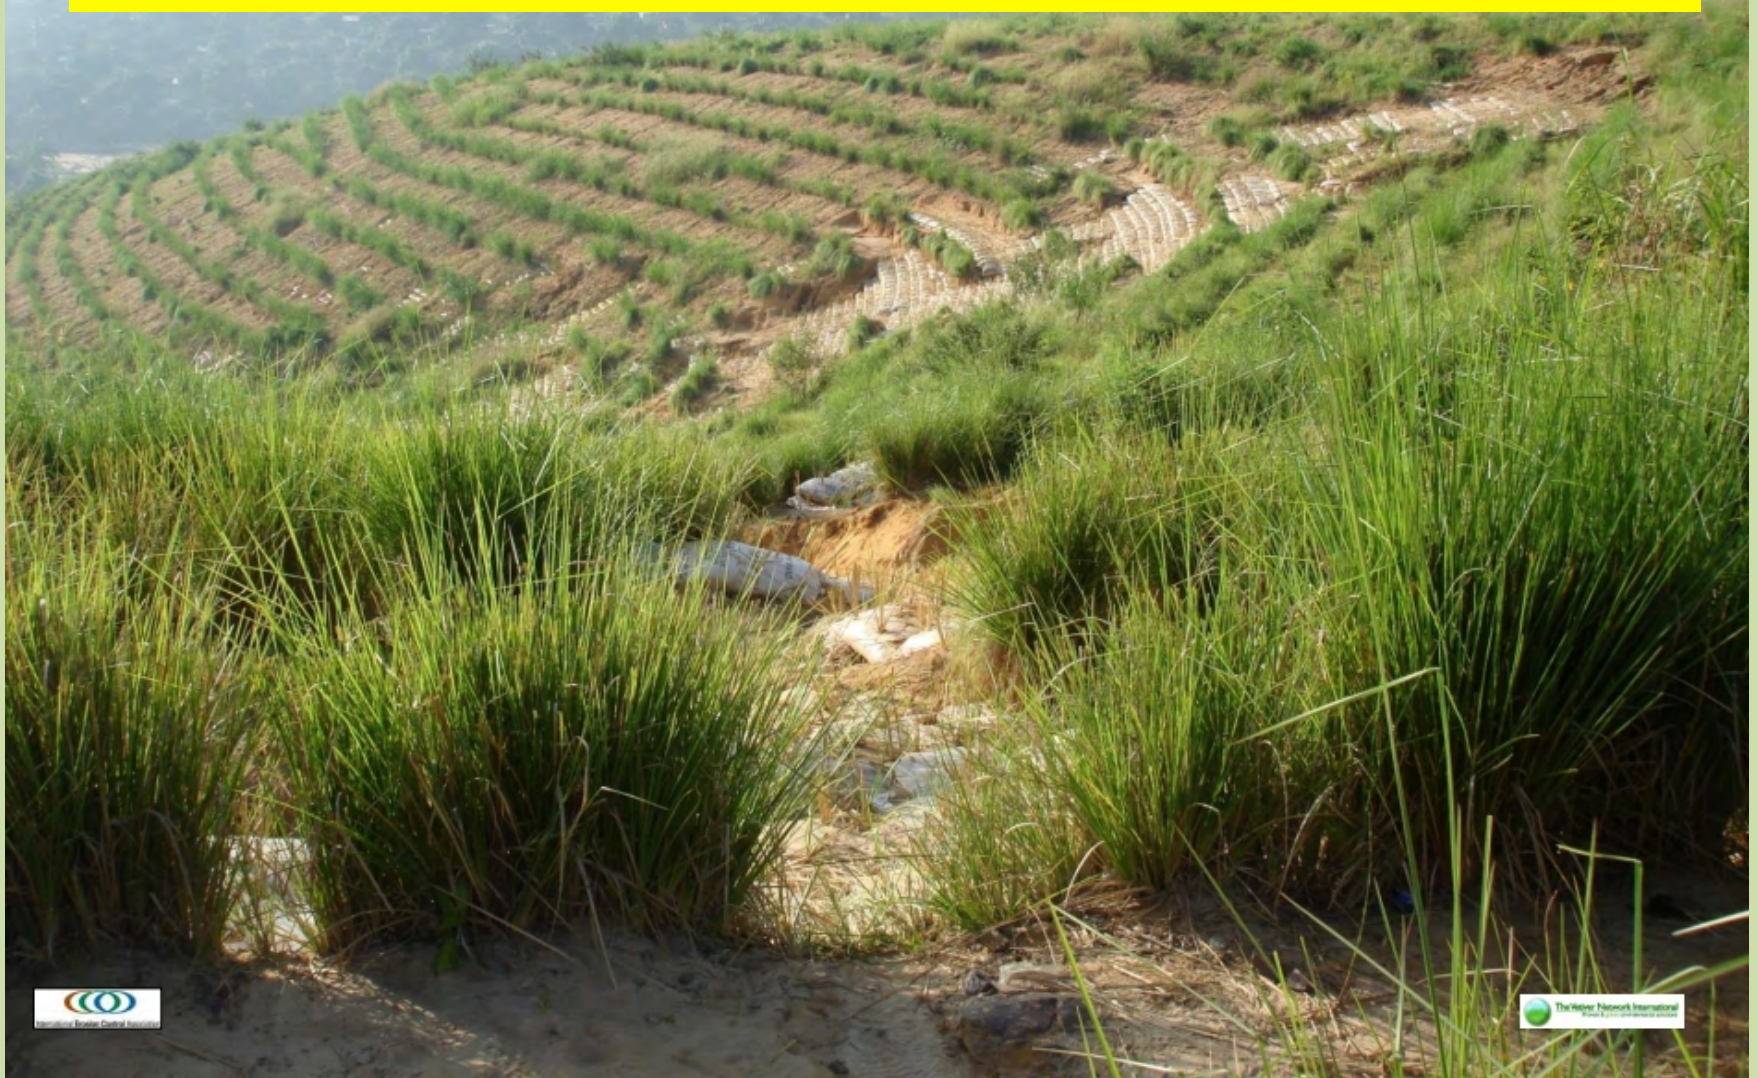
Sand Bags inter-planted with Vetiver were used to repair the extensive erosion caused by surface water runoff

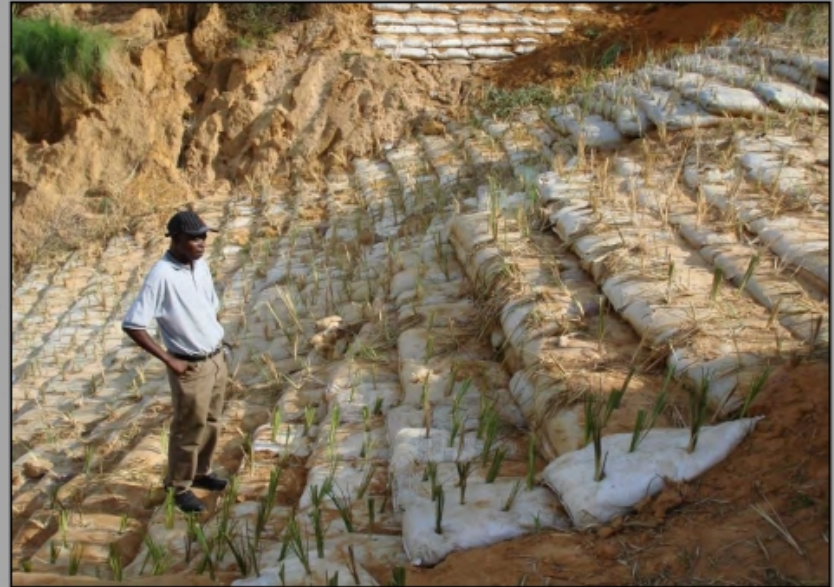
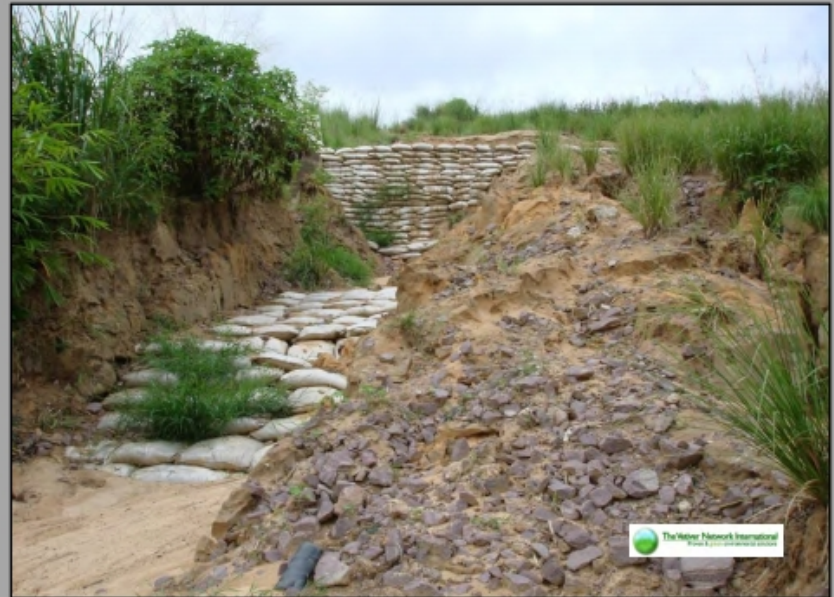
Incorrect method

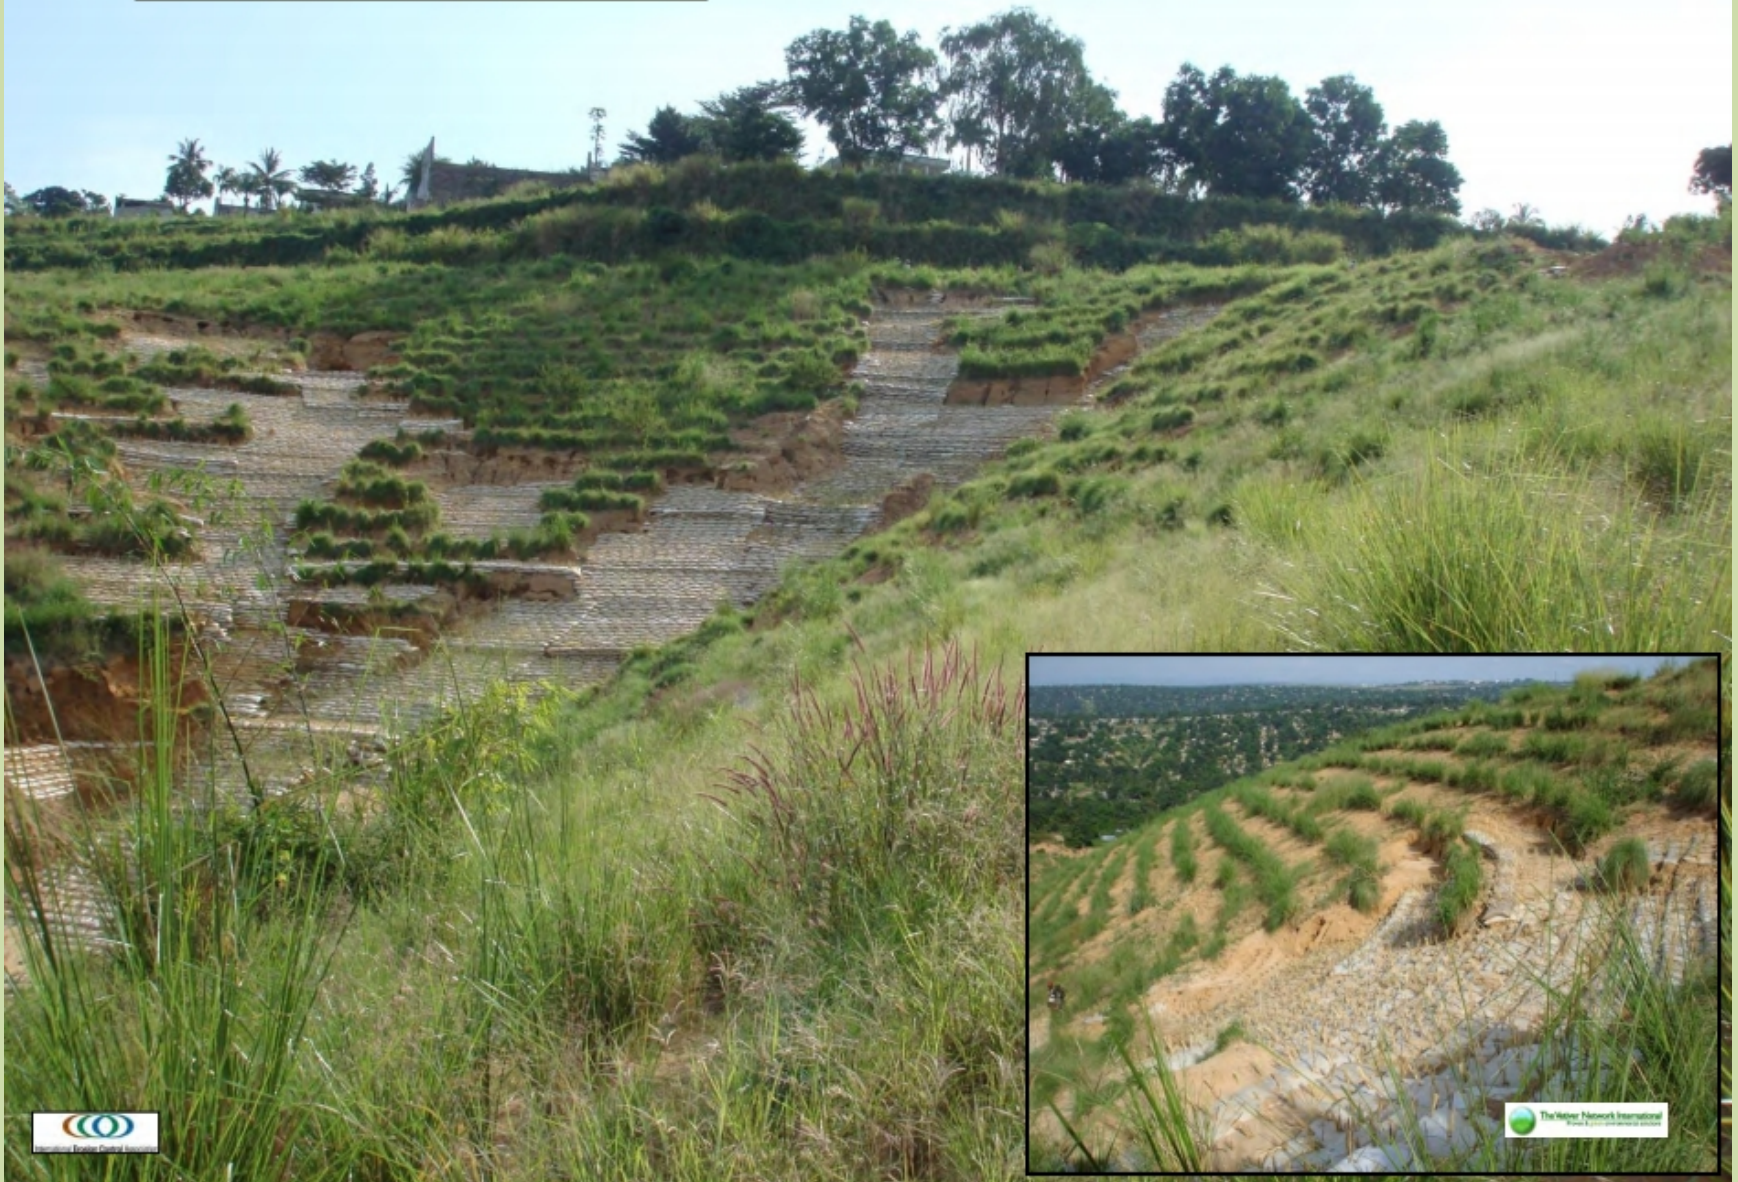
Sand Bag Reinforced & Stabilised Gully

80,000 Sand Bags were used for the stabilisation of the erosion gullies. Vetiver grass was planted into the Sand Bags.

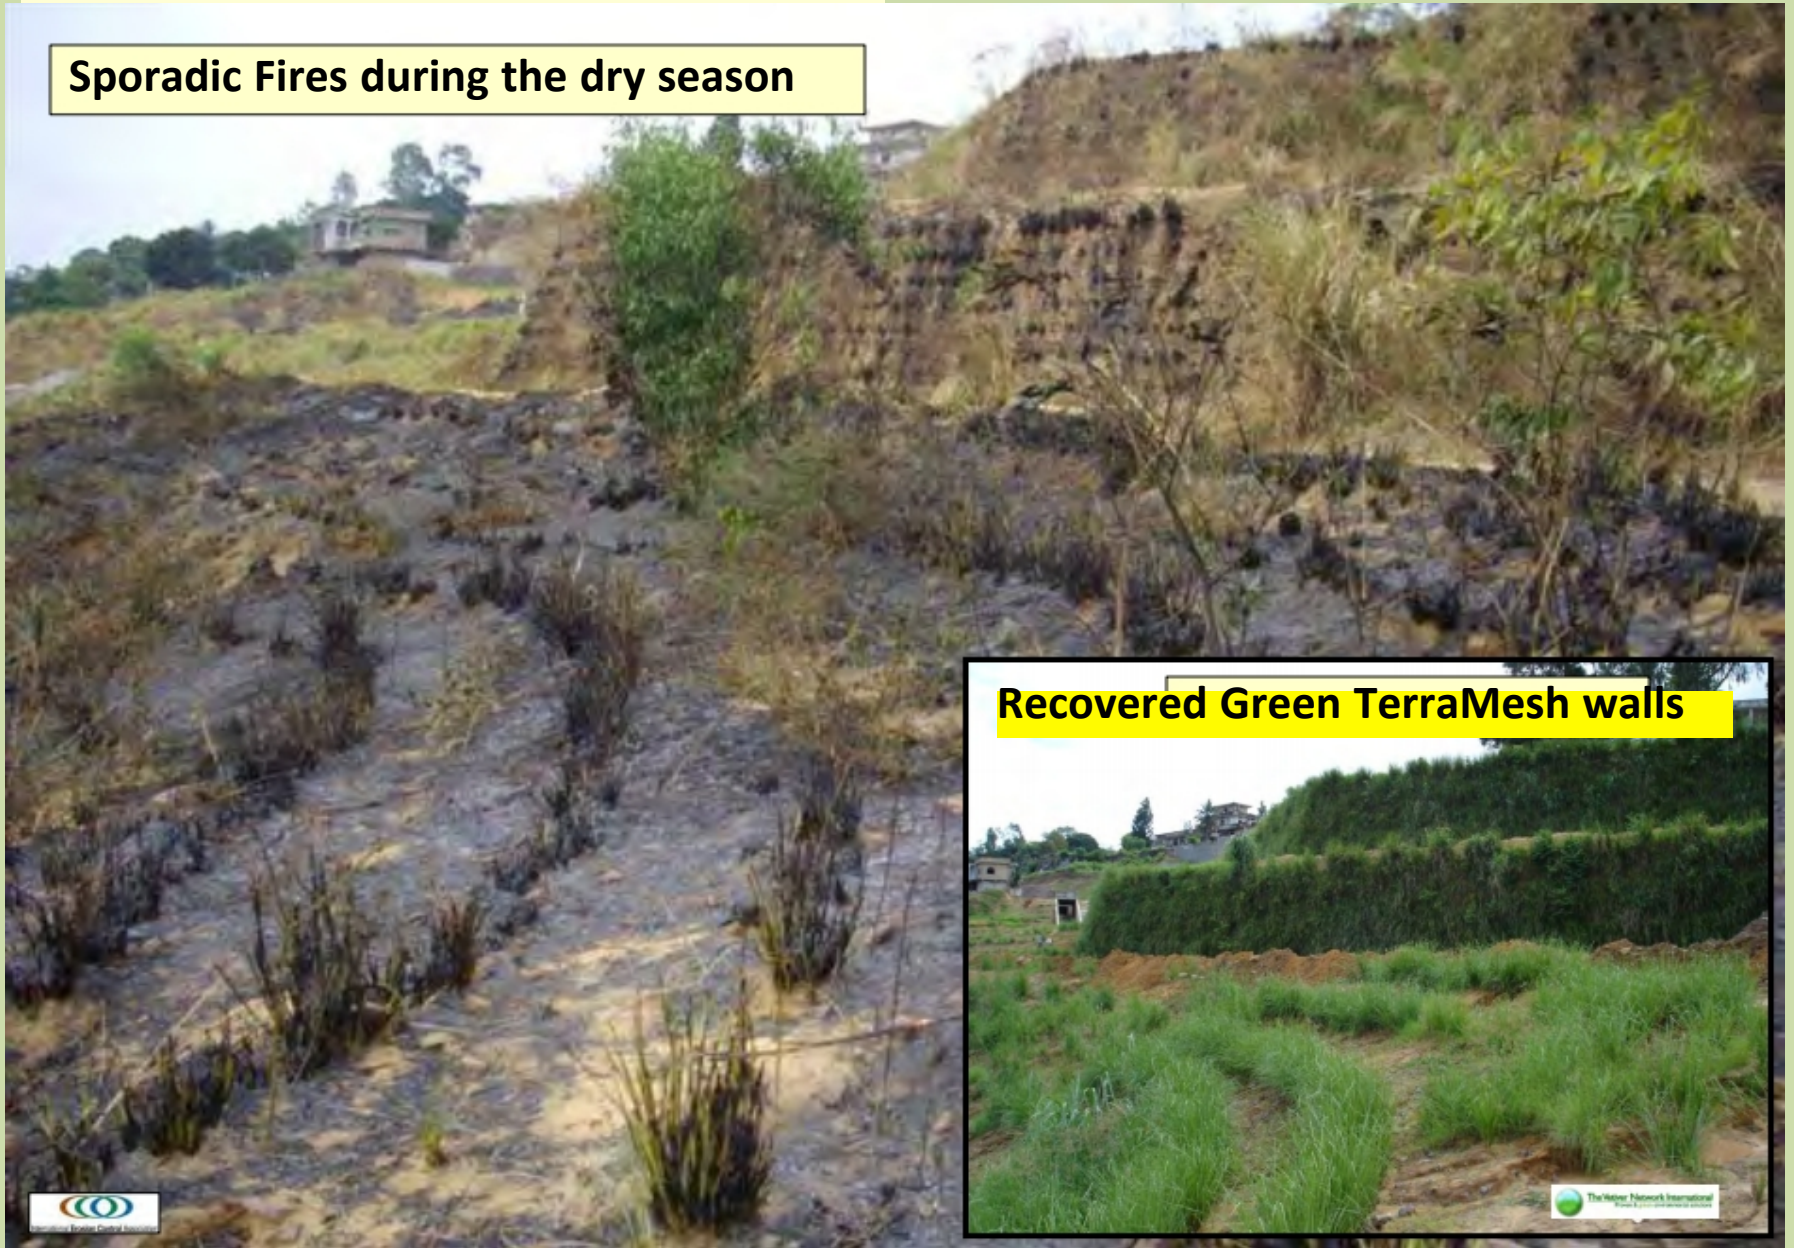
Recovered Green TerraMesh walls

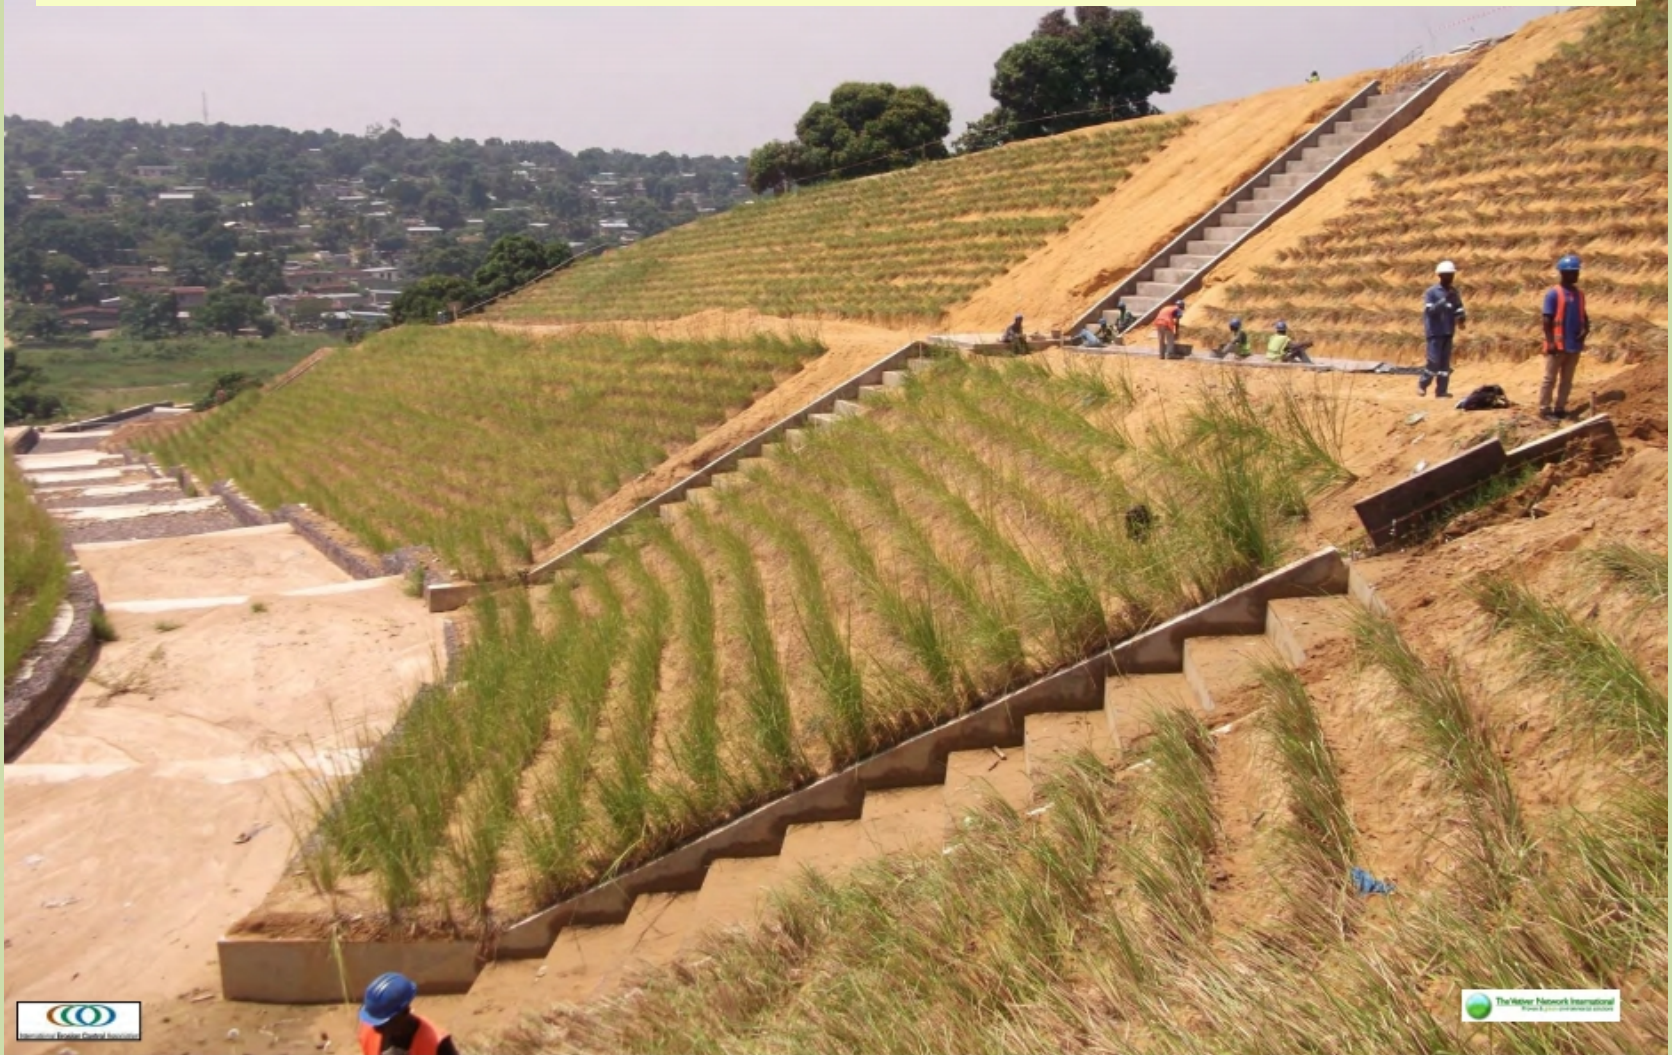
Vegetated Side Slopes of Concrete Drainage Channel

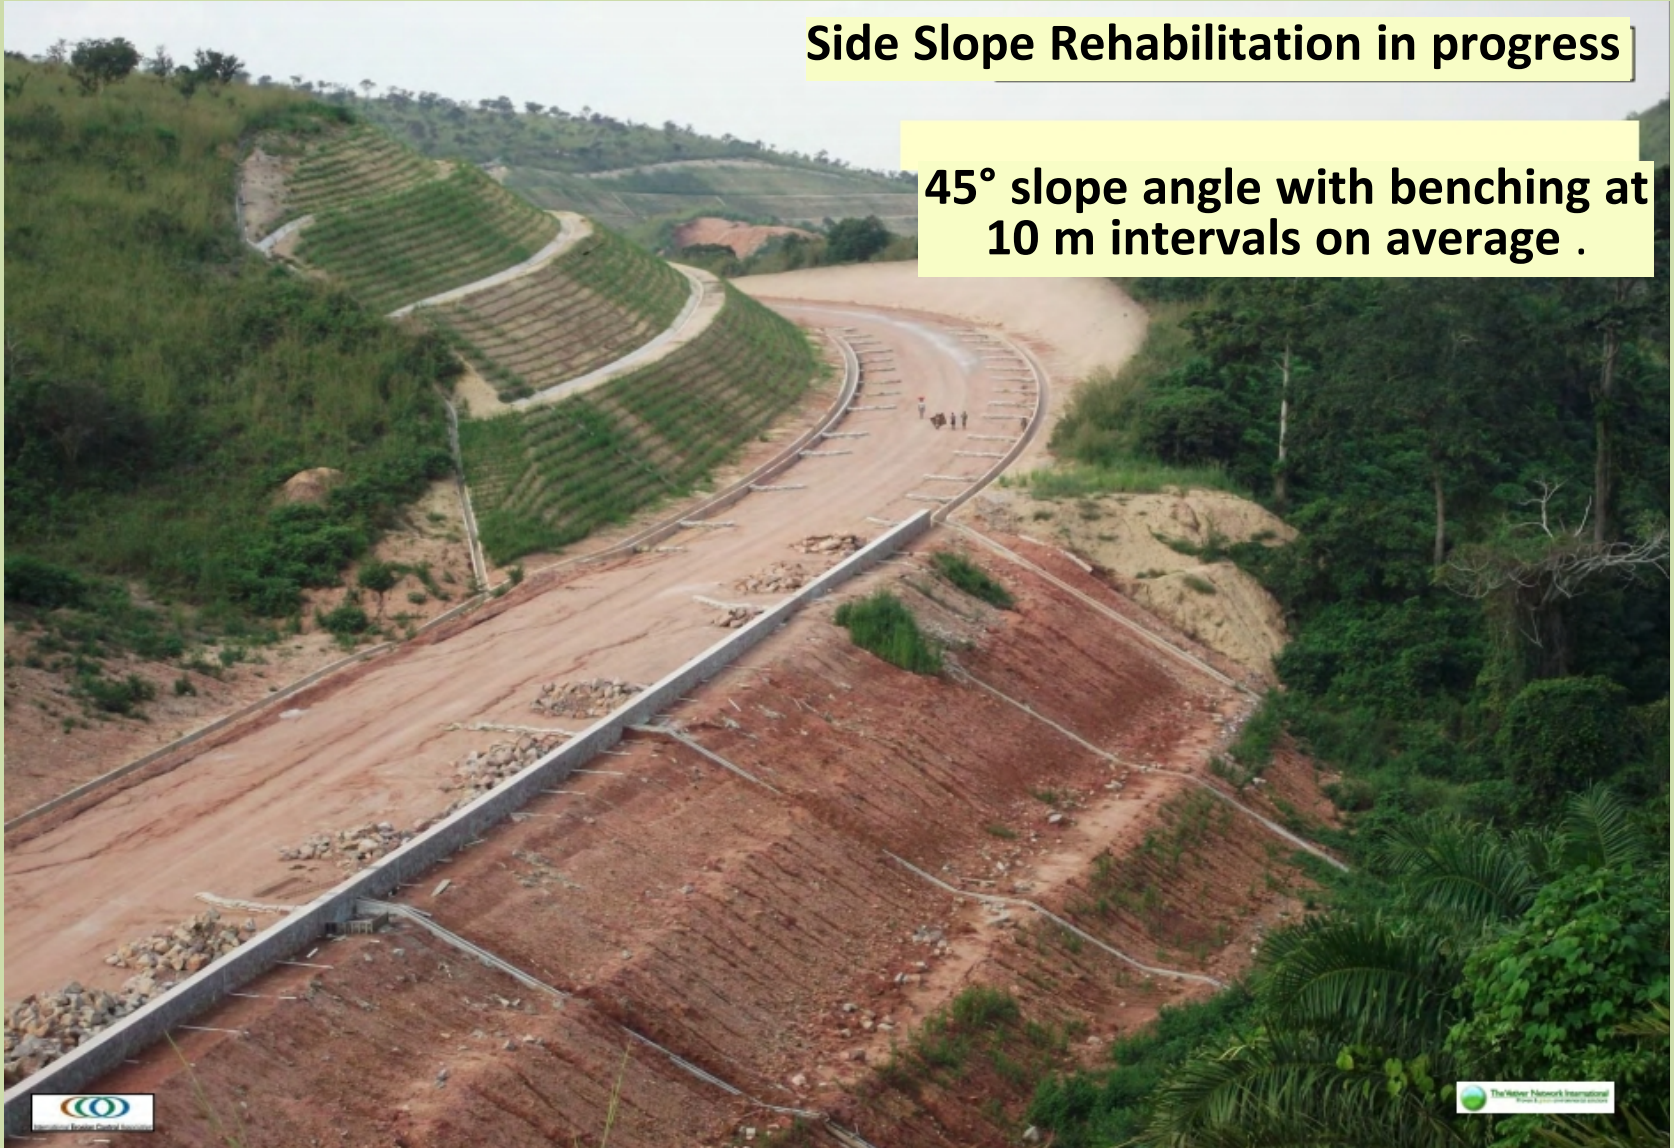
Side Slope Rehabilitation in progress

45° slope angle with benching at 10 m intervals on average .

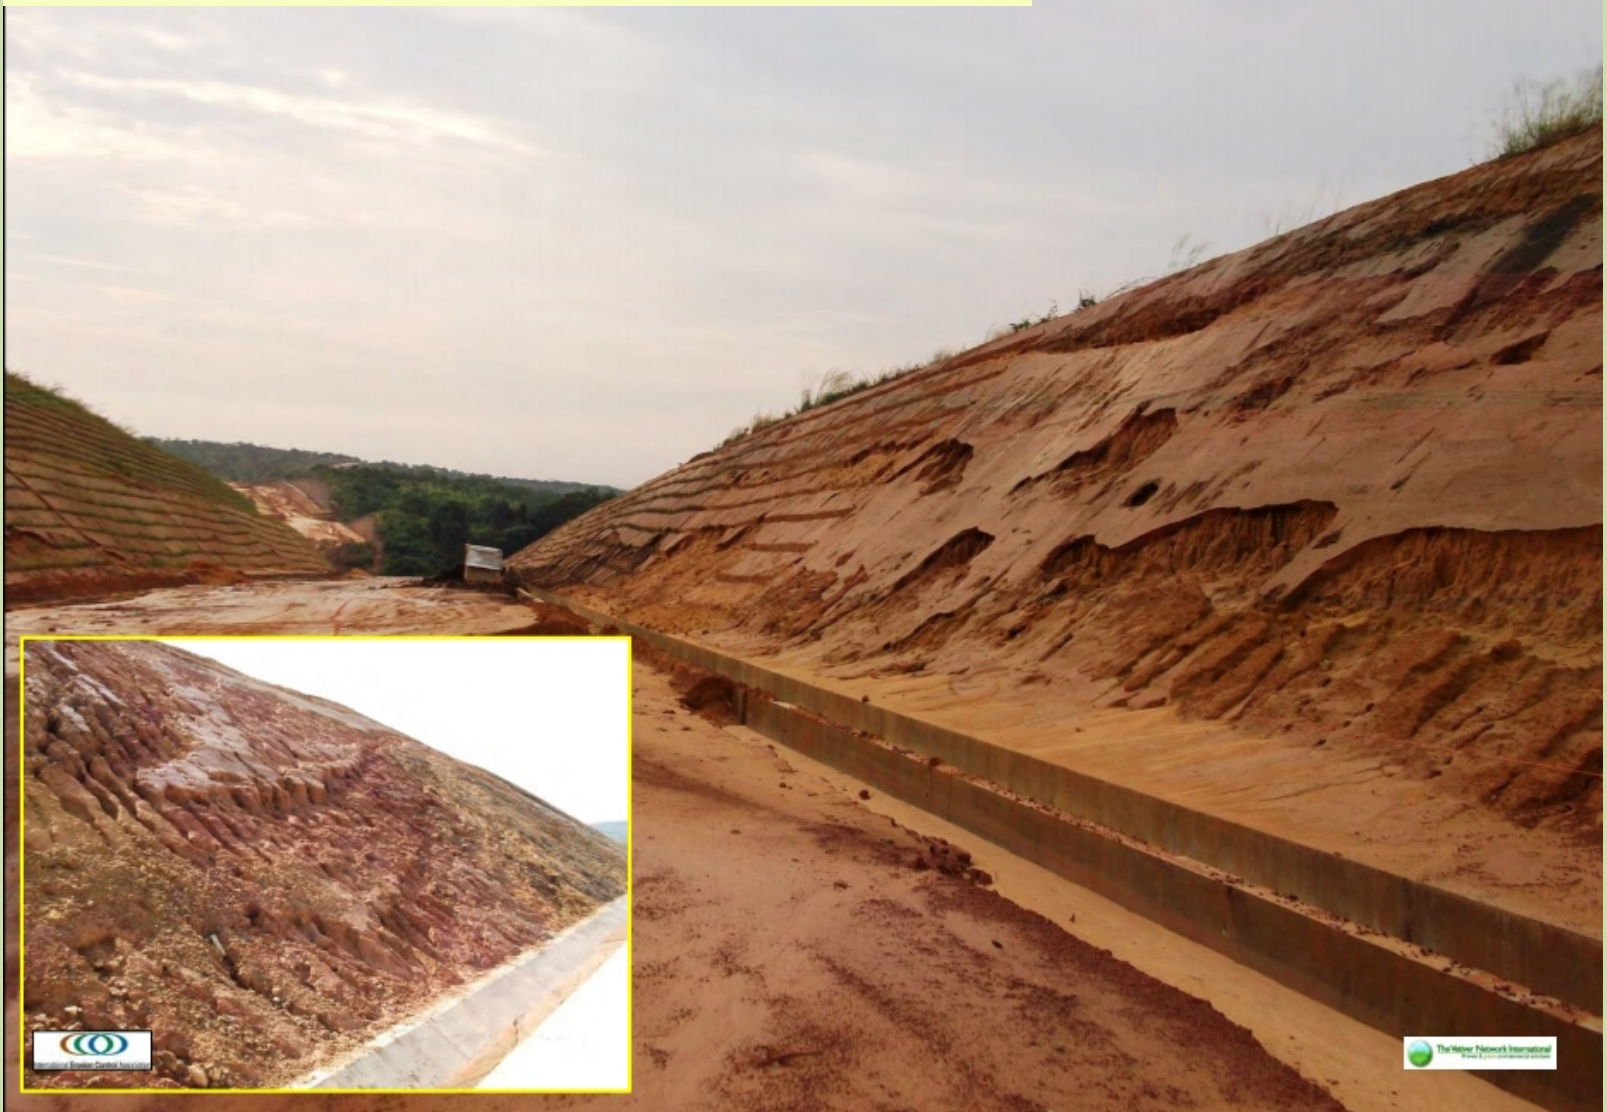
Highly dispersive and erodible side slope material

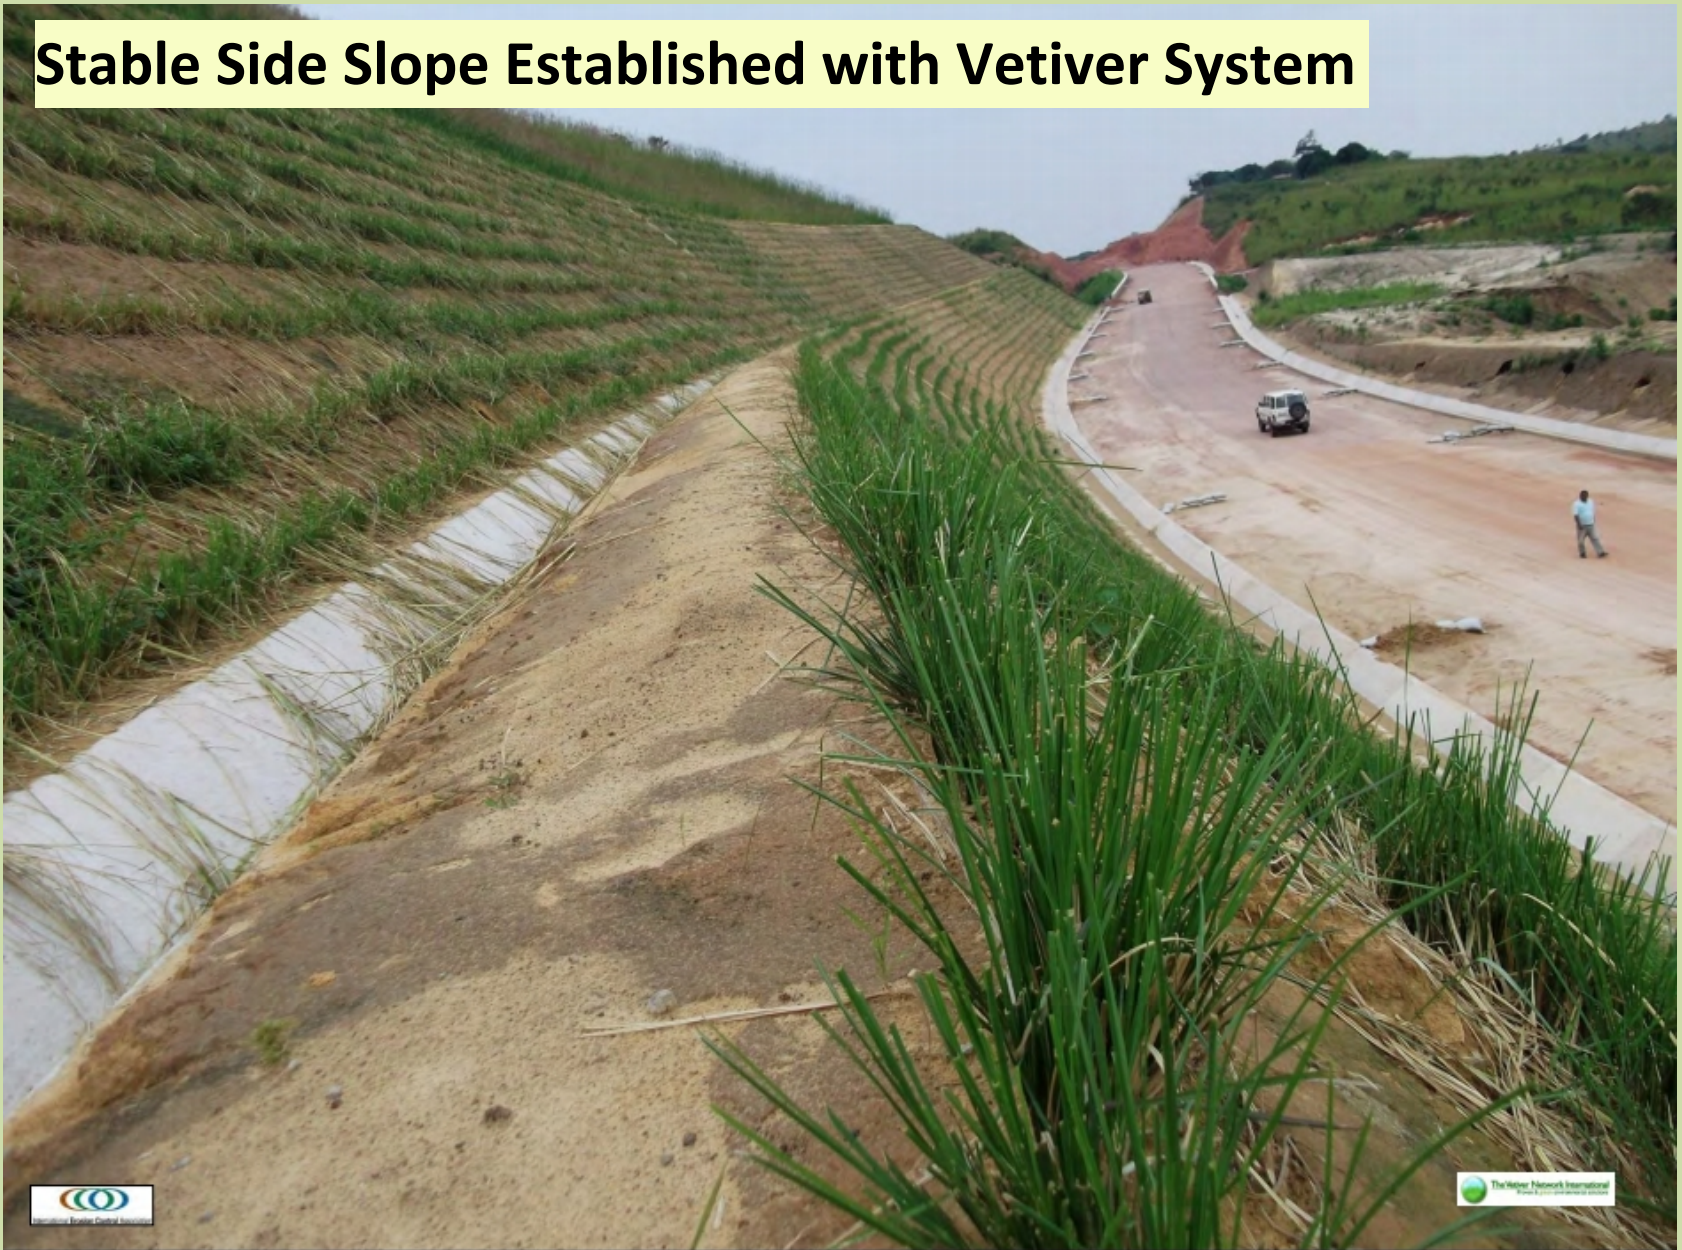
Setting out & Planting of vetiver hedge rows

1 m¹ between rows and 10 plants/m¹

Stable Side Slope Established with Vetiver System

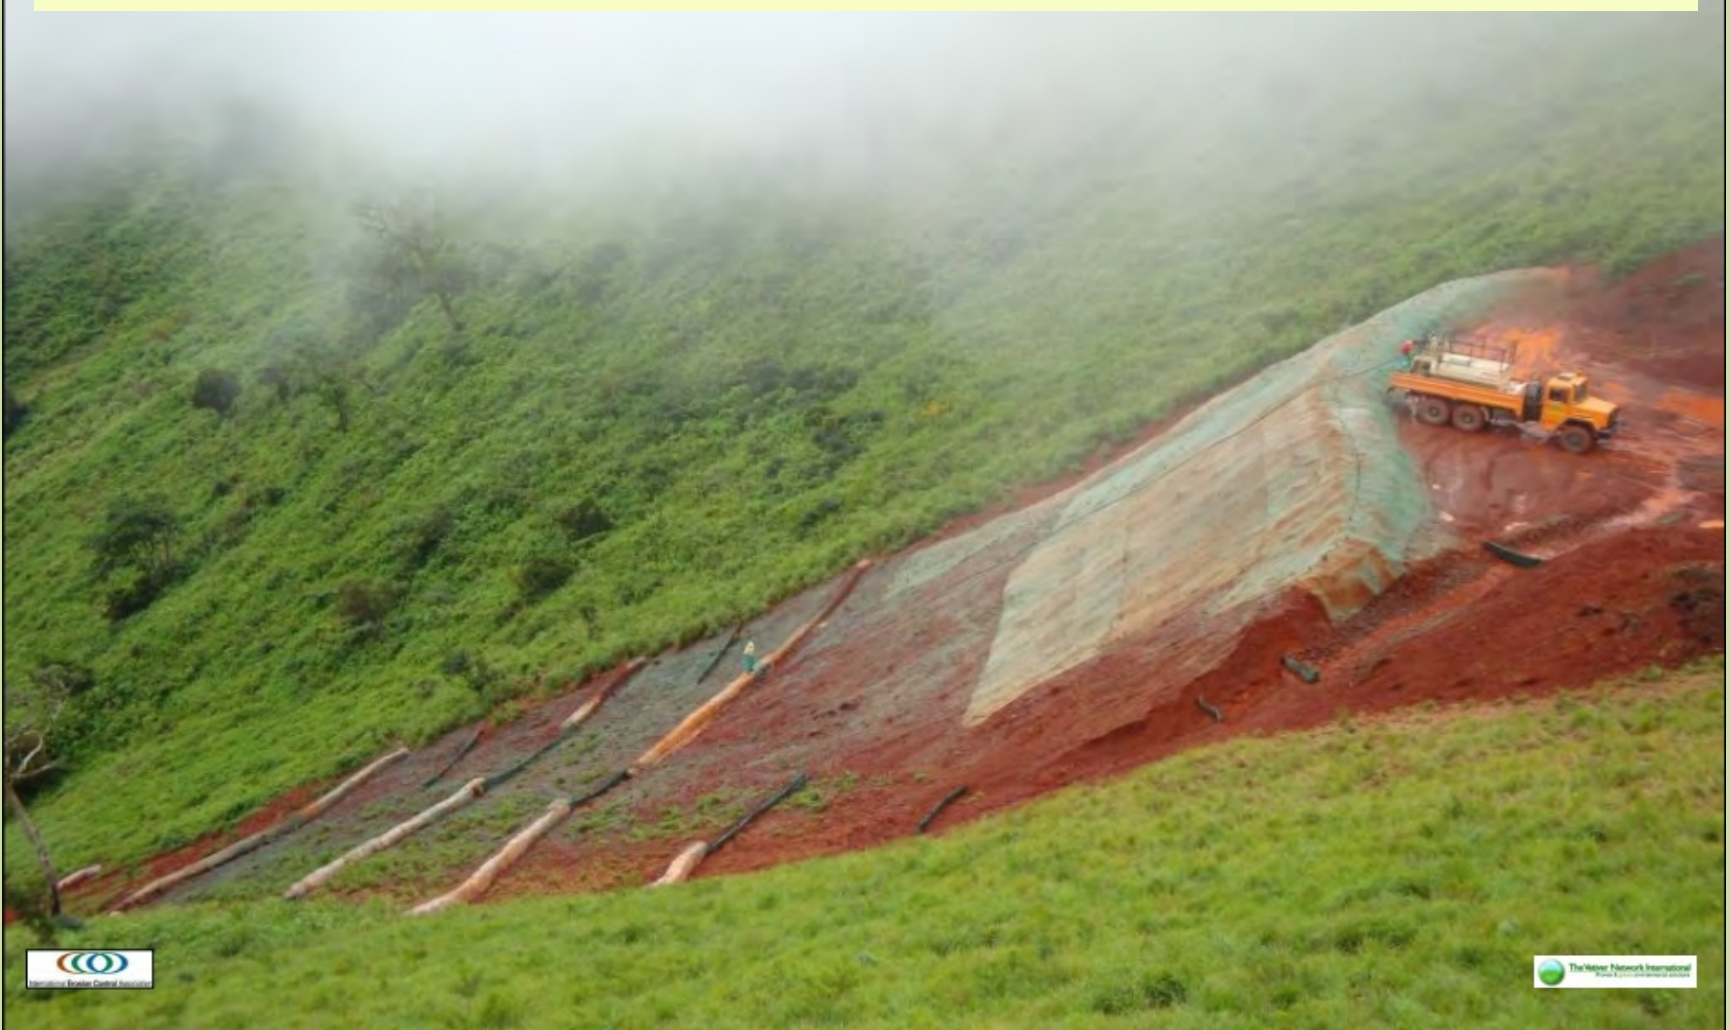
Installation of Bio-Engineering Techniques & Hydroseeding on Exploration Site for protection of chimpanzee habitat
