Mine & Associated Rehabilitation Projects in Africa & the Indian Ocean Islands at Large Industrial Scale Application

Roley Nöffke

Hydromulch (Pty) Ltd

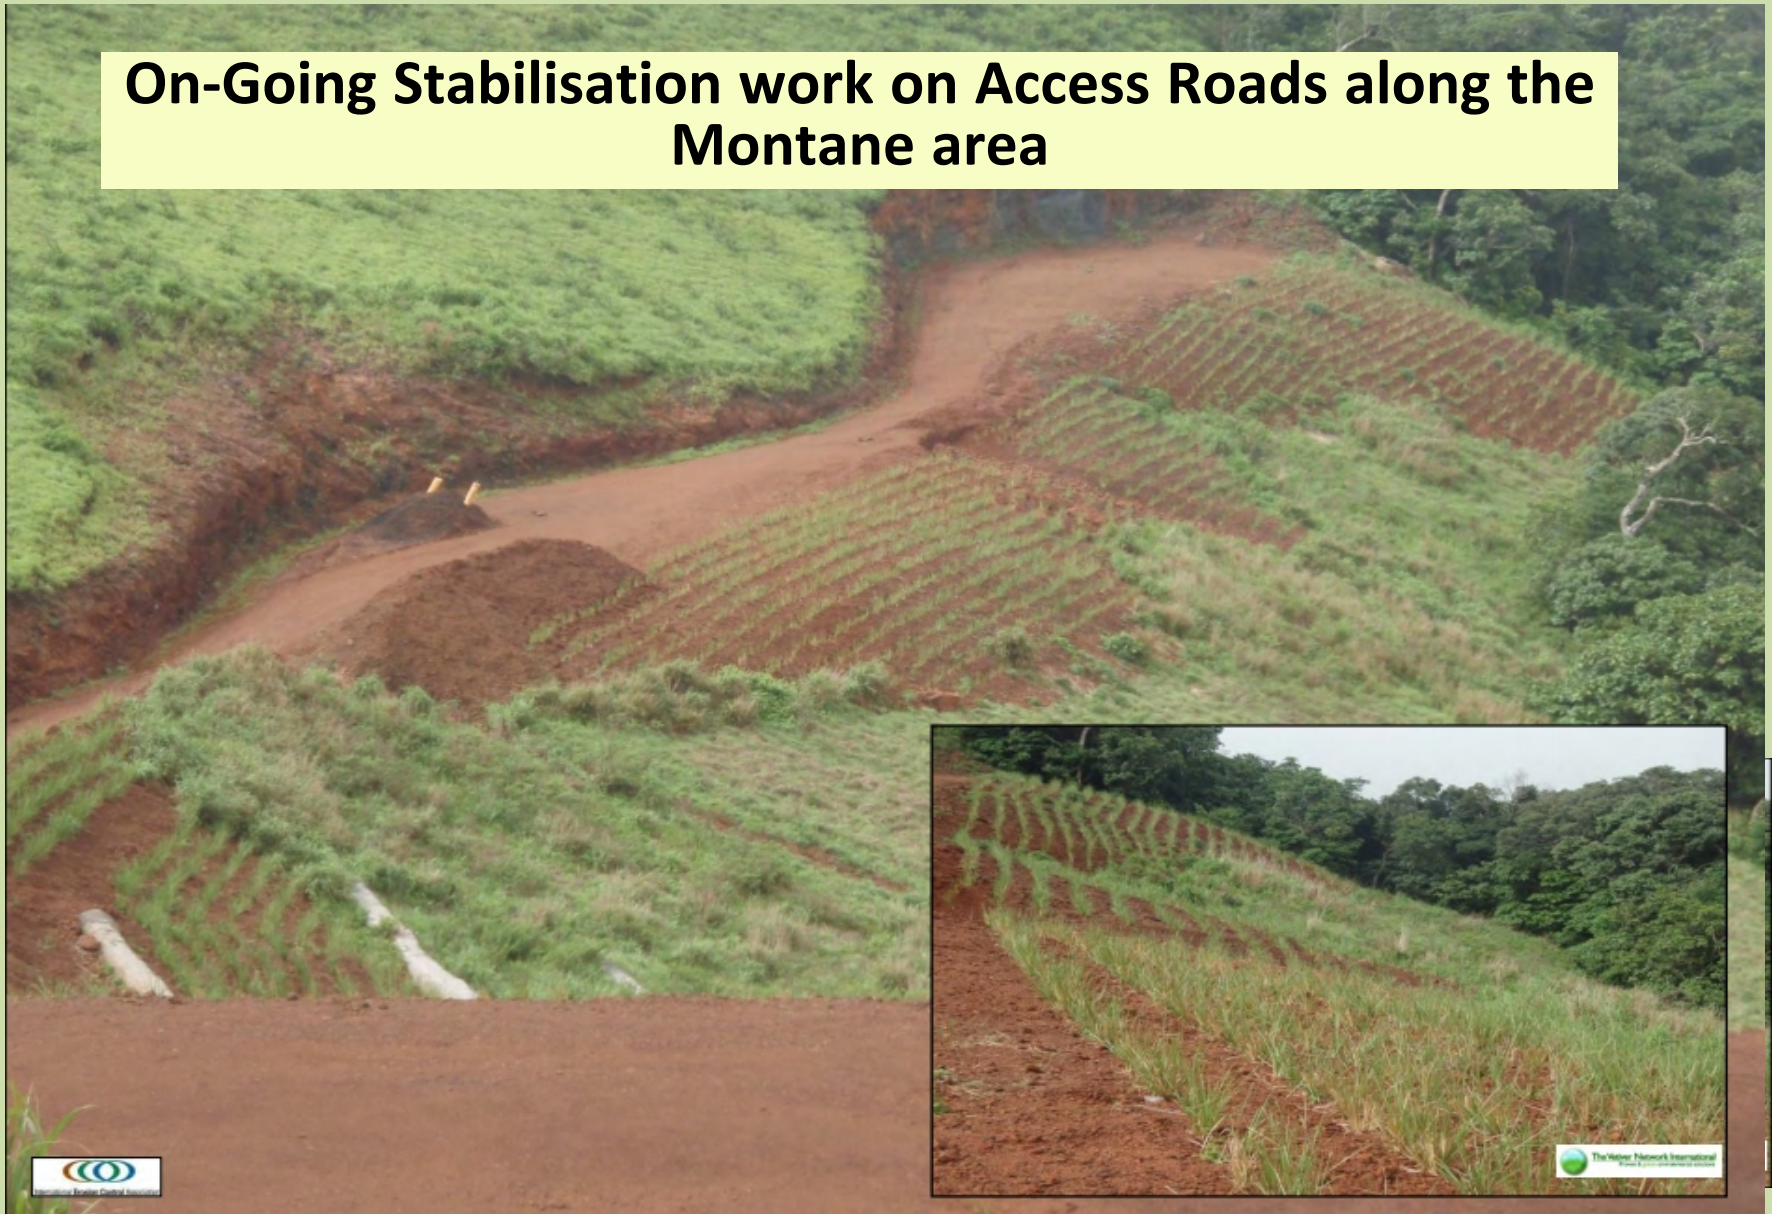
On-Going Stabilisation work on Access Roads along the Montane area

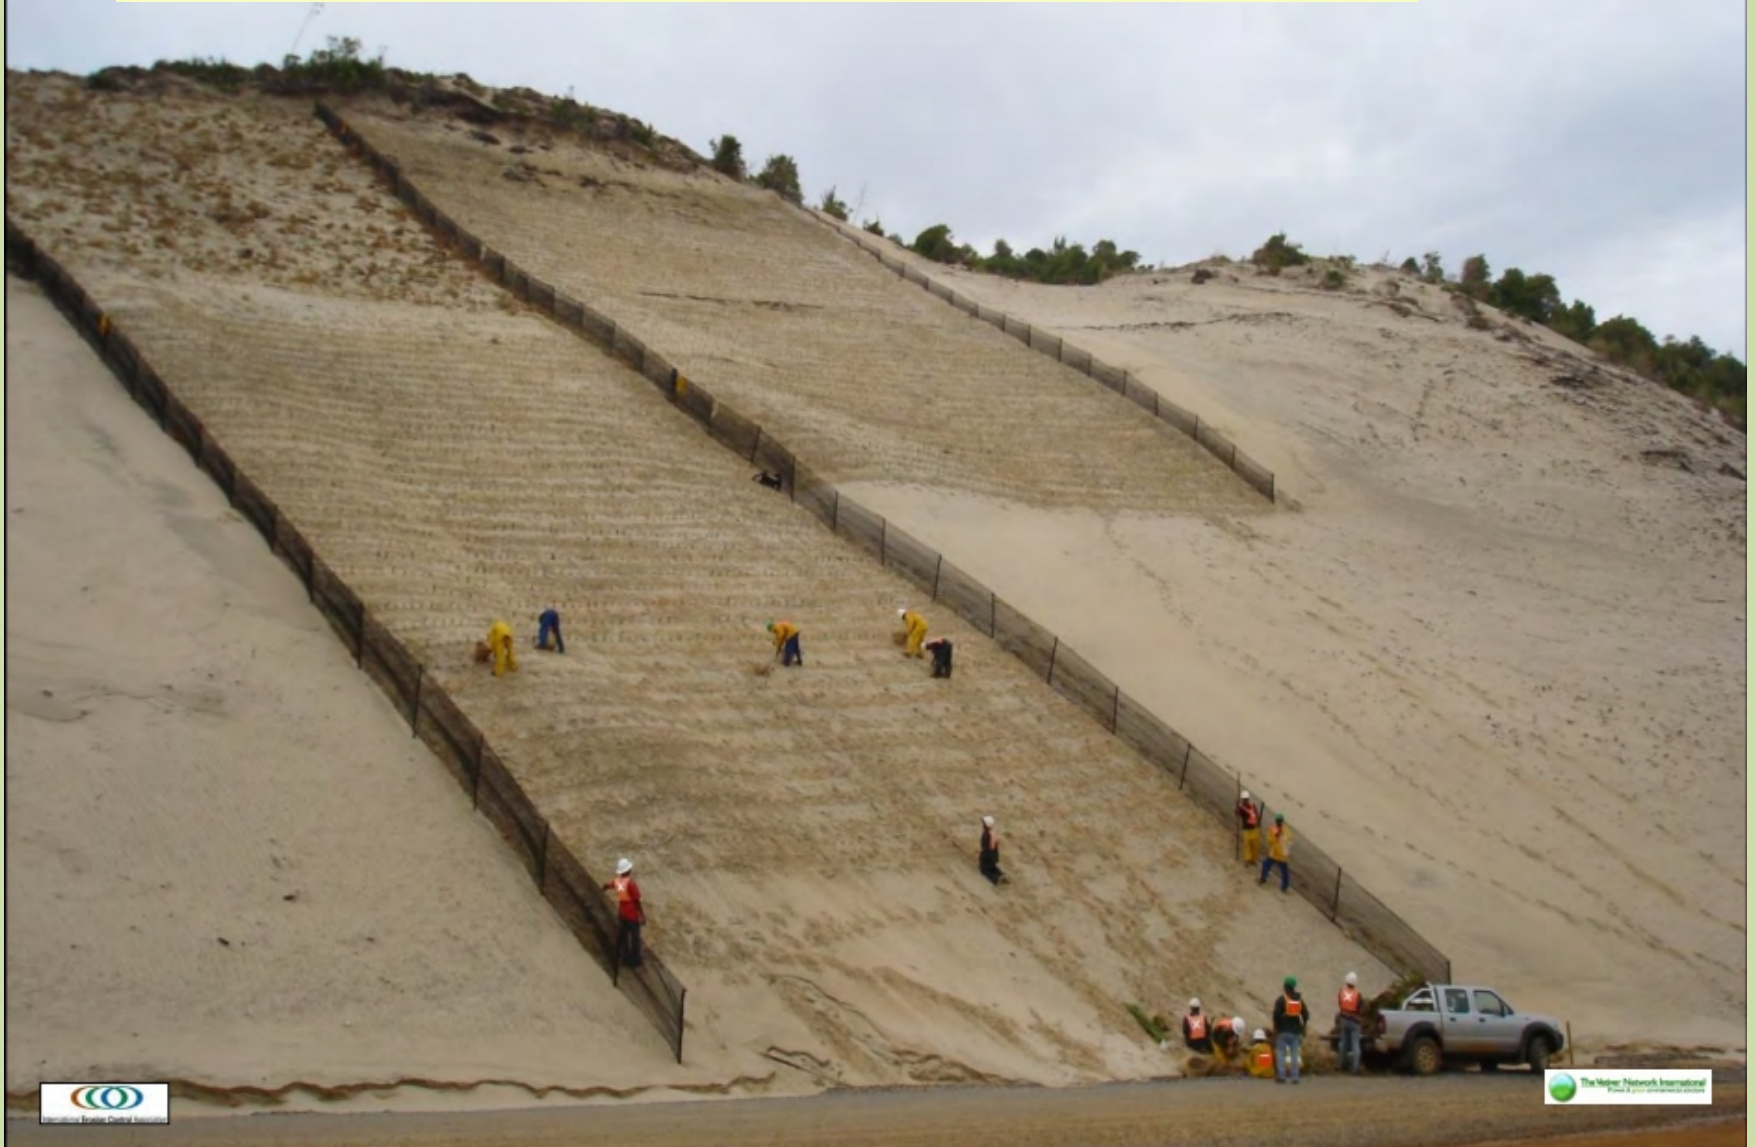
Planting of Vetiver Grass Hedge Rows on the Ehoala Dune

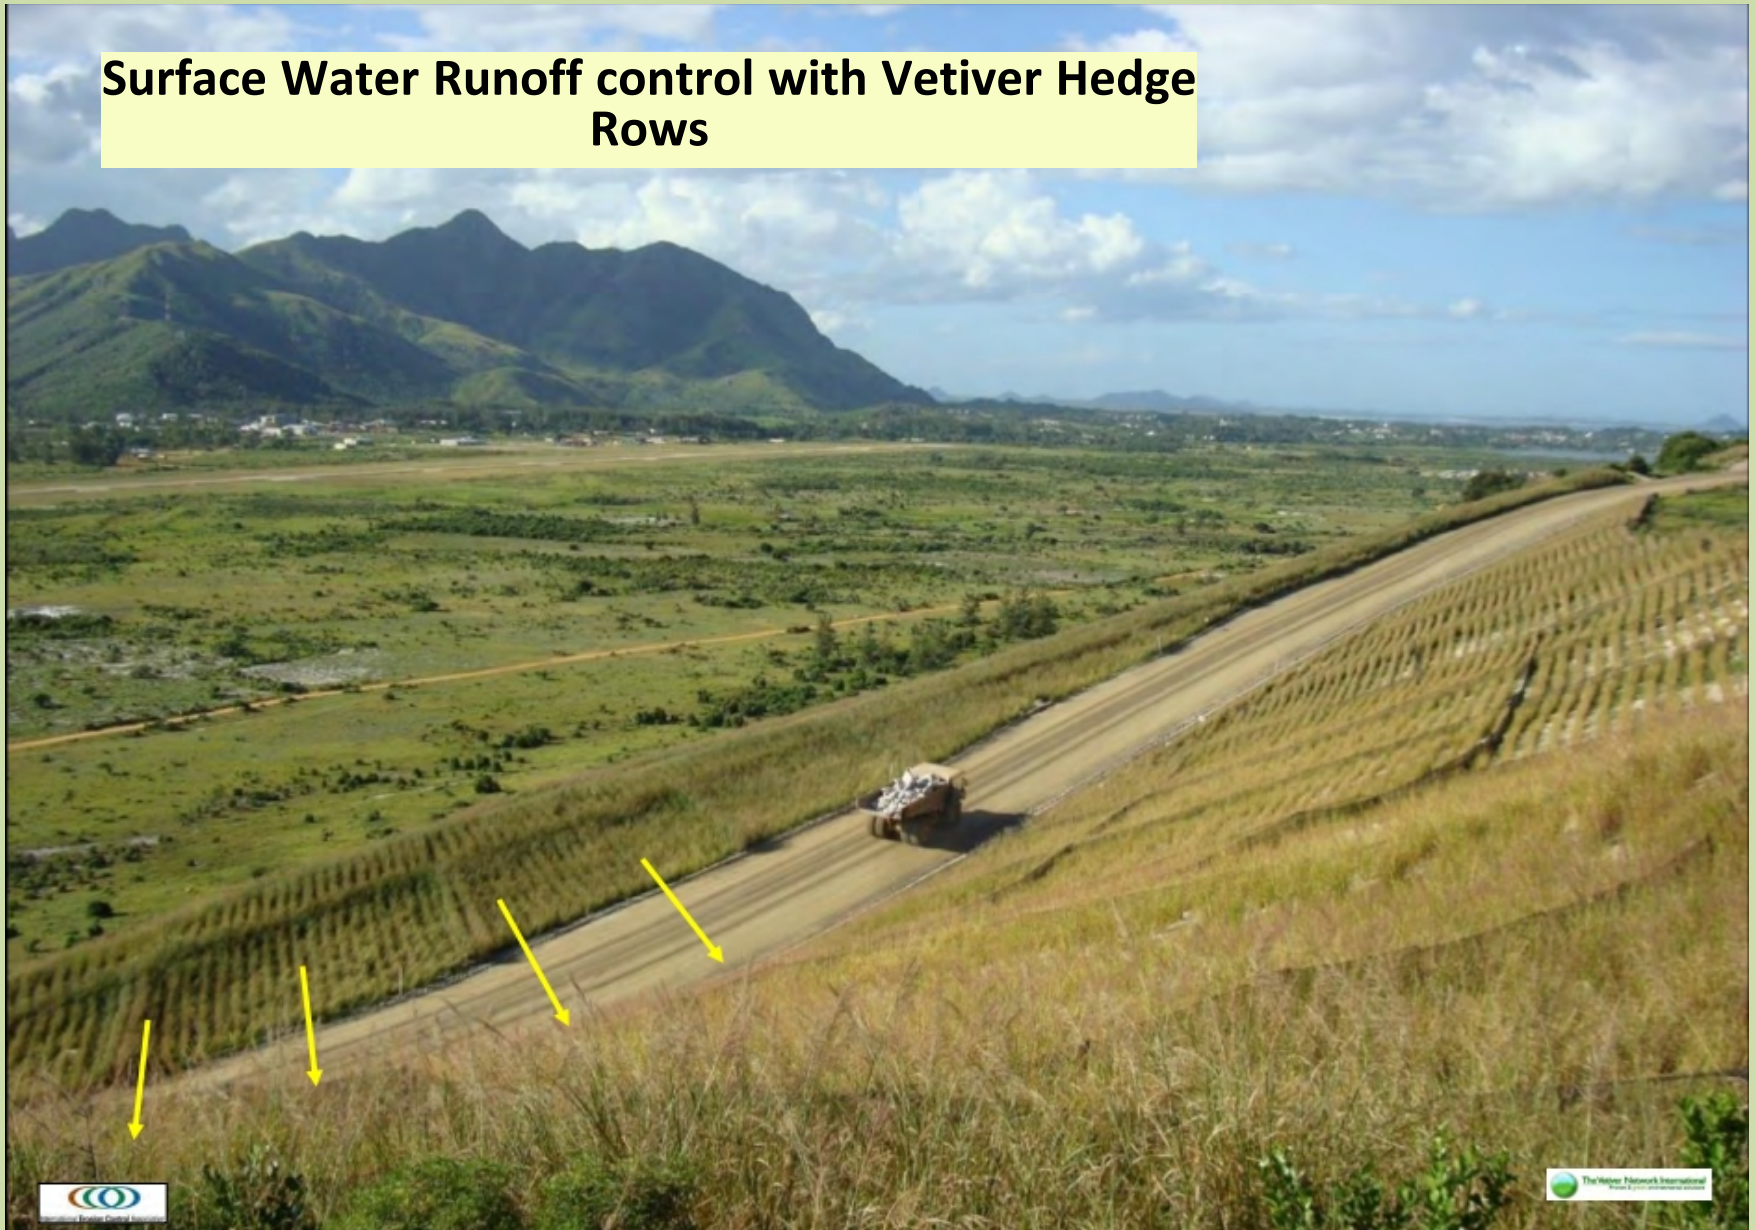
Impact of Prevailing Winds - Primary Dune

Prevailing wind direction
(In excess of 35 days with
intense gusting up to
45 knots at times)

Wind Damaged planted areas

Note -Vetiver root system

Surface Water Runoff control with Vetiver Hedge Rows

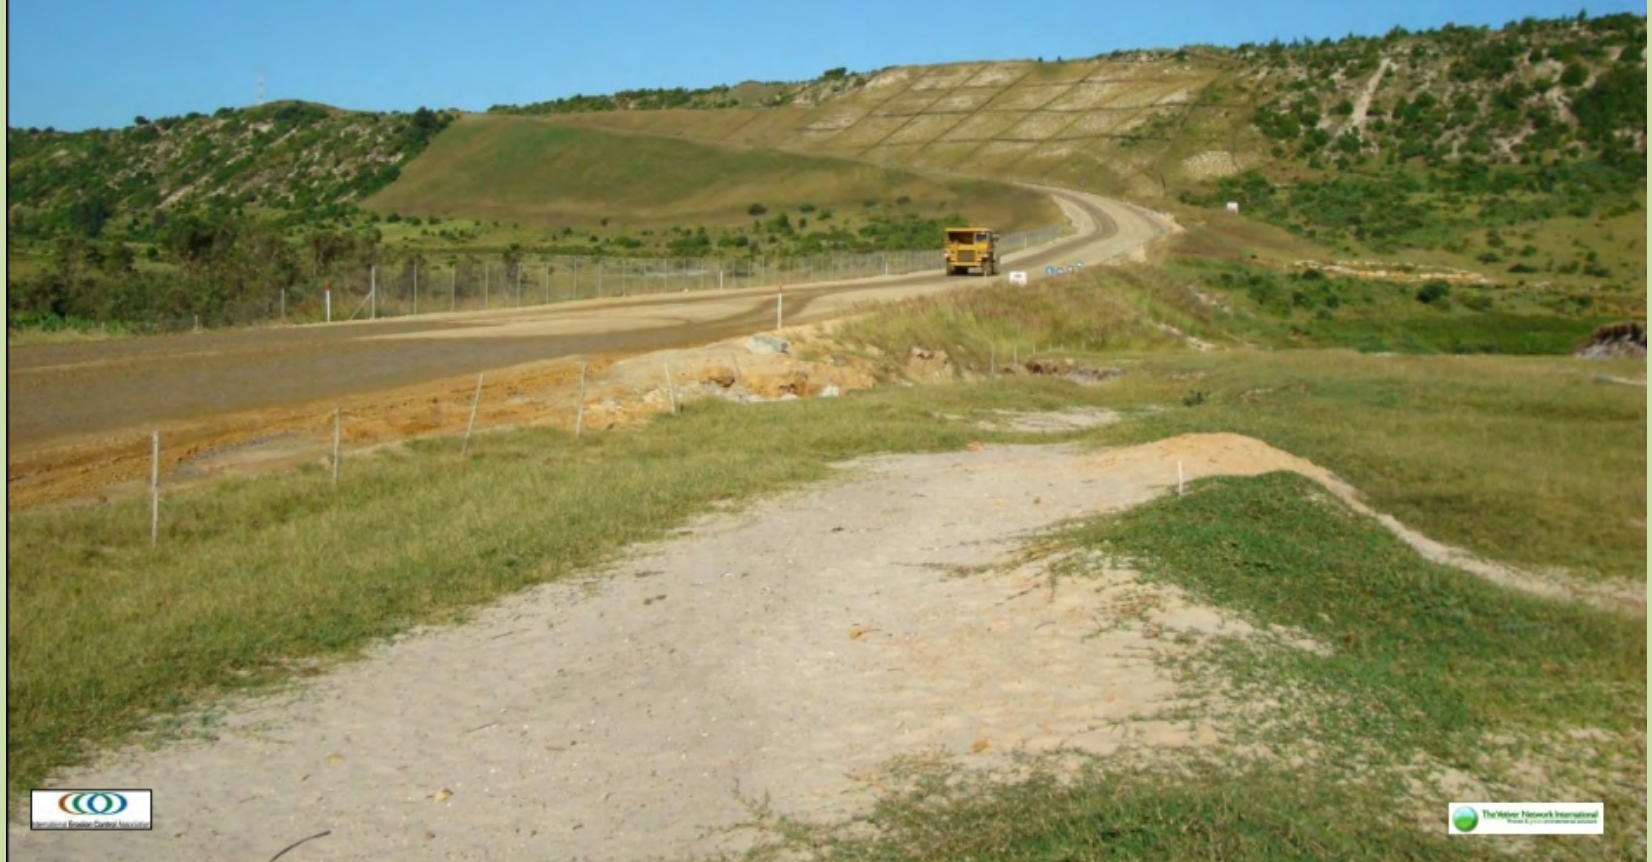
Established & Stable Ehoala Dune – 9 ha in extent

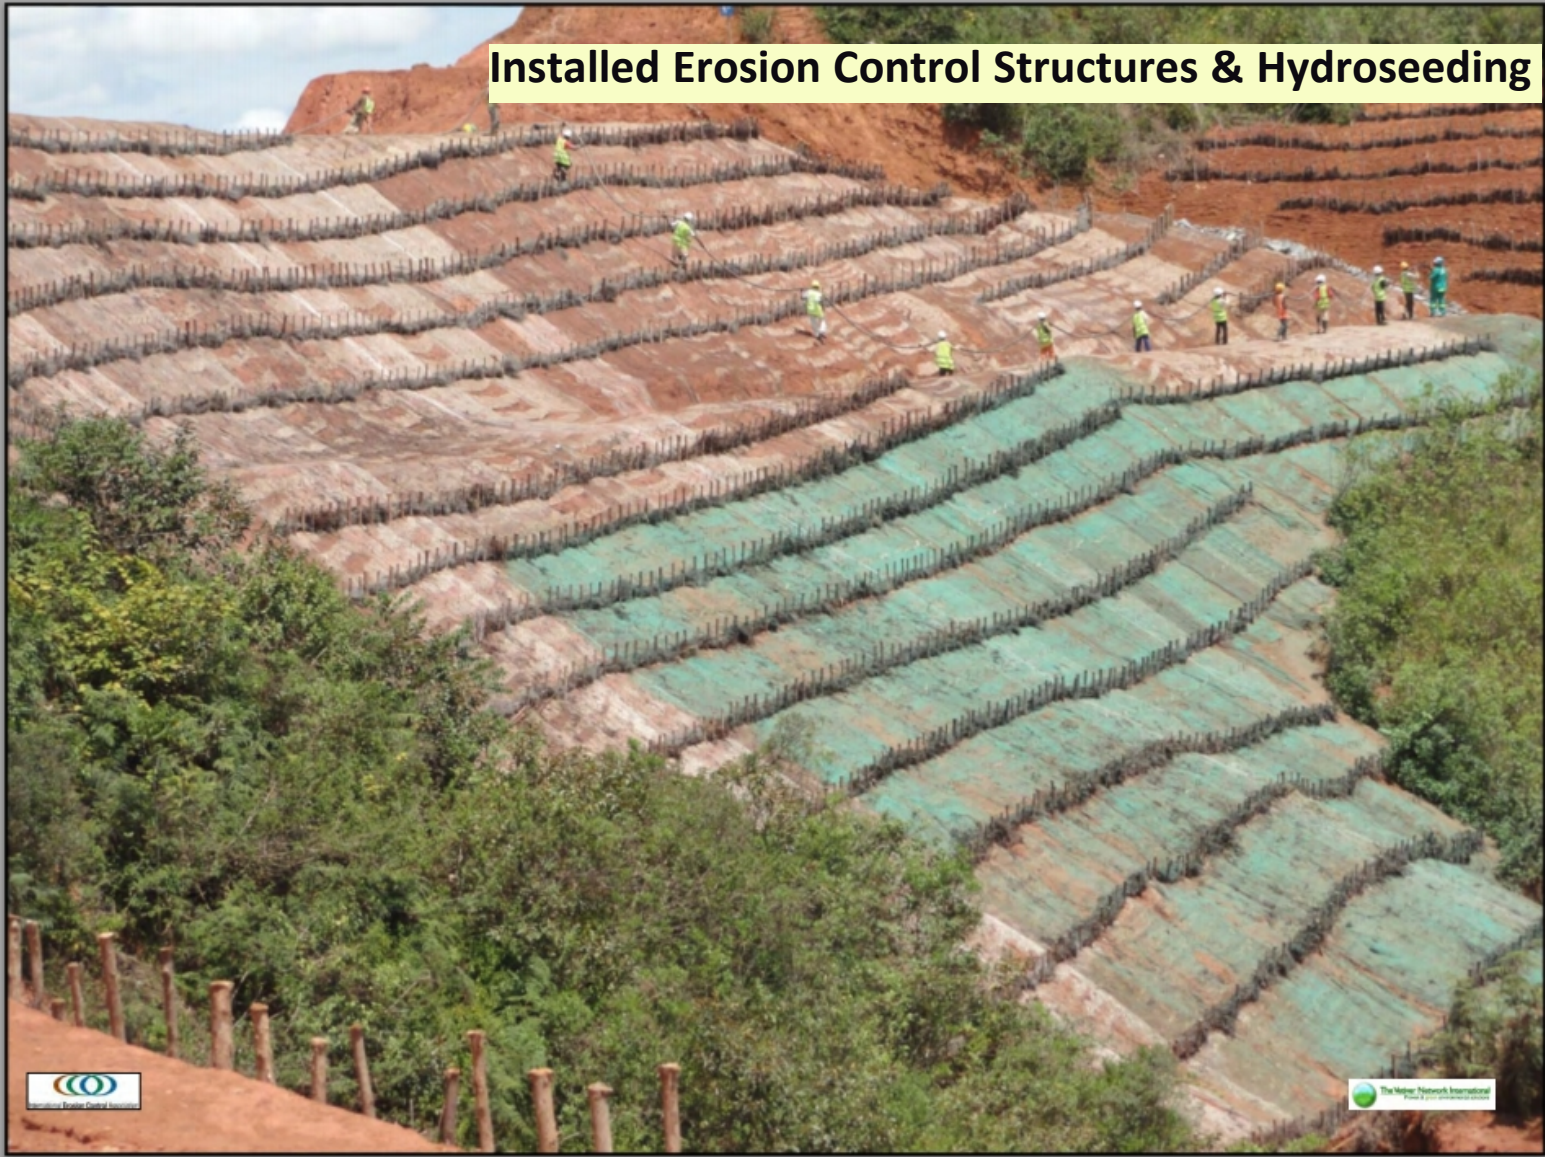
Installed Erosion Control Structures & Hydroseeding

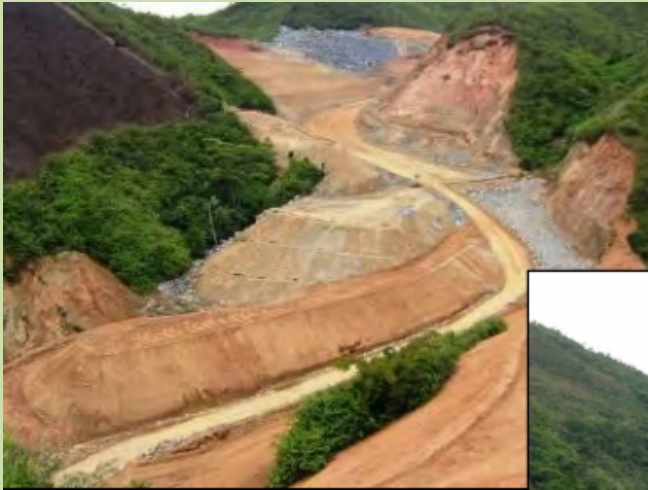
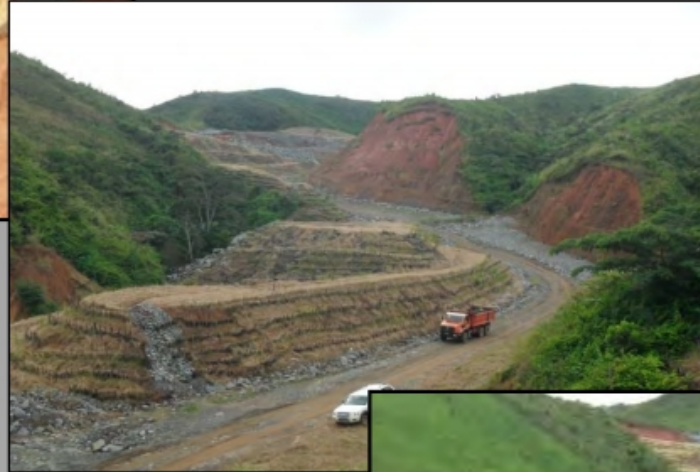
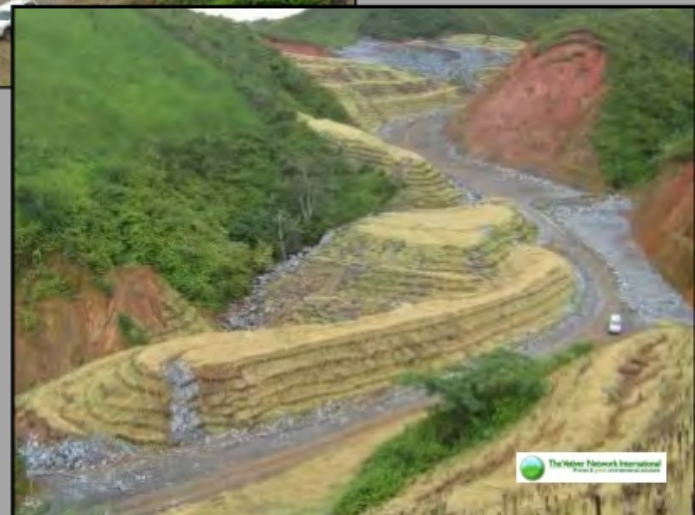
Progressive Rehabilitation Of Pipeline ROW (Right of Way)

Length of ROW: 220 Kilometres
Area rehabilitated – 550 hectares
Rehabilitation period: 3 years
Vetiver plants & fascines sourced
from local communities

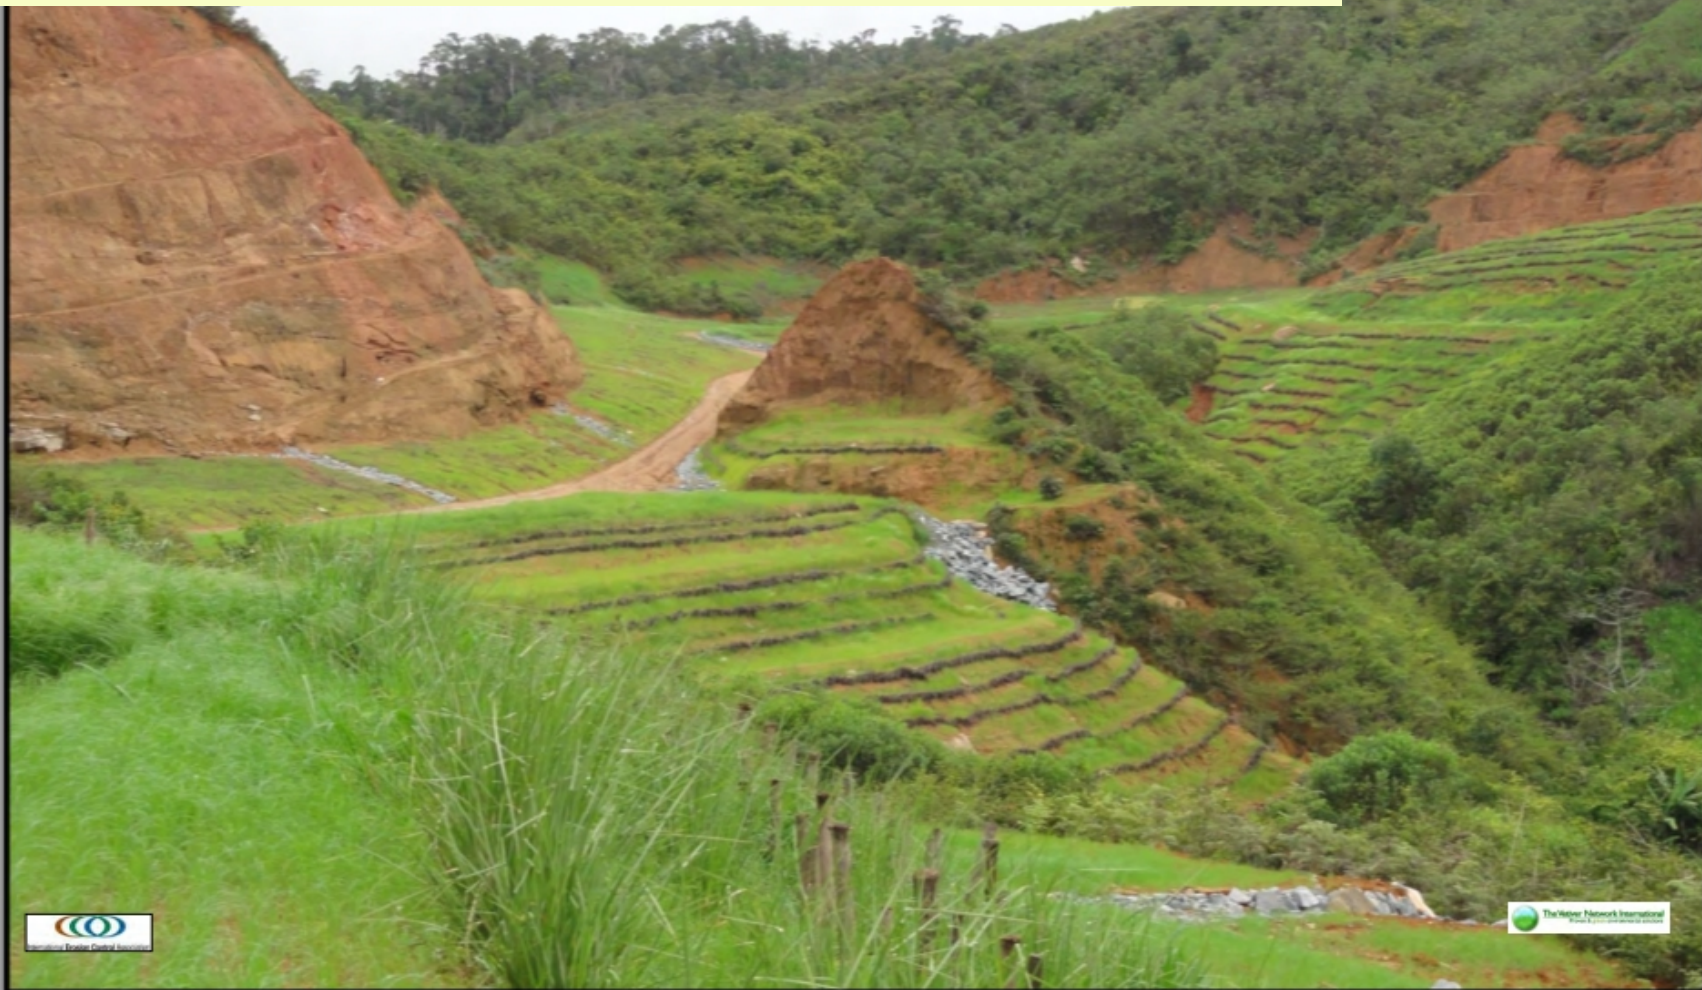
Functional Erosion Control Structures & Established HydroSeeding

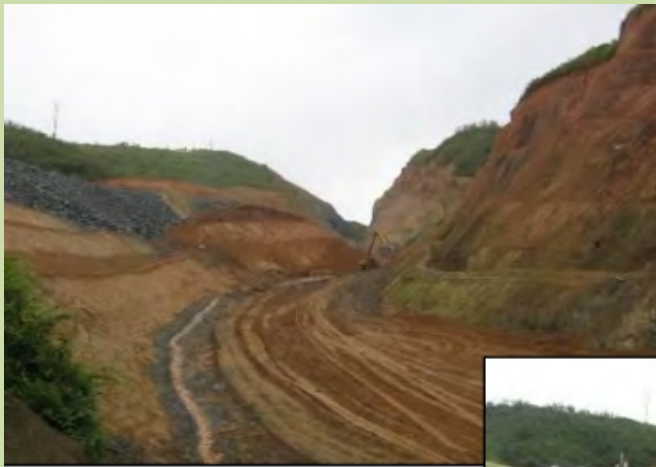
**Rehabilitation of extremely
difficult
rock sections through mountain terrain
- ROW (Right of Way)**

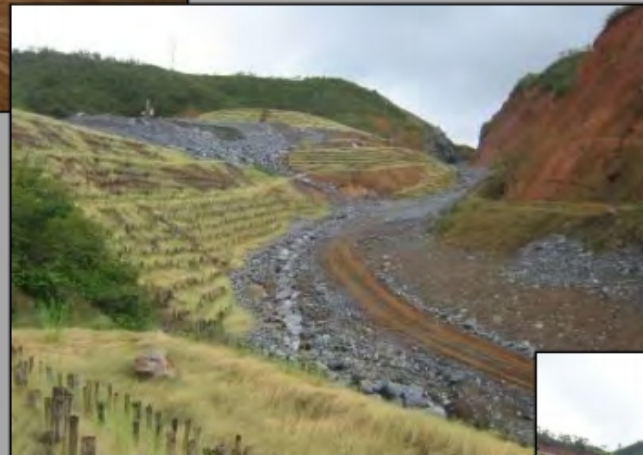
**Accessible only via access roads
Often inaccessible for up to 2
months due to weather conditions
Unstable cut slopes rehabilitated by
Vetiver plants & fascines sourced
from local communities**

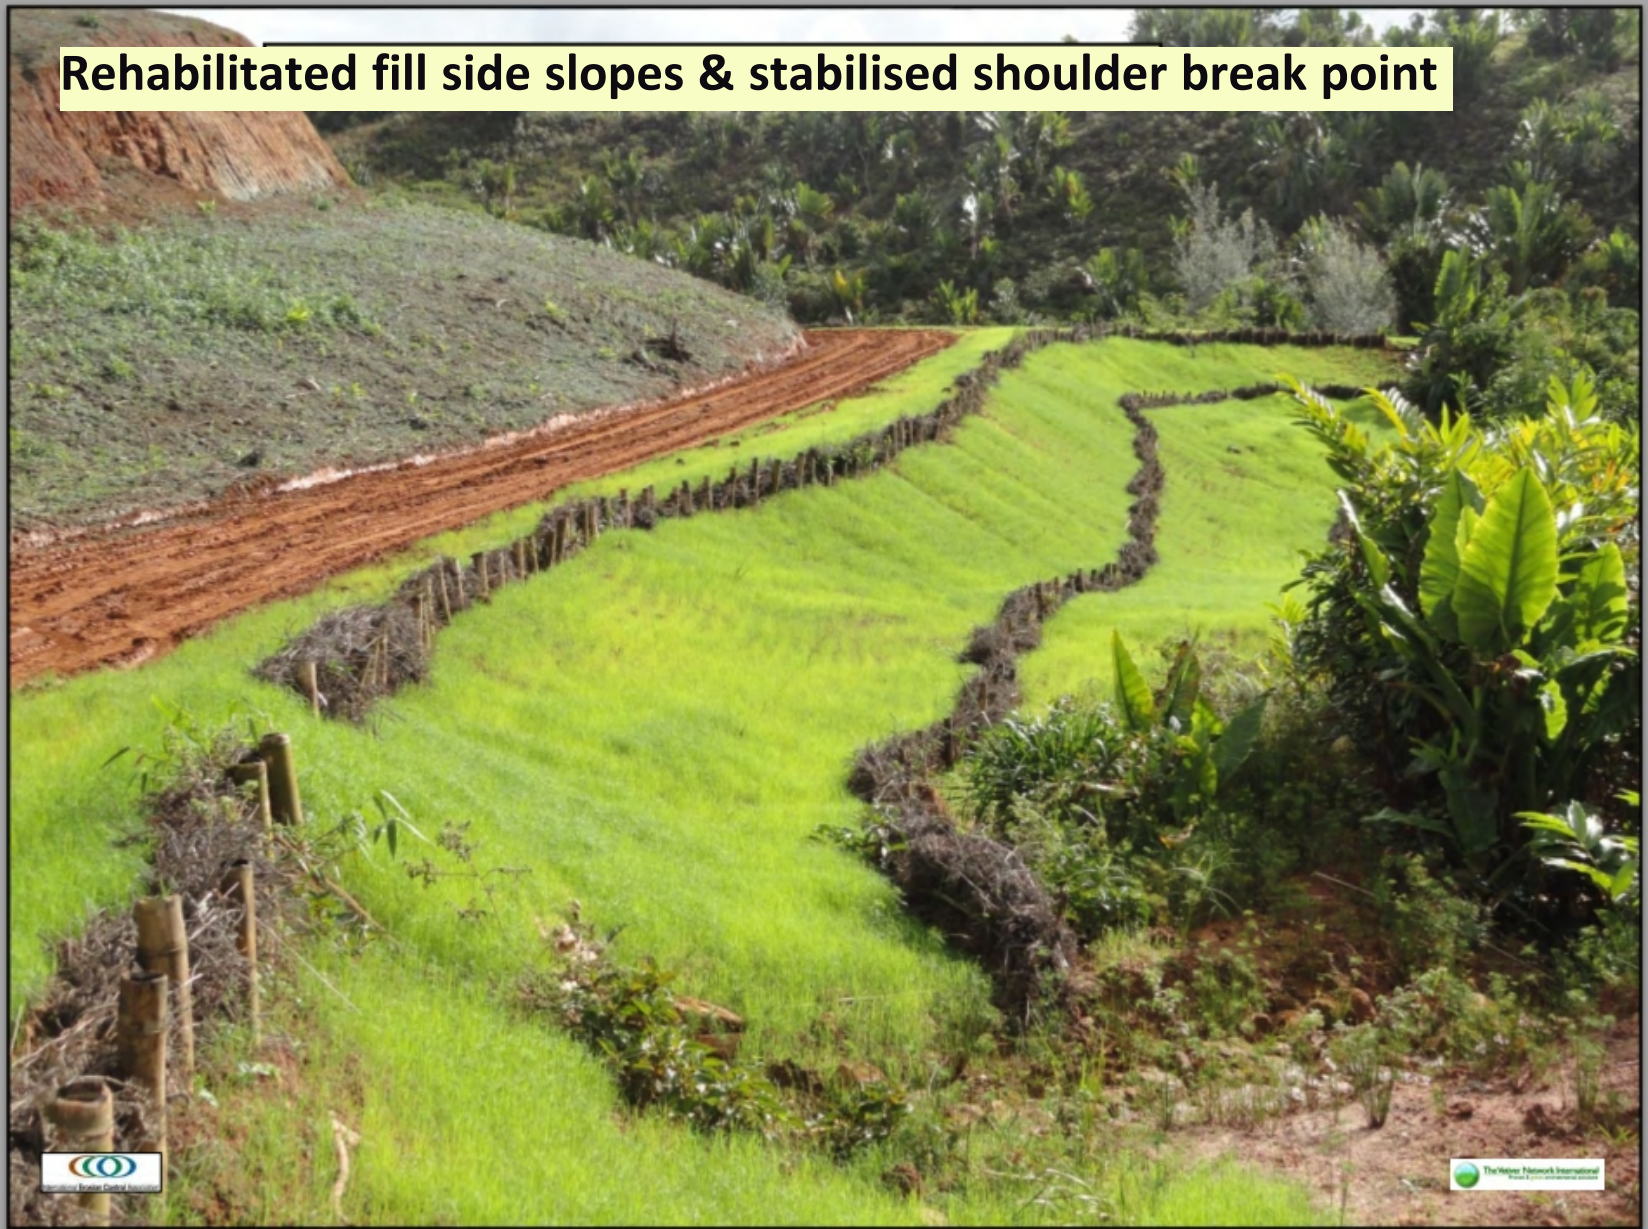
Rehabilitated fill side slopes & stabilised shoulder break point
